**Historic building recording  
at Oxford House, Upper Holt Street,  
Earls Colne, Essex, CO6 2PG**

**July 2016**

**report prepared by Chris Lister**

**CAT Report 1051**  
January 2017

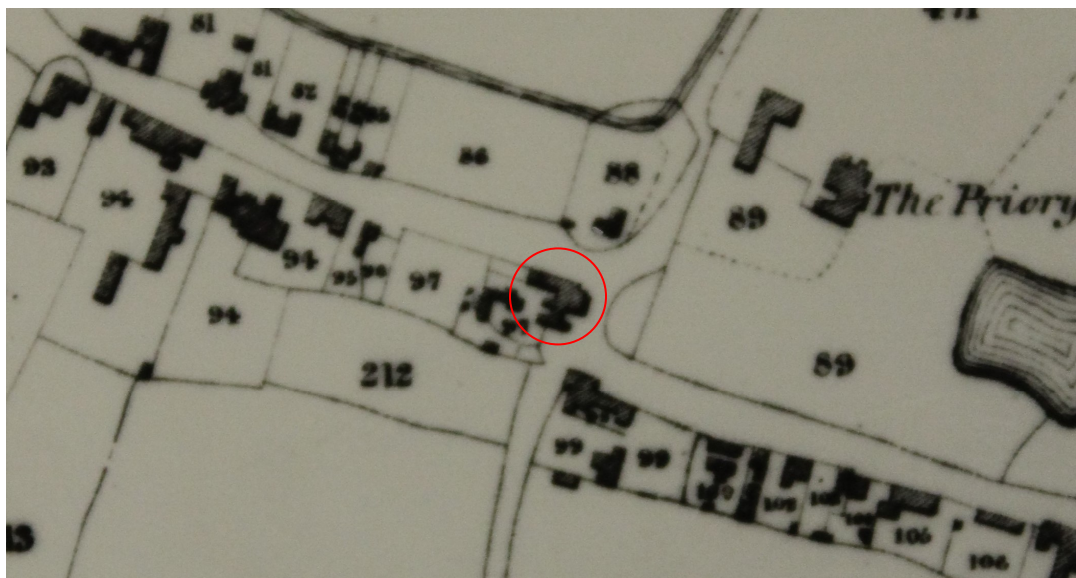
**Map 3** 1838 tithe map (ERO D/CT 101)

The first map evidence that accurately depicts the inn is the 1838 tithe map (Map 3). This shows the 15th-century range as well as the 16th-century cross-wing, but it also clearly shows an extension along the north side of the 16th-century cross-wing, a small projection on the rear of the 15th-century range and an outbuilding to the immediate south of the inn. The tithe award lists parcel 97 as the George Inn, owned by Mrs Elizabeth Hardy and rented to William Lay.

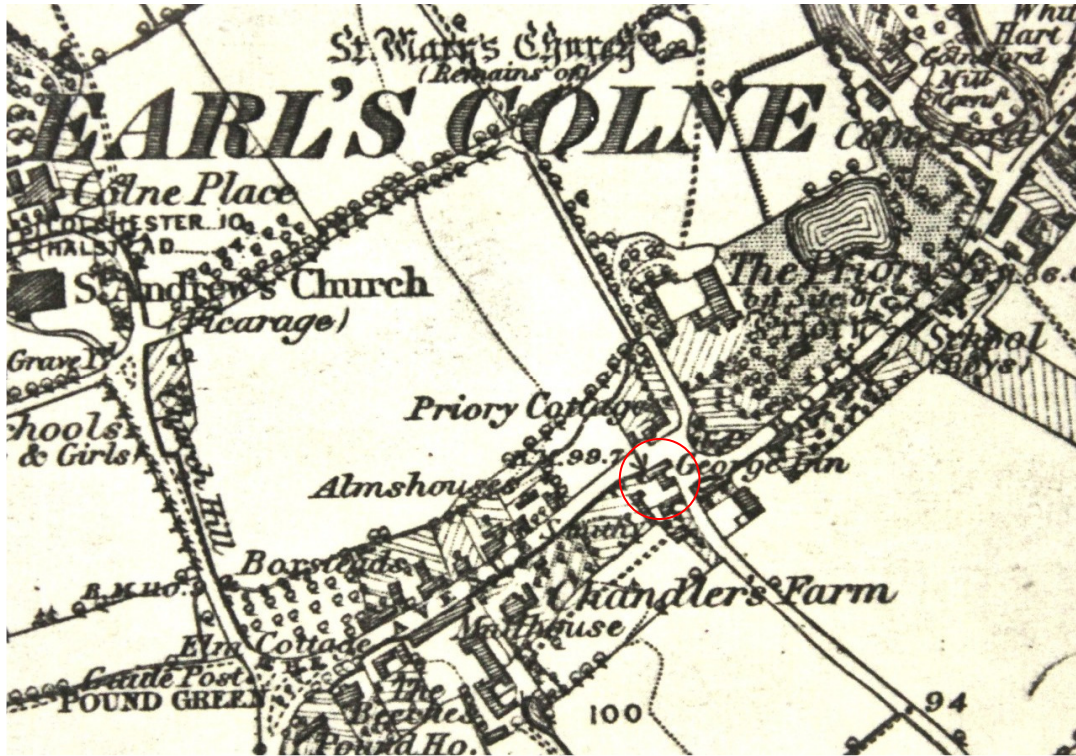
Map 4 1876 6 inch edition Ordnance Survey map (sheet XVII)

The 1876 and 1898 editions of the Ordnance Survey (Maps 4 and 5) show the same information as the 1838 tithe map, although the plan form is a little clearer. In particular, the outbuilding is clearly visible. By the 1898 edition this appears to have increased in size.

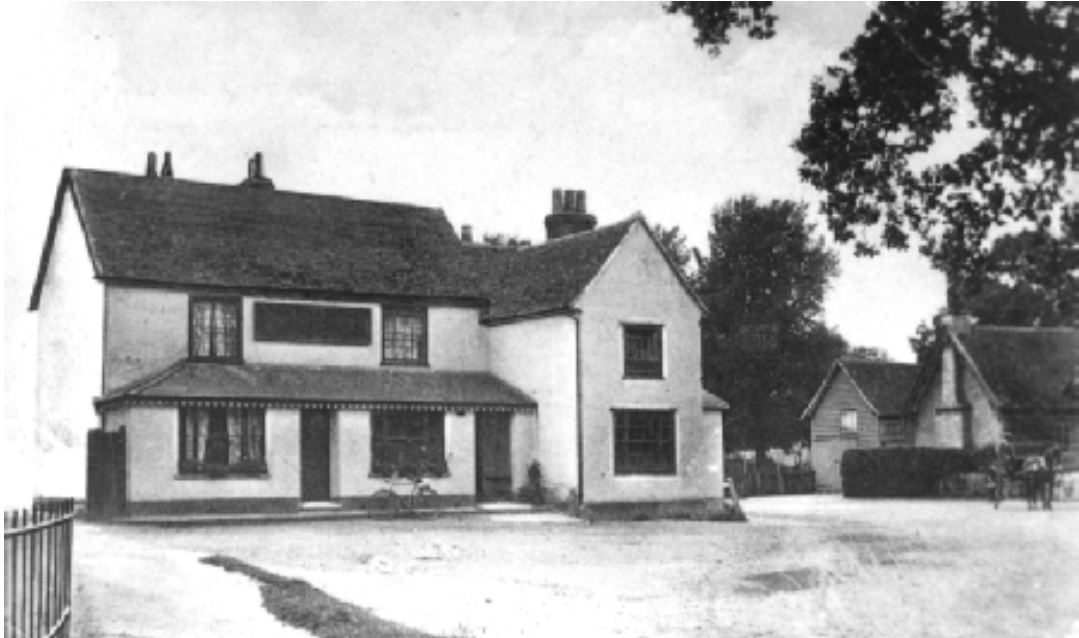
**Photograph 1** The George Inn *circa* 1900 (Earls Colne Heritage Museum)

The earliest photographic image of the building dates to *circa* 1900 and depicts the George Inn much as it appears in the 21st century (Photograph 1). Noticeable differences are a second doorway in the 19th-century lean-to extension on the north-east elevation of the building and what appear to be slates rather than peg-tiles on its mono-pitch roof.

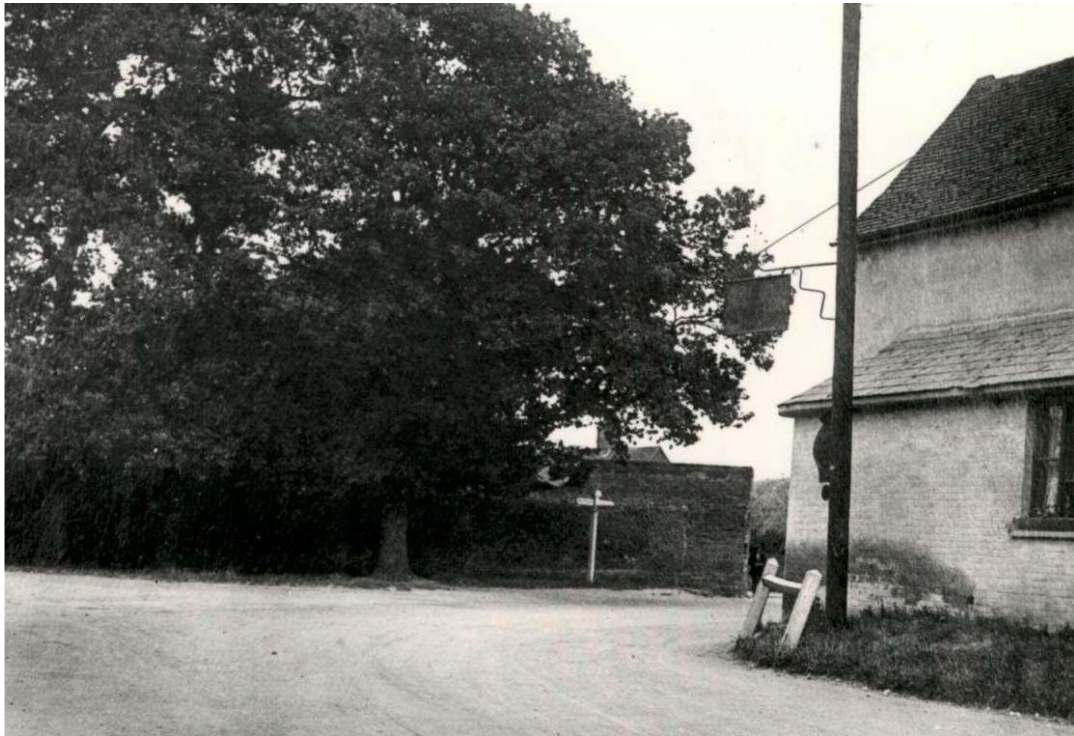
Photograph 3 Upper Holt Street with the George Inn to the right, circa.1930 (ERO I/Mb 104/2/2)

A photograph taken *circa* 1930 (Photograph 3) shows part of the 19th-century lean-to extension on the north-west elevation of the George Inn. Although the focus of this photograph appears to be the large oak tree standing outside the Priory wall, enough of the building is visible to notice that the roof of the lean-to is formed of slates rather than the peg-tiles that were present in 2016, the same as the roof of the lean-to extension on the north-east elevation in the *circa* 1900 photograph.

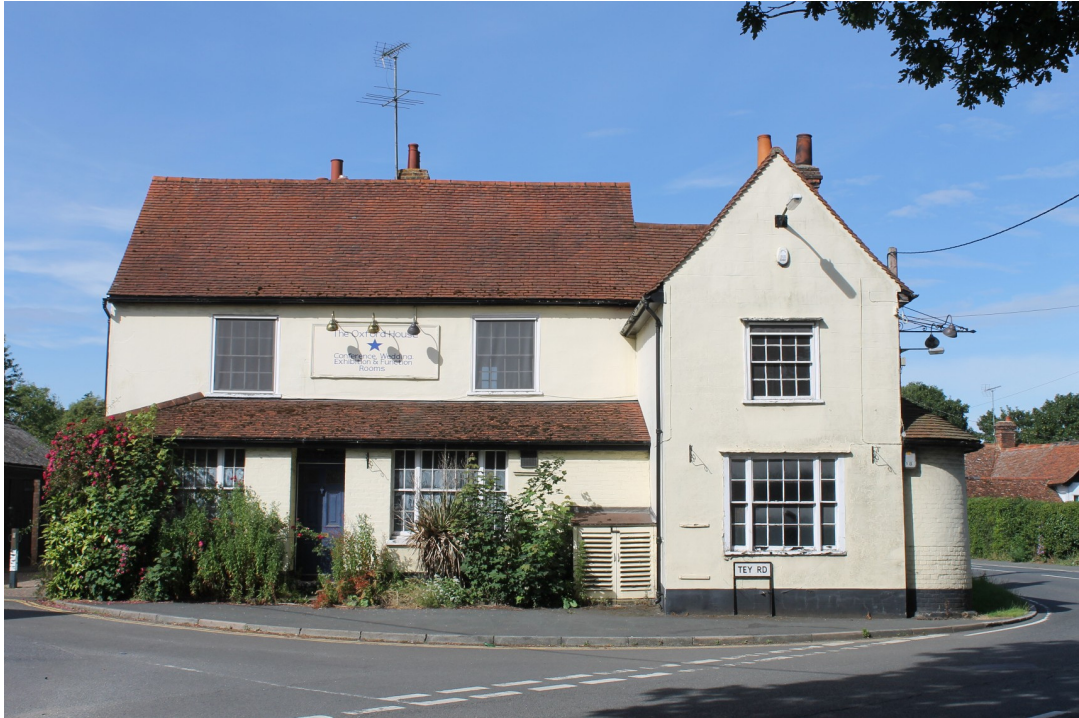
**Photograph 1** North-east elevation - view south-west.

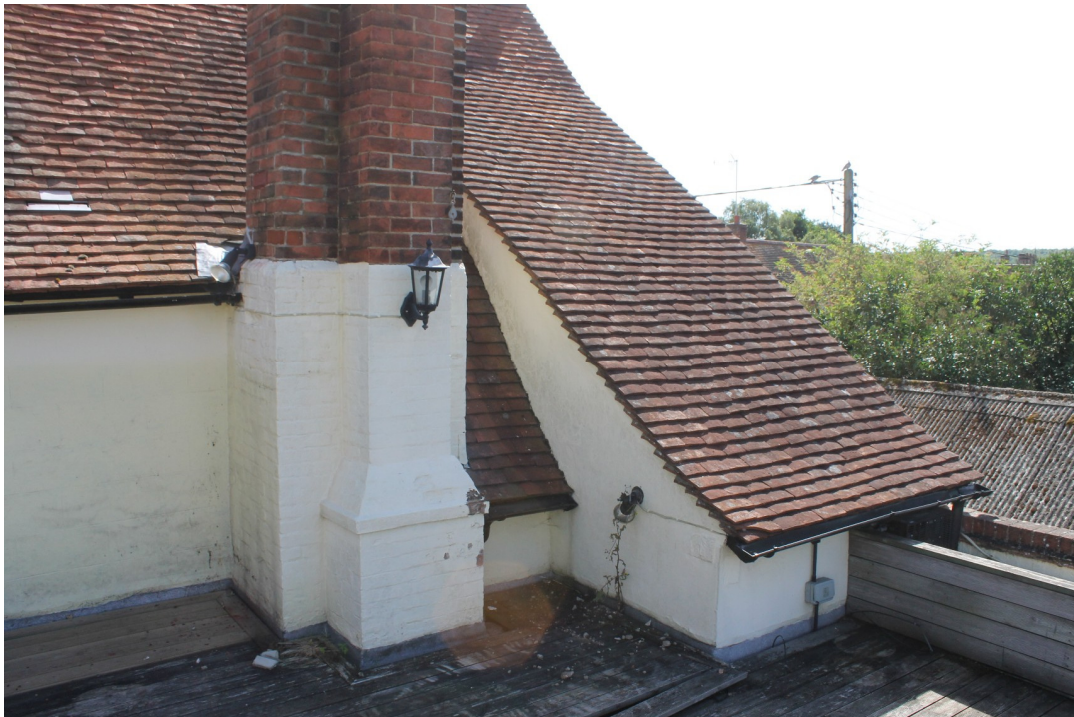
**Photograph 4** South-west elevation of the 15th-century main range with the 18th-century chimney stack and the flared roof covering the probable 18th-century external staircase - view east.

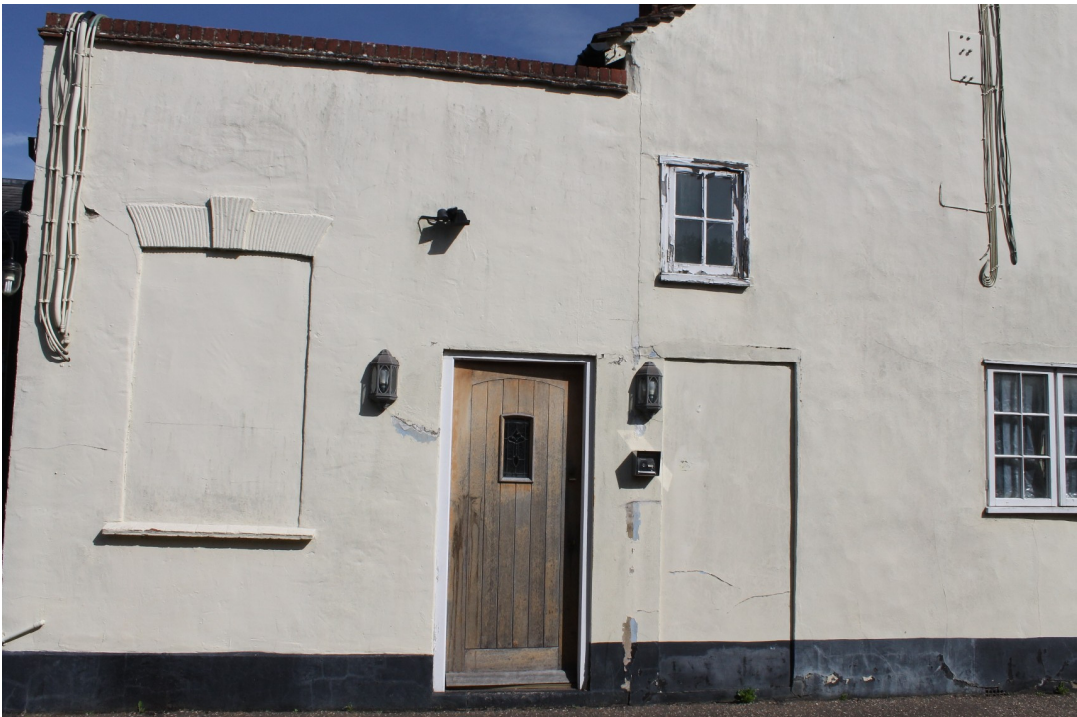
**Photograph 6** South-east elevation of the 1923 extension with blocked window and an earlier blocked doorway to the 18th-century staircase on the right - view north-west.

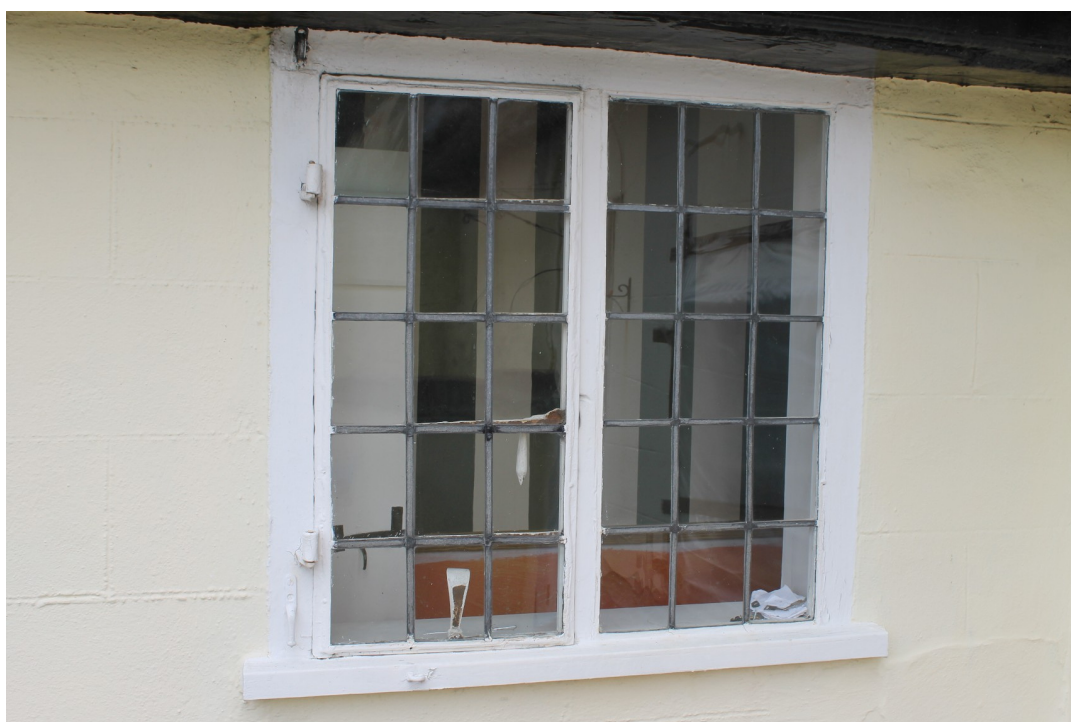
**Photograph 8** 16th-century casement window in south-east wall of 16th-century cross-wing - view north-west.

the wall plate project through the plaster. It is possible that, as this elevation was the only one that was not easily visible from the street, the render was left intentionally undecorated. A casement window has been inserted to the ground floor. The external staircase has a blocked entranceway, probably the original point of egress to this structure, with a small inserted window above it (Photograph 6). The 19th-century single-storey lean-to extension has white-painted brickwork but no further embellishments. The brickwork of the 1923 extension has been rendered to match the main range although, once again, the rustication has been omitted. A window with a sill and a flat arch, both formed from creasing tiles and original to this extension, has been blocked. The south-east elevations of the 16th-century cross-wing and its 18th-century extension both have rusticated render. Only a small part of the first floor to the 16th-century cross-wing is visible and this has a pair of French doors inserted into it, but surviving next to this is an original 16th-century casement window (Photographs 7 and 8).

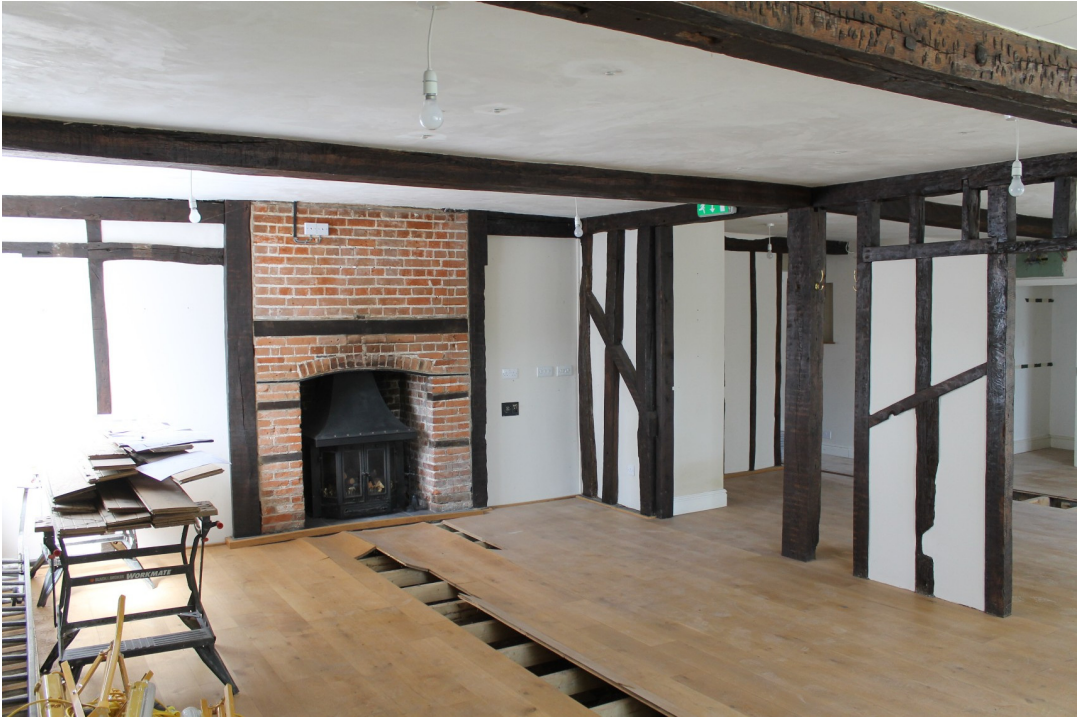
**Photograph 9** Interior of GF1, 15th-century main range with inserted 18th-century fireplace and repositioned stud work - view west.

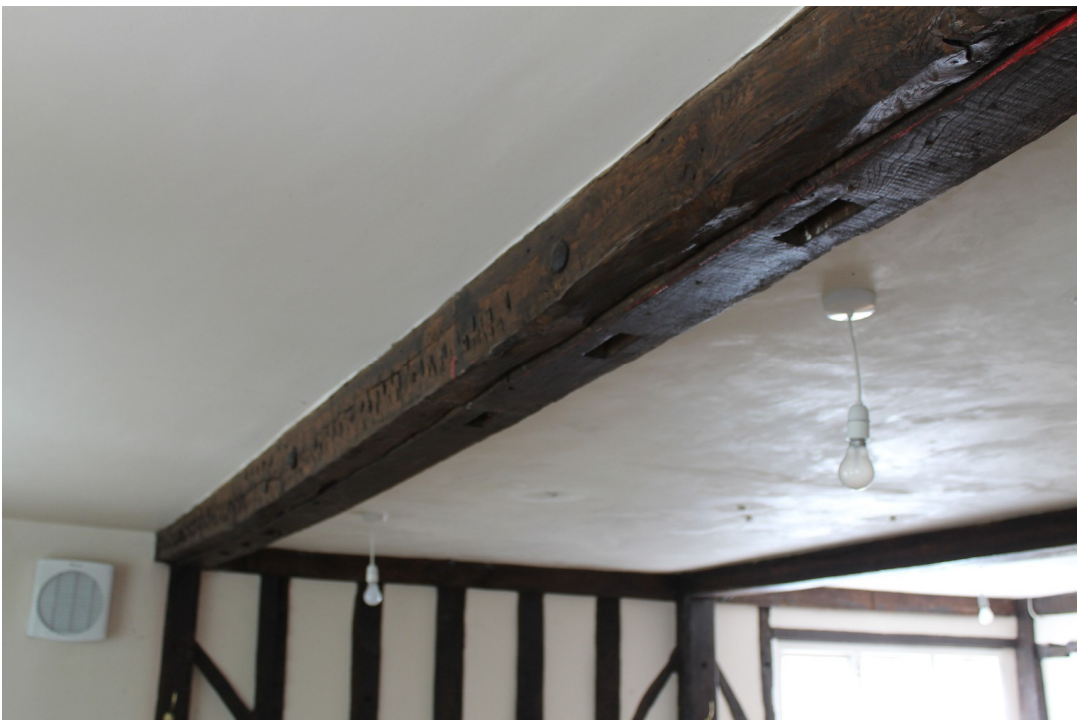
**Photograph 10** Exposed mortises in underside of 15th-century beam in GF1 with strengthening beam bolted to the external face – view south.

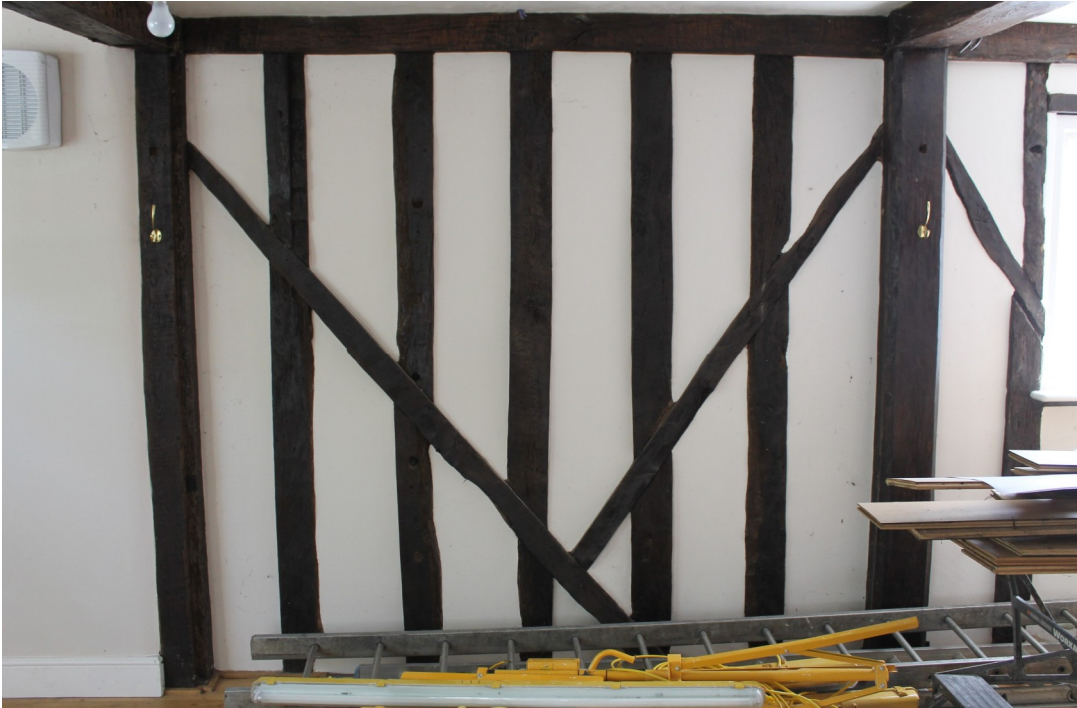
**Photograph 11** Original 15th-century studs in south-east wall of GF1, with later internal bracing - view south-east.

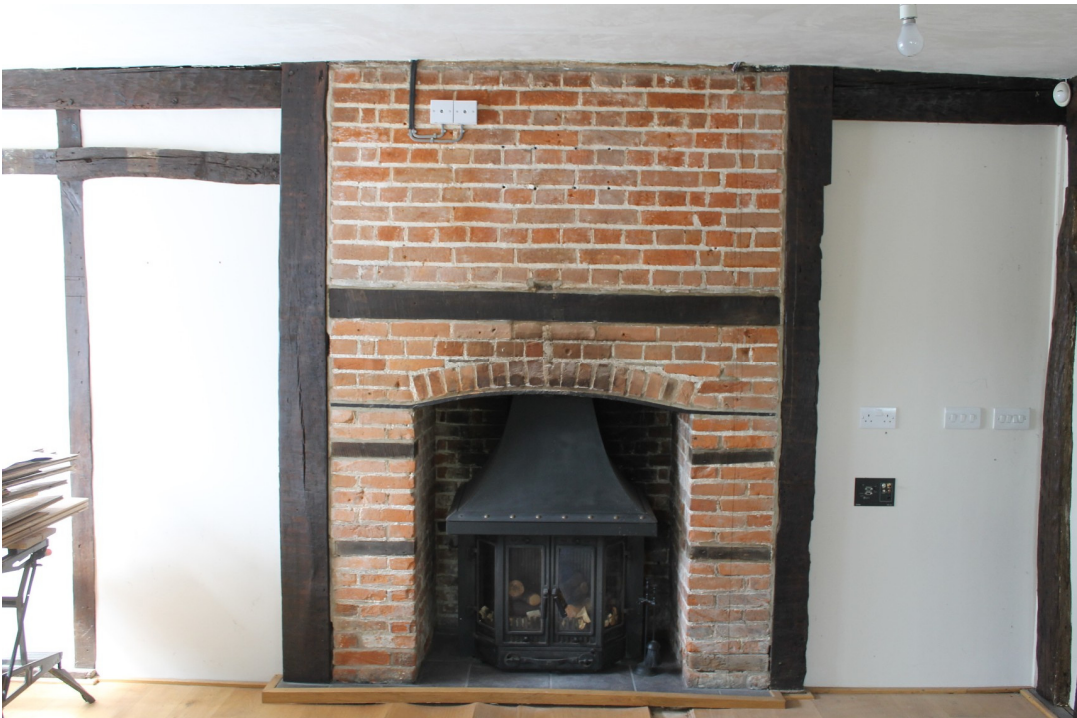
**Photograph 12** 18th-century fire surround in GF1 with blocked access to the external staircase on the left - view south-west.

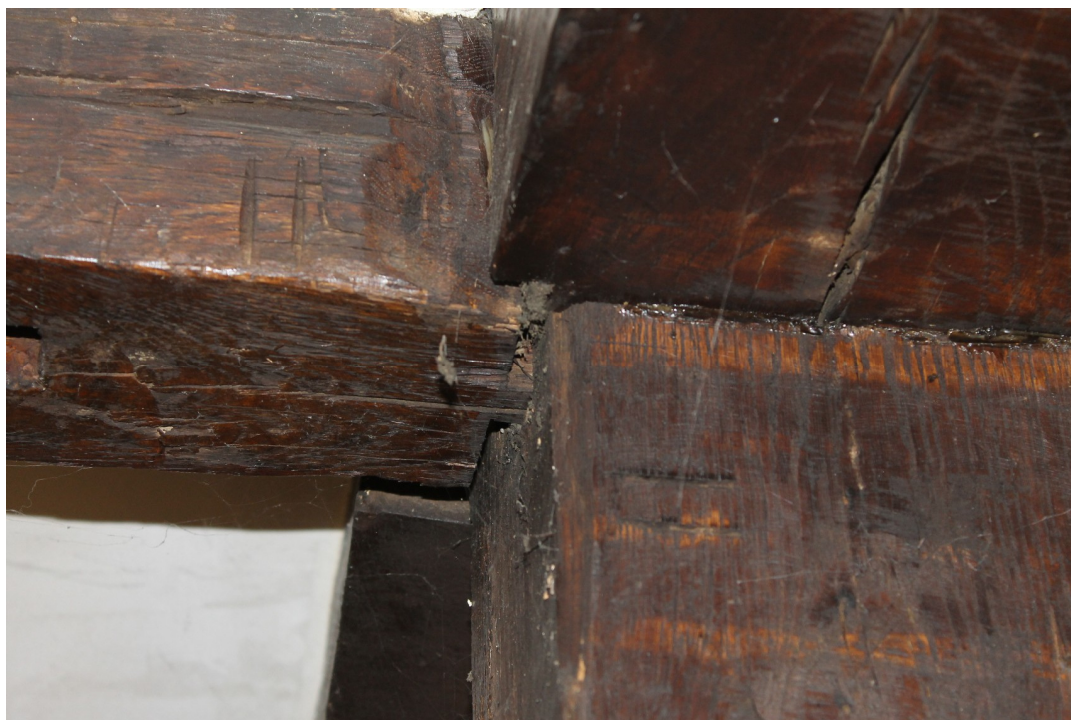
**Photograph 13** Detail of chiselled carpenters' marks on bridging beam and post in GF1.

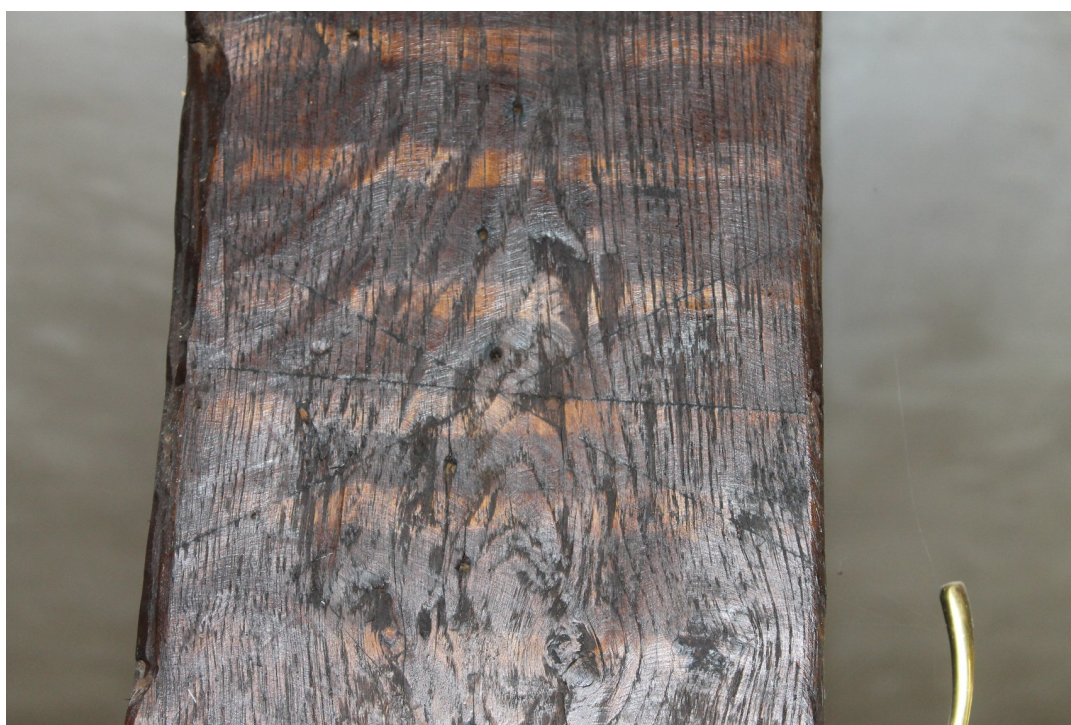
**Photograph 14** Detail of possible apotropaic mark on post in GF1.

GF1 comprises the remains of the 15th-century main range and the 19th-century single-storey extension (Fig 2). With the exception of the south-east wall, the majority of the stud work in the timber framing of the ground floor has been removed leaving the corner posts and storey posts (Photograph 9). The original mortises in the underside of the girding beam of the north-east wall give an indication of what the original framework would have been (Photograph 10). The removal of the framing has created a large open plan space and the work must have been undertaken in the mid to late 20th century as the 1923 plan shows partitions that are no longer present. Some timbers have been repositioned to replicate the missing studwork but they are clearly modern attempts to recreate a medieval look for the building. The surviving frame of the south-east wall has closely-spaced studs typical of the period and internal bracing which is not (Photograph 11). The bracing may have been an attempt to increase the structural integrity of the building when the front framing was removed in the 19th century. A fireplace with a brick surround and an embedded timber mantel dating to the 18th century has been inserted into the rear frame (Photograph 12). The bricks above the mantel have dimensions of 223mm x 108mm x 63mm, whilst those below are 223mm x 100mm x 49mm. Both areas of brickwork are laid in English bond but the upper brickwork is probably a 20th-century embellishment. To the left of this fireplace is a modern partition wall which has blocked access to the probable 18th-century external staircase. Chiselled carpenters' marks were observed on the storey post of the north-east wall and at the junction of the supporting post and the bridging beam (Photograph 13). A possible apotropaic mark is cut into the central storey post (Photograph 14).

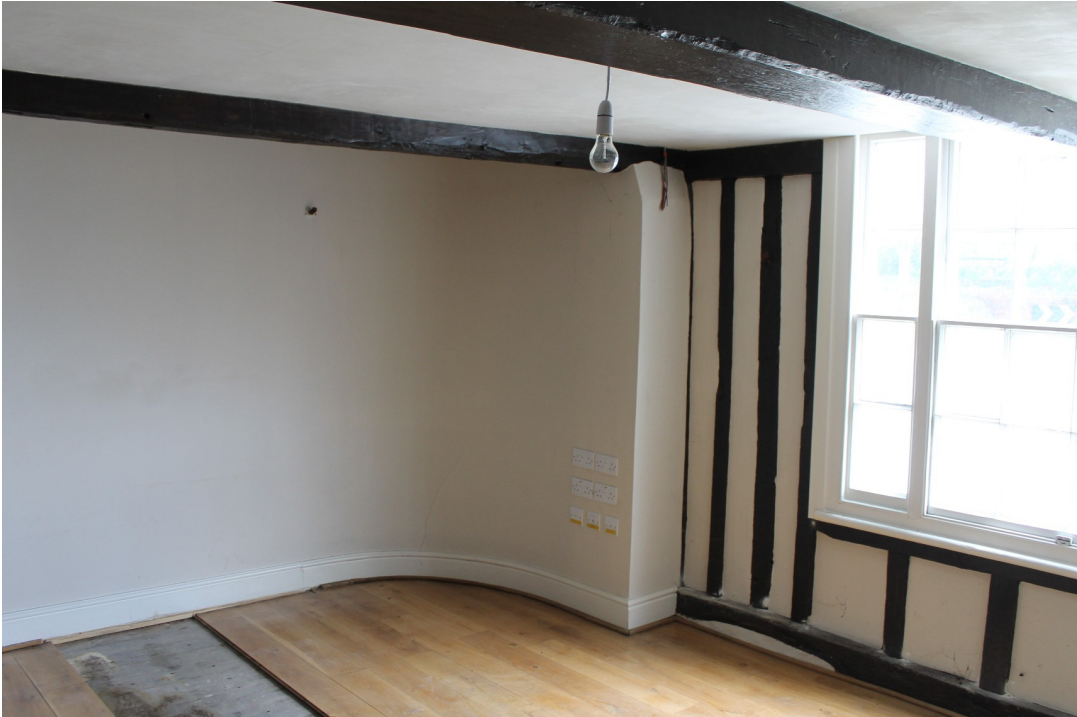
**Photograph 15** Interior of GF2 showing the curved brickwork of the 19th-century single-storey extension on the north-west elevation – view north.

GF2 comprises the 18th-century extension to the 16th-century cross-wing and part of the 19th-century lean-to extension (Fig 2). The floor of GF2 is at a lower level to the rest of the

building and the curved brickwork of the 19th-century extension is prominent (Photograph 15). The 18th-century extension was originally joined to the north-east elevation of the 16th-century cross-wing and the studs of the earlier timber frame have been removed, probably when the extension was added. An original window opening in the north-east wall has been replaced by a larger sash window which has removed part of the girding beam and the head of a centrally-located bridging beam originally carried on the girding beam, necessitating the strapping of this timber (Photograph 16). The studs of the north-west wall of this extension were completely removed when the 19th-century lean-to extension was constructed and the corner post of the 16th-century cross-wing was cut off level with the underside of the girding beam. As this structurally weakened the frame of the cross-wing, a strengthening beam was bolted to the rear of the front girding beam with one end bedded into the brickwork of the lean-to wall (Photograph 17). One advantage of these alterations was that part of the external frame of the 18th-century extension has been preserved and is visible, showing the frame had external bracing (Photograph 17). Connected to the construction of the 19th-century lean-to was the insertion of a fireplace and chimney stack, located just inside the 16th-century cross-wing (Photograph 18). This has a modern brick fire surround of red brick with dimensions of 222mm x 109mm x 61mm but the original brickwork can still be seen within the hearth. The brickwork of this has dimensions of 220mm x 110mm x 57mm. There is a fitted and glazed corner cupboard adjacent to the chimney breast dating to the 19th century.

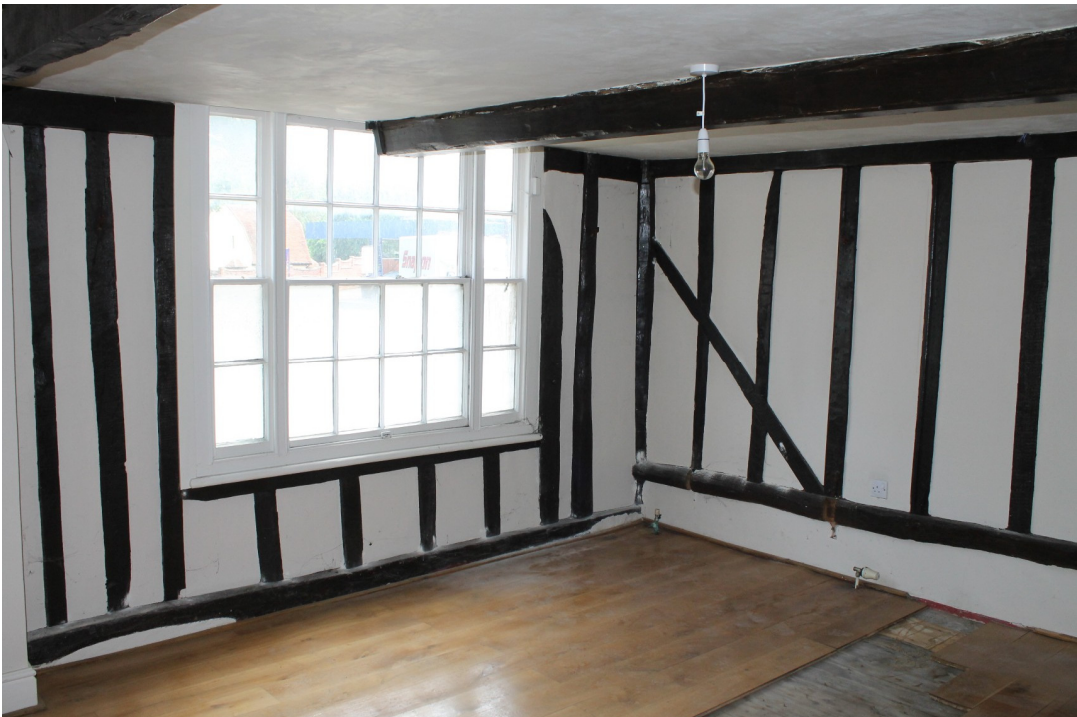
**Photograph 16** 19th-century sash window with margin lights inserted into north-east framing of the 18th-century extension to the 16th-century cross-wing (GF2) – view east.

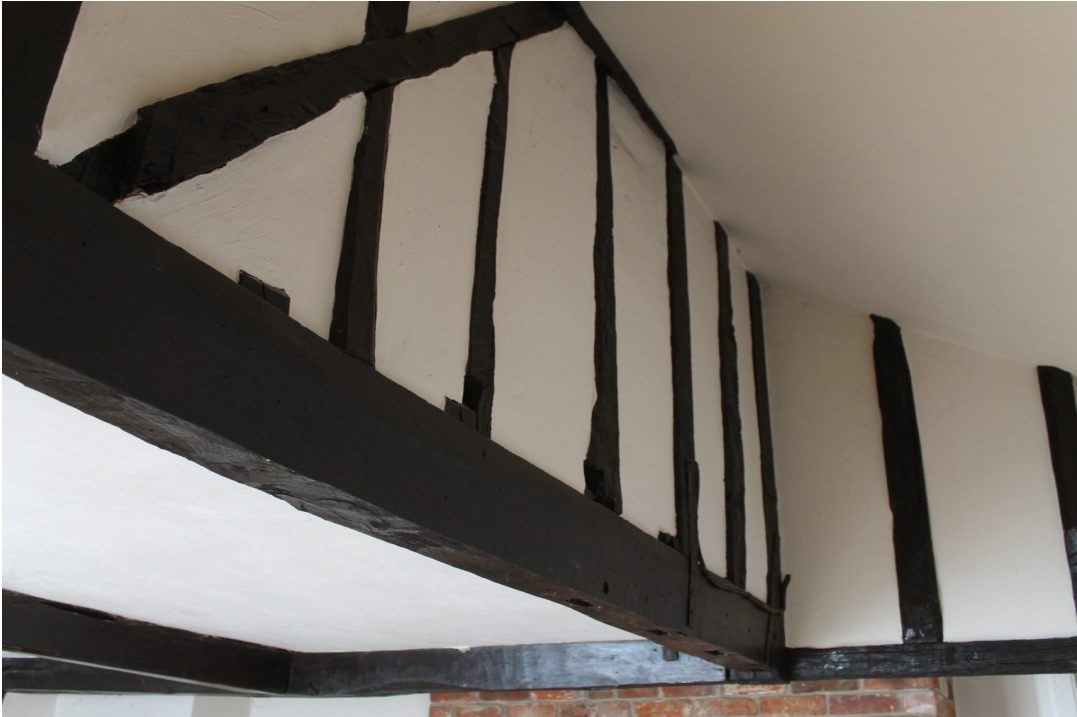
**Photograph 17** External studwork of the first floor to the 18th-century extension to the 16th-century cross-wing concealed by the 19th-century single-storey extension on the north-west elevation (GF2) – view north.

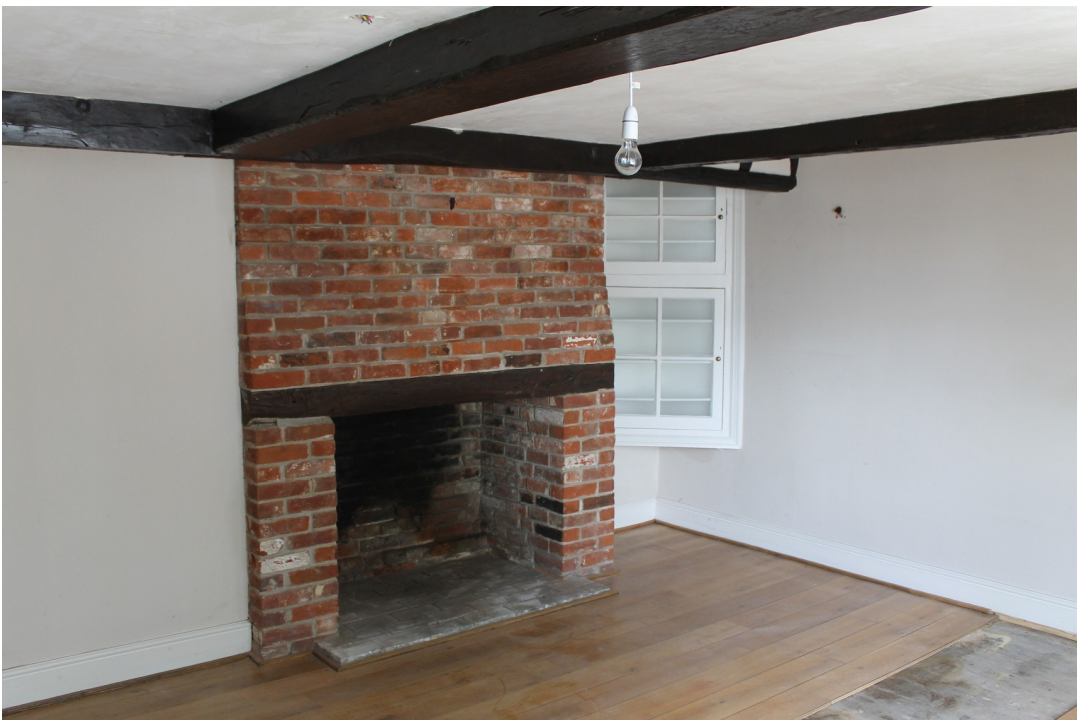
**Photograph 18** Inserted 19th-century fireplace with modern fire surround in GF2 and 19th-century corner cabinet – view west.

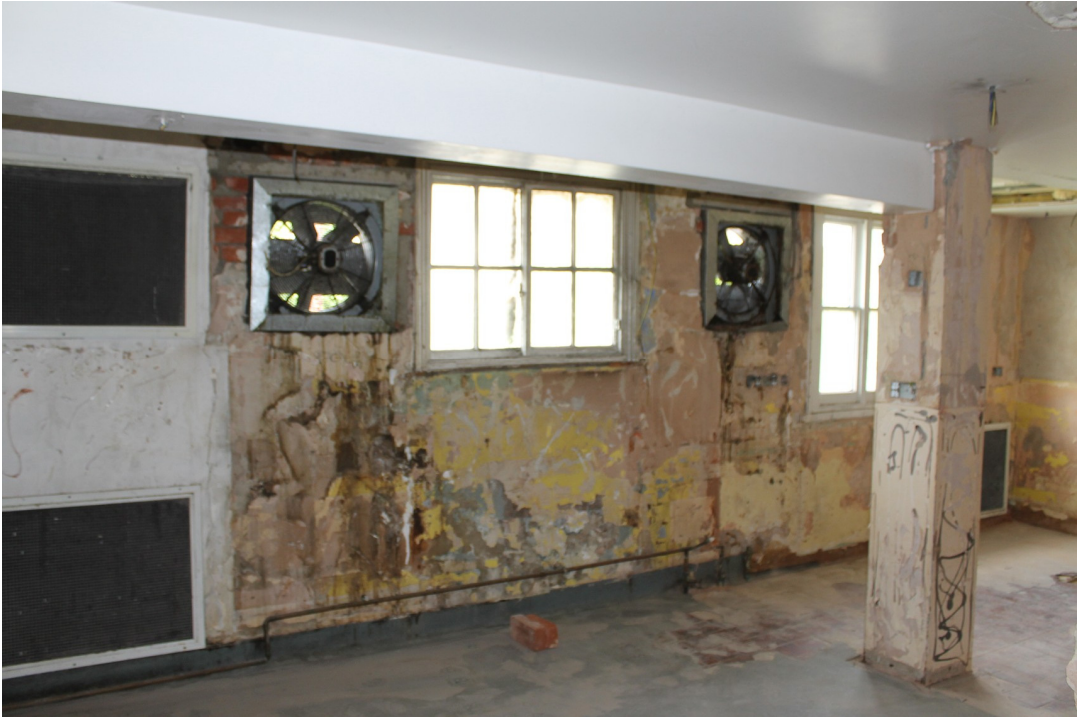
**Photograph 19** Interior of 19th-century single-storey extension on north-west side of GF3 with possible surviving 16th-century storey post and girding beam concealed beneath modern materials – view north.

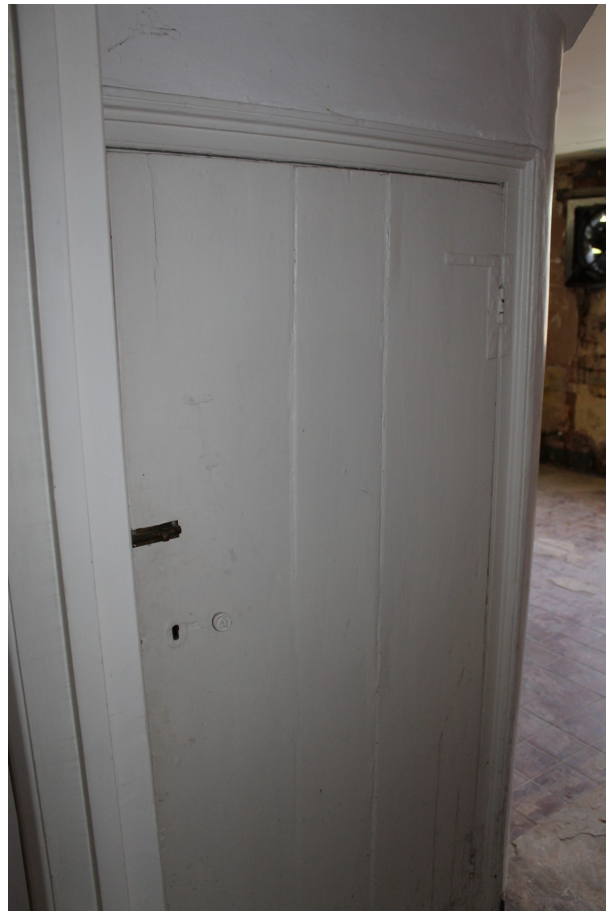
**Photograph 20** 18th-century under stairs cupboard between GF1 and GF3 – view south-west.

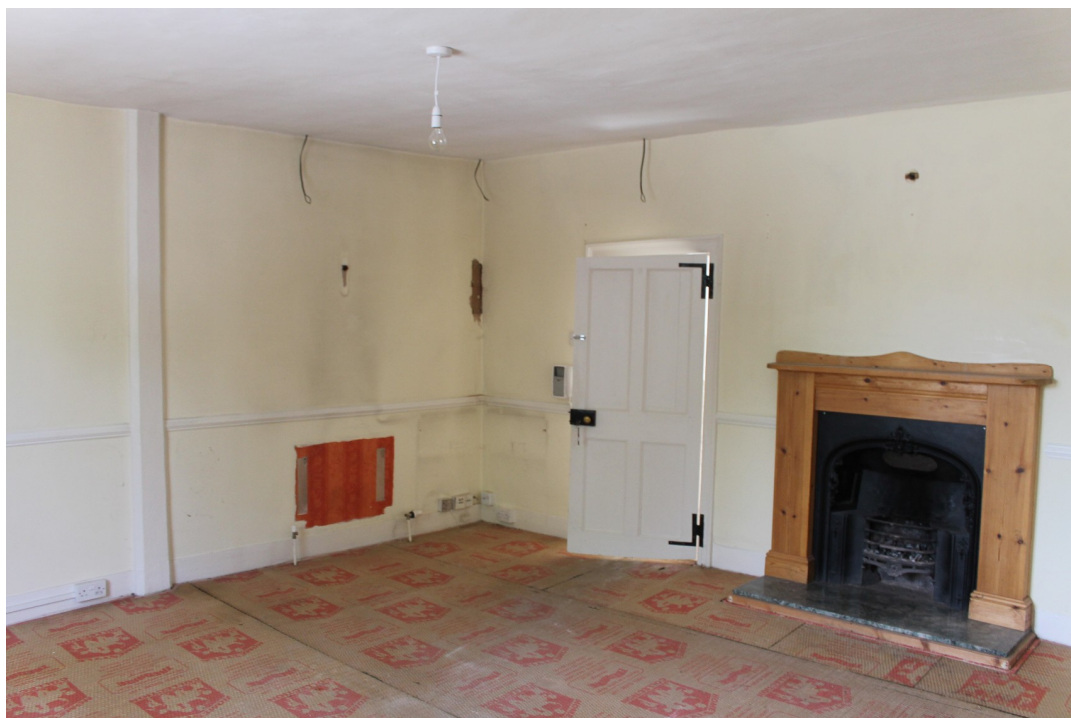
**Photograph 21** Interior of FF1 with 15th-century storey post to the left and 18th-century cast-iron register grate to the right – view south.

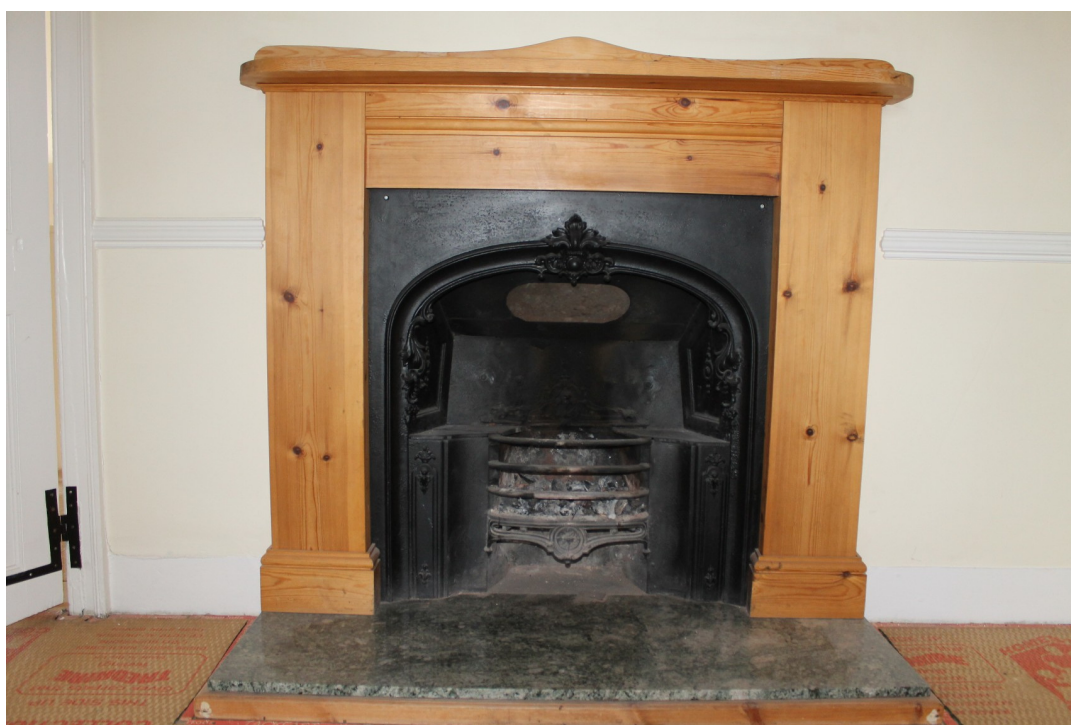
**Photograph 22** FF1, 18th-century cast-iron register grate with modern fire surround – view south-west.

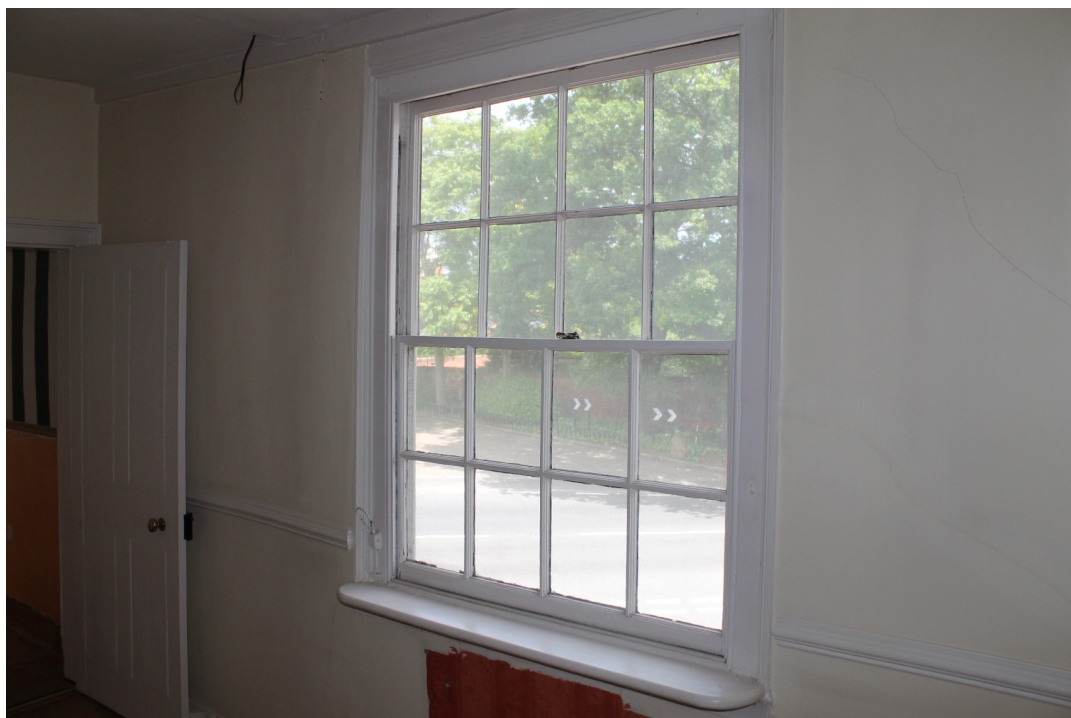
**Photograph 23** 18th-century sash window in north-east wall of FF1 – view north.

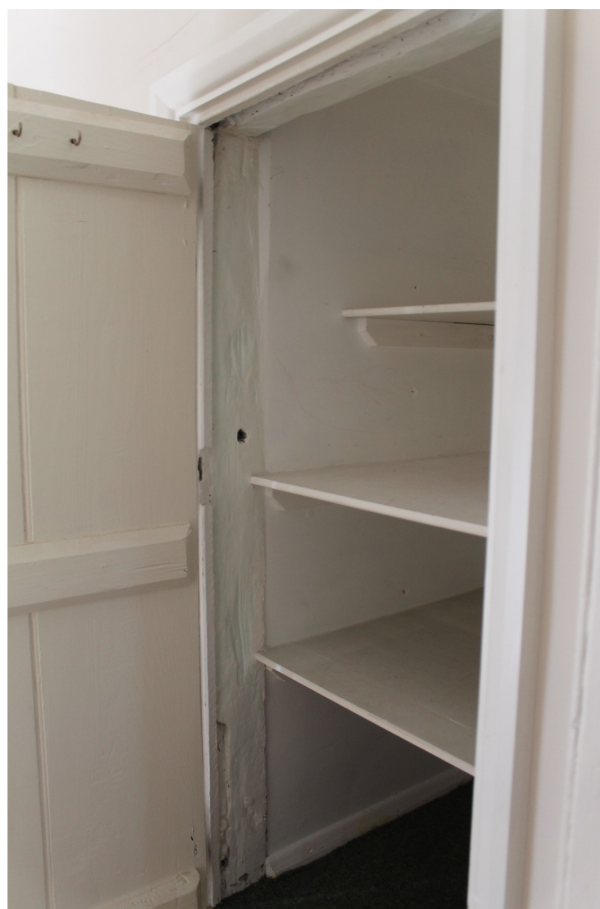
**Photograph 24** Interior of small cupboard built against chimney stack on landing outside FF1 – view west.

FF1 comprises a large room in the 15th-century main range and the landing of the 18th-century external staircase (Fig 3). There are no observable indications of the 15th-century timber frame in FF1 apart from an exposed storey post in the south-east wall. The timber framing of the upper floor has been concealed behind 18th-century renovations (Photograph 21). These renovations include the chimney stack with its cast-iron register grate (Photograph 22 - fire surround is modern) and the sash windows inserted into the north-east wall (Photograph 23). A dado rail present in the room is probably a modern embellishment rather than an original feature. Just outside the entrance to FF1, on the upper landing of the external staircase, a low cupboard is built into the chimney stack (Photograph 24). This appears to be an original feature and may have been for airing linens.

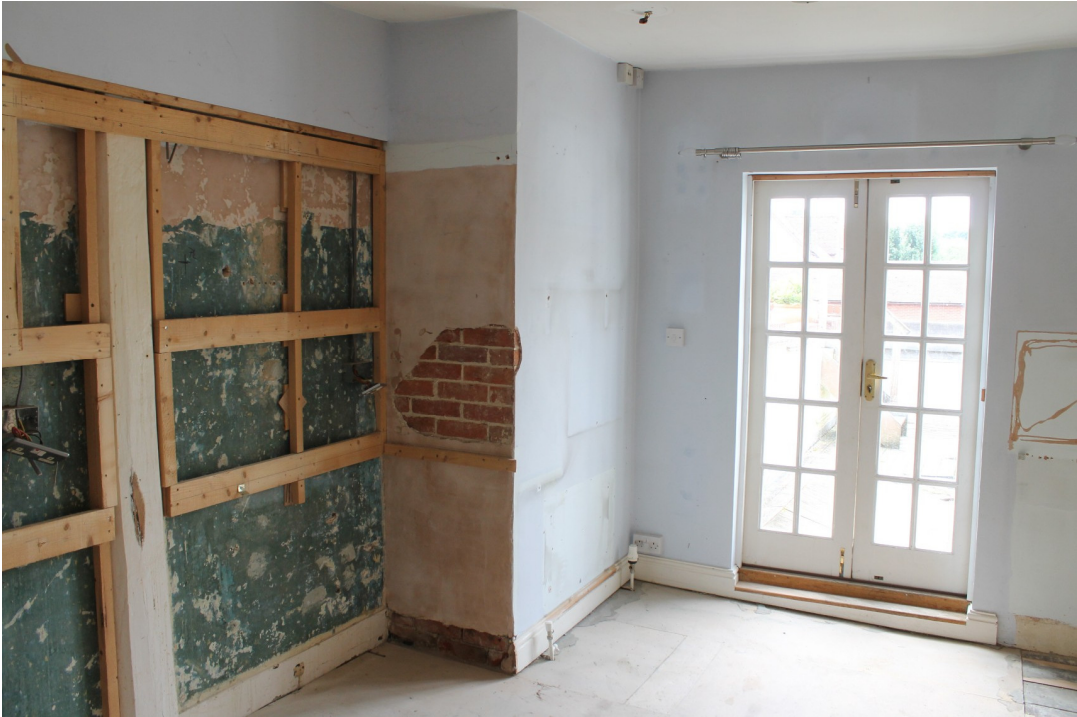
**Photograph 25** 18th-century dividing wall between FF1 and FF2, built around 15th-century storey post and with 20th-century chimney stack and French doors to roof – view south-east.

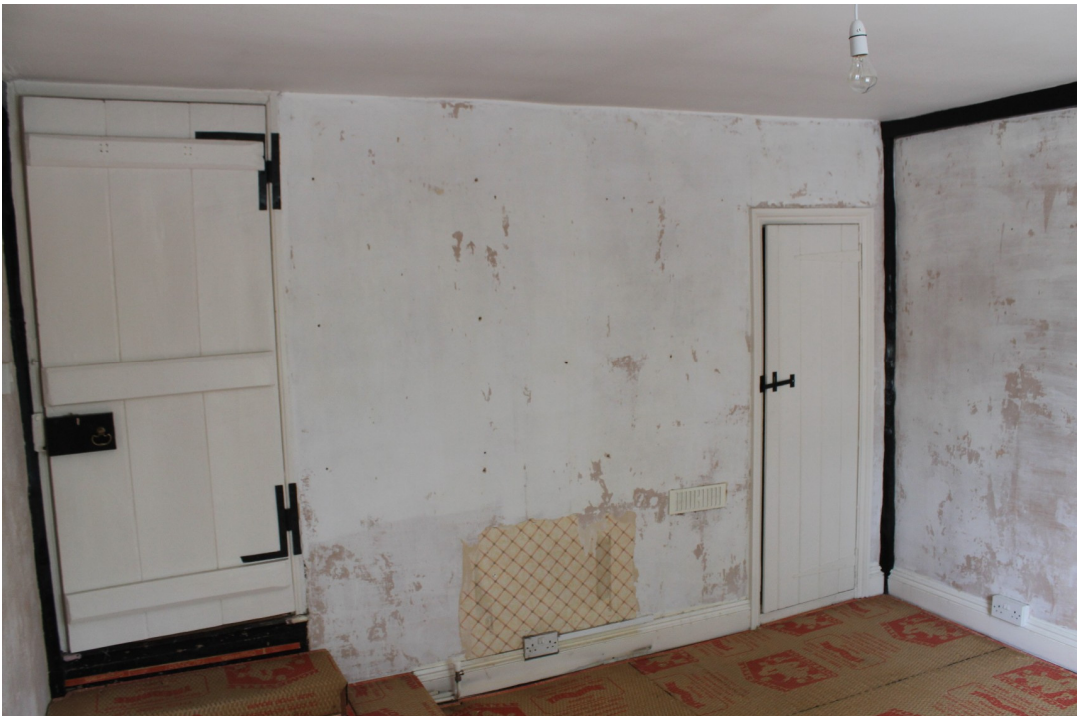
**Photograph 26** Interior of FF4 showing the front of the 16th-century cross-wing (timber frame obscured by modern plaster), with the cupboard to the right – view west.

FF4 comprises the 18th-century extension to the 16th-century cross-wing (Fig 2). As with GF2 below the floor level drops upon entry to the extension. The north-east timber frame of the 16th-century cross-wing has been obscured by modern plaster and a cupboard has been created where the 19th-century chimney stack has been inserted behind this wall (Photograph 26).
