**Historic building recording  
at Oxford House, Upper Holt Street,  
Earls Colne, Essex, CO6 2PG**

**July 2016**

**report prepared by Chris Lister**

**CAT Report 1051**  
January 2017

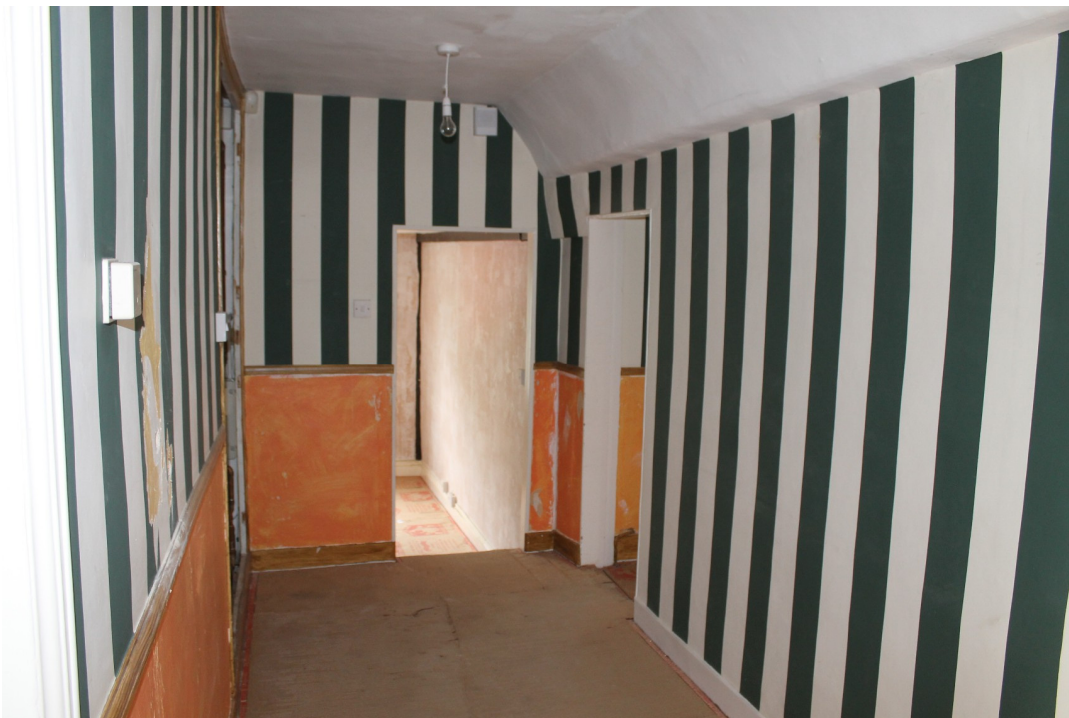
**Photograph 27** FF5, 16th-century cross-wing with the 18th-century extension to the rear and the access to the 15th-century range on the right – view north-east.

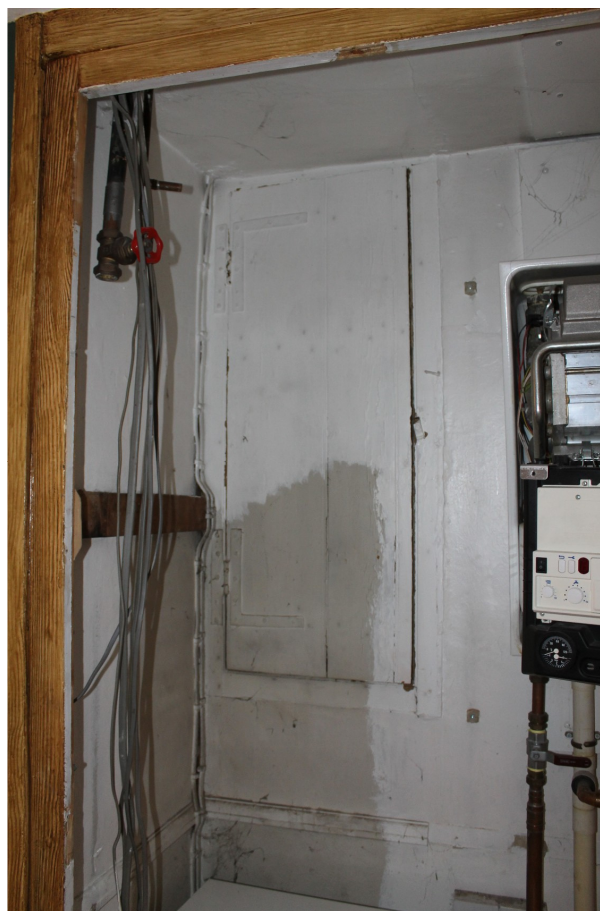
**Photograph 28** Cupboard built against chimney stack off FF5 – view north-west.

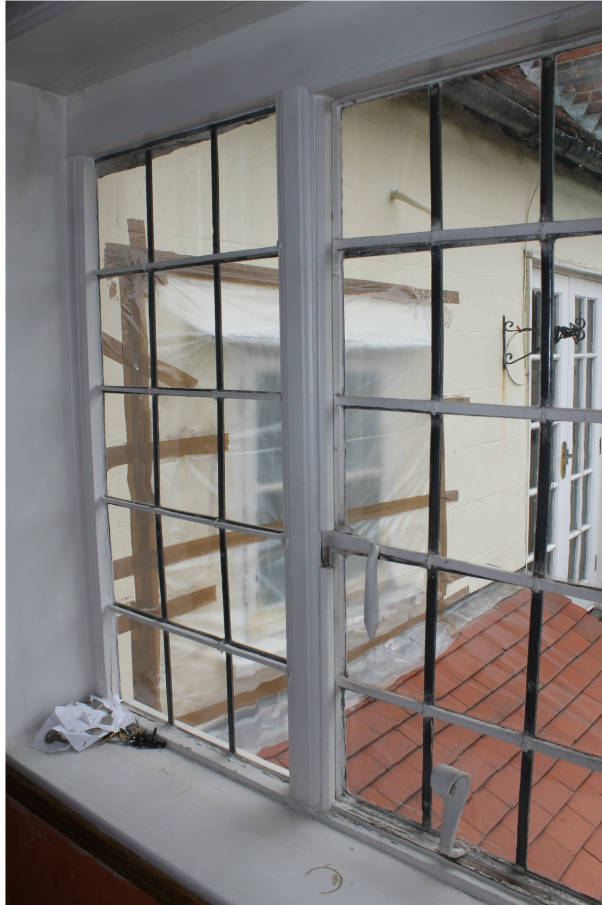
**Photograph 29** 16th-century casement window in south-east wall of FF5 – view east.

FF5 comprises the landing and hallway outside of the rooms located in the 16th-century cross-wing (Fig 2). Until at least 1923 the landing received the head of the staircase from GF3, which accounts for the greater width of the landing at the north-east end (Photograph 27). This area also contains a small cupboard built into the cavity formed by the 19th-century chimney stack, similar to the one built into the side of the 18th-century chimney in FF1, although this one is raised off the floor (Photograph 28). This cupboard may also have been used to air linens. A doorway into FF3, inserted through the framing of the 15th-century main range, opens off FF5. Located at the south-west end of FF5, just outside the entrance to FF8, is an original 16th-century wrought-iron casement window with leaded glazing, complete with an iron catch and stay (Photographs 8 and 29).

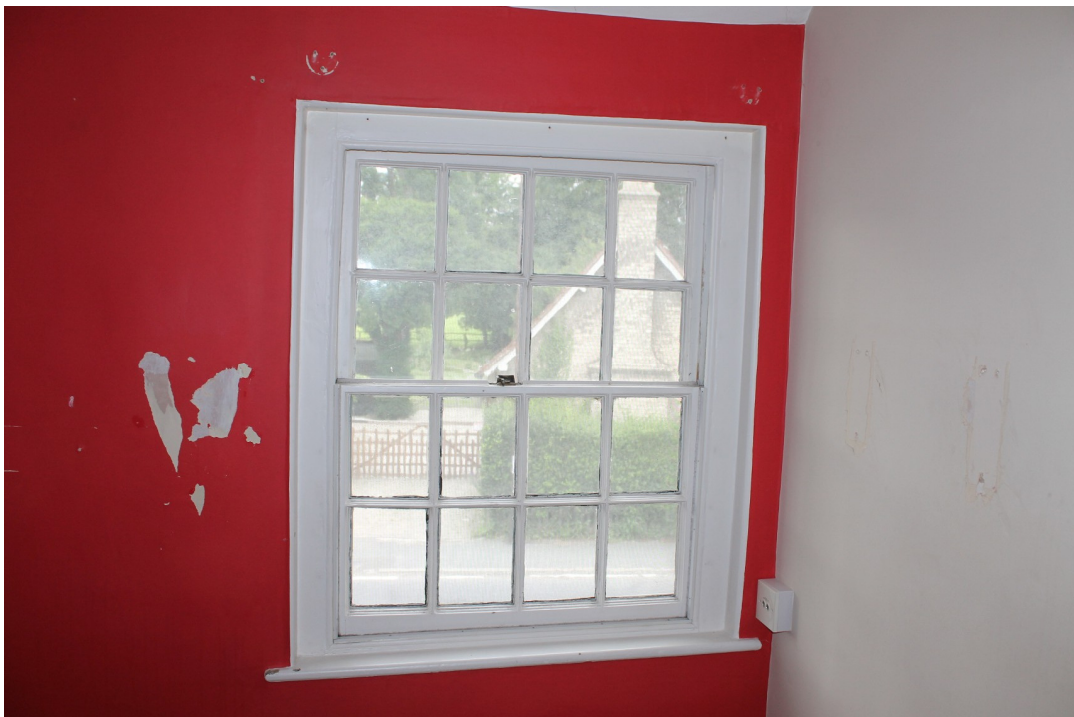
**Photograph 30** 18th-century sash window in FF7 with 20th-century stud wall to the right – view north-west.

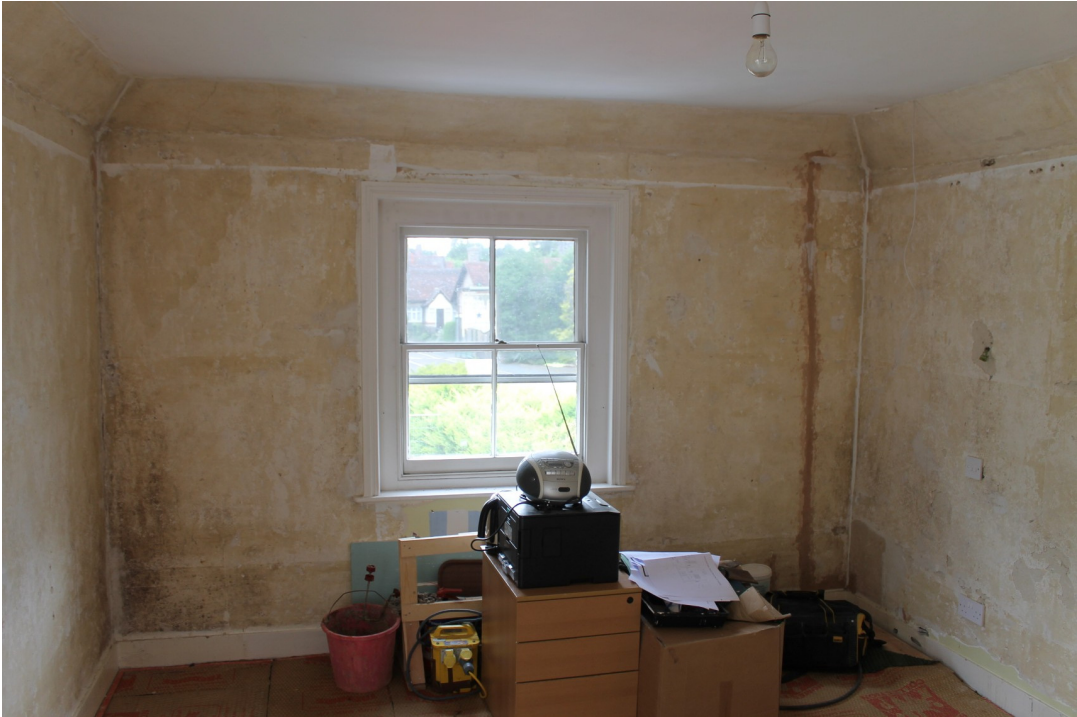
**Photograph 31** Interior of FF8 with inserted 19th-century sash window – view south-west.

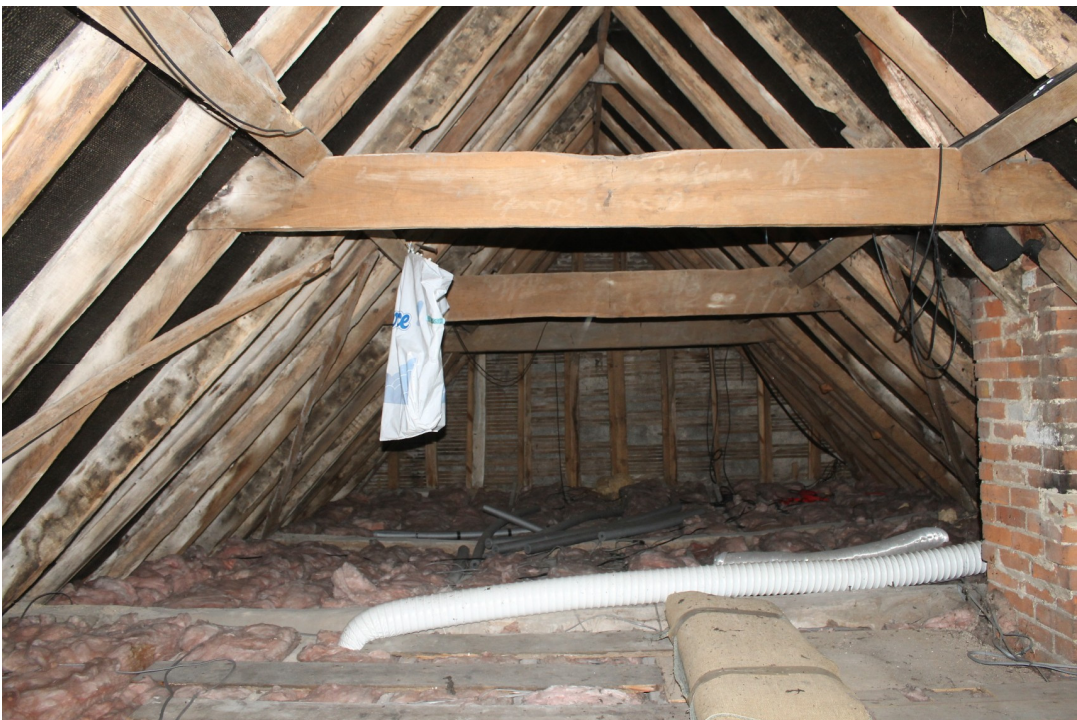
**Photograph 32** Roof timbers above 15th-century main range (FF1-3) – view south-east.

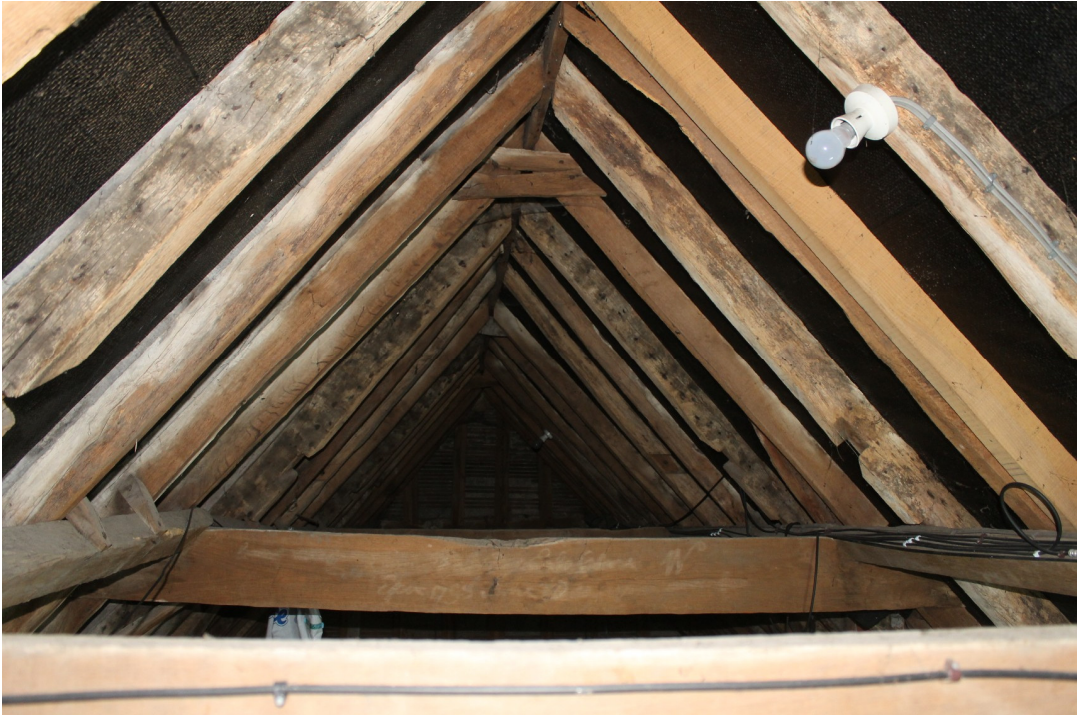
**Photograph 33** Intermediate high collars and ridge board above 15th-century main range (FF1-3) – view south-east.

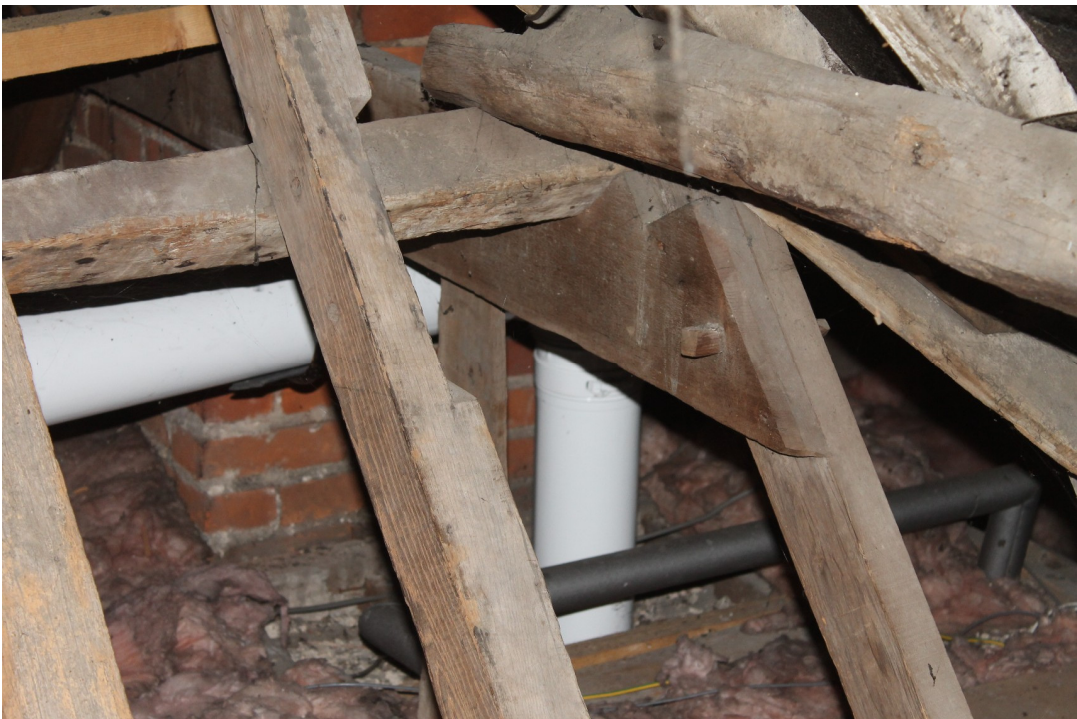
**Photograph 34** Purlin of main range supported on purlin above 16th-century cross-wing – view north-west.

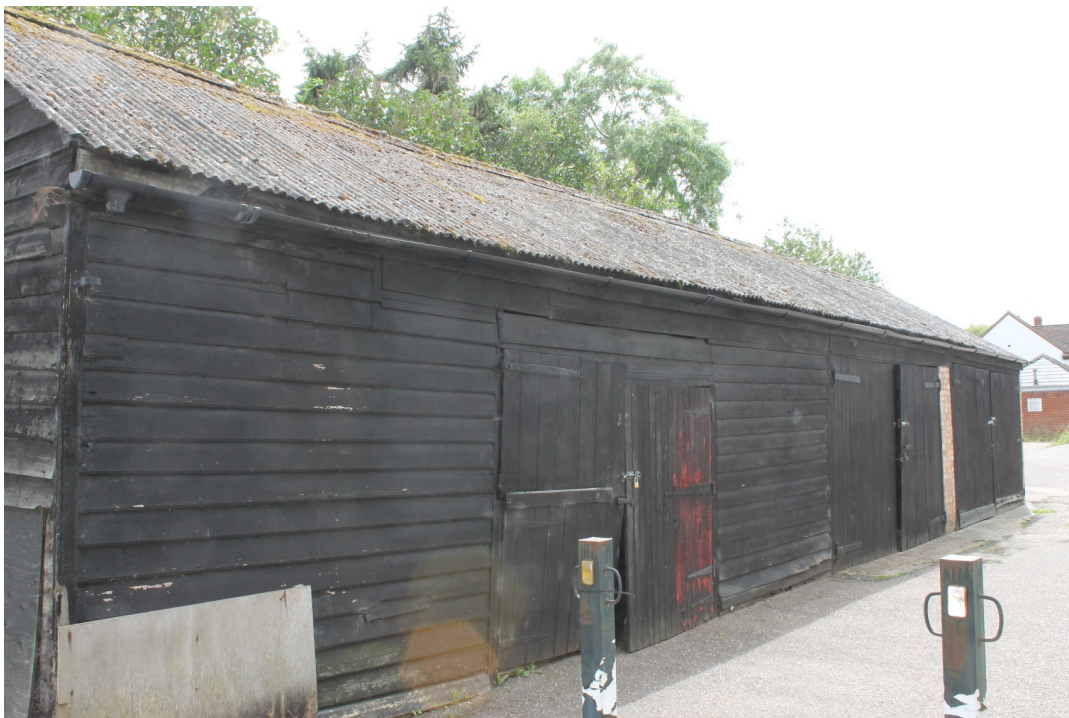
**Photograph 35** North-west elevation of outbuilding – view south.

This structure appears on the tithe map and probably dates to the early 19th century. Externally it appears as a single-storey timber-framed building clad in weatherboard and with one gable end replaced by Fletton brickwork (Photographs 35 and 36). The roof covering of corrugated asbestos sheeting is obviously 20th-century and the three sets of double doors in the north-west elevation are formed from smaller doors sourced from other structures and held on a variety of mismatched hinges.

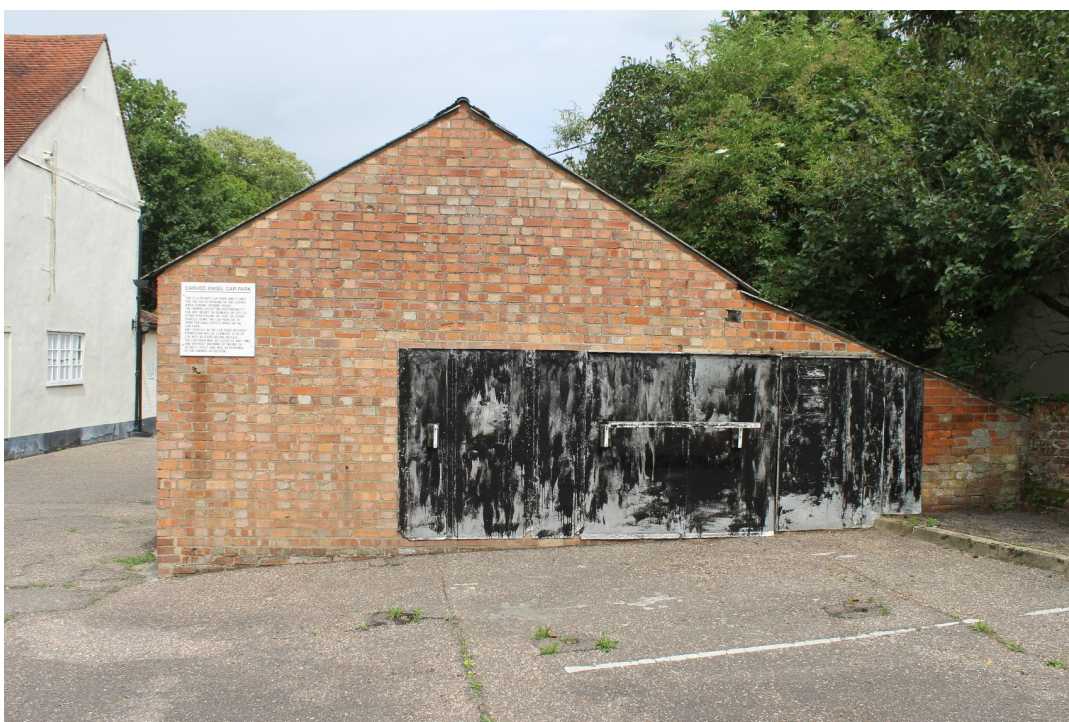
**Photograph 36** South-west elevation of outbuilding – view north-east.

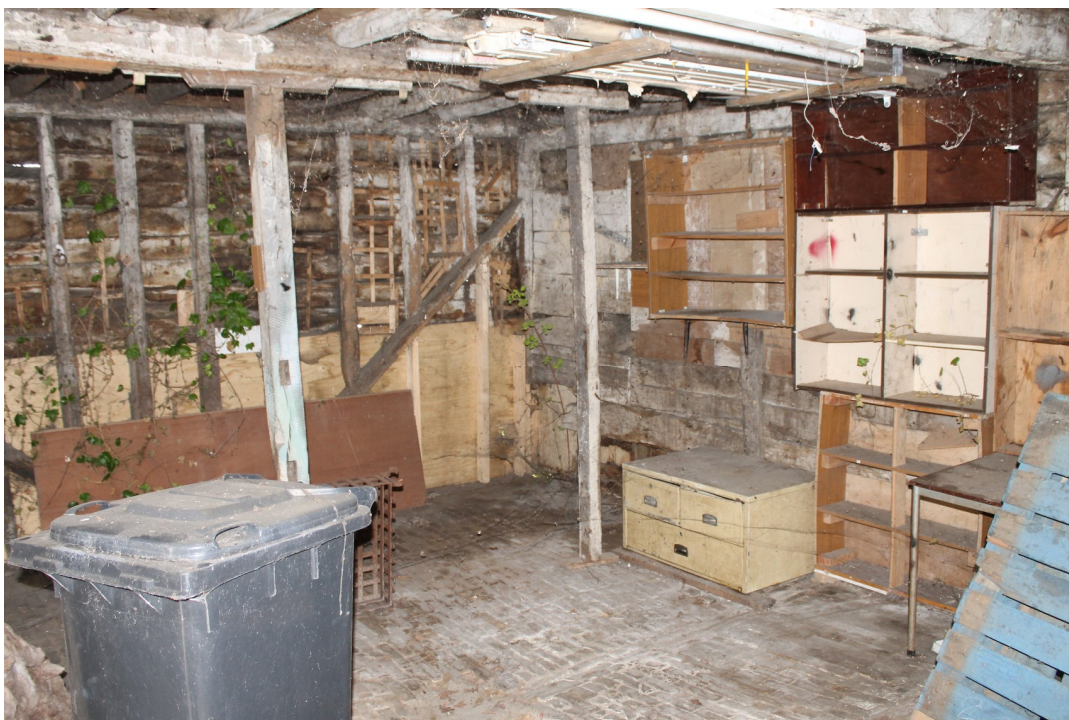
**Photograph 37** Interior of OB1 – view east.

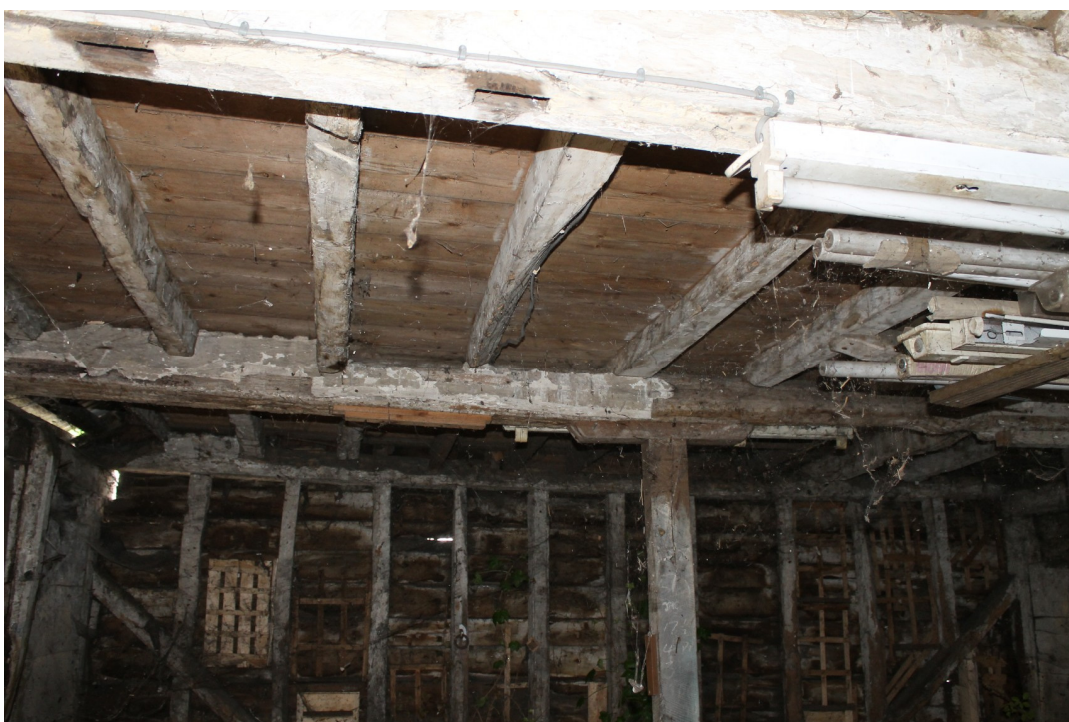
**Photograph 38** Loft above OB1.

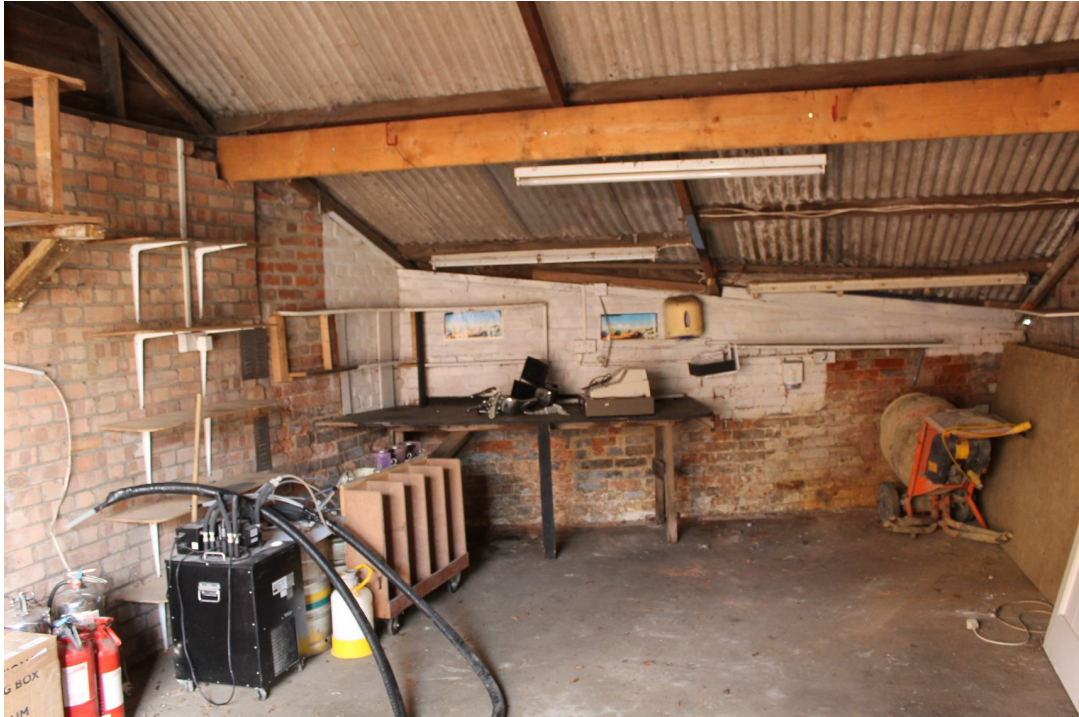
**Photograph 39** Interior of OB3 with possible 18th-century brickwork to the rear – view south-east.

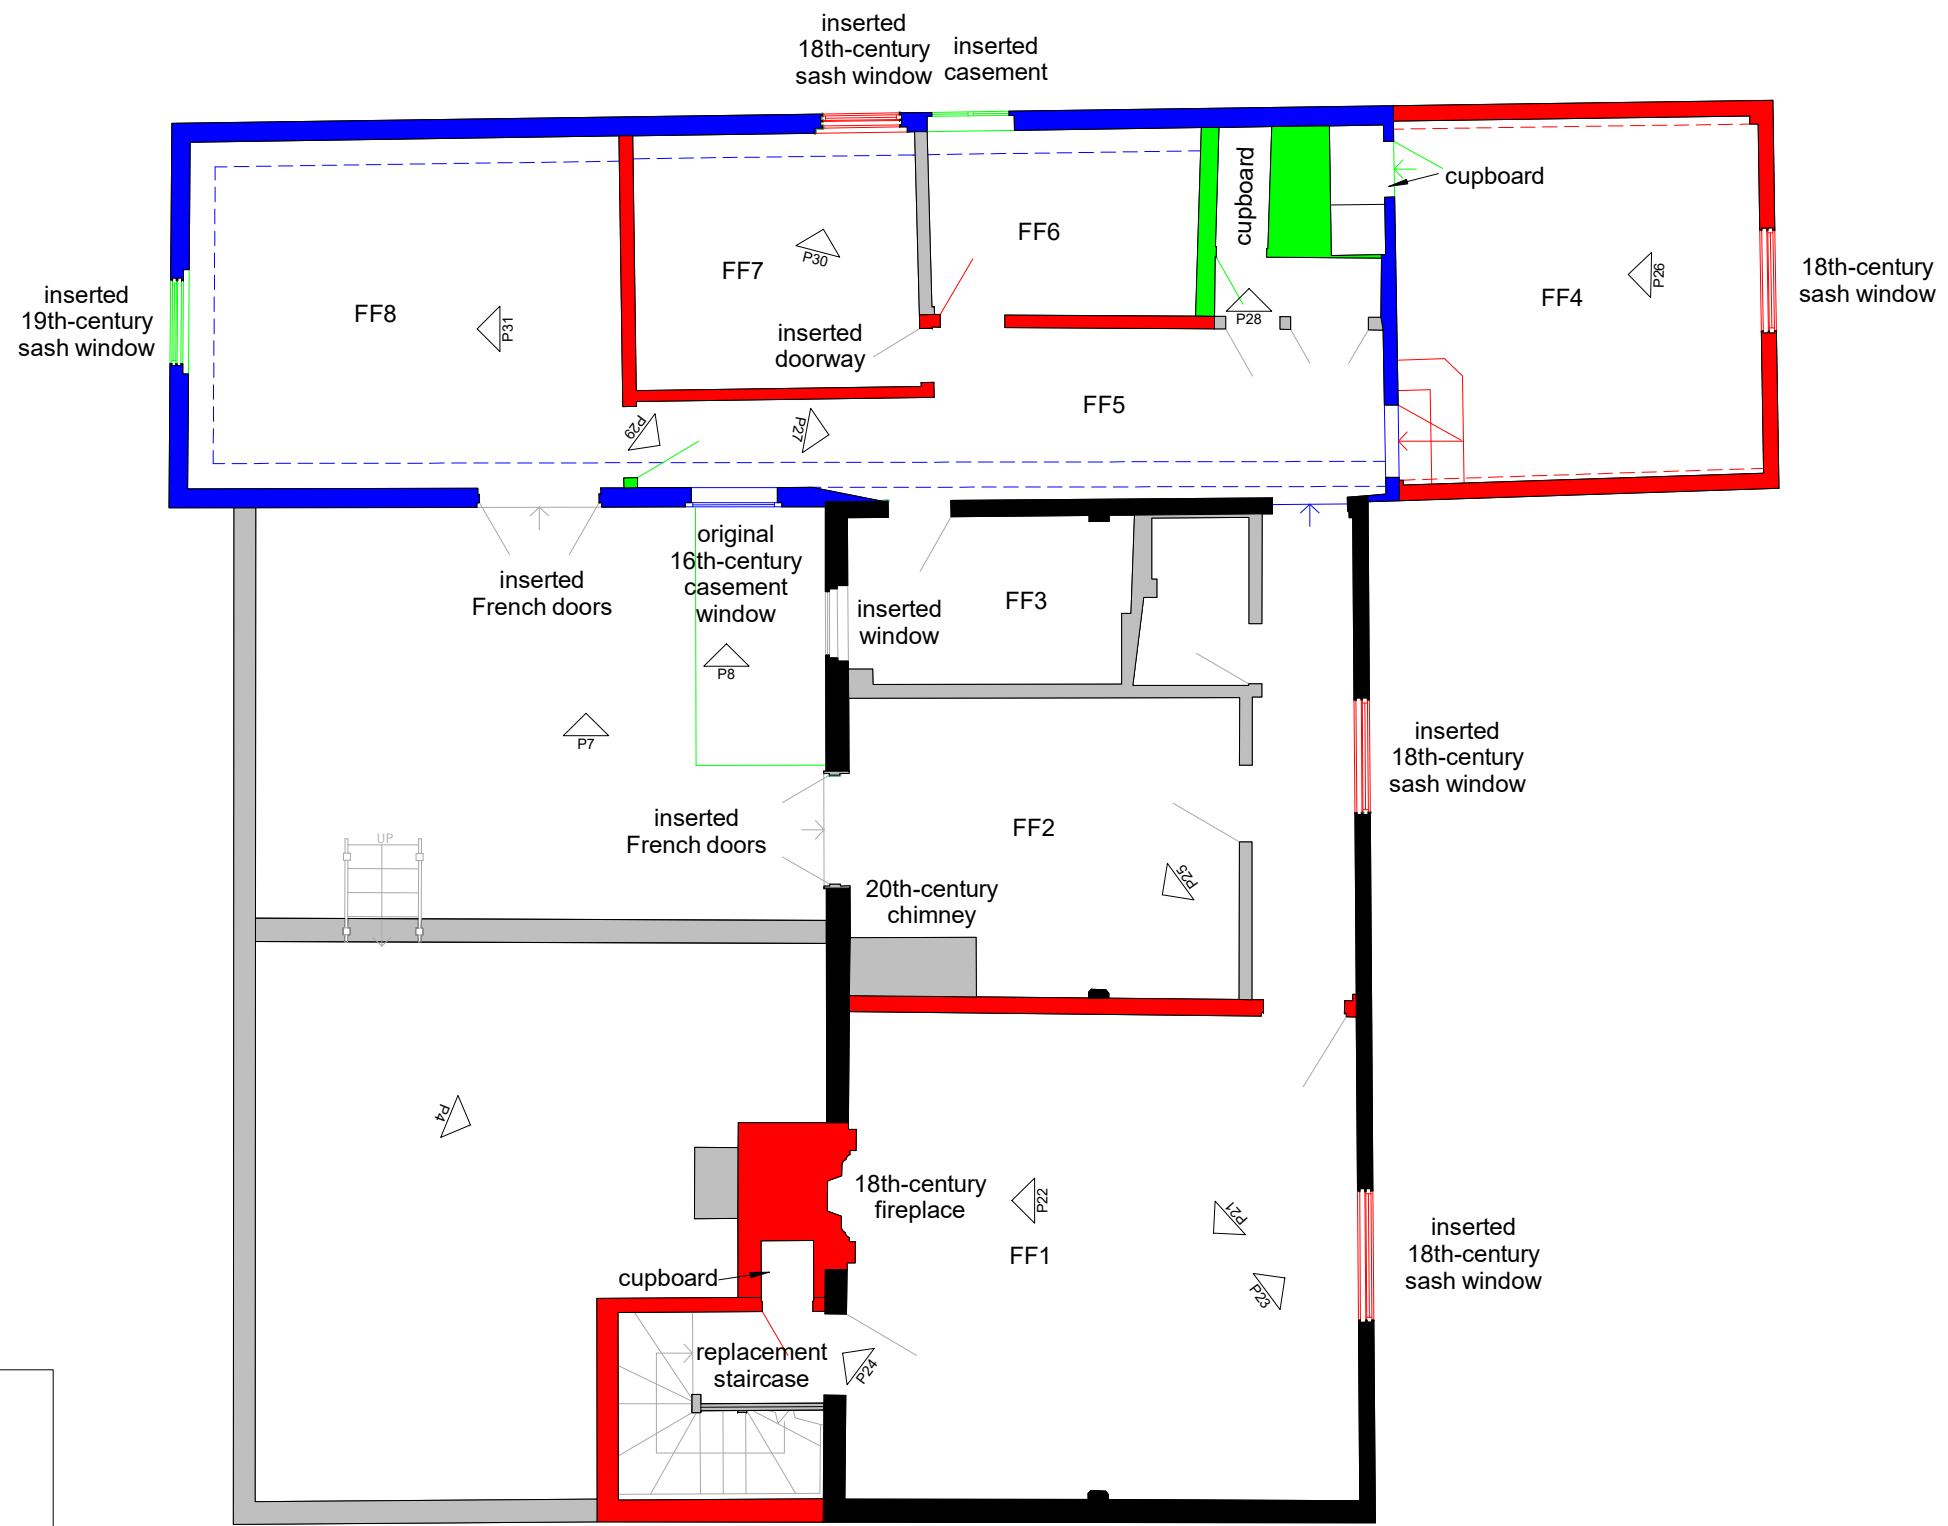
Fig 3 First floor plan with phasing.

The first floor of Oxford House comprises eight distinct areas, labelled FF1 – FF8 on Fig 3.

FF1 comprises a large room in the 15th-century main range and the landing of the 18th-century external staircase (Fig 3). There are no observable indications of the 15th-century timber frame in FF1 apart from an exposed storey post in the south-east wall. The timber framing of the upper floor has been concealed behind 18th-century renovations (Photograph 21). These renovations include the chimney stack with its cast-iron register grate (Photograph 22 - fire surround is modern) and the sash windows inserted into the north-east wall (Photograph 23). A dado rail present in the room is probably a modern embellishment rather than an original feature. Just outside the entrance to FF1, on the upper landing of the external staircase, a low cupboard is built into the chimney stack (Photograph 24). This appears to be an original feature and may have been for airing linens.
