Archaeological monitoring and recording at the Balkerne footbridge, over the A134 Balkerne Hill, Colchester, Essex, CO3 3AA

January – February 2017

by Laura Pooley

NGR: TL 99213 25205 (centre) Planning reference: 160192 CAT project ref.: 17/01d

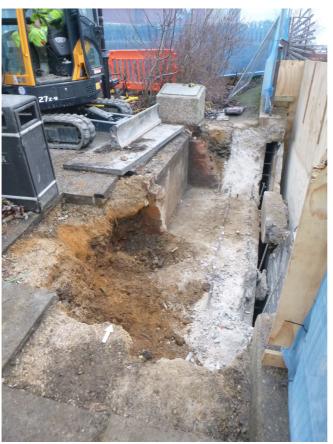
Photograph 1 Trench on west side of footbridge, the concrete abutment wall, brick inspection pit and made-ground can be clearly seen, looking N

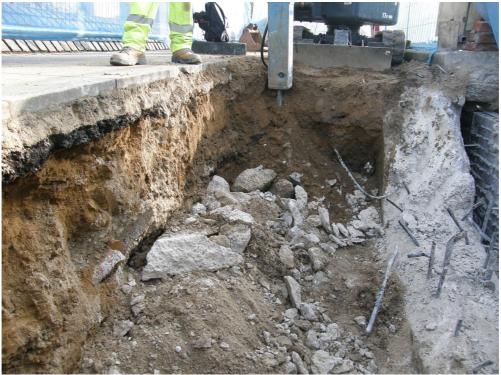
Photograph 2 Trench on east side of footbridge showing concrete abutment wall and made-ground, looking S

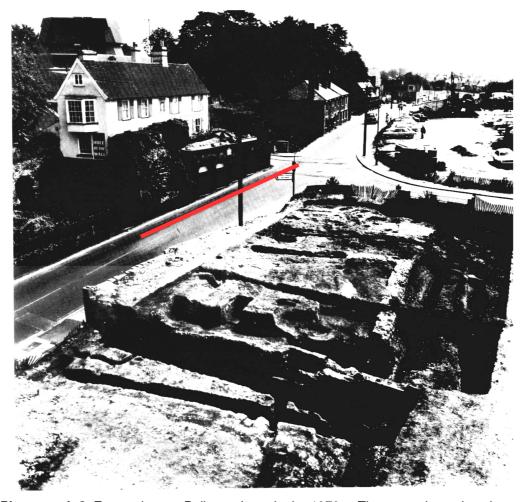
Photograph 3 Excavations at Balkerne Lane in the 1970s. The approximate location of piling to form the abutment wall for the eastern side of Balkerne Hill is shown in red, ground-level in front of that line reduced by approximately 6m for the new dual-carriageway (Colchester Archaeological Report 3, Figure 116).

Despite being located close to Colchester's Roman town wall, Balkerne Gate and an area rich in archaeological remains, only modern material was recorded in both trenches. Balkerne Hill was extensively excavated in the 1970s during which time the ground level was reduced by approximately 6m for the construction of the existing dual-carriageway (A134) (Colchester Archaeological Report 3, 1). The ground level either side of this proposed carriageway was subject to continuous piling to form abutment walls through which the carriageway was excavated (Philip Crummy, pers comm). This means that the ground levels either side of the abutment wall are roughly the same as they were in the 1970s and the two trenches lie directly on-top of these walls. The fact that modern features and made-ground were excavated to a depth of 1.6m in both trenches shows that any archaeological remains that may have been present at these locations has been removed by the groundworks associated with the construction of the abutment walls and former footbridge.

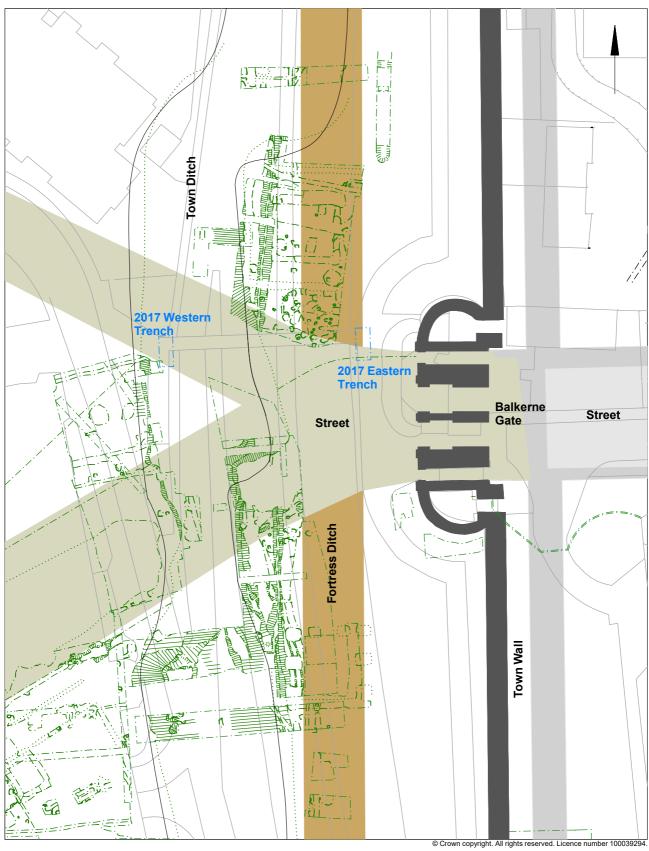
Figure 2 Locations of eastern and western trenches (blue), shown in relation to previous archaeological work (green).

The proposed development comprises the replacement of the 1.9m wide existing footbridge with a new bridge structure approximately 3m wide. Two trenches were excavated by the contractor (Topbond PIC Group) under the supervision of a CAT archaeologist. They were excavated to the east of the eastern abutment wall and the other west of the western abutment wall. Both trenches measured 4m long by 2m wide by 1.6m deep, and were dug to provide a new bearing shelf for the wider bridge. The trenches were excavated through the concrete abutment walls, brick inspection pits for the old footbridge and modern made-ground.

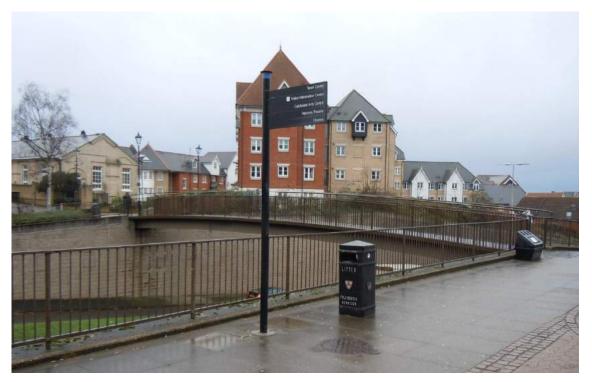
Plate 1 – Existing Footbridge over the A134

The proposed development comprises the replacement of the 1.8m wide existing footbridge (please refer to Figure 2a and Plate 1 in Section 10 of this report) with a new bridge structure which will be approximately 3m wide in order to accommodate a cycle lane (Figure 2b) and segregate pedestrians from cyclists. The proposed scheme will involve three phases¹. More detailed information on the ground works and demolition associated development proposals is provided in Sections 2.2 and 2.3 of this report.

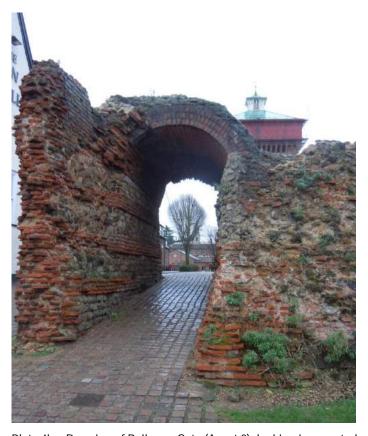
Plate 4b – Remains of Balkerne Gate (Asset 2), looking in a westerly direction towards Jumbo Tower and St Peter's Church

Asset 2 Balkerne Gate is a Scheduled Monument and a Grade I Listed Building, however this asset has been included in this report only once and as a historic building, as it is an upstanding structure to prevent duplication of assets. The upstanding structure of Asset 2 (Balkerne Gate - see Plate 4 included in Section 10 of this report) is located approximately 20m to the south-east of the footbridge site, however it should be noted that the Scheduled Area of the asset covers a wider circumference and extends within approximately 8m of the footbridge. The Balkerne Gate predates the Town Walls of Colchester (Asset 1) as it was constructed in the 2nd century AD. The gateway is over 100ft wide and includes two carriageways and two footways (National Heritage List Ref. 1123668). It also comprised a "quadrant-shaped guard room on each side" and the surviving right arch (Plate 4 in Section 10 of this report) is the former arched entrance to the southern guard-room (Pugh 1963, 93). A historical sketch of one of the guardrooms is presented in Plate 8 in Section 10 of this report. The Victoria History of Essex suggests that Balkerne Gate was rebuilt in the 4th century AD after it had been burnt (Pugh 1963, 94). It is unclear from the documentary sources whether this damage was caused from the Boudican rebellion. It is acknowledged that Balkerne Gate is the only gateway of Colchester which is still extant. Given the importance of this asset; as it is one of the last gates to survive in Colchester, its association with the Roman town and its designation as a Grade I Listed Building and Scheduled Monument, it has been assessed to be of High value.

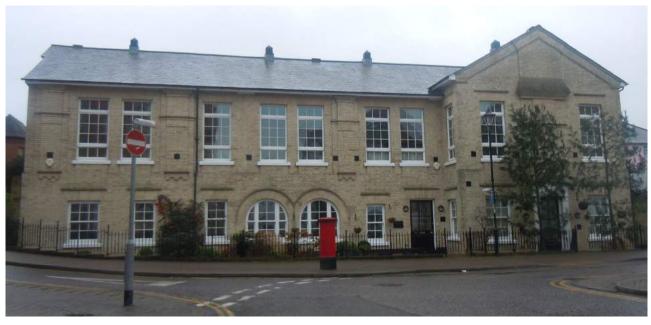
Plate 6 – St Mary's Fields (Asset 6)

St Mary's Fields (Asset 26 – see Plate 6 included in Section 10 of this report) is a locally listed building and was formerly a boardroom block which was part of the St Mary's Hospital complex. Ordnance Survey map of 1969 suggests that this building was constructed between 1897 and 1969. Prior to becoming a hospital, the site was formerly known as Colchester Union which was built in the 1840s and includes a number of airing yards a chapel and an infirmary. Between the 1840s and 1930s a number of buildings were added to the site and it was renamed St Mary's Hospital in 1938 (Stanley Bragg Associates 2001). Following the creation of a new Hospital in the north, St Mary's Hospital closed and was demolished after the mid-1990s.

St Mary's Fields (Asset 26 – see Plate 6 included in Section 10 of this report), a locally listed building, was formerly part of the Colchester Union Workhouse, which was designed by John Brown, built between 1936 and 1937 and was in operation between 1837 and 1929. Between 1930 and 1948 workhouse was renamed the Colchester Public Assistance Institution (Higginbotham 2011), but after 1948 it became known as St Mary's Hospital. The hospital closed in the early 1900s and "remained derelict for a period, but had been converted to residential use by 2007" which was known as 'Henrylaver Court'" (Historic England 2015c). Asset 26 was used as a boardroom or office block and is of brick construction in a T-plan shape, with a gabled cross-wing (Colchester Historic Buildings Forum 2015). The building includes conventional sash windows and a pair of round-arched windows. Even though this building is the last building extant from the former workhouse and hospital, given it has undergone internal alterations and modifications, and it is a locally listed building, this asset has been assessed to be of Low value.

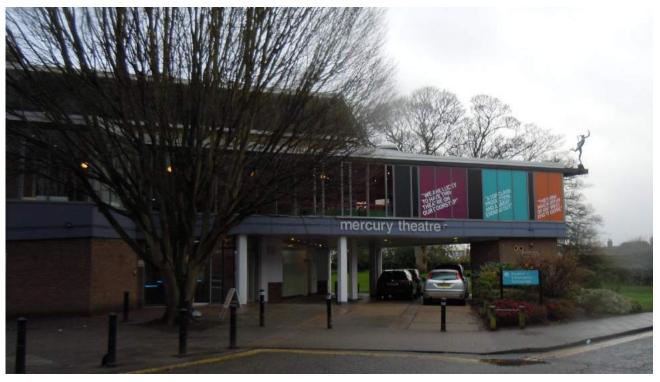
Plate 7 – Mercury Theatre (Asset 5)

The most modern building within the study area is Mercury Theatre (Asset 5 – see Plate 7 included in Section 10 of this report), a locally listed building, which was designed by Norman Downie built in the 1970s of brick into a steel frame. This building is still in use as a theatre today.

The Mercury Theatre (Asset 5 – see Plate 7 included in Section 10 of this report) is a locally listed building which is situated to the south-east of the footbridge site and was built in the 1970s. This is a modern building built of brick onto a steel frame. The structure includes reinforced concrete columns and beams and was constructed in a hexagonal shape which includes a tower. Inside the building, which includes a restaurant and offices, is a hexagonal stage, a bar at first-floor level and has a bronze figure of Mercury on the roof. Since this is a modern building, constructed in the 1970s, which is relatively common in construction technique, and it is locally listed building this asset has been assessed to be of Low value.

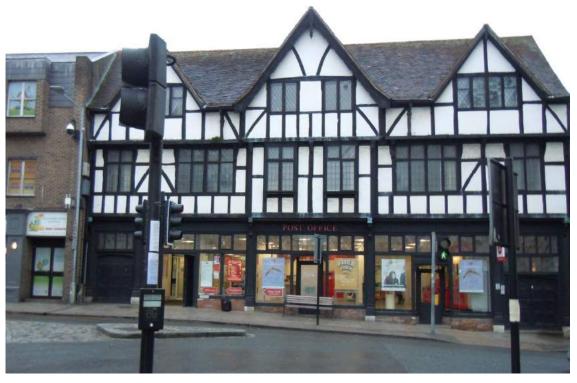
Plate 9 – Colchester Post Office built on the alignment of the Roman High Street

the current High Street ends to the east of Colchester Post Office (see Plate 9 included in Section 10 of this report). Thus the High Street no longer has a physical connection with Balkerne Gate, at the western end.
Communal Value	As the High Street is still used as a main street within the centre of Colchester, there are many local businesses along the road and on-street road parking is available. Given this continuing use of the road as an arterial transport route, this strengthens the community association with the asset. Furthermore, the community can, through direct association with the high street and their knowledge it was a former Roman road, can take a sense of ownership of asset.
Evidential Value	Evidence of the road has been identified during investigations at various locations within the town. In the Balkerne gateway there are 19 inches of gravel overlain with a metalling layer hard rammed loam then sand.
