# Archaeological evaluation and low level historic building recording at White Notley Hall, Church Hill, White Notley, Essex, CM8 1RX

**July 2017**

CAT Report 1141 August 2017

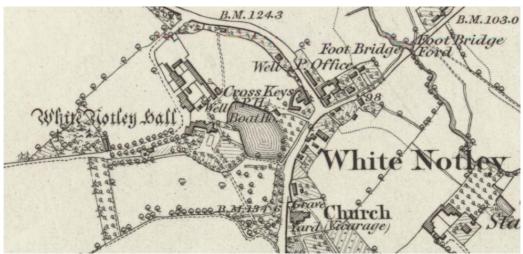
Map 1 1874 6-inch OS map (Essex XXXIV)

The outbuilding appears on the first edition 1874 OS map (Map 1). On the 1895 OS map, it is shown as having a small connected building (probably a lean-to), against its south-eastern elevation (Map 2). This small building has been demolished and the current outshot constructed by the time the 1919 OS map has been surveyed (Map 3).

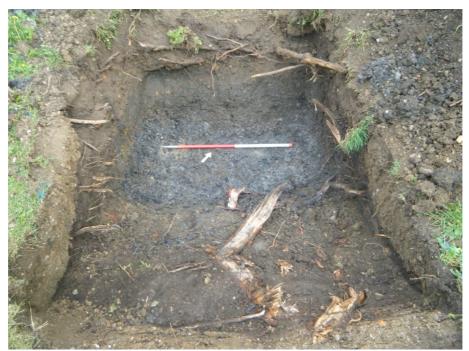
Photograph 1 T1 trench shot – looking northwest

Trench 1 measured 1.8m in width and a total of 7.3m in length. It was excavated in two sections as its course was impeded by two large tree stumps. Four layers were recorded. A layer of modern build-up (L1, c 0.6-0.85m thick, firm dry light to medium yellow/brown clayey-loam with chalk fleck inclusions and abundant gravel and stone containing pottery, CBM, slate, modern plastics, etc) covered the site to create a steeper bank leading from the driveway down to the lake/millpond. Underneath L1 were two layers of modern fill (L2, c 0.26m thick, soft wet dark brown/black sandy-silty-loam with occasional stones, overlaying L3, c 0.21-0.52m thick, friable moist medium-to-dark green/brown silty-clay with occasional stone inclusions). Both layers appear to have also been deposited to raise ground-level in this area, presumably to either reduce the size of the pond (as seen on OS maps, see discussion and Maps 1-2) or to stop the risk of flooding in the direction of the hall and outbuildings. Naturally-deposited green/grey/brown sandy-silts were identified beneath L3 (L4).

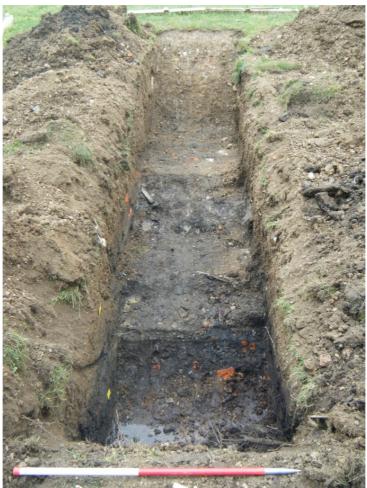
Photograph 2 T2 trench shot – looking southwest

Trench 2 measured 1.5m in width and 7m in length. It was reduced in both width and length to avoid a large drainage pipe and manhole. It was excavated through L1 (*c* 0.62-0.86m thick) and L2 (*c* 0.25-0.63m thick) onto L4.

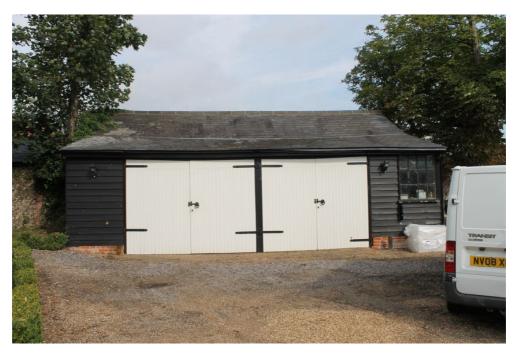
**Photograph 3** Southeast elevation of outshot, showing large double doors – looking northwest.

Projecting 3m from the south-east elevation of the outbuilding is an outshot (intended for demolition), covered by a slate-covered catslide roof. The offshoot is a timber-framed structure, supported on a red brick plinth of four courses. It is clad in horizontal weatherboarding. The south elevation of the outshot has four large double-width doors, arranged so as to make two large double door entrances into the structure (Photograph 3). These entrances (if not the doors themselves) seem to be original to the outshot, as does one twelve-light fixed window to on the same elevation (Photograph 6).

The erection of the outshot was clearly intended to convert the building into a garage, hence the increase in the buildings width and the large double doors. Car manufacturing in Britain didn't begin on a large scale until after the World War I, when the rapid industrialisation encouraged during the war years was turned to more

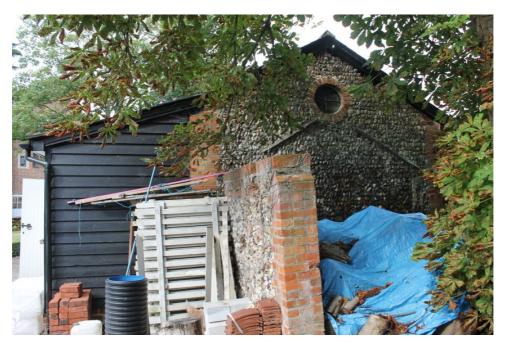
The outbuilding to the north of White Notley Hall is a brick and stone-built rectangular structure with a slate-covered gable-ended roof, measuring 9.5m x 4.5m in size. The corners of the building are made of brick, with the space between infilled with flint and mortar (Photograph 4). The building has two small four-light circular metal-framed windows, one on each gable (Photograph 5). The north-east elevation of the building also has a small wooden hatch framed in brick, which is partially plastered over on the interior (Photograph 9). This elevation also has scarring that suggests a building was built up against this elevation (Photograph 5).

Photograph 4 Northeast elevation of outbuilding and outshot – looking west.

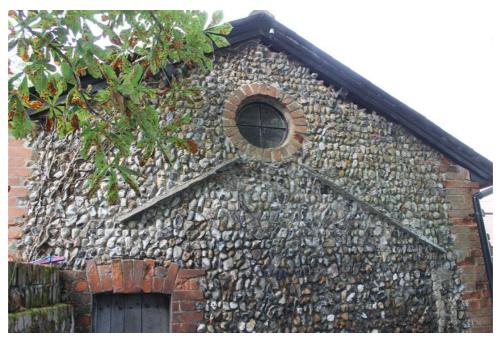
**Photograph 5** Detail of northeast elevation of outbuilding and outshot, showing window, scarring and hatch – looking west.

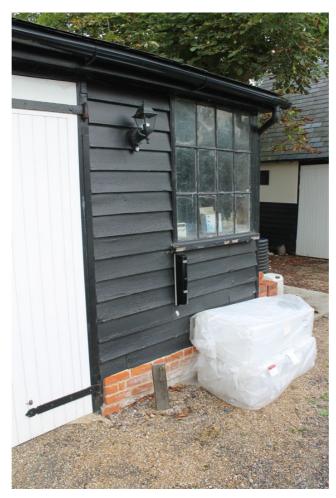
**Photograph 6** Detail of twelve-light window on southeast elevation of outshot - looking north.

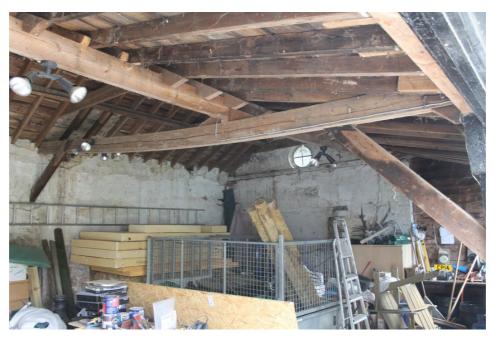
The interior of the building shows the roof, both in the main structure and the outshot, to be constructed of nailed together machine-cut timber, all similar in size and appearance (Photograph 7). This would suggest that the roof was entirely rebuilt when the outshot was added. No evidence remained of the south-eastern wall of the outbuilding, it appears to have been completely removed when the outshot was constructed. The interior brick and stone walls of the outbuilding are plastered over (Photograph 8).

Photograph 7 Interior of outbuilding and outshot - looking north.

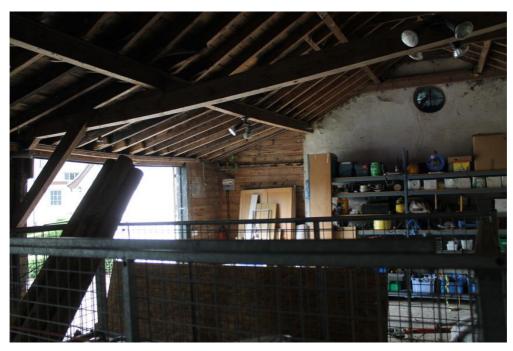
Photograph 8 Interior of outbuilding and outshot - looking south.

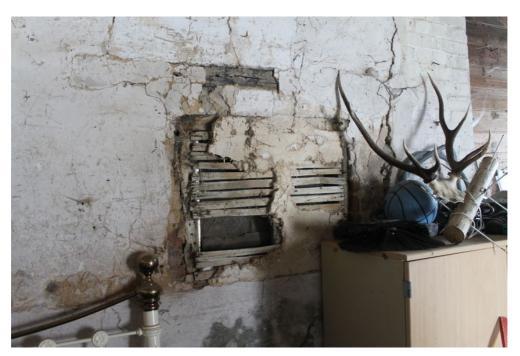
Photograph 9 Partially plastered over hatch from interior of building - looking east.

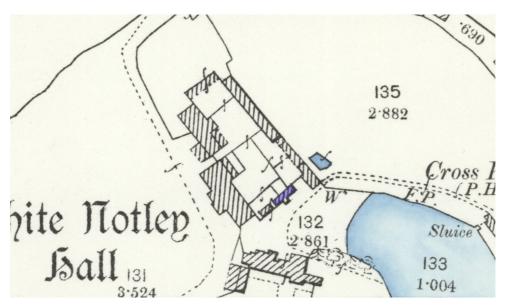
Map 2 1895 OS map. Outbuilding highlighted in blue.

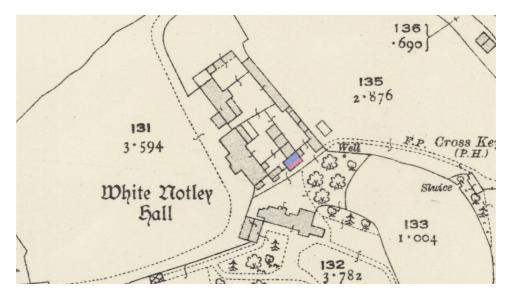
Map 3 1919 OS map. Outbuilding highlighted in blue, outshot highlighted red.

commercial needs. This makes the construction of the outshot and the conversion of the outbuilding into a garage much more likely to be post-1918 (ie post-war).

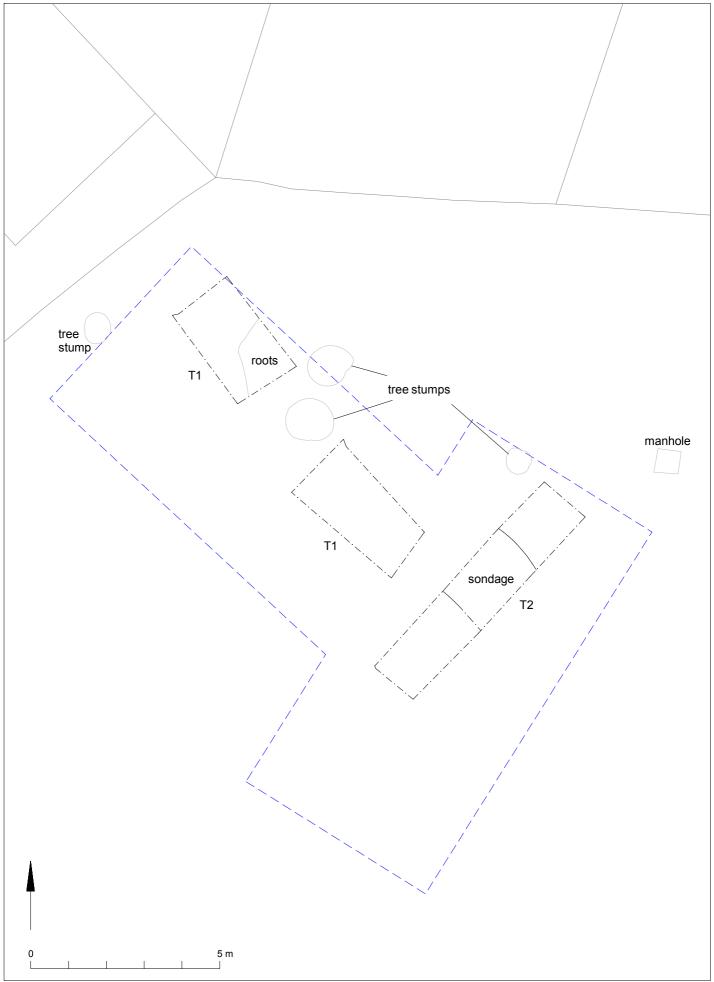
Two trial-trenches were excavated under archaeological supervision.

Fig 2 Results in relation to proposed development (dashed blue).

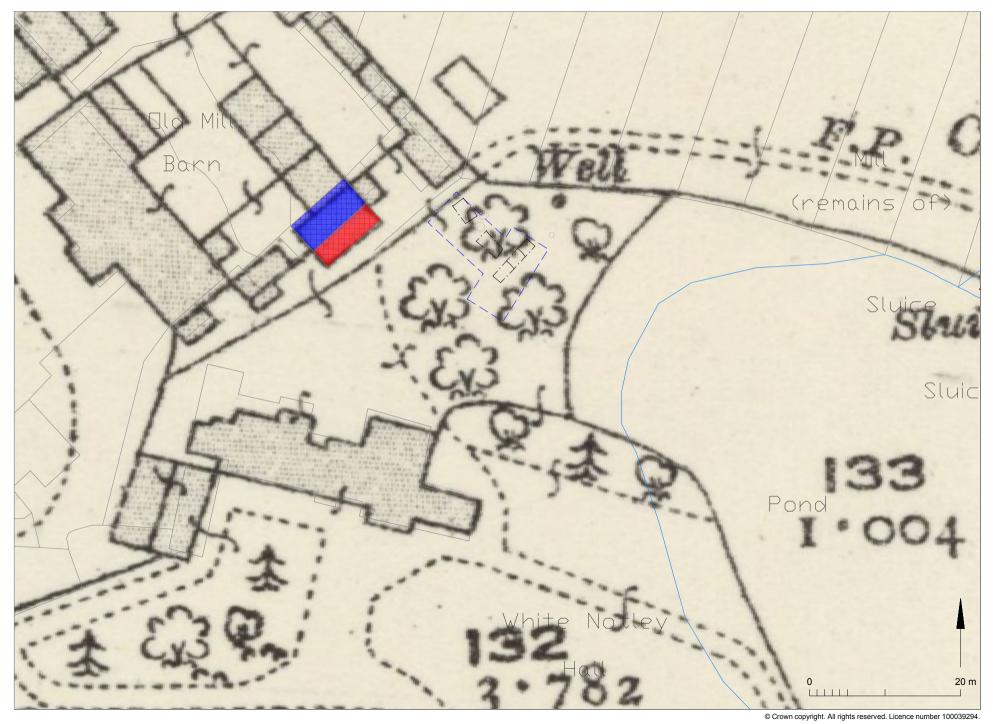
Archaeological evaluation at White Notley Hall revealed three layers of modern landscaping associated with the lake/millpond located to the southeast. Historic OS maps show that the lake/millpond was originally larger with a bank of trees on the northwestern edge (Fig 4). The evaluation trenches were located in this area. Layers L2 and L3 are likely to be layers of modern backfill, dumped onto the bank to either reduced to the size of the pond or to raise the bank to prevent flooding towards the hall/outbuilding. Layer L1 was later laid to create the current bank leading from the driveway to the lake/millpond.

Fig 4 Evaluation trenches in overlaid on the 1919 6-inch OS map (with outbuilding highlighted).

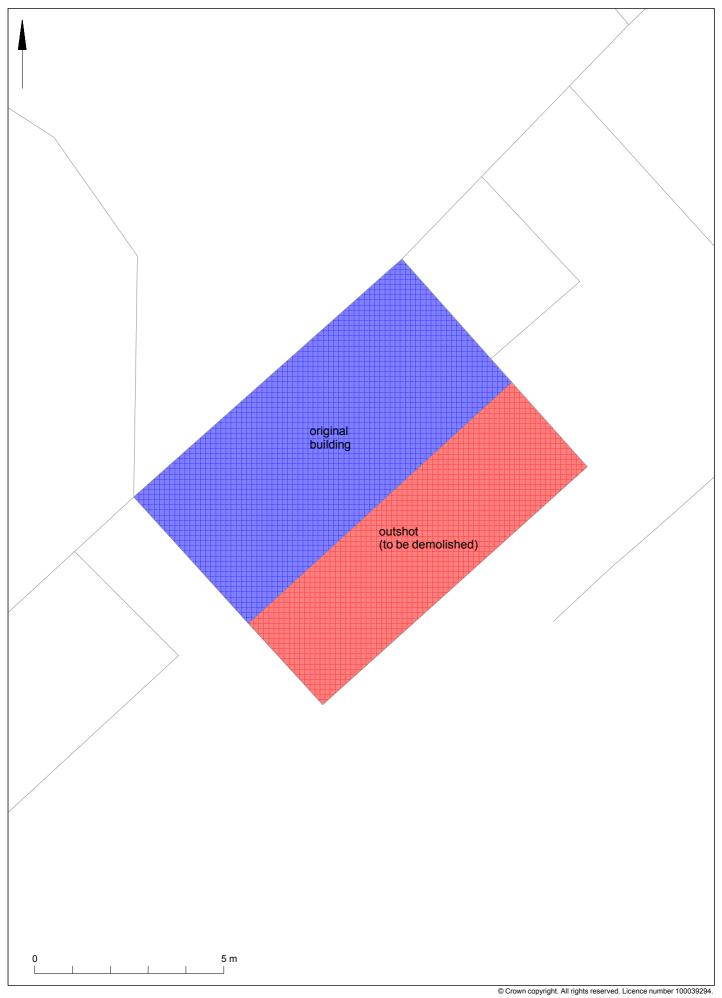
Fig 5 Outbuilding subject of Level 1 historic building recording. Original structure and later outshot highlighted.
