Historic building recording at The Forge, 18 Chipping Hill, Witham, Essex, CM8 2JS

May 2017

CAT Report 1148

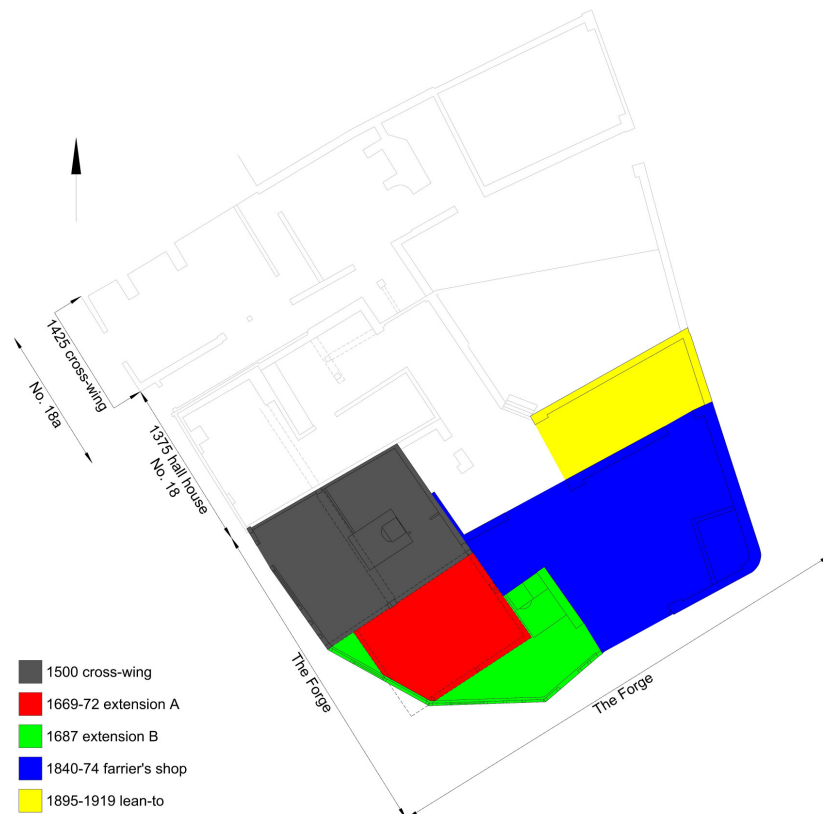
The Forge evolved from a medieval hall house which was built in 1375 (Fig 2 and below).

A cross-wing was added to the north end around 1425 and one was built at the south end around 1500. This second cross-wing was a jettied two-storey building. Chimneys were added in the 16th and 17th centuries, permitting the construction of an upper floor in

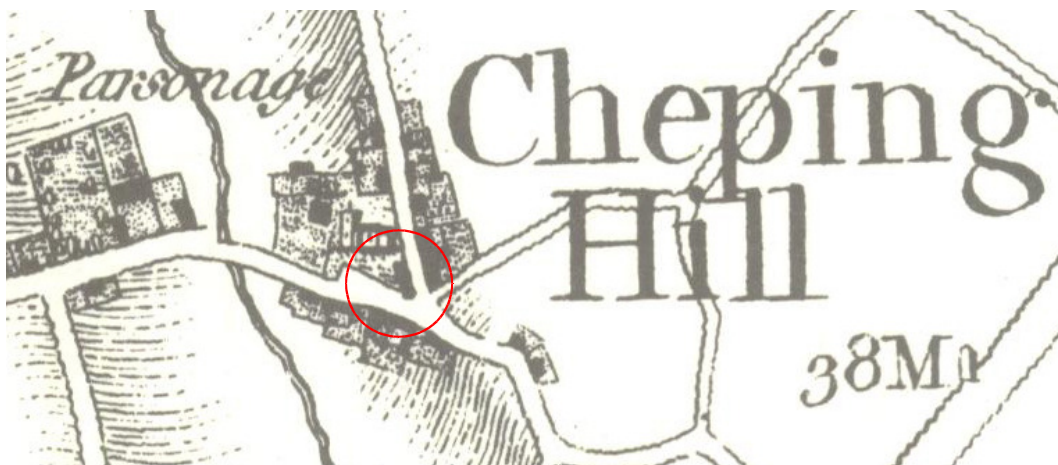
Map 1 1777 Chapman and André map of Essex (sheet 13).

The Forge is shown on the 1777 Chapman and André map of Essex (Map 1). This depicts a north-west to south-east aligned building in the location of the 14th-century hall house, but does not show the cross-wings. Chapman and André, however, employed stylised representations of buildings with roughly-defined dimensions rather than accurate plan forms, which accounts for their failure to record the precise layout of the building.

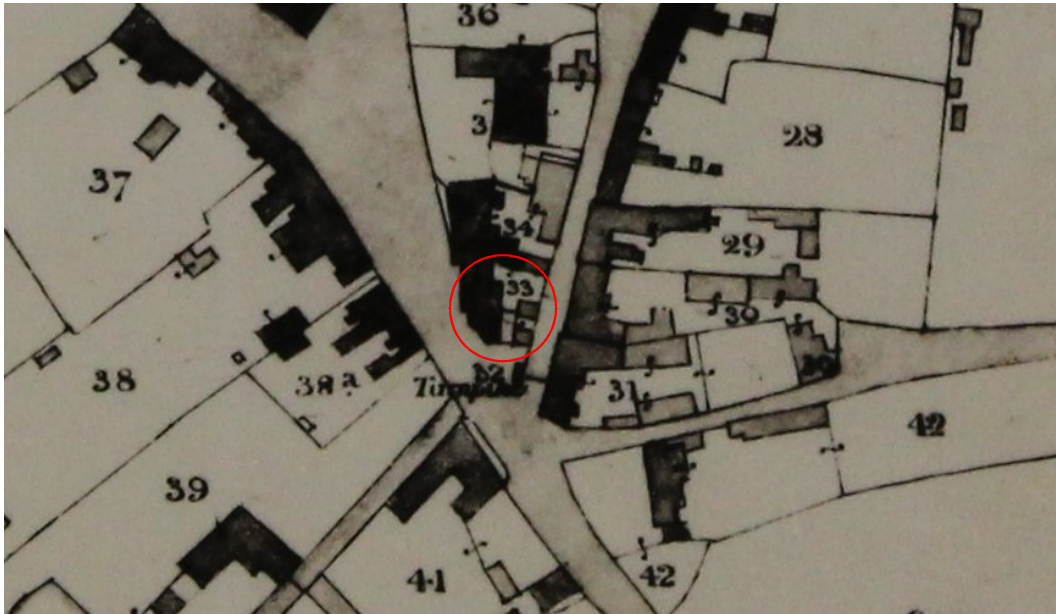
Map 2 1838 Tithe map for Witham (ERO D CT 405).

The first map that accurately represents the plan form of The Forge is the 1838 Tithe map for Witham (Map 2). The Tithe Award lists Parcel 33 as tenements and a blacksmiths shop, owned by Abraham Barnard and occupied by Miriam Richardson and two others. The map clearly shows the 14th-century hall house with the 15th-century cross-wings, the irregular-shaped smithy constructed in 1672 and two structures built on the garden and yard.

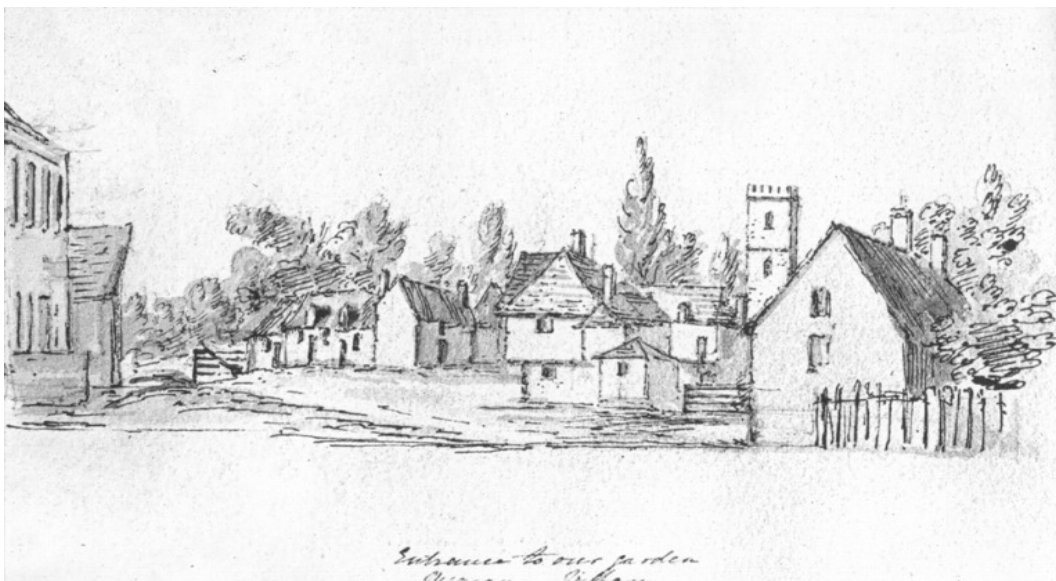
Illustration 1 1840 drawing of Chipping Hill by Mrs Clarissa Bramston (Gyford, 1999).

A drawing of Chipping Hill, made by the local vicar's wife, Mrs Clarissa Bramston in about 1840, has The Forge as its focus (Illustration 1). Drawn looking north-west, The Forge is partially obscured by the toll-house and gate at the bottom of Church Street but enough detail can be discerned to see that the farrier's shop has not yet been built.

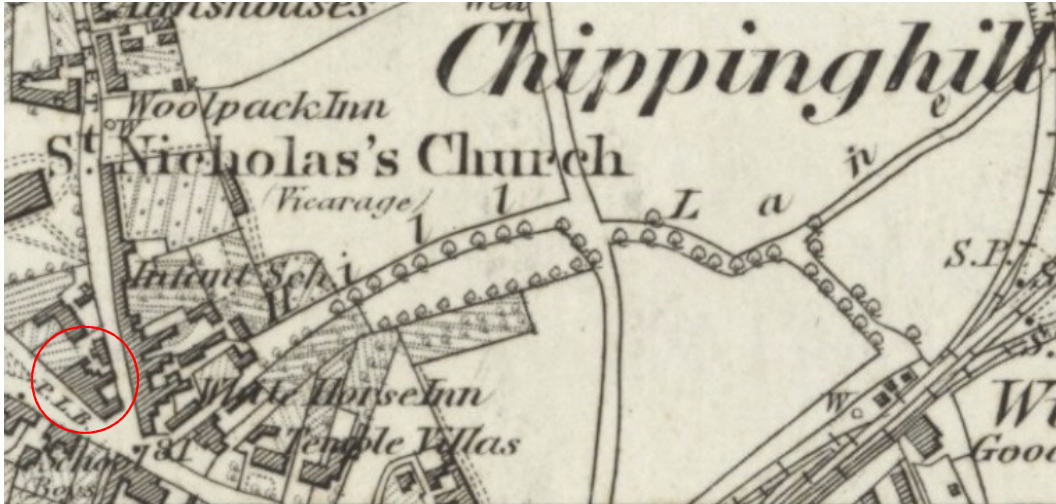
Map 3 1874 6-inch Ordnance Survey (Essex Sheet XXXV).

The 1874 6-inch edition Ordnance Survey map shows little change to the plan form shown by the Tithe map (Map 3). One slight difference is that the two structures shown in the yard on the Tithe map are now depicted as a continuous building joined to the main range which must represent the farrier's shop. The 1895 edition shows no change to the plan form.

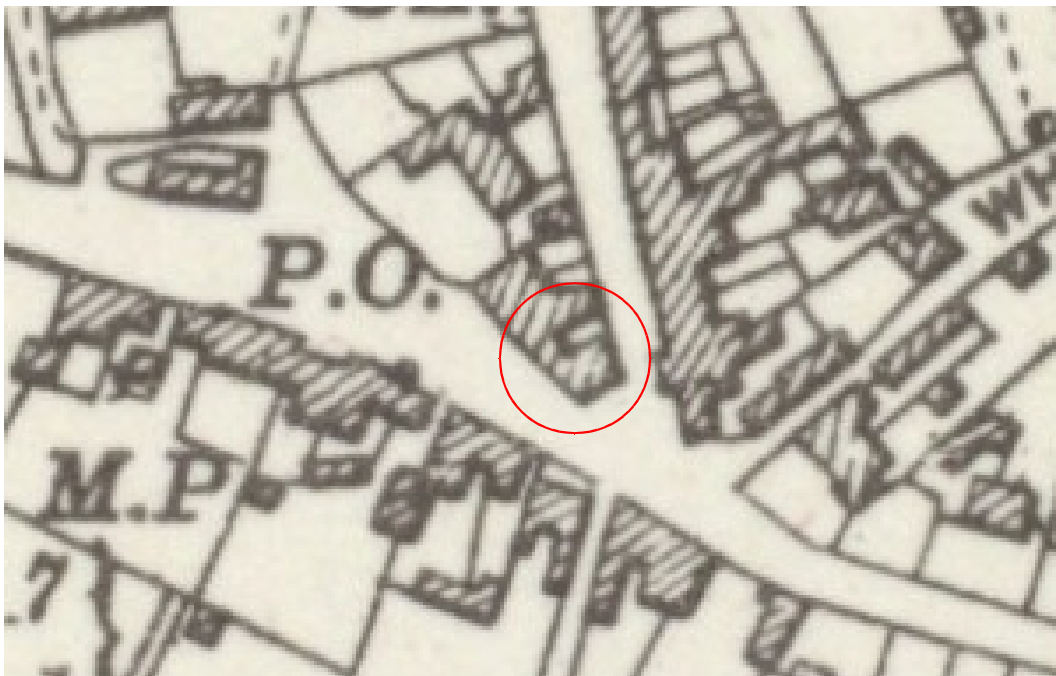
Map 4 1919 6-inch Ordnance Survey map (Essex Sheet nXLV).

A further 6-inch Ordnance Survey map produced in 1919 (Map 4) shows an additional structure built against the north side of the farrier's shop. This represents the single-storey lean-to storage shed.

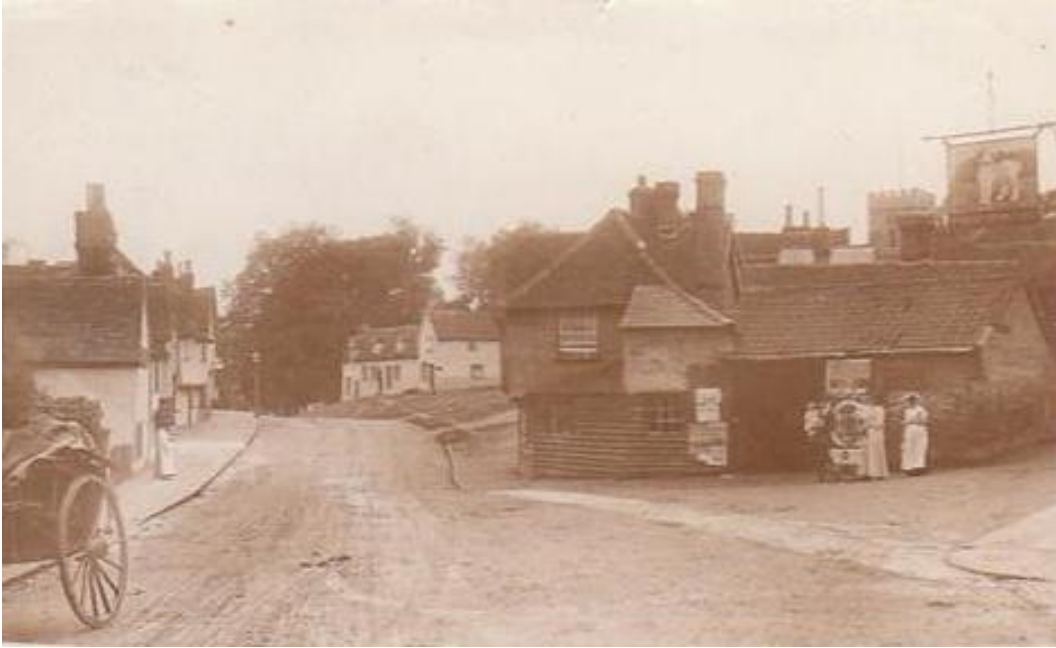
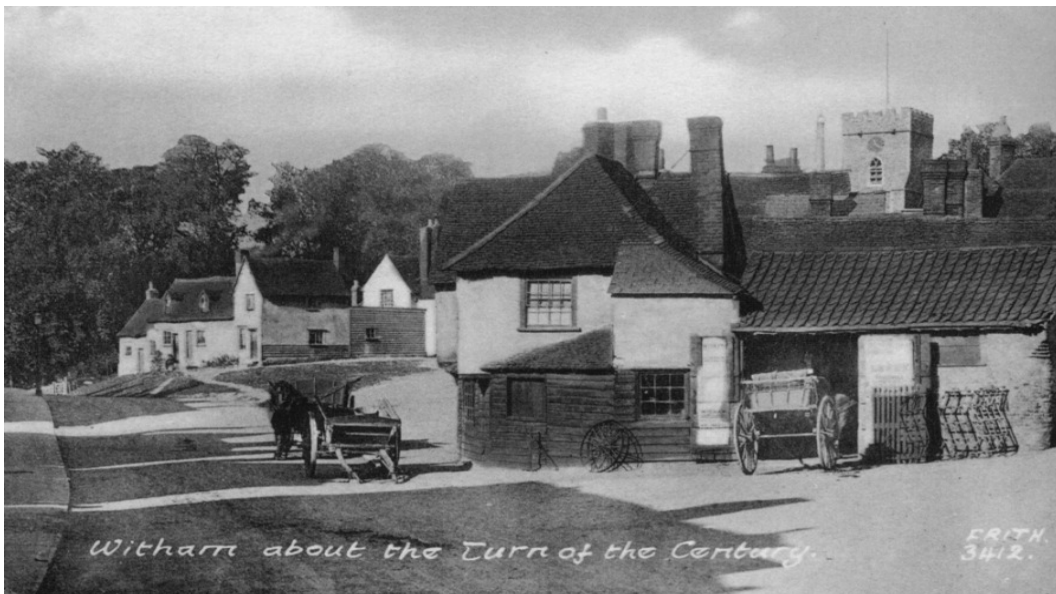
the time. Probably due to the advent of film in 1884 and the spread of (relatively) inexpensive and uncomplicated cameras, the earliest photographic images of The Forge date to c 1900. Historic Photographs 1 and 2 show the south-east elevation of the building looking much as it appears in the 21st century. The figures standing in front of the workshop in Historic Photograph 1 are likely to be the blacksmith of the time, Whitley Daniel Quay, and his family.

Historic Photograph 1 The Forge, Chipping Hill, c 1900 (<https://www.the-saleroom.com>).

Historic Photograph 2 The Forge, Chipping Hill, c 1900 (Palombi, 2009).

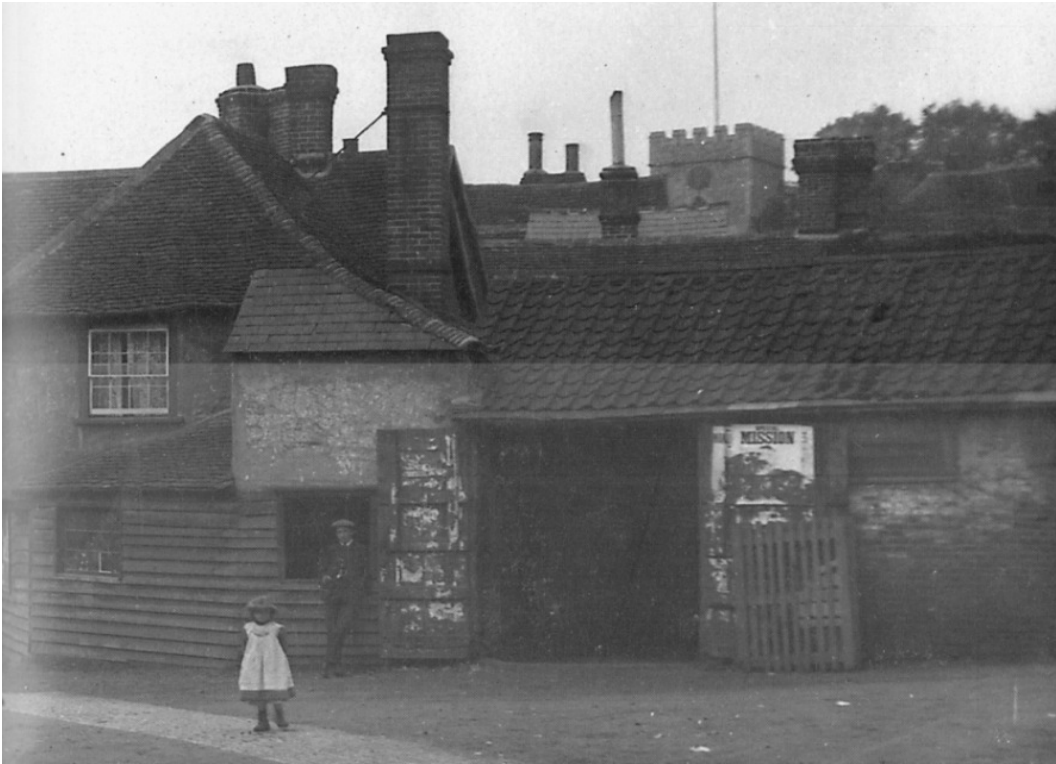
Historic Photograph 3 The Forge, Chipping Hill, c 1910 (Marriage, 1995).

Historic Photograph 3 shows the same view from c 1910. Whilst showing exactly the same building configuration as the earlier photograph, the improved clarity of this photograph shows that the roof of the upper storey extension to the left of the farrier's shop is clad in

slate, presumably a replacement for the original peg-tile. This replacement may date from the mid-19th century as slates became an affordable roof covering with the arrival of the railway in Witham in 1843.

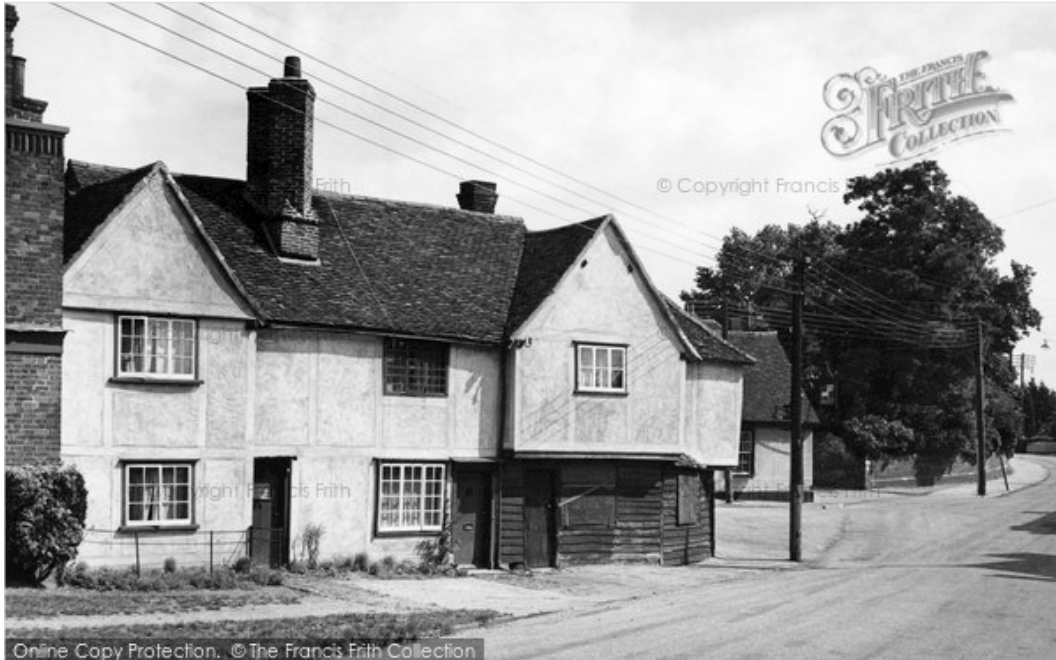
Historic Photograph 5 The Forge, Chipping Hill 1950

This photograph depicts the 14th-century hall house flanked by the 15th-century cross-wings. The Forge occupies the weatherboard-clad ground floor of the right-hand cross-wing, along with the 17th-century extensions to the right. With the exception that the render has been redone and the road surface has improved this could be a black and white photograph from the 21st century.

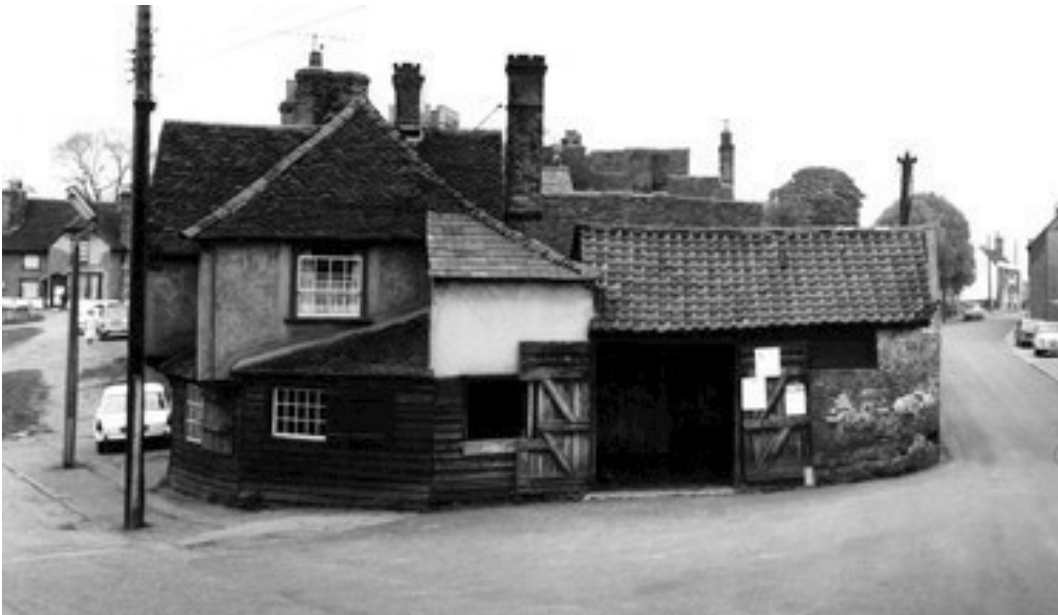
Historic Photograph 9 The Forge, Chipping Hill, c 1965
(https://www.francisfrith.com/witham/witham-the-forge-and-church-c1965_w119041).

This resistance to change is again shown by a postcard from c 1965 (Historic Photograph 9). Although presented in a neat and tidy fashion, the building is identical to what is depicted in the earlier photographs.

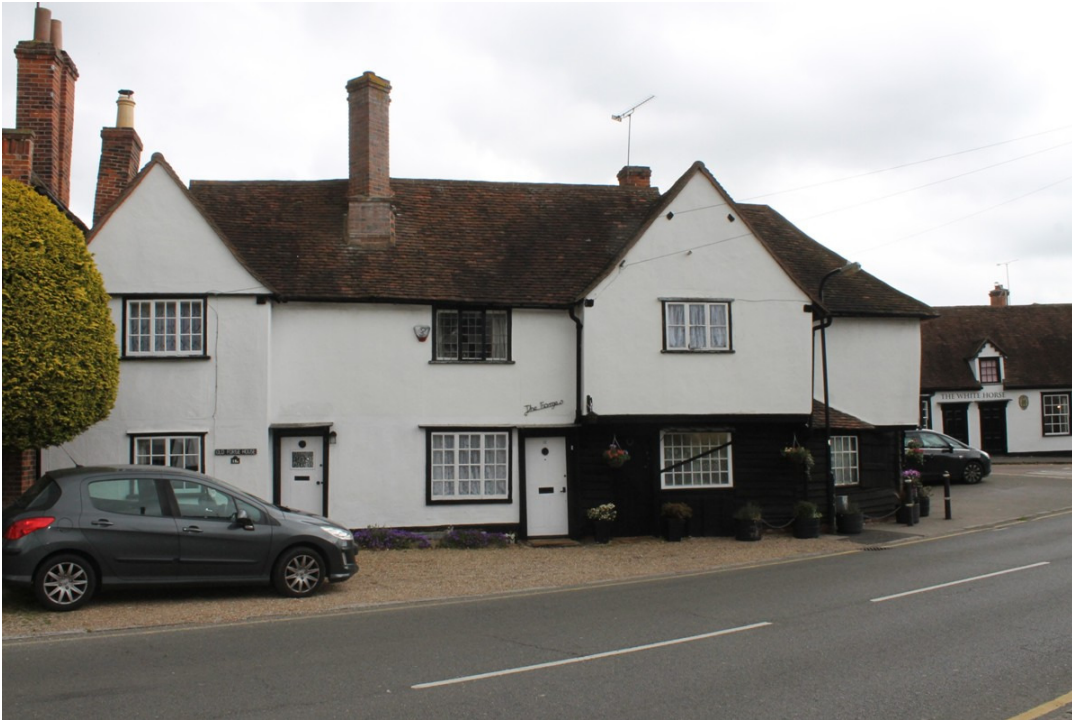
Photograph 1 South-west elevation of the medieval building with the 1425 cross-wing to the left (18a Chipping Hill), the 1375 hall house in the centre (mainly 18 Chipping Hill) and the 1500 cross-wing to the right (18 Chipping Hill to the upper floor, The Forge to the ground floor). The 17th-century extensions are to the right of the 1500 cross-wing - view north-east.

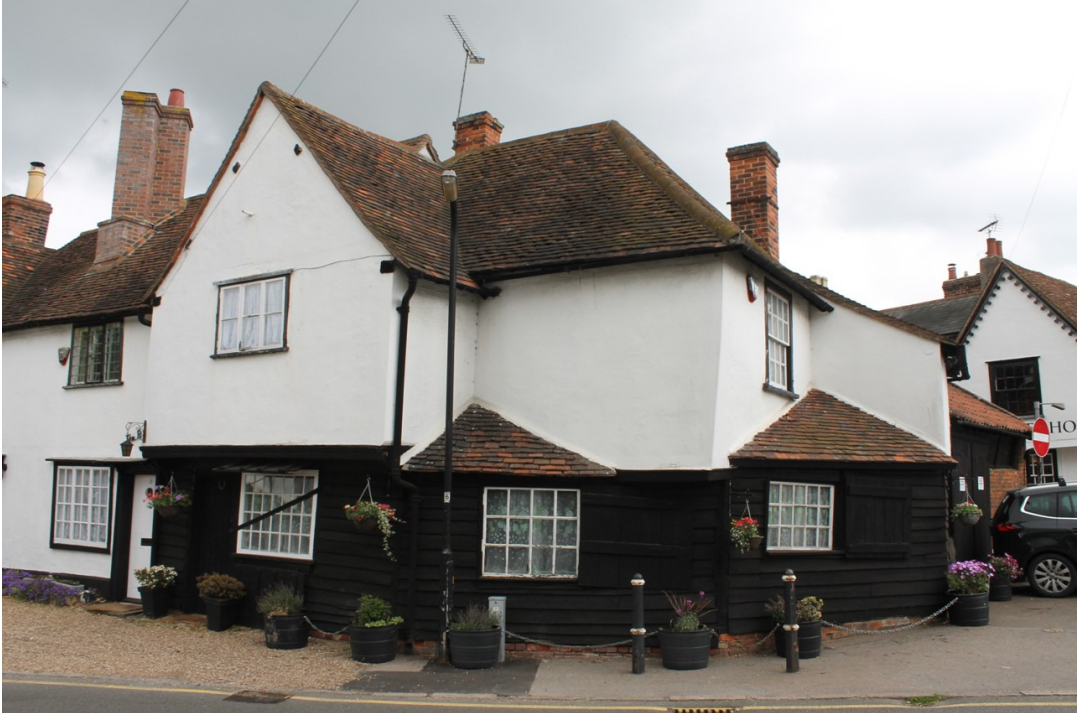
Photograph 2 South facing elevations of The Forge with extension A projecting from the cross-wing and the single-storey components of extension B wrapped around its base - view north.

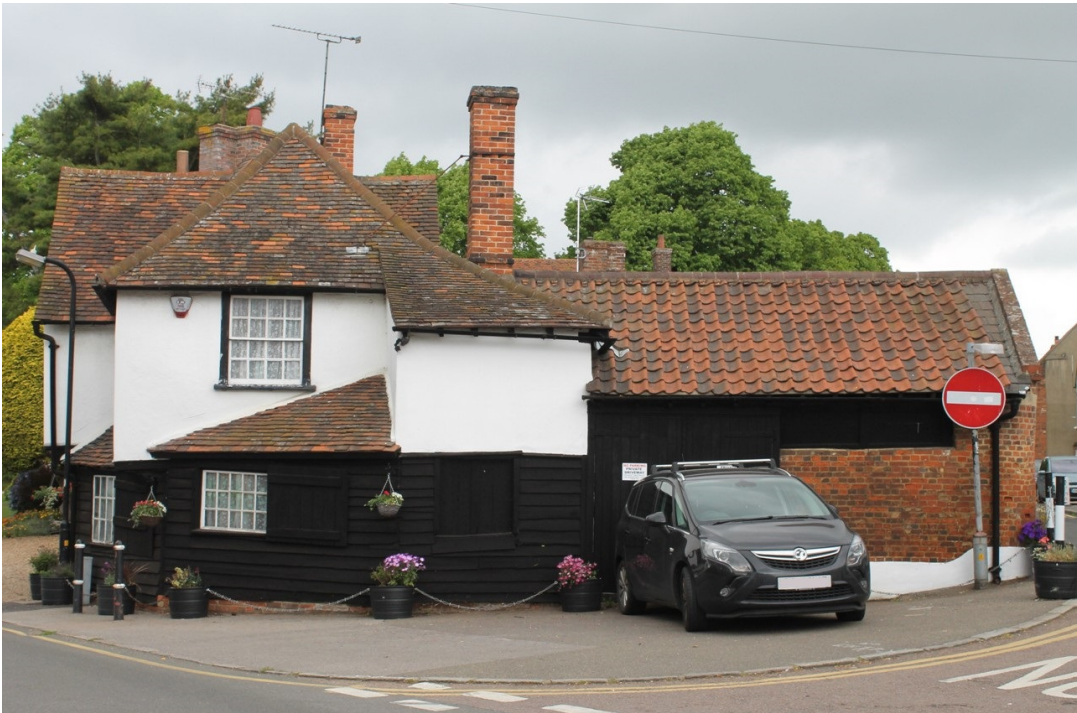
Photograph 3 South-east facing elevations of The Forge with extension A projecting from the cross-wing and the single-storey components of extension B wrapped around its base. The farrier's shop is to the right of the main range - view north-west.

The farrier's shop is a single-storey structure with a gabled roof built up against the main range (Photograph 3). It has a set of full-height doors on both elevations and there are window openings below the eaves in the south-east wall (Photograph 8). These are glassless and have internal, top-hung timber shutters. The structure is made of red brick with dimensions of 210mm x 100mm x 60mm laid in English bond. The wall is curved at the south-east corner and the farrier's shop is irregular in plan (Fig 2). The reasons for these oddities become clear when the north-east wall is viewed (Photograph 9). Changes in the brickwork of this wall indicate that the gable of the farrier's shop was constructed upon an existing wall, either the boundary wall to the yard and garden or on part of the free-standing structure shown on the 1838 Tithe map. The lean-to is built up against the farrier's shop and the mono-pitch roof of this is reflected in the slope of the modern boundary wall.

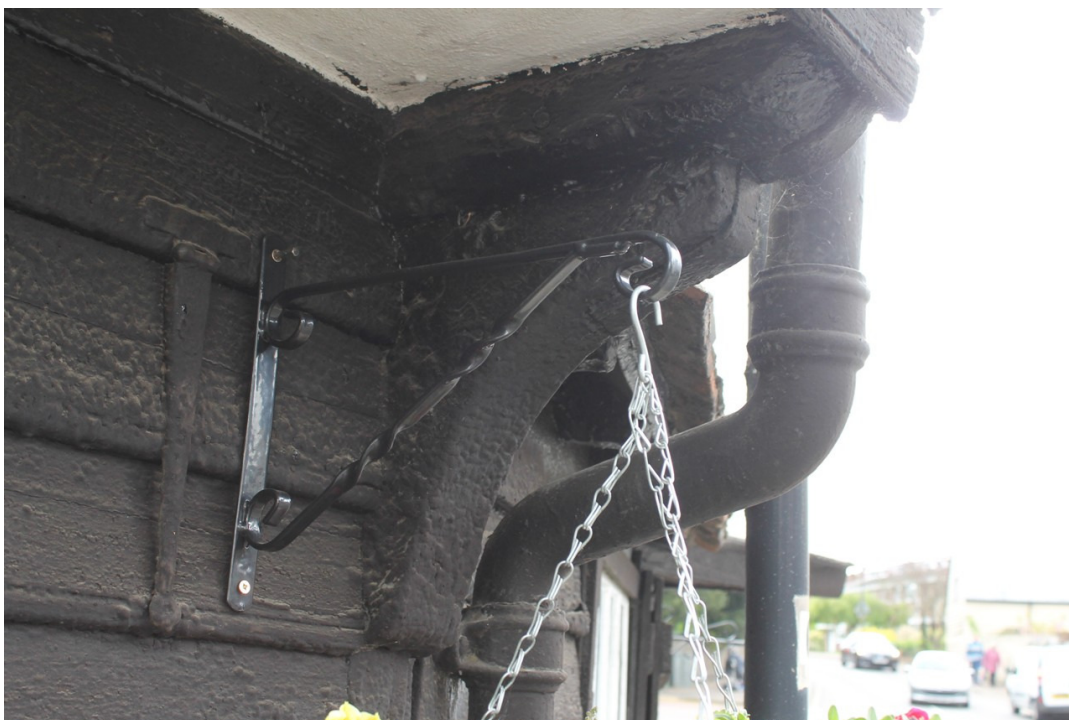
photographs show the walls to have simple panels of textured decoration. The jetty above The Forge is supported on the original brackets (Photograph 4). The walls of The Forge itself are not rendered. The external walls of The Forge comprise the south-west wall of the cross-wing and the angled sections of extension B (Photographs 2 and 3). These are bitumen-coated, horizontal weatherboard with large window openings in each section. Although all but one of these windows now hold frames of multiple lights these would have originally been glassless openings covered with timber shutters. All of the shutters have survived. Two of the shutters to extension B are simple, side-hung shutters, that swing outward from the wall to cover the window opening (Photograph 5), whilst the remaining set are internally-hung and cover a glassless opening (Photograph 6). However, the window opening to the cross-wing has top- and bottom-hung shutters (Photograph 7). The reason for this is that the lower shutter would have been lifted into a horizontal position to use as a counter with the top-hung shutter swinging out to provide an awning to shelter goods being displayed for sale.

Photograph 4 Original bracket supporting the jetty of the cross-wing above The Forge - view south-east.

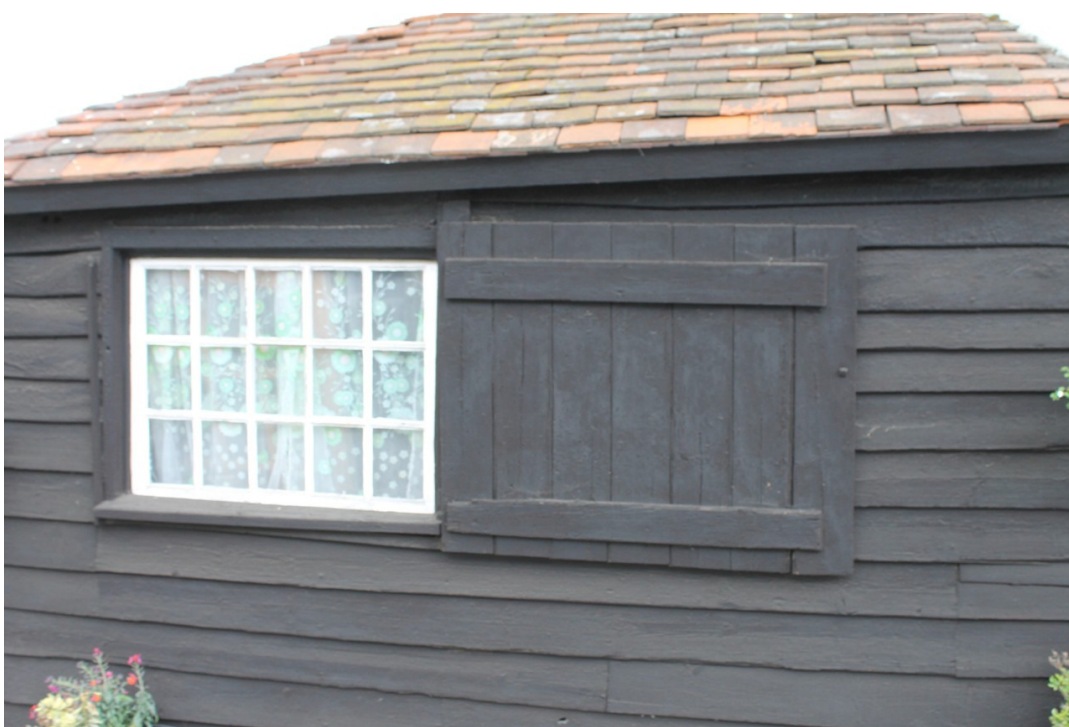
Photograph 5 One of the two window openings in extension B with a side-hung shutter - view north.

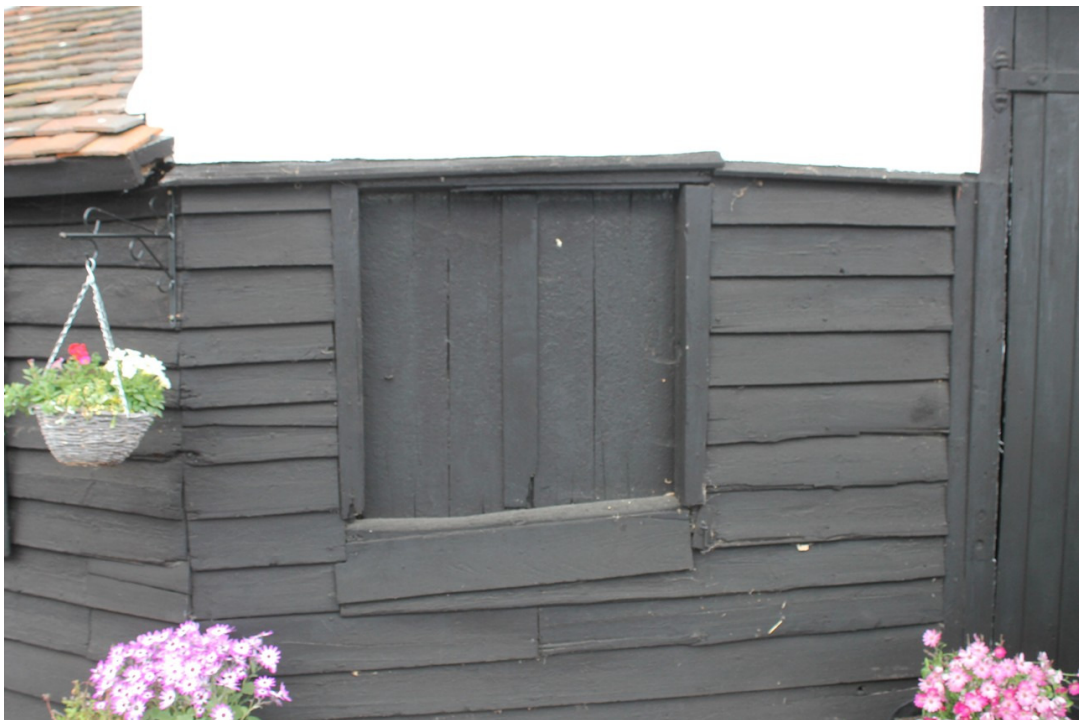
Photograph 6 The glassless window opening in extension B with internal side-hung shutters. The farrier's shop is to the right - view north-west.

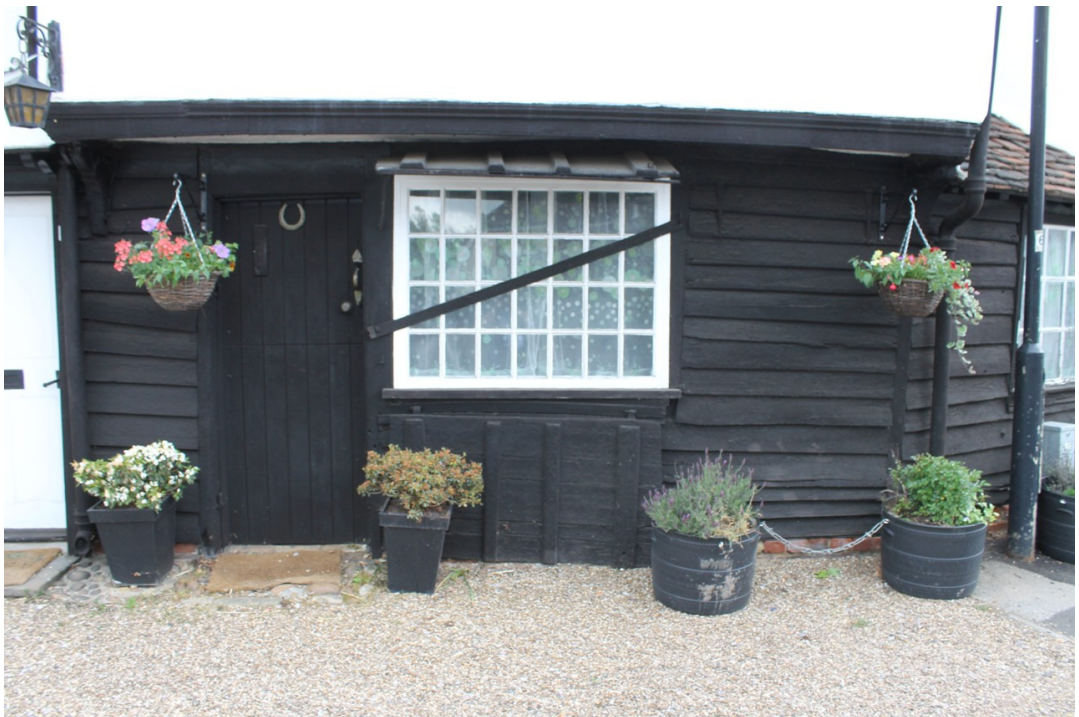
Photograph 7 The window opening in the cross-wing with top- and bottom-hung shutters that would have formed a counter from which the blacksmith sold items made at the smithy - view north-east.

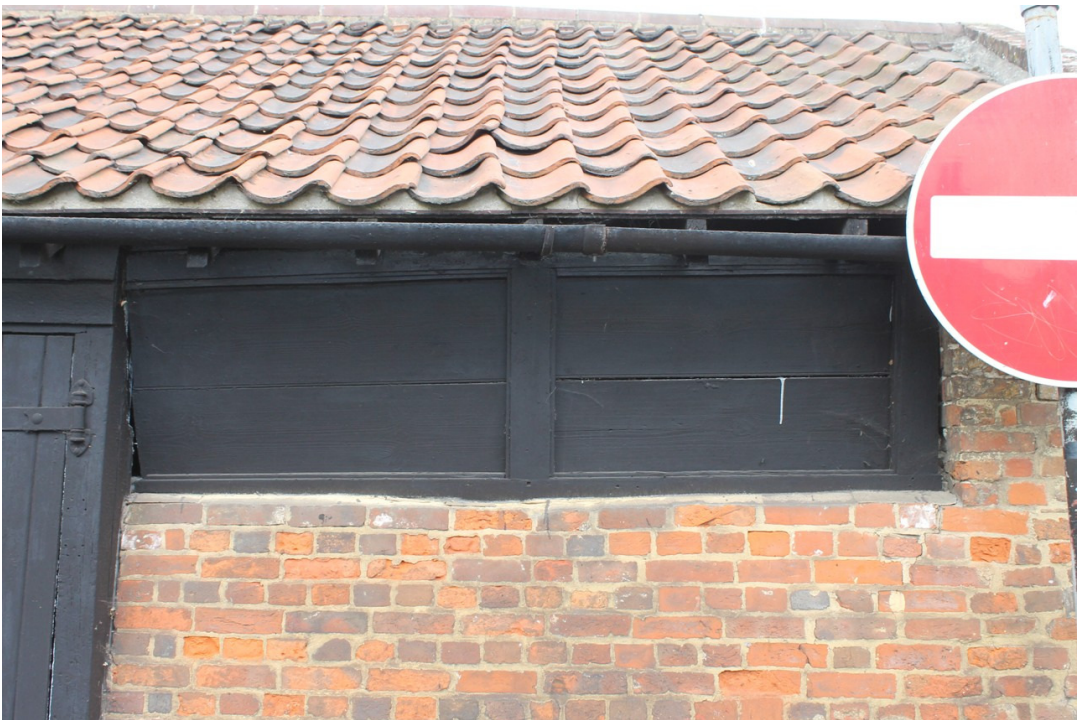
Photograph 8 Window openings below the eaves of the farrier's shop with internal top-hung shutters. These openings have been inserted into an earlier wall, either the boundary wall to the yard and garden or part of the free-standing structure shown on the 1838 Tithe map - view north-west.

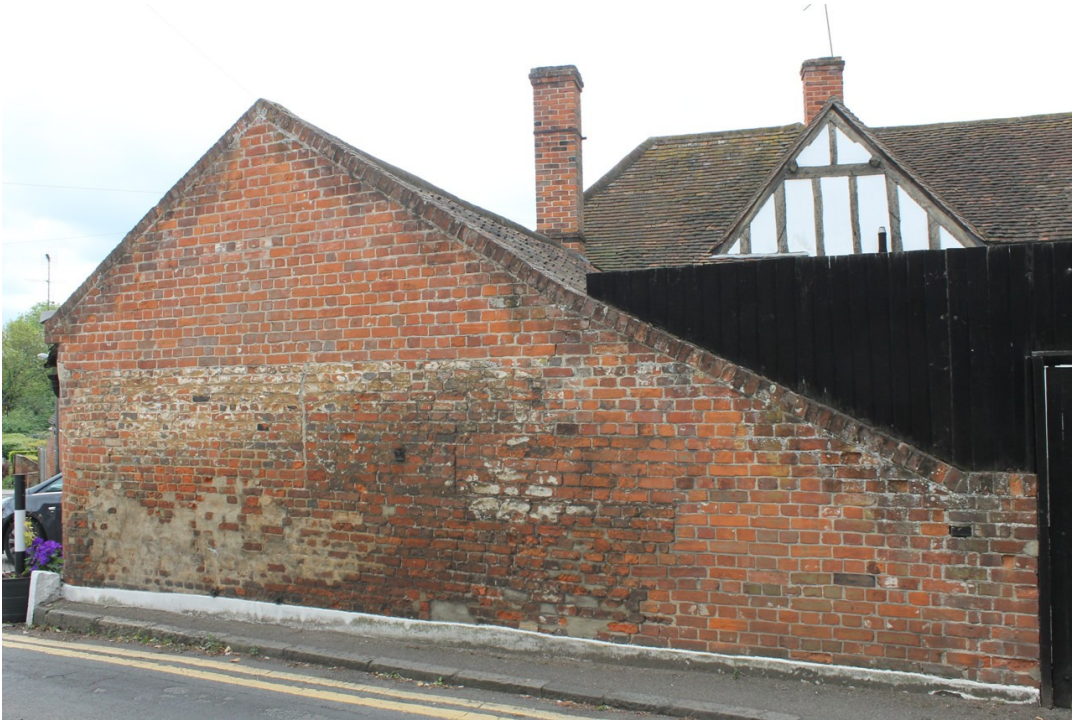
Photograph 9 North-east wall of the farrier's shop and the lean-to. Changes in the brickwork clearly indicate that the gable is constructed upon an earlier wall, either the boundary wall to the old yard and garden or part of the free-standing structure shown on the 1838 Tithe map - view west.

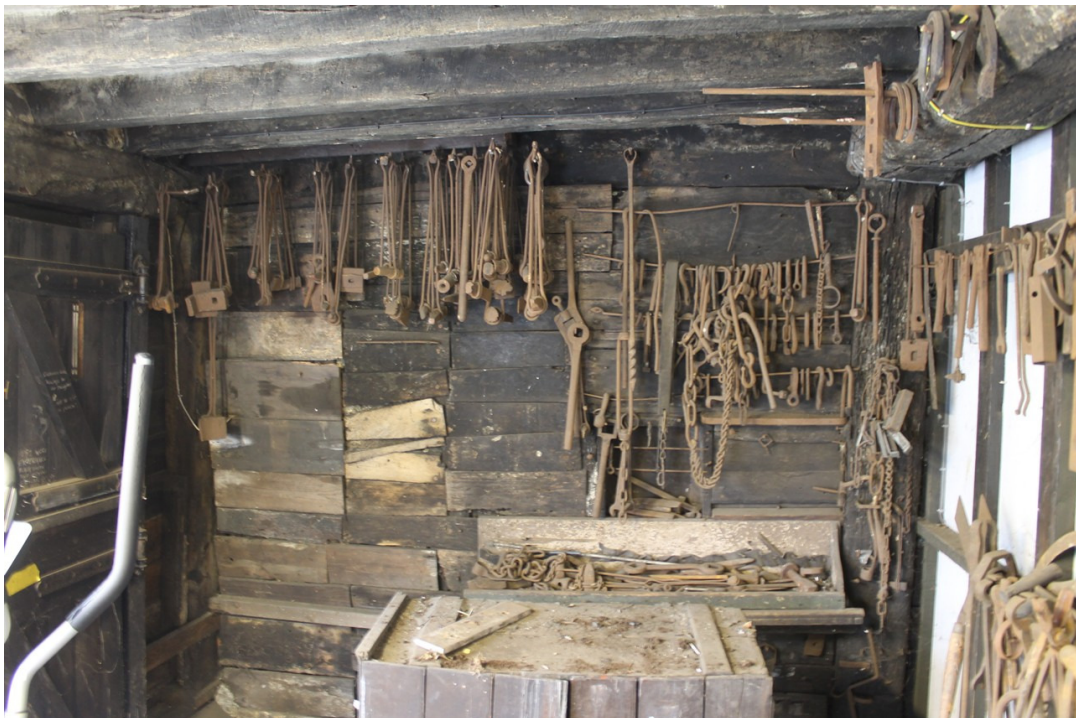
Photograph 10 North-west wall of the front bay to the cross-wing with the original doorway to the left and the inserted stud wall to the right. The studs of the wall frame are concealed behind the plank covering - view north-west.

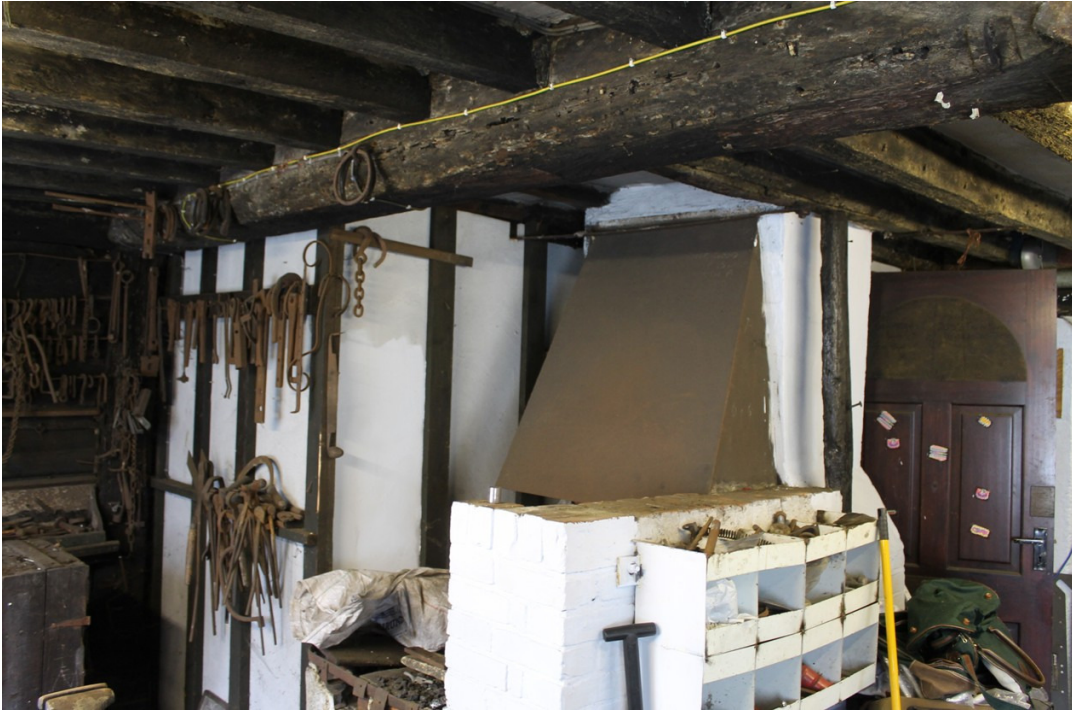
Photograph 11 Rear bay of the cross-wing with one of the two forges and the inserted stud walls behind. The bridging beam has chamfered edges and stepped stops - view north.

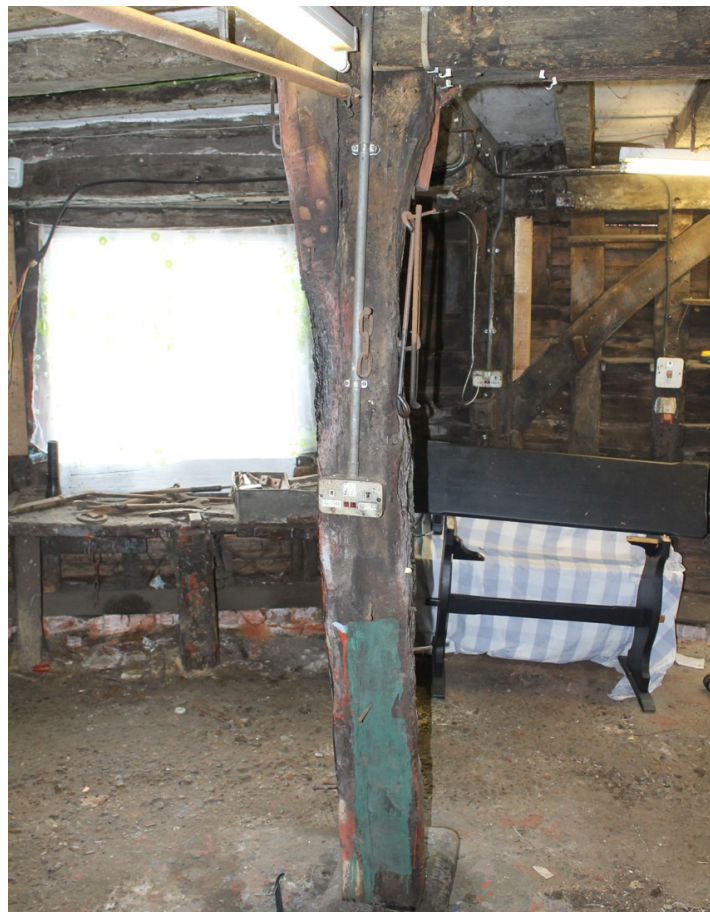
Photograph 12 Intermediate post with jowled head carrying the bridging beam between the front and rear bays of the cross-wing - view south.

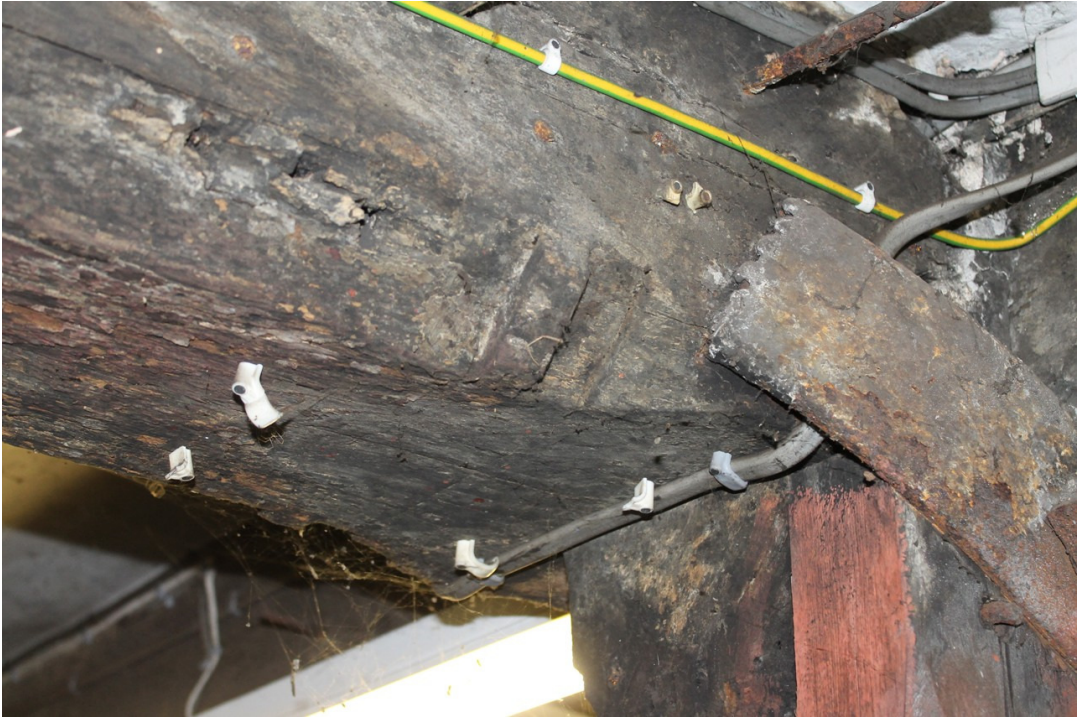
Photograph 13 Detail of the bridging beam between the front and rear bays of the cross-wing, showing the chamfered edges and stepped stops - view east.

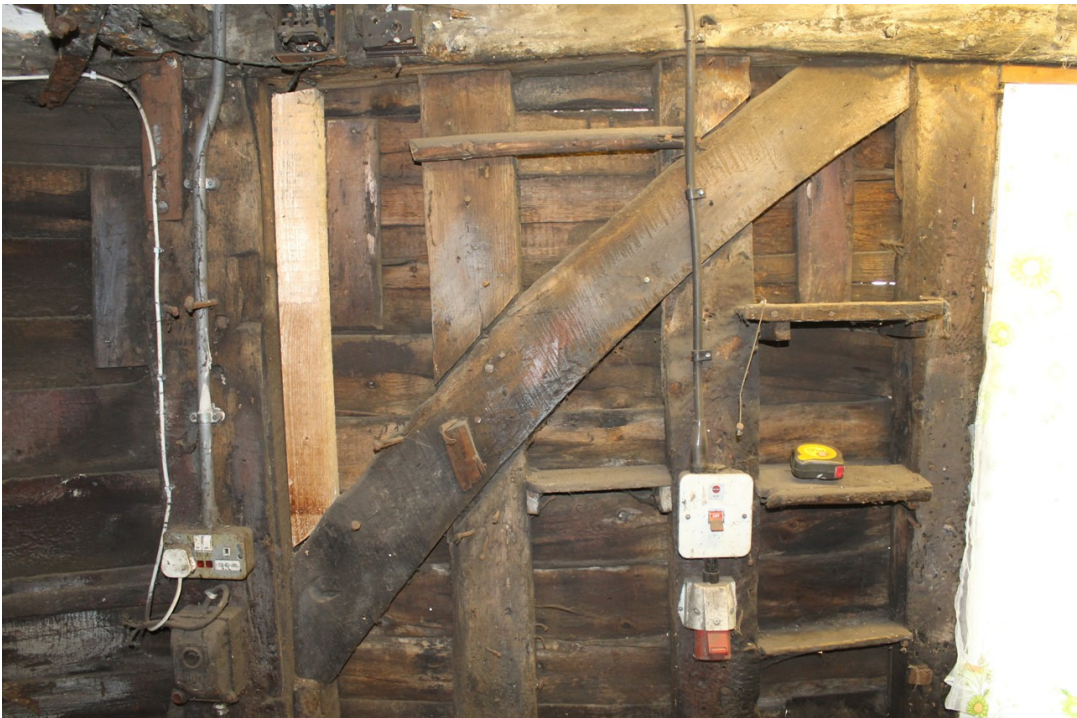
Photograph 14 Internal brace and studs to the front frame of the cross-wing - view south-west.

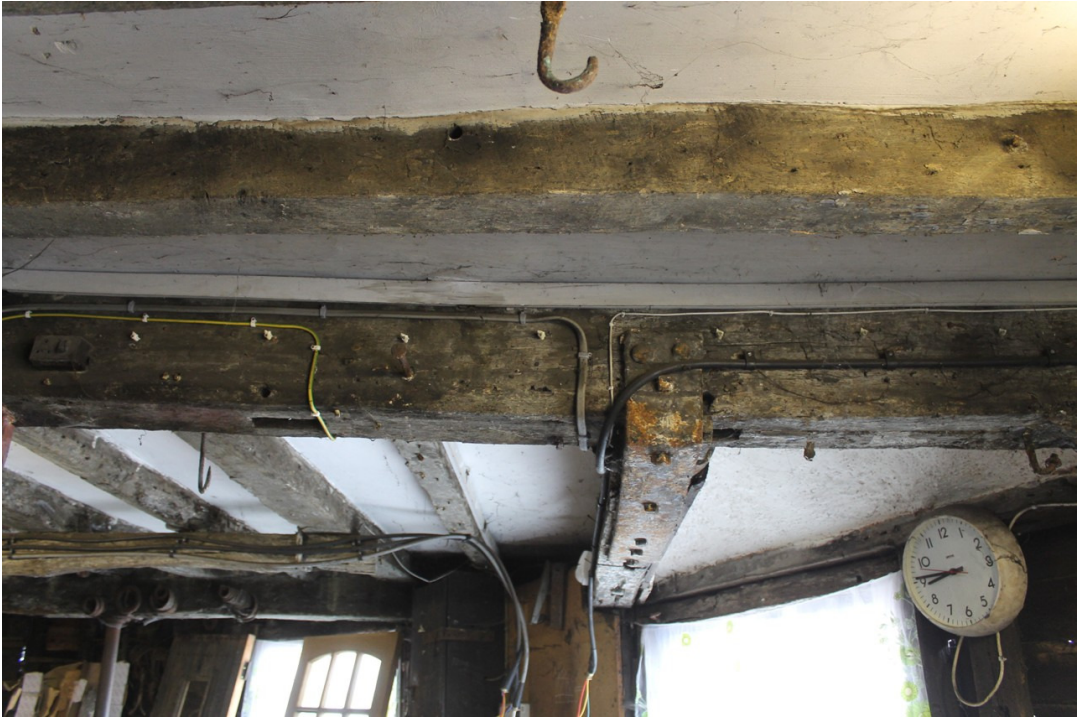
The studs of the south-east frame to the front bay have been completely removed. However, as only two widely-spaced mortices are present in the wall plate, this may be an indication that the framing once held windows (Photograph 15). The missing studs were single-pegged to the wall plate, which has dimensions of 260mm high by 140mm wide. The framing of the north-west wall of the front bay to the cross-wing is concealed behind short sections of horizontal planking (Photograph 10). The floor in the cross-wing (and indeed throughout The Forge) is of patched concrete, although originally dirt floors or rammed clay floors would have been present.

Photograph 15 South-east wall plate to the front bay of the cross-wing with two widely-spaced mortices, perhaps indicating windows were once located here. The 17th-century extensions are behind the wall plate, with extension A's wall plate tied into the wall plate of the cross-wing - view south-east.

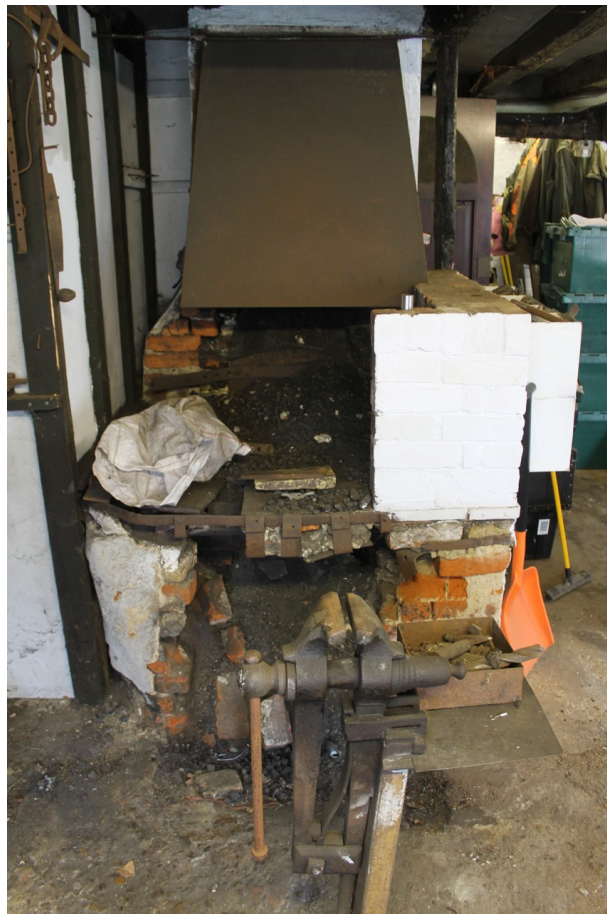
The forge which is located within the cross-wing is constructed from unfrogged red brick with dimensions of 220mm x 105mm x 65mm bonded with lime mortar (Photograph 16). The insertion of the forge chimney stack has partially removed one of the joists.

Photograph 16 Forge in cross-wing - view north-east.

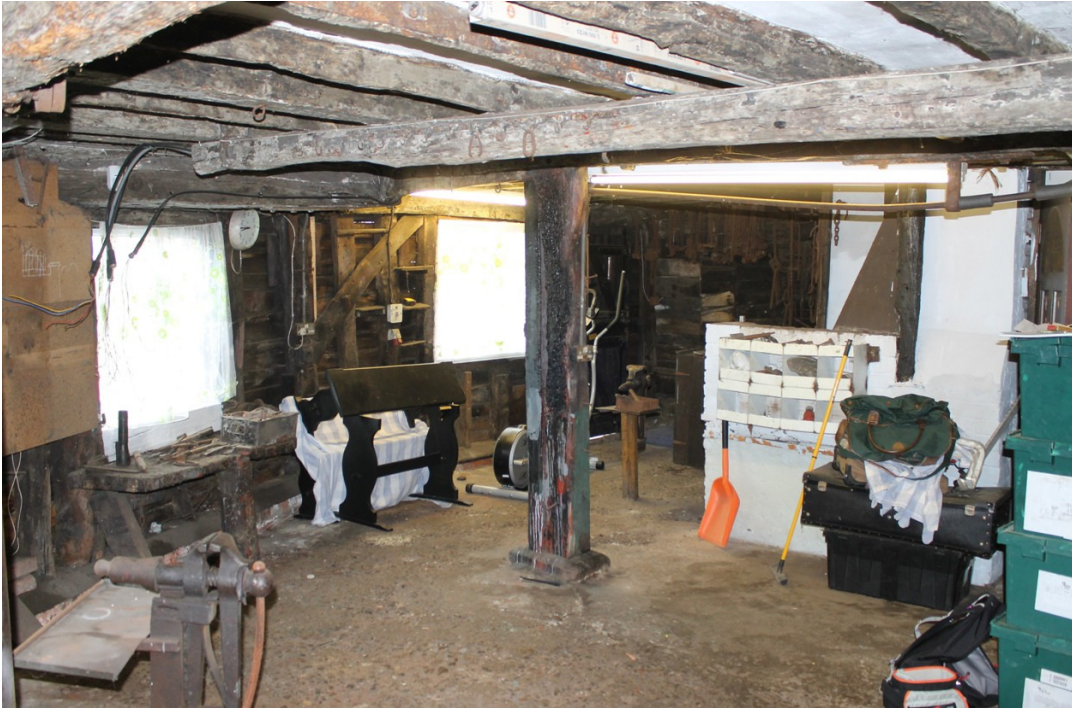
One of the inserted posts below the north-east wall plate supports a re-used beam extending south-west from the rear wall plate, attached to the undersides of the joists, but not connected to the opposite wall plate (Photographs 17-19). This may be an attempt to offset the risk of racking caused by the removal of the corner posts.

Photograph 17 Extension A built against the south-east wall of the cross-wing - view west.
