Historic building recording at The Forge, 18 Chipping Hill, Witham, Essex, CM8 2JS

May 2017

CAT Report 1148

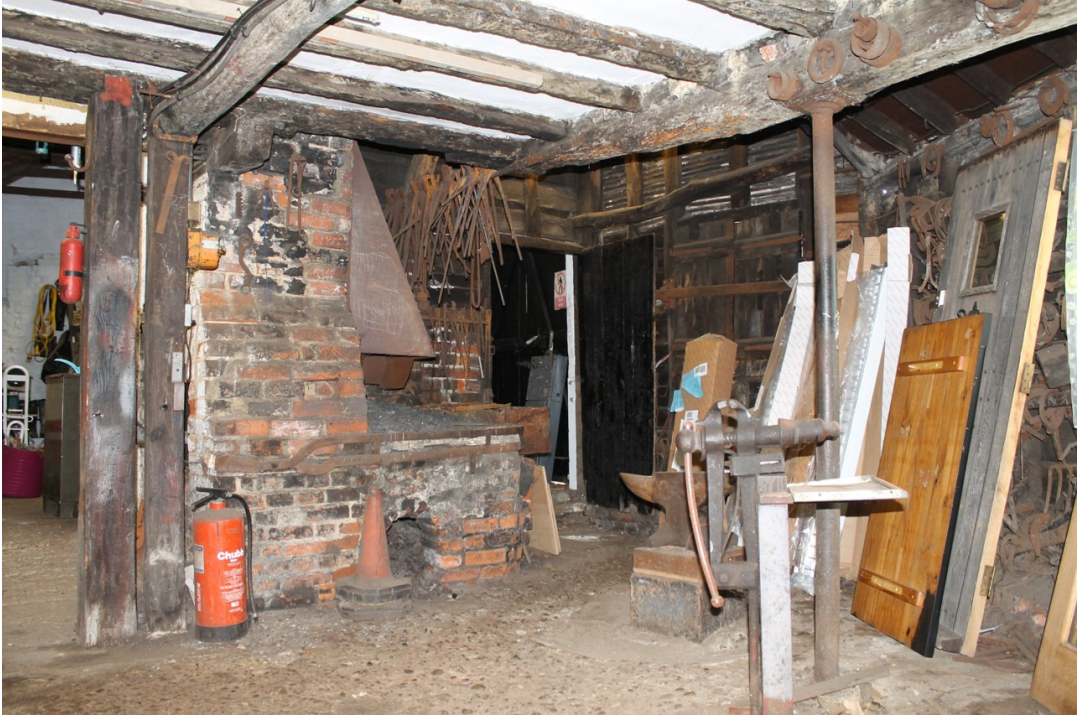
Photograph 19 Extension A with forge located in extension B behind. The wall plates of extension A are supported on iron columns and the replacement timber posts to the left of the forge chimney stack. The corner post of the timber frame has been removed to allow the forge to be worked - view north-east.

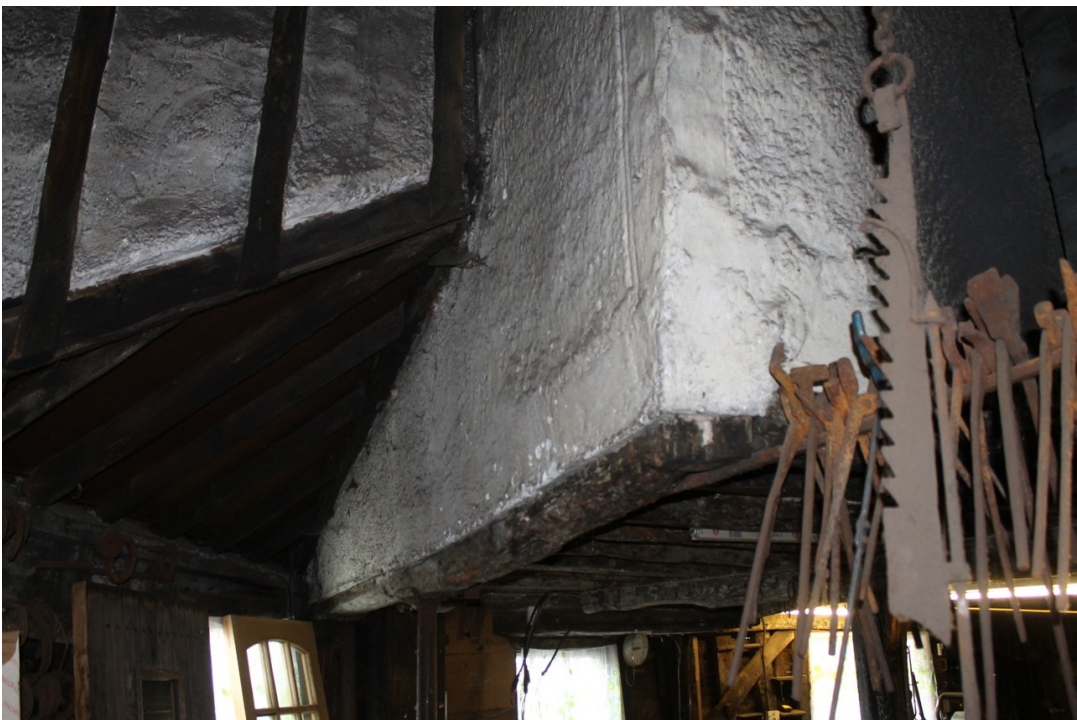
Photograph 20 The north-east corner of extension A viewed from extension B where the corner post of the timber frame has been removed to allow the forge to be worked. The original render of simple panels with textured decoration to extension A has been hidden and preserved by extension B - view west.

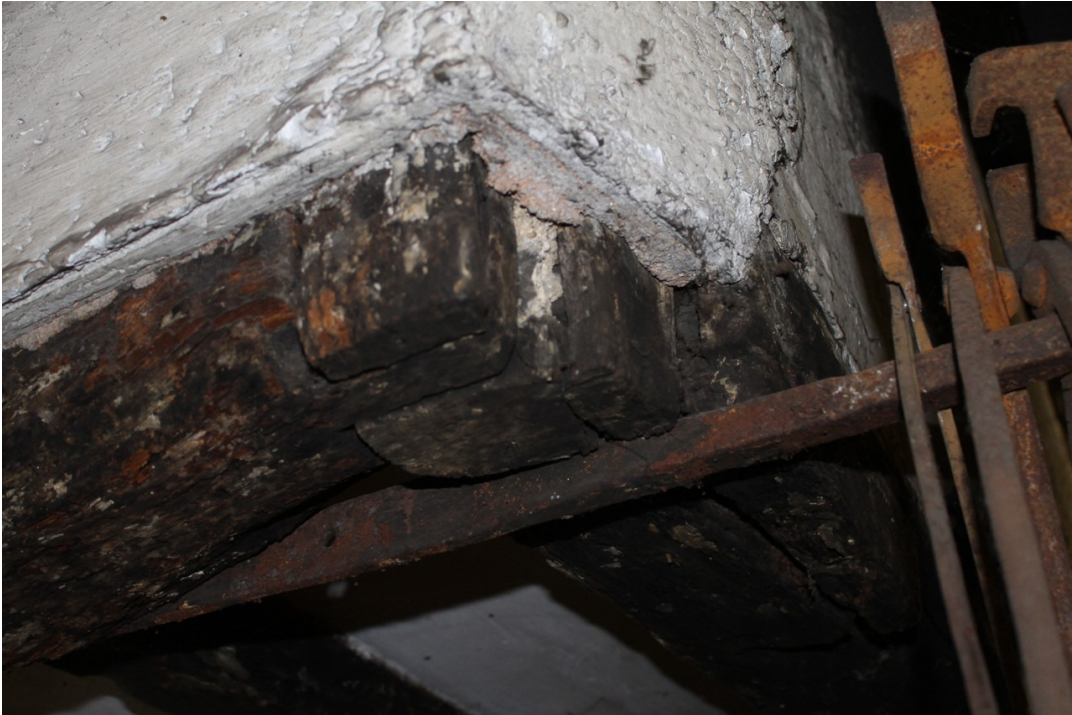
Photograph 21 The north-east corner of extension A viewed from extension B where the corner post of the timber frame has been sawn off, exposing the joints with the adjoining wall plates.

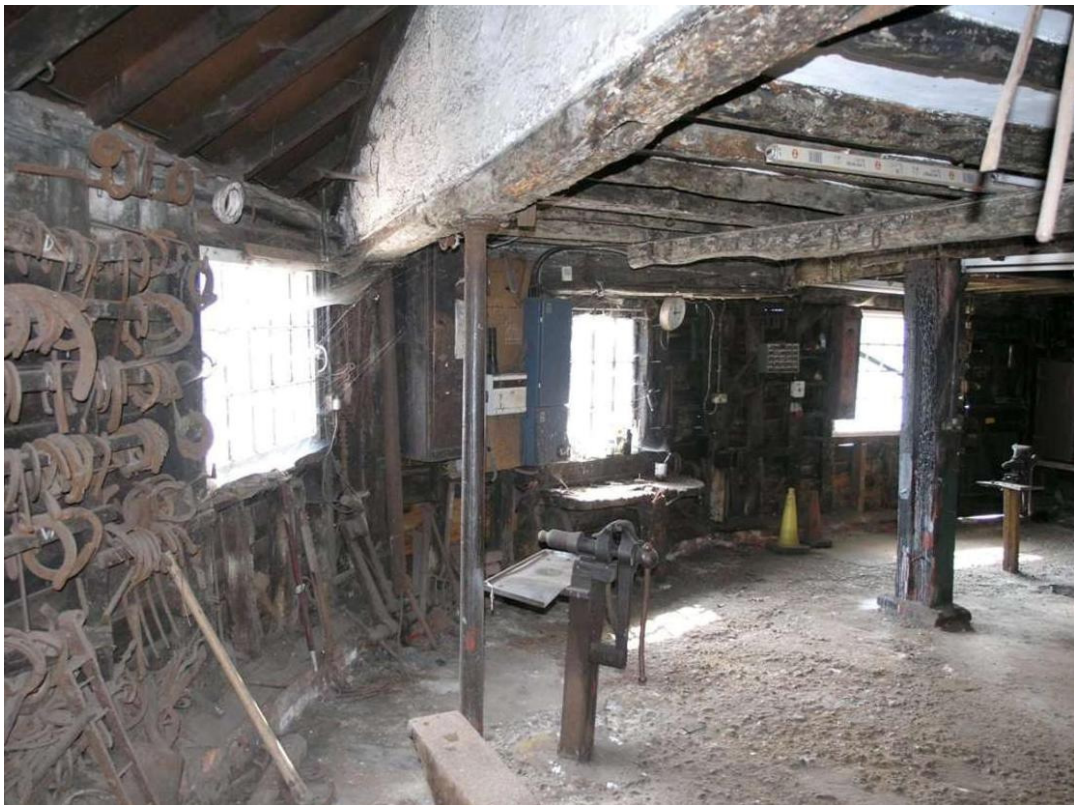
Photograph 22 The first and second sections of the exterior wall to extension B with extension A to the right - view south-west (Copyright John D Wood).

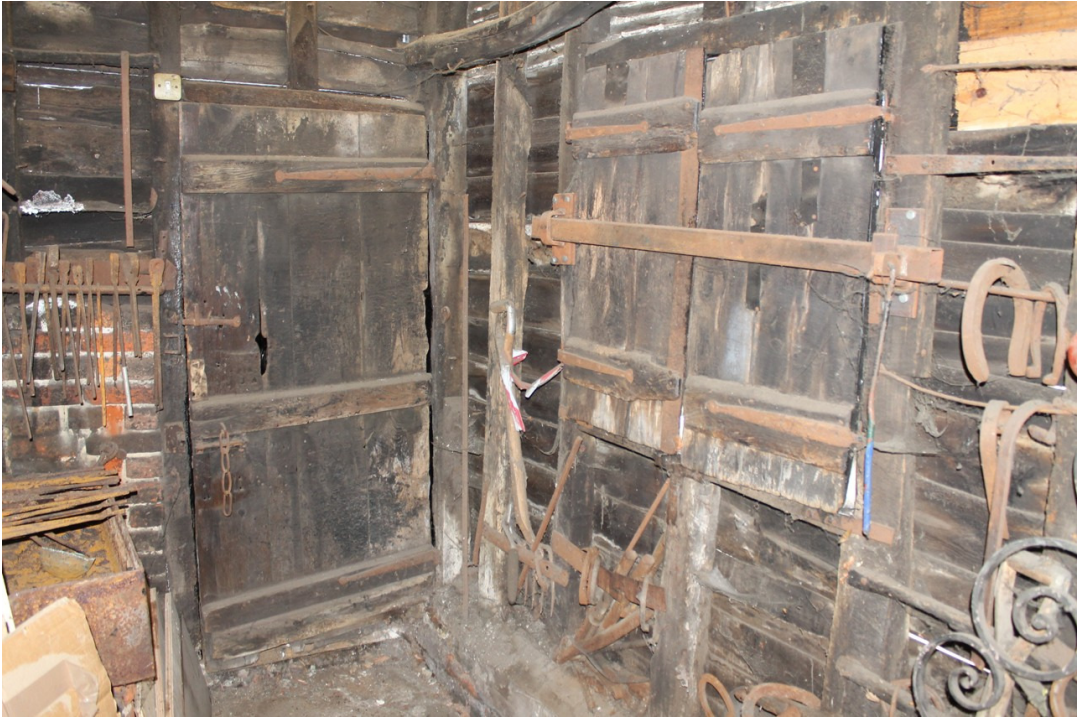
Photograph 23 The third section of the exterior wall to extension B showing the original timber shutters to the right and the door to the farrier's shop - view east.

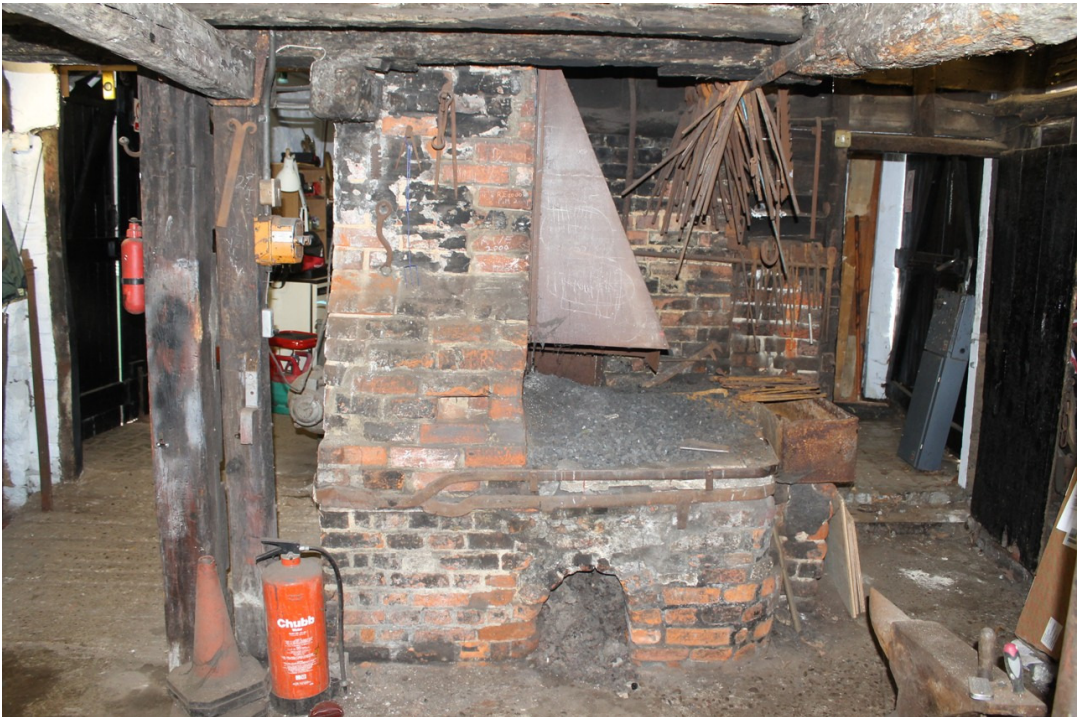
Photograph 24 Extension B behind extension A, housing the second forge with a doorway to the right originally providing access to the yard but now to the farrier's shop. The brickwork behind the forge appears to be a remnant of a yard wall - view north-east.

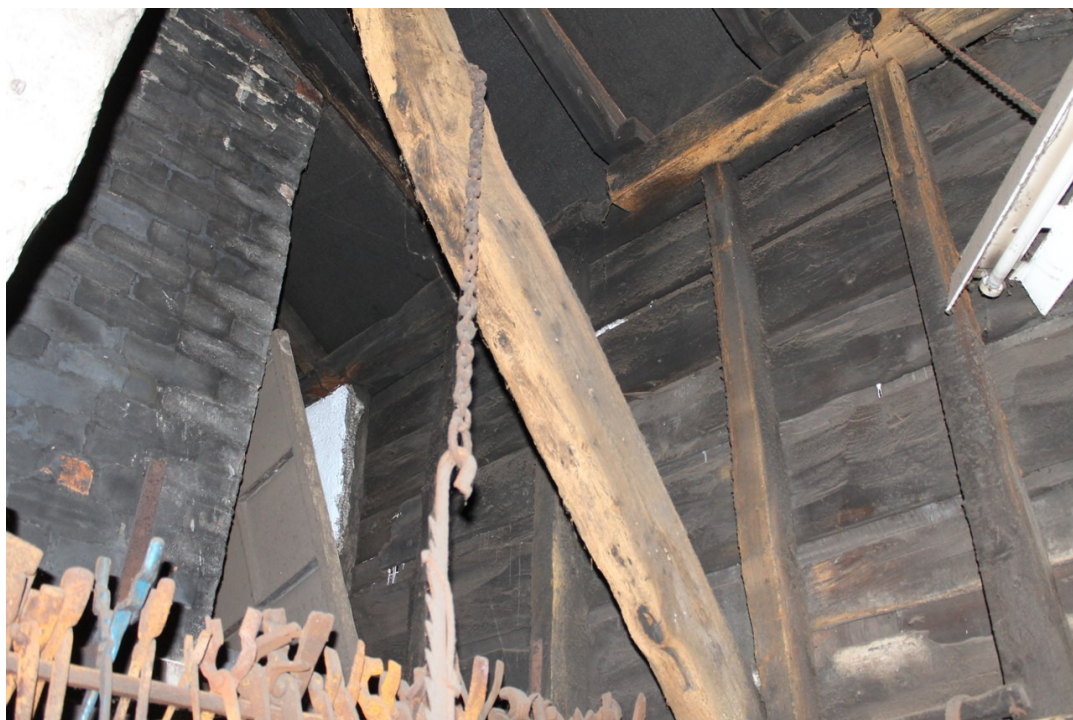
Photograph 25 Extension B behind the second forge with the wide-section weatherboard on top of the earlier yard wall and the straight brace rising to the corner of extension A - view north.

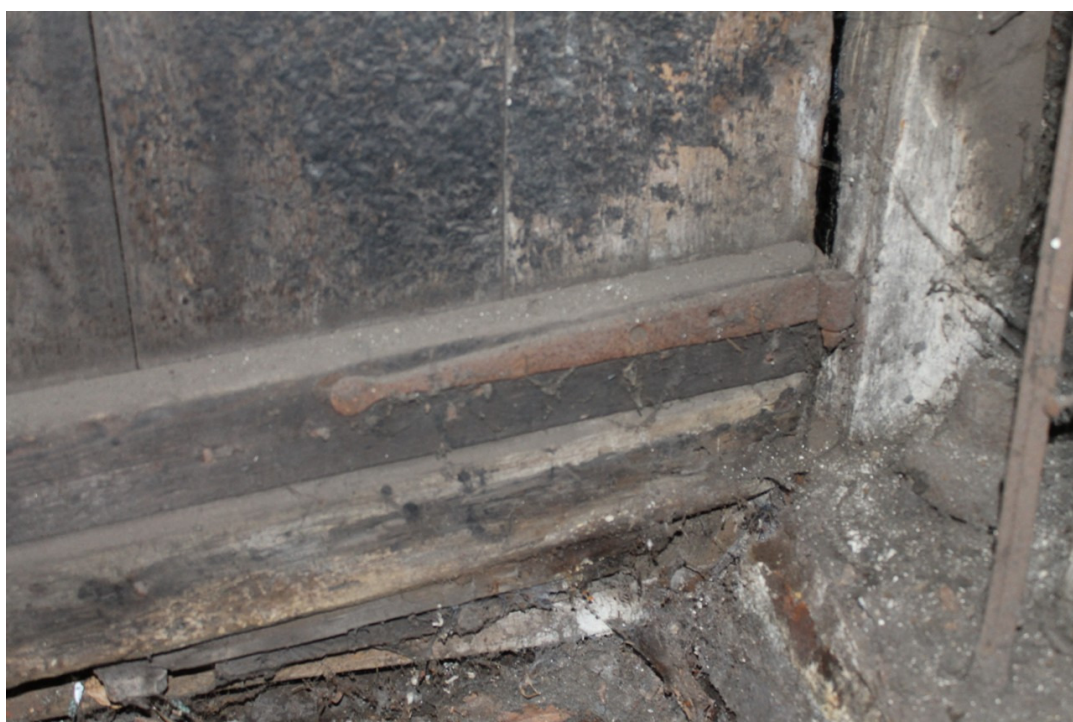
The ironwork of the hinges and latches to the door and the shutters is very simple in design (Photographs 26 and 27) and it is extremely likely that these pieces were made at The Forge.

Photograph 26 Detail of simple strap hinge to door in extension B, likely to have been forged on the premises.

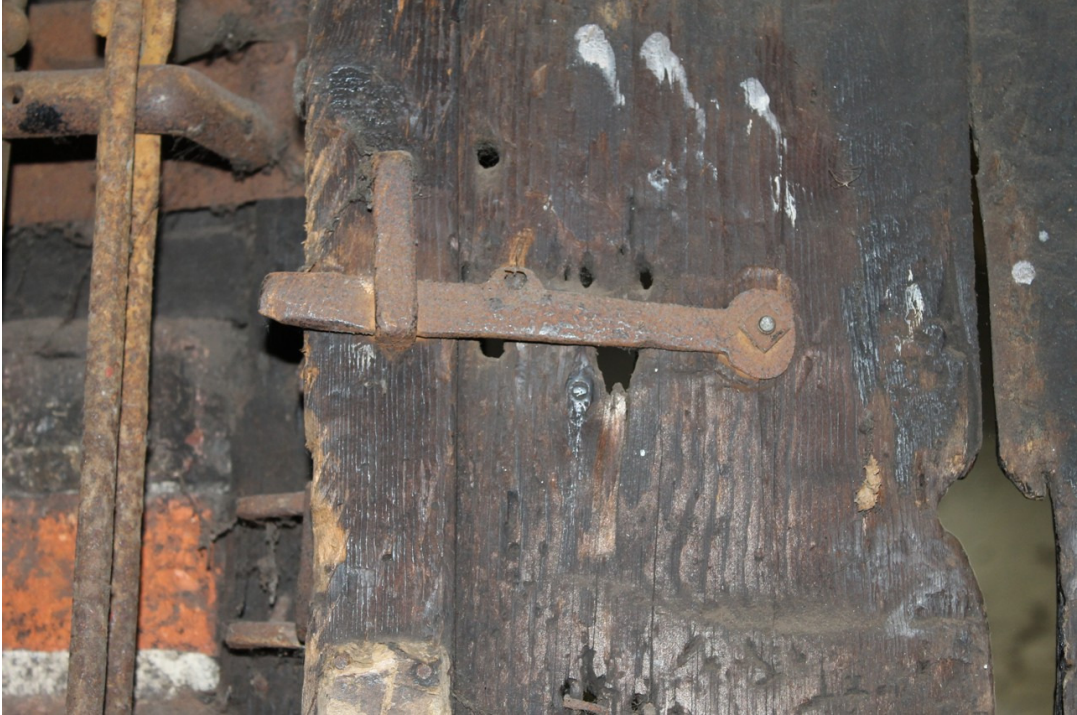
Photograph 27 Detail of simple latch to door in extension B, likely to have been forged on the premises.

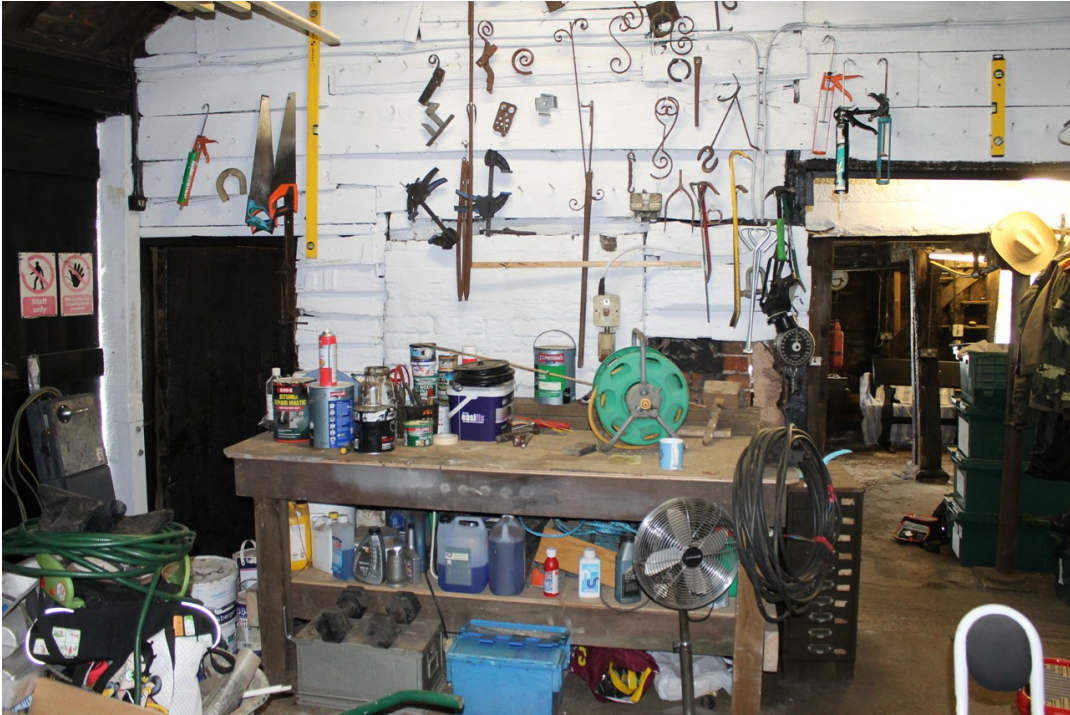
The farrier's shop is accessed from the smithy via either the door in extension B or through an opening in the rear wall on the other side of the forge (Photograph 28). The concrete floor of the farrier's shop is 300mm higher than the floor of the smithy and the irregular-shaped structure is 7m x 5m at its widest points (Photograph 29). Full height double doors are located in each of the long sides directly opposite each other, replacements for the originals. Each entrance has granite setts embedded into the concrete to prevent wear from horses' hooves.

Photograph 28 Entrances to the farrier's shop from the smithy showing the weatherboard on the exterior of the smithy partly carried on the earlier yard wall - view south-west.

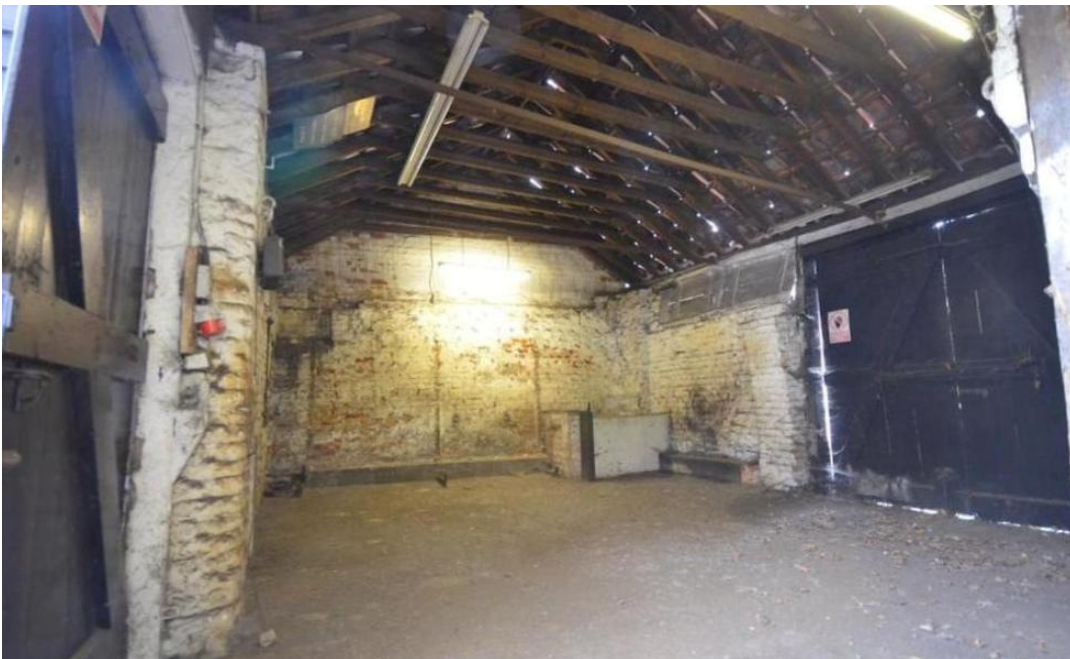
Photograph 29 Interior of the farrier's shop viewed from the smithy showing the gable constructed upon the earlier yard wall - view east. (Copyright Fenn Wright)

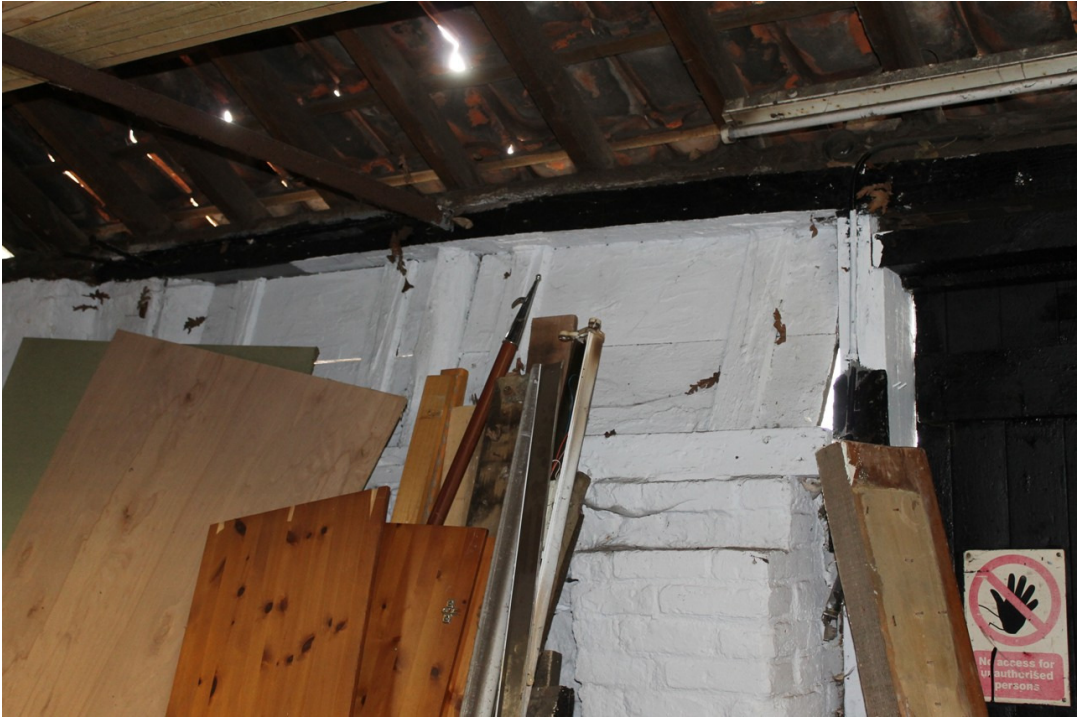
Photograph 30 Original top-hung shutters in the south-east wall of the farrier's shop - view south-east.

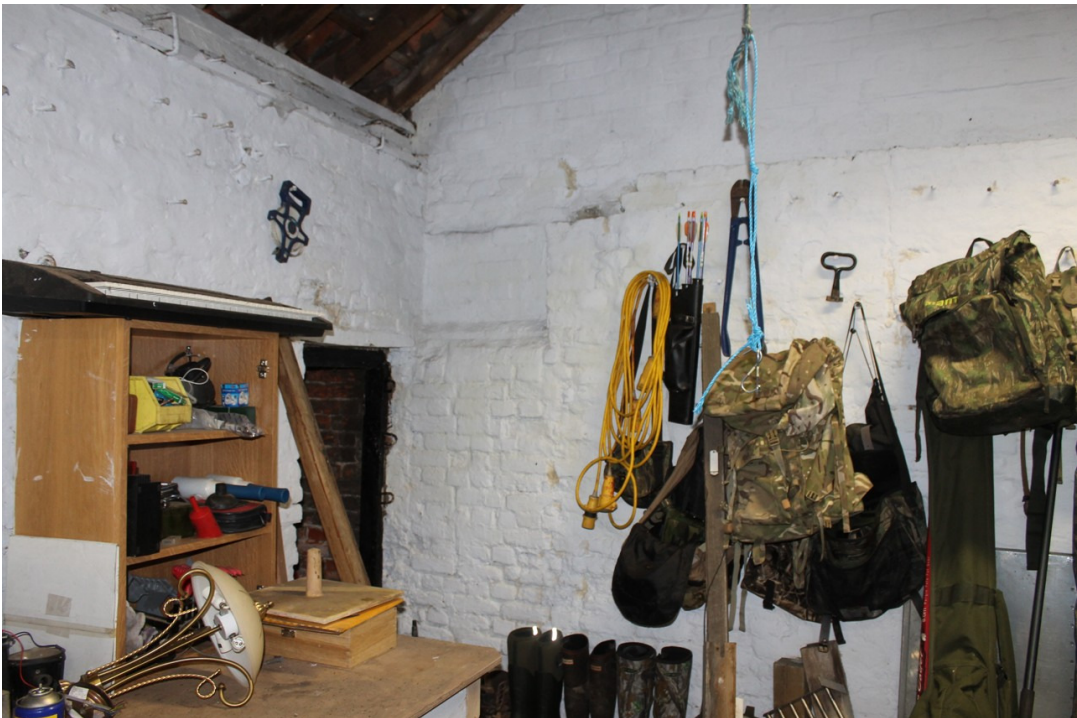
Photograph 31 Doorway inserted into the north-west wall of the farrier's shop providing access to the brick lean-to - view north.

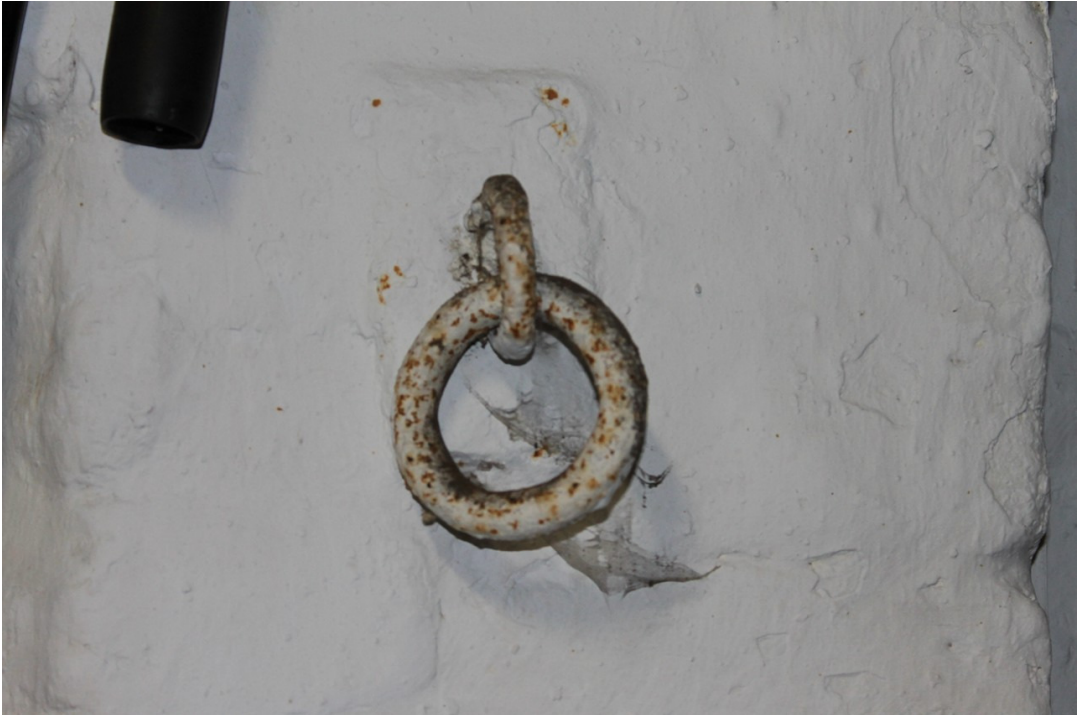
At least three tether rings survive attached to the north-west wall (Photograph 32). These would have been used to secure the horses whilst they were being shod. A coal bunker is located in the south-east corner.

Photograph 32 Detail of original tether ring attached to north-west wall of the farrier's shop - view north-west.

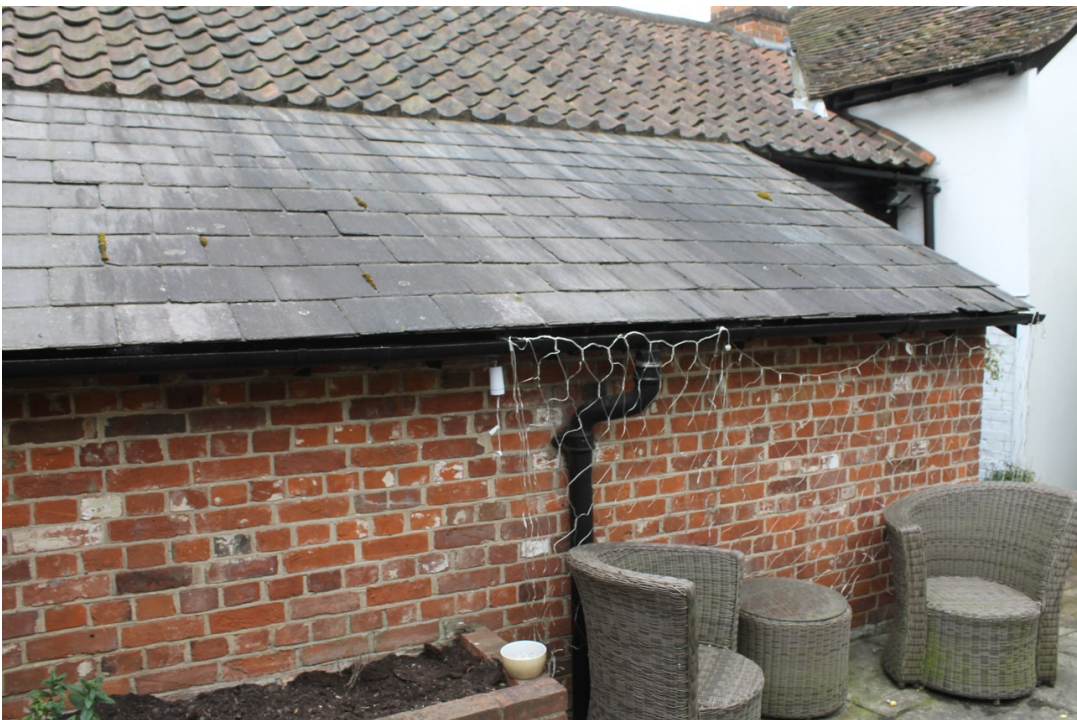
The brick lean-to has a slate clad mono-pitch roof of machine-cut timbers. The floor is of concrete and there is a pair of timber doors at the south-west end opening onto the modern yard and garden.

Photograph 32 Slate-roofed lean-to on the north-west side of the farrier's shop - view south-west.

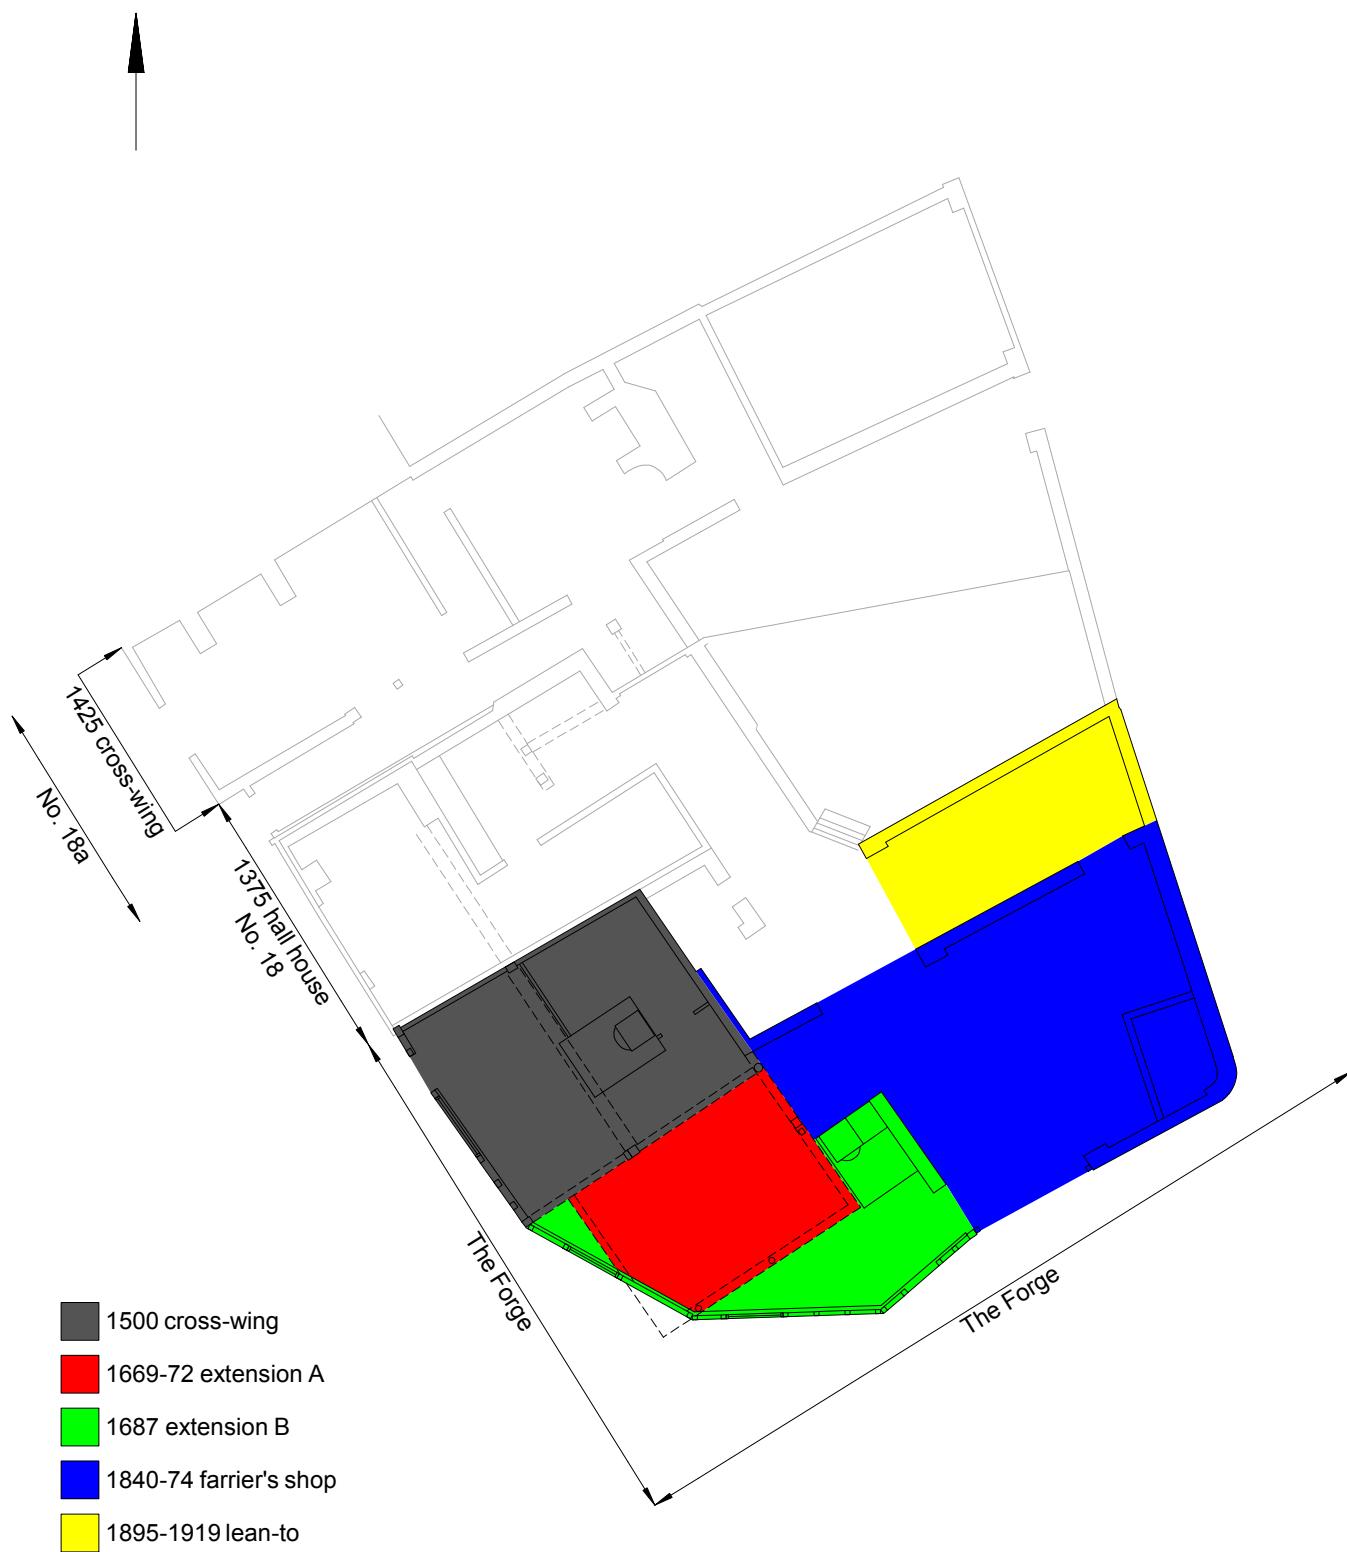
Fig 2 Block plan with phasing.

The Forge evolved from a medieval hall house which was built in 1375 (Fig 2 and below).

A cross-wing was added to the north end around 1425 and one was built at the south end around 1500. This second cross-wing was a jettied two-storey building. Chimneys were added in the 16th and 17th centuries, permitting the construction of an upper floor in
