**Historic building recording at  
Town Wall Section 21,  
Rear of 1 Middleborough,  
Colchester, CO1 1WD**

**August 2017**

**report prepared by Mark Baister**

**CAT Report 1183**  
October 2017

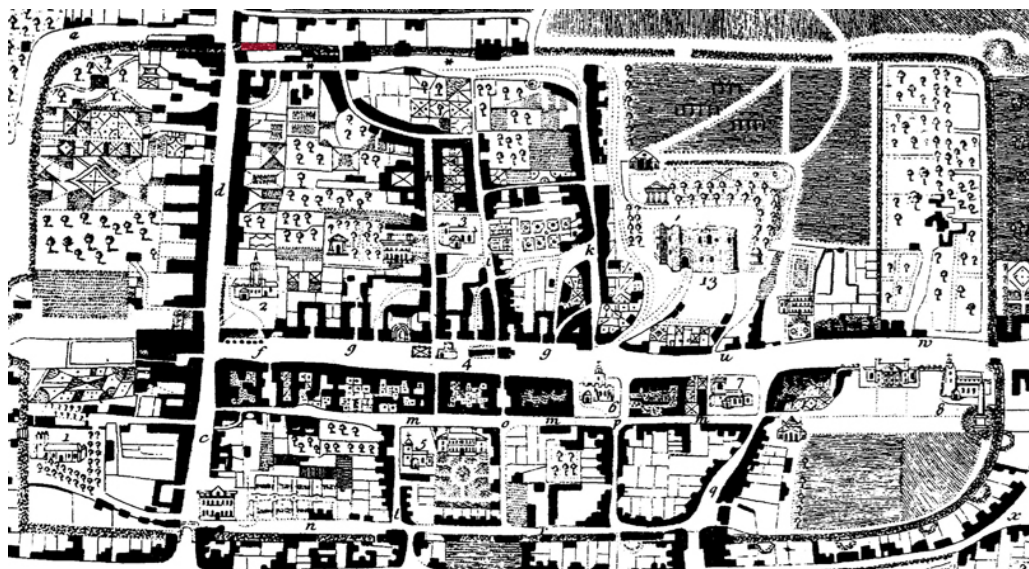
**Map 2** Philip Morant's map of Colchester, 1748. Approximate location of Section 21 highlighted in red.

Philip Morant's map of Colchester from 1748 (Map 2) shows the town in more detail, and again shows buildings adjacent to Section 21. This map also shows that parts of the town wall are starting to be demolished or built upon to make way for new construction, particularly to the north and south of the town. Apart from the buildings adjacent to the west, Section 21 was largely free-standing at this point.

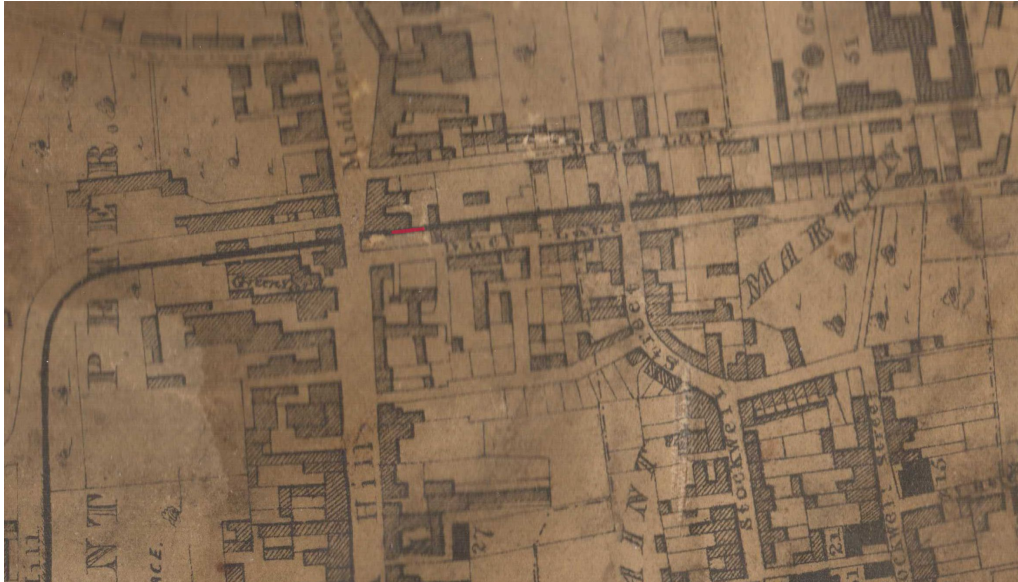
**Map 3** Monson's map of Colchester, 1848. Location of Section 21 highlighted in red.

Monson's Map of Colchester from 1848 (Map 3) shows significantly more detail than its predecessors. Clearly visible are an increased number of buildings built up against the north of the wall, while the southern elevation of Section 21 is unimpeded by later structures. The building shown immediately to the east of North Gate on Morant's map (Map 2), is no longer standing. The map also shows evidence of the continuing demolition of the wall, with less visible above ground than in previous mapping.

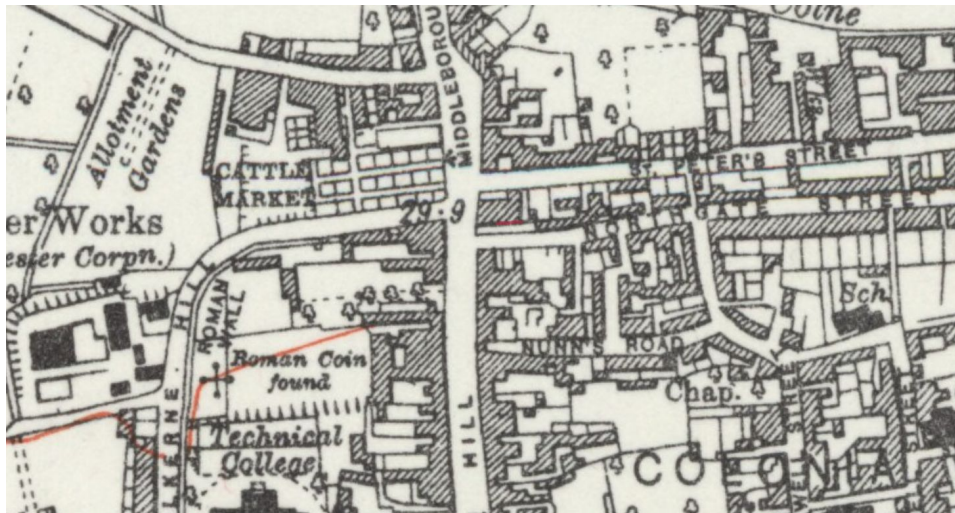
**Map 5** 1938 OS map. Location of Section 21 highlighted in red.

A later OS map from 1938 (Map 5) shows that the building to the south of the wall has been demolished, which would have exposed the southern elevation. The modern layout of the site (Fig 2) shows another building has since been constructed in this location, once again obscuring the southern elevation, and that some of the structures built along the north elevation of the wall have been demolished, exposing the northern face (which is detailed in this building recording).

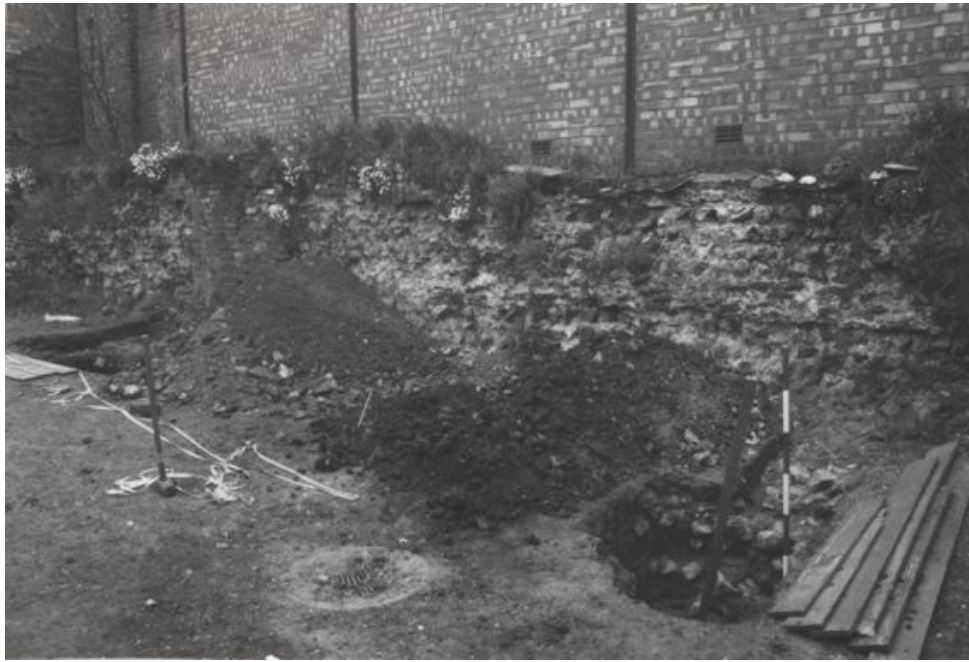
**Photograph 1** Section 21 of town wall during 1987 trenching. Trench A visible to right of frame. Photograph taken facing south-east.

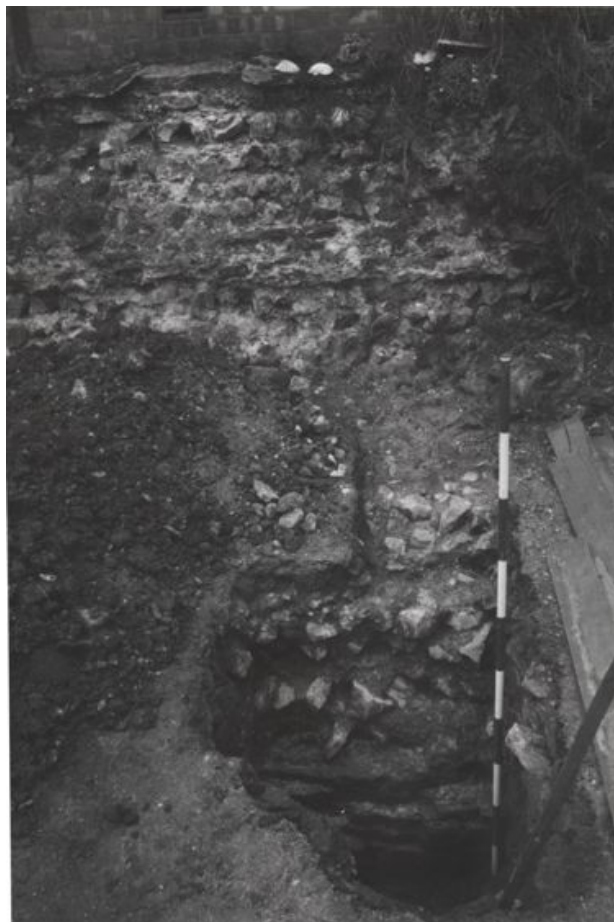
**Photograph 2** Detailed photograph of Trench A during 1987 trenching. Intact facing of wall below ground visible. Photograph taken facing south.

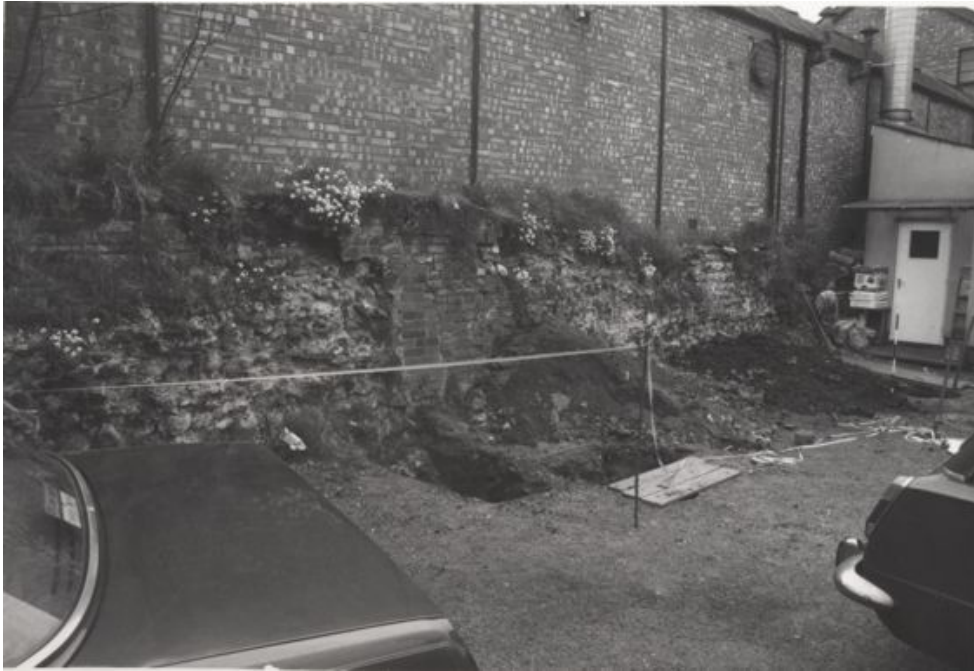
**Photograph 3** Section 21 of town wall during 1987 trenching. Trenches B and C visible in centre of frame. Photograph taken facing south-west.

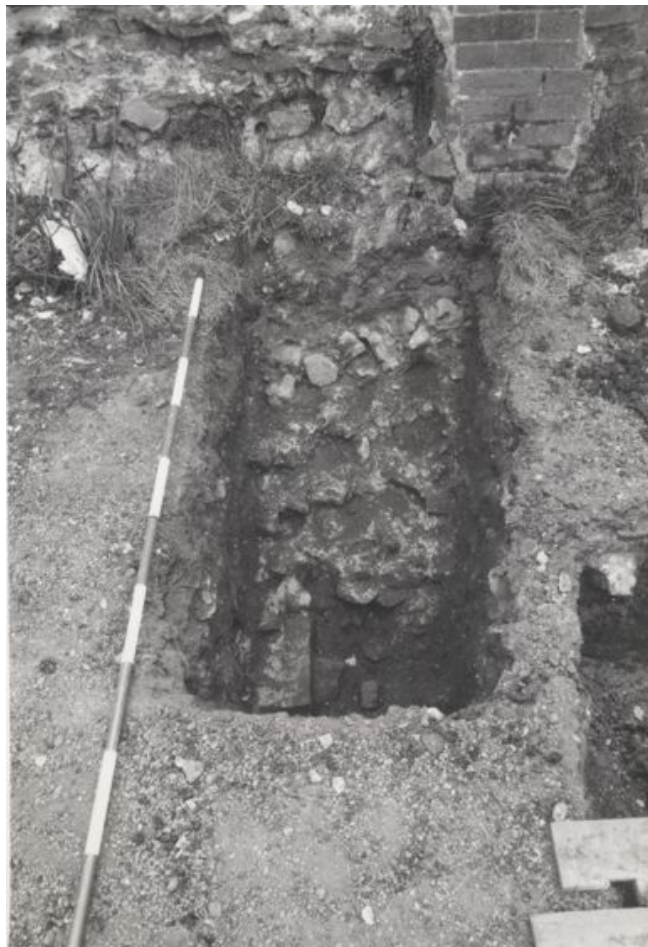
**Photograph 4** Detailed photograph of Trench C during 1987 trenching. Core of wall visible sloping eastwards, suggesting robbing of the face has taken place. Photograph taken facing south.

Trenching in 1987 (CAT Report 144) revealed evidence of robbing, and that the section of wall has lost 1m of its width to the north. The exposed core has been subsequently refaced in the medieval period, most likely in the 14th century, with reused Roman tile and septaria.

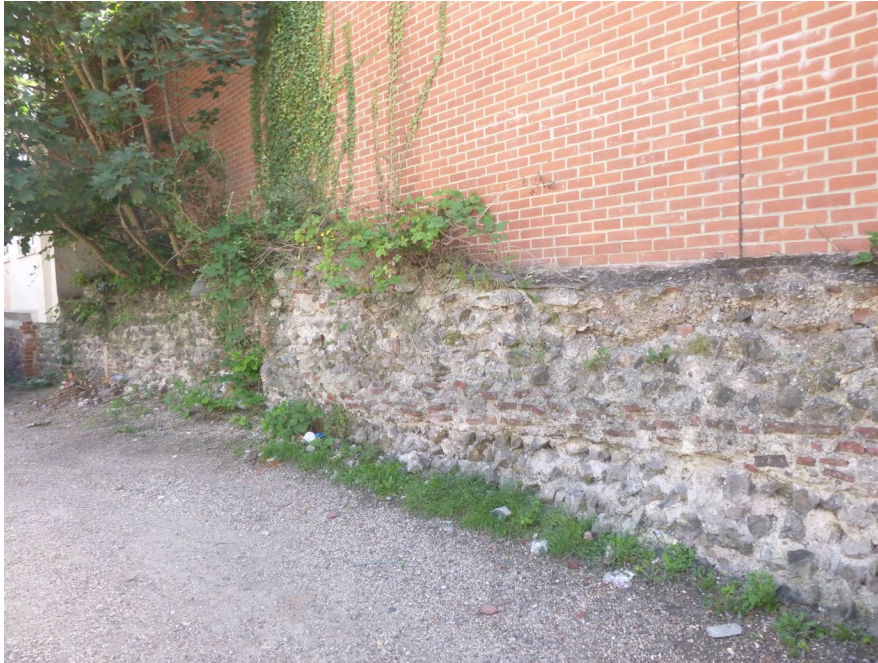
**Photograph 5** Section 21 of the wall before removal of vegetation.  
Photograph taken facing south-east.

Section 21 is overgrown and its fabric is deteriorating. During the course of this investigation it was clear that it was in a state of decay, with several lumps of septaria and mortar scattered around the site that had recently fallen from the wall.

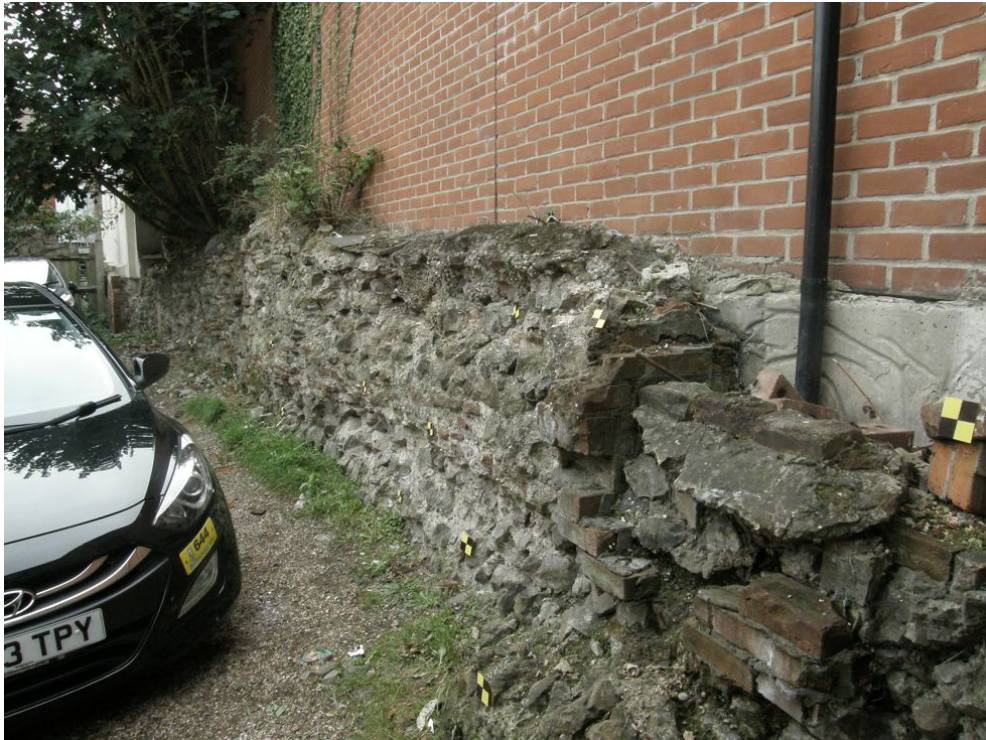
The north elevation of Section 21 is constructed of a mix of septaria, Roman tile and modern bricks (Photograph 6). The top 300-400mm of the entire section is bound in modern concrete, and consists largely of bricks or (re-used) Roman tile. This is also visible in the 1987 photographs, and appears to be a 'capping' that has been added, presumably in an attempt to prevent water seeping into the fabric of the wall. Also present built against the wall are several sections of brick, which are likely to be associated with the buildings visible on the 1896 OS map (Map 4).

**Photograph 6** Section 21 of the wall after removal of vegetation. Photograph taken facing south-east.

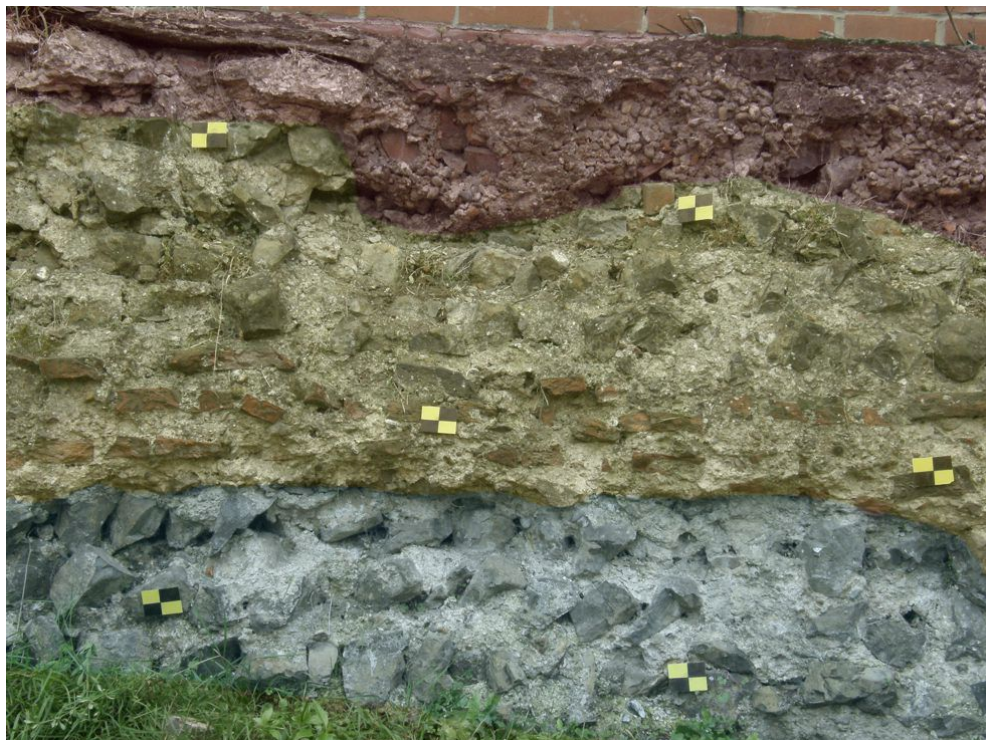
Aside from the modern capping, most of Section 21 of the wall is covered in a facing of septaria and Roman tile, bound in mortar. Beneath this, and visible in some areas (Fig 5), is the septaria and mortar core of the wall (Photograph 7). As it was established through excavation in 1987 that the original Roman face of the wall would have been some 1m further north, the face of septaria and tile on this section must be medieval in origin.

**Photograph 7** Section of wall highlighted to show differing phases of fabric. At the top is the modern concrete capping, the middle is medieval facing, the bottom is the Roman core. Photograph taken facing south.

This facing was presumably added sometime in the 14th century during extensive restoration works to the wall (as detailed by Morant 1748, 6). Its irregular courses of tile and septaria mimic the original Roman ashlar facing, and it is similar in make-up and appearance to the nearest other visible face of the wall, Section 23 on the west side of North Hill (drawn in 1990 and reproduced as Fig 6).
