**Historic building recording at
Town Wall Section 11,
rear of 62 Priory Street (Priory Lodge),
Colchester, CO1 2QE**

August 2017

**commissioned by
Colchester Borough Council**

CAT Report 1184
November 2017

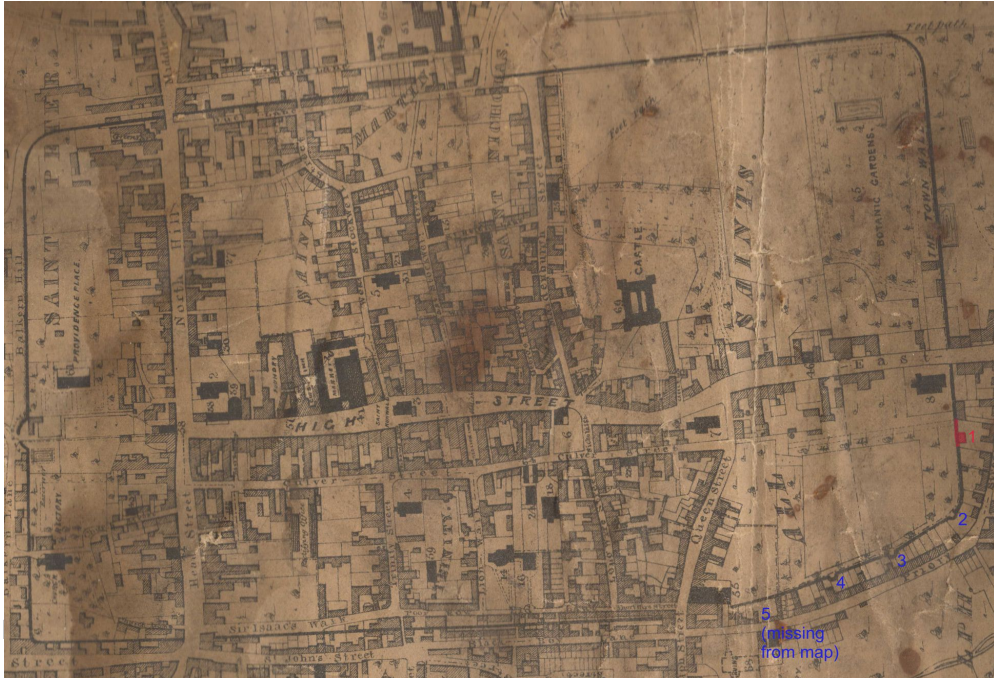
Map 3 Monson's map of Colchester, 1848. Location of Section 11 highlighted in red. Surviving bastions numbered.

Monson's Map of Colchester from 1848 (Map 3) again shows Section 11 as free-standing. Bastion 1 is depicted as a square structure rather than a bastion. This is probably due to the presence of a structure on top of the bastion (see later mapping). Further along the wall, Bastion 5, which is still standing today, was omitted from the map and is not shown at all.

The 1896 OS map shows only 3 bastions surviving (as is still the case). Section 11, and the entire south-east corner of the wall, has had several structures built up against it. There appears to be a structure built on top of Bastion 1, which would account for its portrayal in Monson's map. No evidence of this structure survives today, but there are remnants of it visible in photographs from 1923 and 1986 (see below).

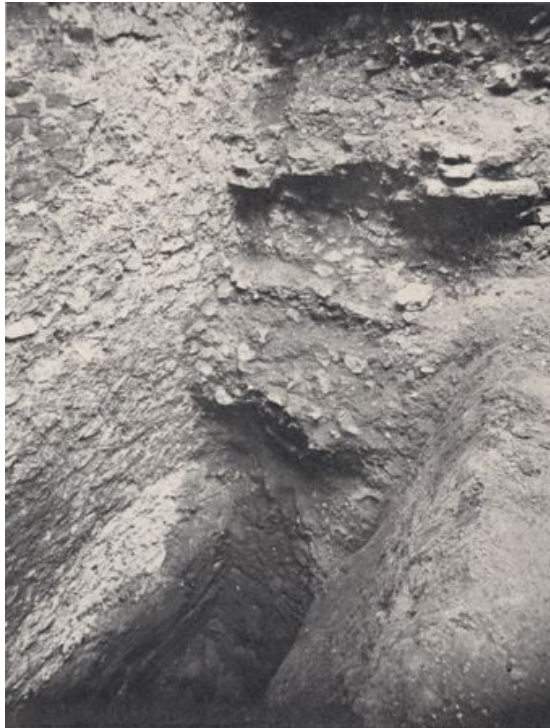
Photograph 1 Photograph of interior of Bastion 1 during excavation in 1923. To right and back of the frame is the face of the town wall, to the left is the foundations of Bastion 1. Taken from Roman Colchester (Hull 1958, pl XI B). For the location of this trench see Fig 2.

The interior of Bastion 1 was excavated in 1923 by P.G. Laver, who exposed the partially robbed town wall behind the medieval bastion (Fig 2). He also uncovered the bastion's foundations, which started 1ft below the foundations of the wall itself (Photograph 1). The soil within the interior of the bastion contained some residual Roman finds but nothing else of interest (Hull 1958, 45-6).

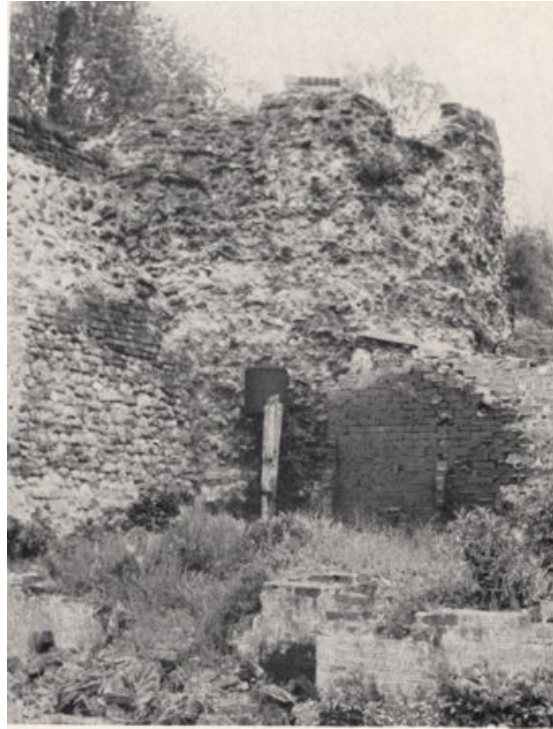
Hull (1958, 45) notes that at the top of the bastion are some foundations that probably belong to some 'eighteenth century ornamental garden work': this is undoubtedly the building visible atop of the bastion on Monson's, and the 1896 OS, map. A photograph of the bastion in Roman Colchester (Hull 1958) shows these foundations. It also shows a small brick building built up against the east elevation of the bastion, partially obscuring it (Photograph 2).

Photograph 2 Photograph of Bastion 1 from Roman Colchester (Hull 1958, pl XI D). Note the remains of later foundations on top of the bastion. Photograph taken facing north-west.

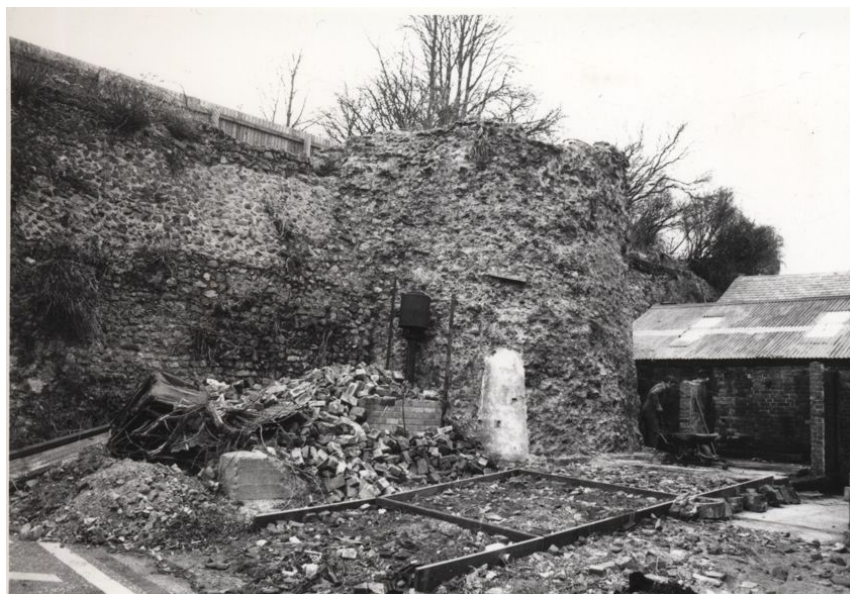
In the CAT photographic archive are a series of photographs of Bastion 1 taken in 1986 after the adjoining building was demolished (Photographs 3-5). Although there is no associated written record, comparing these photos to the current wall (see descriptive record below) shows that Section 11 and Bastion 1 are (although overgrown) in much the same state as they were 31 years ago. The photos show that the foundations on top of the bastion have partially collapsed, but are still visible on one elevation (Photograph 5). Today no evidence of these foundations remains (see descriptive record below).

Photograph 3 Section 11 and Bastion 1, taken in 1986 after demolition of a nearby building. Photograph taken facing north-west.

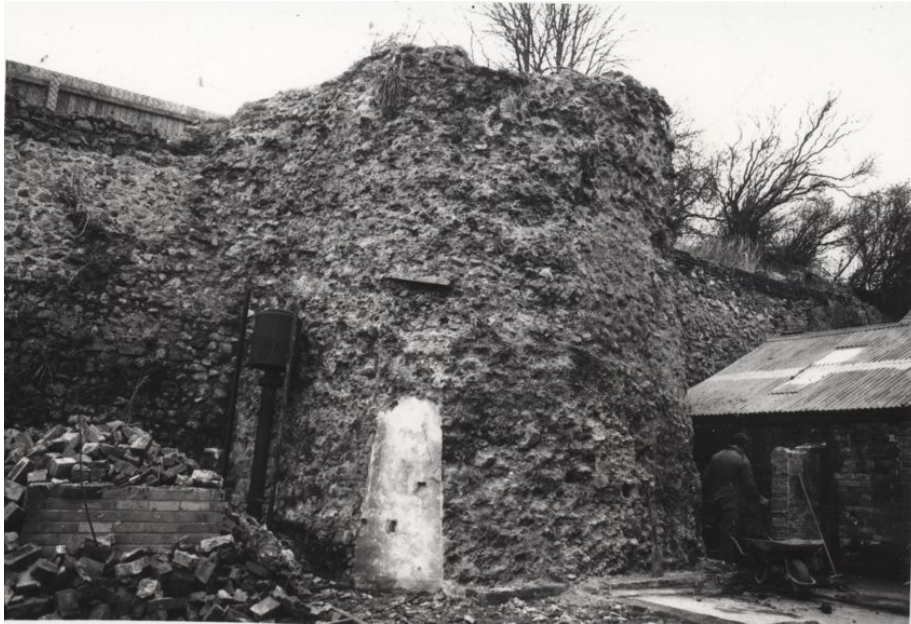
Photograph 4 Detailed shot of Bastion 1, taken in 1986 after demolition of a nearby building. Photograph taken facing north-west.

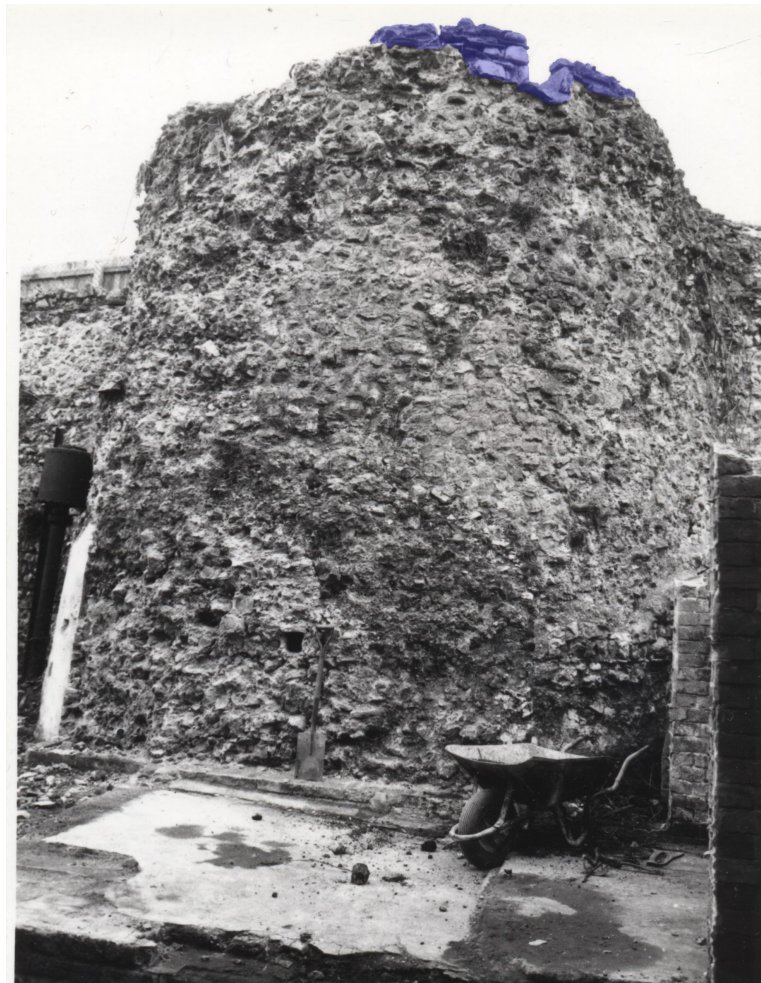
Photograph 5 Detailed shot of Bastion 1, taken in 1986 after demolition of a nearby building. Highlighted in blue at the top of the bastion is the remains of a structure seen on mapping in 1848 and 1896. Photograph taken facing south-west.

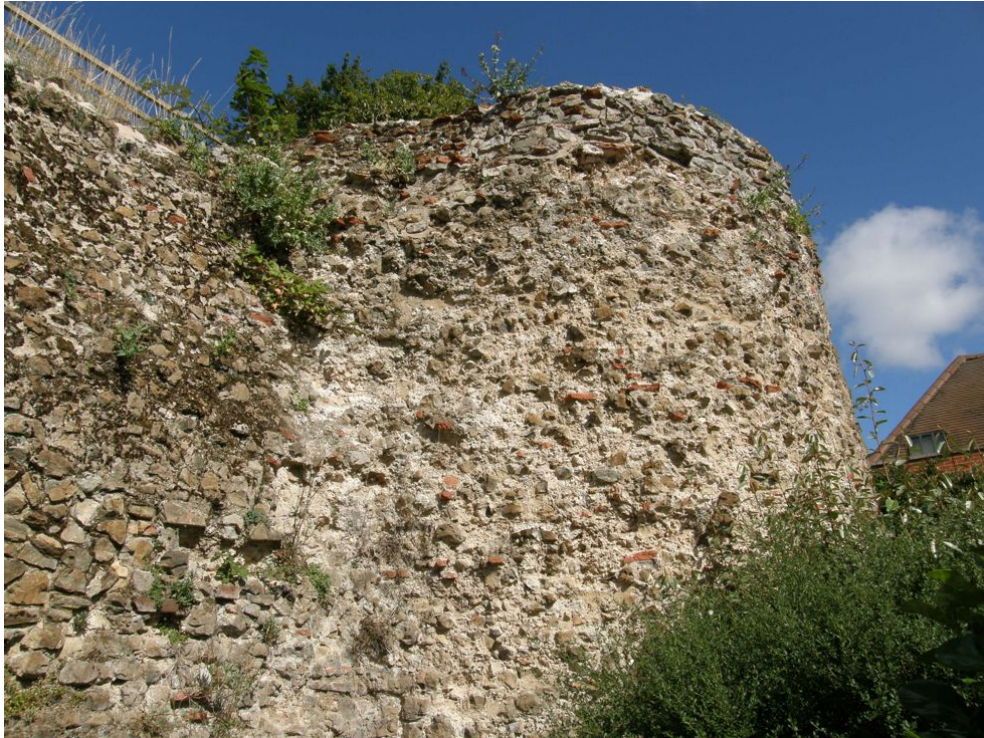
Photograph 6 Section 11 of the town wall, including Bastion 1, prior to removal of overgrowth. Photograph taken facing north-west.

Section 11 is 16.9m in length, and survives to a height of approximately 4.5m above modern ground level to the south of Bastion 1, and 5.6m to the north (although what is visible is mostly medieval or later in origin). The original height of the wall would have been at least 6m (Crummy 1997, 89), although, as mentioned below, modern ground level outside the walls appears to be below the base of the wall foundation.

Section 11 is constructed of a mix of septaria, Roman tile and modern bricks (Photographs 6-11). On top of the wall to the north of the bastion is 300-400mm of uneven red brick courses. The top 250mm of the wall to the south of the bastion has been 'capped' by lime mortar, recently added to the wall in 2014 in an attempt to prevent water seeping into its fabric (Universal Stone 2014). The top of the bastion shows no surviving evidence of the structure visible on the 1896 OS map (or the photographs from 1923 and 1986). The top 700-900mm of the bastion is constructed of large stones, concrete slabs and re-used Roman tile and septaria, all bound in concrete. The large stones appear to be reclaimed and re-used from sources other than the wall, and include fragments of possible Kentish ragstone and broken pieces of worked limestone.

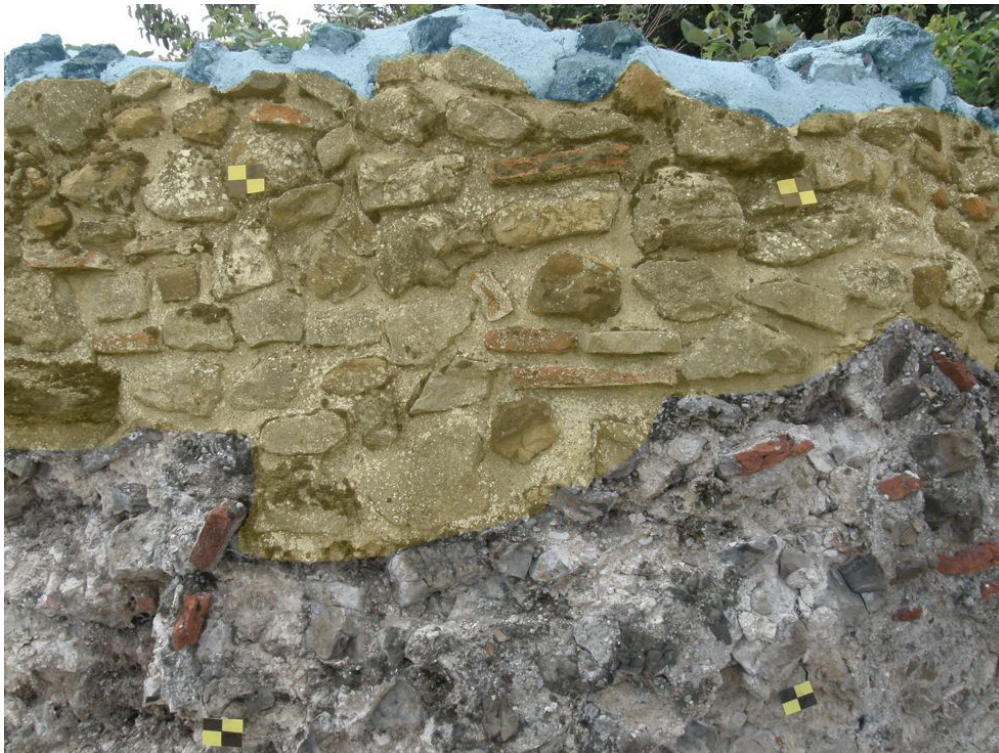
On top of this concrete capping is a later capping of lime mortar, which is modern in origin and corresponds with the wall to the south of the bastion (Photograph 7).

Photograph 7 Section of the top of the bastion photographed during survey (for location see Fig 4). Three phases highlighted; at the top, the modern lime mortar capping, in the middle, stones and re-used Roman tile bound in concrete, and at the bottom, the original bastion material of re-used Roman tile and septaria. Photograph taken facing west.

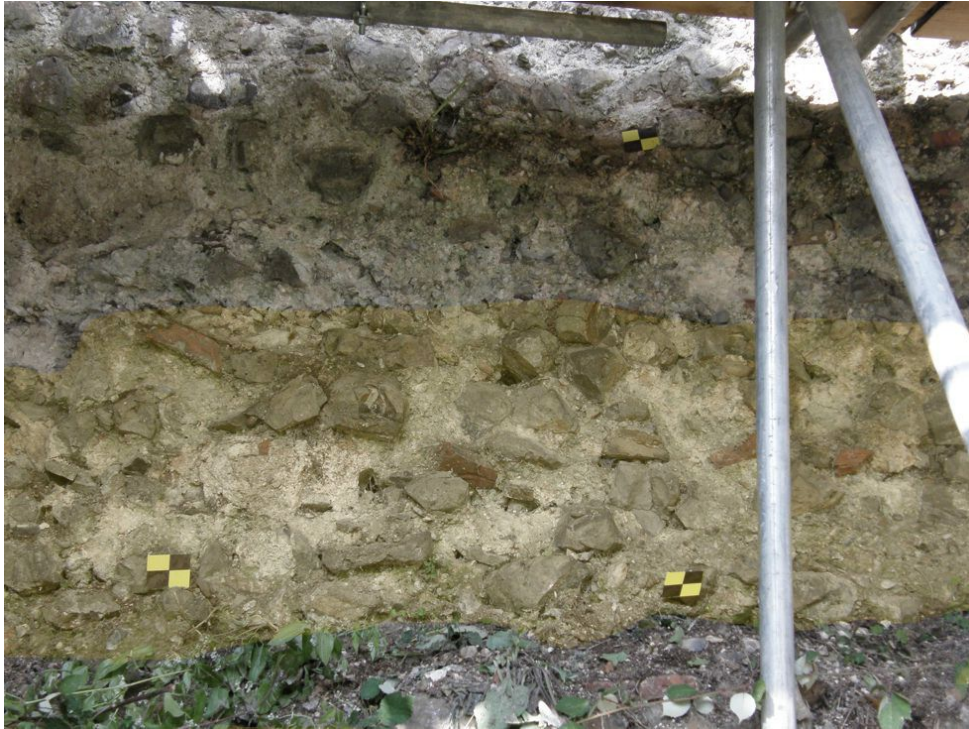
In some areas at the base of the wall in Section 11 there seems to be evidence of underpinning (Fig 4), which, combined with the evidence from the 1923 excavation, suggests that the foundation of the town wall in Priory Street is indeed above modern ground level. Where visible, this underpinning is constructed of re-used Roman tile and septaria bound in lime mortar, and is presumably medieval in origin (Photograph 8). As with the rest of the wall, however, much of the underpinning has been refaced in the

post-medieval period. The need for underpinning would also account for why it was deemed necessary to construct bastions along this part of the wall in the 14th century.

Photograph 8 Section of the base of the wall photographed during survey (for location see Fig 4). Highlighted section shows possible underpinning of wall below foundation. Photograph taken facing west.

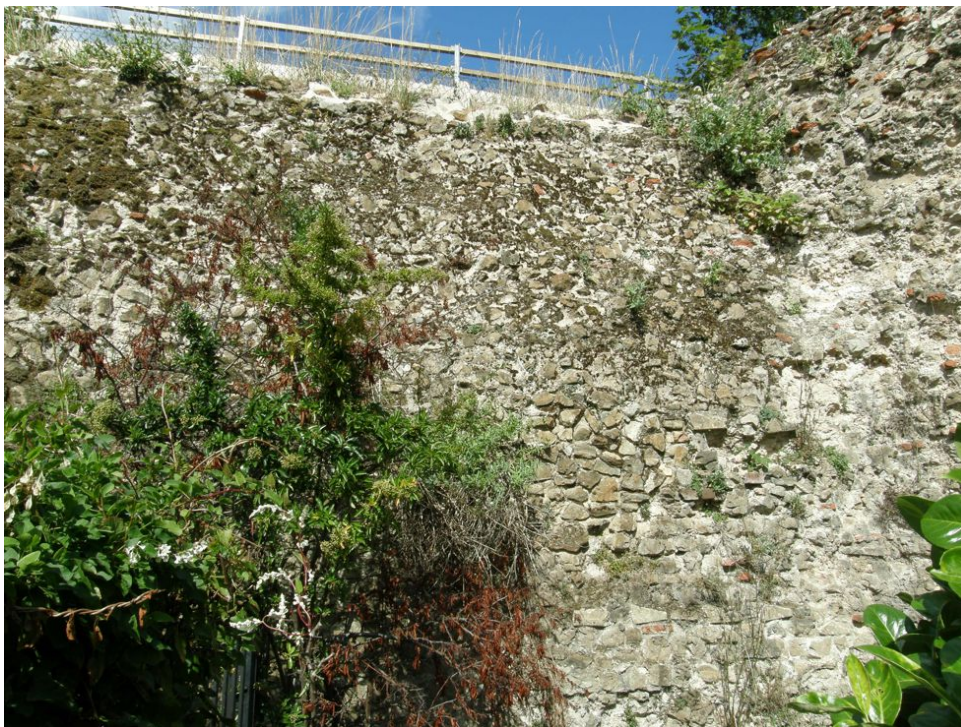
Photograph 9 Wall to the south of Bastion 1 prior to removal of overgrowth. Photograph taken facing west.

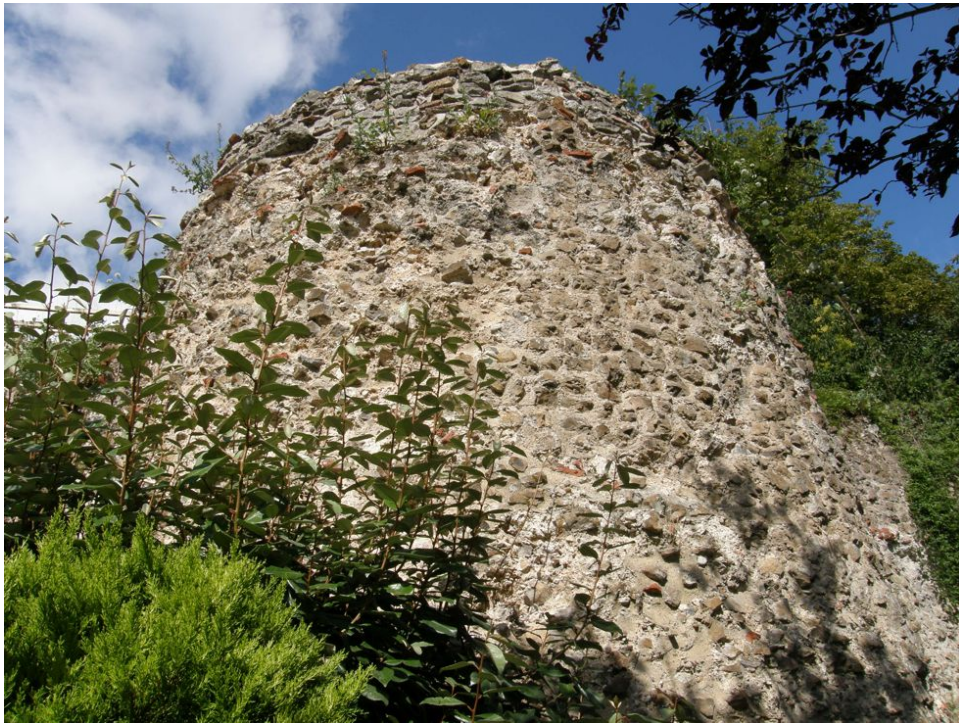
Bastion 1 (like the other bastions) is entirely constructed of re-used Roman septaria and tile. The bastions were added to the wall sometime in the 14th century during extensive restoration works (as detailed by Morant 1748, 6).

Photograph 10 Bastion 1 prior to removal of overgrowth. Photograph taken facing west.

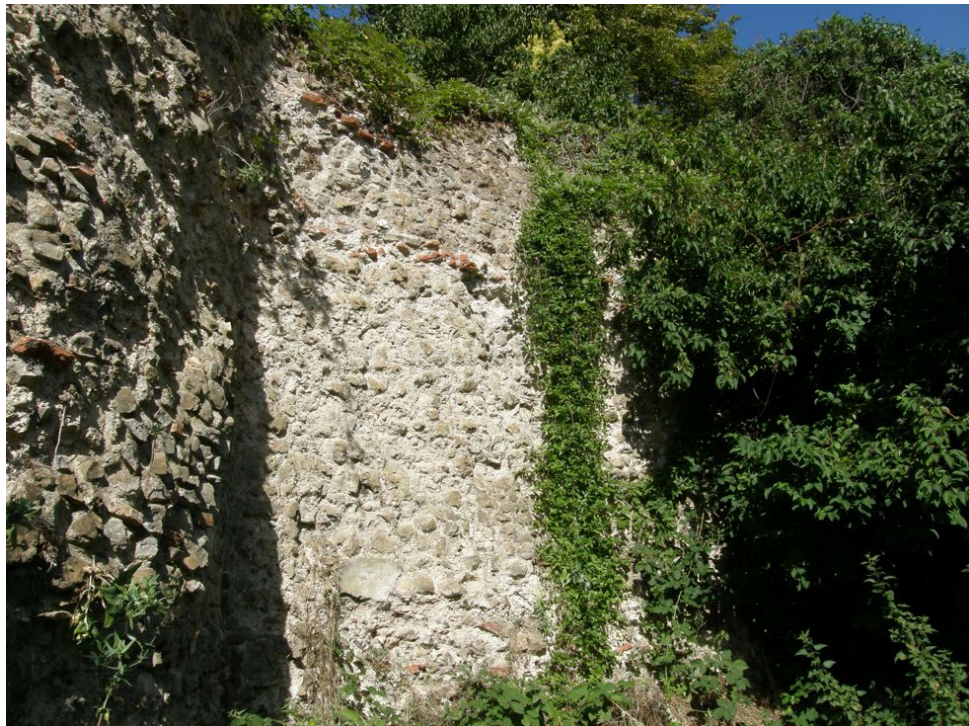
Towards the base of the wall to the north of the bastion (Fig 4) part of the later repairs have collapsed, exposing the Roman septaria and mortar core. Towards the top of the wall in the same area are remnants of the Roman face, with partial courses of tiles (Photograph 9) lining up with coursing seen further to the south in Section 10 (Figs 5 and 6). In Section 10 similar courses were identified as being the back of the inner (west) face of the wall, and given that the width of the wall does not change significantly between Sections 10 and 11, this is also probably the case here.

Photograph 11 Section of wall to the north of Bastion 1 prior to removal of overgrowth. Remains of tile courses visible towards the top of the wall. Photograph taken facing west.

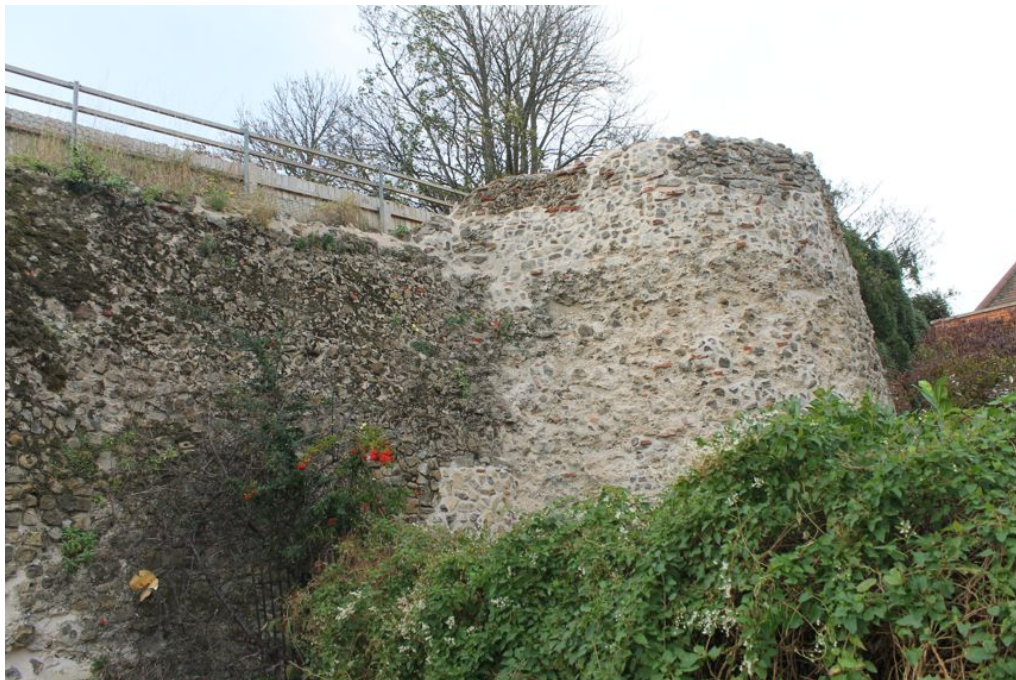
Photograph 12 Section 11 and Bastion 1 after conservation. Photograph taken facing north-west.

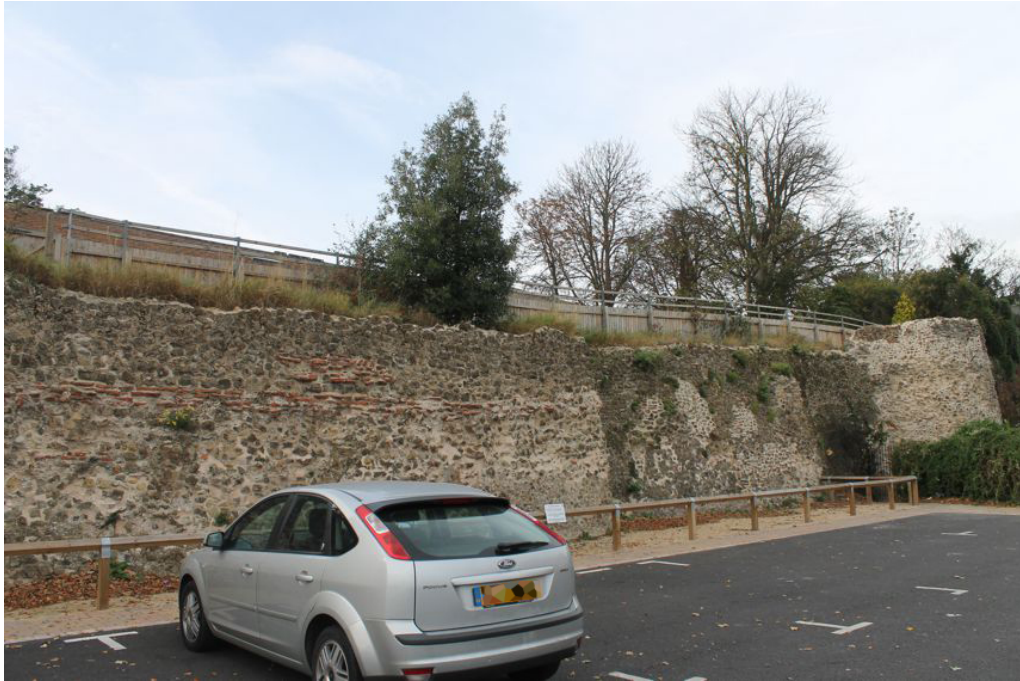
Photograph 13 Section 11 (to right of frame) and part of Section 10 (drawn in Figs 5 and 6). All after conservation. Photograph taken facing north-west.
