**Historic building recording at the  
former Halstead Police Station,  
Trinity Street,  
Halstead, CO9 1JG**

**November 2017**

**CAT Report 1206**  
December 2017

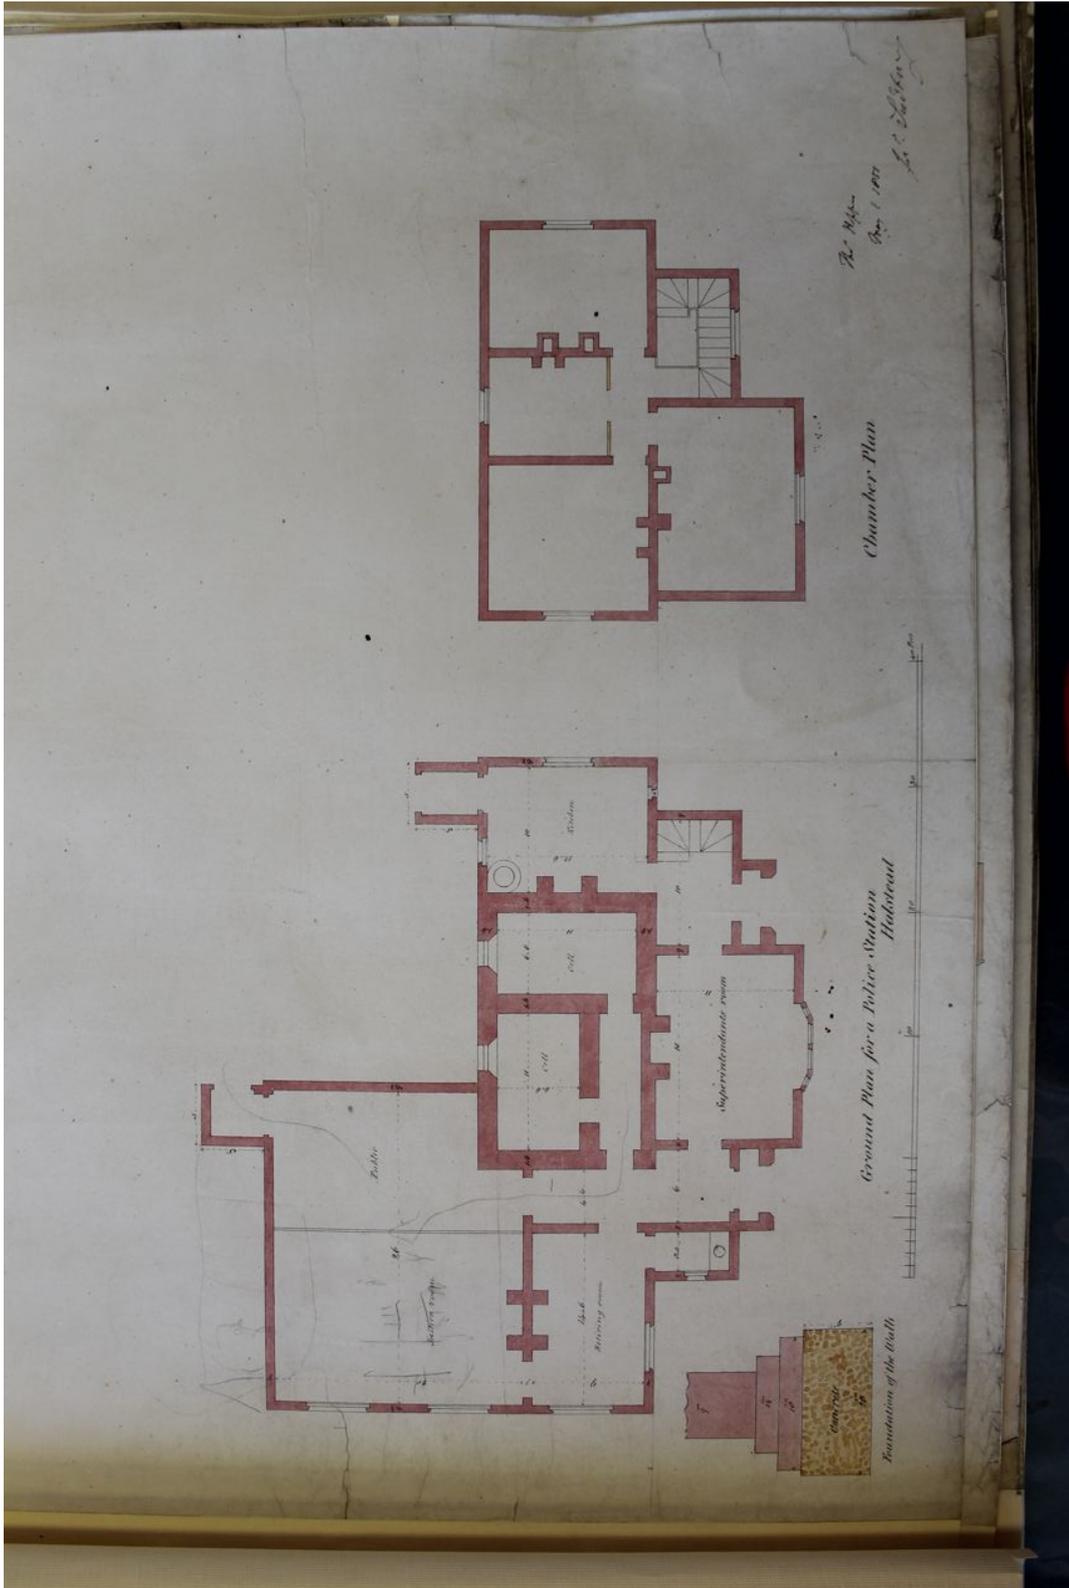
**Plan 1** ERO, Q/APb 15: Plan for a police station in Halstead (1851). Ground floor plan on the left, first-floor on the right. Shows entrance porches to rear. Rooms labelled on ground floor only. Signed by the architect Thomas Hopper in bottom right corner on May 6th 1851.

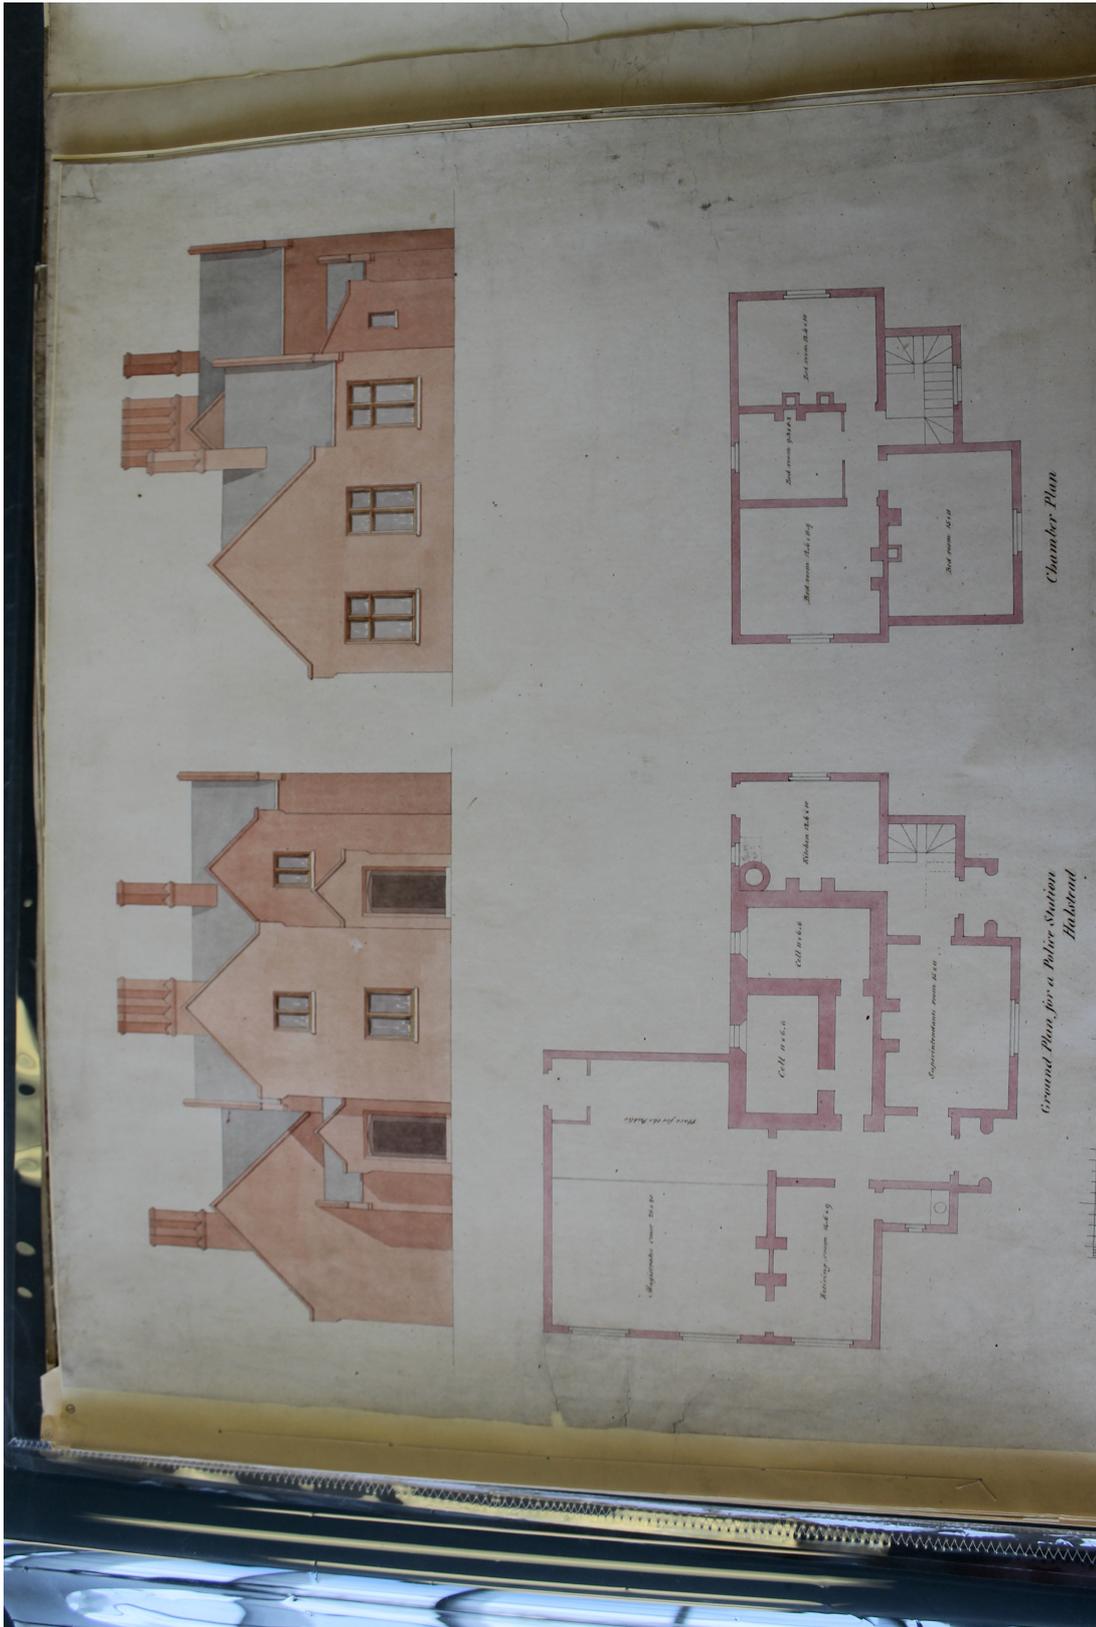
**Plan 2** ERO, Q/APb 15: Plan for a police station in Halstead (1851). All rooms labelled and north-west and north-east elevations shown above floor plan.

The outbuilding in the south of the site is shown as a stable and cart shed in the original plans from 1851 (Plan 2). At some point the entranceway for carts has been blocked up. Like the Police Station, the outbuilding has been thoroughly modernised with divisions added on the ground and first-floors. The brickwork used to infill around the blocked entranceway does not match with any of the extensions, so associating it chronologically with any of them is difficult. As the inserted windows in this brickwork are metal-framed, however, the blocking of the entrance (and the subdividing of the interior) probably happened sometime in the first half of the 20th century.

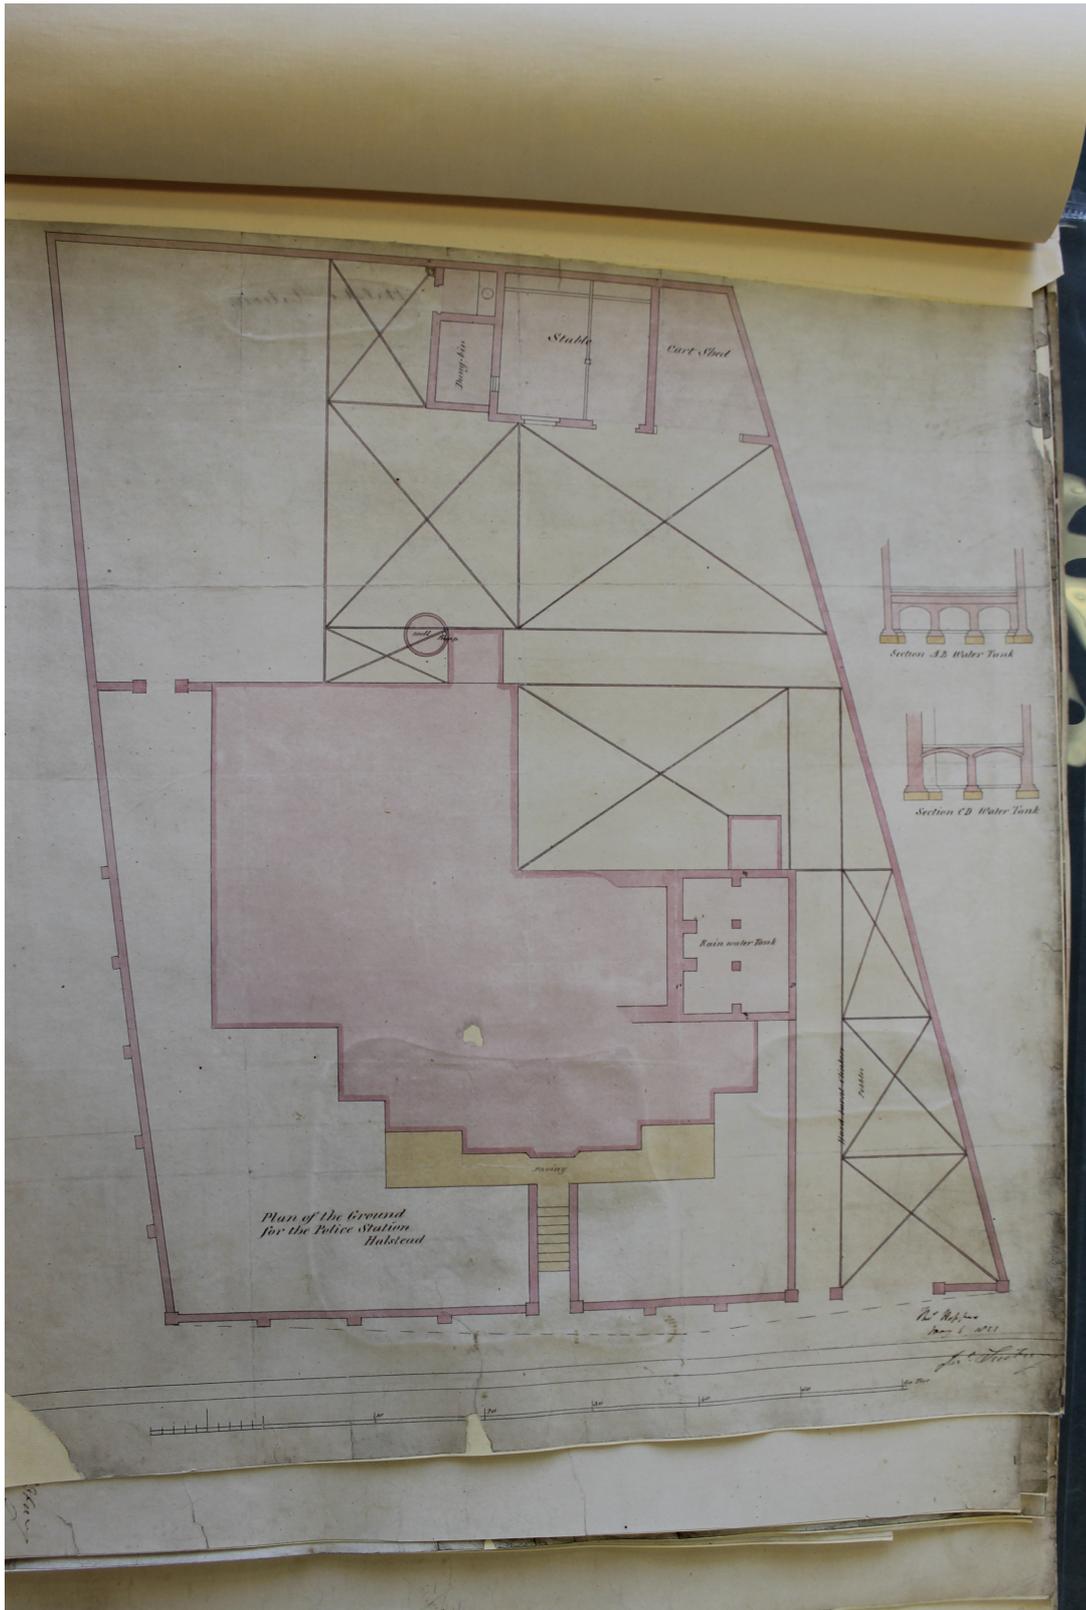
**Plan 3** ERO, Q/APb 15: Plan for a police station in Halstead (1851). Site plan, showing the floor plan and divisions of the outbuilding (top of plan). Again signed by the architect, Thomas Hopper, on May 6th 1851.

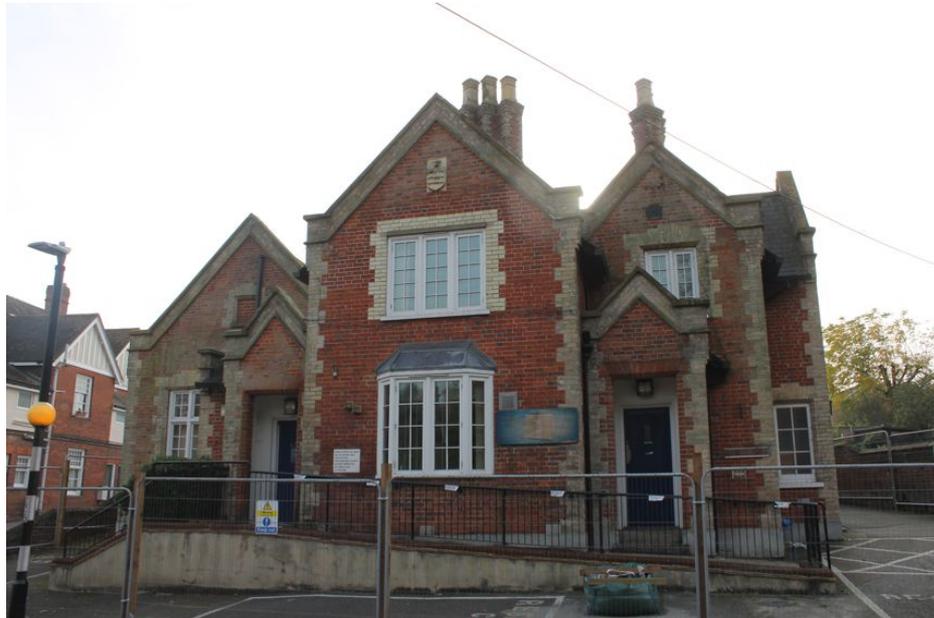
**Photograph 1** North-west elevation of Police Station. Photograph taken facing south-east.

The main public entrance into the building is through a door at the front (Photograph 1), but originally the main public access would have been through the rear of the building into the public gallery of the Magistrates' Court (Plan 1 and Fig 10).

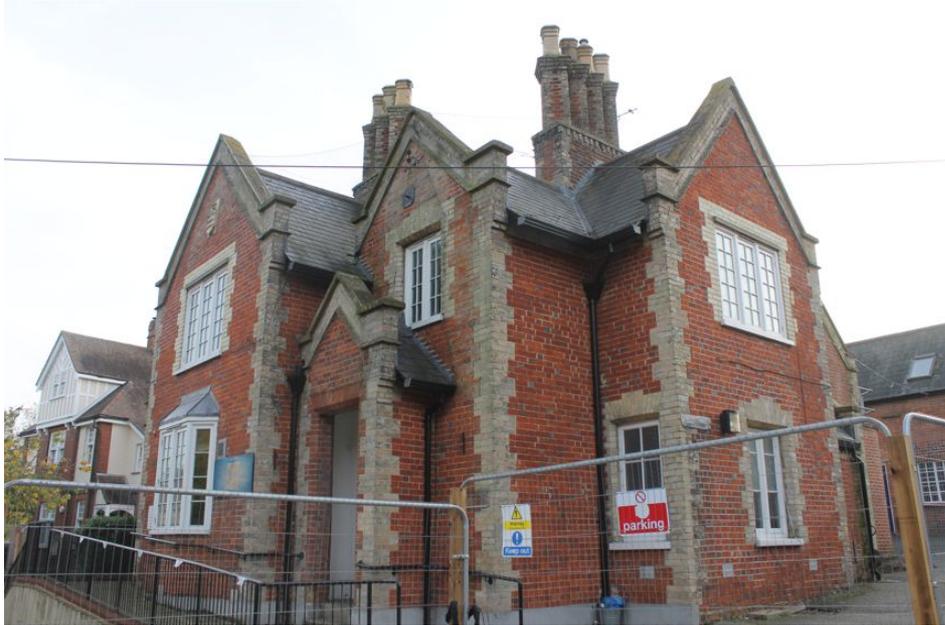
**Photograph 2** North-west and south-east elevations of Police Station. Photograph taken facing east.

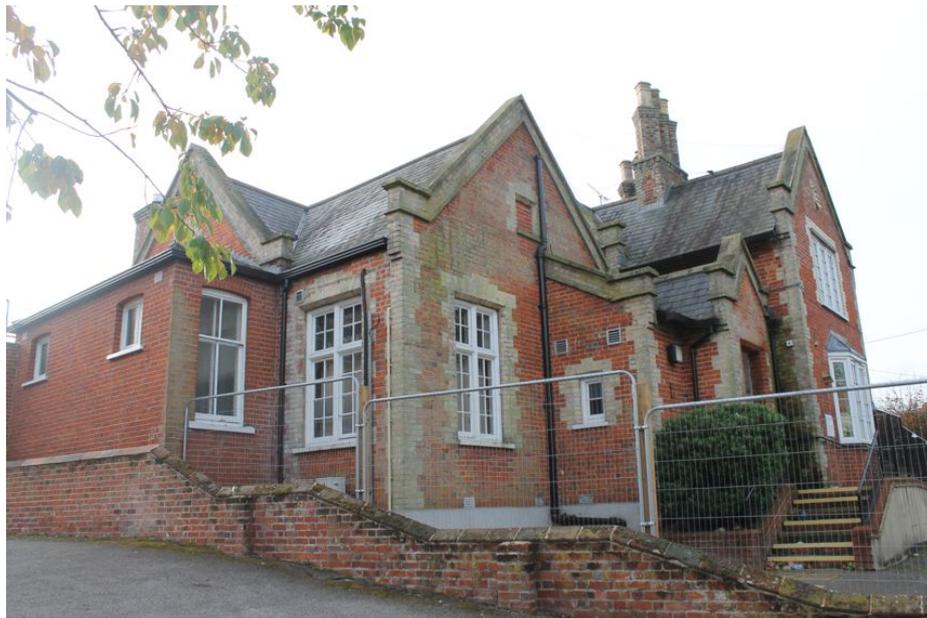
**Photograph 3** North-west and north-east elevations of Police Station. Photograph taken facing south.

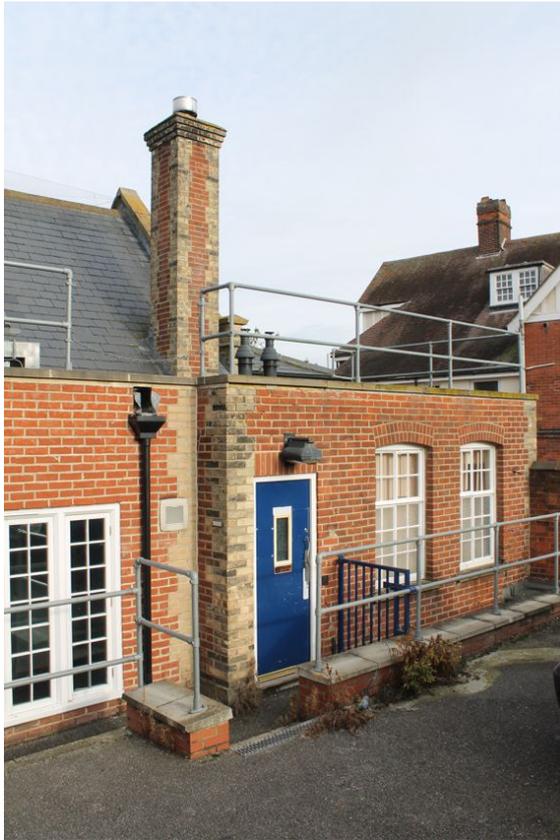
**Photograph 4** South-east elevation of Police Station, showing 1985 extensions and associated chimney. Photograph taken facing north.

Two original chimney-stacks with diamond-set flues remain at the front of the building. The third would have been demolished when a first-floor was added to the Magistrates' Court (see historical background). The chimney to the rear is a later addition associated with the extension in 1985 (Photograph 4 and Fig 3).

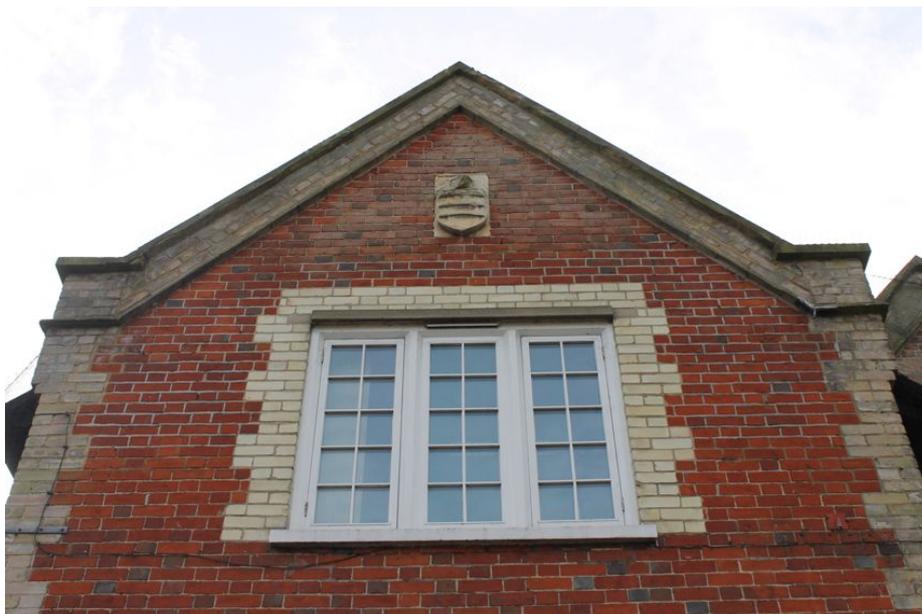
**Photograph 5** North-west gable end of the Police Station, showing the carved Essex crest original to the building, and the later inserted window with modern brickwork surrounding it. Photograph taken facing south-east.

At the front of the building (the north-west elevation) in the gable-end is a stone carving of the Essex crest, which is original to the building (Photograph 5).

Several windows on the original police station were replaced in 2004 (Fig 3), but the remaining windows appear to be original. These original windows, and the later replacements, are all wooden-framed casements (Photograph 6). All the original windows are dressed with brickwork of london stocks, and the 2004 replacements have attempted to replicate this, although bricks are more white than yellow and the resulting pattern is not as ornate (Photograph 5).

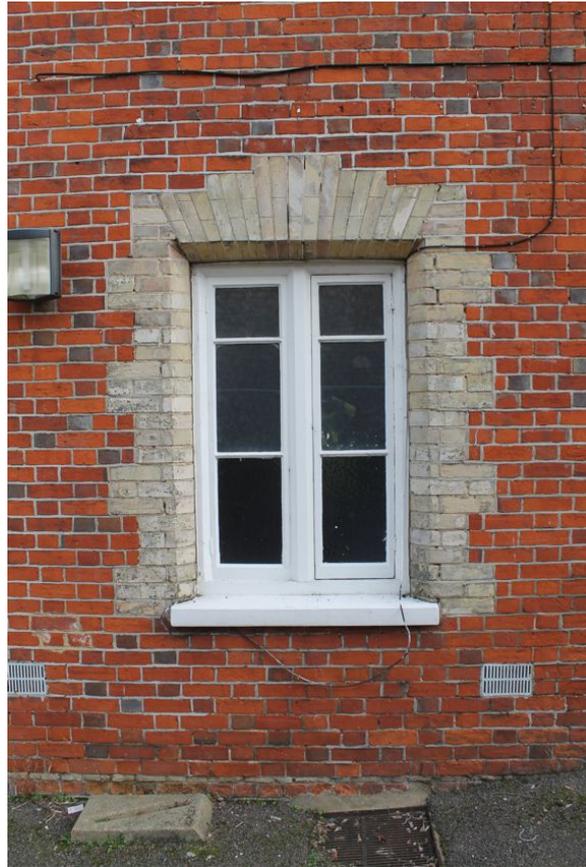
**Photograph 6** Original window and dressing on the south-west elevation of the Police Station. Photograph taken facing north-east.

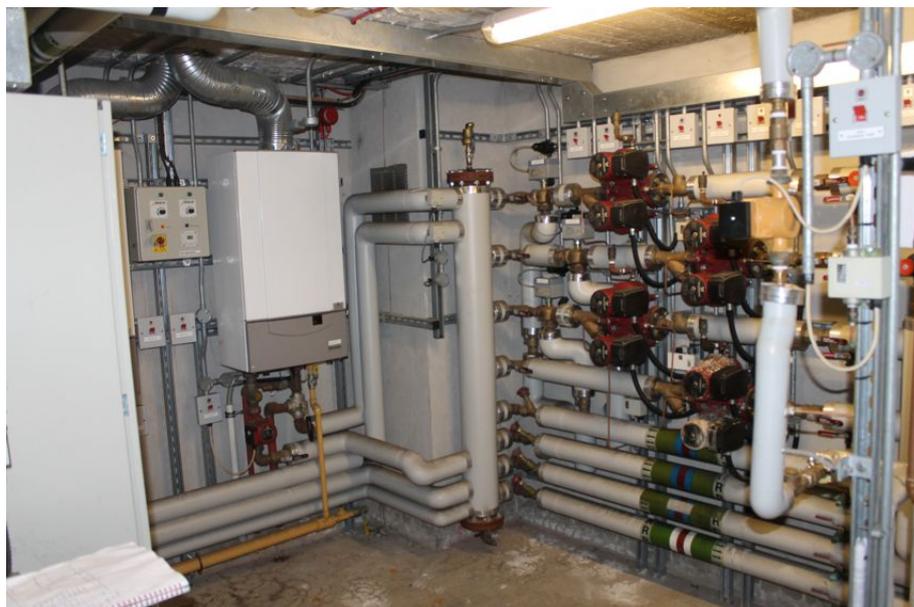
**Photograph 7** Basement underneath 1985 extension to Police Station, showing heating system. Photograph taken facing west.

In the original building the ceiling has been lowered, and several dividing plasterboard walls constructed, largely to divide what was originally the large open space of the Magistrates' Court (Fig 3 and 10). As noted previously, a first-floor has also been added above the court. All of the fireplaces have been blocked and a central heating and air-conditioning system has been installed. These are all powered from the basement below the 1985 extension, which contains a generator and several pumps (Photograph 7).

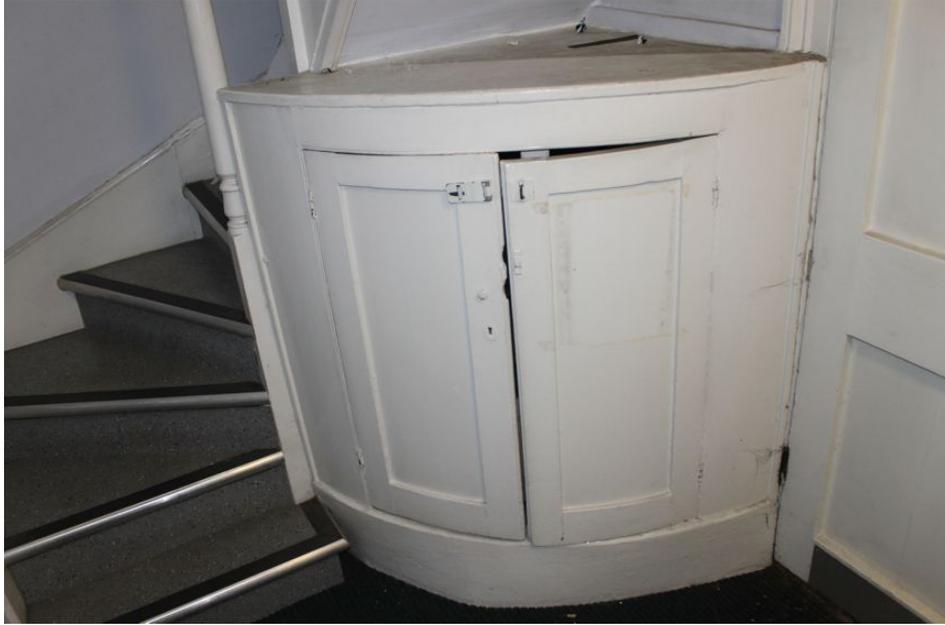
**Photograph 8** Original cabinet underneath stairs in north-west corner of Police Station. Photograph taken facing west.

The stairway in the north-west corner of the building appears to be original, as does the cabinet underneath it on the ground-floor (Photograph 8). The stairway in the centre of the building leads up to the first-floor of the 1938-55 extension, and likely dates from the same time.

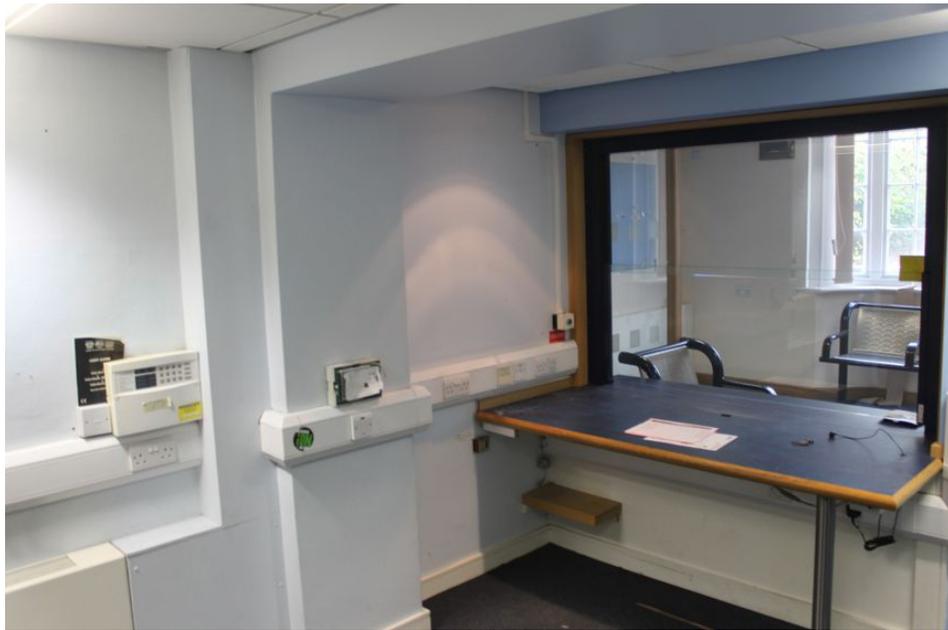
**Photograph 9** Location of original prison cells in Police Station, now the front office. Remains of thick cell walls visible. Photograph taken facing west.

The original prison cells of the building are now the front office and public WC. (Photograph 9). At some point the prison cells were moved to the extension built between 1876 and 1896 (Fig 3), judging from the concrete-framed very thick window on the south-western elevation (Photograph 11). Sometime before the 2004 alterations the prison cells were removed from the building entirely.

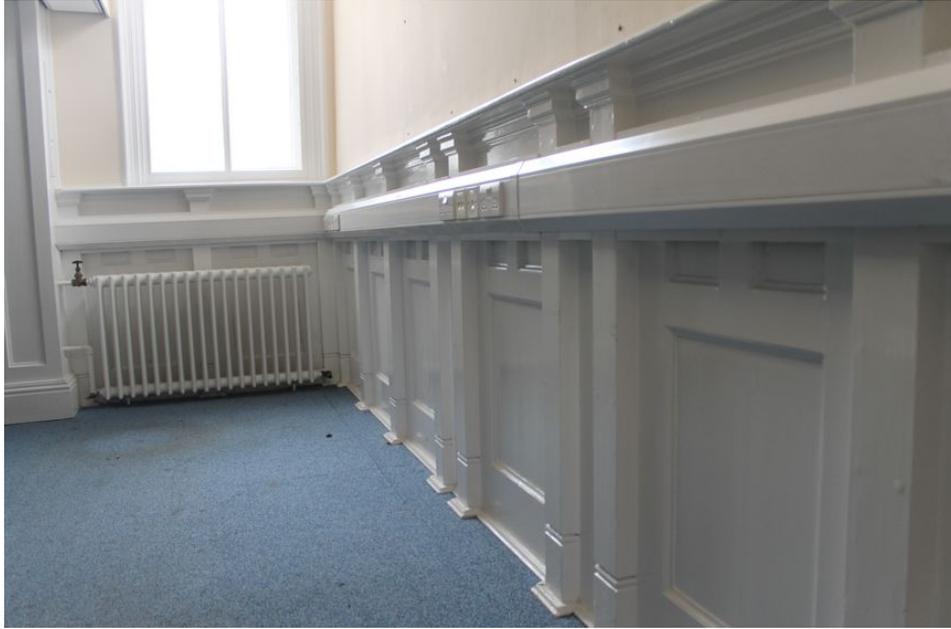
**Photograph 10** Detail of plaster moulding in extension to Magistrates' Court. Photograph taken facing north.

The extension to the Magistrates' Court in 1996-1920 has plaster moulding on its walls that appears to be original (Photograph 10).

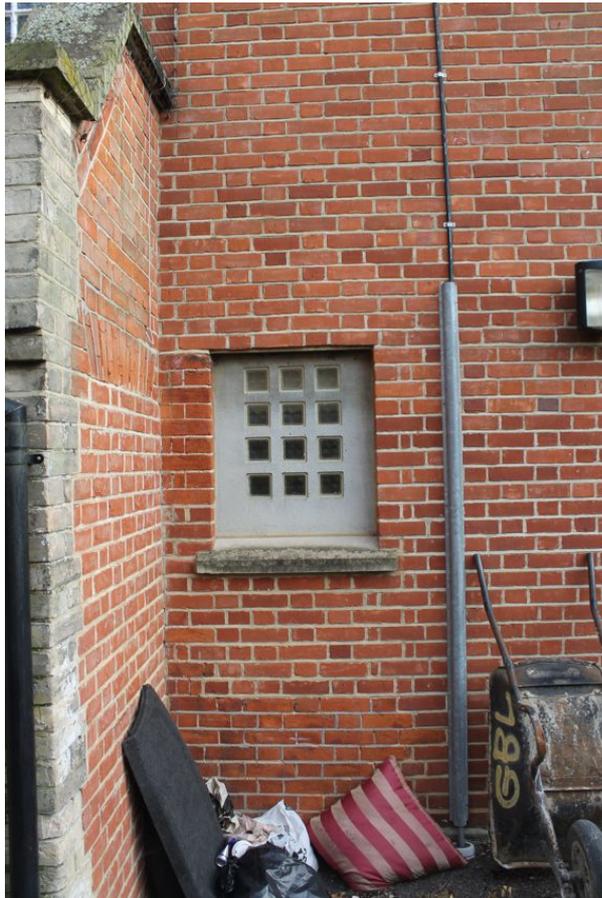
**Photograph 11** Inserted concrete-framed window on south-west elevation of extension to Police Station. Photograph taken facing north-east.

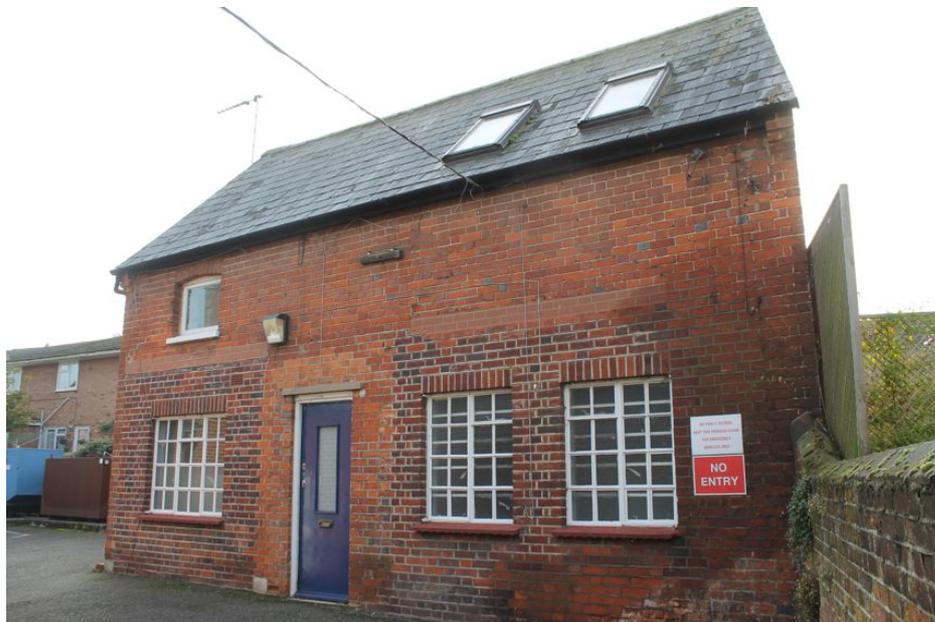
**Photograph 12** North-west elevation of outbuilding. Bricked in openings visible on either side of the door. Photograph taken facing east.

The outbuilding has had two 16-light metal-framed casement windows inserted into its north-western elevation, blocking the original entranceway into the cart lodge (compare Photograph 12 to Plan 3). Two modern skylights have been inserted into the north-western pitch of the roof, and five have been inserted on the south-eastern pitch. The skylights were probably inserted in 2004, at the same time as the ones in the police station.

The door in this elevation is modern, but is in the original doorway.

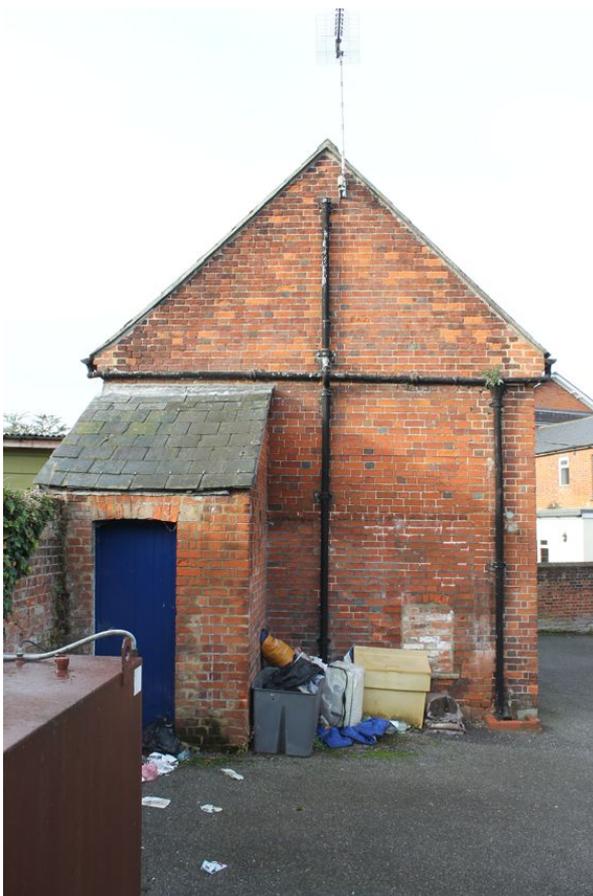
**Photograph 13** North-east elevation of outbuilding. Small bricked-in opening visible, and surviving lean-to. Photograph taken facing south-west.

The north-eastern elevation has a blocked opening and marks on the brickwork which originate from the square brick structure that used to be on the elevation (labelled as a 'dung-bin' on Plan 3). Still surviving on this elevation is a brick lean-to containing a WC (Photograph 13).

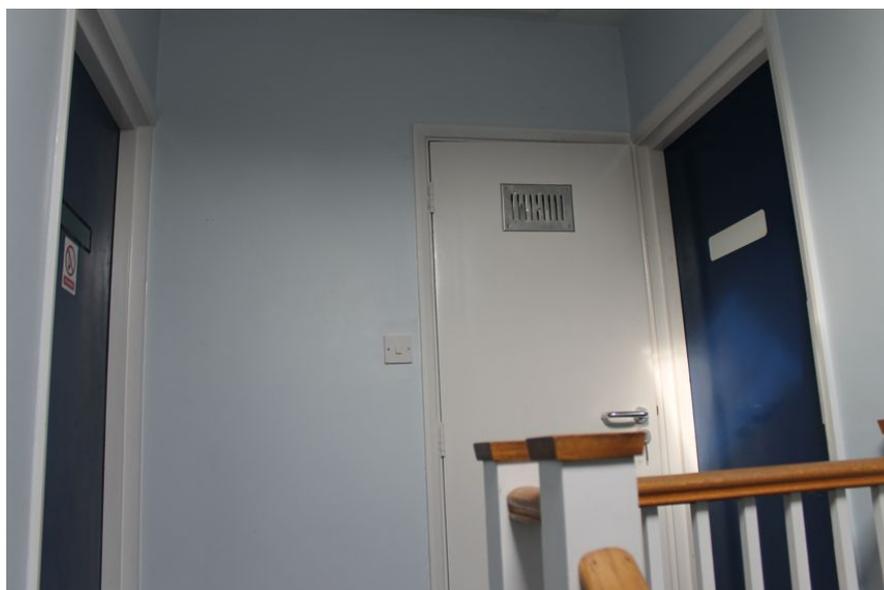
**Photograph 14** First-floor of outbuilding, showing inserted walls. Photograph taken facing north-west.

The interior of the outbuilding, as mentioned previously, is similar to the police station in that it has been thoroughly modernised with several internal walls added (Photograph 14). The first-floor, originally a loft above the stable and accessed via a ladder (Plan 2), is now accessed by an inserted stairway.

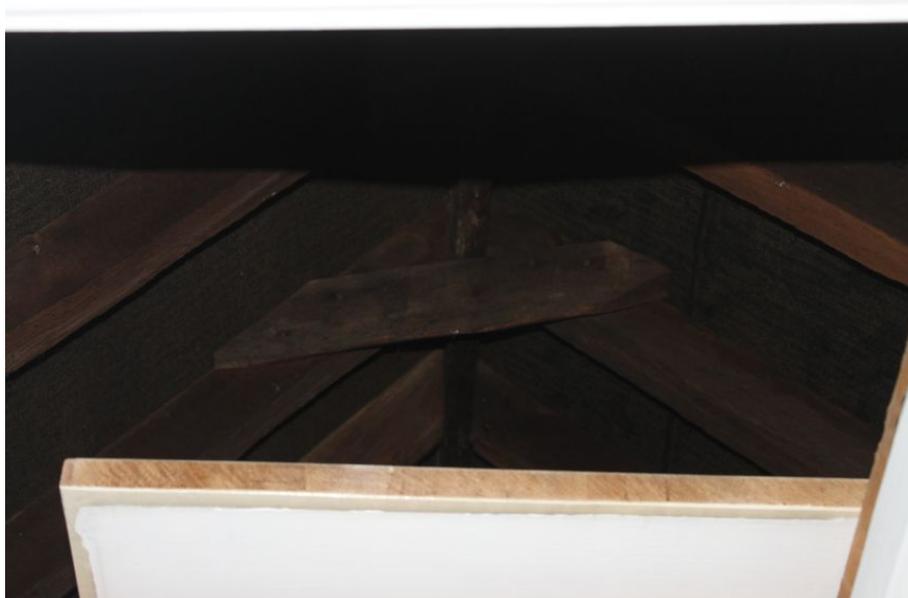
**Photograph 15** Detail of roof of outbuilding through loft hatch. Machine-cut rafters and upper collar visible. Photograph taken facing north-east.

Part of the roof was visible from the interior through the loft hatch. Inspection showed the roof was constructed of machine-cut rafters supported by an upper collar (Photograph 15). Outlines of one purlin on each roof pitch are visible in the rooms on the first-floor.

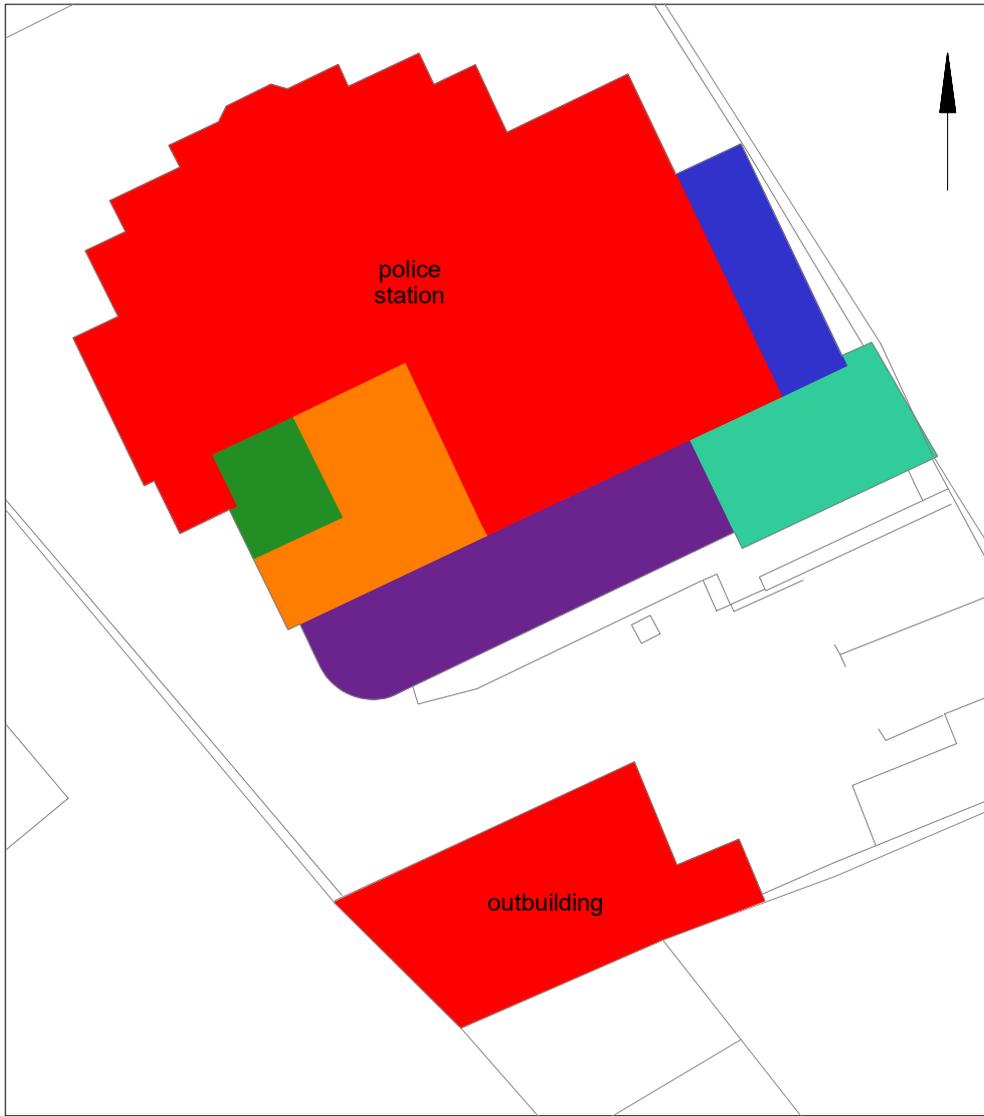
Fig 2 Detailed site plan with phasing.

The outbuilding is on a similar alignment to the police station but is oblong in shape, on account of being built adjacent to the wall surrounding the site (Fig 2). It measures roughly 8m x 4.7m in size and covers approximately 40 square metres. Like the Police Station, it is roofed in slate.

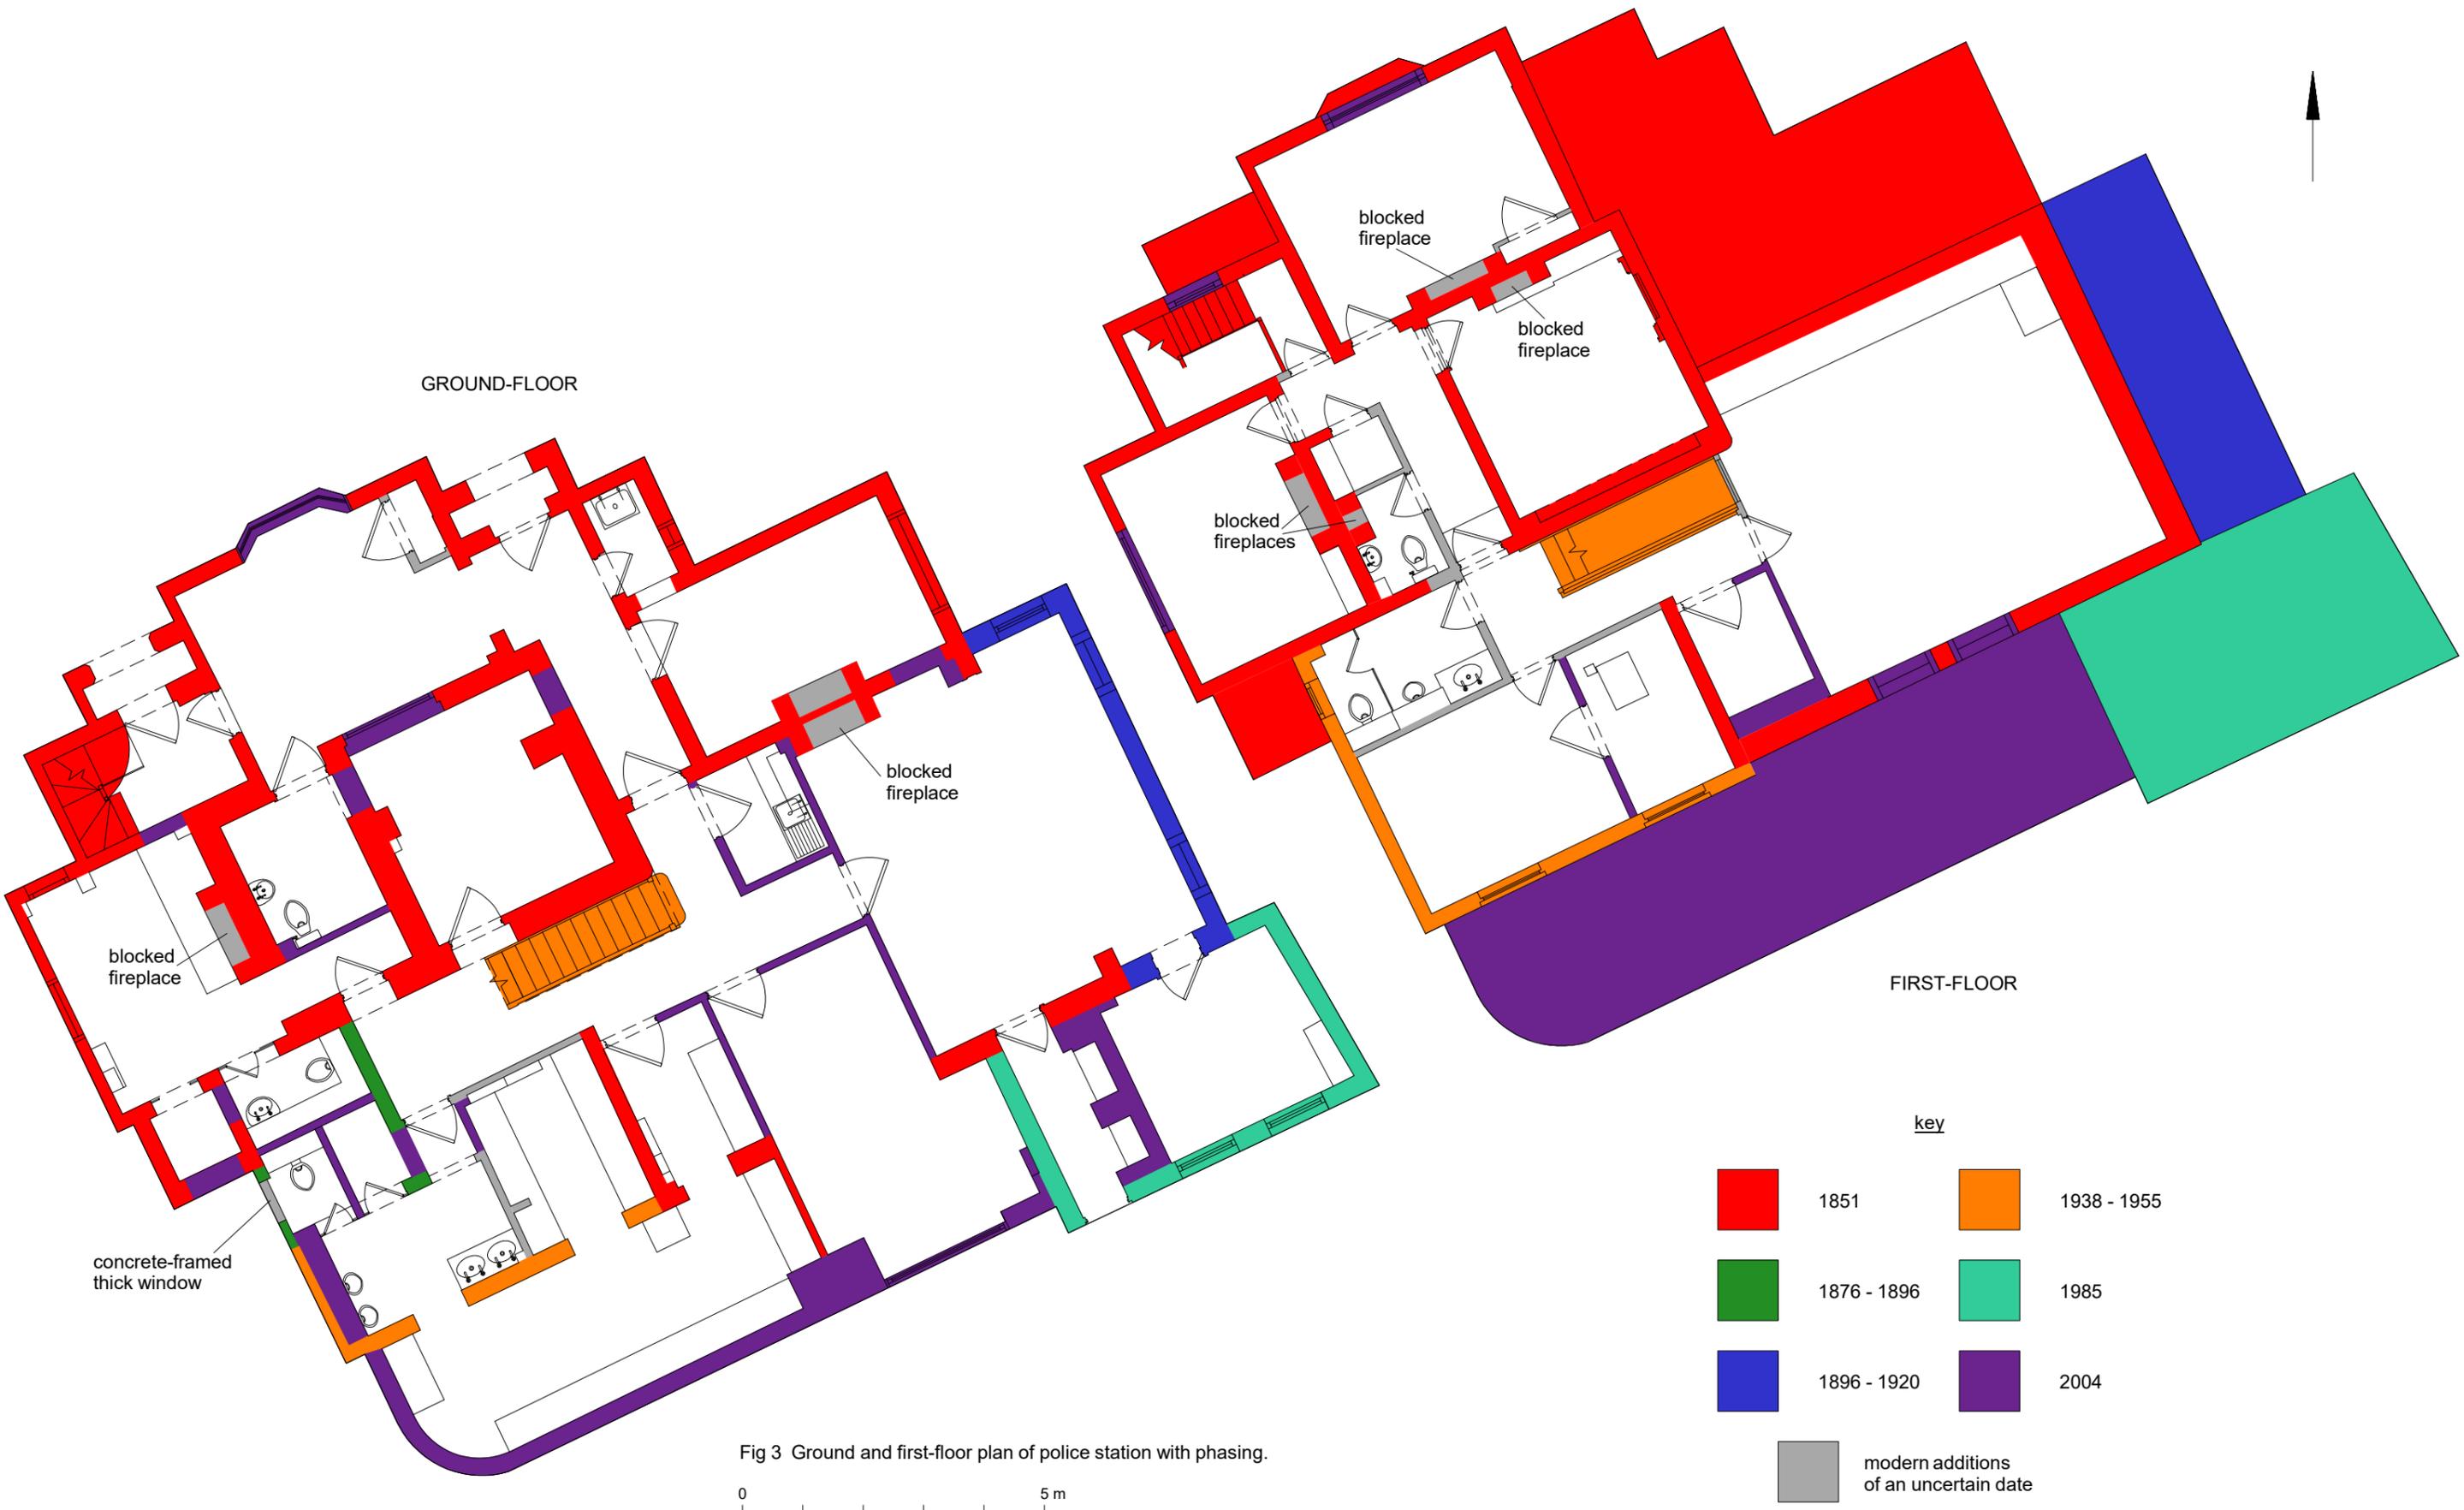
Fig 3 Ground and first-floor plan of police station with phasing.

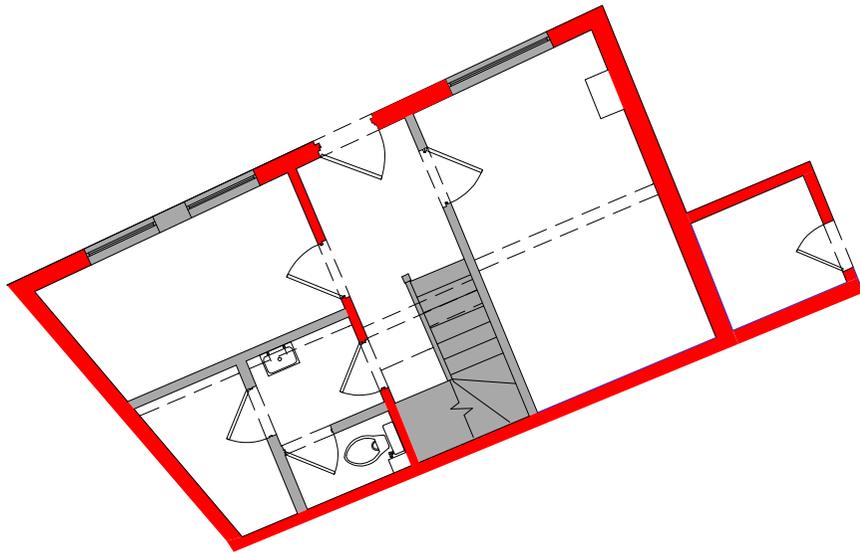
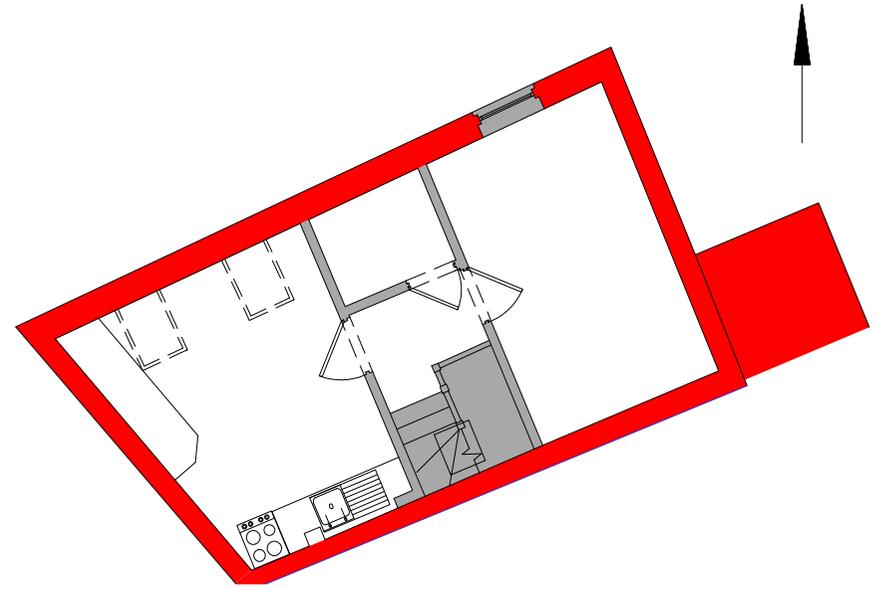
Fig 4 Outbuilding ground and first-floor plans with phasing.
