**Historic building recording at the  
former Halstead Police Station,  
Trinity Street,  
Halstead, CO9 1JG**

**November 2017**

**CAT Report 1206**  
December 2017

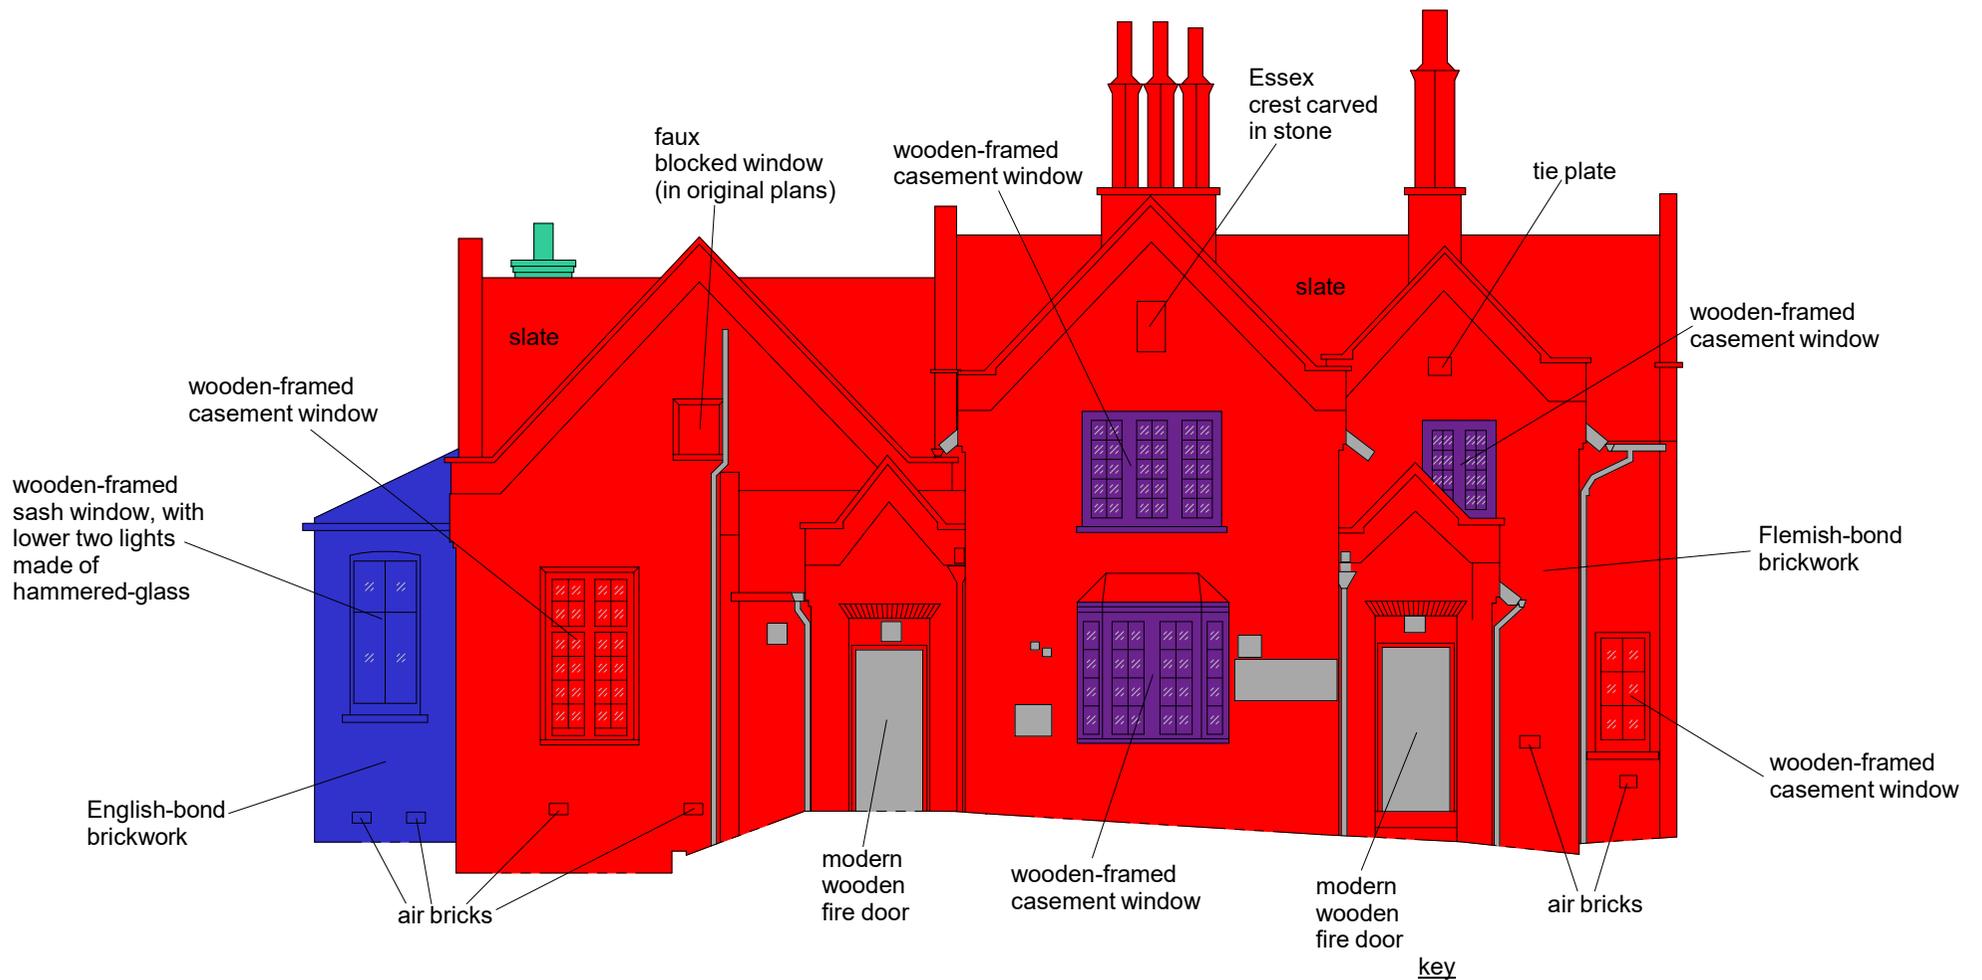
Fig 5 North-west elevation of police station with phasing.

The subsequent extensions to the police station have varying brickwork and windows, as shown on Figs 5-9, although all the extensions have made some effort to stay stylistically similar to the original building by replicating the white brickwork dressing on the corners of the structure.

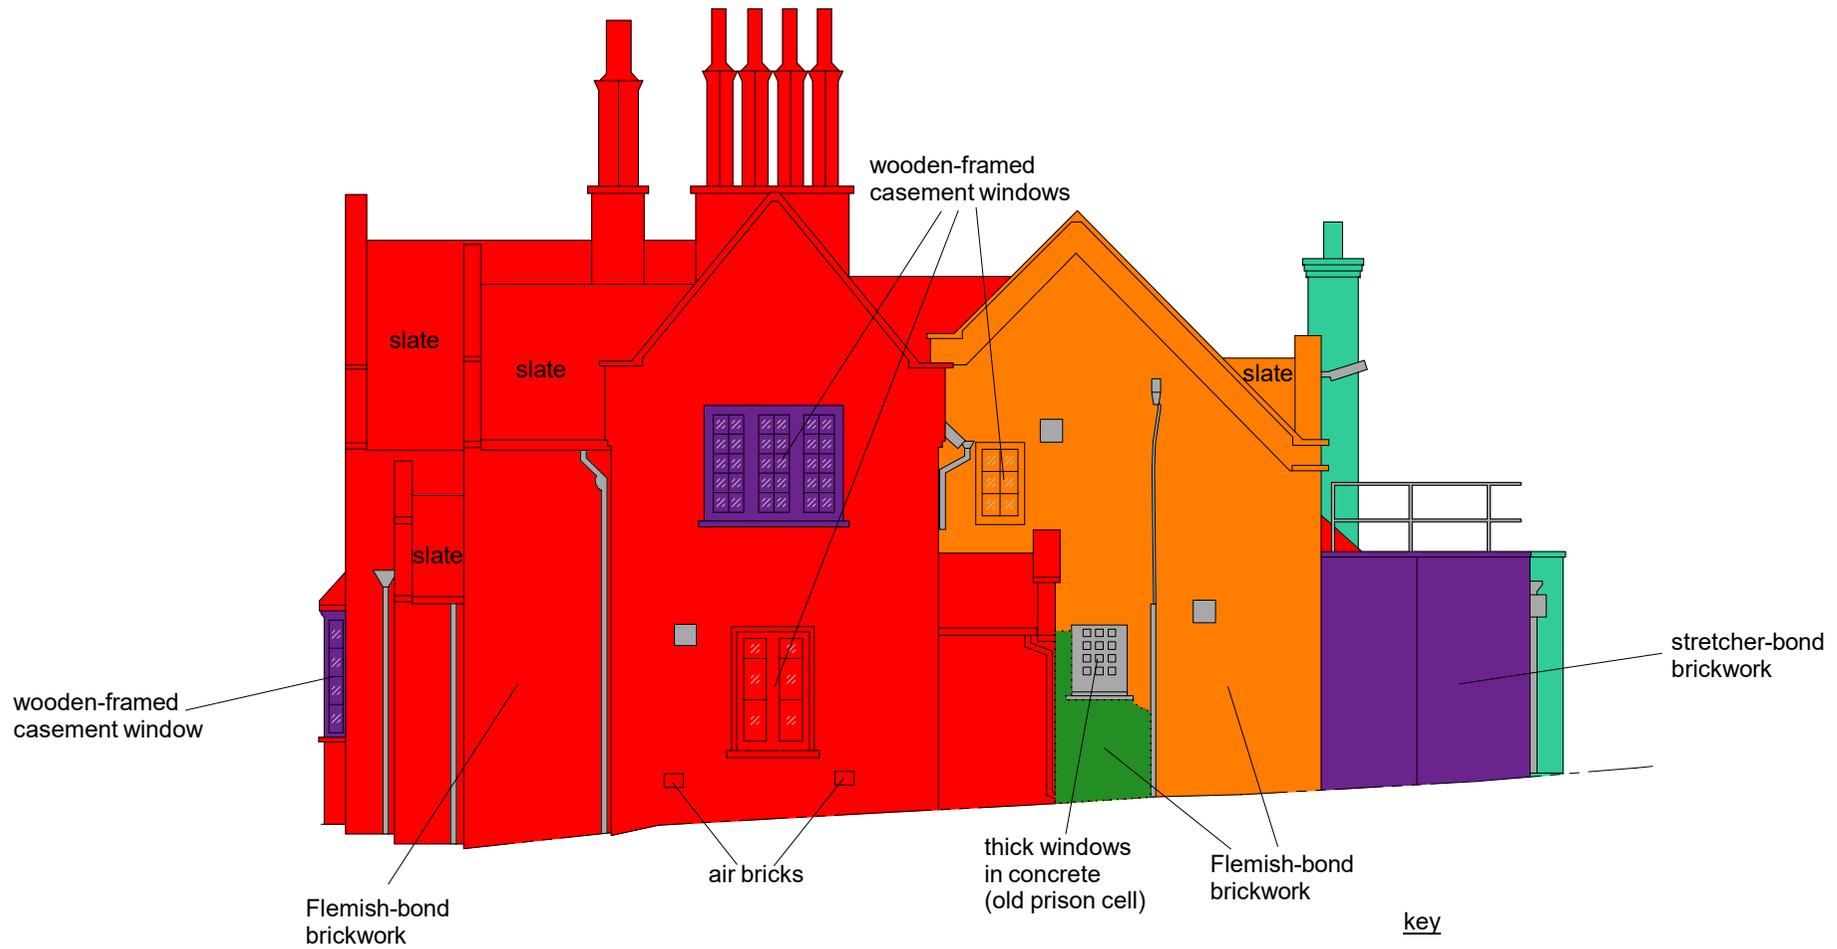
Fig 6 South-west elevation of police station with phasing.

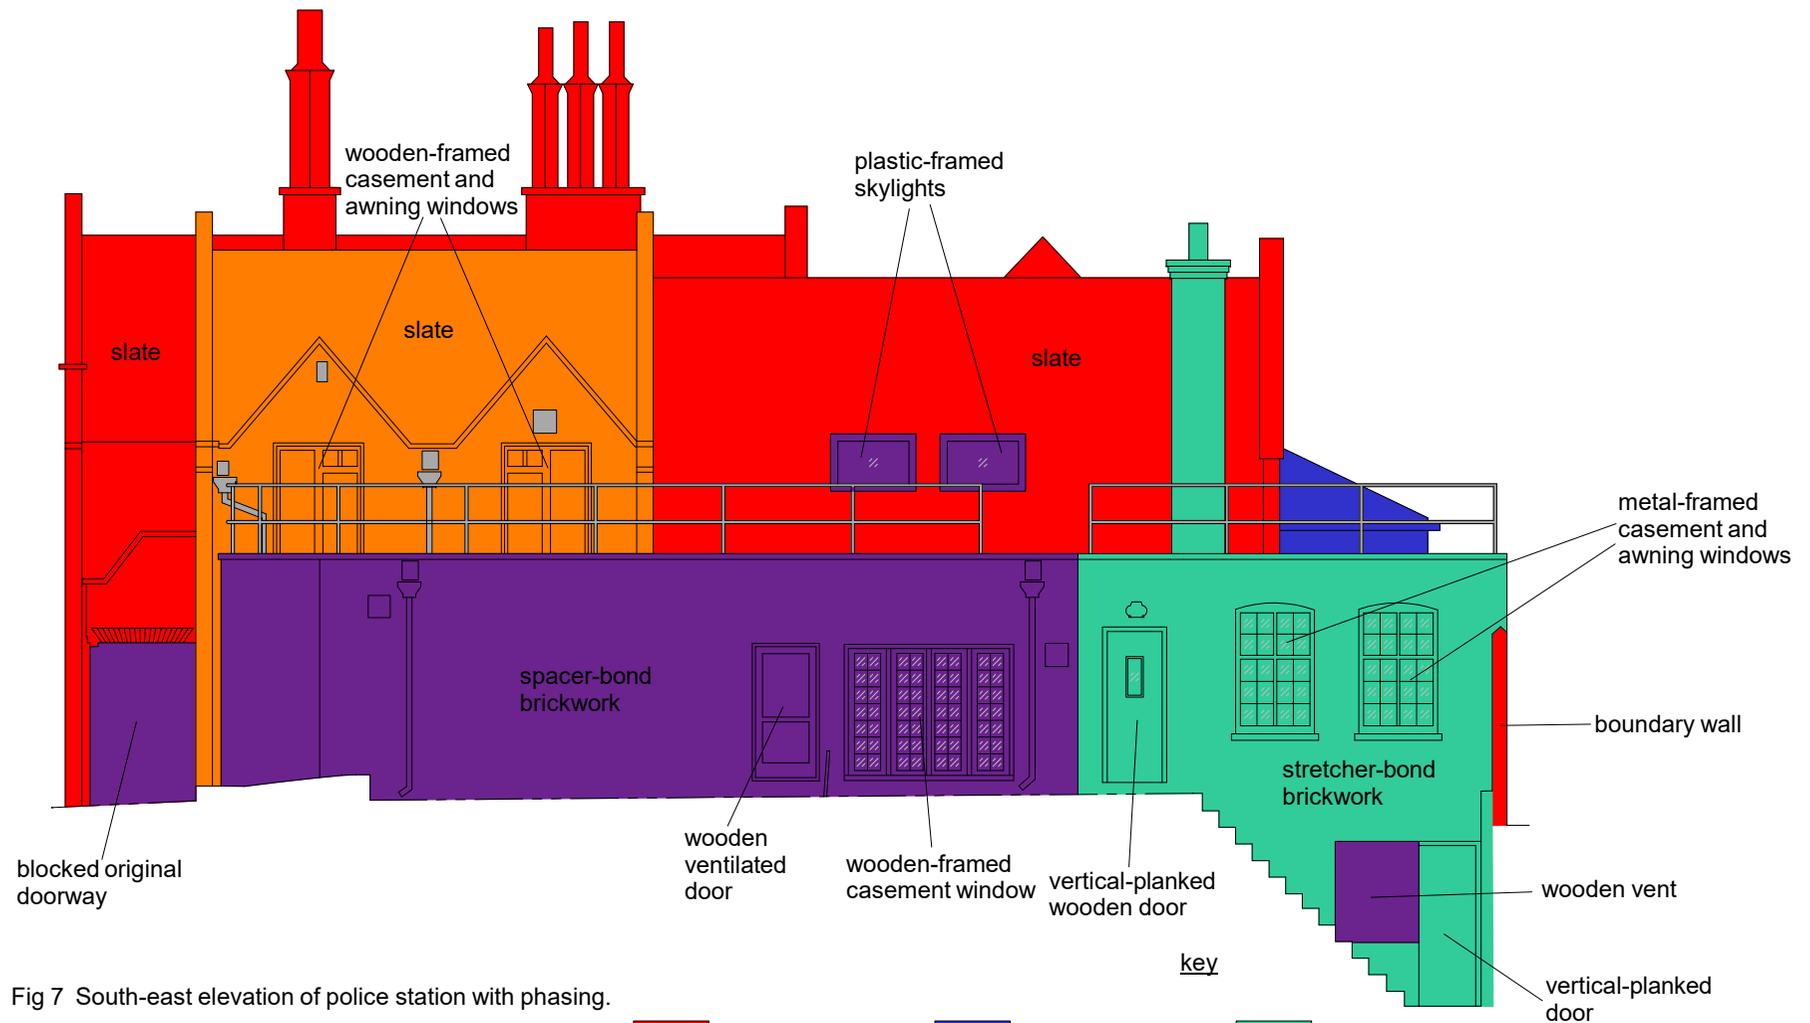
Fig 7 South-east elevation of police station with phasing.

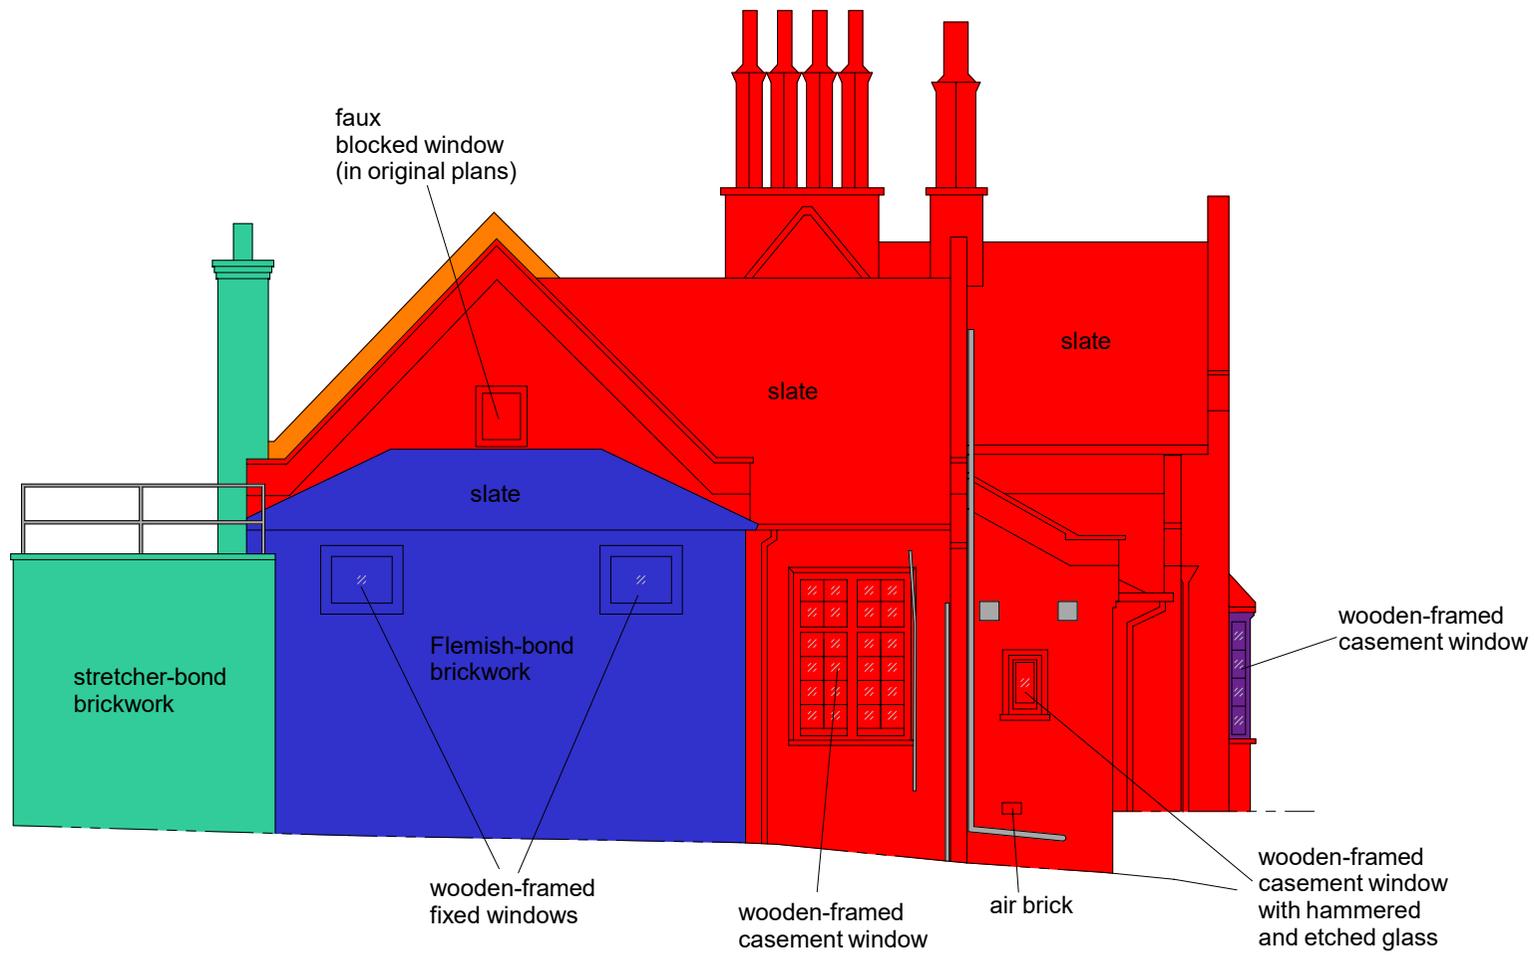
Fig 8 North-east elevation of police station with phasing.

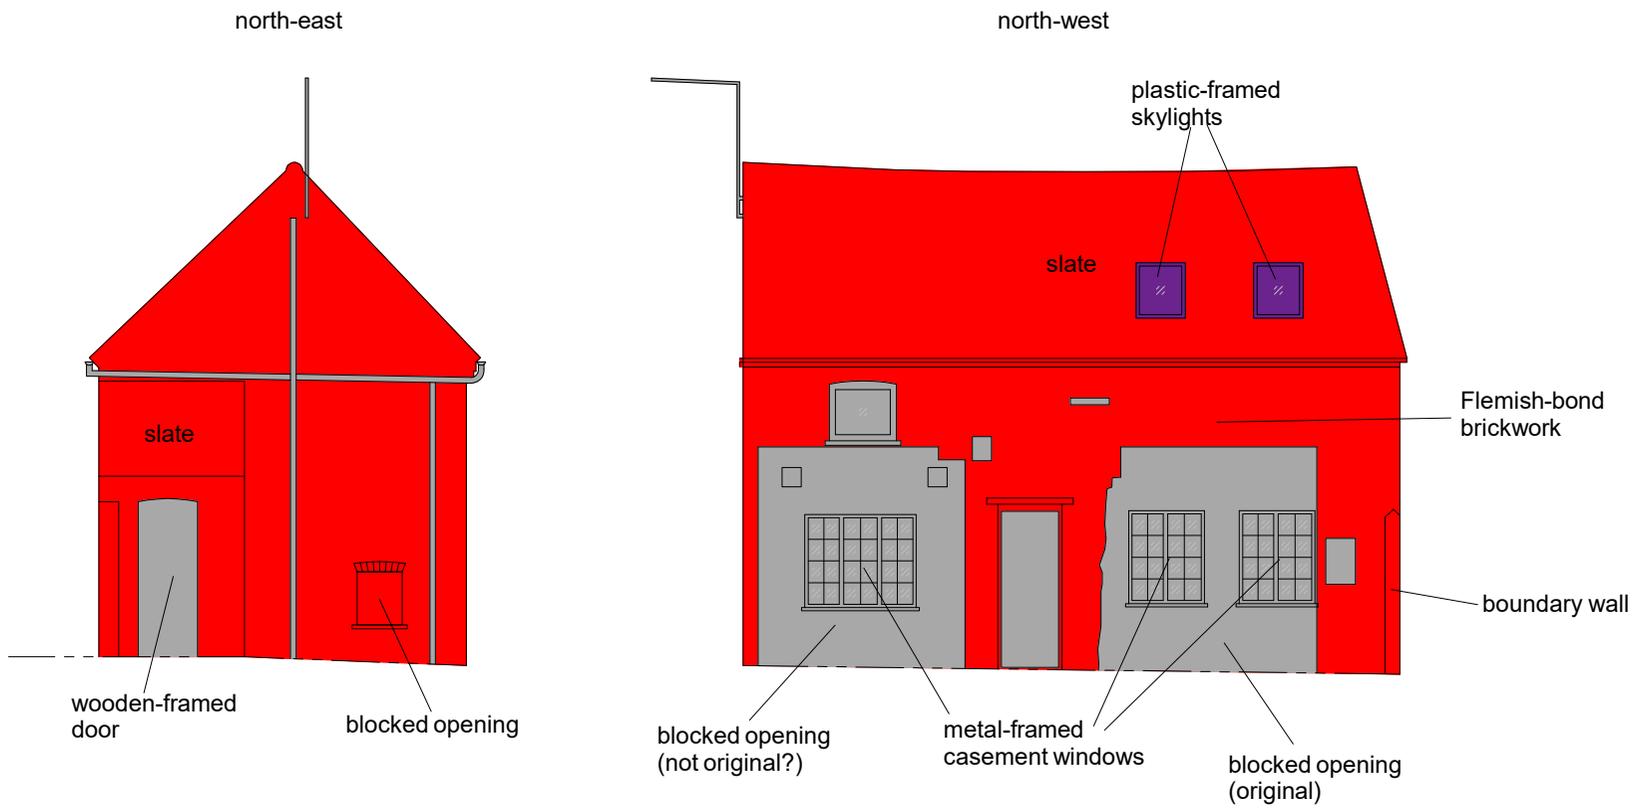
Fig 9 Elevations of outbuilding with phasing.

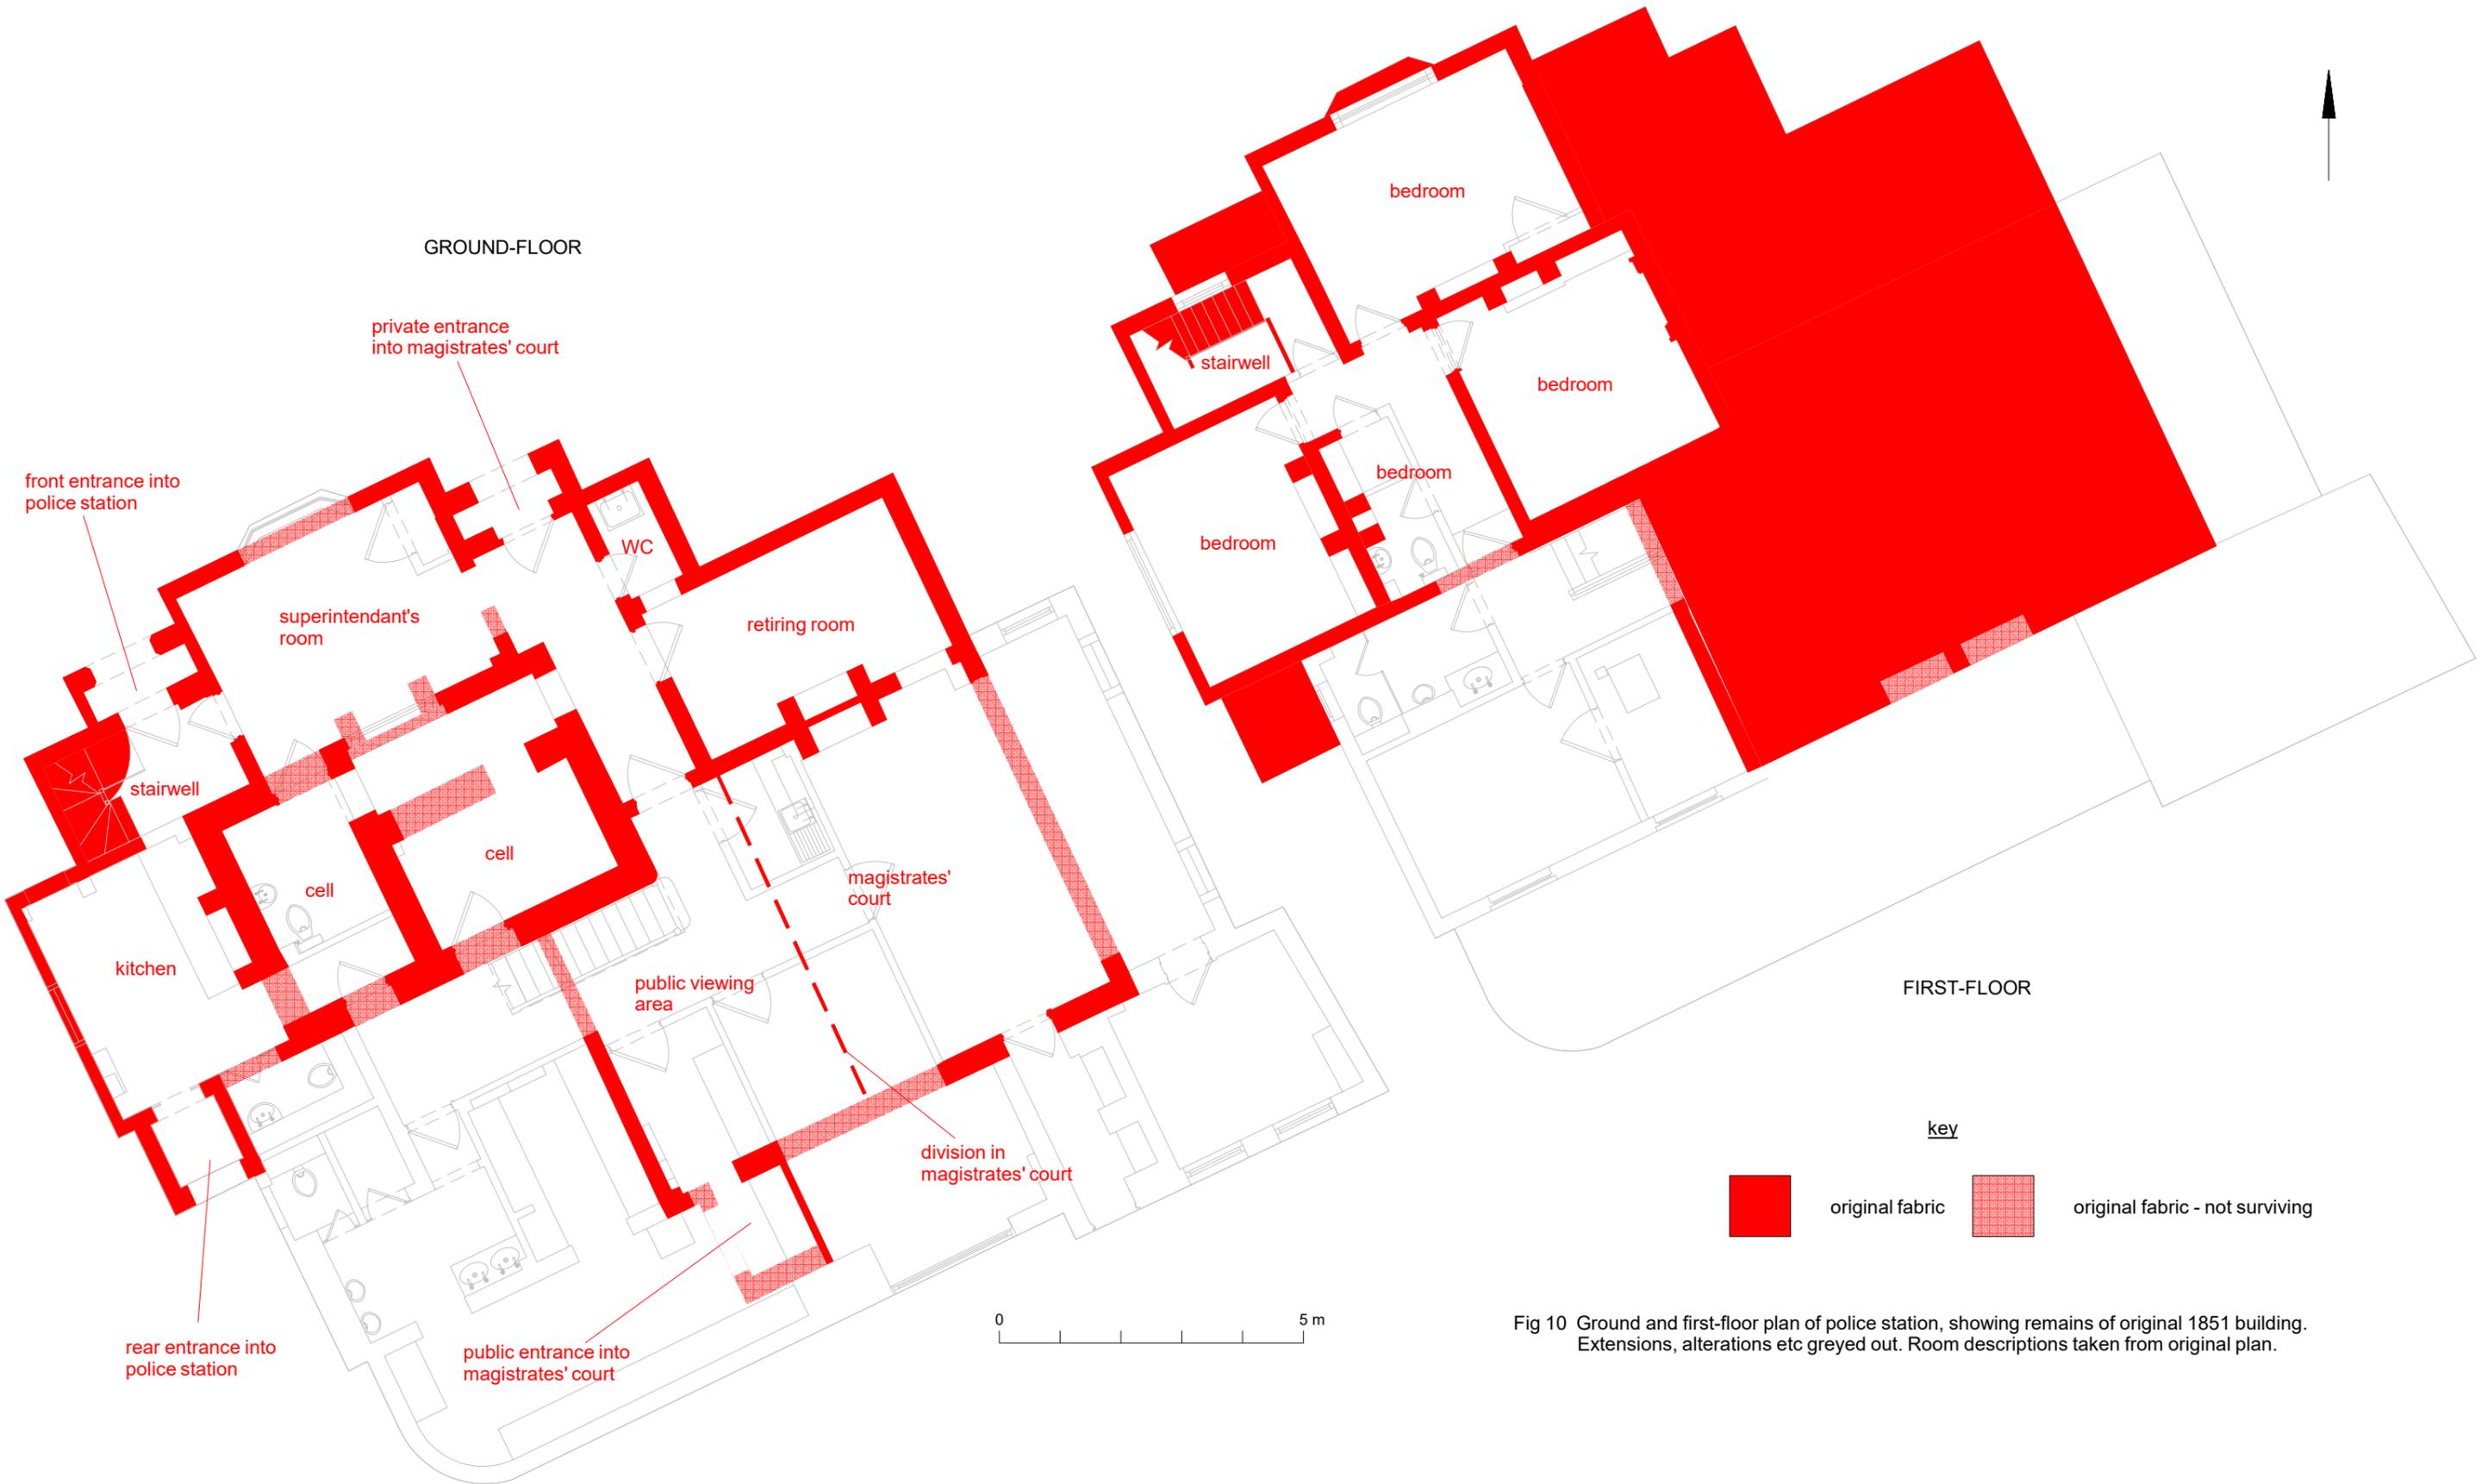
Fig 10 Ground and first-floor plan of police station, showing remains of original 1851 building. Extensions, alterations etc greyed out. Room descriptions taken from original plan.

The original building had two separate functions: as a police station and as a magistrates' court (although clearly these roles would have overlapped). Using the 1851 plans some interpretation has been made as to the functions of each room in the original building, with particular attention on the various doorways. This interpretation is shown at the end of this report (Fig 10).

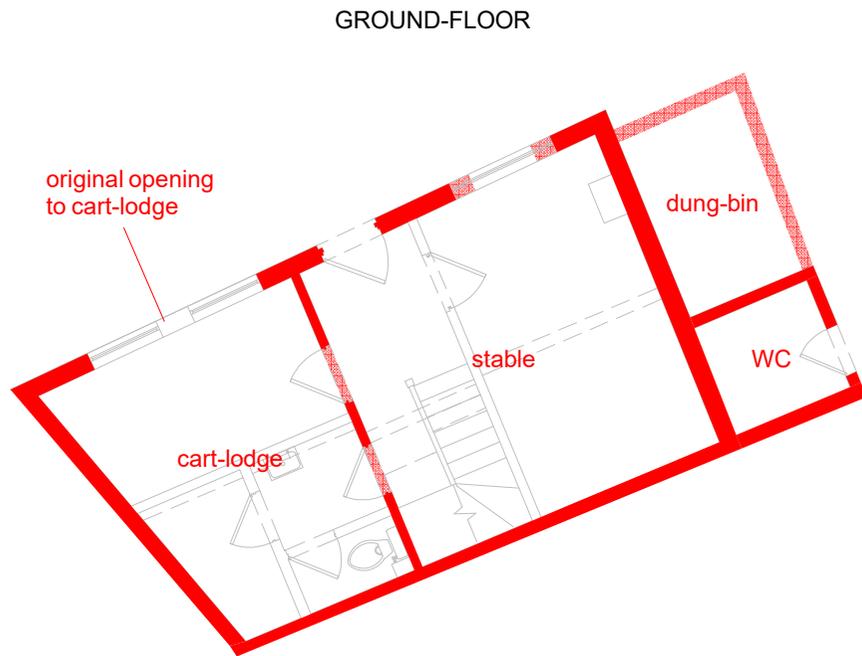
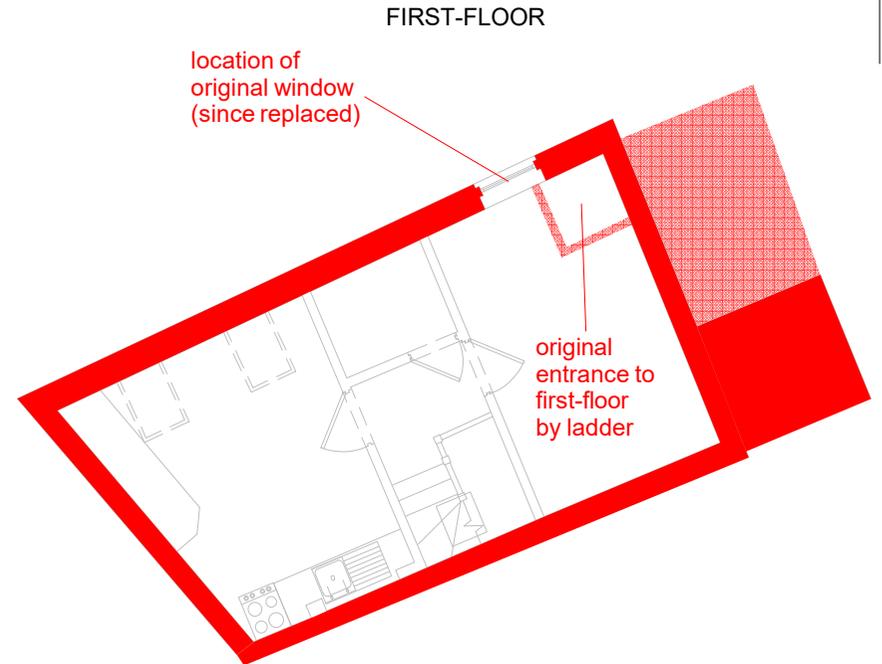
Fig 11 Ground and first-floor plan of outbuilding, showing remains of original 1851 building. Extensions, alterations etc greyed out. Room descriptions taken from original plan.
