# Archaeological evaluation at Manor House Farm, Brentwood Road, Bulphan, Upminster, Essex, RM14 3TJ

**CAT Report 1225**

An archaeological evaluation (six trial-trenches) was carried out at Manor House Farm, Brentwood Road, Bulphan, Upminster, Essex in advance of the construction of storage units, a stable yard and six residential dwellings. The evaluation uncovered the remains of a collection of nineteenth-century cow sheds which formerly stood at this site.

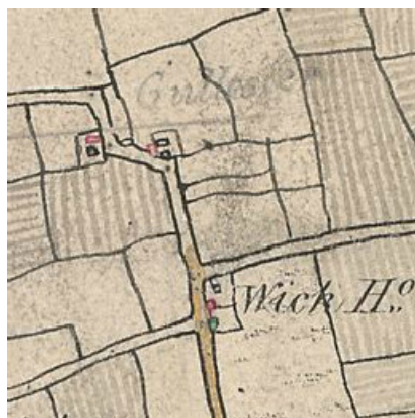
**Map 1** 1805 map of East Tilbury, Essex

Cartographic evidence shows that the proposed development will impact on historic farm buildings dating to the post-medieval period associated with Wick House, a house formerly standing at this site which was extant from at least the early nineteenth century (see Map 1 above). There is also the potential of encountering remains of a much earlier farm complex on the site. During the nineteenth century, a complex of cow sheds was erected on the site (see Map 2 below). According to the present owner of the property, these cow sheds burnt down during the 1950s, and a new barn was built in their stead.

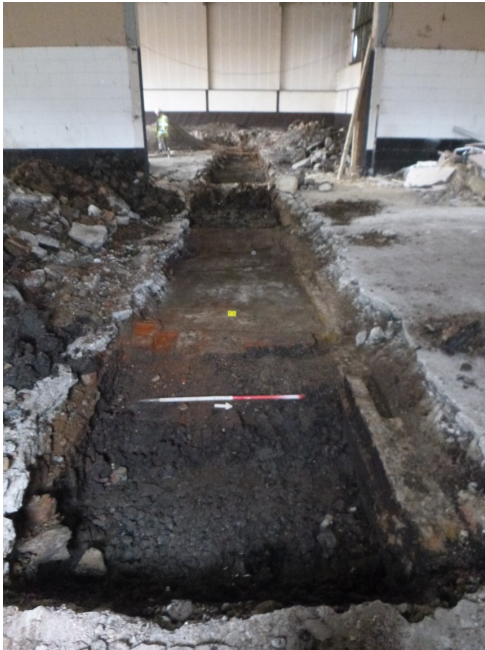
**Photograph 1** T1 trench shot – looking west

T1 was excavated through a layer of modern concrete and crush (L5, c 0.19-0.25m thick) and subsoil (L2, c 0.18-0.21m thick) onto natural (L3, encountered at a depth of c 0.39-0.44m bcgl). T1 was excavated within the barn which now stands at this site.

Post-medieval/modern building foundations F1 were uncovered at the eastern end of the trench. They comprised of a brick structure with concrete flooring and a ceramic drain pipe. Another modern building foundation, F2, also composed of a brick structure and concrete flooring, was uncovered at the western end of the trench.

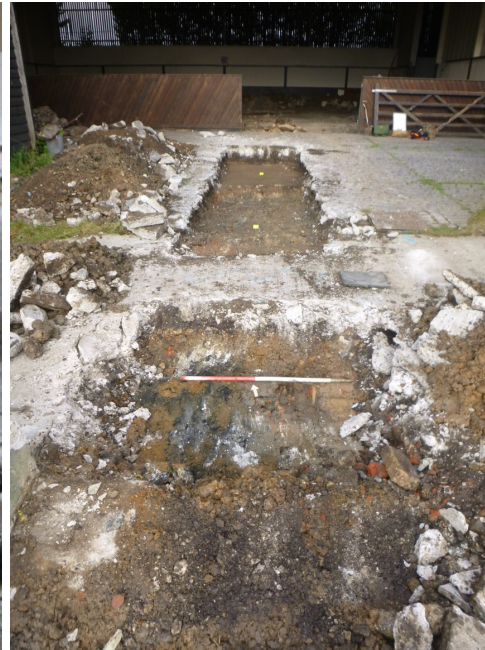
**Photograph 2** T2 trench shot – looking north north-east

T2 was excavated through L5 (c 0.17-0.21m thick) and a modern chalk yard surface (L6, c 0.15-0.22m thick) onto L3. The trench was truncated by modern services and disturbance in several places. T2 was excavated within the barn which now stands at this site.

Modern wall F3 was found towards the northern end of the trench. It was composed of frogged bricks, indicating that it was constructed around or after the mid nineteenth century. Modern concrete surface F4, similar to that of F1, was uncovered midway along the trench. Possibly underlying F4 was F5, a post-medieval/modern gravel surface consolidated with peg-tiles.
