Archaeological recording and evaluation at East of England Co-op, High Street, Dedham, Essex, CO7 6DE

April 2018

CAT Report 1265 May 2018

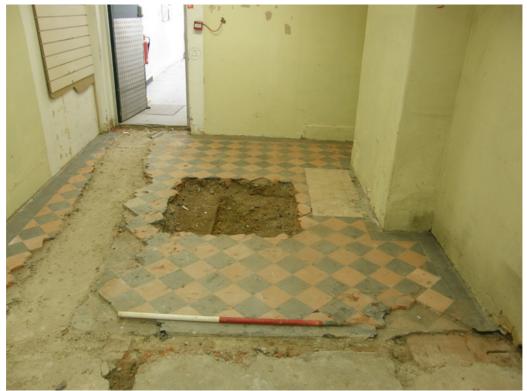
Photograph 1 Room 2 cut by modern service trench and TP4 – view north.

Room 2 is located in the north-west corner of the building, separated from Room 1 by a stairwell. It measures 3.26m north/south and 3.1m east/west (although it narrows to 2.96m wide on its southern edge). The room includes a bricked-up chimney with surviving rectangular hearth of stone-coloured ceramic tiles. The hearth measures approximately 1m long by 0.4m wide and is made of 40 tiles each measuring 10cm². The rest of the floor is composed of red/terracotta and black ceramic tiles set in a diamond pattern with a border of black tiles. The individual tiles were square, measuring 15.24cm² (6") and had been set into mortar. A modern service had previously been cut through the floor along the western side of the room. Soft red bricks laid on edge visible at the southern edge of the tiled floor are probably the remains of an old wall foundation, with the old doorway located close to the where the modern service has been cut through. Victorian tiled floors became fashionable in the 1860s, becoming an essential feature of ordinary Victorian houses by the 1890s (http://www.buildingconservation.com/articles/tiles/tiles.htm).

Test-Pit 4 showed that the mortar for this floor, which was only c 0.06m thick, had been laid directly over an old north/south wall foundation and rubble/demolition layers (see below). The layers contained material dating from the mid/late 19th to the early 20th century.

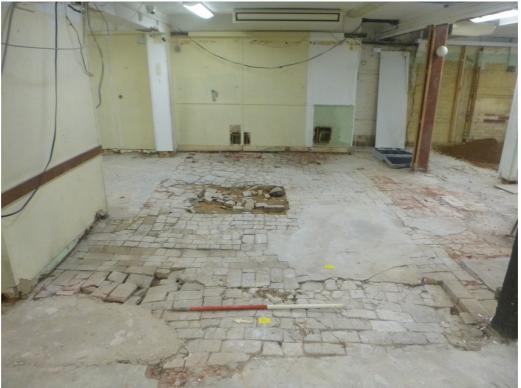
Photograph 2 Room 3, brick pavior and stone cobbled floor, cut by modern concrete and TP3 – view east.

Room 3 is located in the centre of the site, immediately to the south of Rooms 1 and 2. It measures 6.7m east/west and 3.7m north/south. Several patches of concrete remain in this room, particularly on the western side. The far west of the room, approximately 1.15m wide, consists of very modern concrete, and is probably the result of a continuation of the modern service run seen in Room 2. Adjacent to this, also at approximately 1.15m wide, is a thin layer of concrete over crushed red brick rubble. According to the site contractor the remainder of the room was covered in a thin skim of modern concrete, removed prior to CAT's recording. Directly below this was an earlier surface of brick paviors and stone cobbles. Several large areas of concrete truncate this surface, either repairs to this earlier surface or intrusions for unknown purposes.

The pavior surface is in a degraded state of preservation, with many of the bricks cracked or broken and some reduced to fragments. This is usually a sign of heavy wear but may be the result of the paviors being bedded directly onto soil rather than a subbase. The majority of the surface comprises unfrogged cream brick laid flat in a north/south alignment with areas of similar cream brick aligned east/west and areas of unfrogged red brick. These changes in orientation and colour probably represent later repairs.

The main surface is divided by a section of cream brickwork aligned north/south, four bricks wide. These bricks have a shallow frog and are laid bottom side up and slightly angled, creating a shallow gully that was probably to aid in drainage.

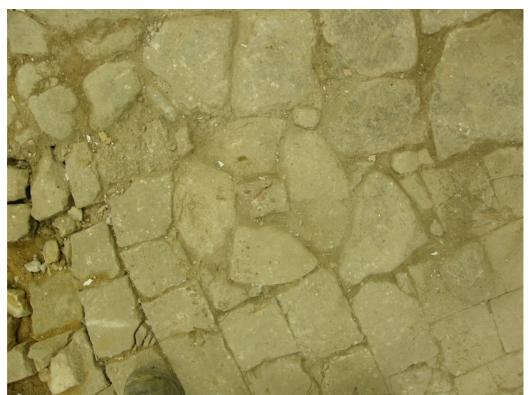
Photograph 3 Room 3, stone repair to brick pavior floor – view north-east.

A particularly intriguing feature of this surface is a large area of repair formed from pieces of smoothed granite of different sizes. The temptation is to refer to these as granite cobbles but that would imply a uniformity of size that does not exist. About half of the stone conforms to an approximate rectangular shape with the remainder being irregular in shape. There are no clear lines of bedding and the whole is more reminiscent of "crazy paving" rather than a cobbled surface. The smooth nature of the surface formed by the granite would suggest that it was sourced from worked stone, either part of a building/surface or perhaps from a stonemason's waste pile. Four pieces in particular appear to form a ring, clearly shaped by hand rather than by geology. Even more intriguing is the presence of several pieces of Purbeck marble within the surface. The provenance of the granite and the marble is unknown.

The large amount of repair to the pavior surface is easily explained by the almost complete lack of adequate bedding for the bricks, combined with what was possibly areas of slumping as organic material in the rubbish pits below rotted away. A significantly deep area of slumping may be the reason why stone had to be used instead of brick in the north-east corner of Room 3, although this does not answer the question of where this material was obtained. That is a particularly difficult question. The stone, both granite and purbeck marble, is not local and there is too much of it to claim it as glacial erratics. It may have come up the River Stour as ballast in the barges or, far more likely, it may be waste from a stone mason's yard.

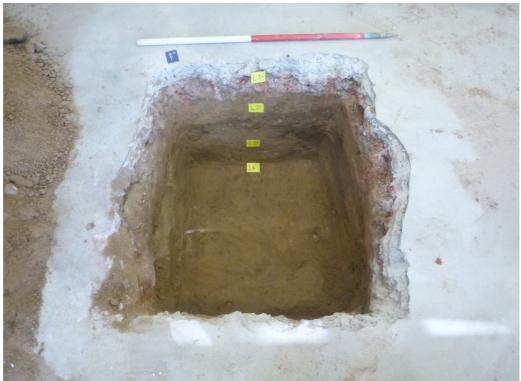
Photograph 4 Test-Pit 1 – view north.

Test-Pit 1 (TP1): Test-pit 1 was excavated through modern concrete at the front of the shop (L1, 0.2m thick). This overlaid a compacted clay floor (L2, c 0.14m thick) sealing a medium grey sandy-silt accumulation deposit (L3, c 0.37m thick). Beneath L3, natural sands (L4) were identified at a depth of 0.7m below current ground level (bcgl).

Cut into L3 was undated pit F2, measuring approximately 0.18m deep. Pit F2 is sealed by compacted clay layer L2 which is likely to be an earlier floor.

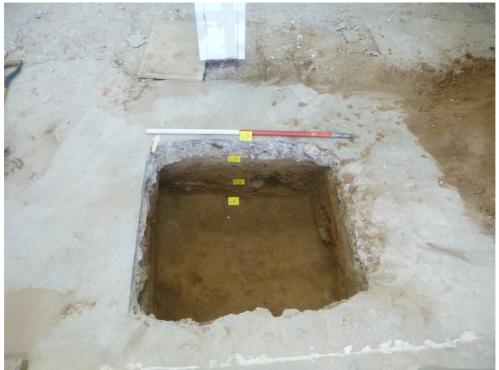
Photograph 5 Test-Pit 2 - view north.

Test-Pit 2 (TP2): Test-pit 2 was also excavated through modern concrete (L1, 0.1m thick), compacted clay floor L2 (*c* 0.12m thick) and accumulation deposit L3 (*c* 0.08m thick). Beneath L3, natural sands (L4) were identified at a depth of 0.3m bcgl.

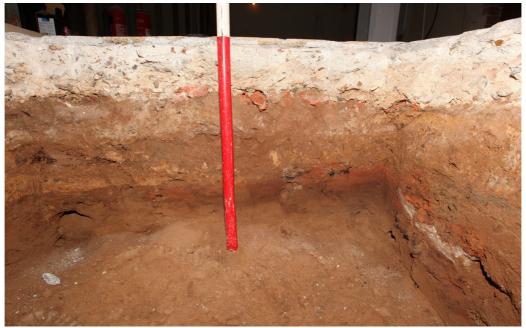
Photograph 6 Test-pit 2, hearth F3, showing *in situ* burning with embedded charcoal – view west. Image courtesy of Leigh Alston.

During excavation a large feature containing patches of charcoal and burning was identified as a pit (F3). However, during an assessment of the site for his building recording, Leigh Alston suggested that this could in fact be the remains of a medieval hearth associated with the 16th century hall (Leigh Alston, pers comm). A small quantity of peg-tile was recovered from F3 along with a single iron nail and oyster shell.

If F3 is a hearth associated with the original 16th century hall then it is perhaps likely that L3, which it cut through, is not an accumulation deposit but an associated floor layer, both sealed by later clay floor L2. The prehistoric pottery recovered from L3 might suggest that the material used to construct this floor was brought in from elsewhere, but it might be associated with other prehistoric activity known from Dedham.

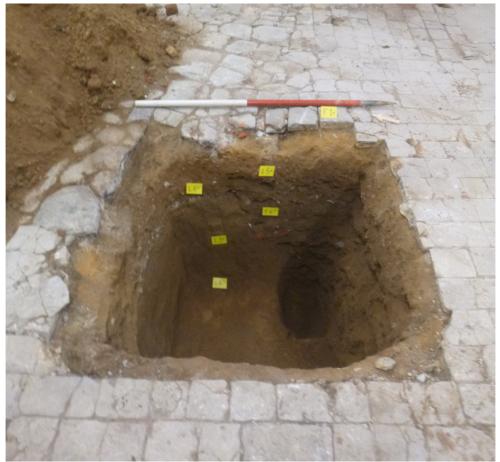
Photograph 7 Test-Pit 3 – view east.

Test-Pit 3 (TP3): Test-pit 3 was located within brick and stone floor F1 to the rear of the shop. The floor, set into a base of soft sand (0.1m thick), overlaid a band of medium brown silt containing crushed peg-tile (L5, 0.06-0.07m thick), possibly a make-up layer for F1. Sealed by L5 was a *c* 18th- to 19th-century buried topsoil (L6, *c* 0.15m thick)

overlaying accumulation deposit L3 (c 0.53m thick). Beneath L3, natural sands (L4) were identified at a depth of 0.85m bcgl.

Cut into accumulation deposit L3 was *c* 18th-century pit F4, measuring approximately 0.85m deep.

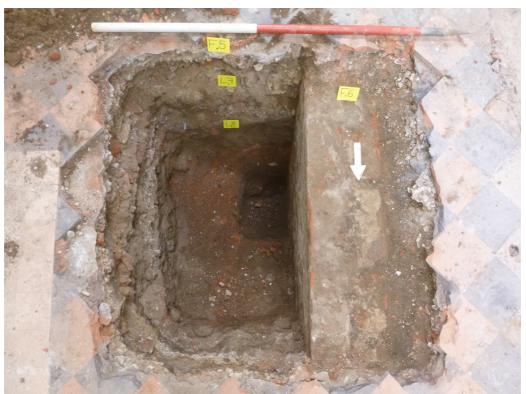
Photograph 8 Test-Pit 4 – view south.

Test-Pit 4 (TP4): Test-pit 4 was located within tile floor F5 to the rear of the shop. The floor, set into mortar (0.1m thick), sealed two layers of modern rubble/backfill (L7, 0.32-0.4m thick and L8, at least 0.58m thick but not bottomed due to safe-working depths; both dated from the mid/late 19th to the early 20th century). Natural was not encountered in this test-pit.

Wall foundation F6, made of unfrogged red bricks, had cut through L7-L8 and these layers are probably associated with the construction of this wall.
