**Historic building recording at 1-7 Winnocks,
Military Road, Colchester,
Essex, CO1 2AF**

April 2018

CAT project ref.: 18/03s
NGR: TM 0008 2472 (centre)
Planning reference: 180308
ECC project code: ECC4179
OASIS project id: colchest3-313426

CAT Report 1277
June 2018

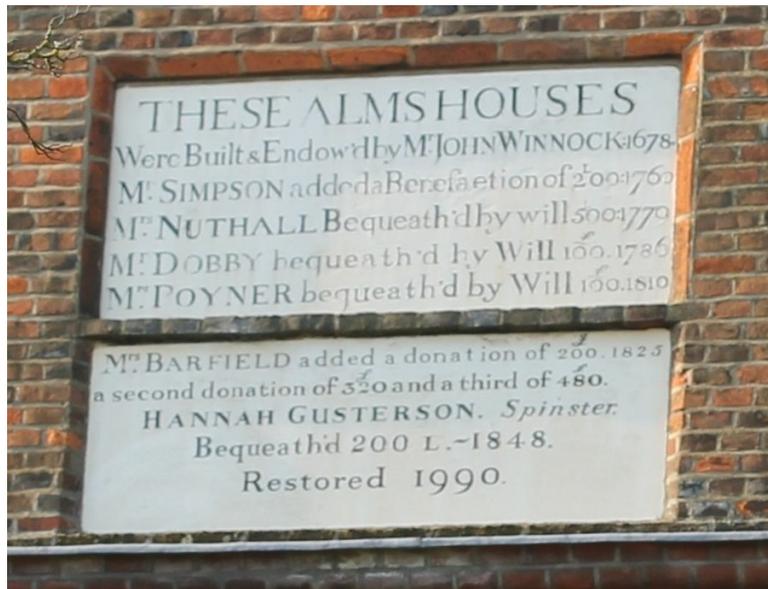
Photograph 1

Inscription in the pediment of the 1678 almshouse listing the benefactors of Winnocks.

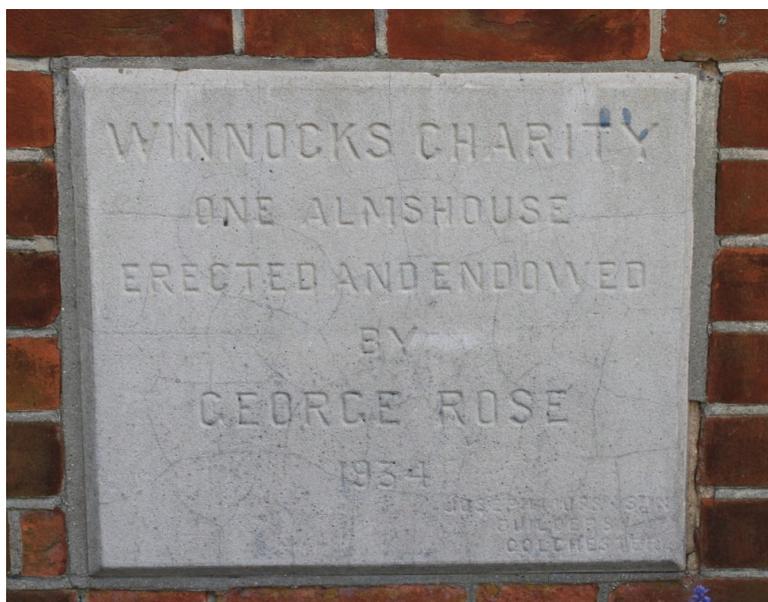
Photograph 2

Inscription stone found below the front window to each of the almshouses, recording the endowment by George Rose.

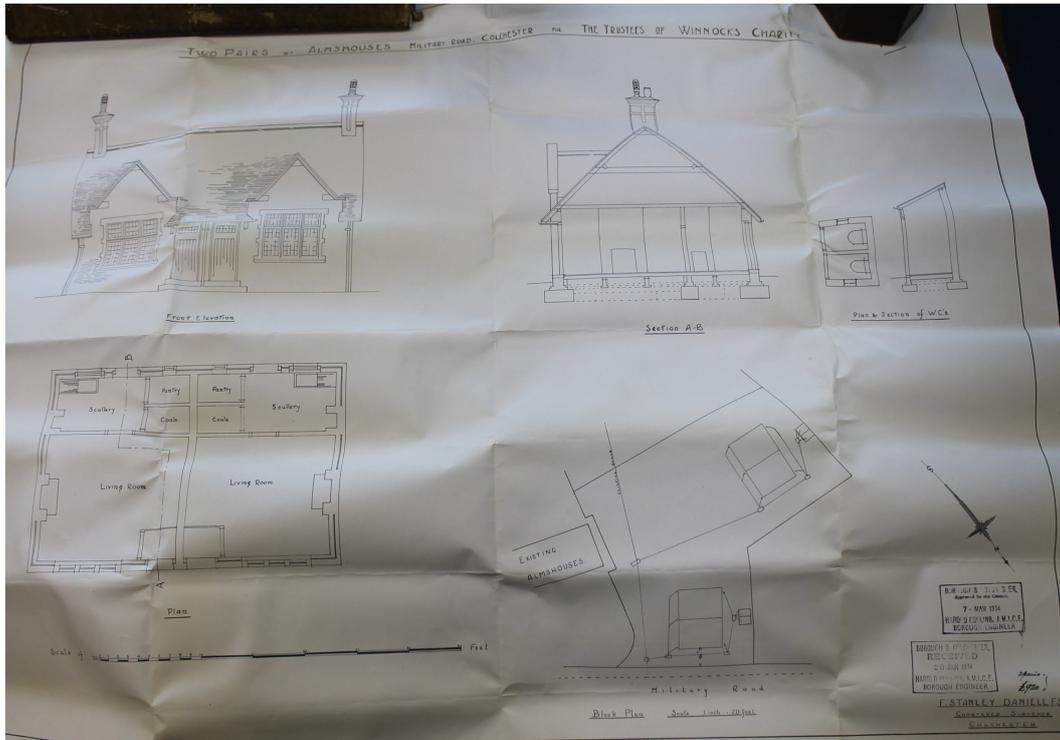
Plan 1 Plan by F Stanley Daniell of the original two pairs of almshouses (Nos. 1-2 & Nos. 3-4). ERO D/B 6 Pb3/6526.

The Essex Record Office contains three building plans for 1-7 Winnocks, designed by F Stanley Daniell, a local chartered surveyor and the Clerk to Winnock's Charity (Plans 1-3). The first (Plan 1, ERO D/B 6 Pb3/6526) shows only the northern and westernmost pairs of almshouses (designated in this report as Nos.1-2 and Nos.3-4) and was approved by Colchester Council on the 7th March 1934. The second (Plan 2, ERO D/B 6 Pb3/6570) includes the southern pair of almshouses (Nos.5-6) and was approved by the council on 2nd May 1934. Finally, the third (Plan 3, ERO D/B 6 Pb3/6729) shows the addition of the single detached almshouse (No.7) to the site and was approved on 3rd October 1934.

The original plans show that the almshouses were all constructed to an identical layout of four rooms, comprising a large living room, a scullery, a coal store and a pantry, with the pairs of almshouses having a mirror symmetry (Plan 4). A single detached WC, in effect an outhouse, was provided for each almshouse (Plans 1-3).

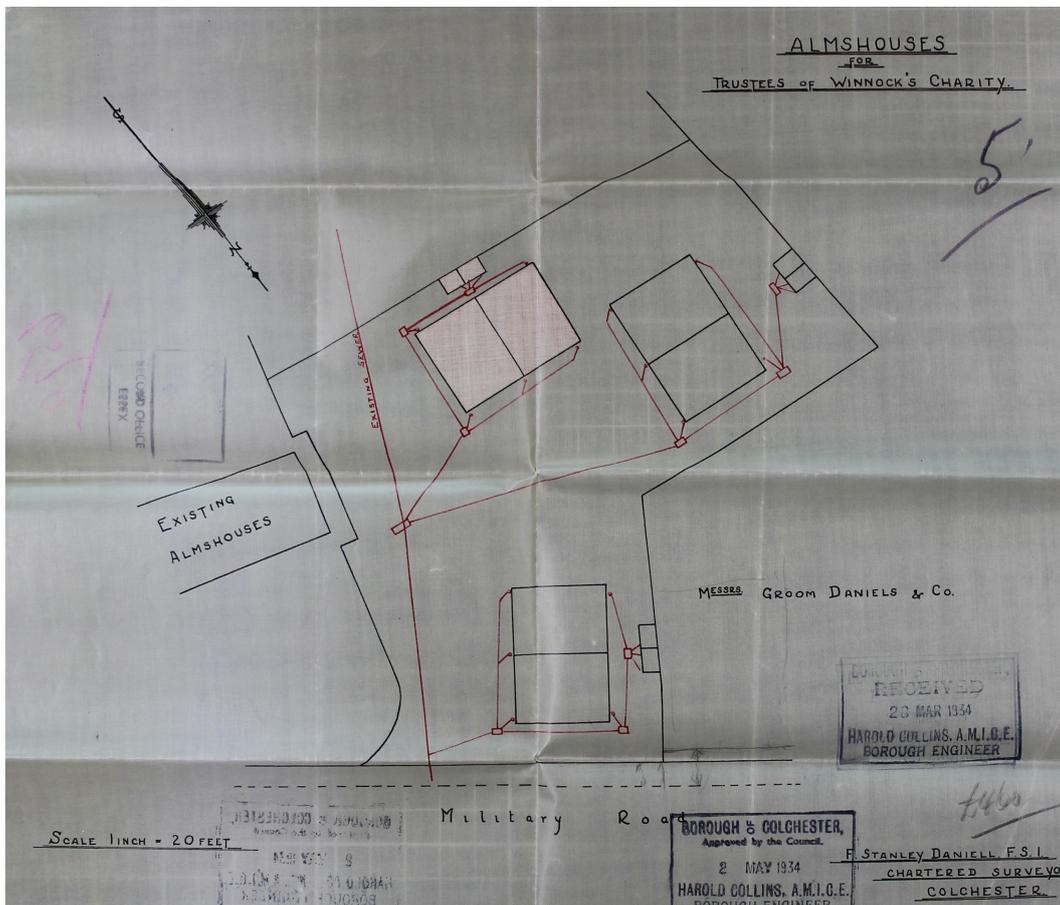
Plan 2 Plan by F Stanley Daniell of the third pair of almshouses (Nos.5-6). ERO D/B 6 Pb3/6570.

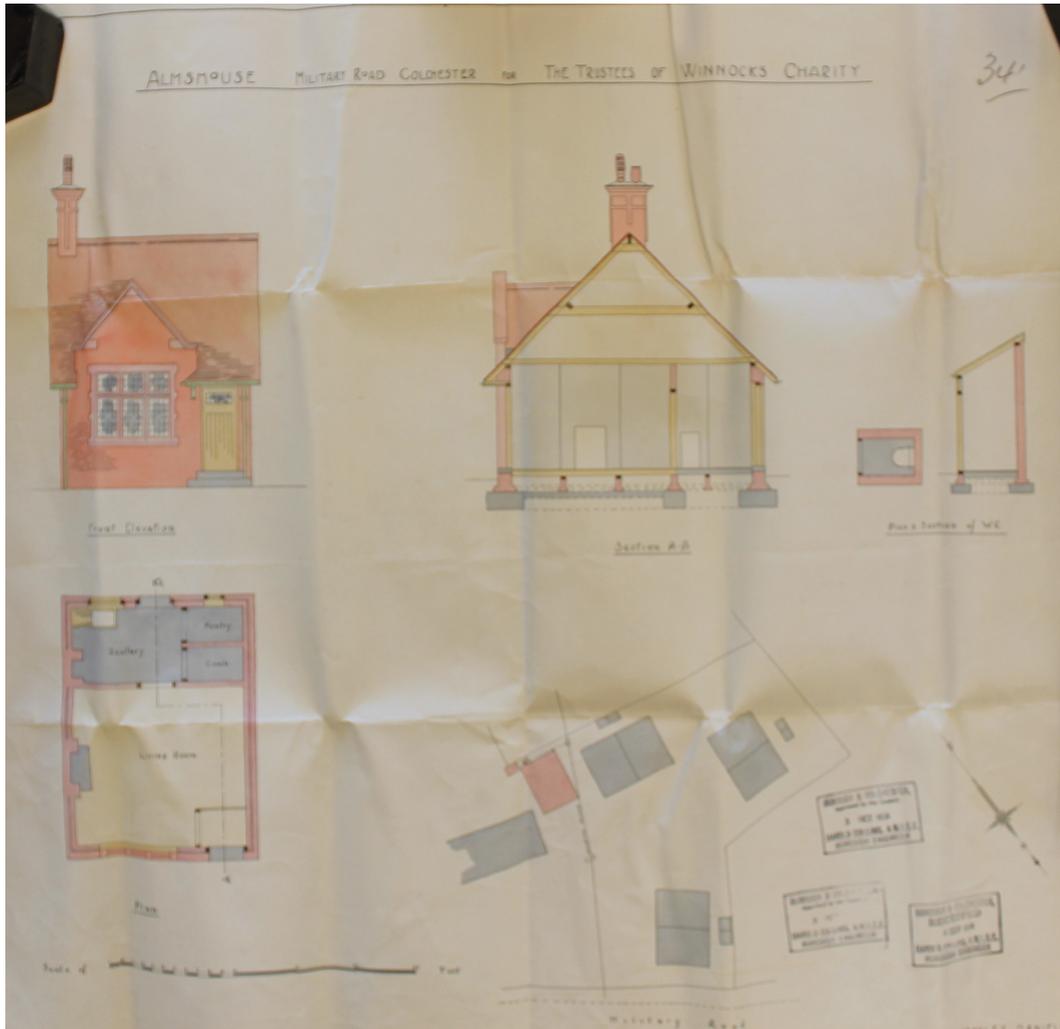
Plan 3 Plan by F Stanley Daniell of the single almshouse (No.7). ERO D/B 6 Pb3/6729.

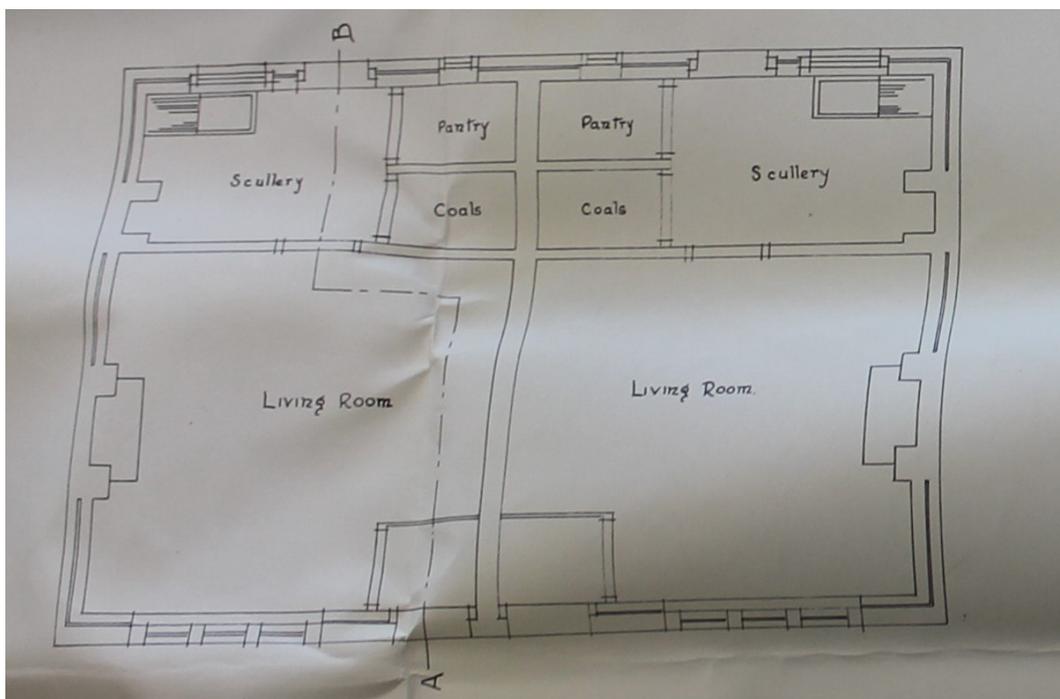
Plan 4 Detail from Plan 1 (ERO D/B 6 Pb3/6526) illustrating the original four-room layout of the paired almshouses.

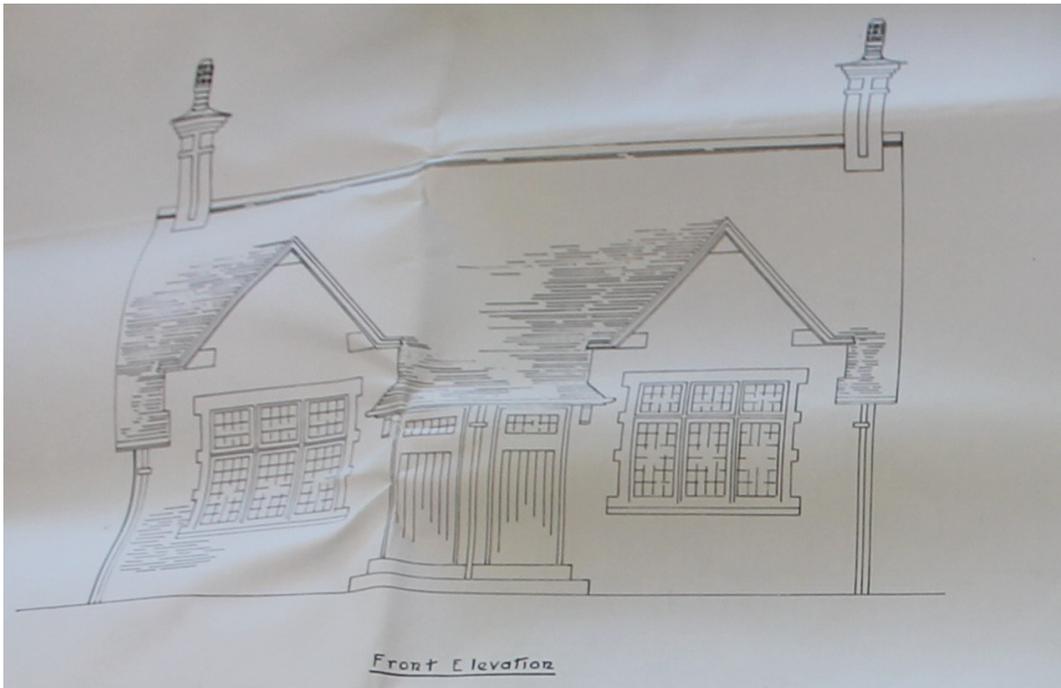
Plan 5 Detail from Plan 1 (ERO D/B 6 Pb3/6526) illustrating the neo-Tudor style elevation to the almshouses.

The almshouses were constructed in a neo-Tudor style with flat-headed stone mullion and transom windows, leaded comes, and a steeply pitched transverse roof with a smaller front-facing gable (Purcell 2018; Plan 5).

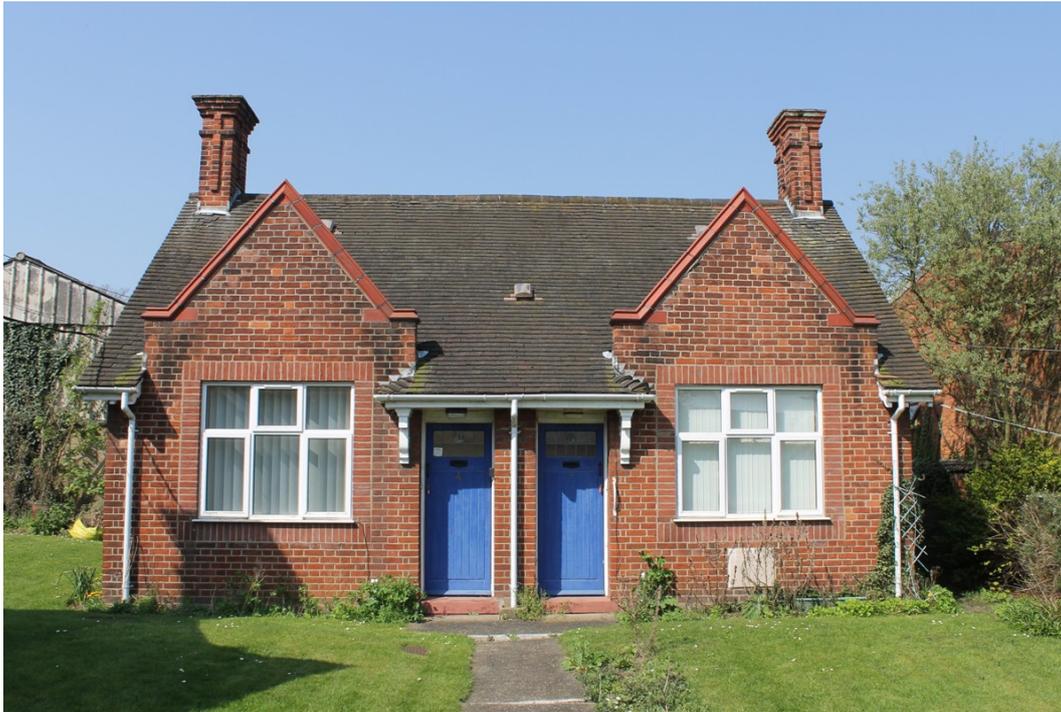
Photograph 3
East elevation of Nos.3-4 Winnocks: the windows are replacement UPVC frames set into a brick surround. The doors appear to be original – view west.

Nos.1-7 Winnocks are built of red brick laid in Flemish bond with tiled roofs and a front-facing pointed gable in a simple neo-Tudor style, with Nos.1-2, 3-4 and 5-6 having mirror symmetry (Photograph 3, Fig 4). The flared chimney stacks have a cruciform pattern of raised brickwork on each face in keeping with the neo-Tudor style. The buildings have blue-painted timber doors with leaded lights and black-painted ironmongery which appear to be the original doors illustrated on F Stanley Daniell's plans and elevations (Photograph 4). Below each gable is a large window with a red brick surround (Photograph 5). These windows are UPVC-framed, double-glazed replacements for the original stone transom and mullion windows and the red brick surrounds are part of the modification. The timber brackets that support the roof over each door are painted white as is the remainder of the joinery. Nos.1,3, 5 & 7 have an inscription stone below the window, recording that the almshouses were endowed by George Rose in 1934 (Photograph 2). Apart from the modern windows the front façades remain predominantly unaltered.

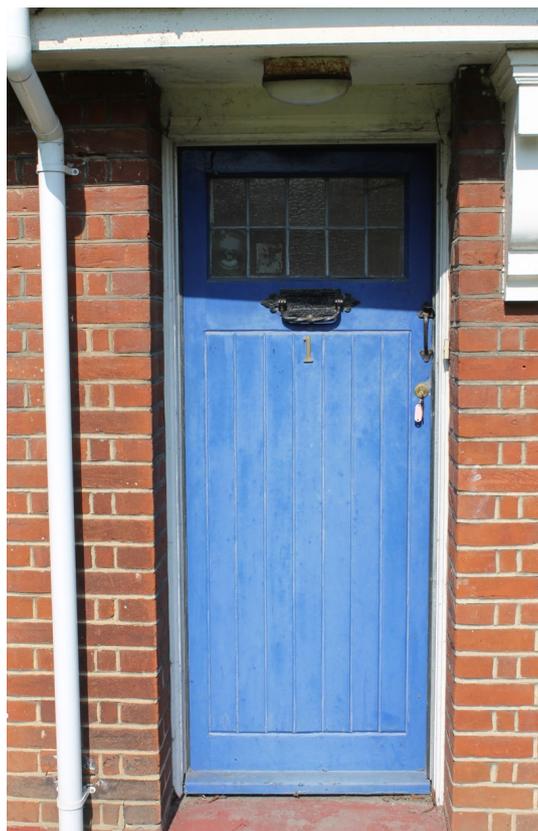
Photograph 4
Original door to No.1 Winnocks – view north-west.

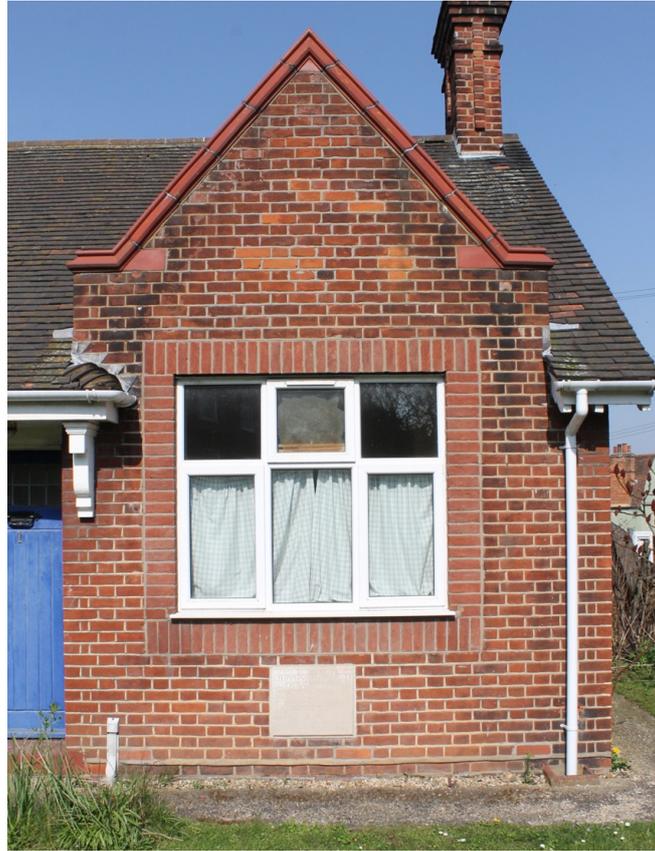
Photograph 5
Replacement UPVC window and brick surround to No.1 Winnocks – view north-west.

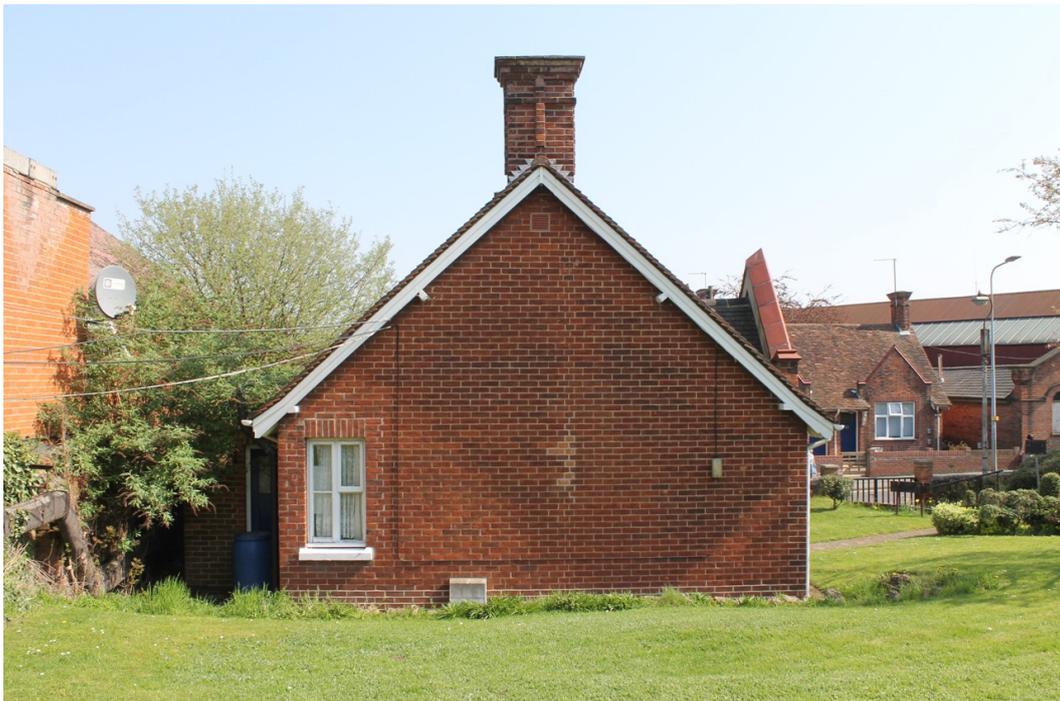
Photograph 6
South-west elevation of No.2 Winnocks, identical to the other gable elevations except for an inserted timber-framed casement – view north-east.

The side elevations are unremarkable brickwork with an air brick or pair of air bricks located directly below the apex of the gable. The exception to this is the south-west elevation of No.2 Winnocks (Photograph 6, Fig 5). Here a timbered-framed casement has been inserted.

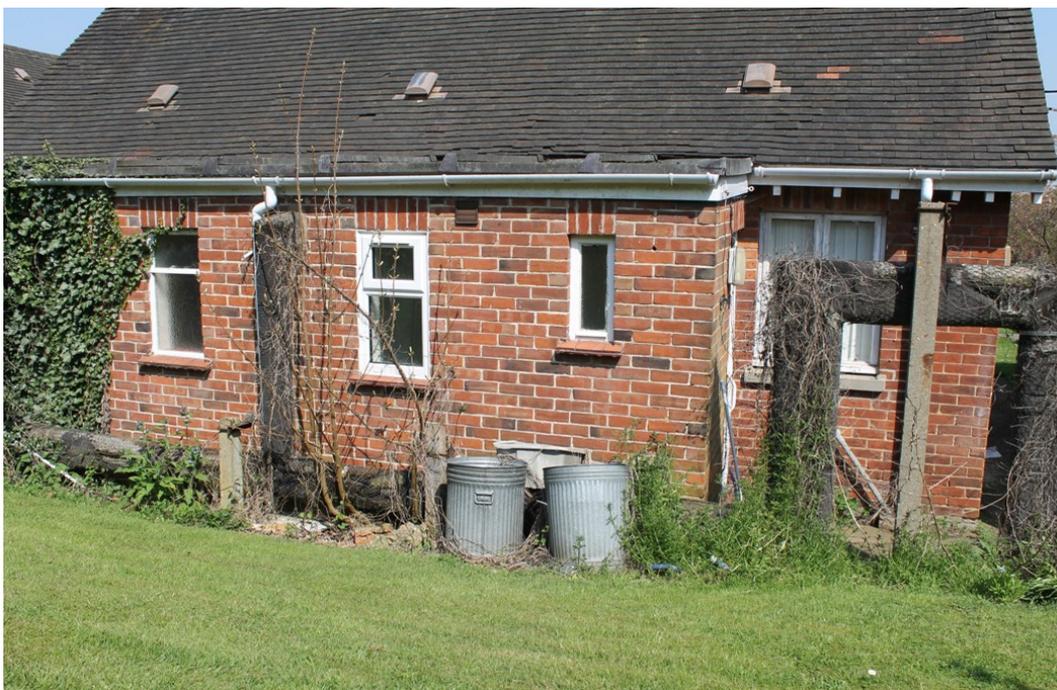
Photograph 7

1962 bathroom extension to Nos.5-6 Winnocks: the larger window is for the bathroom, the smaller one for the storage cupboard - view north-west.

The rear elevation of the almshouses is where there has been the most significant change to the original design. Nos.1-6 have a single-storey flat-roofed extension that extends approximately two-thirds of the width of the original structure (Photograph 7, Figs 2 & 6). These extensions, built in 1962, provided a bathroom with an inside toilet (replacing the original outhouse) along with a storage cupboard and a back door (Photograph 8). Access to the bathroom extension was through the original, centrally-located backdoor opening and it is possible that the original backdoors were rehung in the extensions. Five of the seven backdoors are identical and may date to 1934. The fenestration of the extensions comprise metal-framed Critall windows for the bathroom and the storage cupboard, each with an angled sill of creasing tiles. At No.7 the extension is located at the side of the almshouse as there was not sufficient room to build this at the rear (Photograph 9, Fig 8). This resulted in a slightly different design: the extension has only one window and the new backdoor was in the long elevation not the short one (Photograph 10). The rear to No.7 was also altered to incorporate changes to the backdoor and the original fenestration (Photograph 11, Fig 9). The original backdoor and the pantry window were blocked in,

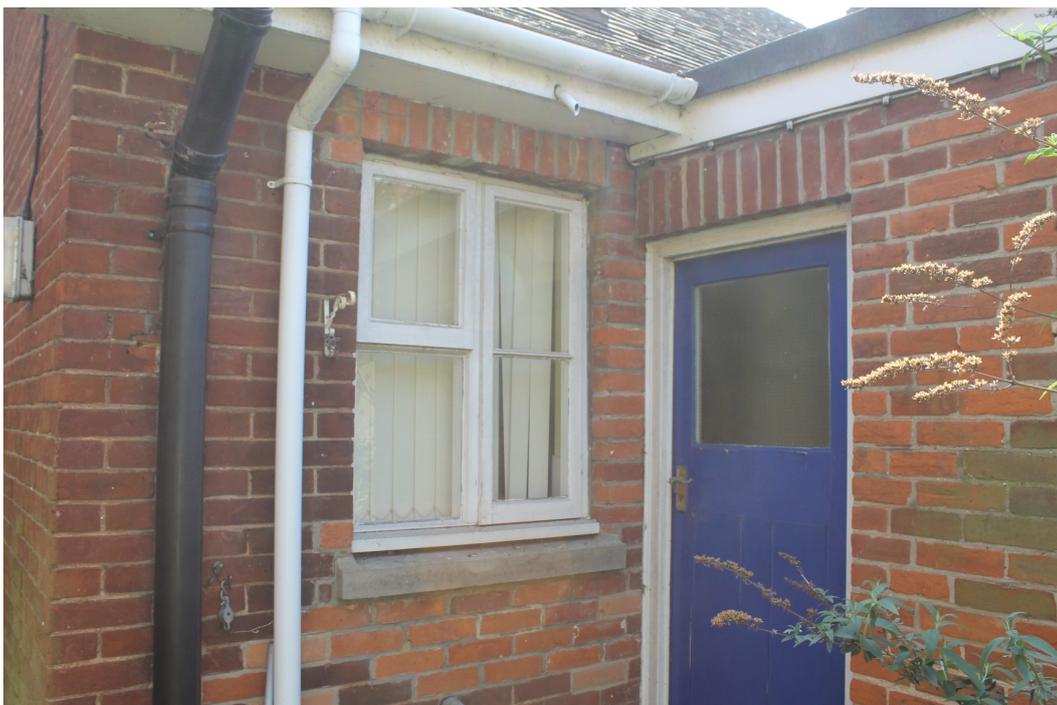
Photograph 8

1962 bathroom extension to No.1 Winnocks: the backdoor of the extension is possibly the original almshouse backdoor, relocated and reused in 1962. The timber-framed casement window is a replacement for the original metal-framed Critall window - view south.

whilst the metal-framed window to the scullery was replaced by a larger timber-framed casement.

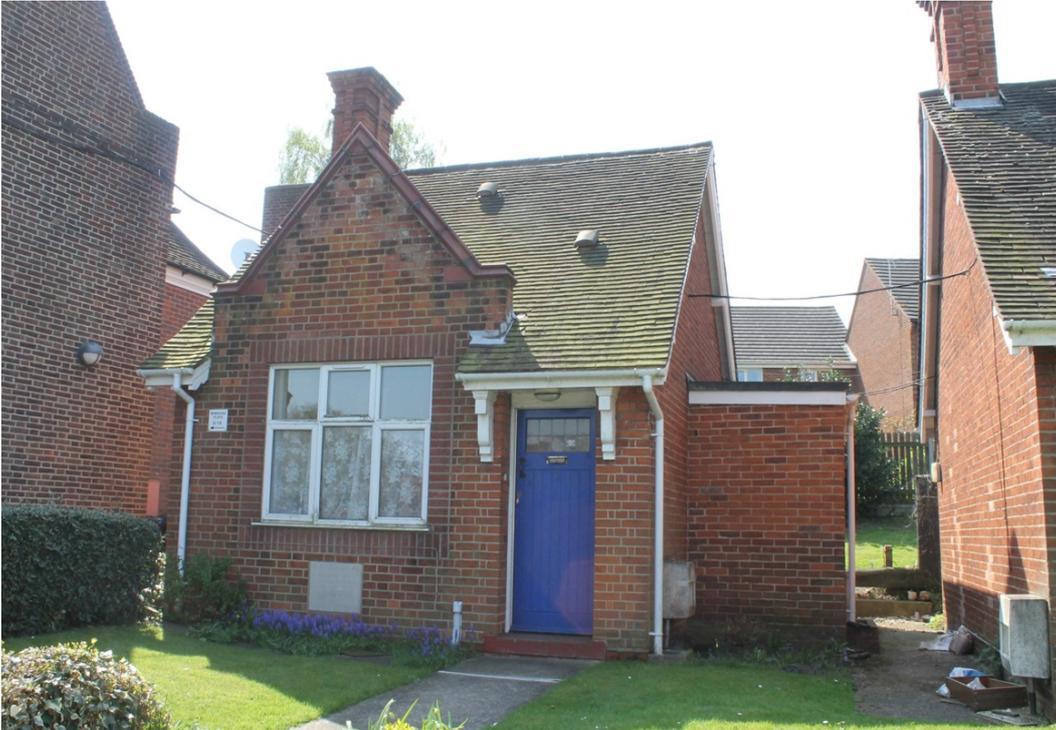
Photograph 9

1962 bathroom extension to No.7 Winnocks: insufficient space to the rear of the almshouse required the extension to be located along the side of the building - view south.

The original plan form of No.7 is identical to the other almshouses, but the inability to locate the 1962 bathroom extension to the rear of the building necessitated changes to the scullery/kitchen layout not present in Nos. 1-6. The conversion of the scullery to the kitchen resulted in a layout predominantly identical to the other almshouses (Photograph 21) but with one major difference. The end of the scullery formerly occupied by the coal store and the pantry has been combined and an opening cut through the rear of the coal store to provide access to the bathroom extension (Photograph 22). A short corridor behind this leads to the new backdoor with the bathroom to the right of the corridor and a double-width storage cupboard on the left (Photograph 23).

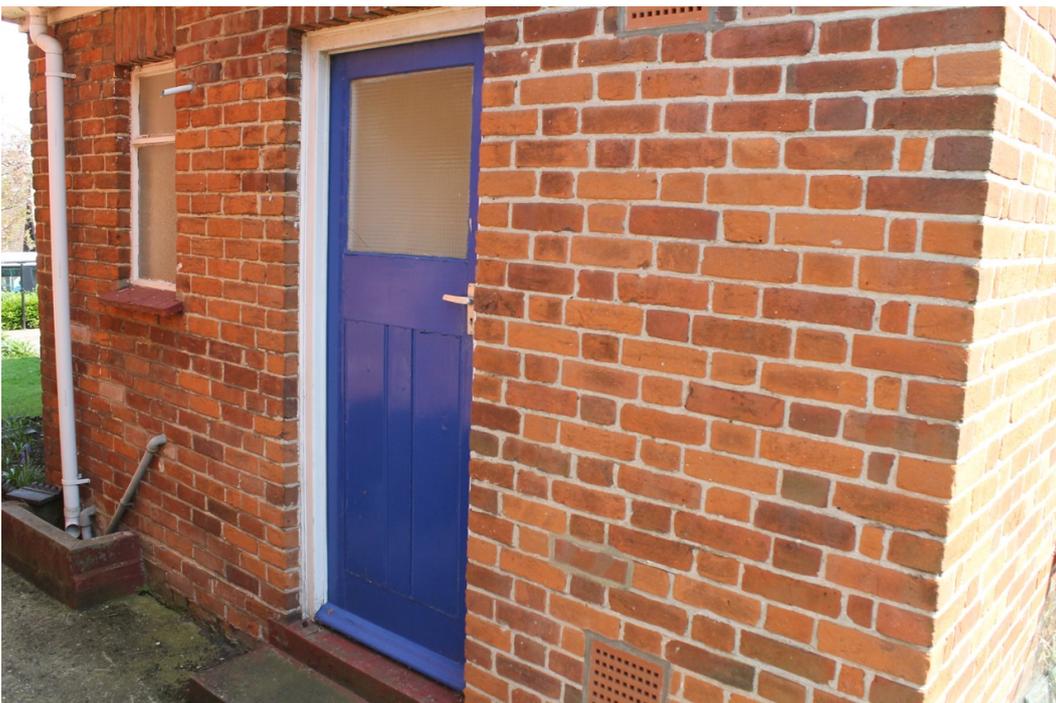
Photograph 10

1962 bathroom extension to No.7 Winnocks with only one metal-framed window and the backdoor located in the long elevation instead of the short - view north-east.

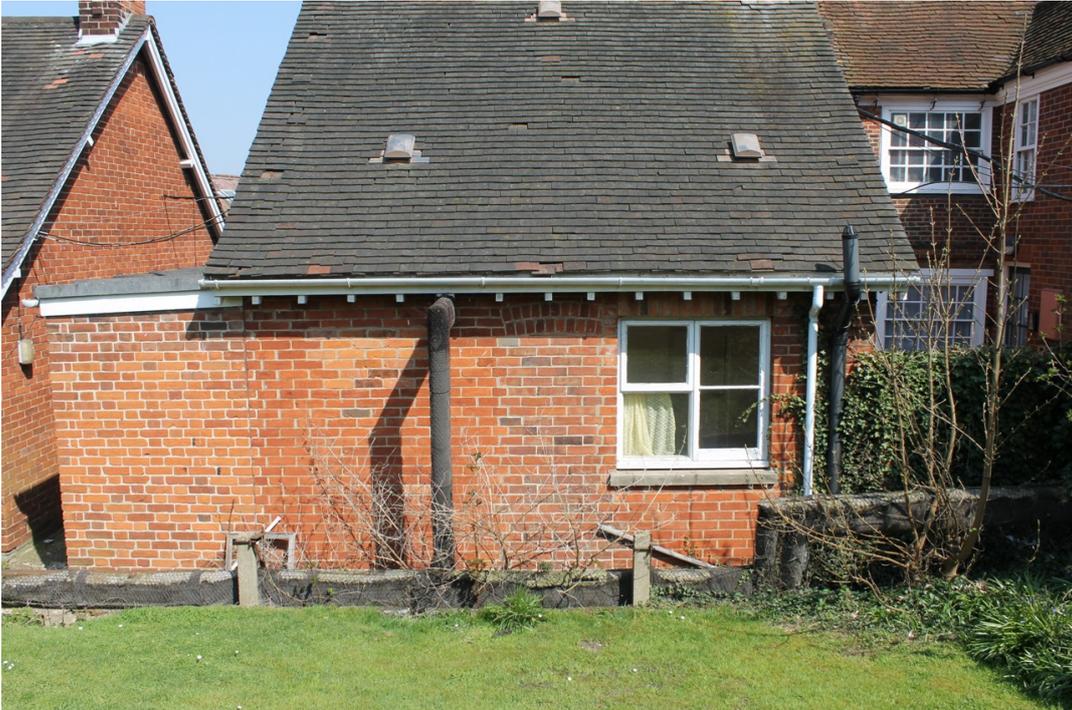
Photograph 11

South-west elevation to No.7 Winnocks with the 1962 bathroom extension to the left. The blocked in pantry window and backdoor are clearly distinguishable by the change in the brickwork and the original metal-framed window has been replaced by a timber-framed casement - view north-east.

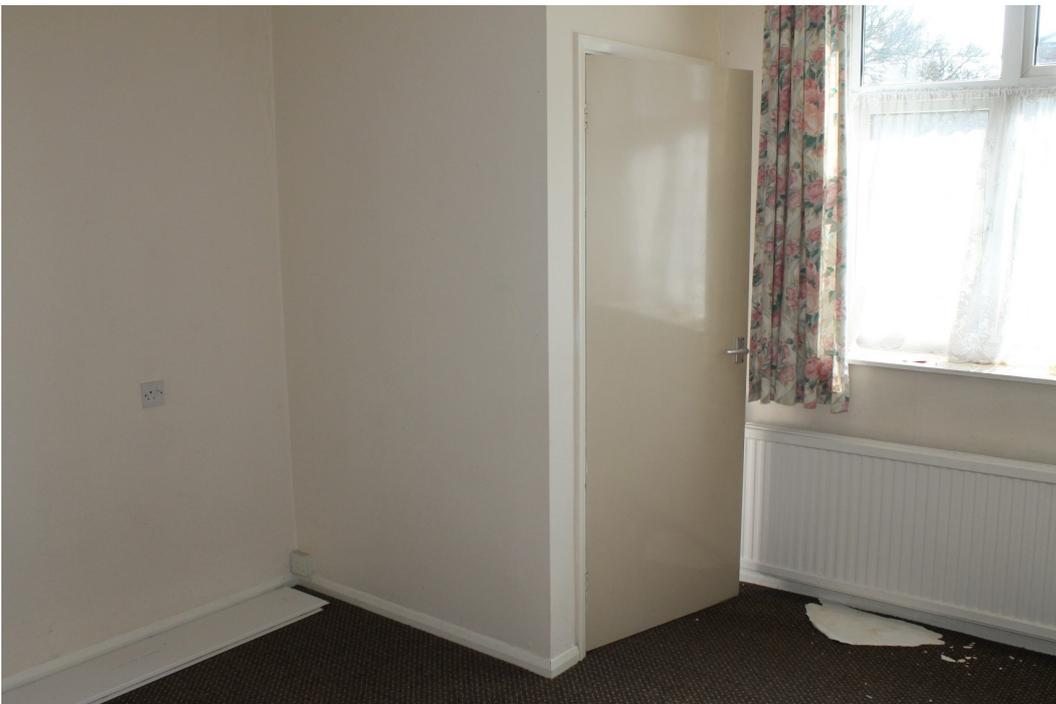
Photograph 12

Entrance lobby to No.2 Winnocks with replacement internal door - view east.

The front door opens into a small entrance lobby, just large enough to accommodate the door, that opens into the bed-sitting room (Photograph 12). This was presumably designed to cut down on draughts for the elderly occupant. In each of the almshouses the original coal-fired hearth in the bed-sitting room has been blocked in and replaced by an electric fire (Photograph 13). The coal-fired hearth was originally the only source of warmth until central heating was installed in the 1970s. To accommodate the hot water tank for the central heating system, cupboards were constructed to one side of the chimney breast. Although not an original feature to the almshouses, Nos.2 & 5 (and presumably all the almshouses at one time) were equipped with intercom systems, linking the residents to the on-site warden (Photograph 14). This is not perhaps an earth-shattering observation until it is noted that the intercom system is by Tunstall Byers, a Doncaster-based company who, in 1966, developed the world's first Warden's Intercommunication Call System. Although the models located in the almshouses are probably later versions it indicates that Winnock's Charity sought to provide the residents with the most up to date care equipment.

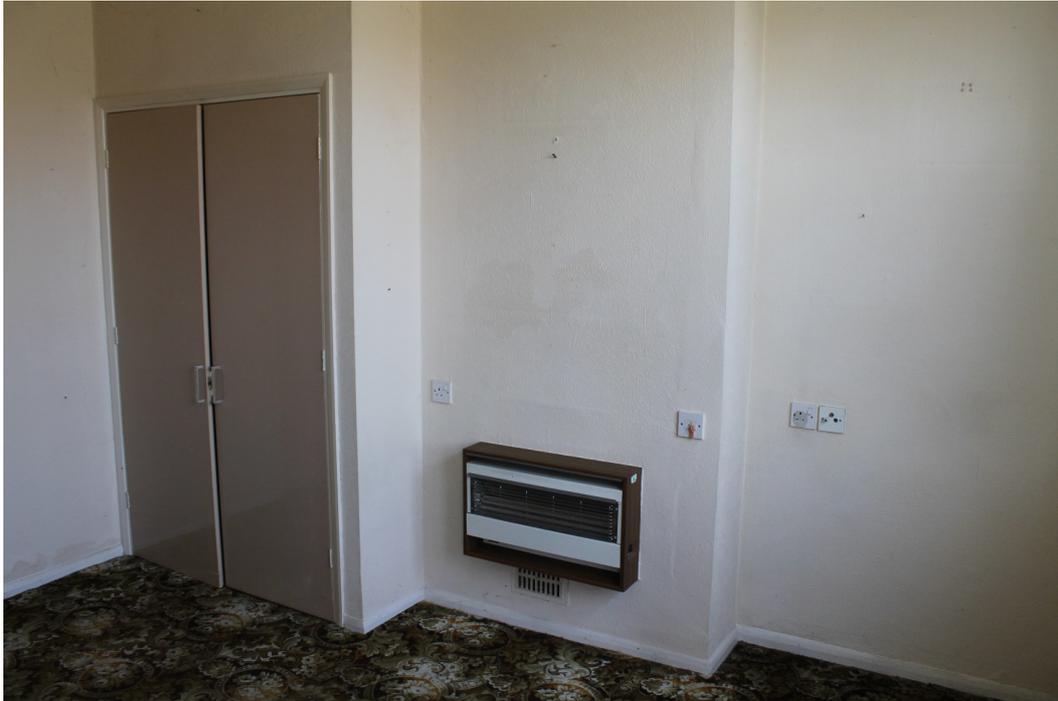
Photograph 13

Bed-sitting room of No.5 Winnocks showing blocked in hearth with replacement electric fire and cupboard for central heating system to the left of the chimney breast - view south-west.

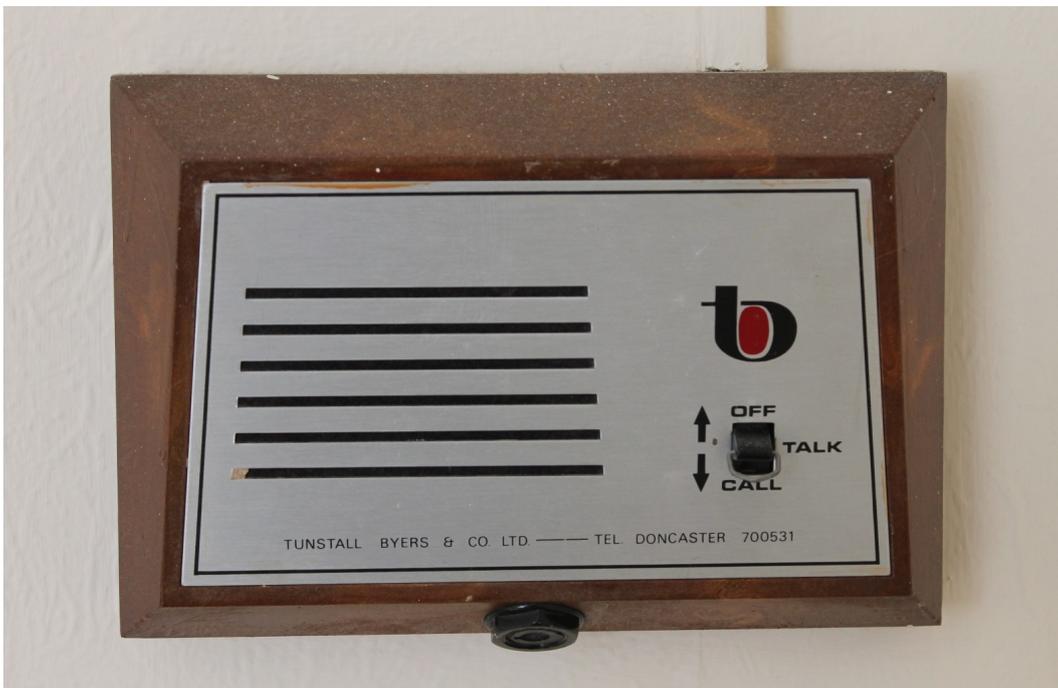
Photograph 14

Tunstall Byers & Co. intercom system located in the bed-sitting room of No.2 Winnocks.

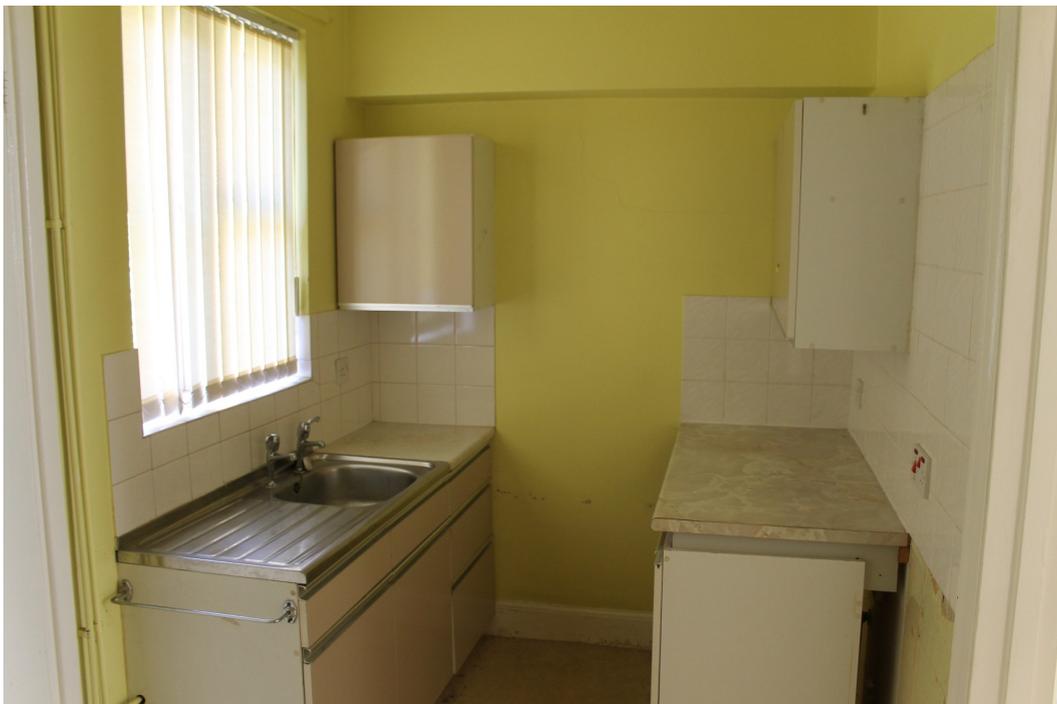
Photograph 15
Kitchen of No.3 Winnocks: the original scullery hearth was in the right-hand corner - view north.

A centrally-located doorway in the rear wall of the bed-sitting room opens onto what was originally the scullery but became the kitchen after the addition of the 1962 bathroom extension (Photograph 15). The scullery hearths have all been removed and the coal stores and pantries converted, the coal stores into additional kitchen space and the pantries into the WC for the 1962 bathroom extension (Photograph 16).

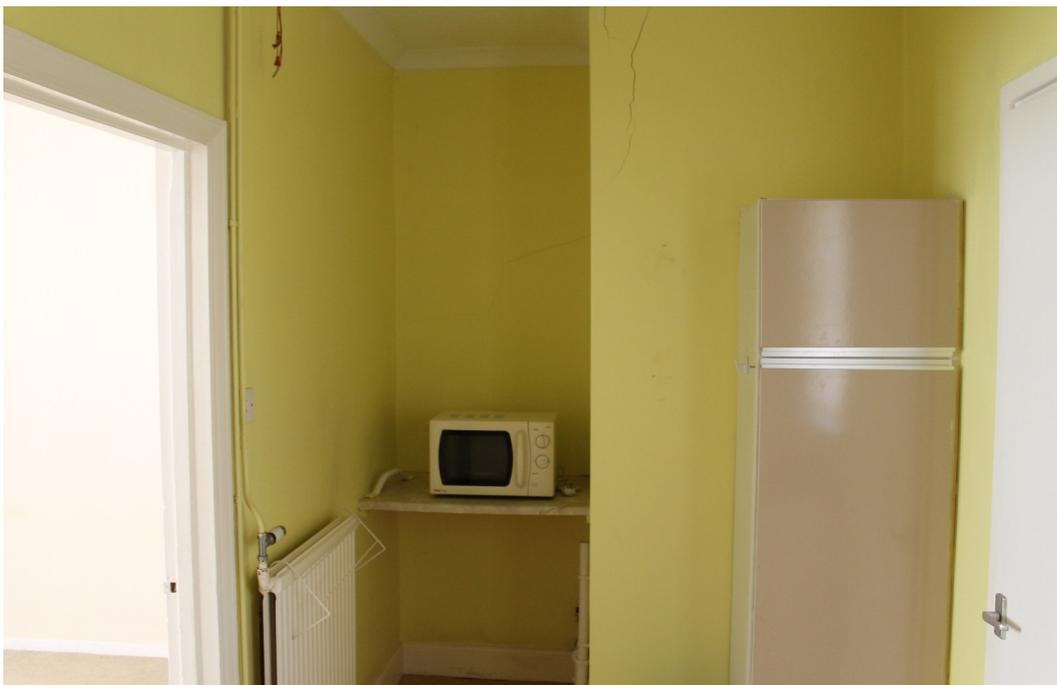
Photograph 16
Kitchen of No.3 Winnocks: the original coal store was located to the left, now a handy nook for a microwave. The pantry has been blocked off from the kitchen and turned into the WC for the 1962 bathroom extension - view south.

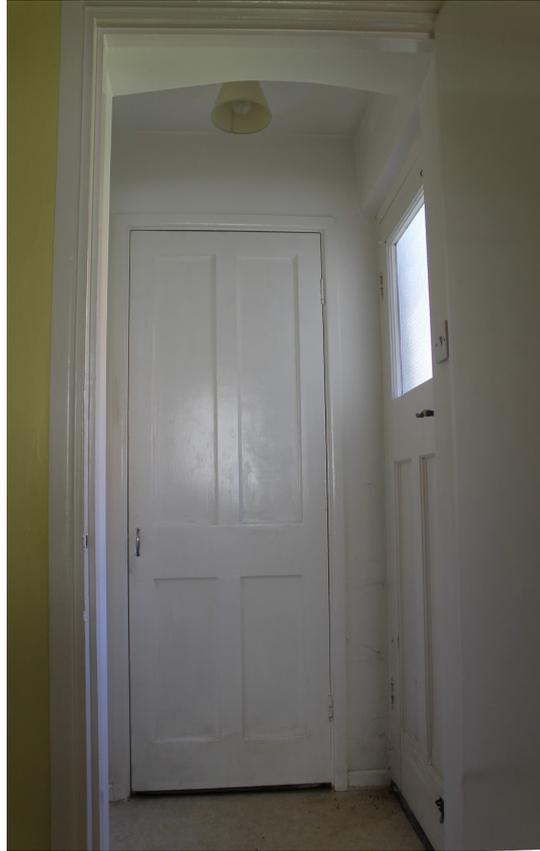
Photograph 17

Original rear entrance to No.3 Winnocks, converted to an access to the 1962 bathroom extension with a storage cupboard directly opposite - view west.

What was originally the backdoor to the almshouse became the access point to the 1962 bathroom extension (with the exception of No.7). Directly opposite the former back doorway is a storage cupboard, with a four-panel timber door (Photograph 17). Each of Nos.1-6 has the original four-panel door. To one side of the storage cupboard is the 1962 backdoor, to the other side is the bathroom itself, behind another four-panel door, this one with a Bakelite door knob on the outside and a Bakelite door handle and locking mechanism on the inside (Photographs 18, 19). The bathrooms themselves consist of a sink and a small bath, with a WC constructed within the former pantry (Photograph 20). Although in Nos.1-5 and No.7 the bathroom furniture is identical this does not appear to be

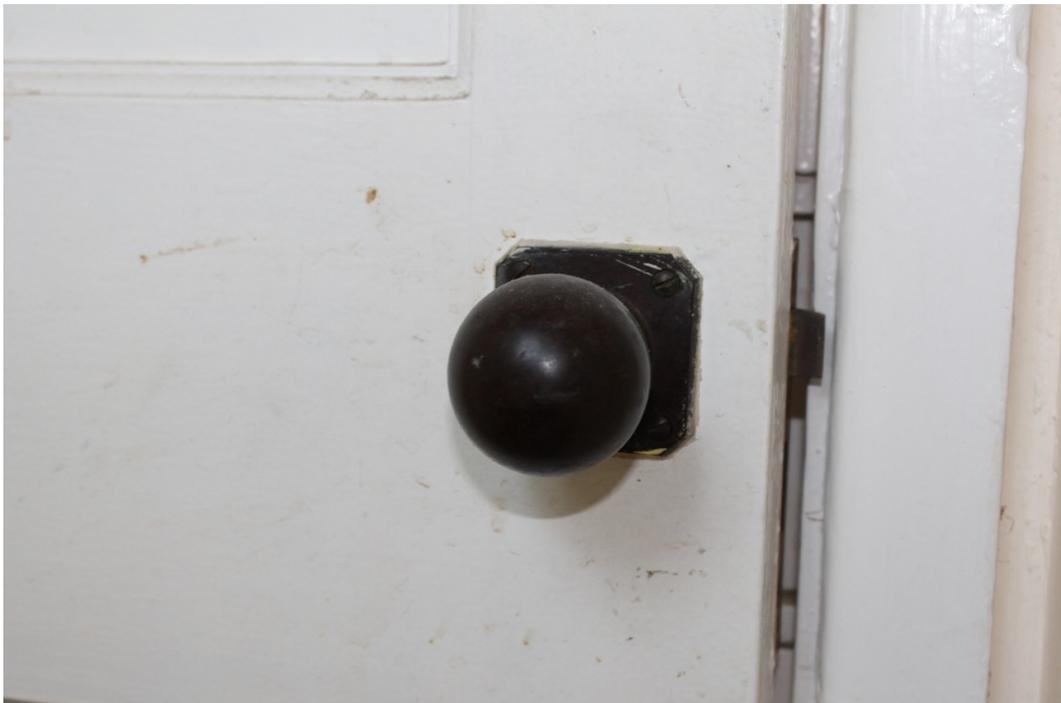
Photograph 18

Bakelite doorknob on the exterior of the bathroom door to No.4 Winnocks.

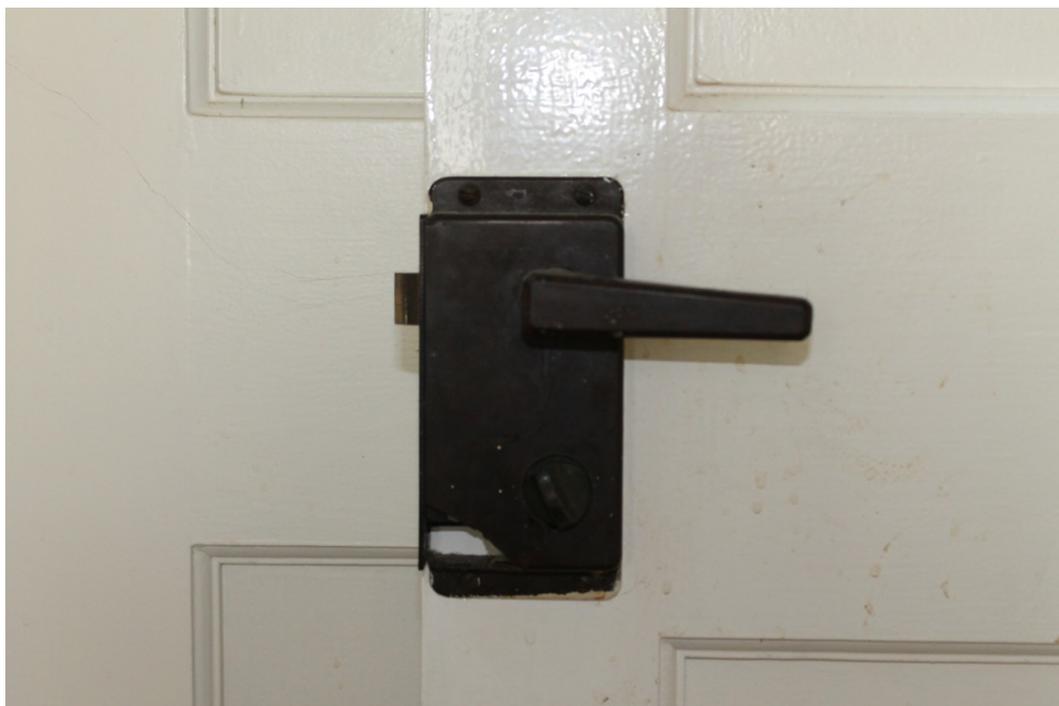
Photograph 19
Bakelite door handle and locking mechanism on the interior of the bathroom door to No.4 Winnocks.

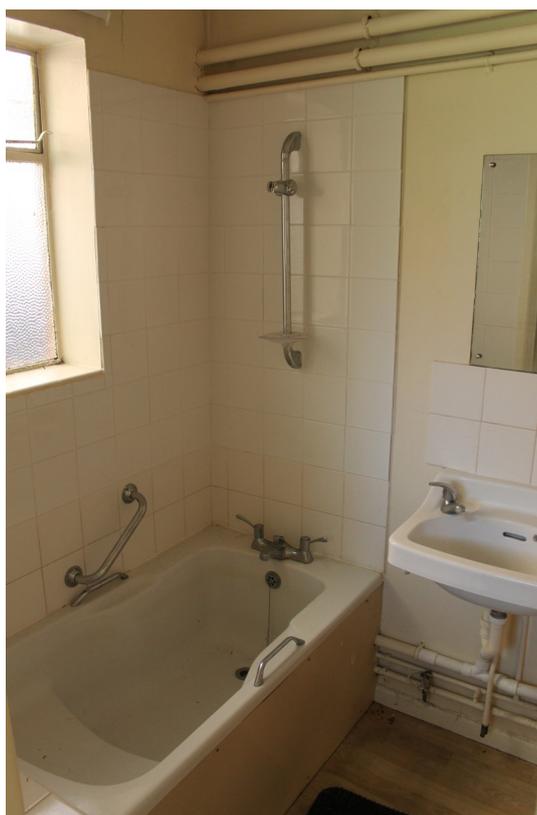
Photograph 20
Bathroom of No.2 Winnocks, probably dating from the 1980s – view north.

contemporary to the 1962 extension. These are probably replacement fixtures, possibly dating to the 1980s when the kitchens were refitted. The bath in No.6 has been replaced with a shower.

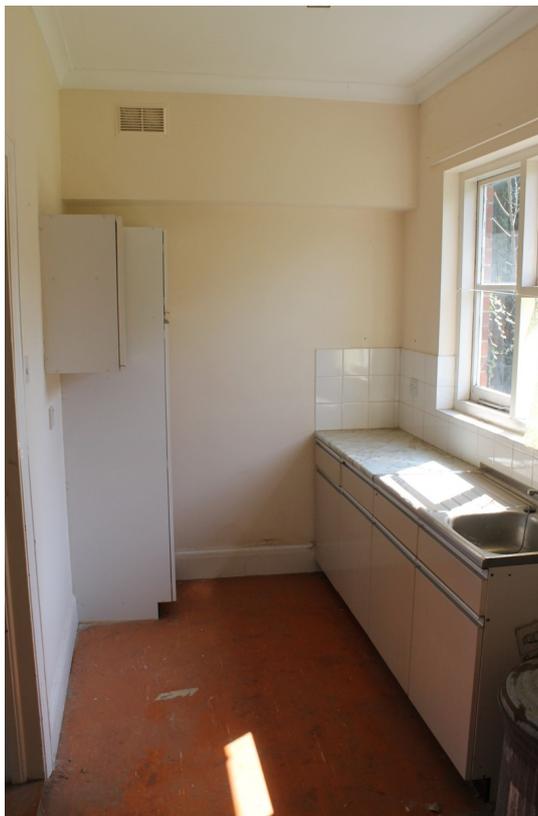
Photograph 21
Kitchen of No.7 Winnocks – view south-east.

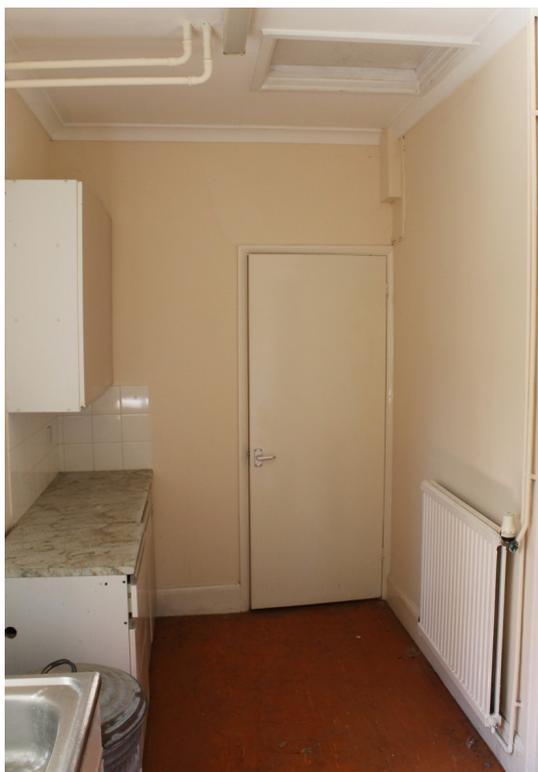
Photograph 22
Former pantry and coal store of No.7 Winnocks, converted to provide an access to the 1962 bathroom extension – view north-west.

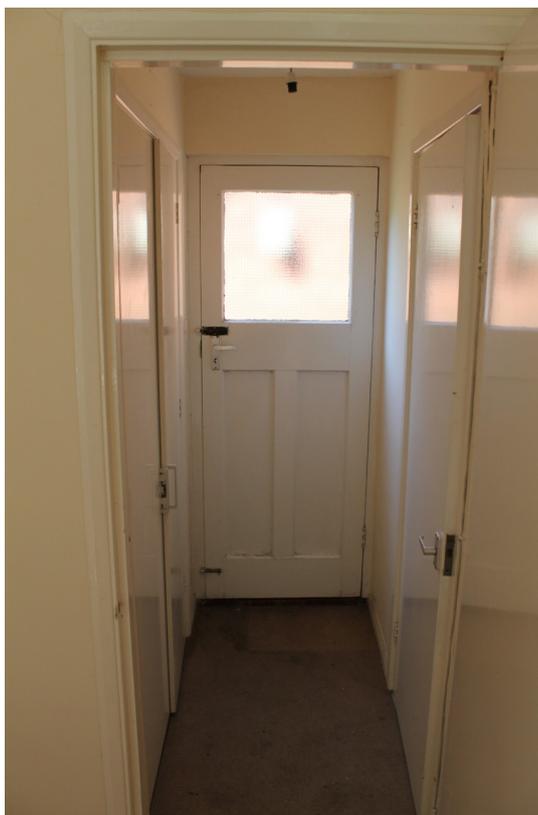
Photograph 23
1962 bathroom extension to No.7 Winnocks,
with storage cupboard to the left and
bathroom on the right – view north-west.

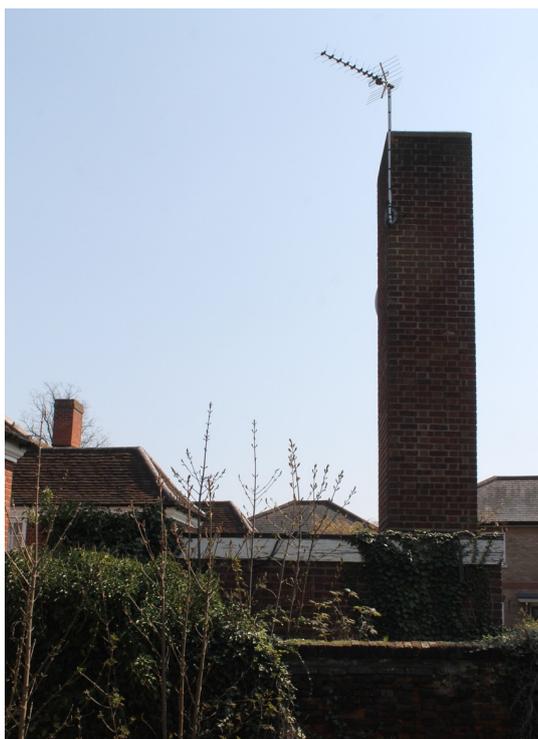
Photograph 24
Boiler house to the rear of the 17th-century
range, dating from the early 1970s – view
south-east.

The boiler house is a single-storey, flat-roofed brick structure located to the rear of the main 17th-century range of almshouses. It has a tall, square brick chimney and dates to the early 1970s when the almshouses were provided with oil-fired central heating, generated within this structure (Photograph 24).
