Archaeological evaluation on land at the former Elmstead Delivery Office, Clacton Road, Elmstead Market, Essex, CO7 7AB

June 2018

CAT Report 1285

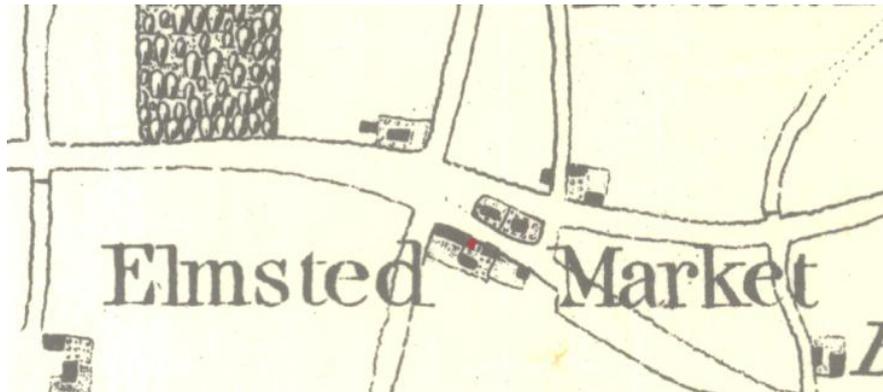
Map 1 1777 Chapman and André map of Essex. A row of buildings is visible in the location of the delivery office (highlighted in red).

The 1777 Chapman and André map shows buildings in the location of the delivery office, but the scale is too small to identify any specific structures (Map 1).

There appears to have been a structure present on the site during its entire cartographic history. However, whether the structure visible on the 1777 map (Map 1) is the same one that was demolished after fire damage in 2015 is uncertain.

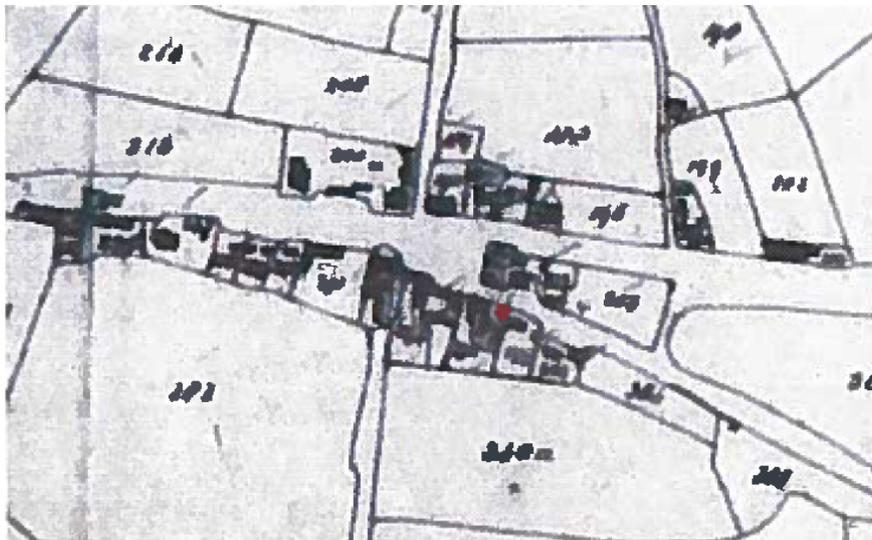
Map 2 1844 tithe map of Elmstead Market (ERO D/CT 129B). Location of delivery office highlighted in red.

The 1844 tithe map is more detailed and shows a building in the location of the delivery office (Map 2). The tithe award lists this plot as a house and garden belonging to a Thurston Bready.

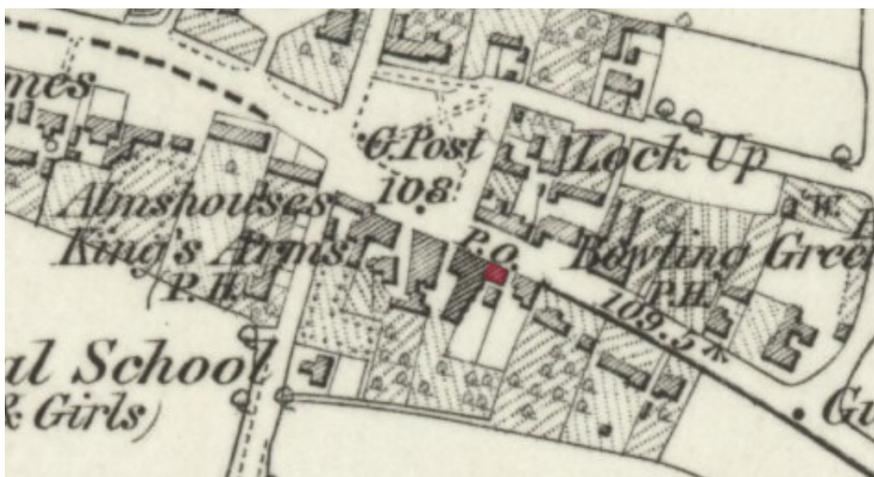
Map 3 The 1874 1st edition 6-inch OS map, with the recently demolished delivery office highlighted. Curiously, the 1874 1st edition 25-inch OS map fails to show the building, presumably due to an omission.

The 1874 first edition 6-inch OS map (Map 1) clearly shows the recently-demolished delivery office. Interestingly it labels both it and the still-standing adjacent listed building to the west ('The Old House' List no. 1111471) as 'Post Office'. Subsequent maps label just the recently-demolished building as a 'Post Office', so this may be an error. Also visible on this map is a small outbuilding to the south of the delivery office.

The rectangular building visible to the south of the delivery office on the 1st edition OS map (Map 1) may be related to the 18th- or 19th-century brick foundation in T2 (F1).

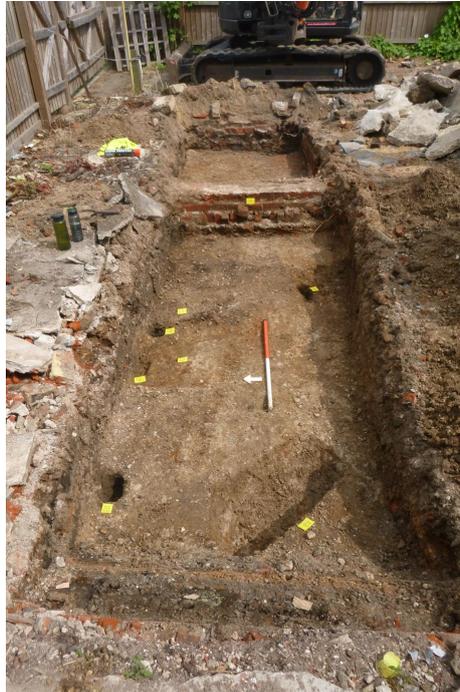
Photograph 1 Long shot of T1, photograph taken facing east.

T1 was excavated along the street frontage at the north of the site. It was originally intended to be 8m long but had to be shortened to avoid potentially impacting the foundations of the adjacent listed building to the west. It was excavated through modern concrete and sub-base (L5, c 380mm thick), before encountering L6, an 180mm thick subsoil/occupation layer containing large amounts of CBM and probably equivalent to L2 and L4 in T2 (see below). Below L6 was L3, compact natural chalky clay.

F4, F17 and F18 are all red brick foundations. F4 was aligned north-south in the centre of the trench (Photograph 1). F17 was also aligned north-south and was at the very eastern end of the trench. F19 was aligned east-west and was in the southern bulk of the trench (Photograph 2).

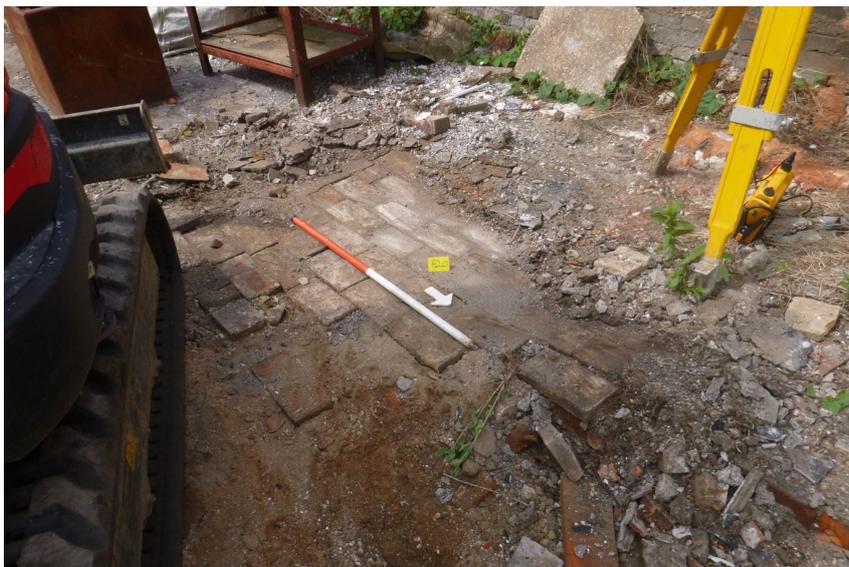
Photograph 3 Pavior brick floor observed to the south of T1. Photograph taken facing south-west.

Finally, 4.5m to the south-west of T1, exposed directly beneath the removed concrete, was an area of pavior brick floor, dating from the 19th century (Photograph 3).

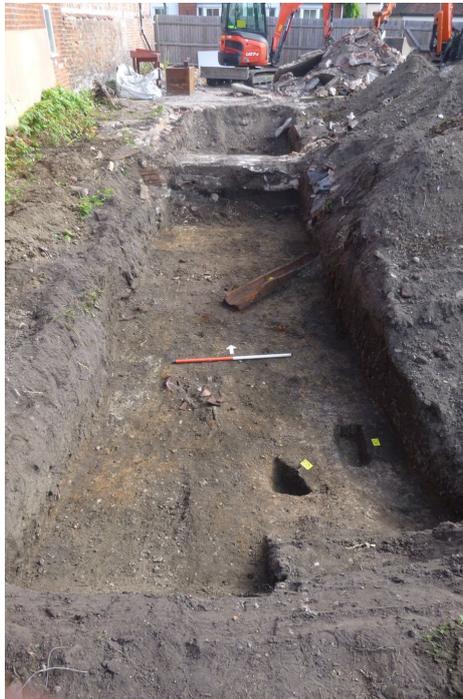
Photograph 4 Long shot of the north-south stretch of T2. Multiple features visible. Photograph taken facing north.

T2 was an 'L'-shaped trench located within the footprint of the proposed new dwellings (Fig 2). It was excavated mostly through topsoil (L1, c 380mm thick), although the northern end of the trench was covered by modern concrete and sub-base (as in T1 above). Beneath this was L2/L4, an occupation layer/subsoil which contained large amounts of CBM and pottery, and varied in thickness between 350mm (to the east of the trench) and 400mm (to the west). In the east of the trench, two features (F1 and F12) were cut into L2/L4, and machining was stopped at the top of this layer. One feature was also observed cut into this layer at the very north of the trench. The remainder of the trench was machined further, exposing the natural chalky clay (L3).

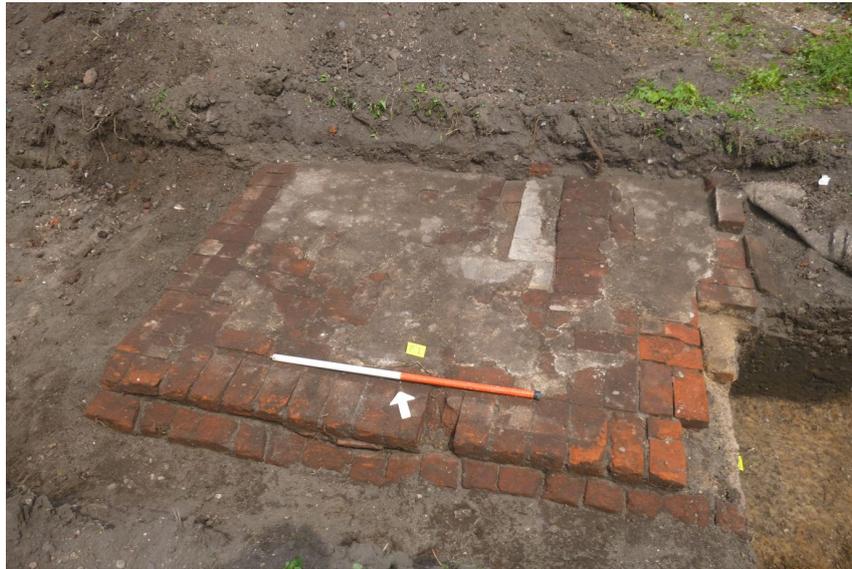
F1 was a brick floor/foundation pad in the east end of the trench, cut into L2/L4. It measured 2.6m wide, but its northern extent continued outside the trench (Photograph 5). A slot was excavated adjacent to F1 to ascertain its depth, which, including a mortar base for the brickwork, was established as 260mm. F1 was primarily constructed of red

brick with dimensions 230 mm x 115 mm x 70 mm, bonded with lime mortar, suggesting a late 18th-19th century date.

Photograph 5 Brick floor/foundation pad F1 in T1. Photograph taken facing north-west.

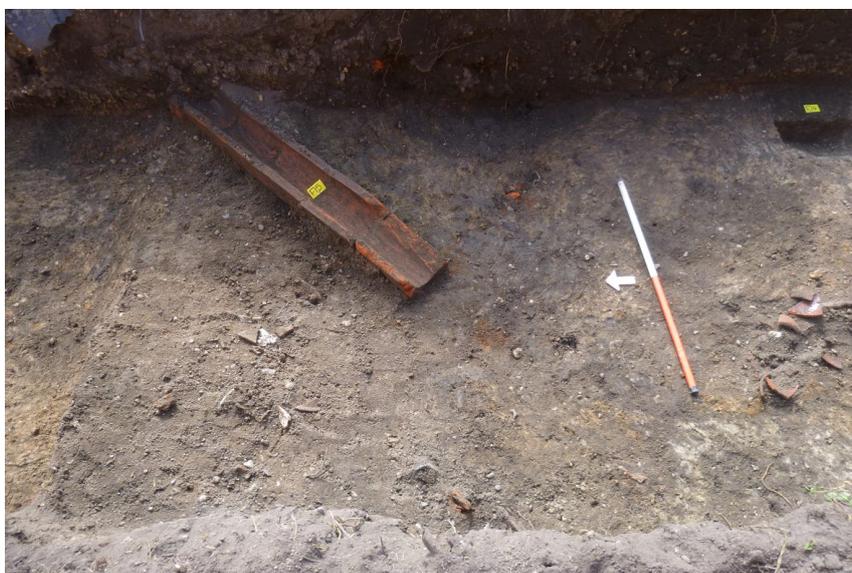
Photograph 6 Detailed shot of centre of T2, showing ceramic drain F15 along with surface planned features. Photograph taken facing east.

F15 was a segmented red ceramic drain (Photograph 6), aligned north-east to south-west, terminating in the middle of the trench. Five segments were present in the trench but the feature continues beyond the trench to the north-east (Fig 4). Each segment measured 320mm in length and in total the drain measured 1.65m. This feature is an early example of a ceramic drain and probably dates from the late 18th-19th century (MERL catalogue).

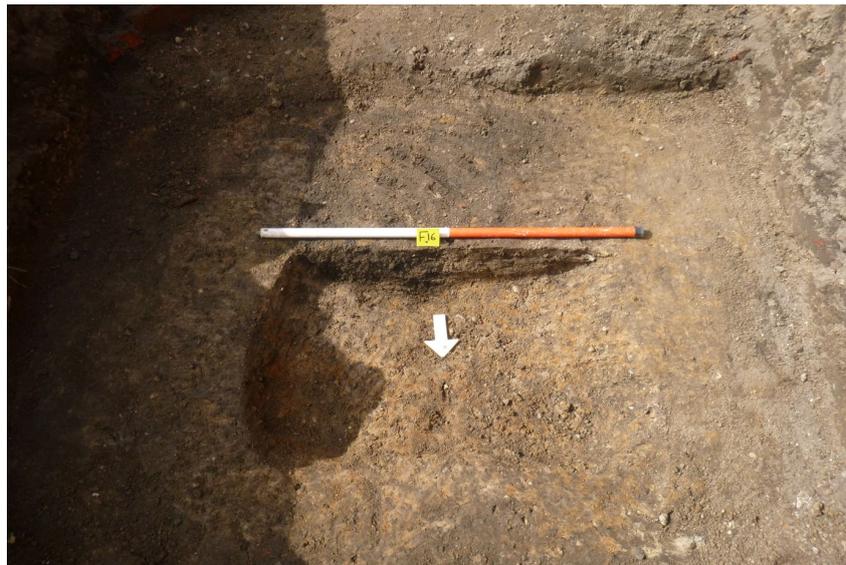
F16 was a late 18th-19th century sub-square pit, 1.1m wide and 0.17m deep. The two excavated corners appeared to have shallow postholes in them, perhaps suggesting that this feature formed part of a structure (Photograph 7).

Photograph 7 F16 after excavation. Two possible postholes visible in north corners. Photograph taken facing south.

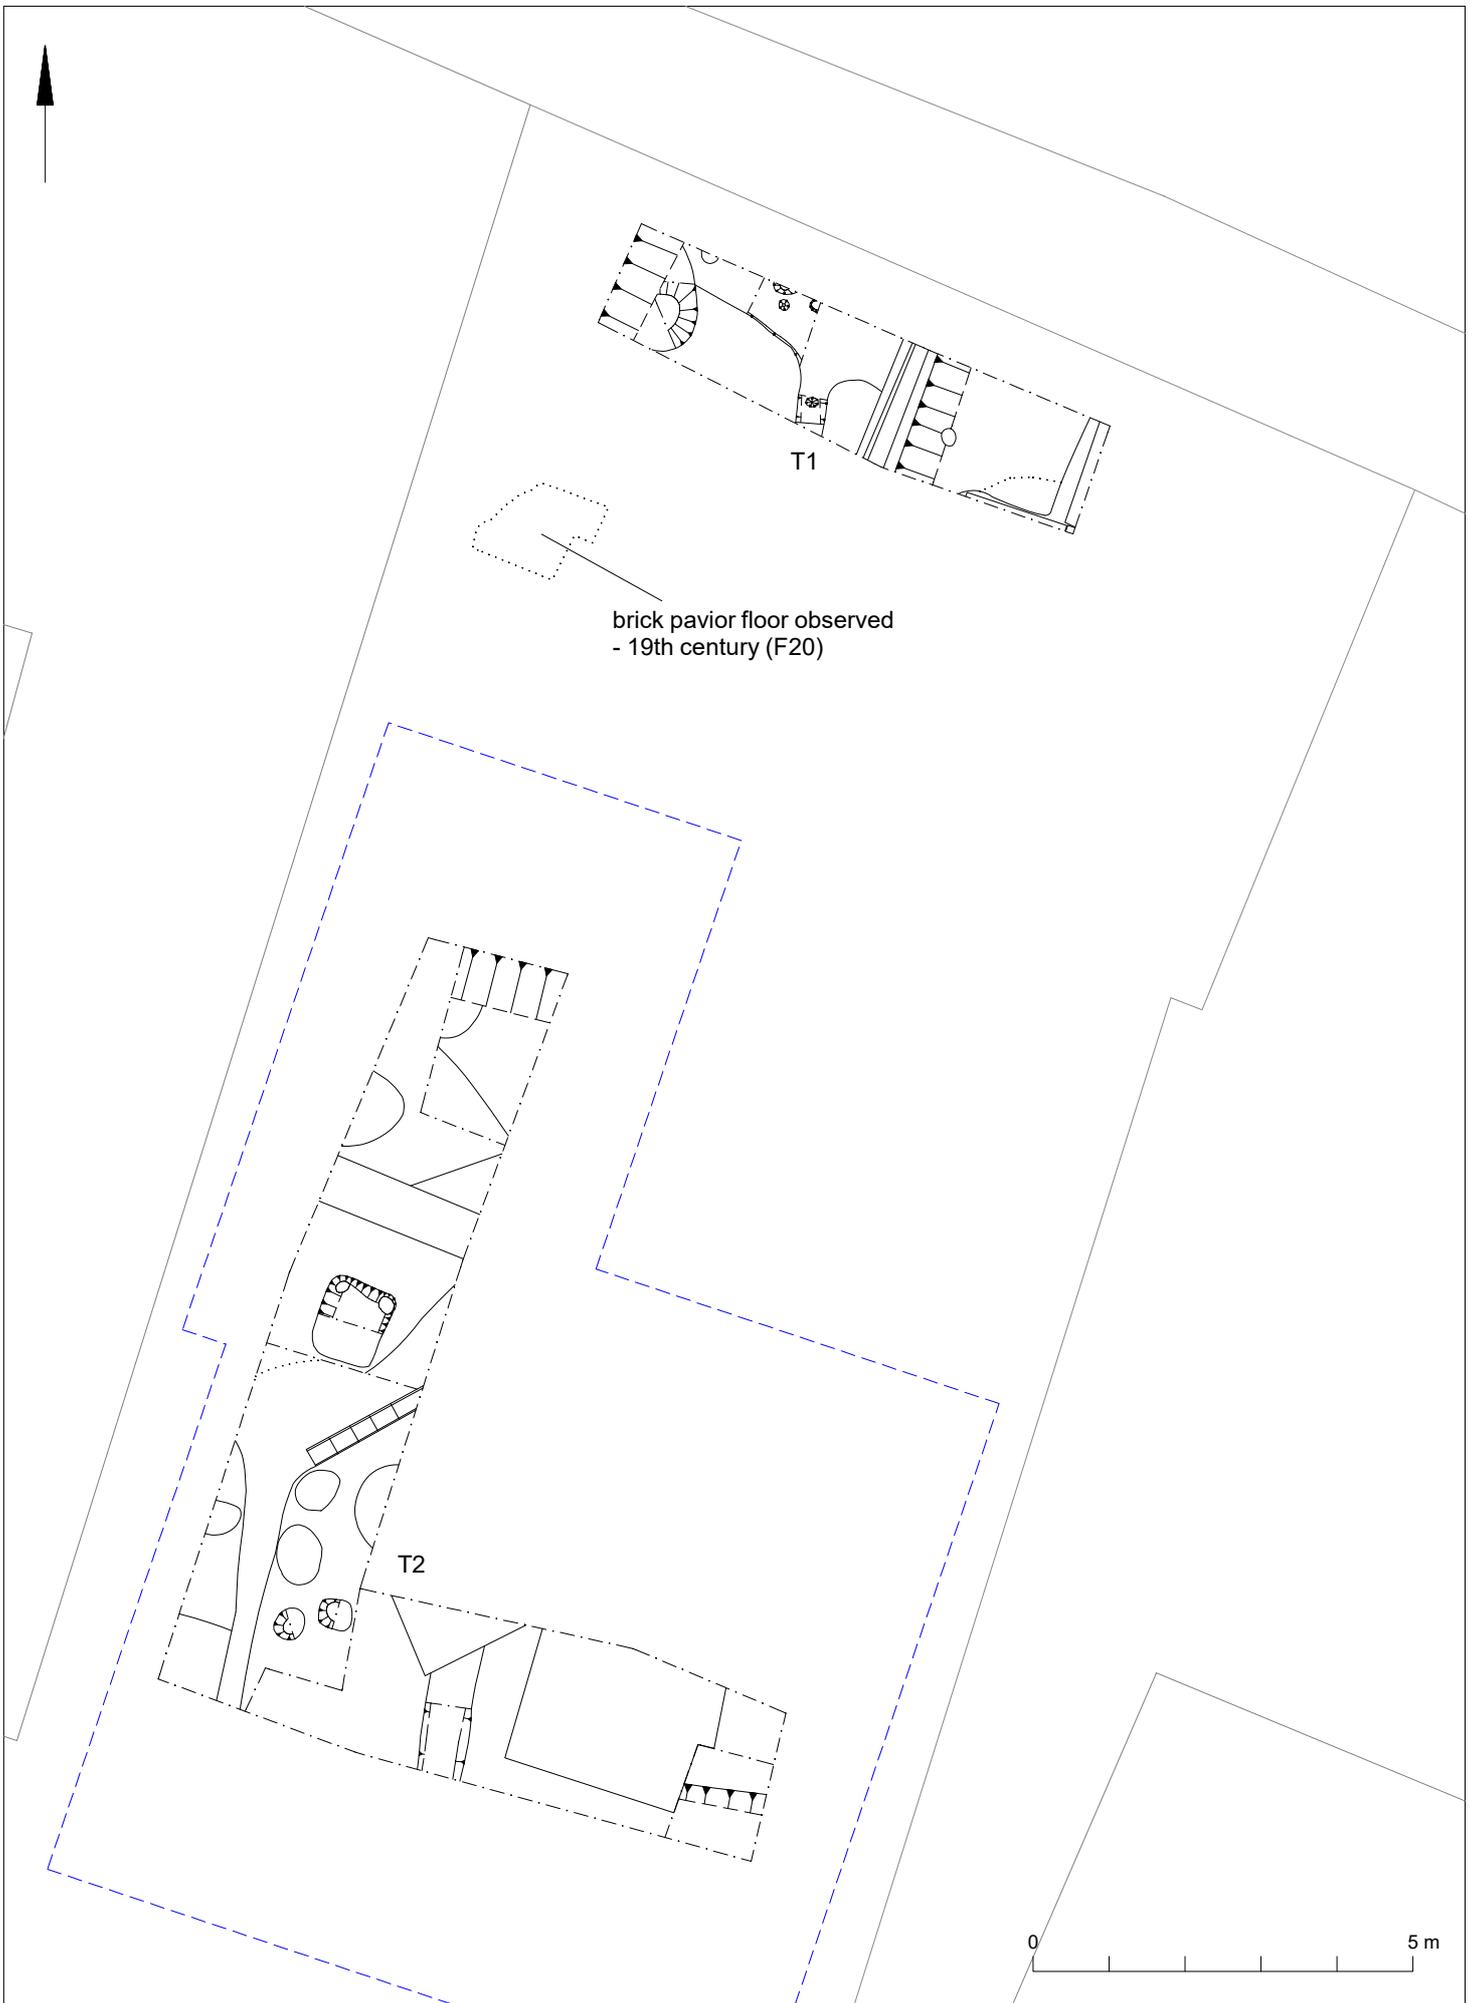
Fig 2 Detailed plan of site. Proposed development shown in blue.

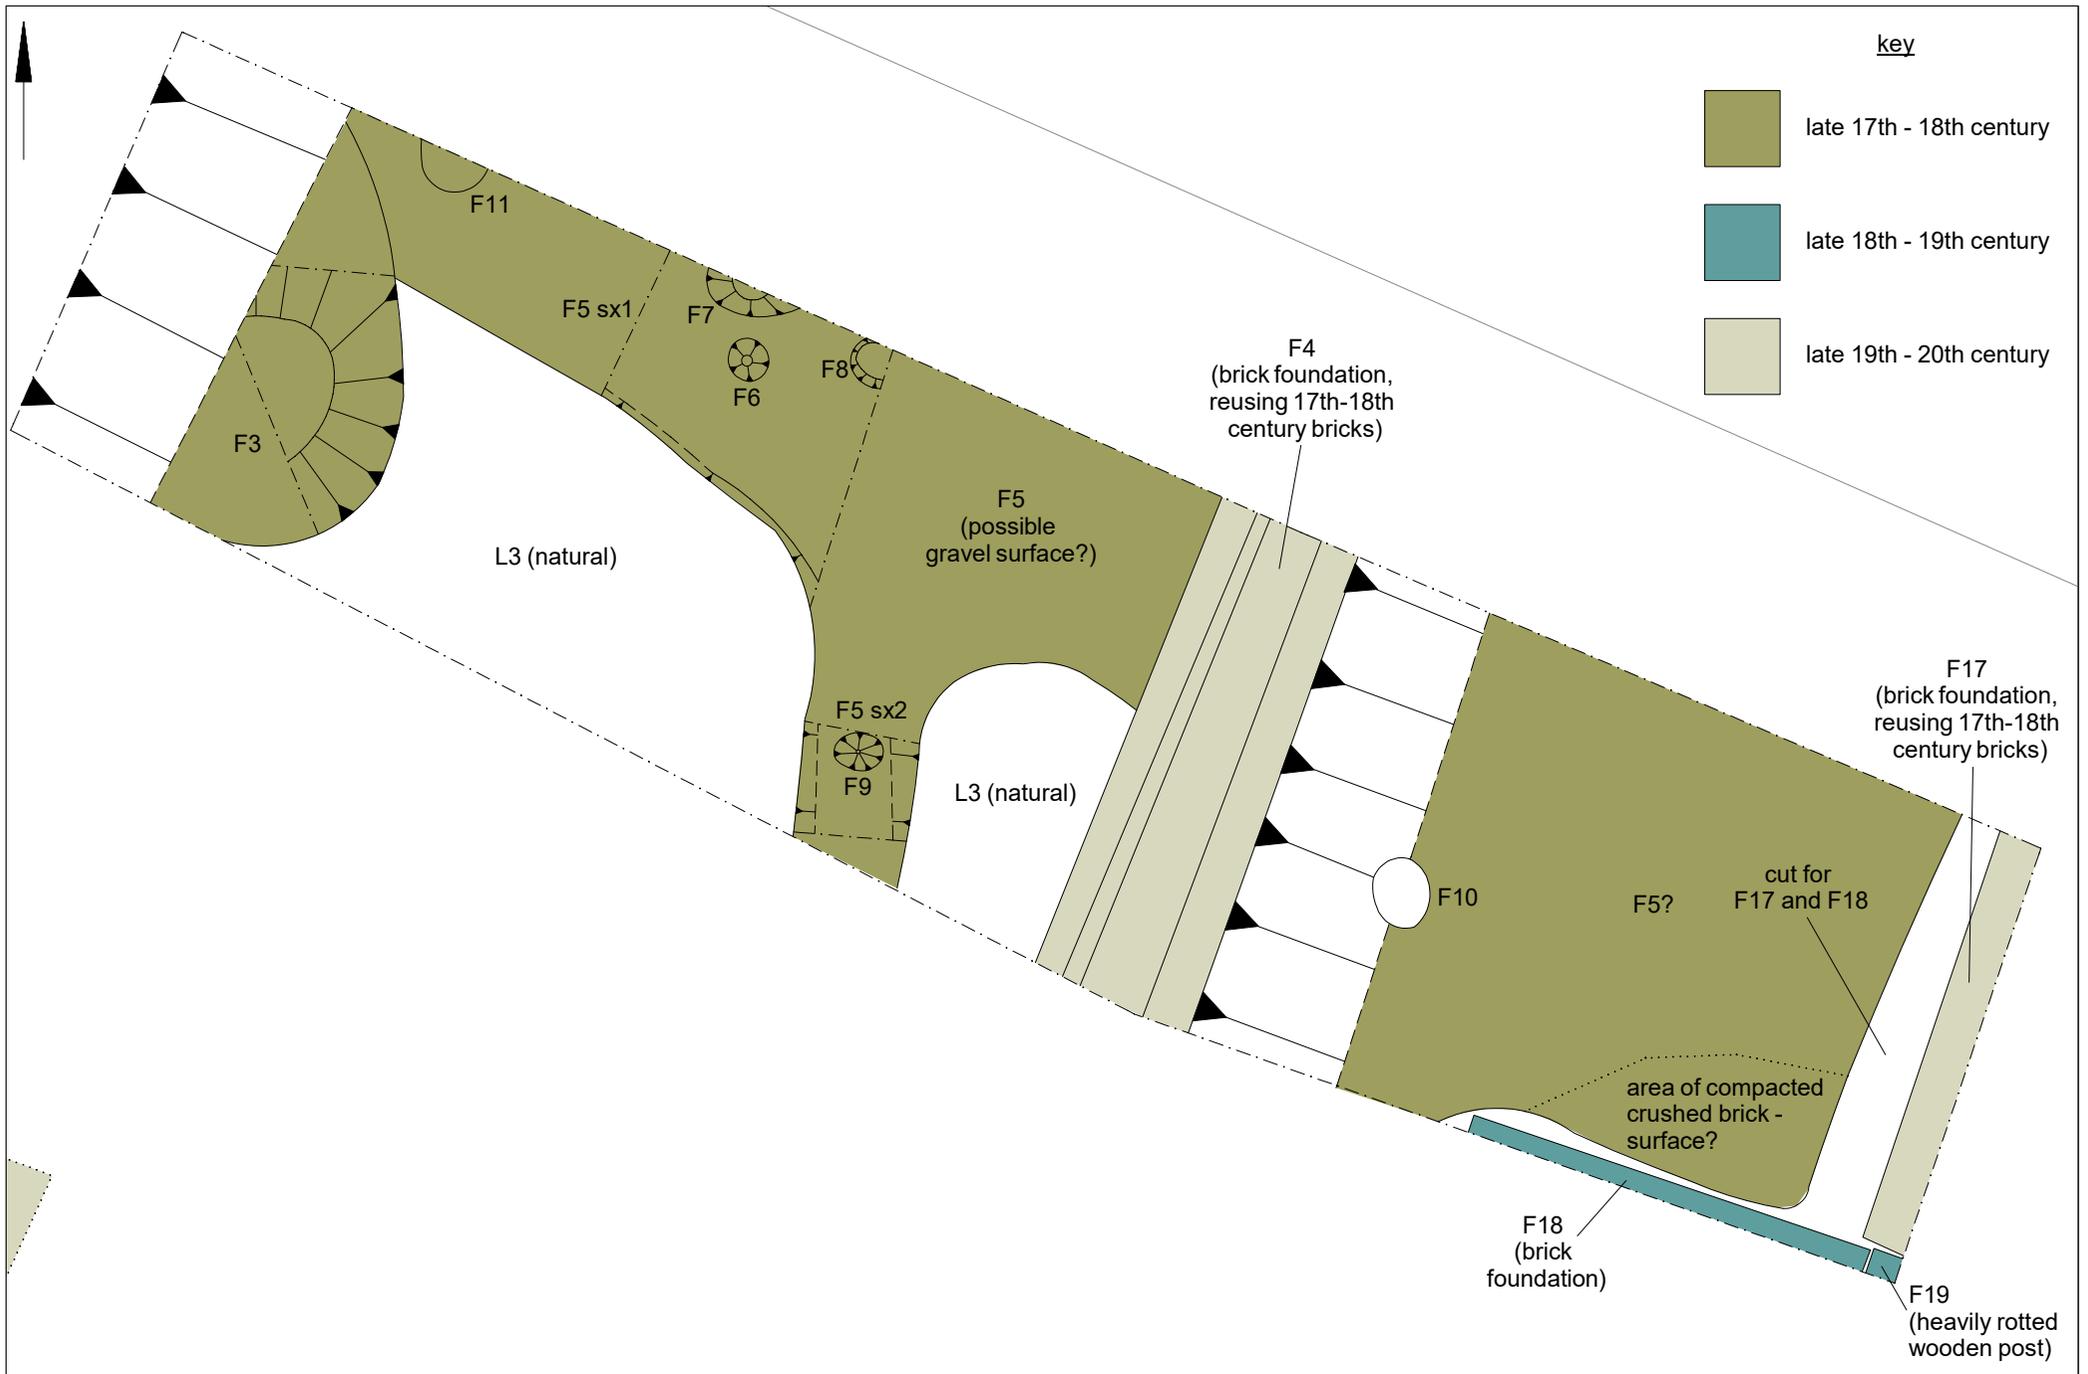
F3 was a late 17th-18th century oval pit partially within T1, and partially beneath the north-western bulk (Fig 3). Its overall size in plan failed to be ascertained, but it was 350mm deep.

F6 to F11 were a series of postholes beneath ?gravel surface F5. The postholes vary in size (Fig 3), although none are smaller than 130mm wide and none bigger than 310mm. All of the postholes had extremely soft and loose fill. Two of these postholes, F10 and F11, were visible in plan, despite being sealed by F5, as the fill of F5 had sunk

Fig 3 Detailed plan of T1, with feature numbers and phasing.

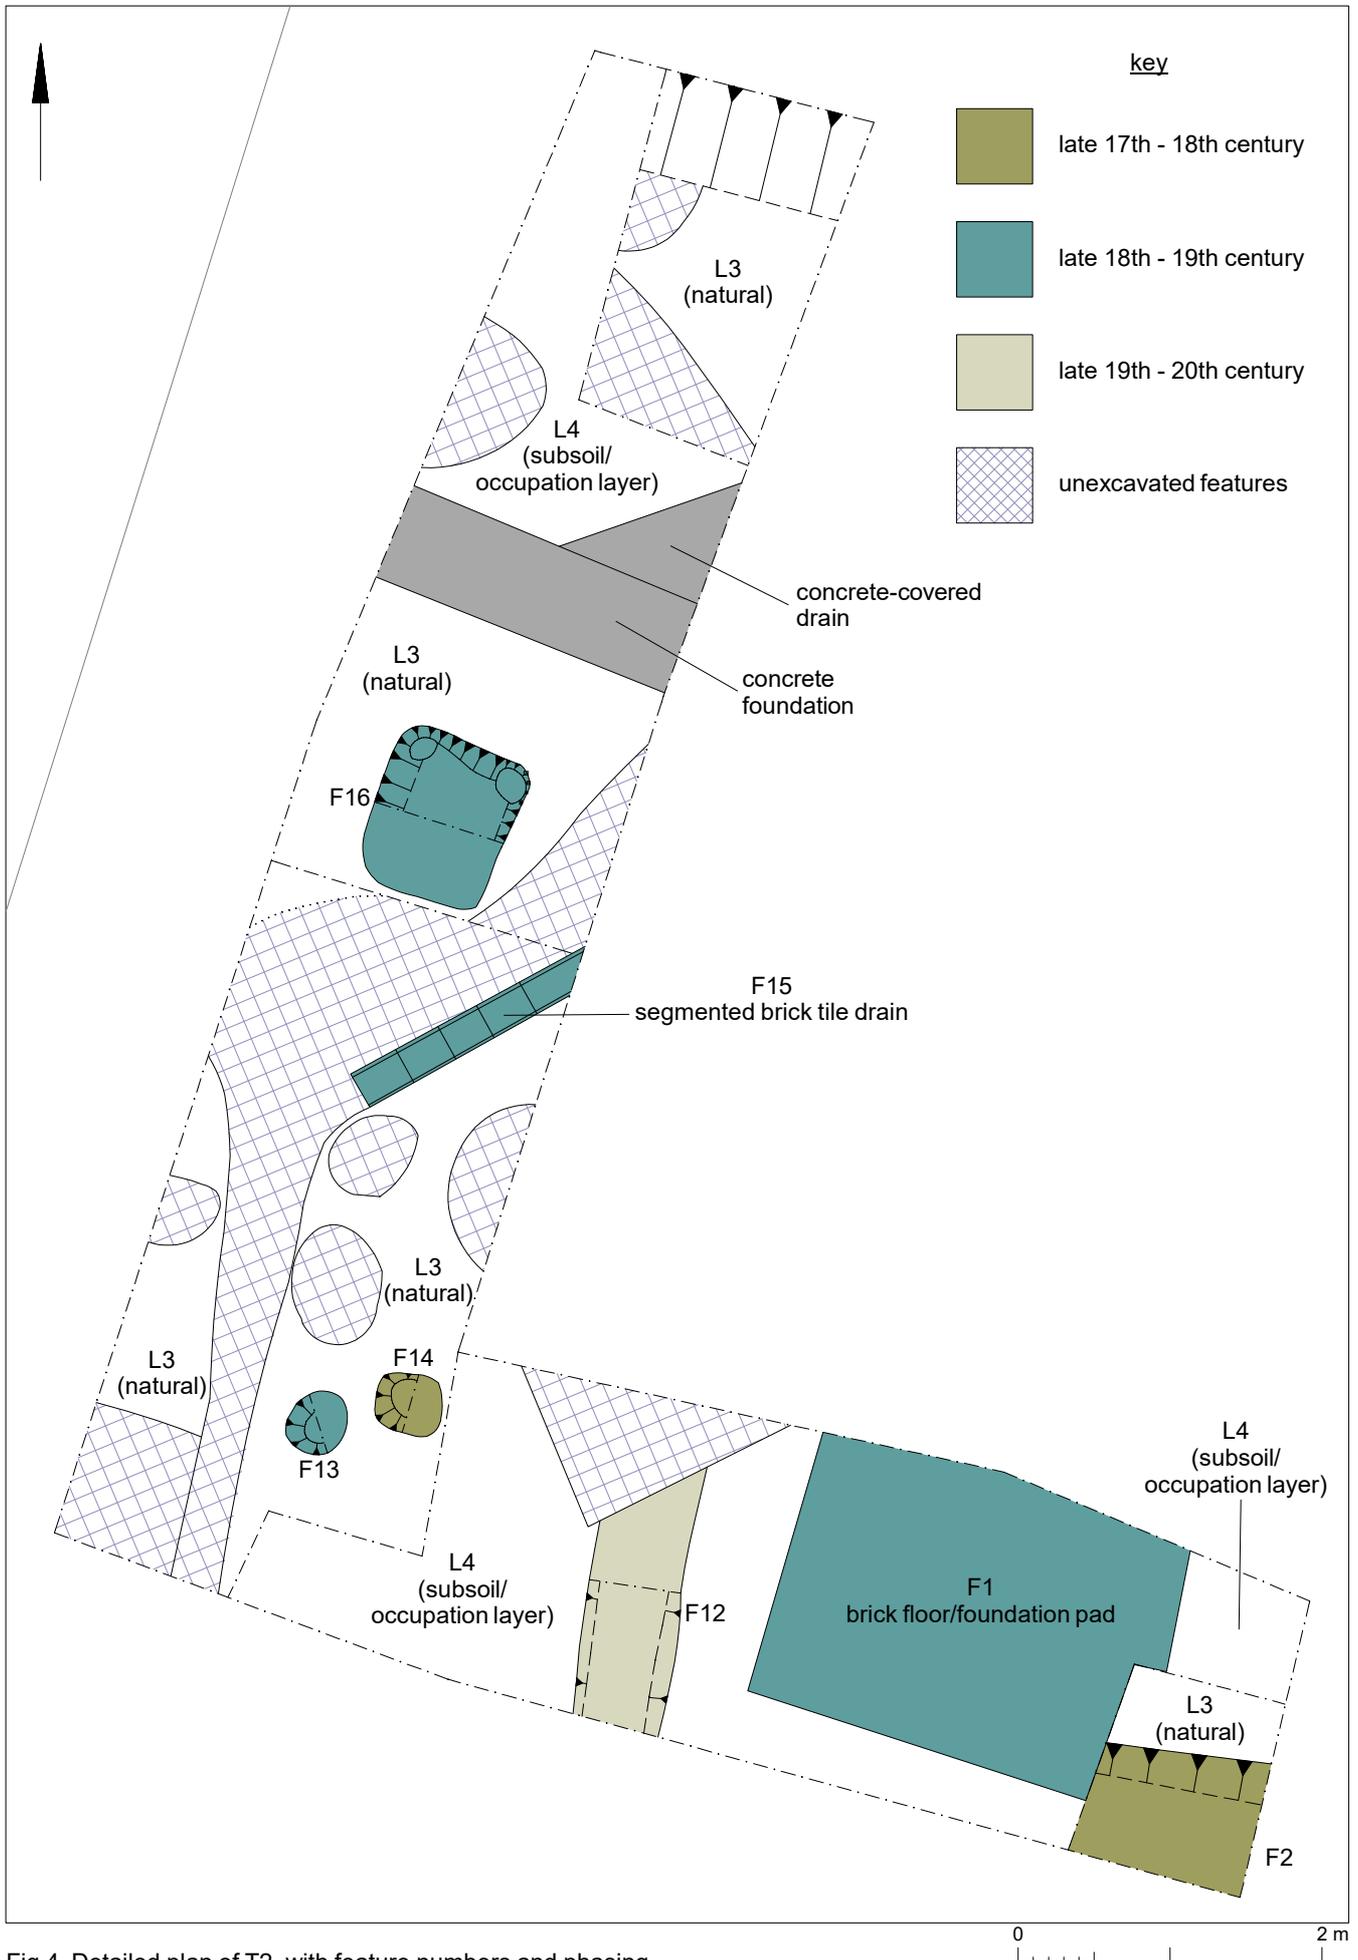
The remaining features in the trench had their extents recorded and were surface planned (Fig 4). They are presumably of a similar date, i.e. late 17th to early 20th century.

Fig 4 Detailed plan of T2, with feature numbers and phasing.

In the northern part of the trench was a substantial concrete foundation, associated with an extension to the rear of the recently demolished delivery office (Fig 4 and 5).

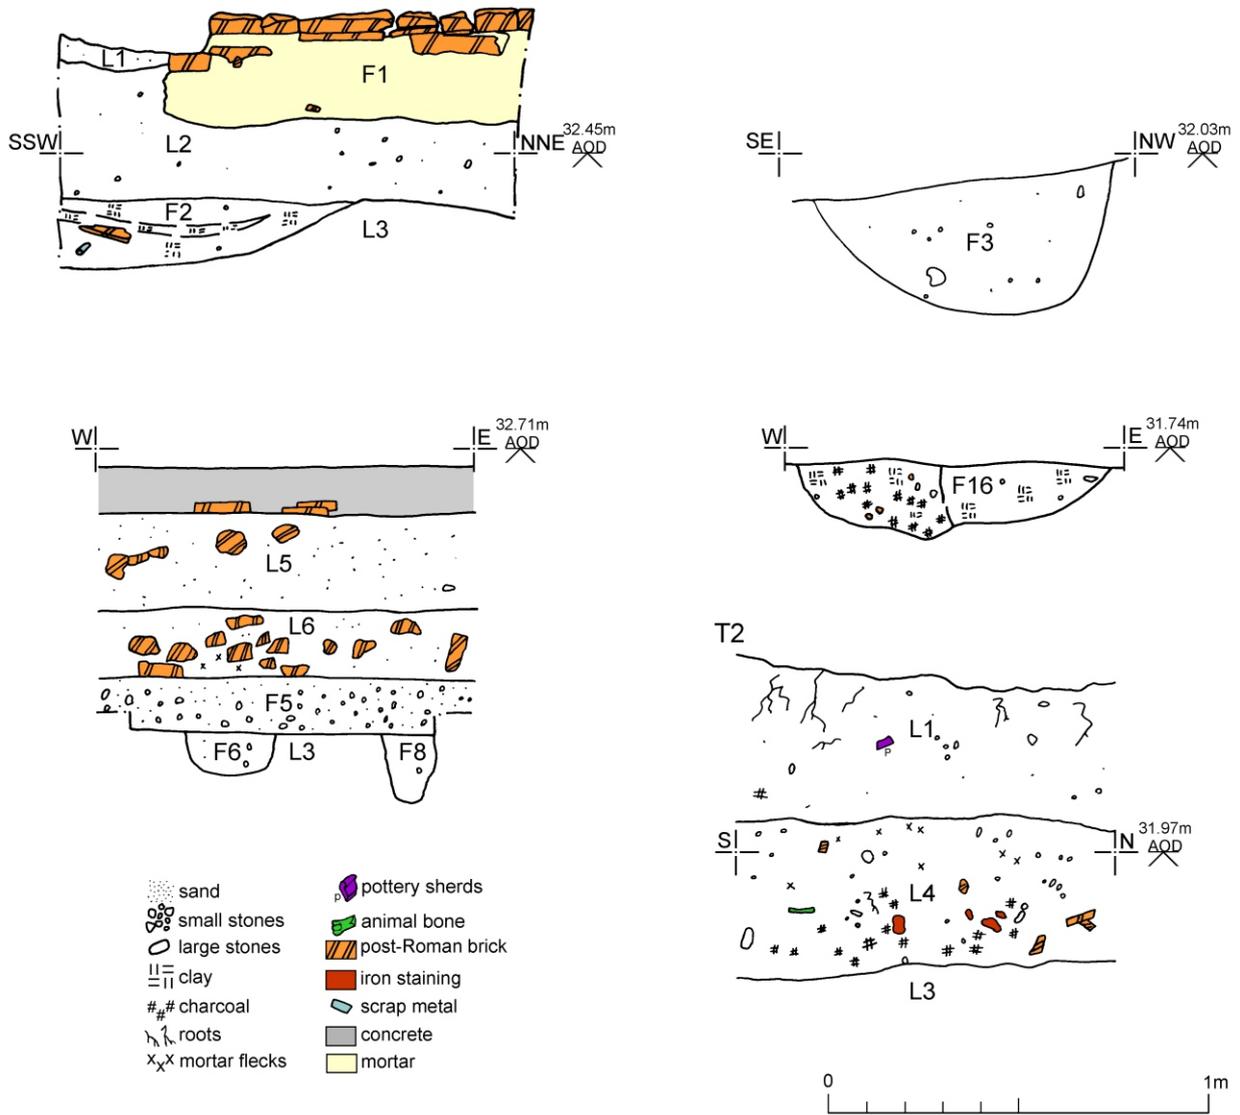
Fig 6 Feature and representative sections.

F2 was a late 17th-18th century linear, aligned east-west. It was only observed in the east of the trench, in the slot dug to ascertain F1's depth (Fig 6).
