# Archaeological monitoring at St Michael's Church, Kirby-le-Soken, Essex, CO13 0EF

September 2018-January 2019

**CAT Report 1370**  
March 2018

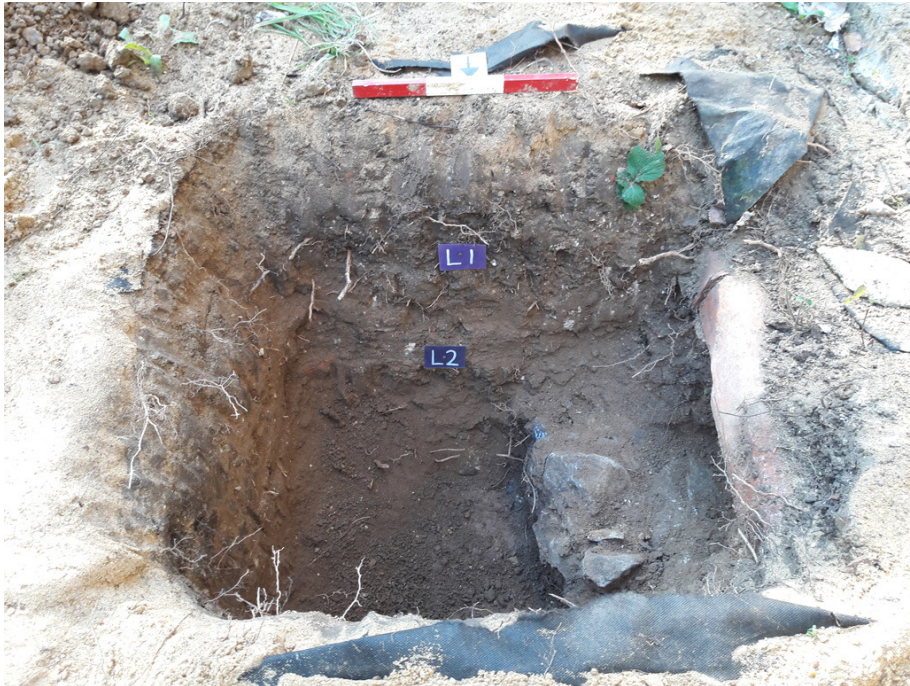
**Photograph 2** Trial-hole showing L1, L2, the land drain and wall foundation (F1) beneath, looking S

**Trial-hole:** A small trial-hole was initially excavated to establish the depth of the foundation of the chancel wall. Once the modern paving slabs, sand bedding and geomembrane had been removed, the trial-hole was excavated through topsoil (L1, 0.35m thick) into an accumulation layer (L2, probably associated with the construction of the church). The trial-hole was excavated to a depth of 1.3m below current ground level (bcgl). A modern land drain was recorded above the foundation of the chancel wall (F1). The foundation was recorded for the full depth of the trench (see below for description).

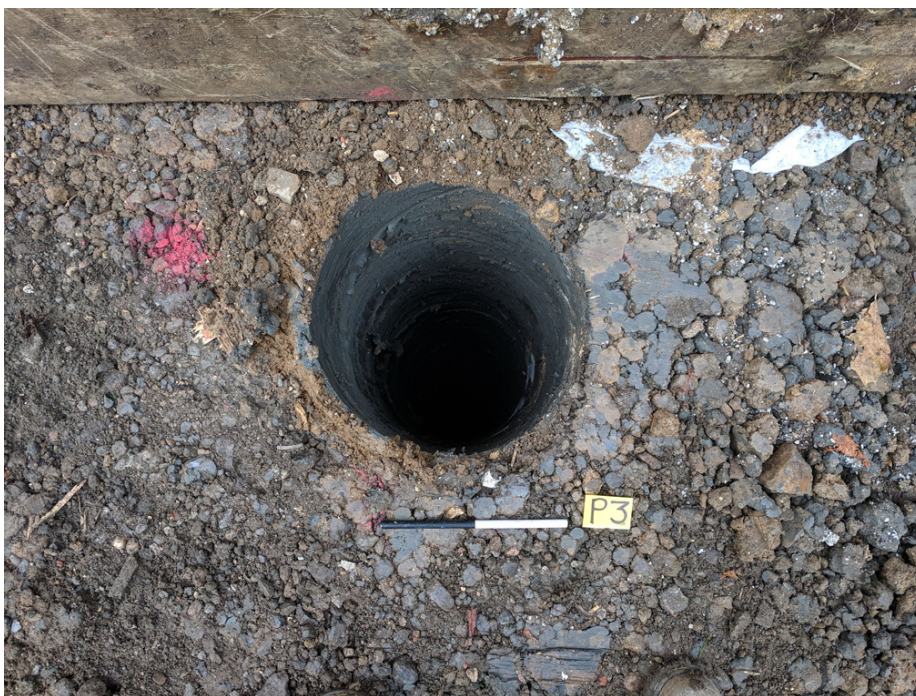
**Photograph 3** Pile-hole, looking W

**Piles:** Following the trial-hole, ground level was reduced by approximately 0.3m and a piling mat constructed. Eight piles (0.3m diameter), two per ground-beam, were excavated to a depth of 16m, through L1, L2 and into natural clay (L3).

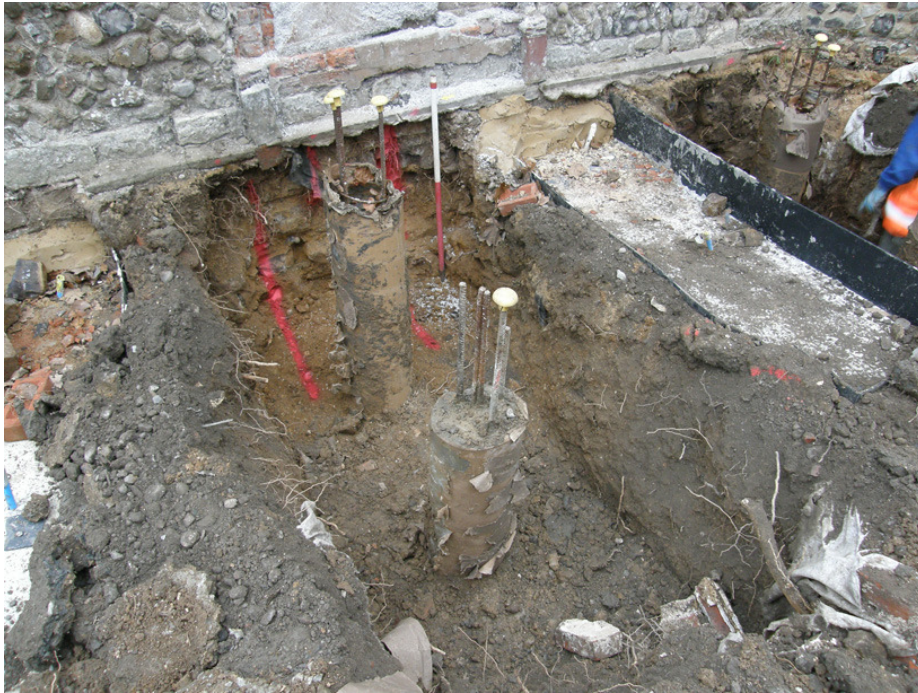
**Photograph 4** Excavation of the ground-beams around the pile caps, looking NW

**Ground-beams:** Four ground-beams, each 2.51m long by 0.6m wide, were excavated along the chancel wall (and around the pile caps) to a depth of 0.9m bcgl. In each of the four trenches, wall foundation F1, its associated construction cut and a modern land drain

were recorded. The ground-beams had been excavated through the piling mat, L2 and into L3 (identified at a depth of 0.86m bcgl).

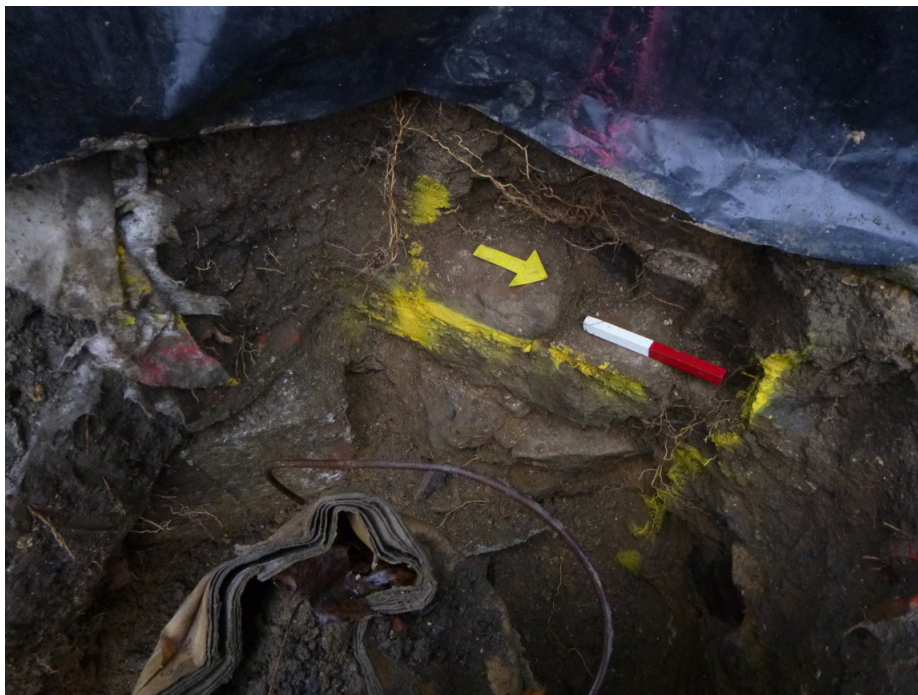
**Photograph 5** Wall foundation F1 within one of the ground-beams, looking SW

Wall foundation F1 consisted of loosely-bonded and irregularly-coursed pieces of worked stone, septaria and flint set into mortar. Once the wall foundation had been identified and recorded in each of the four ground-beams, it was tunnelled through to allow the wall to be underpinned and properly supported.

Archaeological monitoring revealed the 14th-century wall foundation of the chancel. It measured at least 1.3m deep, was 0.3m wider than the wall and had been constructed of

loosely-bonded and irregularly-coursed pieces of stone, septaria and flint set into mortar. Despite the apparent size and depth of the foundation, the loosely-bonded construction may have played a part in the current structural instability of the chancel wall. No evidence for earlier phases of the church or archaeological deposits that predate the church were uncovered.
