Archaeological evaluation of Maldon's proposed Central Flood Alleviation Scheme (MAL 2) on land adjacent to Brickhouse Farm Community Centre, Pulton Close, Maldon, Essex, CM9 6NG

February 2019

CAT Report 1389
March 2019

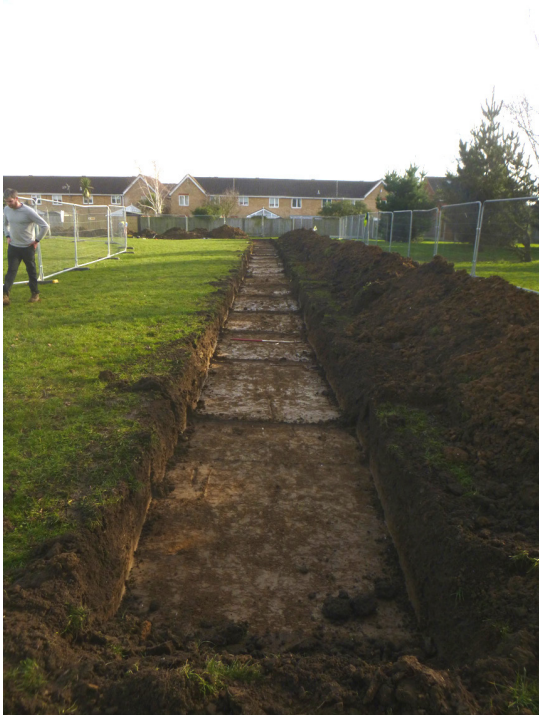
Photograph 1 Trench T1, looking south southeast

Trench 1 (T1) (45m long by 1.8m wide): The only features present were a modern drainage trench and pit.

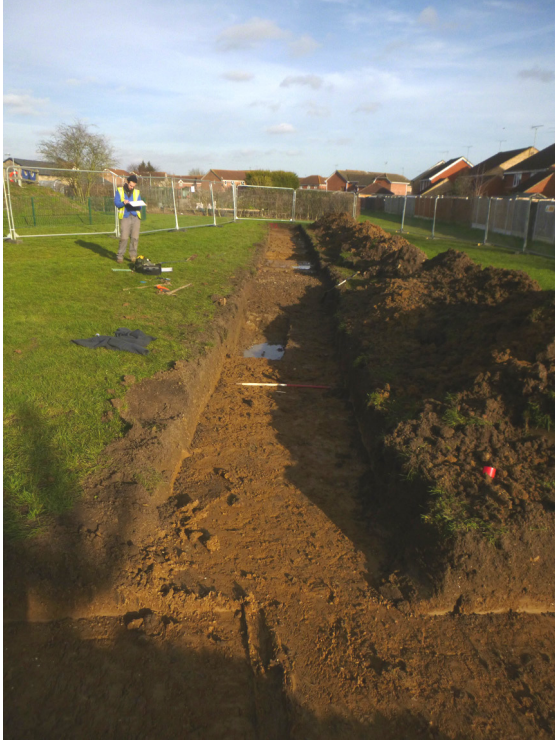
Photograph 2 Trench T2, looking east northeast

Trench 2 (T2) (30m long by 1.8m wide): A post-medieval pit (F1) and drainage ditch (F3) were excavated along with a loose spread of pebbles, gravel and some peg-tile mixed into a sandy-clay (F2).
