**Historic building recording of
the precinct wall of St John's Abbey
along Flagstaff Road, Colchester, Essex
CO2 7EZ**

CAT Report 1402
April 2019

A programme of historic building recording was carried out by Colchester Archaeological Trust of the precinct wall of St John's Abbey along Flagstaff Road, Colchester, Essex in October 2018.

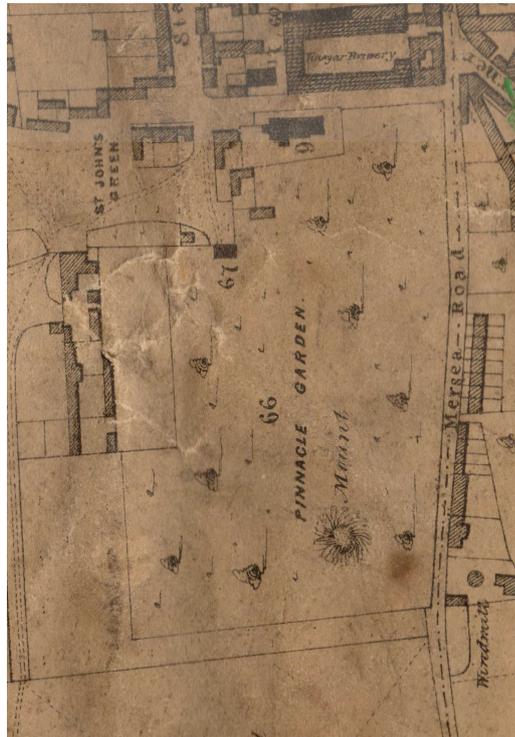
Map 3 1848 map by E. Monson.

A map printed in 1848 by E. Monson (Map 3) shows the abbey grounds to be much the same. Both St Giles church and the gatehouse are depicted, and the grounds are labelled as "Pinnacle Garden". A series of buildings are shown adjacent to the abbey wall on the west side of the circuit. Evidence that may be associated with these buildings was observed during this survey (see below).

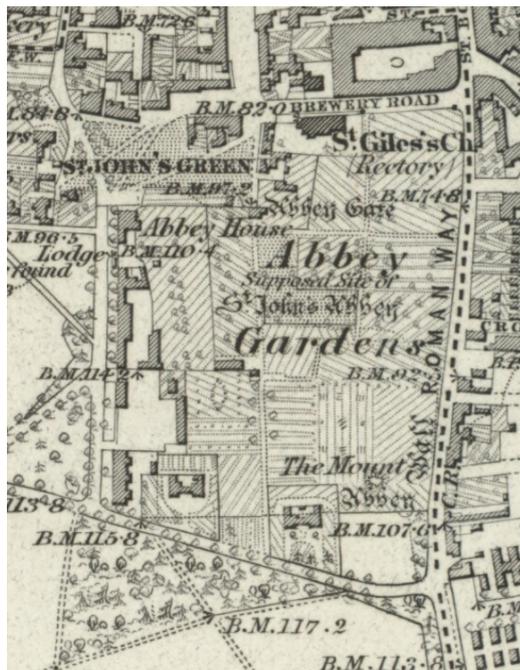
Map 4 1875 6-inch OS map.

The first edition 6-inch OS map shows the abbey grounds with several more buildings to the south-west, with diminishing evidence of the precinct wall visible (Map 4).

The north of the eastern elevation has a peculiar feature; at the base of the wall is a shallow recess, measuring about 1m in height by 1.3m wide with a wooden lintel above (Fig 7). Superficially this resembles a fireplace opening although clearly, without a chimney, it wouldn't have functioned as one. To the north of this recess is a large timber post partially built into, and bolted to, the wall (Fig 7). The purpose of these features is uncertain, but it seems likely they are in some way associated with the buildings built up against this section of wall shown on the 1875 OS map (Map 4).

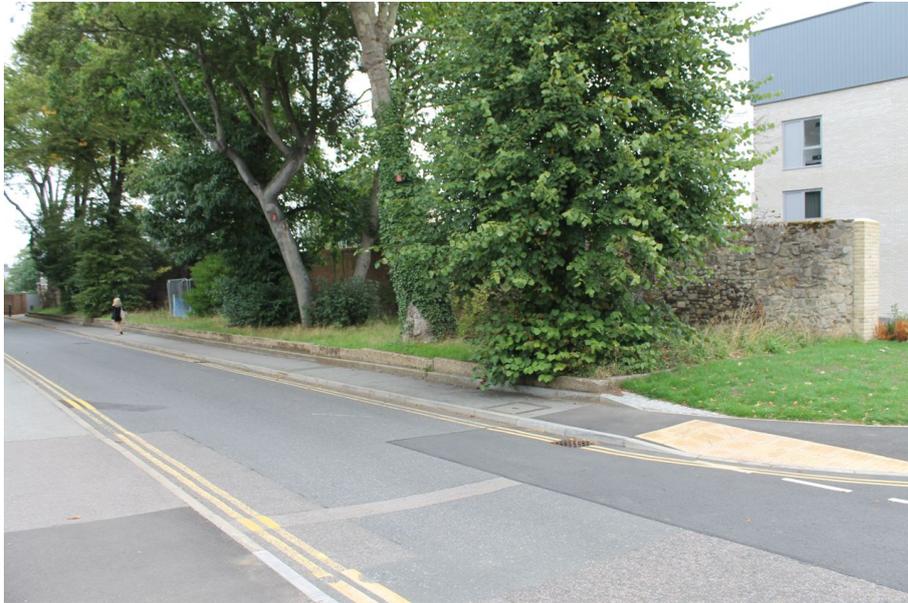
Photograph 1 West elevation of wall prior to recording, showing level of overgrowth. Photograph taken facing north-east.

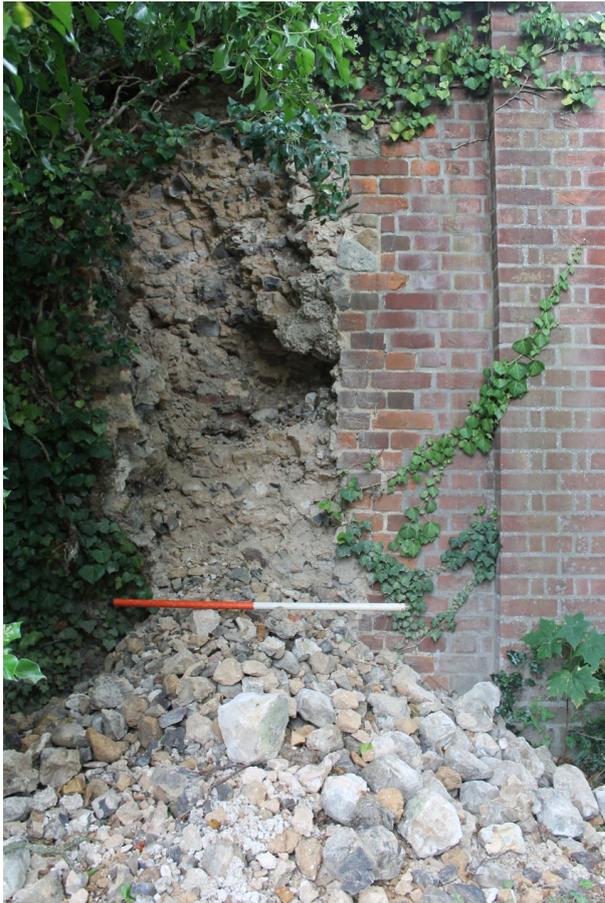
This recording was prompted by the partial collapse of this section of abbey wall (Photographs 2-3). Prior to the recording taking place, the area of partial collapse had to be stabilised and made safe. As a result, the wall was reduced down to 1m in height, with all the loose material above this point being removed. In the collapsed and removed material were seven large pieces of worked stone with remnants of lime mortar attached (Figs 9-12). These pieces of worked stone are similar to ones present in the refacing to the south (see below) and several examples were also recovered in various contexts during the recent excavation and monitoring of the adjacent housing development within the abbey grounds (CAT Report forthcoming). They have been interpreted as originating from the abbey and associated buildings within the abbey grounds, and having been added to the wall as part of a refacing episode carried out subsequent to the abbey's demolition. The initial collapse, prior to stabilisation and further reduction, appeared to be the result of the (rebuilt) face of the wall coming away from the lime mortar and septaria core (Photograph 3).

Photograph 2 Collapsed section of wall prior to recording and reduction in height for stabilisation. Photograph taken facing east.

The repair of the collapsed section of wall was carried out subsequent to this recording project being undertaken. Photographs of the repaired section are reproduced below (Photographs 4 and 5).

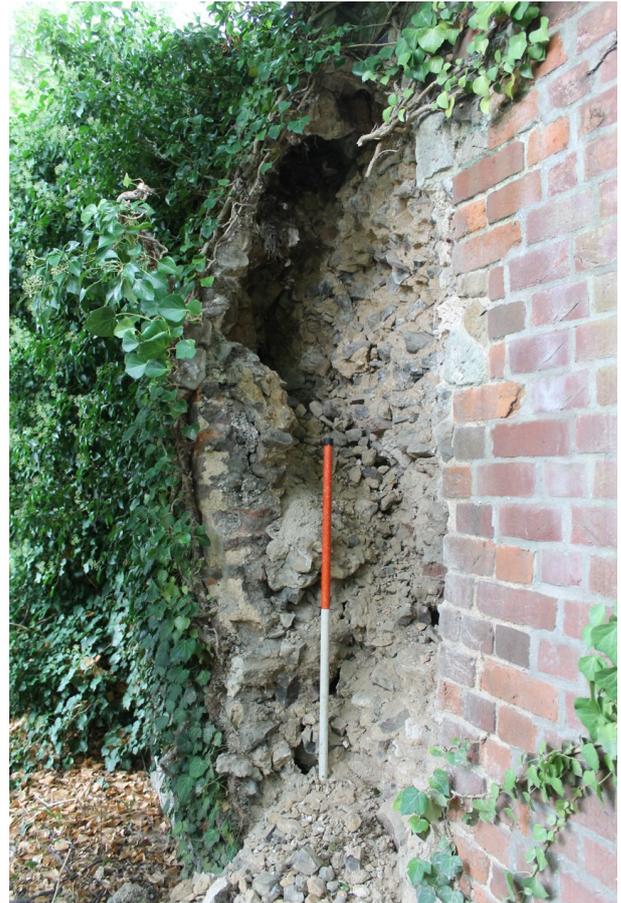
Photograph 3 Collapsed section of wall prior to recording and reduction in height for stabilisation. Photograph taken facing north-east.

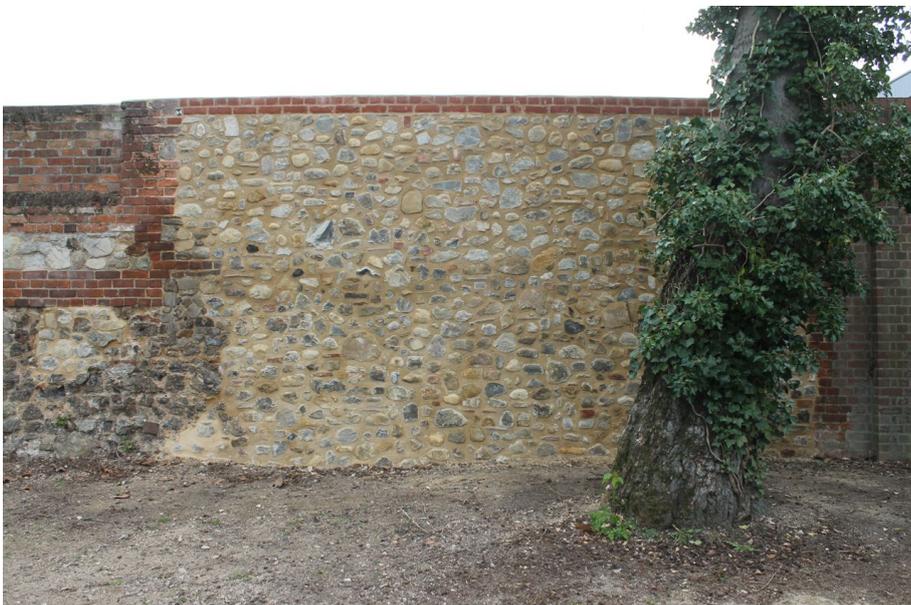
Photograph 5 West elevation of wall after repair work. Photograph taken facing east.

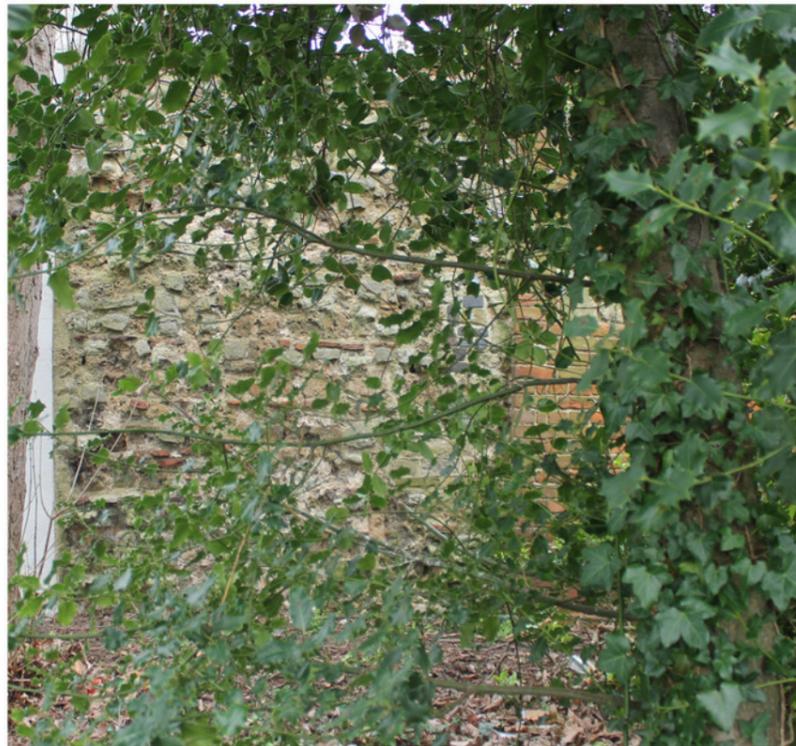
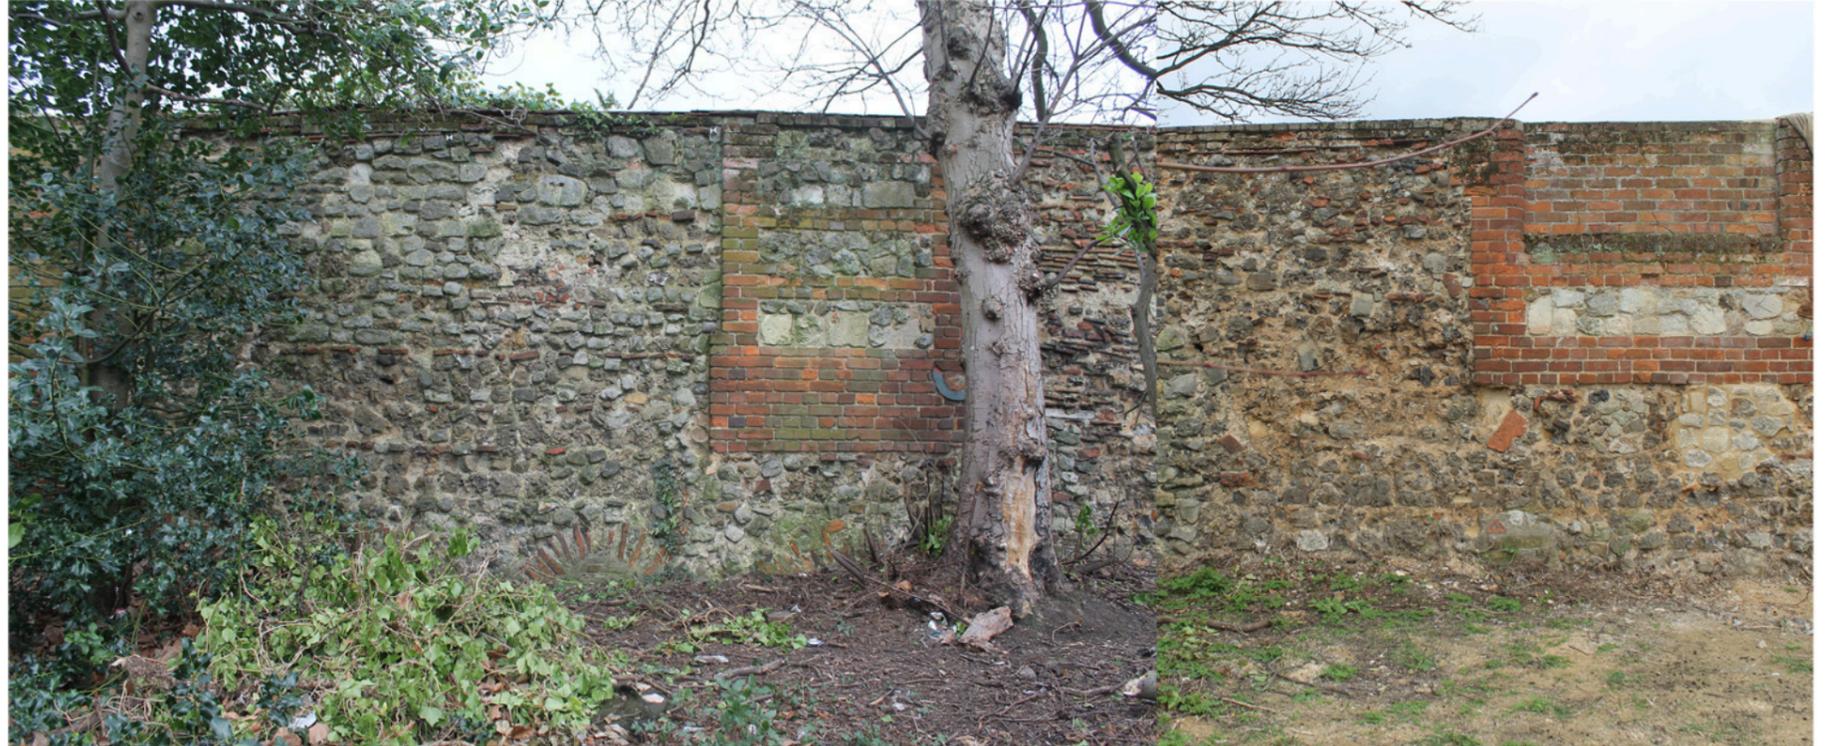
Fig 3 Western elevation of abbey wall 1 of 3. Rectified elevation above, photo below.

Visible on the western elevation of the wall are three arches, close to the ground-level, made of reused Roman tile (Fig 3). These may be the remains of culverts in the wall that have since been blocked, although without any below-ground investigation, it is difficult to be certain. Alternatively they could be providing additional support for this section of wall, or are simply decorative elements added to the wall during an episode of refacing.

blocked culverts?

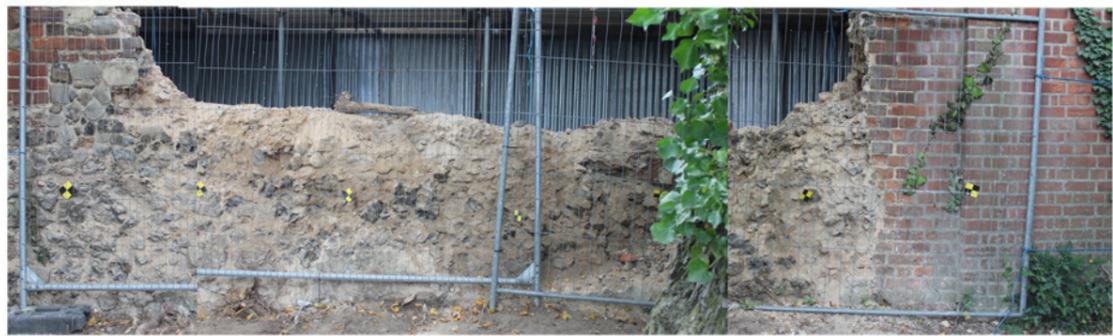
Fig 4 Western elevation of abbey wall 2 of 3. Rectified elevation above, photo below.

The collapsed wall segment along this section exposed the original medieval core of the wall, which is constructed entirely of mortar and septaria, with no brick or ragstone visible (Fig 4).

collapsed section of wall

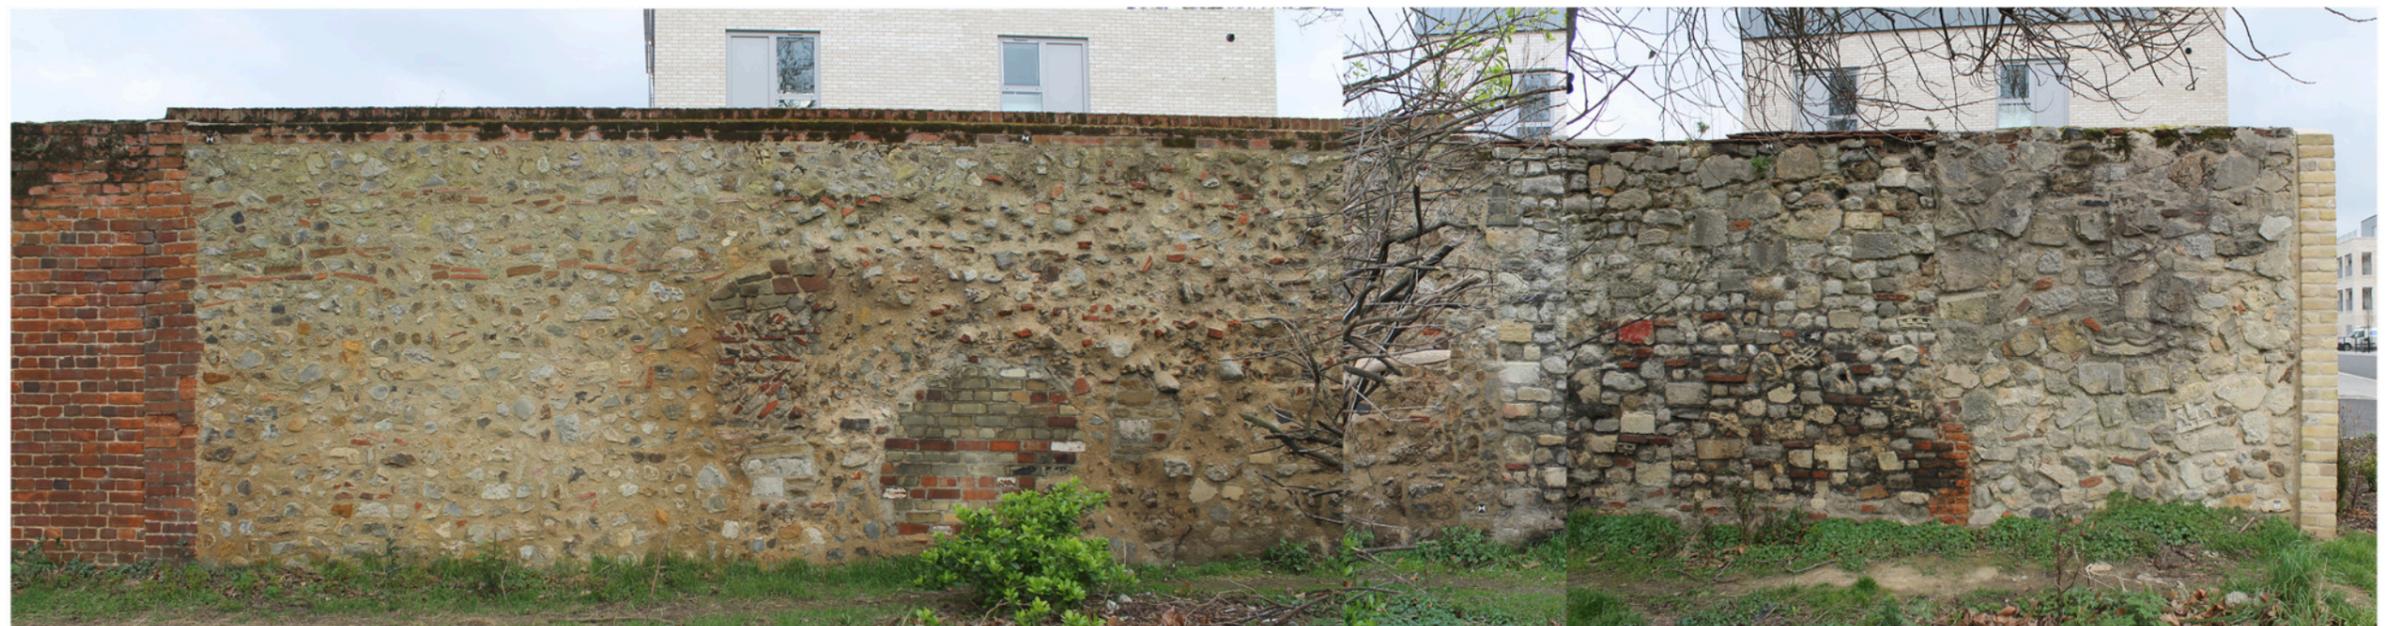
Fig 5 Western elevation of abbey wall 3 of 3. Rectified elevation above, photo below.

The southern segment of this wall section has been entirely refaced on both the east and west elevations (Figs 5 and 6). This refacing comprises large segments of Roman and post-medieval brick, septaria and ragstone, all closely bonded with lime mortar. Also of note within this section of refacing are several large worked ragstone pieces. Like the worked stone recovered from the collapsed section of wall (see above), this stone presumably originated from the abbey buildings, meaning this refacing must

post-date the abbey's demolition. The high amount of worked stone on the face of this section of wall is noted in the 1922 RCHME survey (pg 48).

refaced section of wall

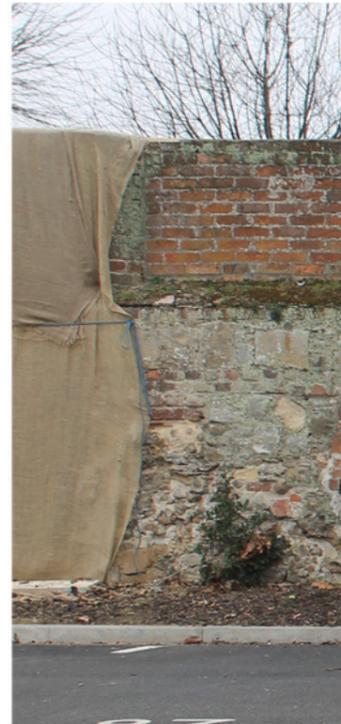
Fig 7 Eastern elevation of abbey wall 2 of 3. Rectified elevation above, photo below.

obscured during recording

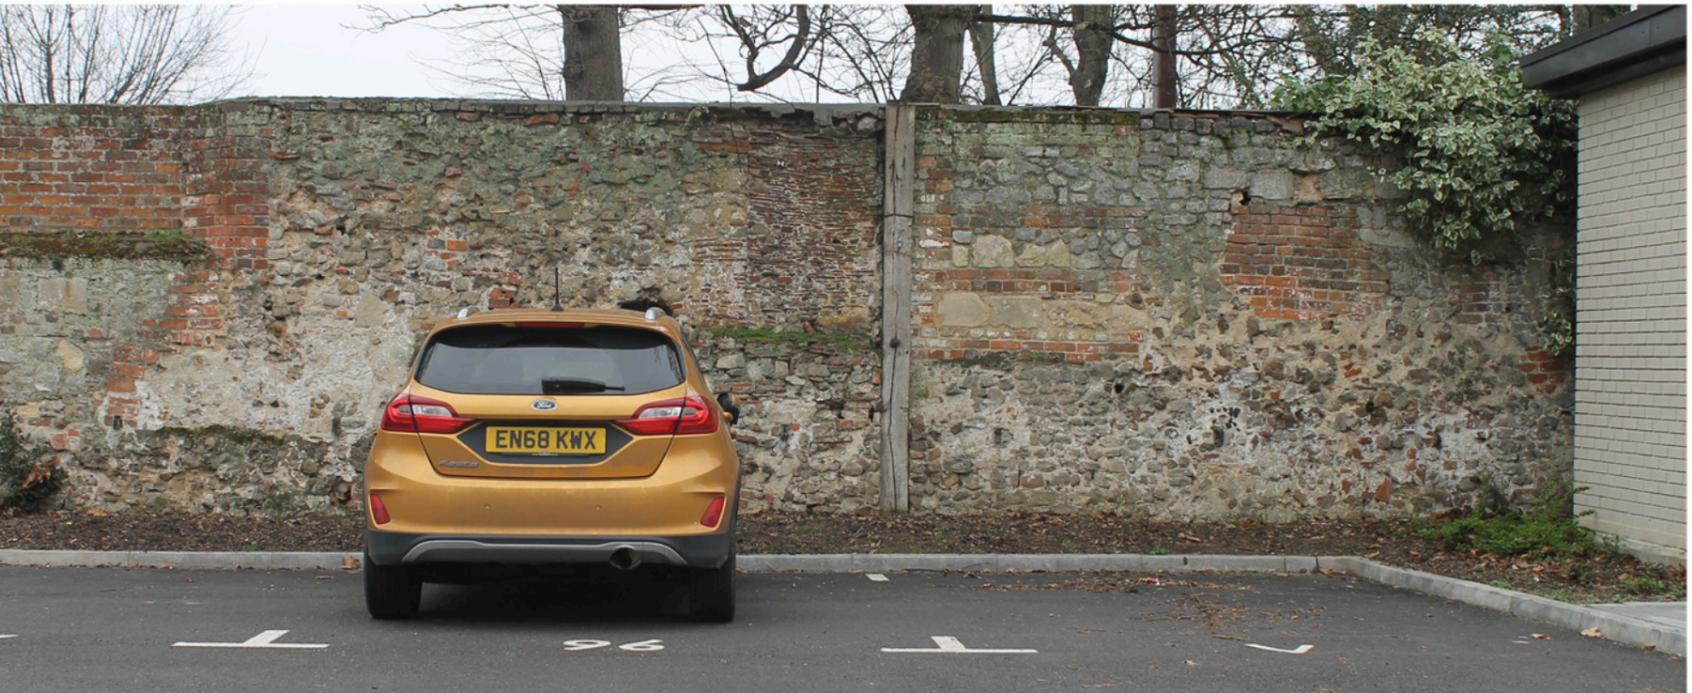
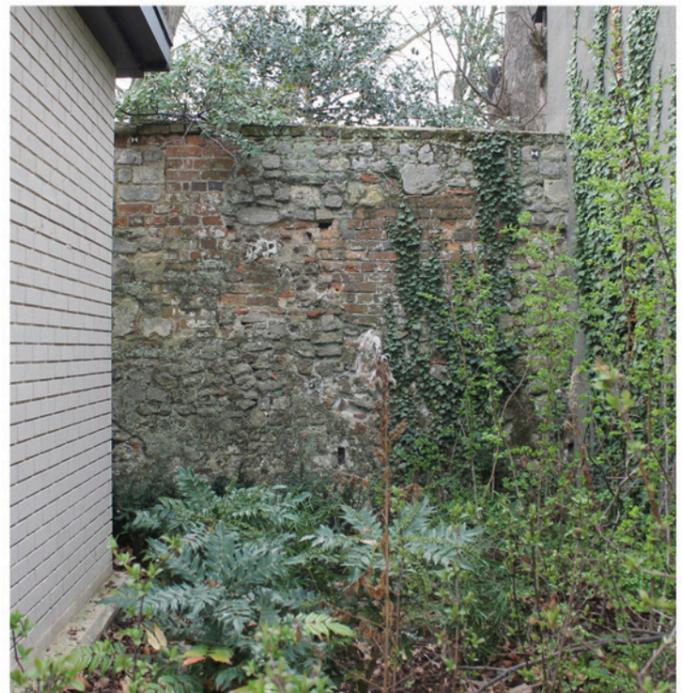
Fig 8 Eastern elevation of abbey wall 3 of 3. Rectified elevation above, photo below.

recess in wall

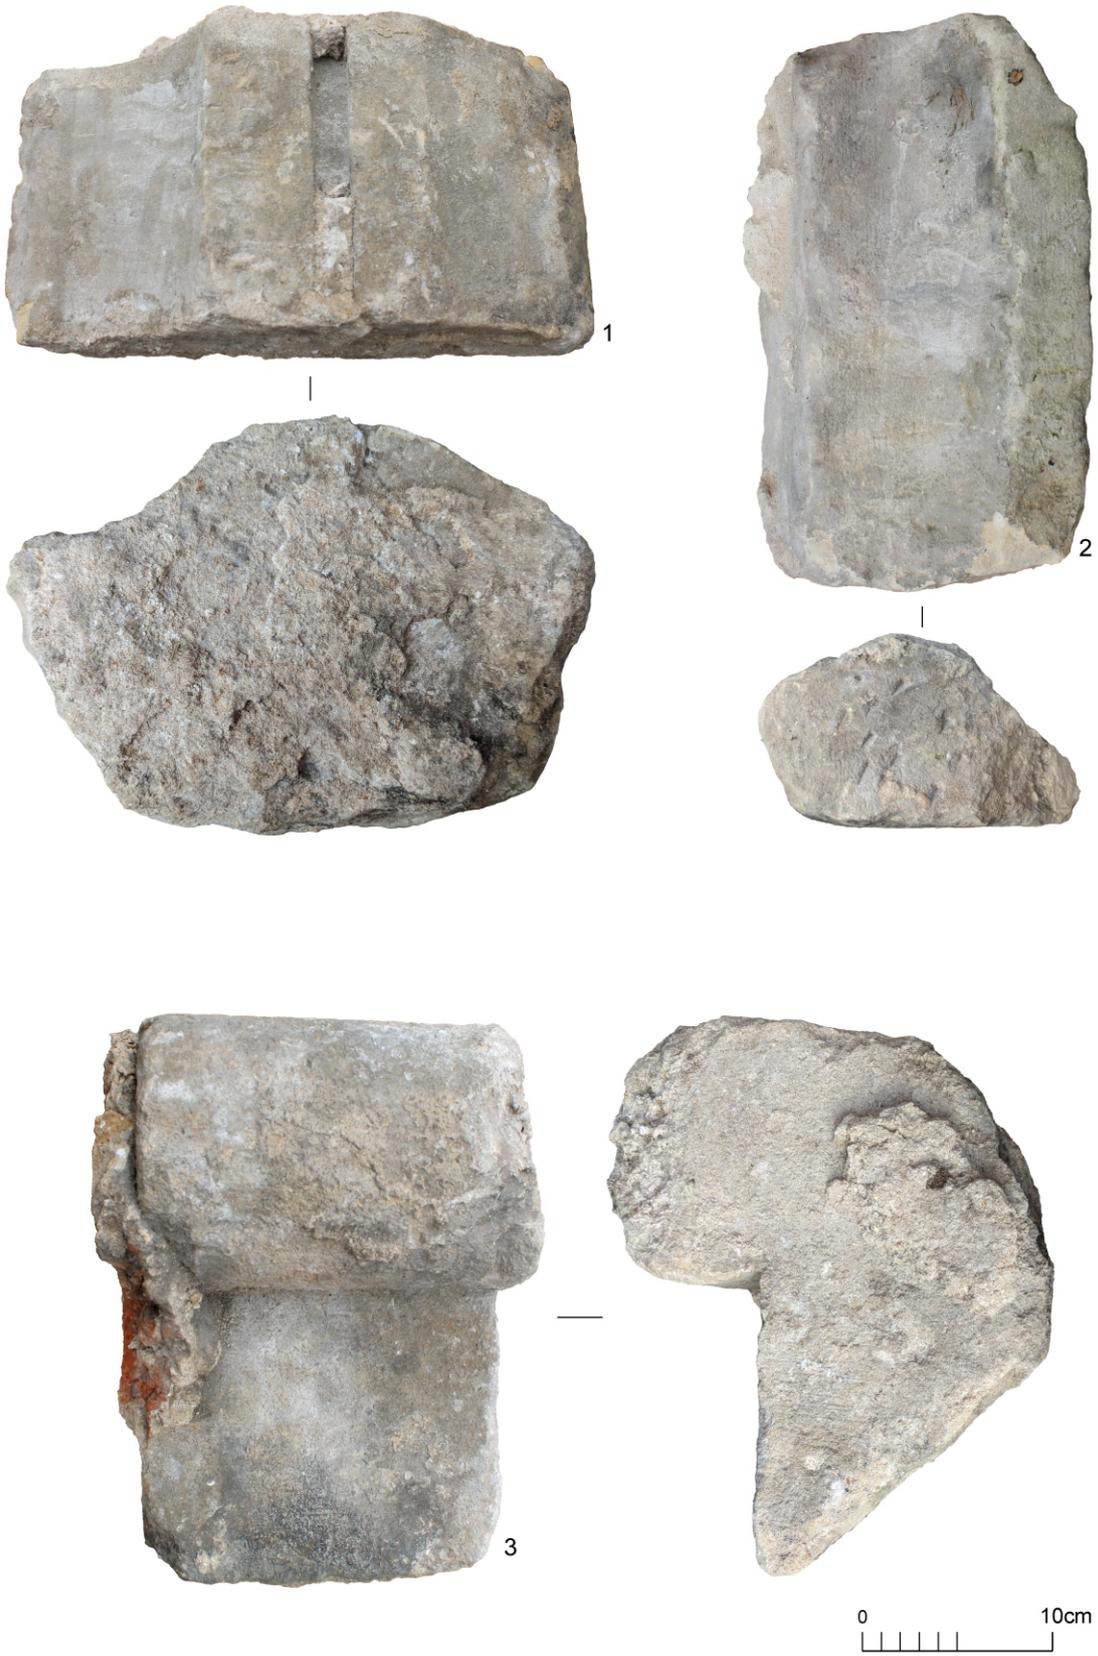
Fig 9 Worked stone recovered from collapsed section of wall.

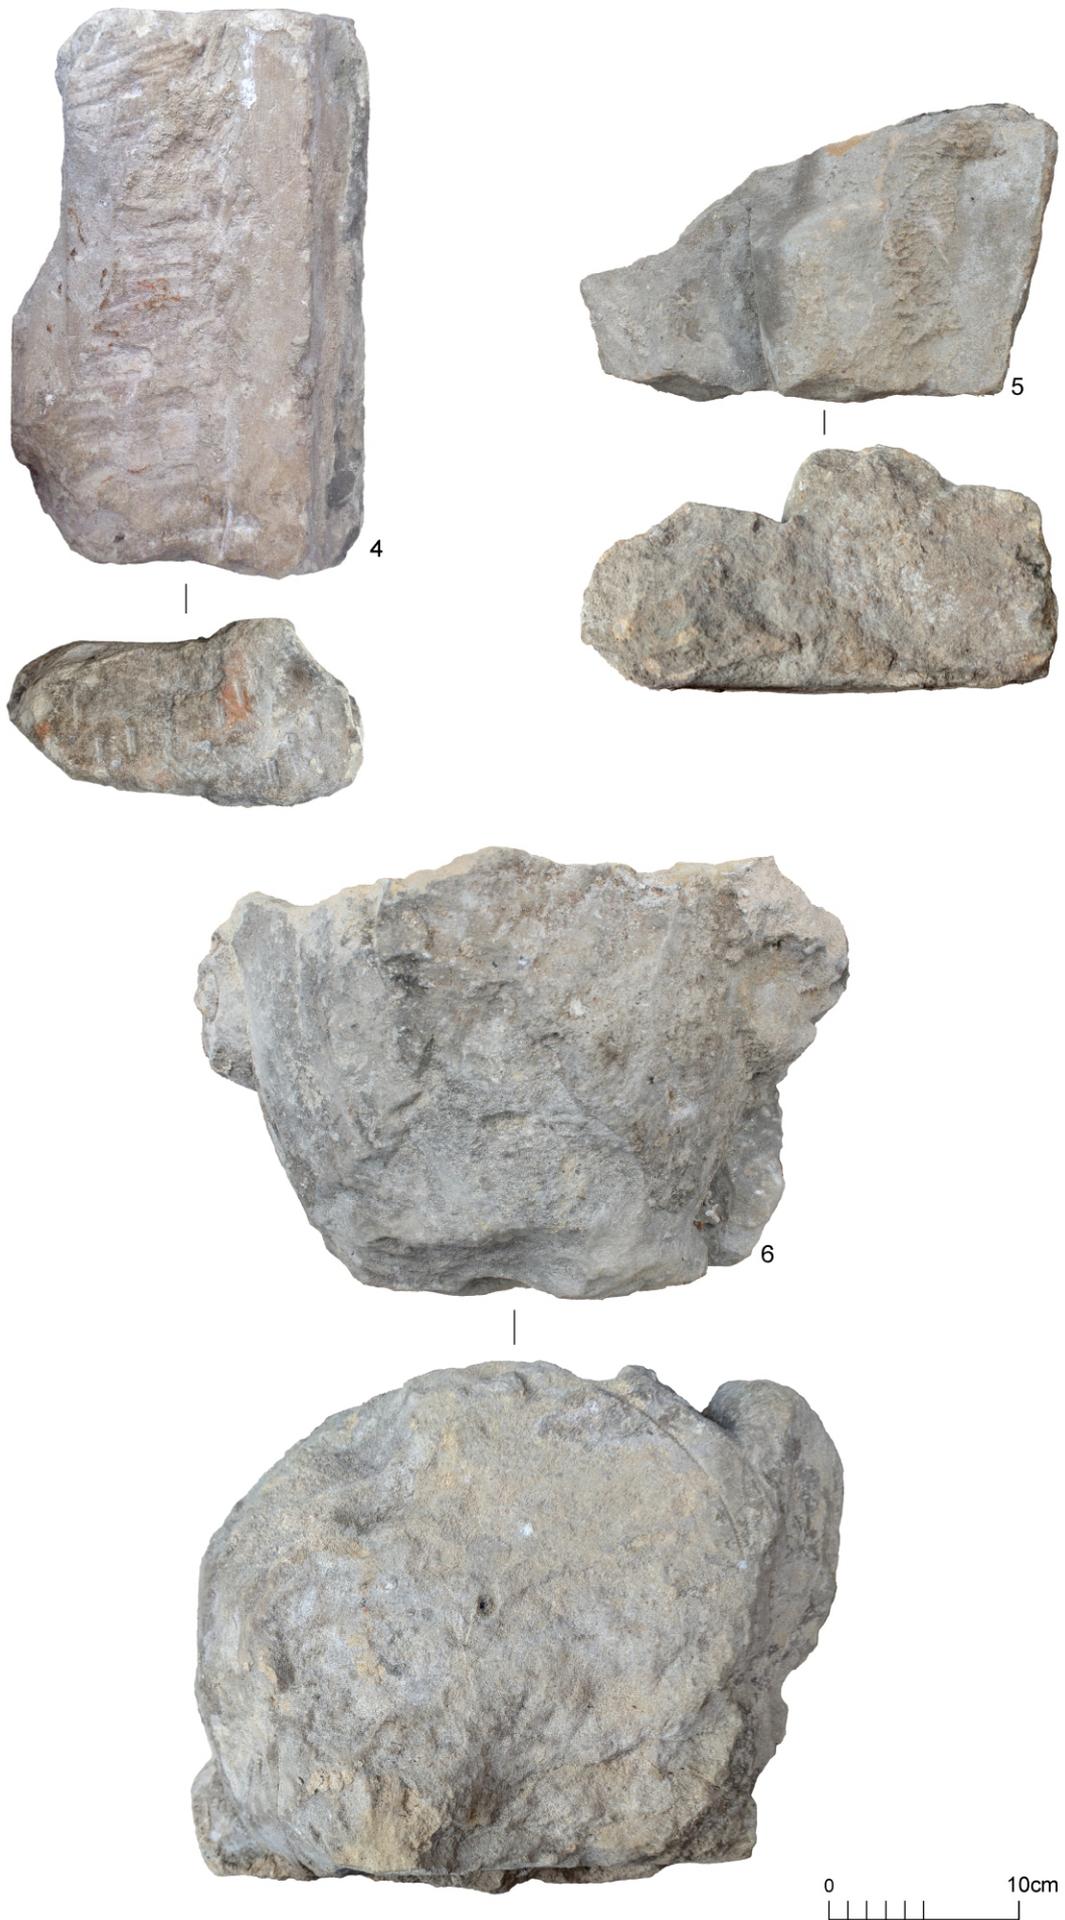
Fig 10 Worked stone recovered from collapsed section of wall.

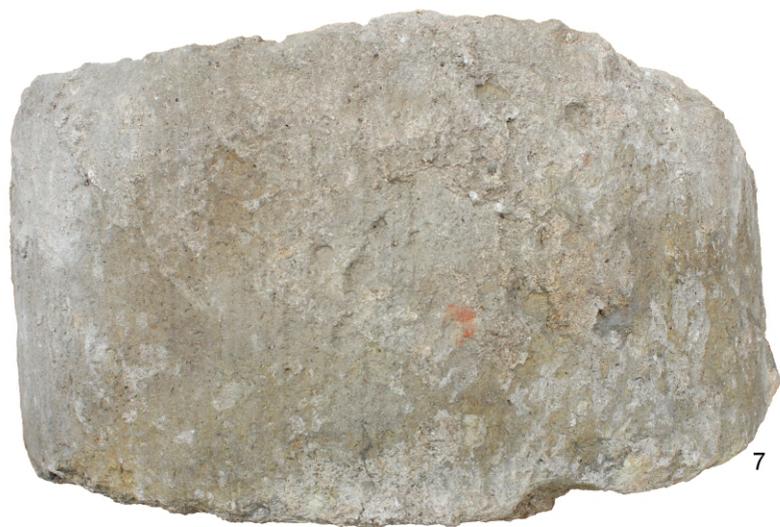
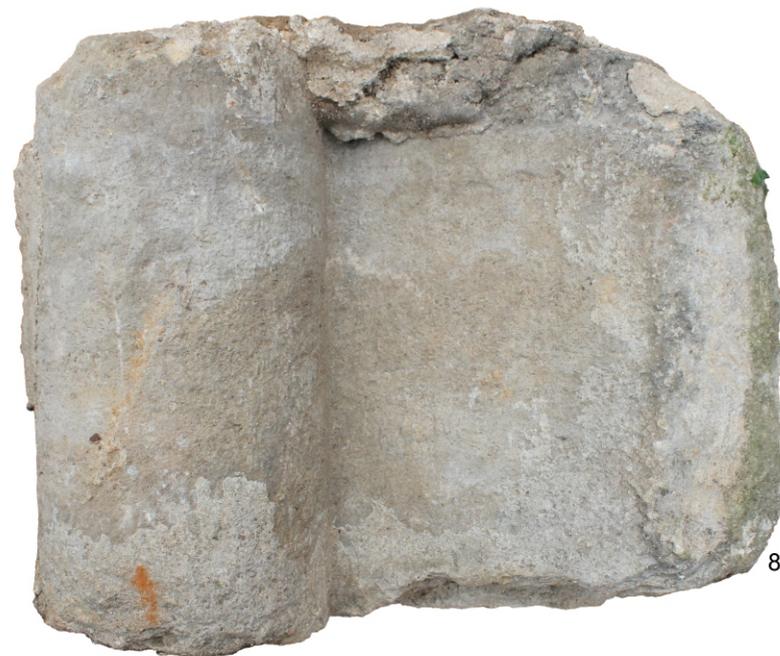
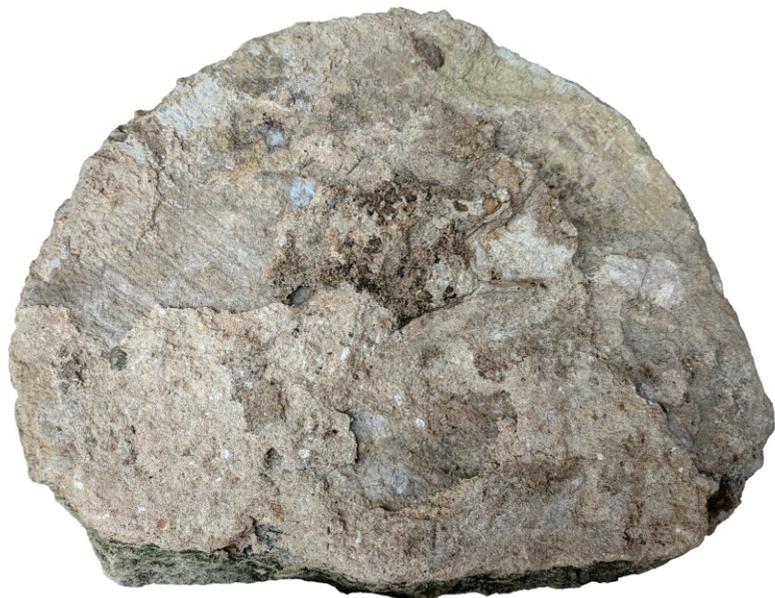
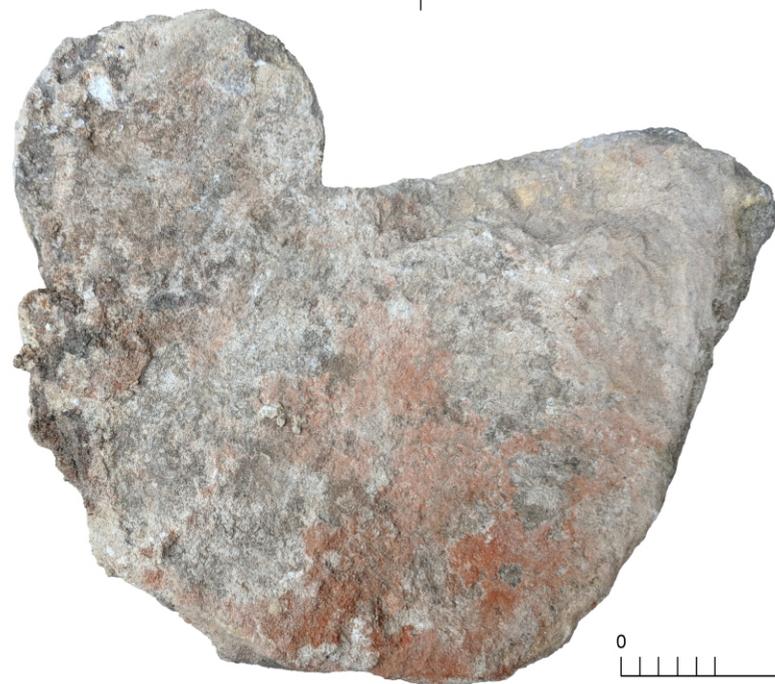
Fig 11 Worked stone recovered from collapsed section of wall.

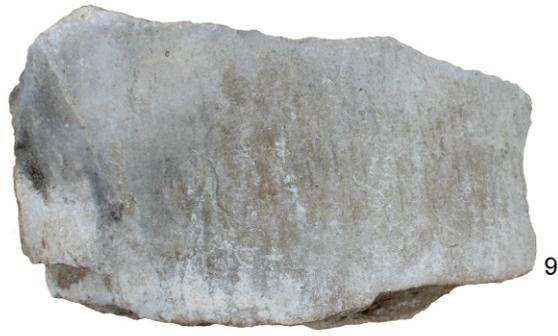
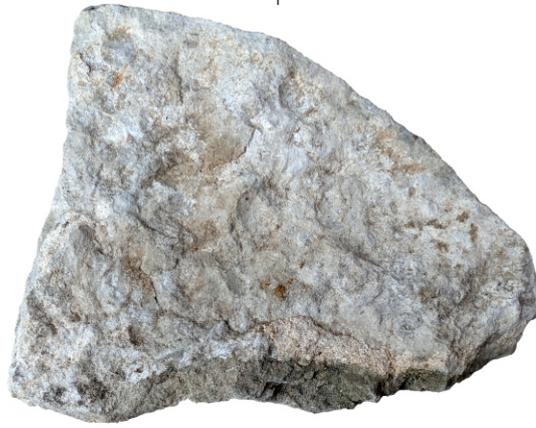
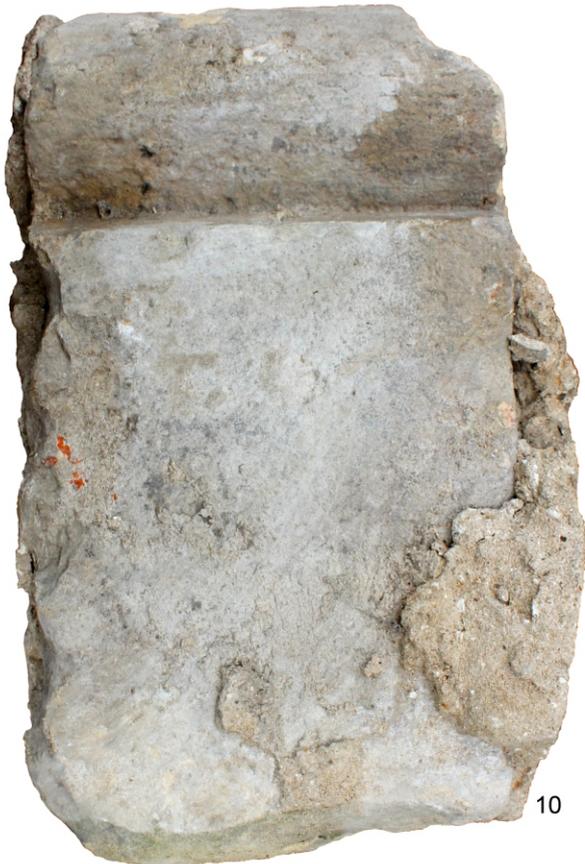
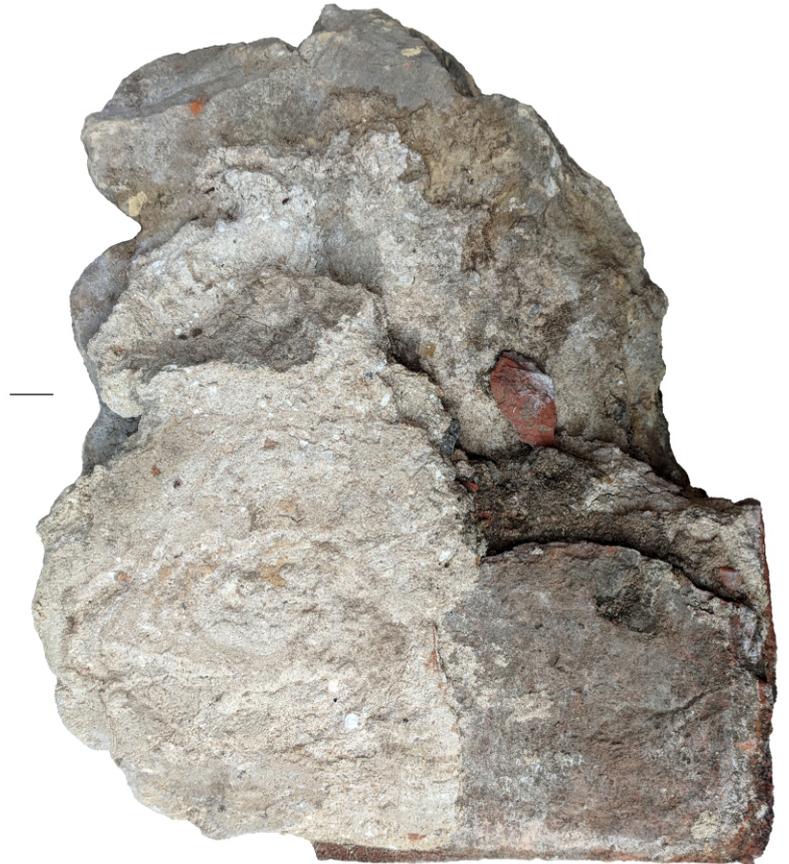
Fig 12 Worked stone recovered from collapsed section of wall.
