Archaeological monitoring at 34a London Road, Maldon, Essex, CM9 6HD

April 2019

CAT Report 1418
May 2019

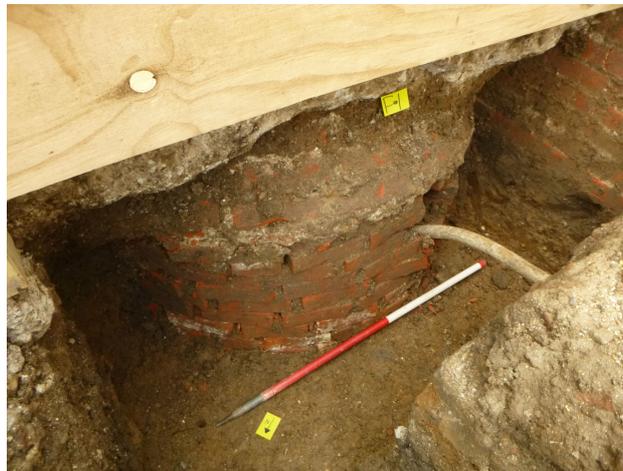
Photograph 1 19th or 20th century well F1, looking south southeast

Well F1, which was of 19th or 20th century date, was uncovered in the easternmost N-S branch of the rear extension foundation trenching. It was a circular structure composed of bonded unfrogged red bricks. A lead pipe fed into the structure.

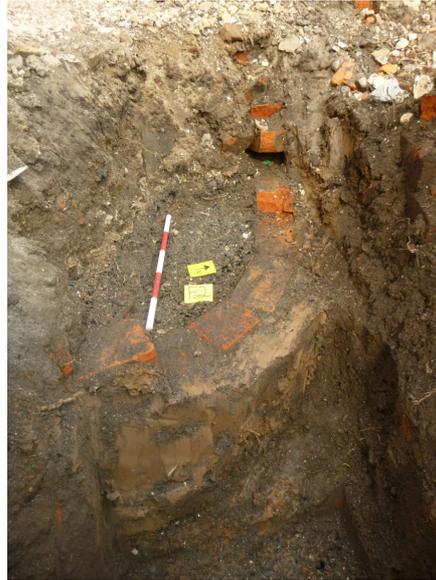
Photograph 2 19th or 20th century well F2, looking west northwest

Another well, F2, which also had its origins in the 19th or 20th century, was located in the westernmost N-S branch of the rear extension foundation trenching. Like F1, it was a circular structure constructed from bonded unfrogged red bricks and was externally lined with clay. It contained a large deposit of ash and coal.

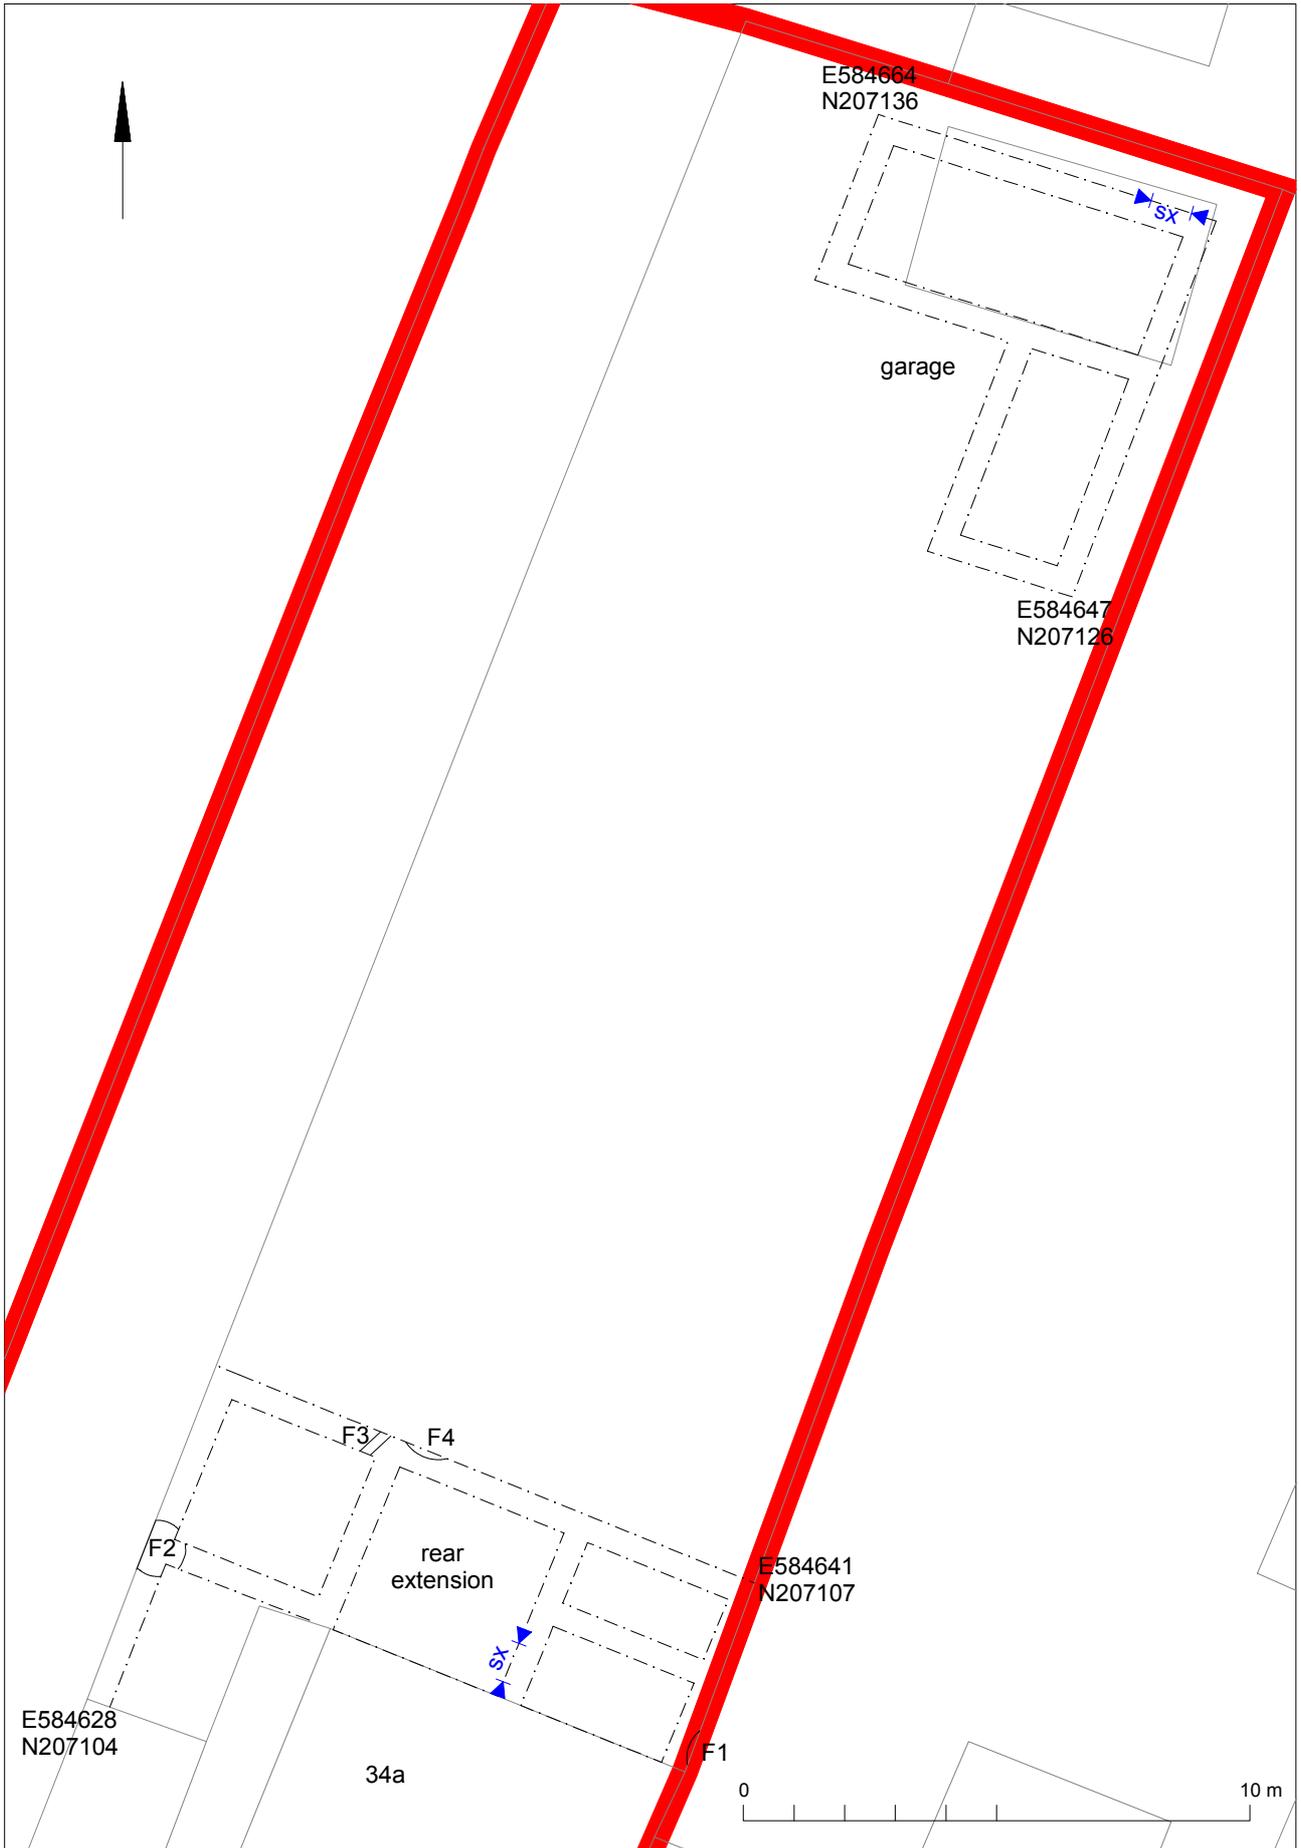
Fig 2 Monitoring results.

A CAT archaeologist supervised the excavation of foundation trenching to accommodate a new rear extension approximately 30.5m long, 0.5m wide and 1.1m deep, and foundation trenching for a new garage, approximately 26.5m long, 0.5m wide and 0.35m deep.

Five layers were recorded. The trenching for the extension was excavated through a modern make-up layer (L1, c 0.36m thick), a compaction layer (L2, c 0.11-0.13m thick) and subsoil (L3, c 0.42-0.48m thick) onto natural (L4, encountered at a depth of 0.92-0.98m below current ground level). The trenching for the garage was excavated through a layer of topsoil (L5).

A pipe structure, F3, of 19th or 20th century date, was uncovered in the most northerly E-W branch of the rear extension foundation trenching. It was composed of bonded red brick and appeared to lead into soakaway F4.

A further well of 19th- or 20th-century date, F4, lay adjacent to F3. Like F1 and F3, it too was a circular structure of bonded unfrosted red brick, and, like F2, it contained a deposit of ash and coal.
