Archaeological evaluation by test-pitting at St. Mary the Virgin Church, Layer Marney, Essex, CO5 9UX

August 2019

CAT Report 1463
September 2019

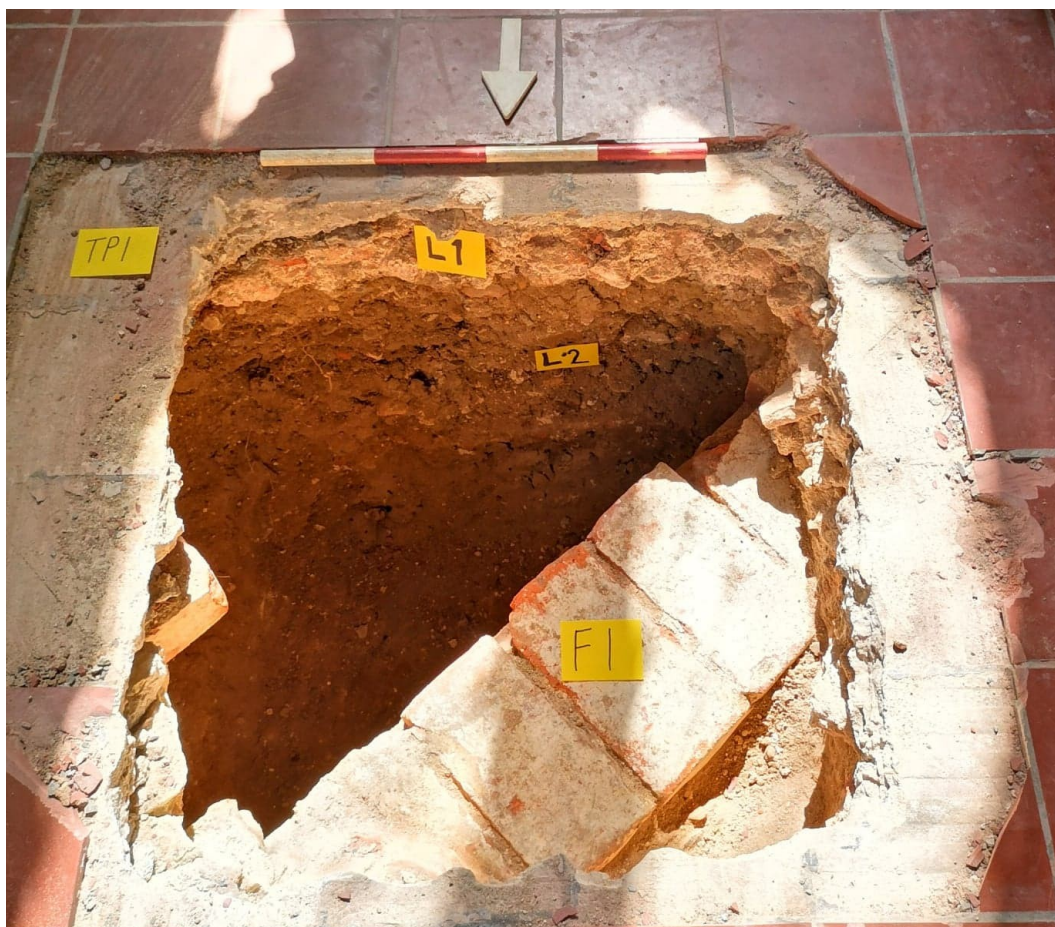
Photograph 1 Test-pit 1, looking south

Two layers were identified. Concrete and made-up ground beneath the tiles of the existing floor (L1, c 0.2m thick) sealed a layer of friable dark brown/green silty clay with frequent flecks of mortar, fragments of CBM and small and medium stones (L2, over 0.48m thick). A piece of window glass was recovered from this layer. A modern brick wall foundation cut directly across the middle of this test-pit, directly below the concrete floor base. Neither the base of the wall or the base of L2 were encountered before excavation of the test-pit was halted at a depth of 1m.

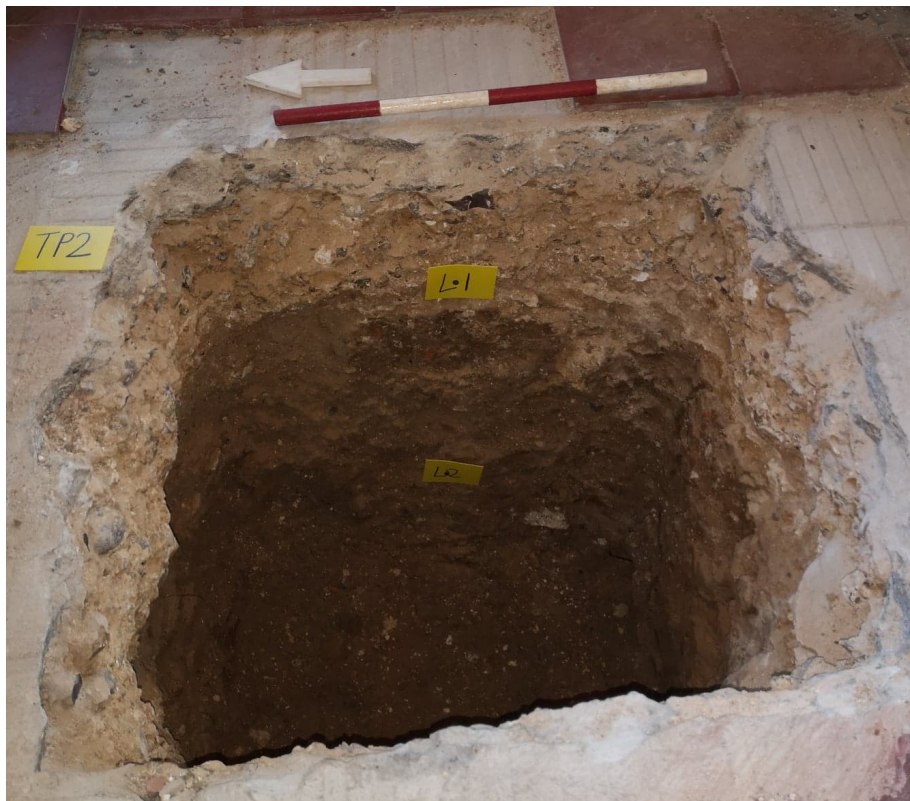
Photograph 2 Test-pit 2, looking east

L1 (0.38m thick) and L2 (over 0.32m thick) were also identified in TP2. However, here they were separated by a spread of sand. Some fragments of medieval mortar and floor tile were found in L2. No features were present in this test-pit.

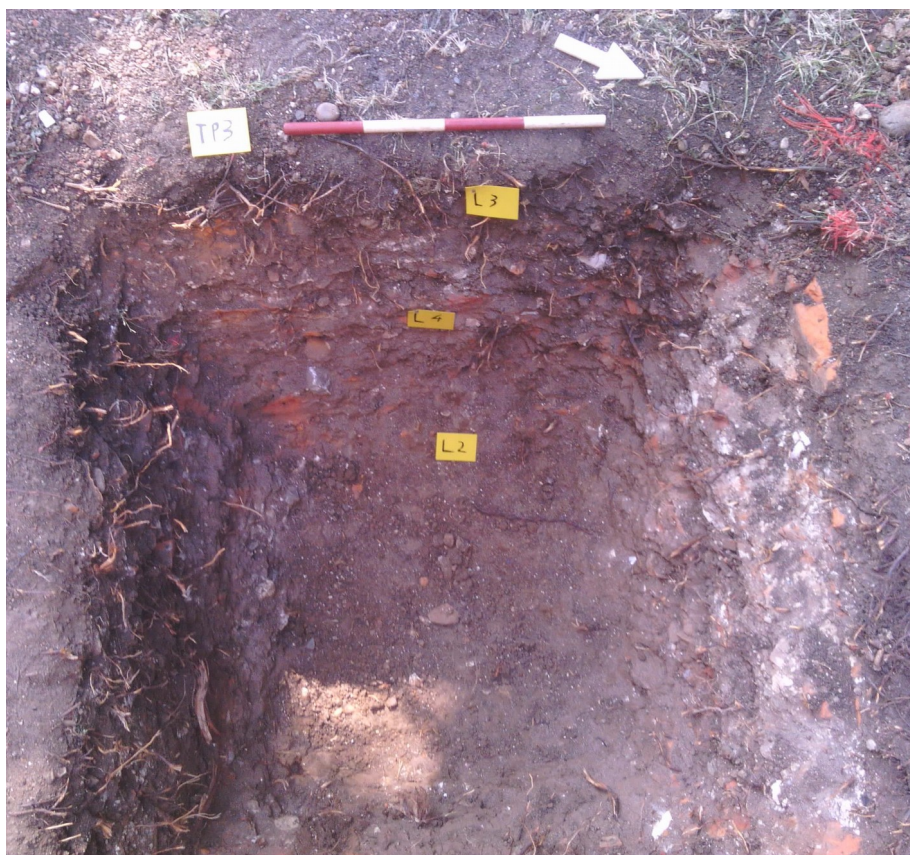
Photograph 3 Test-pit 3, looking south-west

Three layers were identified in TP3. A thin layer of friable dark grey/brown sandy silt topsoil (L3, 0.1m thick) overlay a very hard, dry grey/brown made ground containing large quantities of peg tile as well as some animal bone, post-medieval glass and an iron nail (L4, 0.43m thick). Below this made ground was a layer of the same friable dark brown/green silty clay

with frequent flecks of mortar, fragments of CBM and small and medium stones (L2, over 0.2m thick) identified in the internal test-pits.

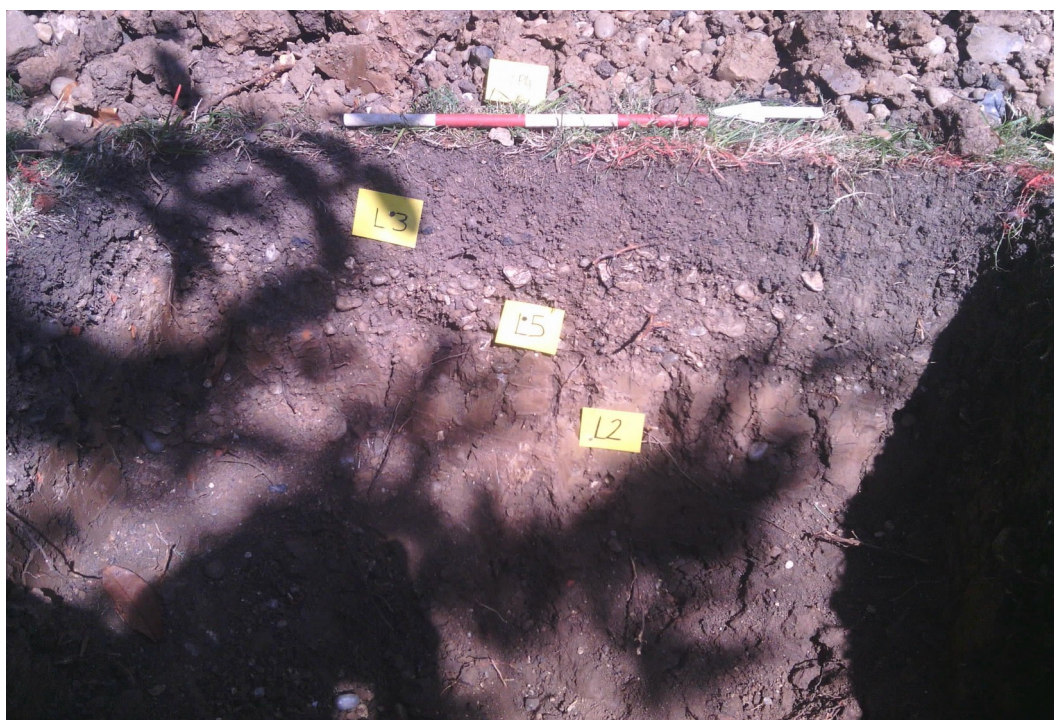
Photograph 4 Test-pit 4, looking east

TP4 also contained three layers – a thicker layer of friable dark grey/brown sandy silt topsoil than was present in TP3 (L3, 0.1-0.2m thick), which contained fragments of post-medieval brick. This overlay a solid gravel layer (L5, 0.08-0.23m thick). This gravel layer sealed the same friable dark brown/green silty clay with frequent flecks of mortar, fragments of CBM and small and medium stones (L2, over 0.24m thick) identified in the other test-pits.

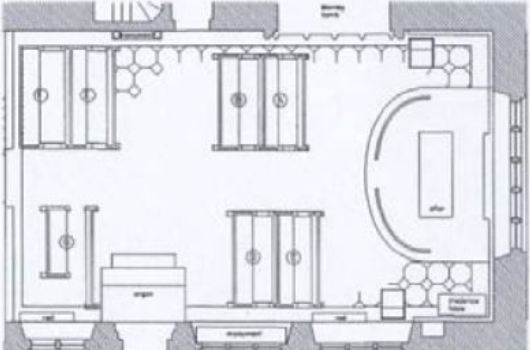
CHANCEL PEW LAYOUT OPTION 1

Semi-circular lightweight timber Dais, pinnacled retained, add pinnacled to extend to finish floor level.

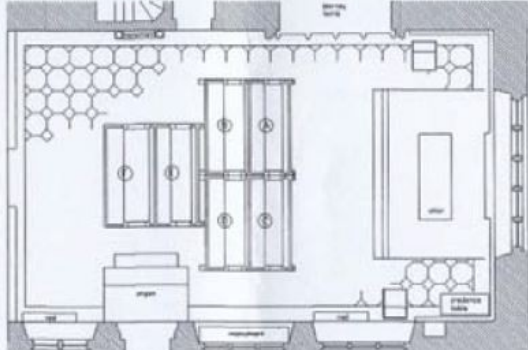
CHANCEL PEW LAYOUT OPTION 2

Rectangular lightweight timber Dais, pinnacled retained, side glass/walling to extend to finish floor level. Pew and frontal D shown in base northeast corner.

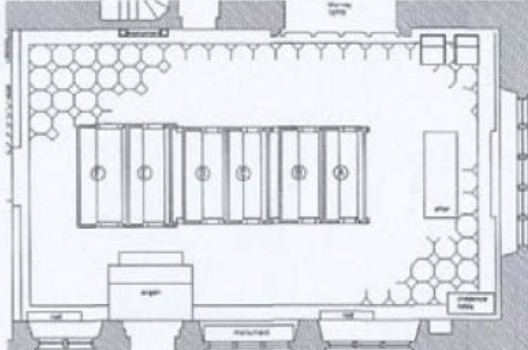
CHANCEL PEW LAYOUT OPTION 3

No Dais, remove pinnacled from east and west walls, only return to east wall, add pinnacled to extend to finish floor level. Pew and frontal G shown in base northeast corner.
