Archaeological monitoring at Harbour House, 6-8 Hythe Quay, Colchester, Essex, CO2 8JF

March-April 2021

CAT Report 1733

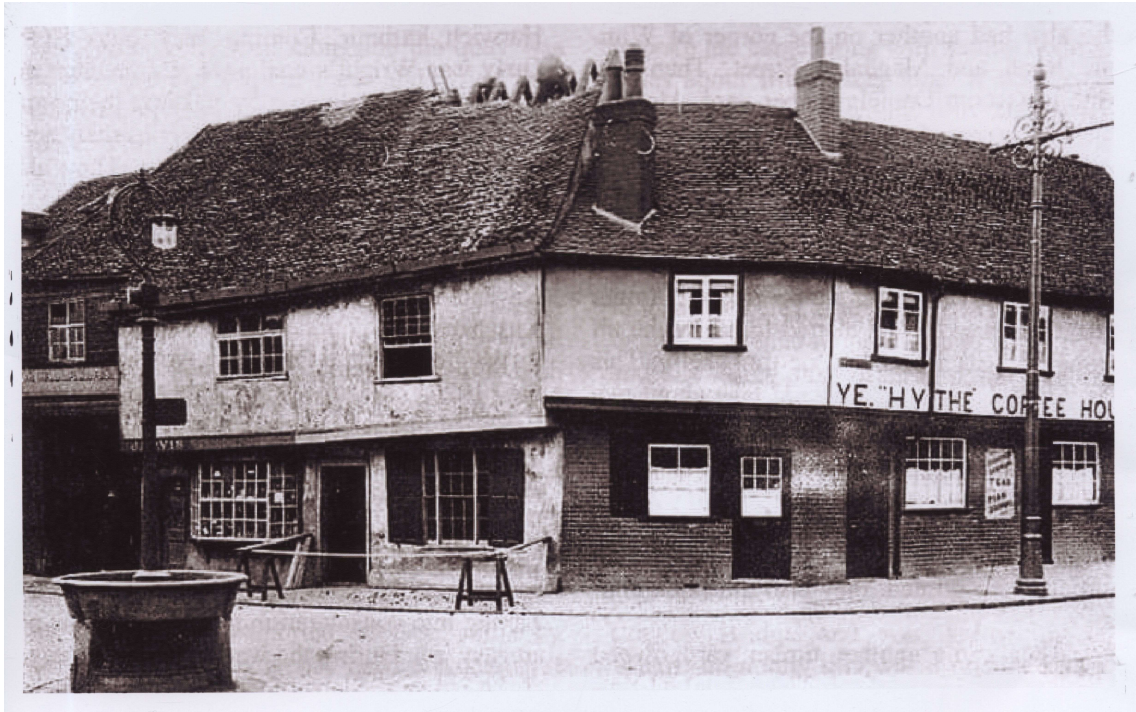
Photograph 1 Nos 4-5 Hythe Quay (left) and nos 98-99 Hythe Hill (right), c 1897, kindly provided by local resident Mr Terry Lloyd.

Photograph 1 from c 1897 shows a passageway to the south of this building, leading from the road through to what was probably a rear yard. Granite setts F9 represent part of the historic pavement for Hythe Quay with cobbles F8 (with brick border F10) forming the passageway.

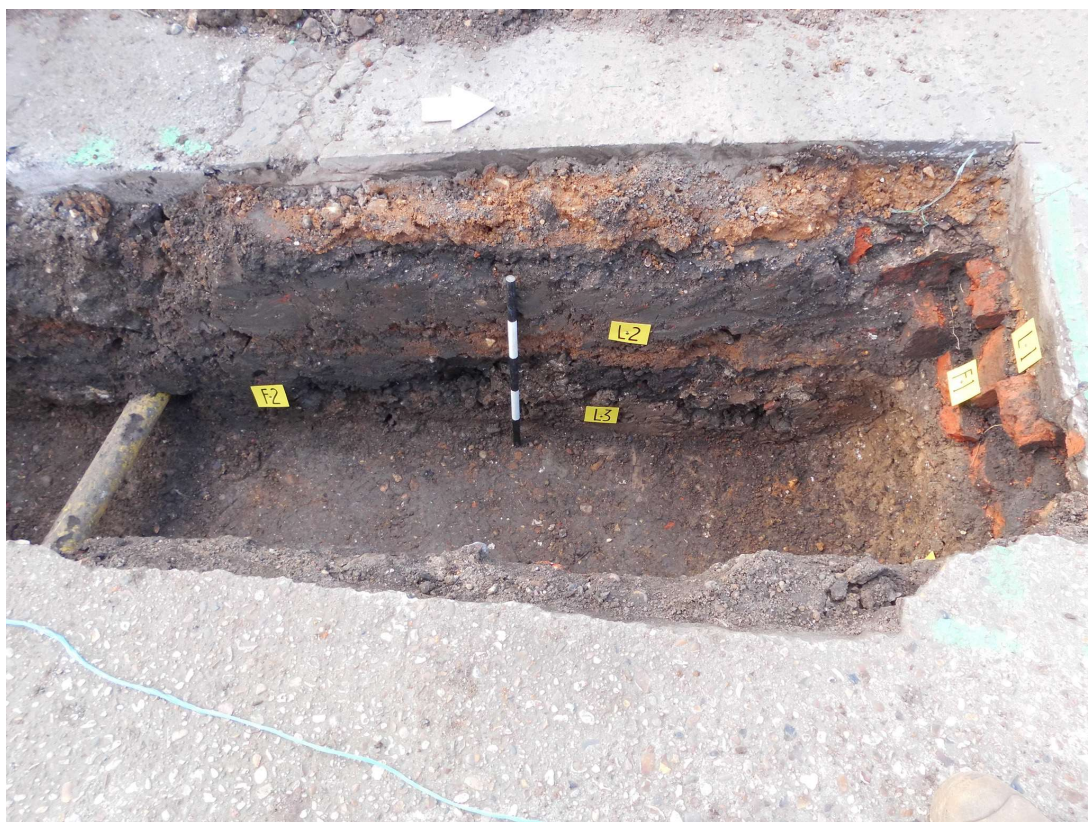
Trench 1 was 1.5m long, 0.4m wide and 0.65m deep (Photograph 2). It cut a layer of tarmac on sand (L1) and levelling layers (L2 and L3). Brick drain F1 cut L2 at the northern end of the trench. Levelling layer L2 and drain F1 both sealed a large feature (F2) which had been cut into L3 and was recorded along most of the trench. Too little of F2 was uncovered/excavated to determine what it was.

Photograph 2 Trench 1, east-facing section, L1, L2, L3, F1 and F2, looking west

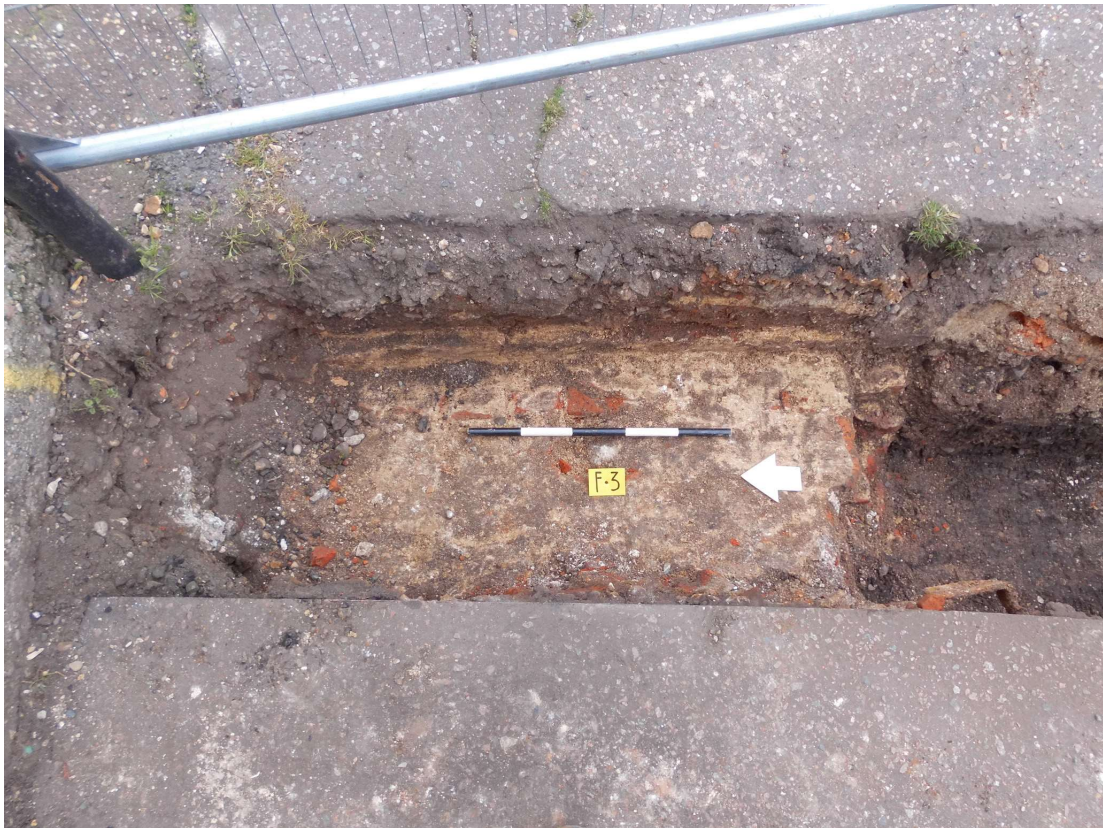
Trench 2 was 8.12m long, 0.4m-0.55m wide and 0.6m deep. It cut through tarmac (L1) and levelling layers beneath (not numbered, up to 0.2m thick) into a thick deposit of silty-clay (L4) which extended beyond the base of the trench. Four brick plinths (F3, F4, F5 and F6) had been cut into L4, each made of courses of brick set in a soft sandy yellow mortar. Brick plinths F3, F4 and F5 were aligned NNW/SSE (Photographs 3-5) and were recorded for a depth of five/six courses of brick (0.35-0.50m deep). Plinth F3 was 1.4m long, F4 was 2.3m long and F5 2.6m long. The full width of the plinths could not be established within the limits of the trench. At the southern end of the trench, brick plinth F7 was at a right angle to F3, F4 and F5, on a ENE/WSW alignment (Photograph 5).

Photograph 3 Trench 2, brick plinth F3, looking east

There is little doubt that brick plinths F3, F4, F5 and F7 are part of the remains of 4-5 Hythe Quay, the 15th-century building which was demolished in the early 20th century. However, brick samples taken from F3, F4 and F5 all dated from the 18th to the 19th century. The most-likely explanation is that the plinths were inserted underneath the 15th-century timber-framed building to raise the wooden ground-plate of the timber-frame off of the ground to stop them from rotting and underpin the building. The structural remains butt against nos. 98-99 Hythe Hill to the north, and extend for 8.7m along the street frontage.

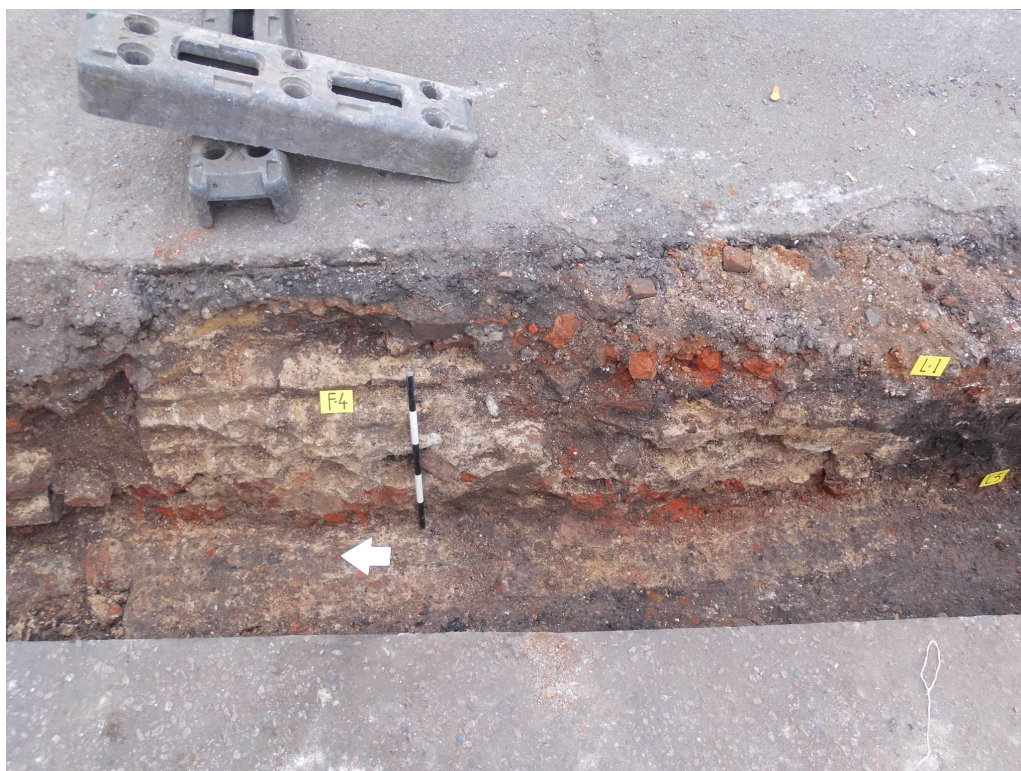
Photograph 4 Trench 2, brick plinth F4, looking east

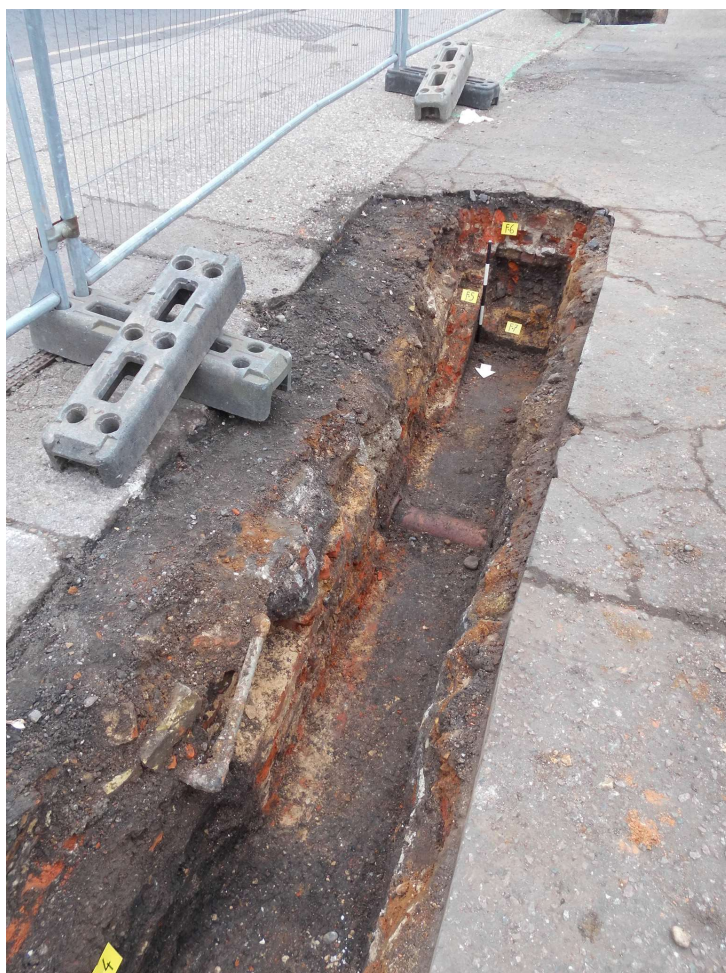
Abutting F7 was slightly later wall F6, probably dating to the 19th/20th century.

Photograph 5 Trench 2, brick plinth F5 with F6 and F7, looking south

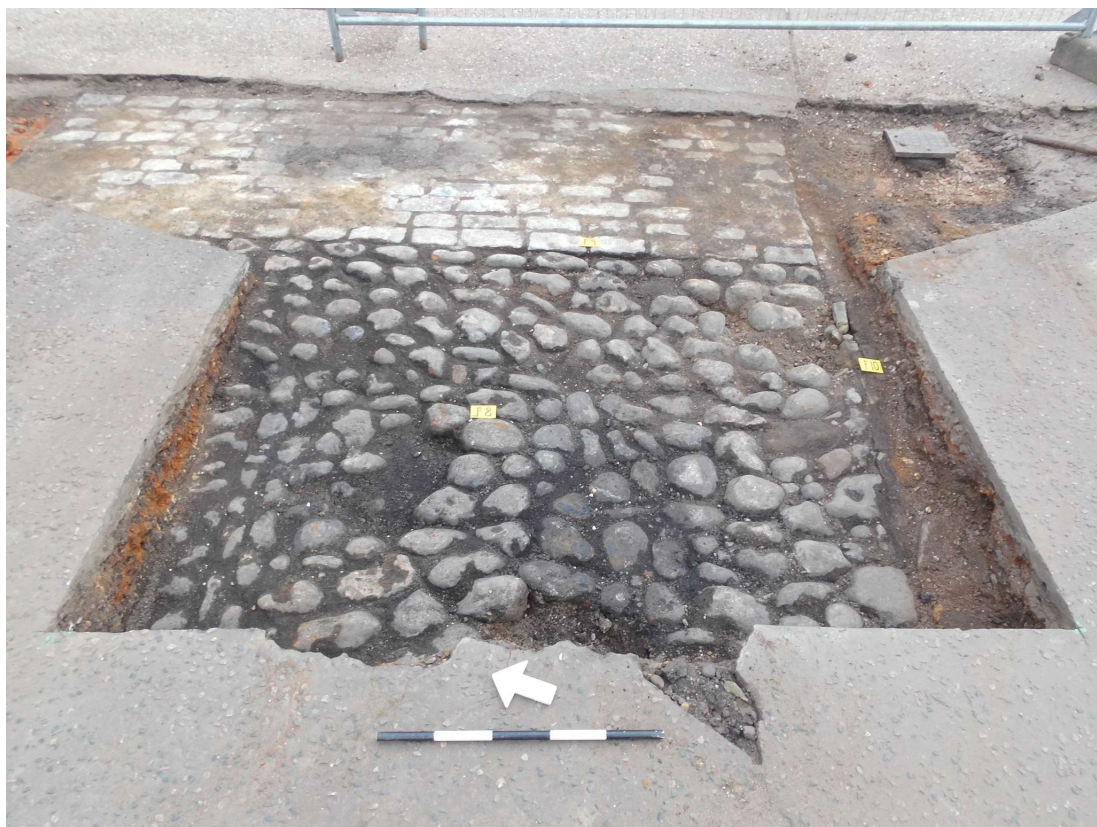
An area approximately 9.5 square meters was stripped of tarmac (L1) (Photograph 6). This uncovered a layer of granite setts (F9) from the pavement of the historic street frontage. Immediately behind was a layer of cobbles (F8) set within a border of yellow bricks (F10 and F24) which date from the 19th to the 20th century. The far left-hand edge of Photograph 1 shows that the cobbles are likely part of a passageway leading from the road through to the rear of the properties. All these layers were stripped out to allow for resurfacing at the front of the site and for the continued excavation of Trench 3.

Photograph 6 Trench 3, granite setts F9, cobbles F8 and brick border F10, looking east

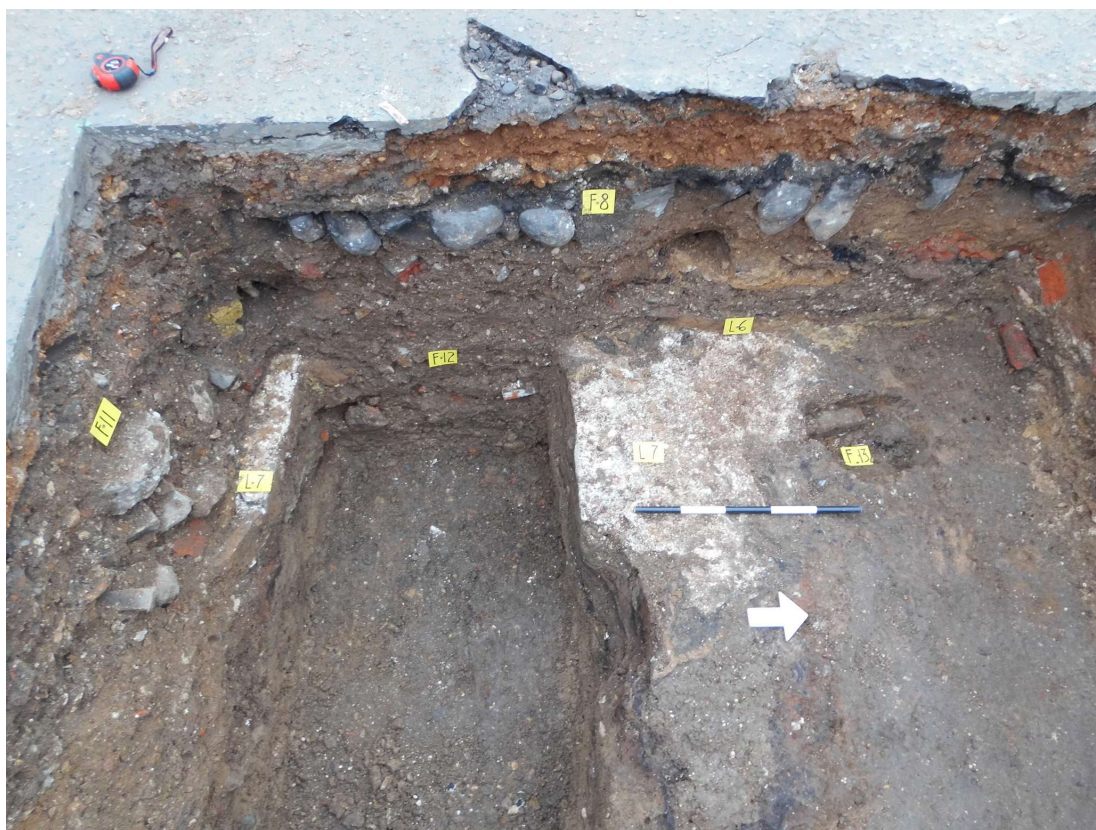
A small area within Trench 3, 2m long by 1.4m wide, was excavated to a depth of 1.2m for a new soakaway. Service trench F12 cut across the trench from east to west (and cut cobbles F8 which had been subsequently reinstated) through to natural. Service trench F11 (probably associated with brick drain F1 in Trench 1) was also located on the far southern edge of the soakaway.

Photograph 7 Trench 3 part excavated, including F8, F11, F12, F13, L6 and L7, looking west

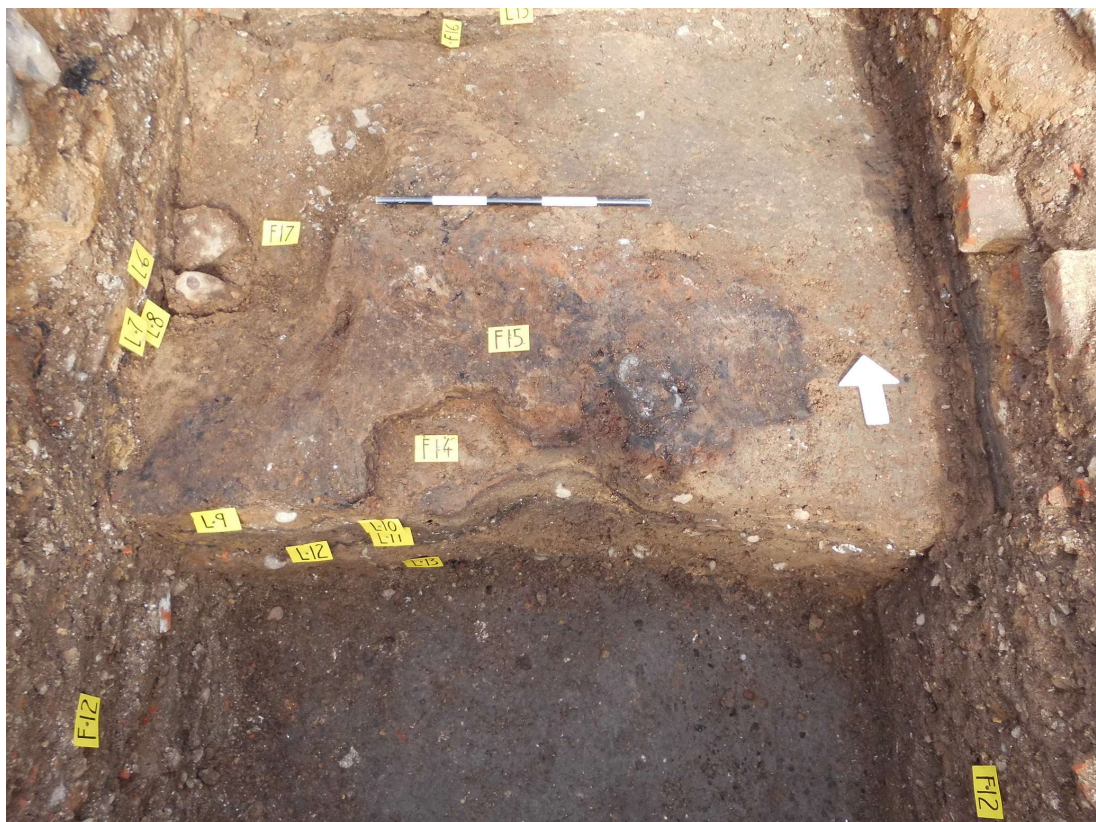
Photograph 8 Trench 3 part excavated, including possible hearth F15, looking north

Cut into these layers were post-holes F13, F14, F19 and F20, possible hearth F15, irregular cut or depression F17, and a slot for a burnt-out timber ground-plate F18 (0.2m wide by 0.14-0.18m deep). Possible hearth F15 and possible floor/occupation layers L6, L7, L10 and L14 are likely to be broadly contemporary (identified c 0.65m below current ground level) (Photograph 8). Even earlier are post-holes F19 and F20, slot F18 and metalled surface L16 which had been laid on natural (L13/L17) (0.8m below current ground level) (Photograph 9). Together these features represent at least two earlier phases of occupation on the site.

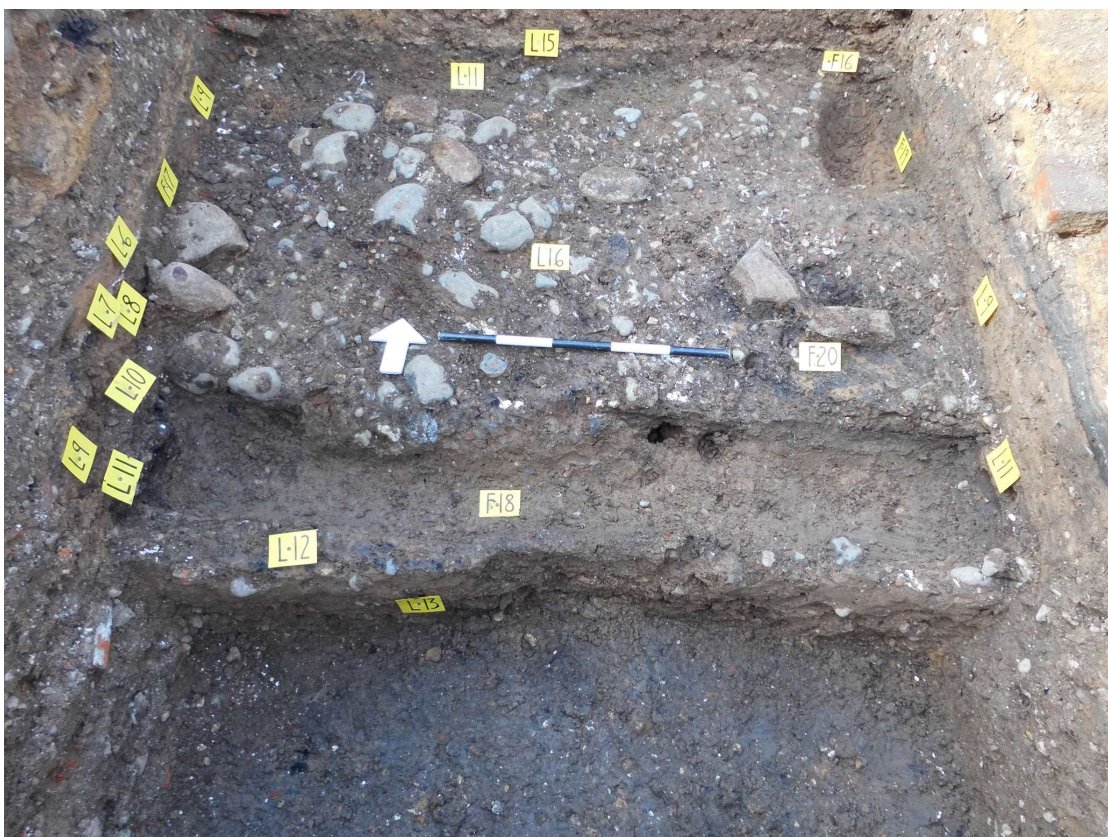
Medieval pottery (early 11th to early 13th century) was recovered from the earliest of these deposits, metalled surface L16/F21, with pottery dated c AD 1200-1550 also recovered from the backfill of slot F18.

Photograph 9 Trench 3 part excavated, with cobbles L16, slot F18, and post-holes F19 and F20, looking north

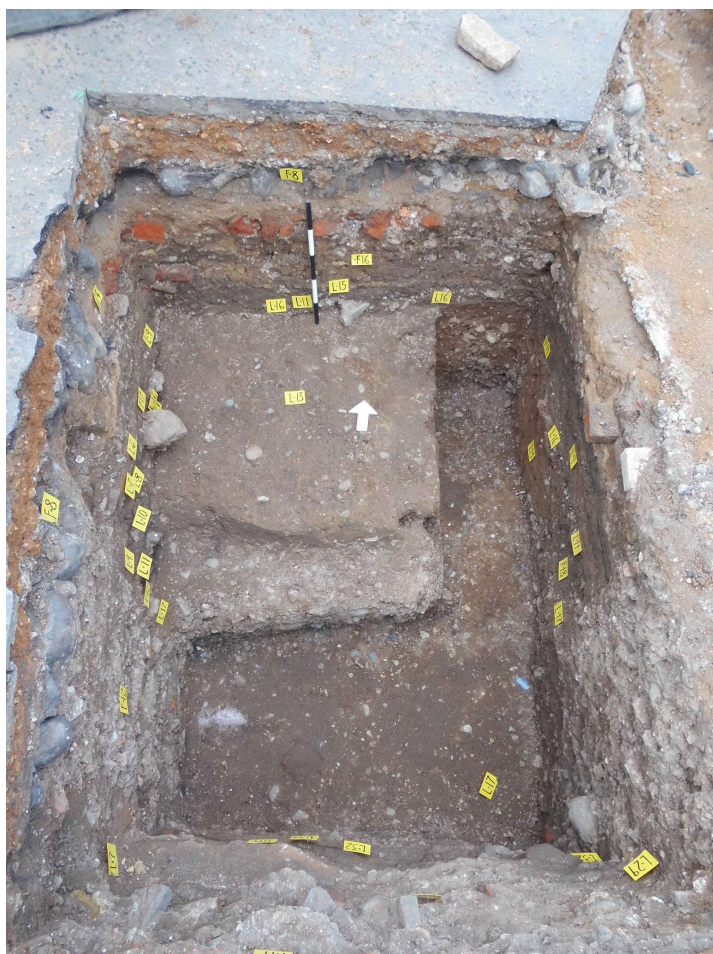
Photograph 10 Trench 3 fully excavated, looking north

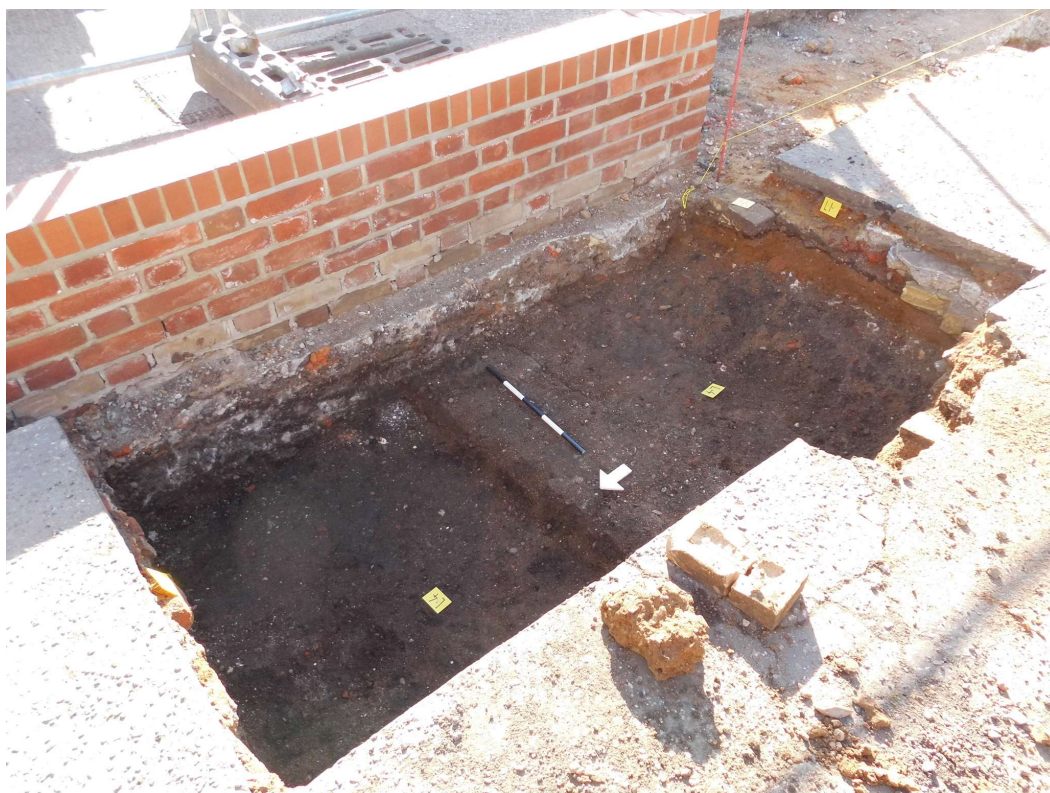
Photograph 11 Trench 4 fully excavated, showing wall F24 to far right, looking south-east

Trench 4 was 2.4m long by 1.2m wide and 0.4-0.65m deep. It was excavated through tarmac L1 which revealed a strip of yellow frogged bricks (F24), one course deep, along the far southern edge. This could be the same brick border recorded in Trench 3 (F10). However, this border is located too far to the north, which would mean that the passageway extended into 4-5 Hythe Quay, and is therefore likely to be a separate feature.

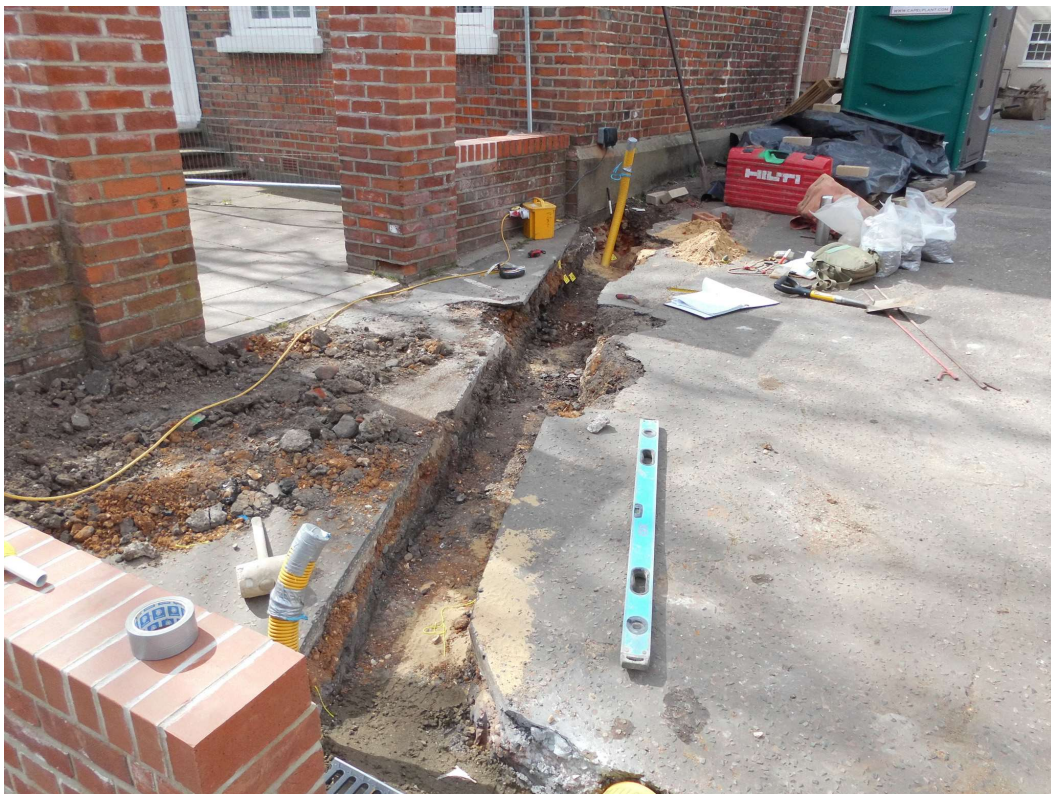
Trench 5 was 5.1m long by 0.35m wide and 0.3m deep (Photograph 12), and cut through tarmac L1 on a bedding layer of orange sand, cobbles L39 and levelling layer L40. A small section of another brick wall foundation, F22, was exposed as the western end of the trench, butting the north-east corner of Harbour House (Photograph 13). Four courses of unfrogged red brick (18th-19th century) were set in a cream-coloured sandy mortar, and the wall was aligned roughly NNE/SSW (in line with Harbour House). A short length of wall may be visible in this location, joining the NE corner of Harbour House, in a photo from the “Britain from the air” website dated 1950 (www.britainfromabove.org.uk/image/EAW032321), and may originally have been part of a boundary wall.

Photograph 12 Trench 5, looking south-west

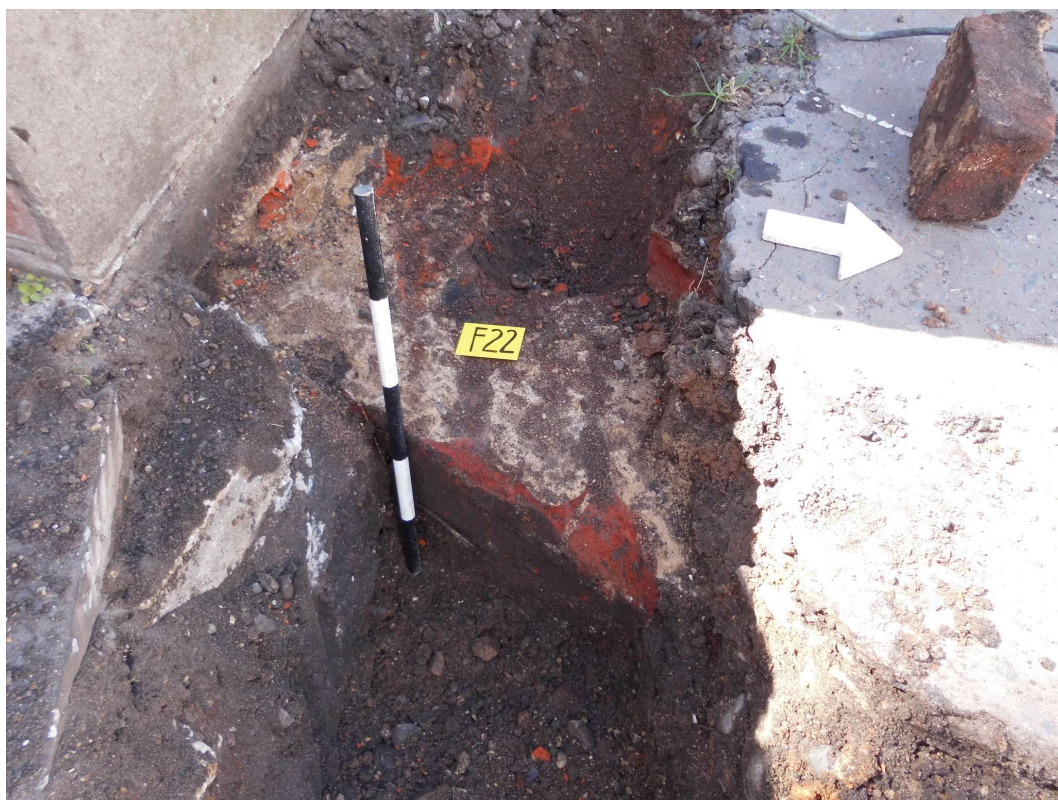
Photograph 13 Trench 5 showing wall foundation F22, looking west
