Archaeological evaluation at Hedingham Castle, Castle Hedingham, Essex, CO9 3DG

February 2022

CAT Report 1789

An archaeological evaluation was carried out at Hedingham Castle, Castle Hedingham, Essex. The evaluation consisted of three test-pits located to the south-west of the Norman keep. Two were positioned alongside the standing remains of turrets from a Tudor tower, and the third alongside a later wall built over the foundations of the tower. The aim of the evaluation was to expose the buried remains associated with these structures to allow a programme of Historic Building Record and Photogrammetry to take place to better assess the remains of the Tudor tower.

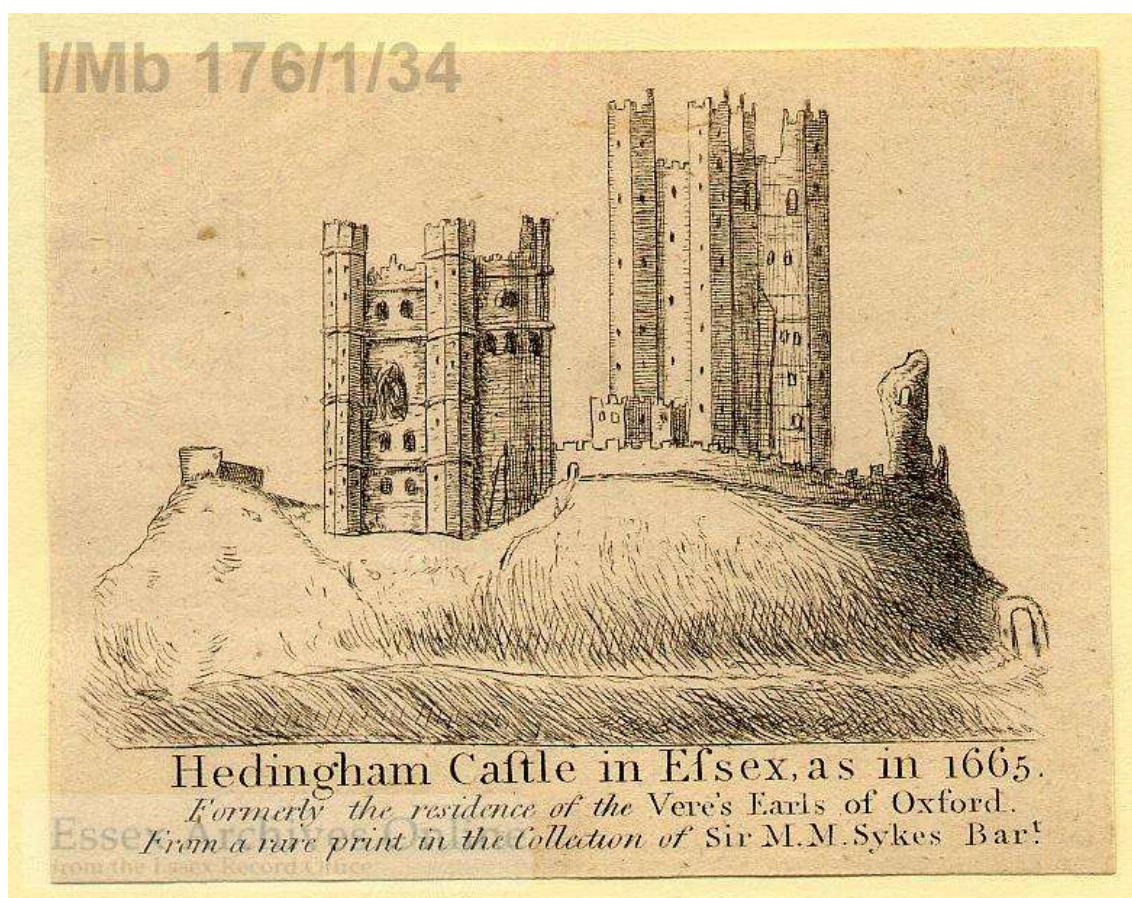
Plate 1 Drawing of Hedingham Castle dated 1665, the Tudor tower visible in the foreground (I/Mb 176/1/34)

The turrets of the Tudor tower would have both originally had an octagonal exterior, which can be seen in Plate 1 (see above). The octagonal exterior of the western tower is still visible, however, due to the deterioration of the brickwork and the lower modern ground level the eastern turret has lost this octagonal shape and appears more square. The eastern tower has a circular interior, perhaps an indication it contained a spiral staircase.

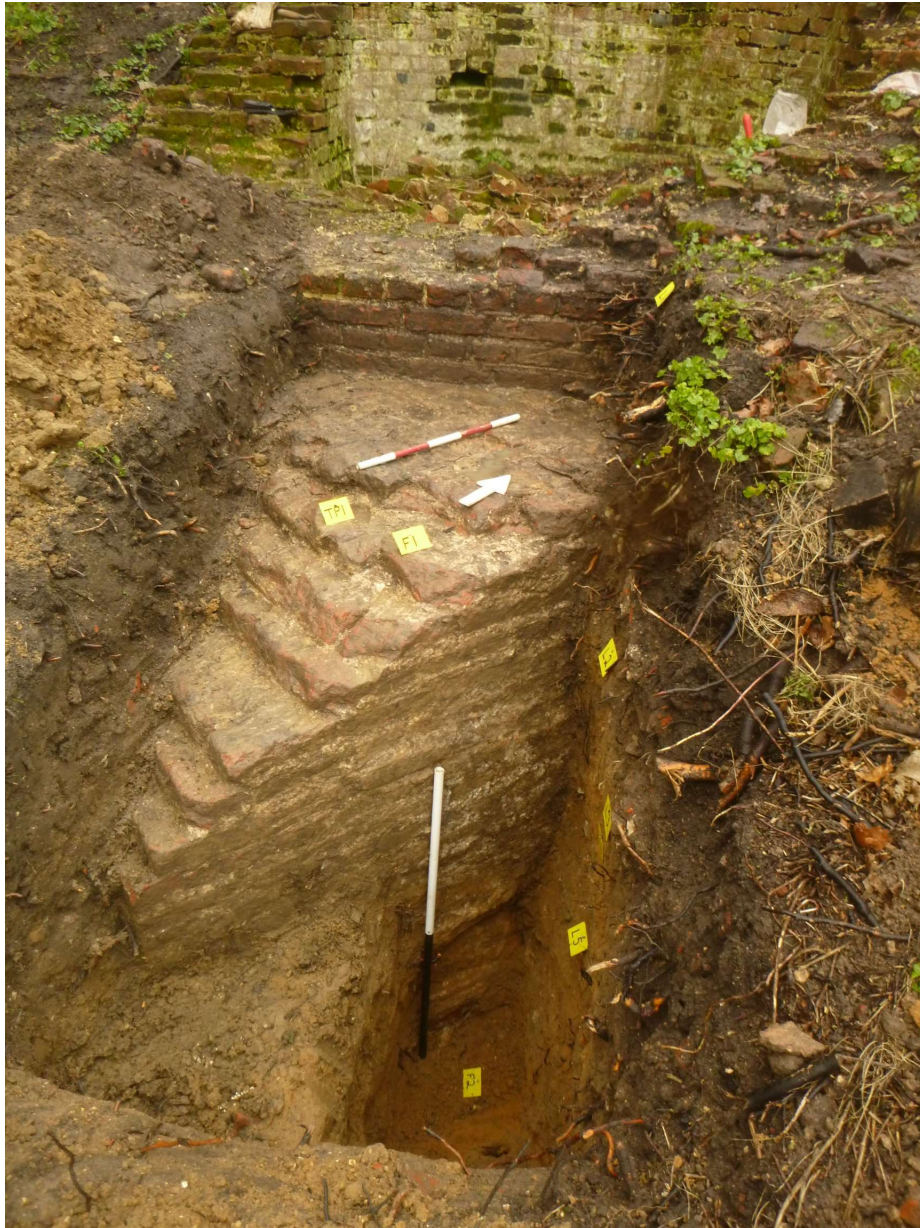
Brick foundation F1 was located 0.45m below ground level, sealed by L2. It extended 0.75-1.4m from the turret, was 1.8m deep and was constructed of red bricks (dimensions: 220 x 105 x 50mm). At the base of the test-pit, a possible construction cut (F2) for the foundation was uncovered, sealed by L5 and cutting L6.

Photograph 1 Test Pit 1: wall foundation F1 with construction cut F2 in the base, looking north-west

Substantial brick foundations were uncovered for both turrets during the evaluation. Located in TP1, brick foundation F1 was 1.8m deep. Extending out 0.75-1.4m from the above ground remains, the foundations are likely to be squarer and of a similar shape to those of the eastern turret. A possible construction cut for the foundation was also identified in TP1. Located in TP3, brick foundation F3 was 1.9m deep.

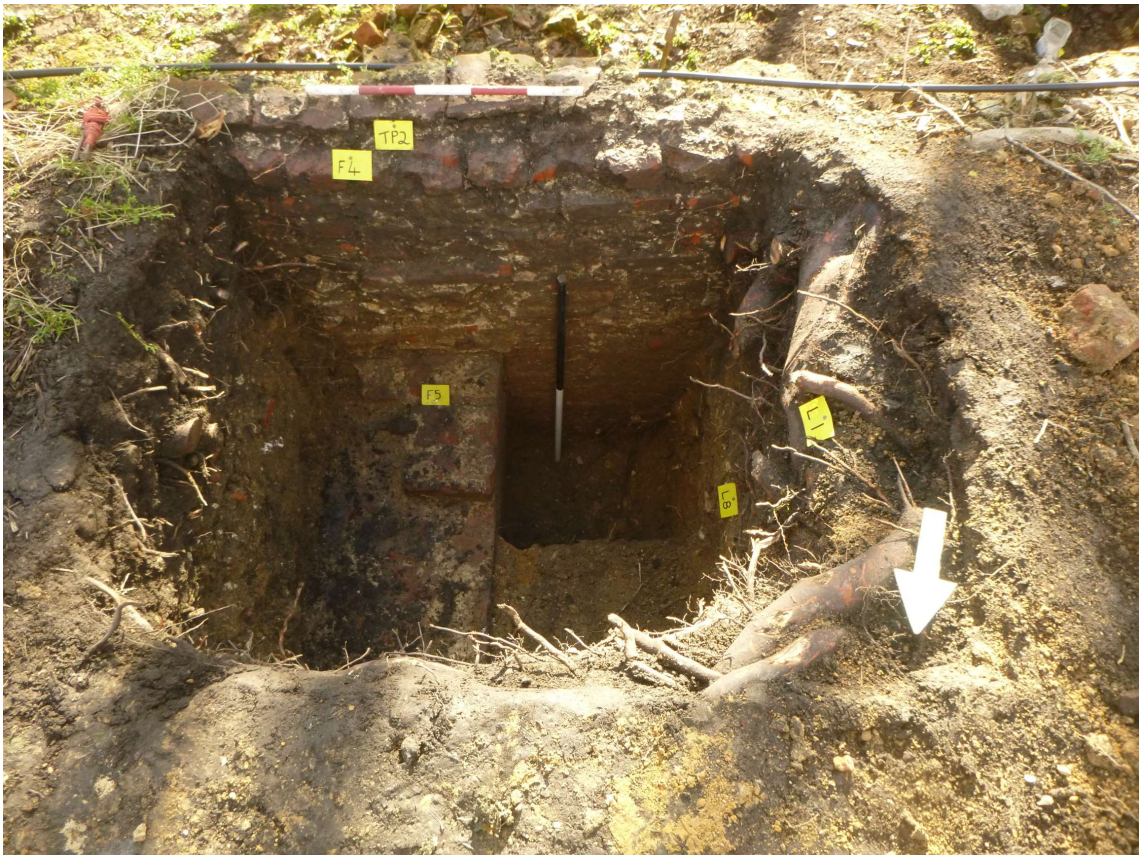
The later brick wall, F4, was aligned north-west/south-east, constructed of re-used Tudor bricks and was 1.35m deep. It was likely constructed to support the edge of the earthworks.

At a depth of approximately 0.65m, north/south wall F5 was also revealed. Constructed of red bricks (dimensions: 230 x 110 x 55mm) it is likely that it is an internal wall within the Tudor tower that was truncated by later wall F4.

Photograph 2 Test Pit 2: later wall F4 with internal wall F5, looking south

Two brick walls were observed in TP2. Wall F5 was aligned north/south and is likely to be an internal wall associated with the Tudor tower. It is truncated by later wall F4, a brick wall constructed to support the earthworks. Wall F4 is later in date than the Tudor tower but was constructed of reused Tudor brick, possibly from the remains of the tower.

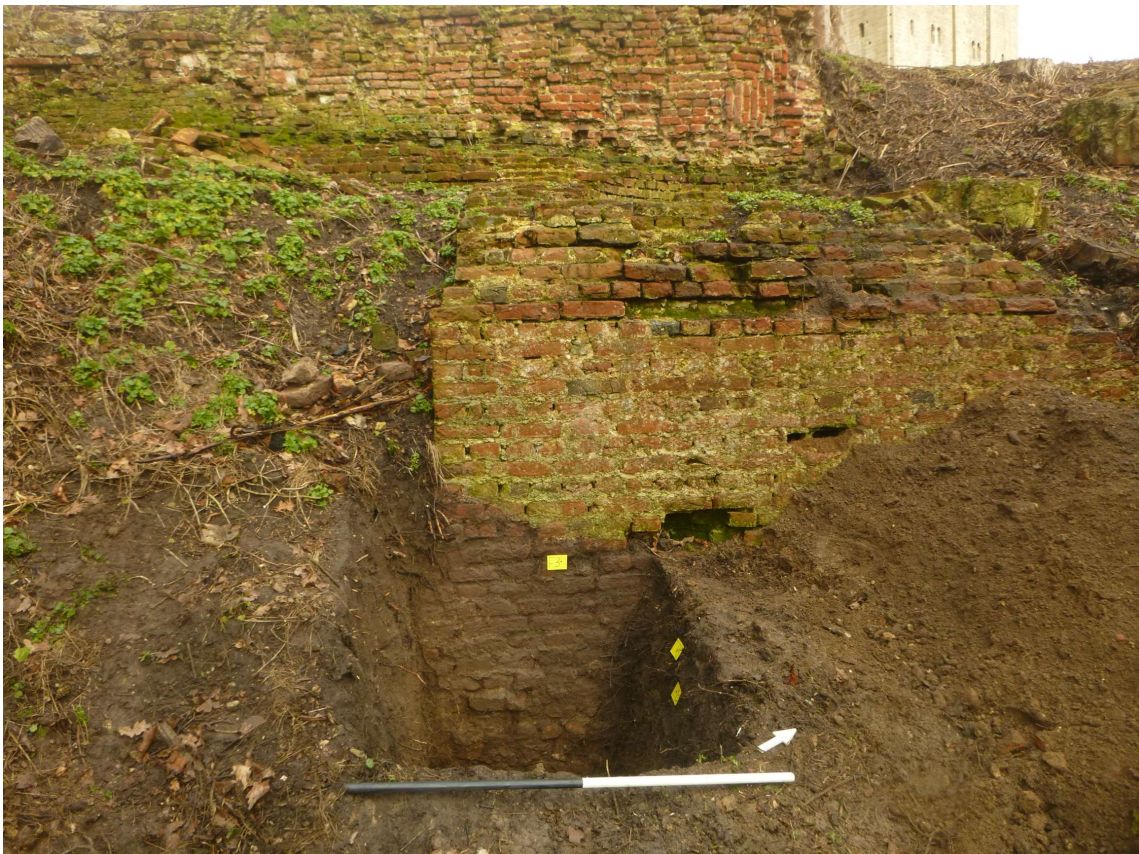
Photograph 3 Test Pit 3: wall foundation F3, looking north- west

Wall foundation F3 was aligned roughly east/west, was constructed of Tudor bricks (dimensions: 220 x ?? x 50mm) and extended 1.11m bcgl (totalling 1.9m deep). The foundation was noted to warp outwards slightly at the corner.
