**CAT Report 2017
issued January 2024**

**Historic building recording and archaeological
evaluation on land to the rear of Colne Place,
97 High Street, Earls Colne, Essex, CO6 2RB**

**CAT project ref.: 2023/12b
ECC code: ECCP24**

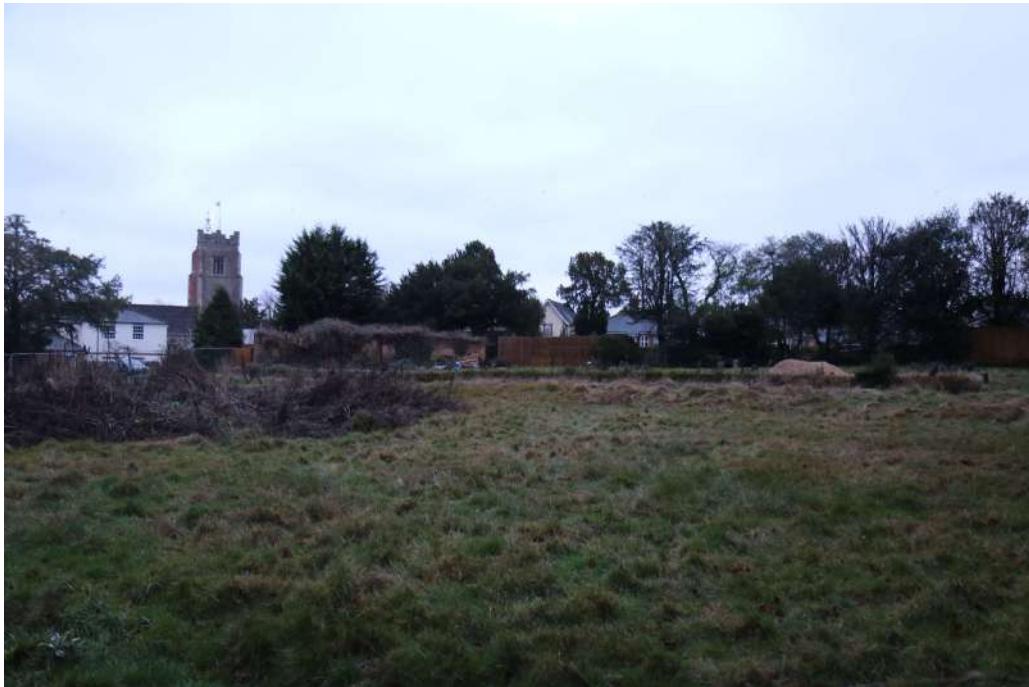
Photograph 1 Overview of garden. Photograph taken facing south-east.

Much of the garden is laid with turf with intercutting gravel paths (see Fig 2). The north-eastern, north-western and south-western boundaries are lined with a mixture of fir and deciduous trees, most of which have become overgrown. In several areas, small shrubs have been used to line the pathways and denote the flower beds. At the northern end of the garden are four beds, arranged in a rough semi-circular shape.

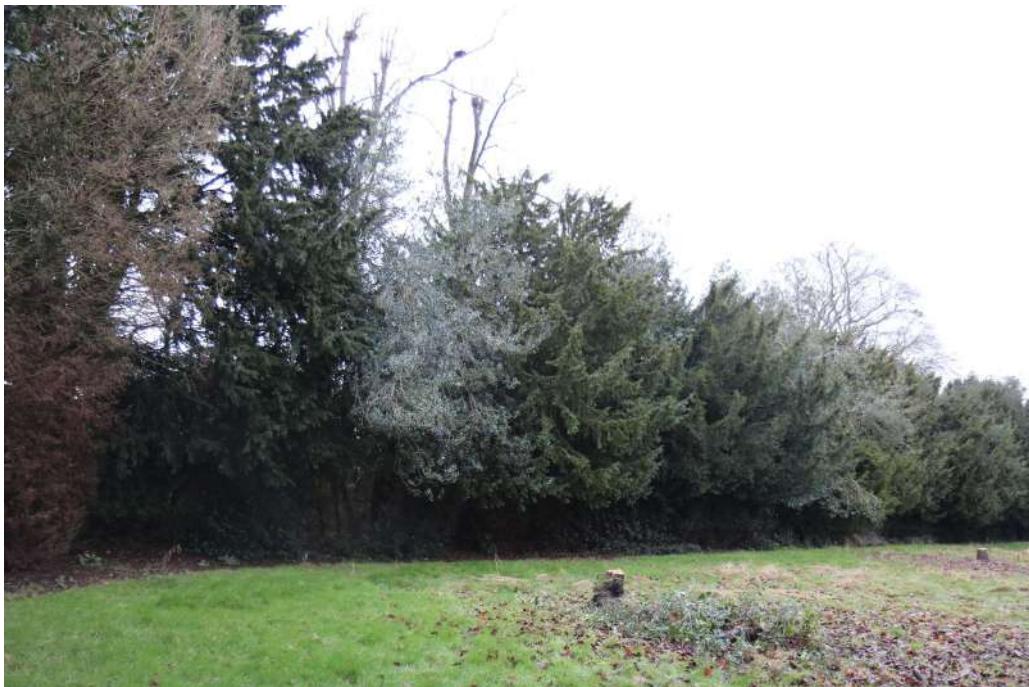
Photograph 2 Detail of south-western tree-line. Photograph taken facing south-west.

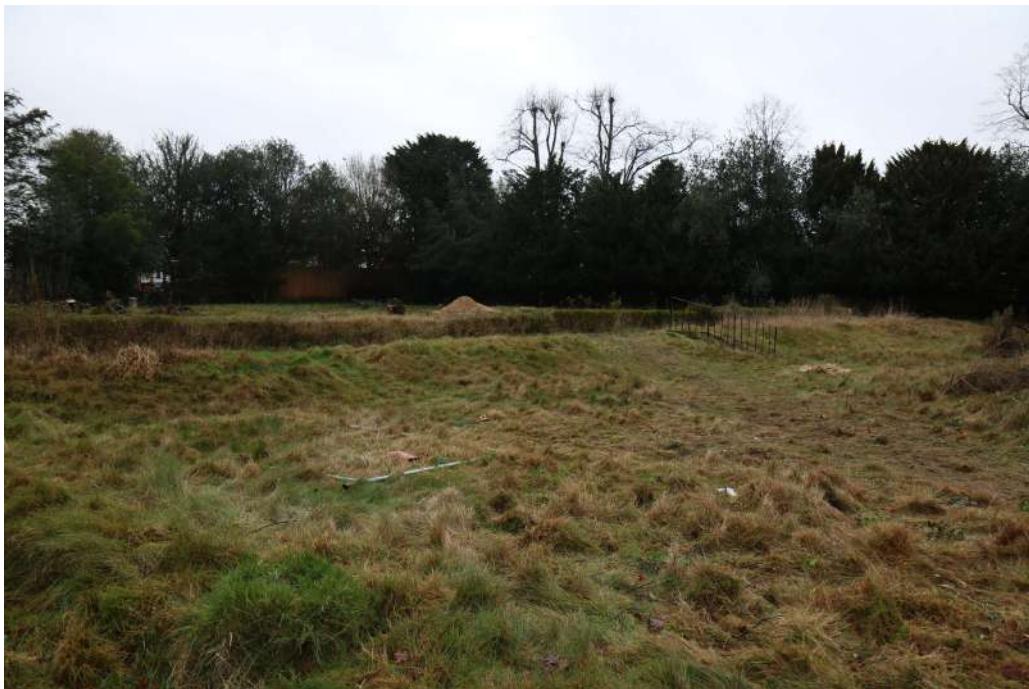
An earthen bank, with a height of approximately 1m, crosses the centre of the garden, dividing it into an upper and lower level. A second smaller and less prominent bank is located in the north of the garden.

Photograph 3 Location shot of large steps, showing bank. Photograph taken facing north-west.

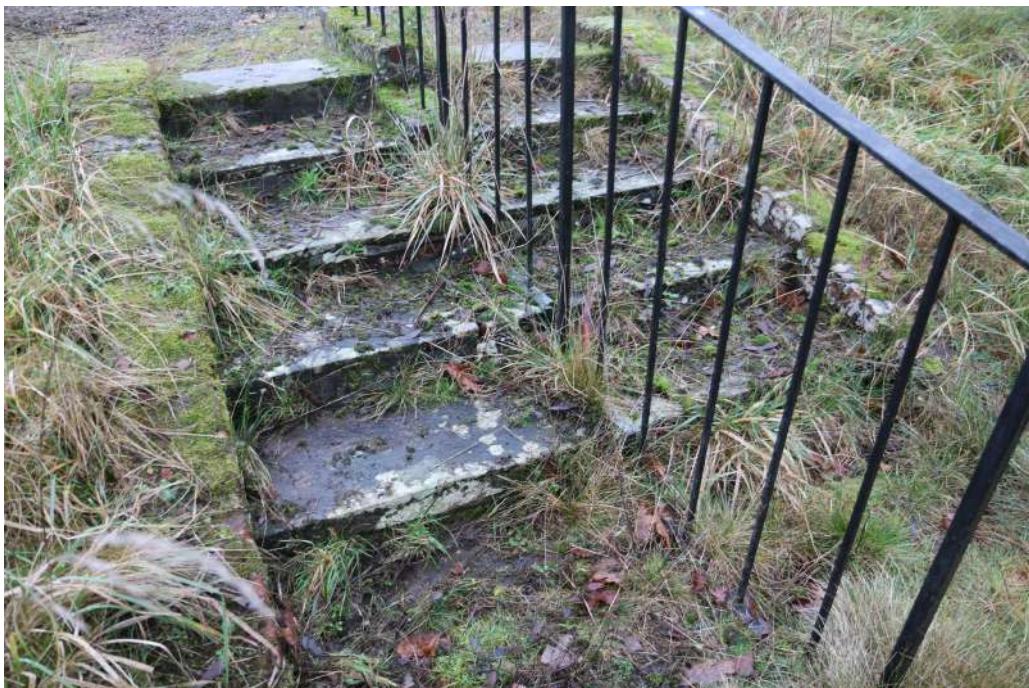
Both banks contain a small flight of stairs. The steps comprise bricks (brick dimensions: 220 x 110 x 65mm, three courses for the small steps and one course for the larger steps) topped with

a stone tread. The stairs are flanked with short walls comprising red brick laid in Header bond. Both sets of stairs have a modern metal handrail, painted black.

Photograph 4 Detail of large steps. Photograph taken facing west.

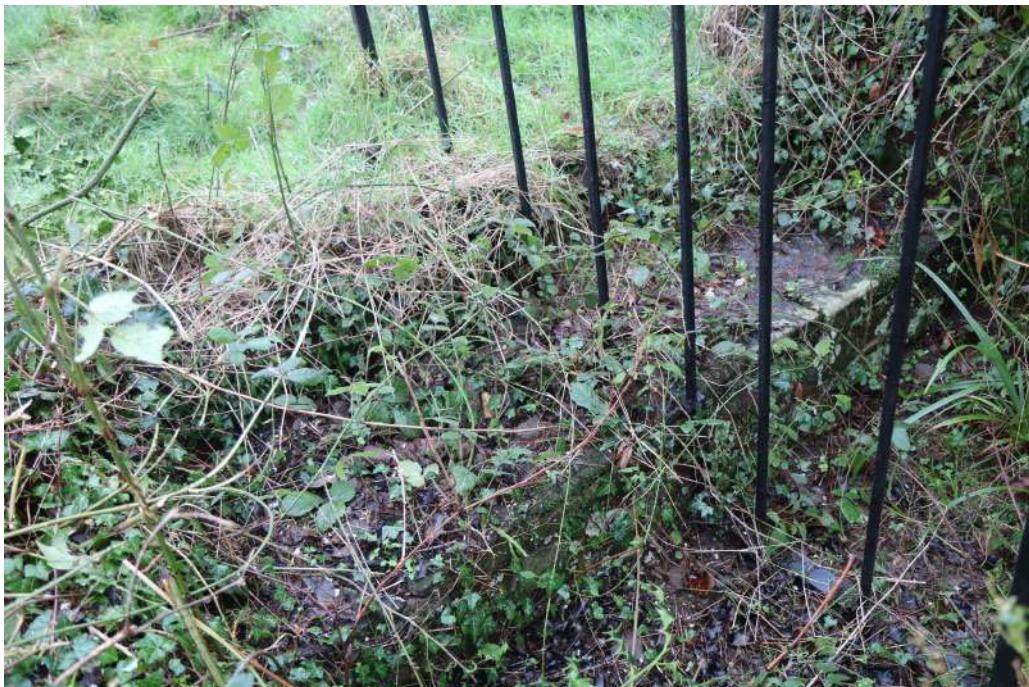
Photograph 5 Detail of small steps. Photograph taken facing south-west.

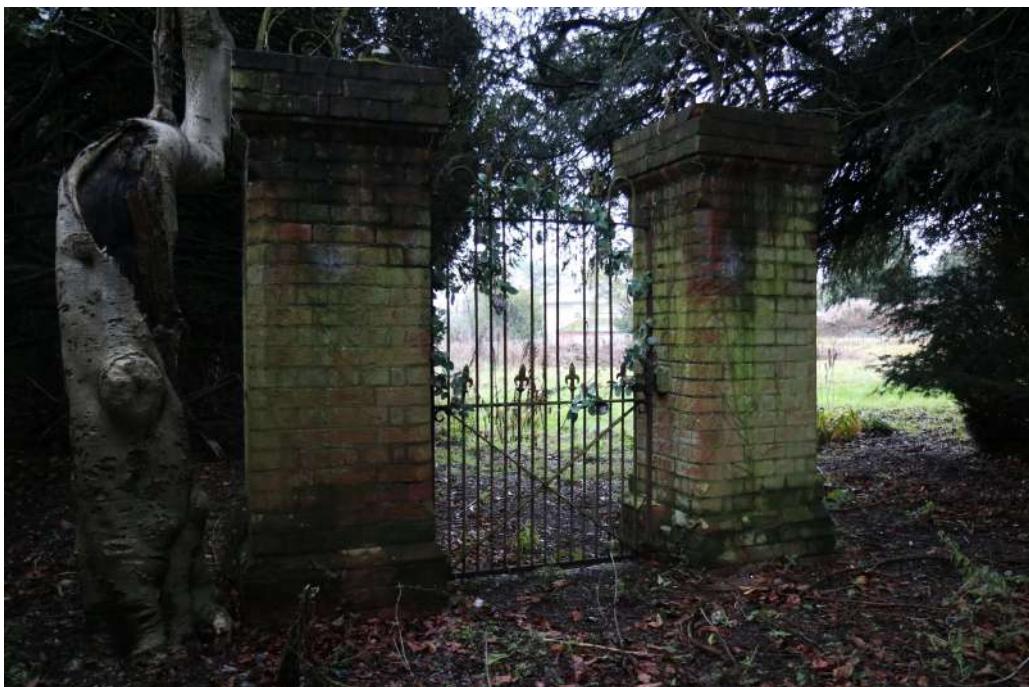
In the north-eastern corner of the garden, amongst the tree-line, is an iron gate with brick piers. The piers consist of red brick (brick dimensions: 225 x 110 x 65mm) laid in English-bond with queen closers. At the top of the piers are three courses of brickwork, with a slight oversail, followed by a course of chamfered bricks. At the base of the piers are four courses of bricks topped with a course of chamfered bricks. The main body of the piers have king closers on their corners. On top of the piers is an iron ogee arch with a filigree infill. The gate itself is iron, with fleur de lis finials and a stone step at ground level. As there is no evidence that a wall or fence ever projected from any face of the piers, it is likely the gate served as an entrance/exit in the tree-line.

Photograph 6 Detail of gate. Photograph taken facing south south-east.

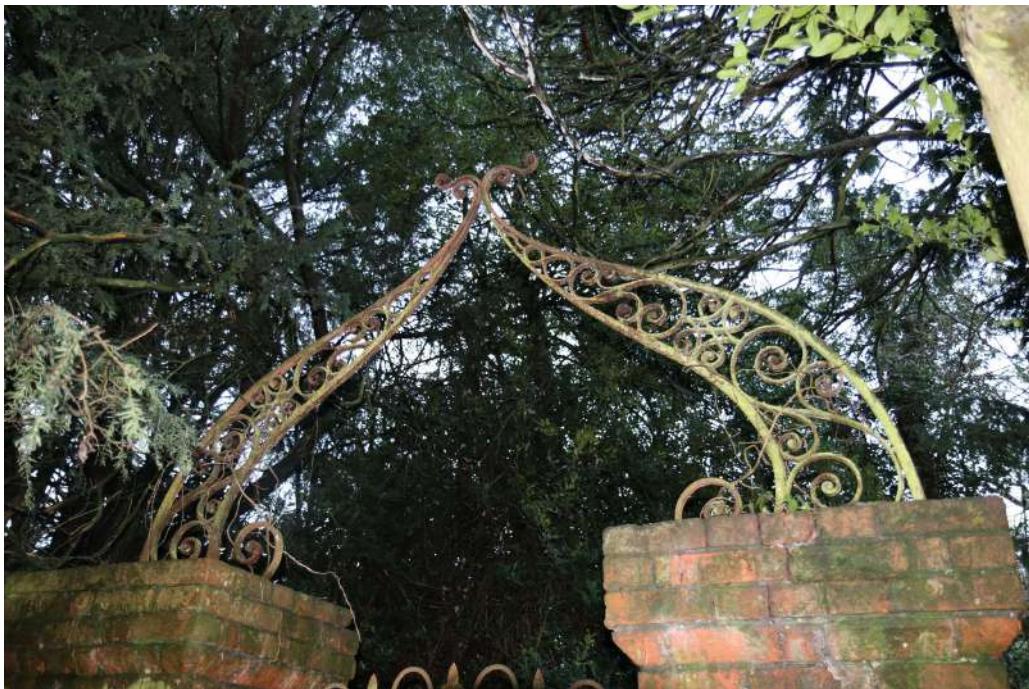
Photograph 7 Detail of iron arch above gate. Photograph taken facing north-west.

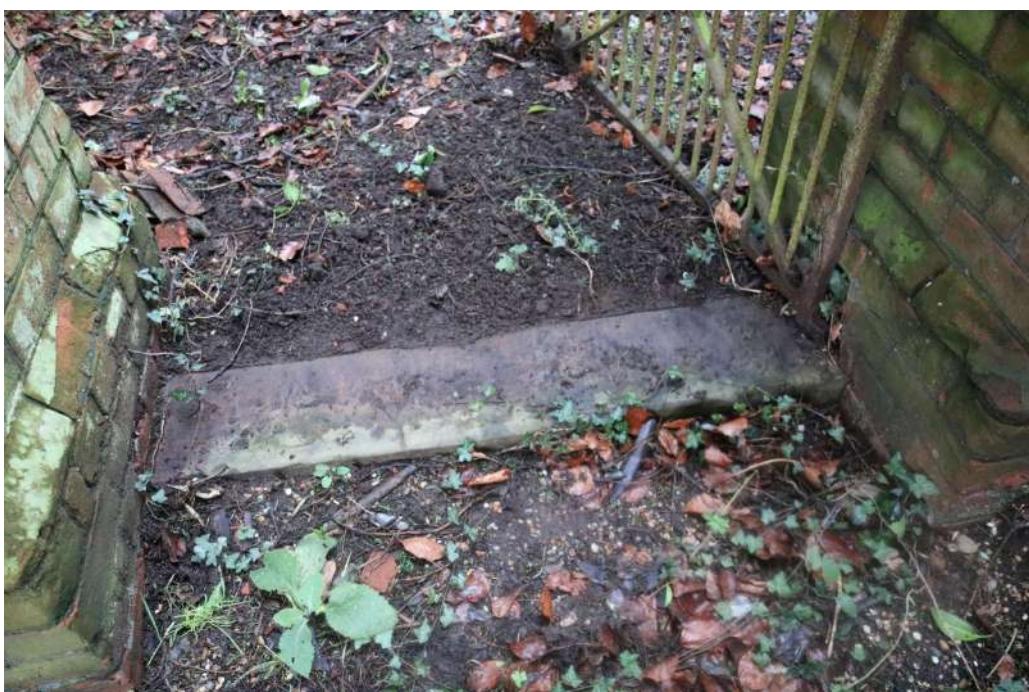
Photograph 8 Detail of stone step in gateway. Photograph taken facing north-west.

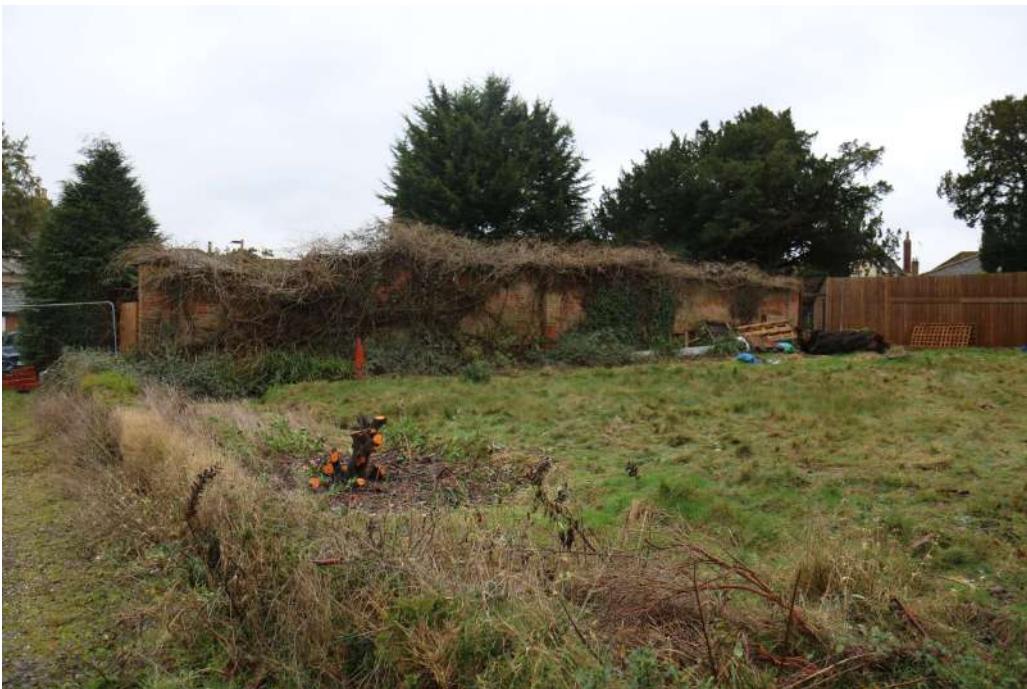
Along the south-eastern boundary of the development area is a wall consisting of red brick (brick dimensions: 225 x 110 x 65mm) laid in Flemish bond and topped with a row of headers. The wall is approximately 22m long with a pier at each end and a central buttress (on the north-western elevation). In the wall, low to the ground and adjacent to the buttress, is a brick arch which has been blocked, perhaps evidence of a historic water course or a hearth for a hot house (although, no on-site evidence was present for either of these). Queen closers have been used in the construction of the piers, with no evidence the wall was ever extended in either direction. The wall's original purpose was likely a solid surface for plants to grow against.

Photograph 9 Detail of wall. Photograph taken facing south south-west.

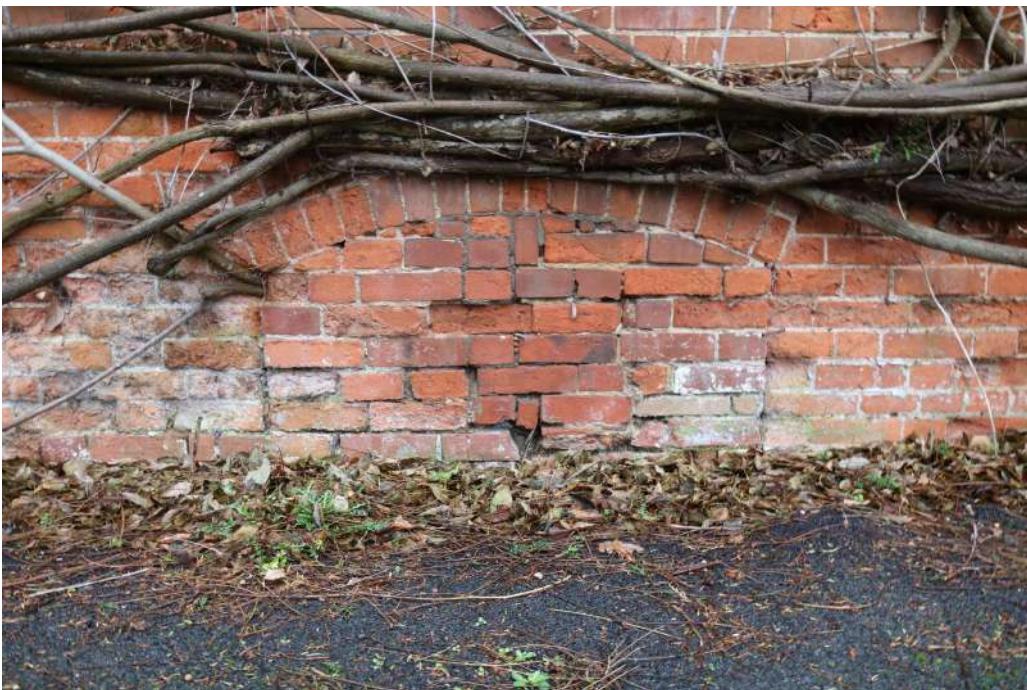
Photograph 10 Detail of bricked up arch in wall. Photograph taken facing north-west.

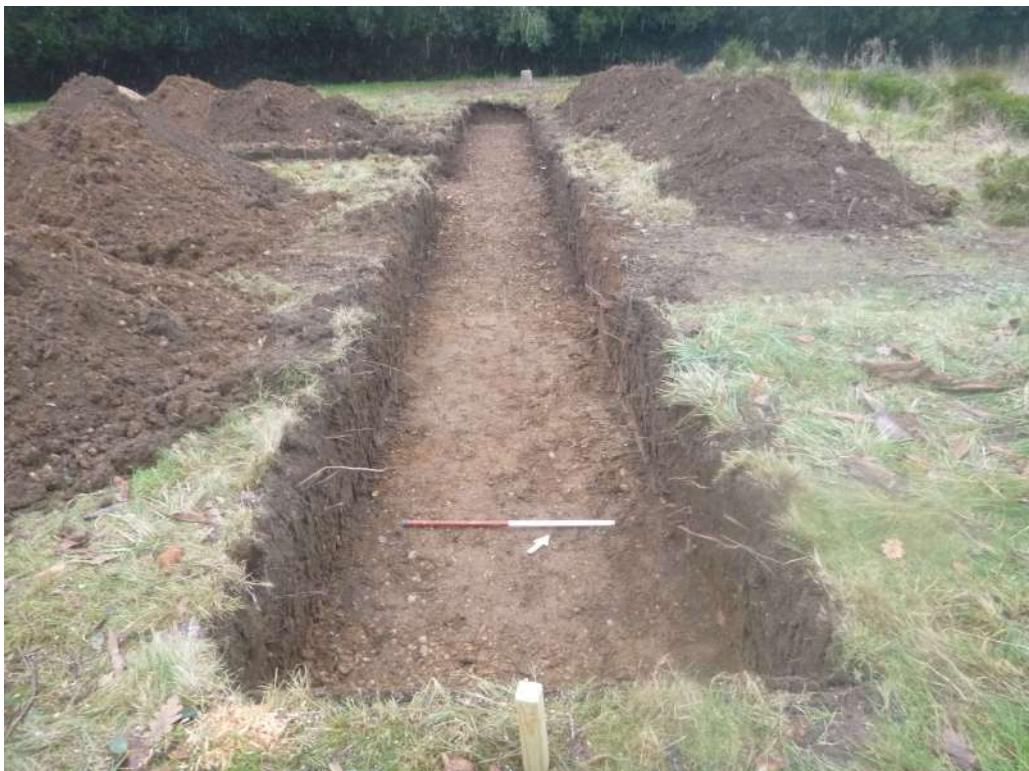
The trenches were excavated through a layer of topsoil (L1, c 0.1-0.41m thick, soft moist dark grey/brown silt and inclusions of: stone 1%) and subsoil (L2, c 0.05-0.41m, firm moist medium brown clayey silt and inclusions of: stone 5%) into the natural geology (L3, c 0.30-0.76m below current ground level, loose friable moist medium orange/brown clay and inclusions of: gravel 20% stone 60%).

No archaeological features were identified in either trench.

Photograph 12 Trench 1. Photograph taken facing north-west.

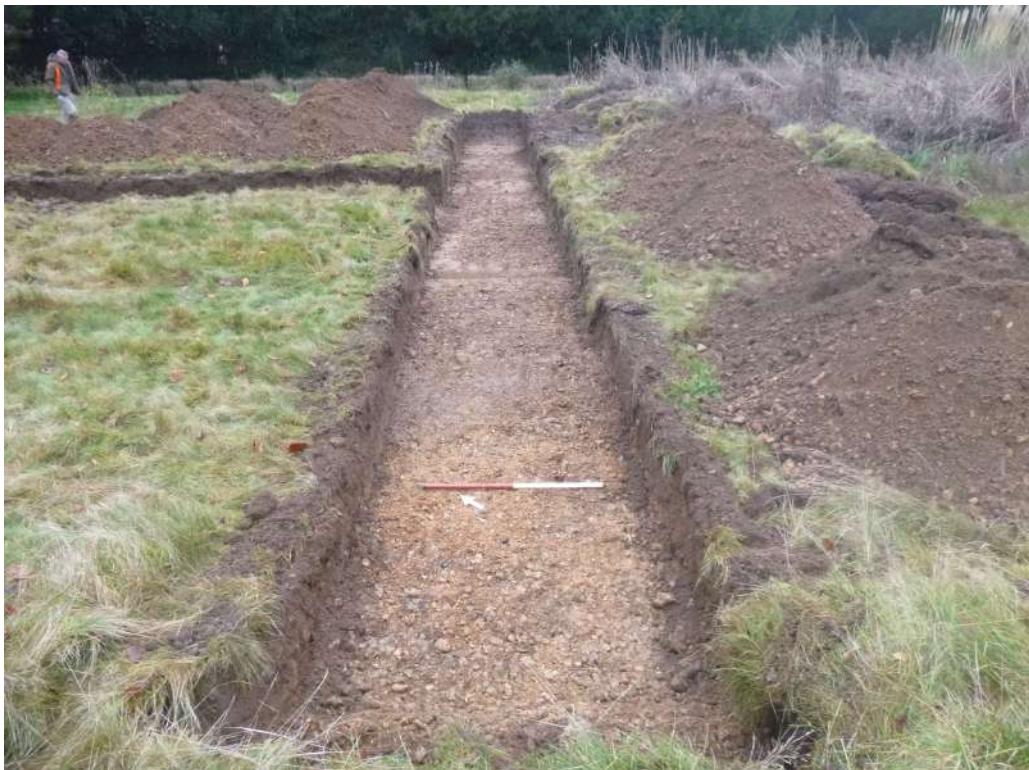
Photograph 13 Trench 2. Photograph taken facing north-east.

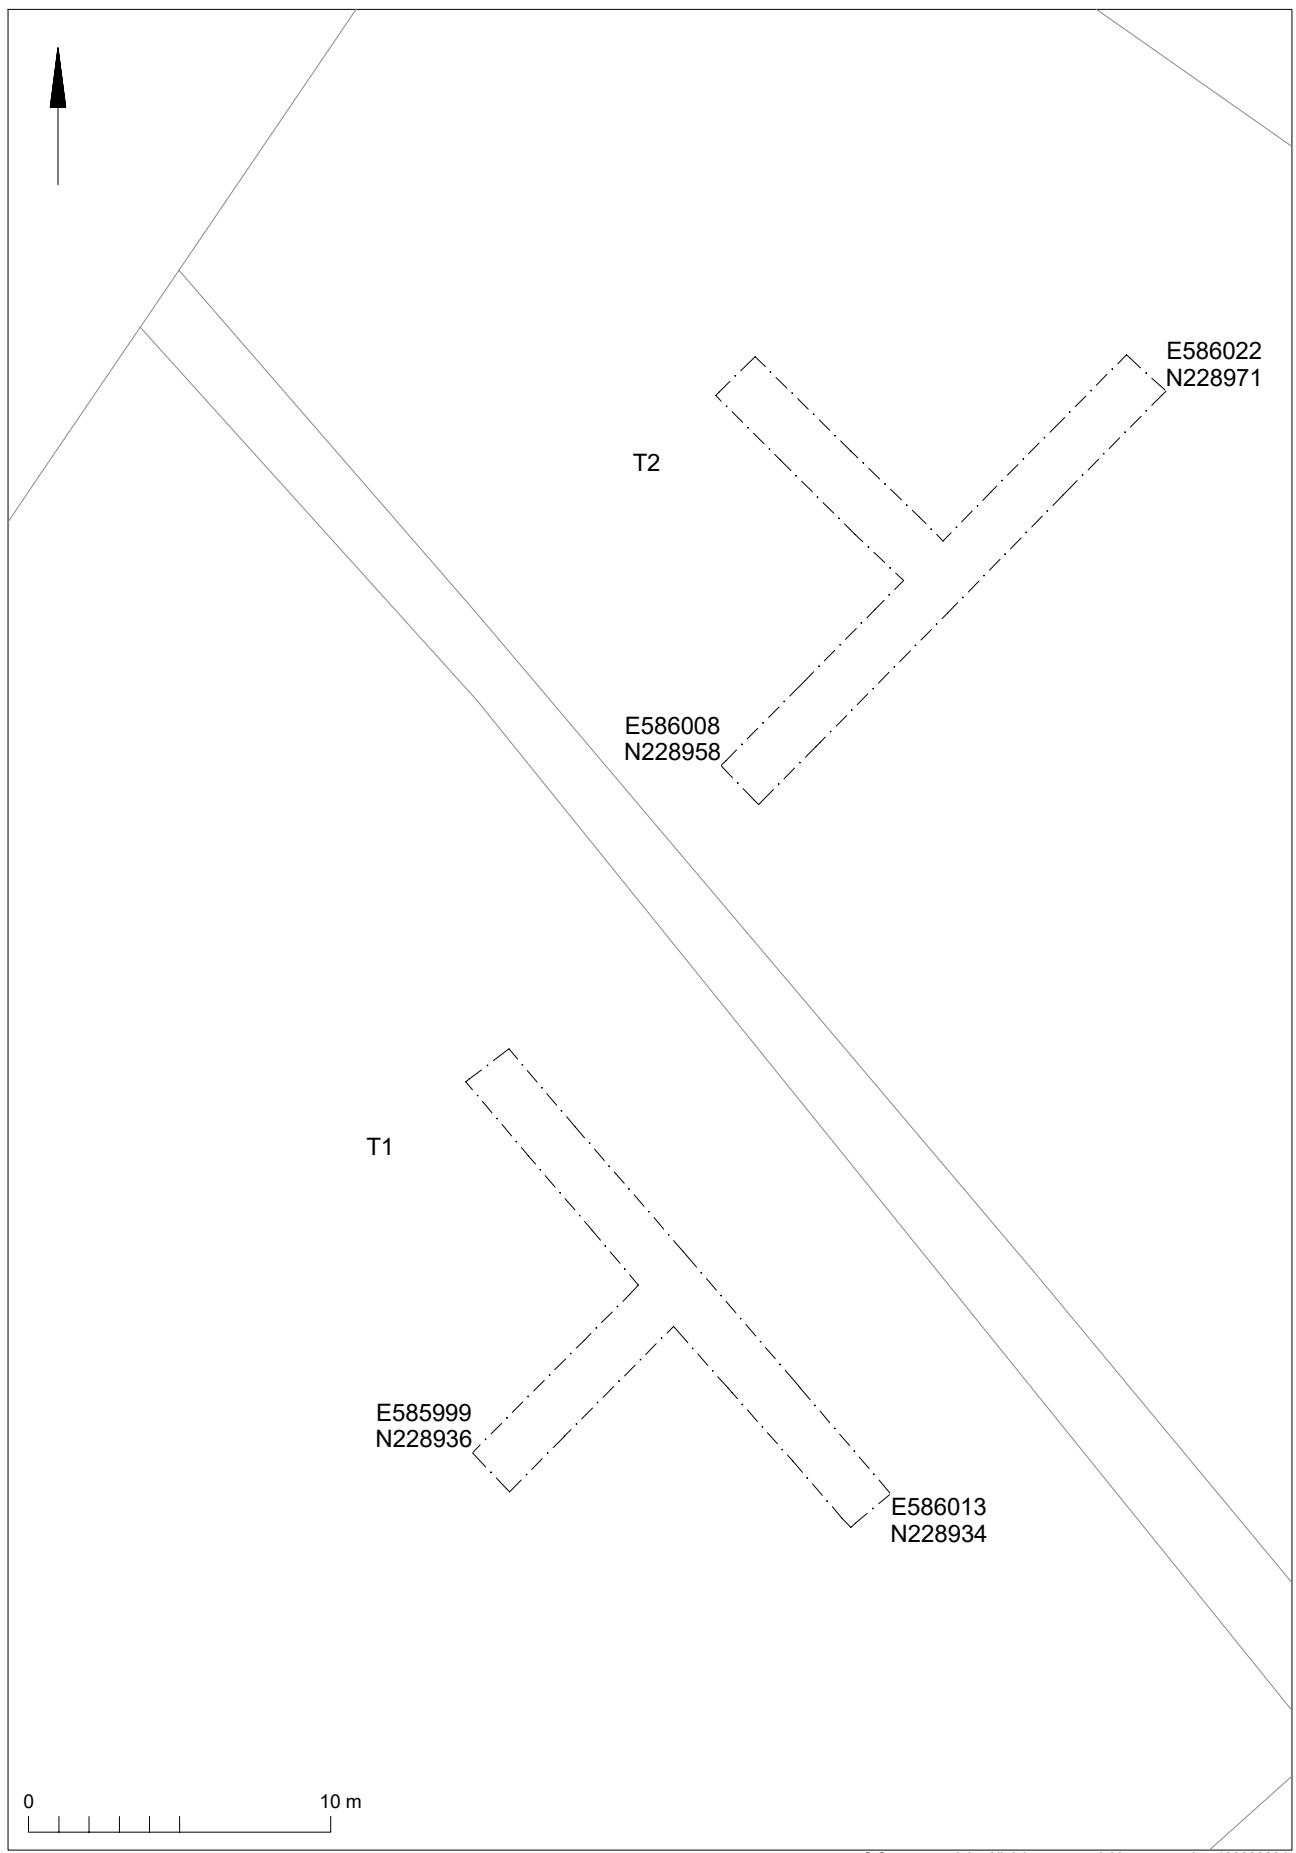
Fig 4 Evaluation Results.

Two evaluation trenches were machine-excavated under the supervision of a CAT archaeologist. Both trenches were T-shaped and total length of 27m with a width of 1.8m.
