**Archaeological monitoring and recording at  
Bantam House, Church Lane, White Roding, Essex,  
CM6 1RJ: October 2024**

**CAT project ref.: 2024/07c  
ECC code: WHRBH24**

**Planning district: Uttlesford  
Planning ref.: UTT/24/0455/FUL**

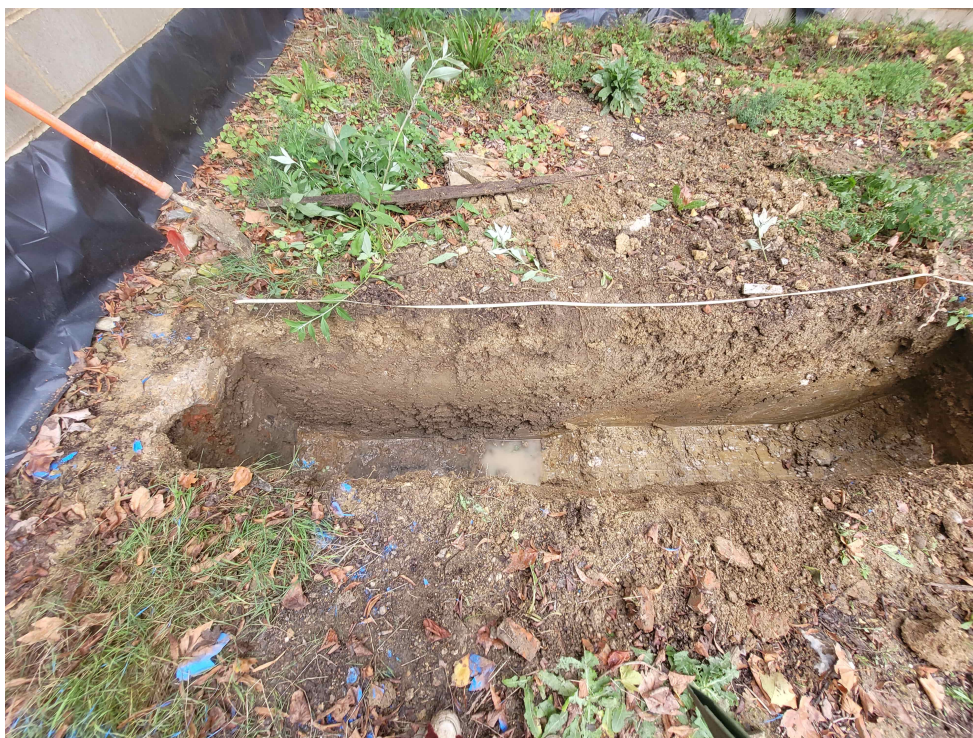
A large north-east/south-west oriented ditch (F5) was identified in two of the foundation trenches. The feature was >2.6m wide where it could be seen in section, and >1.35m deep. It was noted that the fill was a wet, blue-grey clay, suggesting that it was likely an alluvial deposit rather than colluvial. It is likely that this ditch forms the northern extent of the moat around the site.

**Photograph 1** Section of moat F5, looking north-east.

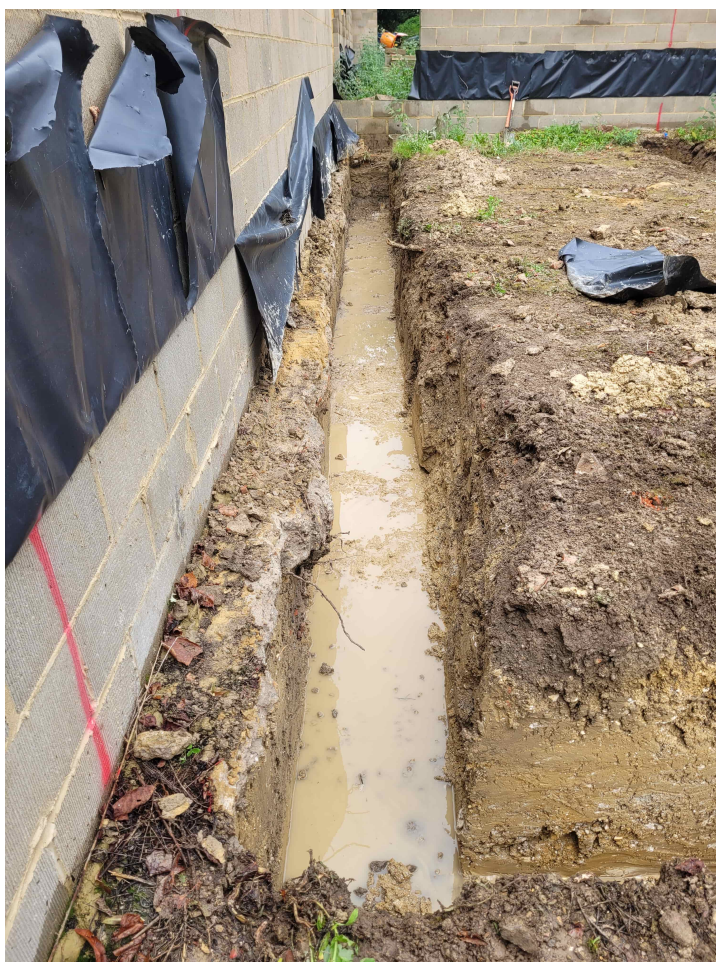
**Photograph 2** North-east/south-west oriented footing, looking north-east.

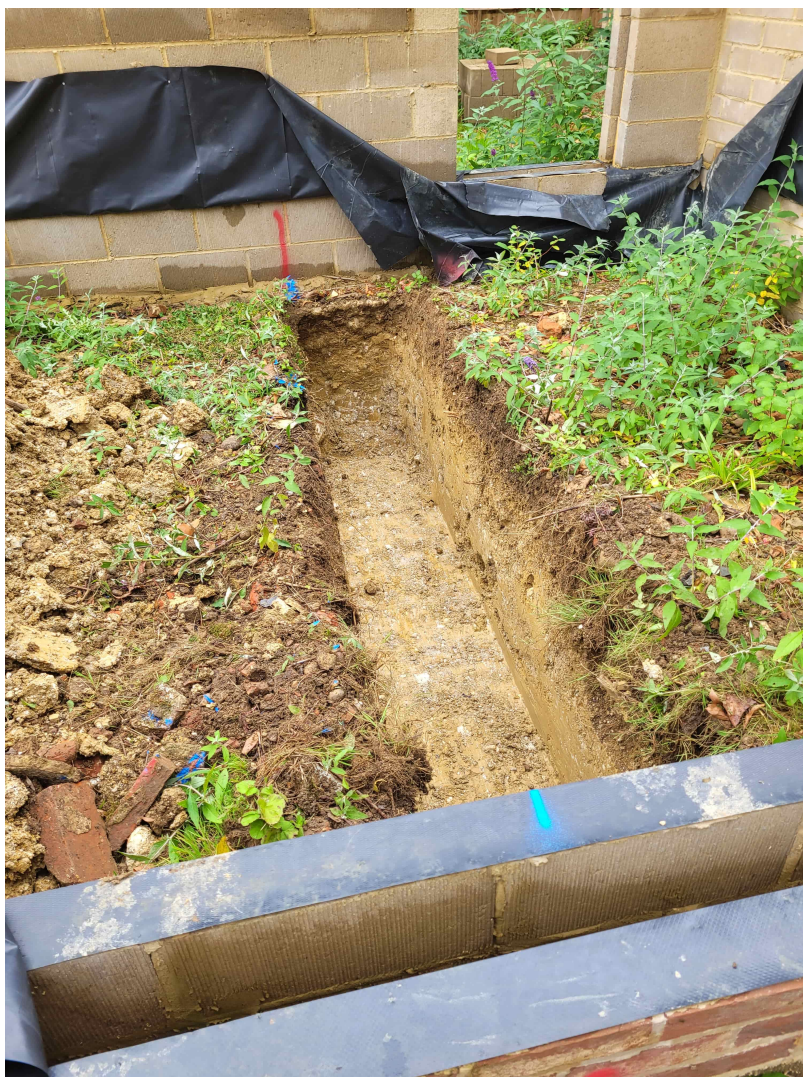
**Photograph 3** Central footing, looking north-north-east.

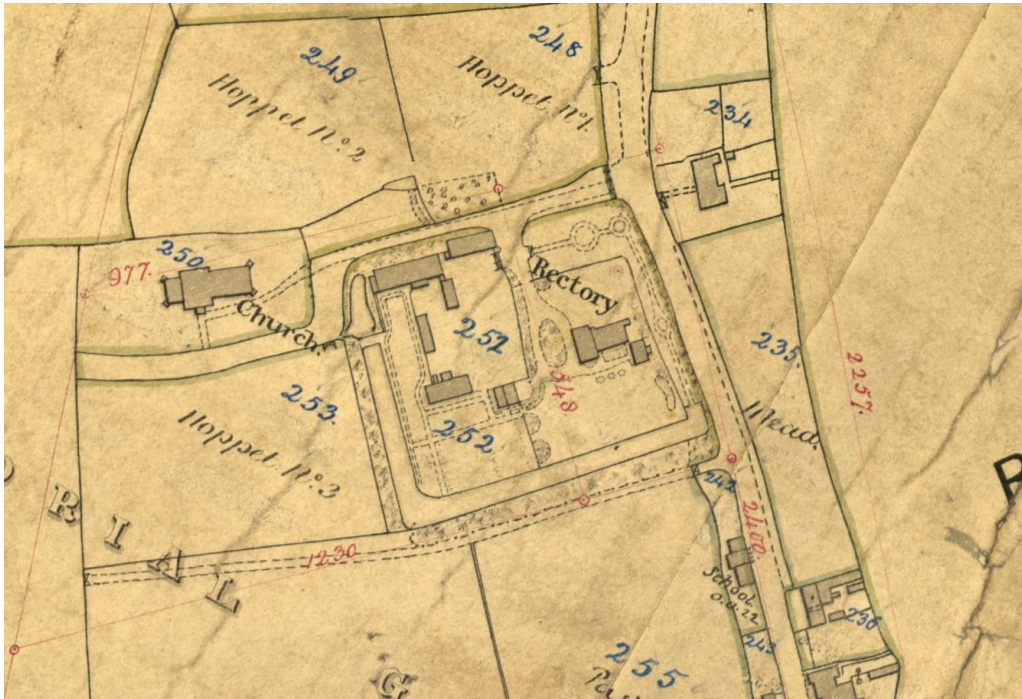
**Map 1** 1837 Tithe Map of the site showing the outbuildings and moat. Whilst the moat cannot be seen to the north or east, a possible water feature is noted along the eastern boundary and in the north-west corner.

Archaeological monitoring at Bantam House, Church Lane, White Roding revealed the northern extent of the medieval homestead moated site. The moat had been backfilled before 1837 as it is not shown on the Tithe Map (Map 1), however some form of possible water feature is recorded on the eastern edge of the site and in the north-eastern corner which is still visible to some extent on the site today (Photograph 4). Pits F1, F2 and F3 are probably associated with activity around the outbuildings of the Old Rectory.

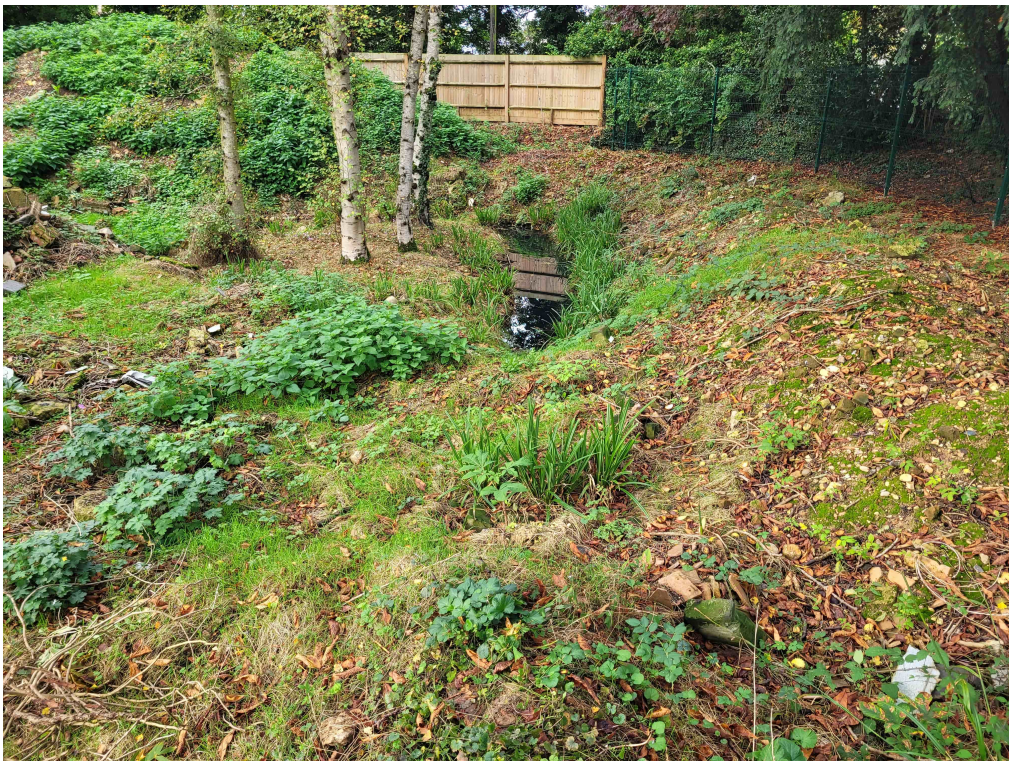
**Photograph 4** View of an existing water feature on the development site that could be related to the features shown on the Tithe Map. It continues west towards F5. Looking north-north-west.
