**A historic building survey at  
High House Farm, Woodham Road,  
Battlesbridge,  
Chelmsford, Essex**

**report prepared by  
Leigh Alston**

**on behalf of  
Churchgate Project Management Ltd**

**CAT Report 470**  
April 2008

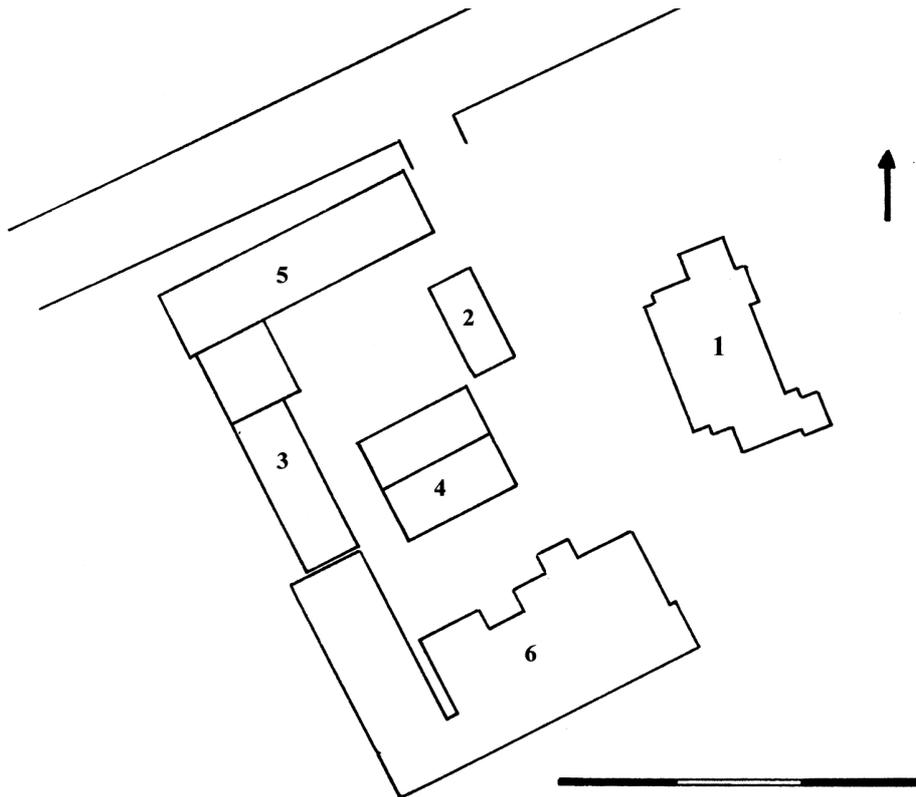
Fig 1 Block plan of farm buildings showing historic elements numbered as follows (30 m scale).

1. Listed farmhouse. 19th-century, timber-framed and weatherboarded, with some late 17th- or early 18th-century framing at the northern end. Heavily altered in the late 20th century
2. Probable cart lodge. Mid 19th century, timber-framed in three bays. Subsequently enclosed. Converted for domestic purposes in the late 20th century.
3. Open-sided shelter shed. Mid 19th century, timber-framed in 5 bays. Enclosed and converted for domestic purposes in the late 20th century.
4. Workshop. Early 20th-century white brick.
5. Barn. Mid 20th-century red brick on site of earlier barn.
6. Complex of animal sheds and Dutch barn, mainly mid 20th century but possibly incorporating parts of a 19th-century building.
