**Historic building recording at
50 Silver Street, Buckden, St Neots,
Huntingdonshire, Cambridgeshire, PE19 5TS**

June 2016

**commissioned by
S. Pell Builders Ltd**

CAT Report 976
August 2016

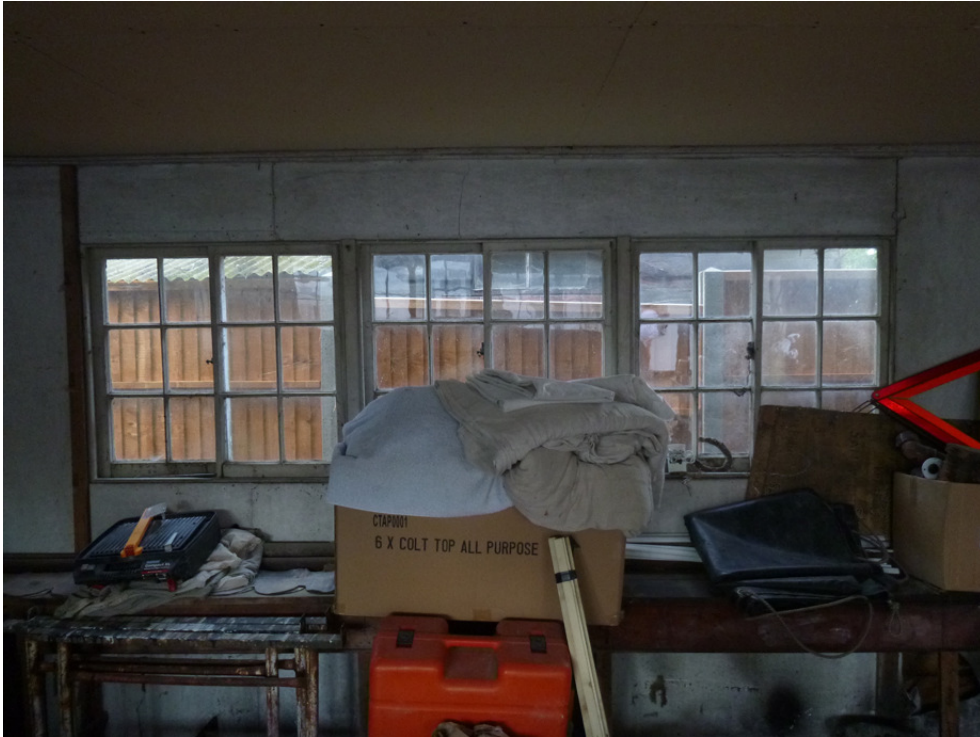
The western elevation (Fig 5) has three twelve-light sliding casement windows centrally positioned on main building (Photograph 4). Like every other elevation, there is a wooden

Photograph 7 Interior shot of three sliding casement windows on west elevation – shot taken facing west.

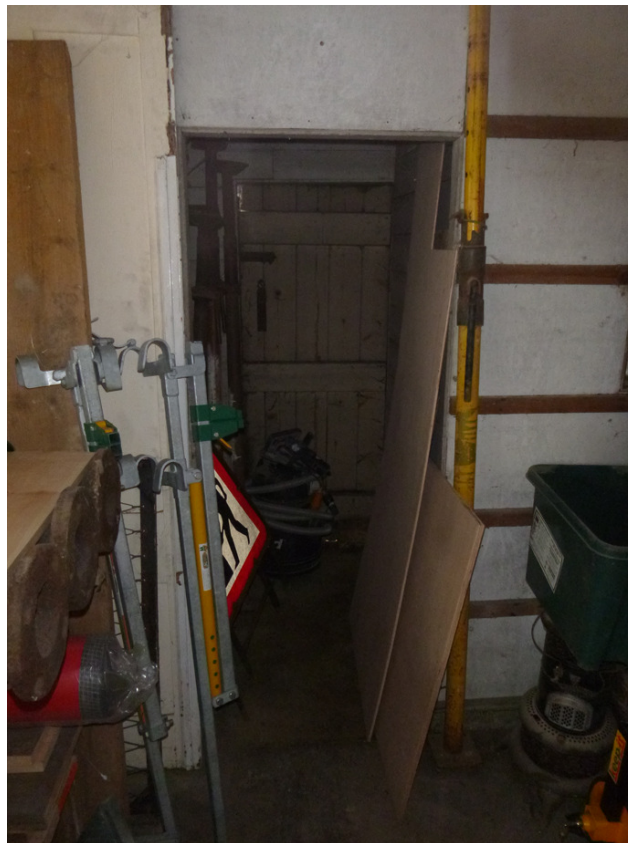
Photograph 8 Interior shot of south wing – shot taken facing south.

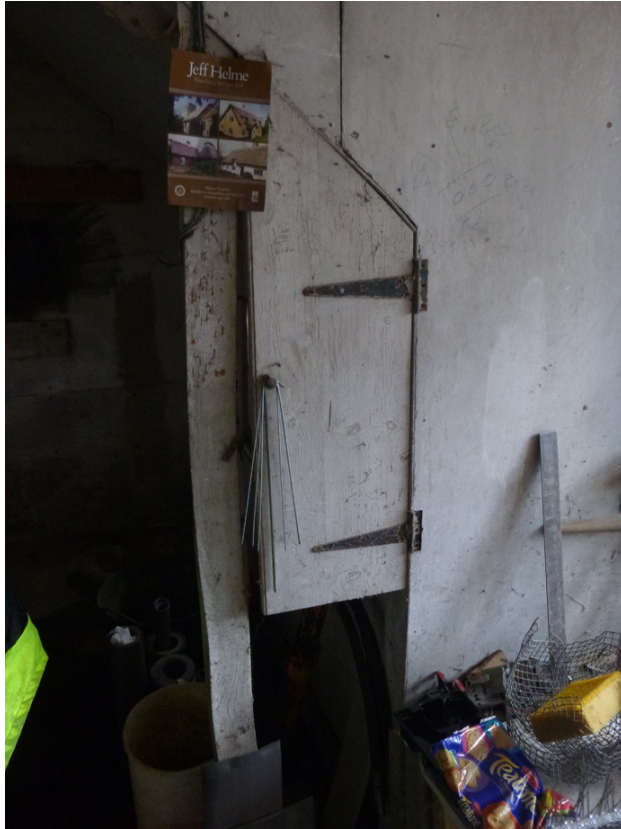
In the north wing (Photograph 9) the concrete floor has several scars, possibly suggesting that there was at one time machinery in this location (Photograph 10). There is also a small hatch between the wall and a supporting post in the north wing (Photograph 11). Presumably at some point, this would have provided access to a cabinet or set of drawers – possibly associated with the machinery.

Photograph 11 Hatch in-between wall and supporting post in north wing – shot taken facing north.

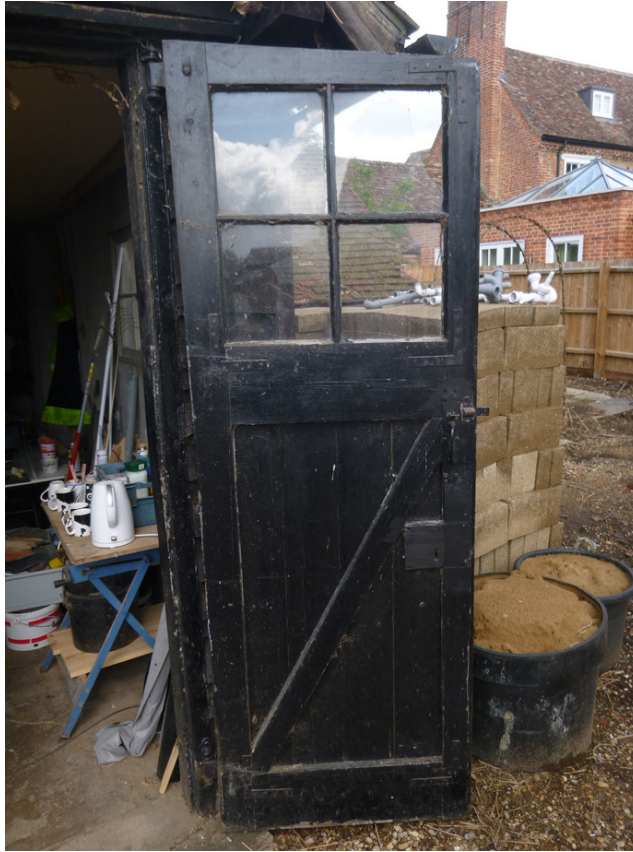
The eastern elevation (Fig 3) has four large half-glazed doors providing access, held in place by large metal hinges (Photograph 2). Two of these doors are double width. These four doors are positioned to create two sets of double doors. These are original to the building and suggest that it was a garage from the outset. The doors have four-lights or eight-lights in the upper panels, depending on width. Also on this elevation on the north wing is an eight-light sliding casement window, with hammered glass.

Photograph 13 Detail of single width door on east elevation – shot taken facing north-west.

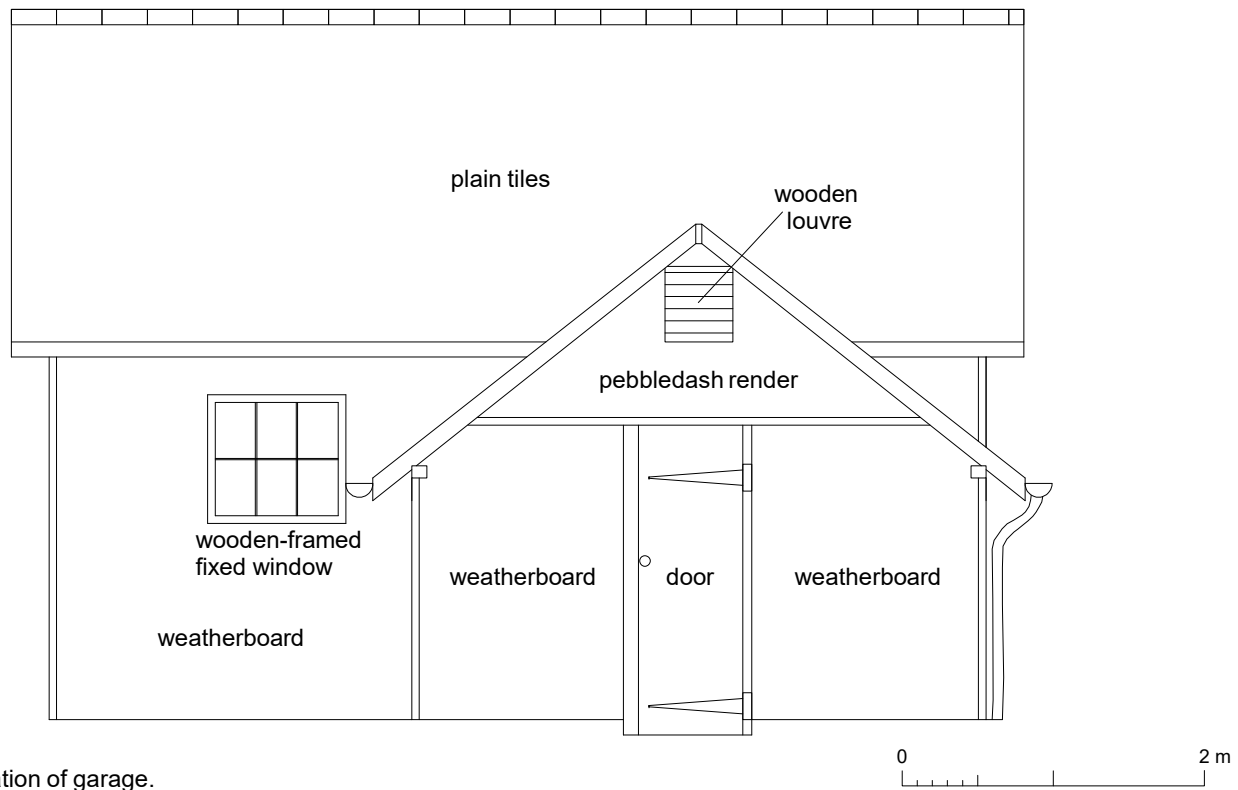
Fig 2 Northern elevation of garage.

The northern elevation (Fig 2) has a vertical-planked door with three battens and attached with metal hinges below the north wing gable (Photograph 1). The gable itself is covered by pebble-dash render and contains a small wooden louvre. There is six-light fixed window in the wall of the main garage on this elevation.

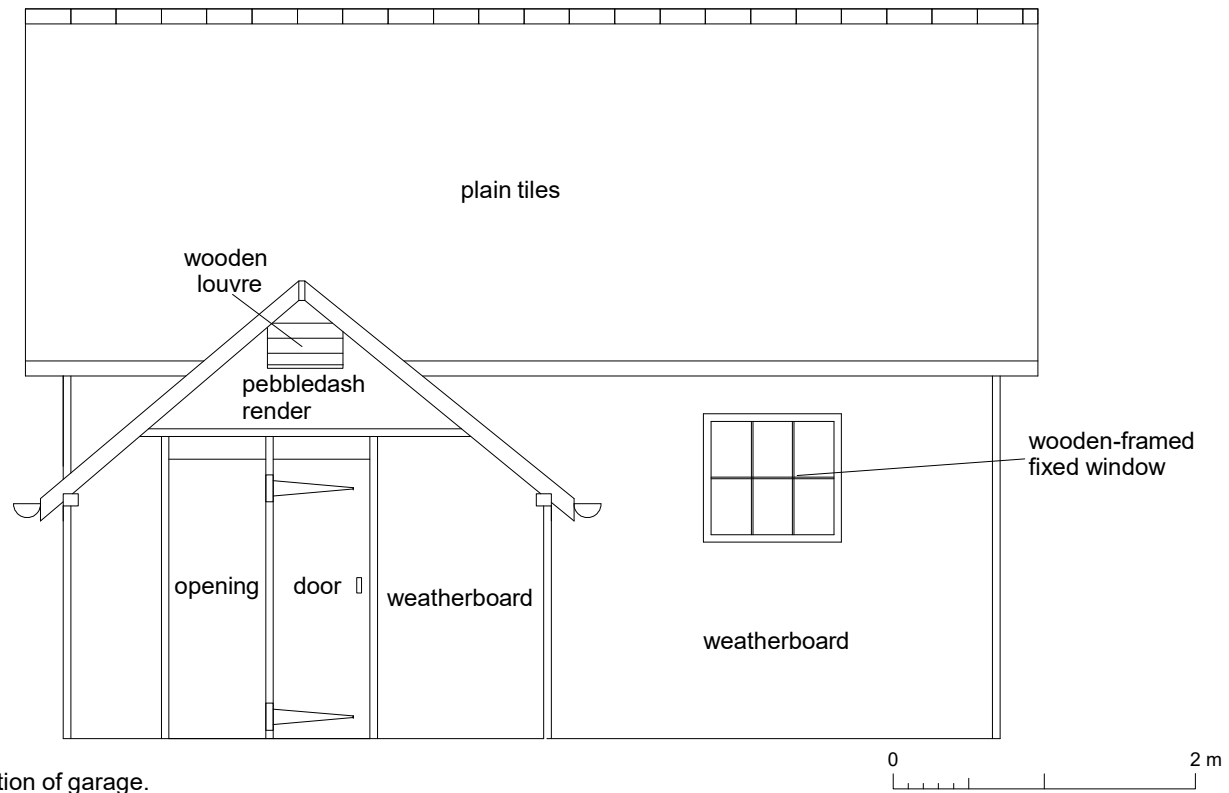
Fig 4 Southern elevation of garage.

The southern elevation (Fig 4) has two entrances, both on the south wing (Photograph 3). One is into the building proper and has a vertical planked door, and the other has no door and leads into a separate room not accessible from the main structure. This separate room is totally devoid of features and, like the rest of the building, the interior is clad in asbestos panels (Photograph 6). The owner suggested that at some point it was in use as an outside privy (*pers comm*) – although, given the use of the building, it seems more likely to have been a petrol store. Also on the south elevation on the main building is a six-light fixed window, identical to the one on the north elevation (see above). As in the north wing, the south wing gable is covered by pebble-dash render and contains a wooden louvre.

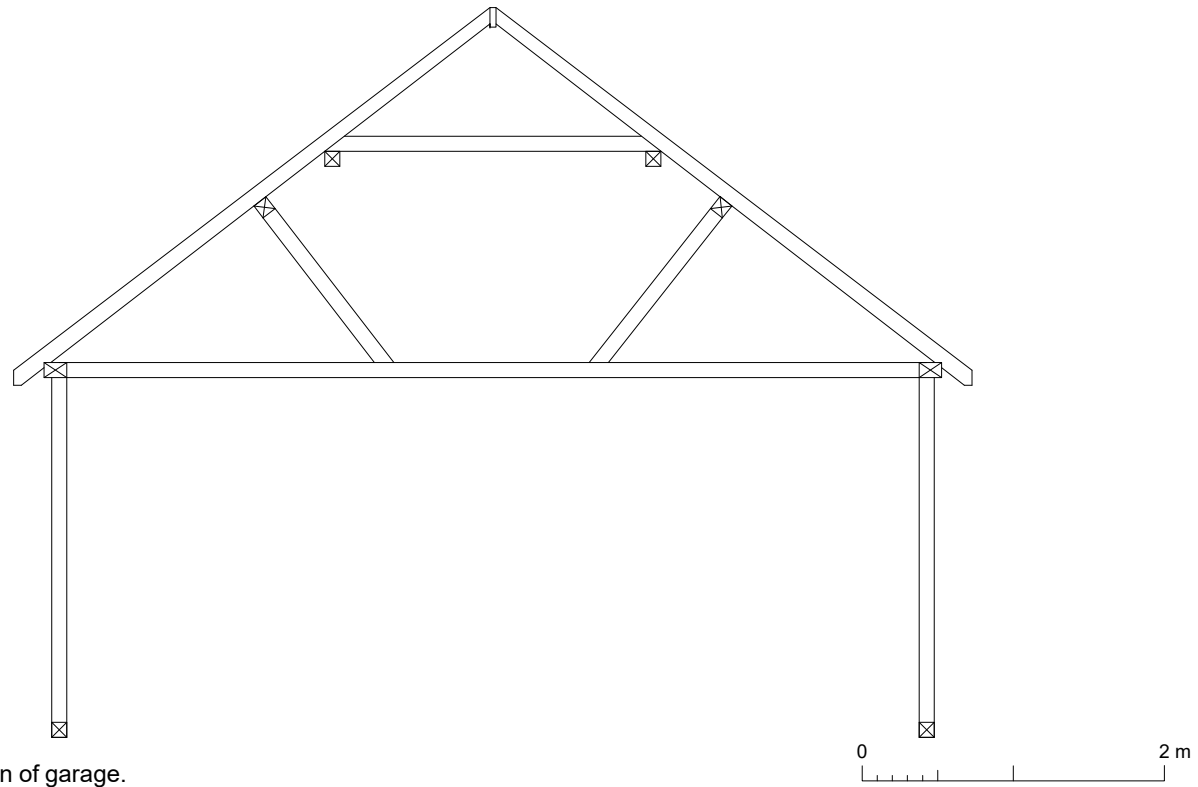
Fig 6 Truss cross-section of garage.

When the roof was observed through an inserted hatch, it was found to be made of nailed machine-cut timbers (Photograph 15). Several timbers had been nailed in place at various angles in order to further support the roof, running from one truss to another and varying in length and size. The truss cross-section (Fig 6) shows only what appears to be the original elements of the roof's structure.

A key factor in interpreting this building is the pitch of the roof – at 38 degrees it is too gradual for the tiles that are currently on it (tiled roofs usually requiring a pitch of 45 degrees or more – Brunskill, 1985). This suggests that the tiles are not original to the structure and have been added at a later date. The hanging of tiles on a roof of inadequate pitch would cause immense pressure on the buildings timber frame. This is likely the reason for a lot of the structural issues with the building, as well as the *ad hoc* reinforcement of the roof with modern timbers (see description above).

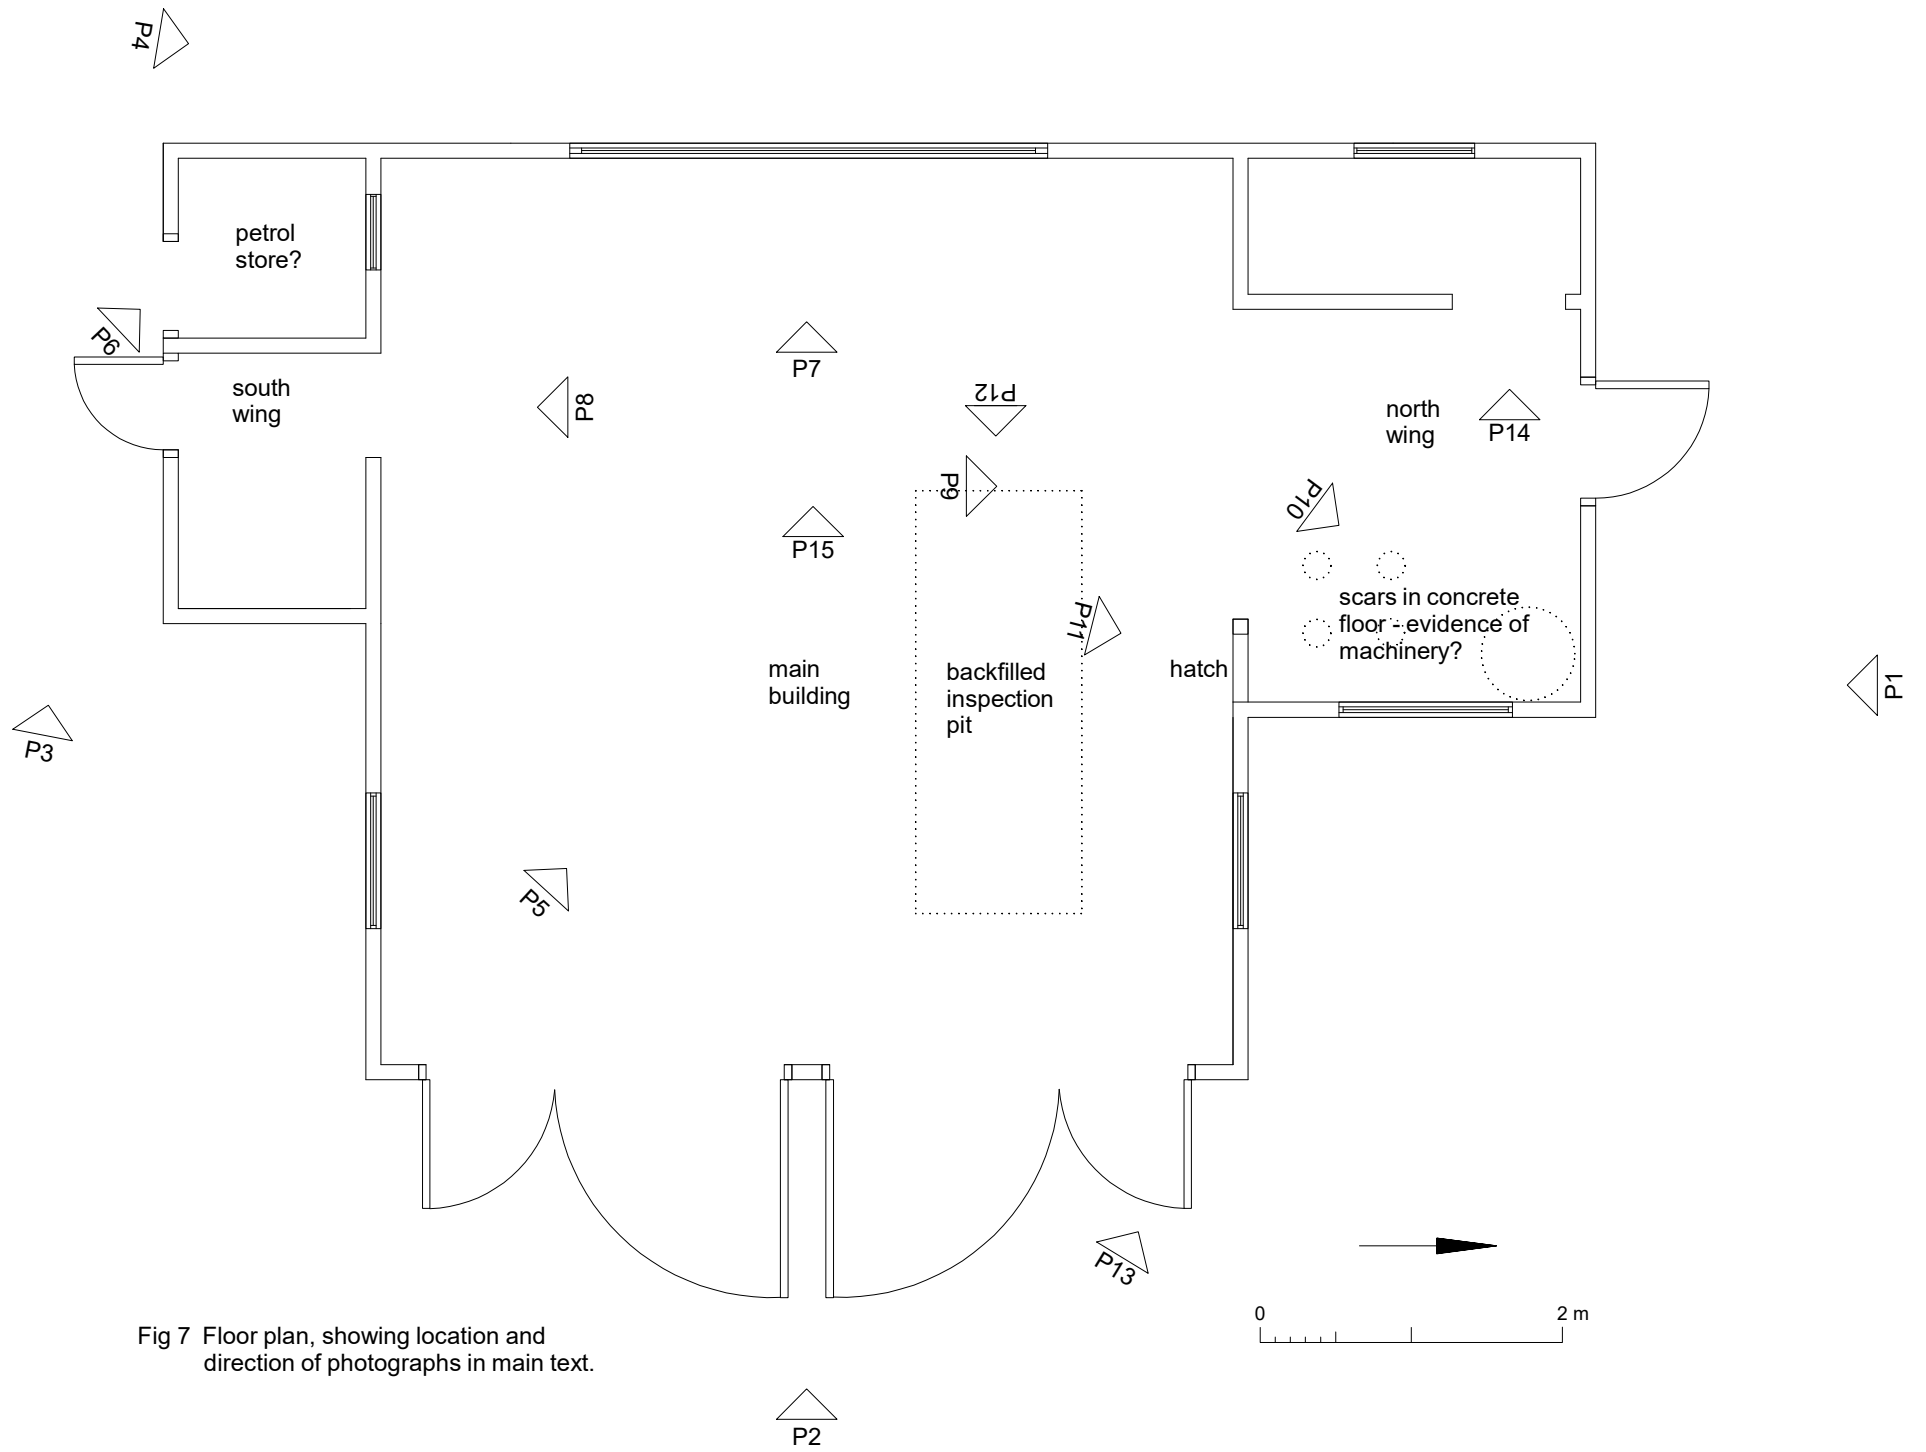
Fig 7 Floor plan, showing location and direction of photographs in main text.

The garage is aligned north-south. It is one-storey and is T-shaped in plan (Fig 7), with a central main building and wings to the north and south. The term 'wing' is grandiose given the building under discussion, but is used as it serves to differentiate between the parts of the building. It is a softwood machine-cut timber-framed building, 6.1m long x 9.5m wide with a concrete floor. The building is clad in traditional weatherboarding, with a modern nib tile-covered gable-ended roof.
