Historic building recording and test-pit evaluation at Duncan's Gate, Colchester, CO1 1UN

July 2016

CAT Report 1022
November 2016

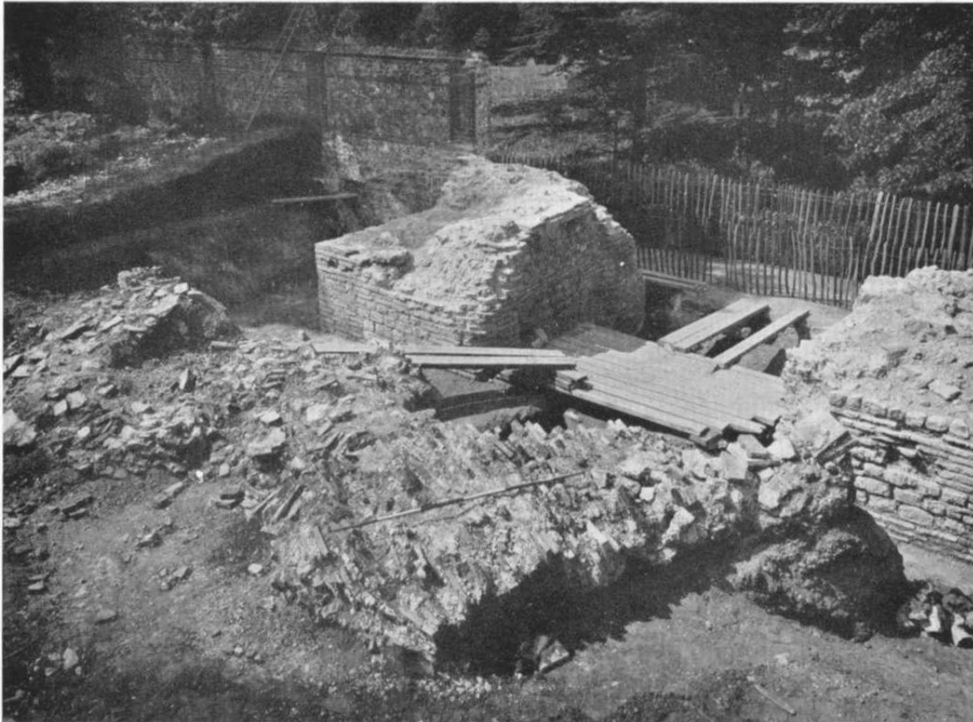
Photograph 1 Duncan's Gate under excavation in 1927-9. Collapsed masonry visible in foreground. Photograph taken facing north-west (reproduced from Roman Colchester, 1958, plate VIIa).

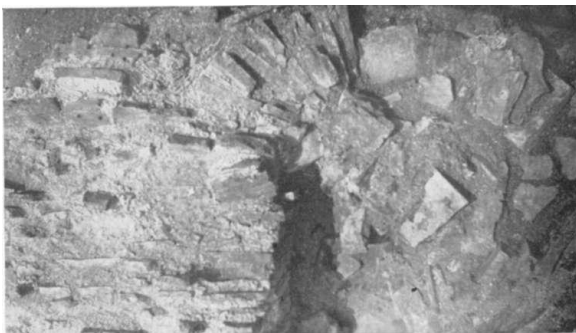
The gate was next investigated in 1927-9 by the Colchester Excavation Committee, overseen by M. R. Hull (Hull 1958, 36-41). He determined that the collapsed masonry to the south of the gate was in fact the remains of the gate tower, containing the arches of windows, rather than a gateway (Photographs 2 and 3). Hull's report (Hull, 1958) goes on

Photograph 2 Detailed photo of window arch visible in collapsed masonry (reproduced from Roman Colchester, 1958, plate IVb).

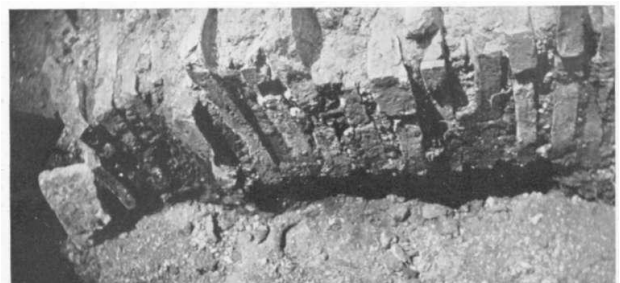
Photograph 3 Detailed photo of window arch visible in collapsed masonry (reproduced from Roman Colchester, 1958, plate IVc).

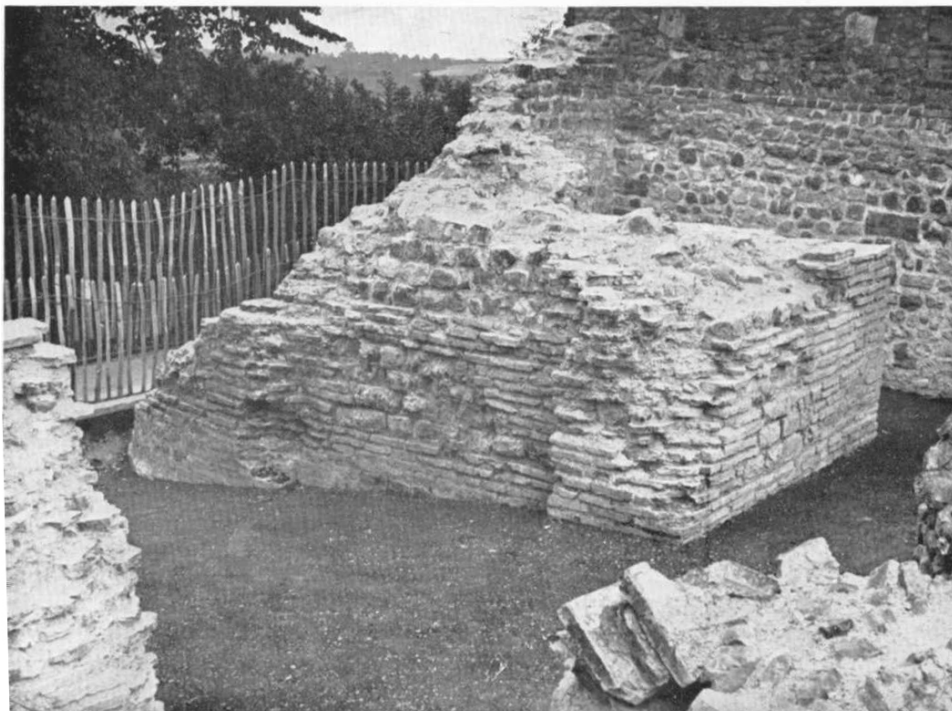
Although not discussed in the Hull's report (save for one labelled photograph - Photograph 4), after the excavations of 1927-9 the gate and collapsed masonry was the subject of significant conservation. This attempt at conservation was observed during the fieldwork for this report, and is noted in the descriptive record below.

Photograph 4 The eastern pier of Duncan's Gate after conservation (reproduced from Roman Colchester, 1958, plate VIIb). Note that the sides of the gate are free-standing at this stage.

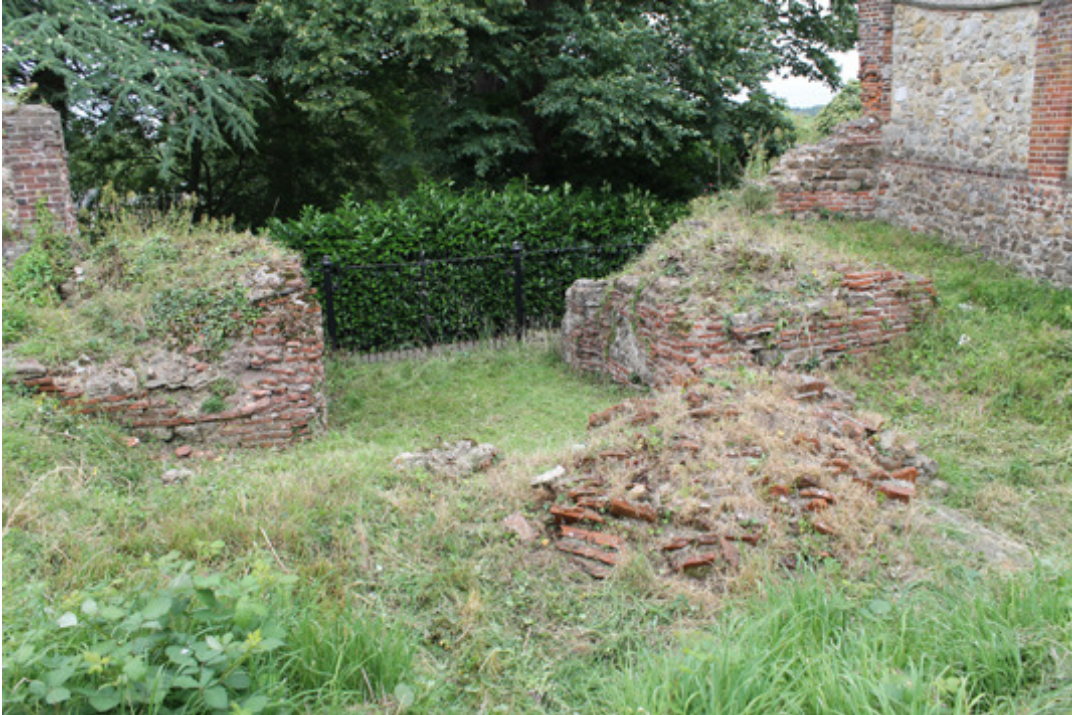
Duncan's Gate is located on the north-east corner of Colchester town wall (Photograph 7). It has two sides coming south off from the main wall at right angles, leaving an opening 3.7m wide (Fig 2). Each side of the gate extends 5.4m south of the north face of the wall. Each side is 2.6m wide, and their outer and inner faces are identical to the town wall proper: four courses of septaria alternating with four courses of brick, all bonded together with lime mortar. The interior make-up of the sides, where visible, also mirrors that of the town wall (i.e. irregular layers of septaria and mortar).

Photograph 7 General shot of Duncan's Gate. Collapsed masonry visible in foreground. Photograph taken facing north-east.

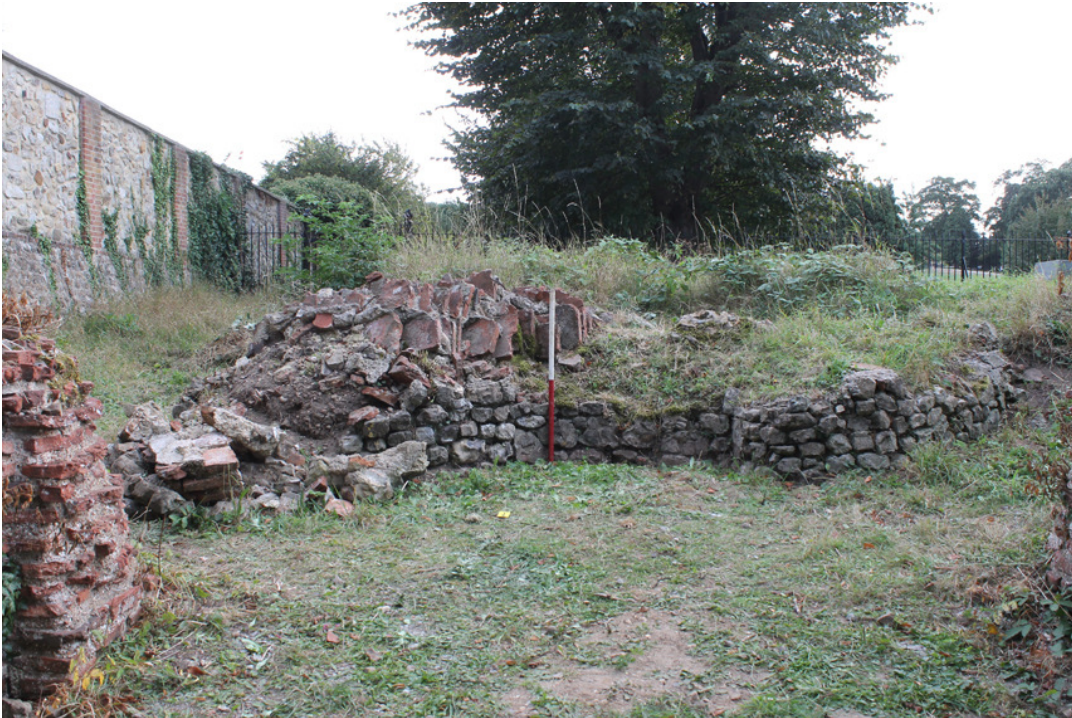
The collapsed masonry lies approximately 1m to the south of Duncan's Gate, and is heavily overgrown (Photograph 12). Even after removal of a substantial amount of overgrowth, the only section identifiable on the surface were the tile courses (with some occasional septaria fragments) defining the windows of the gate tower (Photographs 13, 14 and 19). The entire western half of the collapsed masonry is covered in grass, making any identification impossible. Although the limits of the collapse are difficult to define, the masonry appears to be about 10 square metres in area.

Photograph 13 Collapsed masonry after the removal of overgrowth. Photograph taken facing south.

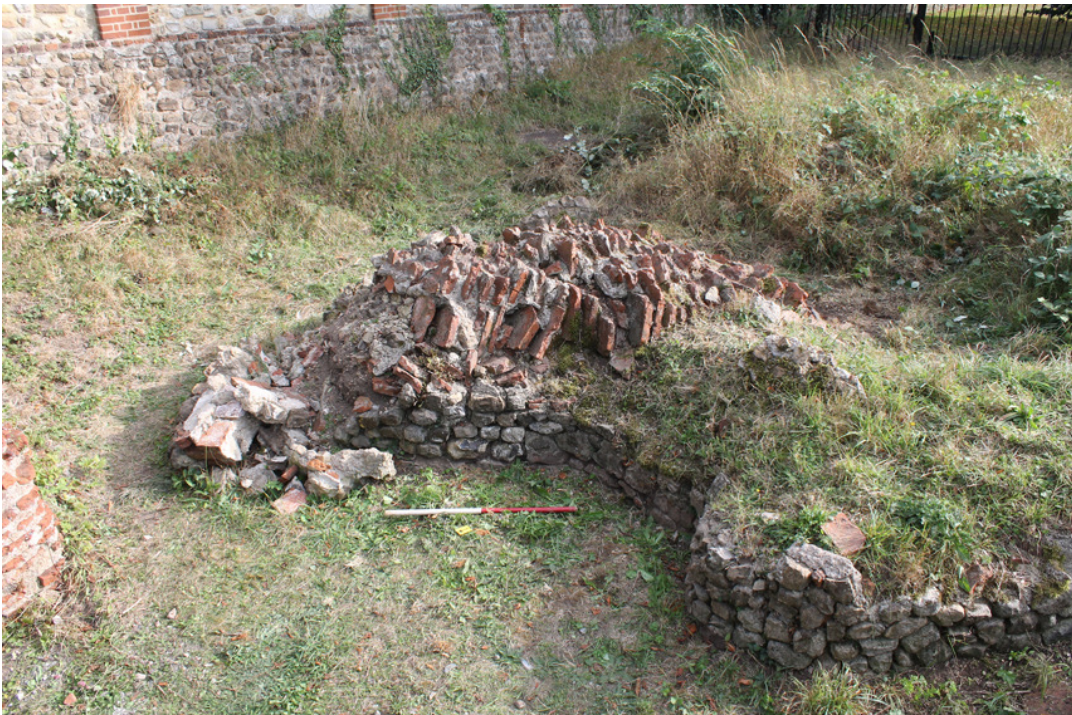
Photograph 14 Collapsed masonry after the removal of overgrowth. Photograph taken facing south-east.

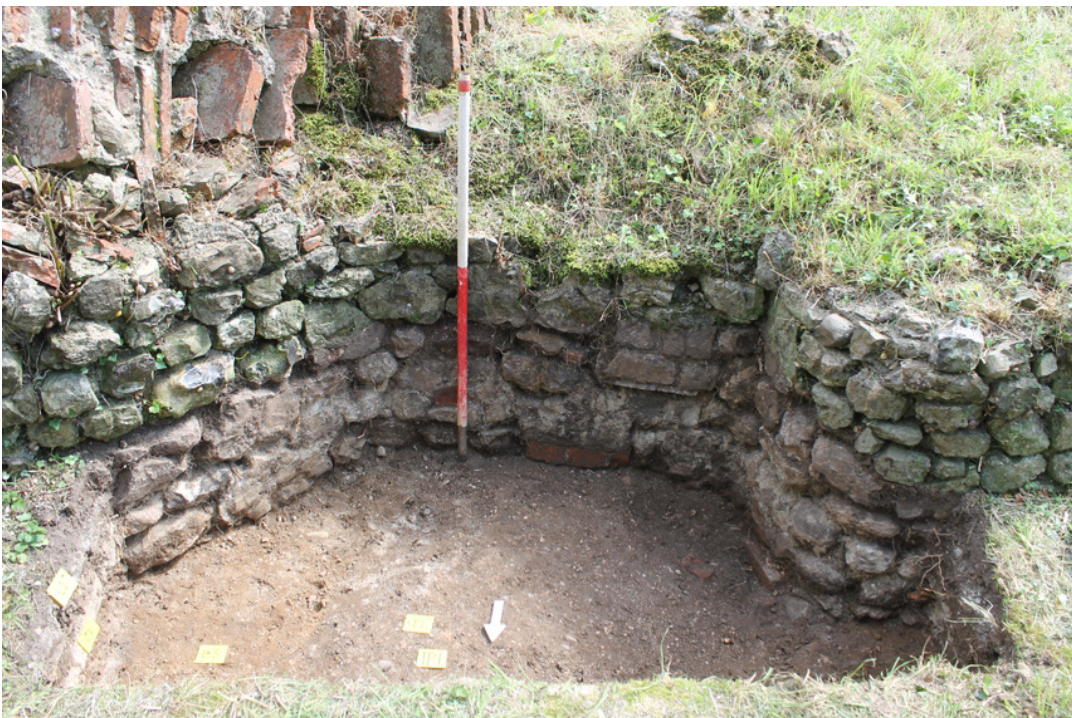
The masonry was heavily modified and conserved in the 20th century. Like the south faces of the gate itself, the collapsed tile courses and the entire exterior of the masonry (where visible) was re-rendered in modern concrete (Photograph 15). The entire north side of the masonry has had a crescent-shaped retaining wall built against it, constructed of septaria and modern brick (Photograph 16). How much this retaining wall represents the original extent of the collapse is unclear.

Photograph 16 View of retaining wall after test-pit excavation. Modern brick and septaria visible in make-up. Photograph taken facing south.

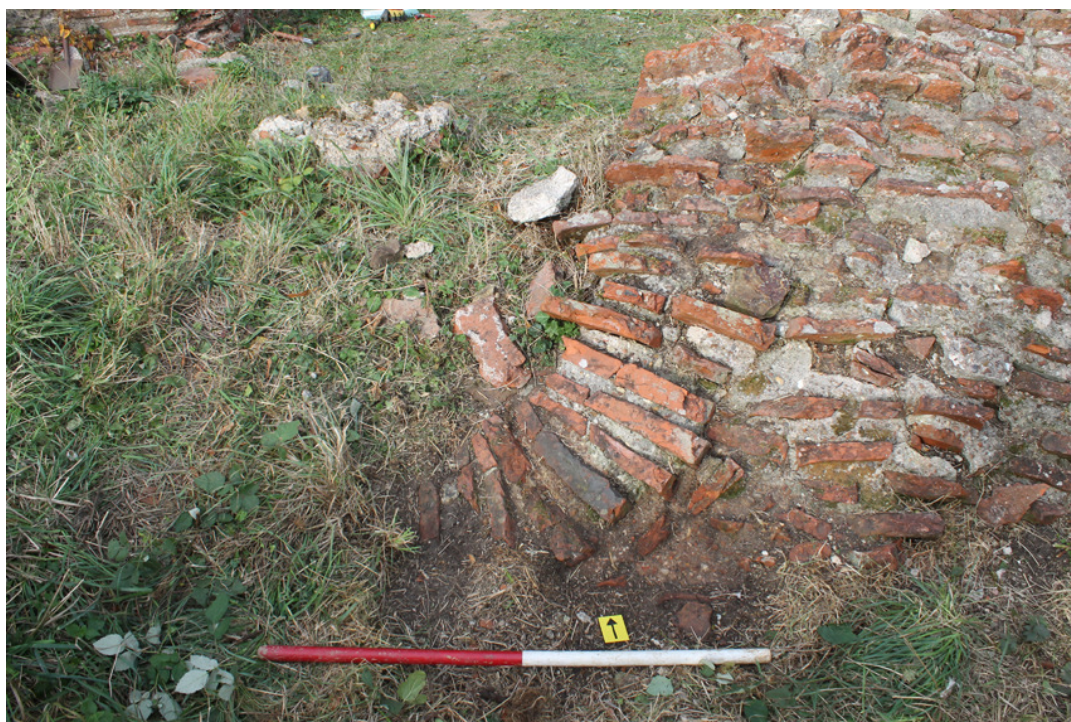
Photograph 19 Arch of window in collapsed masonry. Photograph taken facing north.

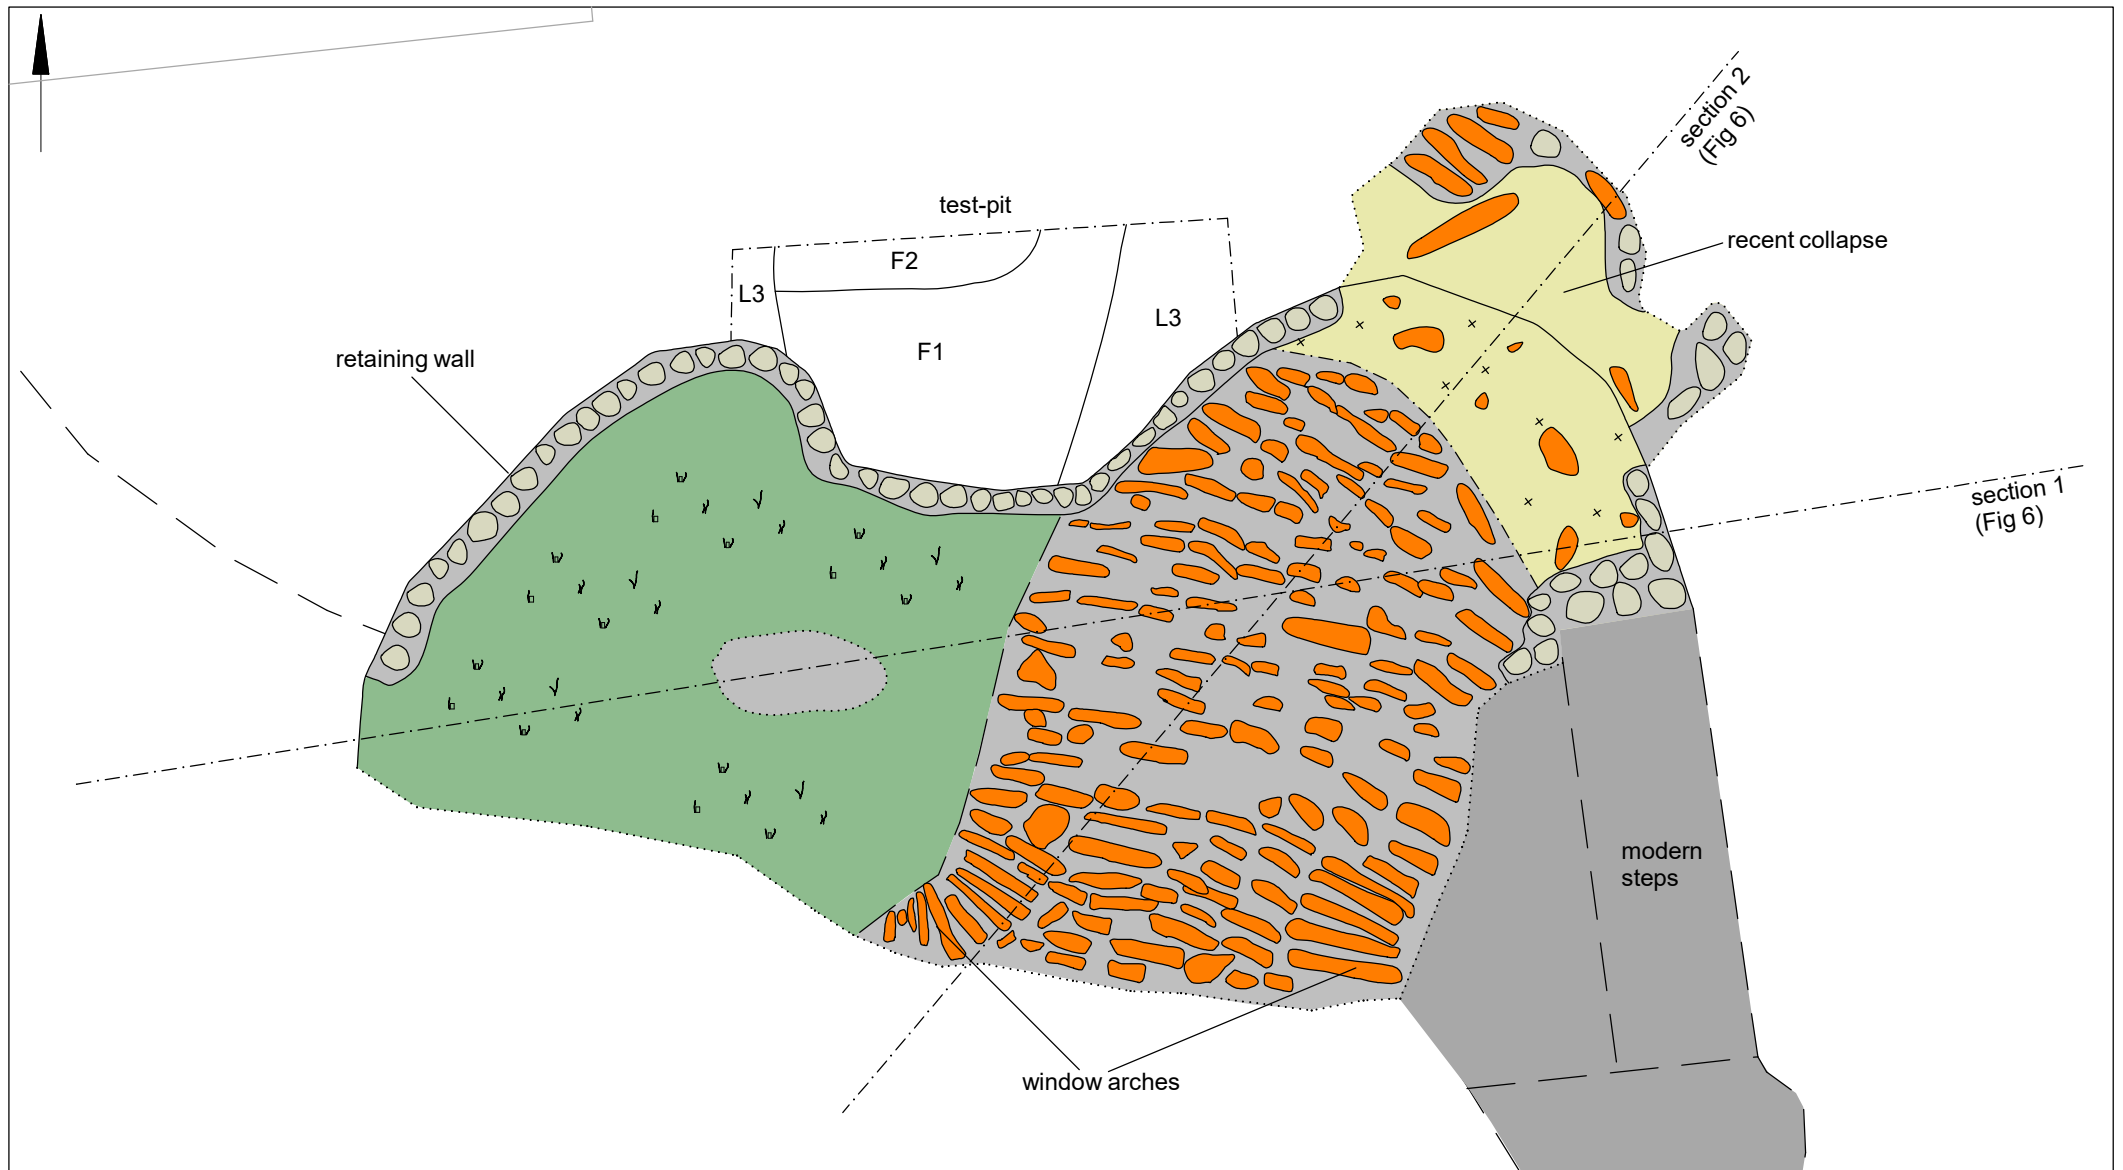
Fig 3 Detailed plan of collapsed masonry and test pit.

Due to the irregular size, footprint and overgrown nature of the masonry, it was decided the best way to record elevations would be as two sections – one east to west across the whole footprint, and one south-west to north-east, following the arch of a collapsed window (Fig 3).

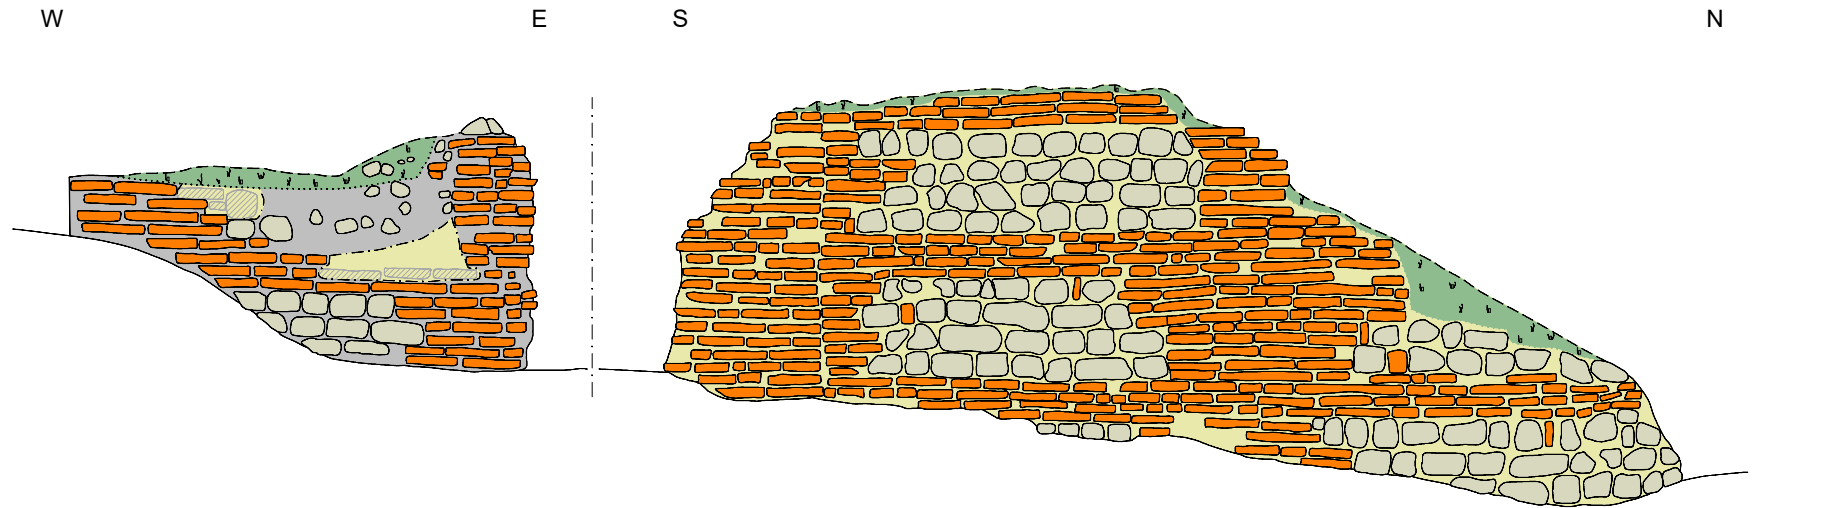
Fig 4 Elevations of western side of gate.

The two sides of the gate vary in preservation, with the western side being in better condition than the eastern – the western side stands 2.4m from the current ground level (Photograph 8), while the eastern side stands 1.7m (Photograph 9). As a result of this height discrepancy, the western side has more courses of brick and septaria remaining (Fig 4). As with the rest of the town wall, neither of the sides stand at their original height at the time of construction (the town wall is thought to have been at least 6m tall – Crummy 1997, 87).

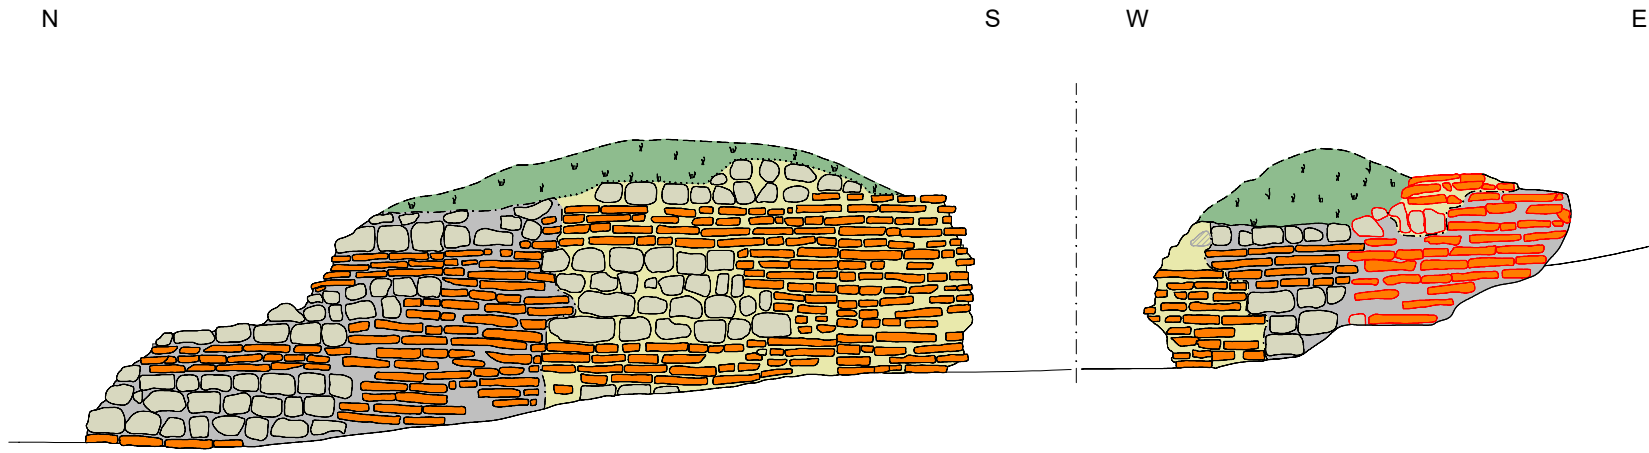
Fig 5 Elevations of eastern side of gate.

conservation was restricted to the south face of each side (where they are most damaged- Photographs 10 and 11), but part of the west facing elevation of the eastern side was also conserved (Fig 5).
