**Historic building recording at
Waples Mill, Ongar Road, Margaret Roding,
Essex, CM6 1QS**

July 2016

CAT Report 1060
January 2017

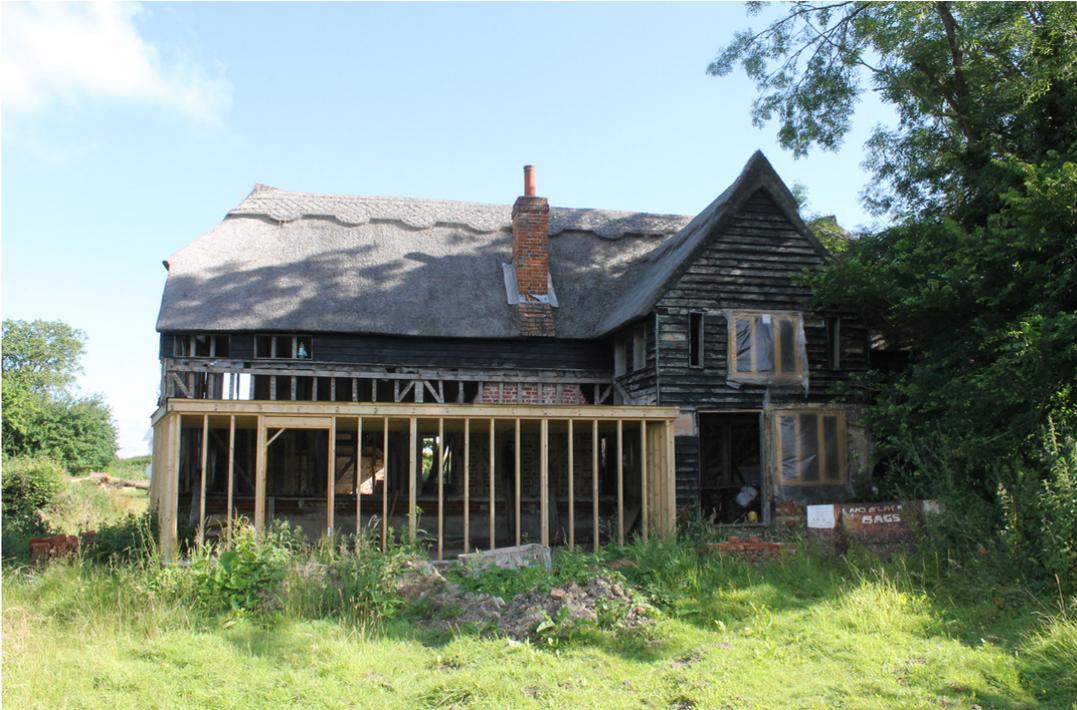
brickwork and timber and at the time of writing was still in the process of being constructed (Photograph 1).

Photograph 1 South elevation of barn, with modern building on footprint of Building C in foreground – photograph taken facing north.

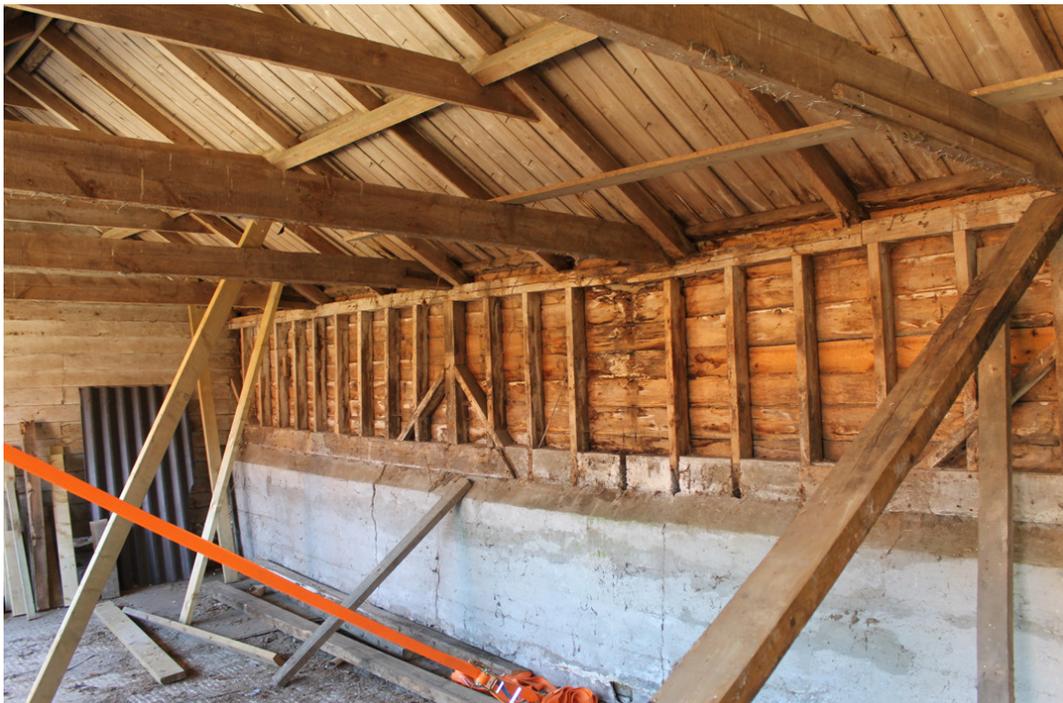
The timber-frame on the eastern side of the building is the only one that appears to be original. It consists of machine-cut timber studs with diagonal down bracing supporting principal posts, all embedded in concrete (Photograph 6). The wall-plate has two face-halved and bladed scarf joints with two edge-pegs. This eastern frame is in the process of being altered, with one modern window frame already inserted.

The original timber-frame is in poor repair, with evidence of extensive damage to the studs. This may have necessitated the concrete supports at the base of the frame. Various timbers and straps are supporting the buildings frame while it is under renovation (Photograph 7).

Photograph 6 Interior of Building B, showing original machine cut timber on eastern elevation – photograph taken facing north-east.

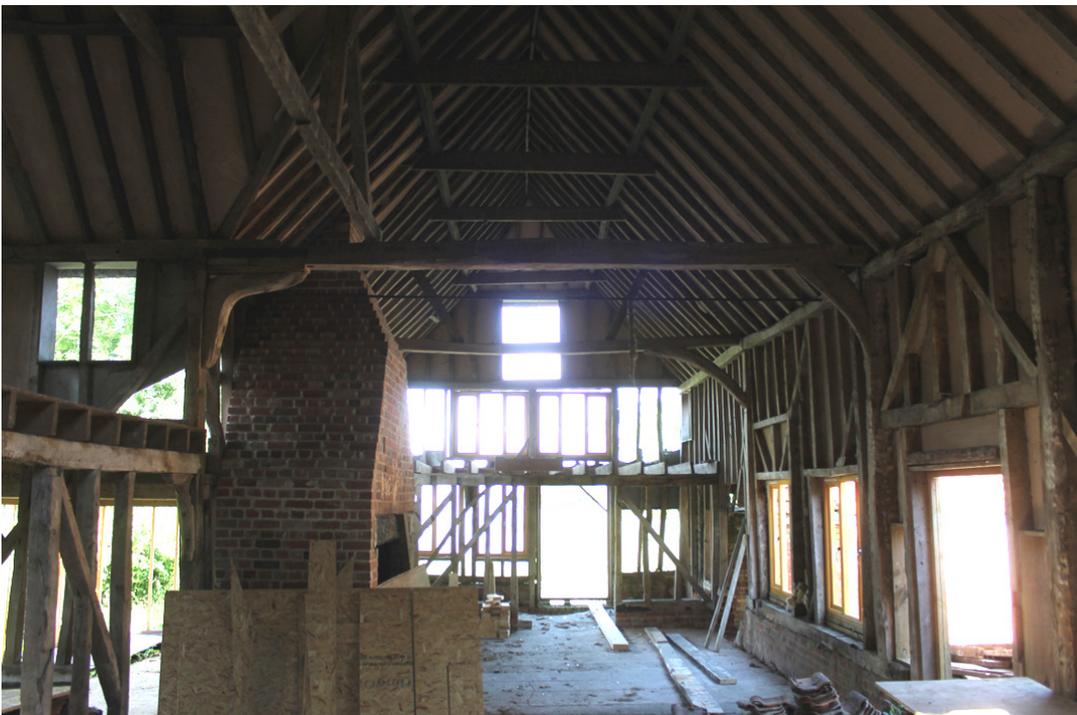
Photograph 8 Interior shot of barn – photograph taken facing west.

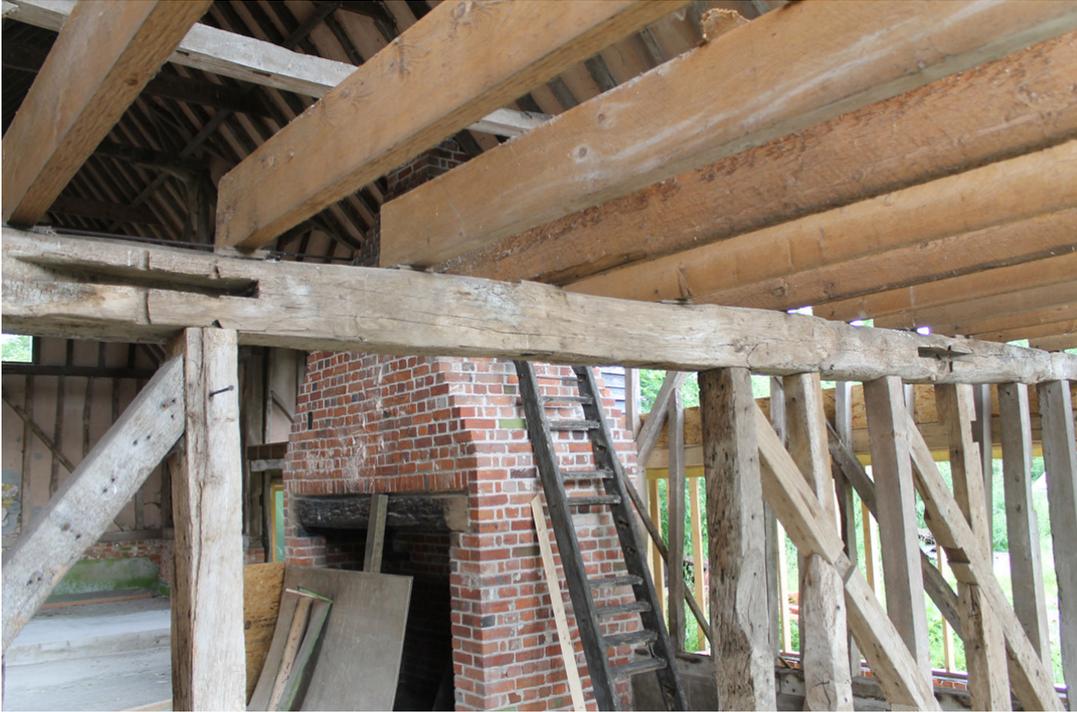
Photograph 9 Back of the beam supporting the inserted floor in Bay 1, showing disused mortices in the old timbers. Photograph taken facing south-east.

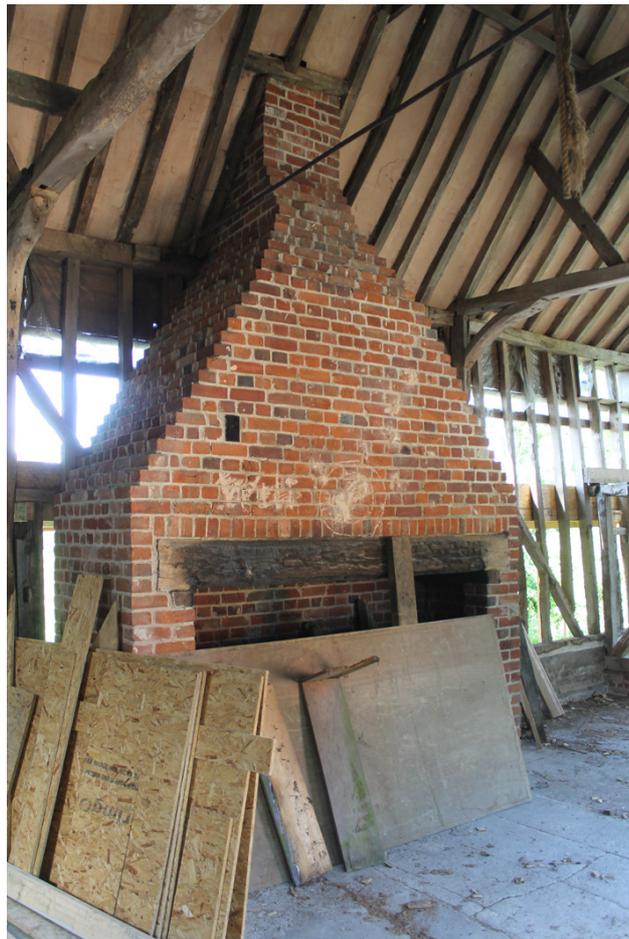
Photograph 10 Inserted modern brick oven in south of Bay 2. Photograph taken facing south-west.

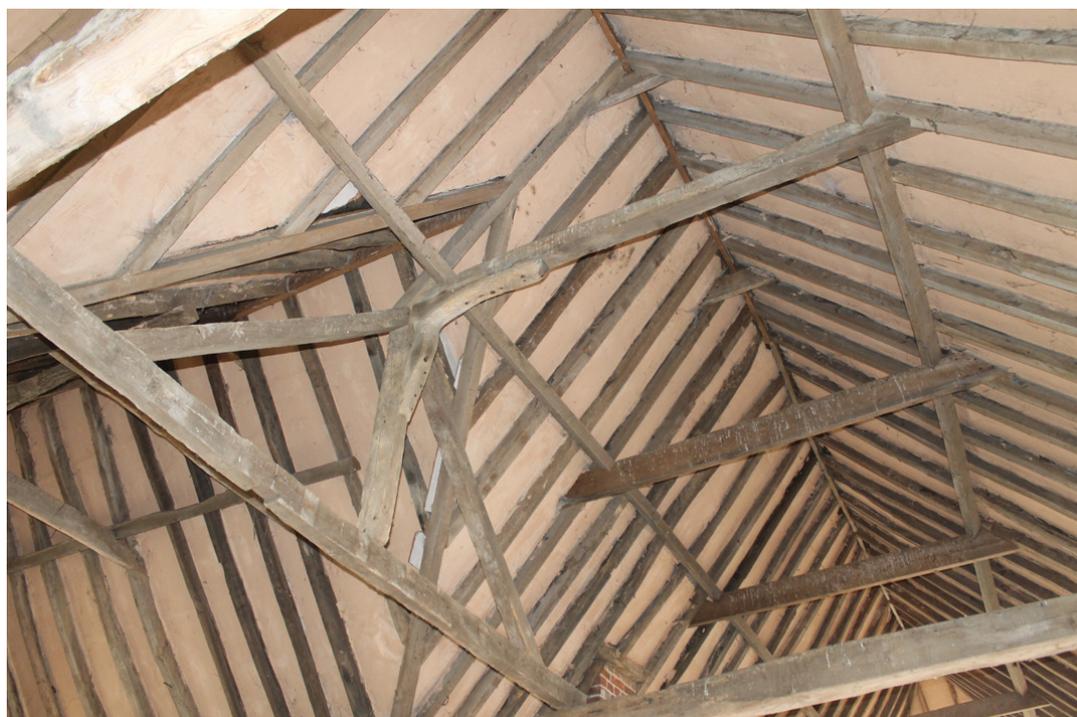
Photograph 14 Shot of bracing arrangement of timbers at intersection of midstrey and main range. Photograph taken facing south-west.

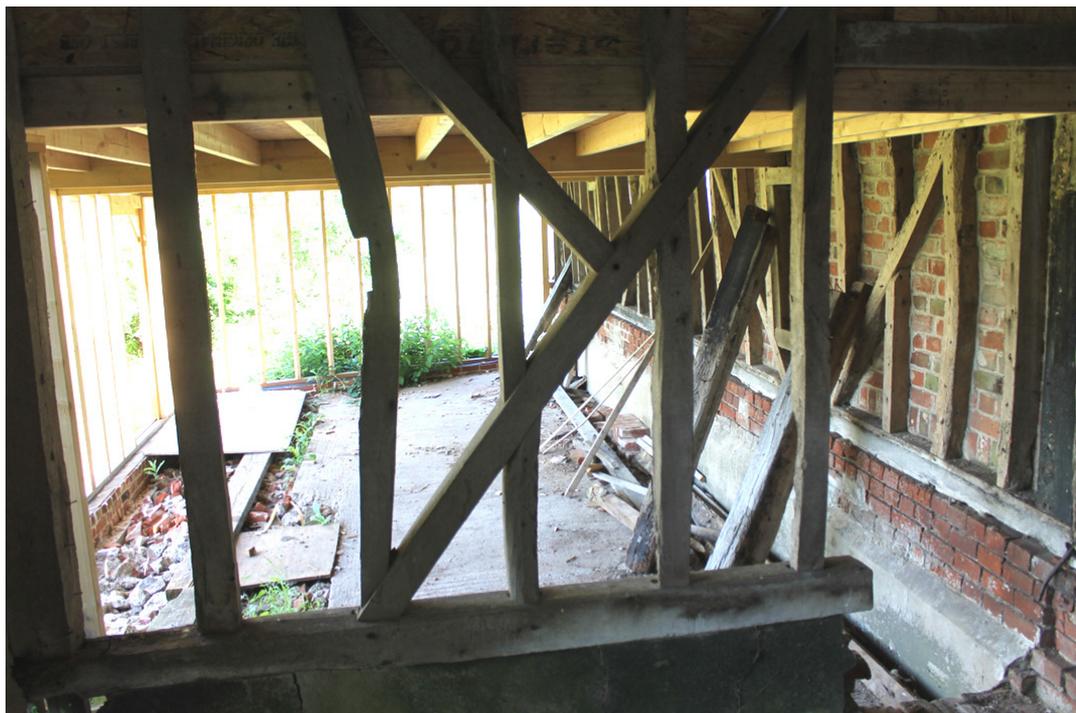
Photograph 17 Western elevation of midstre, showing y-bracing and modern hole for access into Building C. Photograph taken facing west.

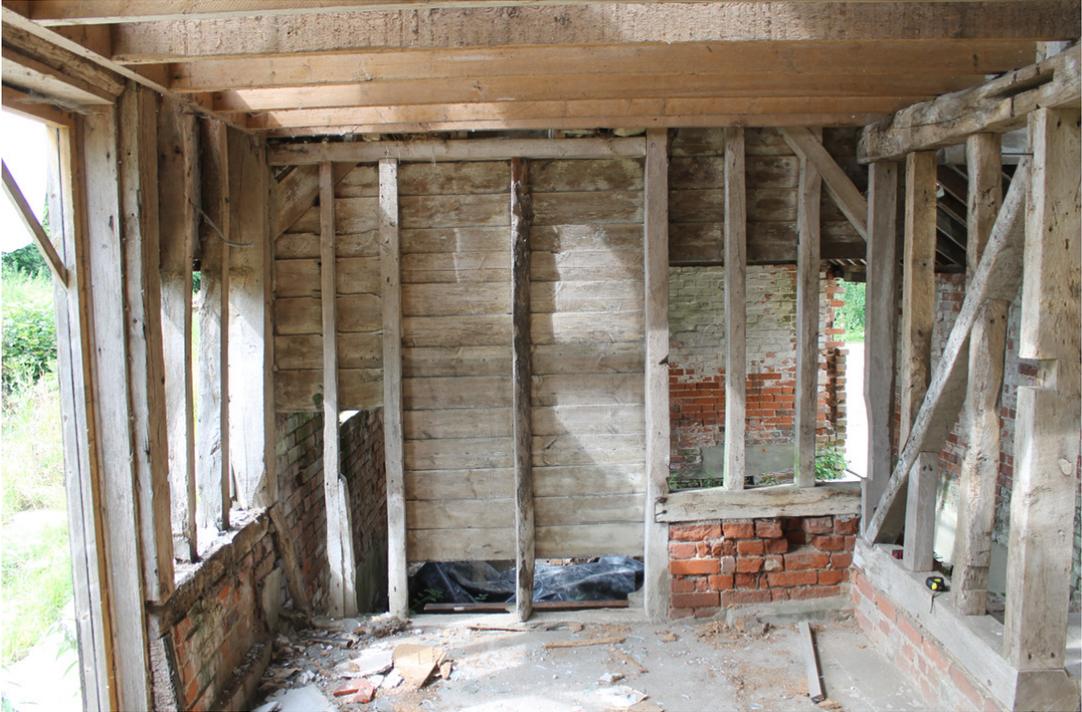
Photograph 19 Blocked ?original entrance into barn on northern elevation of bay 1. Photograph taken facing north.

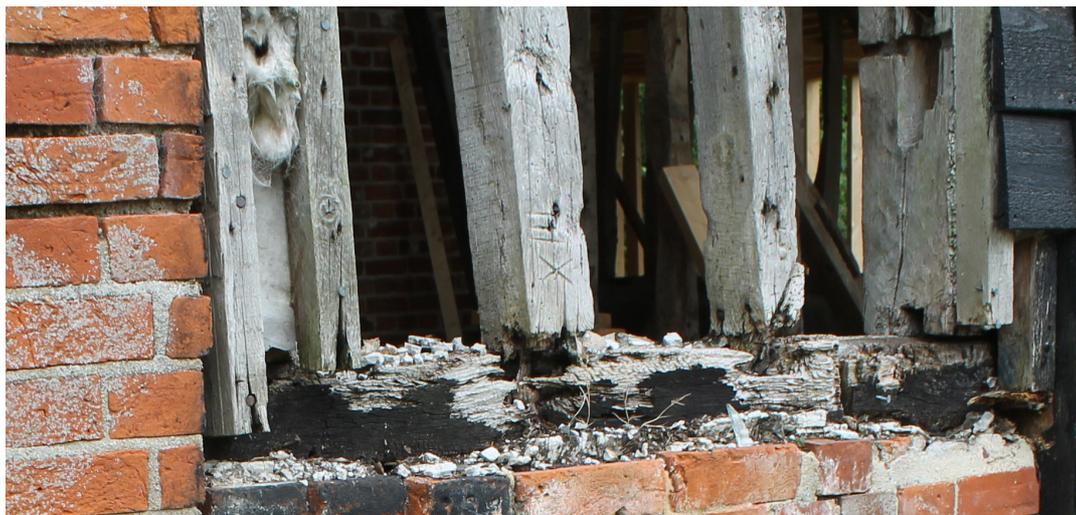
Photograph 21 Carpenter's mark visible on exterior of stud in western elevation of Bay 1. Photograph taken facing south-east.

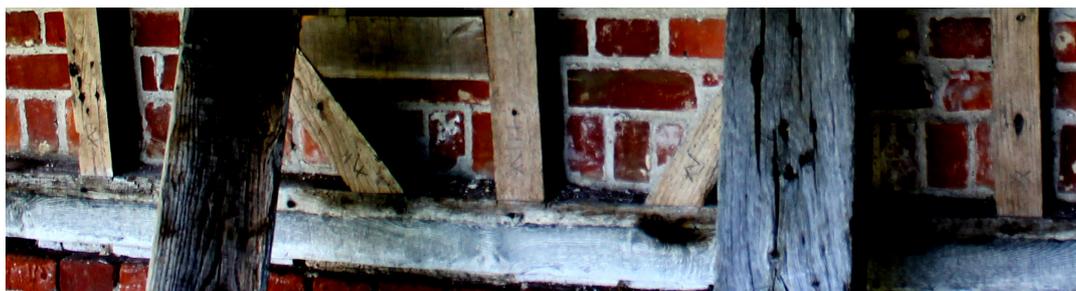
Photograph 22 Carpenter's mark visible on the exterior of studs and braces in southern elevation of Bay 2. Contrast enhanced for better visibility. Photograph taken facing north.

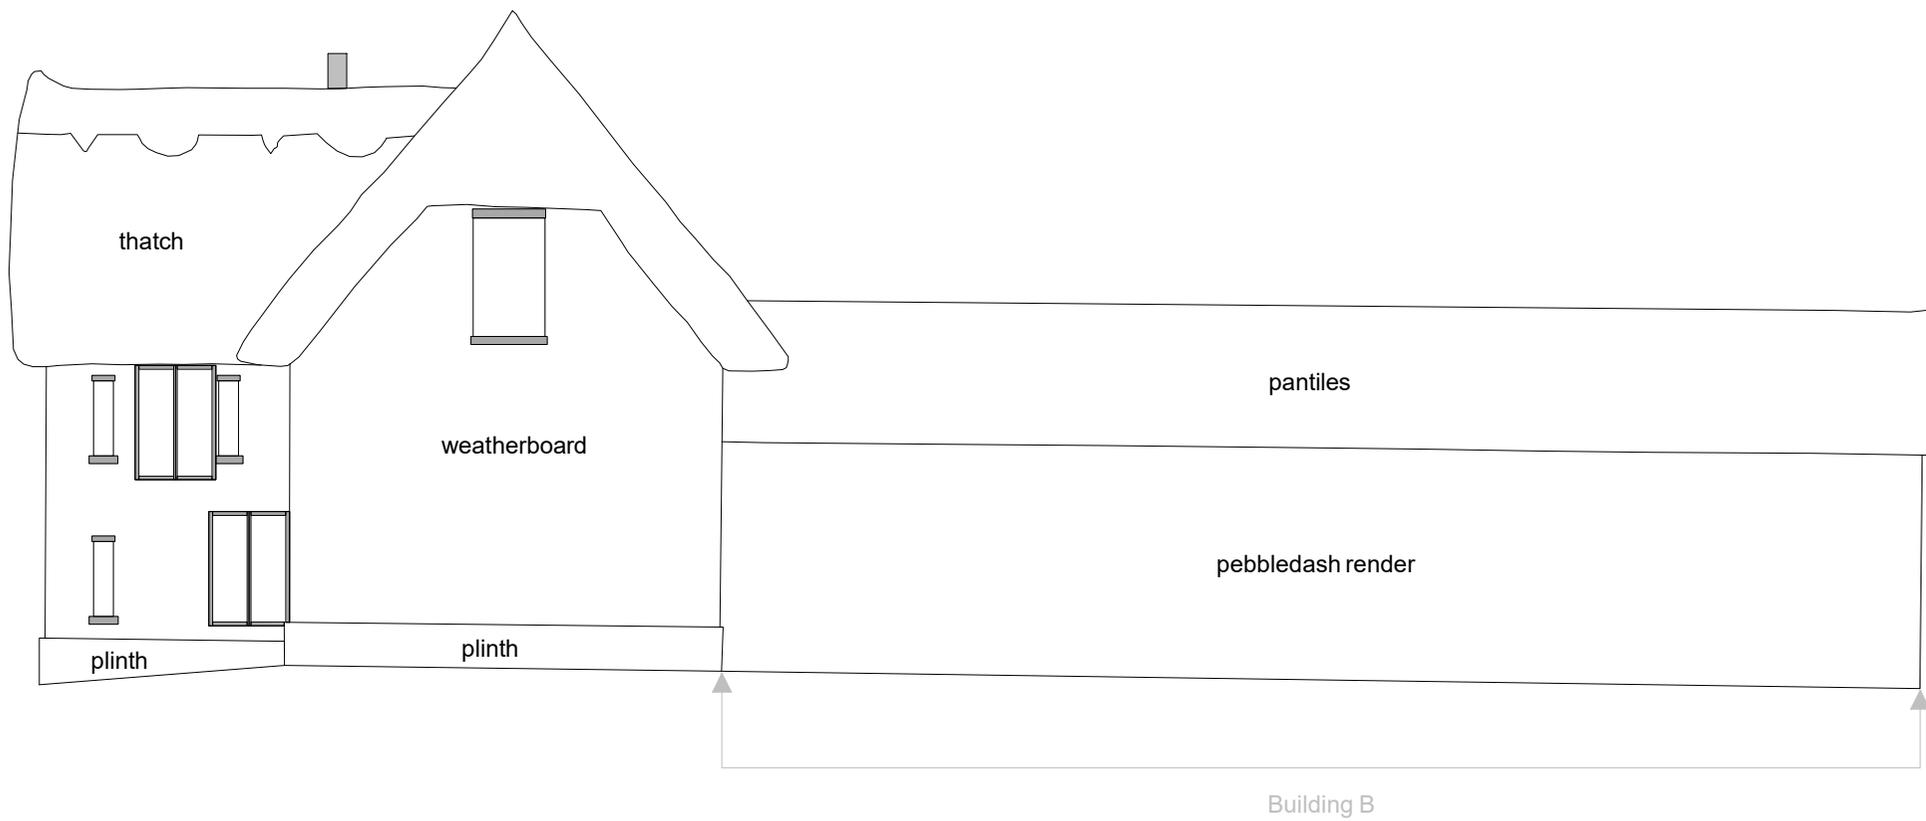
Fig 4 Eastern elevation of barn and Building B. Modern windows additions shown in grey.

The eastern elevation (Fig 4) has an opening at the top. This entire elevation was rebuilt in 1981 but the current opening replicates one that was originally on this elevation (*pers comm* the owner).

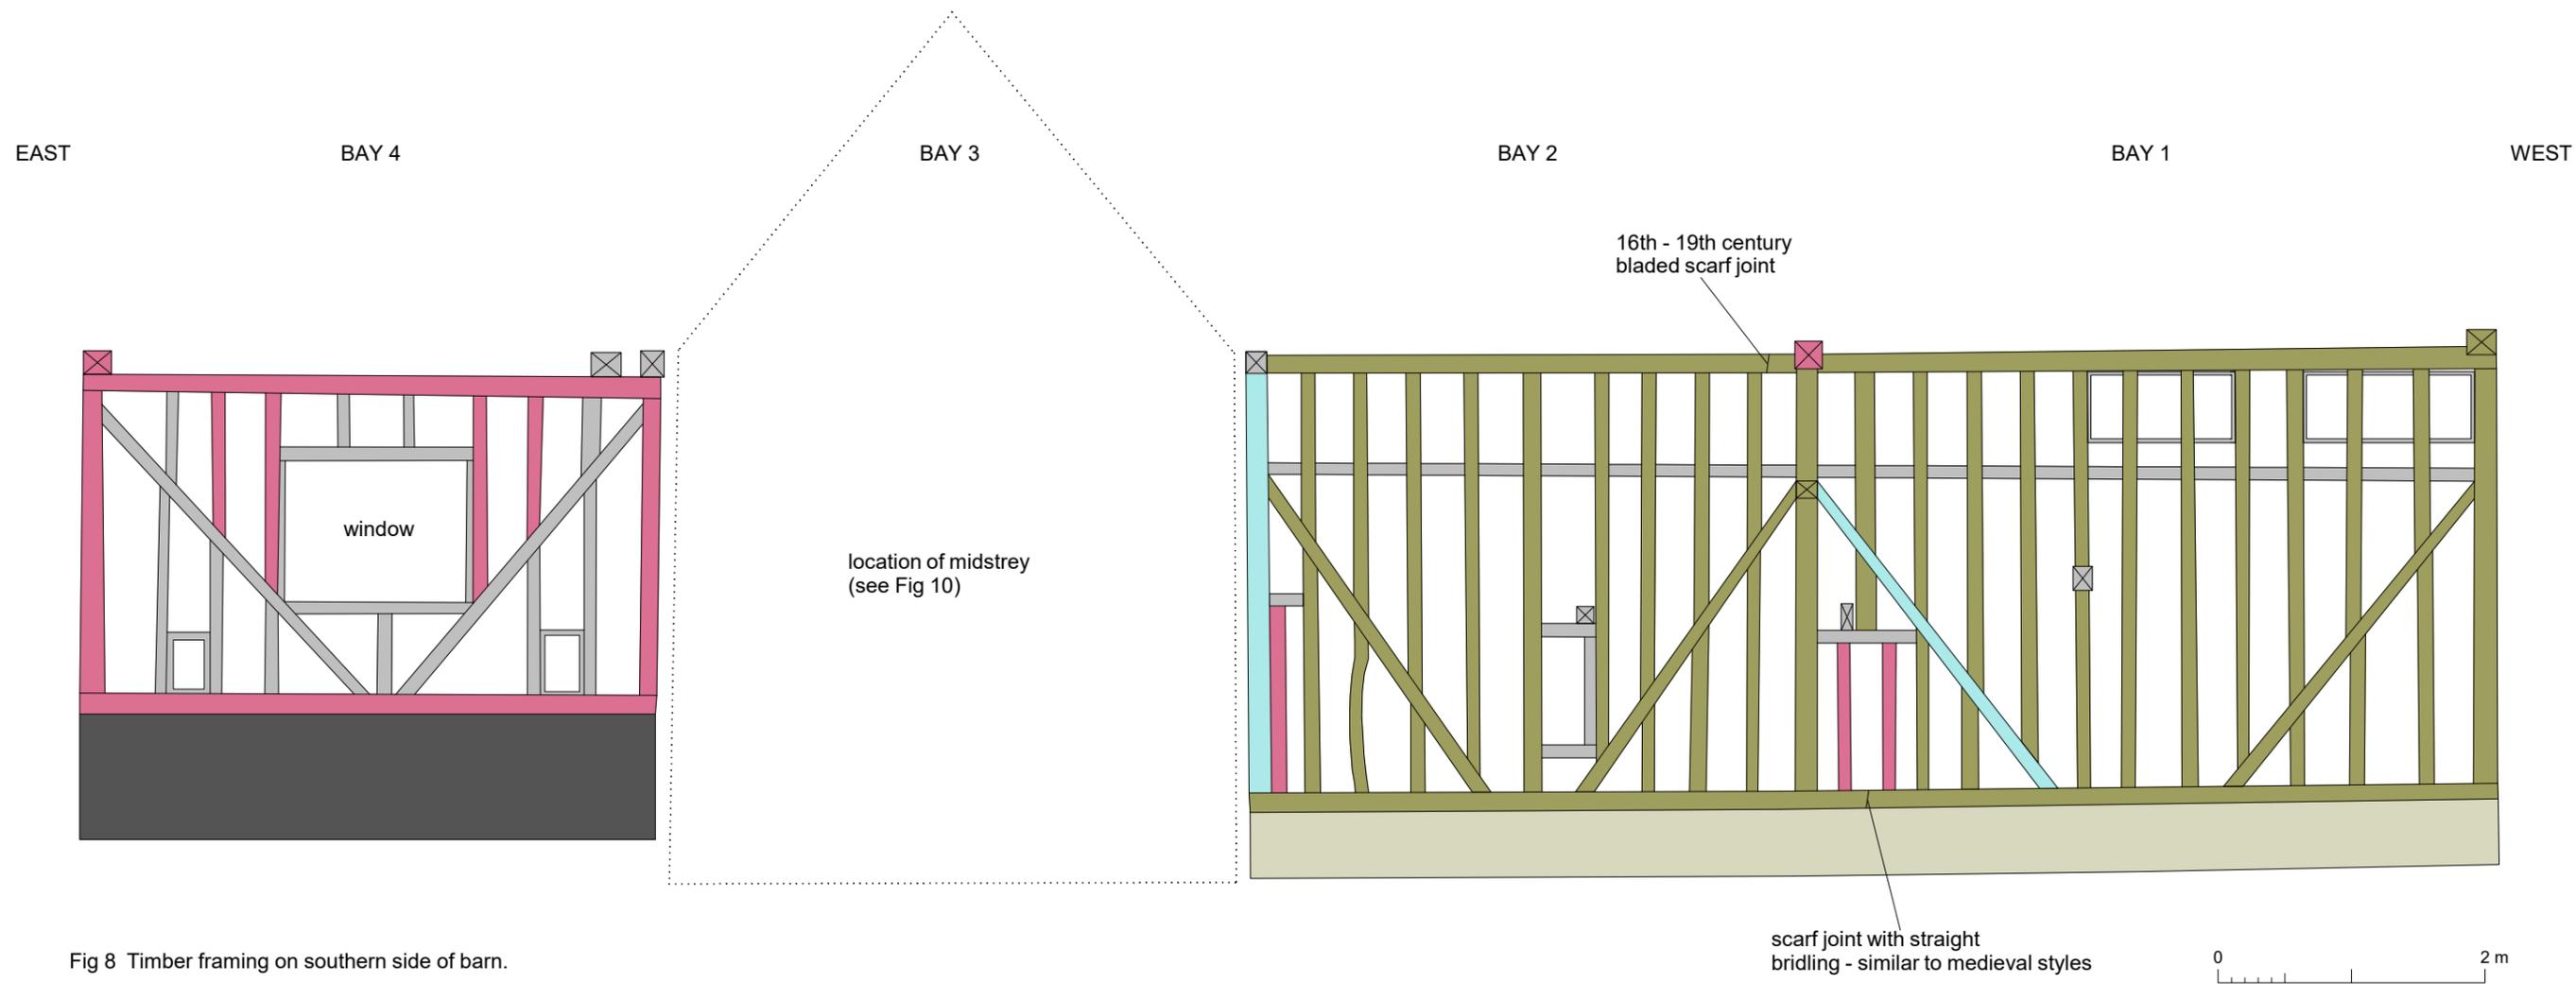
Fig 8 Timber framing on southern side of barn.

The southern timber-frame of the barn has had several modern timbers added into it in order to support the roof of Building C (Fig 8).
