**Historic building recording
of a barn at Cowlass Hall Farm,
Radwinter End,
Radwinter, Essex,
February 2017**

Planning reference: UTT/2063/15/FUL

CAT Report 1087
July 2017

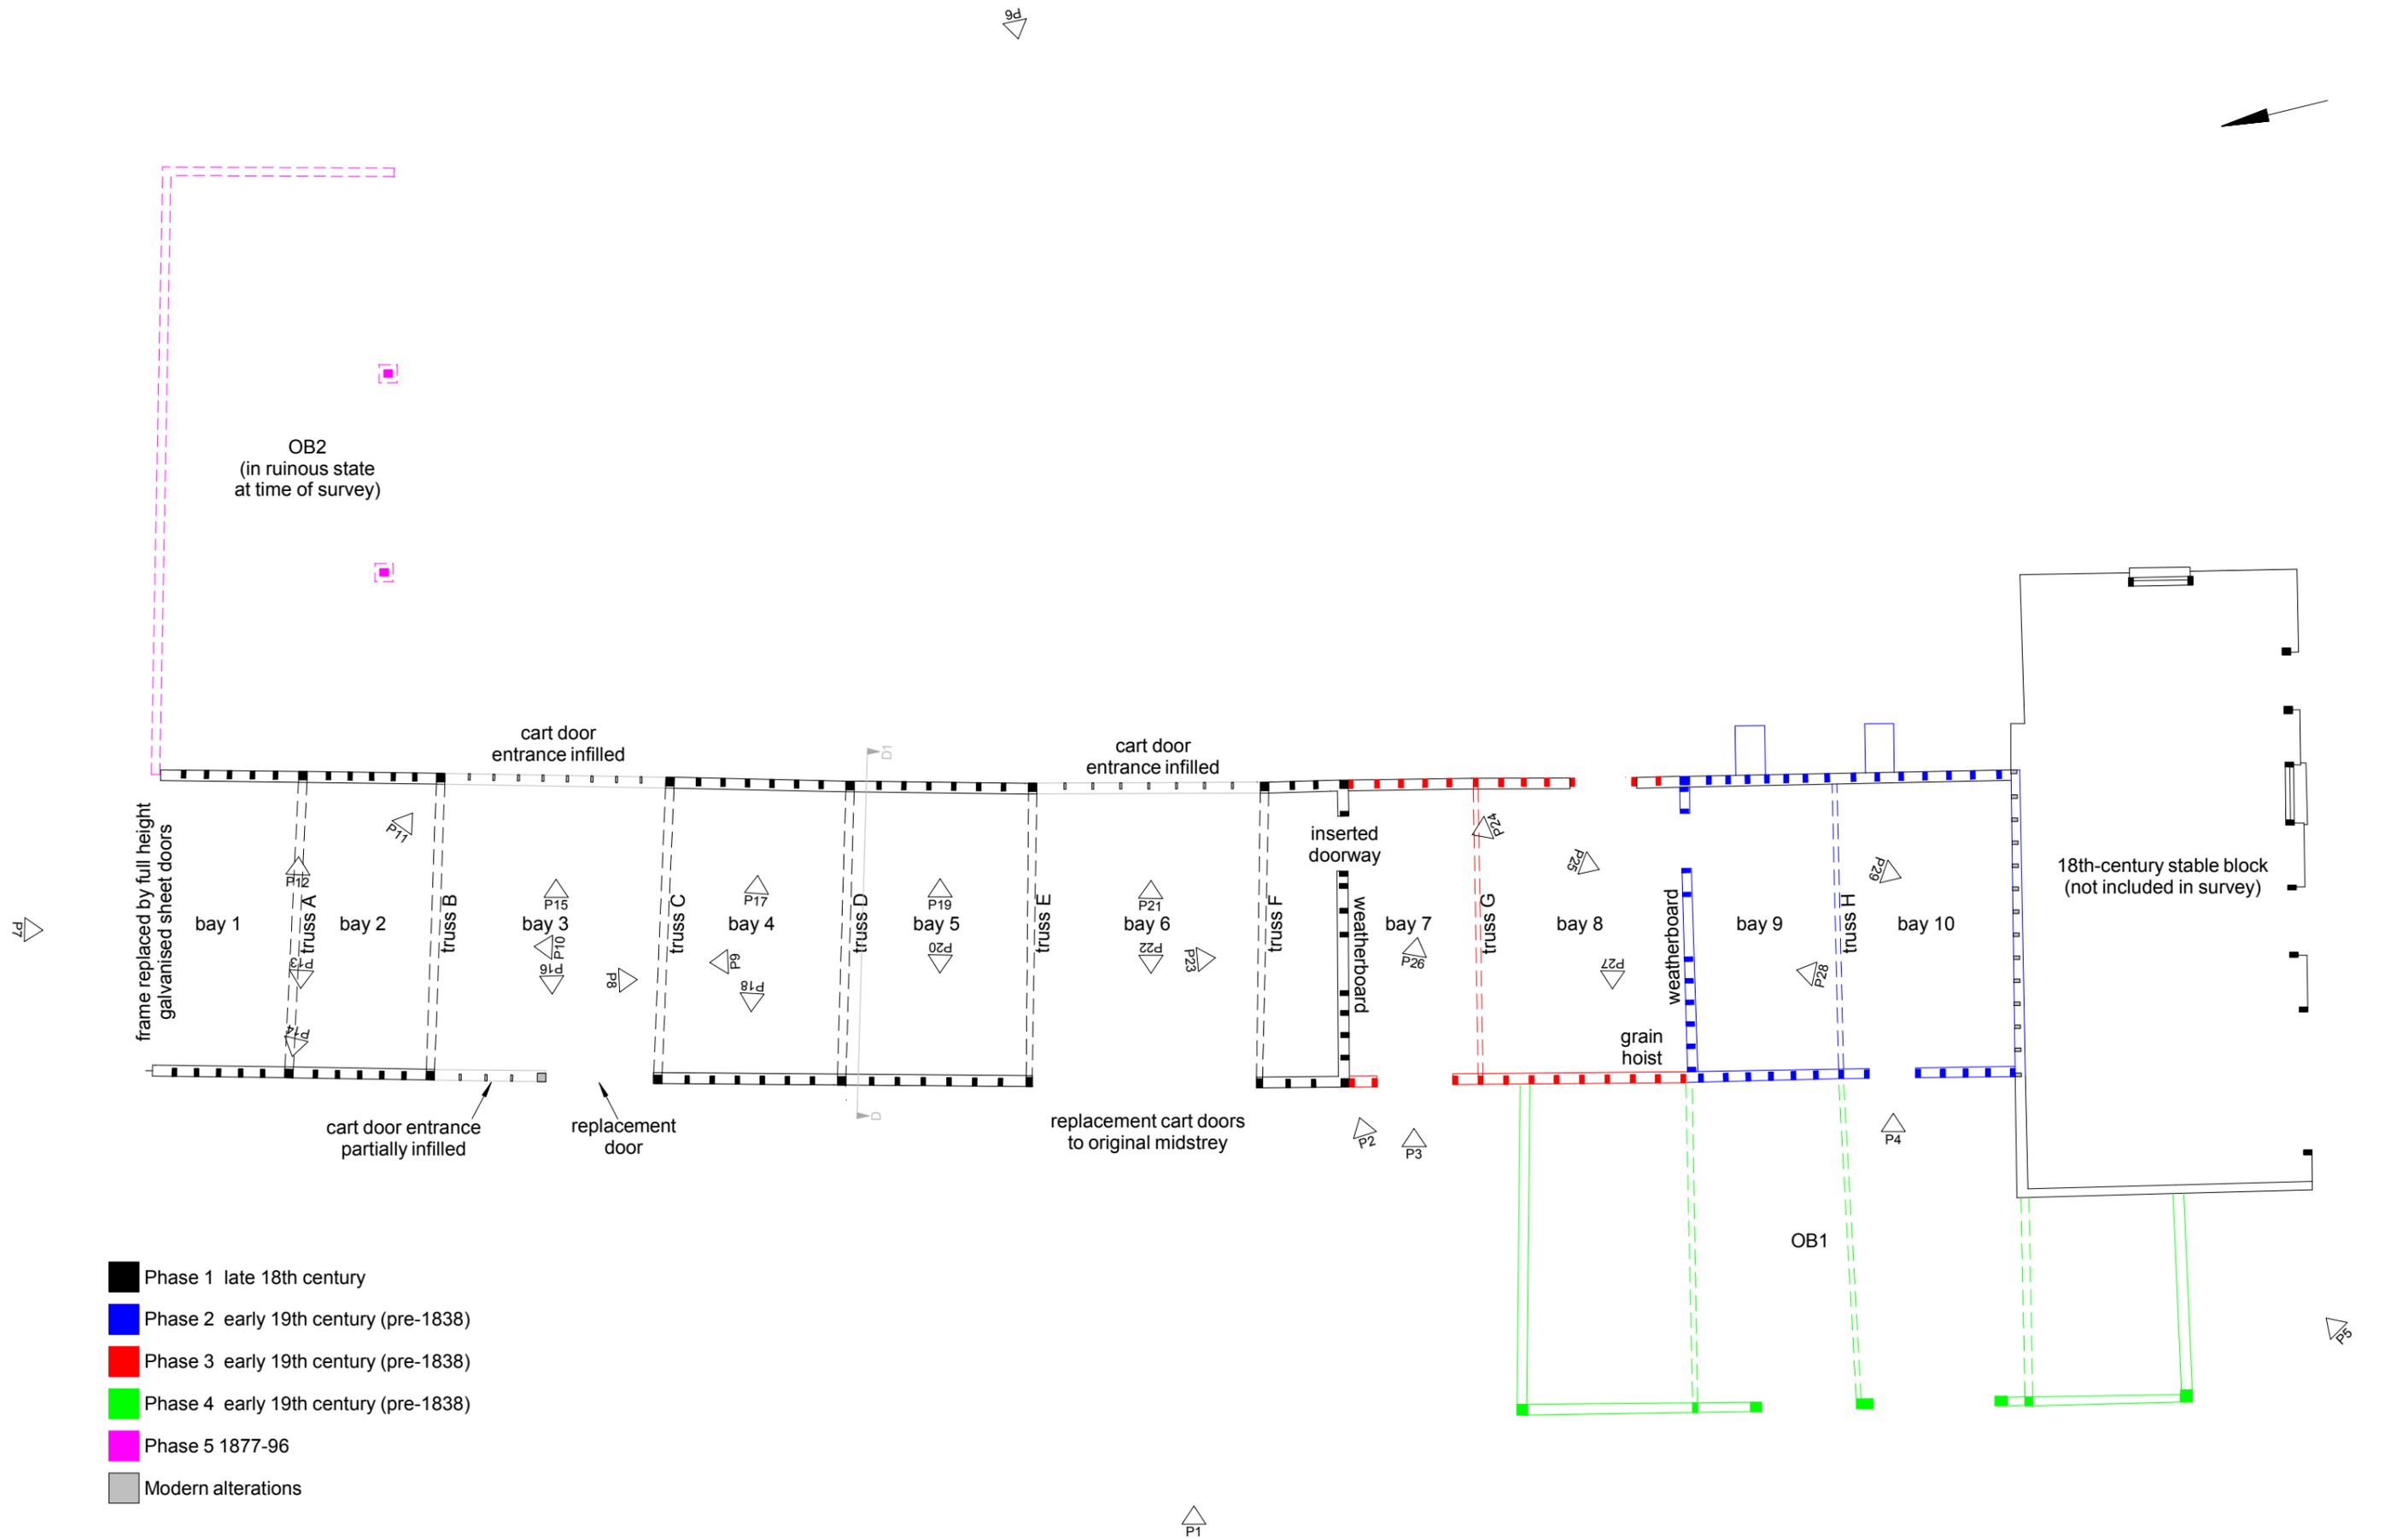
The barn comprises a main range of ten bays, aligned north-east to south-west, built up against the rear wall of the brick stable block and is 31.1m long by 5.1m wide (Fig 2). At the south-west corner there is a single-storey lean-to (OB1) and projecting from the north-east corner are the ruins of a single-storey cart lodge (OB2). The barn has a gabled roof of corrugated iron sheeting and the exterior is clad in black-painted horizontal weatherboard.

The interior of the barn comprises ten bays, labelled 1 – 10 on Fig 2. These ten bays incorporate the original 18th-century barn (bays 1-6) and the early 19th-century extensions to its south (bays 7-8 and 9-10).

Fig 2 Plan of Cowlass Hall Farm barn with phasing.
 Location and direction of photographs reproduced in Appendix 1 indicated by the numbered arrows.

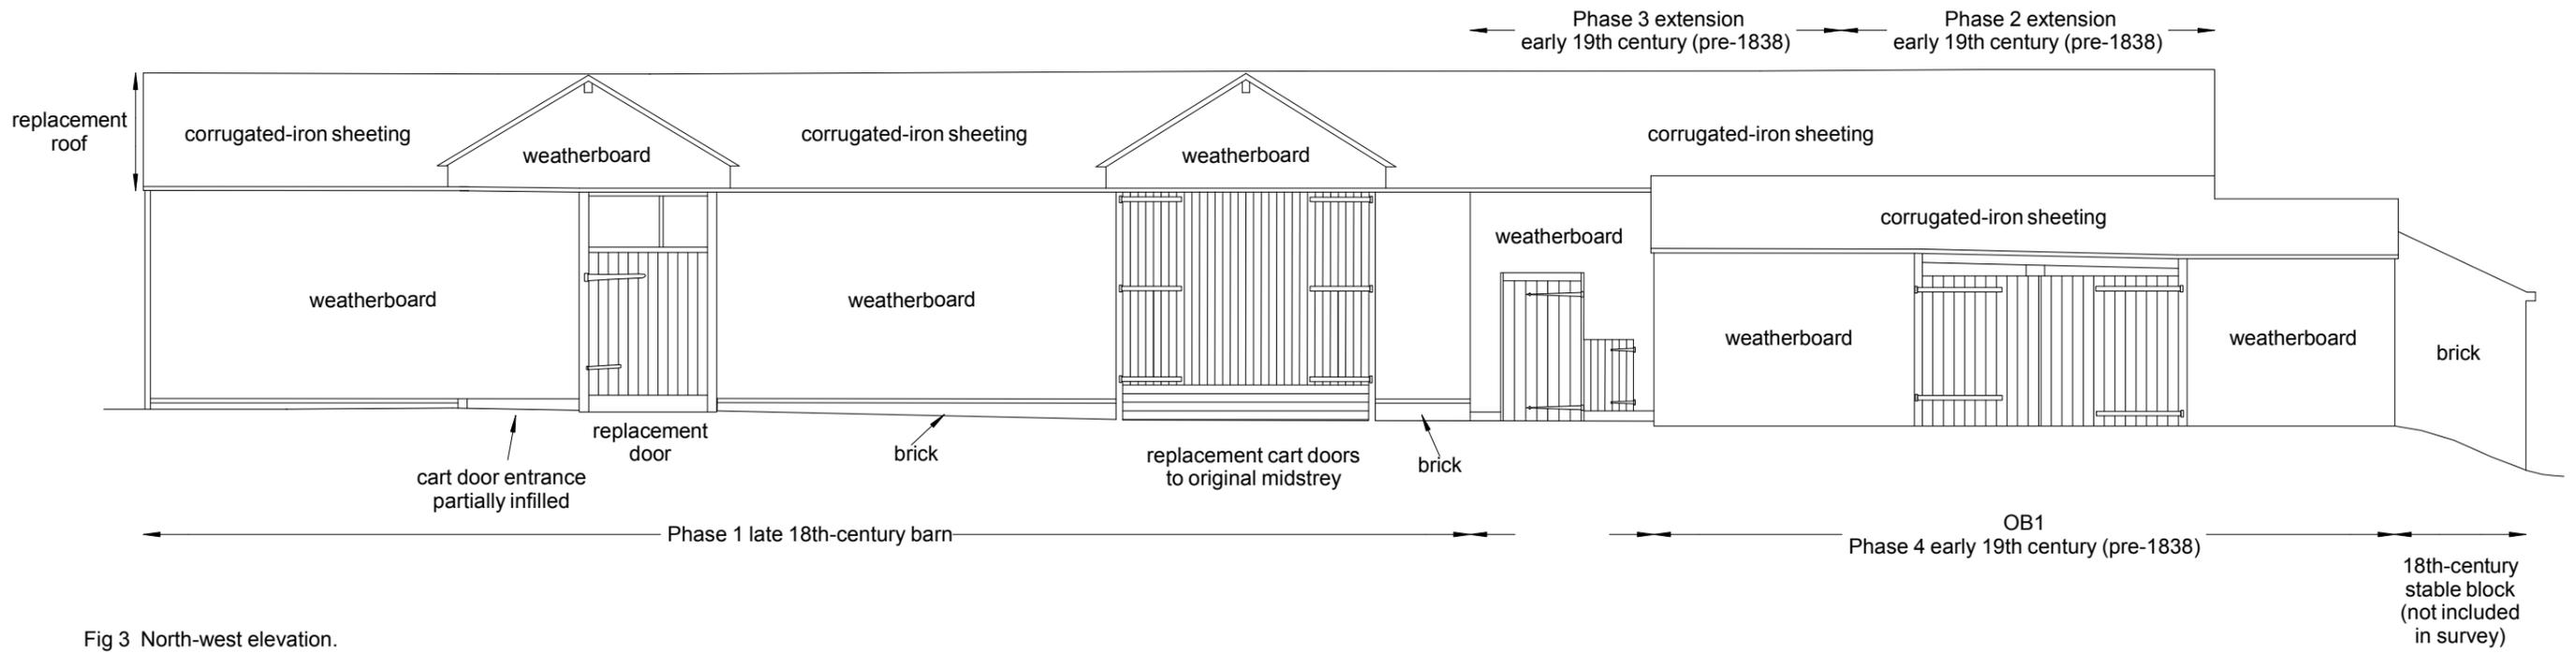
Fig 3 North-west elevation.

The north-west elevation (Photograph 1, Fig 3) has two non-projecting midstreys at bays 3 and 6, which indicate the barn was used for threshing. These midstreys have gabled pediments rising from the eaves. The opening for the barn doors of the midstrey to bay 3 has been diminished with the northern barn door completely replaced by studwork and the southern door replaced by a smaller door with two lights above it. The opening for the barn doors of the midstrey to bay 6 retains full height cart doors as well as the threshold leap, although these are replacements for the originals. The majority of the north-west frame sits on a plinth of red brick with dimensions of 230 x 120 x 66mm, laid in a rough Flemish bond. The top course of this is chamfered. Approximately 1.5m to the right of the midstrey to bay 6 this plinth stops, with the remainder of the barn to the south (19th-century extensions) carried on a much lower plinth (Photograph 2). A doorway provides access to bay 7 (Photograph 3). A much smaller doorway is located next to this, the purpose of which is unclear but may be linked to machinery located inside. The remainder of the north-west elevation is obscured by OB1 but visual inspection within the lean-to shows that the horizontal weatherboard continues and that there is an entrance to bay 10 with a hatch directly above this (Photograph 4).

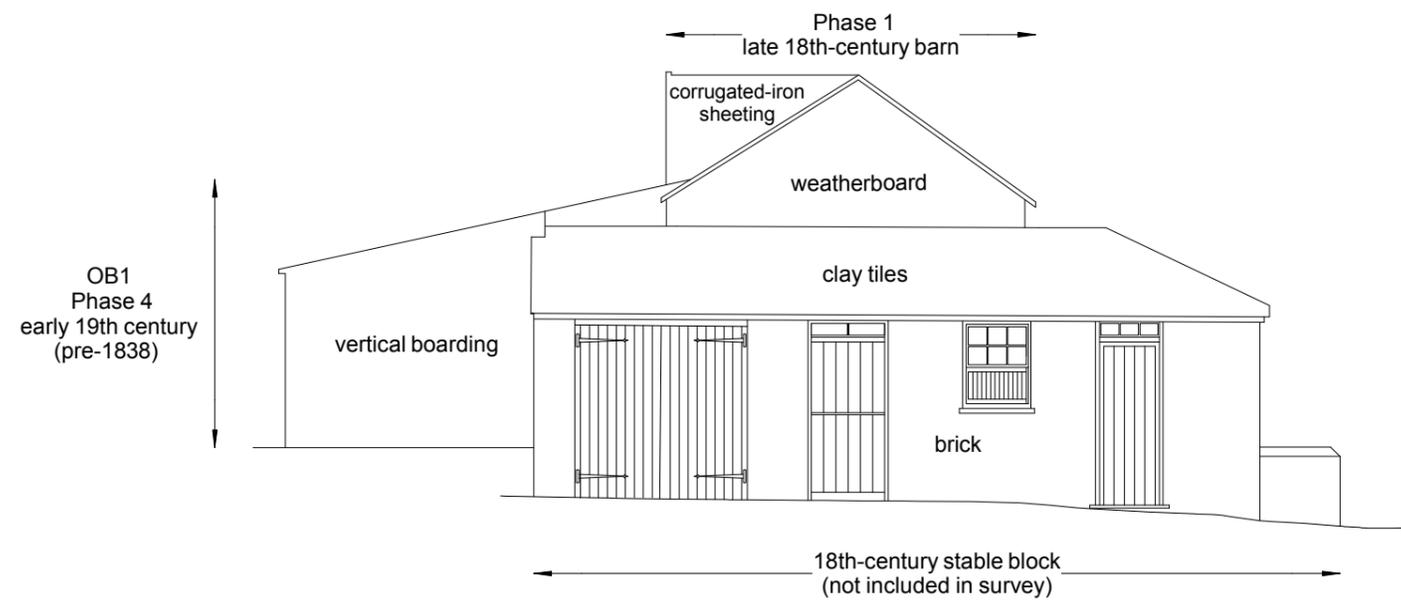
Fig 4 South-west elevation.

The majority of the south-west elevation of the barn is obscured by the 18th-century brick stable block (Photograph 5, Fig 4). All that is visible is the gable end, clad with horizontal weatherboarding. A weathervane with a canine motif is affixed to the apex of the gable.

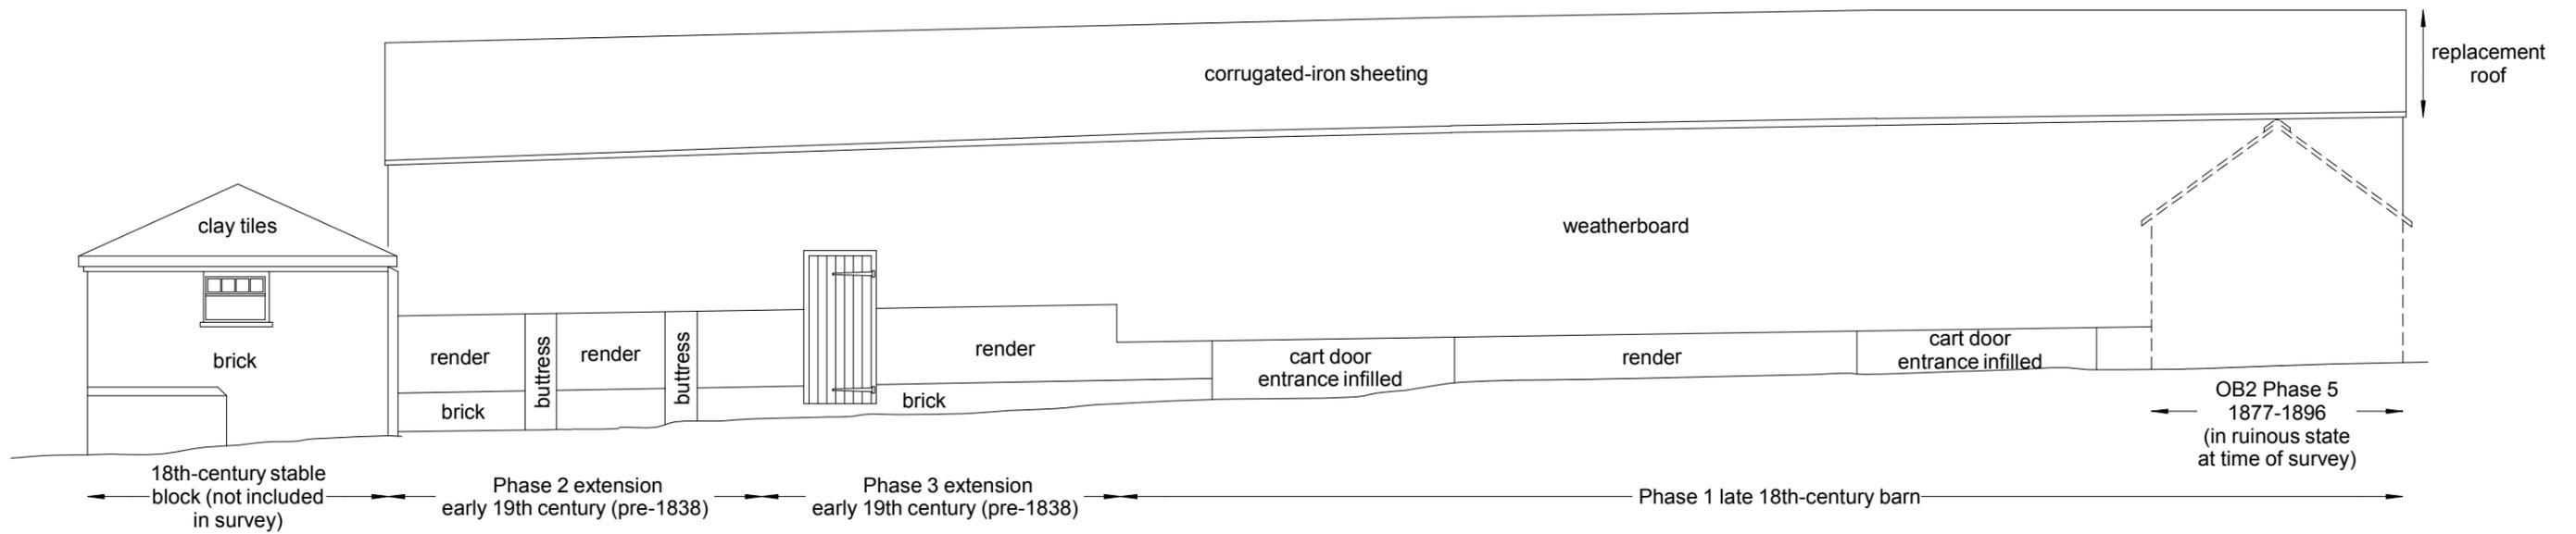
Fig 5 South-east elevation.

The south-east elevation is plain weatherboard above areas of render and brickwork (Photograph 6, Fig 5). This clearly shows that the plinth walls of the extensions to the south end of the main barn are significantly higher than the plinth wall of the main barn. Two buttresses to the plinth wall of bays 9 and 10 are probably modern additions. An entrance to bay 8 is the only access to the barn on this side. The original cart door entrances on this elevation have been blocked, although it is clear where these were originally located. The north end of this elevation is partially obscured by the ruins of OB2.

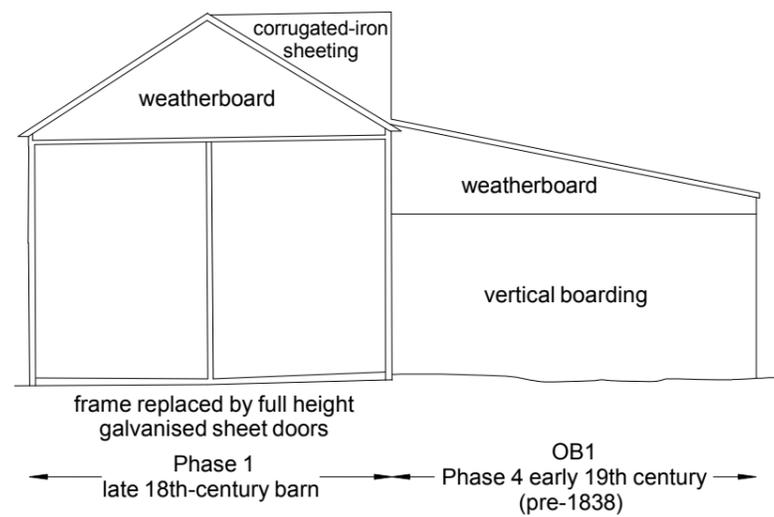
Fig 6 North-east elevation.

The north-east elevation has been completely converted to accommodate full height doors formed from galvanised sheets on a steel frame (Photograph 7, Fig 6). The gable end above this is horizontal weatherboard and has probably been completely rebuilt.

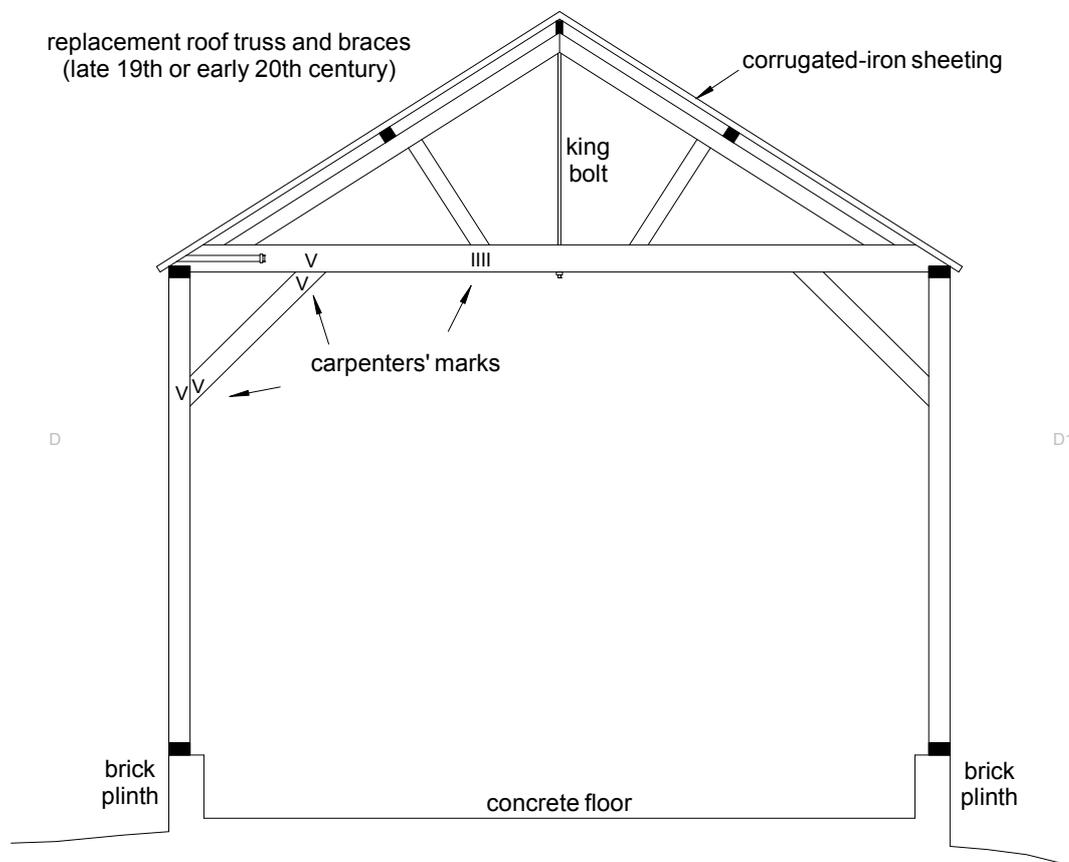
Fig 7 Cross-section of truss D.

The south-east side of bay 4 (Photograph 17) has 'II' marked on the feet of the studs and bracing with 'IIV' to the heads. The north-west side (Photograph 18) has a combination of 'IIII' and 'IV' to the feet and 'III' to the heads. Truss D has 'IIII' at the joints and 'V' where the tie beam and principal post are braced on the north-west side (Fig 7).
