**Historic building recording at  
5 and 6 St Nicholas Street (formerly 'Jacks'),  
Colchester  
CO1 1LB**

**September 2017**

CAT project ref.: 17/05i  
NGR: TL 9982 2517 (centre)  
Planning reference: 161296  
CHER event number: ECC4001  
Colchester Museum accession number: COLEM 2017.71  
OASIS reference: colchest3-285635

**CAT Report 1222**  
March 2018

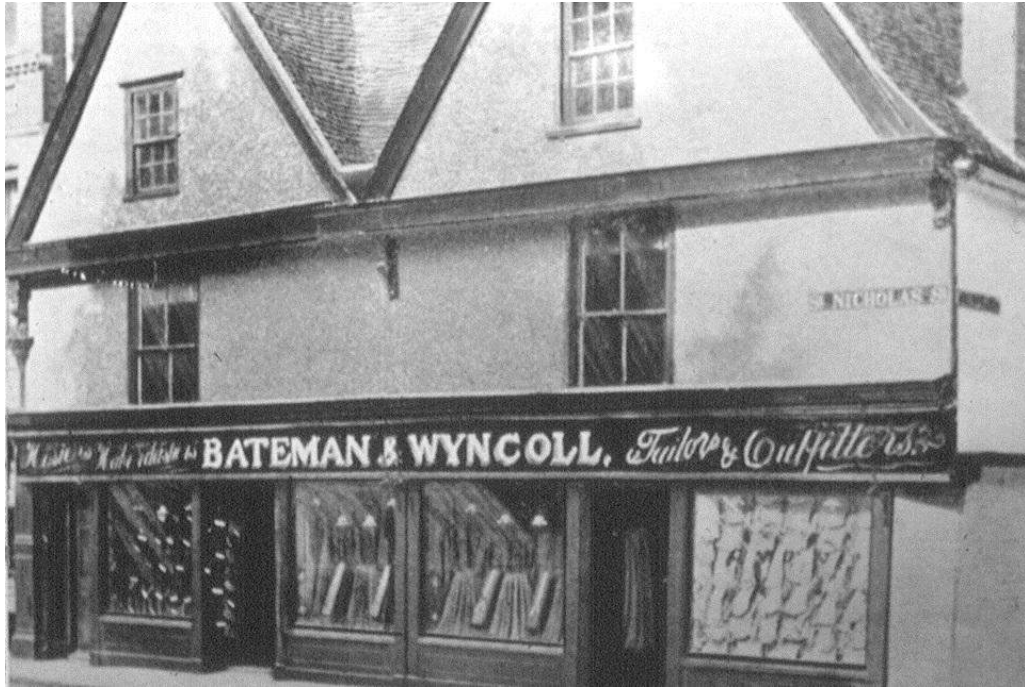
**Photograph 1** Western elevation of 5 & 6 St Nicholas Street (Buildings A and B), taken in 1908. Note different windows and shop front (and lack of pargeting) compared to modern appearance (Photograph 2). Taken from [www.gazette-news.co.uk/history/1528359.NOSTALGIA\\_Pictures\\_of\\_the\\_1d\\_JacksHardware\\_store\\_as\\_it\\_used\\_to\\_be](http://www.gazette-news.co.uk/history/1528359.NOSTALGIA_Pictures_of_the_1d_JacksHardware_store_as_it_used_to_be) Labelled as being from a Colchester Guide book in 1908.

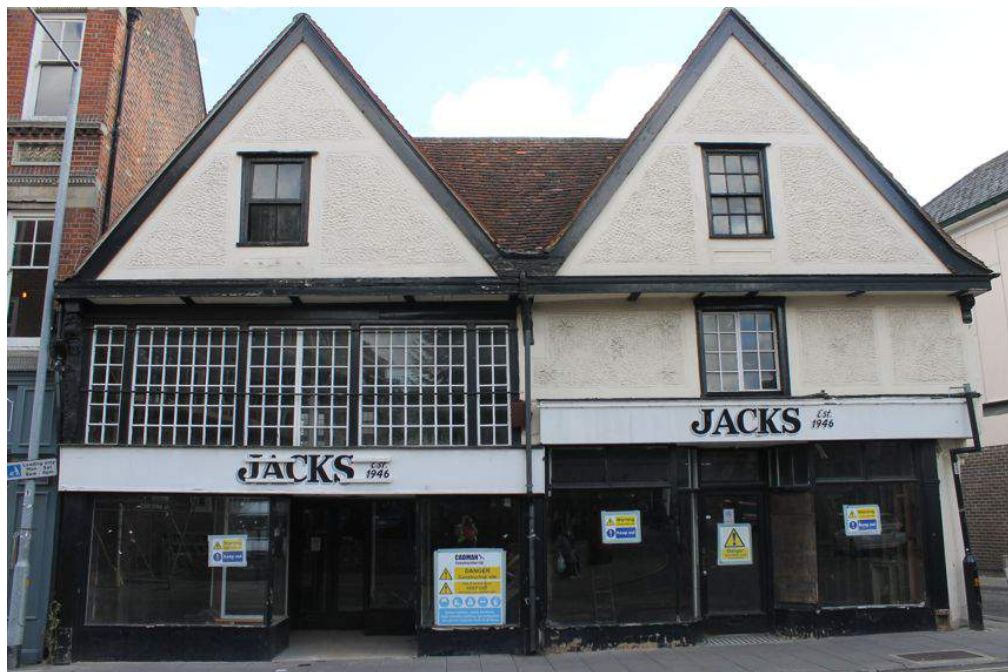
**Photograph 2** Current western elevation of Buildings A (left) and B (right).

Comparing the 1908 photograph (Photograph 1) with the current frontage of Buildings A and B (Photograph 2), shows that the facade of the building has changed significantly in the last century, with the entire lower floor shop front and signs having been completely replaced, and a large range of windows inserted in the first-floor of Building A. These

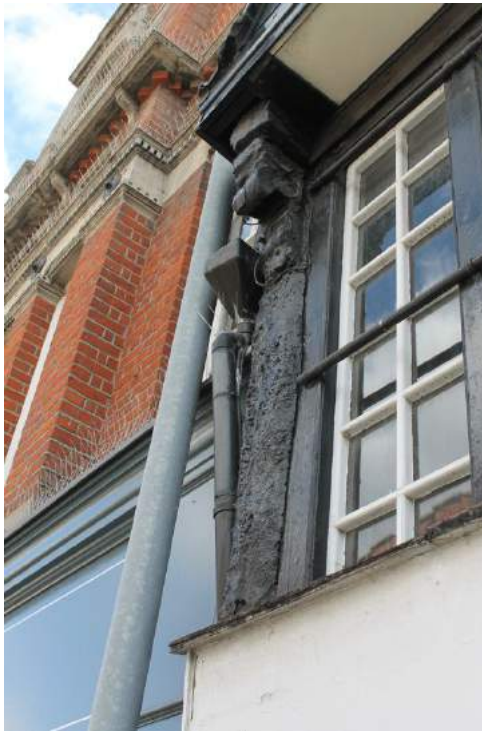
**Photograph 5** North-west corner-post supporting second-floor jetty. Note carved top. Photograph taken facing north-east.

The western elevation of Building A is jettied on the first- and second-floor, with both overhanging the floor below (Photograph 2). The corner-post supporting the second-floor's jetty has a carved decoration at its apex (Photograph 5). There is simple pargetting on this rendered gable-end, which contains an off-centre inserted four-light sash window. Below this the entire first-floor wall has been removed and five large windows have been inserted (two fixed twelve-lights, two fixed 42-lights and one 36-lights casement). The ground-floor on this elevation is a windowed shop front, wooden-framed with large panes of glass and a double door. The pargetting, windows and shop front on this elevation have all been added to the building since 1908 (see historical background pg 11).

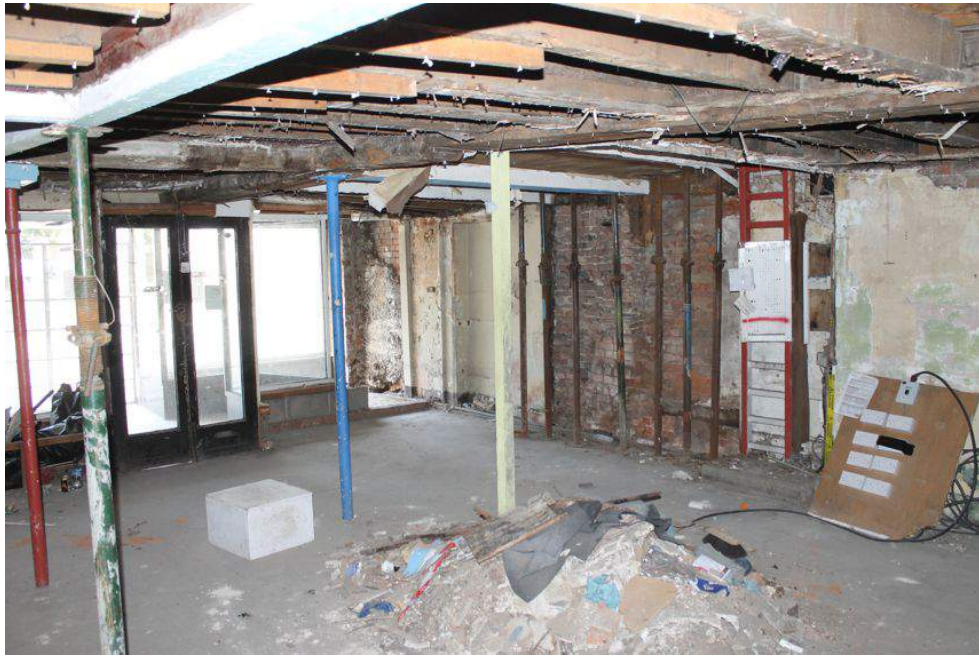
The ground-floor of Building A is open plan, with no surviving divisions (Photograph 6). It has a modern concrete floor. As mentioned previously, very little of the building's original fabric survives at this level, with brick-built walls and pillars, as well as some replacement timbers, now supporting the upper floors. It seems likely that most of the structure's stability is the result of it being directly adjacent to the large brick-built structure to the north (4 St Nicholas Street).

**Photograph 6** Ground-floor of Building A. Photograph taken facing north-west.

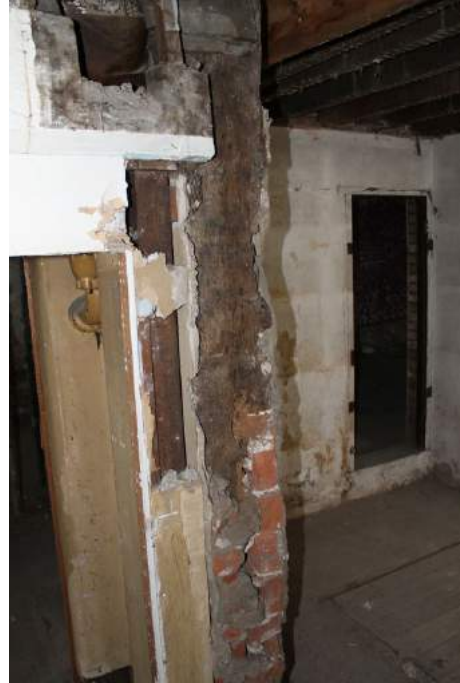
Three of the four corner-posts are still present, but none survive to ground level, either being supported by brickwork, or, in some cases, not being supported at all (Photograph 7 and 8). The corner-post in the south-west corner is not visible, and has probably been replaced by a metal girder (see Building B below). No studs survive. Only one small section of the northern sill-beam survives. Beneath this is a section of brick plinth that may be original to the building: it is in very poor condition, with three courses of indeterminate bonding and bricks measuring 170 x 100 x 60mm (Photograph 9).

**Photograph 8** Remains of south-east corner-post of Building A at the ground floor. Photograph taken facing north-east.

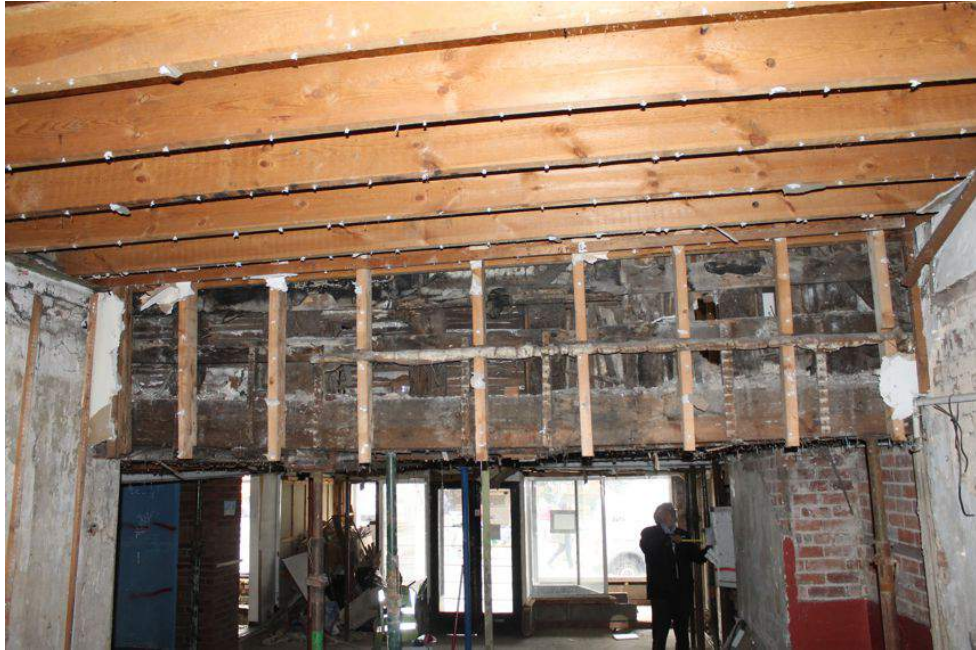
The eastern elevation of the ground-floor is devoid of any features, and largely opens up into Building E (Photograph 12). The south-east corner of the structure is supported by a later rendered-over brick wall. The principal-post in this elevation is entirely absent. Of note on this elevation, however, is the intact girding-beam, and on the underside of it a series of diamond window mullions and a shutter groove, as well as mortices for studs (Photograph 13). These features are remnants of an unglazed opening on this elevation, a feature found in buildings up to the early 16th century, but typically dating to the 15th century or earlier (Historic England 2017, 8). The implications of the date of this feature is examined in the discussion.

**Photograph 12** Eastern elevation of Building A at ground level. Photograph taken within Building E and facing west.

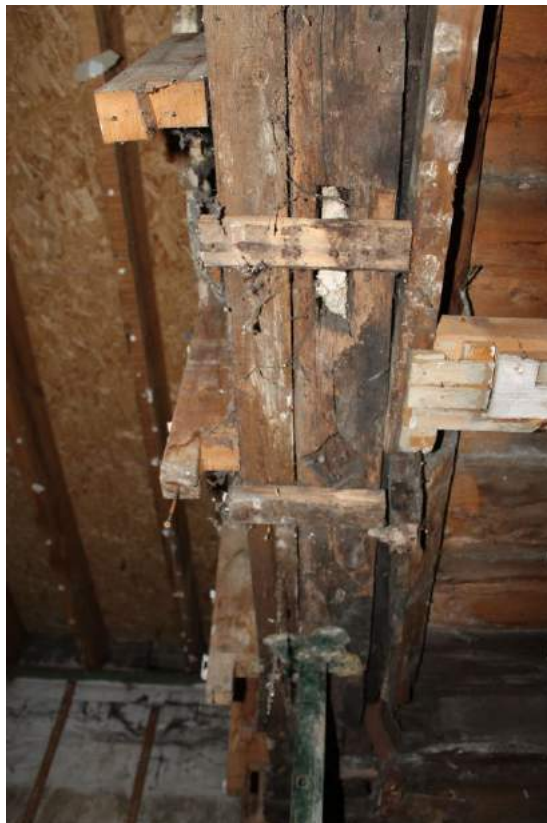
The southern elevation of the ground-floor is, like the eastern, devoid of features. A brick pillar encases and reinforces the surviving principal-post in this elevation but no studwork remains. The underside of the girding-beam, where visible, has mortices spaced 250-300mm apart. No gaps in the mortices were observed that could indicate an opening into the building. To the west of the southern elevation (below where the

girding-beam has been replaced by a metal beam), the studs have been replaced by a modern plasterboard wall.

**Photograph 13** Underside of girding-beam on eastern side of Building A. Diamond window mullions visible.

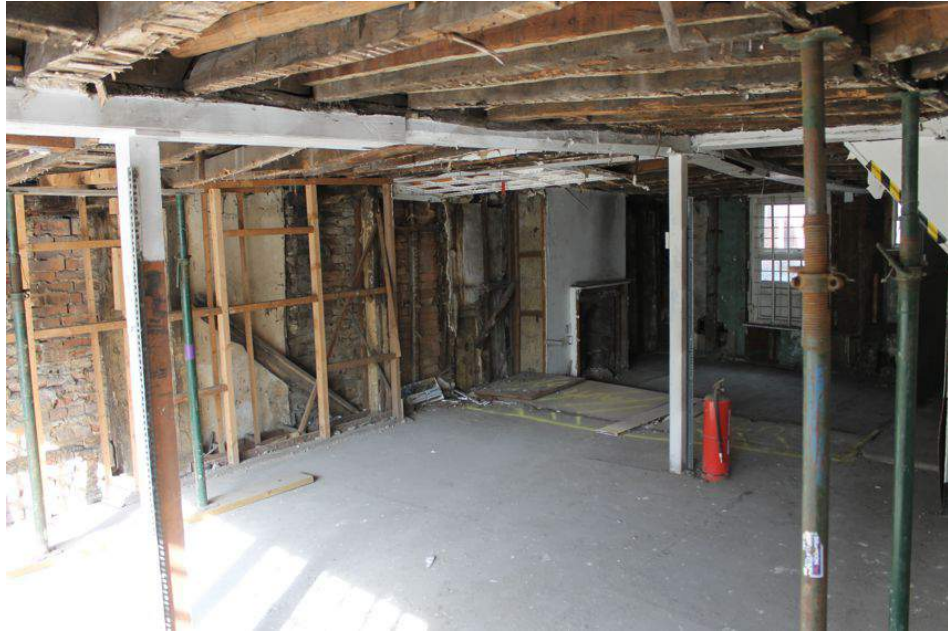
The first-floor of Building A is mostly open plan (Photograph 15). There is a single modern plasterboard division that extends 2.2m into the main room from the eastern wall, and the stairwell leading to the second-floor occupies part of the floor space, but apart from these two the features the first-floor is a single room. The floor is partially exposed floorboards, partially modern plasterboard, and partially concrete (in the south-east corner).

More of the original fabric of the building survives on this floor than the ground-floor, but it is still heavily damaged, with several areas of modern insertion and repair. The wall-plate survives around most of the building, although it is completely obscured by modern plasterboard on the western elevation, above the row of large inserted windows. Like the binding-beams, the wall-plate is chamfered. Several studs on the northern elevation are missing or have been replaced by modern machine-cut timbers. All four corner-posts, rising from the ground-floor, are intact at this level.

**Photograph 15** First-floor in Building A. Photograph taken facing north-east.

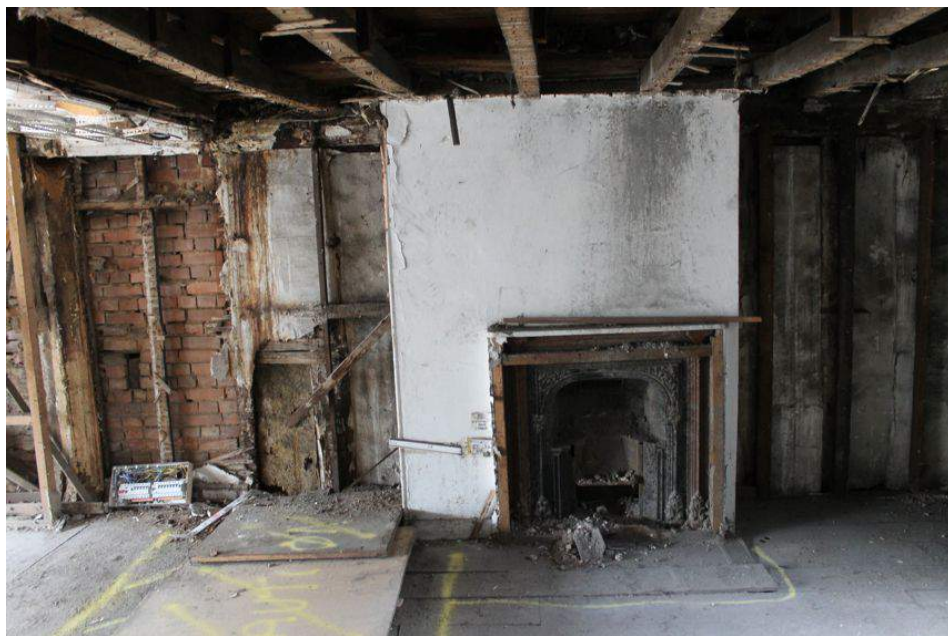
**Photograph 16** Chimney-stack and later fireplace in first-floor of Building A. Photograph taken facing north.

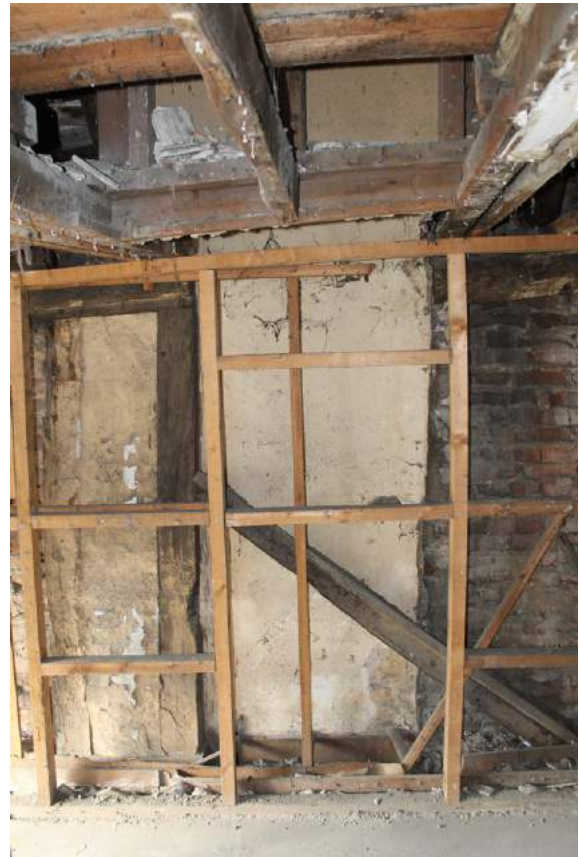
**Photograph 17** Wall-plate cut and lath and plaster added behind on first-floor of Building A. Photograph taken facing north.

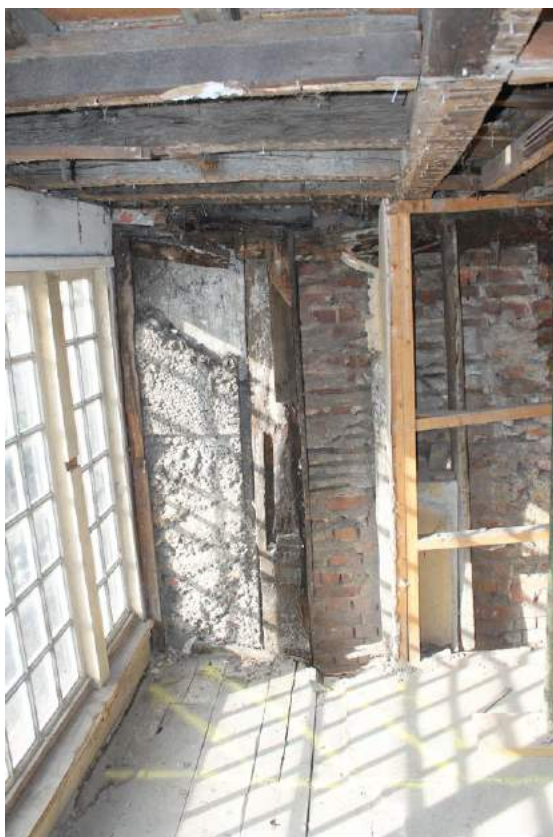
The north-west corner-post on the northern elevation has a large unused mortice in its face, probably for an arched brace (Photograph 18). Above this corner-post on the wall-plate is a large and rudimentary scarf joint; an edge-halved scarf with square abutments (Photograph 19). This joint connects the main wall-plate of the building with that of the jetty overhanging onto St Nicholas Street. Having a scarf joint in such a location would provide little structural stability to the jetty and would put a lot of pressure on the wall-plate and corner-post. This feature is one of the few instructive and diagnostic elements left in the building's frame, and is examined in detail in the discussion.

**Photograph 18** North-west corner-post of Building A, showing unused mortice for arch brace and scarf joint above. Photograph taken facing north.

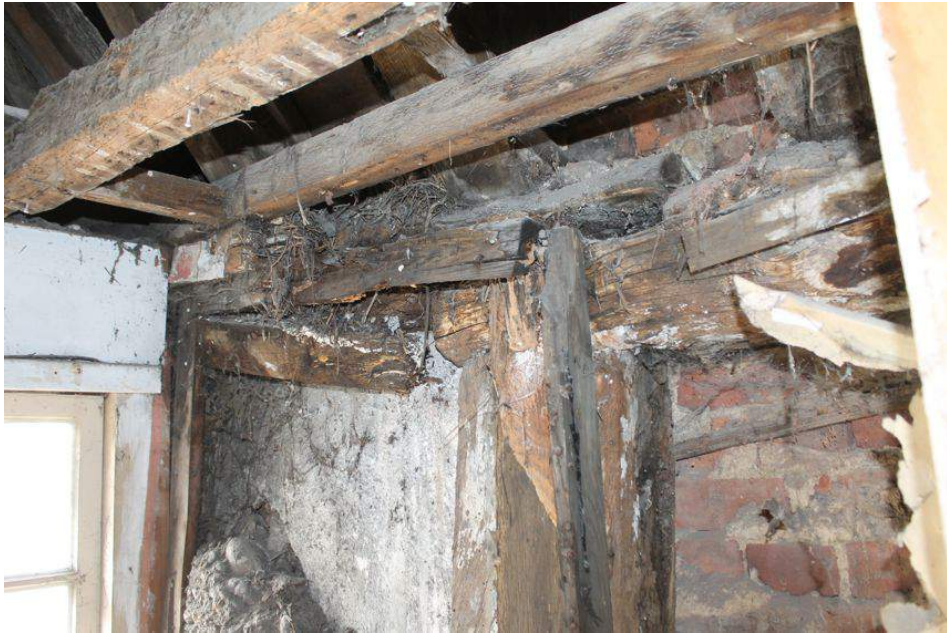
**Photograph 19** Detailed photograph showing scarf joint in wall-plate above north-west corner-post in Building A. Photograph taken facing north-west.

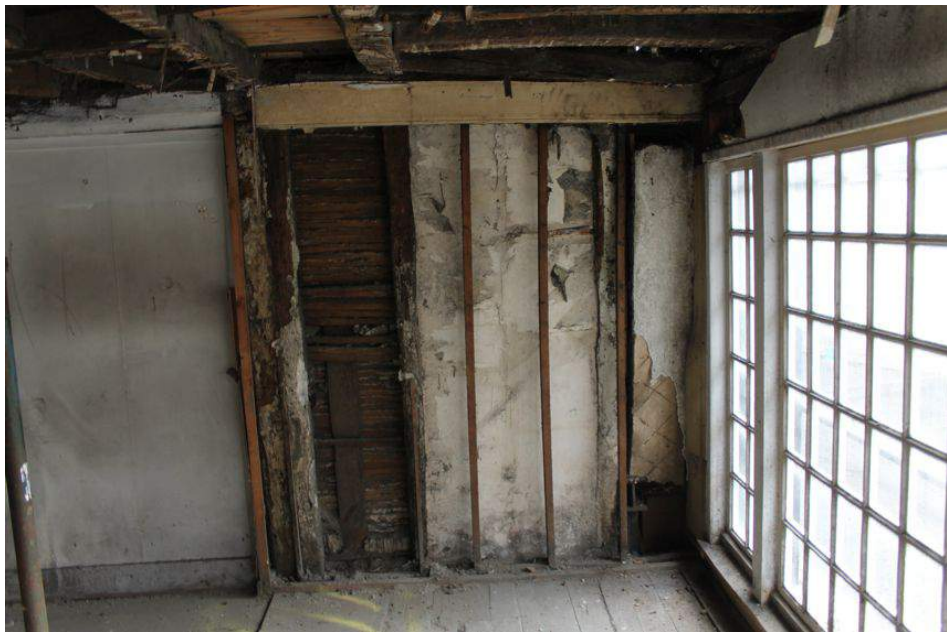
(and later machine-cut replacements) are visible. Also visible towards the west of the this elevation, nearby the inserted door between Buildings A and B, is some lath and plaster on the exterior of the building (Photograph 20).

**Photograph 20** Photograph of internal southern elevation of first-floor in Building A. Exposed lath and plaster render visible on exterior of building, as well as bricked over inserted door between Buildings A and B. Photograph taken facing south.

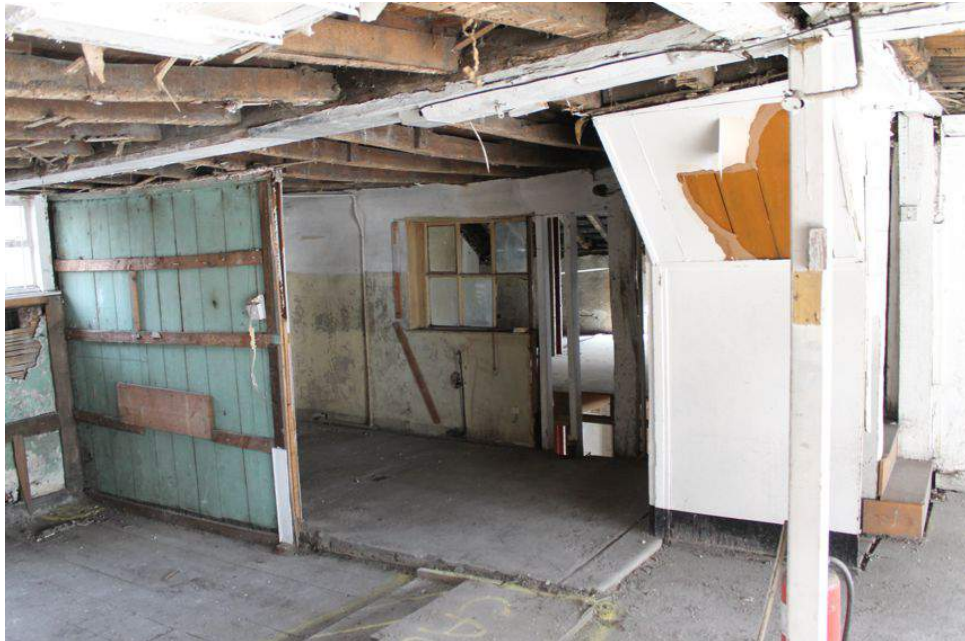
Above this level, the second-floor is supported in much the same way as the first: by three chamfered binding-beams, that are jointed onto the principal-posts of each elevation. The larger one is jointed on the east and west elevations, and two jointing out from it to the north and south (Photograph 21). Like on the ground-floor, there is a modern post supporting these beams in the centre of the building. Unlike on the ground-floor, however, the two smaller binding-beams between the north and south elevations have mortices on their underside, suggesting that this floor was originally divided in two (Photograph 22). There is no gap between any of the mortices that would suggest an entranceway, but the binding-beam jointed to the southern elevation is partially covered by modern boards, obscuring several mortices. The west binding-beam is supported by an additional modern post.

**Photograph 21** First-floor of Building A, with binding-beams visible supporting floor above and modern post in centre of building. Photograph taken facing south-east.

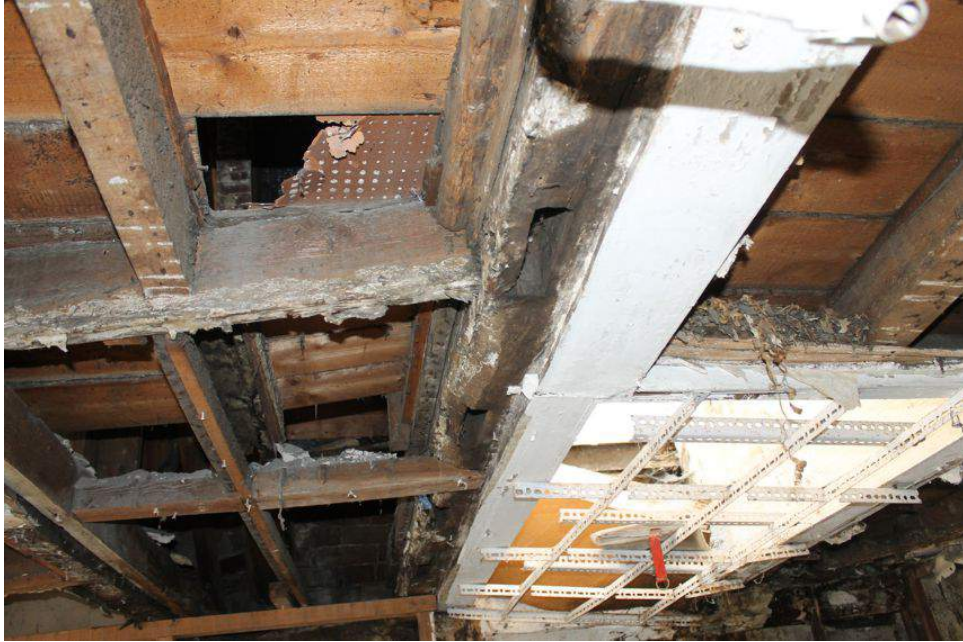
**Photograph 22** Underside of north-south binding-beam supporting the second-floor, showing unused mortices. Photograph taken facing north.

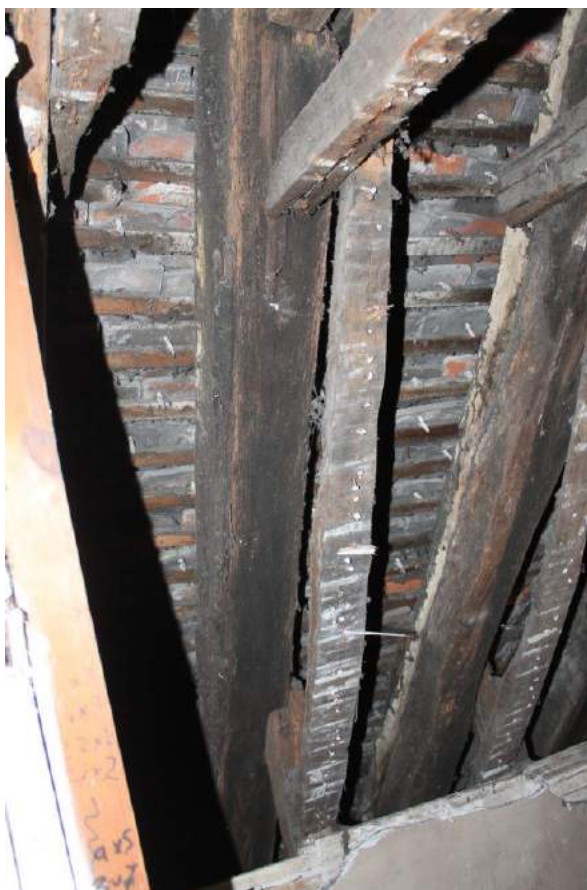
Most of the rafters have evidence of smoke blackening, particularly at their apex (Photographs 26 and 27). The smoke blackening seems most concentrated in the centre of the roof, becoming less prominent towards the eastern and western ends of the building (Photograph 27). The pair of rafters on the extreme western end of the building (above the jetty) are made of a noticeably different wood to the rest, and have no evidence of smoke-blackening at all.

**Photograph 26** Detail of smoke-blackening on rafters in centre of Building A. Photograph taken facing south-west.

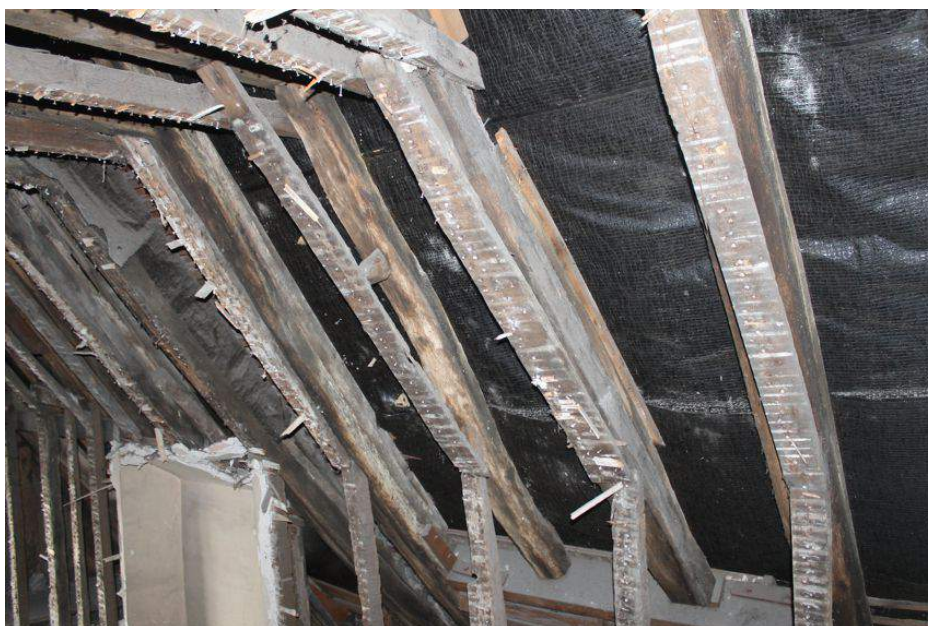
**Photograph 27** Smoke-blackening on rafters in Building A. Shows variation in smoke-blackening from centre of building (right) outwards. Photograph taken facing north-west.

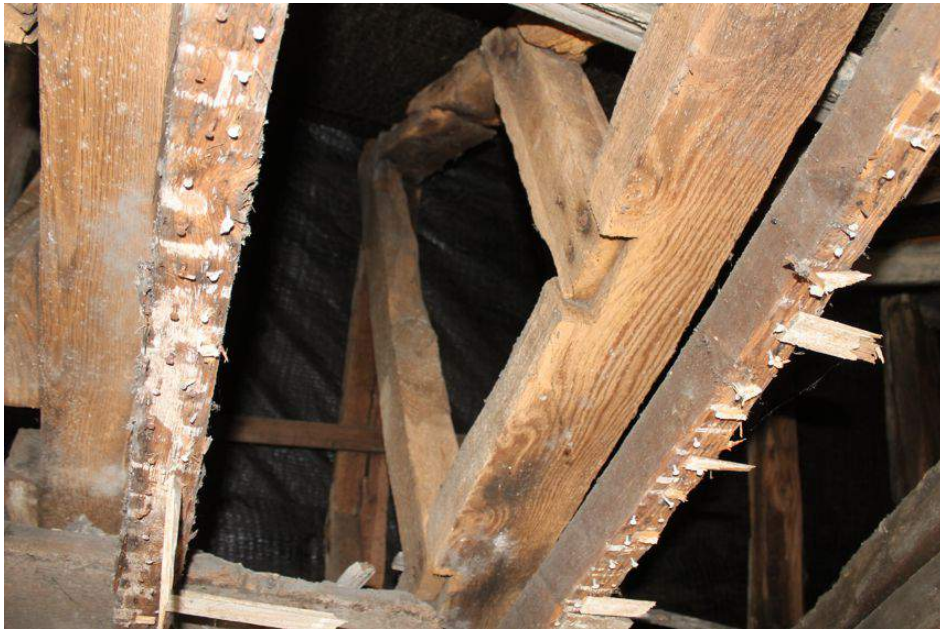
**Photograph 31** Queen and king-posts nailed in place on the two westernmost collars in Building A.

The western room on the second-floor (Photograph 23) measures 5.3 x 5.7m. The western gable end has several hand-sawn studs and a beam, all of which have thinner planks nailed to them which until recently were rendered in lath and plaster. These studs and beam are all pegged into place. In this room all the collars between each pair of rafters have a later collar nailed in place just below them, which was rendered in lath and plaster until quite recently, just like the gable end. The westernmost two collars (the ones above the jetty) both have nailed in place queen-posts and king-posts (Photograph 31).

As well as these king and queen-posts, there is also a very thin and wide collar purlin projecting out from the western gable, that ends some short distance before the second collar. This collar-purlin is resting on the lower collars, and was probably inserted at the same time. These additions to the western gable (the queen- and king-posts and the collar purlin) were all presumably

added in order to provide more stability to the jetty.

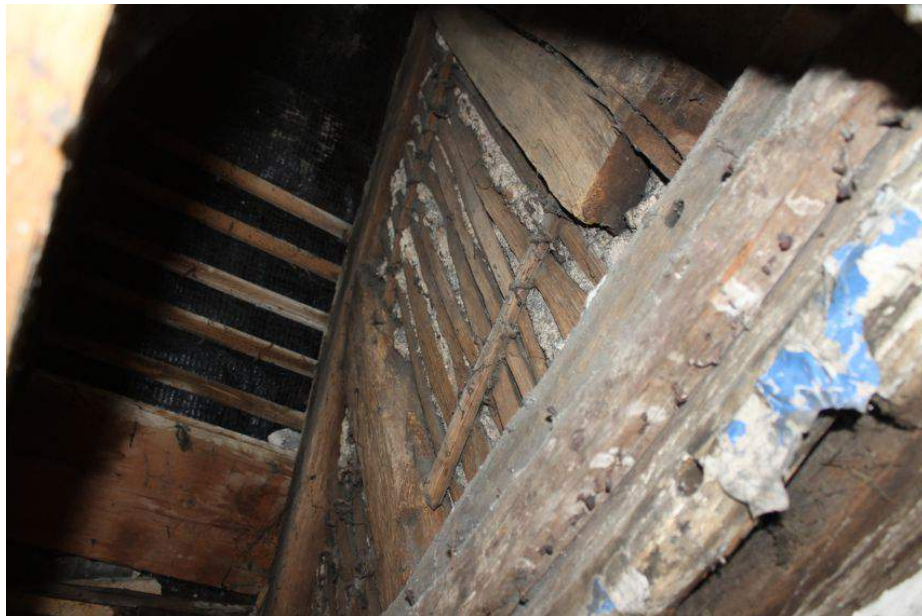
**Photograph 33** Possible original rudimentary lath and plaster on west side of the modern skylight in Building A. Photograph taken from first-floor looking up.

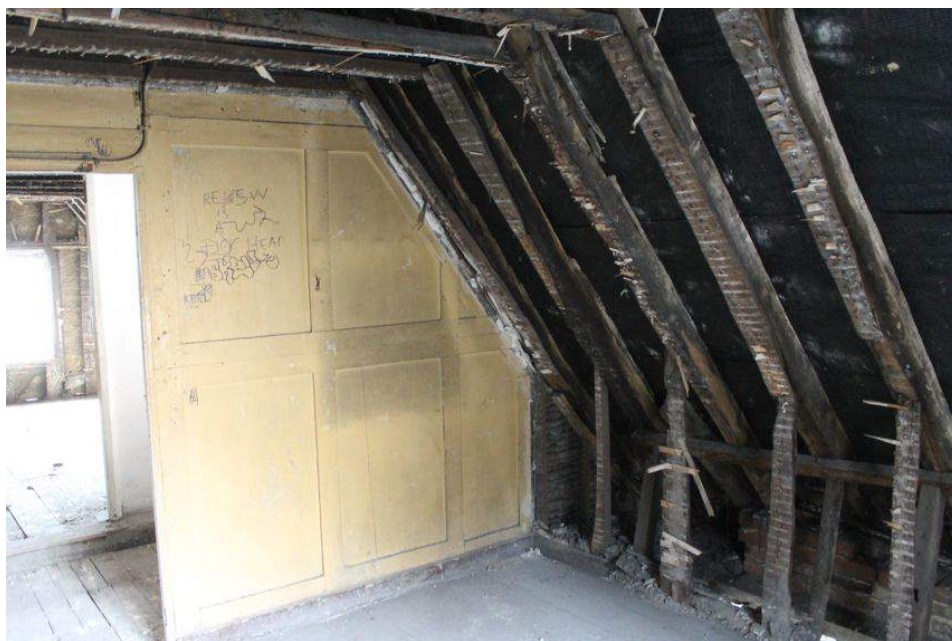
**Photograph 34** East room on second-floor of Building A. smoke-blackened rafters visible. Photograph taken facing north-west.

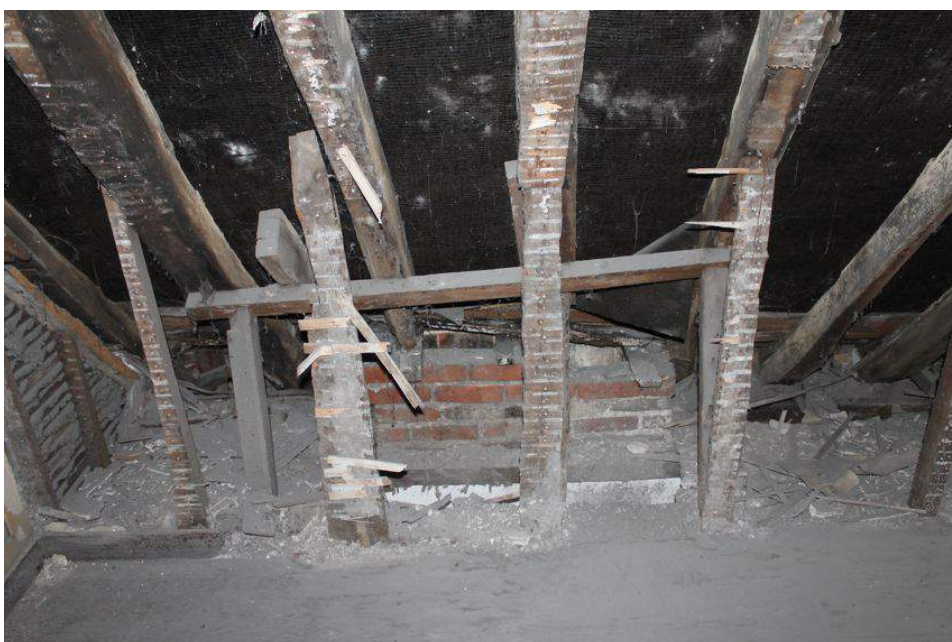
In the northern elevation of the eastern room is the chimney stack (as observed in the lower floors) surviving to a height of four brick courses above the floorboards (Photograph 35).

**Photograph 35** Remaining top of chimney-stack in Building A. Possible original lath and plaster on east side of modern skylight visible to left. Photograph taken facing north.

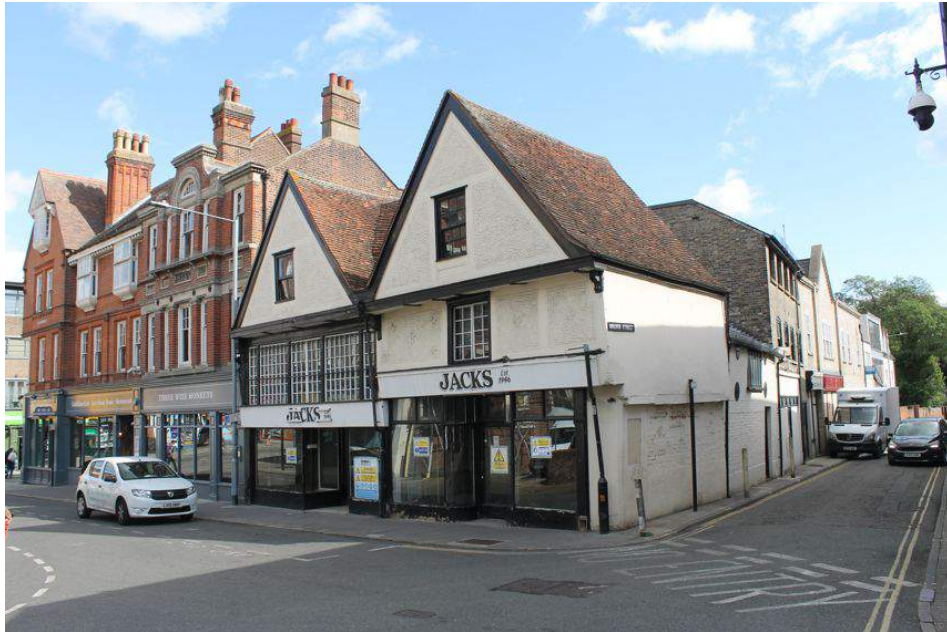
**Photograph 36** Entire site, showing Buildings A, B, C and D. Underbuilding in brick below Building B's southern jetty visible. Photograph taken facing north-east.

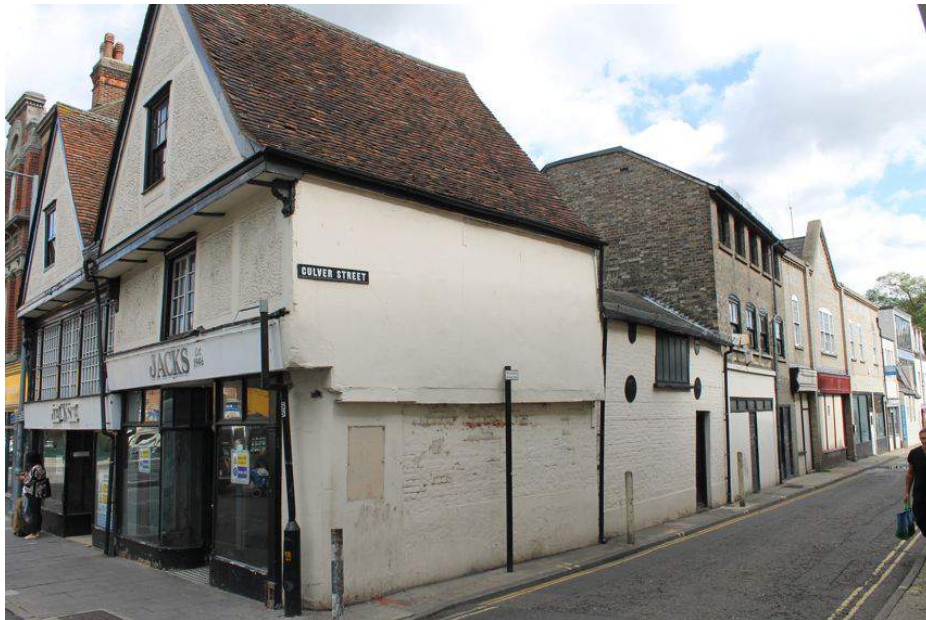
The southern elevation of Building B is jettied on the first-floor, but not on the second. This jetty has been under-built in brick (with dimensions of 215 x 100 x 60mm) laid in English-bond and bonded to the wall of Building C (Photograph 40). The first-floor has no features, and is rendered-over.

**Photograph 40** Southern elevation of Building B, showing brick underbuilding. Photograph taken facing north-east.

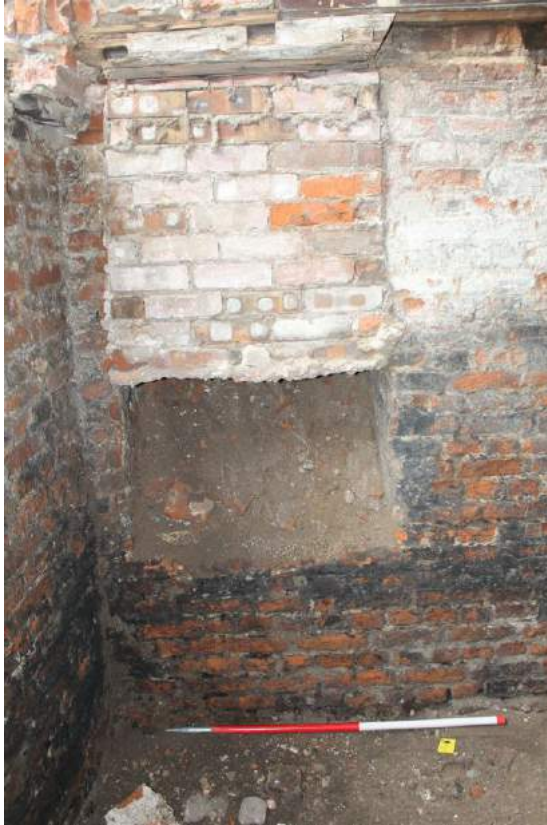
**Photograph 42** Bricked-up opening in northern elevation of cellar. Photograph taken facing north.

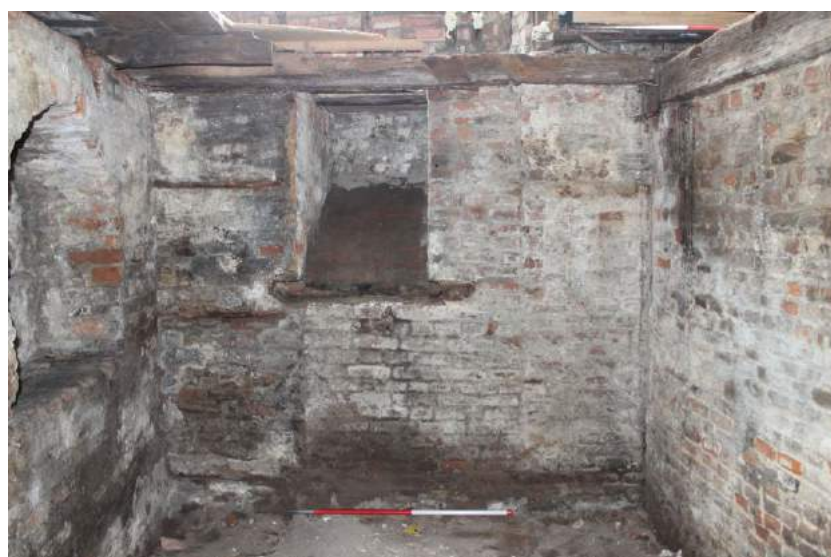
**Photograph 45** Western elevation of southern room, showing coal chute inserted into an earlier, bricked up, opening. Photograph taken facing west.

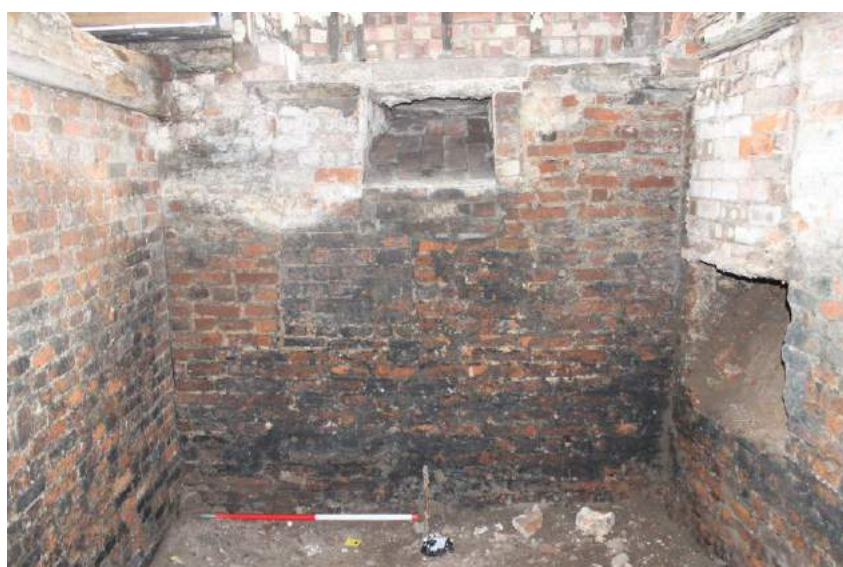
**Photograph 46** Western elevation of northern room, showing coal chute replacing an earlier, bricked up, opening. Photograph taken facing west.

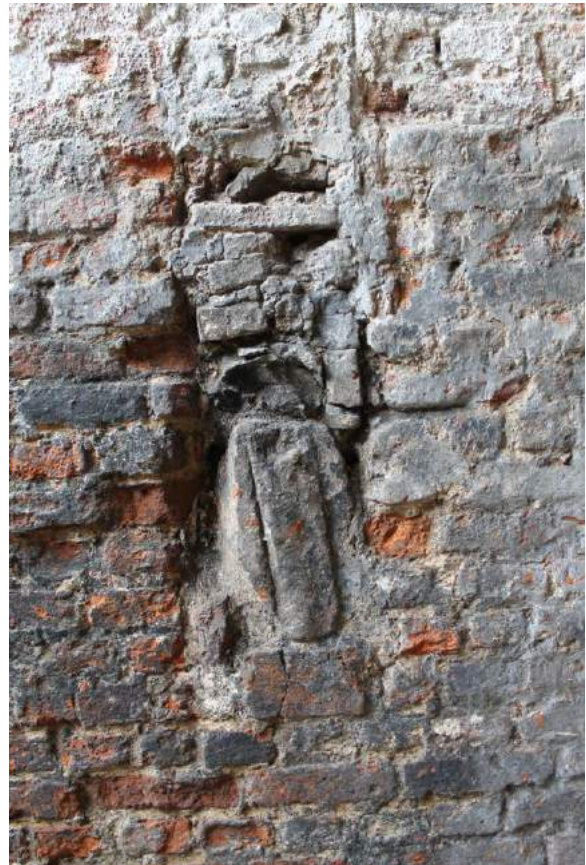
There is also a significant area of infilling within the brick wall on the northern elevation (Photograph 47). As well as more substantial brickwork (230 x 140 x 110mm) and irregular bonding, there is a large piece of worked stone that has been inserted into the wall (Photograph 48). This infilling appears to be where a post was embedded into the brickwork and has since been removed, with associated damage to the top of the wall.

**Photograph 48** Detail of worked stone in northern wall of cellar.

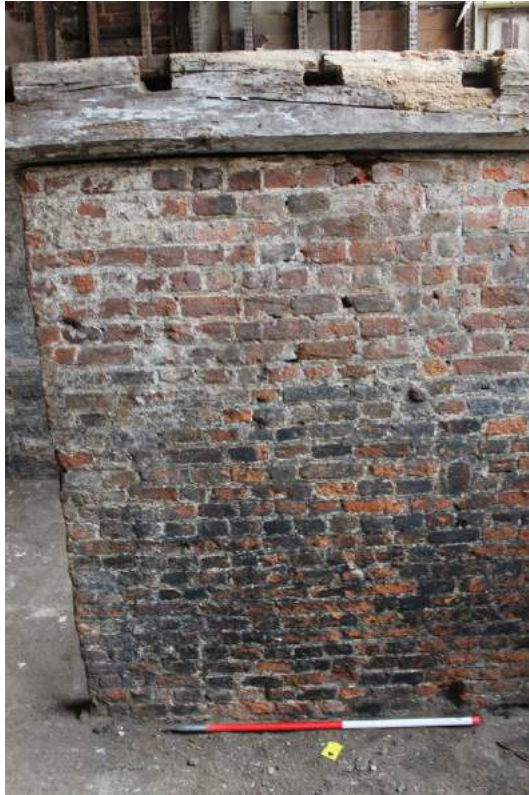
The central wall has two distinct phases of brickwork, with smaller, earlier, bricks (120 x 90 x 50mm in size) making up the bottom 1.3m of the wall, and larger bricks (180 x 90 x 60mm in size) making up the top 0.7m (Photograph 49). Both types of bricks are laid in an irregular bond. Whether this change in brickwork indicates a repair of the wall, or that originally the wall was lower and then increased in height, is unclear.

**Photograph 49** Detail of dividing wall in cellar, showing two phases of brickwork. Photograph taken facing south.

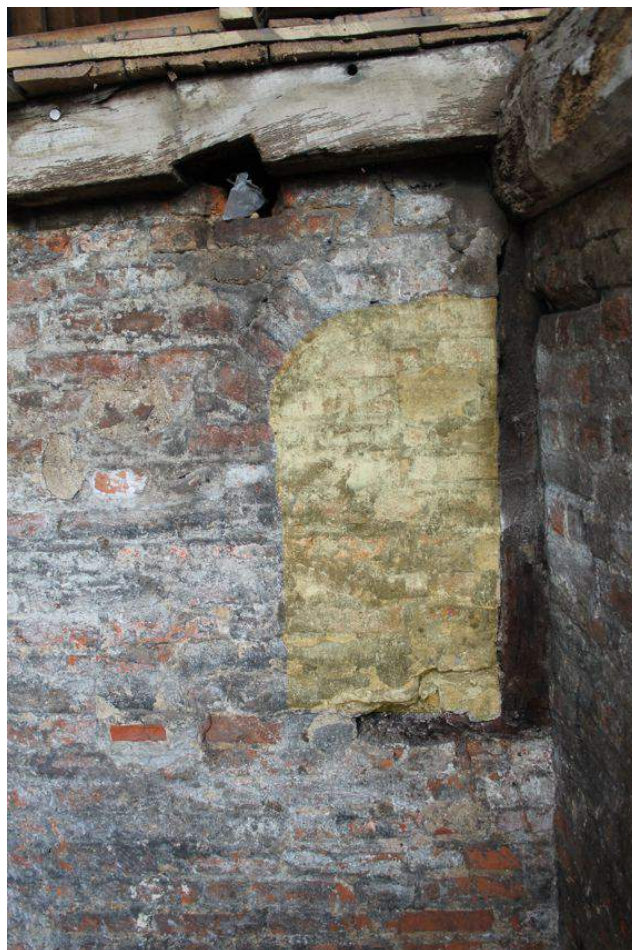
Above the dividing wall is a binding-beam that would have supported the joists above the cellar (Photograph 41). This beam is itself supported on two timber posts embedded in the brickwork on the east and west sides of the cellar. The eastern post of these is embedded in a bricked up arched opening, similar to the ones still open on the southern elevation (Photograph 50). This means that this post was a later insertion into the cellar, and might suggest the binding-beam is not original. Alternatively the binding-beam above the cellar could have initially been supported on the brickwork alone.

**Photograph 50** Highlighted blocked archway in eastern wall of cellar, including post supporting binding-beam. Photograph taken facing east.

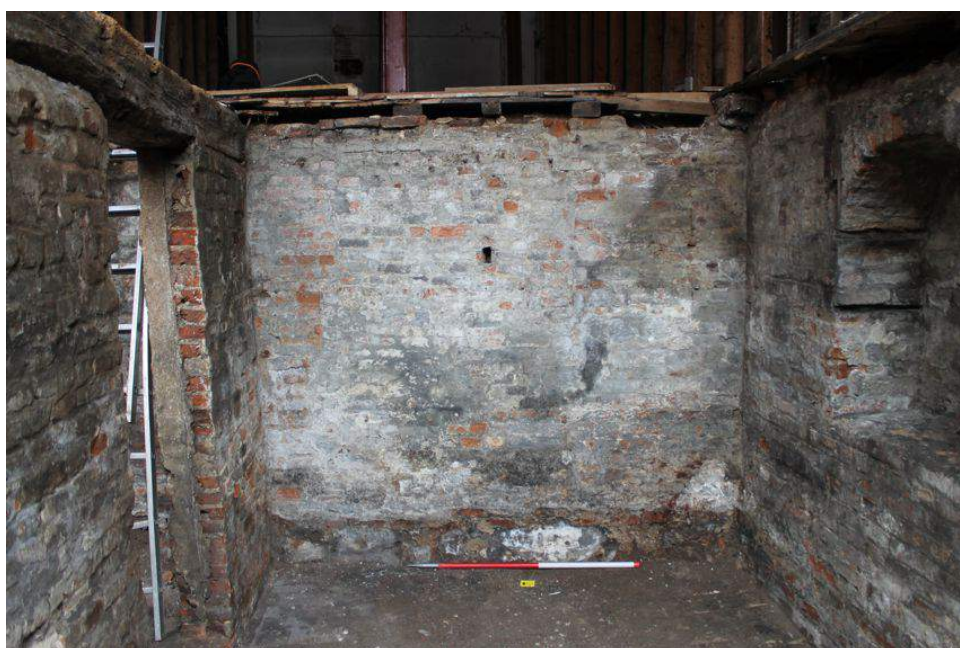
One final note of interest concerning the cellar is that the eastern wall appears to be partially built upon a Roman foundation, constructed of lime mortar and septaria (Photograph 51).

**Photograph 51** Eastern wall in southern room of cellar, with Roman foundation at base. Photograph taken facing east.

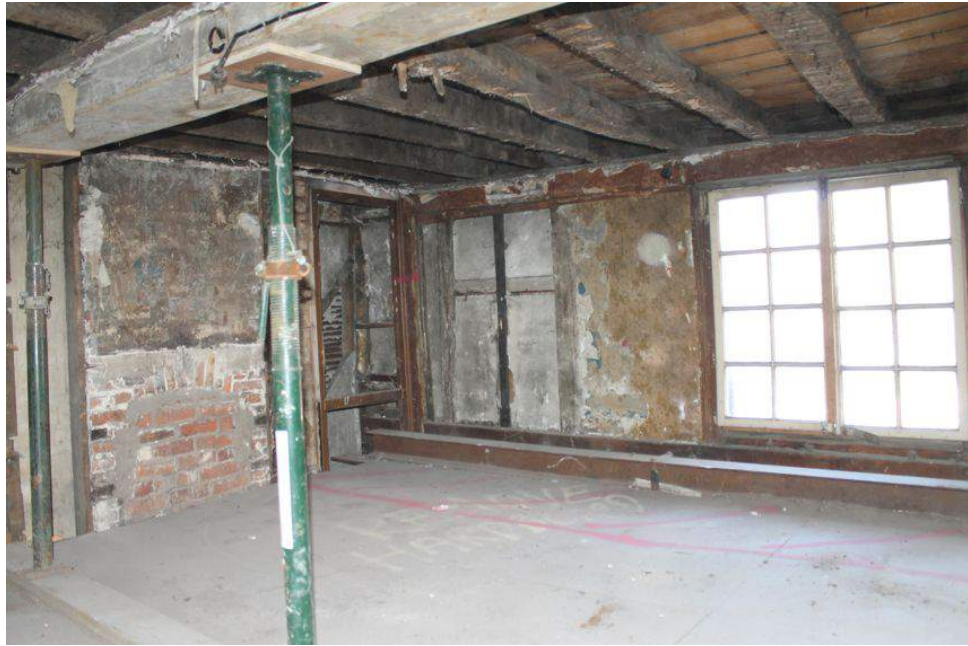
The first-floor of Building B is divided by three thin inserted walls covered in lath and plaster (Fig 5). The entire floor level has been raised to create more space on the ground-floor, and is supported on several metal girders (Photograph 39). The result is that this floor is very compact in size, with only 1.5m between the floor and ceiling (Photograph 54).

**Photograph 54** First-floor of Building B, showing blocked fireplace and raised floor level. Photograph taken facing south-west.

The wall-plate survives around the entire building, although it is partially obscured on the southern elevation by an inserted chimney-stack (Photograph 54). All four corner-posts are intact at this level.

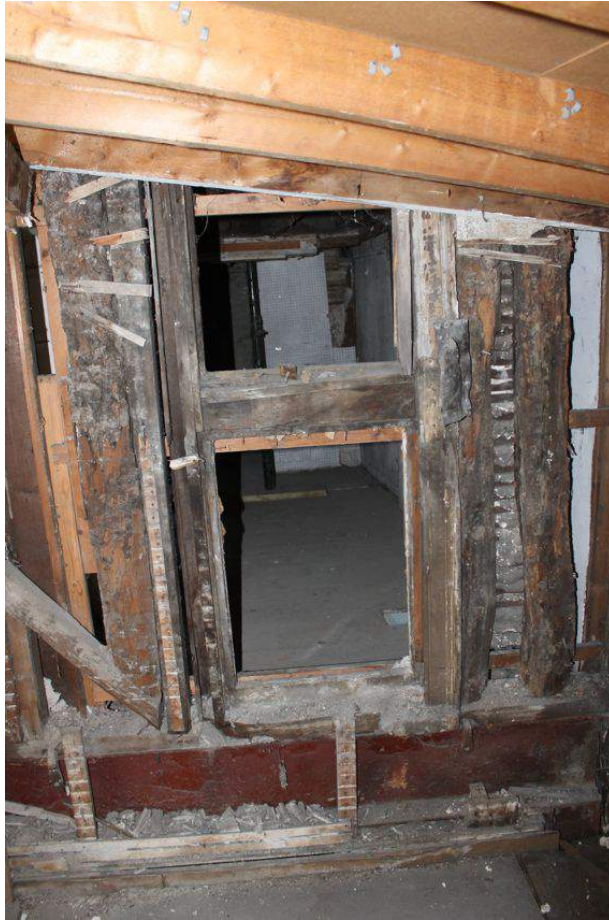
The eastern elevation of the first-floor has an inserted wooden-framed two-light fixed window, with no surviving glass (Photograph 55). Also on this elevation is an inserted entrance into Building C, formed by removing a stud to the north of the principal-post (Photograph 39). There is a section of diagonal primary-bracing on this elevation which stylistically dates from the end of the 16th century onwards (Stenning 2013, 130).

**Photograph 55** Detail of inserted window-frame in east wall of Building B's first-floor. Photograph taken facing west.
