**Historic building recording at  
5 and 6 St Nicholas Street (formerly 'Jacks'),  
Colchester  
CO1 1LB**

**September 2017**

CAT project ref.: 17/05i  
NGR: TL 9982 2517 (centre)  
Planning reference: 161296  
CHER event number: ECC4001  
Colchester Museum accession number: COLEM 2017.71  
OASIS reference: colchest3-285635

**CAT Report 1222**  
March 2018

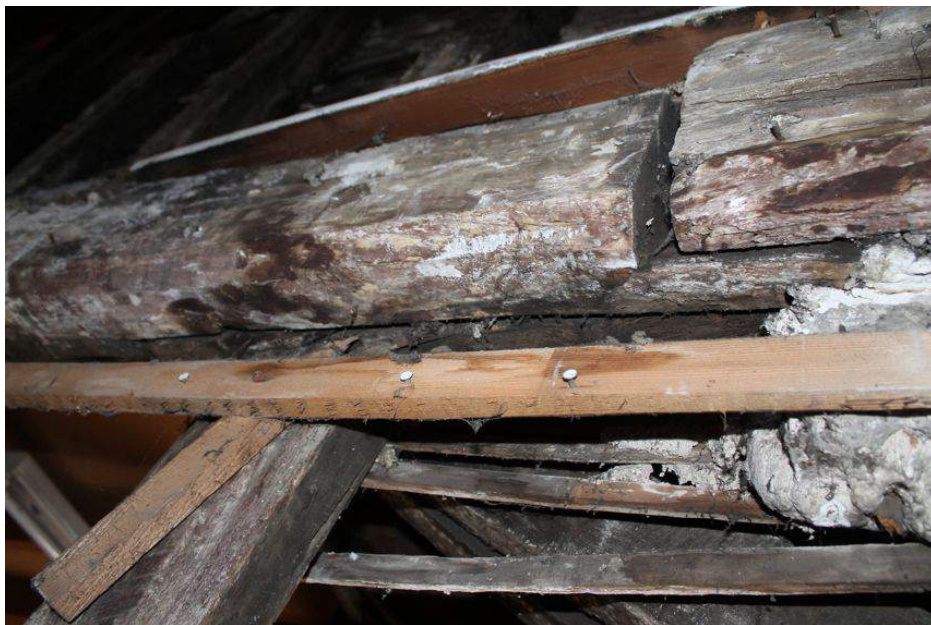
On the wall-plate on the eastern elevation is a face-halved and bladed scarf joint (Photograph 56) with one visible edge peg (although in actuality it probably has two or more that are not visible beneath remaining render and the roof timbers of Building C). This style of scarf joint is first seen in the late 16th century and continues in use right through to the present day (Hewett 1980, 269).

**Photograph 56** Detail of scarf joint on eastern wall-plate of Building B.

The scarf joint on the eastern wall-plate of Building B (pg 48) can narrow this date range further. This style of scarf joint is not seen until the late 16th century, from about 1575 onwards (Hewett 1980, 269). In addition to this joint, the through-bracing observed in the eastern elevation of Building B first appears at the end of the 16th century (Stenning 2013, 130).

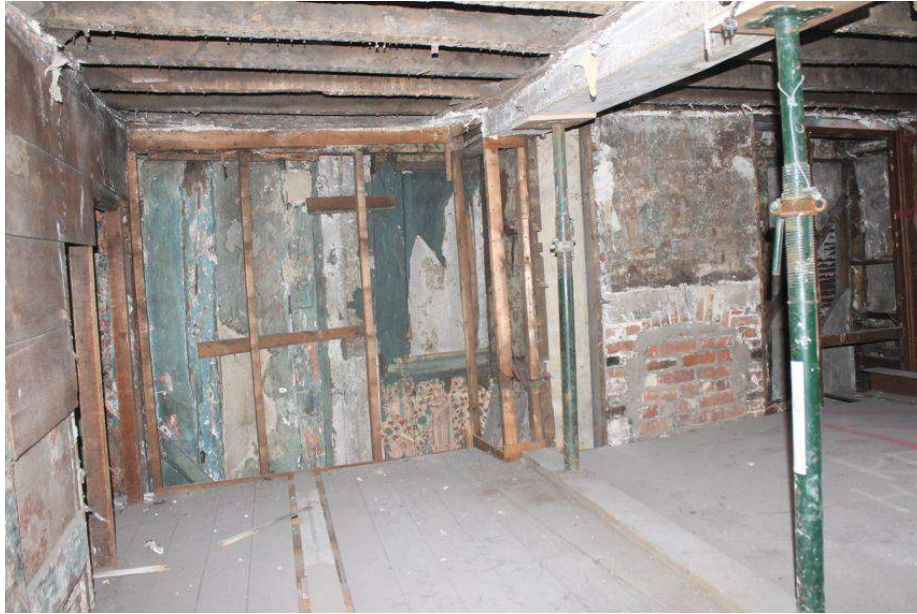
The southern elevation of the first-floor contains a blocked in brick-built fireplace and chimney stack. The original timber-frame survives intact to either side of the fireplace, and includes one stud that is a re-used timber (Photograph 58). The studs on this floor have divisions of 400mm, and have average dimensions of 150 x 80mm. They are smaller and have bigger divisions between them than the studs in the first-floor of Building A (see above). Visible on this elevation is the back of the lath and plaster rendering covering the exterior of the building.

**Photograph 57** Internal southern elevation of first-floor in Building B. Photograph taken facing south.

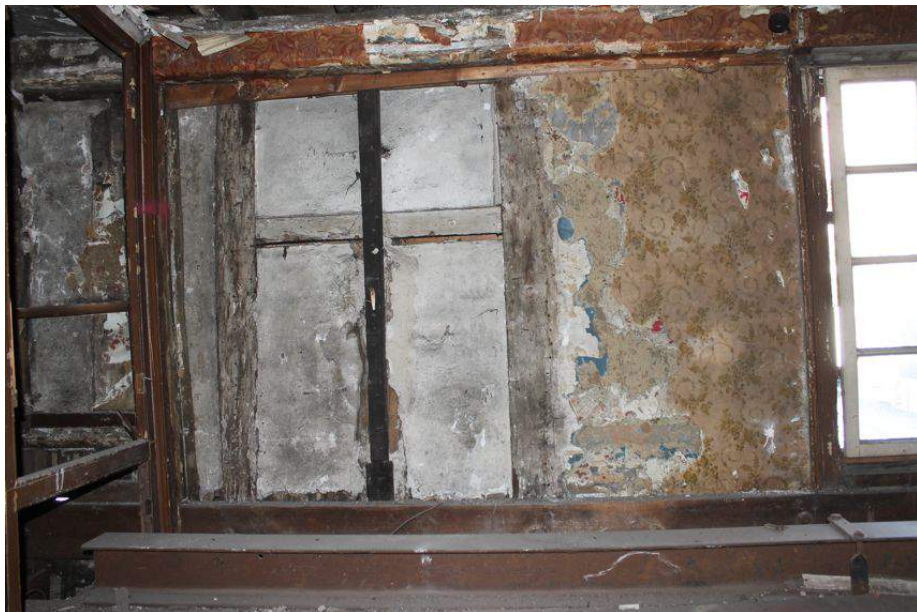
The western elevation has an inserted machine-cut timber on the northern side of the inserted window. To the south of the window the original studs have a double width

division between them, with one infilled with a modern machine-cut stud (Photograph 58). Whether these large division are indicators of earlier windows or not is uncertain. Unfortunately closer examination was impossible due to the unstable nature of the floorboards.

**Photograph 58** Western wall of first-floor in Building B, showing possible infilled window opening. Photograph taken facing west.

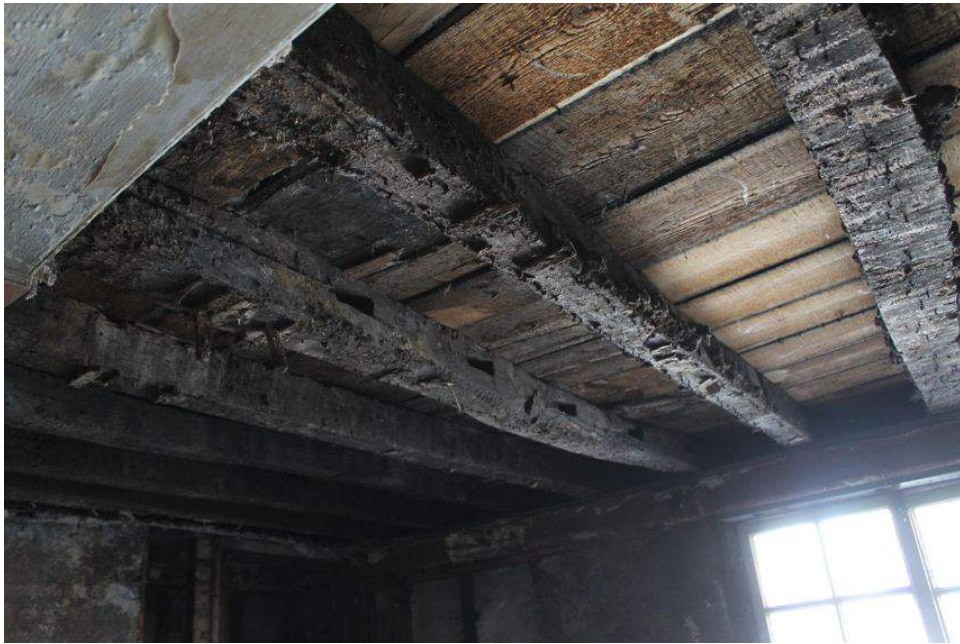
of the fireplace or the floor level being raised may have removed it (and a principal-post would not be expected on the northern elevation, as it is part of the frame of Building A). One of the joists supporting the second-floor is re-used, and has several empty mortices on its northern side (Photograph 59).

**Photograph 59** Unused mortices on joist of second-floor of Building B. Photograph taken facing south-west.

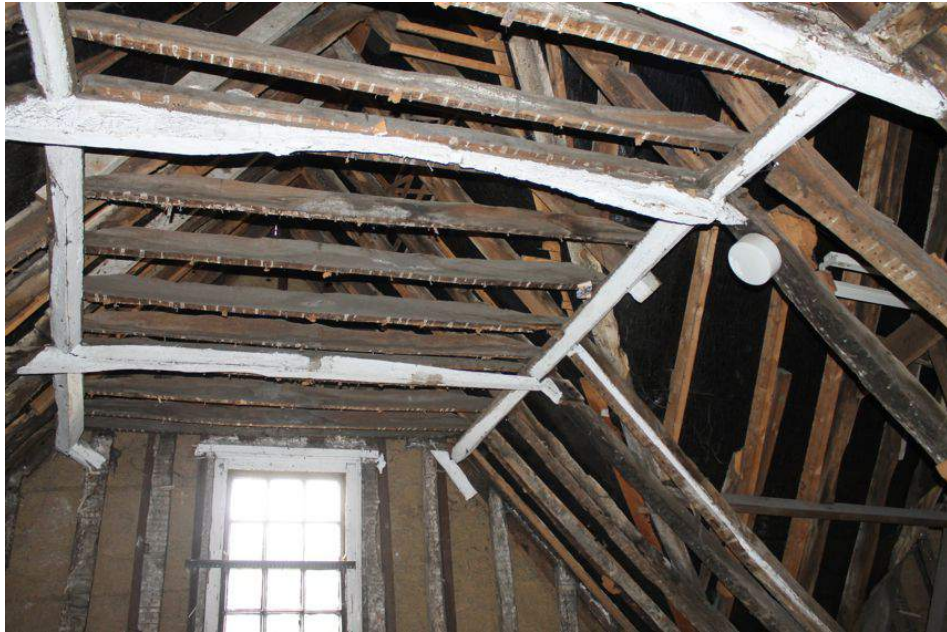
Building B has a roof supported with five large arched collars irregularly spaced across the rafter pairs (Fig 6). Further supporting the rafters are two large clasped-purlins (Photograph 60). Nailed to the purlins are 19 hand-sawn braces; they not attached to the rafters and as a result are not collars in the strictest sense. They appear to be later additions to the building and were probably added to the purlins in an attempt to prevent the roof racking. The building has no ridgeboard, and each pair of rafters are pegged at their apex (Photograph 61). Several rafters have simple splayed scarf joints, or possibly repairs, often with large numbers of face pegs and nails keeping them together (Photograph 61).

**Photograph 60** Roof of Building B, showing original collars and purlins, as well as later braces. Photograph taken facing west.

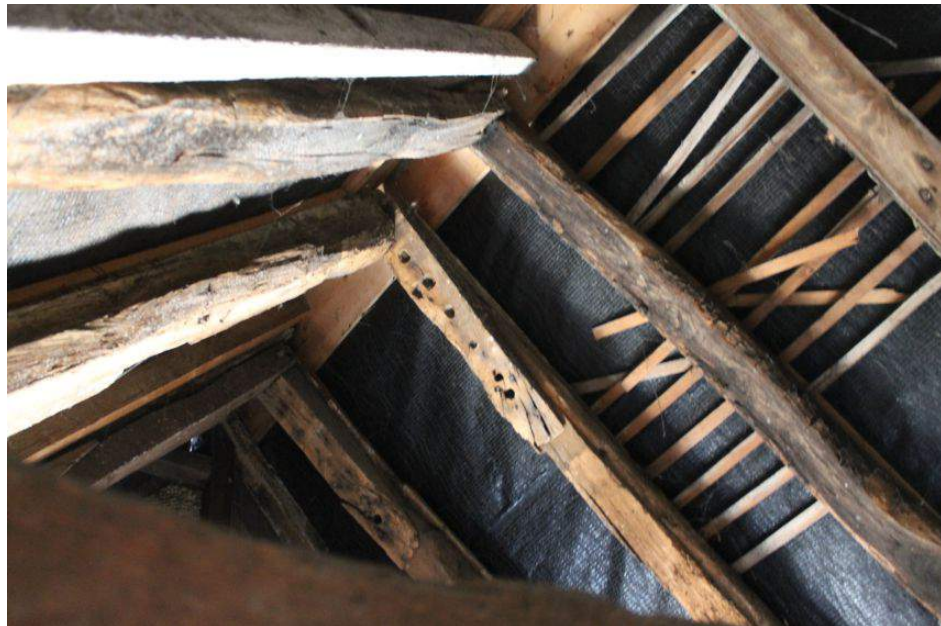
Like Building A, several of the rafters have evidence of smoke blackening. Several rafter pairs are heavily blackened, but, unlike in Building A, are adjacent to rafter pairs that are not blackened at all (Photographs 61 and 62). This suggests that the smoke-blackened rafters are re-used and that the roof has been built using rafters from an earlier building that had an open fire. Additionally, several of the non-blackened rafters

**Photograph 61** Roof of Building B with scarf joints on rafters. Photograph taken facing south-east.

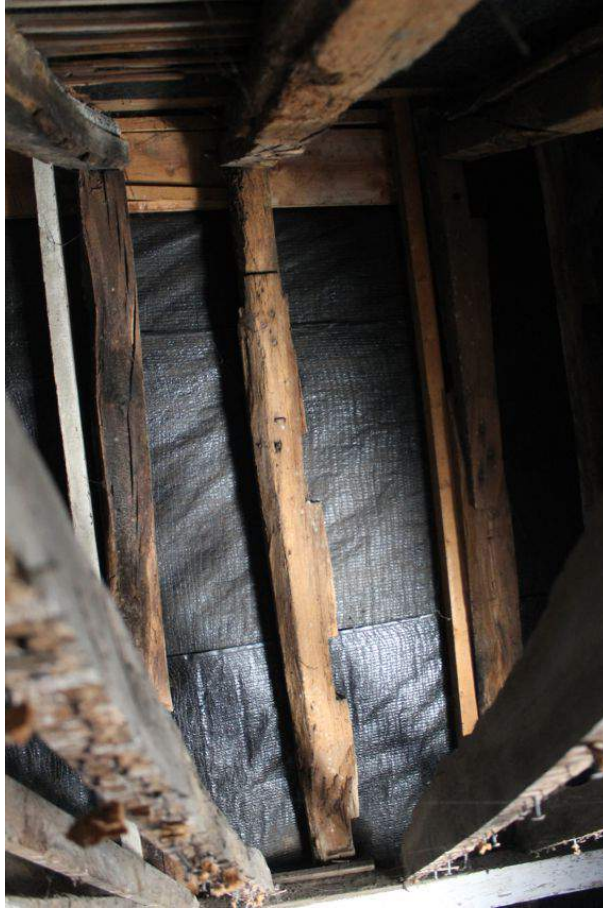
have evidence they were originally from another building in the form of empty mortices (Photograph 62).

**Photograph 62** Reused timber in roof of Building B, and evidence of smoke-blackening. Photograph taken facing south.

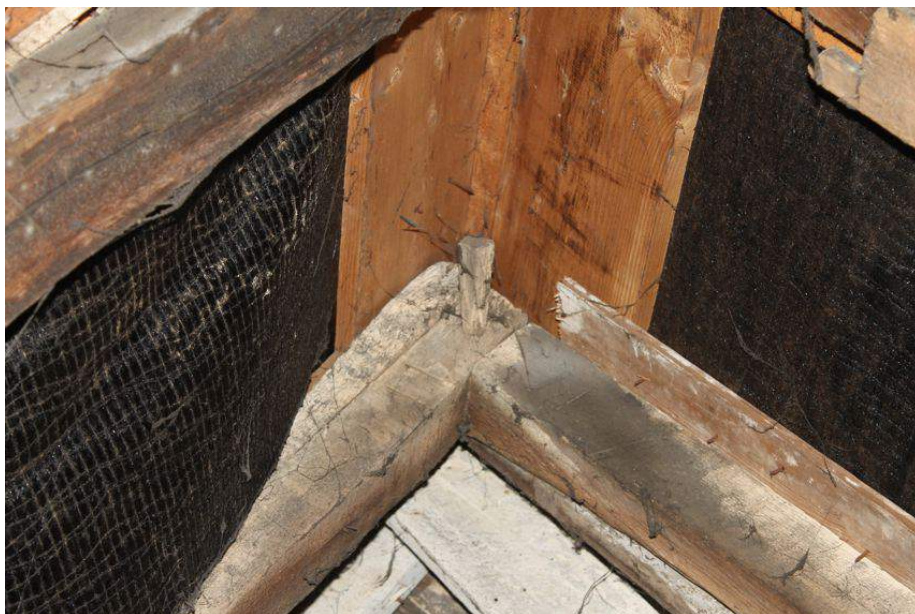
Two carpenter's marks (Photograph 63) were observed on the rafters. Both had a match on their opposing rafter, but they do not make sense sequentially (since they are 'II' and 'III' and are two rafter pairs away from each other). As with the smoke blackening and the unused mortices, these carpenter's marks are probably a result of the rafters being re-used from an earlier building.

**Photograph 63** Carpenter's mark "III" at apex of roof in Building B.  
**Photograph 63** Carpenter's mark 'III' at apex of roof in Building B.

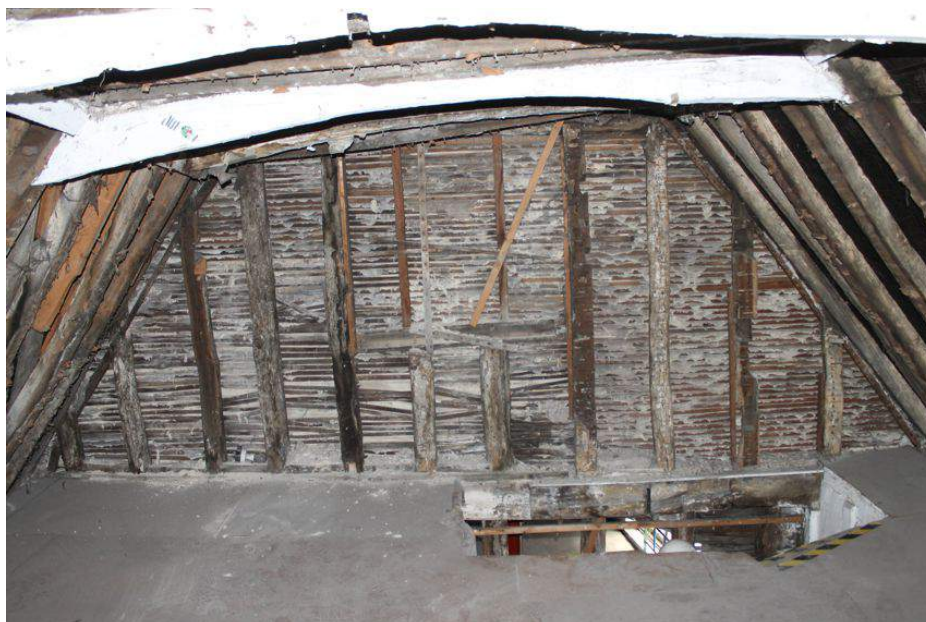
The eastern elevation of the second-floor has an inserted window opening, that has been covered the lath and plaster rendering (Photograph 64). This means that the lath and plaster currently on the building is not original, and has been redone.

**Photograph 64** East gable end in Building B, showing inserted window opening that has been covered in lath and plaster. Photograph taken facing east.

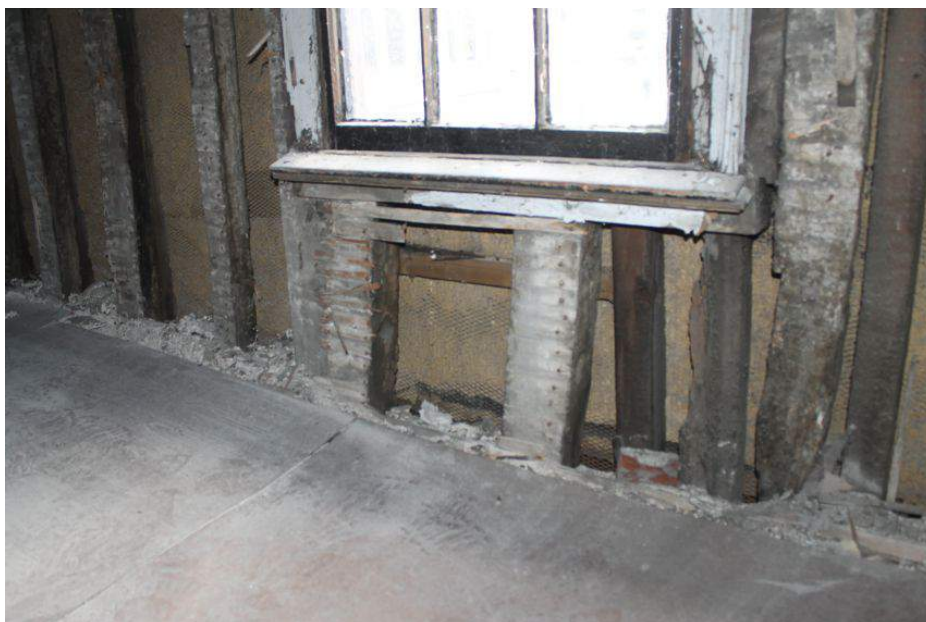
The western elevation has an inserted window supported by a modern timber to the south, and by two cut off original studs

below. One of these cut studs has evidence of re-use in the form of diamond mullions on its northern face (Photograph 65).

**Photograph 65** Cut studs beneath inserted window in west gable end of Building B. Diamond mullions visible on left stud. Photograph taken facing south-west.

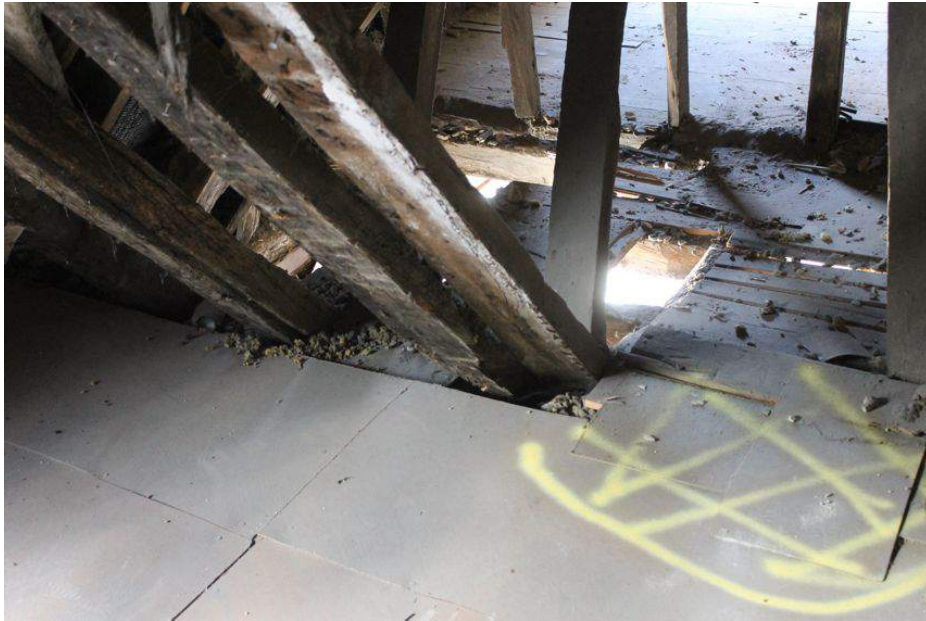
The northern elevation has a cut rafter, allowing access into the second-floor of Building A. In addition, two of the rafters on this elevation rise from one point on the wall-plate (Photograph 66). This may have been a later alteration to allow better access into Building A.

**Photograph 66** Two rafters rising from one point on wall-plate to north of Building B. Photograph taken facing north-west.

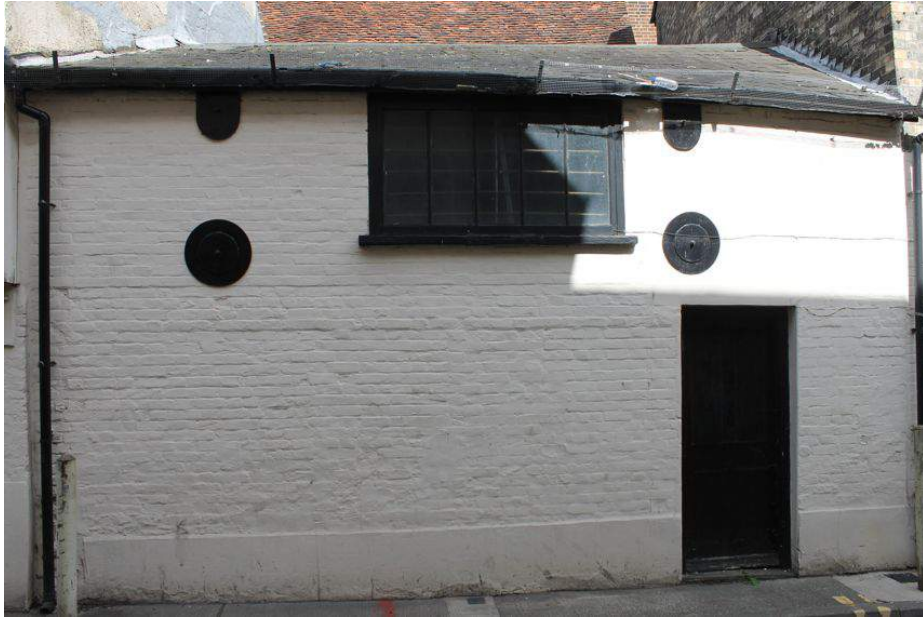
The southern elevation has an inserted wooden-framed four-panel door, and an inserted five-light fixed window (Photograph 67). These were both added to the structure in 1936, when several other alterations were carried out to Building D (see historical background pg 13).

The southern elevation has two distinct phases of brickwork (Photograph 67). The lower 2.25m of bricks are smaller, measuring at 200 x 95 x 70 mm. The top 1.3m of brickwork is made of larger bricks, measuring at 230 x 110 x 75 mm. The upper bricks are laid in Flemish bond, whereas the lower bricks are laid irregularly (although in some areas

resemble a form of Sussex bond). The larger bricks represent a second-storey that was added to the building between 1848 and 1876 (see historical background pg 9).

**Photograph 67** Southern elevation of Building C. Photograph taken facing north.

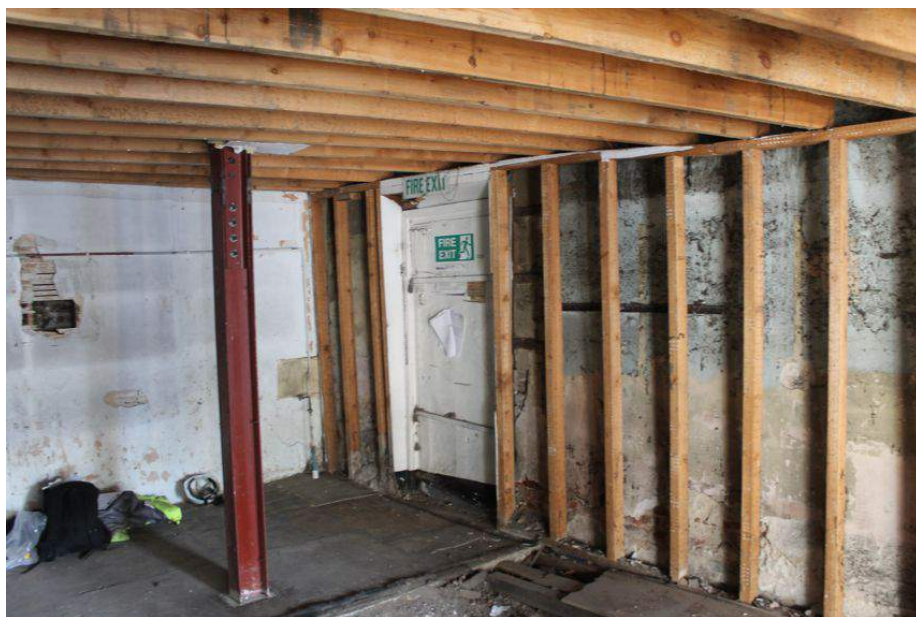
The ground-floor of Building A is open plan, with no surviving divisions. Two large metal posts are set into concrete in the centre of the building and go through the first-floor to support the roof (Photograph 68). The floor is plasterboard laid on floorboards.

**Photograph 68** Ground-floor of Building C, showing modern timber-frame in inside brickwork exterior. Photograph taken facing south-east.

As with the exterior, nothing remains of three of the four elevations in this structure. The wall on the eastern elevation is the exterior wall of Building D, and will be described when detailed that building (see below). A modern stairway on the ground-floor until recently was the location of a skylight (see historical background pg 12). The southern elevation is rendered over and has a modern timber-frame in front of it that until recently would have supported a plasterboard wall (Photograph 68).

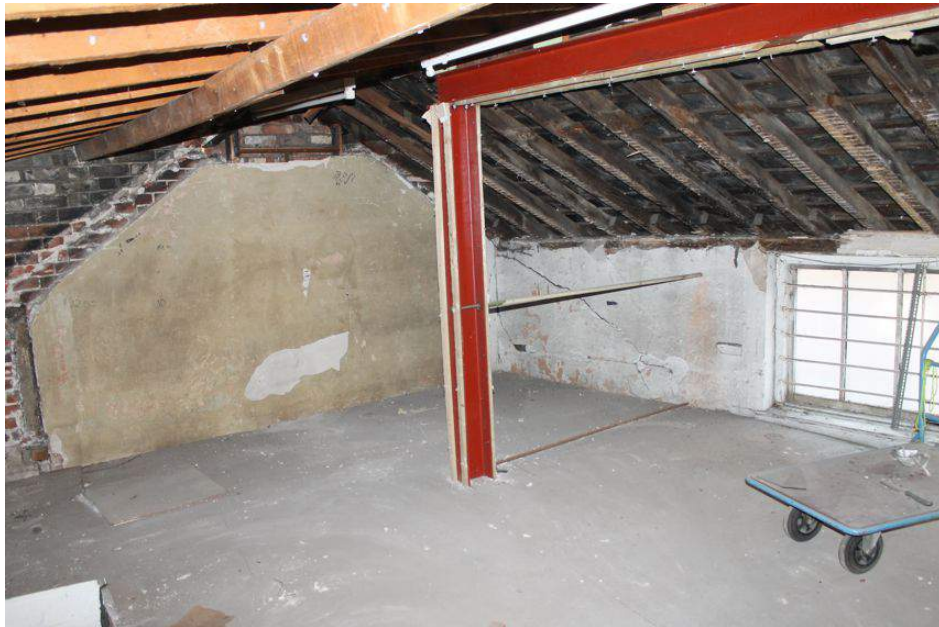
The southern wall is plastered over at this level as well. Again the floor is plasterboard. The roof is supported by metal posts and a purlin along the northern pitch (Photograph 69). There are no collars or braces. The northern pitch of the roof is constructed of modern machine-cut timber, and until recently was the location of a skylight. The original outline of the northern pitch of the roof is visible against the wall of Building D to the east (Photograph 69).

**Photograph 69** First-floor of Building C, with original outline of roof against Building D visible. Photograph taken facing south-east.

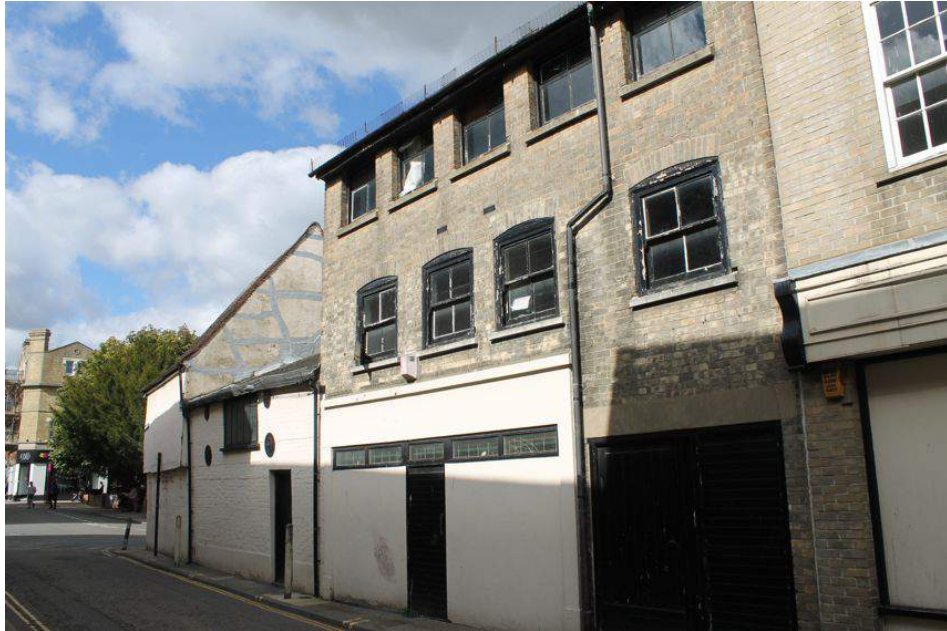
Building D is an 8.5m long and 8.8m tall oblong brick-built three-storey building fronting onto Culver Street (Photograph 70). It narrows as it goes eastwards, being 6.6m wide at its western end and 4.5m wide at its eastern (Fig 4). The building has a slate covered gambrel roof with a flat apex, that narrows to a gable at the eastern end.

**Photograph 70** Southern elevation of Building D in foreground, with Buildings D and B in background. Photograph taken facing north-west.

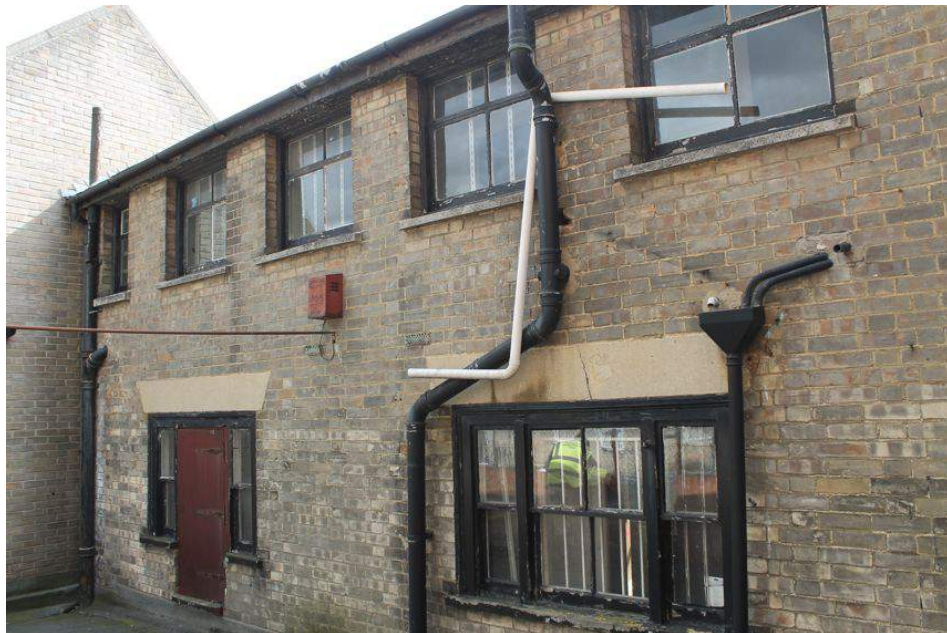
On the first-floor of the northern elevation are two wide wooden-framed sash windows, both of which are original to the first phase of the building. The northernmost one of these windows has had a door inserted into it, leading onto the roof of Building E (Photograph 72). Clearly this would have been inserted at the same time Building E was constructed. On the second-floor level of the northern elevation are five wooden-framed awning windows (4 four-light and 1 two-light), all original to the second-floor addition.

**Photograph 72** Northern elevation of Building D. Photograph taken from roof of Building E, facing south-east.

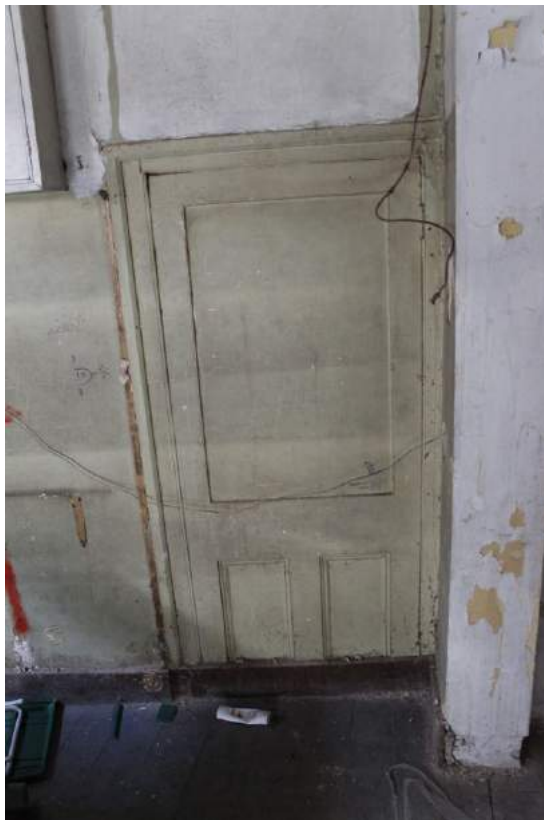
**Photograph 73** Blocked door in western wall of ground-floor of Building D. Photograph taken facing west.

modern concrete floor, but in the shop the concrete is covered with floorboards. Most of the structures original internal divisions at this level have gone, having been removed in 1936. The shop room has two doors, one on the western elevation that is original to the structure and was blocked in 1936 (the door survives: Photograph 73), and one on the eastern elevation that was added in 1936. The joists of the floor above are supported by a large metal beam positioned east/west across the shop room and itself supported on brick pillars.

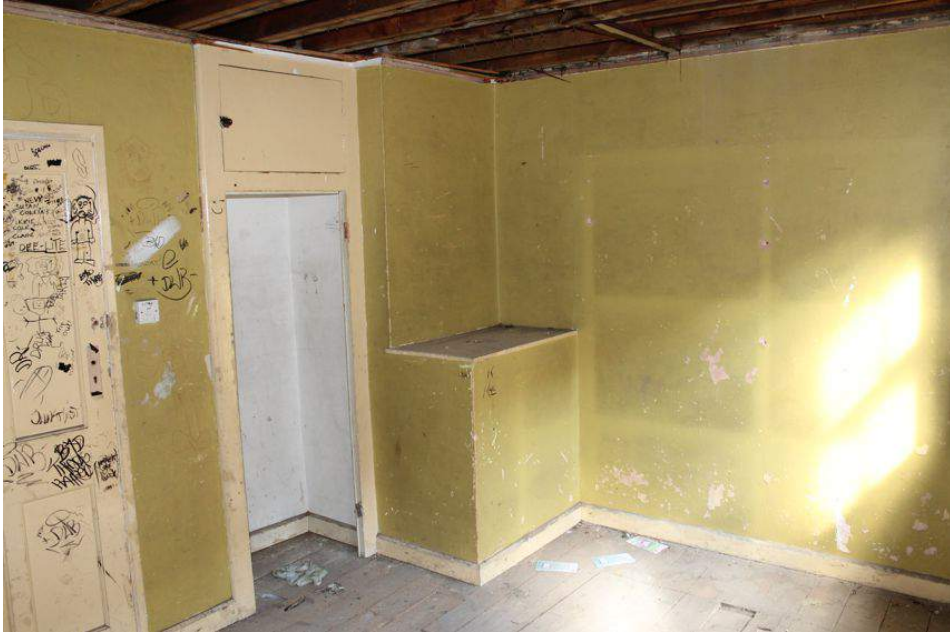
The first-floor of Building A is divided into four rooms, all of which are separated by plastered over hollow-tile block walls (Photograph 74). Again, all these divisions date from the 1936 alterations. The floors is made of floorboards, with no covering.

**Photograph 74** First-floor of Building D, showing internal divisions. Photograph taken facing north-east.

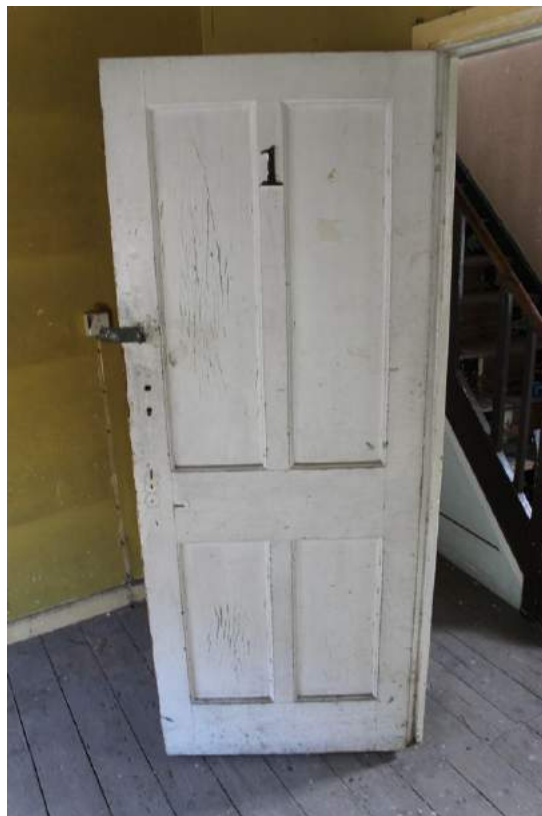
**Photograph 75** Four-paneled door on first-floor of Building D. Photograph taken facing north-west.

All the walls on this level are rendered over and painted, with little surviving in the way of features. The four-paneled doors separating the rooms are wooden (Photograph 75). The stairs leading up to the second-floor are entirely wooden, including the baluster and handrail. They are shown on the alterations plan of 1936 as having been moved from their original location in the east of the building. As a result they are unique in being original to the building, but not in their original position.

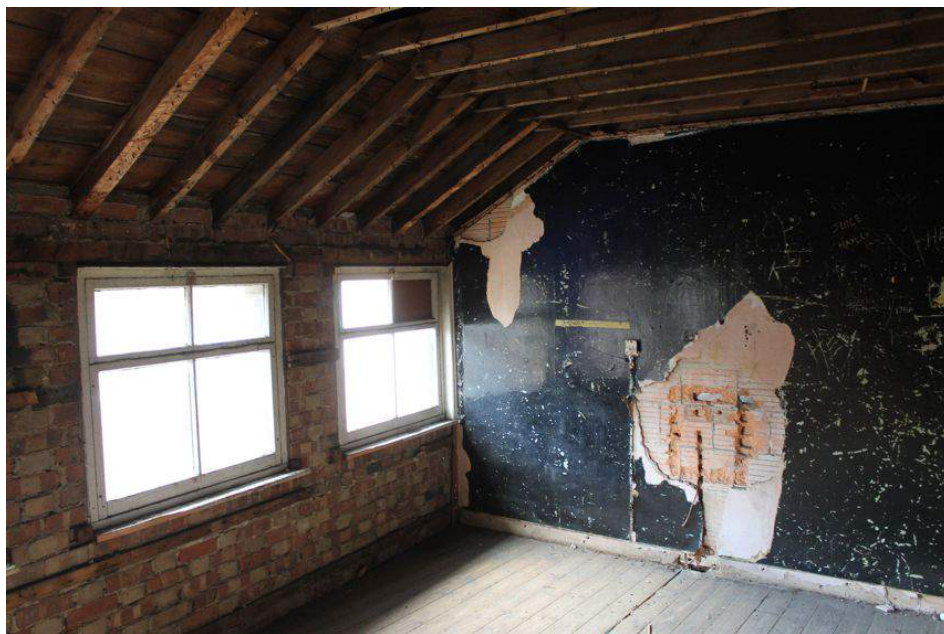
Like the floor below, all the interior walls on this level are rendered over and painted, with little surviving in the way of features. The southern exterior wall is exposed brickwork (Photograph 76), although until the soft-strip it would have been covered in plasterboard. As with the floor below, the four-panel doors are wooden. Exposed behind the plaster on some internal walls are hollow-tile blocks, used to facilitate the plaster adhering to the walls (Photograph 76).

**Photograph 76** Second-floor of Building D. Hollow-tile bricks visible beneath plaster to right. Photograph taken facing south-west.

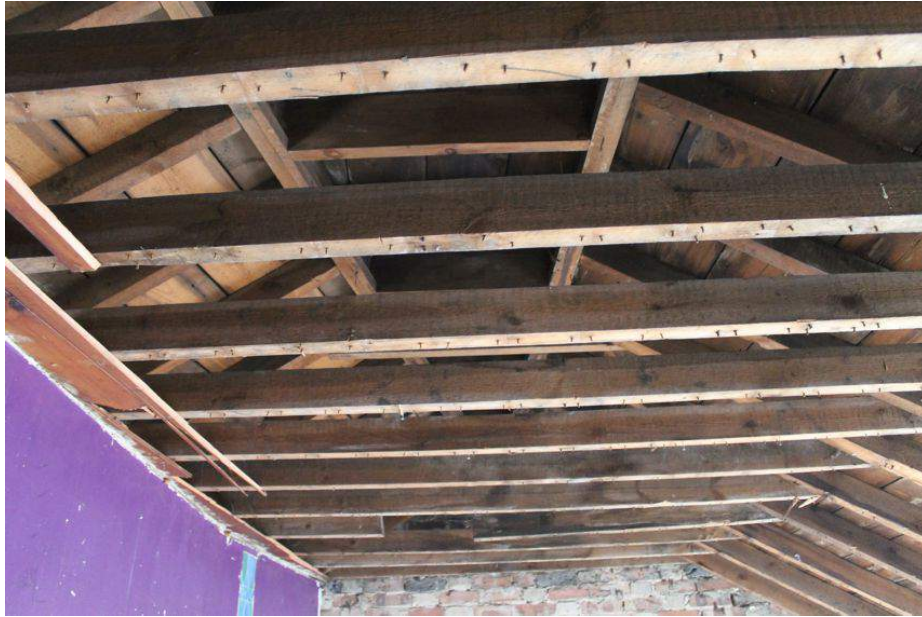
The roof has a collar between every pair of rafters and consists entirely of machine-cut timber (Photograph 77). It narrows down to a gable at the eastern end, in contrast to the gambrel at its western end.

No carpenters marks were observed on the timbers making up the roof, as would be expected from a modern building.

**Photograph 77** Detail of roof in Building D, showing the tapering of the gambrel roof to a gable. Photograph taken facing east.

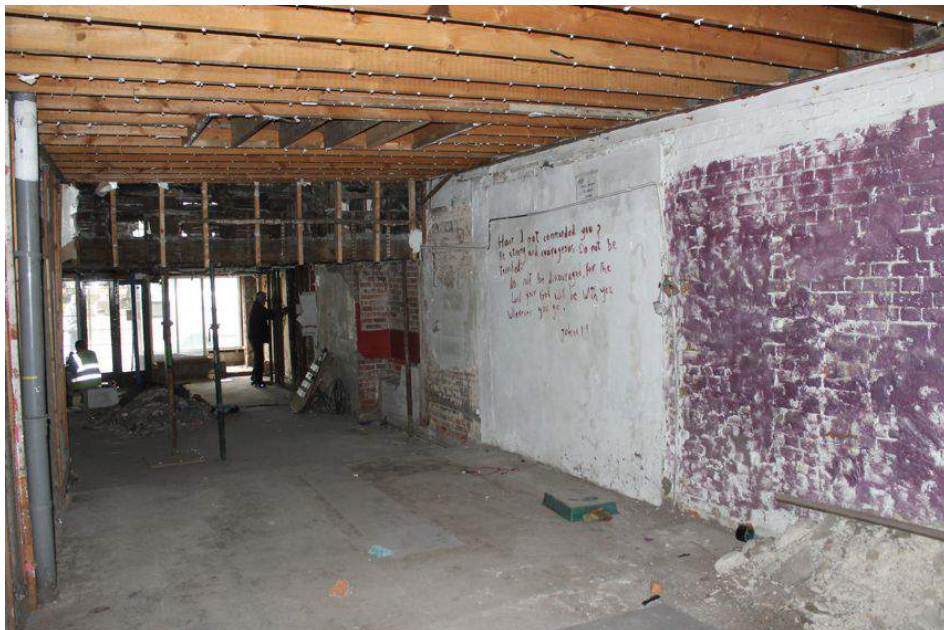
**Photograph 78** Interior of Building E. Photograph taken facing north-west.

remaining modern brickwork of the northern wall is also laid in Flemish-bond (Photograph 78). The eastern wall of Building E is the wall of the adjacent structure. The southern wall is the northern wall of Building D (see description above), the western part of which is, again, originally part of an earlier building in the yard that has been demolished. There is no western wall of Building E, it just opens into Building A.

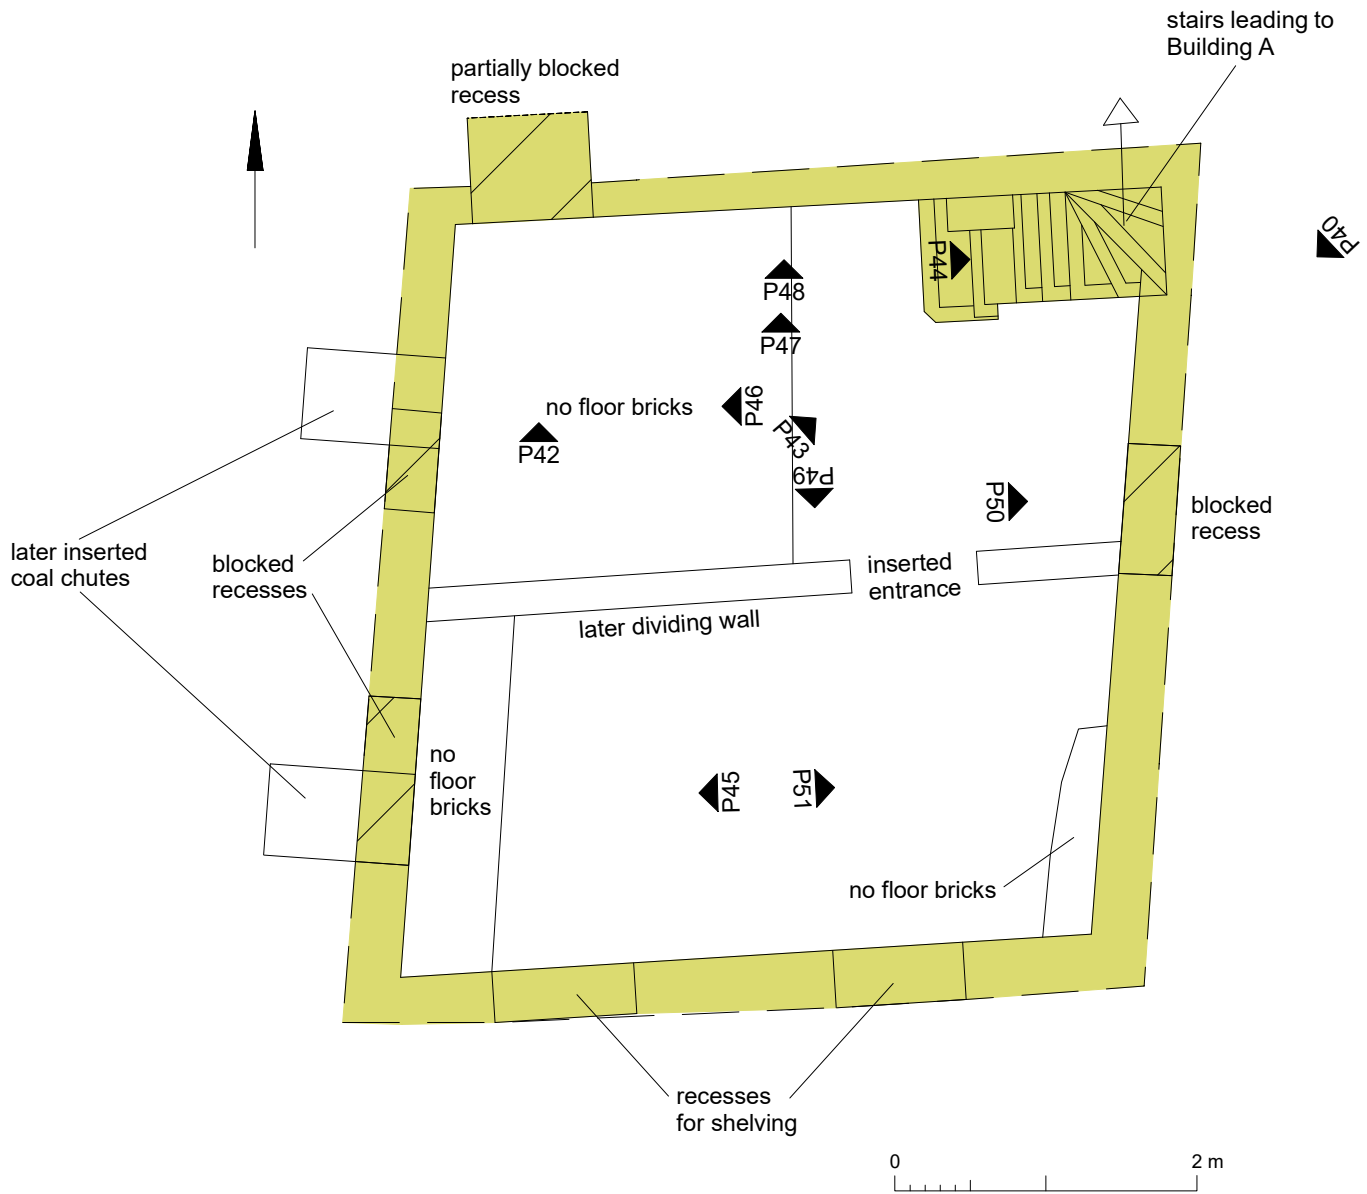
that they were laid when the cellar was divided. The western half of the northern room has no paving bricks at all; the floor is just soil. A small strip to the west of the southern room is also unpaved (Fig 3). At the foot of the stairs on the northern elevation there is a concrete surface, presumably inserted because of the increased wear in this location (Photograph 43).

Fig 3 Basement phasing plan (Building B), showing location and orientation of photographs reproduced in text.

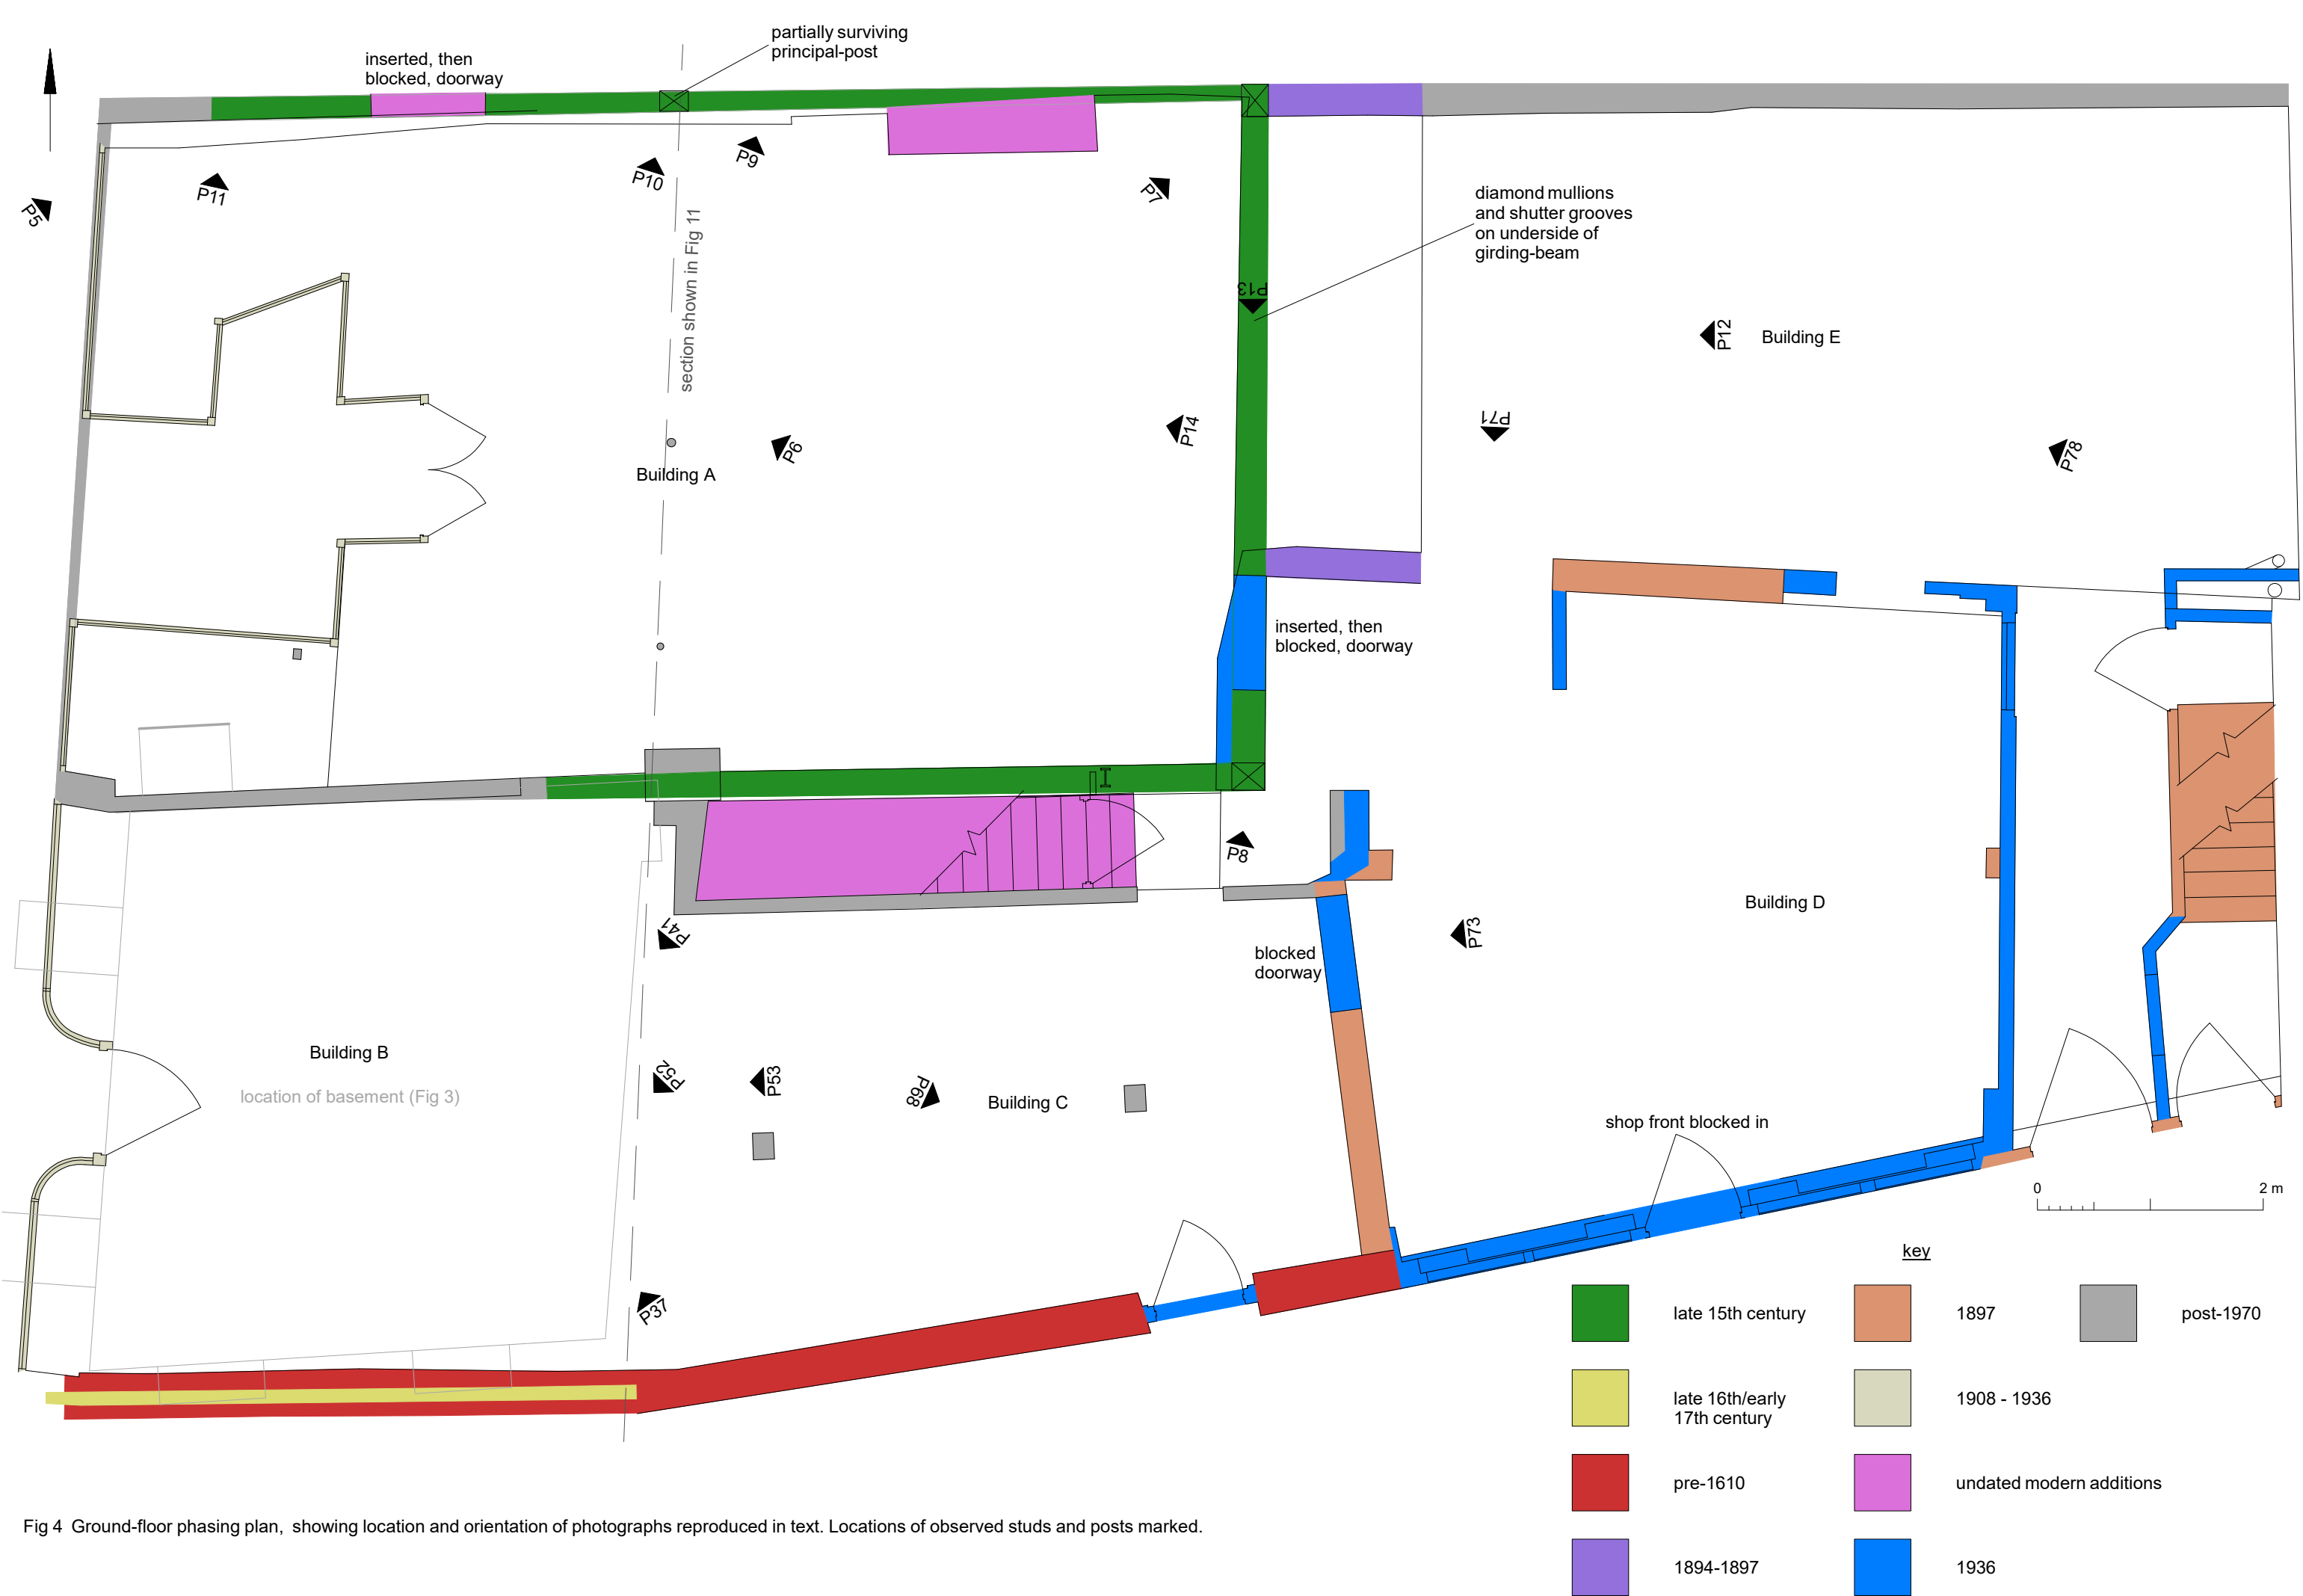
The western part of the northern wall of Building E is the remnants of an earlier building in the yard that has since been demolished, and is laid in Flemish-bond (Fig 4). The

Fig 4 Ground-floor phasing plan, showing location and orientation of photographs reproduced in text. Locations of observed studs and posts marked.
