**Historic building recording at  
5 and 6 St Nicholas Street (formerly 'Jacks'),  
Colchester  
CO1 1LB**

**September 2017**

CAT project ref.: 17/05i  
NGR: TL 9982 2517 (centre)  
Planning reference: 161296  
CHER event number: ECC4001  
Colchester Museum accession number: COLEM 2017.71  
OASIS reference: colchest3-285635

**CAT Report 1222**  
March 2018

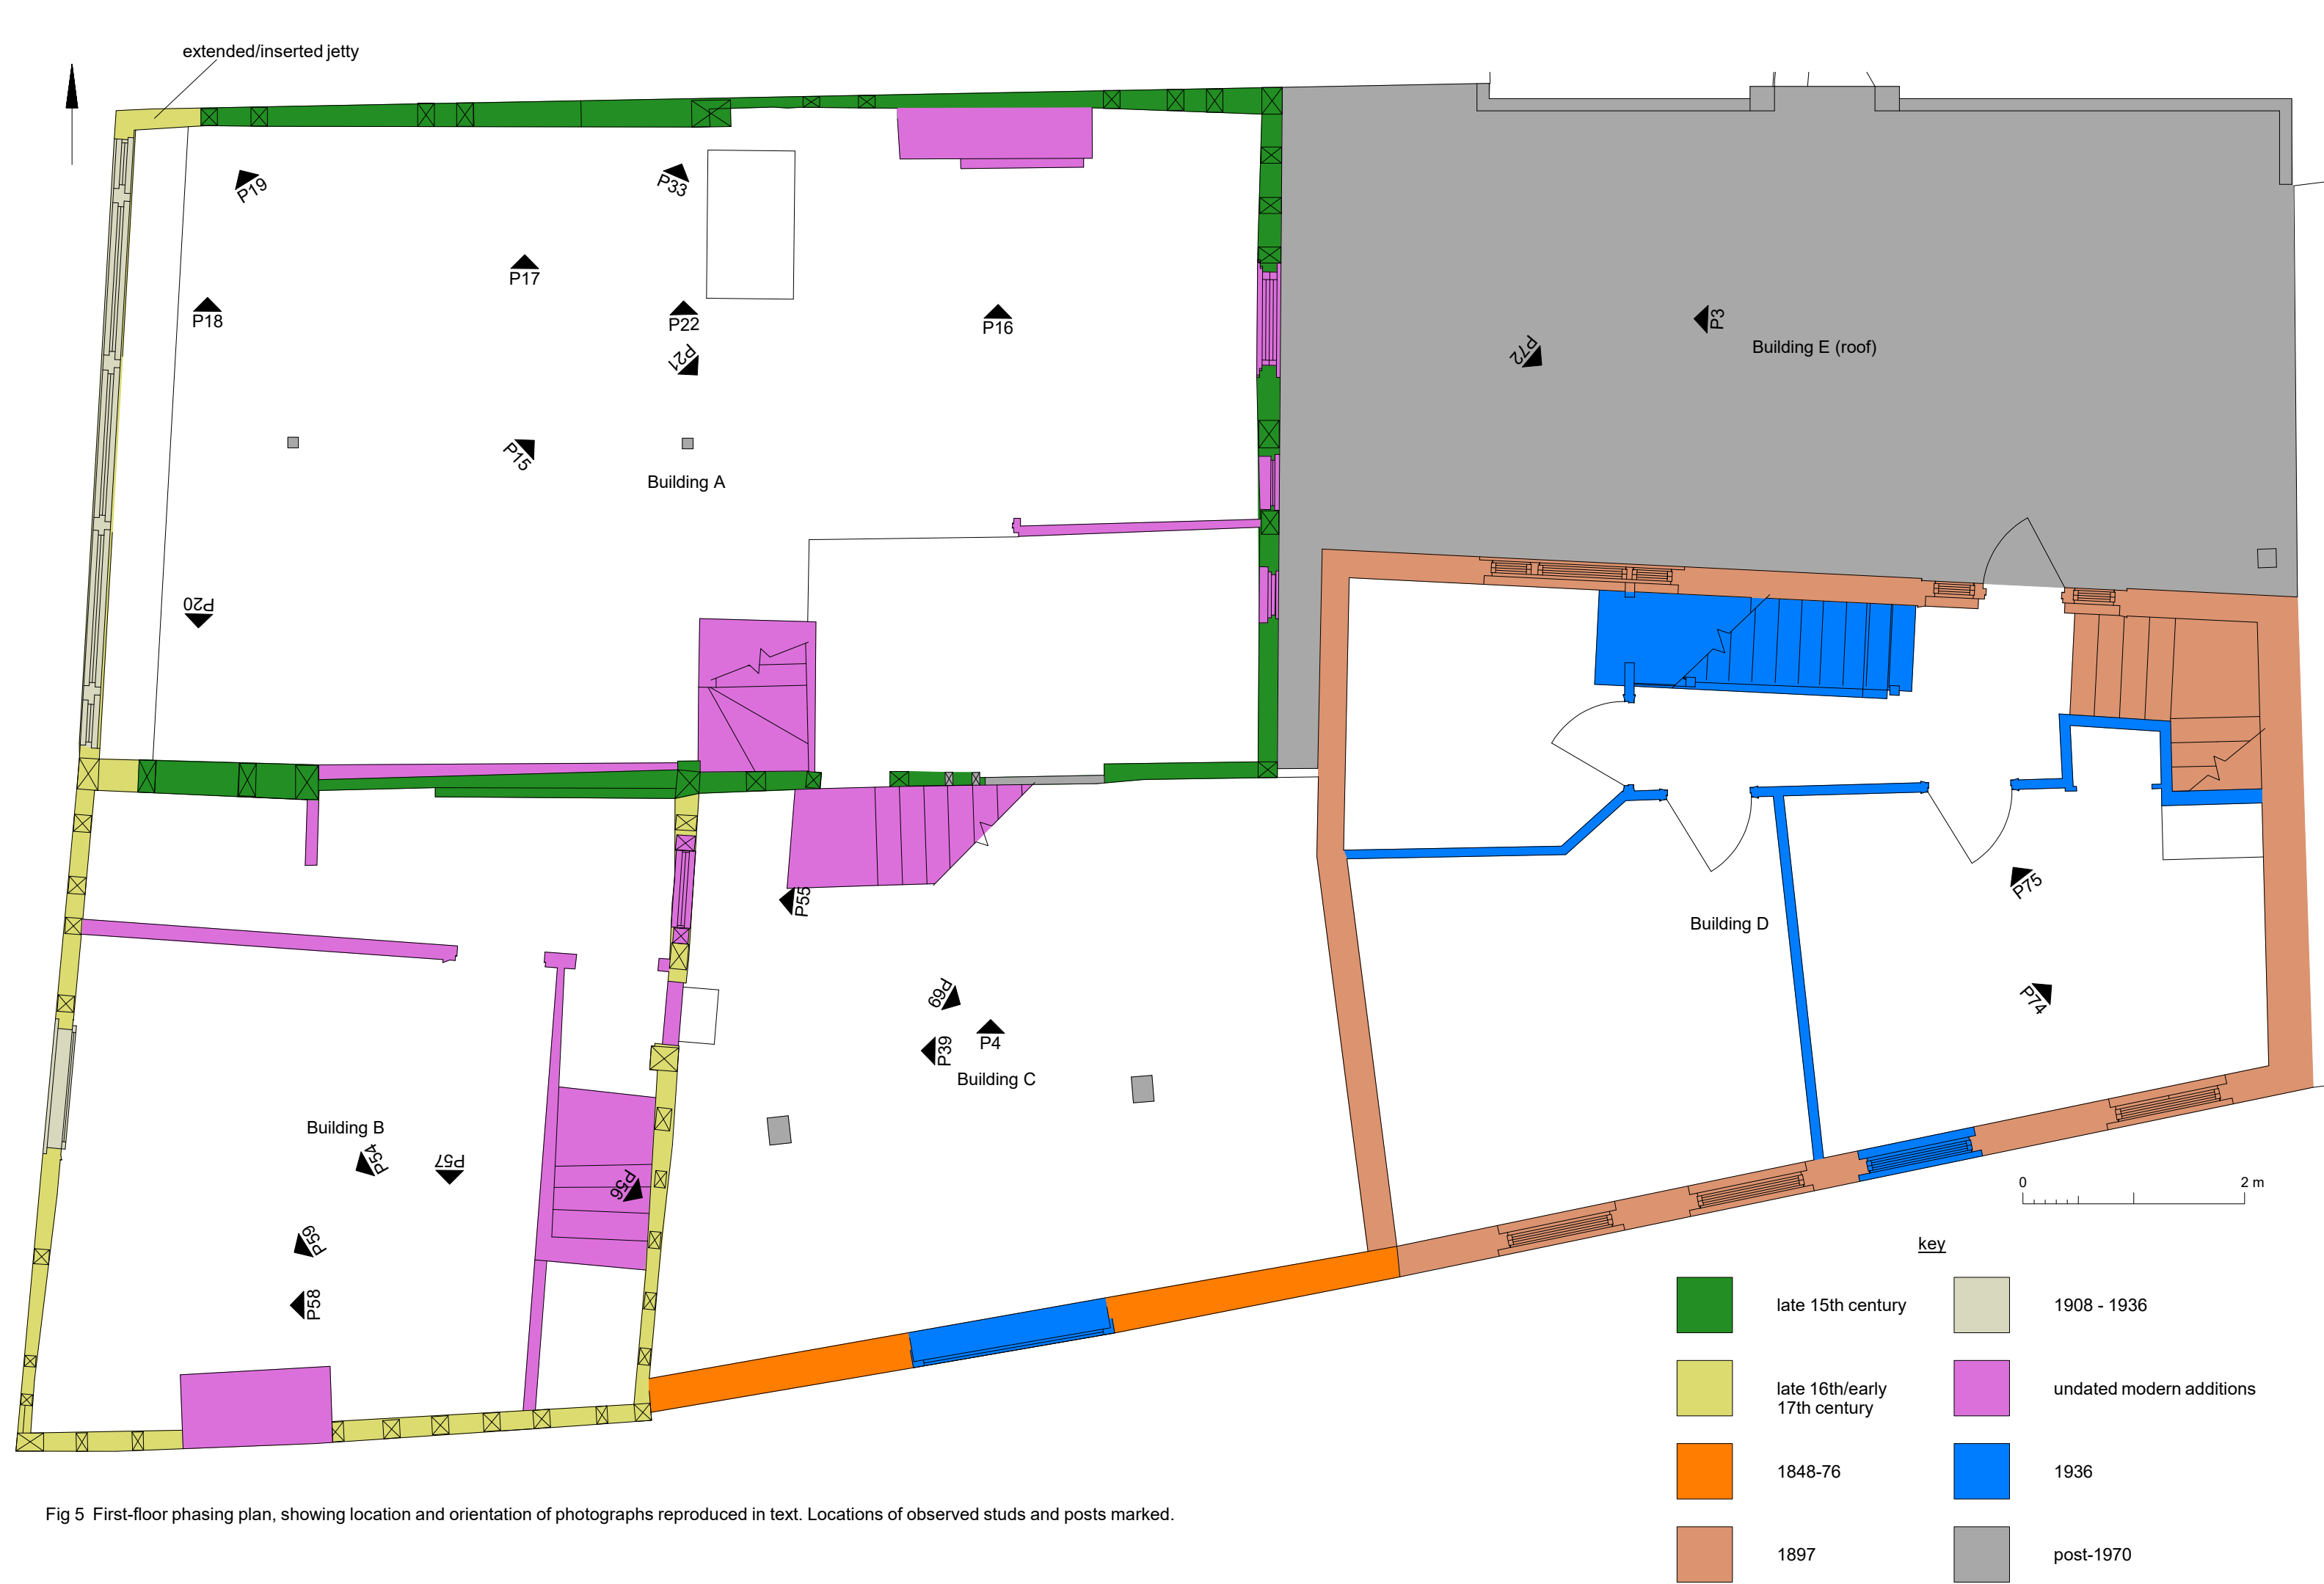
The first-floor of Building B is divided by three thin inserted walls covered in lath and plaster (Fig 5). The entire floor level has been raised to create more space on the ground-floor, and is supported on several metal girders (Photograph 39). The result is that this floor is very compact in size, with only 1.5m between the floor and ceiling (Photograph 54).

Fig 5 First-floor phasing plan, showing location and orientation of photographs reproduced in text. Locations of observed studs and posts marked.

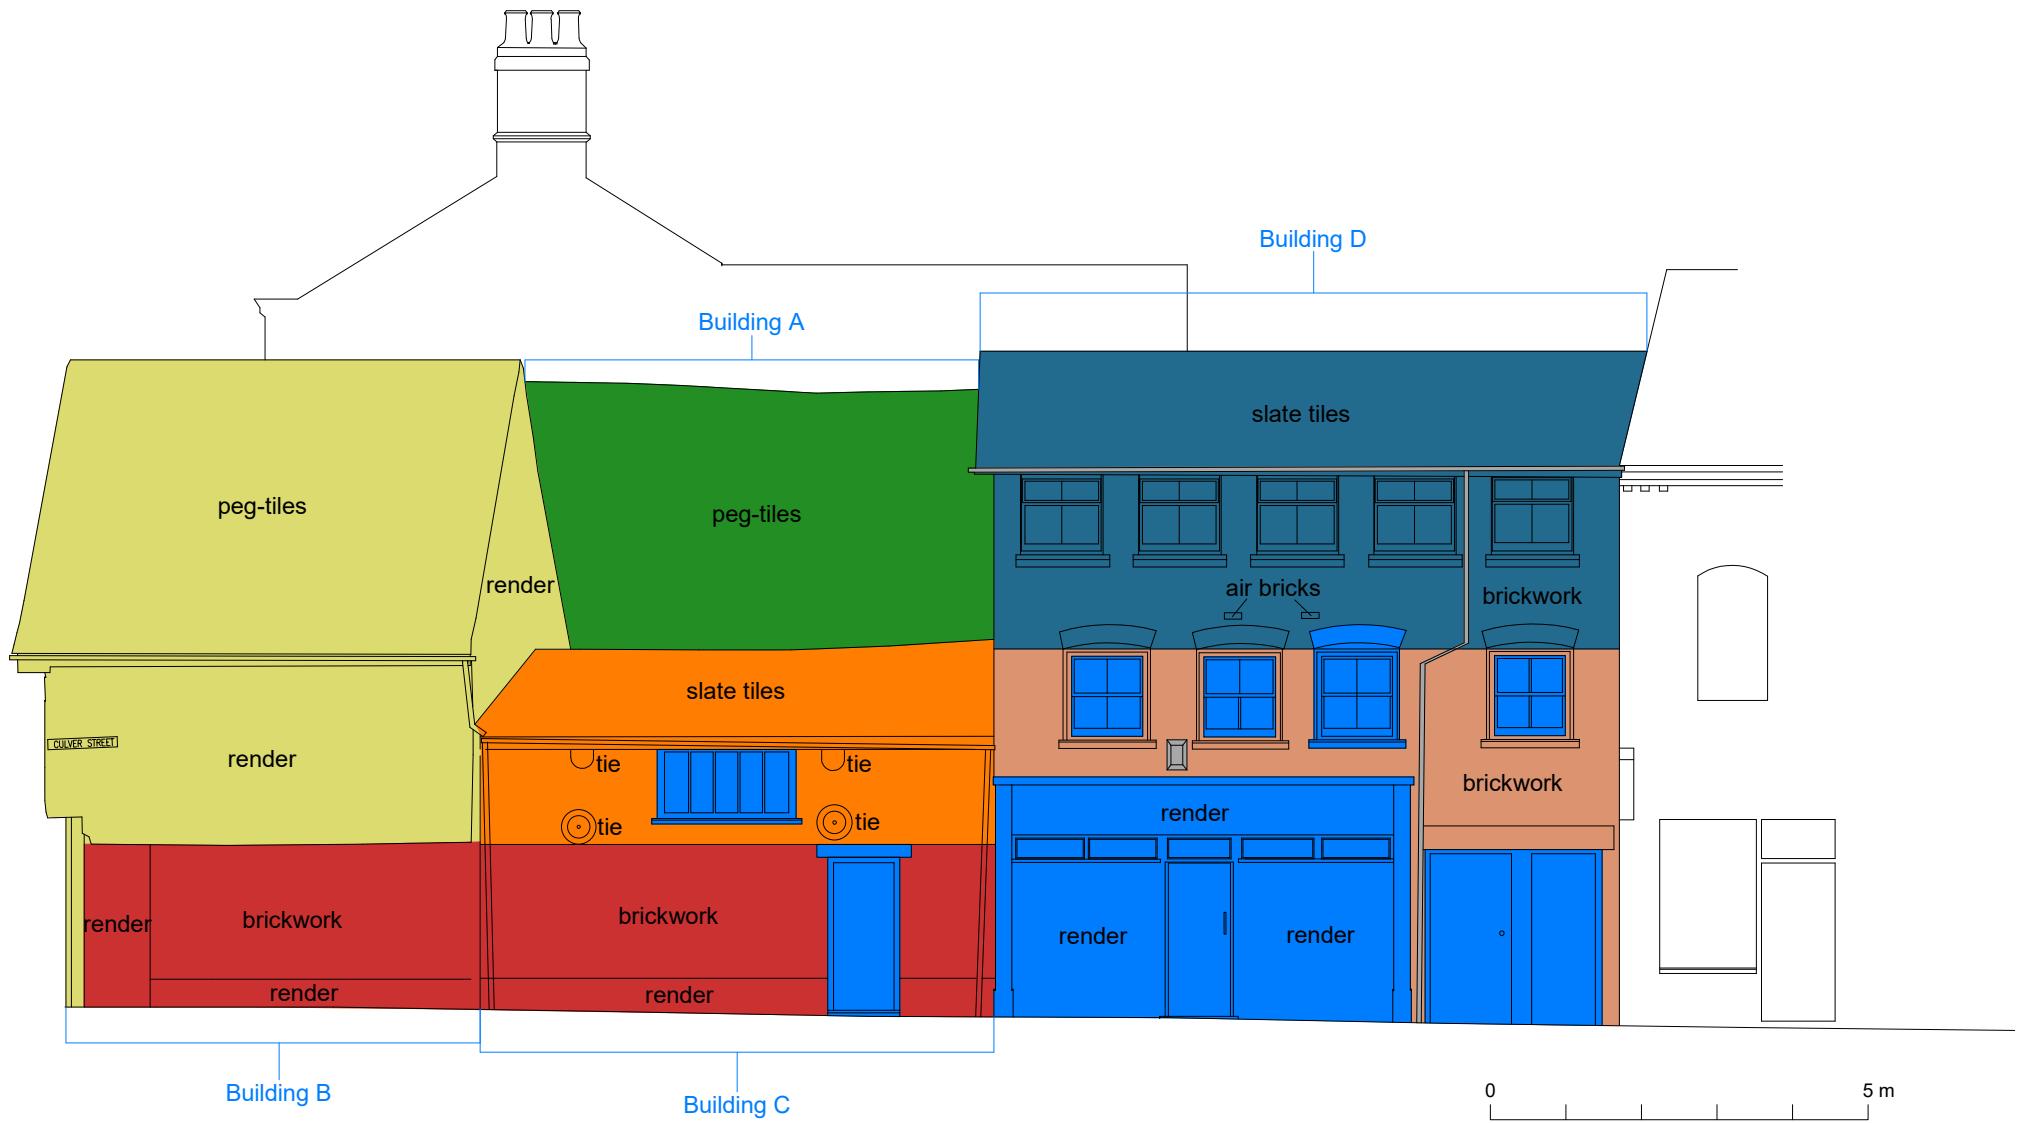
70). The first-floor level on this elevation has four wooden-framed four-light sash windows. All of these are later insertions into existing openings, with the exception of one that is into an inserted opening (Fig 7). These windows and the new opening were added in 1936 during general alterations carried out to the building (see historical background pg 13). The second-floor level of this elevation has five four-light awning windows, all of which are original to the second-floor addition.

Fig 7 Southern elevation of buildings with phasing.

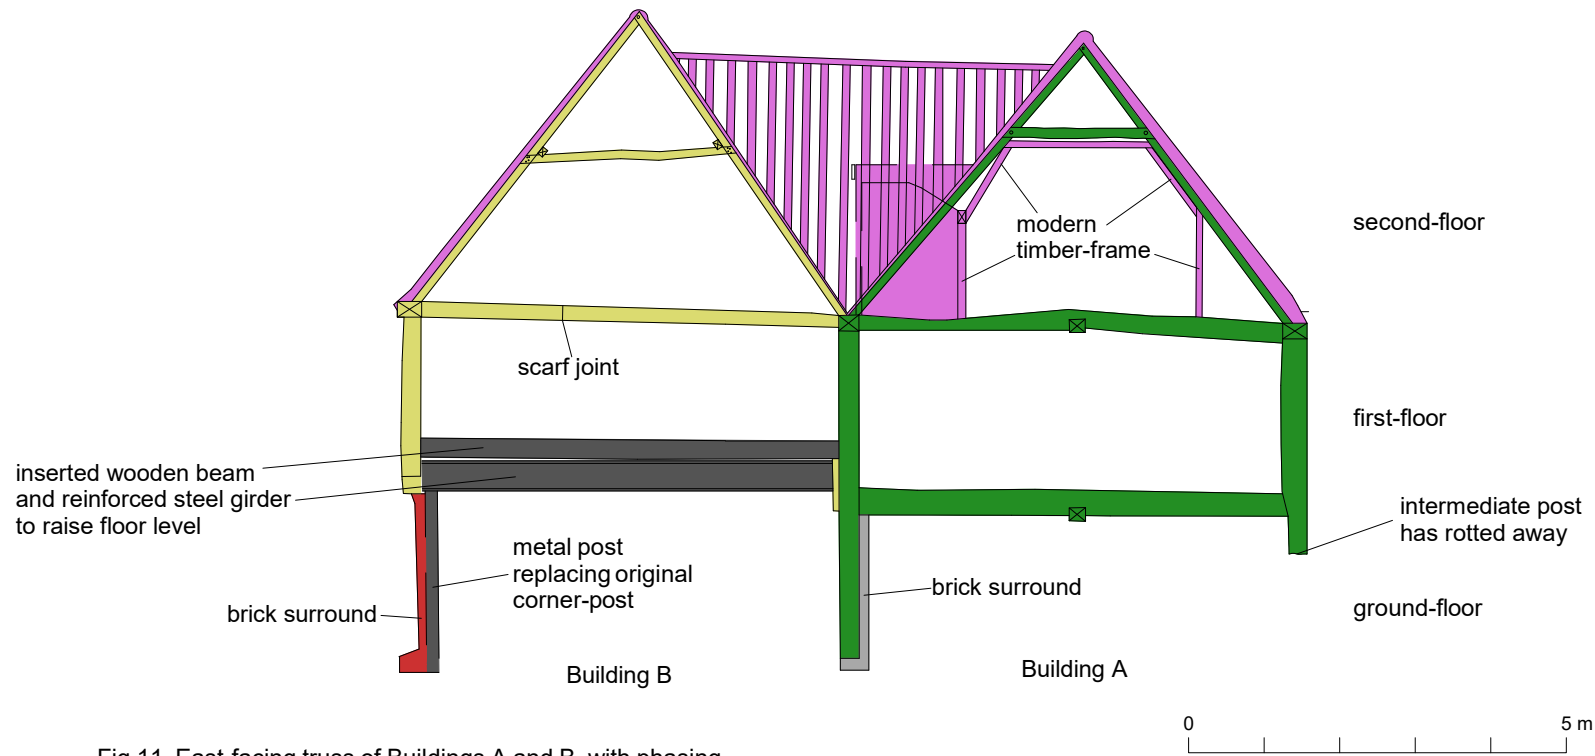
A major reason for this lack of surviving original timber is that the level of first-floor has been raised, with a new floor inserted, the joists of which are reinforced with herringbone strutting (Photograph 53). The raising of the first-floor accounts for the almost complete absence of the girding beam around the structure, and also the replacement of part of the girding-beam in Building A with a metal beam (Building B shares all of its major timbers with Building A on the northern elevation – see Fig 11).

Fig 11 East-facing truss of Buildings A and B, with phasing.

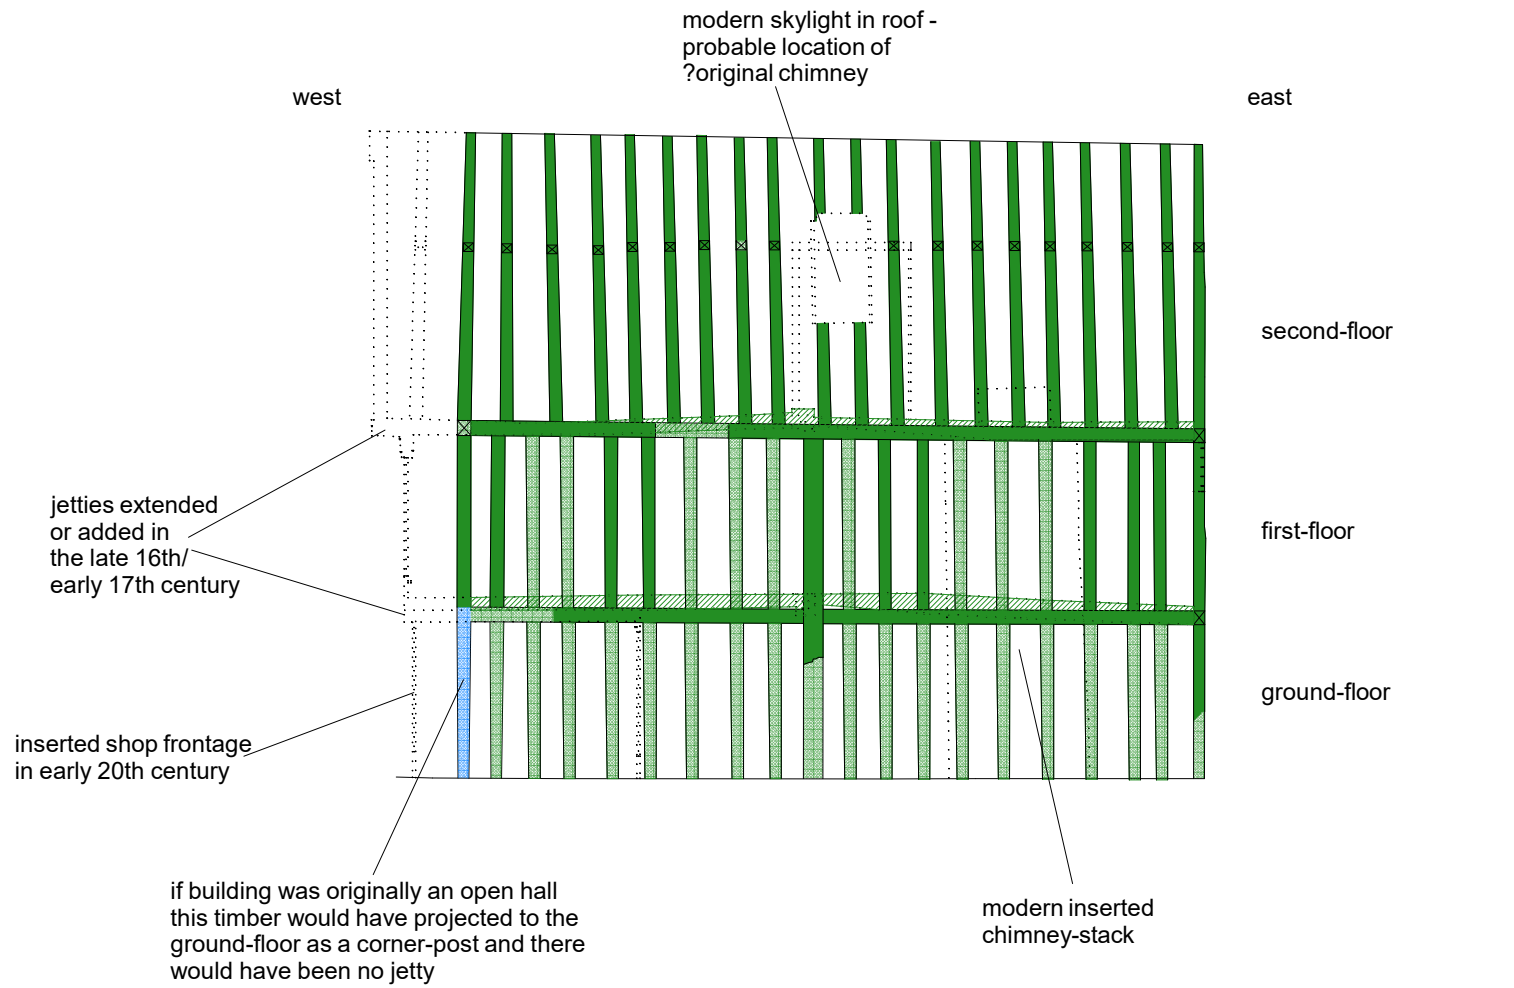
However, while town buildings did not precisely follow the evolution of their rural equivalents, there are significant parallels. Brunskill (2000, 175) describes a typical house and workshop in a medieval town as fundamentally similar in style to that of a hall-house: "two-storey ends to a single storey hall in the medieval rural manner but roofed with a gable facing the street". Certainly the gable facing the street and the single storey hall both could be used to describe Building A (Fig 12), but again we encounter the issue of a lack of two-storey bays at either end of the structure.

Fig 12 Timber-frame at northern elevation of Building A. Showing original structure and later additions. 0 5 m
