**Historic building recording at  
the Rising Sun and Maçonite buildings,  
3 Hythe Station Road,  
Colchester, Essex CO2 8JZ**

**November 2018**

CAT project ref.: 18/10g  
NGR: TM 0155 2474 (c)  
Planning reference: 163196  
CHER number: ECC4271  
Colchester Museum accession code: COLEM 2018.105  
OASIS project id: colchest3-3314814

**CAT Report 1359**  
December 2018

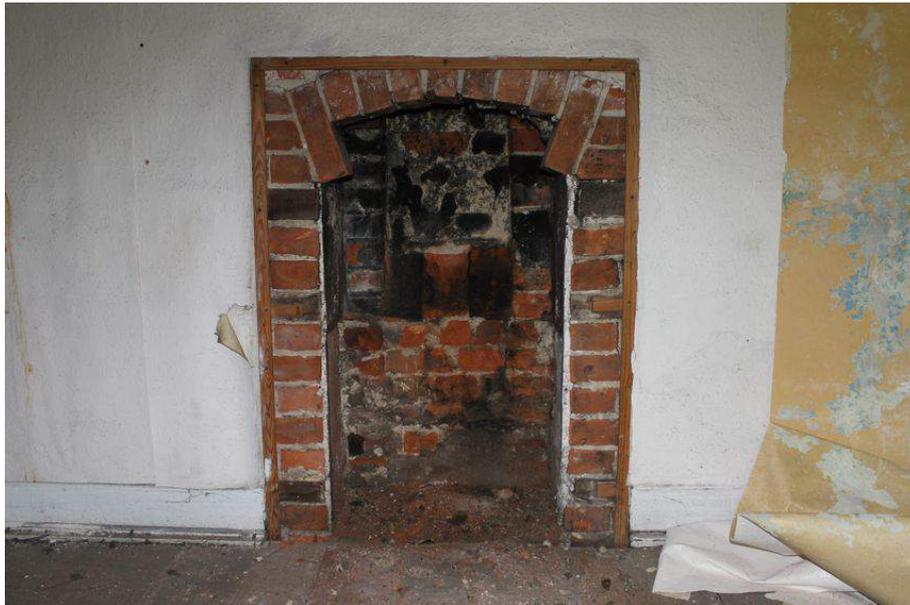
The two southern fireplaces have been bricked-up, but the northern two still have their original openings, with brickwork measuring 230 x 110 x 70mm (Photograph 18). The floorboards on the first-floor are reasonably consistent in size, ranging from 220-250mm in width.

**Photograph 18** Original brick fireplace in north-east room on the first-floor of the Rising Sun. Photograph taken facing north-east.

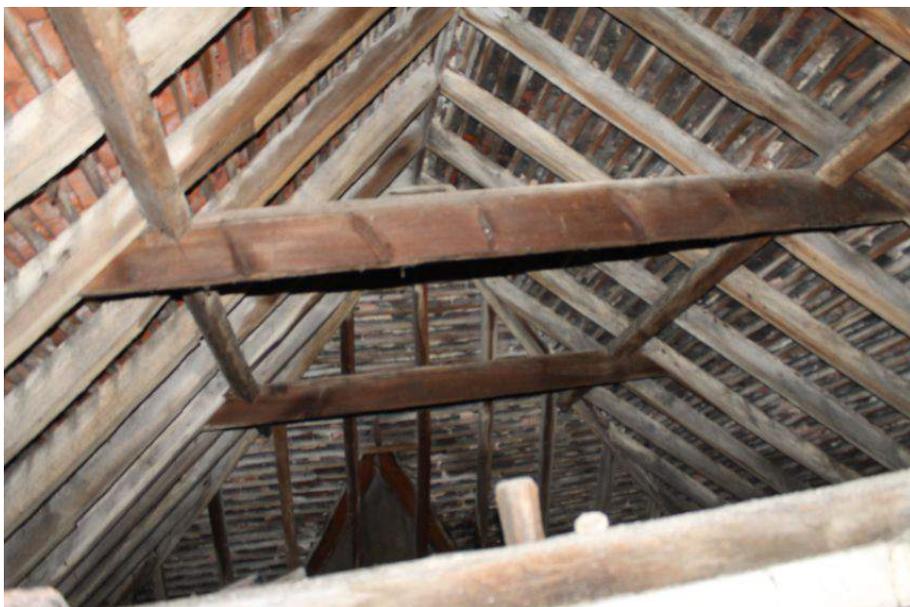
**Photograph 19** Roof structure above southern range of Rising Sun, observed from first-floor. Photograph taken facing east.

The roof structure of the Rising Sun was partially visible on the first-floor, and is entirely constructed of machine-cut timber. In both ranges of the building the roof consists of rafters rising to a ridgeboard, supported by collars and upper-collars (Photograph 19). The roof is also supported by a purlin on each pitch. Near to the central collar location the purlins are supported by queen-posts. The battens and nib-tiles are all visible from the interior of the building, with the exception of the southern pitch of the northern range, which has modern cladding beneath the battens; obscuring them from view. No carpenter's marks or scarf joints were observed in the roof structure, although only a small section was visible.

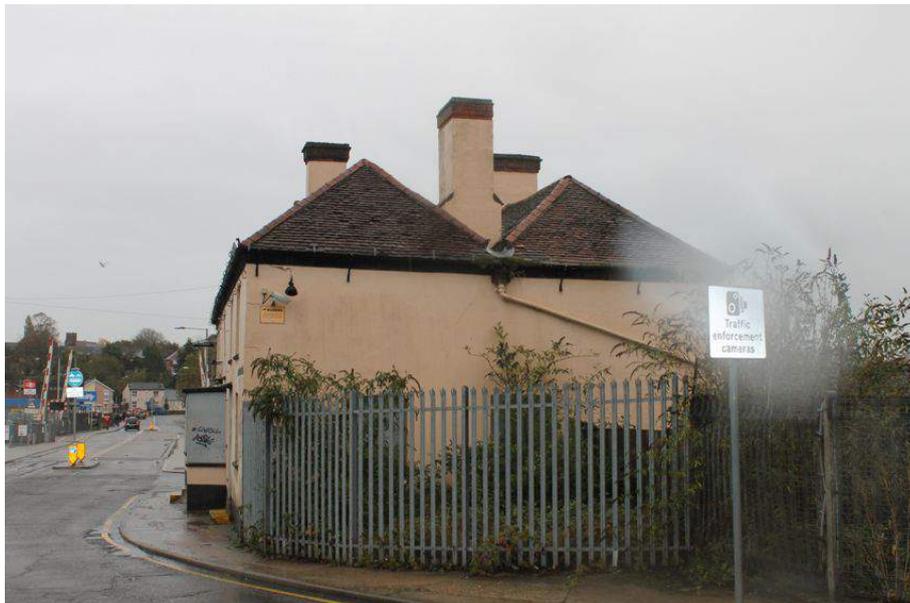
The south-west elevation of the house extension has a single window on the ground-floor, a partially removed wooden-framed sash (Fig 8). Also on the ground-floor is a modern two-panel door. There is an opening in the basement on this elevation, but no door or window remains.

**Photograph 20** South-west elevation of the house extension (Structure 2). Photograph taken facing east.

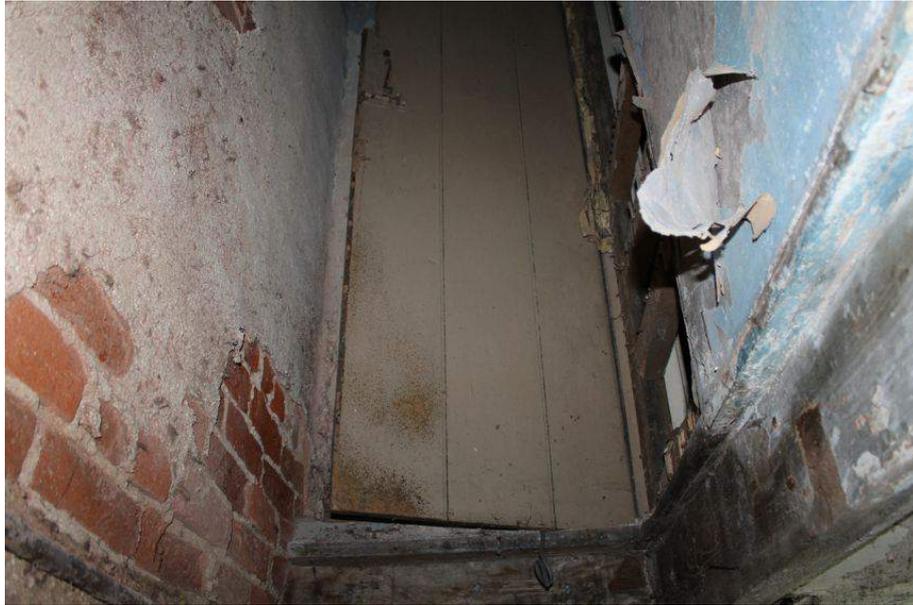
The northern room of the cellar has the partial remains of a (probably original) pavior-brick floor surviving to the east, with brick dimensions of 230 x 110mm (Photograph 22). Also in this room are several inserted brick pillars, supporting timber-beams that, in turn, support the floor above (Photograph 23). Unlike to the south (see above) the structural brickwork in this room is largely original, although there are still areas of repair and patching. In particular, the chimney-stack in this room is in a very poor state of repair (Photograph 24). There is an opening in the ceiling of this room to the south-east, which presumably would have been the location of a stairway, mirroring the one to the south and leading up to the ground-floor (Photograph 25).

**Photograph 25** View of original door on ground-floor from location of removed stairway in basement of Structure 2. Photograph taken facing south-west.

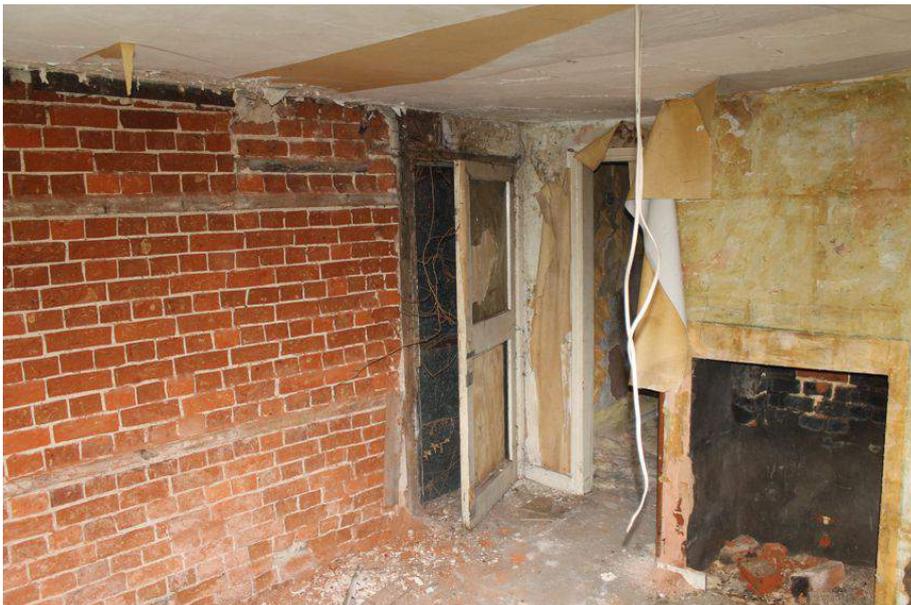
Part of the western brick wall of the building has been exposed on this floor, it is laid in English-bond, bonded in lime mortar, and has brick dimensions of 220 x 120 x 70mm (Photograph 28). Every 11 courses there is a timber inserted into the brickwork, presumably to assist with the addition of plaster to the wall.

**Photograph 28** South-west room on ground-floor of house extension. Showing external entrance, fireplace and exposed brickwork. Photograph taken facing north-west.

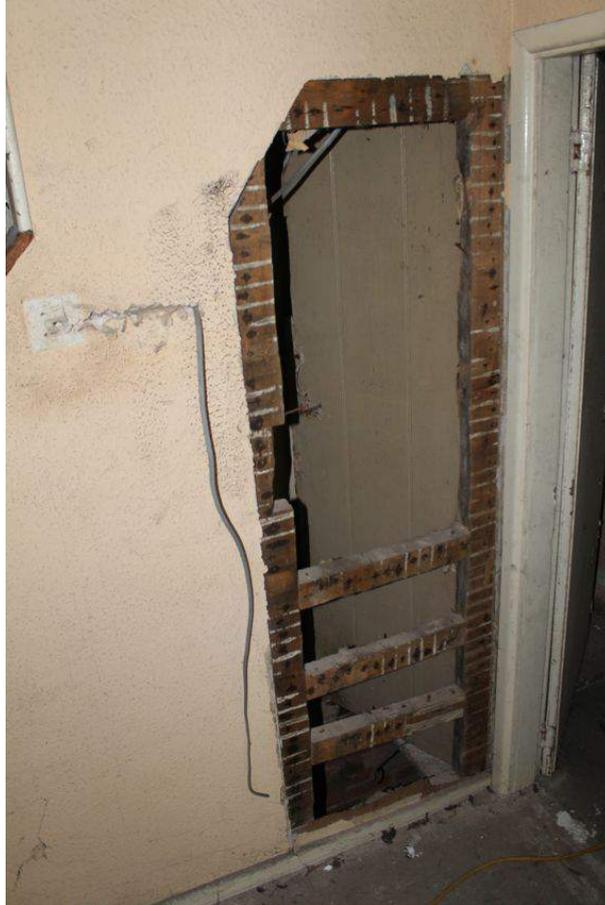
A surviving vertically-planked door in the north-east room on the ground-floor would have lead down into the cellar (when the stairs in the northern room of the cellar were extant; see pg 25 above). This door is constructed of three wide, irregular-sized planks and is probably original to the building (Photographs 25 and 29). At a later date, presumably when the staircase down to the cellar was removed, this doorway (complete with door) has been blocked with timbers and lath and plaster (which has only recently been removed).

**Photograph 29** Partially boarded over original door to basement in north-east room of ground-floor in Structure 2. Photograph taken facing south.

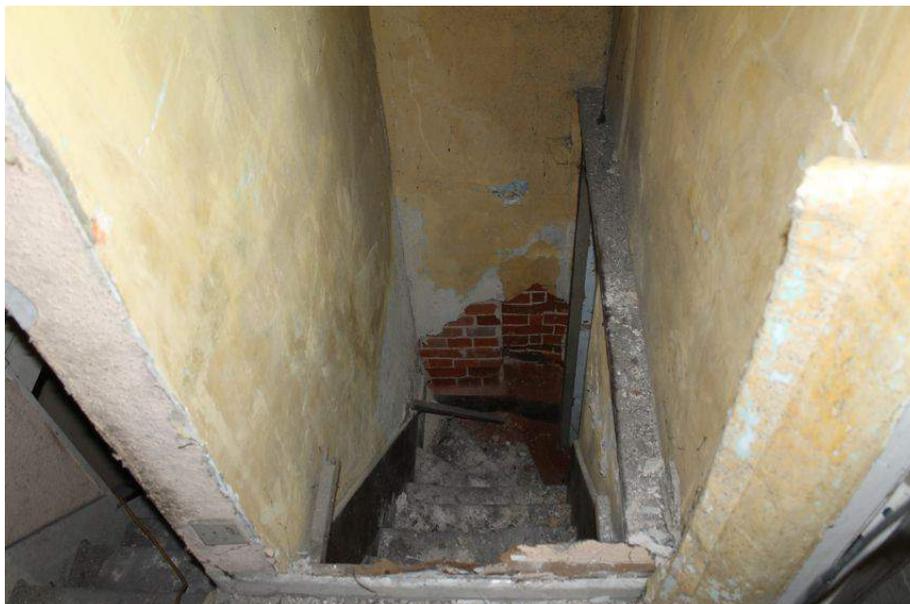
**Photograph 30** Southern staircase, view from the first-floor. Note top step is boarded over. Timber to right of frame would have supported boards covering whole staircase. Also visible at bottom of staircase is exposed brickwork with joint and queen closers. Photograph taken facing north-east.

At the base of the southernmost staircase (Fig 4) the plaster and wallpaper has been removed from the western brick wall of the Rising Sun, exposing a join in the brickwork, and what appears to be queen closers to the south of the join (Photograph 30).

The southern set of stairs leading up to the first-floor appear to have been boarded over at some point in their history. The top step of the stairs is still boarded over and a timber on the southern wall would have supported the remaining boards (Photograph 30).

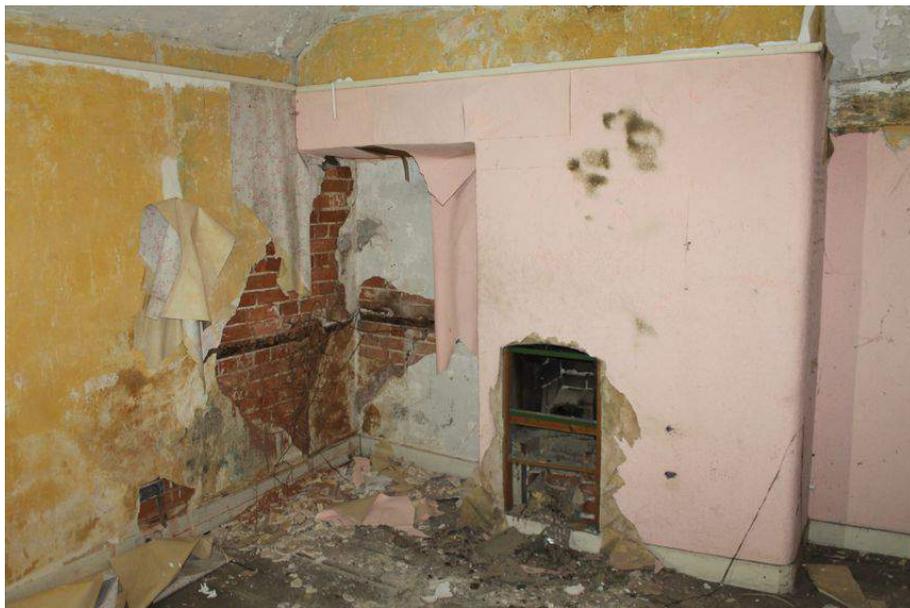
The southern fireplace in the central chimney-stack was until recently panelled over (Photograph 31), whereas the northern one is still entirely blocked (Fig 5).

**Photograph 31** South-west room on first-floor of Structure 2, showing exposed brickwork and fireplace. Photograph taken facing north-west.

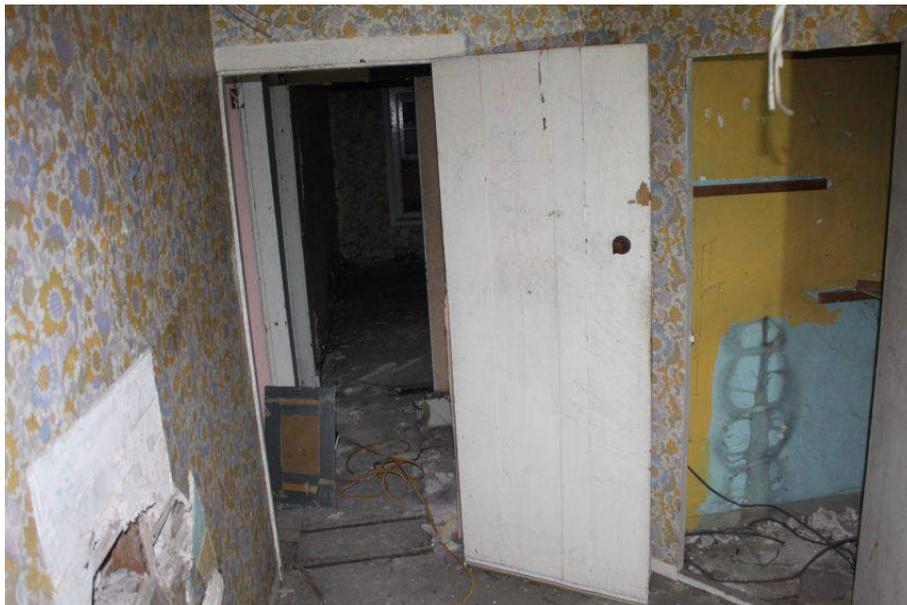
Only one door on this floor survives (Fig 5); it is vertically-planked and has four-panels, each of varying widths (Photograph 32). The door is supported by four horizontal battens on its rear (Photograph 33). It has a Victorian rim latch with a replacement Bakelite handle, but like the door on the ground-floor (see above) is probably original to the building.

**Photograph 32** Vertical-planked door on first-floor of the house extension. Photograph taken facing north-west.

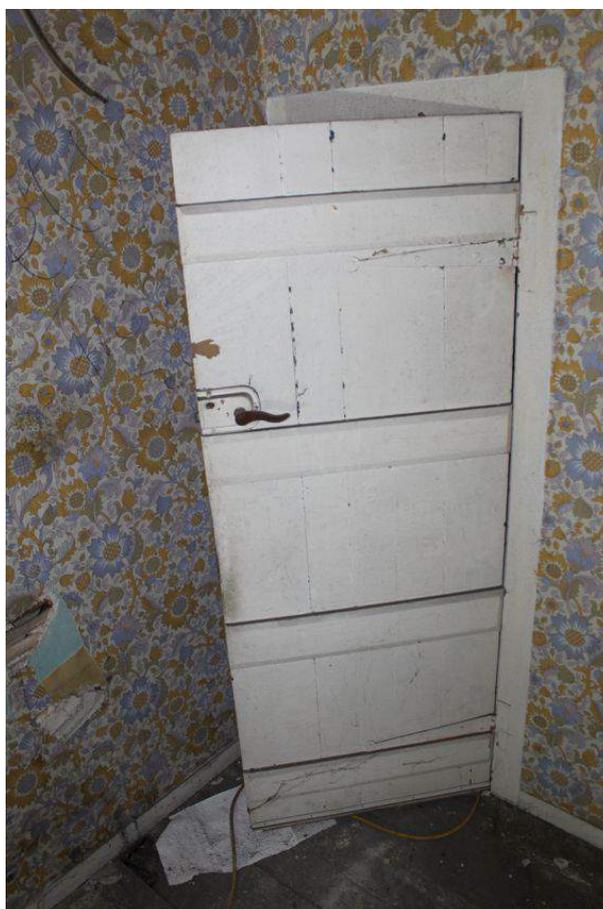
**Photograph 33** Rear of vertical-planked door, showing Bakelite handle and rim latch. Photograph taken facing west.

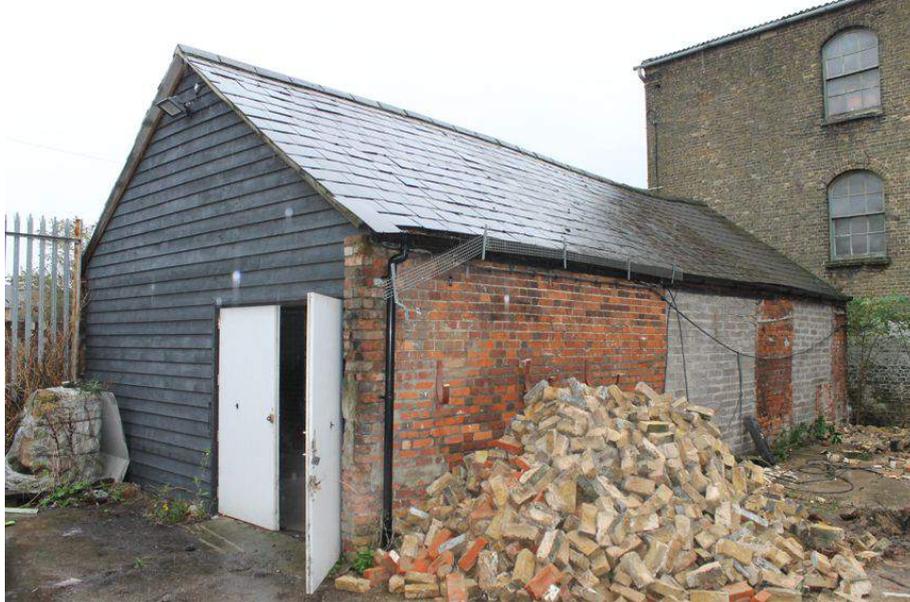
This structure is aligned north-west to south-east, measures 12.2 x 6m in size and covers approximately 73.9 square metres. It is located to the south-east of the Rising Sun (Fig 2) and is a single-storey brick built structure, with brickwork laid in Flemish bond and bonded with lime mortar. The brick dimensions are 220 x 100 x 65mm. The northern elevation differs in that it is constructed of cement bricks covered in weatherboarding (Photograph 34). The building has a slate-covered gable roof.

**Photograph 34** North-west and south-west elevations of the outbuilding (Structure 3). Photograph taken facing south-east.

The eastern and southern elevations of Structure 3 are featureless. The western elevation has two double-width openings that have been blocked with cement bricks (Fig 9). The northern elevation has a double-width opening filled with a modern door (Photograph 34).

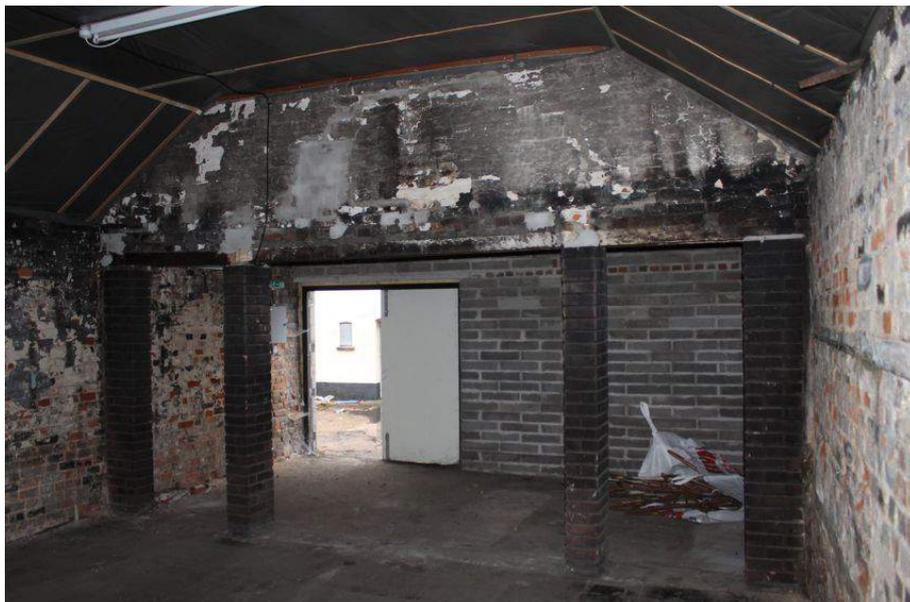
The interior of Structure 3 is divided into two rooms, both with a concrete floor. The rooms are divided by four modern brick pillars, which support a metal beam and a suspended section of brickwork (Photograph 35). The roof is covered in modern cladding and no structural timbers are visible.

**Photograph 35** Internal division within Structure 3, showing brick pillars. Cement block wall visible behind. Photograph taken facing north-west.

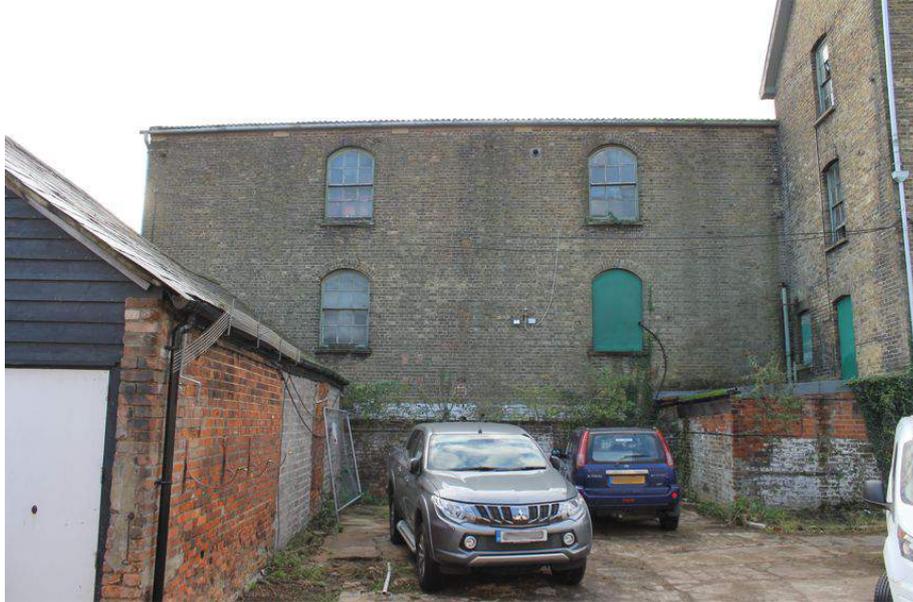
**Photograph 36** Northern elevation of Structure 6 (northern warehouse). Also shows Structure 4 to right of frame. Photograph taken facing south.

It is a two-storey building with a gable roof covered in corrugated asbestos (Photograph 36). It is brick-built with yellow London stock bricks, laid in English-bond and bonded with lime mortar (Photograph 53). The brickwork has queen-closers around the windows, entrances and corners of the building. The brick measurements are 200-230 x 105 x 65mm.

The north elevation of Structure 6 is partially obscured by Structures 4 and 5 (Fig 13). Visible on this elevation are four hornless wooden-framed twelve-light sash windows (Photograph 36). The upper two of these windows are on the first-floor, the lower two are bisected by the inserted floor inside the building (see below).

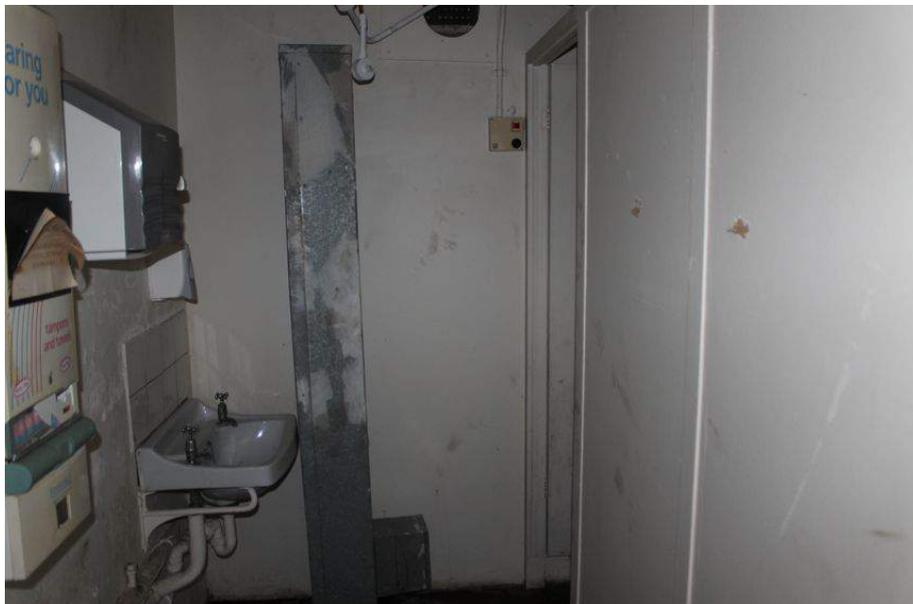
The interior of Structure 4 is subdivided into two modern W.C's, with no trace of historical features or fittings (Photograph 37).

**Photograph 37** Interior of Structure 4. Photograph taken facing north.

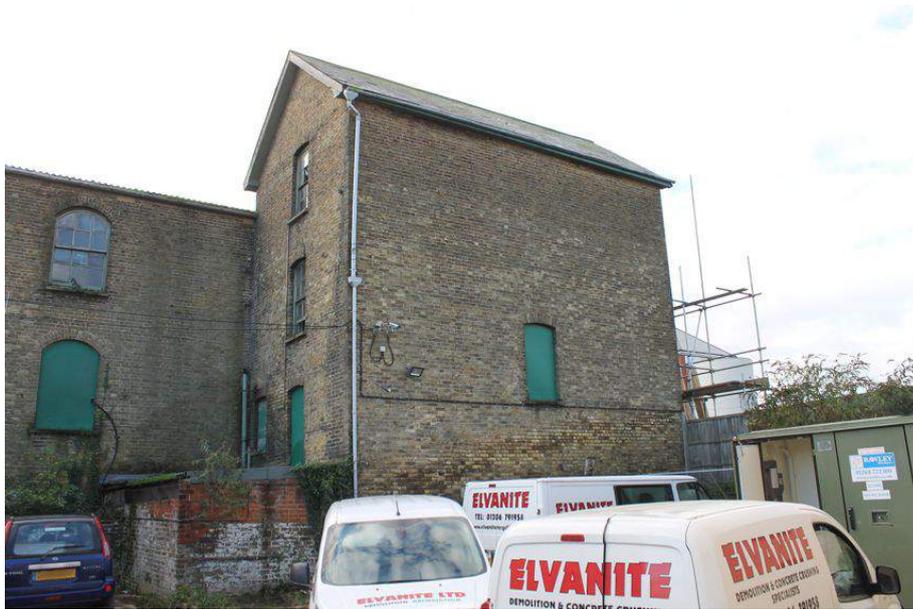
The building has a gable roof, covered in slate (Photograph 38). No chimney-stacks project from the roof today, but originally there would have been two (see interior description below).

**Photograph 38** Northern elevation of four-storey house (Structure 5).  
Photograph taken facing south-west.

The north elevation of Structure 5 (fronting onto the yard behind the Rising Sun; Photograph 38) has two small window openings in the cellar but no surviving windows. The first-floor on this elevation has a larger window opening, but, again, no window survives.

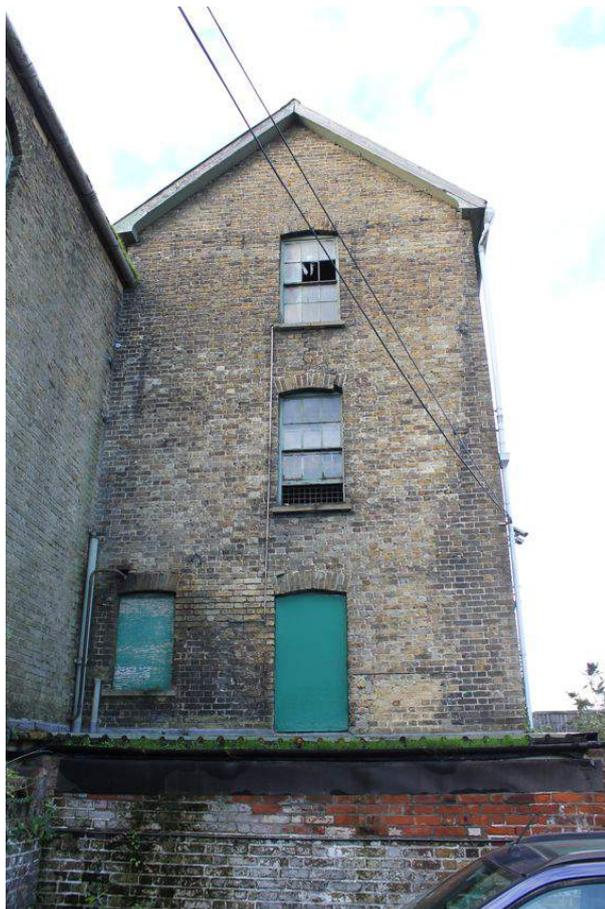
The east elevation of the house has three twelve-light hornless sash windows, one each on the ground, first and second-floors (Photograph 39). It also has a smaller window opening on the ground-floor that has been blocked.

**Photograph 39** Eastern elevation of Structure 5.  
Photograph taken facing west.

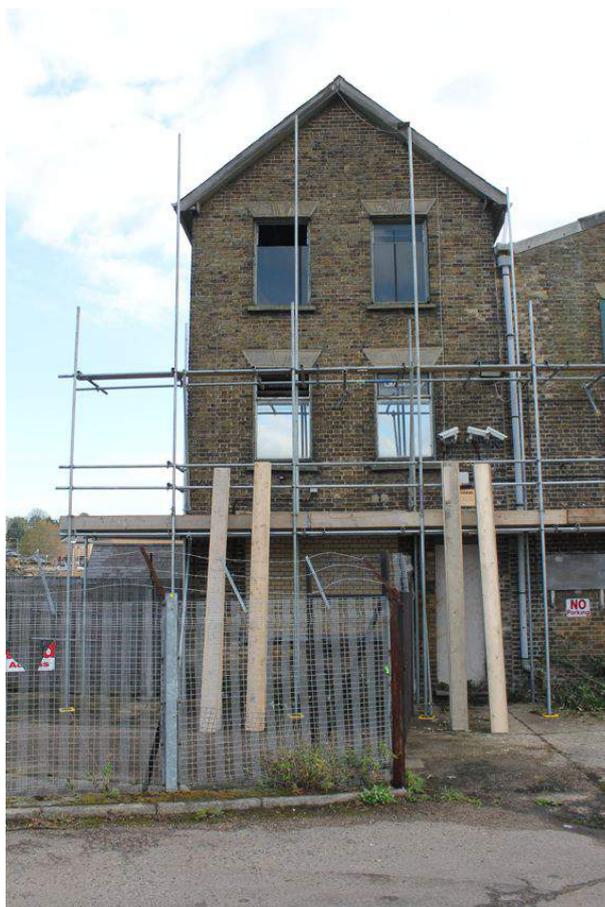
**Photograph 40** Western elevation of Structure 5.  
Photograph taken facing east.

The western elevation of the four-storey house has four modern wooden-framed fixed windows, with awning ventilation panels at their apex (Photograph 40). Two of these windows are at the second-floor level and two are at the first-floor level, and they all appear to be in original window openings, judging from the surrounding queen closers. On the ground-floor on this elevation is a large bricked-in window opening and a blocked doorway (Fig 12). Clearly visible on this elevation is a line of mortar between Structure 5 and 6; they are not bonded together.

All the window and door openings on the western elevation of Structure 5 have a decorative lintel – a single trapezoidal block of cement with incised lines (Photograph 40).

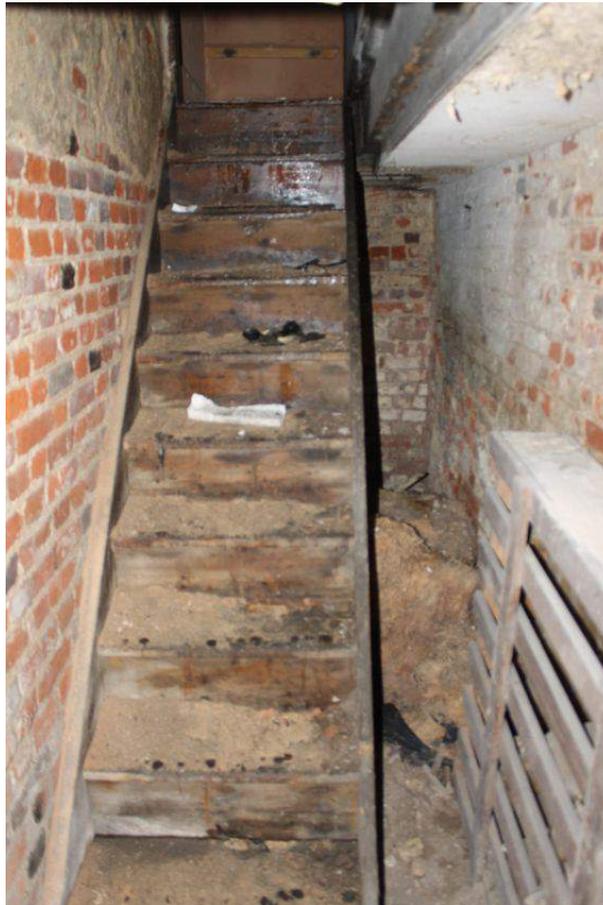
The basement of Structure 5 has a concrete floor and is subdivided into two rooms by a central staircase that rises up through every floor of the building (Fig 9). The walls of this staircase are brick-built, although the stairs themselves are wooden (Photograph 41).

**Photograph 41** Staircase leading up from basement of four-storey house (Structure 5). Photograph taken facing north.

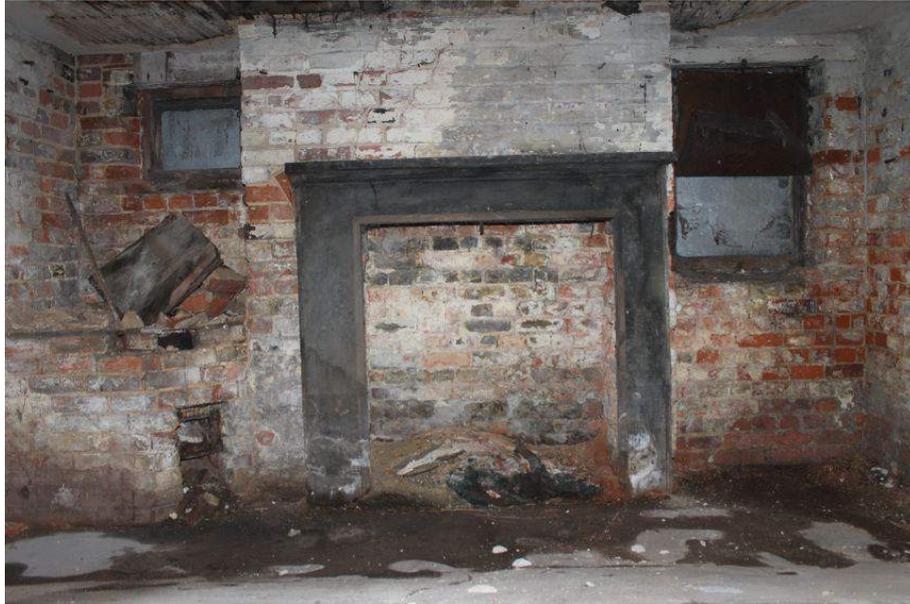
Both the east and the west room in the basement have an open fireplace and chimney-stack on the northern wall, although they differ slightly in size (Photographs 42 and 43). The fireplace in the eastern room has a simple carved wooden surround that may be

original (Photograph 42). Also in the eastern room is a small brick-built water heater (Photograph 44) that is adjacent to the chimney and also probably original. The western room has a collection of rudimentary modern shelving on most of the elevations (Fig 9).

**Photograph 42** Fireplace in eastern room of basement in Structure 5. Note carved wooden surround. Water heater visible to left. Photograph taken facing north.

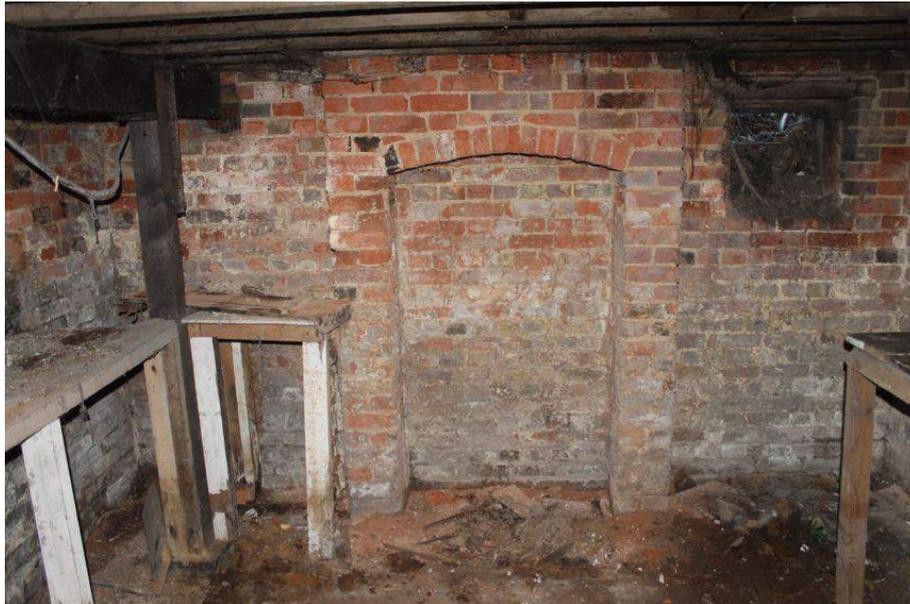
**Photograph 43** Fireplace in western room of basement in Structure 5. Photograph taken facing north.

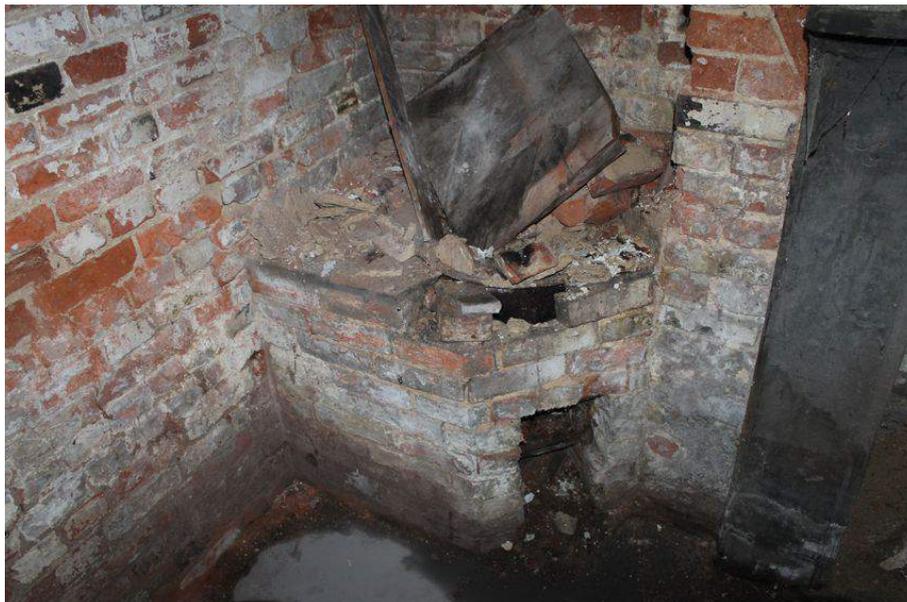
**Photograph 44** Brick-built water heater in eastern room of Structure 5's basement adjacent to fireplace. Photograph taken facing north-west.

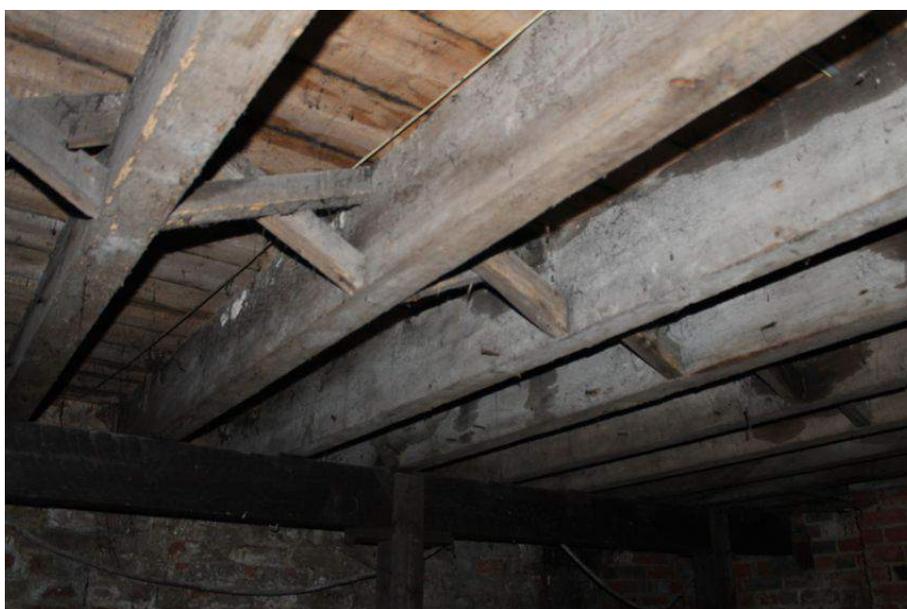
The floor above the basement is supported by herringbone strutting, visible in the western room (Photograph 45).

**Photograph 45** Herringbone-strutting supporting the ground-floor in the four-storey house. Photograph taken facing north-west.

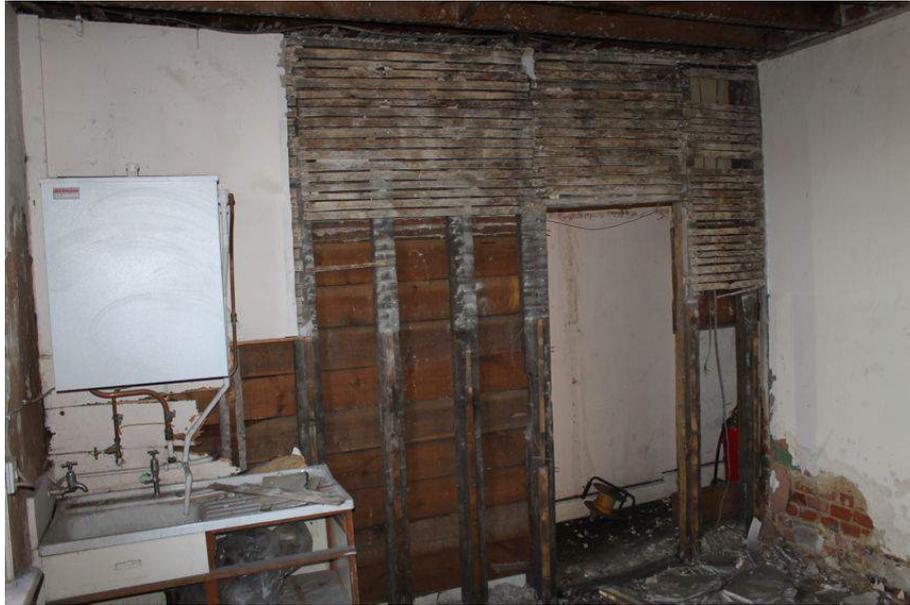
The ground-floor, like the basement, is subdivided by the central staircase rising up through the building. The two rooms are further divided by a machine-cut timber wall covered in lath and plaster (Photograph 46). This wall is aligned east-west across the floor, forming a corridor to the south of the building (Fig 10). The fireplaces in both rooms are still open, although the openings have both been reduced in size by the insertion of modern brickwork (Photograph 47).

**Photograph 46** Exposed lath and plaster wall forming division in ground-floor of Structure 5. Photograph taken facing south-west.

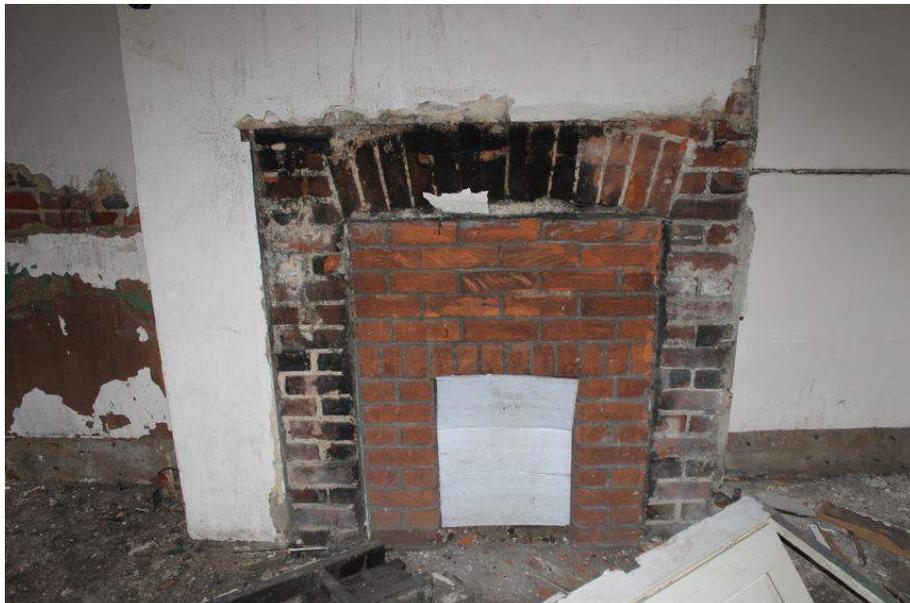
**Photograph 47** Partially blocked fireplace in eastern room on ground-floor of Structure 5. Photograph taken facing north.

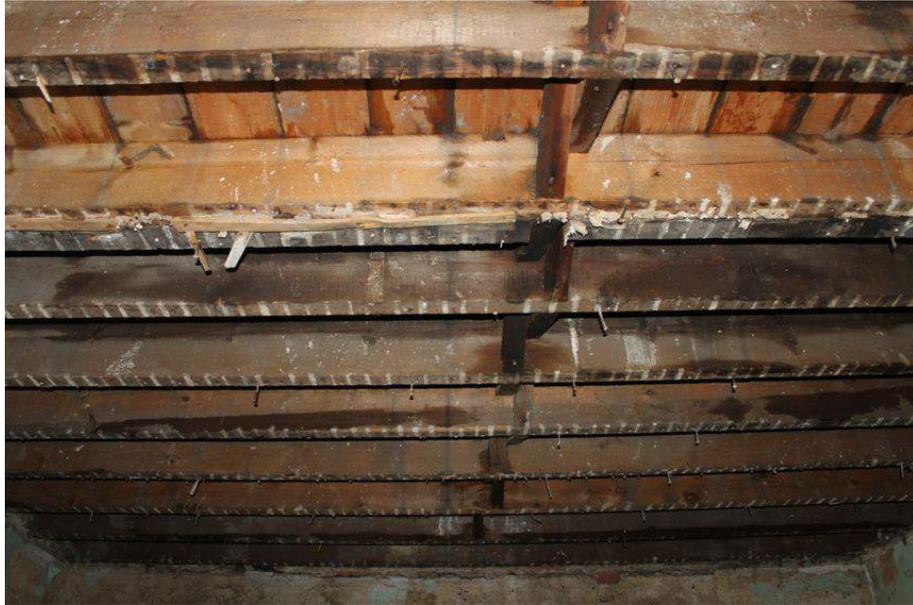
Both the upper-floors have the same 170mm wide floorboards; and both floors are supporting with herringbone strutting (Photograph 48). The western room on the

**Photograph 48** Underside of second-floor in Structure 5, showing supporting herringbone-strutting. Photograph taken facing north.

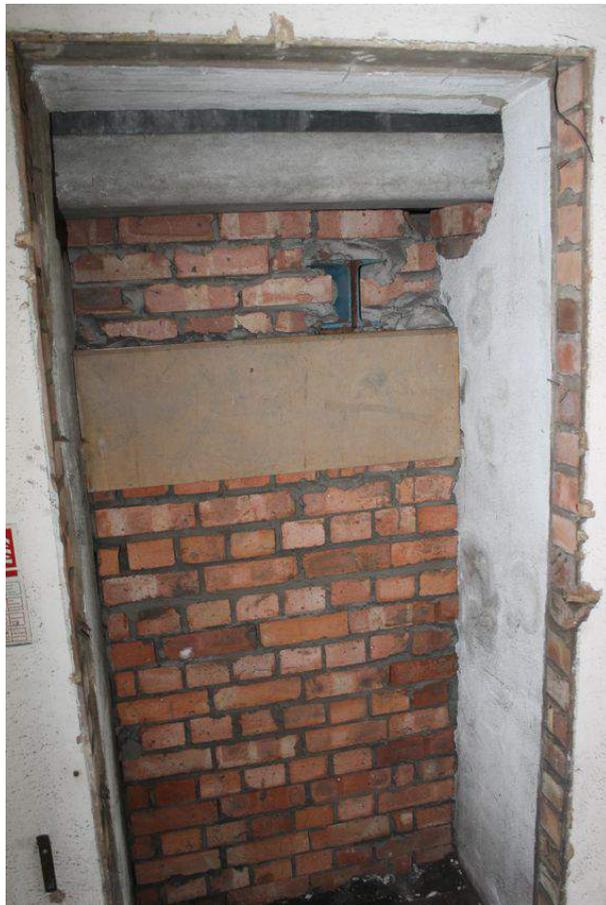
**Photograph 49** Blocked entrance from second-floor of Structure 5 into northern warehouse. Metal girder supporting roof of northern warehouse visible. Photograph taken facing south-west.

On the southern elevation, both the first- and second-floors have an opening into Structure 6. The opening on the first-floor leads onto Structure 6's first-floor (Fig 10), and as a result must be a modern insertion (see below). On the second-floor a probable original opening has been blocked with modern brickwork and a metal girder that forms part of the roof truss of Structure 6 (Photograph 49).

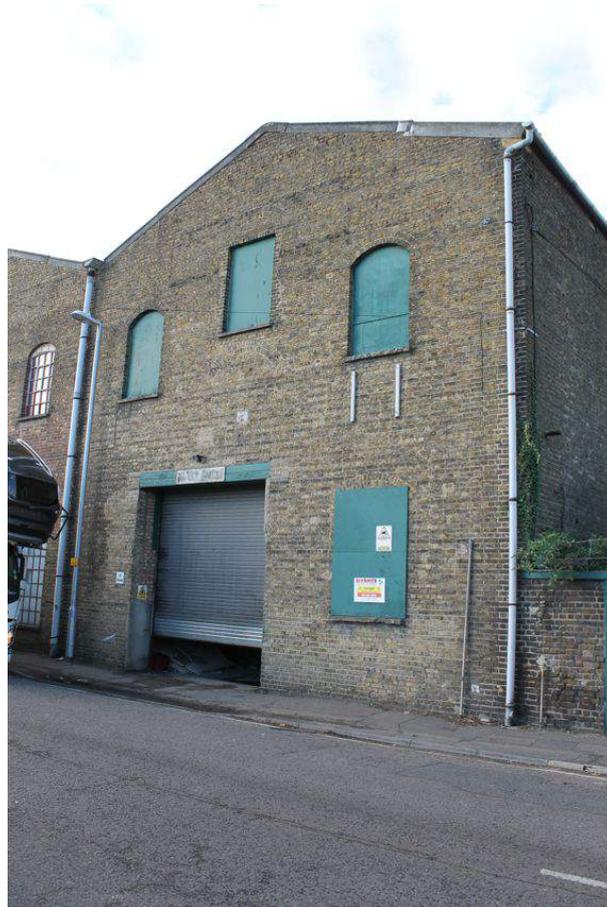
**Photograph 53** Eastern elevation of northern warehouse (Structure 6). Photograph taken facing south-west.

The east elevation of the warehouse has another (partially blocked) six-light sash window at the ground-floor level. Also on this level is a large inserted entrance with a roller door which has removed evidence of another window, as well as the original entrance into the building (Photograph 53 and Fig 12). Above this entrance is a faded wooden sign that reads "Maponite Buildings" (Photograph 54). This sign dates from the time that the building was occupied by the Maponite Ltd (see historical background pg 9).

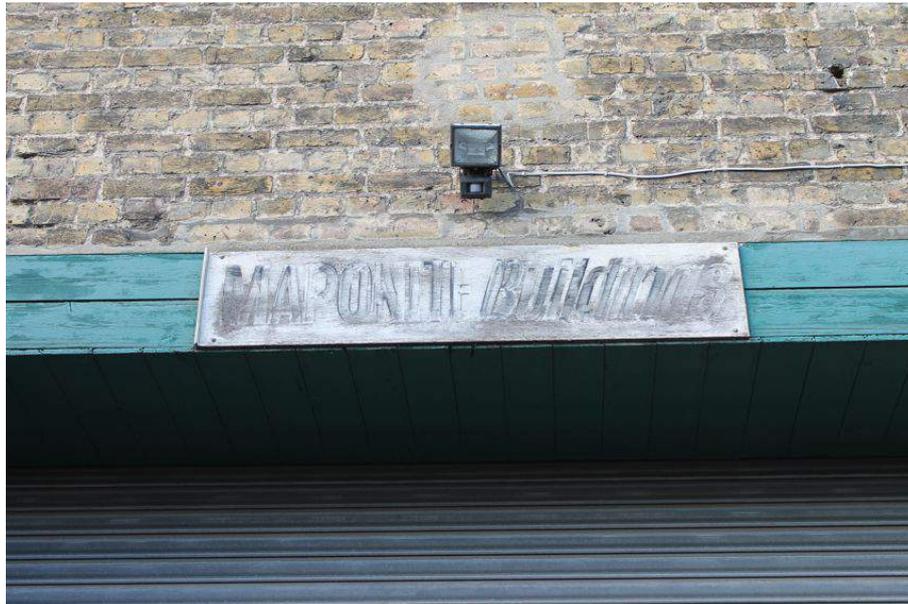
**Photograph 54** Wooden sign above inserted entrance on eastern elevation of Structure 6. Reads "Maponite Building". Photograph taken facing west.

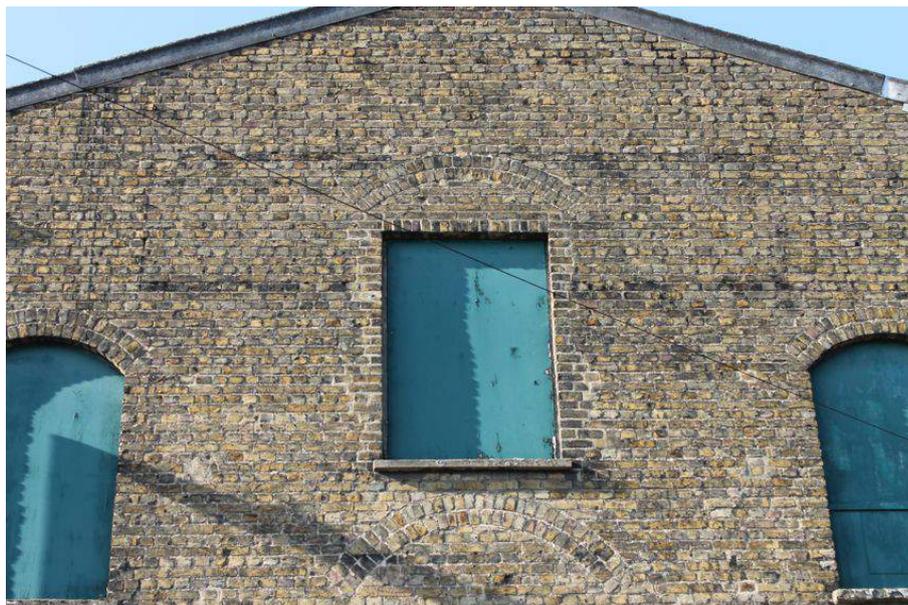
On the first-floor of the east elevation are three more windows (Photograph 53). The two lower ones are, again, six-light wooden-framed sashes. The upper one is an inserted wooden-framed nine-light awning window which takes the place of an original window, as evidenced by the surrounding brickwork (Photograph 55).

**Photograph 55** Upper window in east elevation of Structure 6. Rebuilt brick surround visible. Photograph taken facing west.

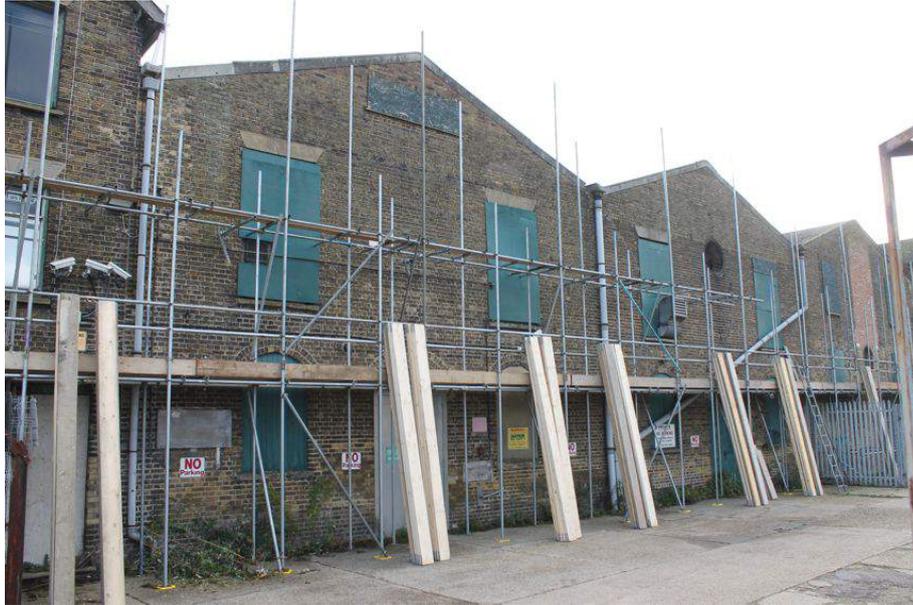
presumably of the same type (Fig 12). The original doorway into the building survives on this elevation, but is occupied by a modern fire-door (Photograph 56).

**Photograph 56** Western elevation of range of warehouses. Structure 6 to left, Structure 8 to right. Photograph taken facing south-east.

At the first-floor level on the western elevation are two long, wooden-framed, six-light awning windows (Photograph 56). Like the windows on the adjacent four-storey house (Structure 5), these large awning windows have a cement lintel. Unlike on Structure 5, however, the lintels are not decorated.

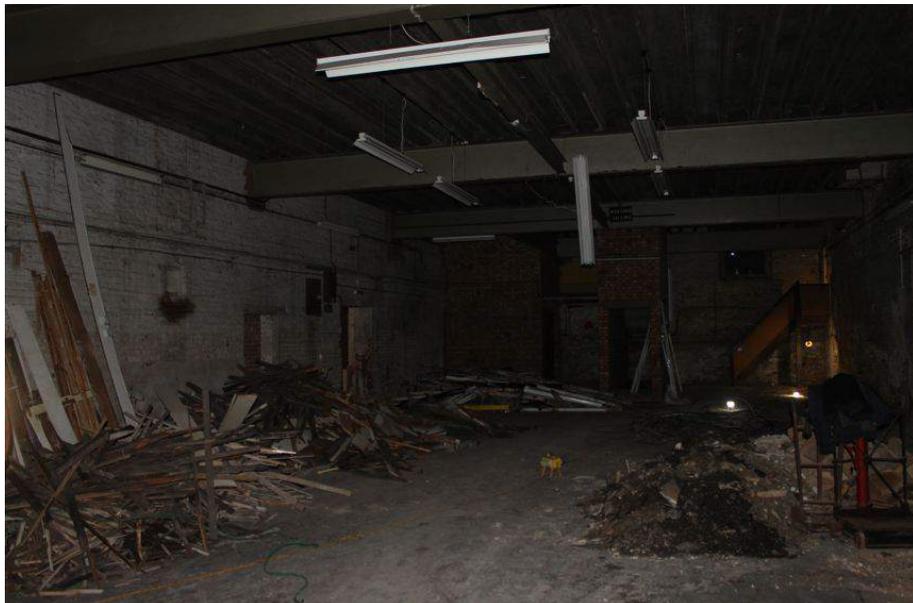
**Photograph 57** Ground-floor of Structure 6. Photograph taken facing south-west.

The ground-floor of the northern warehouse is a single large room with a concrete floor (Photograph 57). There are several modern insertions at this level, most notably the brick-built staircase leading up to the first-floor (Photograph 58).

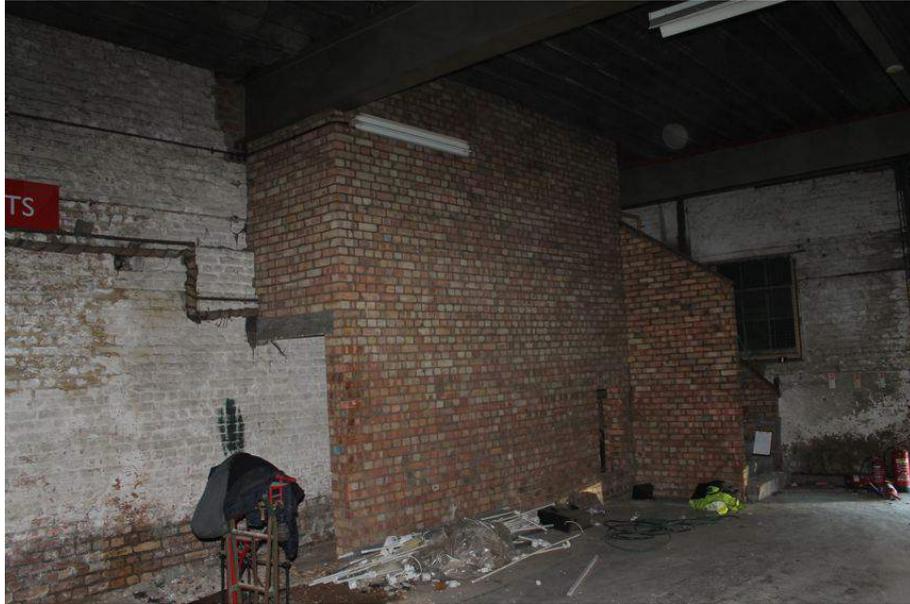
**Photograph 58** Modern brick staircase leading up to first-floor of Structure 6. Photograph taken facing north-east.

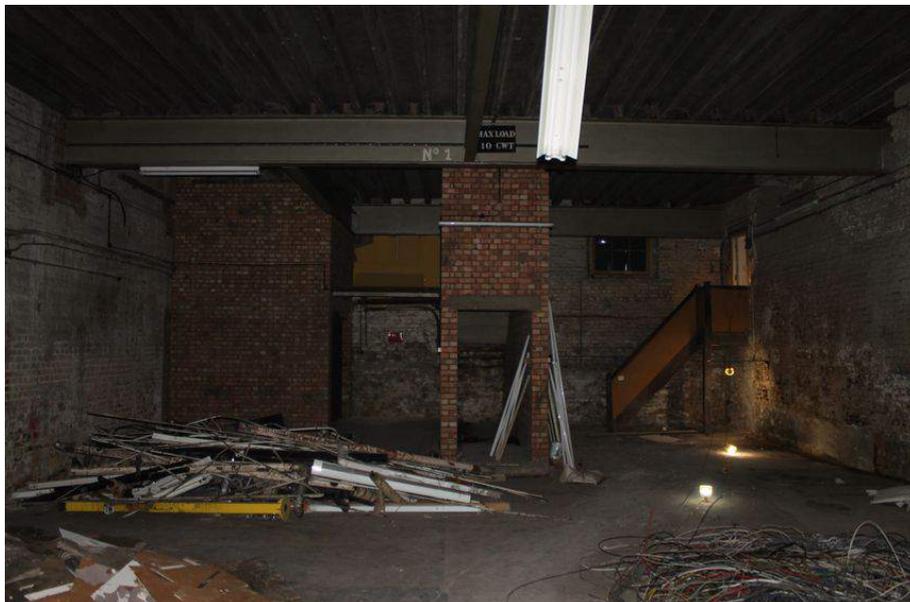
When viewed from the inside the external door on the western elevation is shown to be some 2.8m above the ground-floor level of the warehouse. A modern staircase comes down from the first-floor to access this door (Photograph 59). At a similar level is the doorway into the ground-floor of Structure 5, which is accessed by a modern wooden staircase (Photograph 59). This difference in ground-floor level between the River Colne side of the building (west) and the Hawkins Road side (east) is repeated in the other two warehouses (see below). Visible in some parts of the wall of Structure 6 is a brick ledge (Photograph 58), as well as two square recesses in the brickwork, one on the north wall and one on the south (Photograph 60). These recesses were possibly for a binding-beam which, along with the ledge, could have supported the original floor in the building.

**Photograph 59** Inserted modern features in western end of Structure 6's ground-floor. Stairway leading down from first-floor to external door visible in centre. Staircase up to first-floor of Structure 5 visible to right. Photograph taken facing west.
