**Historic building recording at  
the Rising Sun and Maçonite buildings,  
3 Hythe Station Road,  
Colchester, Essex CO2 8JZ**

**November 2018**

CAT project ref.: 18/10g  
NGR: TM 0155 2474 (c)  
Planning reference: 163196  
CHER number: ECC4271  
Colchester Museum accession code: COLEM 2018.105  
OASIS project id: colchest3-3314814

**CAT Report 1359**  
December 2018

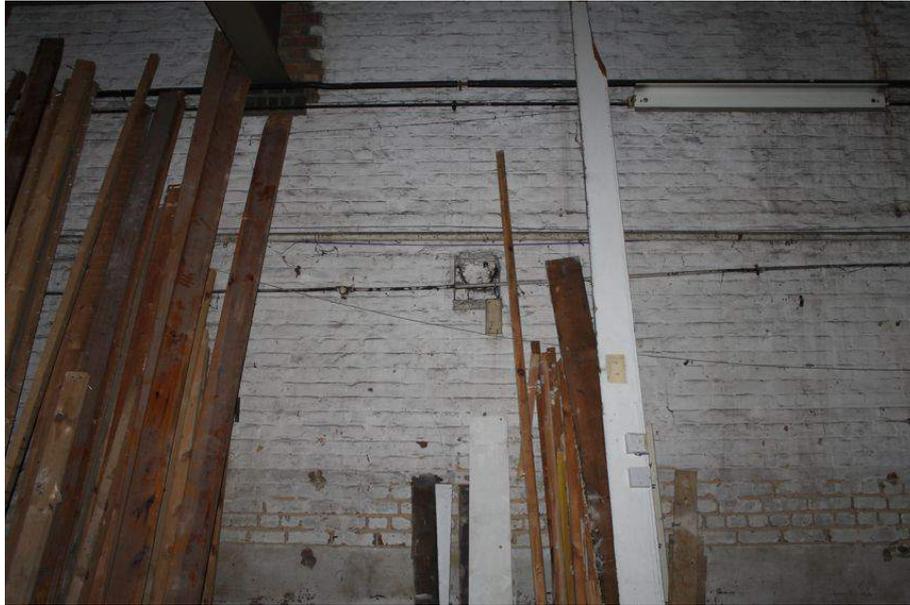
**Photograph 60** Recess in southern ground-floor wall of Structure 6, possibly to support a binding-beam for the original floor. Photograph taken facing south.

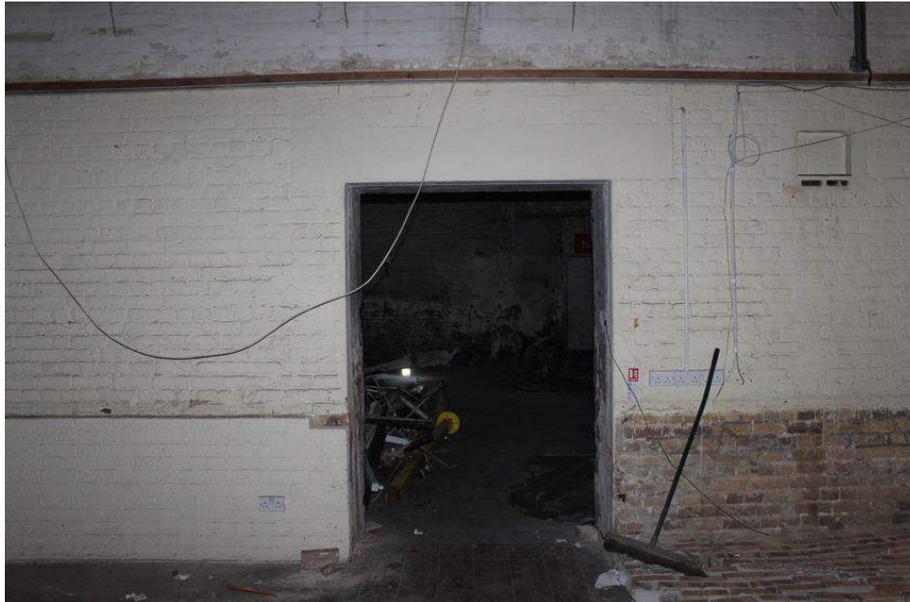
An entrance into the central warehouse (Structure 7) on the southern elevation is at ground-floor level and is a later insertion with a concrete lintel (Photograph 61). The location of the original doorway between the two buildings is still visible but has been bricked-over (Photograph 62).

**Photograph 61** Inserted entrance with a concrete lintel between Structures 6 and 7 on the ground-floor. Photograph taken facing north.

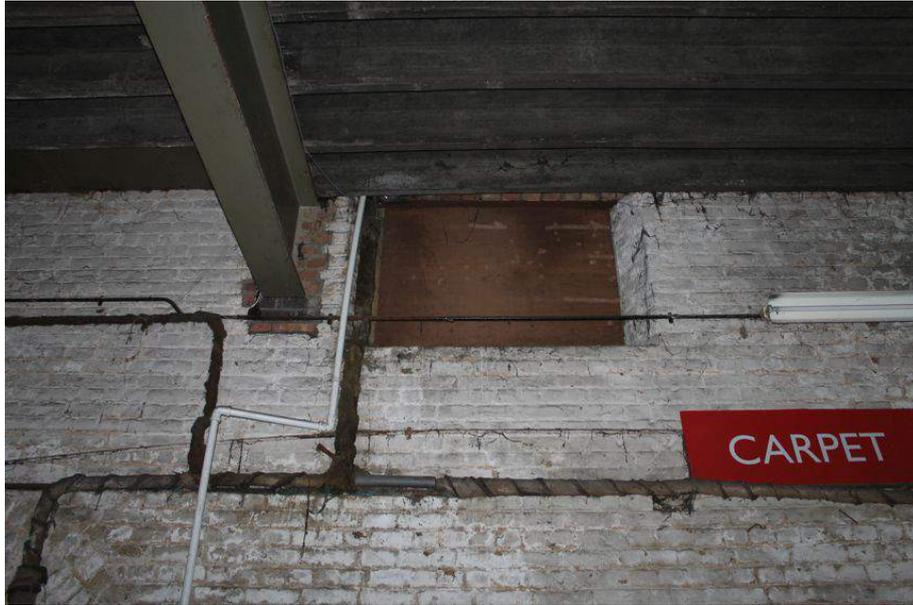
The underside of the first-floor is supported by substantial metal beams that have been inserted into the brickwork on the north and south walls (Photograph 64 ).

**Photograph 64** Metal-beam supporting inserted first-floor of Structure 6, adjacent to a bisected window opening. Photograph taken facing north.

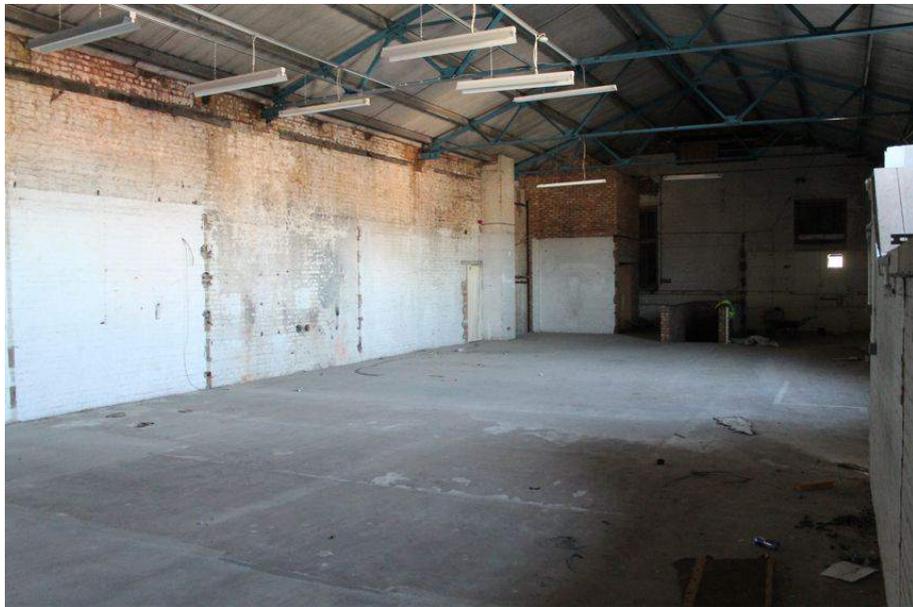
The first-floor itself has a screed floor over the floorboards. There is the aforementioned modern stairway that leads down to the entrance on the western elevation (Photograph 65), but apart from that the first-floor is featureless (Fig 10).

**Photograph 65** First-floor of Structure 6. Photograph taken facing south-west.

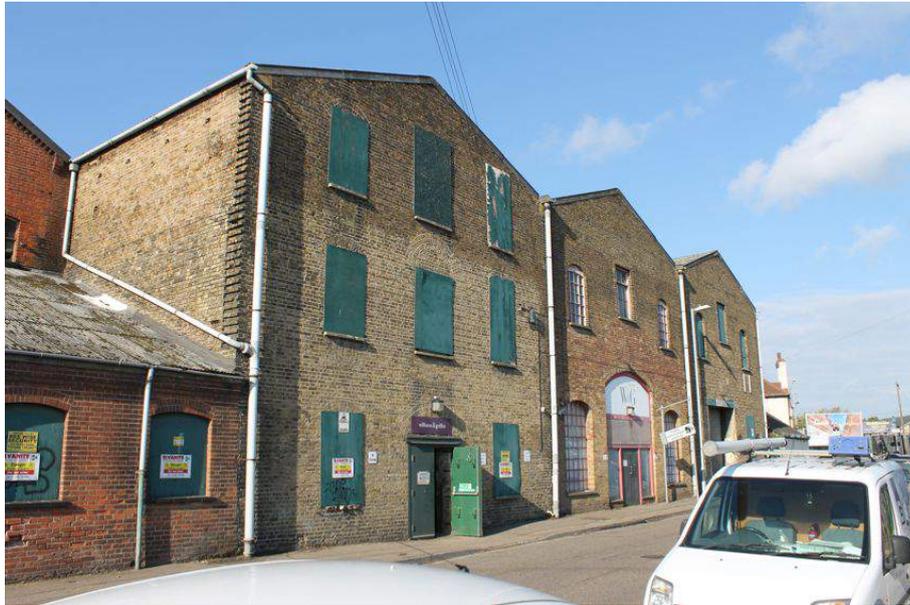
It is a three-storey building with a gable roof covered in corrugated asbestos (Photograph 66), the walls are brick-built with yellow London stock bricks, laid in English-bond and bonded with lime mortar. The brickwork has queen-closers around most of the openings in the building, although the entrance on the western elevation does not have any (see below). The brick measurements are 200-230 x 105 x 65mm.

**Photograph 66** East elevation of warehouse range. Structure 8 to left, Structure 6 to right. Photograph taken facing north-west.

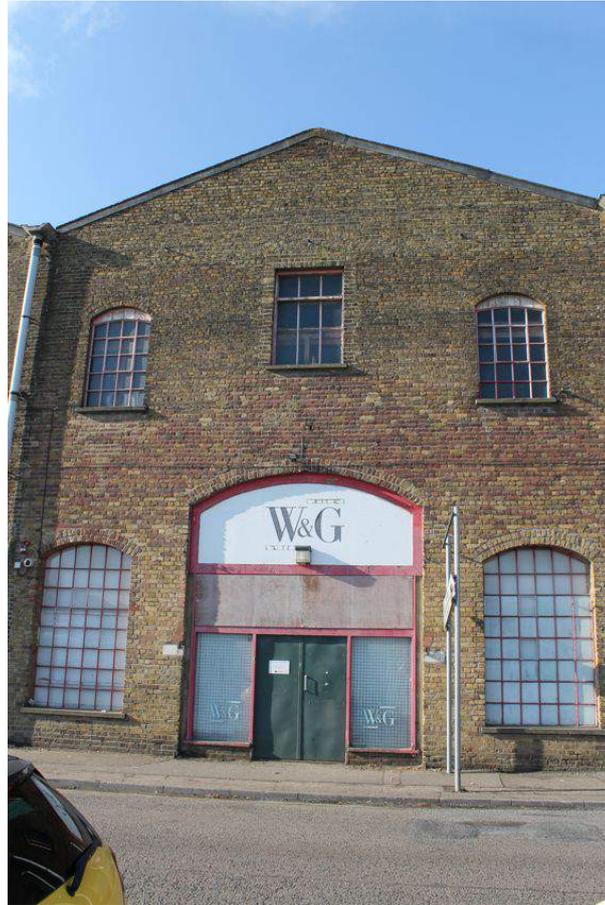
The east elevation of the central warehouse has a noticeably different appearance to the other two warehouses in this range. The lower-half of the elevation, while still being laid in English-bond and bonded in lime mortar, contains a high proportion of red bricks in addition to yellow London stocks (Photograph 67). This, combined with the inserted windows and entranceway in the ground-floor (see below), suggests that the east elevation of Structure 7 has been the subject of some rebuilding.

The inserted windows on the ground-floor are two metal-framed 48-light fixed windows (Photograph 67). The inserted doorway is a large arched opening, mostly panelled over, with two single-pane windows and a set of double-doors (Photograph 67). The logos on the panelling and windows date from its recent history as a storehouse for the local Colchester department store Williams and Griffin (see historical background above).

**Photograph 67** East elevation of Structure 7.  
Photograph taken facing west.

Intersected by the second-floor on this elevation are three more windows, all of which are later insertions. The two lower ones (Fig 12) are metal-framed twenty-light awning windows, very similar in appearance to the ones on the ground-floor (Photograph 67). These windows appear to be in original window openings. The final window, a wooden-framed nine-light awning window is modern in date but is in the location of an original window (although its insertion has totally removed the original window opening; Photograph 67).

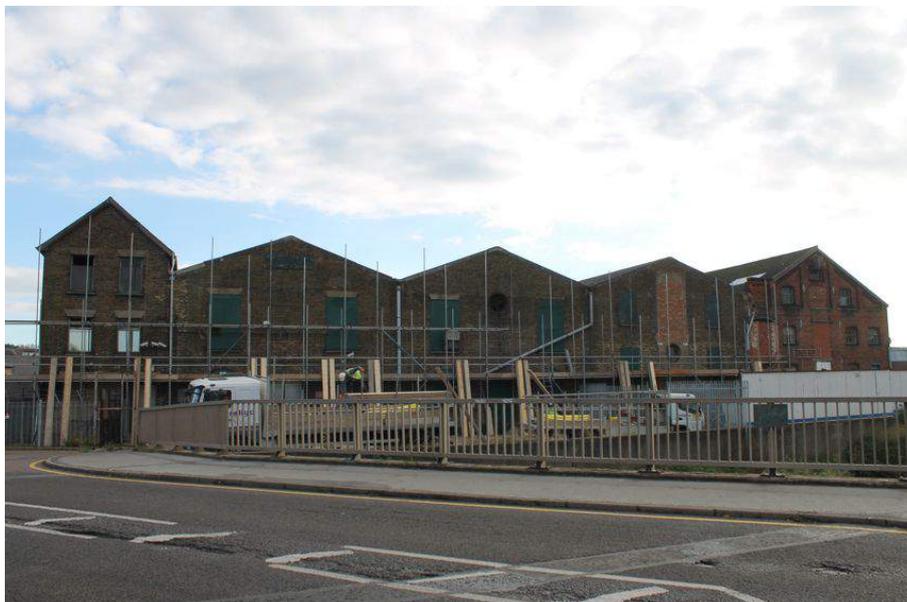
**Photograph 68** Range of buildings fronting onto River Colne. From left to right; Structure 5, Structure 6, Structure 7, Structure 8 and red-brick warehouse (outside the site). Photograph taken facing east.

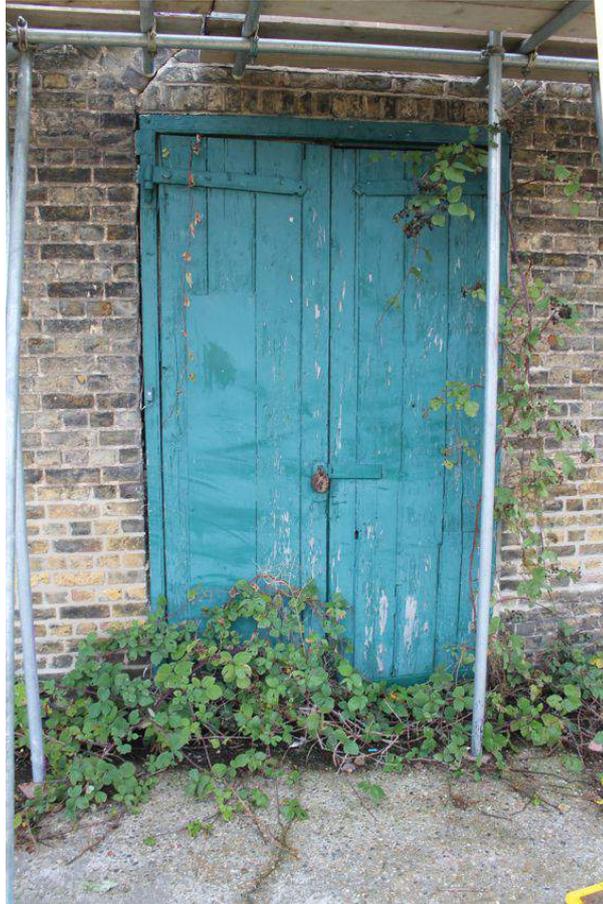
The western elevation of the warehouse has two partially blocked sash windows at the ground-floor level. Although only partly visible, they appear to be 16-light wooden-framed sashes. The entrance on this elevation, although bricked over on the interior (see below), is visible on the exterior as a vertically-planked double-door constructed of evenly sized planks (Photograph 69).

**Photograph 69** Vertical-planked door on western elevation of Structure 7 (blocked from the inside). Photograph taken facing east.

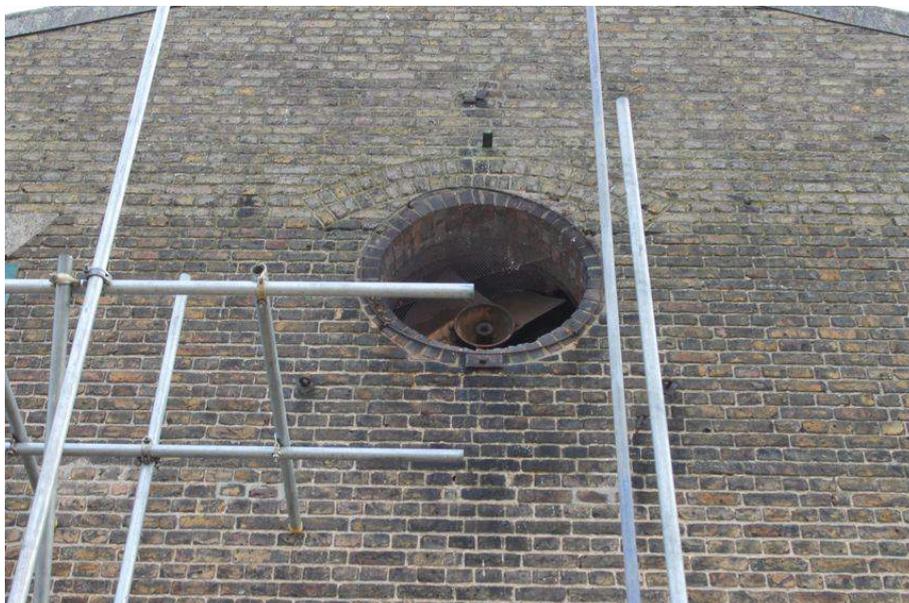
**Photograph 70** Inserted metal fan with brick-surround on west elevation of Structure 7. Photograph taken facing east.

Bisecting the first and second-floor are two long window-openings with no surviving windows (Photograph 56). These are identical to the window-openings on the first-floor of Structure 6 (see above), and originally contained six-light awning windows (as are visible on the photograph of this elevation from 1956; Photograph 4). Also present on the western elevation is an inserted circular opening, surrounded by red-bricks and containing a large metal fan to provide ventilation to the upper floor of the building (Photograph 70).

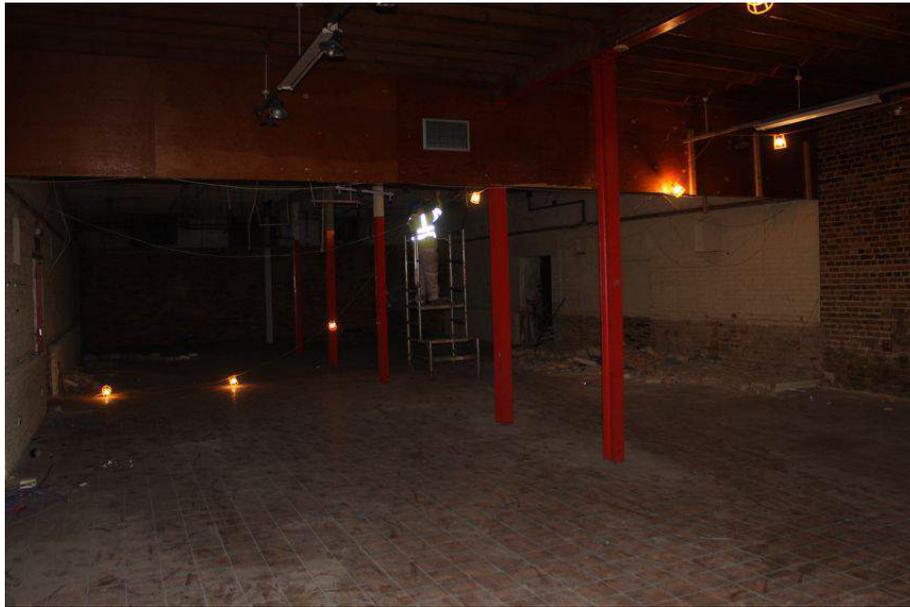
The ground-floor of the central warehouse is a single large room with a modern tiled floor (Photograph 71). There is an inserted modern glass and timber foyer around the entrance on the eastern elevation (Fig 9).

**Photograph 71** Ground-floor of Structure 7. Photograph taken facing north-west.

The underside of the first-floor is supported by a metal binding-beam that is aligned east-west across the building and supported on six metal posts (Photograph 71). Above this, the timber joists are turned on end and reinforced with herringbone-strutting (Photograph 76).

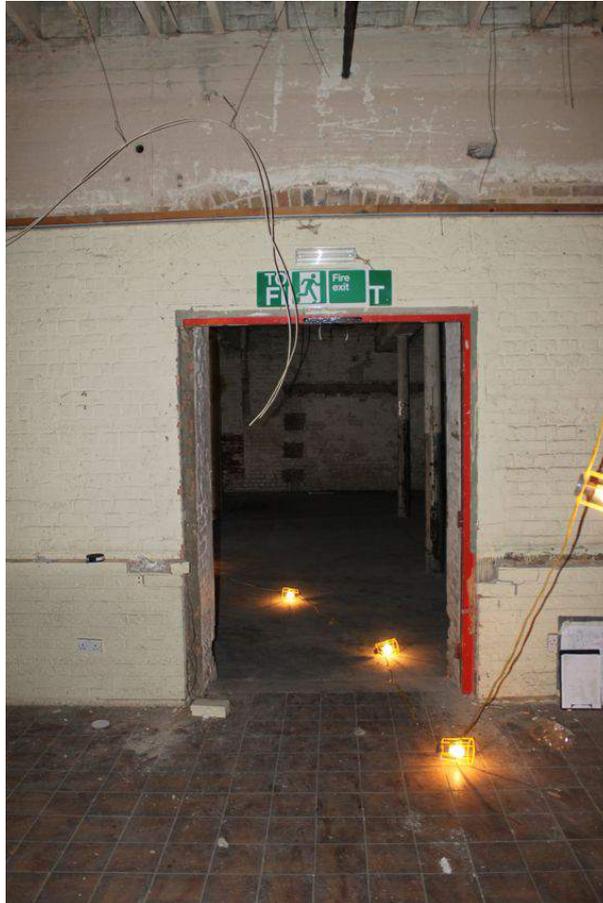
**Photograph 73** Original entrance on ground-floor between Structures 7 and 8. Archway above. Photograph taken facing south.

The access between Structure 7 and Structure 8 on the ground-floor is through a central doorway that appears to be original, with a brick arch above it (Photograph 73). There are two more entrances into Structure 8 from the ground-floor, but both are later insertions and have since been bricked over (Fig 9).

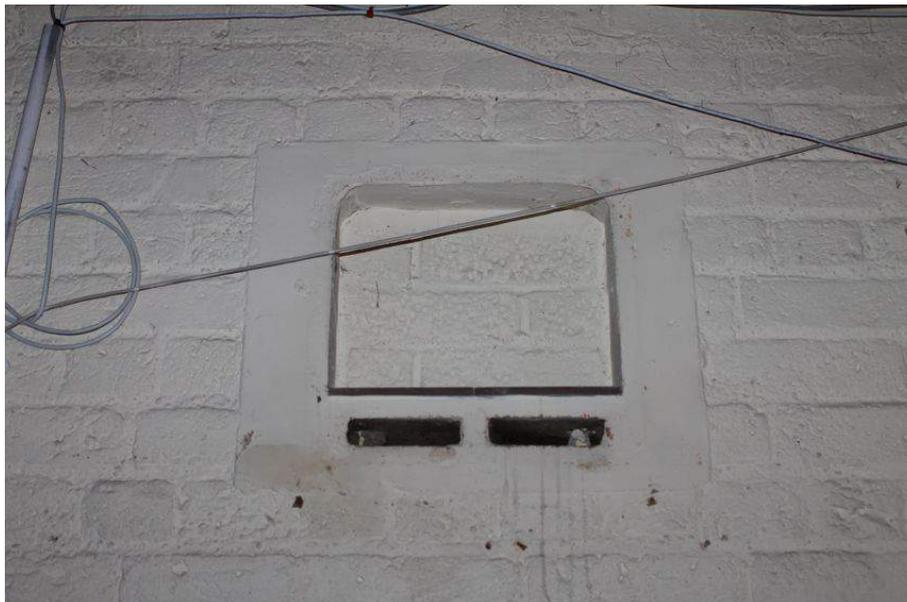
There are four recesses in the ground-floor walls (two to the north and two to the south) that contain the same possible gas-light holders as observed in Structure 6 (see above; Photograph 74). These are symmetrically placed, with the exception of the north-western one which was presumably moved when the current entrance into Structure 6 was inserted (Fig 9).

**Photograph 74** Possible ?gas-light holder in northern brickwork on ground-floor of Structure 7. Photograph taken facing north.

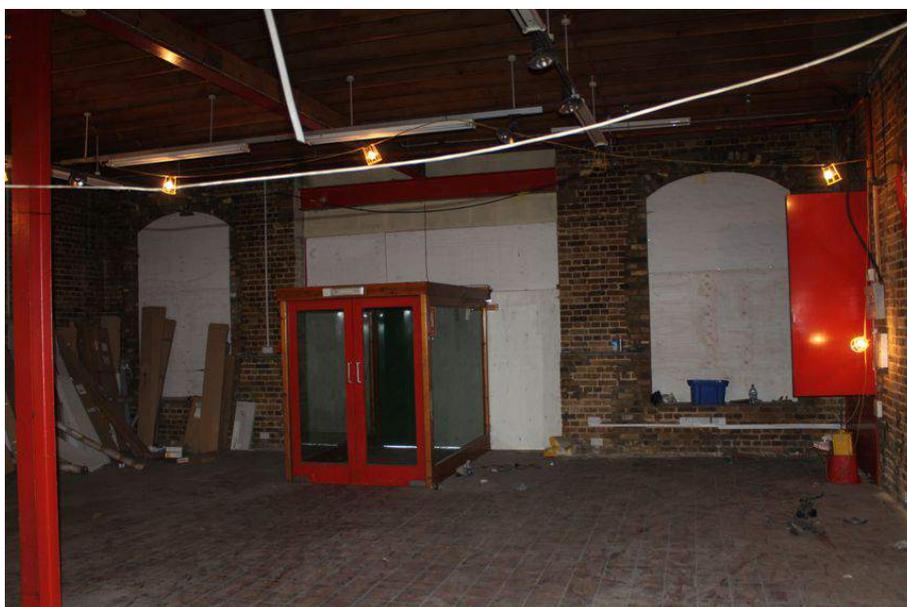
The internal brickwork to the east of the building resembles the exterior eastern elevation, in that there are an amount of red bricks mixed in the with the yellow London stock English-bond (Photograph 75). This suggests that any rebuilding affected the whole of the eastern side of the structure, and probably coincided with the insertion of the current first-floor (see below).

**Photograph 75** Eastern end of ground-floor of Structure 7. Photograph taken facing north-east.

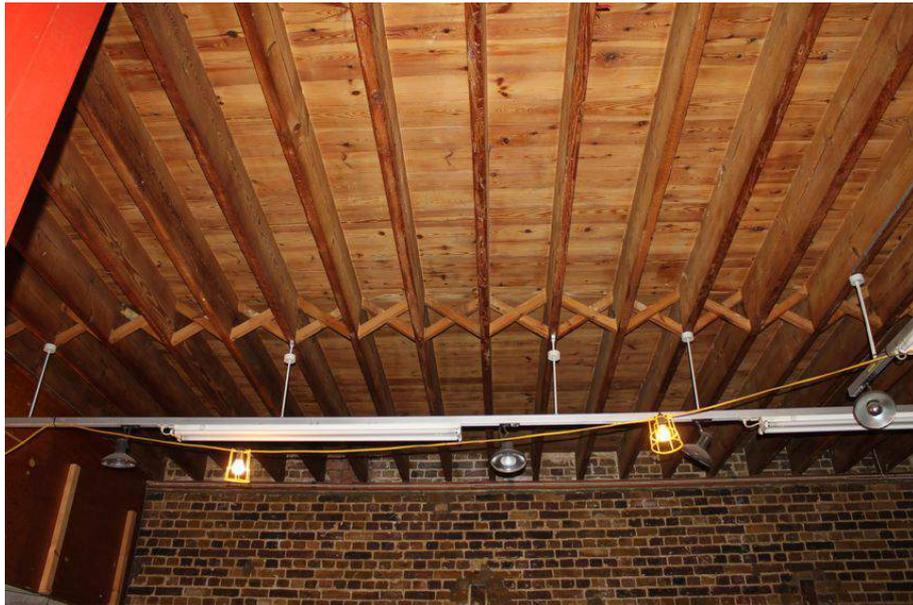
**Photograph 76** Herringbone strutting supporting first-floor of Structure 7. Photograph taken facing south.

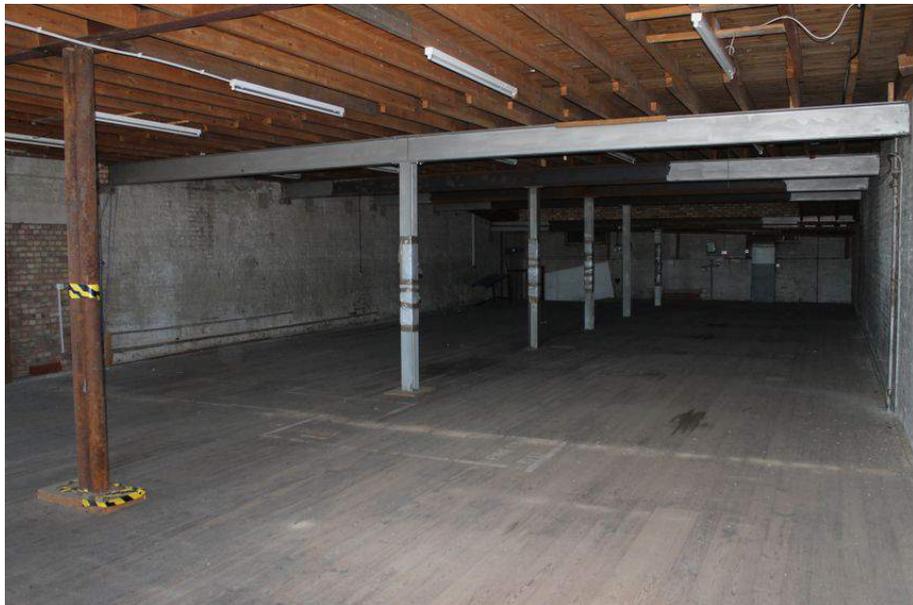
The first-floor itself is constructed of regularly-spaced floorboards measuring 140mm in width (Photograph 77). Visible on the eastern and western walls of the first-floor are the window openings bisected by the insertion of the first- or second-floors (Photograph 78).

**Photograph 77** First-floor of Structure 7. Photograph taken facing south-west.

The second-floor is supported on six metal binding-beams, themselves supported by metal posts (Photograph 77). These posts are in the same location as the posts on the ground-floor (see above).

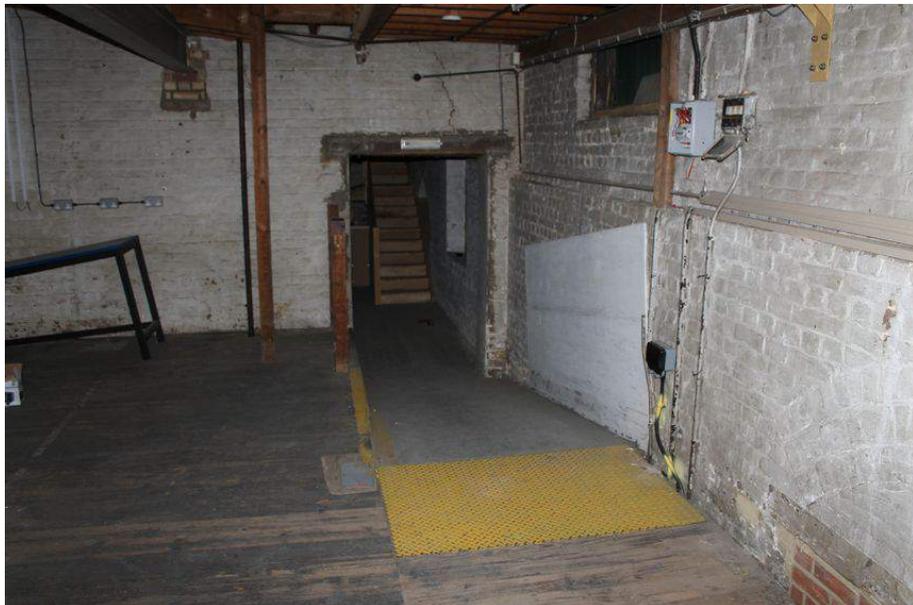
There is an inserted entrance into Structure 8 on the first-floor, opposite the entrance into Structure 6 to the north (Fig 10 and Photograph 79). There were two other entrances in to Structure 8, but they have both been bricked over (Fig 10).

**Photograph 79** Entrance between Structures 7 and 8 on first-floor. Photograph taken facing south-west.

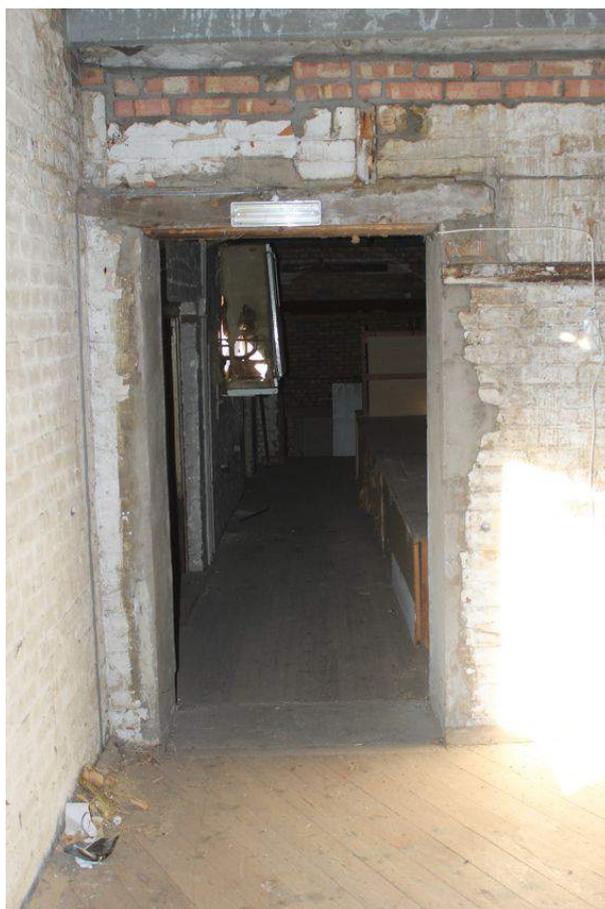
The second-floor has two levels; between the entrance to Structures 6 and 8 (on the north and south walls) there is a narrow corridor (Fig 11 and Photograph 80). From this corridor a ramp rises up to the east, leading to the rest of the floor which is raised 570mm higher (Photograph 81). Like the floor below, the floorboards at this level are 140mm wide.

**Photograph 80** Entrance into second-floor of Structure 7, showing differing floor-levels. Photograph taken facing north.

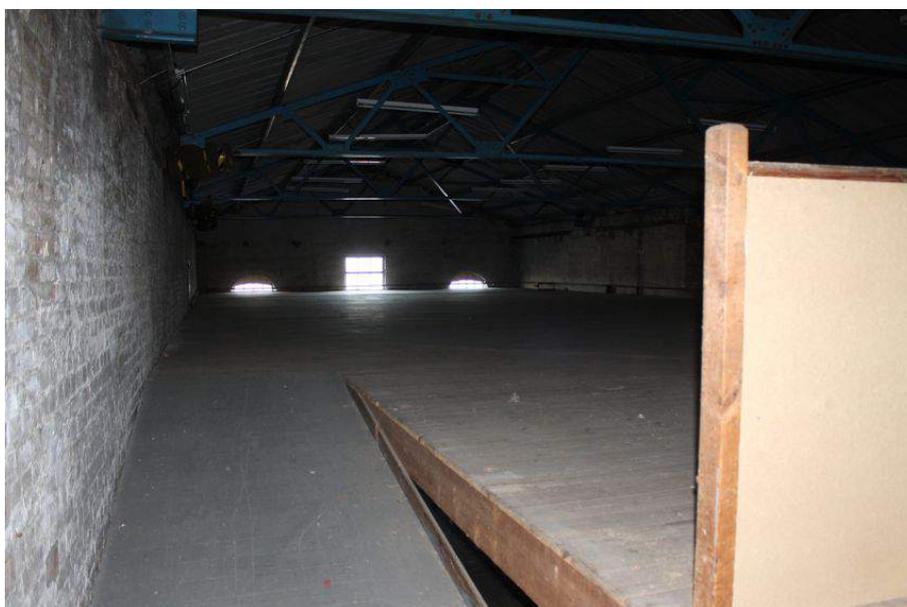
**Photograph 81** Second-floor of Structure 7. Ramp visible in foreground. Photograph taken facing east.

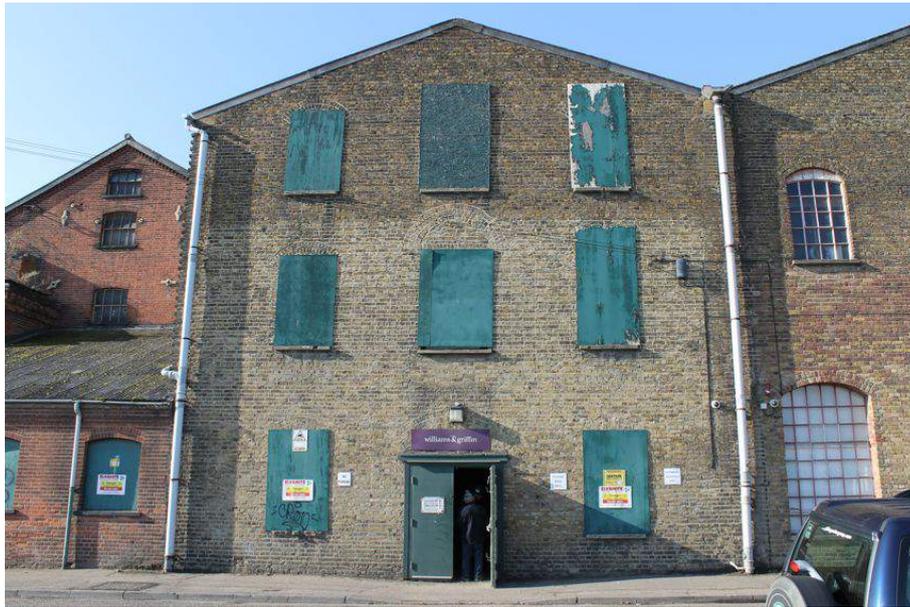
It is a three-storey building with a gable roof covered in corrugated asbestos (Photograph 82), the walls are brick-built with yellow London stock bricks, laid in English-bond and bonded with lime mortar. The brickwork has queen-closers around most of the openings in the building. As with the other warehouses, the brick measurements are 200-230 x 105 x 65mm.

**Photograph 82** East elevation of Structure 8. Photograph taken facing west.

The east elevation of the southern warehouse has eight window openings across its three-storeys, three on the second, three on the first and 2 on the ground-floor, flanking a doorway (Photograph 82 and Fig 12). All of the surviving windows are wooden-framed twelve-light sashes, with the exception of the centre window on the second-floor, which is an inserted modern six-light awning window (Fig 12). The door on the ground-floor, although in an original doorway, is a modern fire-door (Photograph 82).

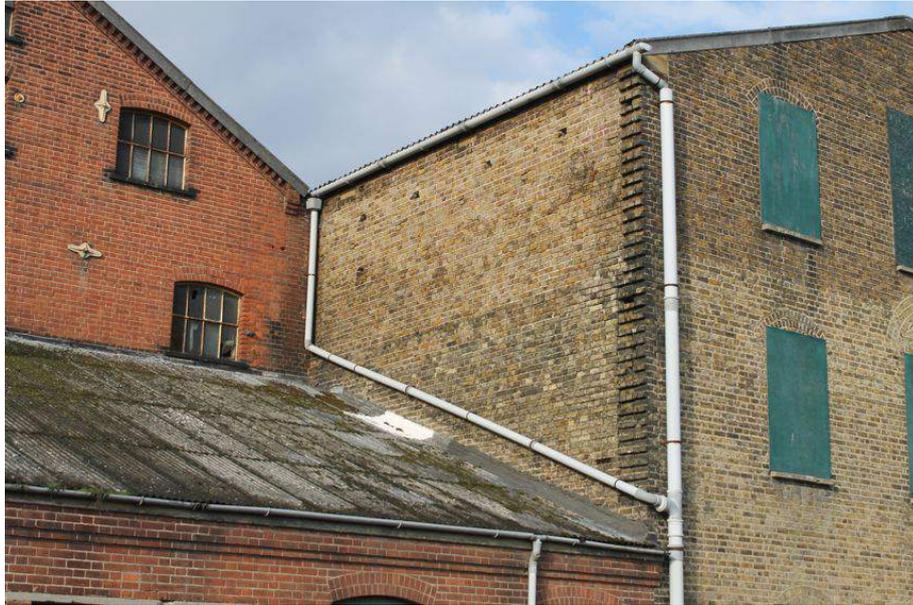
The south elevation of Structure 8 is partially obscured by Structure 9 and the adjacent red-brick warehouse. The visible section of brickwork is featureless, with the exception of a series of projecting headers on the south-east quoin (Photograph 83). The reason for this projecting brickwork is examined in the discussion (pg 66).

**Photograph 83** South elevation of Structure 8. Projecting bricks visible. Photograph taken facing north-west.

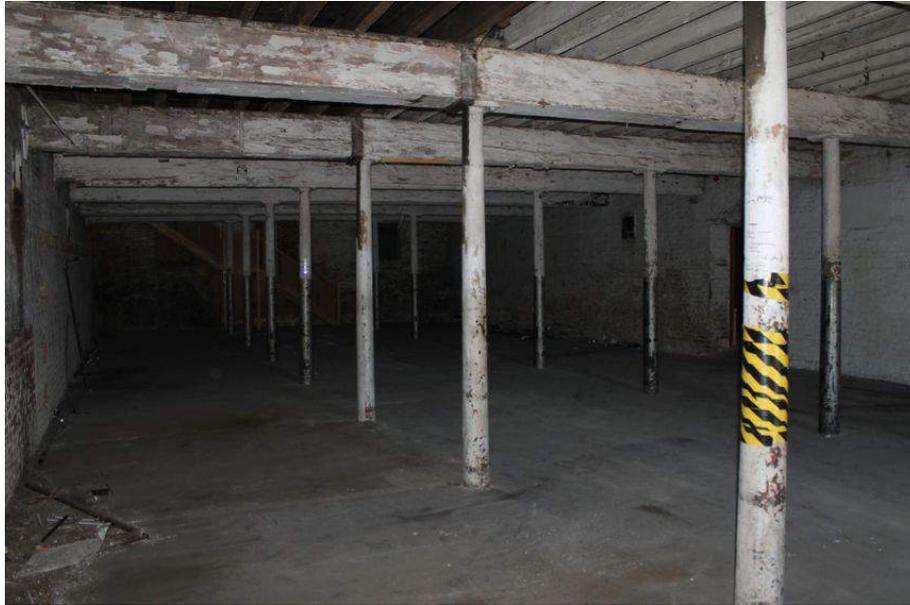
The ground-floor of the southern warehouse is a single large room with a modern concrete floor (Photograph 85). There is an inserted modern staircase at the western end of the floor, leading up to the first-floor (Fig 9). Judging from scars on the brickwork, this staircase overlaps with the location of the original staircase (Photograph 86). There is also a modern lift inserted into the south-east corner of the building that rises up to the second-floor (Fig 9).

**Photograph 85** Ground-floor of Structure 8. Photograph taken facing north-west.

Unlike the other warehouses, the existing floors within Structure 8 appear to be original to the building (Fig 14). The underside of the first-floor is supported by eight large timber binding-beams, measuring 420mm x 420mm, that are aligned north-south across the building. These beams are themselves supported on two metal posts each (Photograph 85).

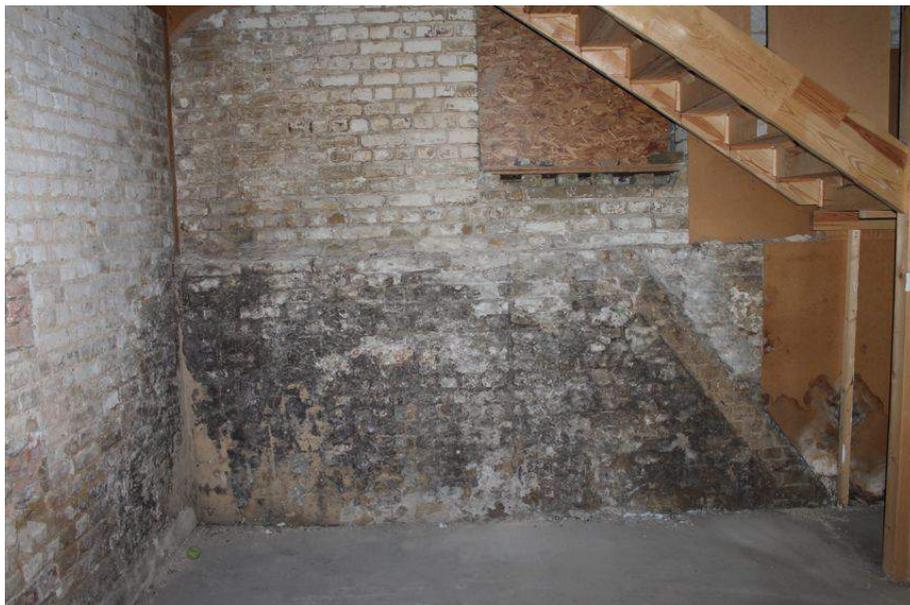
**Photograph 86** Visible scarring on brickwork of original staircase in ground-floor of Structure 8. Modern staircase visible to right of frame. Photograph taken facing west.

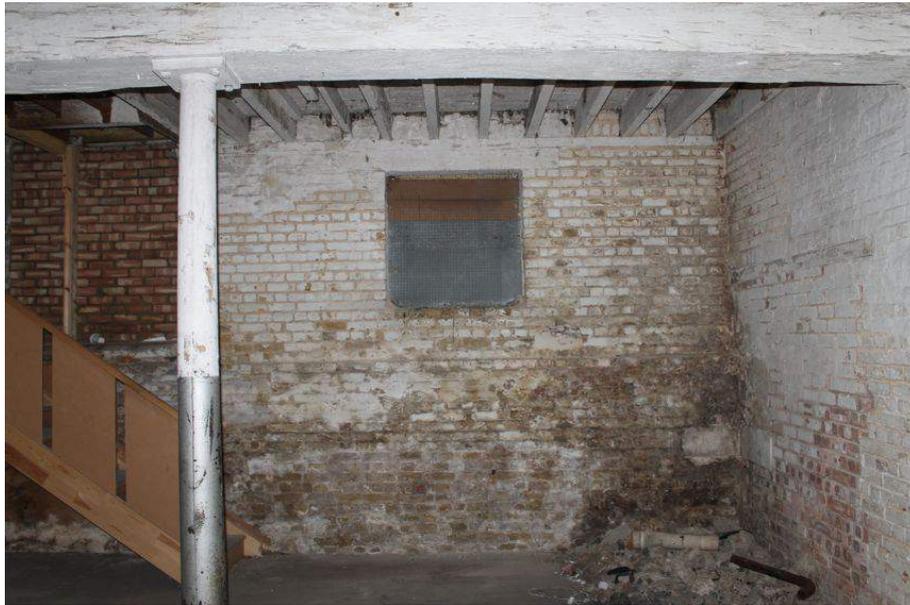
Although it has been completely blocked, it was possible to ascertain that the western entrance into the ground-floor, as with the other warehouses (see above), was significantly higher than the internal floor level (Photograph 87).

**Photograph 87** Western wall in ground-floor of Structure 8, showing blocked western doorway, and its height above floor-level, to left of frame. Also visible is a blocked window and another blocked opening in the northern wall to the right. Photograph taken facing west.

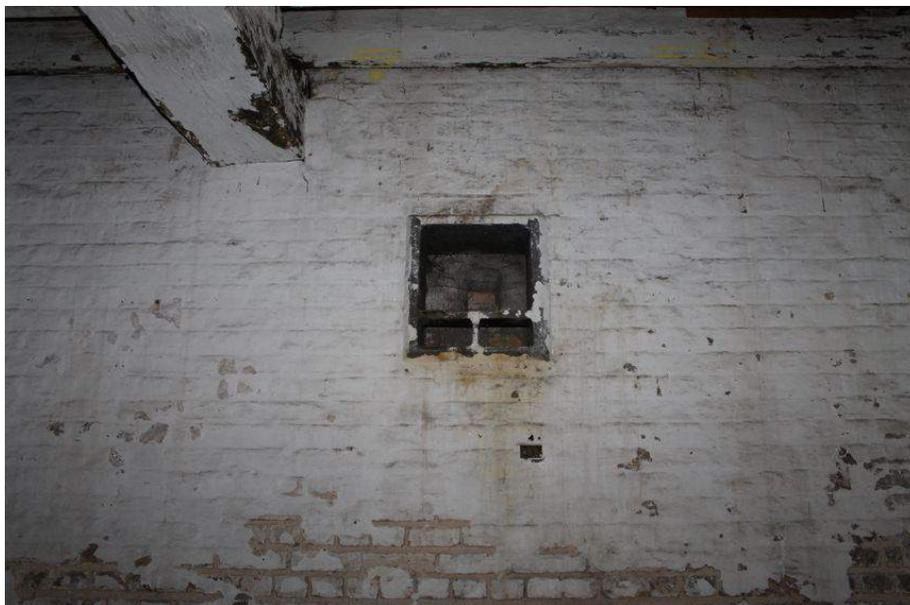
As in the previous warehouses, there are recesses in the ground-floor walls (two to the north and two to the south) that contain metal ?gas-light holders (Photograph 88). As with Structure 7, these are symmetrically placed (Fig 9).

**Photograph 88** Possible ?gas-light holder on southern ground-floor wall of Structure 8. Photograph taken facing south.

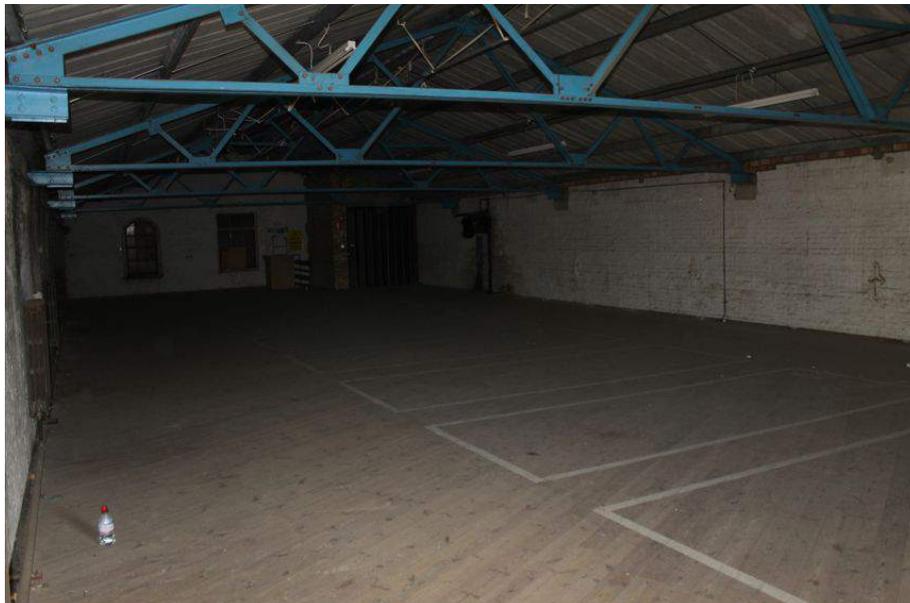
**Photograph 90** Second-floor of Structure 8. Photograph taken facing south-east.

The floorboards of the second-floor are 140mm wide and evenly spaced, but unlike the first-floor they are aligned diagonally to the walls of the building, rather than perpendicular (Photograph 90).

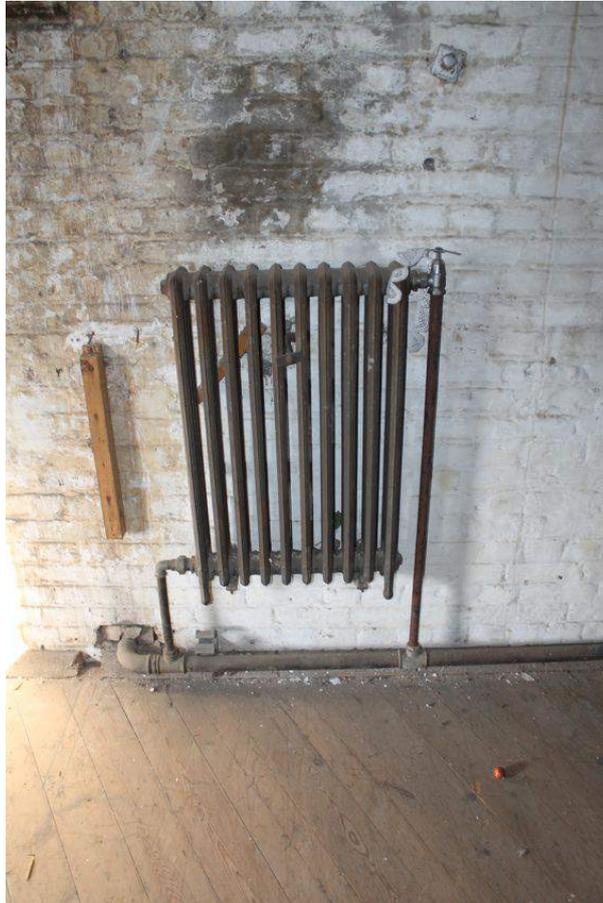
Present on the second-floor of Structure 8 is a series of inserted large metal radiators (Photograph 91).

**Photograph 91** Inserted radiator on second-floor of Structure 8. Photograph taken facing north.

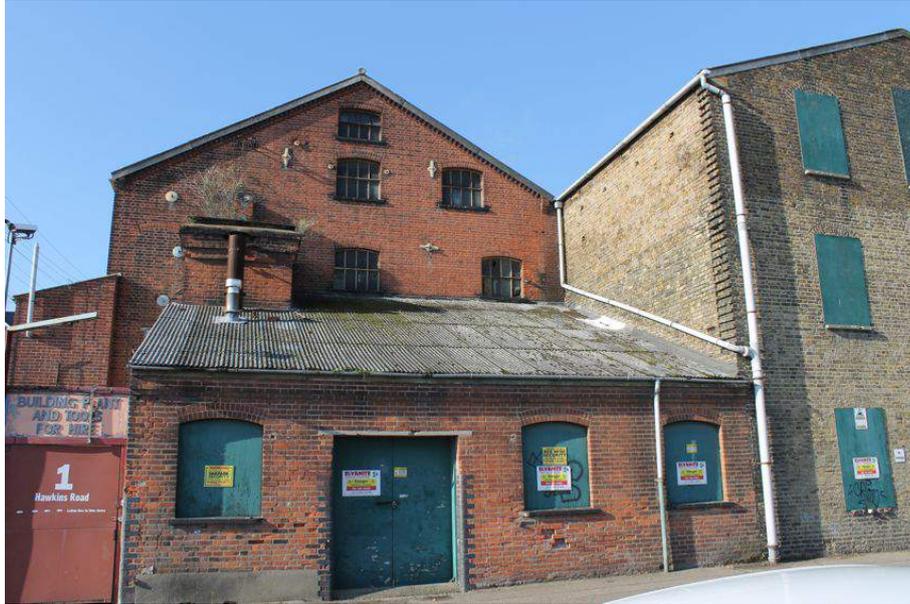
This extension is aligned north-south and projects off the east end of the southern wall of Structure 8 (Fig 2). It measures 10.3 x 7.8m in size and covers approximately 80 square metres. It is single-storey brick-built structure, with brickwork laid in Flemish bond and bonded in cement, measuring 225 x 105 x 65mm (Photograph 92). Its roof consists of a single-pitch, covered in corrugated asbestos sheeting. Projecting from the south end of the roof is a substantial brick chimney. The northern and western elevations of Structure 9 are obscured by the adjacent buildings. The southern elevation is featureless. The eastern elevation has three sixteen-light fixed windows and a modern double-width doorway (Fig 12).

**Photograph 92** East elevation of Structure 9. Photograph taken facing west.

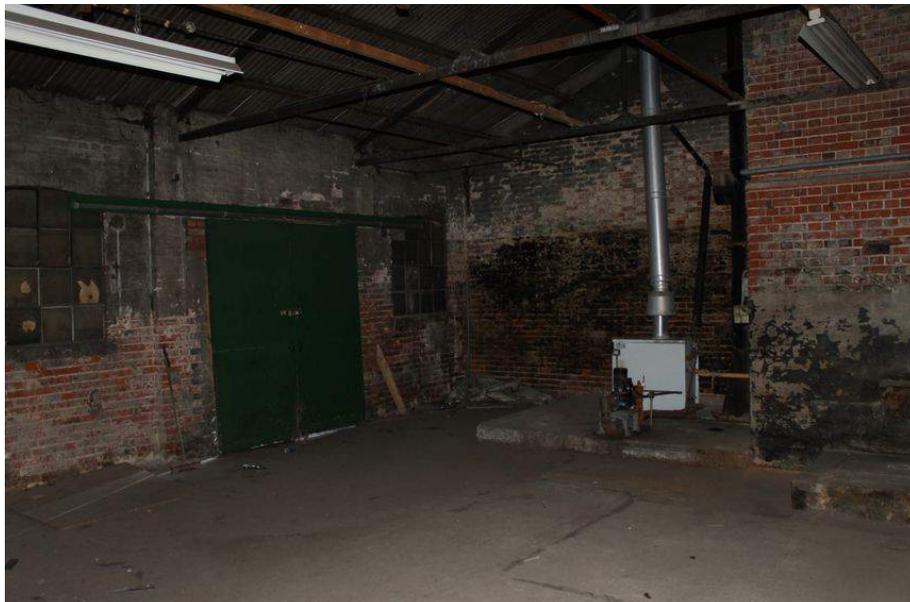
**Photograph 93** Interior of Structure 9. Photograph taken facing south-east.

The interior of Structure 9 is a single room with a concrete floor. There are two raised areas adjacent to the chimney-stack that would have contained machinery associated with the buildings use as a boiler-house (Photograph 93). On the interior of the eastern elevation are three shallow brick buttresses supporting the wall (Fig 9).
