**Historic building recording at
79 Magdalen Street,
Colchester, Essex CO1 2LA**

February 2019

CAT Report 1391
March 2019

A programme of historic building recording was carried out by Colchester Archaeological Trust at 79 Magdalen Street, Colchester, Essex in February 2019.

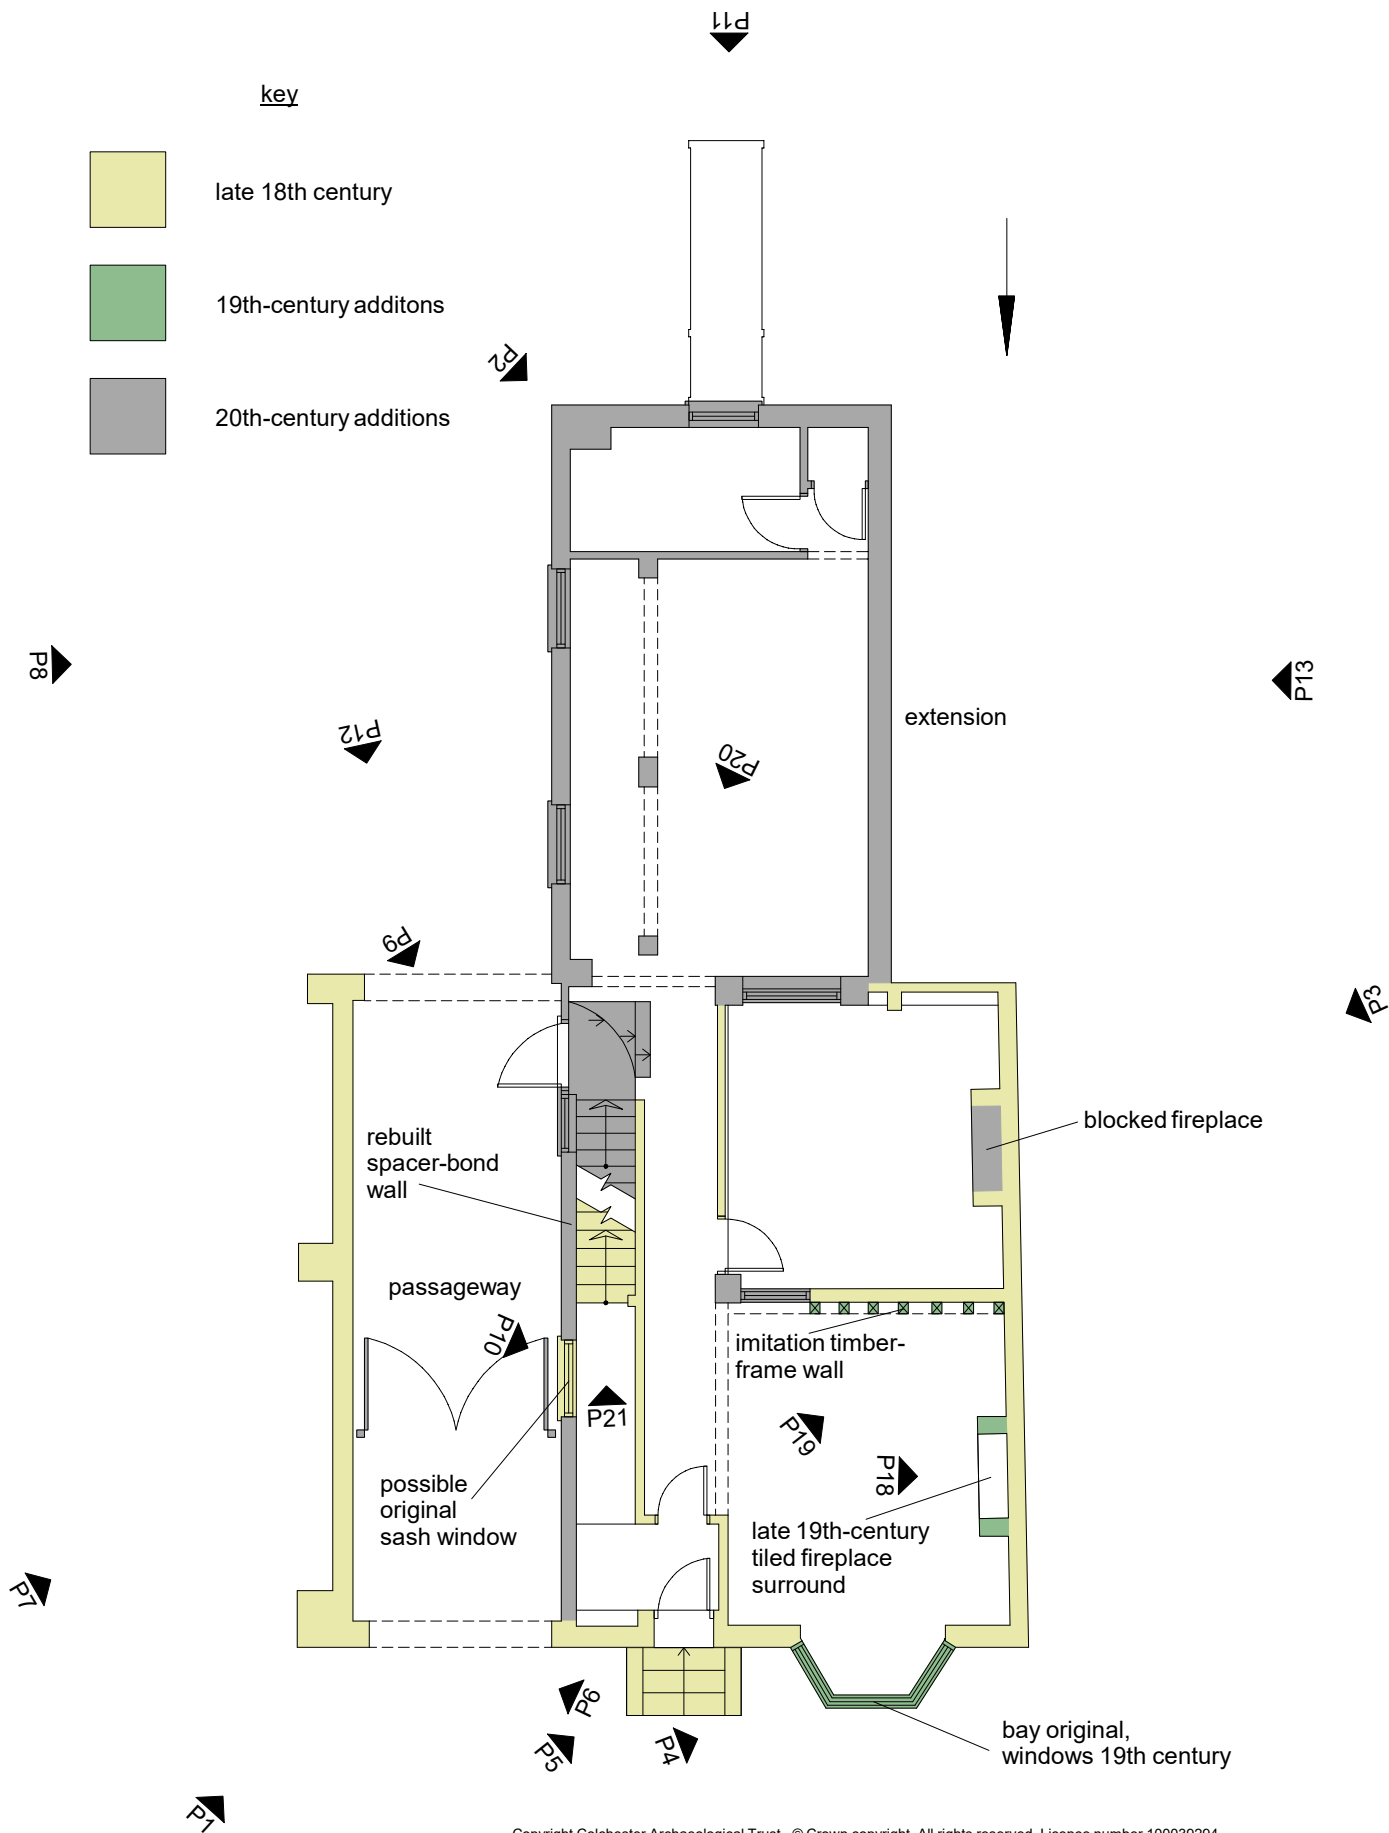
Fig 3 Ground-floor of 79 Magdalen Street with phasing. Location and direction of photographs reproduced with text shown.

The cellar is only present beneath the north-western quarter of the main range. It is accessed by a concrete staircase on the ground-floor (Fig 3) and has a six-panel modern replacement door. It is constructed of brick laid in Flemish-bond, with bricks measuring 220mm x 100mm x 60mm and bonded with cement. Its eastern wall contains several modern hammered thick-glass windows that are just above ground-level in the passageway to the east (Photograph 14). A small fireplace remains open on its western wall.

Although there are no original features, some are still of note. Within the northern room on the ground-floor is an example of a late 19th-century fireplace (Yorke 2005, 75). While the cast-iron fireplace has been removed and replaced with a wood burner, the decorative surround, with its tiles and carved brackets, survives (Photograph 18). The fireplace in the southern room has been blocked (Fig 3).

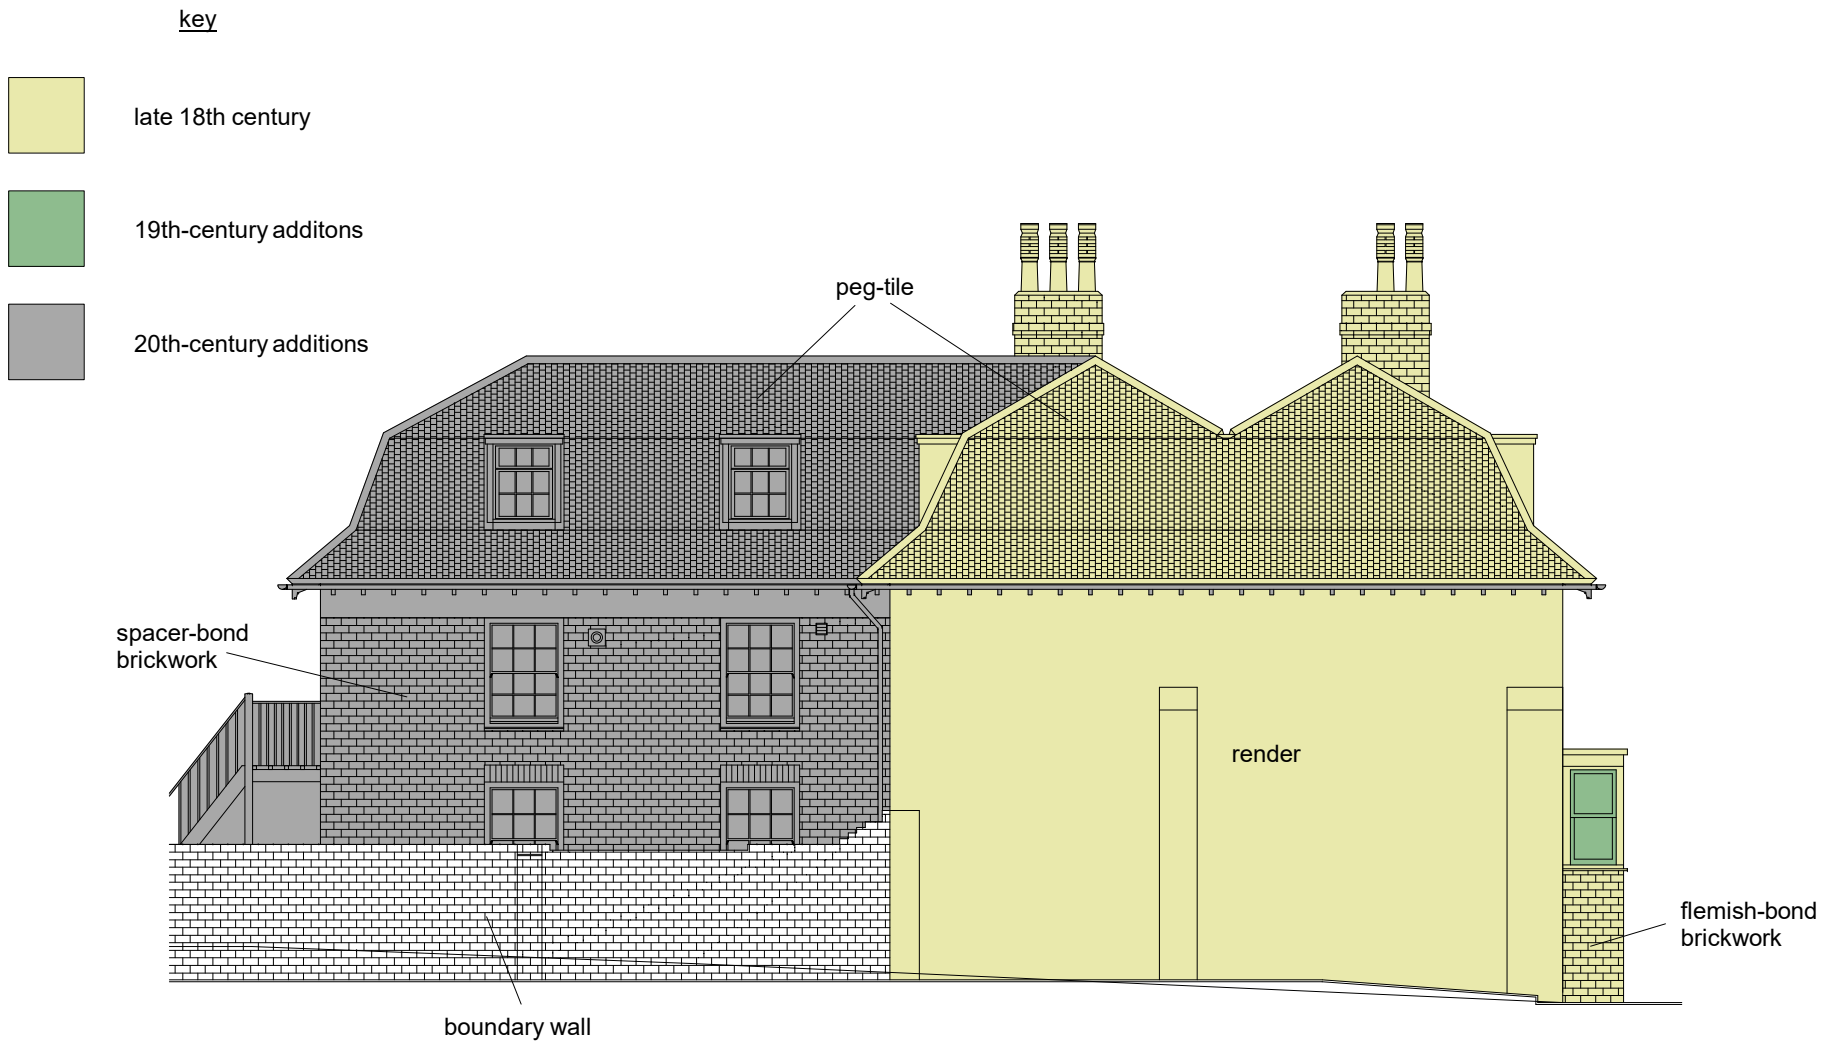
Fig 6 East elevation of 79 Magdalen Street with phasing.

East elevation (Fig 6)

The main range of the building is rendered on this elevation (Photograph 7). It has no windows, but it has three brick buttresses. The extension on this elevation has two twelve-light horned sash windows on the ground-floor, mirrored by two more above on the first-floor (Photograph 8). In the mansard roof above, like on the main range, are two dormers each containing six-light fixed and three-light awning windows.

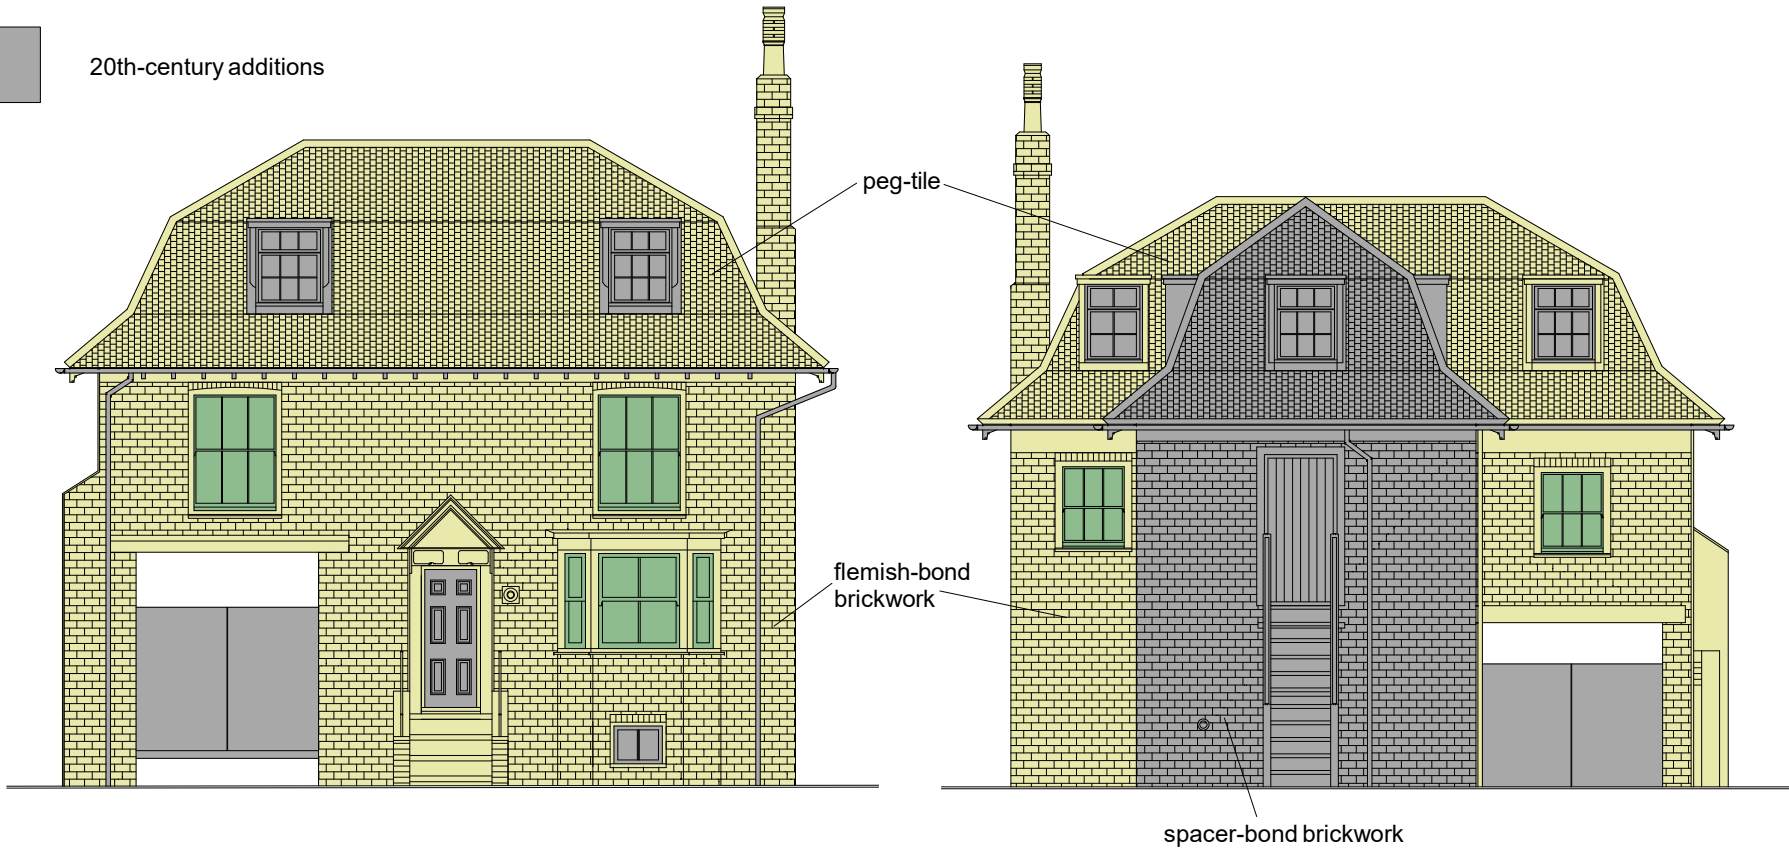
Fig 7 North and south elevations of 79 Magdalen Street with phasing.

North elevation (Fig 7)

There is a bay window at ground-floor level on this elevation (Photograph 4) containing 2 two-light fixed and one three-light horned sash window. Below this bay window is a small fixed window providing light to the cellar. The main entrance into the building is on this elevation, consisting of a doorway about 1m above ground-level, accessed by a flight of brick-built steps with concrete treads and metal balusters and handrails (Photograph 5). The doorway is heavily recessed into the building and surrounded by a porch-like slight forward projection with a hood above (Fig 7). Within the doorway is a six-panel door that appears to be a modern replacement.

On the first-floor are two large six-light horned sash windows, directly above these on the second-floor are two dormers in the mansard roof, both containing six-light fixed and three-light awning windows (Fig 7).

This elevation is dominated by the extension, which has another central dormer with the same six-light and three-light windows as the others around the building. The extension has an inserted modern vertical-planked door on the first-floor, which is accessed by a timber staircase (Photograph 11). Behind this staircase on the ground-floor is a six-light fixed and three-light awning window on the ground-floor. The main range on this elevation has two more six-light horned sash windows and two more dormers, one on each side of the extension (Fig 7).

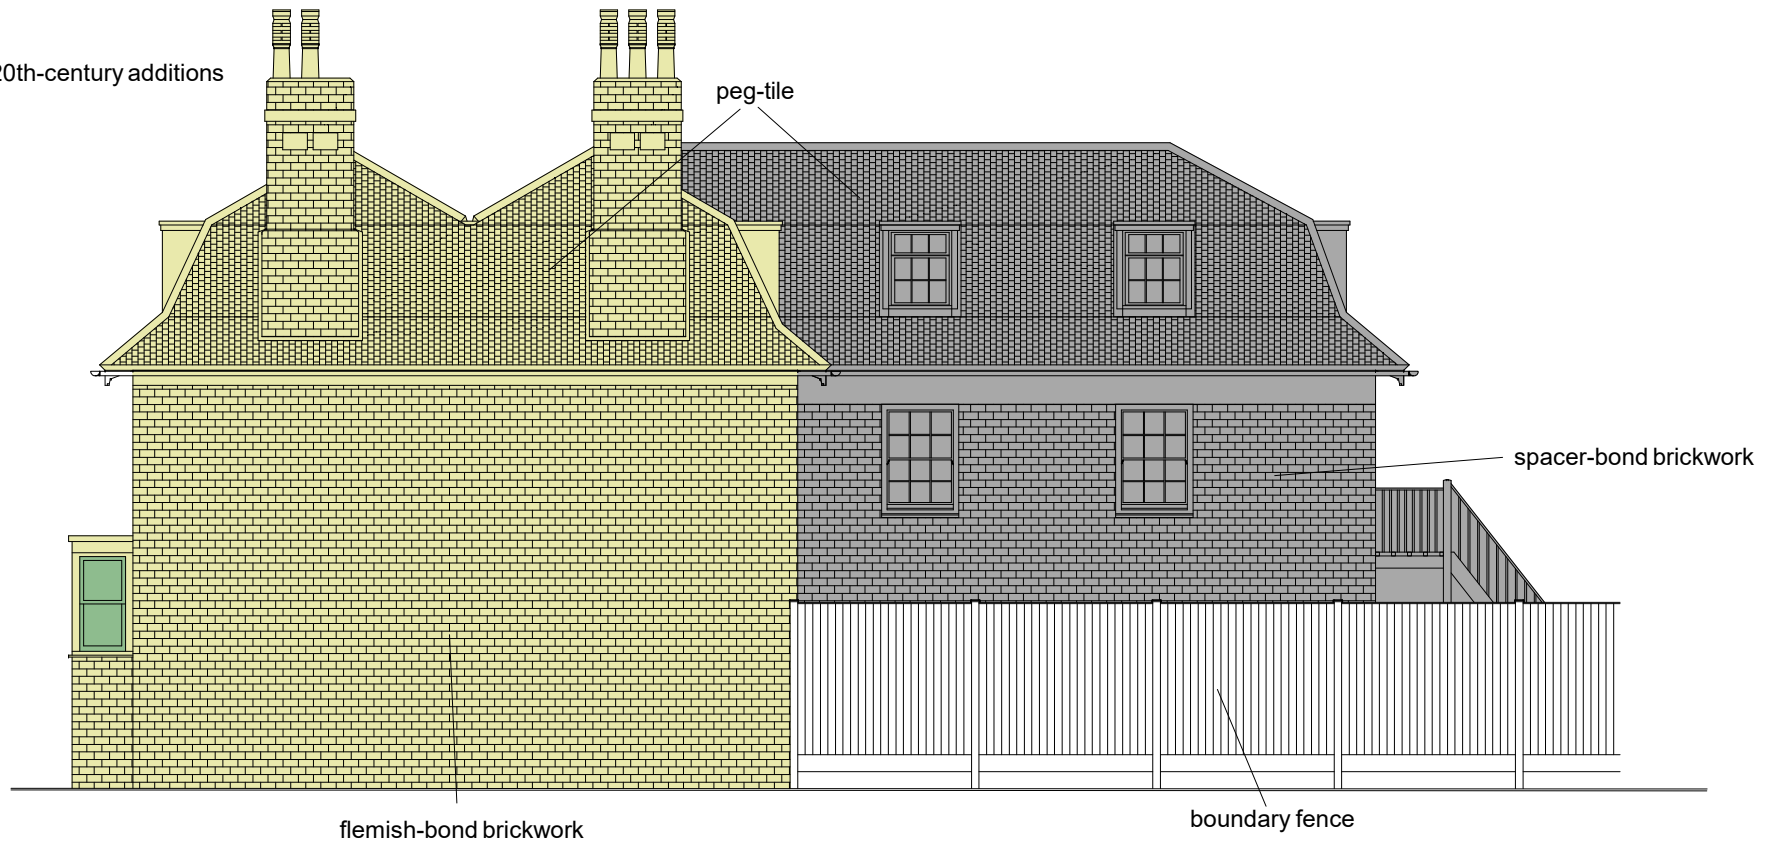
Fig 8 West elevation of 79 Magdalen Street with phasing.

The building has two brick chimney stacks on its western end (Photograph 3). The extension has no chimney.
