**Historic building recording at  
No 10-12 Botany Cottages,  
London Road, Purfleet,  
Essex, RM19 1PS**

**March 2019**

**commissioned by  
Thurrock Council**

**CAT Report 1427**  
May 2019

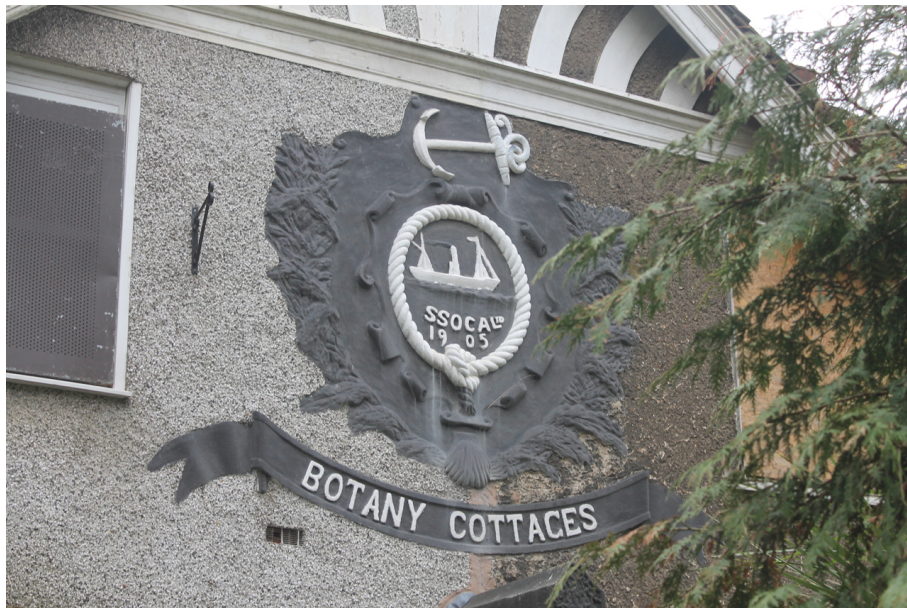
The Historic Environment Record (HER) shows that No 10-12 Botany Cottages form part of a line of workers' cottages on the south side of London Road (EHER 40636). A large plaque attached to the gable of No 6-7 Botany Cottages (further along on the west of the range) attests that the cottages were constructed in 1905 for the employees of the Steam Ship Coal Owners' Association Ltd (Photograph 1).

**Photograph 1** Detail of plaque on north-facing gable of No 6-7 Botany Cottages. Photograph taken facing south-west.

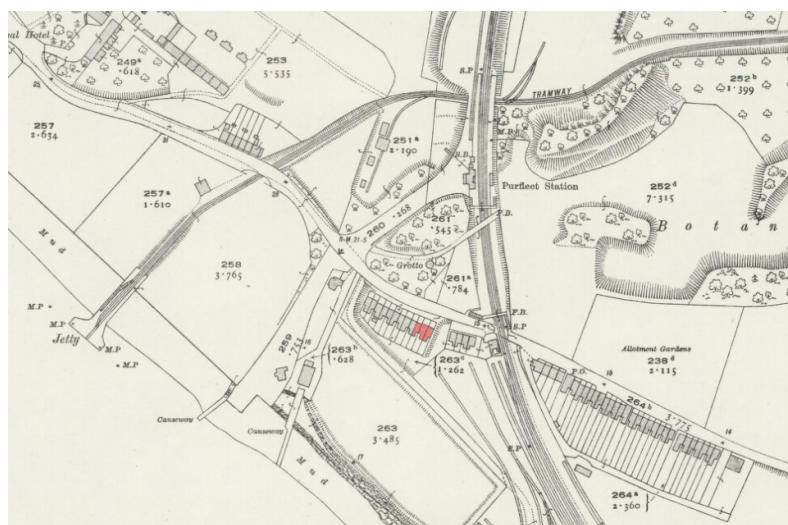
The cottages are first depicted on the 1915 OS map as part of a long development of similar workers' cottages on the south side of London Road, opposite Purfleet train station (Map 1).

**Map 1** 1915 25-inch OS map, with 10-12 Botany Cottages highlighted.

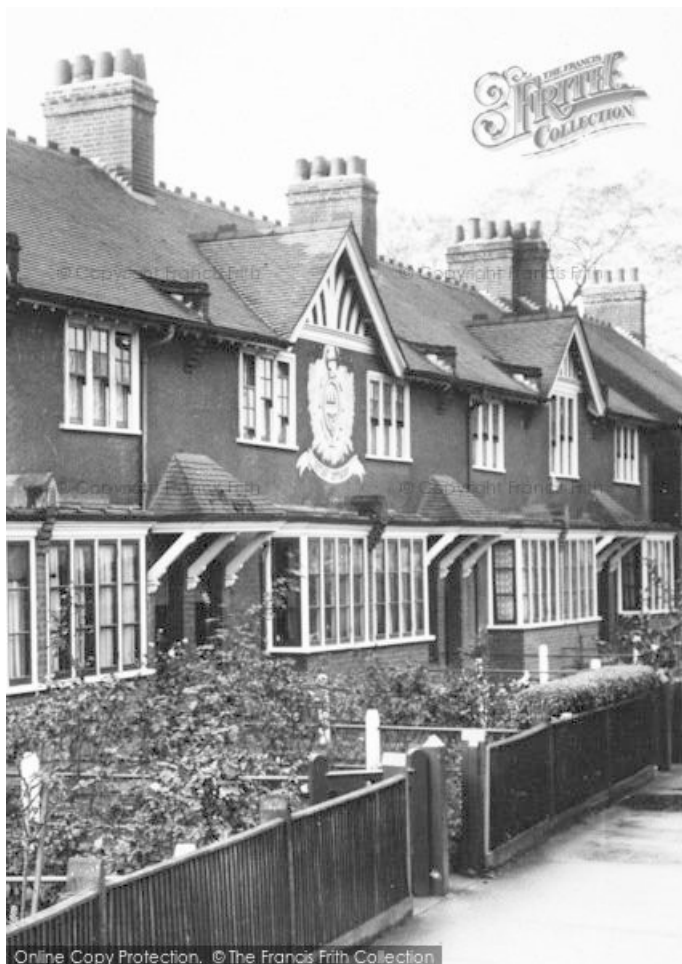
**Photograph 2** North elevation of Botany Cottages, with plaque in centre. None of the cottages visible in this photo are detailed in this report. Taken from [www.francisfrith.com](http://www.francisfrith.com).

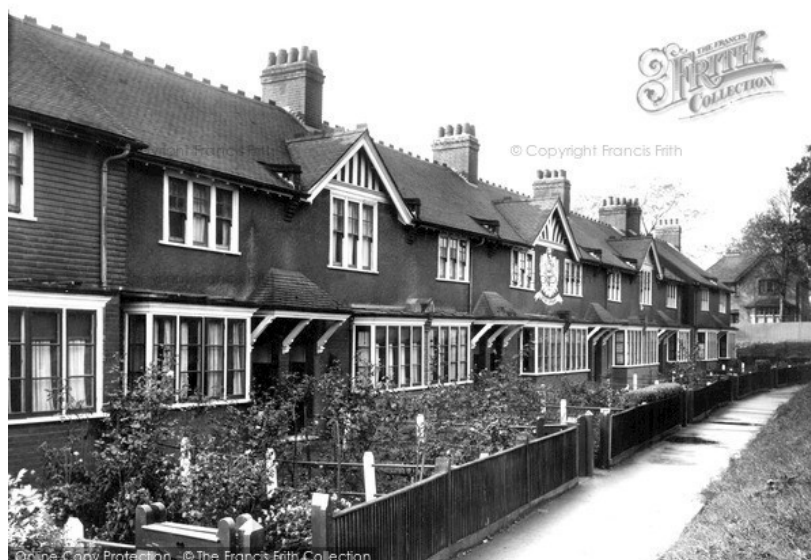
**Photograph 3** North elevation of Botany Cottages. No 10 and 11 visible to left of frame. Taken from [www.francisfrith.com](http://www.francisfrith.com).

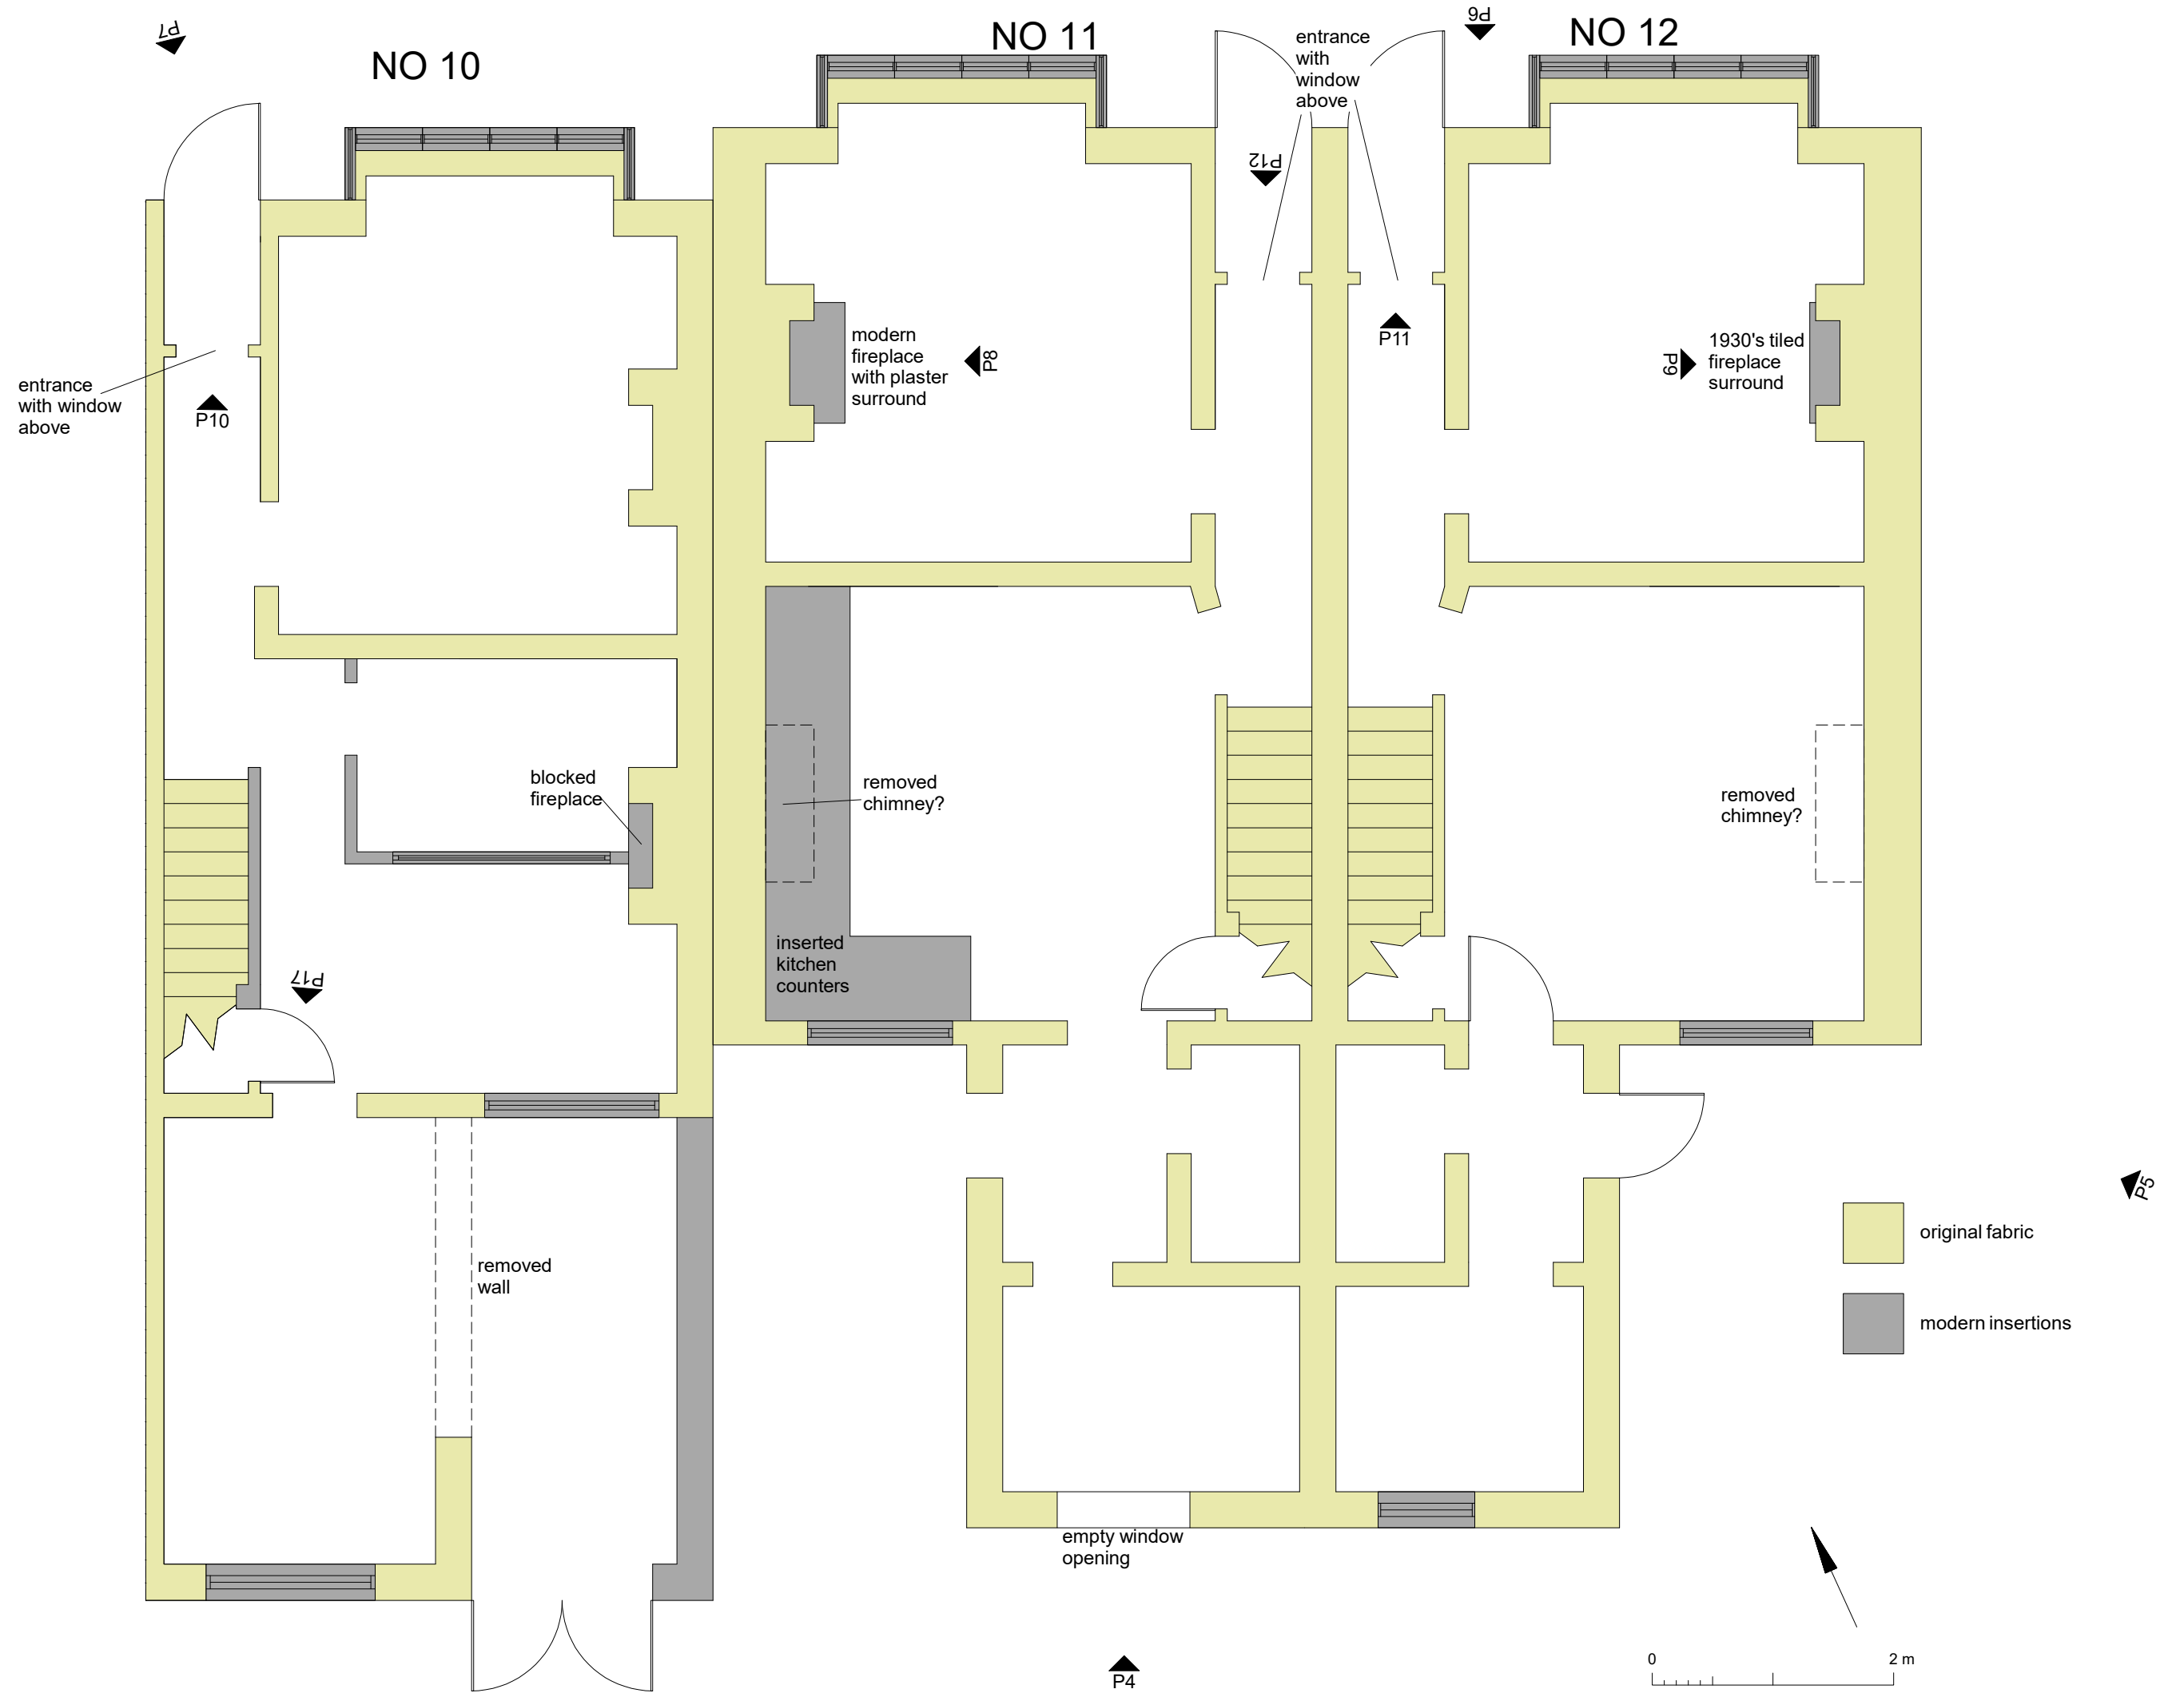
Fig 2 Ground-floor plan of 10-12 Botany Cottages. Location and direction of photographs reproduced in text shown.

Presumably, all three cottages would have originally been identical in their layout and it is only modern alterations that have caused any divergence in plan (Fig 2). The ground-floor of each building has two large rooms in the main range, a living-room to the north and a kitchen to the south. To the side of these is a corridor leading from the front door to the stairs (Fig 2). In each building the ground-floor of the south-west wing is accessed from the kitchen and contains a small room for a W.C. and another for a scullery or storeroom. Beneath each staircase is a cupboard (Fig 2).

No 10 has fireplaces in both the ground-floor rooms and in all three bedrooms upstairs (although one on the ground-floor has been blocked; Fig 2). This contrasts to No 11-12 which only have fireplaces in the northern rooms on the ground and first-floors, and apparently none elsewhere (Figs 2-3). However, evidence for a chimney survives in the roof space of the south-west wings of No 11-12 (see below), so presumably this absence of fireplaces is due to their removal, rather than them never having existed.

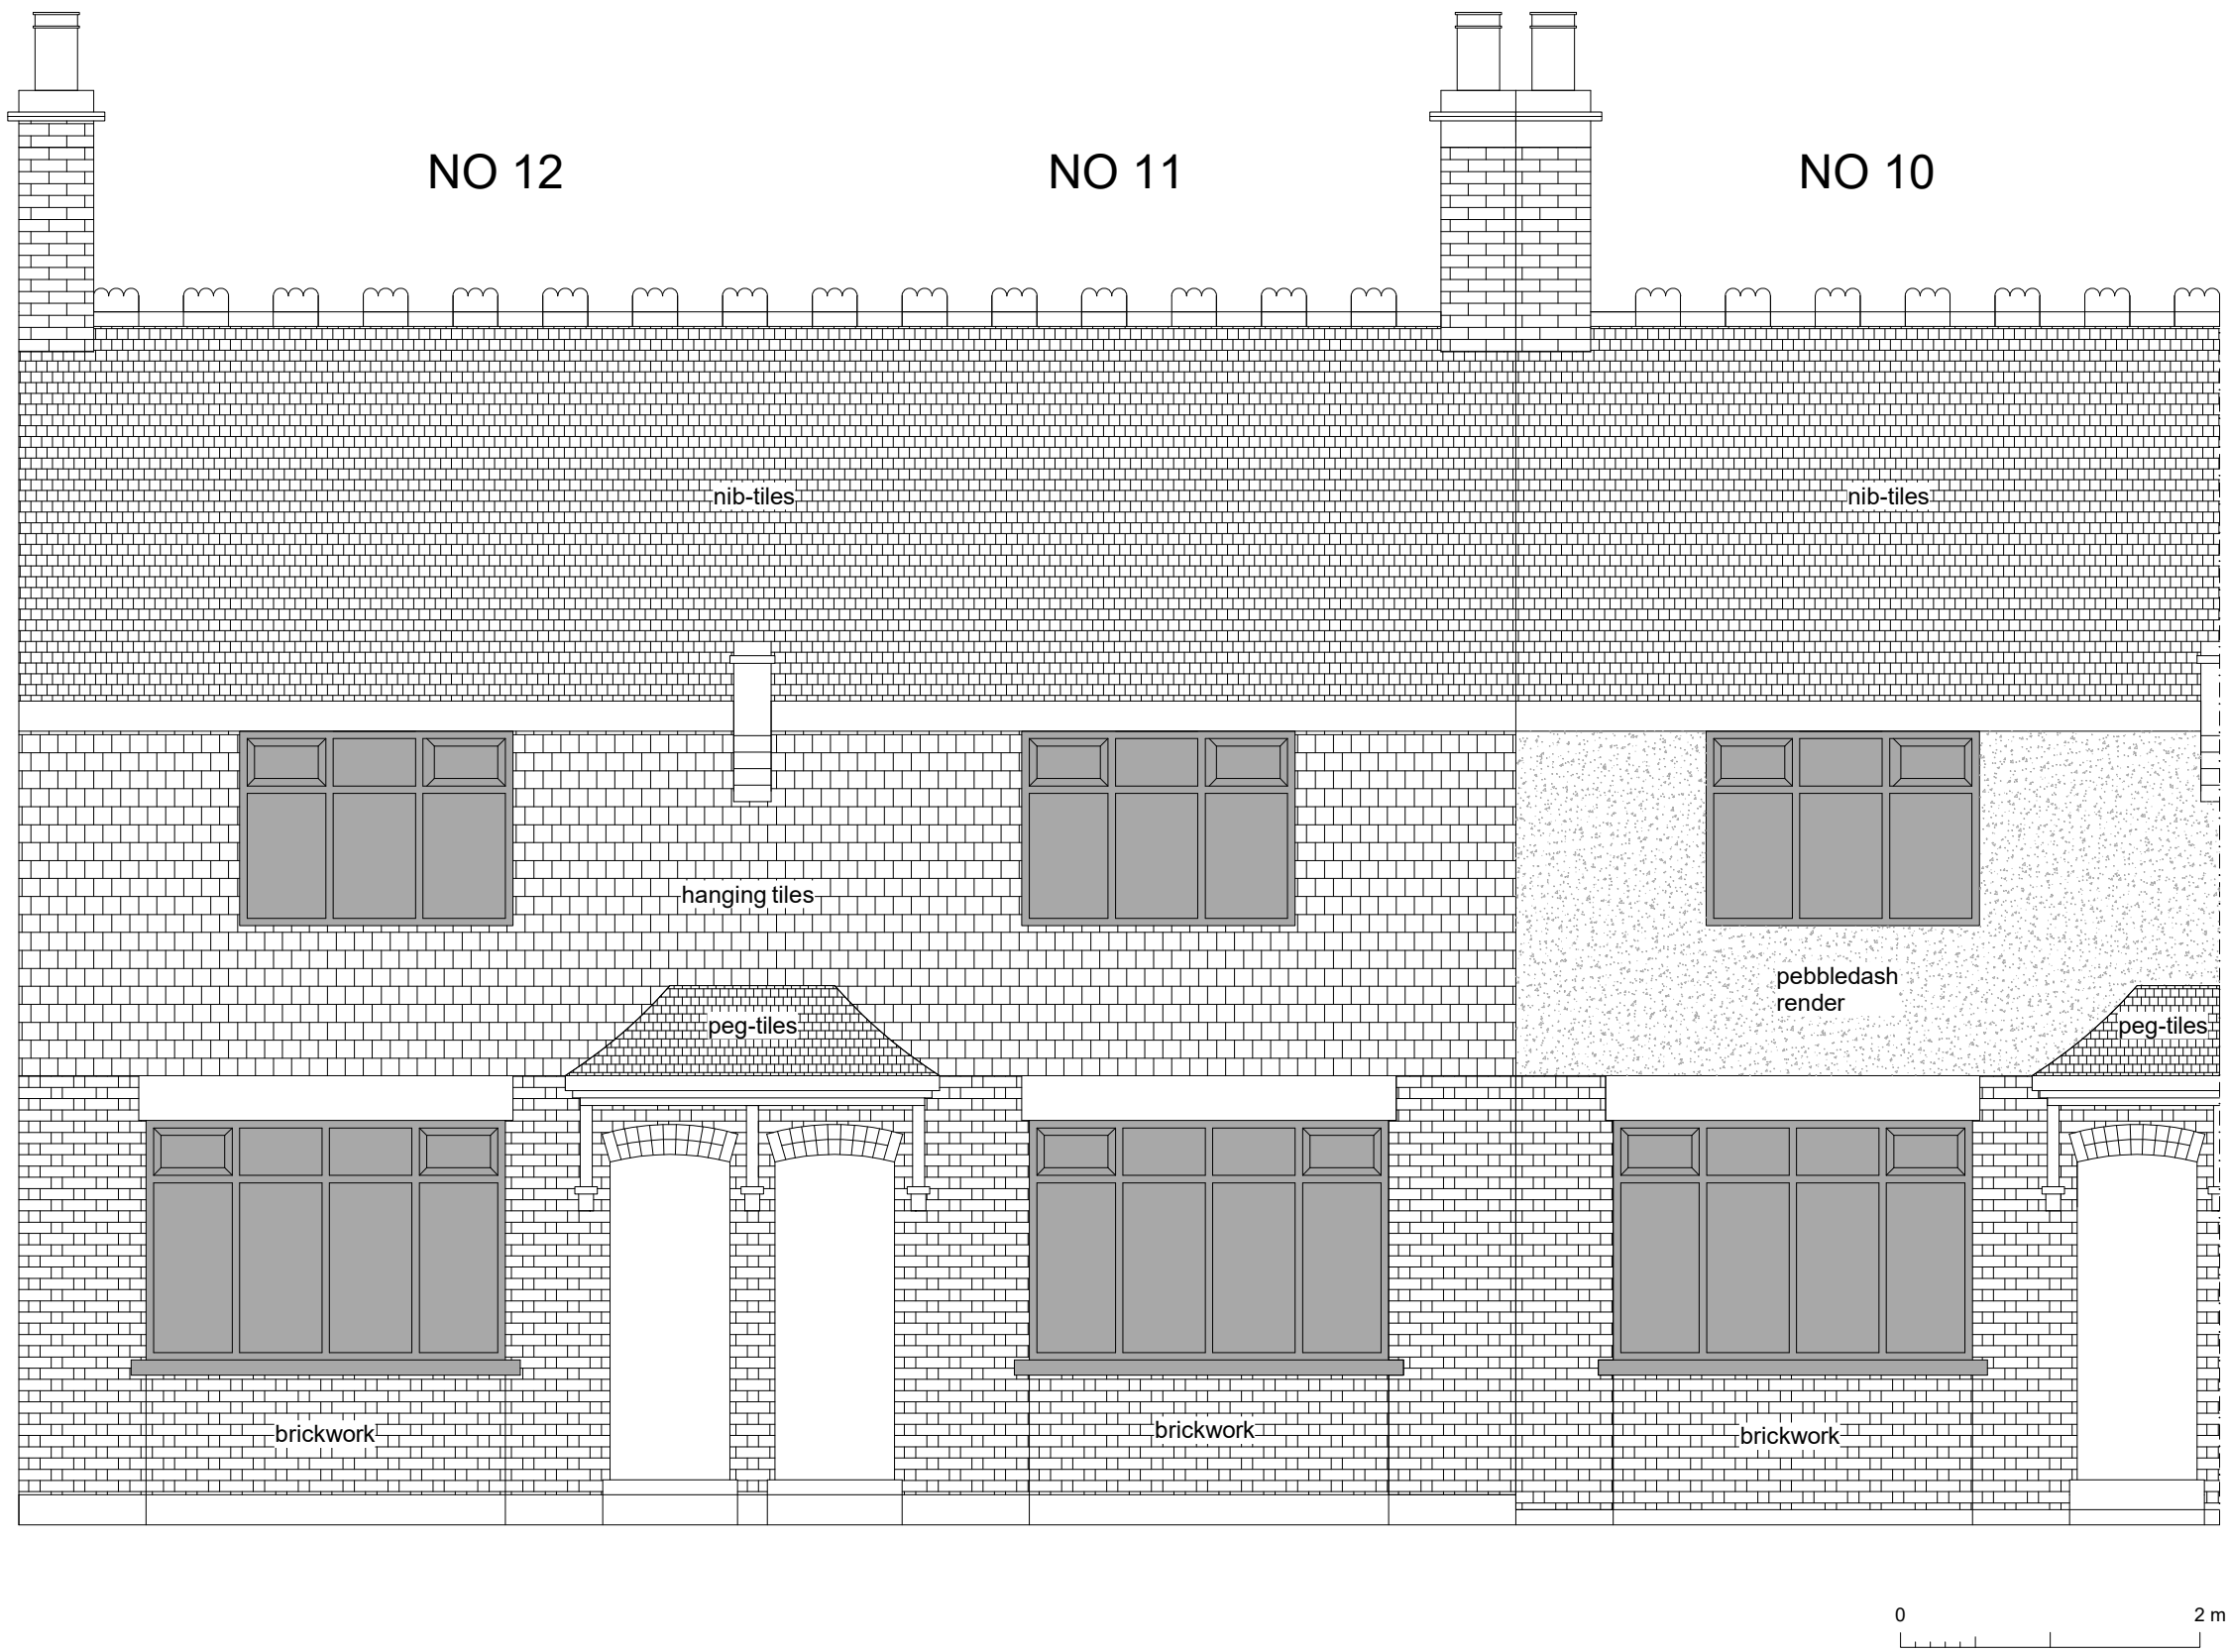
Fig 4 North-east elevation of 10-12 Botany Cottages.

On the north-east elevation the brickwork of the buildings is exposed at the ground-floor level and consists of red bricks laid in Flemish-bond with queen-closers around the windows and corners, with brick dimensions of 220 x 110 x 70mm (Photograph 6). On the first-floor level No 11-12 are covered with hanging tiles, and No 10 with pebbledash render. Each building has a projecting square bay window on the ground-floor, containing plastic-framed casement and awning windows (Photograph 6). Originally these bays would have contained wooden-framed casements, judging by the photographs of the frontage from 1955 (Photographs 2 and 3). Each building also has a plastic-framed six-light awning and casement window on the first-floor (Fig 4), which seems to have replaced three wooden-framed sash windows (Photographs 2 and 3).

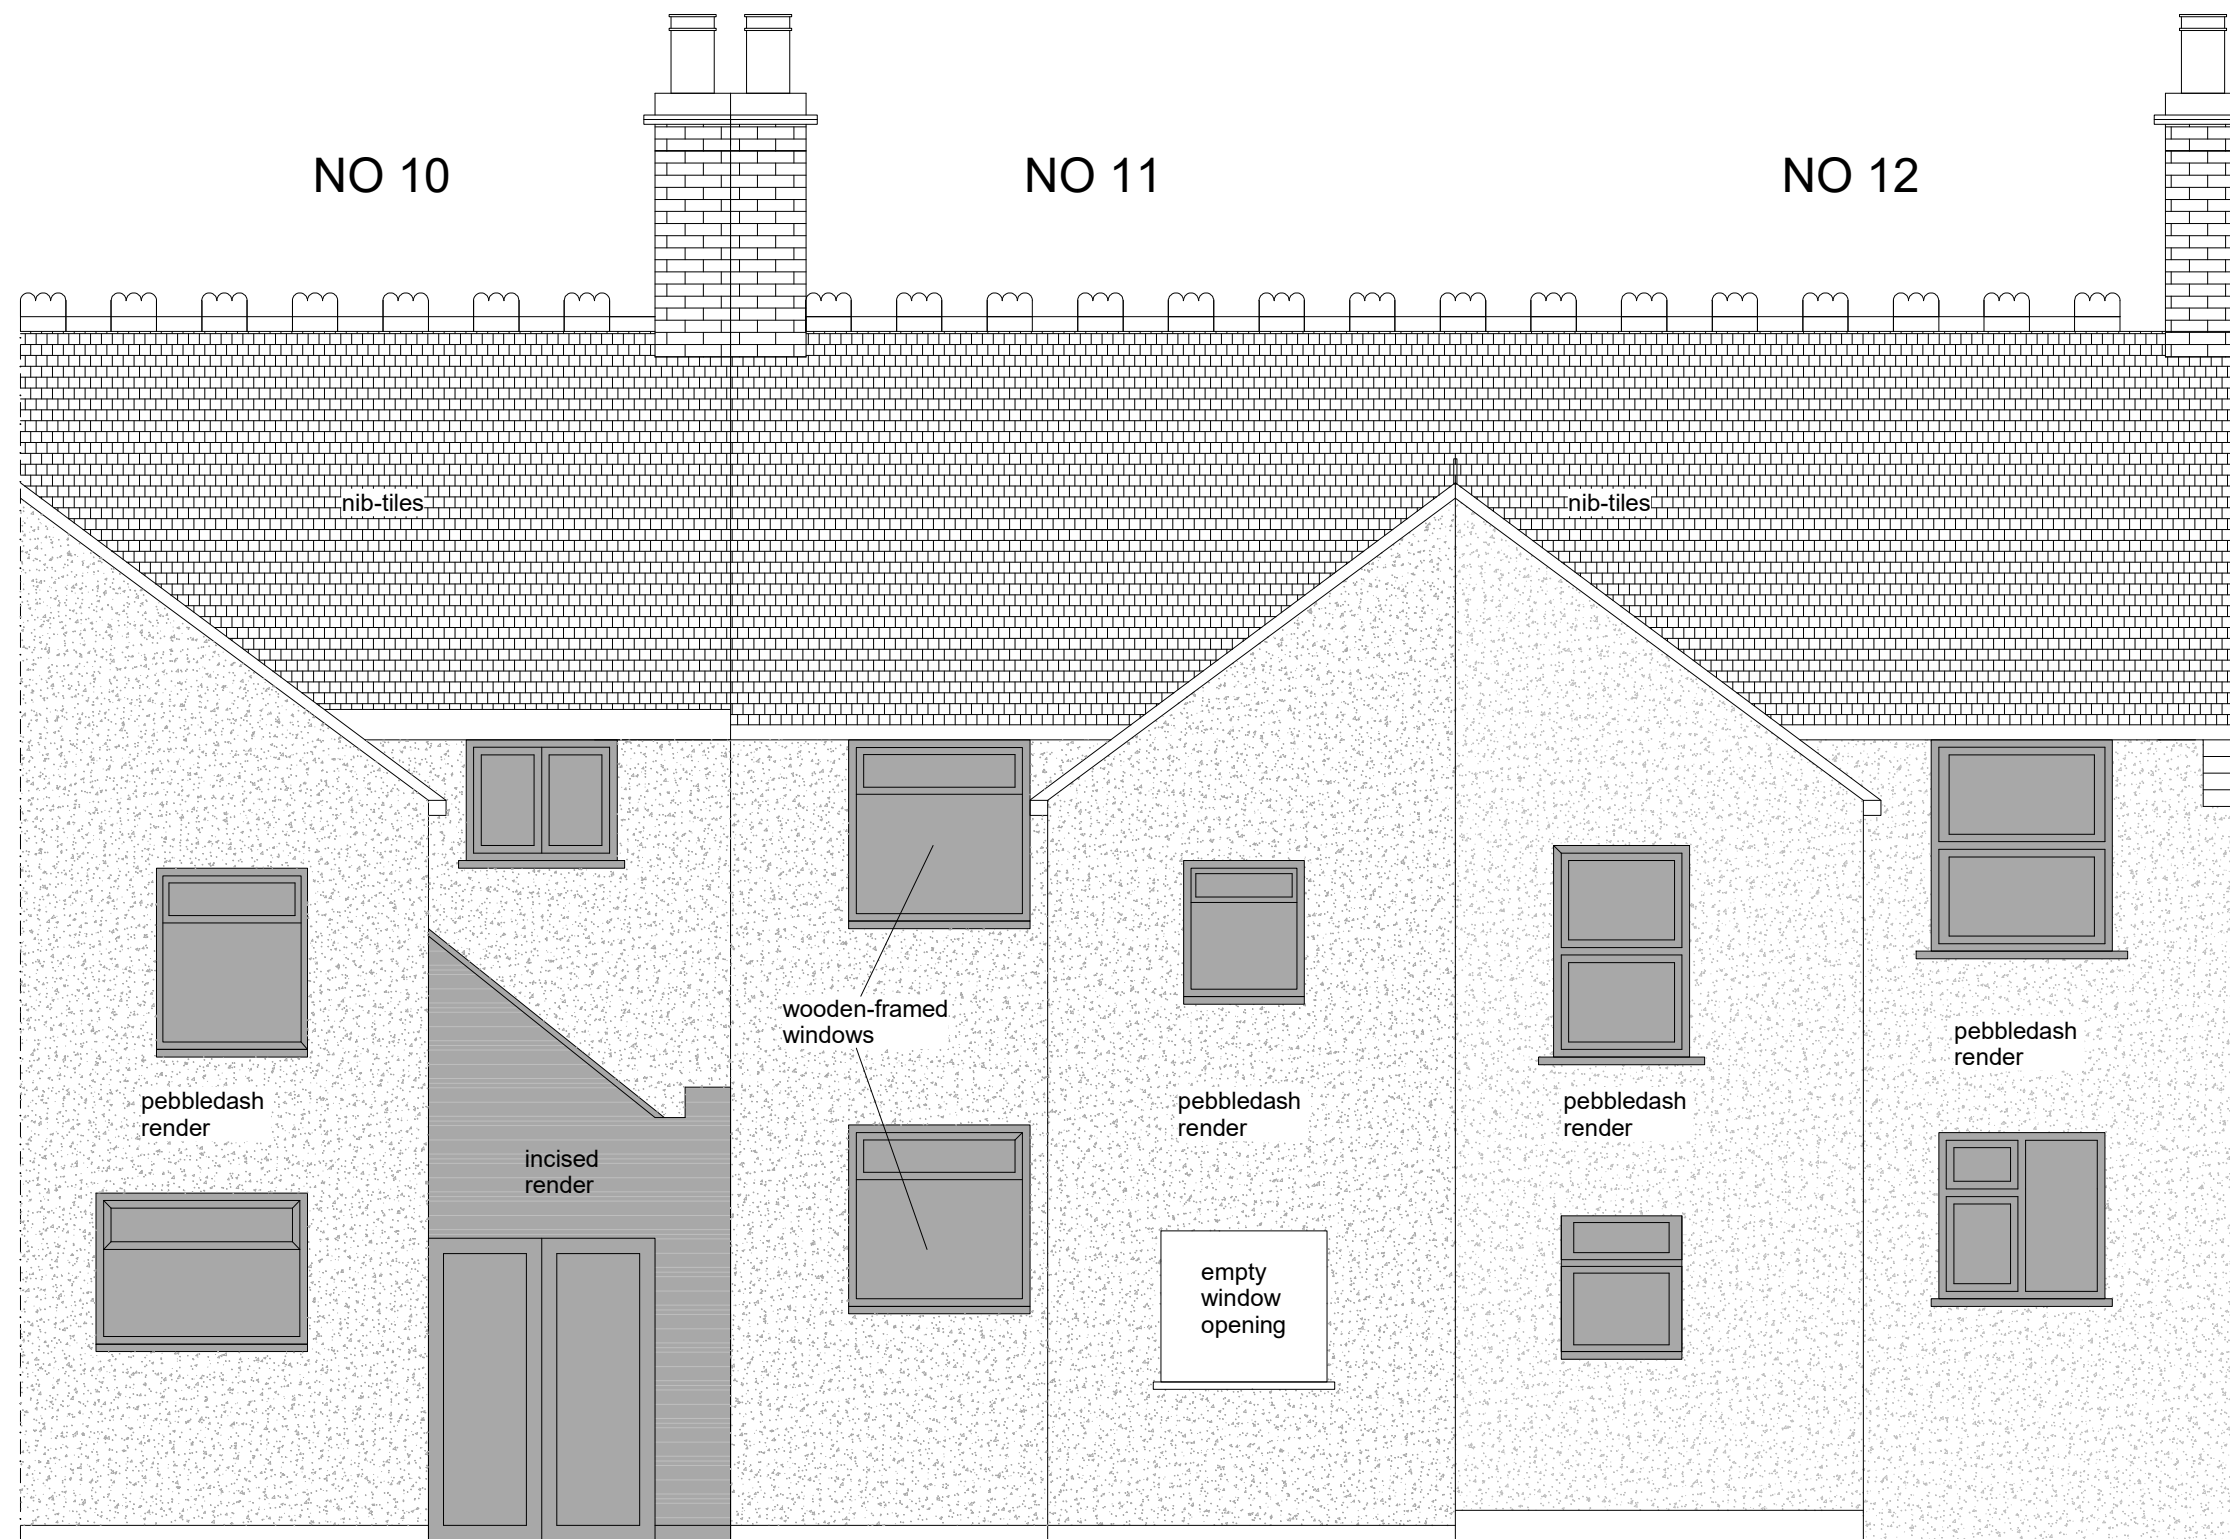
Fig 5 South-west elevation of 10-12 Botany Cottages.

No 10 differs slightly on this elevation: it has a modern extension infilling the space between the main range and the south-west wing (Fig 5). This extension has a single roof pitch covered in plain tiles, and has no windows. It does, however, contain a glazed plastic-framed double-door.
