Historic building recording at the former Great Wigborough Village Hall, School Lane, Great Wigborough, Essex CO5 7RJ

June 2020

CAT Report 1594
September 2020

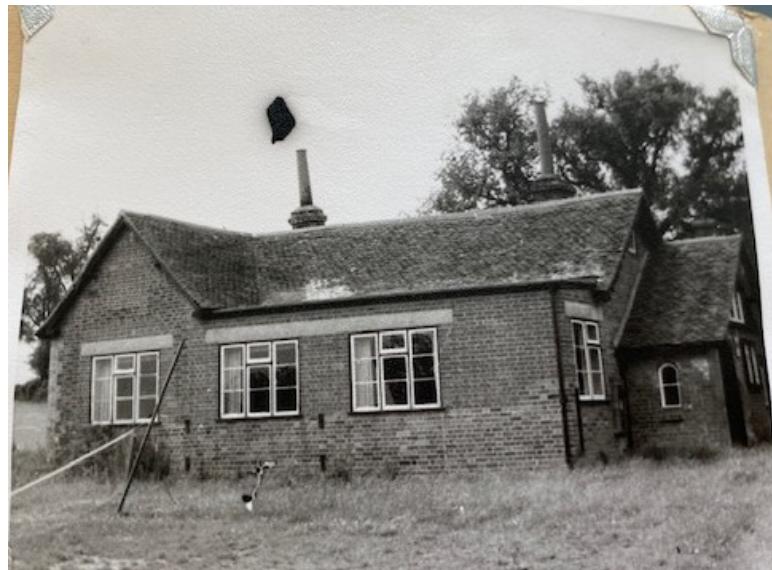
Photograph 5 South-east elevation of the building, taken sometime between 1950-1975. Photograph taken facing north-west. ERO D/DU 1464/42.

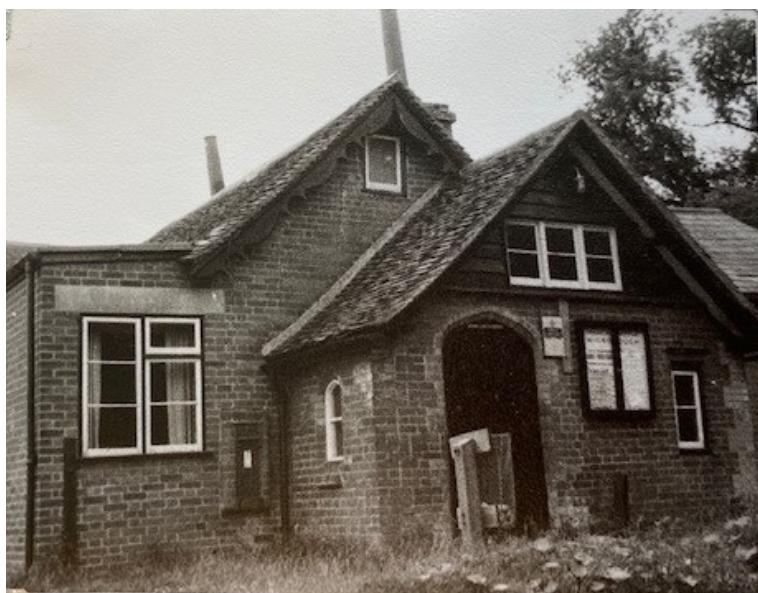
Photograph 6 North-east elevation of the building, taken sometime between 1950-1975. Postbox visible to left of porch. Photograph taken facing west. ERO D/DU 1464/42.

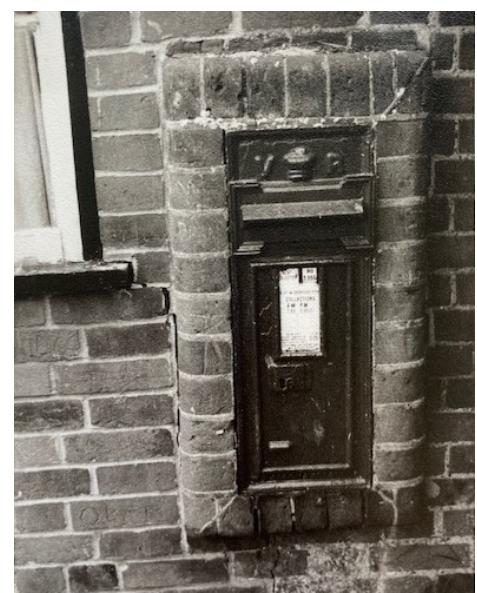
Photograph 7 Detail of postbox on north-east elevation of building, taken sometime between 1950-1975. Photograph taken facing south-west. ERO D/DU 1464/42.

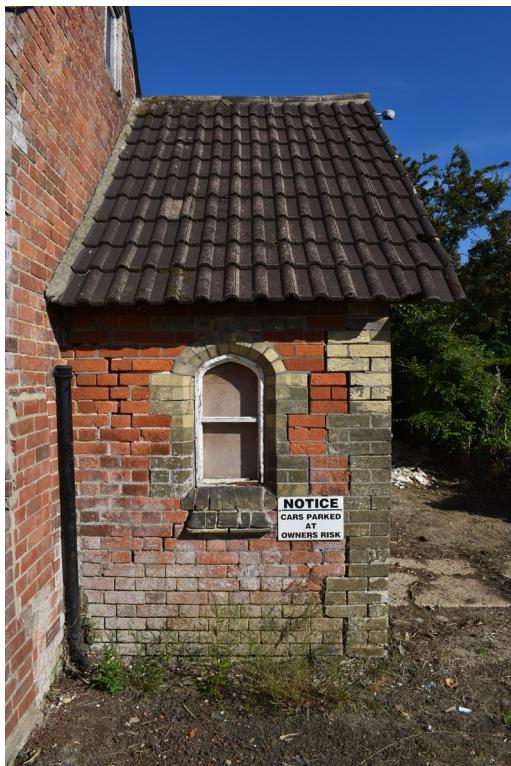
Photograph 10 South-east elevation of porch extension, showing small fixed window. Photograph taken facing north-west.

The external corners of the porch extension are also highlighted with yellow bricks (Photograph 10).

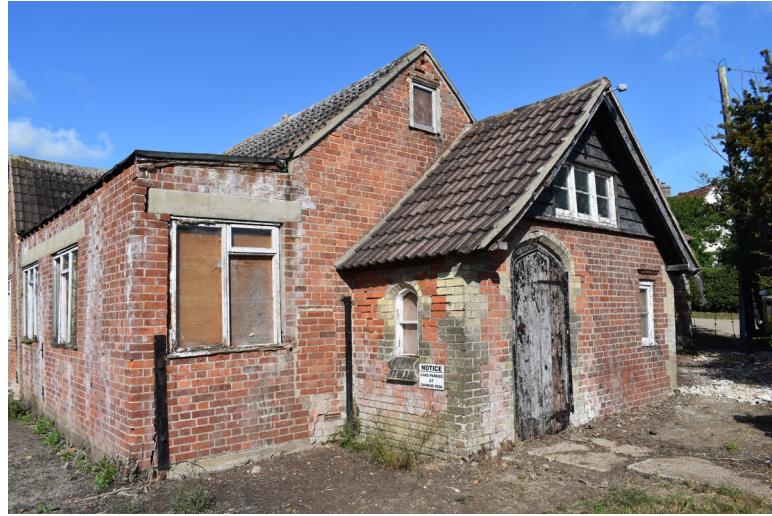
Photograph 11 North-east and south-east elevation of building.
Note postbox visible in earlier photographs has been removed.
Photograph taken facing west.

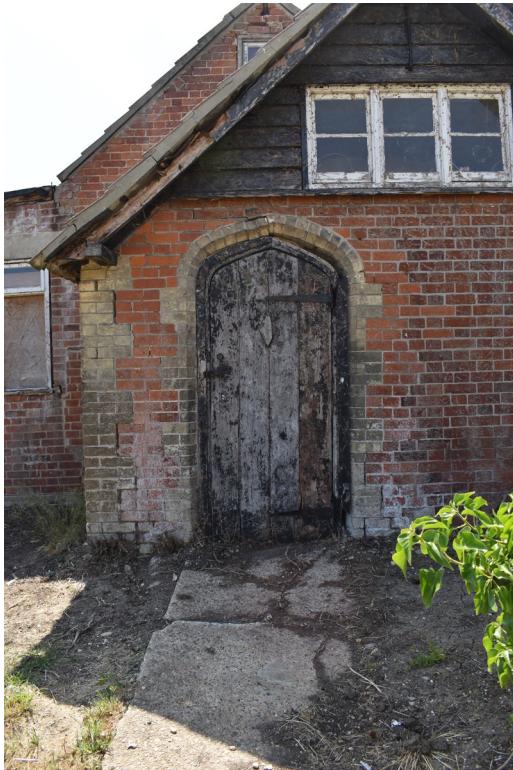
Also on this elevation of the porch extension is a large plank and batten door, constructed of four vertical-planks and with a plain iron latch and hinges. Like the corners of the porch extension and the window on its south-east elevation, the door has a moulded yellow brick surround (Photograph 12).

Photograph 12 Detail of door on north-east elevation of porch extension.
Photograph taken facing south-west.

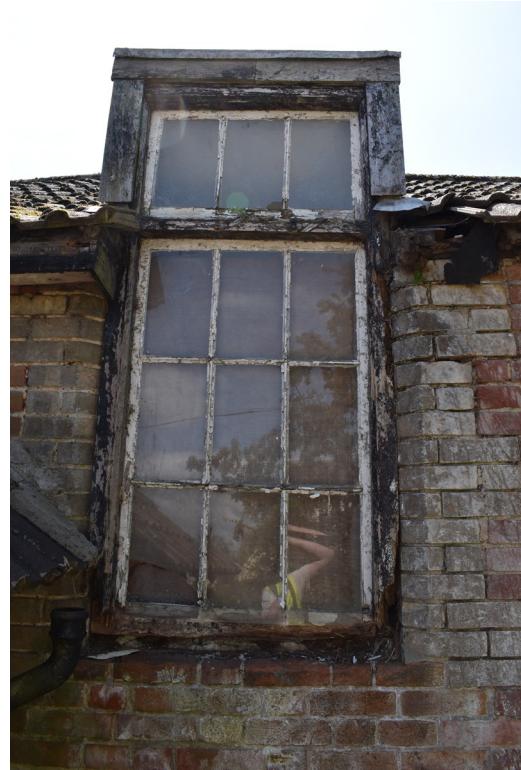
The north-west/south-east range on this elevation has a tall twelve-light fixed/awning window that projects upwards into a flat-roofed dormer on the roof pitch (Photograph 13). Like other windows on this range of the building, it has a moulded yellow brick surround, although the moulded bricks continue below the current modern window; it appears that the lower section of the original window opening has been bricked-up when the modern window was inserted and the dormer added.

Photograph 13 Detail of dormer window on north-east elevation of original range.
Photograph taken facing south-west.

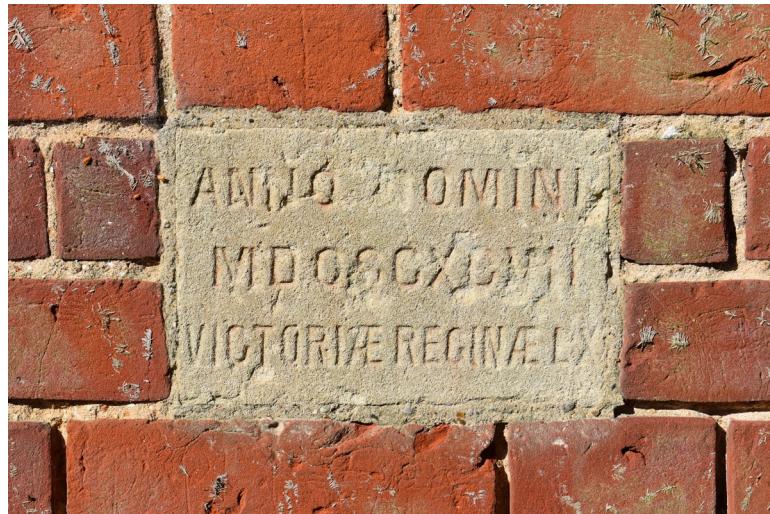
This inserted stone commemorates the Diamond Jubilee of Queen Victoria on the 22 June 1897. It may indicate that the building was renovated around this time, possibly with the addition of the porch extension (see historical background above).

Photograph 14 Detail of tablet stone on north-east elevation of main range, commemorating Queen Victoria's Diamond jubilee.
Photograph taken facing south-west.

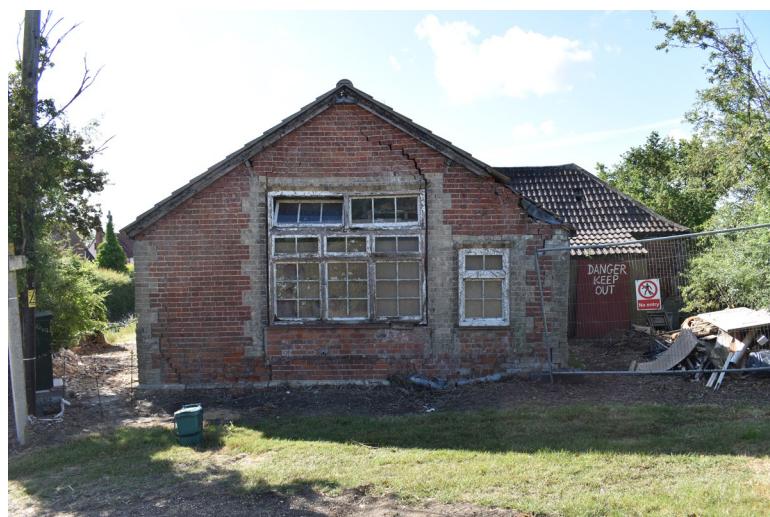
The north-west elevation of the building is dominated by a large 30-light fixed/awning window, again with a moulded yellow brick surround (Photograph 15). Like the dormer window on the north-east elevation, however, the surround continues below the current modern window, with the space below it having been bricked up. There is a smaller six-light awning/fixed window on this gable end with identical bricking-up and surrounds (Photograph 15).

Photograph 15 North-west elevation of building, showing inserted windows in original partially bricked-in window openings.
Photograph taken facing south-east.

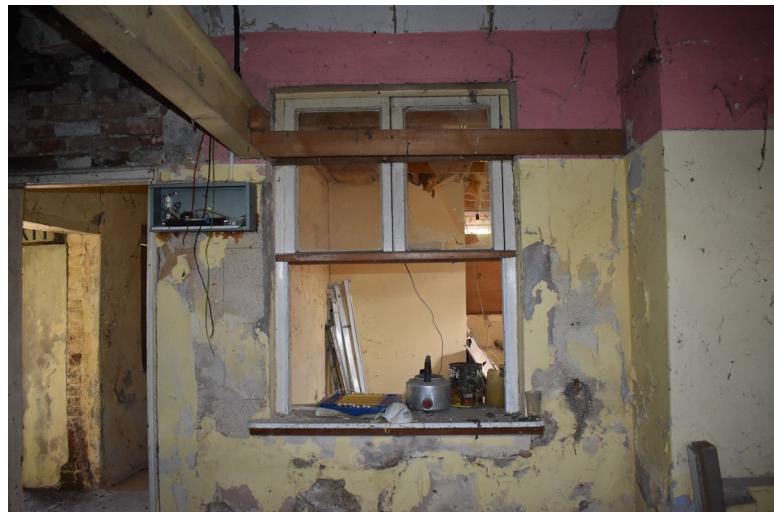
Also on the north-west elevation of this room, looking into the northern room is an adapted fixed two-light window, with a permanent opening in the bottom half (Photograph 18).

Photograph 18 Detail of internal window between southern and northern room in building. Photograph taken facing north-west.

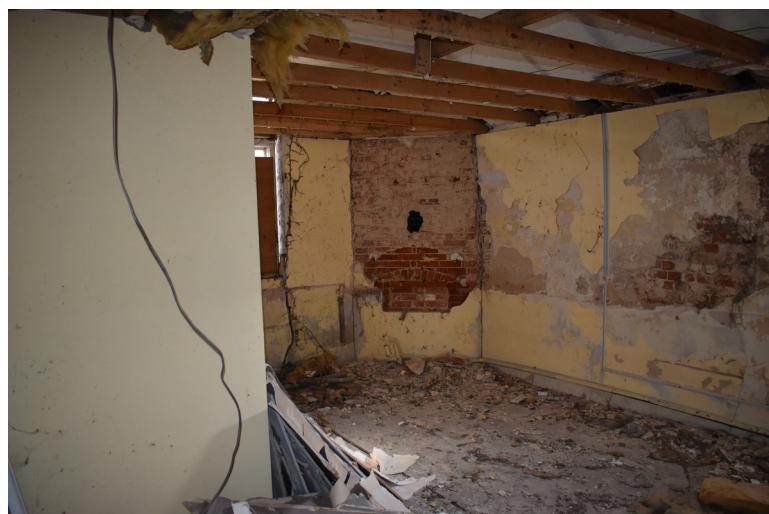
The northern room comprises the entirety of the northern range of the building, and measures 6m x 6.3m in size (Photograph 22). It is partially subdivided by a section of modern stud wall to form two bathrooms in its north-west corner (Fig 2). A section of original brick walling survives in the centre of the room that seems to be the remnants of a short corridor that lead to doorways into the northern and southern rooms (Fig 2). A short section of scarring on the floor at the end of this section of wall suggests it turned and joined the south-west wall of the northern room, presumably in the location of an original (since blocked) entrance into the building (Photograph 23).

Photograph 22 Northern room in building, with modern stud wall to left. Photograph taken facing north.

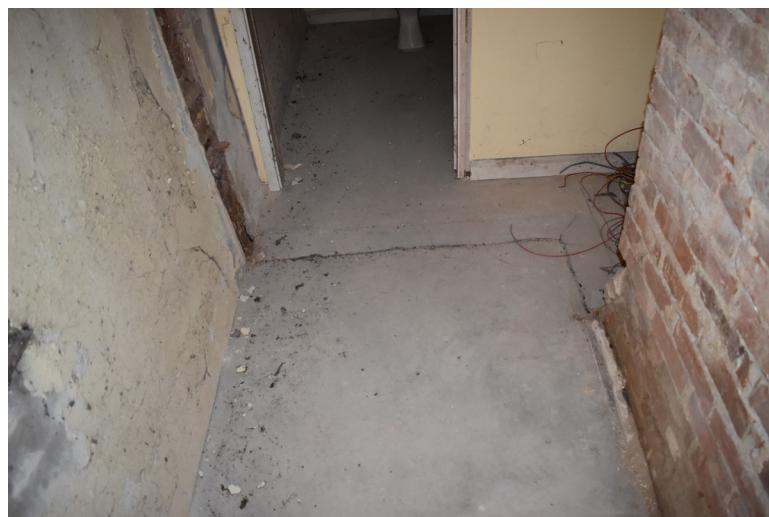
Photograph 23 Detail of scarring on floor of north room, showing location of original brick wall forming end of corridor. Location of original entrance into building to the left. Photograph taken facing north-west.

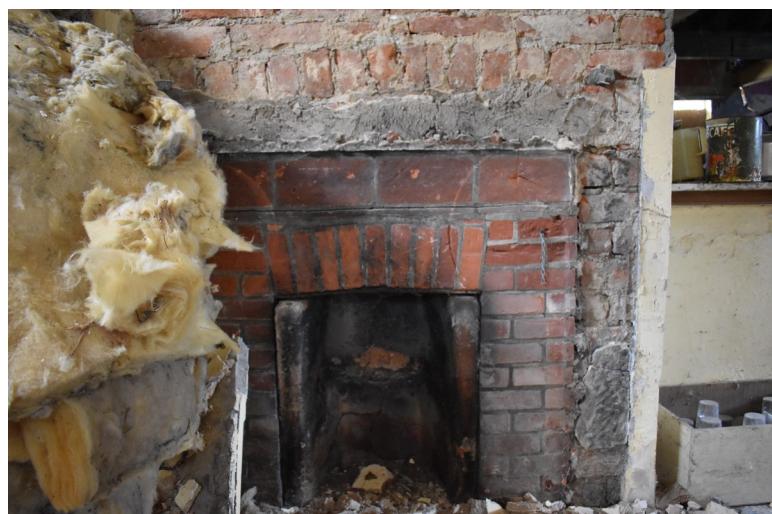
The floor of the northern room is rendered over with a concrete screed, but through the observation of damaged sections, it appears to be laid over floorboards. This room has a chimney-breast to the south-east, containing a modern fireplace. A sizeable amount of render has been removed from the brickwork of the chimney-breast, however, exposing the arch of the original fireplace above the modern insertion (Photograph 24). There is also a chimney-breast in the northern corner of the room. The fireplace is blocked, but again enough render has been removed to expose the original arch (Photograph 22).

Photograph 24 Detail of inserted fireplace in chimney-breast on south-east elevation of northern room. Arch of original fireplace visible above. Photograph taken facing south-east.
