**Historic building recording
of the former Fleece public house,
27 West Street, Coggeshall,
Essex, CO6 1NS**

August 2020

CAT project ref.: 2020/07g
NGR: TL 84772 22503 (c)
Planning reference: 13/01071/FUL
ECC code: CG24
OASIS project id: colchest3-400127

CAT Report 1595
September 2020

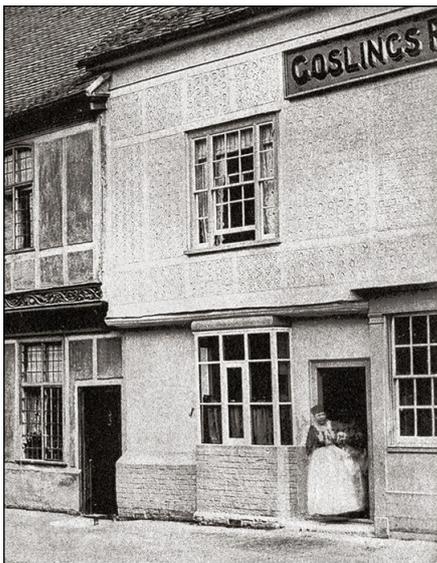
Photograph 1 North-west elevation of pub. Taken around 1900. Brick plinth supporting building visible (since rendered over). Pargetting more detailed than currently. Windows appear unchanged (although lower panes of projecting window have since been replaced with frosted examples). "Goslings" visible at top of elevation name of local brewery which closed in 1904 (http://breweryhistory.com/wiki/index.php?title=Gosling_Family_History). Photograph taken facing east. Reproduced from www.coggeshallhistory.com.

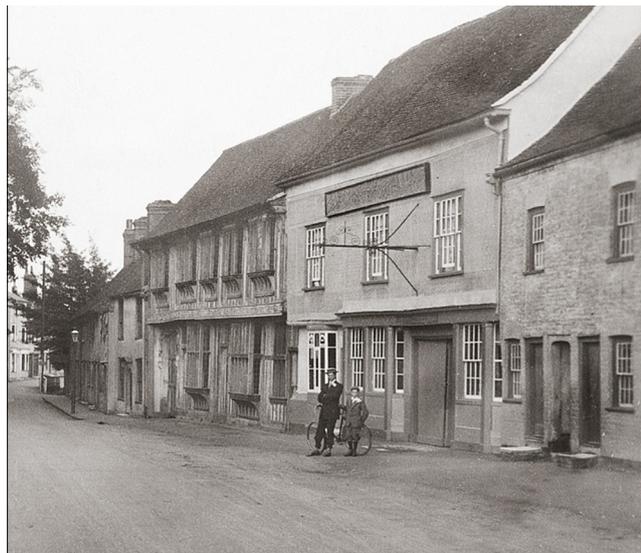
Photograph 2 North-west elevation of pub. Taken around 1908. Pargetting unchanged from earlier photograph. Lack of pub sign or branding at top of elevation suggests the pub was closed when this photograph was taken. Photograph taken facing east. Reproduced from www.coggeshallhistory.com.

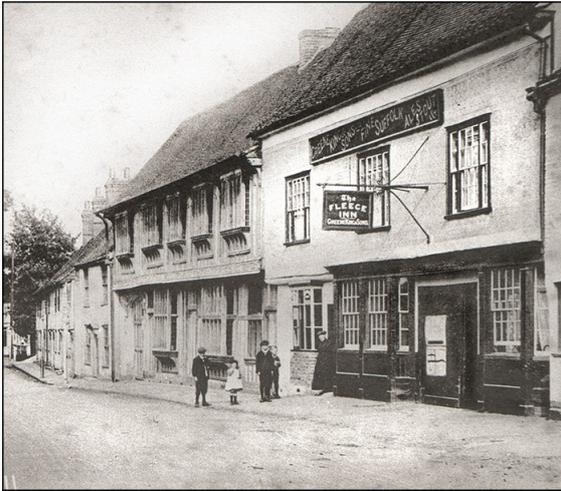
Photograph 3 North-west elevation of pub. Taken around 1910. Pargetting unclear, but appears unchanged from earlier photographs. Pub sign and branding now shows the pub is owned by Greene King. Photograph taken facing east. Reproduced from www.coggeshallhistory.com.

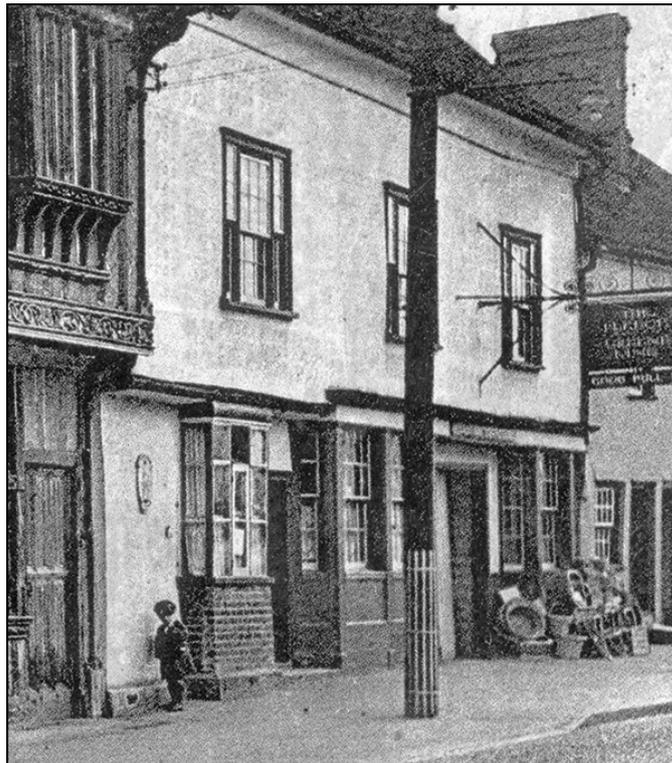
Photograph 5 North-west elevation of pub. Taken around 1935. Pargetting unclear, but appears unchanged from earlier photographs. Pub sign is new, and branding at top of elevation has been removed. Greene King Plaque has been added to east of window. Photograph taken facing west. Reproduced from www.coggeshallhistory.com.
