**Historic building recording
of Maldon Wycke Barn,
Spital Road, Maldon,
Essex, CM9 6SQ**

April 2021

CAT Report 1675
May 2021

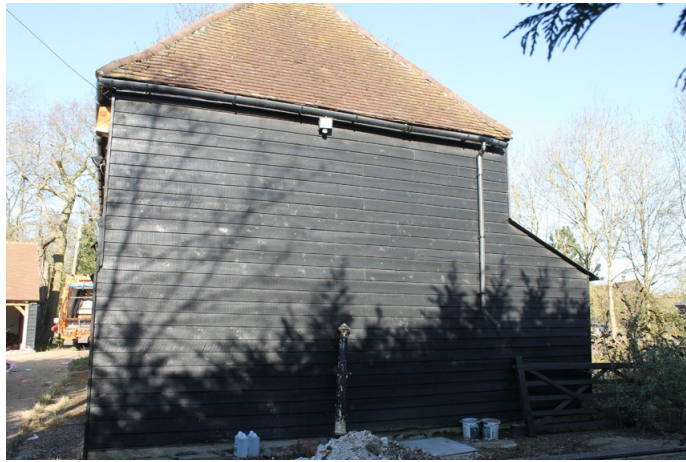
The eastern elevation of the building is featureless (Photograph 3).

Photograph 3 Eastern elevation of building. Photograph taken facing west.

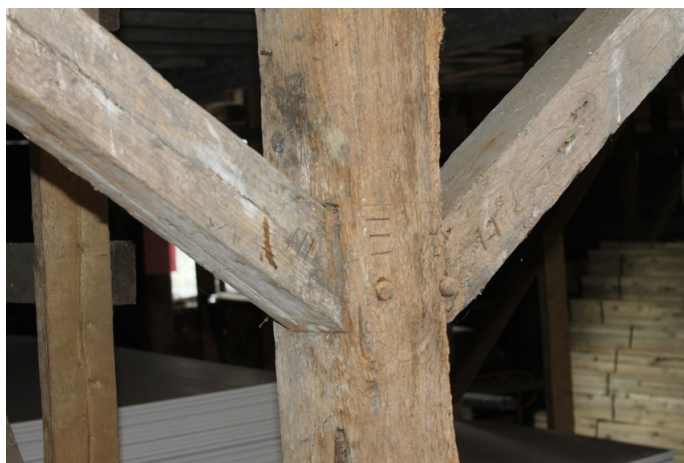
Photograph 27 Detail of northern principal-post between bays 4 and 5, showing carpenter's marks 'II' and 'III'. Photograph taken facing south-west.

The principal-post between bays 4 and 5, on the northern elevation, has two more carpenter's marks on its northern face (Photograph 27). To the west is a 'II' and to the east is a 'III', both of which are mirrored by identical marks on their corresponding braces. On the southern face of this post is another empty mortice, which, like the one on the post between bays 3 and 4, would probably have been in use before the building's extension (Photograph 28).

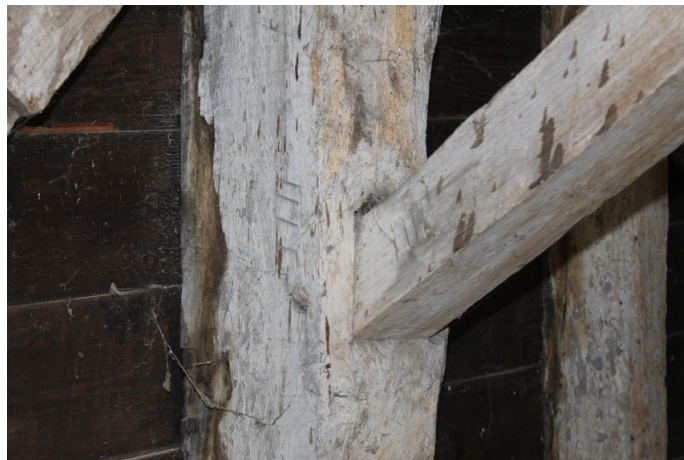
Bay 5 also contains a higher percentage of hand-sawn timber than the western bays. Aside from the inserted garage door on the southern elevation and some replacement studs on the first-floor, the bay is entirely constructed of hand-sawn timber. On the north side of the north-east corner post is the carpenter's mark 'IIII', which is replicated on the brace supporting the northern girding-beam (Photograph 29).

Photograph 29 Detail of north-east corner-post of building, showing carpenter's mark 'IIII' on post and brace. Photograph taken facing south-east.

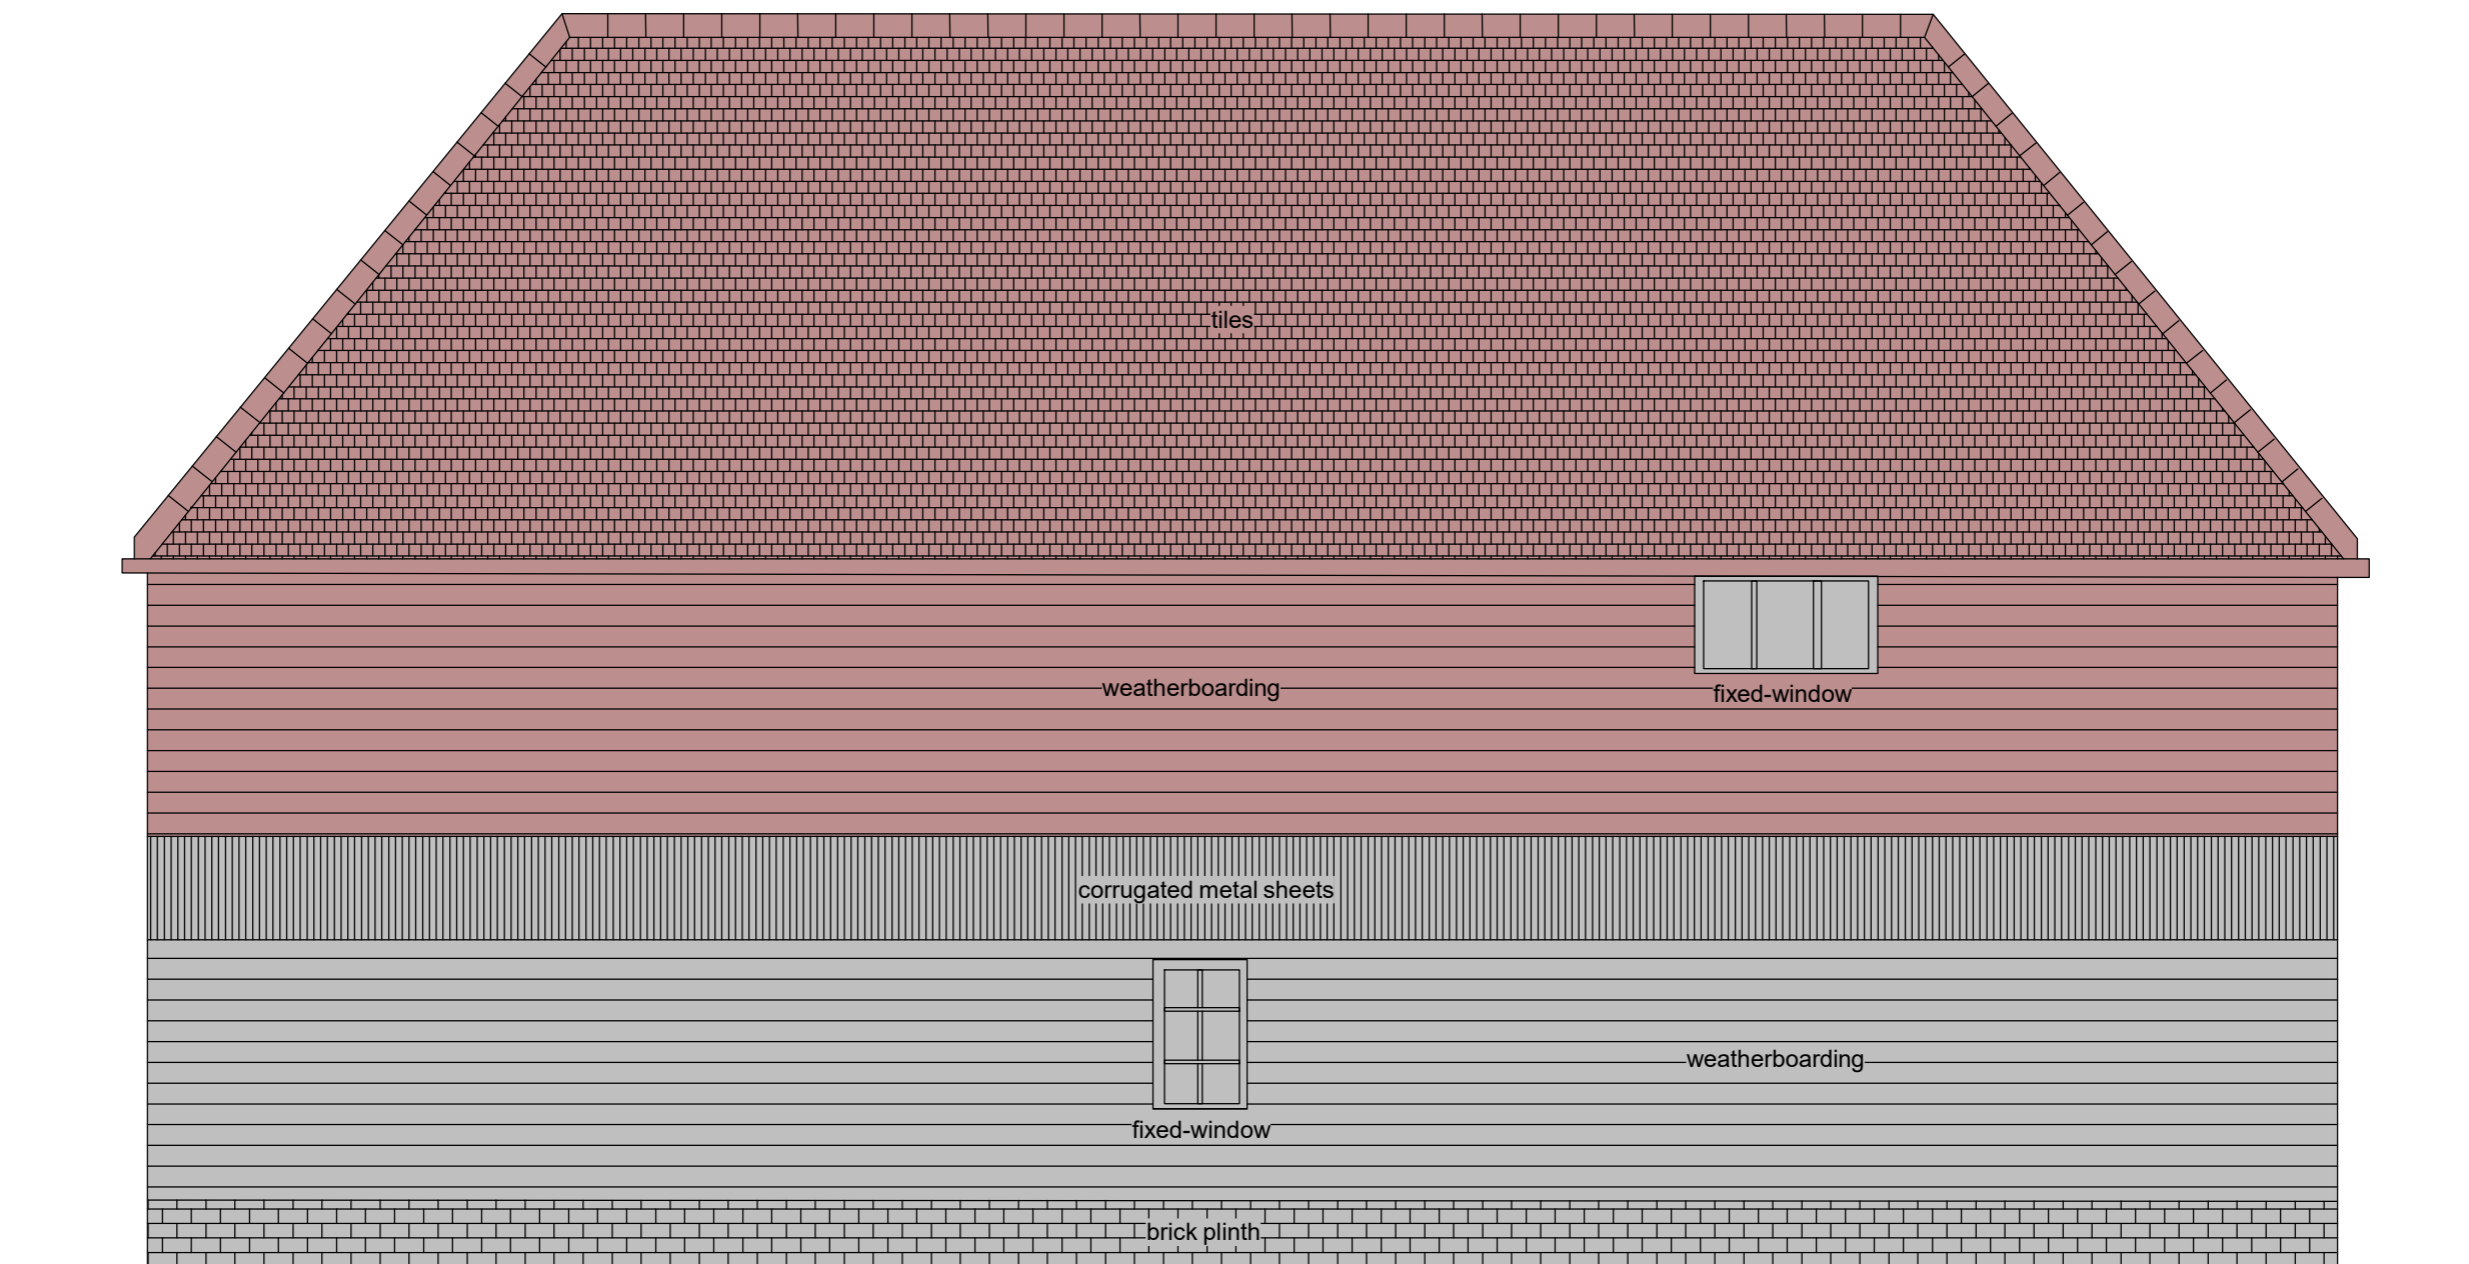
Fig 5 Northern elevation of building, with phasing (phasing shows dates of the structural elements, not the weatherboarding).

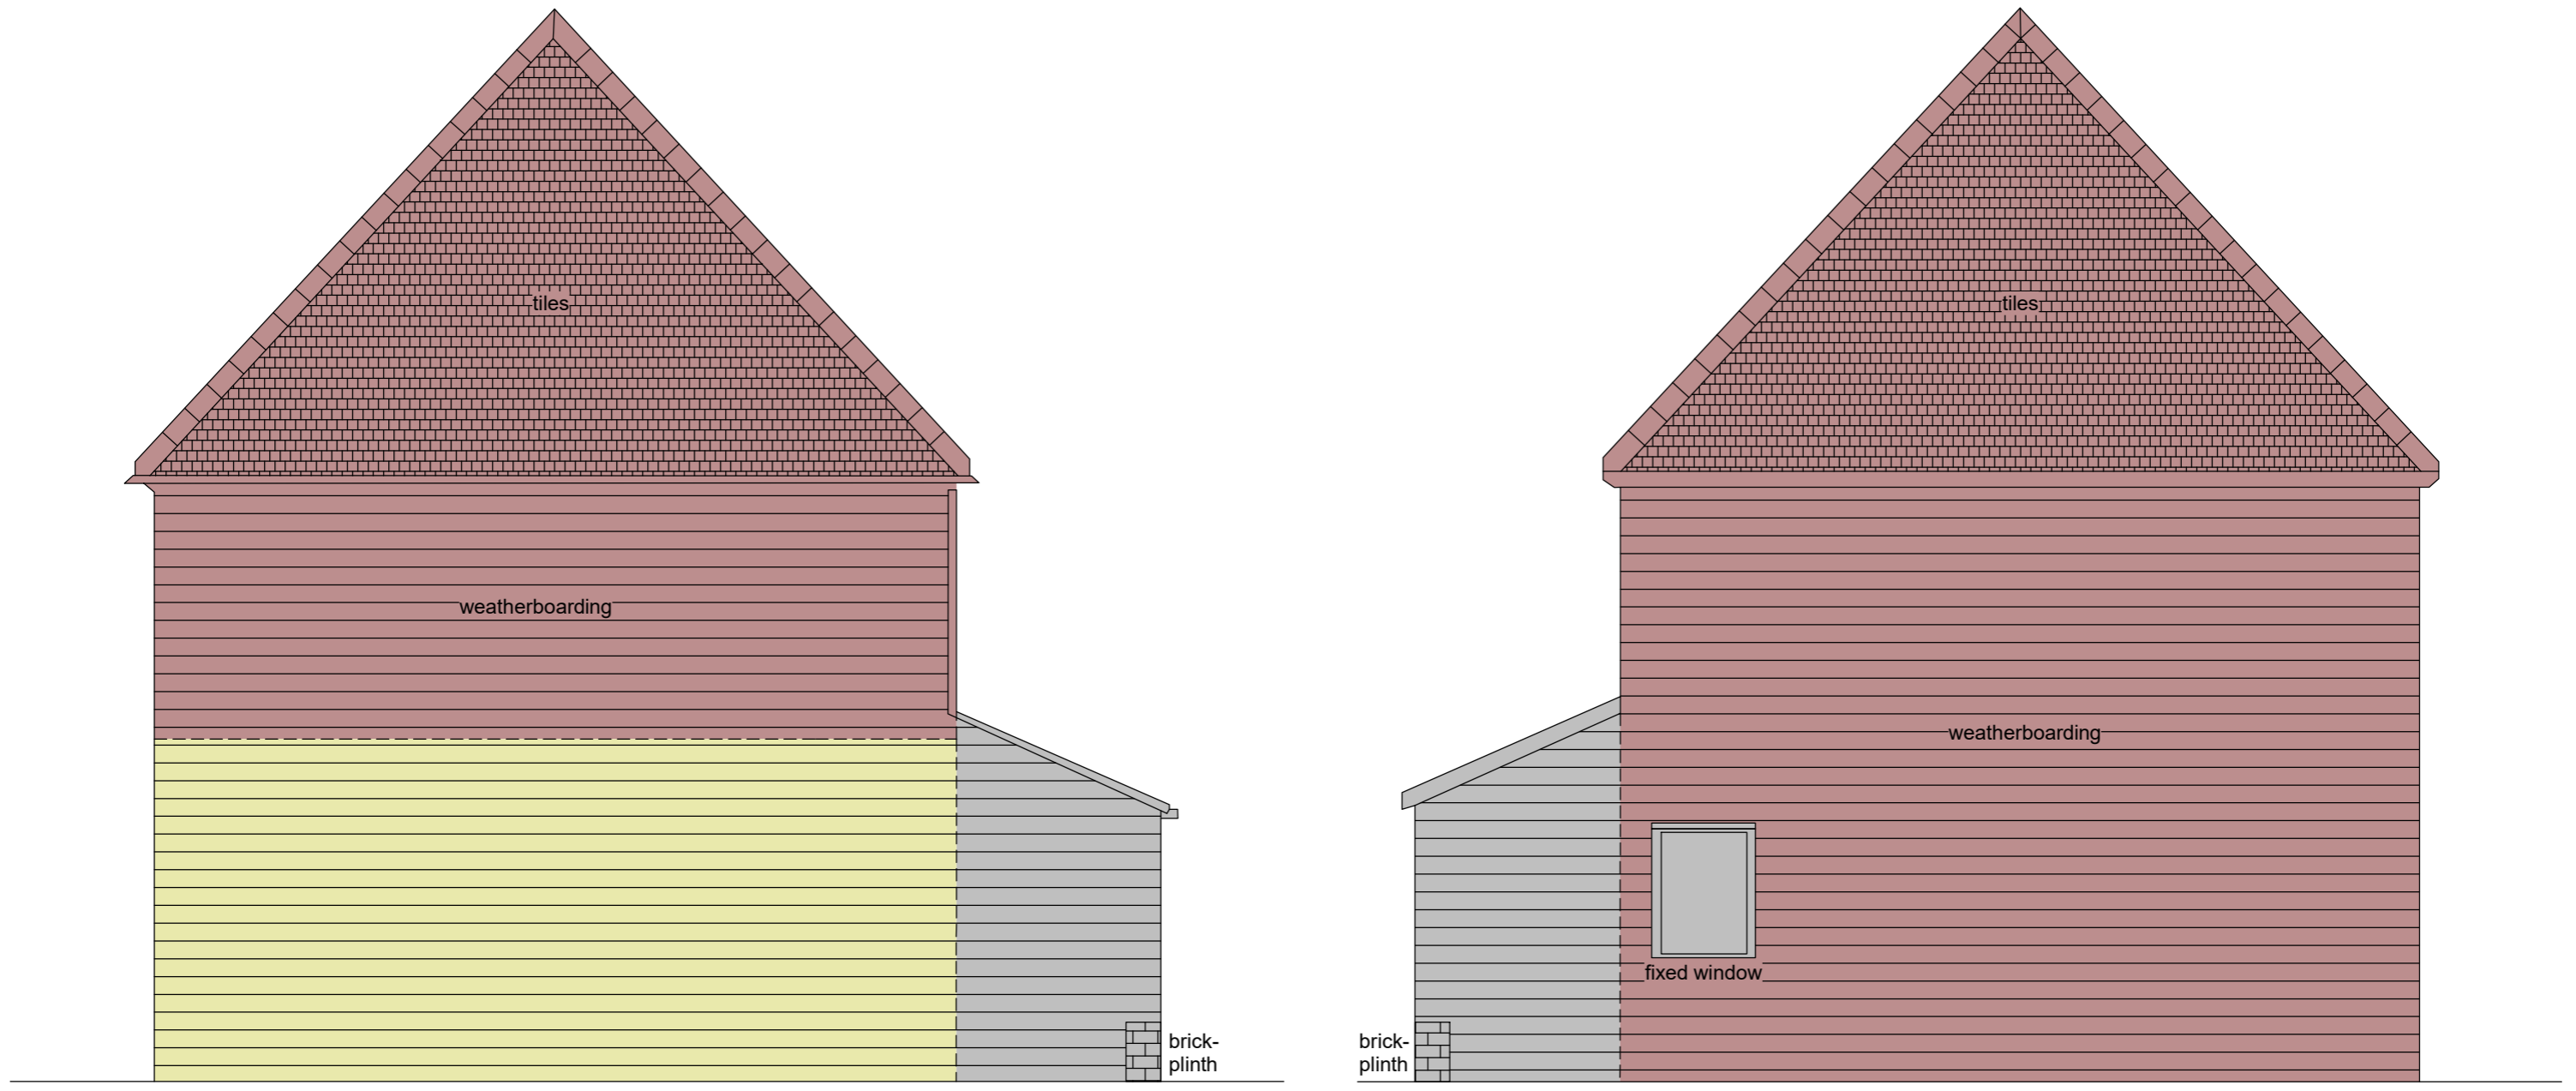
Fig 6 Eastern and western elevations of building, with phasing (phasing shows dates of the structural elements, not the weatherboarding).
