Historic building recording of a barn north of Cooper's Farm House, Whatfield Road, Nedging- with-Naughton, IP7 7BS

November 2021

CAT Report 1744
May 2022

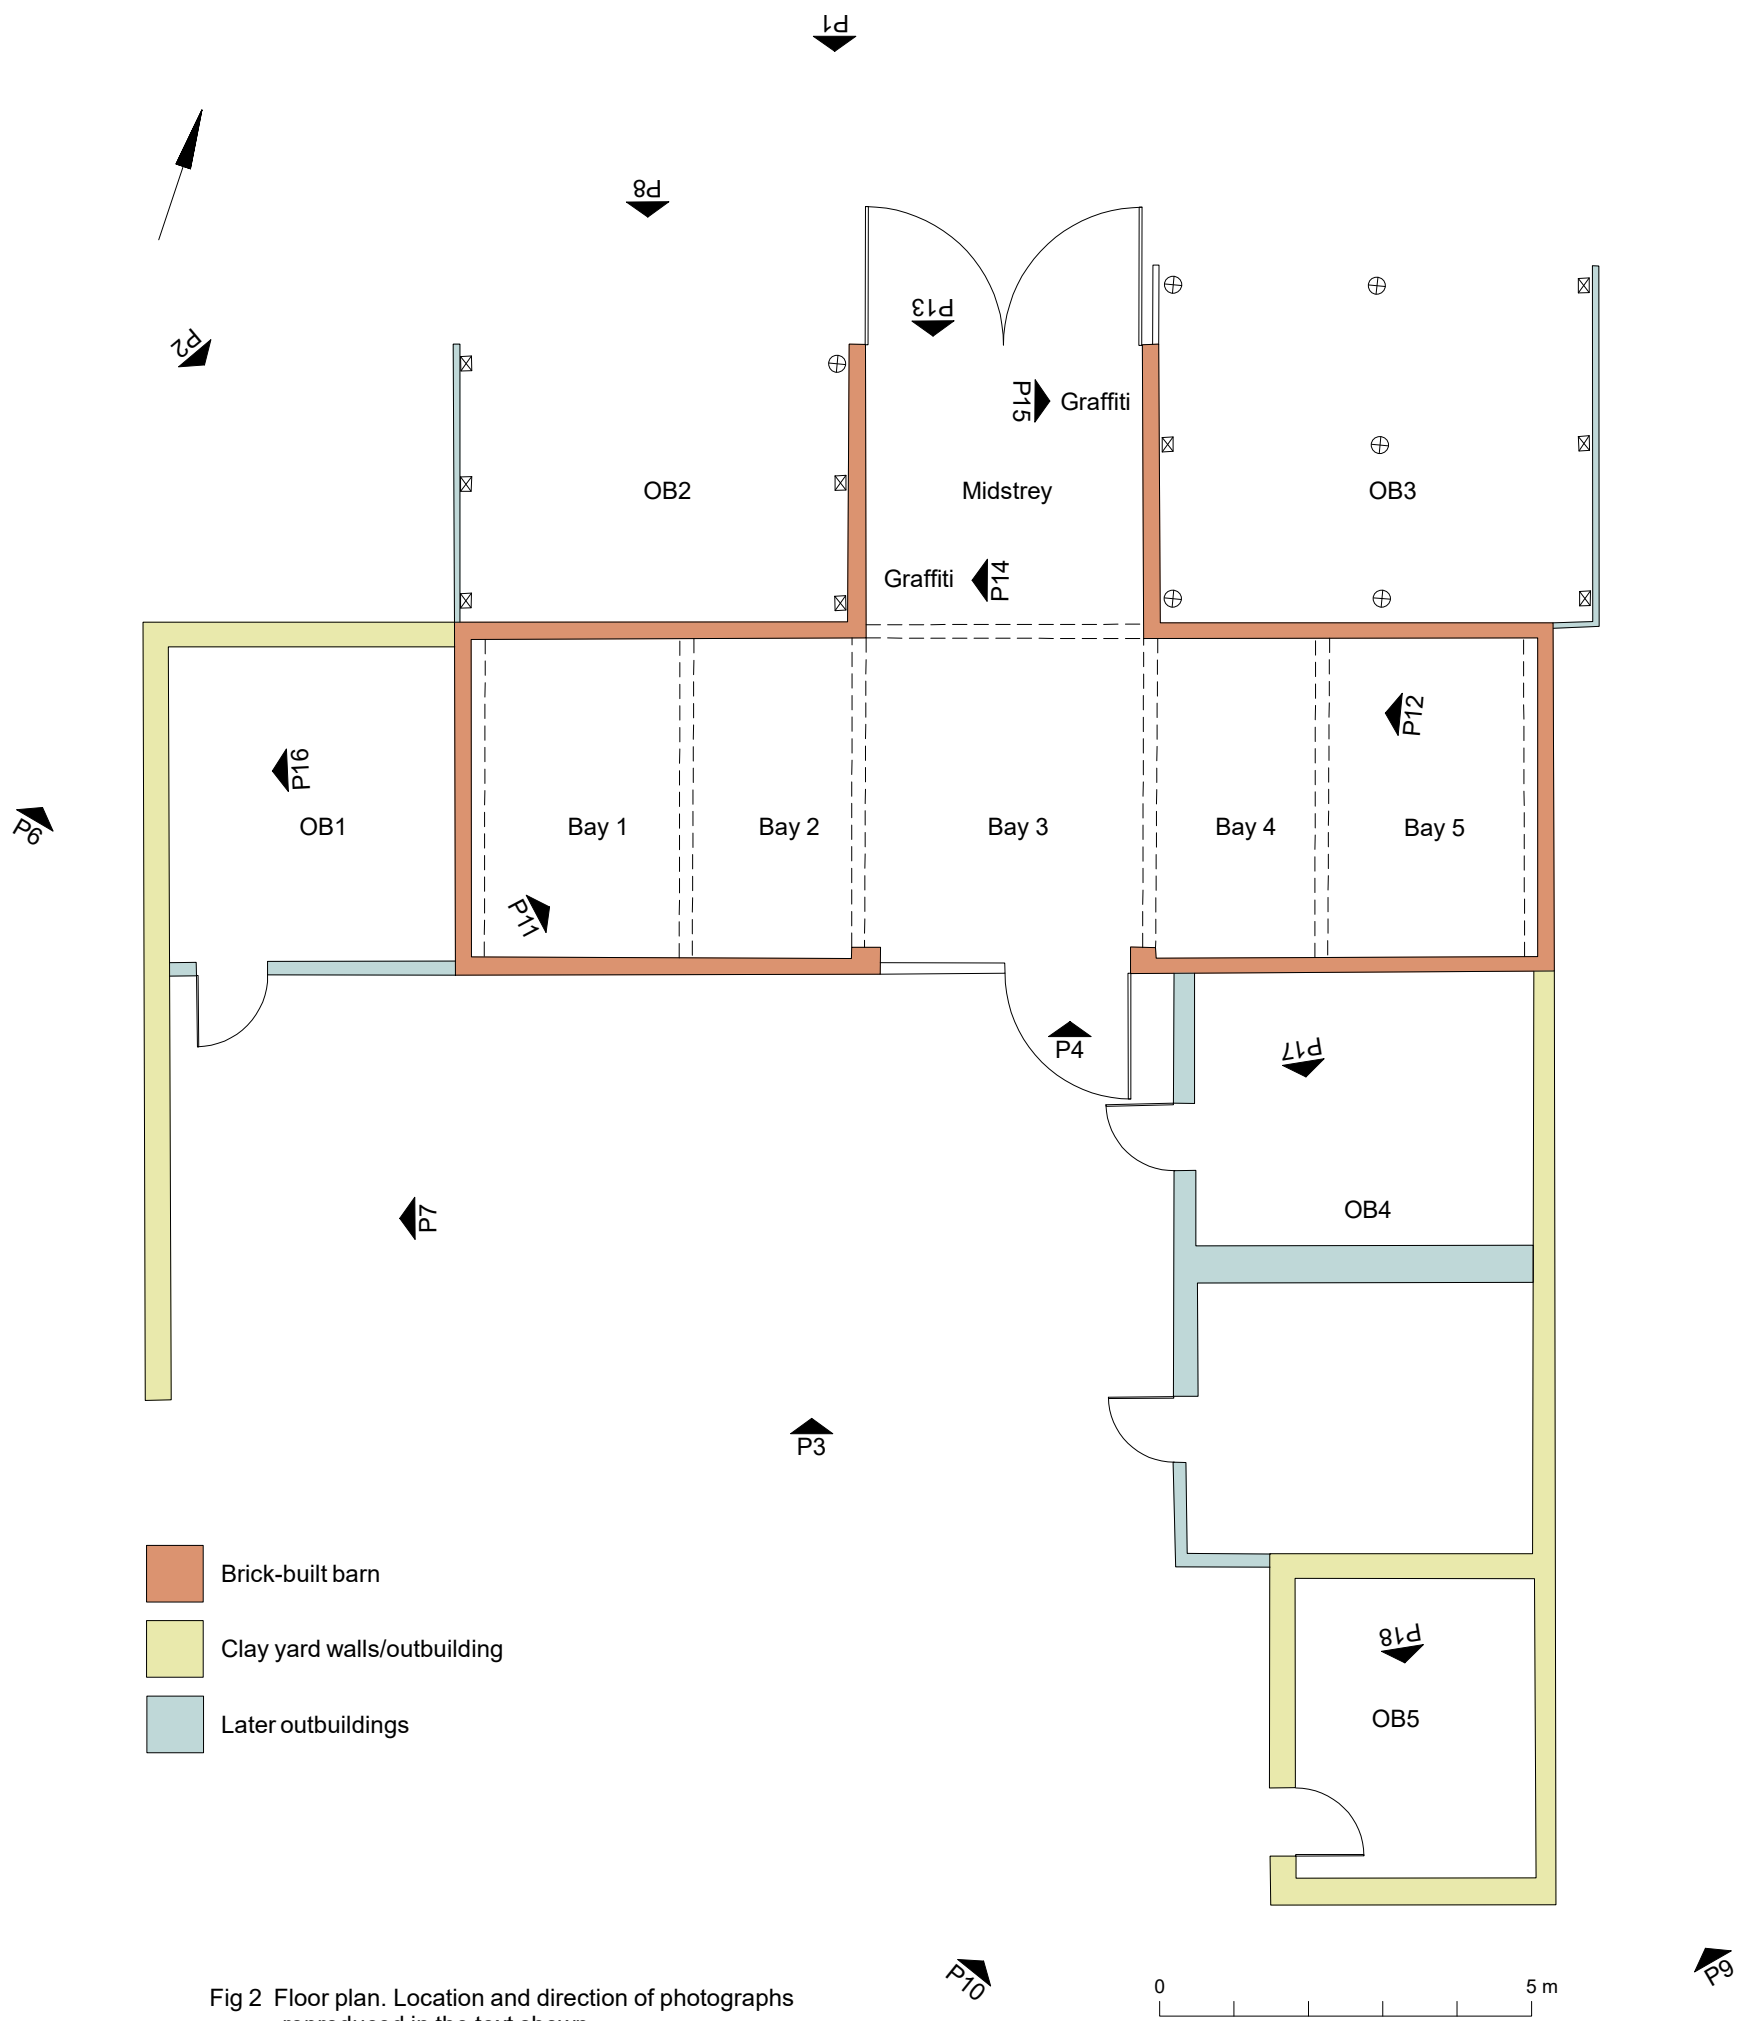
Fig 2 Floor plan. Location and direction of photographs reproduced in the text shown.

The buildings surveyed included a threshing barn and five outbuildings, labelled OB1-5 on Fig 2.

The threshing barn is aligned north-east/south-west with a midstrey projecting from the north-west elevation. The barn measures 14.54m by 8.34m and covers an area of approximately 82.72 m². (Fig 2).

The building consists of five bays which have been labelled 1-5, from south-west to north-east (Fig 2).

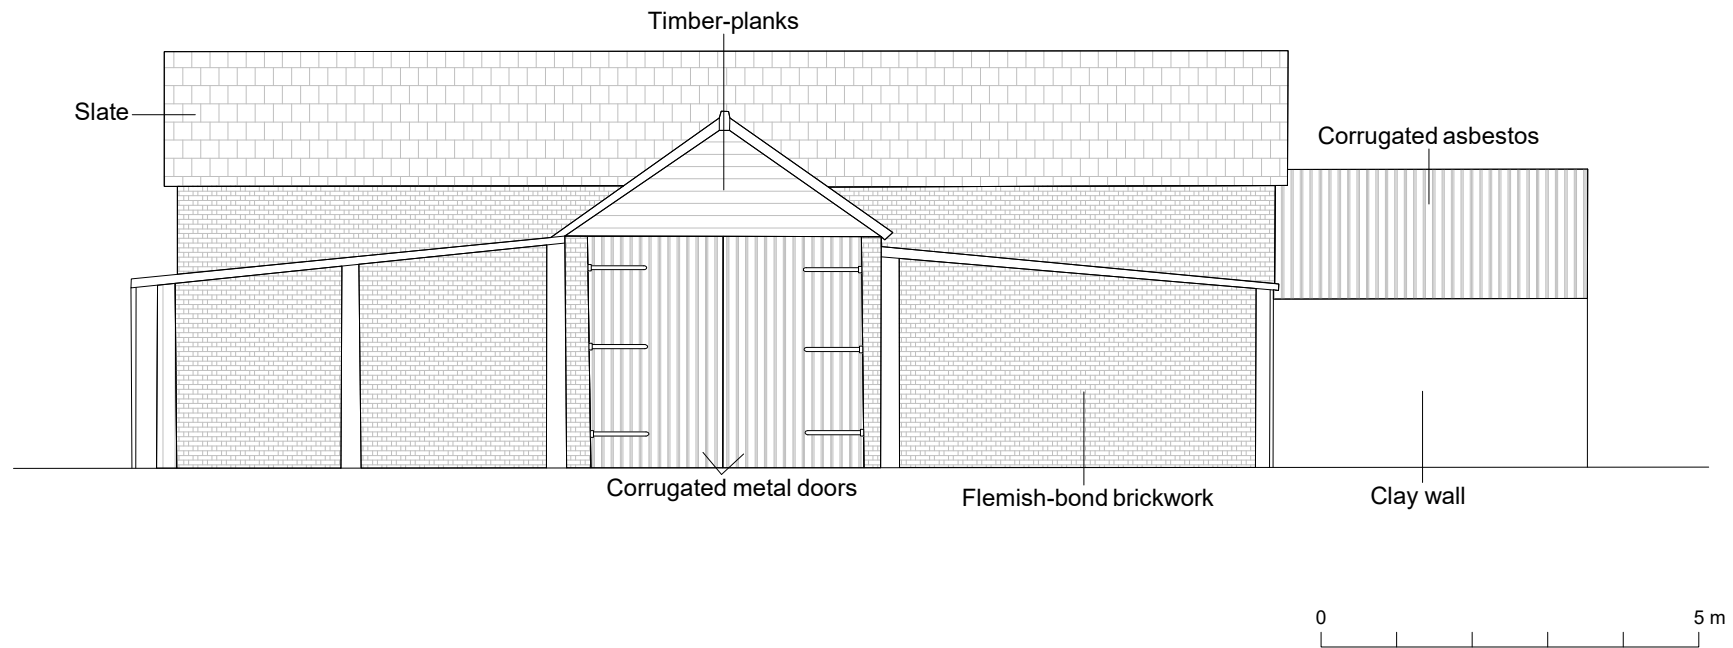
Fig 3 North-west elevation.

The north-west elevation of the barn contains the centrally-located midstrey. The north-west elevation of the midstrey is dominated by a full-height double doorway. The original cart doors have been replaced with a modern replacement constructed from timber and corrugated metal. Above these the gable-end is clad in timber boarding.
