CAT Report 1898 issued February 2023

Historic building recording at Boxted Methodist Chapel, Chapel Road, Boxted, CO4 5RP

January 2023

CAT project ref.: 2022/11i CAT Report 1898

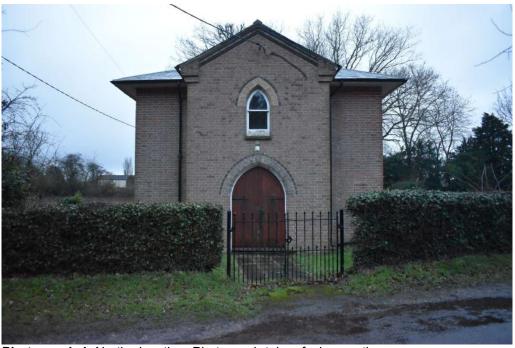
**Photograph 1** North elevation. Photograph taken facing south.

areas of carved graffiti are present on the main chapel (see Fig 4), along with a chiselled OS benchmark symbol.

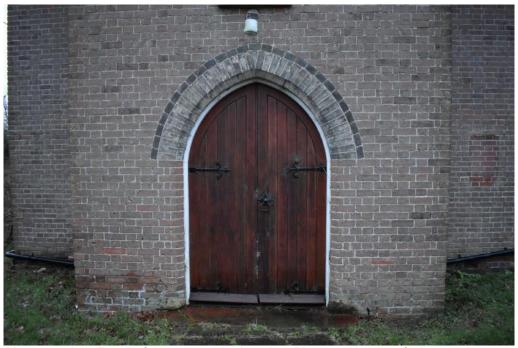
**Photograph 2** Detail of door on north elevation. Photograph taken facing south.

On the northern elevation, the porch has a pointed-arched double door with a stone doorstep. On the first floor is a pointed-arched two-light sash window. Both have a point-arched lintel constructed from yellow and dark red bricks. There is a single course of ornamental moulded brickwork along the edge of the gable-end. Several

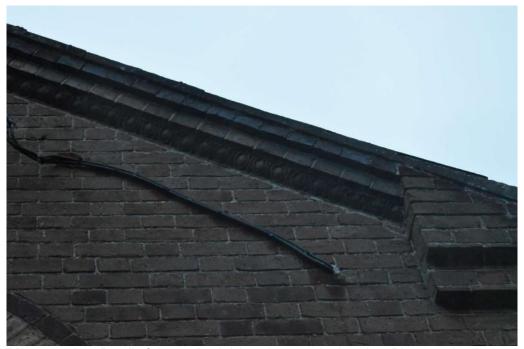
**Photograph 3** Detail of decorative brickwork on north elevation. Photograph taken facing south.

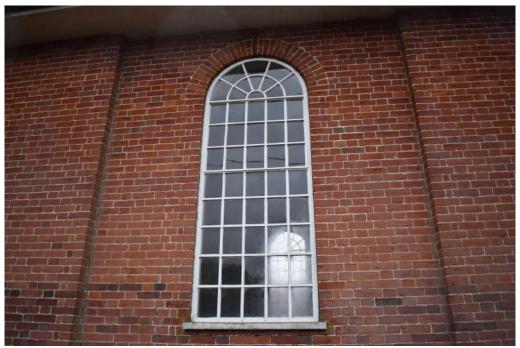
On the eastern elevation, the chapel has two large 51-light round-headed windows, both with an arched brick lintel. These windows are set into an area of recessed brickwork. There is a single two-light fixed pointed-arch window located at ground-floor level on the porch that has a yellow and dark-red brick lintel. The lean-to is partially rendered with concrete.

Photograph 5 Detail of window on east elevation. Photograph taken facing west.

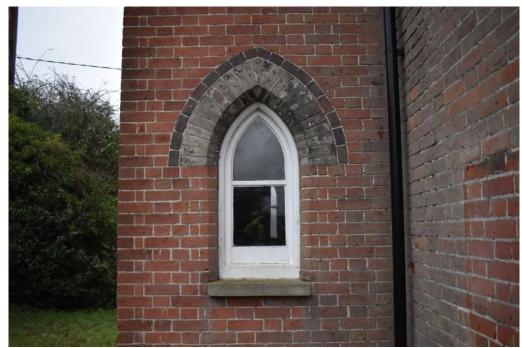
The western elevation has five windows in total. The chapel and porch mirror the eastern elevation with two round-headed windows and a single point-arched window. The vestry has two rectangular windows – both replacement PVC – with a stone lintel. The vestry's parapet has three courses of protruding decorative brickwork and is topped with coping stones. It also has square pilasters on the north and south corner. The letters TD have been gratified on the western elevation of the chapel.

Photograph 8 Detail of window on west elevation. Photograph taken facing east.

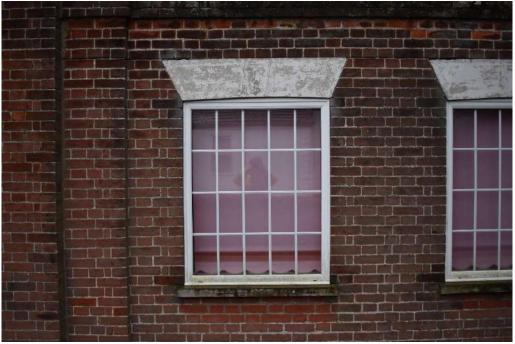
**Photograph 9** Detail of PVC window on west elevation. Photograph taken facing east.

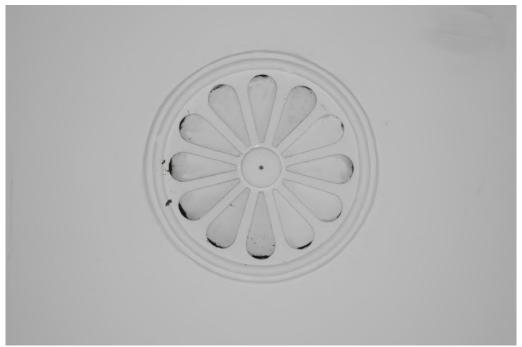
There are round-headed windows on the east, south and west walls. The eastern and western windows are 51-light and have a middle awning opening while the southern windows are 36-light and are fixed. In the ceiling are two lightly decorative round vents and a timber loft-hatch.

Photograph 11 Detail of ceiling vent, main room.

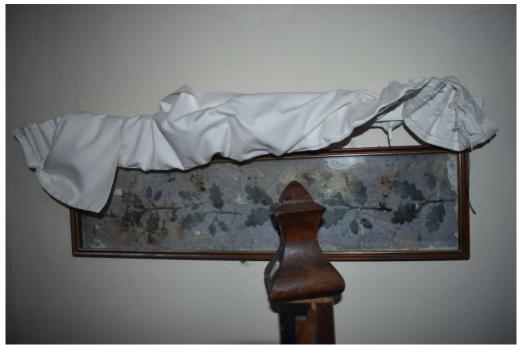
A small panel on the southern wall shows a piece of the original interior wall decoration, apparently discovered during work carried out in the 1980's. The painting is of oak leaves and acorns.

Photograph 13 Detail of preserved painting in main hall. Photograph taken facing

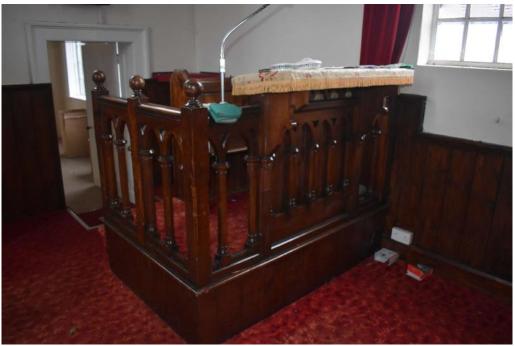
In the south-west corner of the chancel is a rectangular pulpit. It is constructed from timber with a carpeted base. A timber lectern, covered with a tapestry-style fabric, is present at the front of the pulpit. Against the southern wall is a free-standing timber organ. Neither appear to be original to the chapel.

Photograph 14 Detail of pulpit in main hall. Photograph taken facing south-west.

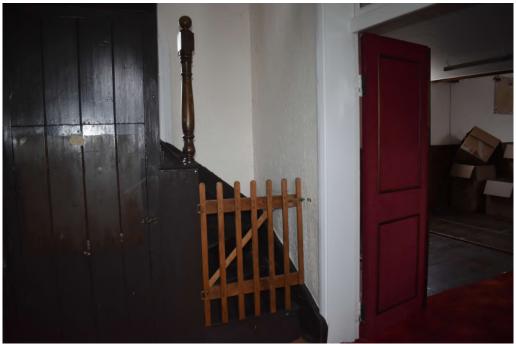
There are two sets of double doors in the entrance hall – one on the northern wall and one on southern. The northern doors are wooden and in a pointed-arch shape. The southern doors are covered in red felt and have a decorative brass handle. There is a fixed two-light pointed-arch window in the east and west walls. A Bakelite light-switch is present on the southern wall.

Photograph 16 Internal view of entrance hall. Photograph taken facing south-east.

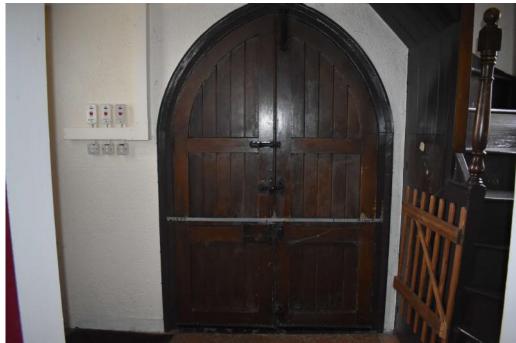
**Photograph 17** Detail of door in north wall of entrance hall. Photograph taken facing north.

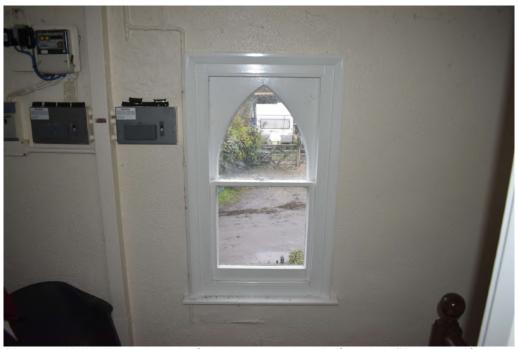
The landing is located on the first floor of the northern extension. The floor is covered in carpet and the walls are plastered and painted white. The stairs are located in the west of the landing and have a timber balustrade. There is a two-light sash pointed-arch window in the northern wall. On the southern wall there is a single timber door with three steps up into the gallery.

Photograph 18 Internal detail of window on north wall of landing. Photograph facing north.

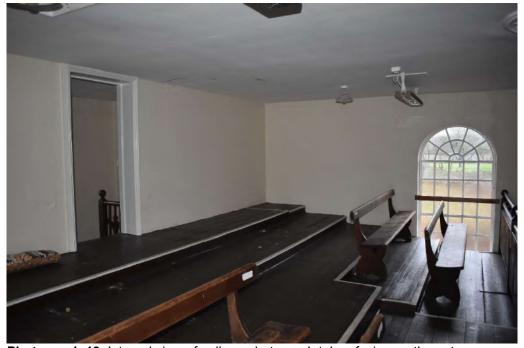
Photograph 19 Internal view of gallery. photograph taken facing north-east.
