**CAT Report 2034
issued April 2024**

**Historic building recording of a barn and store
on land at Glebe House, Rectory Road, Stisted,
Essex, CM77 9AL**

**CAT project ref.: 2024/02m
ECC code: SSGH24**

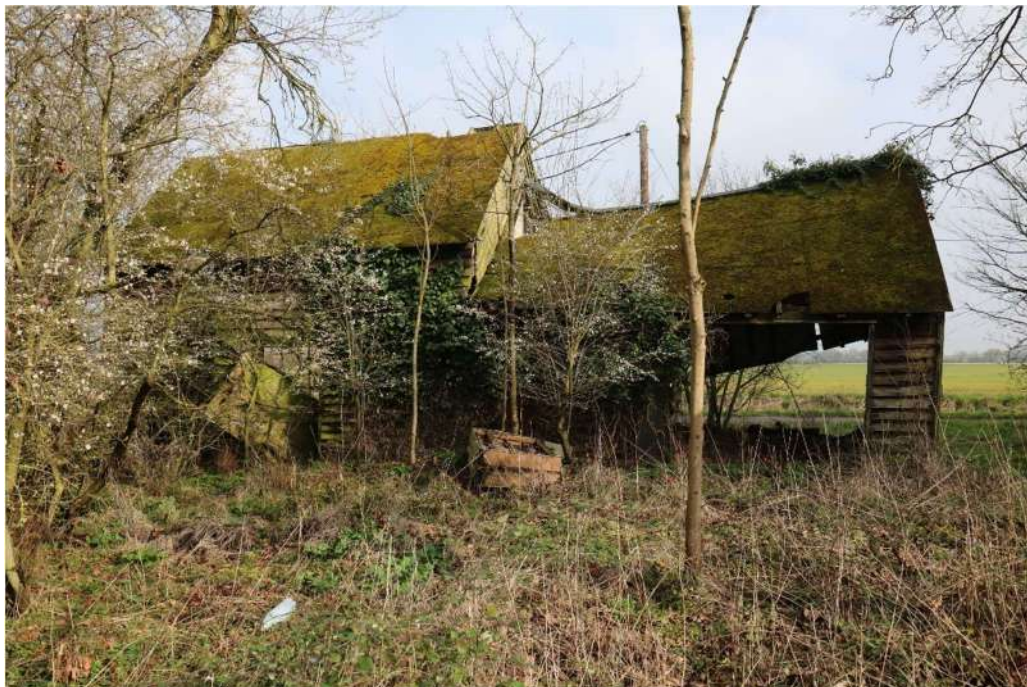
This report details a small rectangular timber-framed barn and adjacent store. The building is on a north-west/south-east alignment and measures 13.41m by 4.75m, covering an area of 63.65m². The building was in a particularly dilapidated state and the surrounding area overgrown with vegetation, limiting the level of recording possible (Photograph 1).

Photograph 1 South-west elevation. Photograph taken facing north north-east.

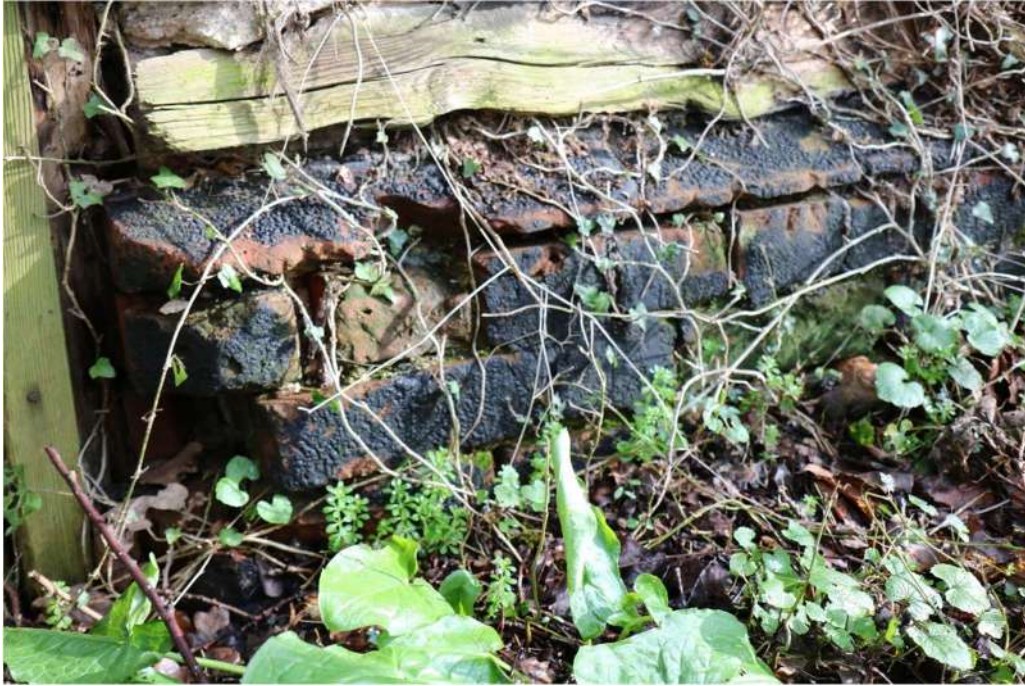
The roofs of the barn and the store are gabled at both ends and clad in asbestos roofing sheets while the exterior of the building is clad with timber weatherboards. The timber-framing is supported on a plinth comprising red bricks (brick dimensions: 225 x 110 x 65mm) laid in English bond, topped with a course of chamfered bricks. Due to differences in the ground level, the plinth on the north-east elevation is more substantial than that of the south-west elevation (Photographs 2 and 3).

Photograph 2 Detail of brick plinth on south-west elevation. Photograph taken facing east.

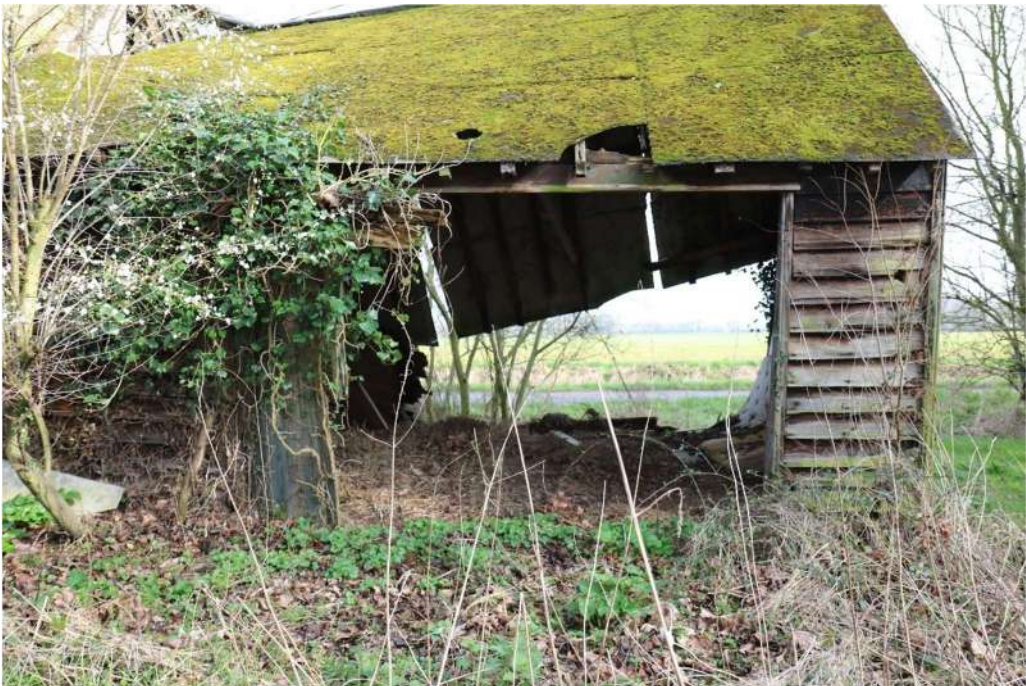
The south-west elevation (Photograph 1) of the barn has a slightly off-centre doorway flanked by two blocked windows (Photograph 4). Above the doorway, a break in the weatherboarding indicates the doorway was originally the full height of the elevation. A replacement door is present but is hanging off the hinges. On this elevation, the store has one blocked window and a double doorway, within which are the partial remains of a single door (Photograph 5).

Photograph 5 Detail of double doors on south-west elevation. Photograph taken facing north-east.

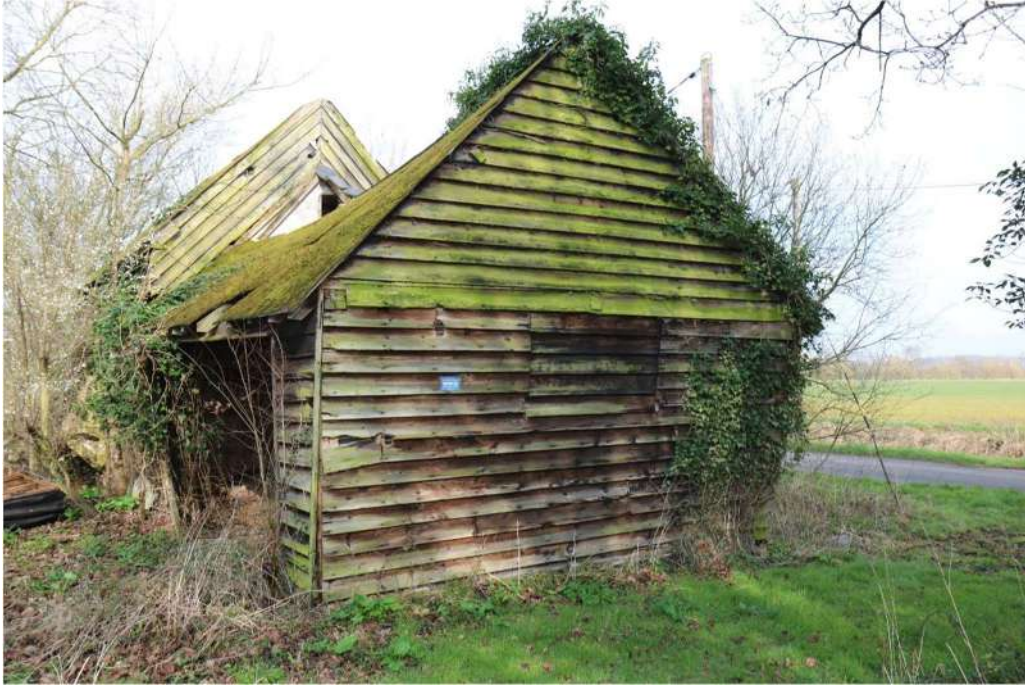
Photograph 6 South-east elevation. Photograph taken facing north.

In the centre of the store's south-east elevation is a blocked window (Photograph 6). The rest of the elevation remains featureless. The gable of the barn is clad with diagonal weatherboard on this elevation.

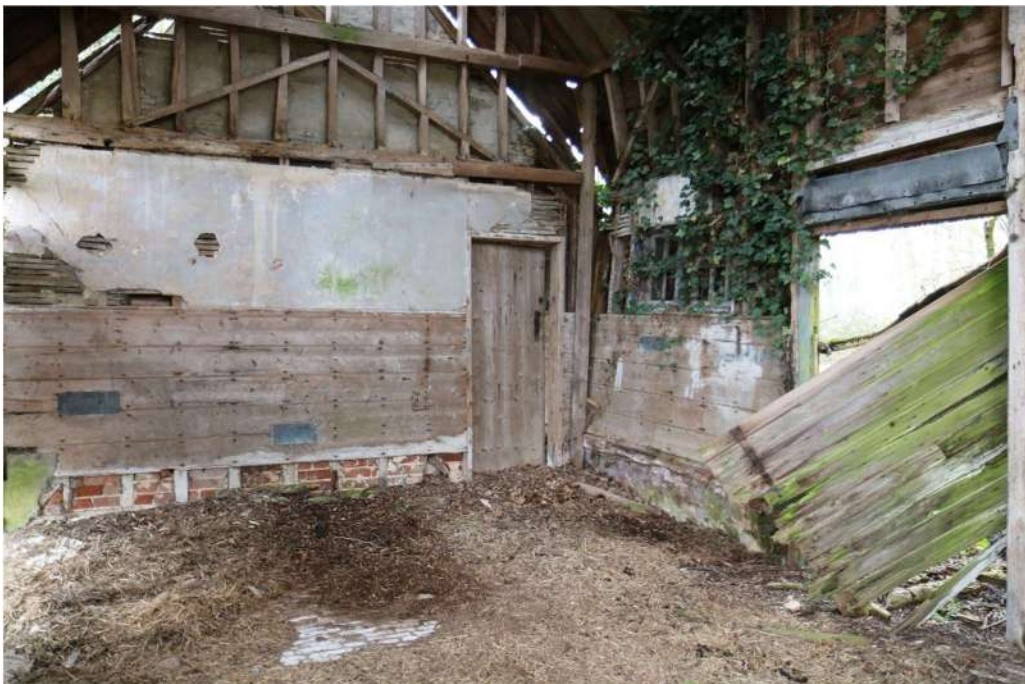
Photograph 9 Interior of barn. Photograph taken facing south.

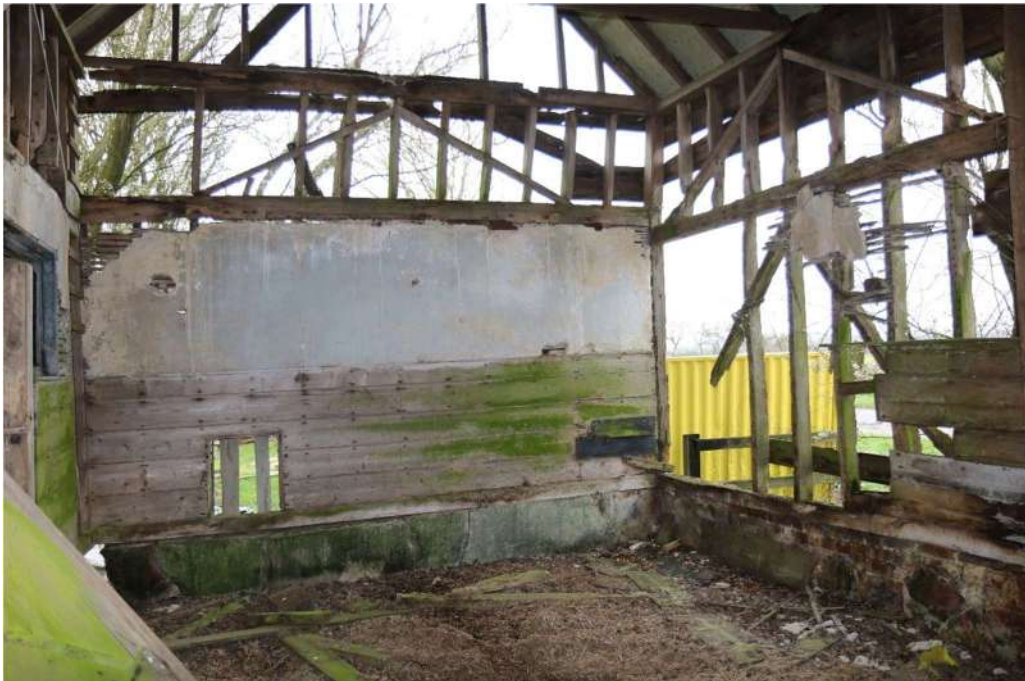
The frame of the barn (Photograph 11) has a high girding-beam, which is interrupted by the intermediate and corner posts. Diagonal through-bracing is present in both the upper and lower registers of the barn. The frame of the barn is constructed mostly from hand-sawn timbers. The walls of the barn have been clad with horizontal timber-planks on the lower half and laths and horse-hair plaster on the top half.

Photograph 11 Interior of barn. Photograph taken facing north.

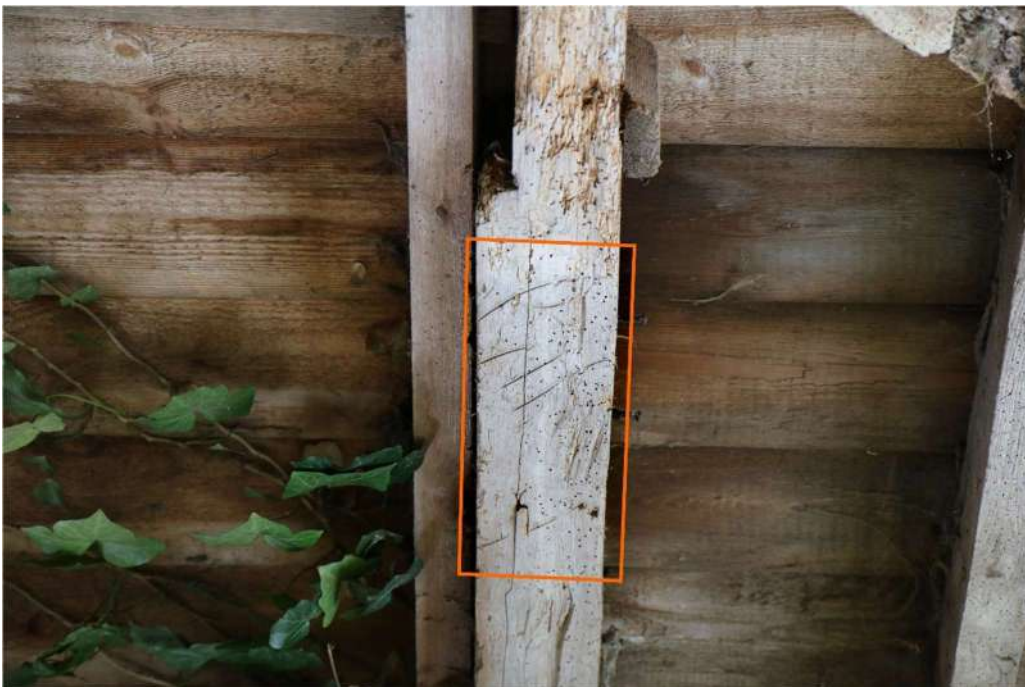
There is a door slightly off-centre in the south-western wall, straddling both bays (Photograph 14). A Baltic timber mark is present near the top of north-eastern door post (Photograph 15). Above the Baltic timber mark is an iron pintle (Photograph 16), further evidence the doorway was originally the full height of the barn. A second door is present in the south-eastern wall of bay 1, whilst the opening is original to the barn the door is a replacement. Where the wall-cladding has come away at the base of the south-east wall, brick infill between the studs has been exposed.

Photograph 15 Detail of Baltic timber mark on door post in south-west wall of barn. Photograph taken facing south-west.

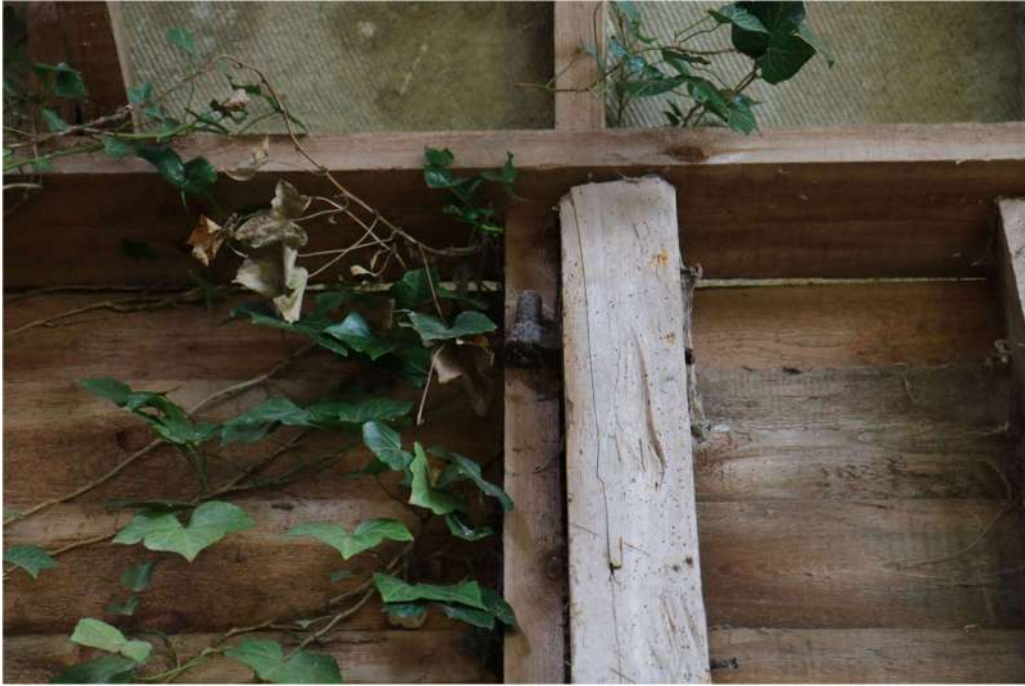
Photograph 16 Detail of pintle on post in south-west wall of barn. Photograph taken facing south-west.

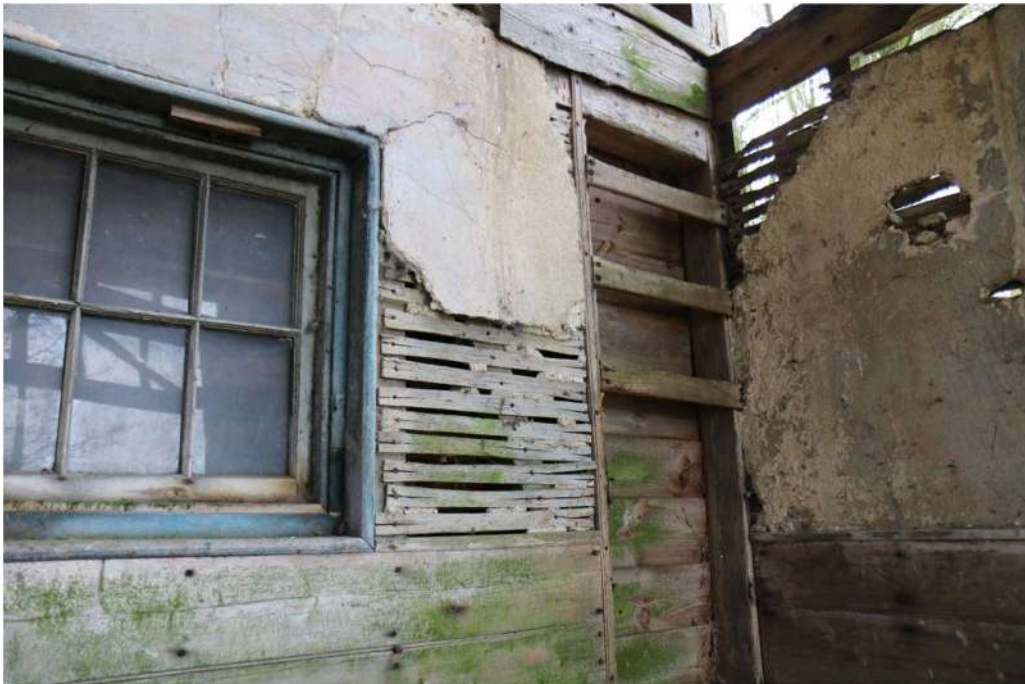
In the west corner of bay 2, several small lengths of timber have been nailed between the last stud and the corner post, seemingly forming a crude ladder (Photograph 17). The insertion of this ladder suggests that a high loft level may have been present in the barn at some point.

Photograph 17 Detail of exposed laths and ladder in the western corner of barn. Photograph taken facing west.

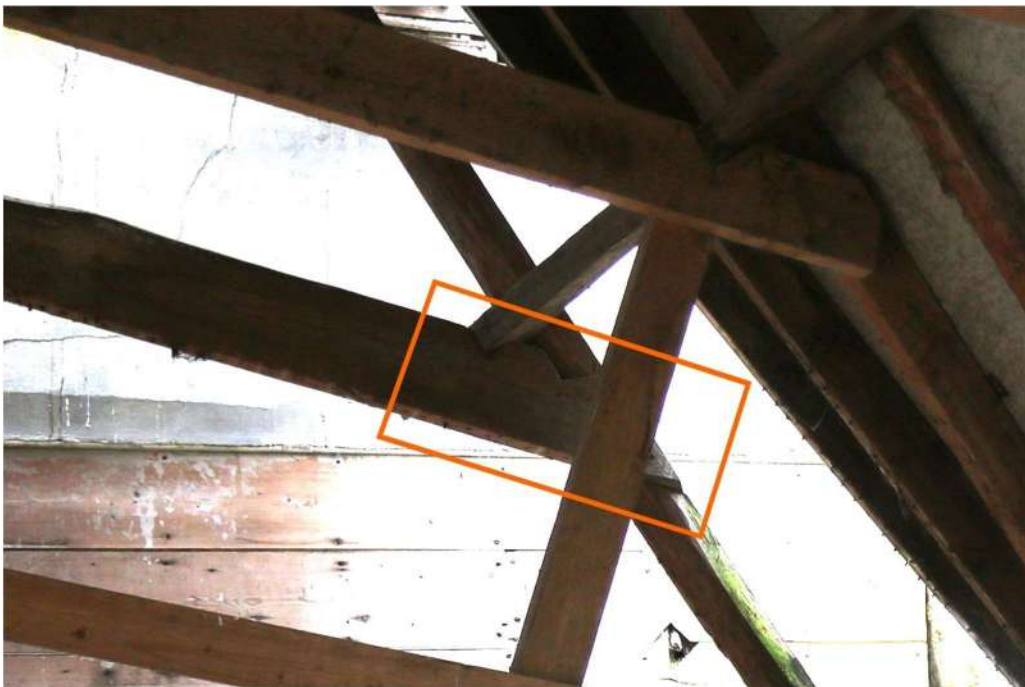
have lap-dovetailed joints at either end (Photograph 19), evidence they are reused as this is a carpentry technique identified in timber-framed buildings of the mid-17th century and later. A Baltic timber mark is present on the north-eastern purlin (Photograph 20), evidence it has been reused. Two tie-beams are present, both of which have two inclined struts projecting from them. A series of nails along some of the collars and rafters with the remains of laths at the south-eastern end of the building suggests that a lath and plaster ceiling used to be present in the store (Photograph 21). The floor of the building was completely obscured by a thick covering of hay.

Photograph 19 Detail of lap-dovetail joint on collar in store. Photograph taken facing north.

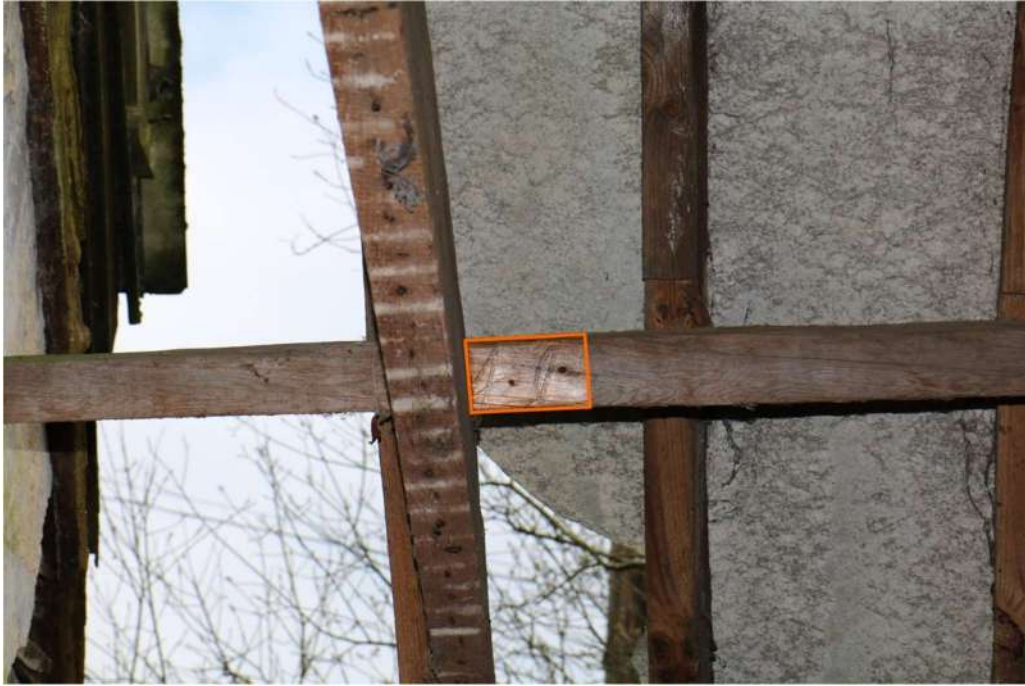
Photograph 20 Detail of Baltic timber mark on north-east purlin in roof of store. Photograph taken facing north-east.

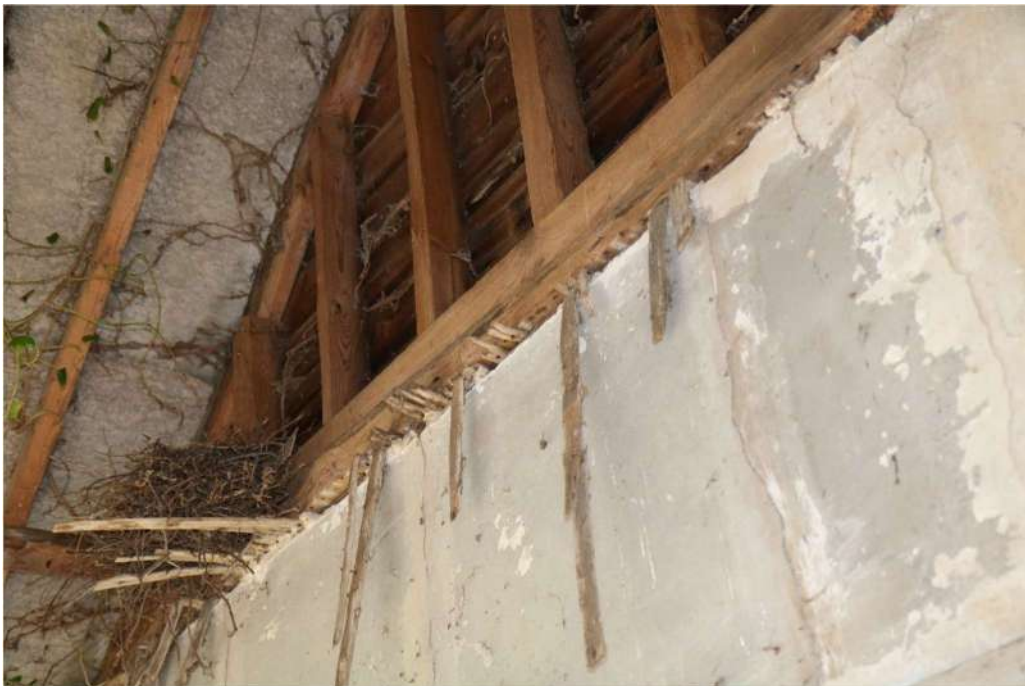
Photograph 21 Detail of remains of ceiling laths in store. Photograph taken facing east.

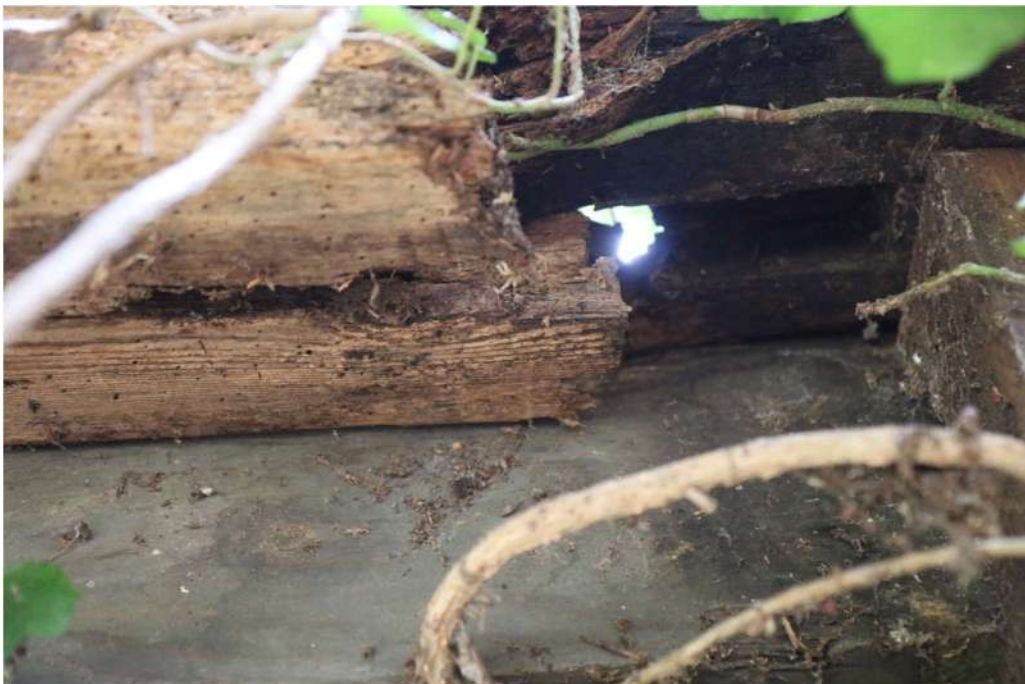
western wall-plate, but the deterioration in the timber makes it difficult to ascertain what type (Photograph 23).

Photograph 23 Detail of possible scarf-joint in south-west wall-plate. Photograph taken facing south-west.

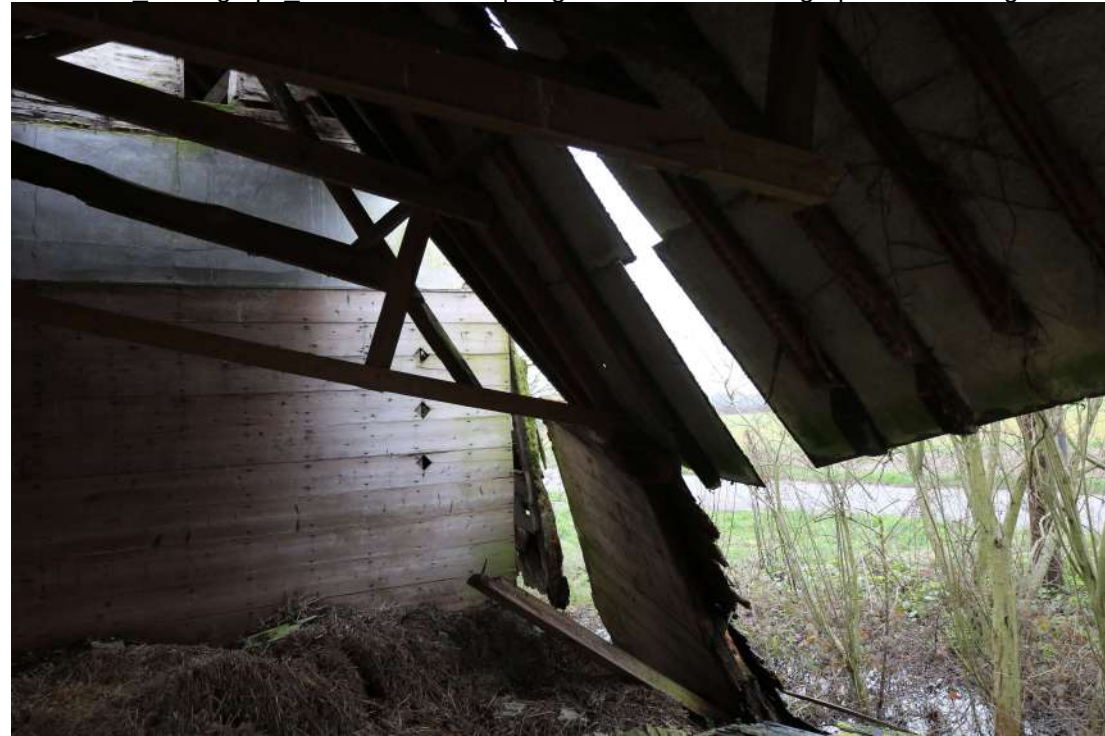
SSGH24 Photograph 038Detail of collapsing roof of store. Photograph taken facing north.

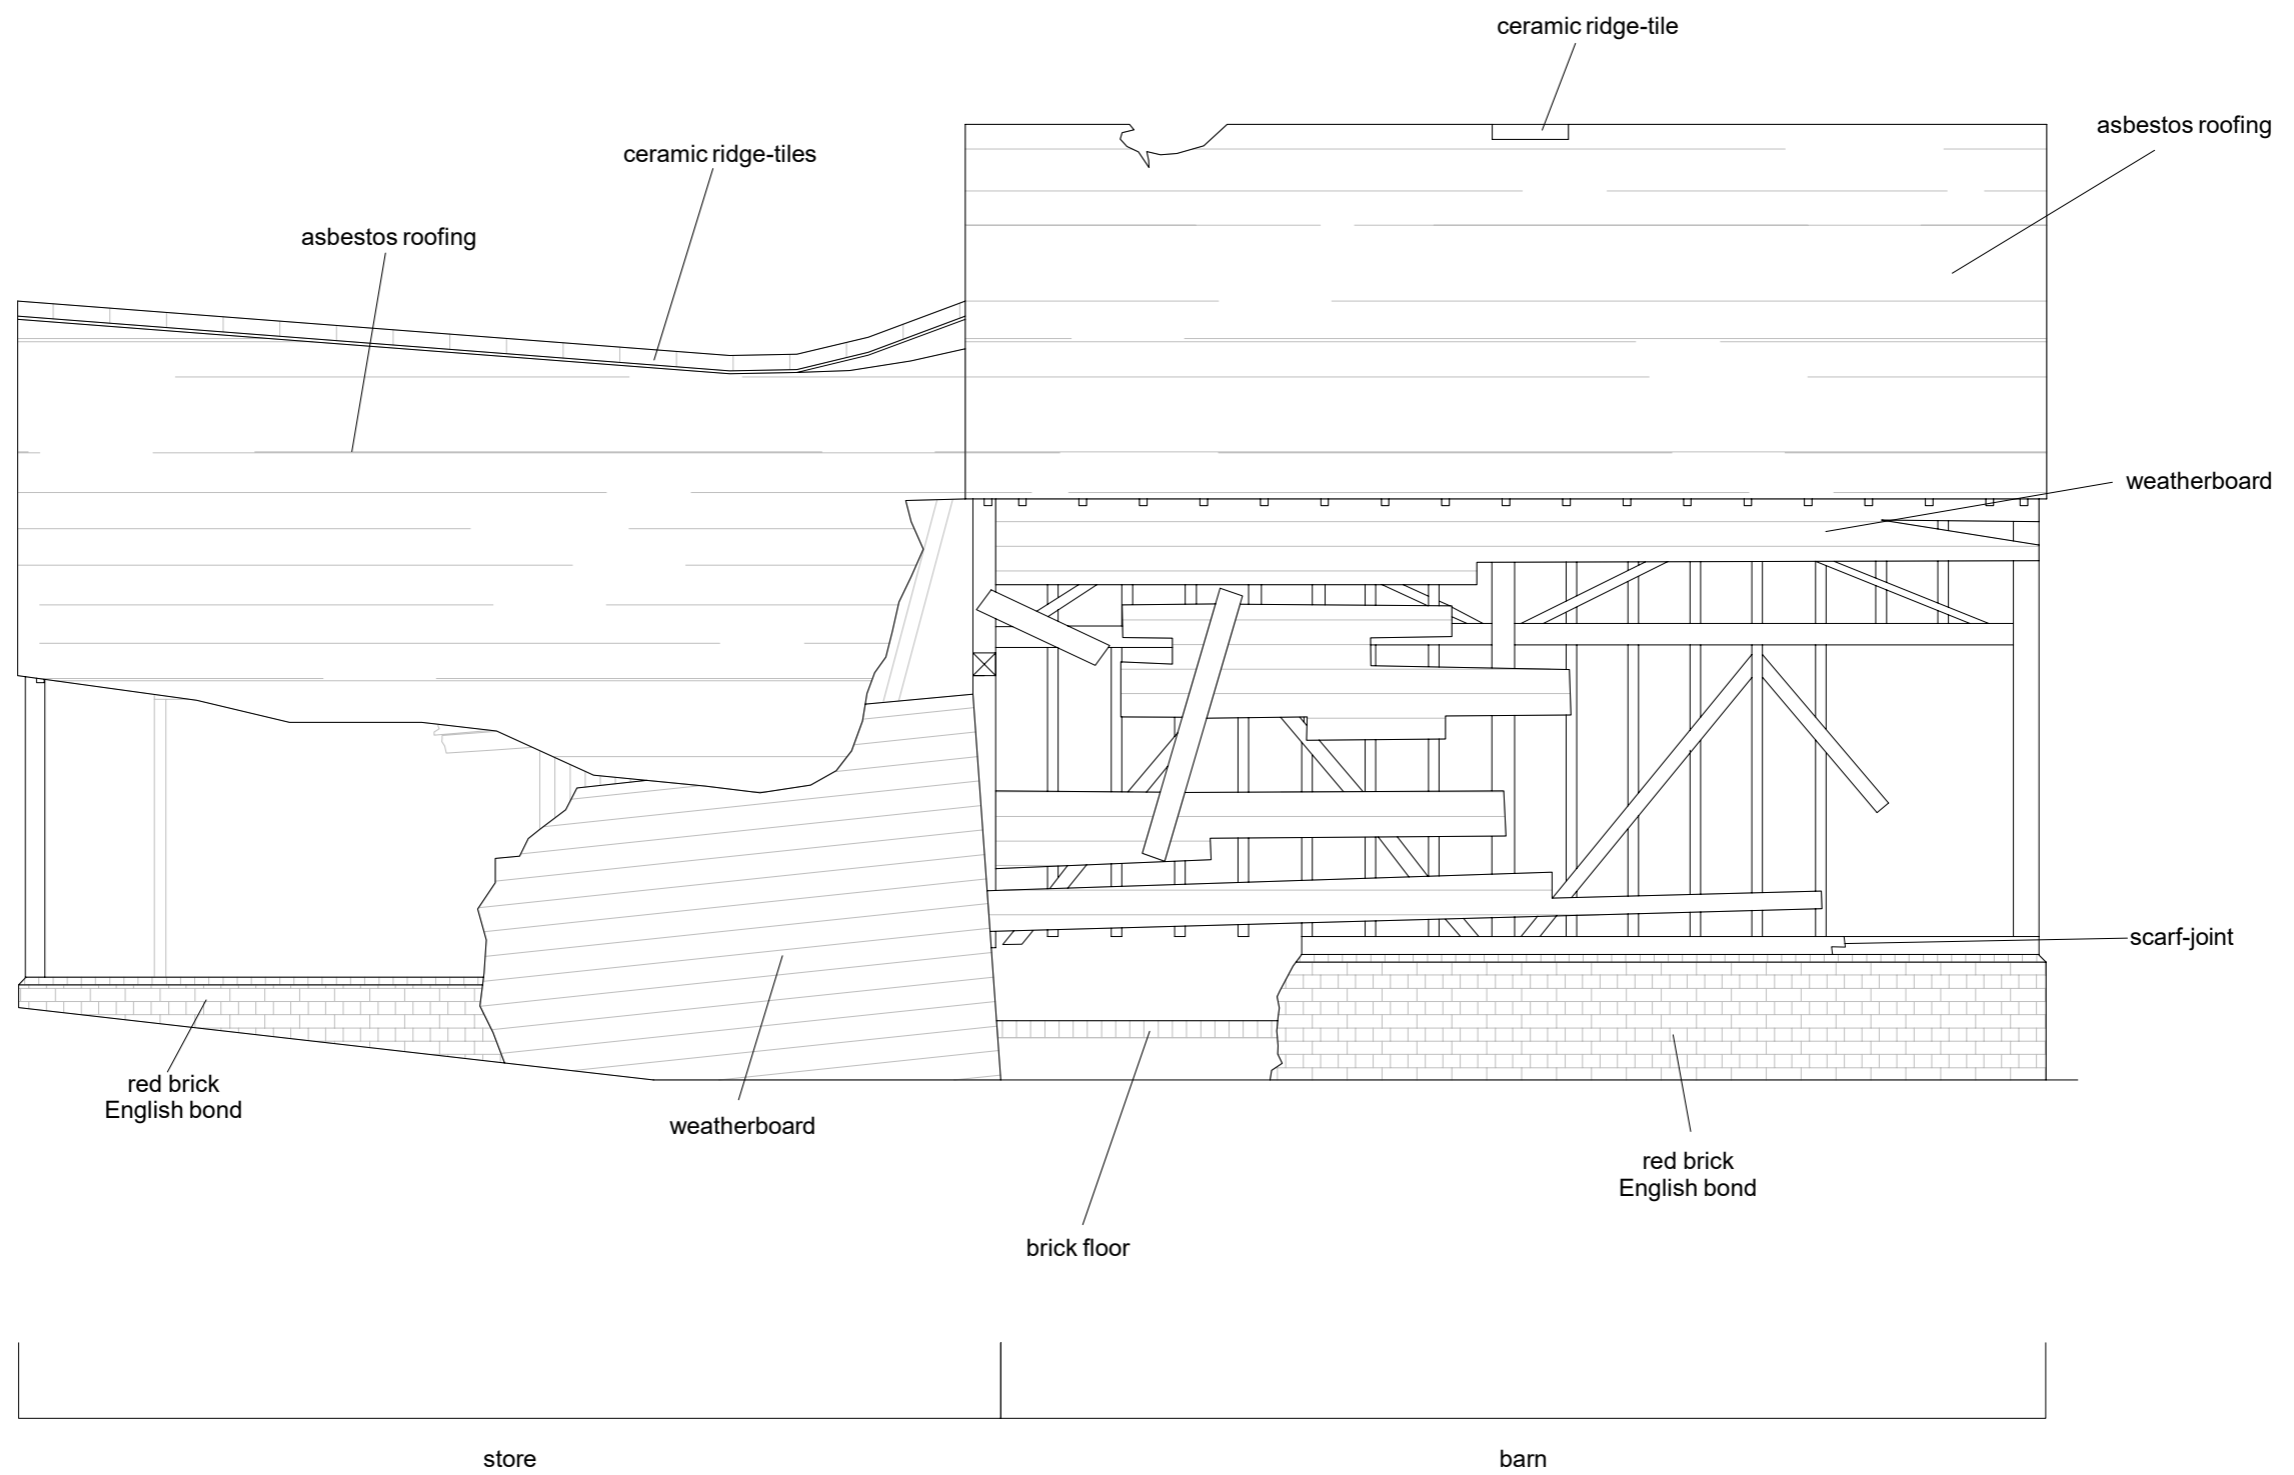
Fig 5 North-eastern elevation.

The north-east elevation is severely dilapidated (Photograph 7). The wall of the store has collapsed, which has caused the roof to buckle. From what remains of the store's elevation, it seems to have been largely featureless. The barn's elevation is somewhat more stable, although much of the weatherboard is missing. Damage to south-east end of the barn's plinth has revealed the brick floor inside the barn. A side-halved scarf-joint in the barn's wall-plate has been exposed due to the loss of the weatherboard.
