CAT Report 2095
Issued December 2024

**Historic building recording at 141 Thorpe Road,
Kirby Cross, Frinton On Sea, CO13 0NQ**

October 2024

**Planning district.: Tendring
Planning ref.: 23/01726/FUL**

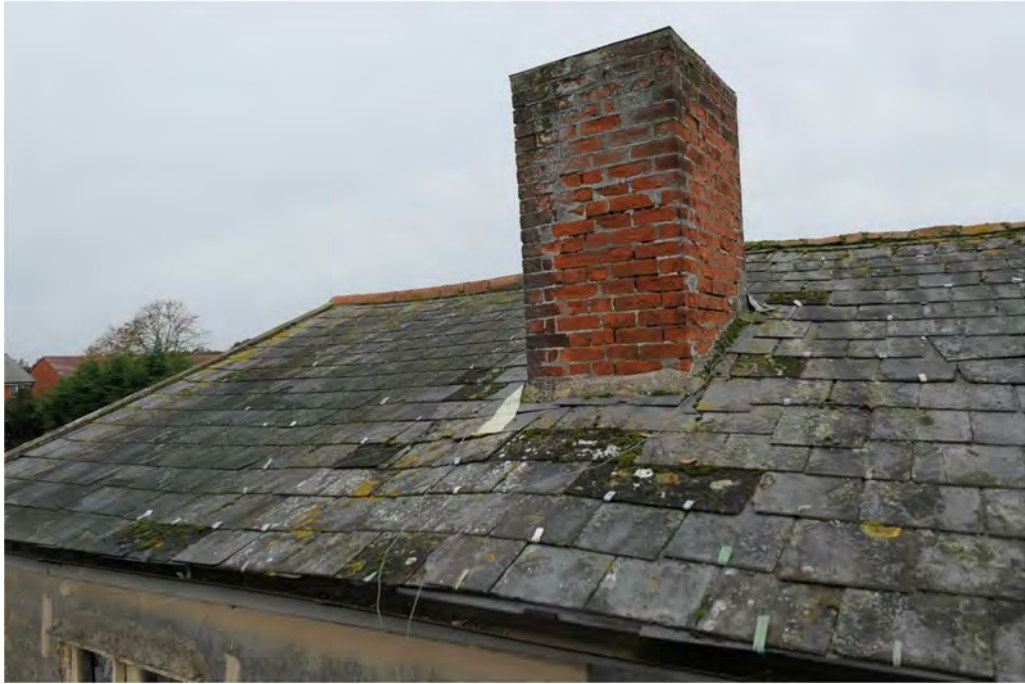
The roof of 141 Thorpe Road is gabled at both ends and covered with slate tiles. The ridge-line of the roof is not central and sits further to the west, giving the western roof pitch a steeper slope. A red brick chimney (Photograph 2) is predominantly visible on the eastern elevation, appearing to lean more towards building A. The chimney is constructed in a rough Stretcher bond, showcasing stretchers and headers in no obvious pattern. Building A is rendered on all elevations while building B is clad with weatherboard.

Photograph 2 Detail of red brick chimney. Photograph taken facing south-west.

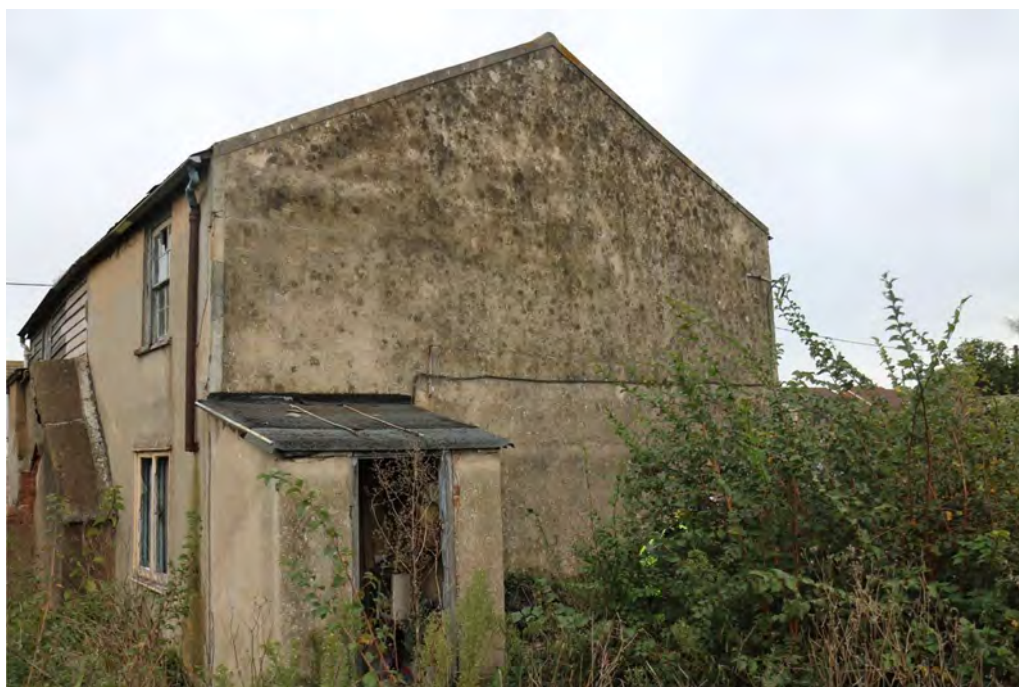
The southern elevation (Photograph 5) is largely plain render. The small modern extension projecting from this elevation has a mono-pitch roof covered with roofing felt and a single doorway.

Photograph 5 Southern elevation of building A. Photograph taken facing north-east.

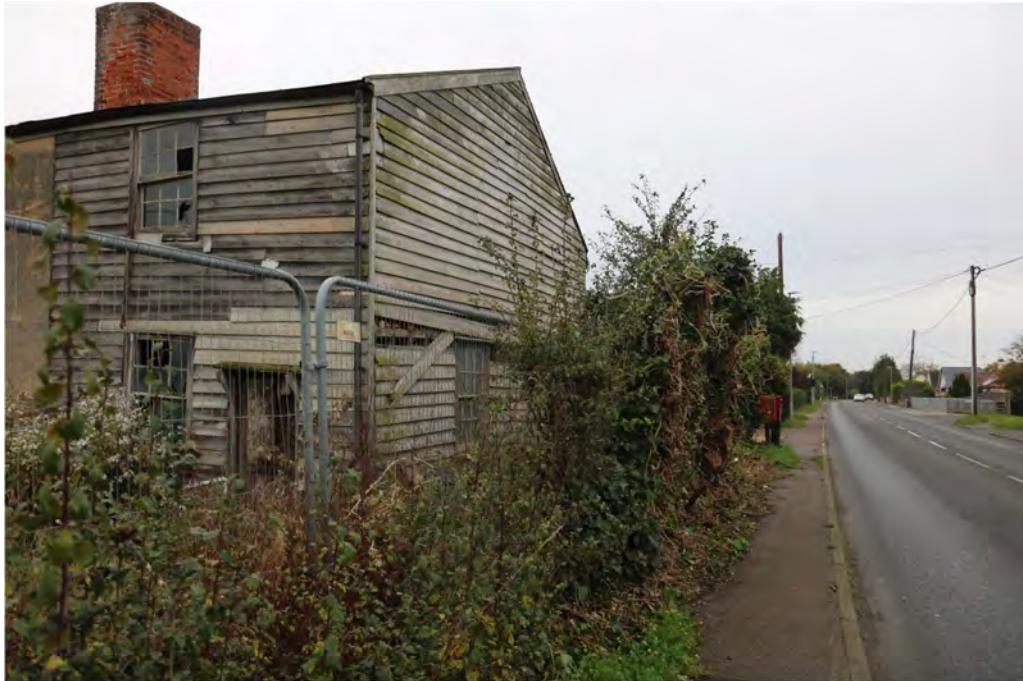
Photograph 8 Eastern and northern elevation of building B. Photograph taken facing south-west.

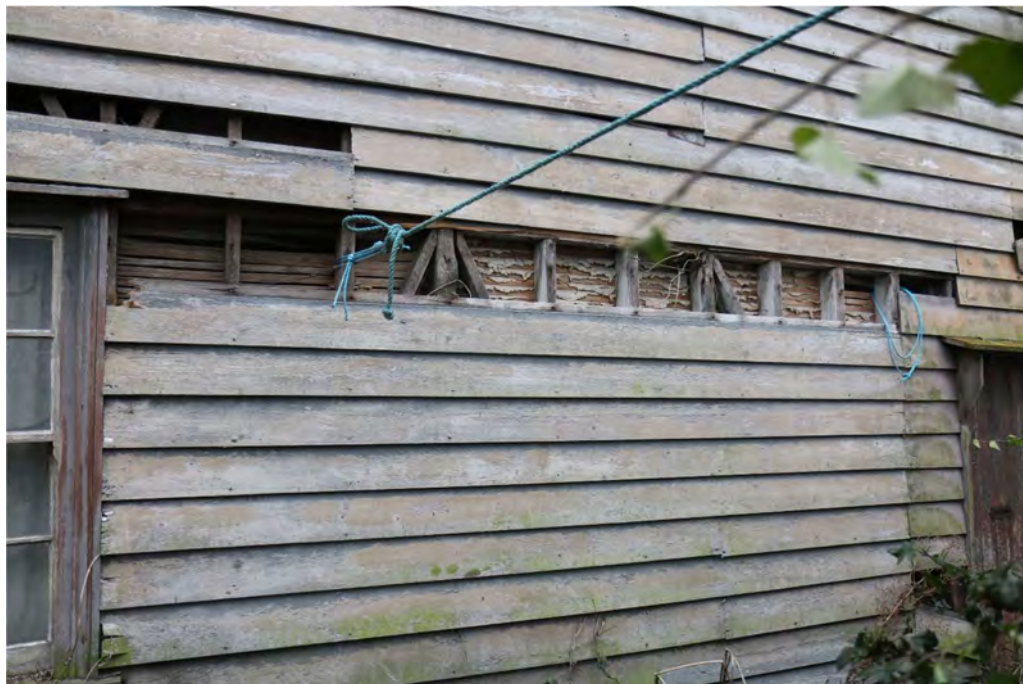
The northern elevation (Photograph 8) has a single twelve light sash window on the ground floor and a single timber-framed door. The weatherboarding on this elevation has come away to reveal the timber-framing beneath (Photograph 9). From the small

amount of framing exposed, it appears to be composed of mostly machine-cut timbers and uses diagonal bracing.

Photograph 9 Detail of exposed timber-framing on northern elevation of building B. Photograph taken facing south-west.

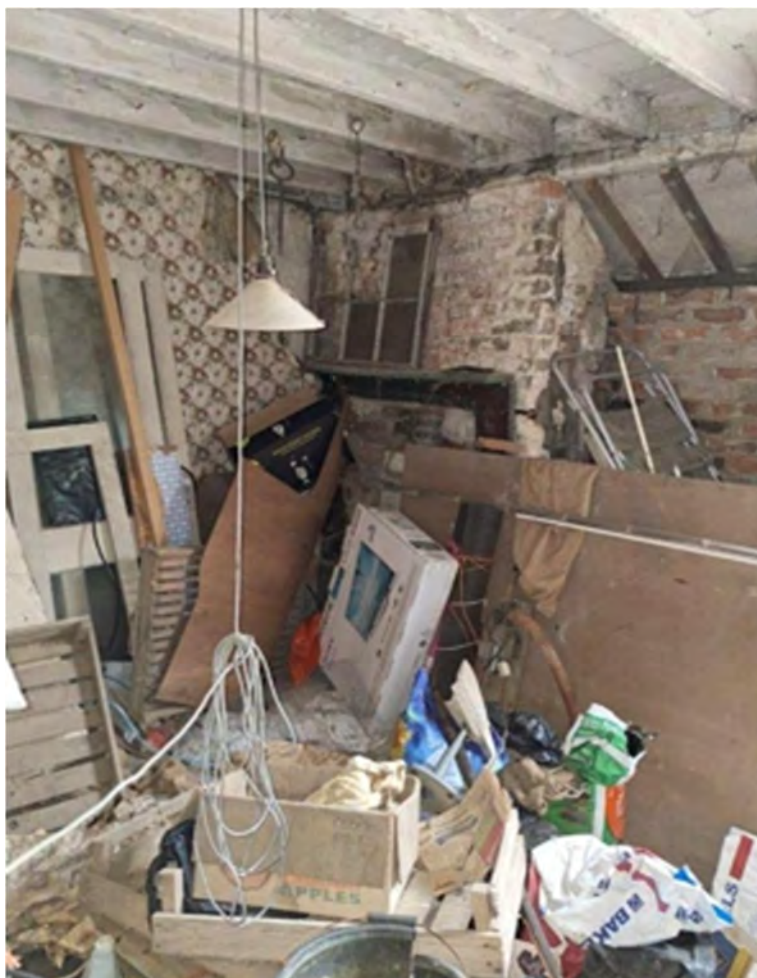
Room B1 (Photograph 14) has a window on the western wall and with doors in the eastern and southern walls. A fireplace has been inserted in the western wall, which appears to have been bricked up but still has a timber surround. The ceiling of room B1 comprises exposed timber joists. Hanging from one of the joists are what appear to be original hanging hooks, possibly an indication this room was used as a kitchen at some point.

Photograph 14 Interior shot of room B1 on the ground floor in building B, inserted fireplace visible. Photograph taken facing south-west. (Photograph provided by client).

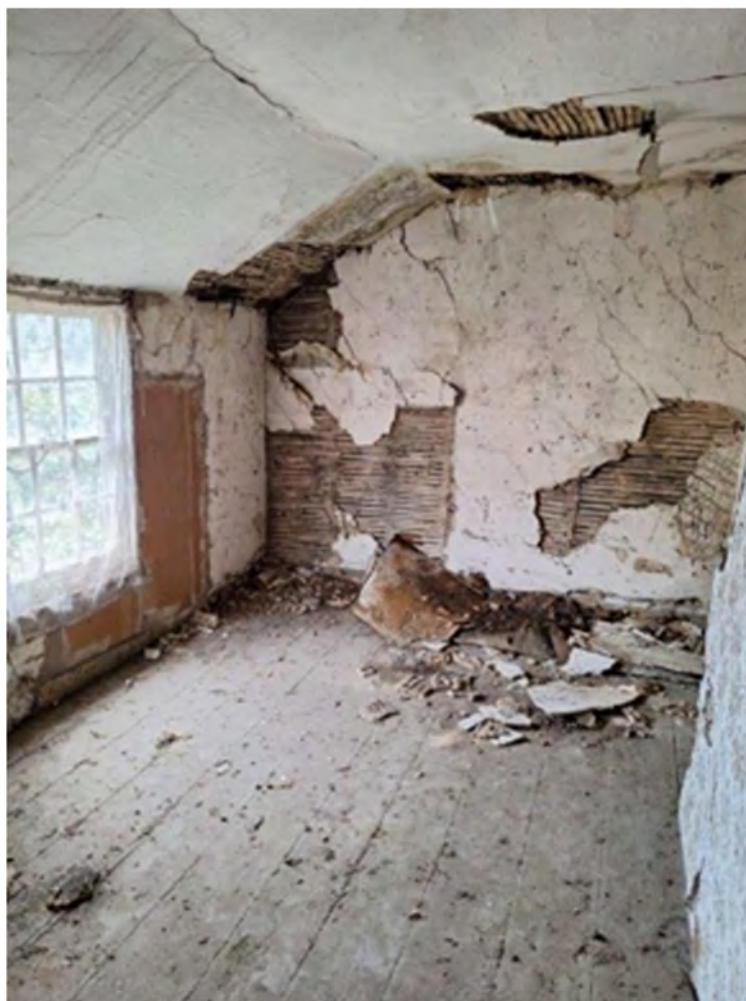
Photograph 16 Interior of room B3 in building B. Photograph taken facing north-west. (Photograph provided by client).

Room 3 (Photograph 16) has a single window on the western wall with a single wooden door, to enter the room, on the eastern wall. The flooring comprises the original wooden floorboards. As with room 3 of building A, the ceiling slopes downwards towards the western wall. Large quantities of plaster have come away from the walls, exposing the laths beneath.
