**CAT Report 2149
Issued March 2025**

**Historic building recording at
Fairfields Farm, Mowden Hall Lane, Hatfield Peverel,
Essex CM3 2NT**

February 2025

**CAT project ref.: 2025/01h
ECC code: EEX61203**

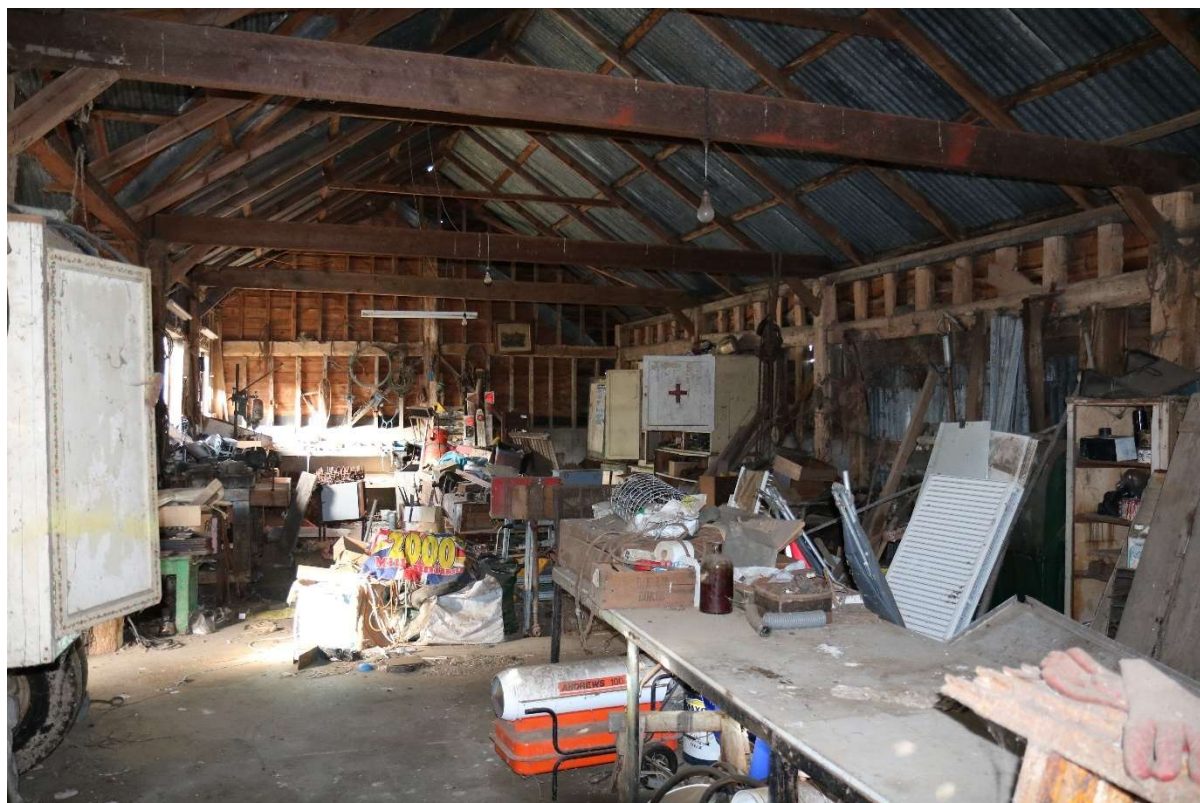
Photograph 33 Interior of threshing barn B. Photograph taken facing north-west.

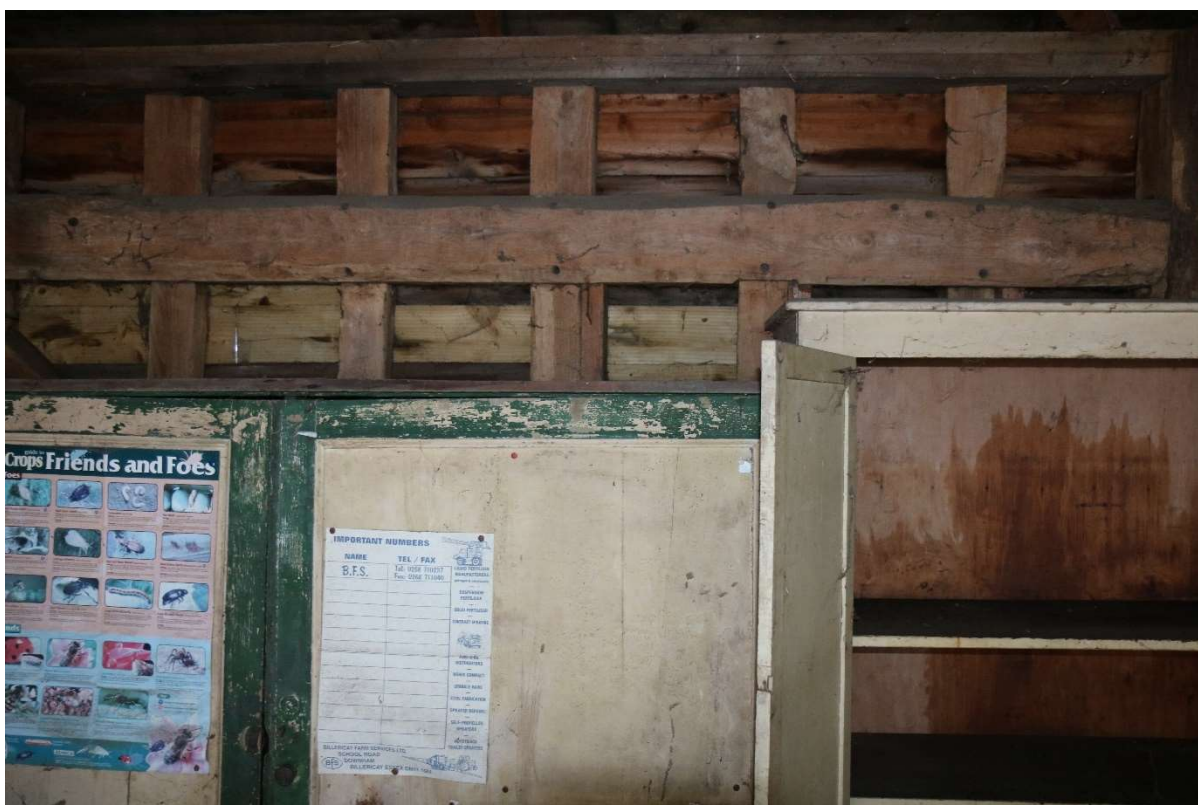
In bay 1 the intermediate post and girding beam of the north-western wall are hand-sawn while the rest of the wall is rebuilt in machine-cut timber. The south-eastern intermediate post shows signs of reuse, in the form of empty mortices (photograph 34). A metal framed window is fixed into the south-western wall. Concealed tension bracing has been removed from what is left of the upper register of the north-eastern wall, evidenced by a recess in one of the studs and a used peg in the girding-beam.

Photograph 35 Detail of pegged studs in the north-eastern wall of bay 1 of threshing barn B. Photograph taken facing north-east.

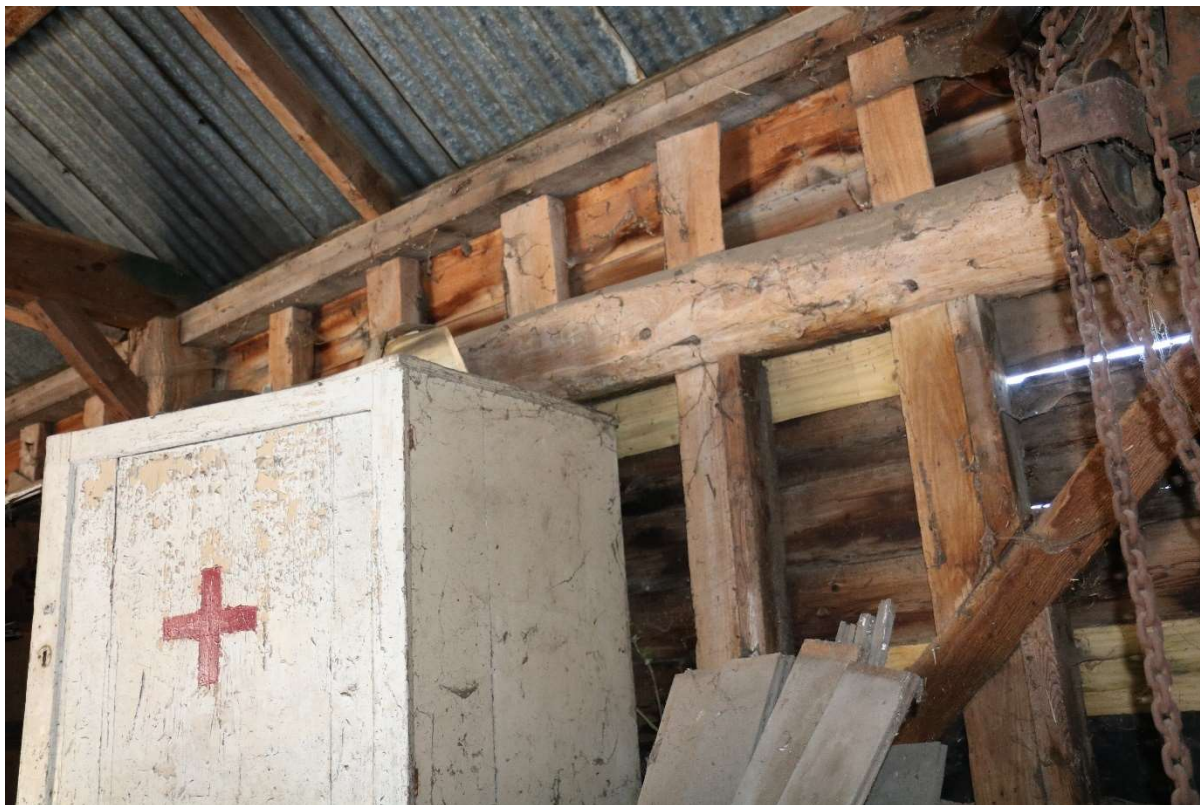
In bay 2, the south-eastern intermediate post has empty mortices, which likely represents the removal of older timbers when the machine cut replacements were added. The replacement wall-plate in the north-eastern wall has a simple scarf joint.

Photograph 36 Detail of pegged studs in north-eastern wall of bay 2 of threshing barn B.
Photograph taken facing north.

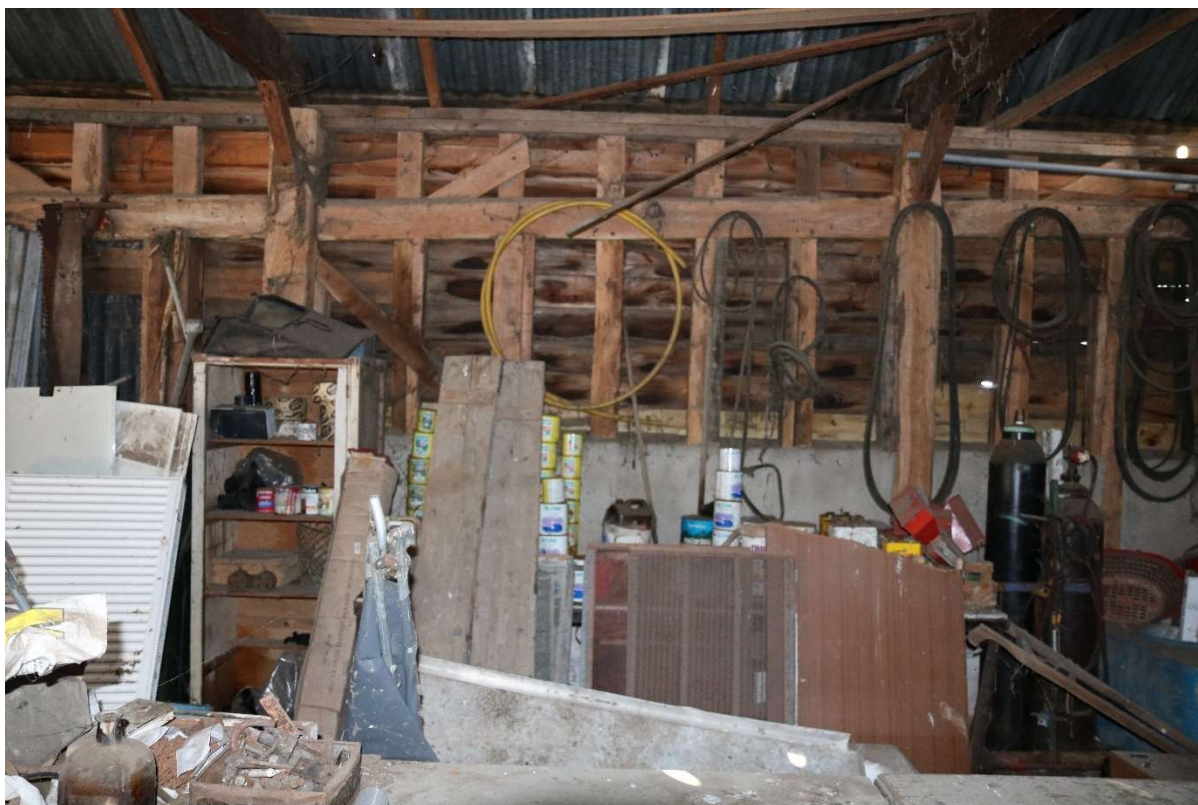
In the north-eastern wall of bay 4, the upper register contains the remains of a cut tension brace. In the south-western wall, the intermediate posts have empty mortices, likely a result of the removal of the original girding-beam or bracing.

Photograph 39 North-eastern wall of bay 4 of threshing barn B. Photograph taken facing north-east.

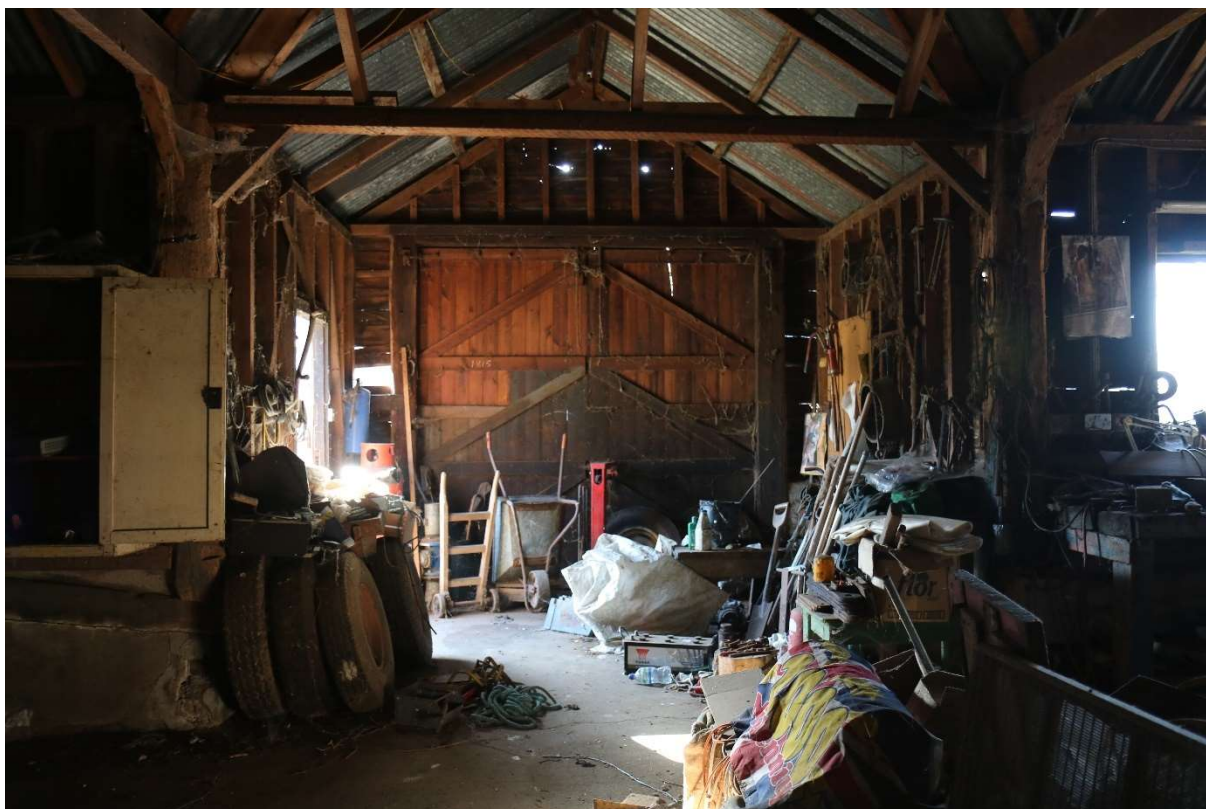
In the midstrey, the eastern doorpost shows signs of reuse, in the form of empty mortices. The rest of the frame comprises modern machine cut timbers.

Photograph 41 South-western wall of bay 3 of threshing barn B. Photograph taken facing south-west.

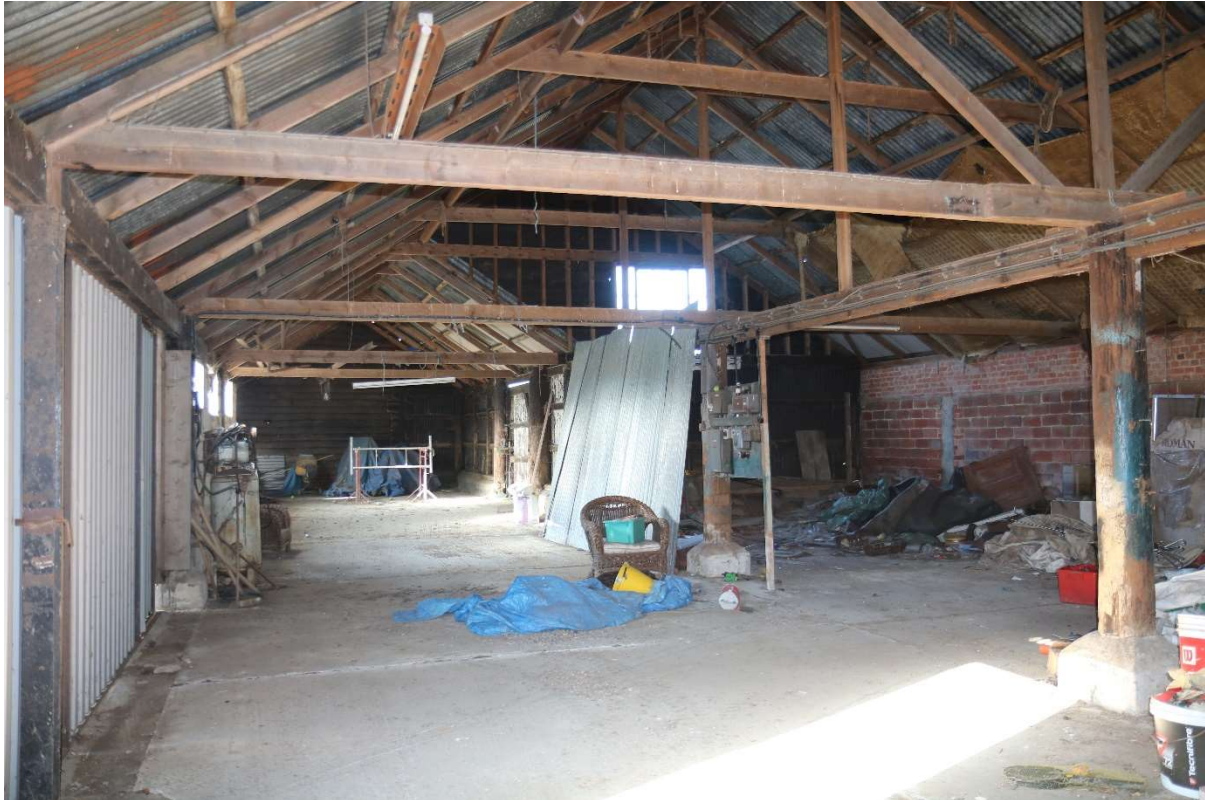
Photograph 42 Interior of linking shed. Photograph taken facing north-west.

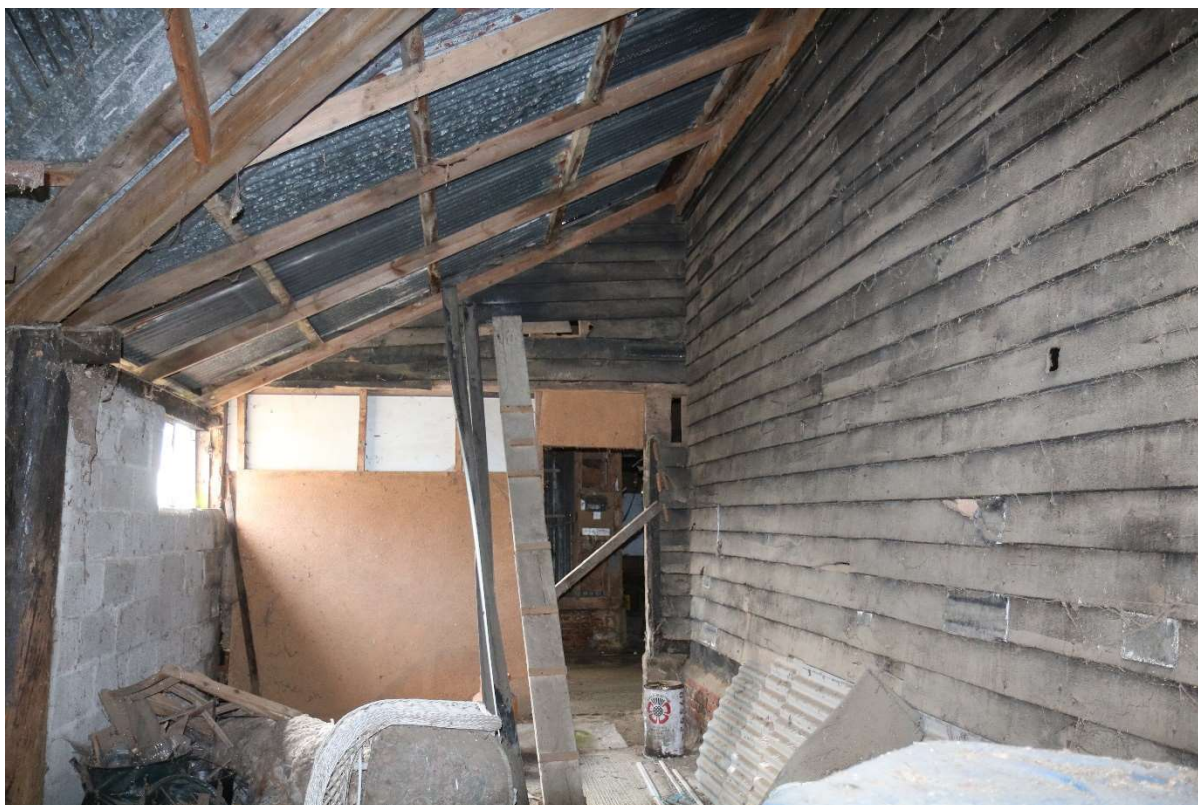
In the linking corridor, the north-western and south-western walls consists of the exterior walls of threshing barn A and are clad in weatherboard. A doorway is formed in the southern-western-wall, linking the building to threshing barn A. A metal framed window is fixed into the blockwork of the south-eastern wall.

Photograph 43 Interior of linking shed. Photograph taken facing south-west.

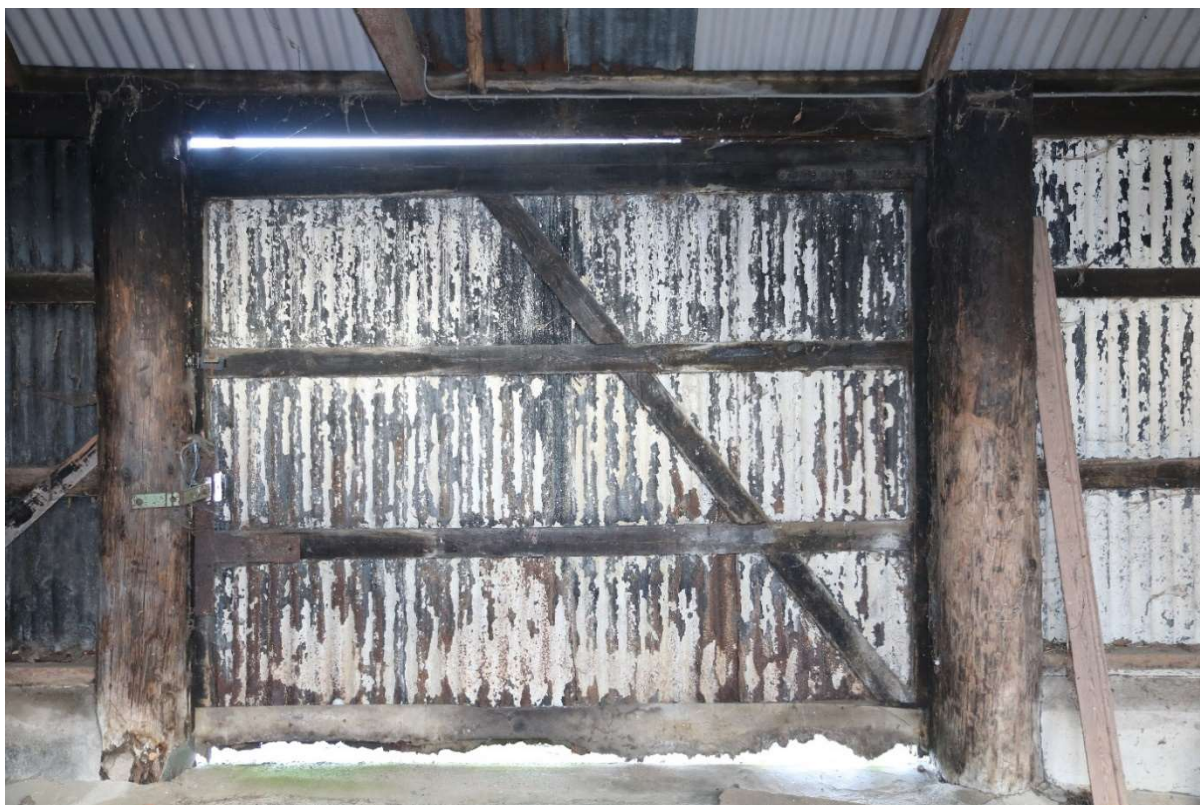
Photograph 44 Detail of door in north-eastern wall of linking shed. Photograph taken facing north-east.

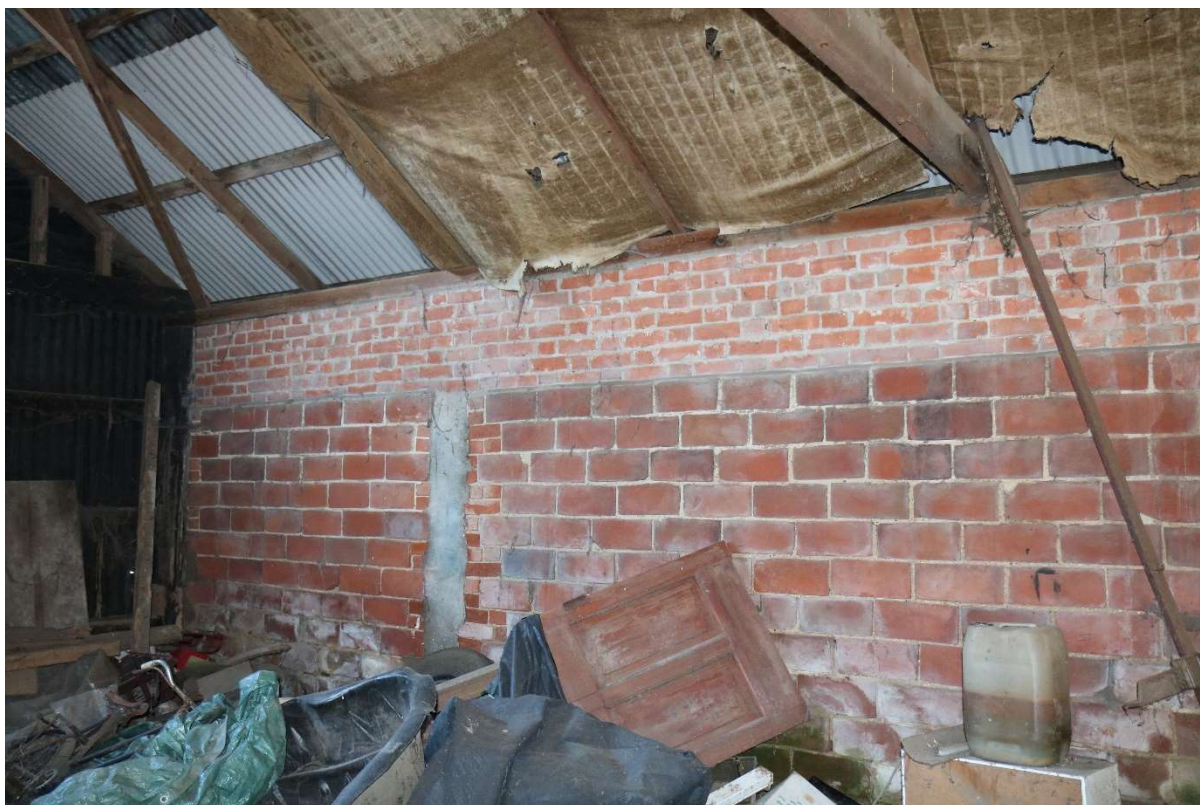
Photograph 45 Detail of brickwork in north-eastern wall of linking shed. Photograph taken facing north.

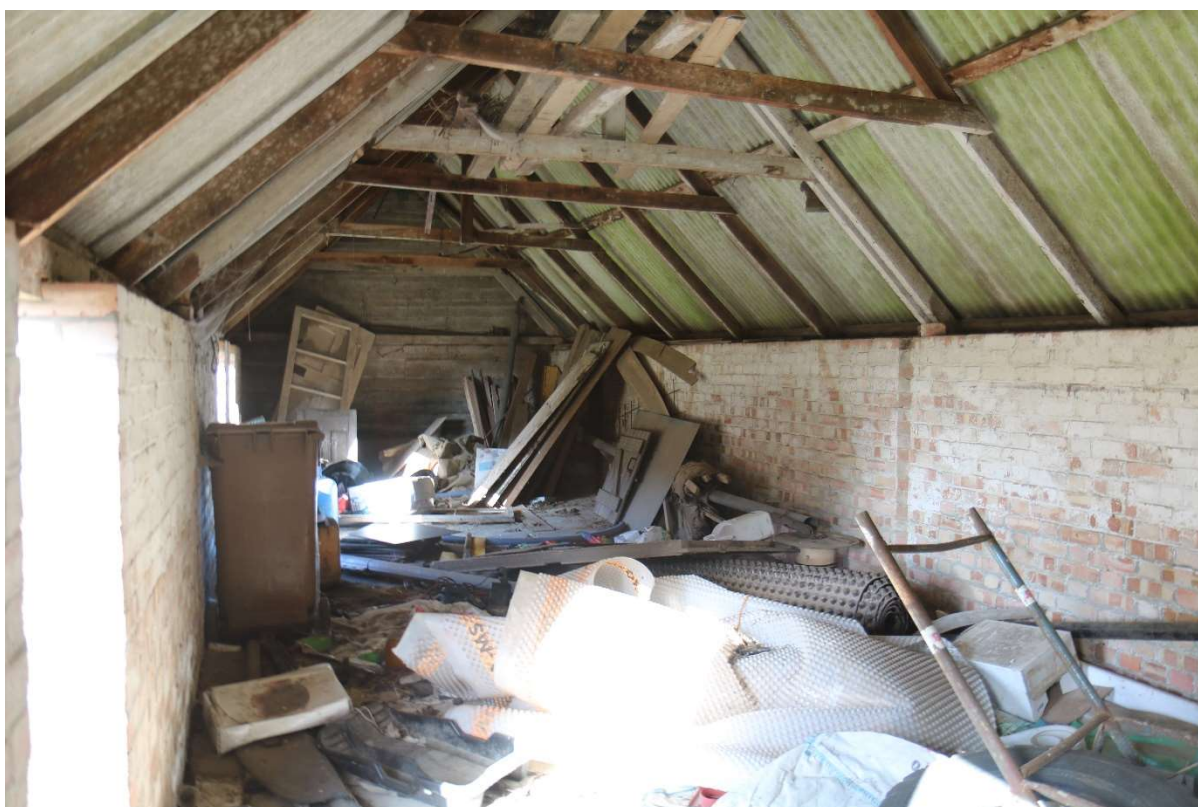
Photograph 48 Interior of brick shed. Photograph taken facing north-west.

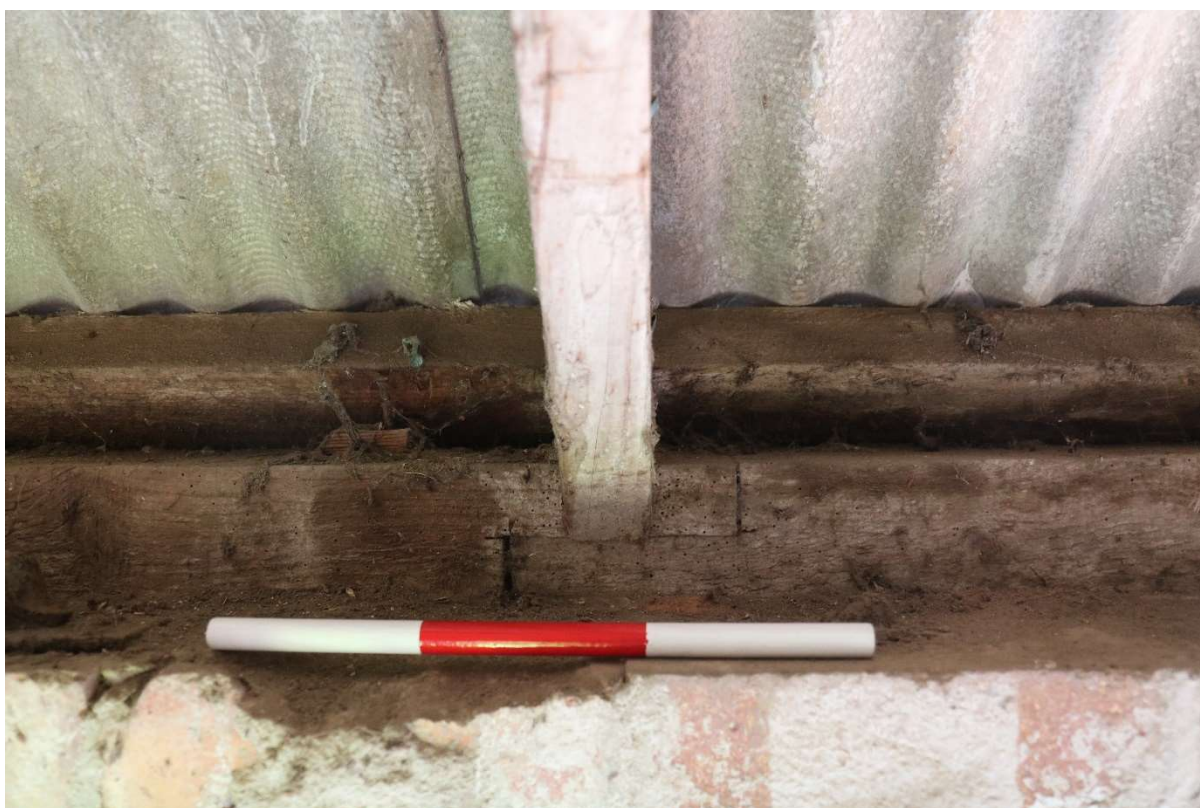
The north-western wall is formed of the weatherboard exterior of threshing barn B. The south-western wall has four doorways forming breaks in the brickwork. Three side-halved scarf-joints are present in the wall-plate, two on the south-western wall (photograph 50) and one on the north-eastern. Two internal walls have been removed from the brick shed, leaving behind two distinct lines of brickwork in the floor (photograph 49). The north-eastern wall dividing the open space from the inaccessible room has corrugated metal forming its upper register.

Photograph 50 Detail of scarf joint in wall-plate in south-western wall of brick shed. Photograph taken facing south-west.
