**CAT Report 2154
Issued April 2024**

**Historic building monitoring and recording at
Rye Cottage, Larks Lane, Great Waltham,
Essex, CM3 1DT**

**CAT project ref.: 2025/02L
ECC code: EEX61395**

**NGR: TL 6935412432
Planning district: Chelmsford
Planning ref.: 24/01361/FUL**

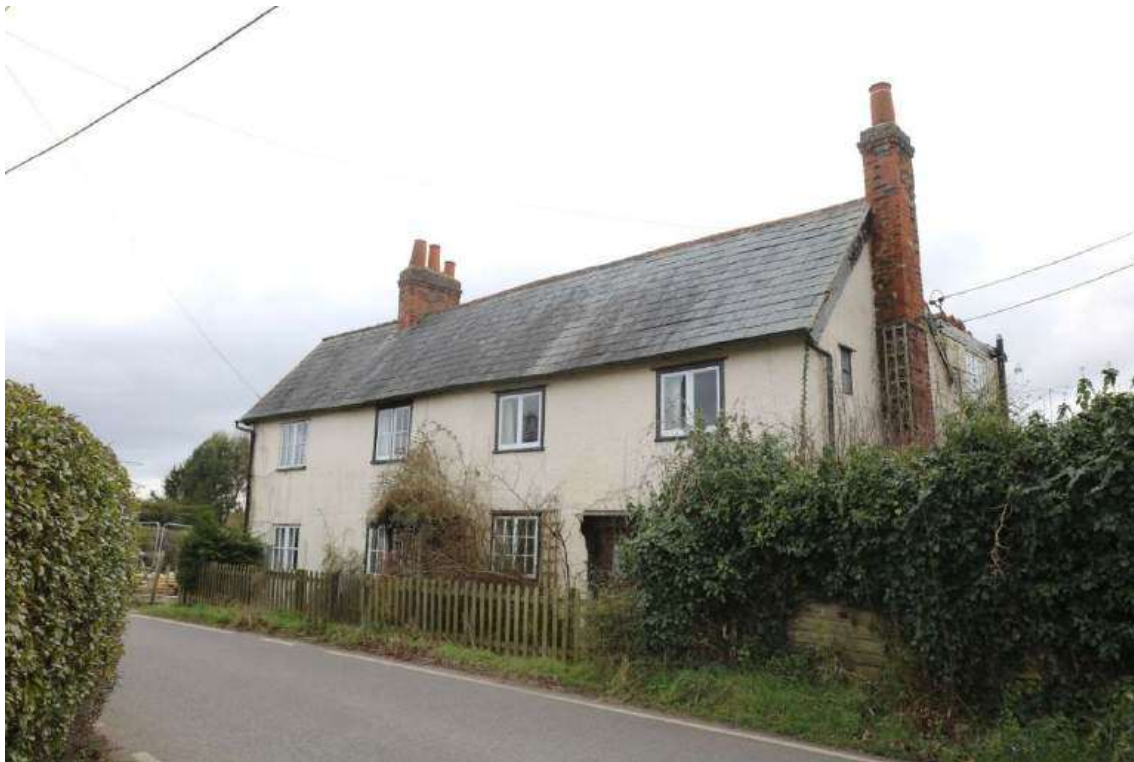
Photograph 1 Northern elevation. Photograph taken facing south-east.

The northern elevation (Photograph 1) of the cottage has eight windows, with either two, eight or twelve lights. They are all timber-framed with casement openings. Two timber doors are present in the elevation, the eastern of which has a small projecting porch (Photograph 3). The render on the eastern half of the northern elevation has a pressed dotted pattern arranged into a number of rectangles (Photograph 4).

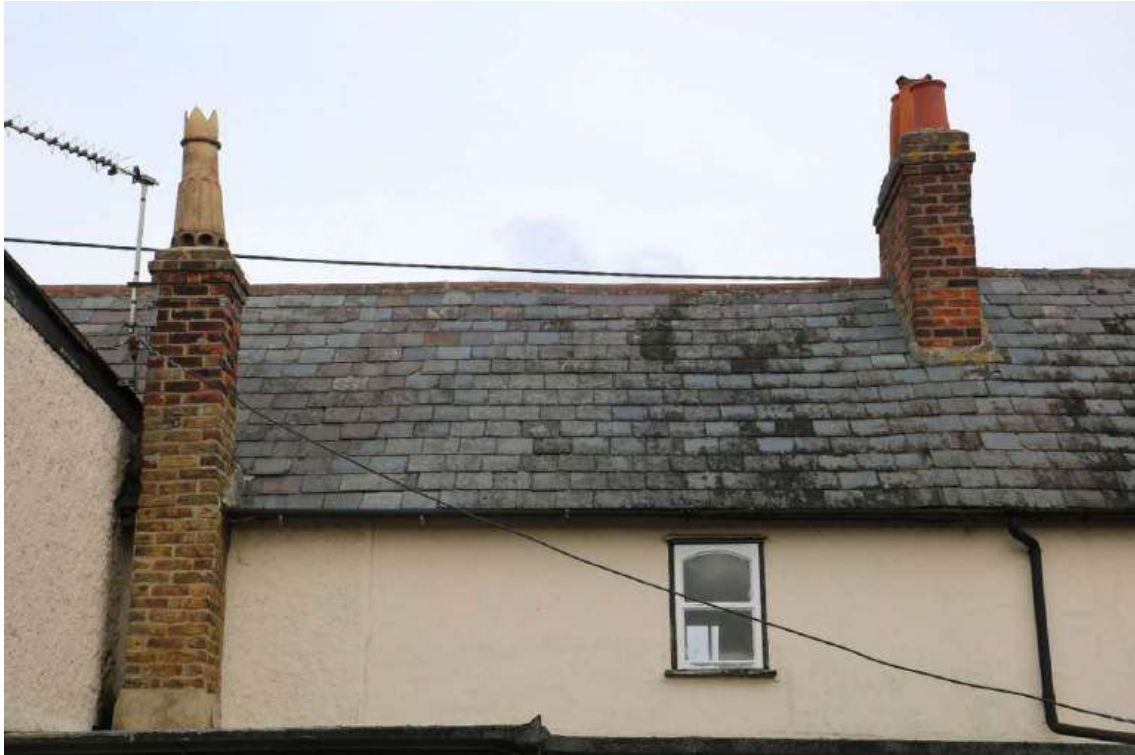
Both chimneys that project from the gabled roof are constructed from red brick. The stack of the western chimney is narrow, with only a single chimney pot, while the eastern is much wider and finished with three chimney pots. The lower courses of the third chimney are laid in London stock bricks while the upper 13 courses of brickwork are red brick. The chimney is topped with a Peyton's

Champion chimney pot (Photograph 2). All three chimney stacks have two courses of oversailing brickwork towards their tops.

Photograph 2 Detail of chimneys on southern elevation, the Peyton's Champion chimney pot to the left. Photograph taken facing north.

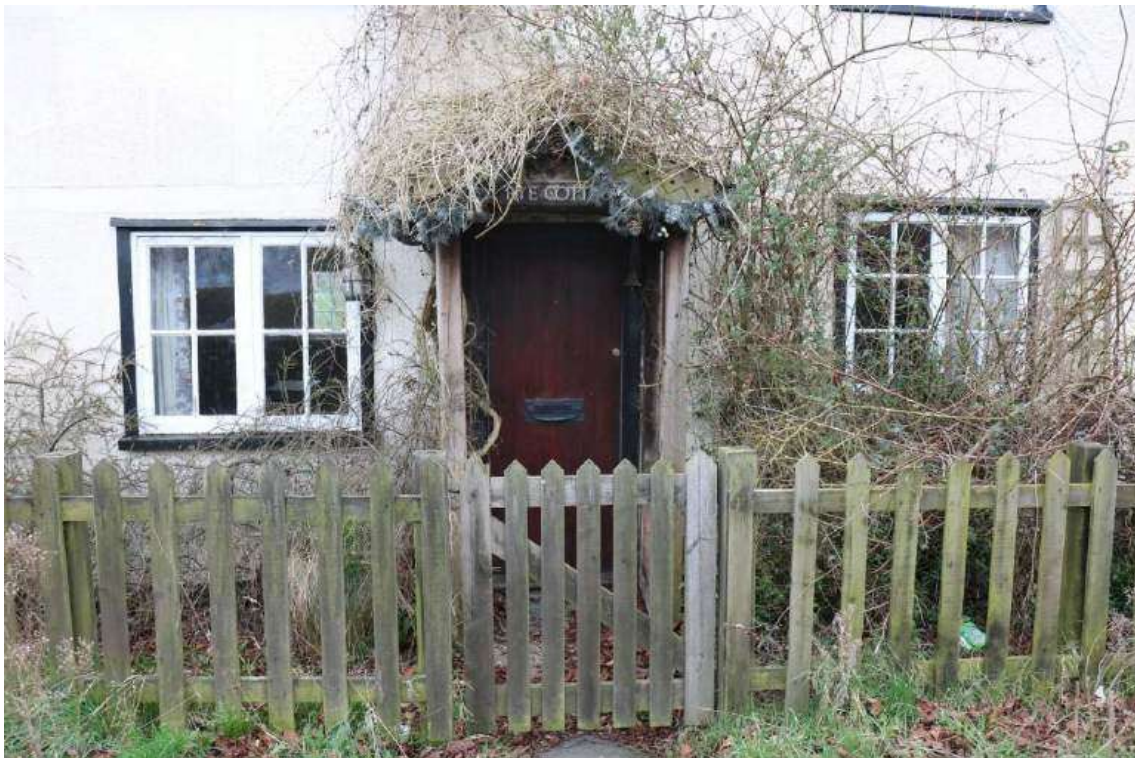
Photograph 3 Detail of windows and door on northern elevation. Photograph taken facing south.

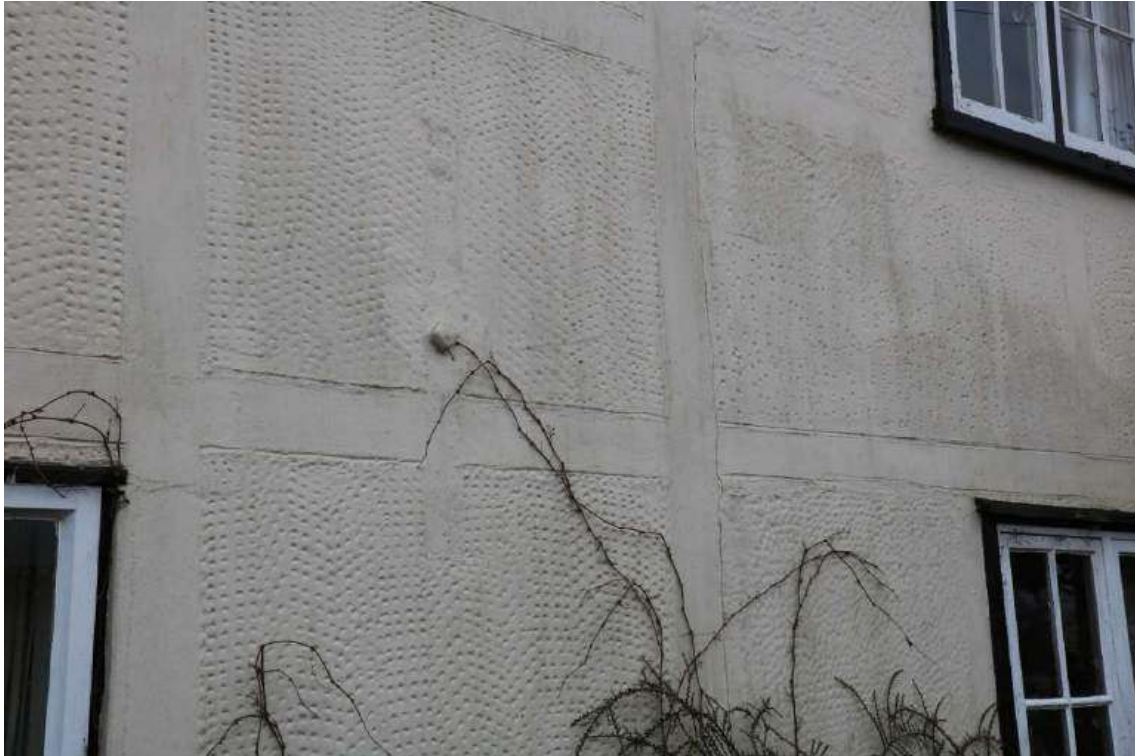
Photograph 4 Detail of plaster on northern elevation. Photograph taken facing south-west.

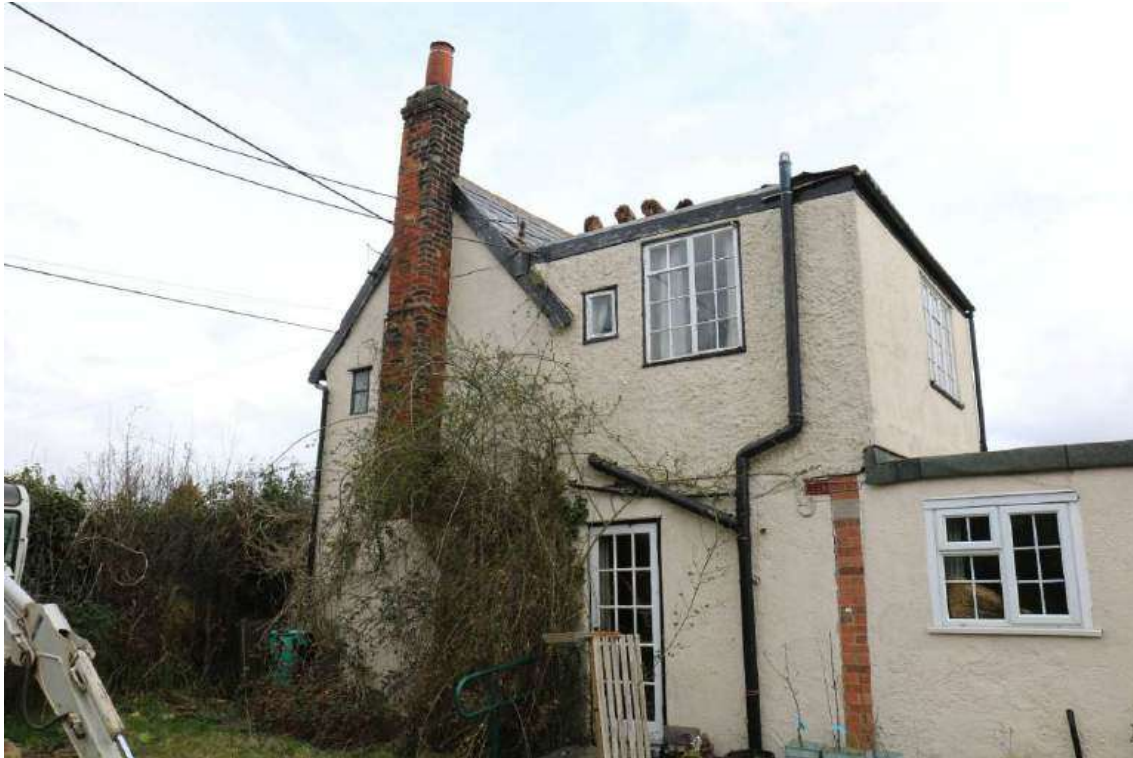
A chimney breast projects from the western elevation (Photograph 5) of Rye Cottage, comprising red bricks (brick dimensions: 225 x 105 x 65mm) laid in Stretcher bond. At ground floor level, where the chimney breast is at its widest, it is rendered above which it narrows and is bare brick. At gable level, the chimney breast has an iron strap with an S-shaped anchor plate (Photograph 6). The bargeboards on the gable end of the western elevation are timber and have a rounded design at their ends (Photograph 7). Eight windows are present across the western elevation, a combination of timber-framed, uPVC and Crittall windows. The smallest window is a single-light while the largest has 16 lights. All either have a casement or awning opening. A single panelled door is also present. There is an area of exposed modern brickwork between two of the modern extensions.

Photograph 5 Western elevation. Photograph taken facing north-east.

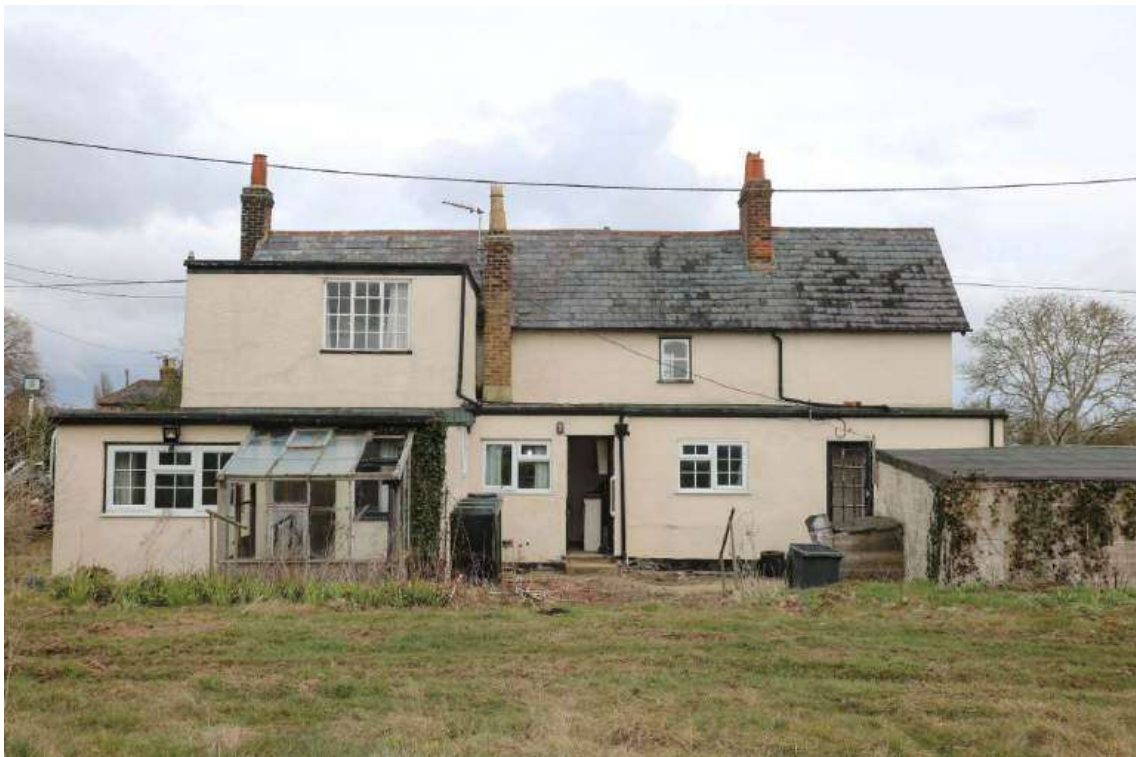
Photograph 8 Southern elevation. Photograph taken facing north.

The southern elevation (Photograph 8) of Rye Cottage has six windows, again a combination of timber-framed, uPVC and Crittall windows. They all have casement or awning openings and between

two and 24-lights. Three timber doors are present in this elevation, two stable doors and one panelled door. A dilapidated timber lean-to is also on this elevation.

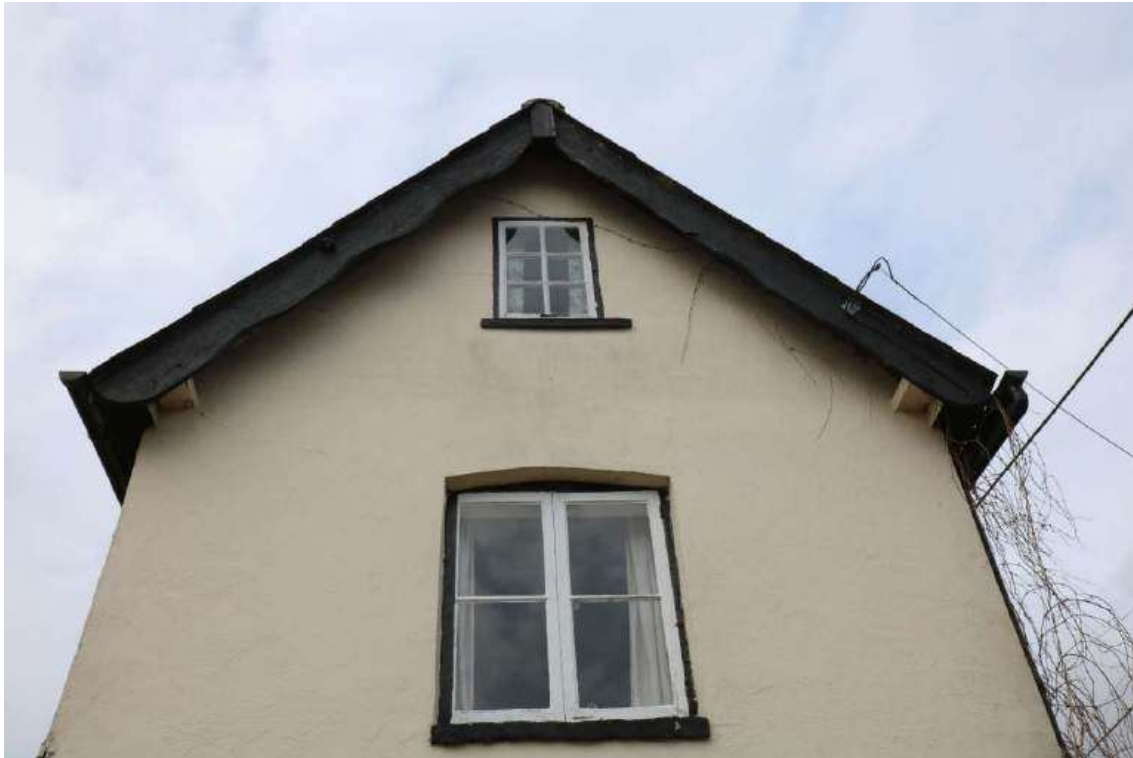
The eastern gable (Photograph 9) of Rye Cottage has timber bargeboards, with wavy patterned edges (Photograph 10), differing in design to those on the western elevation. Four timber-framed windows and one uPVC window are present across the elevation. They have between three and six lights with casement openings.

Photograph 10 Detail of bargeboards and windows in eastern elevation. Photograph taken facing west.

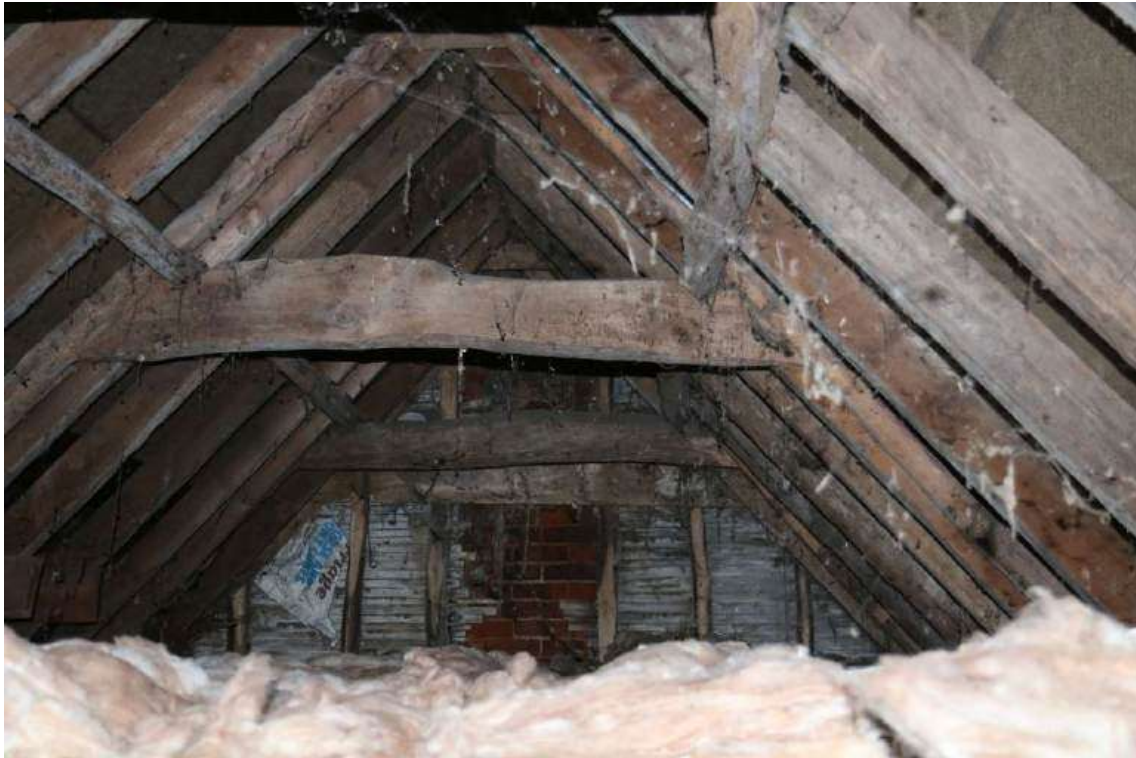
The roof of the original range of Rye Cottage (Photograph 11) is constructed from pairs of rafters, which rise from the wall-plates to meet a ridge-board at the apex of the roof. There is a single clasped purlin on each roof pitch, which are held by a series of collars, which presumably correspond to a series of tie-beams. Each collar has a corresponding upper collar. The timbers used in the roof framing are both hand-sawn, some of which are very roughly hewn, and machine-cut. Occasional modern timbers have been added for reinforcement.

Photograph 11 Detail of original range roof construction. Photograph taken facing west.

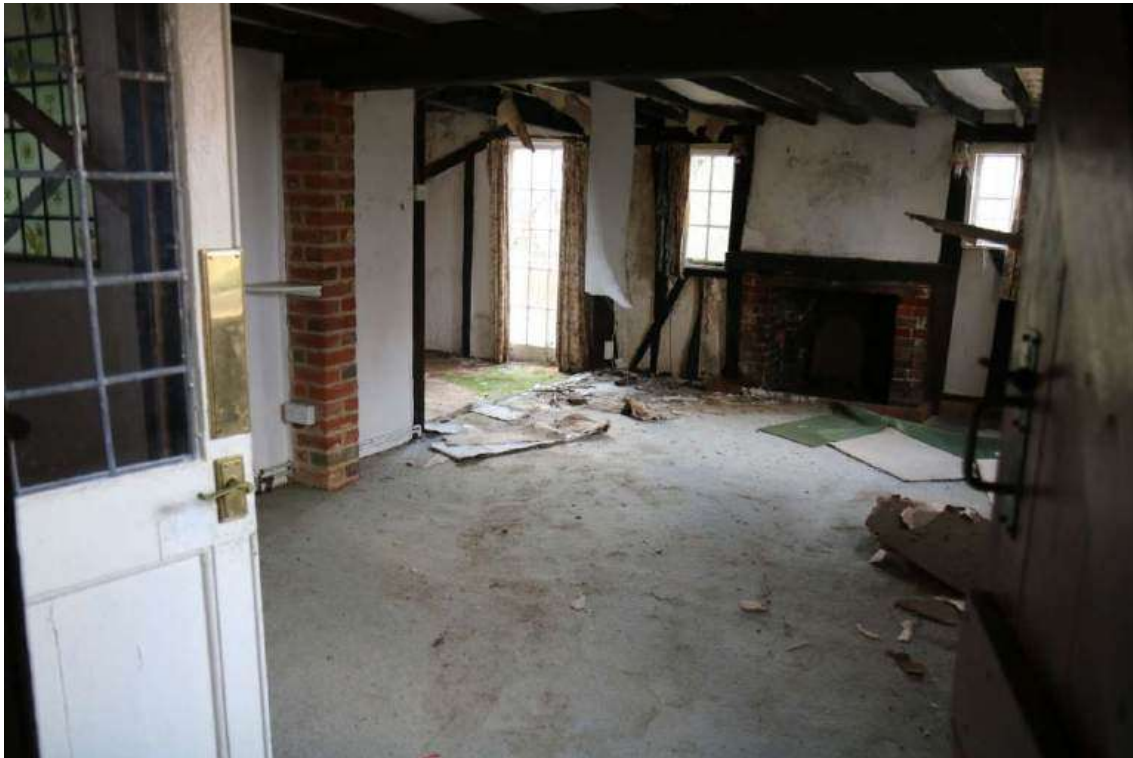
The remaining ground floor of the original range is dominated by the lounge (Photograph 18), which also expands into a modern extension. The ceiling of the lounge comprises exposed floor joists with the underside of the above floorboards papered between the joists (Photograph 23). In the centre of

the ceiling is a sheathed RSJ (rolled steel joist), which presumably is supporting the above binding-beam. At either end, the RSJ is supported on a modern brick pier. To the west of the RSJ are the remains of a stair trimmer, evidencing the removal of a staircase (Photograph 24). In contrast to the rest of the ceiling, the area between the RSJ and trimmer has been plastered. The walls are plastered, with areas of exposed timber-framing (Photograph 19). There are occasional reused timbers within the original timber-framing, including studs and diagonal-bracing (Photograph 20). The northern wall has been partially rebuilt using modern machine-cut timbers (Photograph 21). In the north-western corner of the room, the sill-beam has been replaced and is supported on course of modern red bricks. A replacement door is present in the northern wall and an inserted door in the eastern wall, evidenced by a short length of stud still present above the doorway (Photograph 22). A number of windows are in the northern and western walls. A red brick fireplace (brick dimensions: 225 x 105 x 65mm) is located in the western wall, which has an iron fire back, with a Tudor rose design, and a red brick hearth (Photograph 25). In the south-eastern corner of the room is a replacement L-shaped staircase, which is surrounded by a stud wall. The floor is covered with carpet, concealing floorboards beneath.

Photograph 18 Interior of lounge. Photograph taken facing south-west.

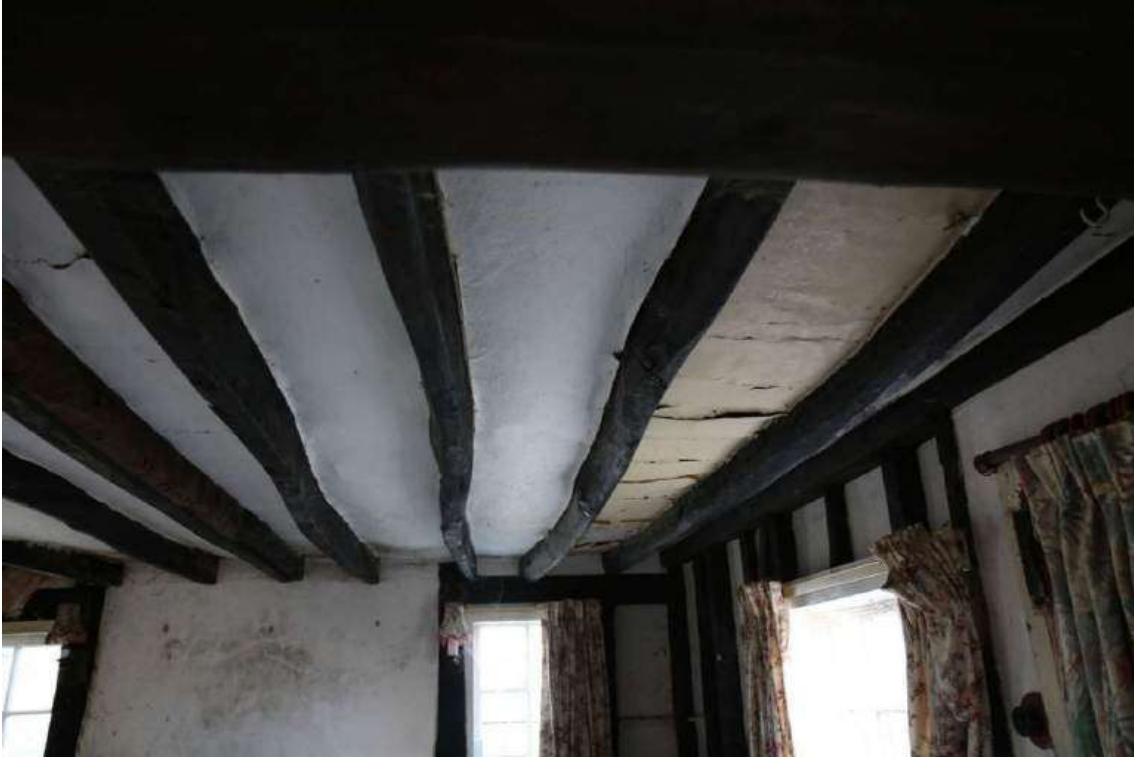
Photograph 23 Detail of floor joists in ceiling of lounge. Photograph taken facing west.

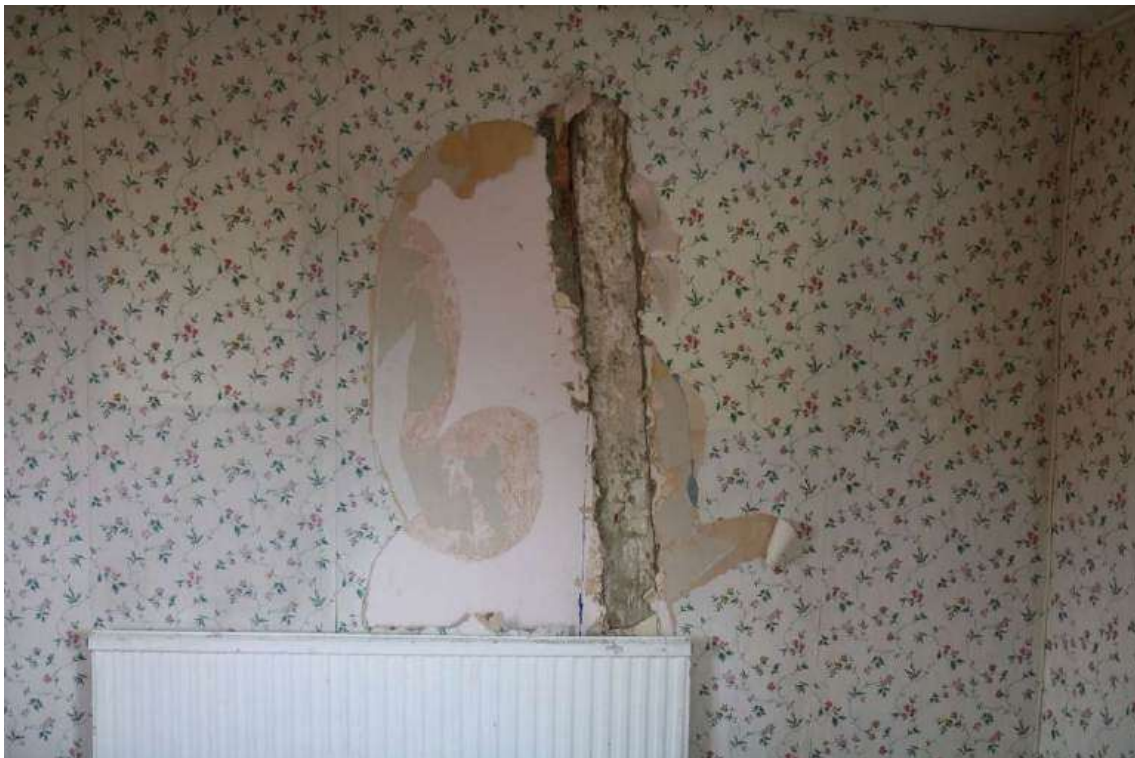
Photograph 28 Detail of plaster removal in eastern wall of bedroom 2. Photograph taken facing east.

Bedroom 2 (Photograph 27) is adjacent to bedroom 1, in the eastern-most bay of the original range. As with bedroom 1, the ceiling is covered with polystyrene tiles and the walls are wall-papered. Removing the plaster of the eastern wall was challenging, resulting in only a single exposed timber, adjacent to the chimney breast (Photograph 28). The eastern wall has been rebuilt in brick. The rest of the walls are timber-framed but the framing was not exposed. The floor is covered with a series of modern floor coverings, including carpet and linoleum.

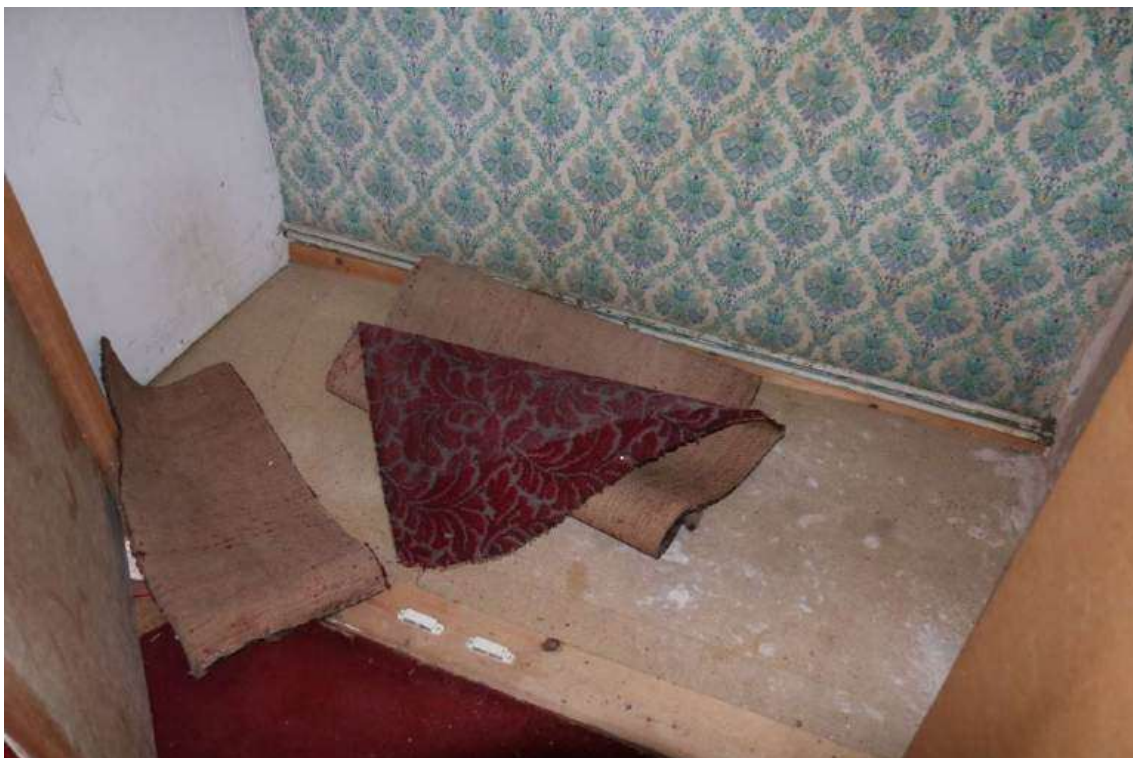
extents of the chimney. Removal of the plaster between these timbers has exposed a further two posts, both of which have been crudely hewn, as well as the brick work of the external chimney (Photograph 32). Cupboards are present along the eastern wall of bedroom 4, the southern of which has sheet timber flooring from the removal of the below staircase (Photograph 34). An inserted door is present in the southern wall, evidenced by a series of empty mortices in the above wall-plate (Photograph 35).

Photograph 34 Detail of modern sheet timber floor in southern cupboard in bedroom 4. Photograph taken facing north-east.

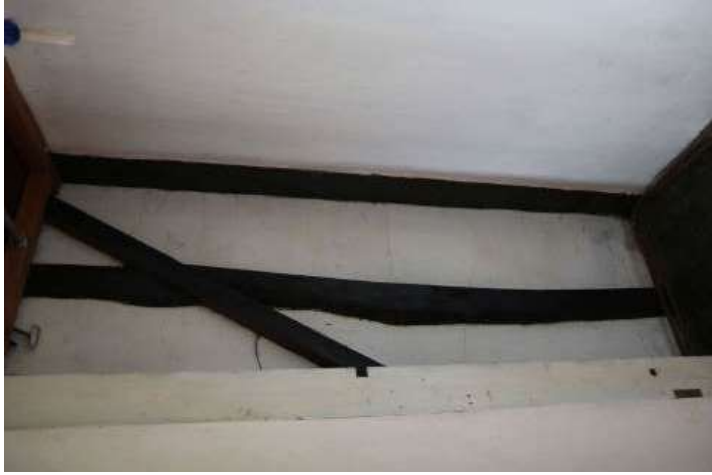
EEEX61395_PhotoGraph_0129
Detail of reused stud in northern wall of bedroom 4. Photograph taken facing north-west.

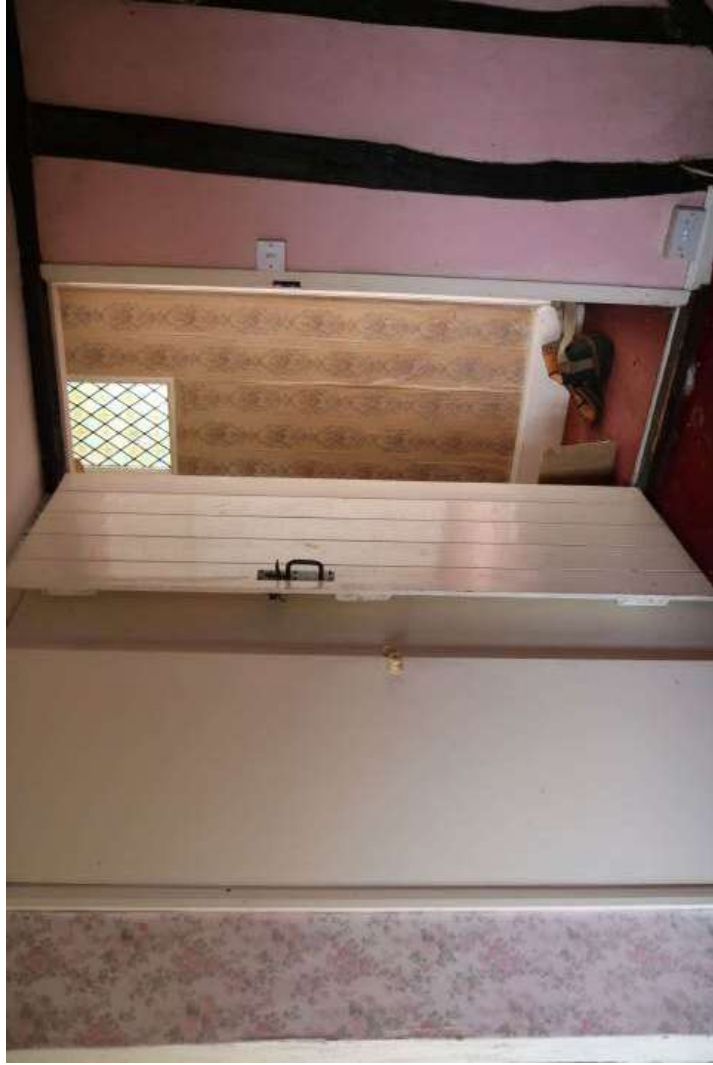
EEEX61395_PhotoGraph_0130
Detail of timber-framing in northern wall of bedroom 4. Photograph taken facing north-east.

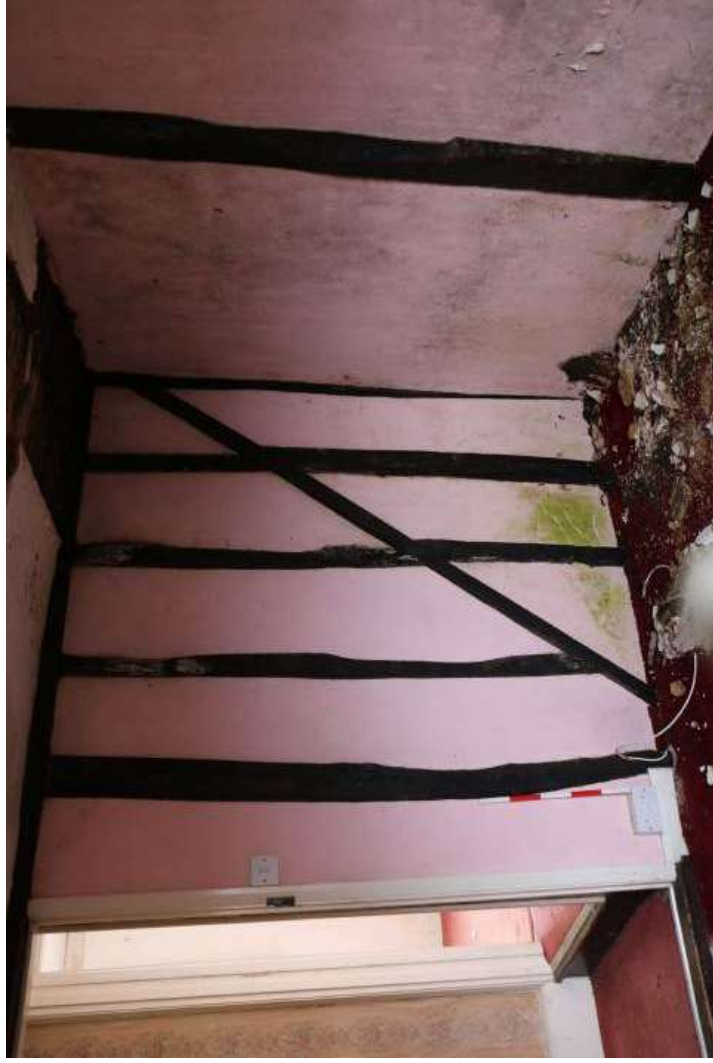
EEEX61395_PhotoGraph_0131
Detail of doorway in southern wall of bedroom 4. Photograph taken facing south-east.

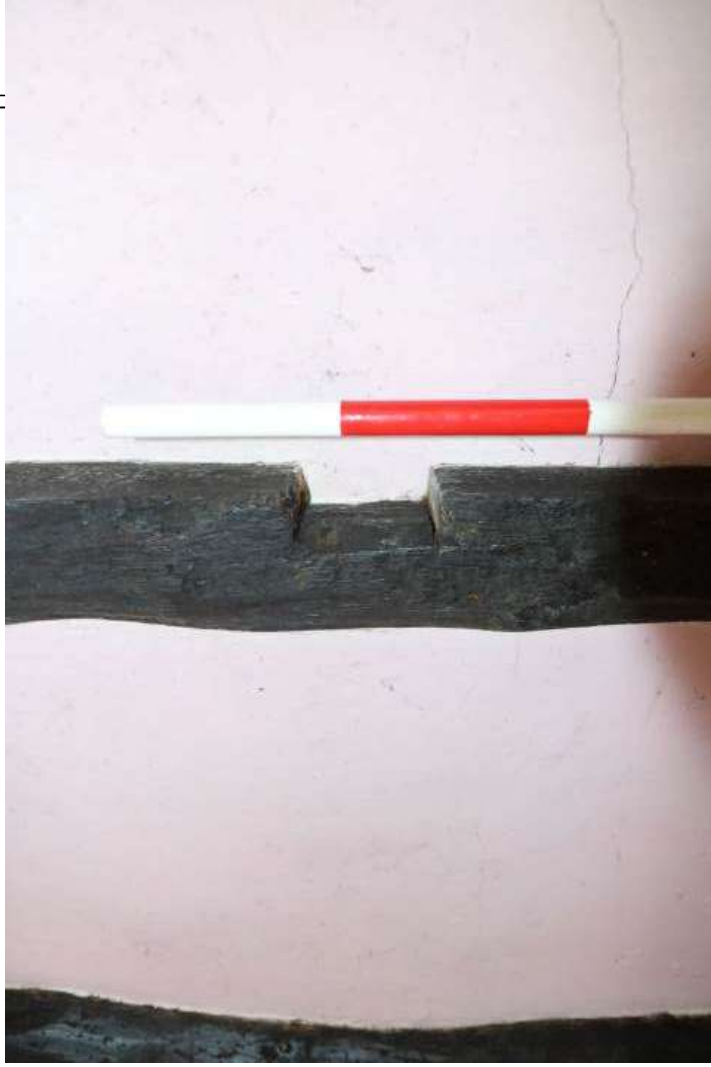
EEEX61395_PhotoGraph_0132
Detail of timber-framing in southern wall of bedroom 4. Photograph taken facing south-west.

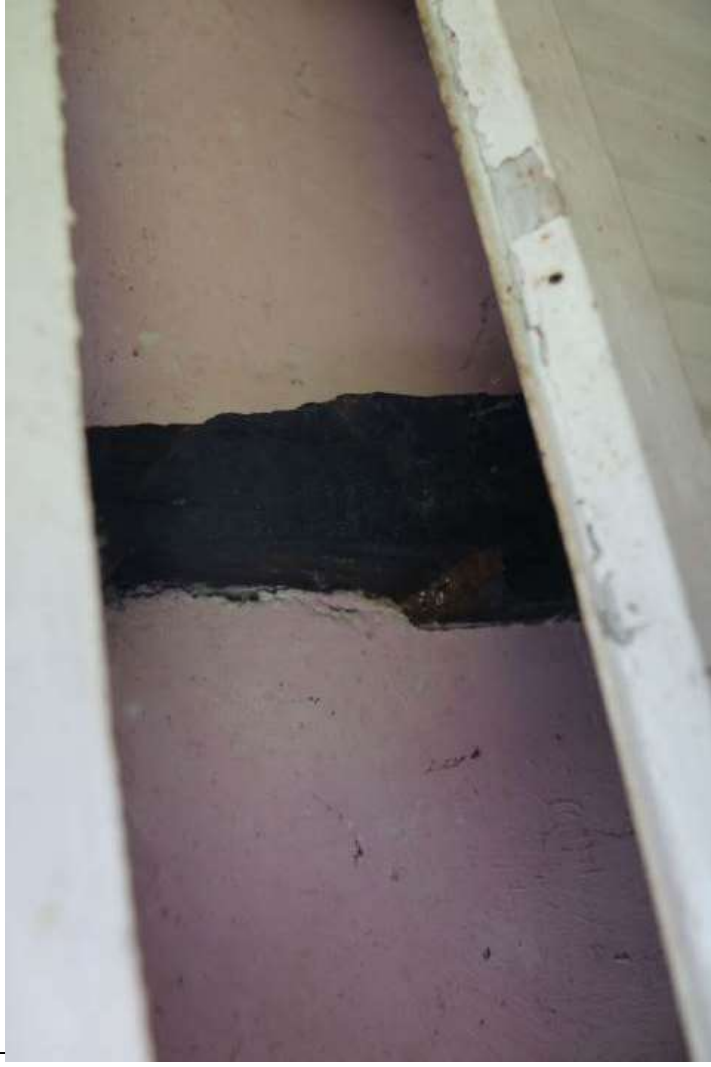
EEEX61395_PhotoGraph_0133
Detail of reused stud in northern wall of bedroom 4, Photograph taken facing north.

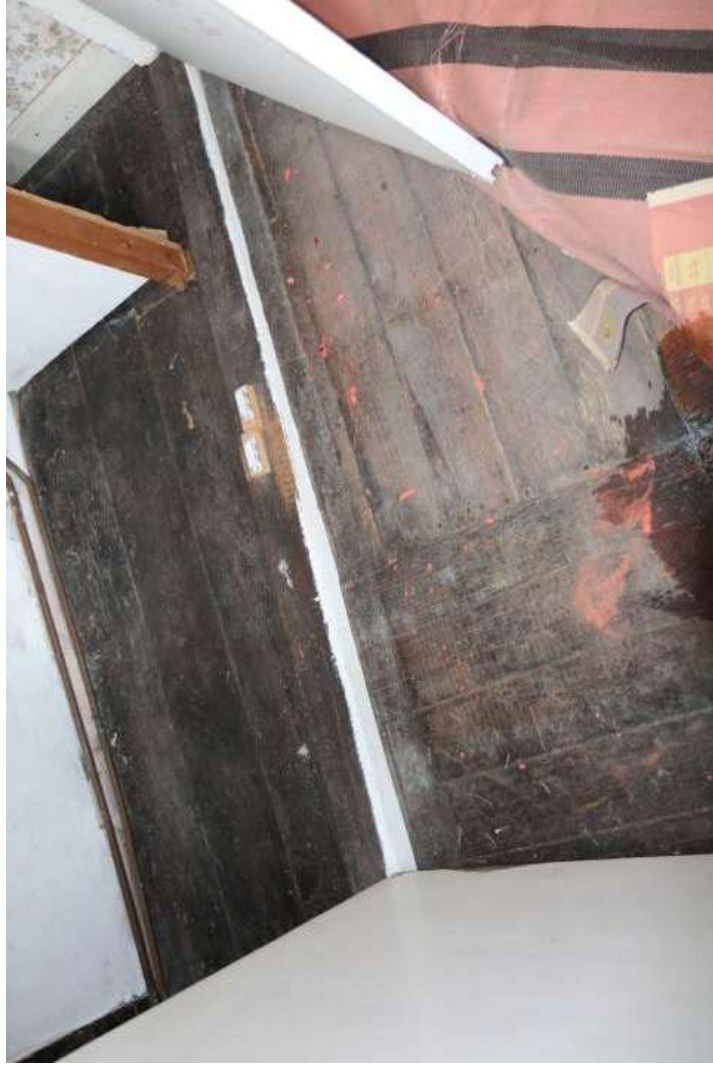
EEEX61395_PhotoGraph_0134
Detail of possibly reused timber in northern wall of bedroom 4, Photograph taken facing north north-east.

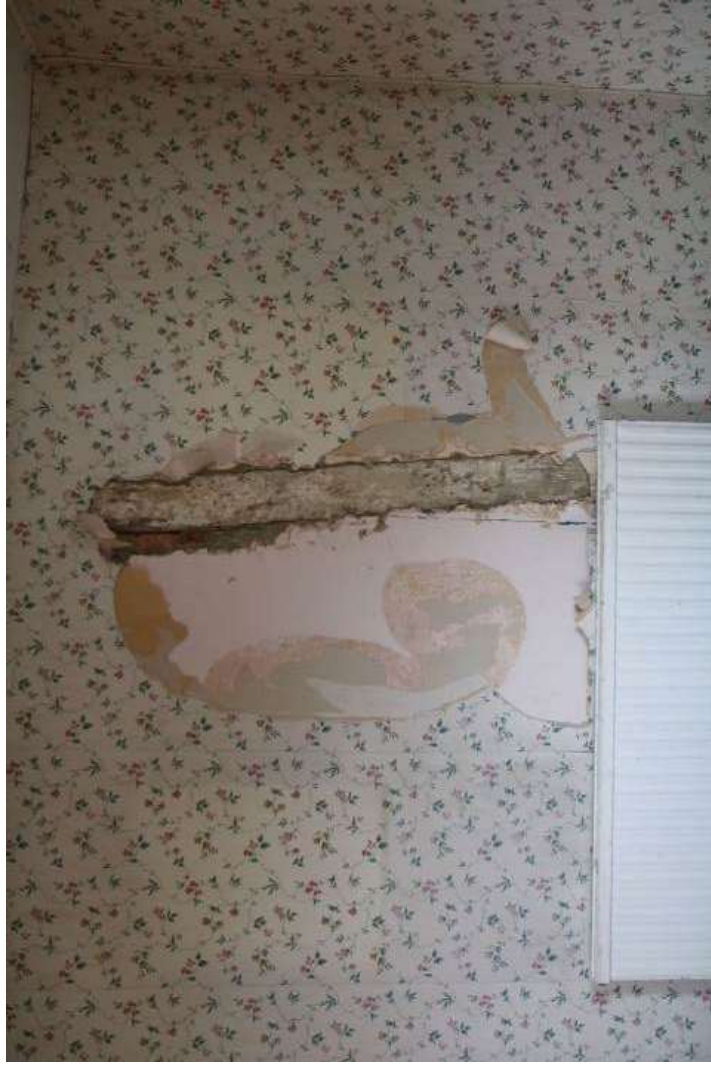
EEEX61395_Photograph_0143
Detail of plaster removal in western wall of bedroom 4, exposing brickwork of chimney. Photograph taken facing west.

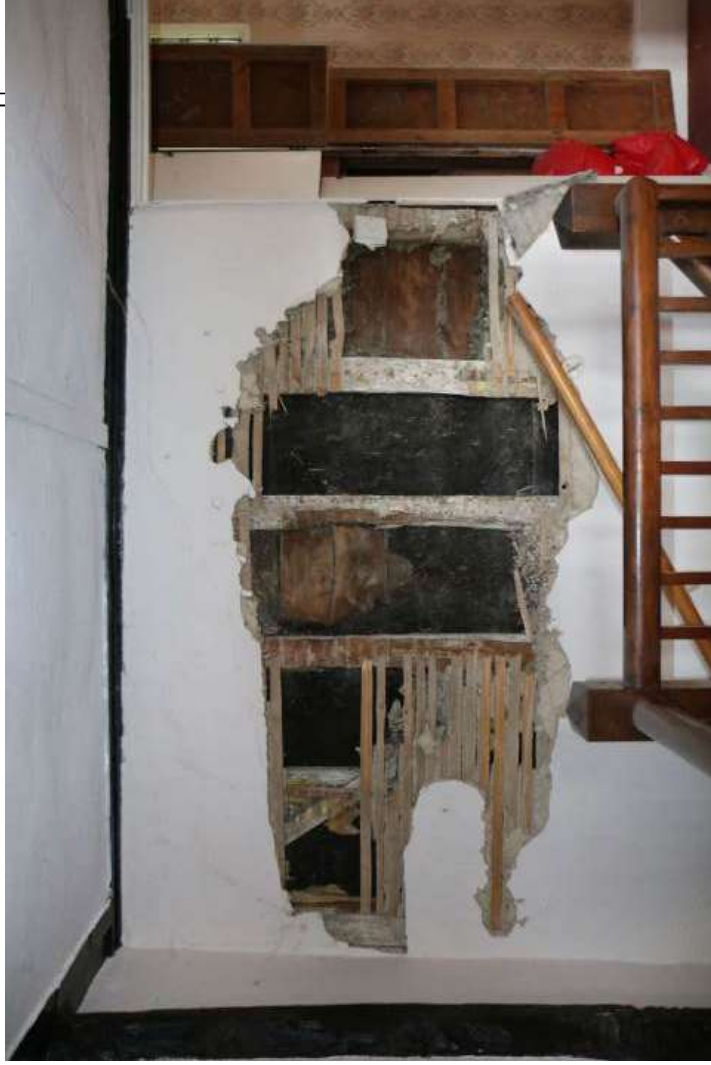
EEEX61395_Photograph_0144
Detail of plaster removal in eastern wall of bedroom 2. Photograph taken facing east.

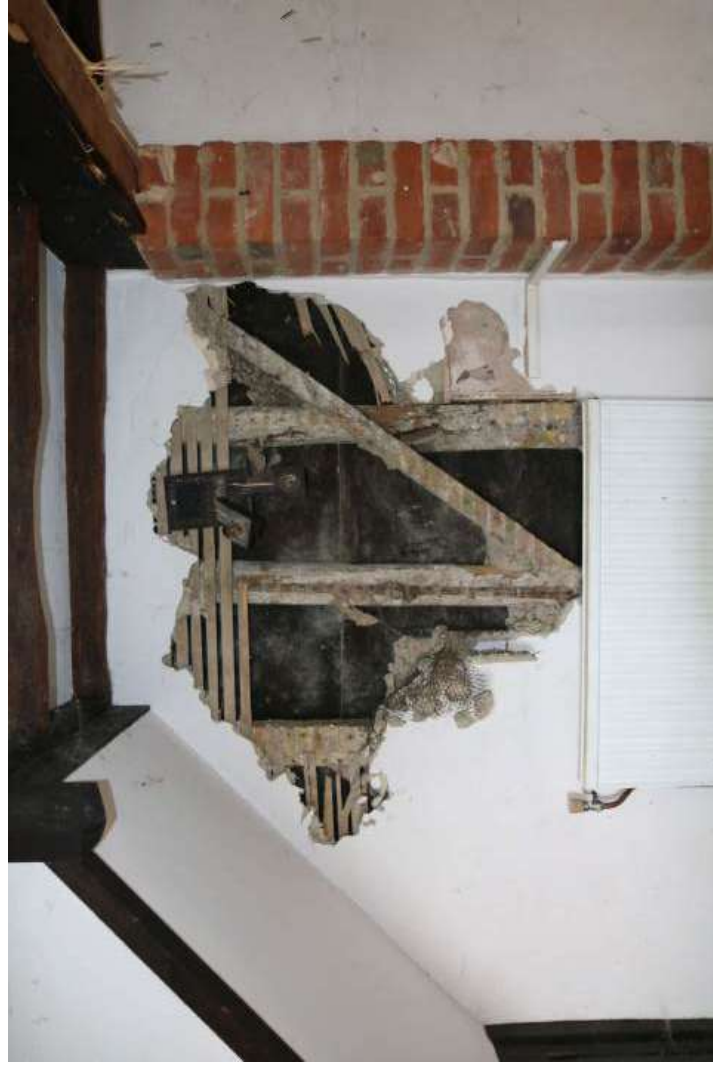
EEX61395_PhotoGraph_0147

Detail of plaster removal in lounge. Photograph taken facing south-west.

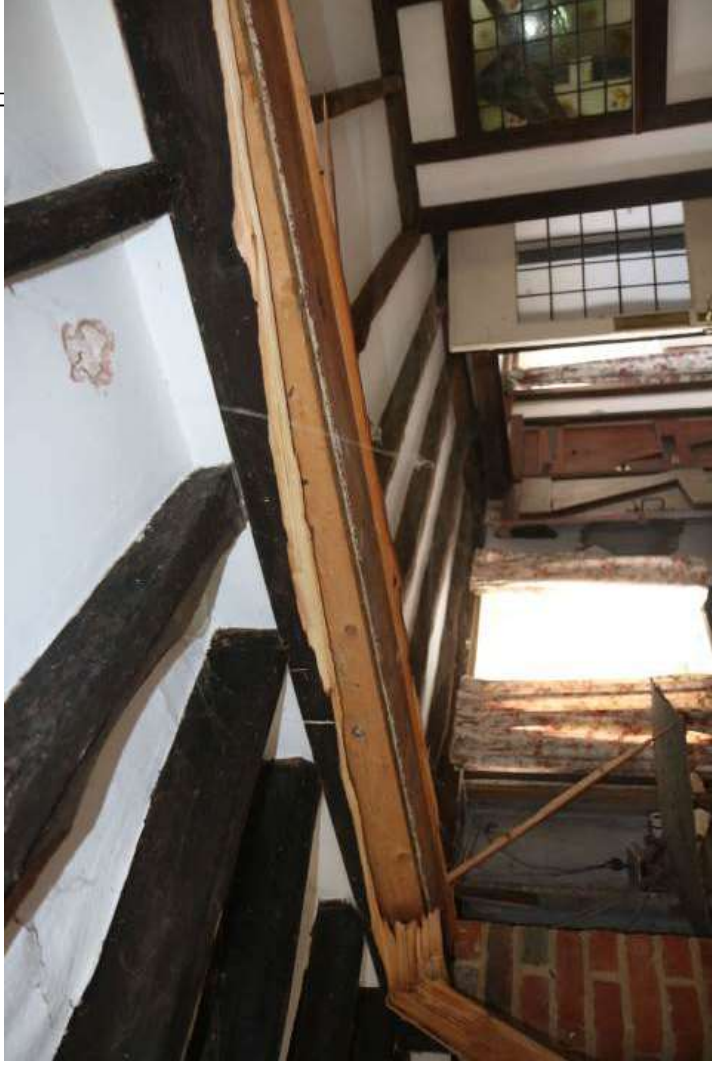
EEX61395_PhotoGraph_0148

Detail of plaster removal in southern wall of lounge. Photograph taken facing south.

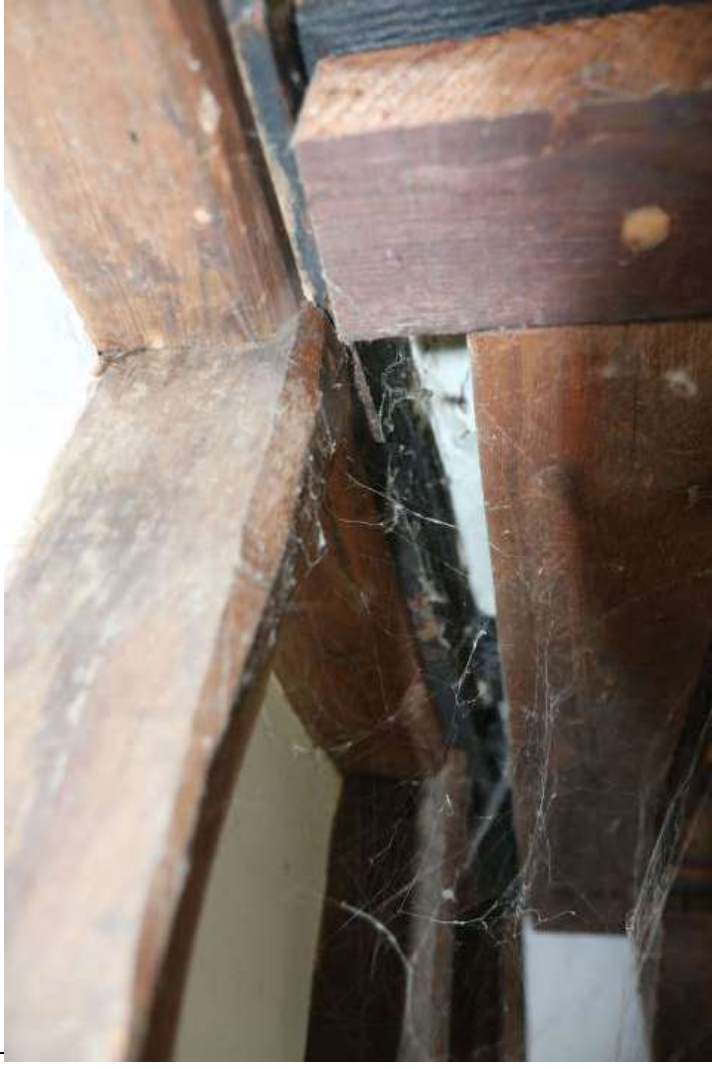
EEEX61395_PhotoGraph_0149
Detail of exposed RSJ in lounge. Photograph taken facing north-east.
