**Historic building recording
at Wickham Hall, Hadham Road,
Bishop's Stortford, Hertfordshire
August 2012**

**report prepared by
Chris Lister**

**commissioned by
Foxley Builders**

CAT Report 733
December 2013

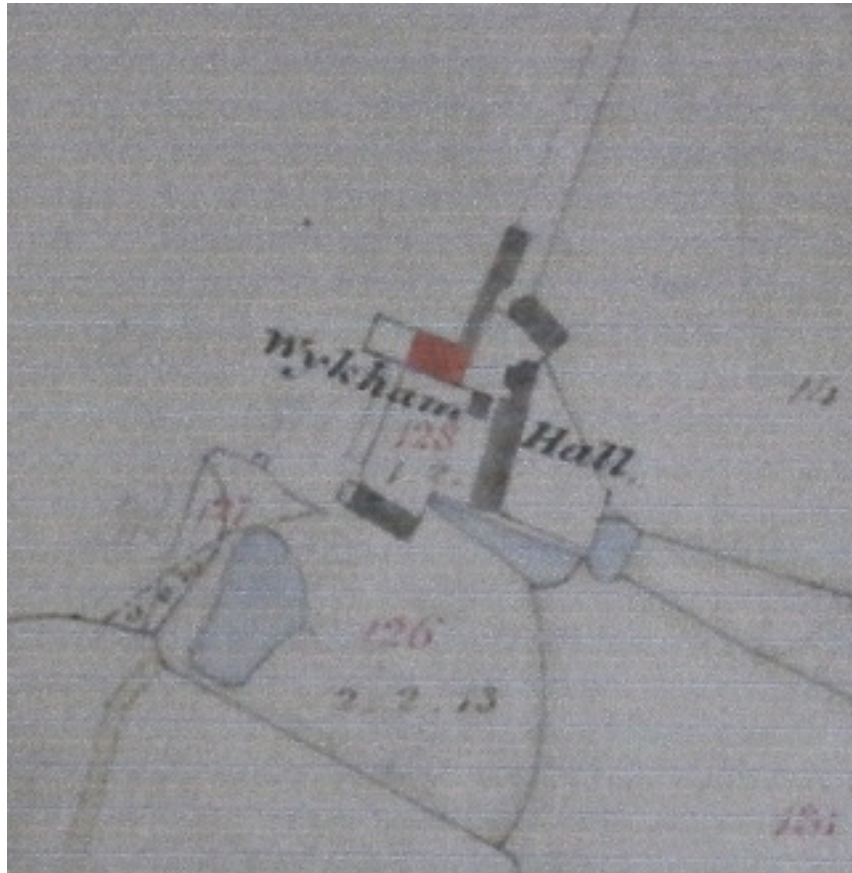
Fig 1 1823 map for 'Equalising the Poor Rates' (HALS D/Z61/P1)

The earliest map depicting Wickham Hall is a map of Bishop's Stortford for the purpose of 'Equalising the Poor Rates', dating to 1823 (HALS D/Z61/P1, Fig 1). This map shows the original hall in red, with later additions to the west and a perpendicular range extending south. The original hall and the later range form a courtyard with structures 2 and 4, the 17th-century barns. Structure 2 forms the southern boundary of the courtyard, whilst structure 4 provides the eastern side of the yard. The form of the historic yard has begun to be altered by the presence of structure 3, the 19th-century granary. Further expansion has taken place to the north of the historic farm core, with structure 1, the free-standing 19th-century barn, located at an angle to the buildings of the courtyard. A range of buildings, comprising stables and sheds (not included in the development area) extend north from the hall. A sizeable extension is shown attached to the north end of structure 4. An interesting omission is structure 5, the outbuilding believed to be contemporary with the 17th-century barns. This should be found at the south-west corner of structure 5 but there is no indication of a building in this location. However, the map does show a small structure attached to the west end of the barn, not present on the later Ordnance Survey mapping. It is possible that this represents the outbuilding, subsequently relocated.

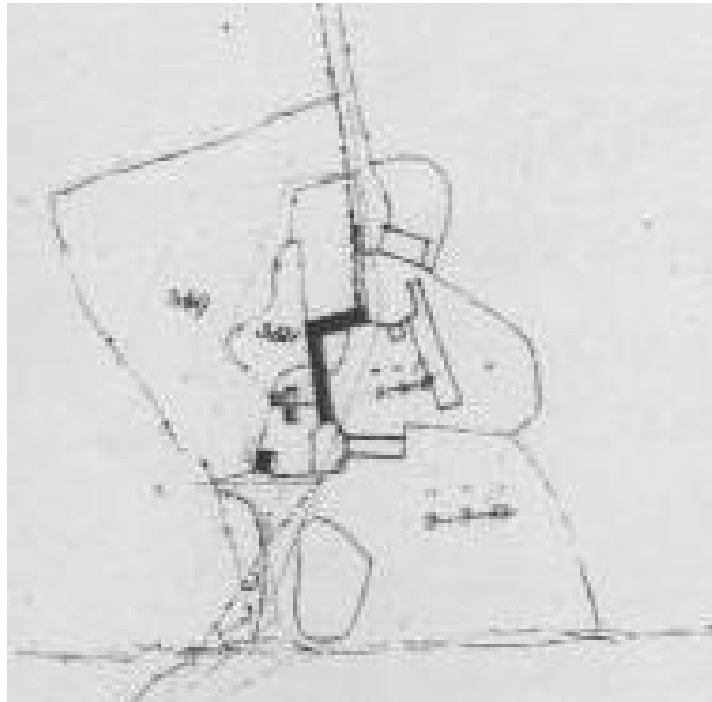
Fig 2 1843 tithe map (ERO D/CT 135B).

The 1843 tithe map for Farnham parish (ERO D/CT 135B, Fig 2) shows little change to the 1823 layout. No additional buildings have been constructed at this point and the small structure at the west end of structure 2 is not present, although neither is there any indication for the 17th-century outbuilding, structure 5. The extension to the north of structure 4 has changed in shape and this may indicate a replacement building. The tithe

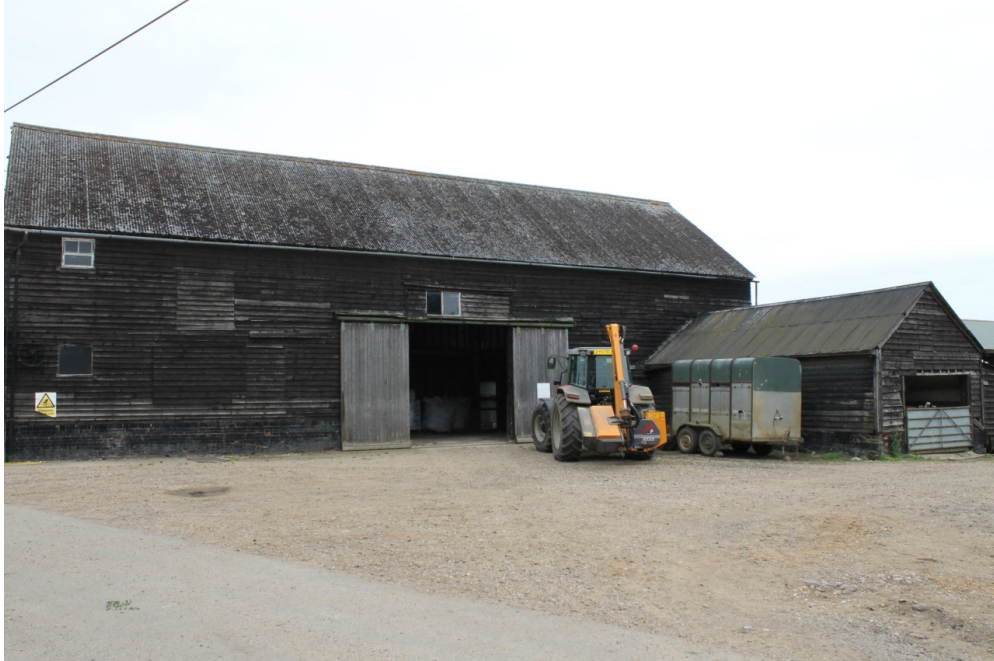
Plate 1 South-west elevation of structure 1 (19th-century barn) with structure 11 (19th-century lean-to) on the right - view north-east

This is a rectangular two-storey timber-framed barn, 9.4m wide by 24.7m long, constructed from softwood timbers and with a gabled roof of corrugated asbestos sheeting. It is aligned north-west to south-east and clad in black-painted horizontal weatherboarding (Plate 1). There is a loose box (structure 11) projecting from the south-west elevation and a single storey extension attached to the north-west end, which dates to the 20th century. The north-east side is obscured by structure 10, the 20th-century horse shed (structure 10). The entire structure sits on a plinth constructed from red brick laid in Flemish bond. The south-west elevation (Fig 9) has a large, centrally located doorway that has been reduced in height, with the original cart doors replaced by a pair of sliding doors. There are two small windows on the north-west corner and two larger blocked openings to the right of these. An iron drive wheel is mounted at the north-west corner of the elevation (Plate 2). The north-west elevation (Fig 8) is partially obscured by the 20th-century extension and is unremarkable. There is a small window inserted near the apex of the gable. The south-east elevation (Fig 10) has plywood sheeting replacing much of the weatherboard below the gable. Towards the north-east corner of this elevation the brick plinth has been cut by the insertion of a doorway. The north-east elevation (Fig 11) has a centrally located doorway. Although this is in the same position as the original doorway, the doors are much smaller replacements, with the original opening partially blocked. A doorway has been inserted through the brick plinth to the left of the larger opening.

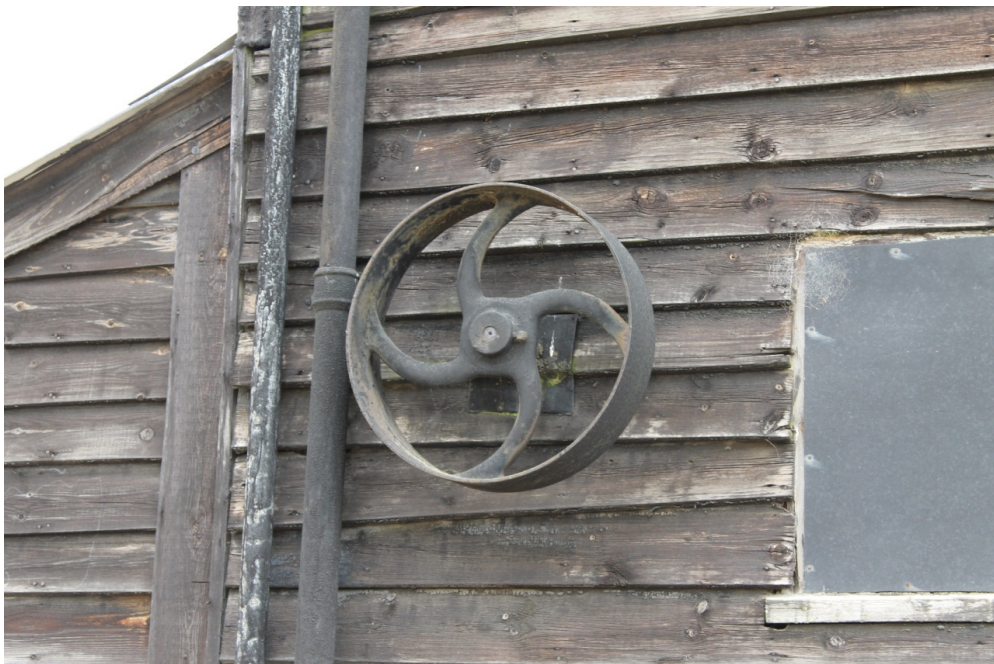
Plate 2 Iron drive wheel on corner of structure 1 – view north

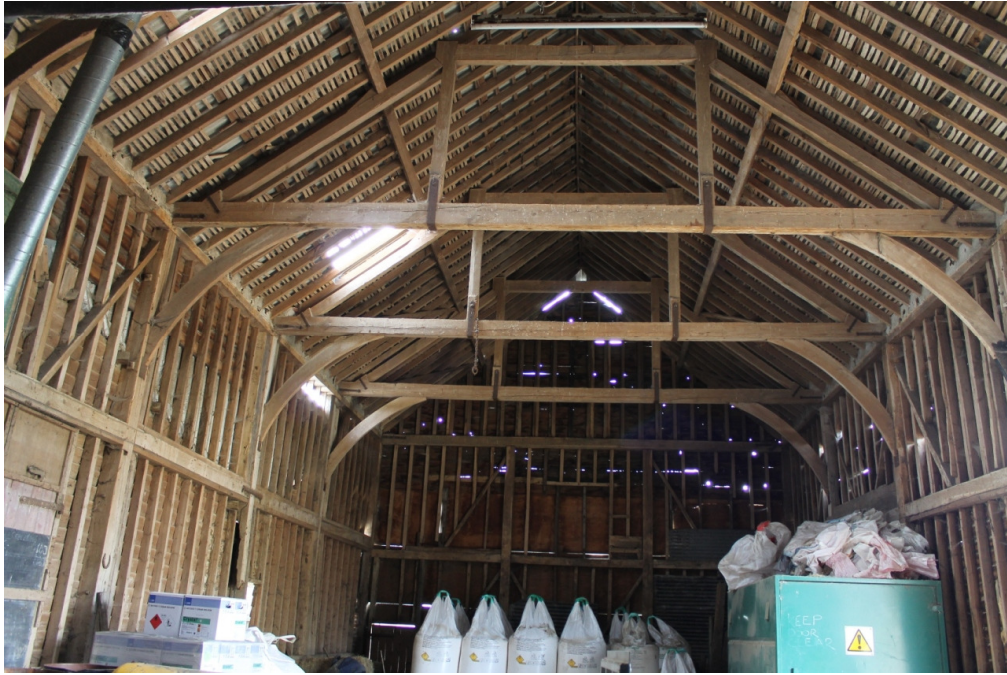
Plate 3 Interior of barn 1 – view south-east

The interior of the barn is divided into seven bays of roughly equal width (Fig 7, Plate 3). The floor is of loose dirt, apart from bay 4, part of bay 5 and a section connecting the two inserted doors, which is of degraded concrete. The principal posts are large section, square-cut timbers rising from a sill beam carried on the brick plinth, with girding beams in between. The wall frames have close studs with primary straight braces, although in places, notably the north side of bays 5-7, the studding has been replaced and the bracing omitted. The principal posts are held under tension by tie beams carried on the wall plate. These support queen post trusses, the joints of which are strengthened with iron strapping (Fig 12, Plate 4). Queen post roofs were often constructed when the width of the building required a tie beam longer than the timber available. The tie beam would then be

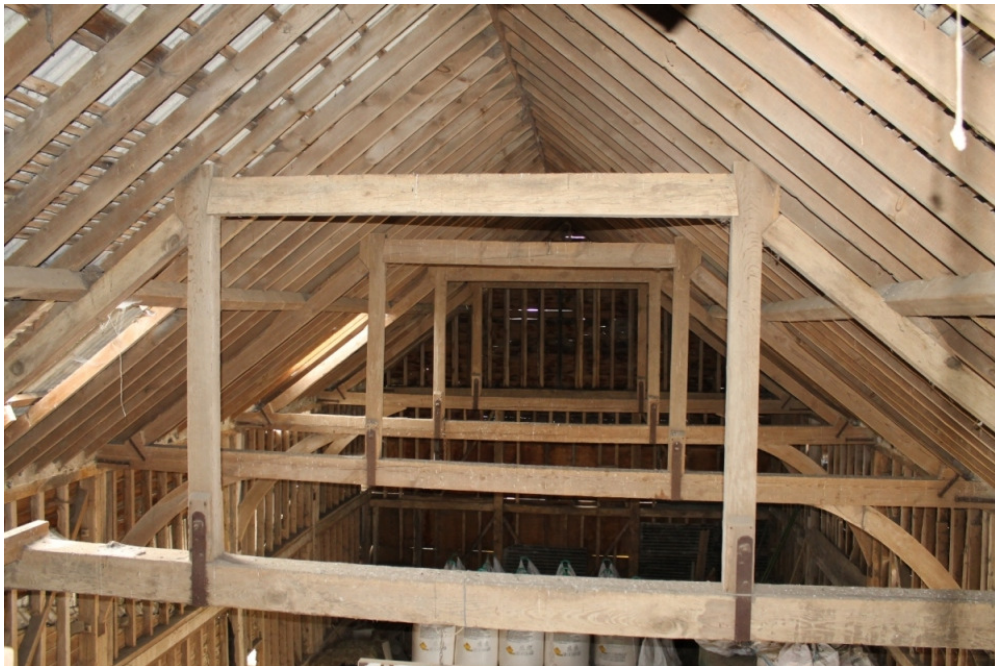
Plate 4 Interior of barn 1a showing queen post roof trusses – view south-east

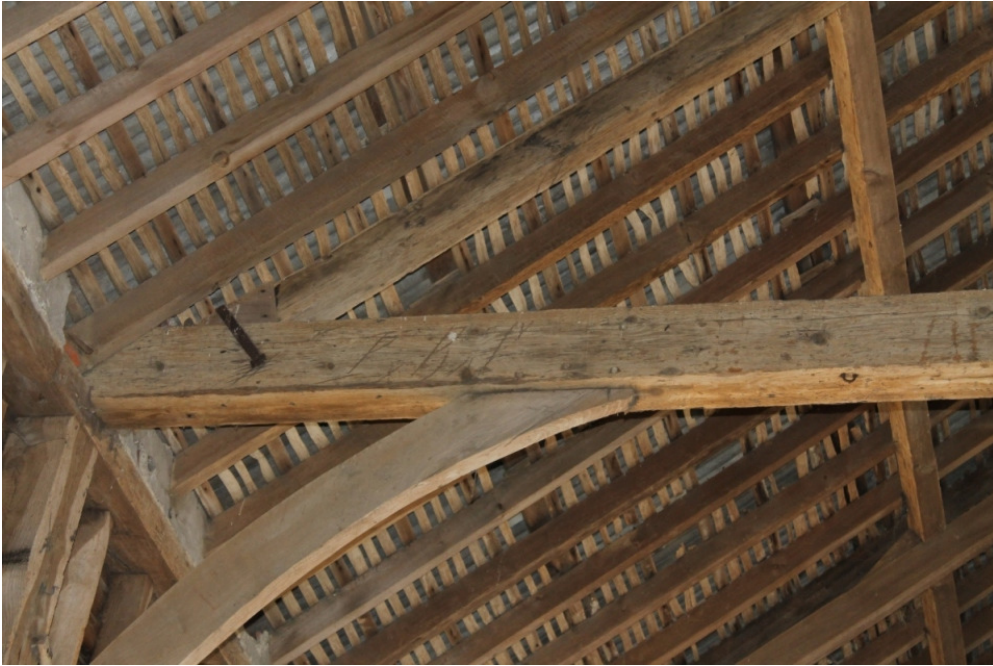
Plate 5 Baltic marks on tie beam of truss D – view west

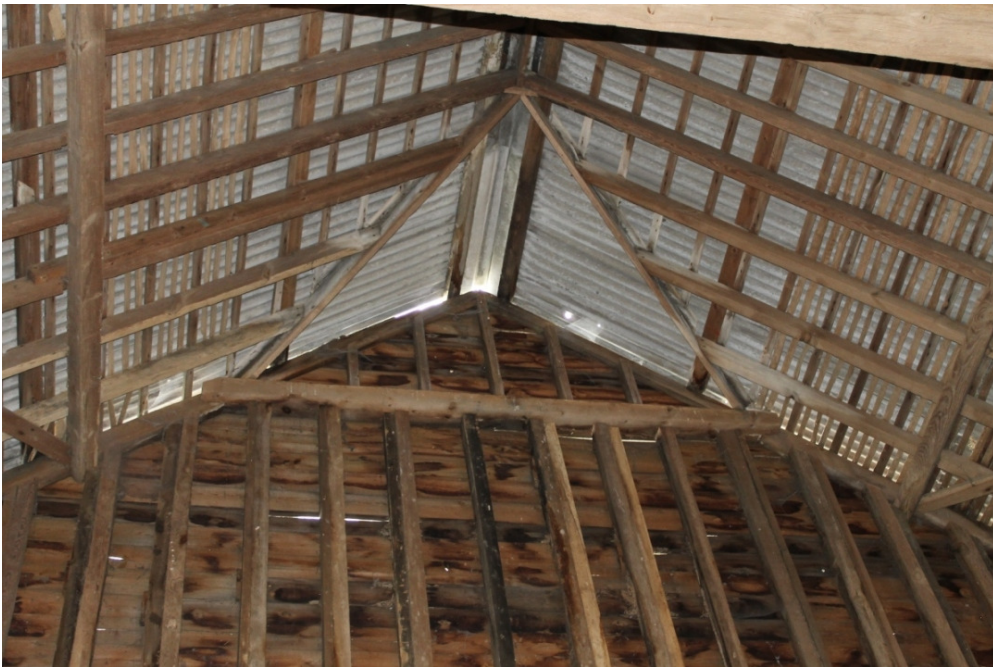
Plate 6 South-east gable of structure 1, showing the earlier half-hipped roof

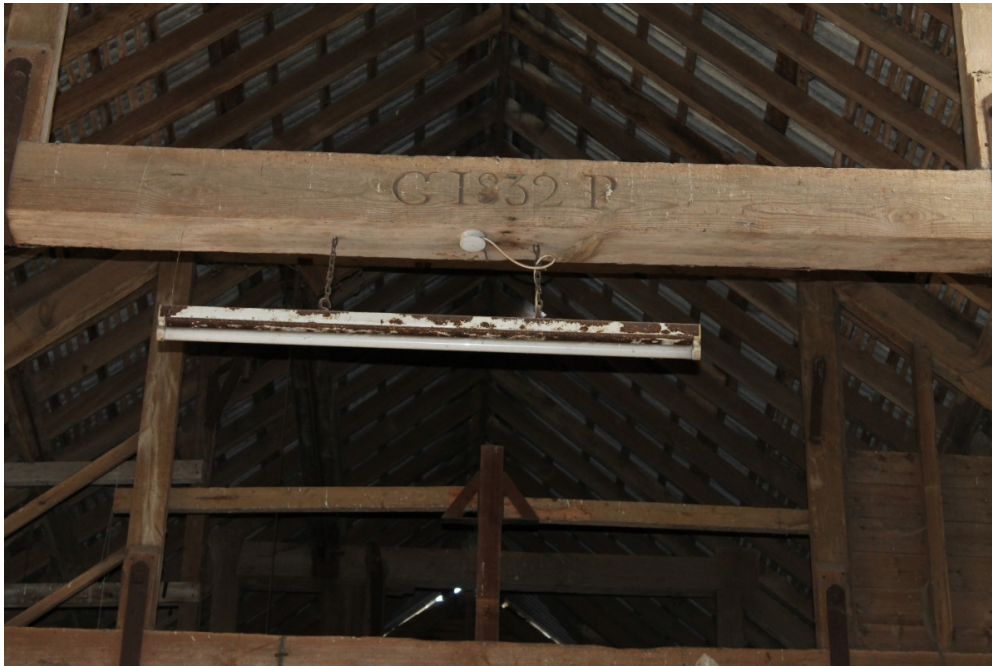
Plate 7 Structure 1, inscription "G 1832 P" on tie beam of truss C, probably commemorating the date the barn was built and the initials of the builder - view north-west.

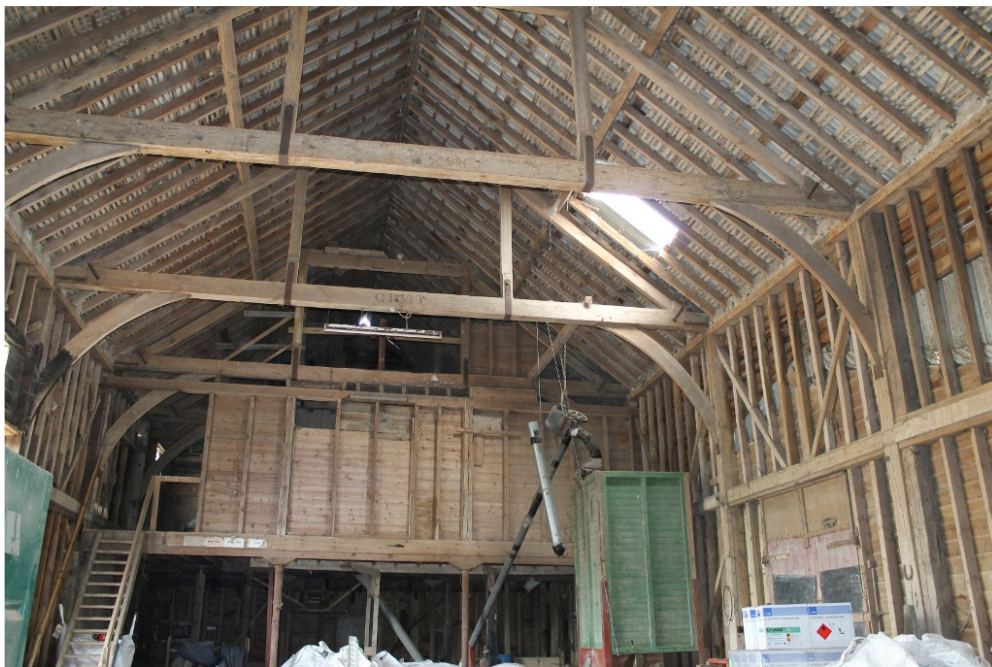
Plate 8 Mezzanine occupying bays 1 and 2 - view north-west.

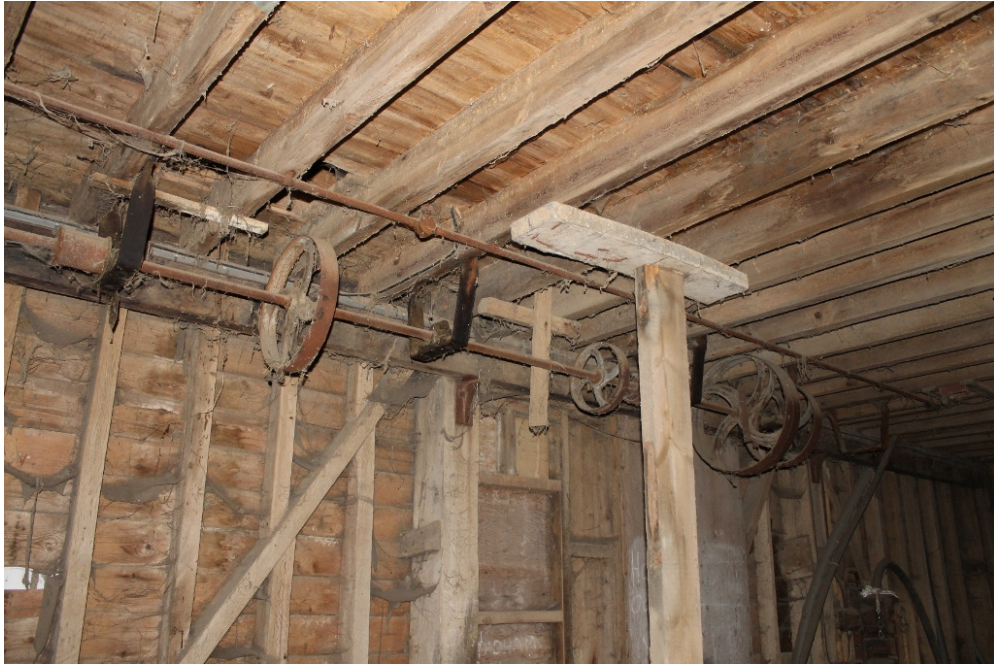
Plate 9 Structure 1, drive belt linkage in bay 1 below the mezzanine. The power was transferred from the wheels via belts passing through voids in the mezzanine floor to machinery on the first floor - view north-west.

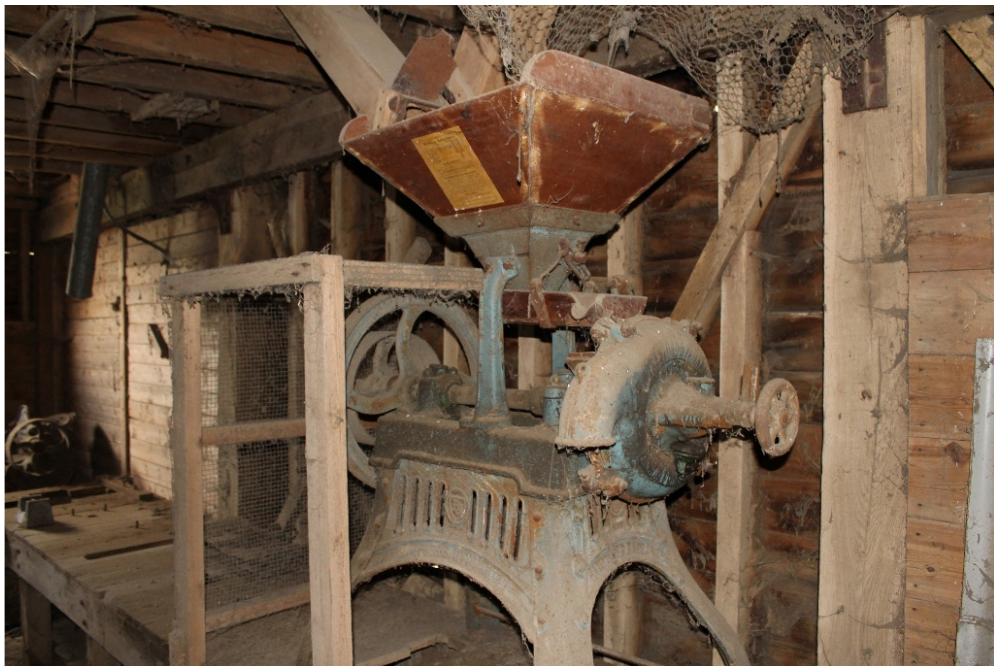
Plate 10 Victorian belt-driven grinder by Bamfords on the first floor of the mezzanine. The slots for the transfer belts can be seen in the top of the workbench and the oil cake breaker can be seen on the far left - view west

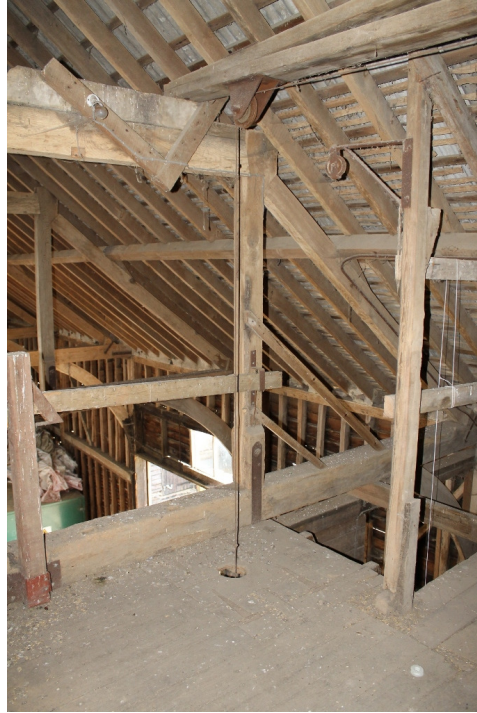
Plate 11 Second floor of the mezzanine showing grain hoist trap door and ladder to the first floor - view south-east.

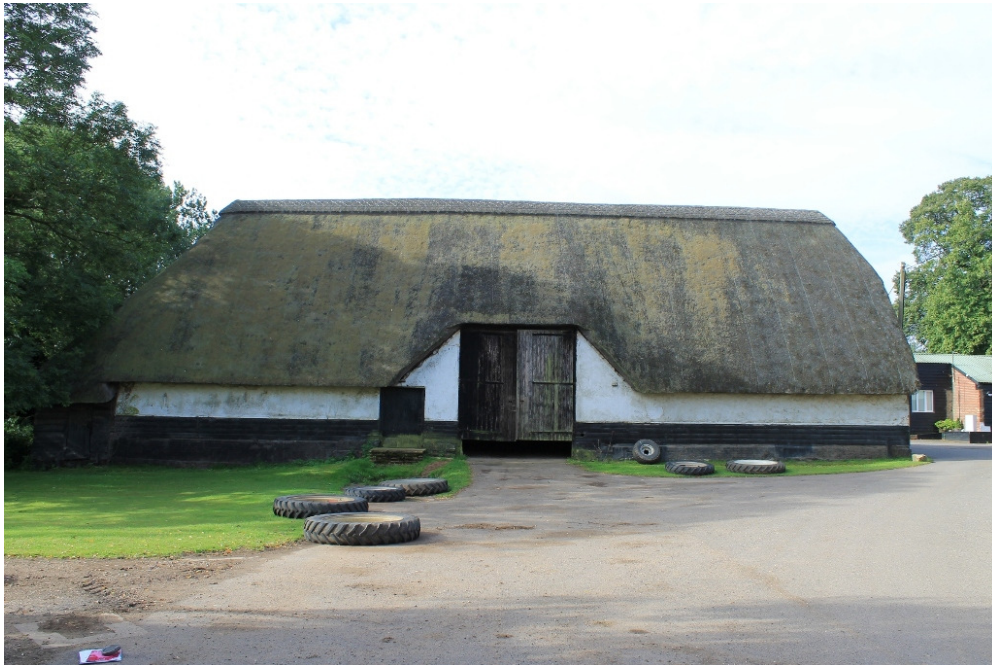
Plate 12 Structure 2, 17th-century aisled barn - view south.

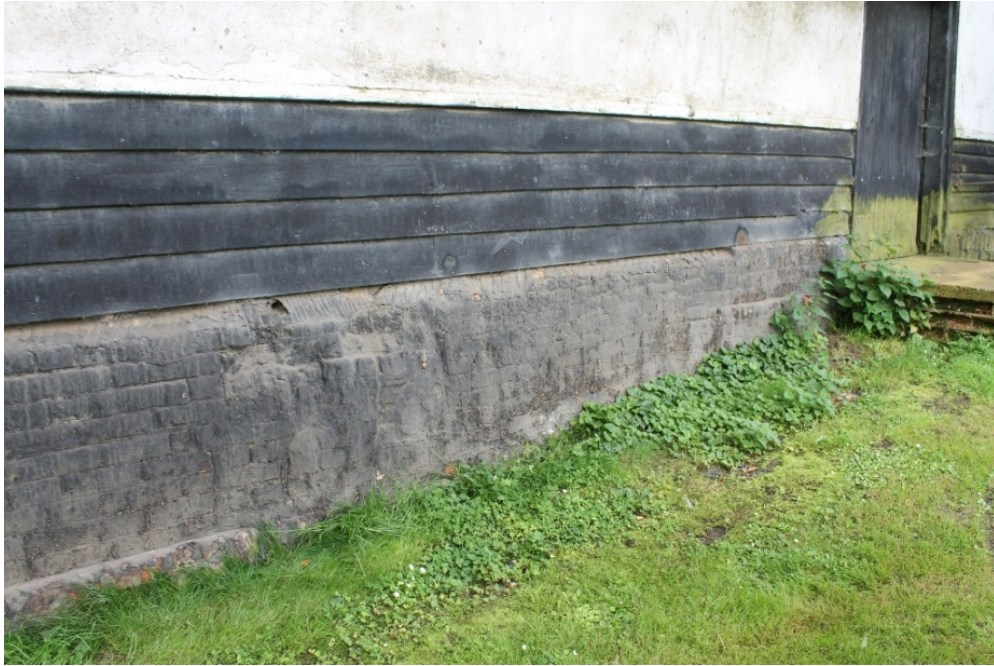
Plate 13 The brick plinth to the north elevation of structure 2, showing the change in brickwork where the original cart door entrance has been filled in - view south-west.

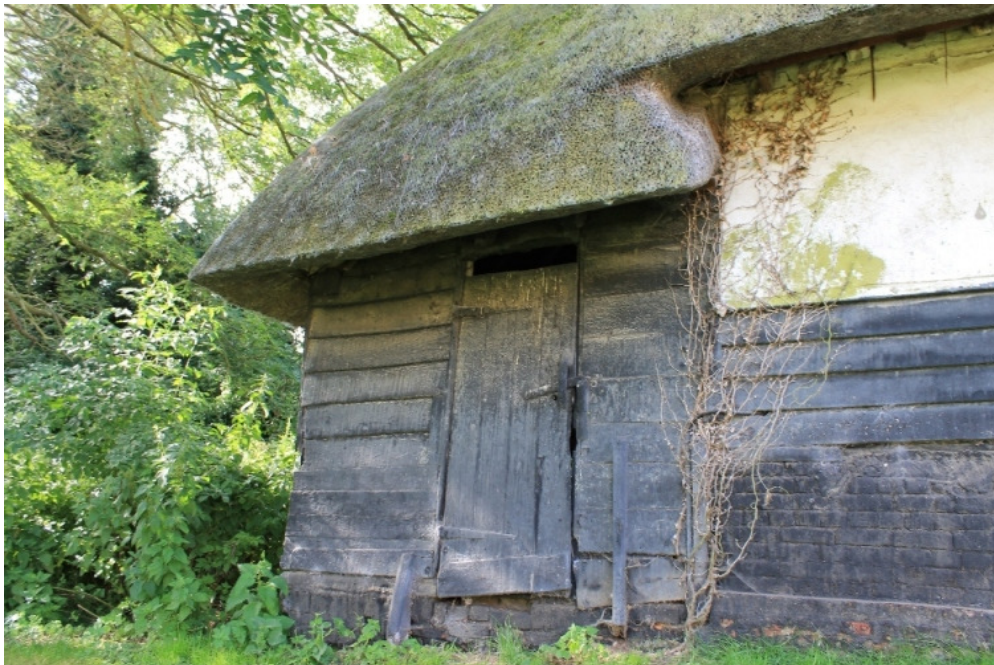
Plate 14 North elevation of the lean-to at the end of structure 2, possibly with the original weatherboard and door - view south-east

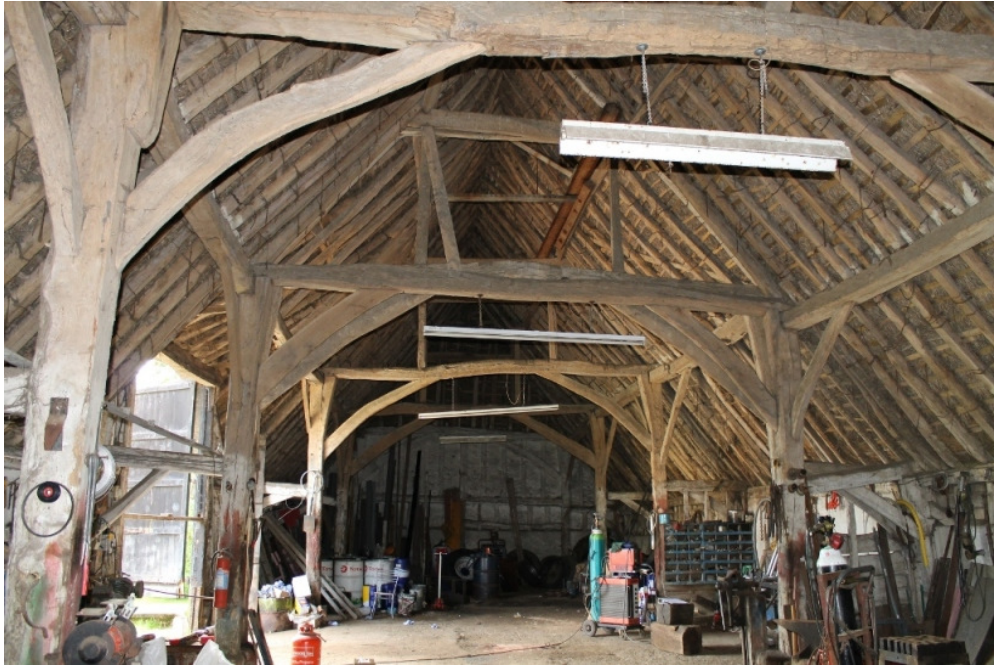
Plate 15 Interior of structure 2 – view east

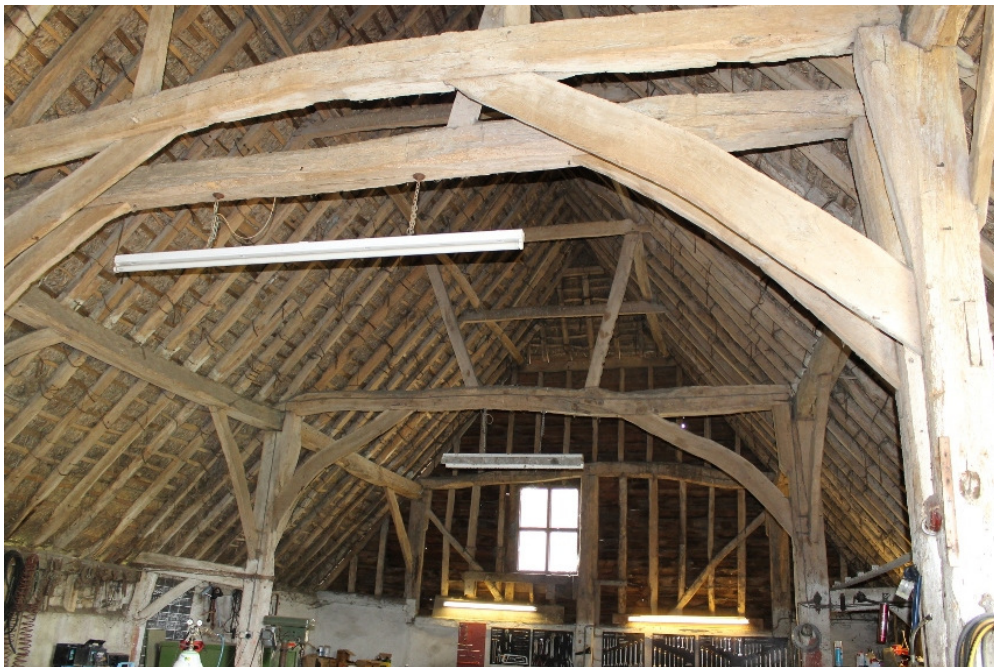
Plate 16 Abutting arcade posts to trusses of structure 2 where the early 17th-century barn joins the mid-late 17th-century barn - view west

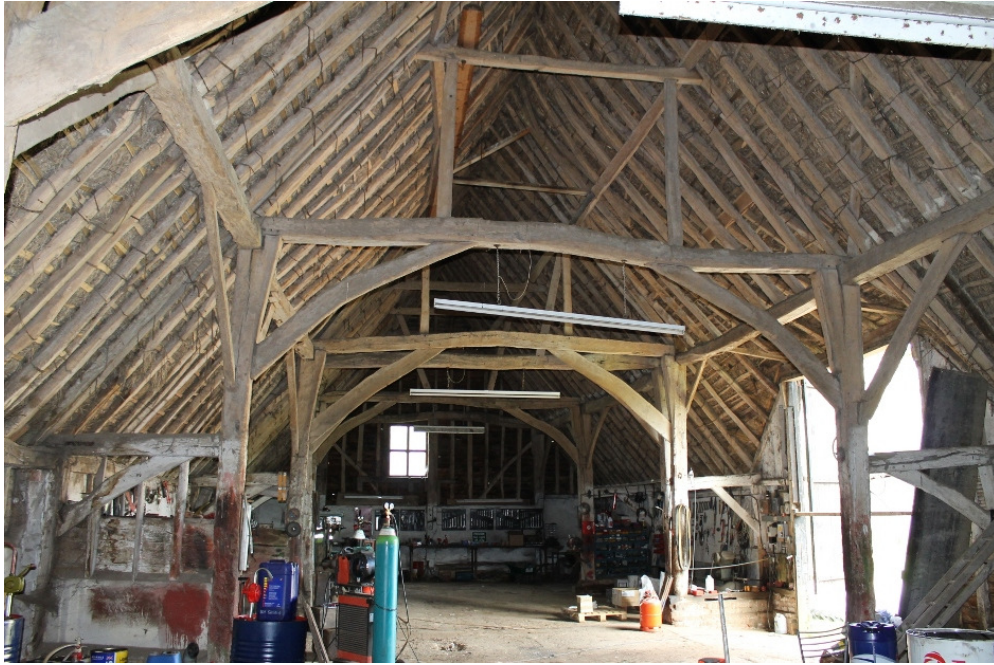
Plate 17 Structure 2, truss D of the early 17th-century barn with straight queen posts – view west

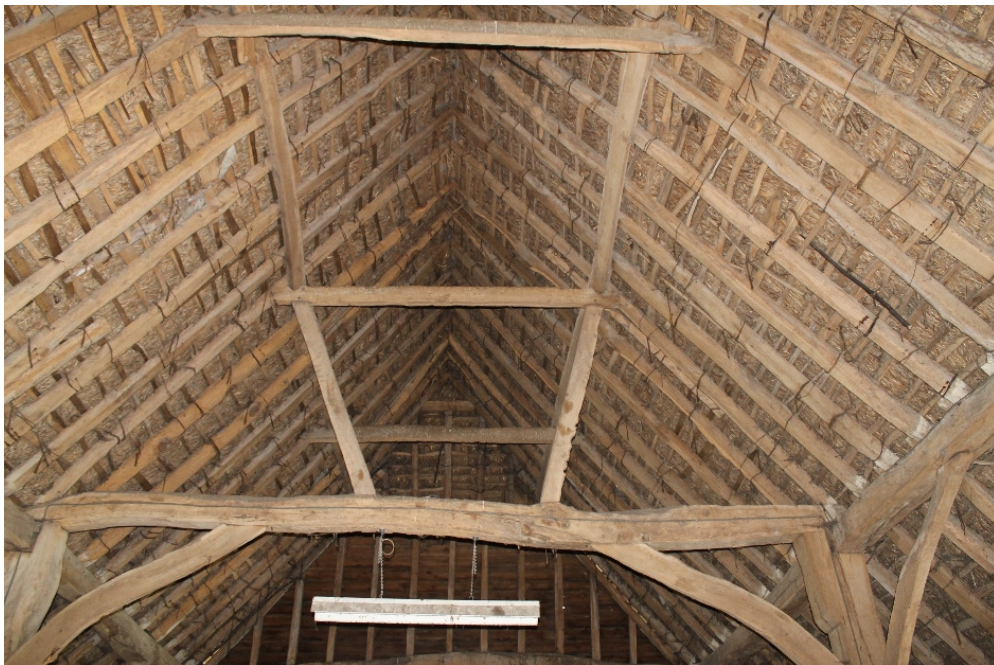
Plate 18 Structure 2, truss A of the mid-late 17th-century barn with inclined queen posts – view west

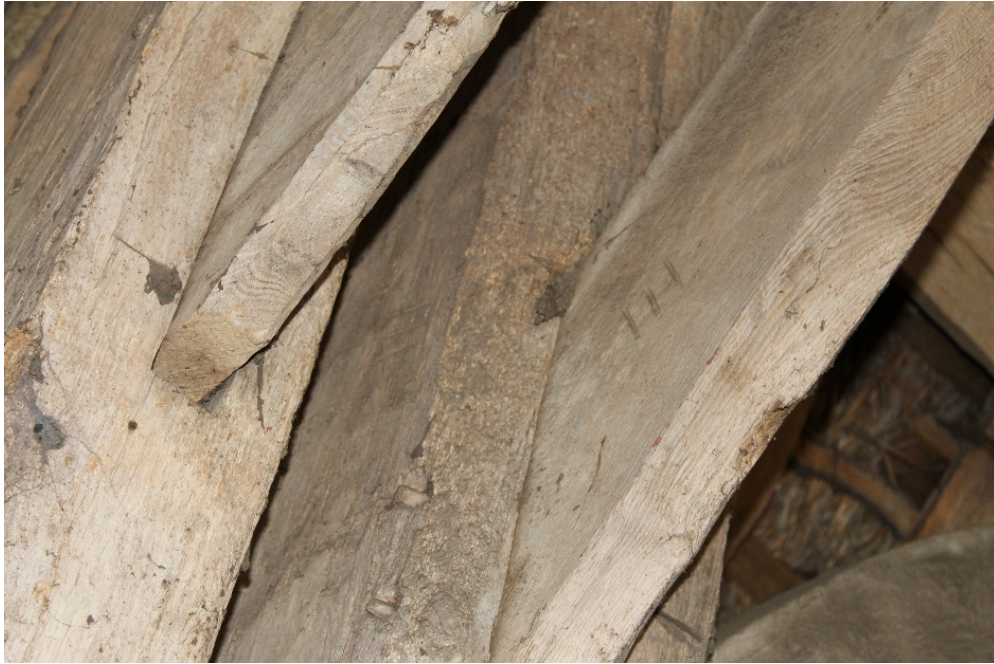
Plate 19 Carpenter's mark (III) on south arcade post and tie beam brace of truss B - view south-west

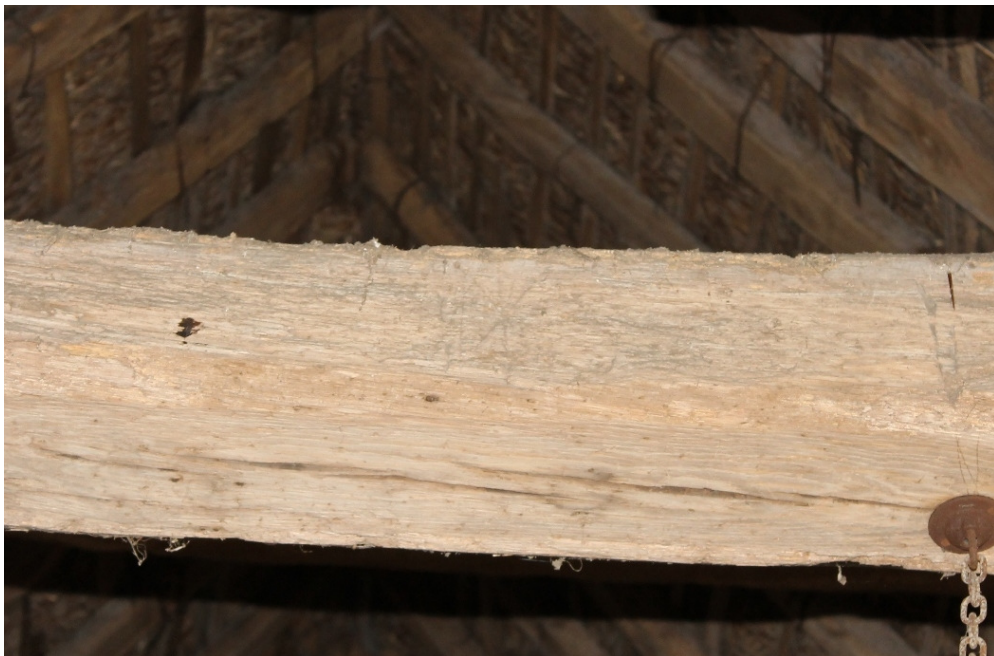
Plate 20 Unusual carpenter's mark on tie beam of truss B – view south-west

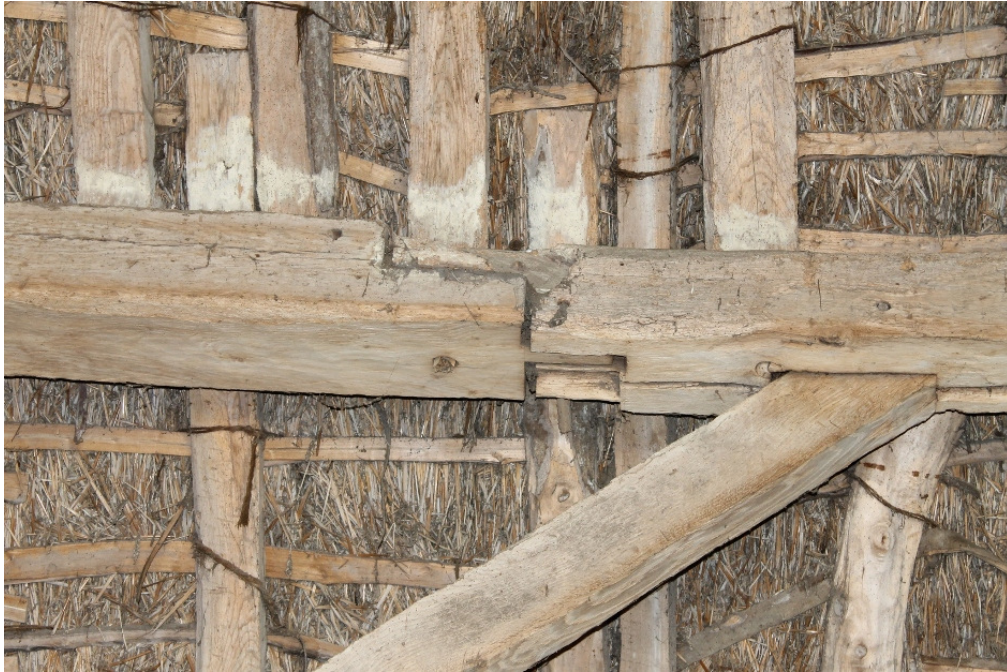
Plate 21 Edge-halved scarf joint with bladed abutments on south arcade plate of bay 3 – view south

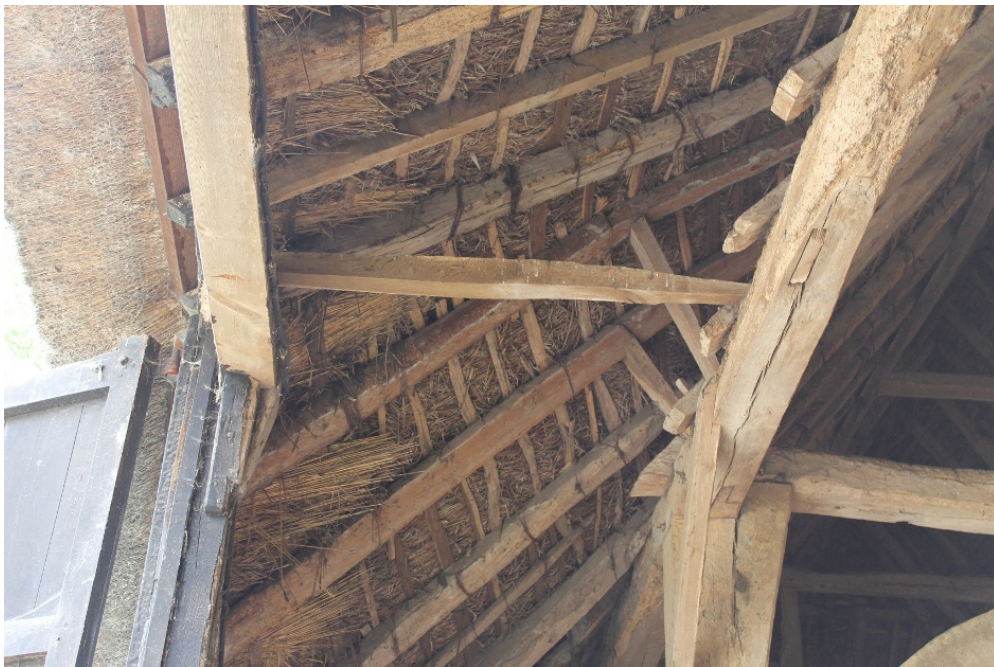
Plate 22 Re-located porch to structure 2 showing rafters ending at the arcade plate and the sawn-off ends of the brace - view east

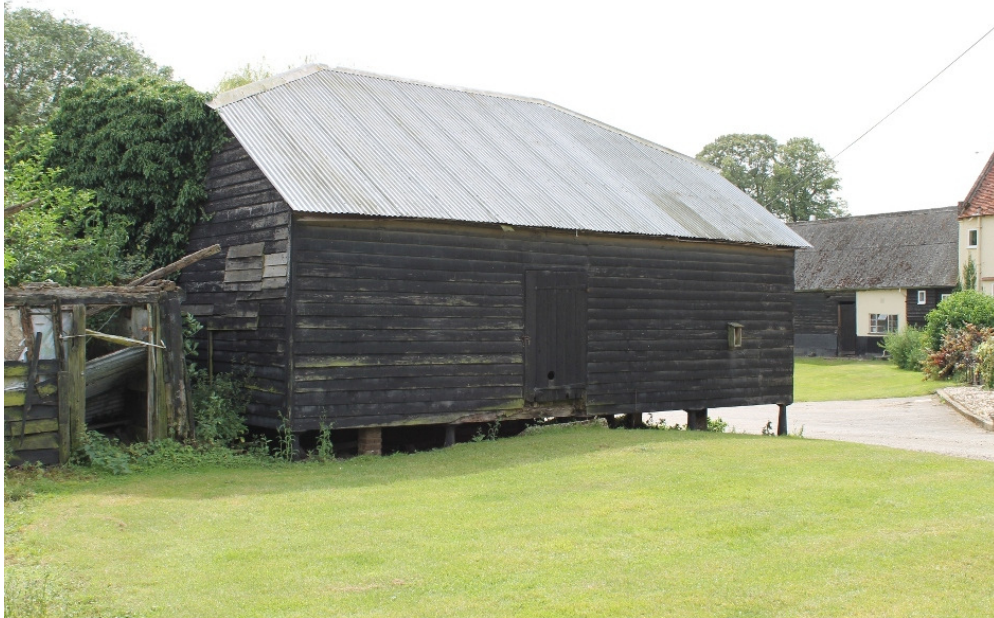
Plate 23 Structure 3, 19th-century granary - view south-west

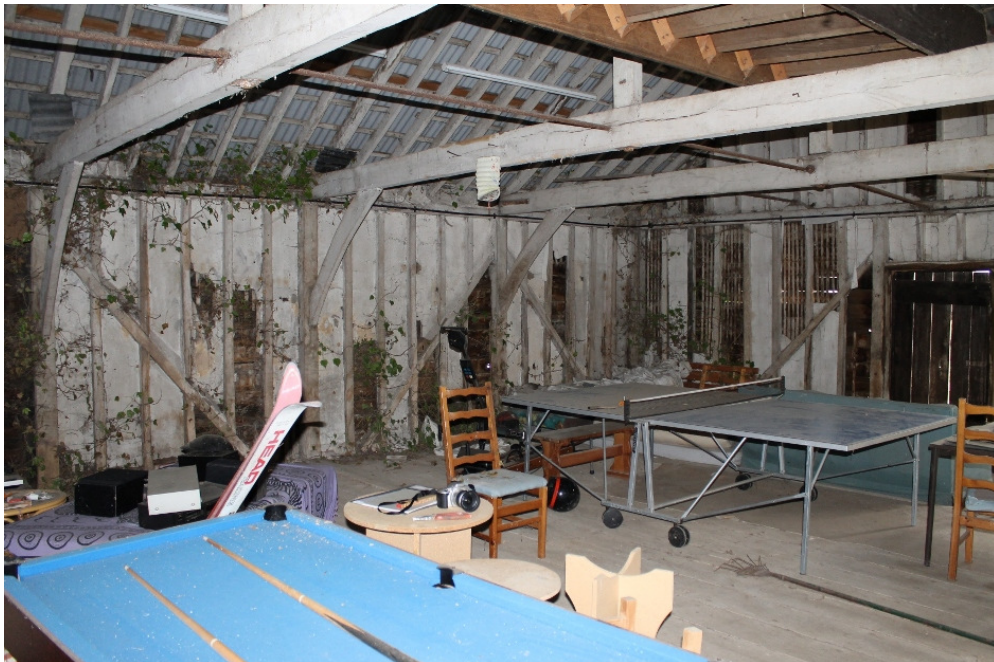
Plate 24 Interior of structure 3, 19th-century granary – view south-west

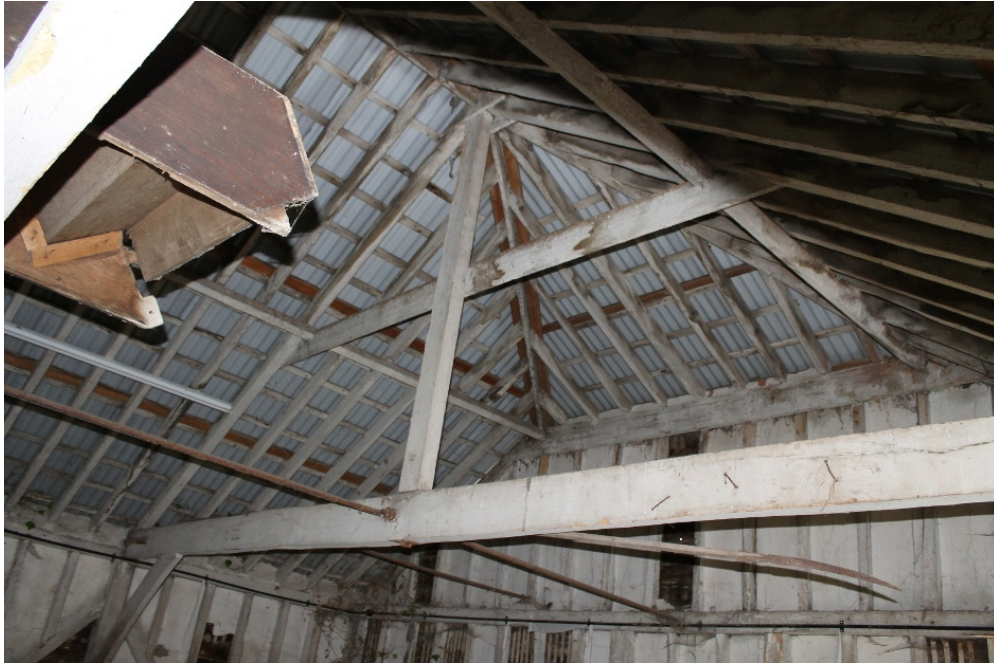
Plate 25 Structure 3, kingpost roof truss showing strengthening tie bolt and collar – view south-west

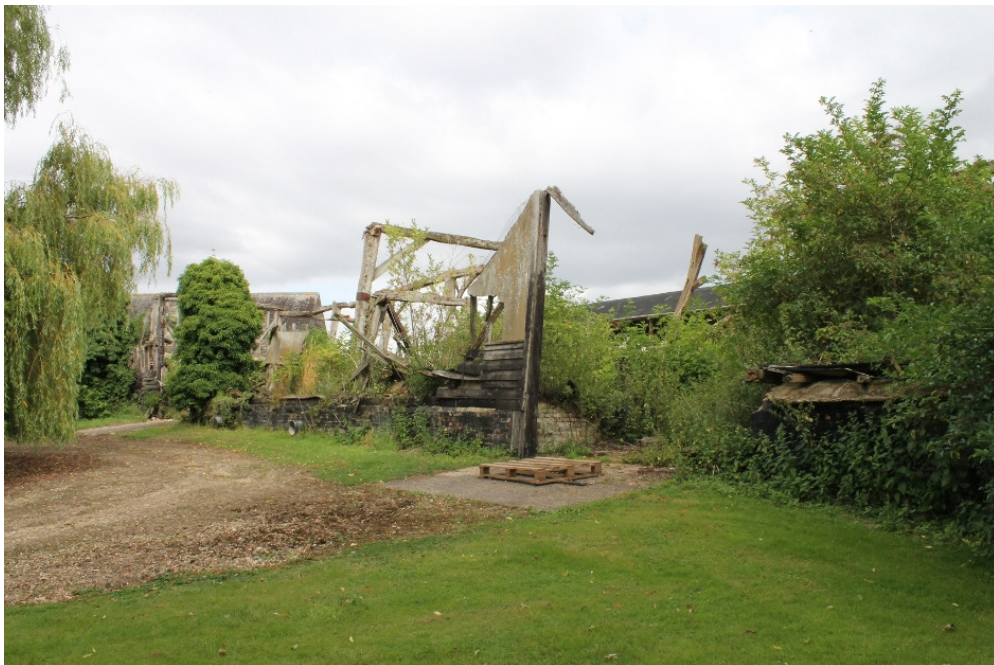
Plate 26 Structure 4, 17th-century aisled barn – view north-east

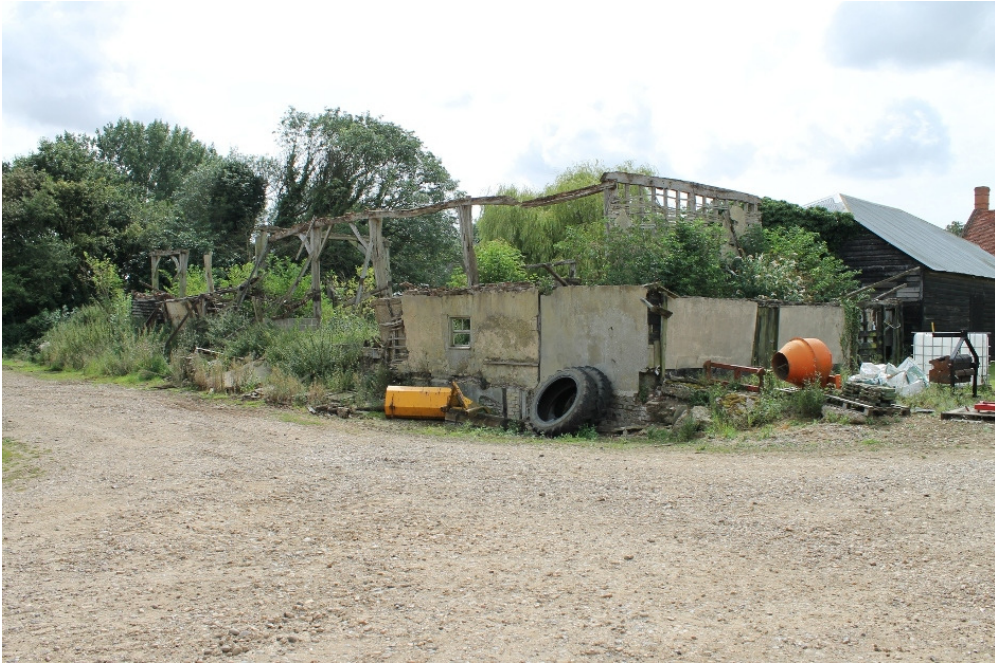
Plate 27 Structure 4, with the 19th-century extension in the foreground – view south-west

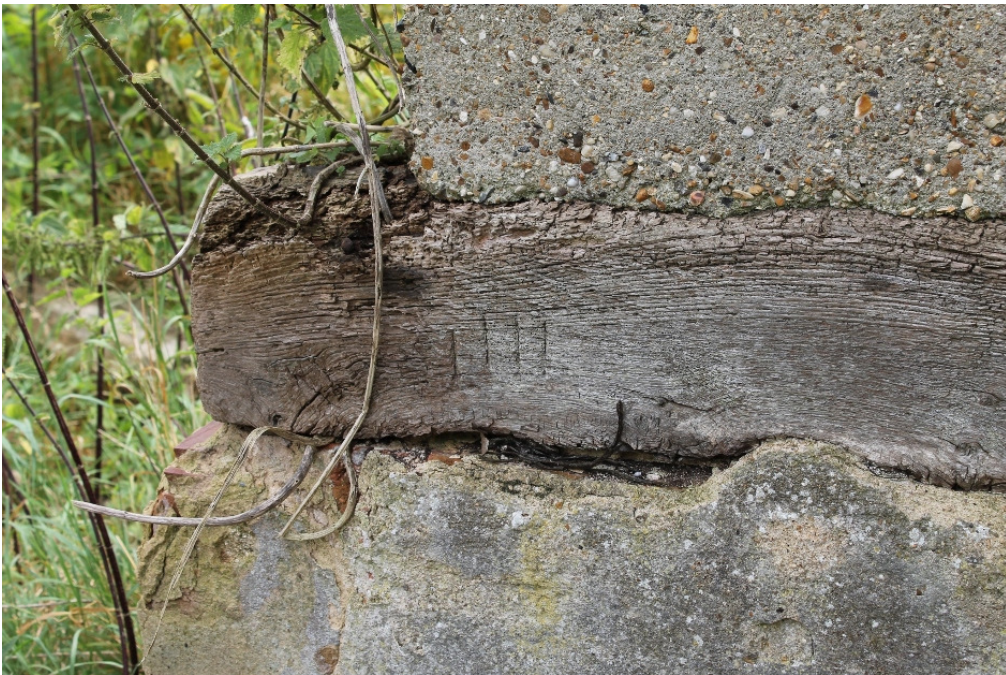
Plate 28 Structure 4, carpenter's mark (III) on aisle sill beam to bay 3/4 - view south-east

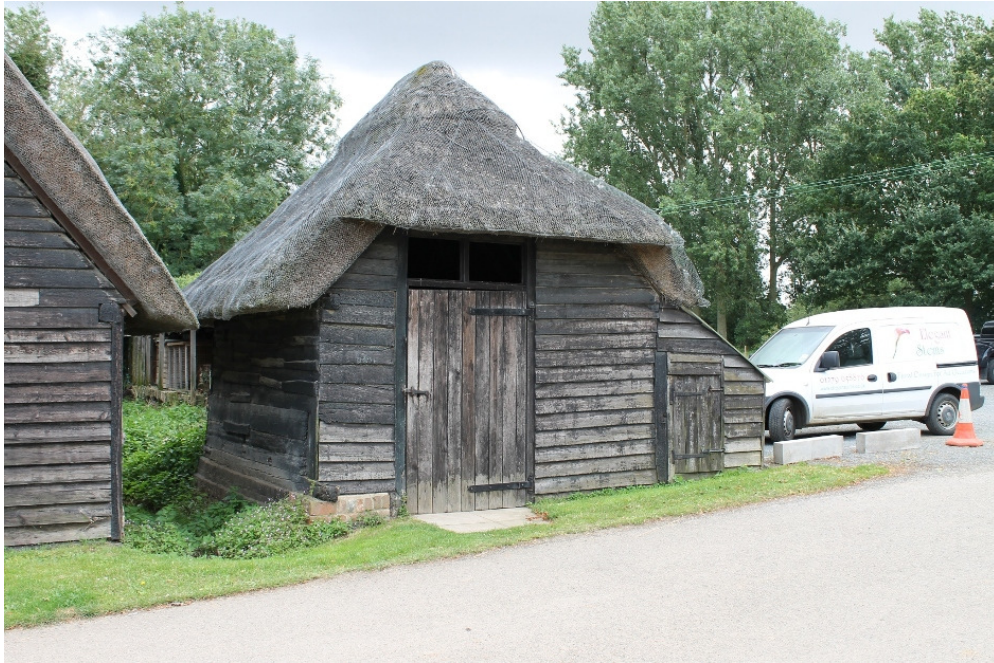
Plate 29 Structure 5, 17th-century outbuilding with 20th-century attached lean-to and structure 2 on the left – view south-east

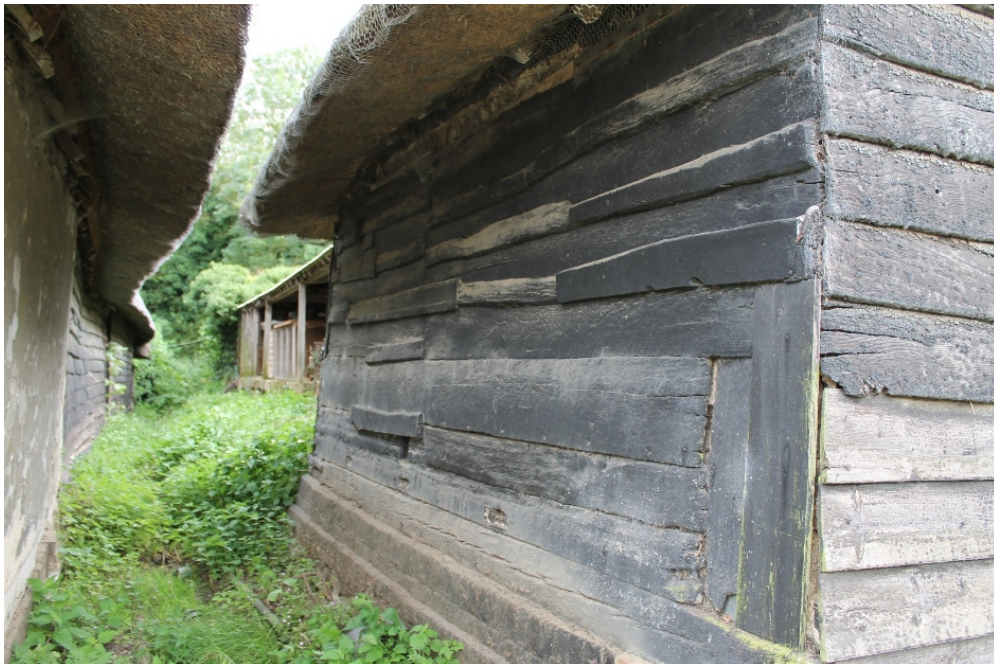
Plate 30 Structure 5, north elevation with possibly original weatherboard – view south-east
