**Historic building recording
at Wickham Hall, Hadham Road,
Bishop's Stortford, Hertfordshire
August 2012**

**report prepared by
Chris Lister**

**commissioned by
Foxley Builders**

CAT Report 733
December 2013

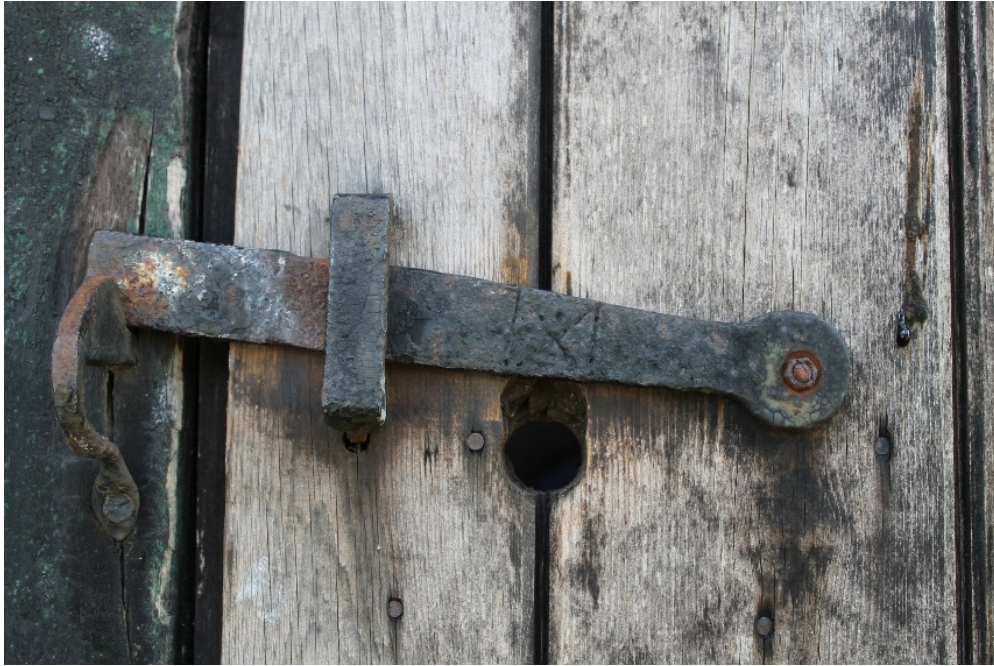
Plate 31 Detail of iron latch on door of structure 5; possibly original to the building it shares similarities (the incised (IXI)) with a carpenter's mark on a tie beam in structure 2

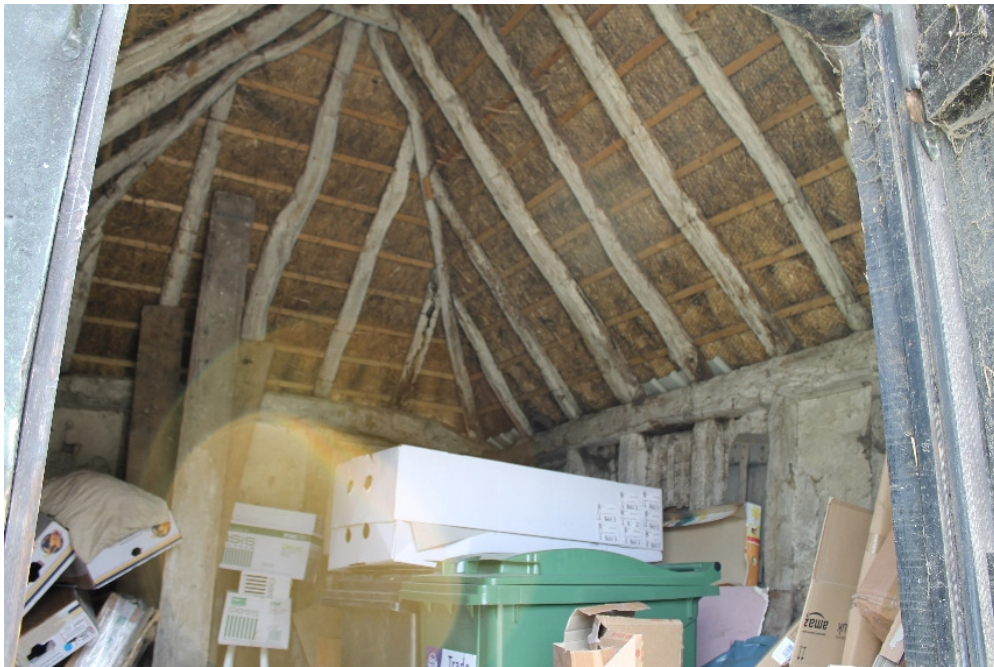
Plate 32 Interior of structure 5 – view south-east

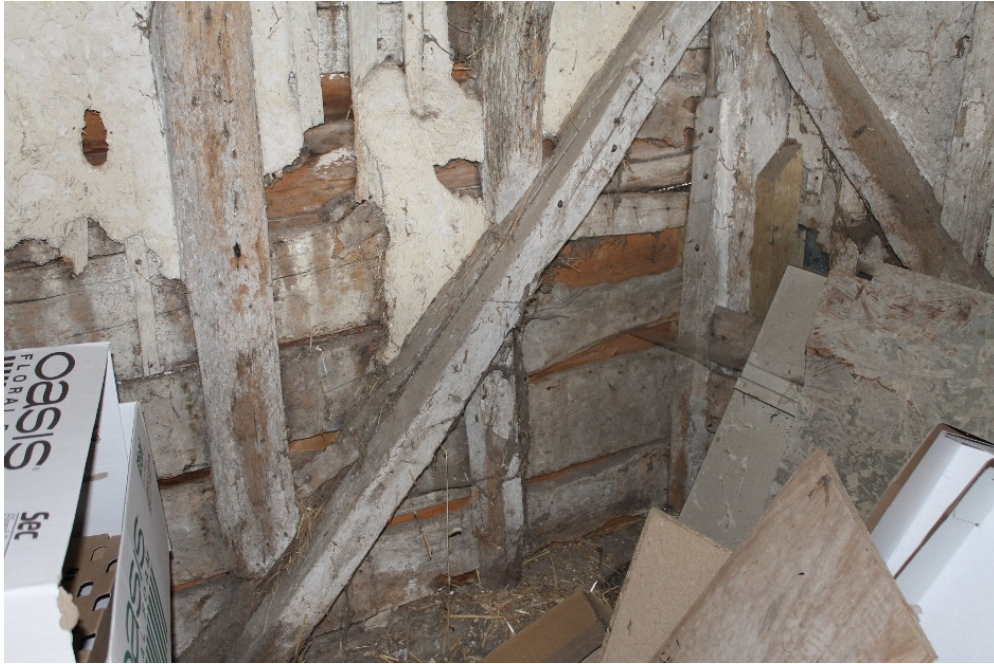
Plate 33 Primary bracing to the frame of structure 5 with the possibly original thick plank cladding attached to the exterior of the frame – view north-east

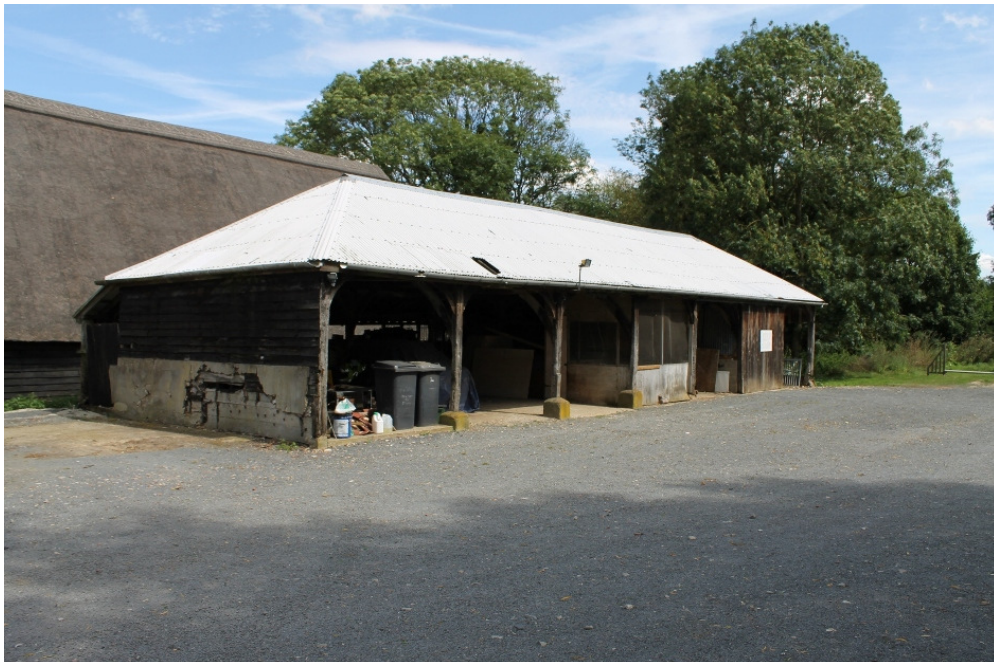
Plate 34 Structure 6, 19th-century wagon lodge – view north-east

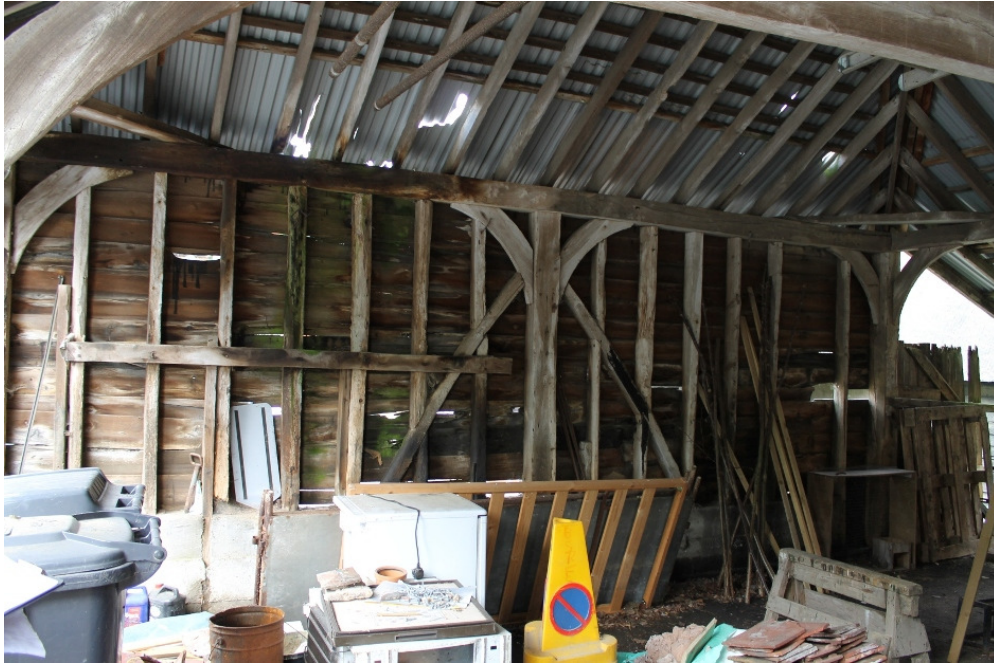
Plate 35 North-west wall frame of structure 6 – view north-west

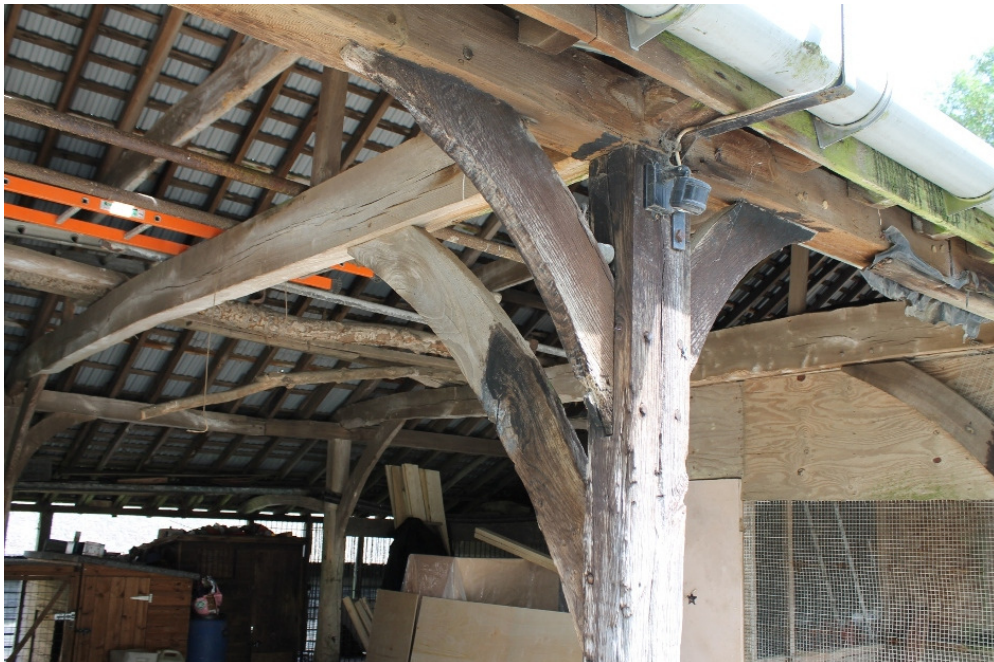
Plate 36 Structure 6, detail of bracing to south post of truss B - view east

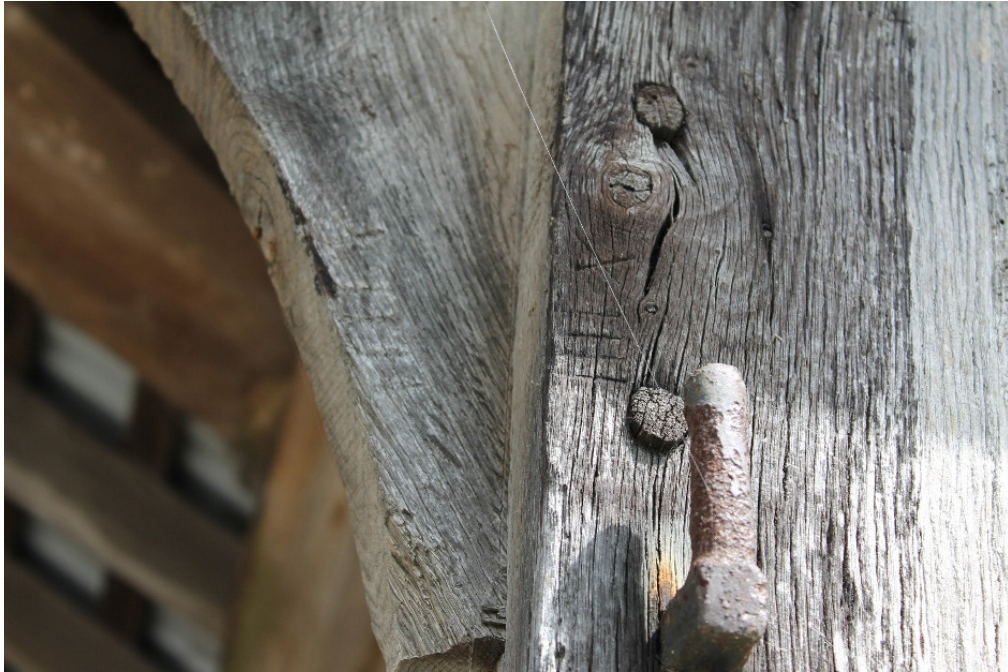
Plate 37 Detail of carpenter's marks (XIII) on the post and brace of the south-east corner – view north-east

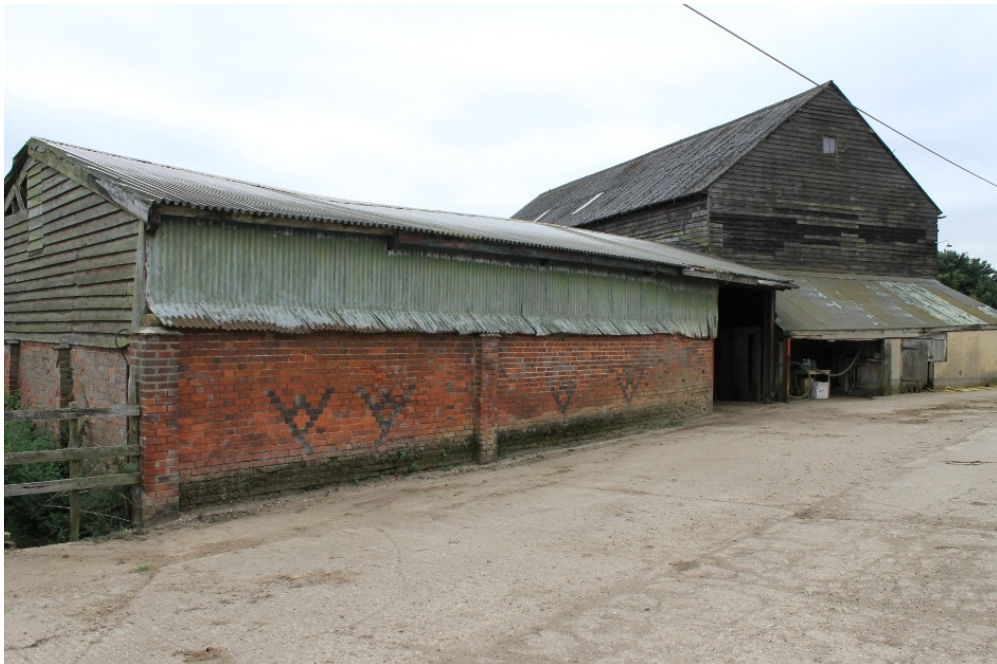
Plate 38 19th-century brick wall to structure 10 – view south-east

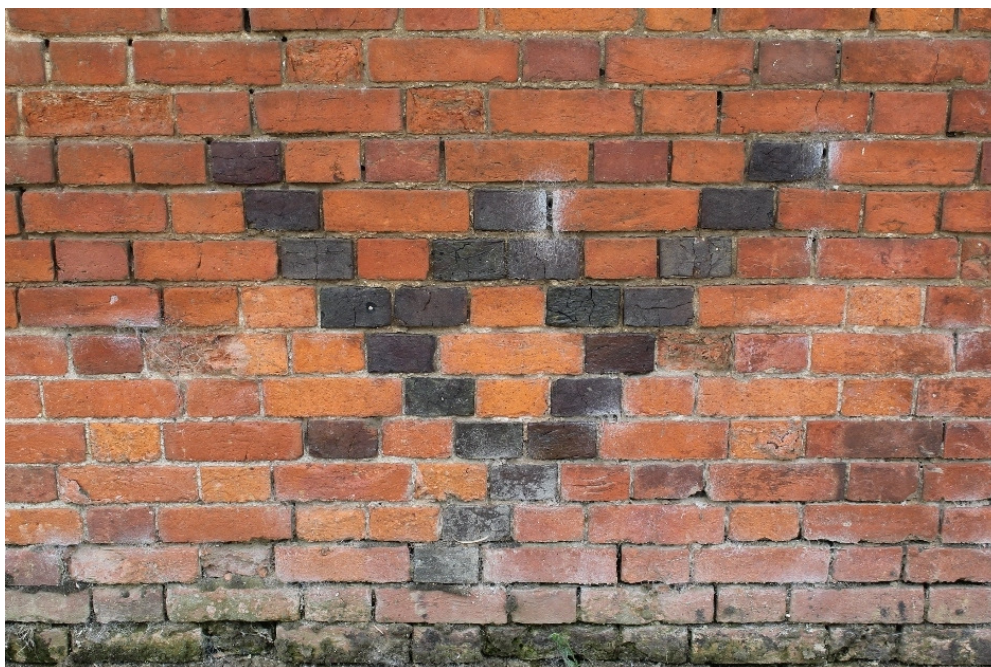
Plate 39 Stylised 'W' and 'Y' on 19th-century brick wall to structure 10

pattern that could be considered as a stylised 'W' over a 'Y' (Plate 39). These are the first and last letters in William Stacey's name, the tenant listed on the 1843 tithe award, and it is tempting to see the patterning as a monogram recording his tenancy.

127.jpg Structure 10, 19th-century wall to cattle yards incorporated into 20th-century horse shed - view south-west.
128.jpg Structure 10, detail of burnt brick stylised pattern on 19th-century wall to cattle yards.

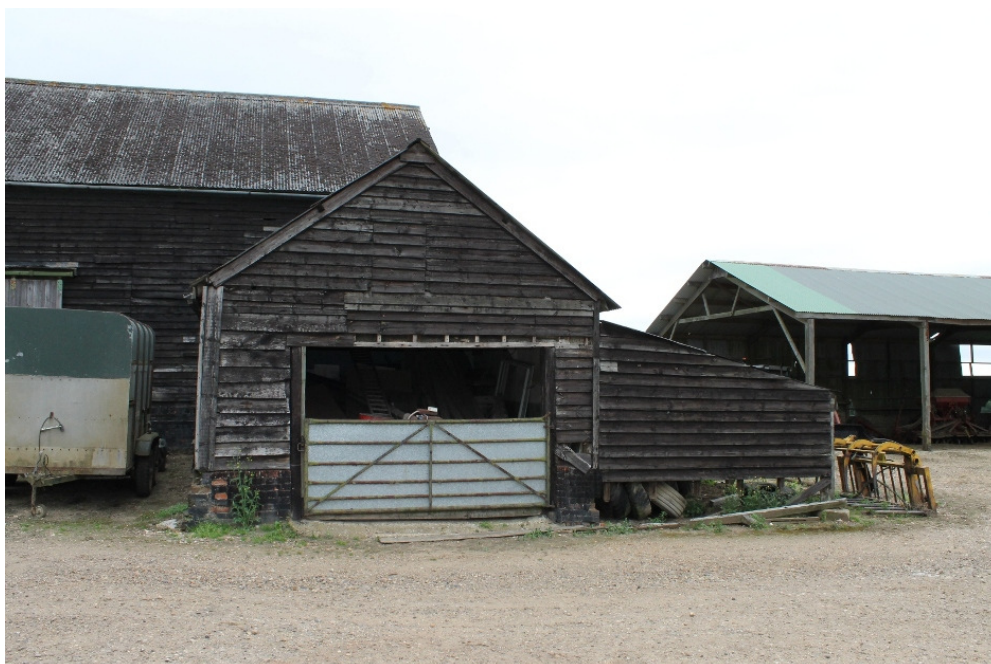
Plate 40 Structure 11, 19th-century loose box – view north-east

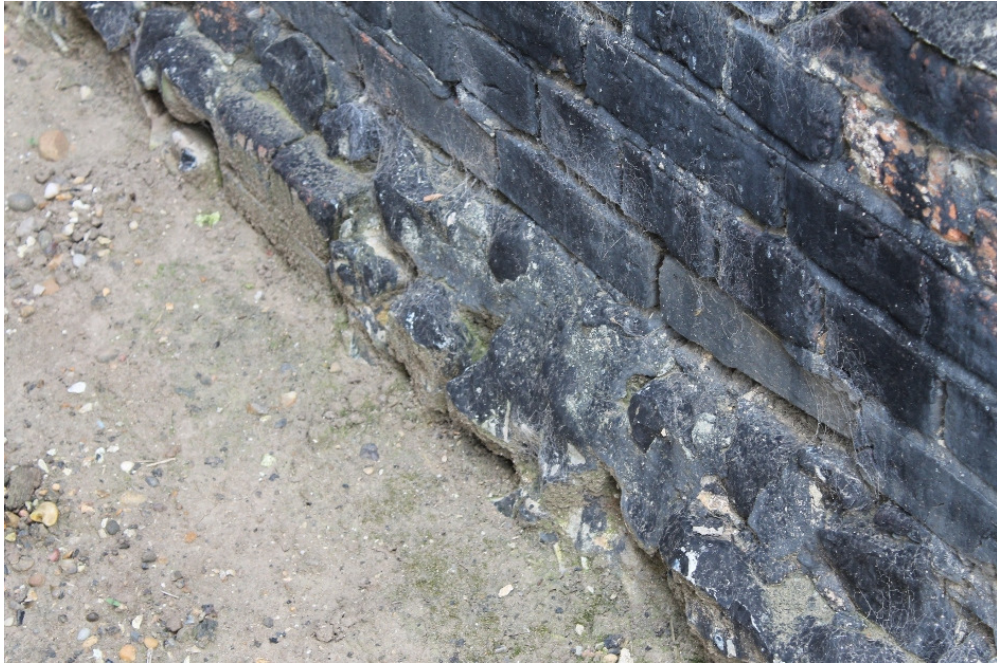
Plate 41 Flint rubble foundation to brick plinth of structure 11 – view north-east

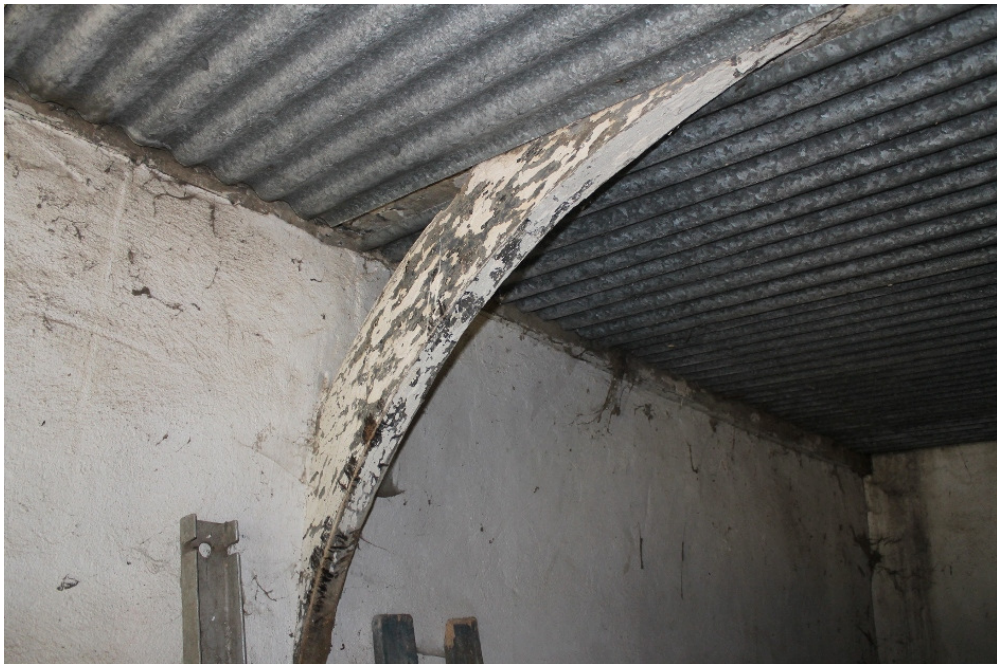
Plate 42 Interior of structure 11 showing a curved brace. The framing has been obscured by modern render and the insertion of a corrugated iron sheet ceiling - view north

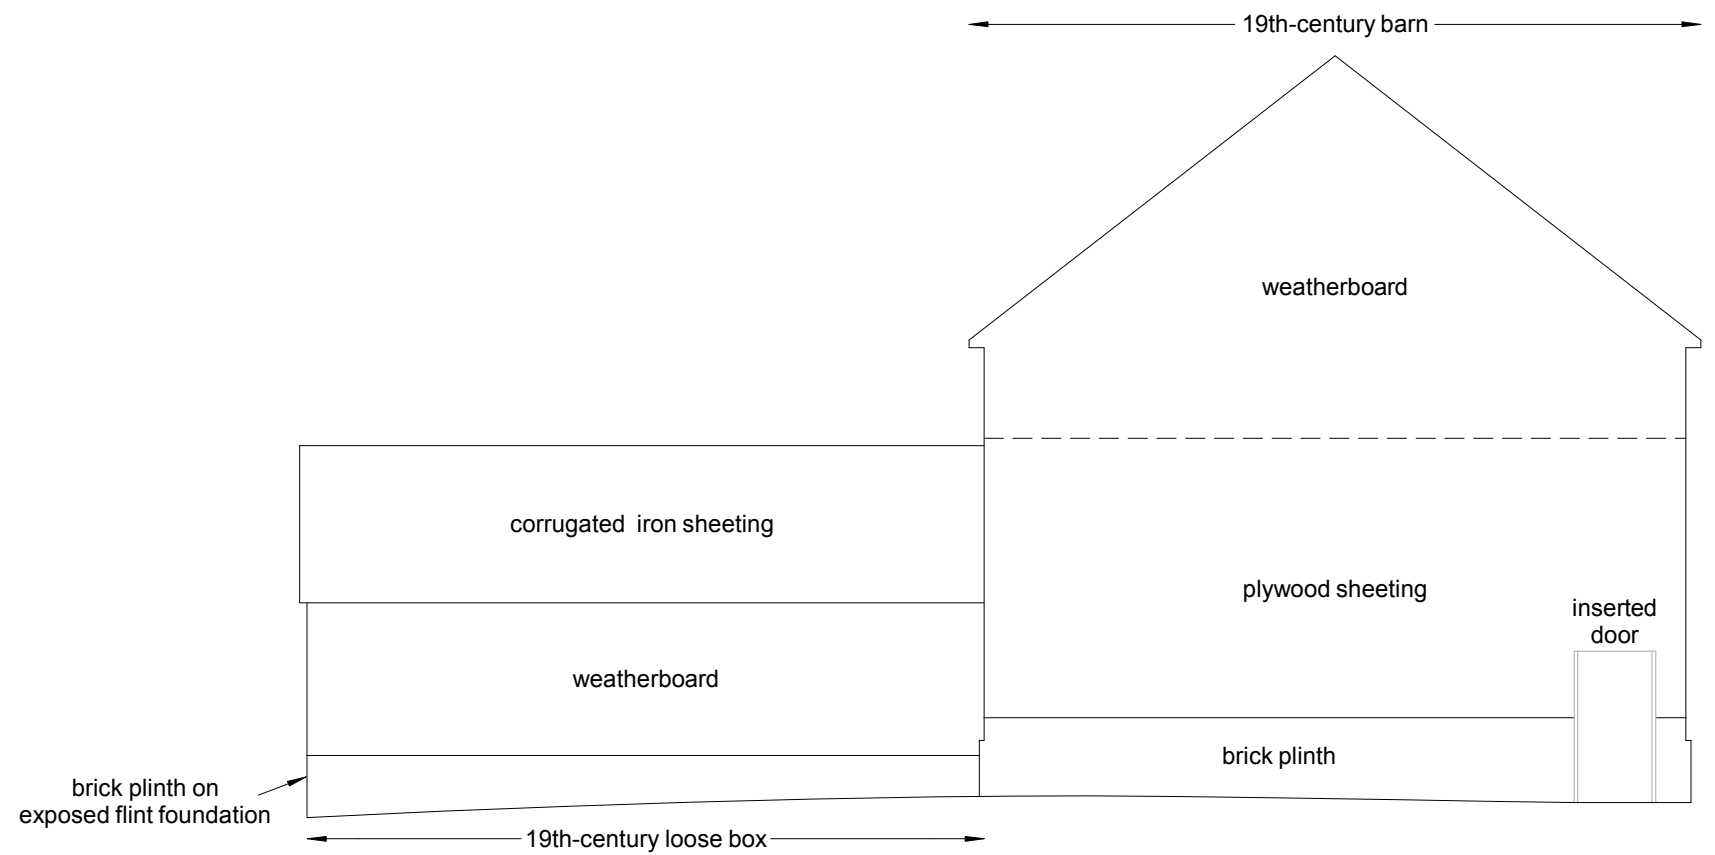
Fig 10 South-east elevation of structure 1 (19th-century barn) and structure 11 (19th-century loose box), with alterations shown grey.

Structure 11: 19th-century loose box (Figs 6-10)

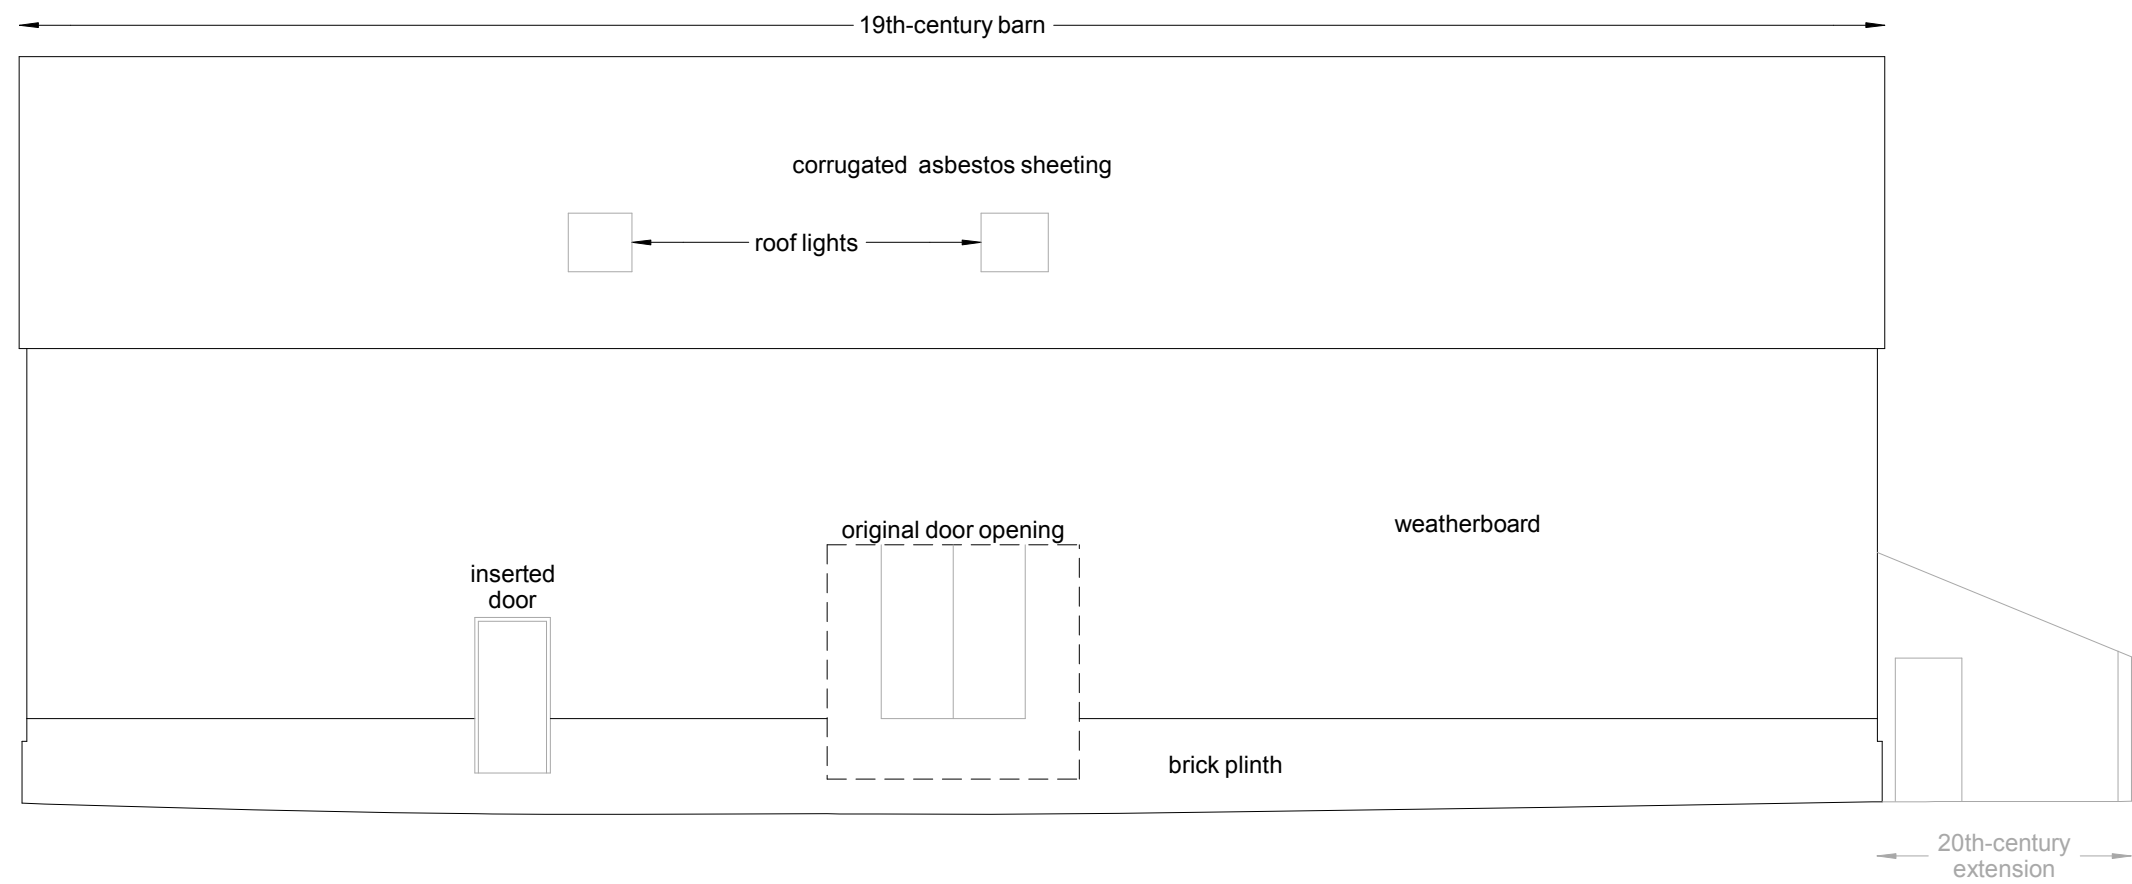
Fig 11 North-east elevation of structure 1 (19th-century barn), with alterations shown grey.

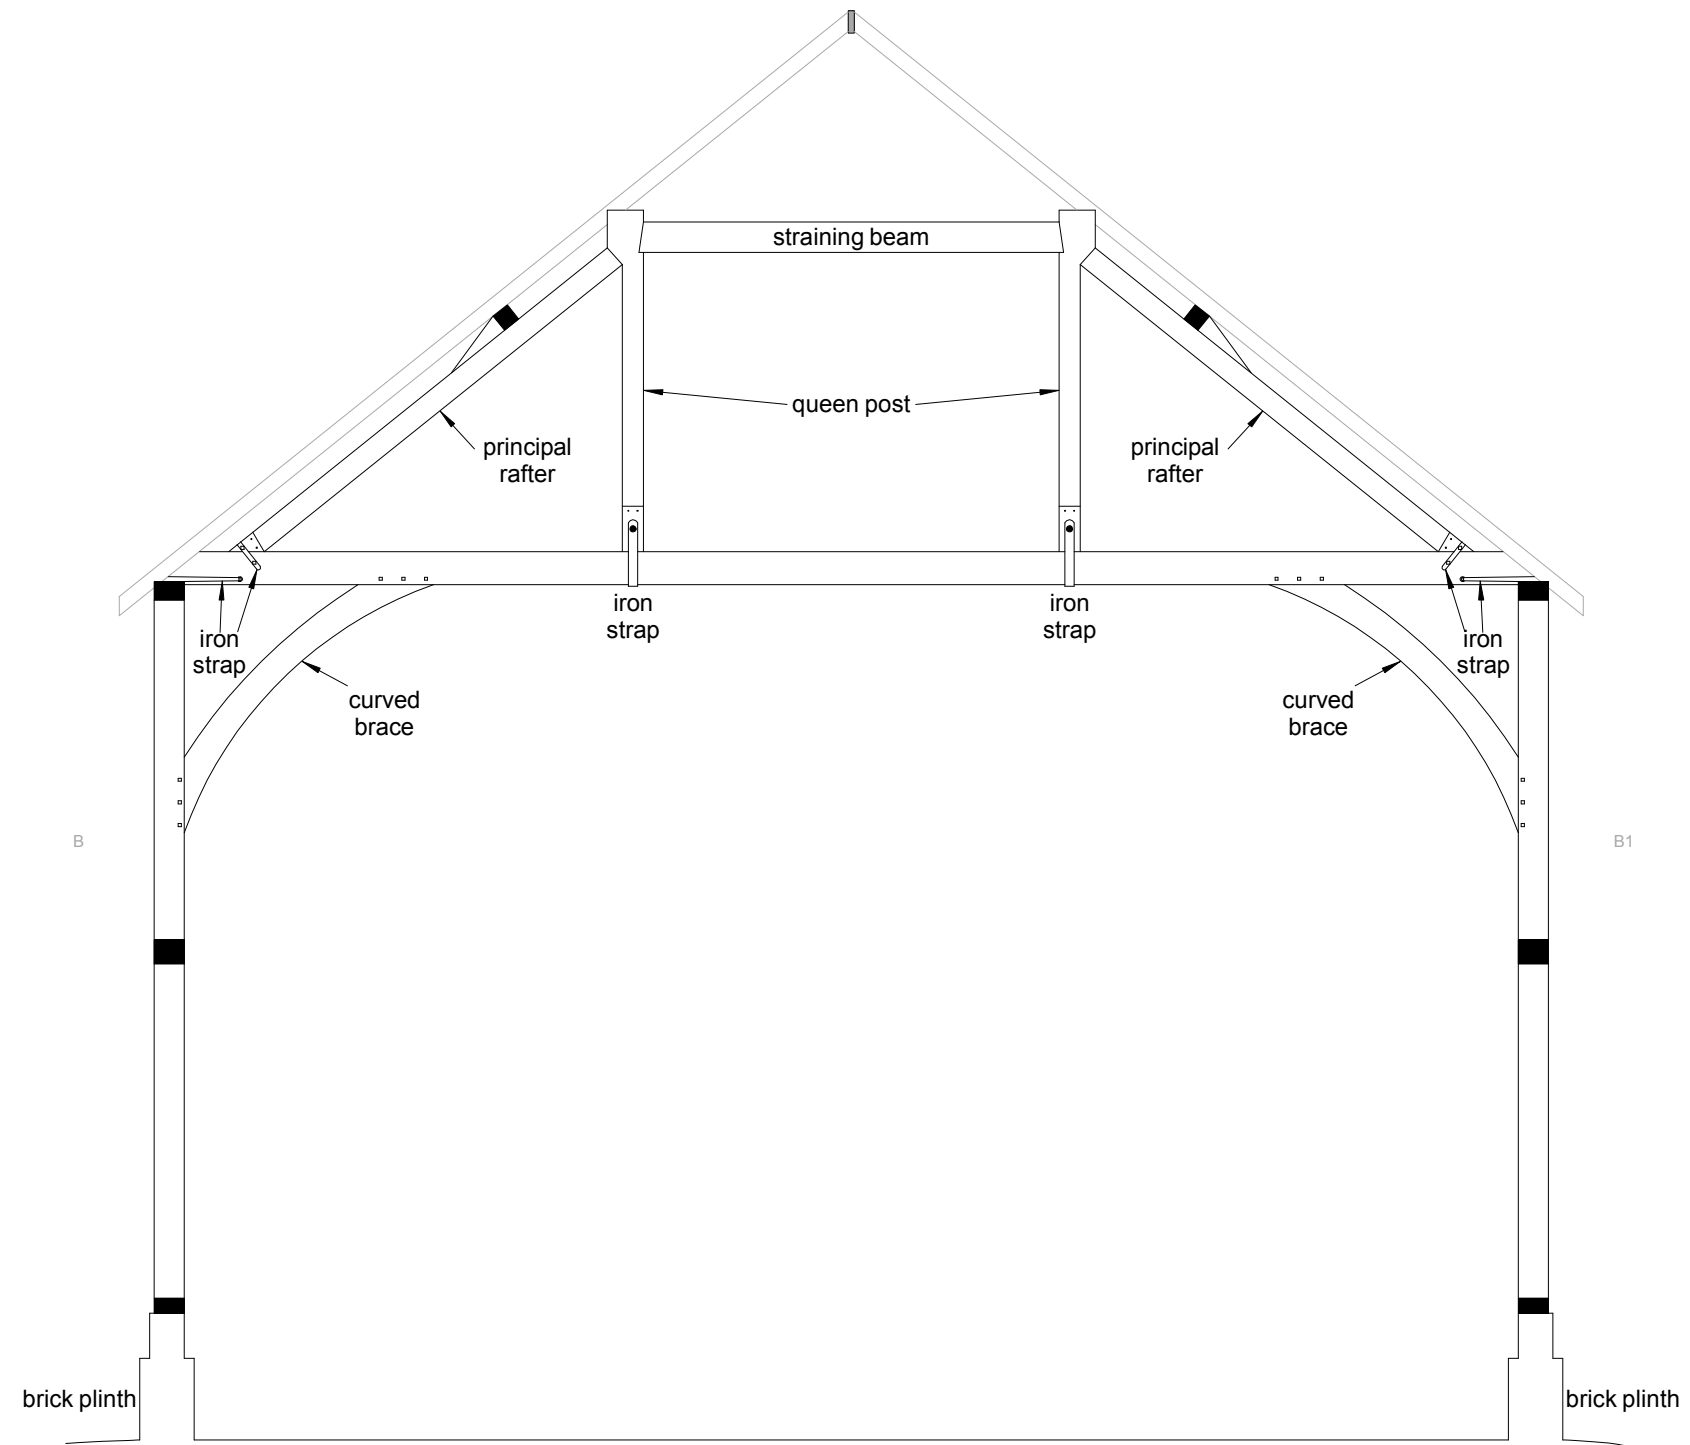
Fig 12 Structure 1 (19th-century barn): cross-section of truss B, with alterations shown grey.

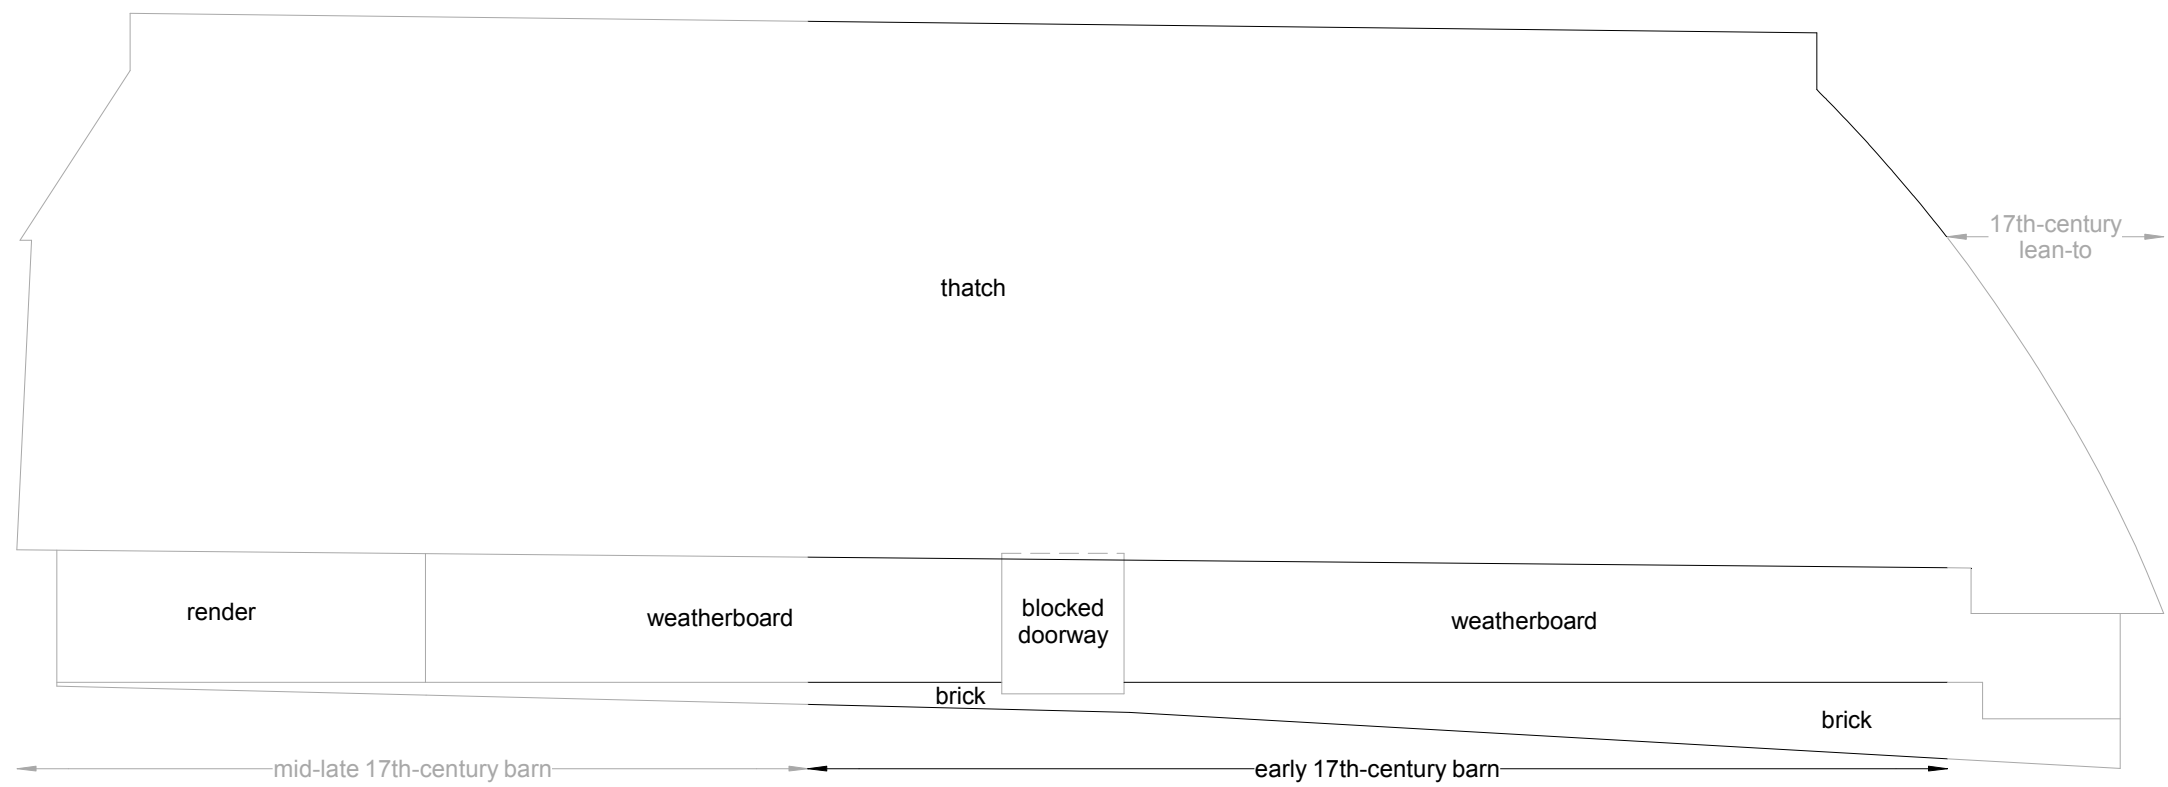
Fig 15 South elevation of structure 2 (17th-century aisled barn), with alterations shown grey.

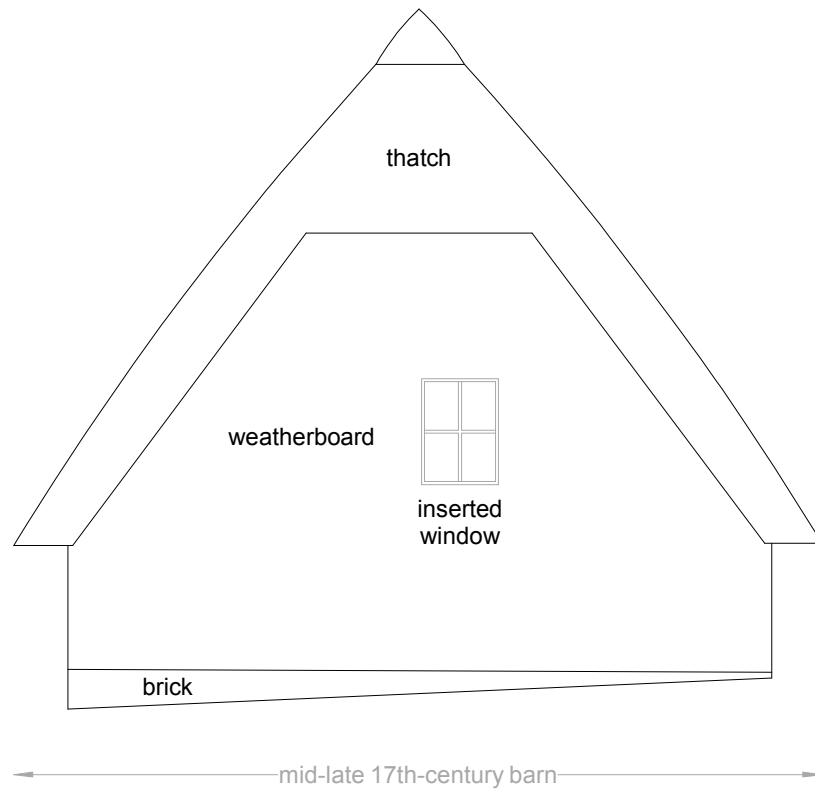
Fig 16 West elevation of structure 2 (17th-century aisled barn), with alterations shown grey.

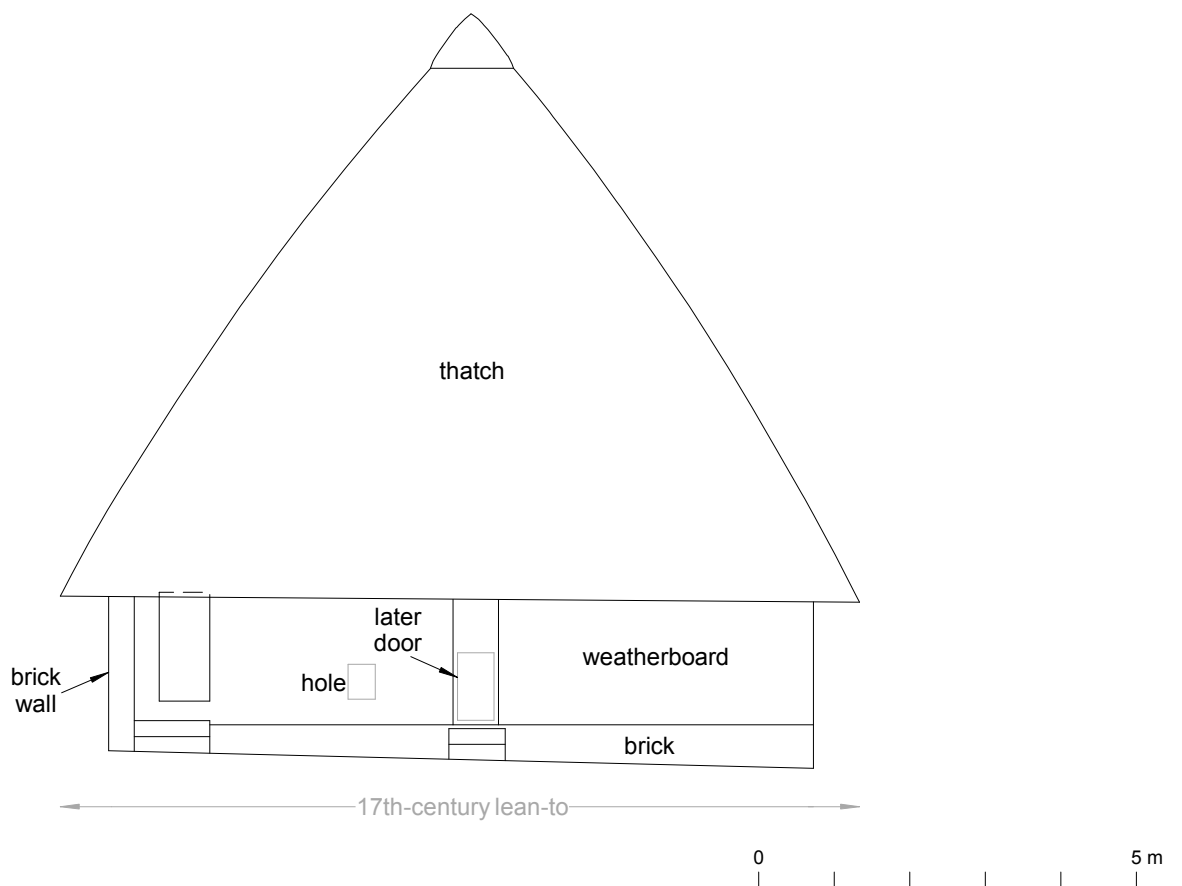
Fig 17 East elevation of structure 2 (17th-century aisled barn), with alterations shown grey.

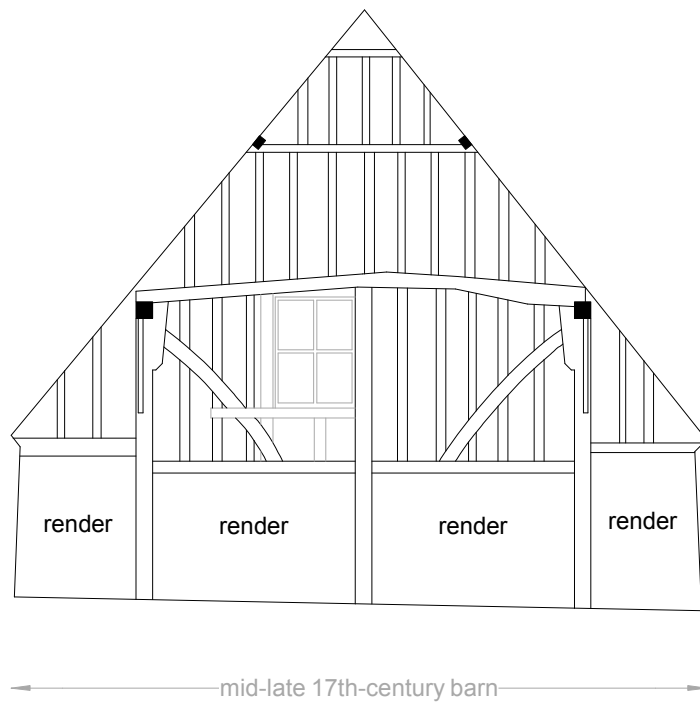
Fig 20 Structure 2 (17th-century aisled barn): timber-framing of west wall, with alterations shown grey.

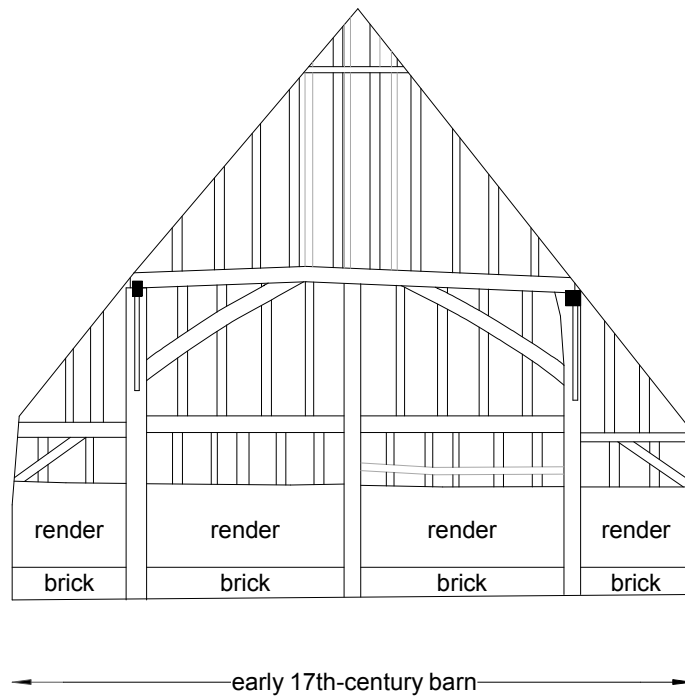
Fig 21 Structure 2 (17th-century aisled barn): timber-framing of east wall, with alterations shown grey.

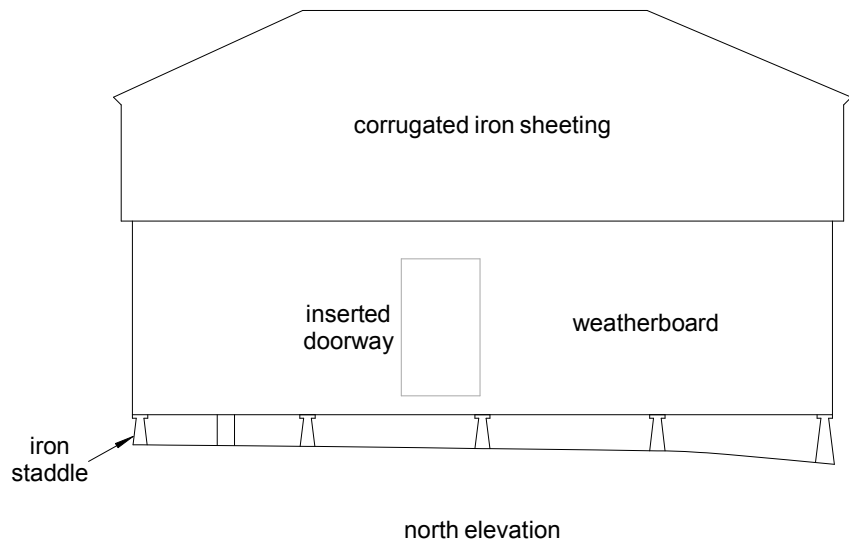
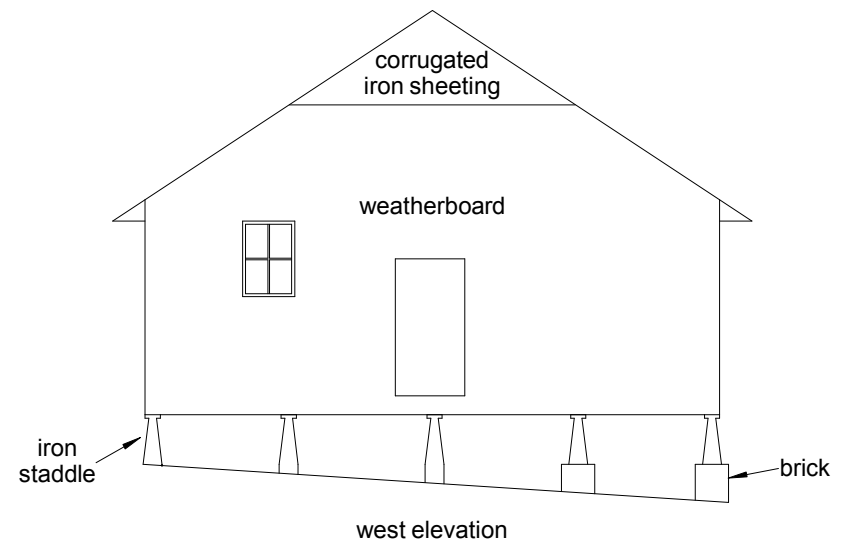
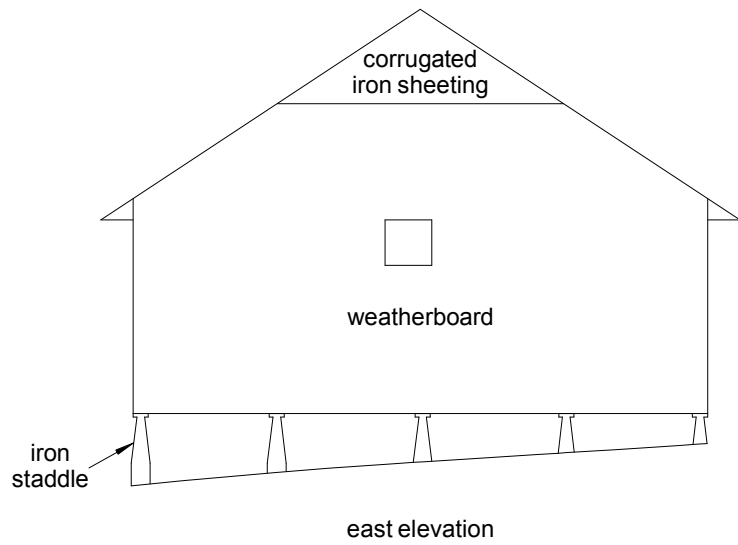
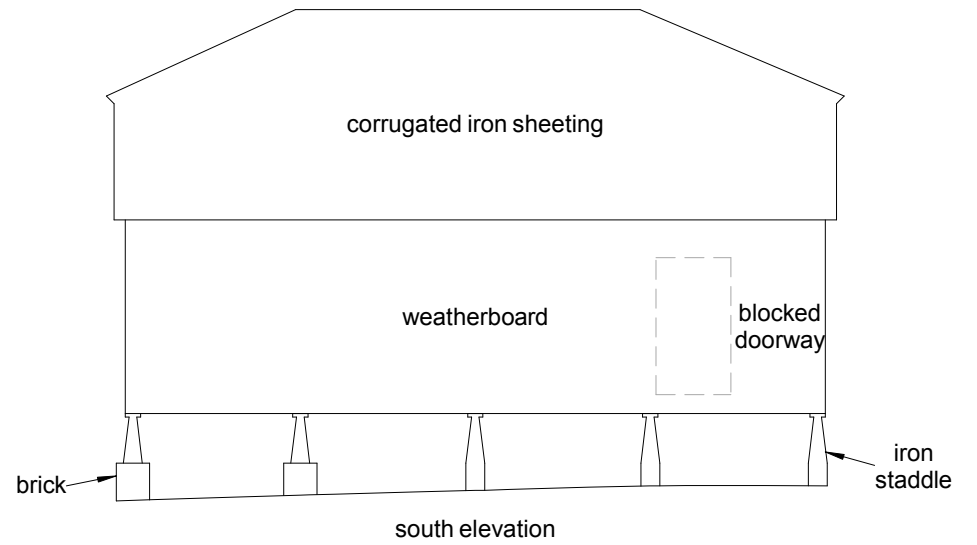
Fig 25 Elevations of structure 3 (19th-century granary), with alterations shown grey.

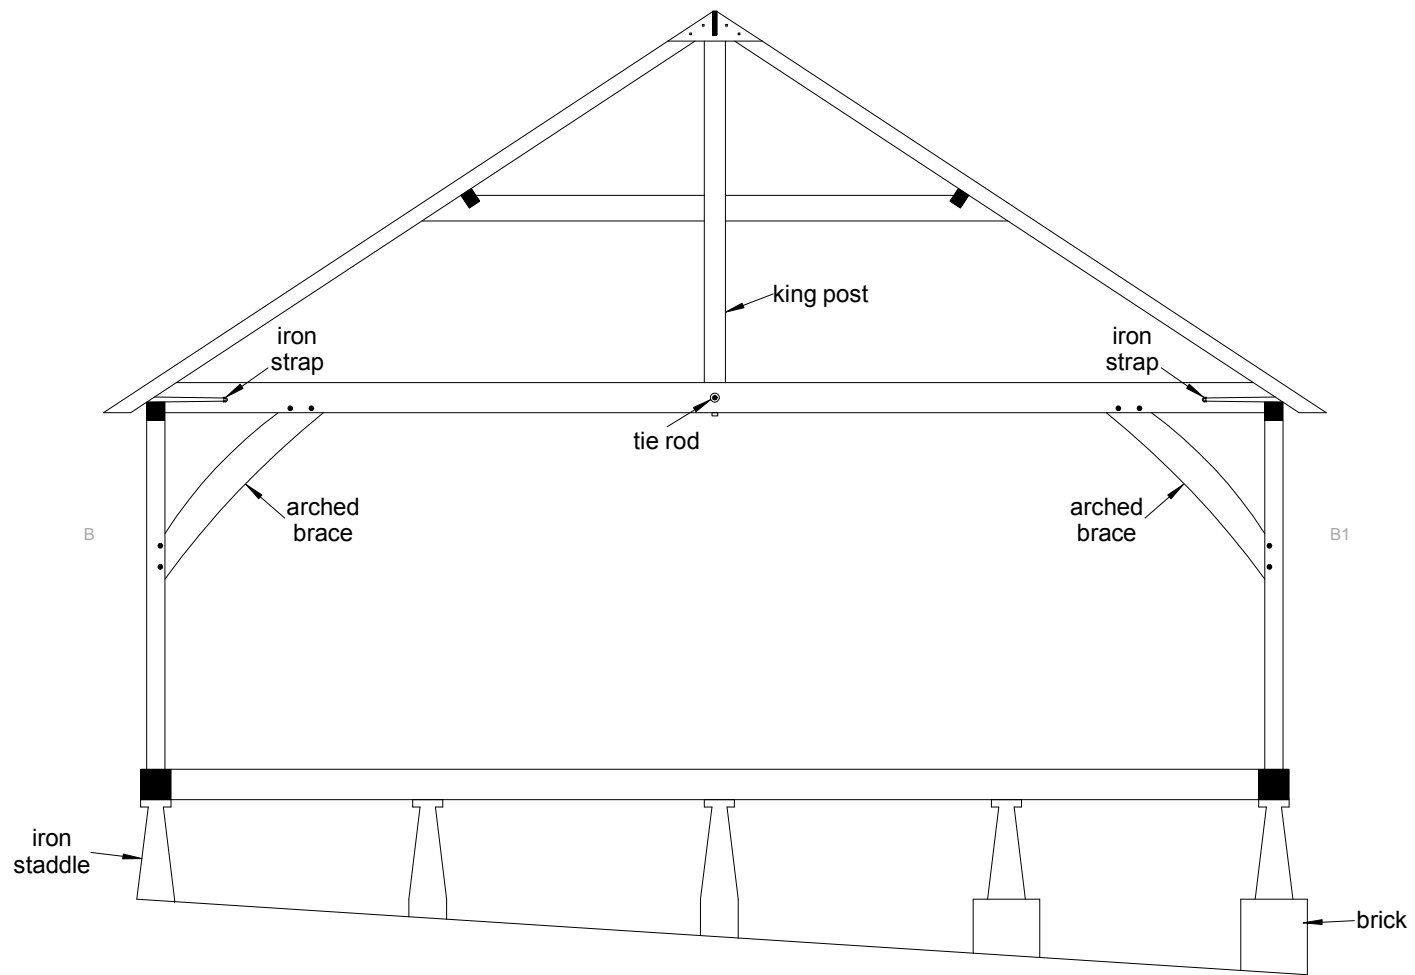
Fig 26 Structure 3 (19th-century granary): cross-section of truss B.
