**Historic building recording
at Wickham Hall, Hadham Road,
Bishop's Stortford, Hertfordshire
August 2012**

**report prepared by
Chris Lister**

**commissioned by
Foxley Builders**

CAT Report 733
December 2013

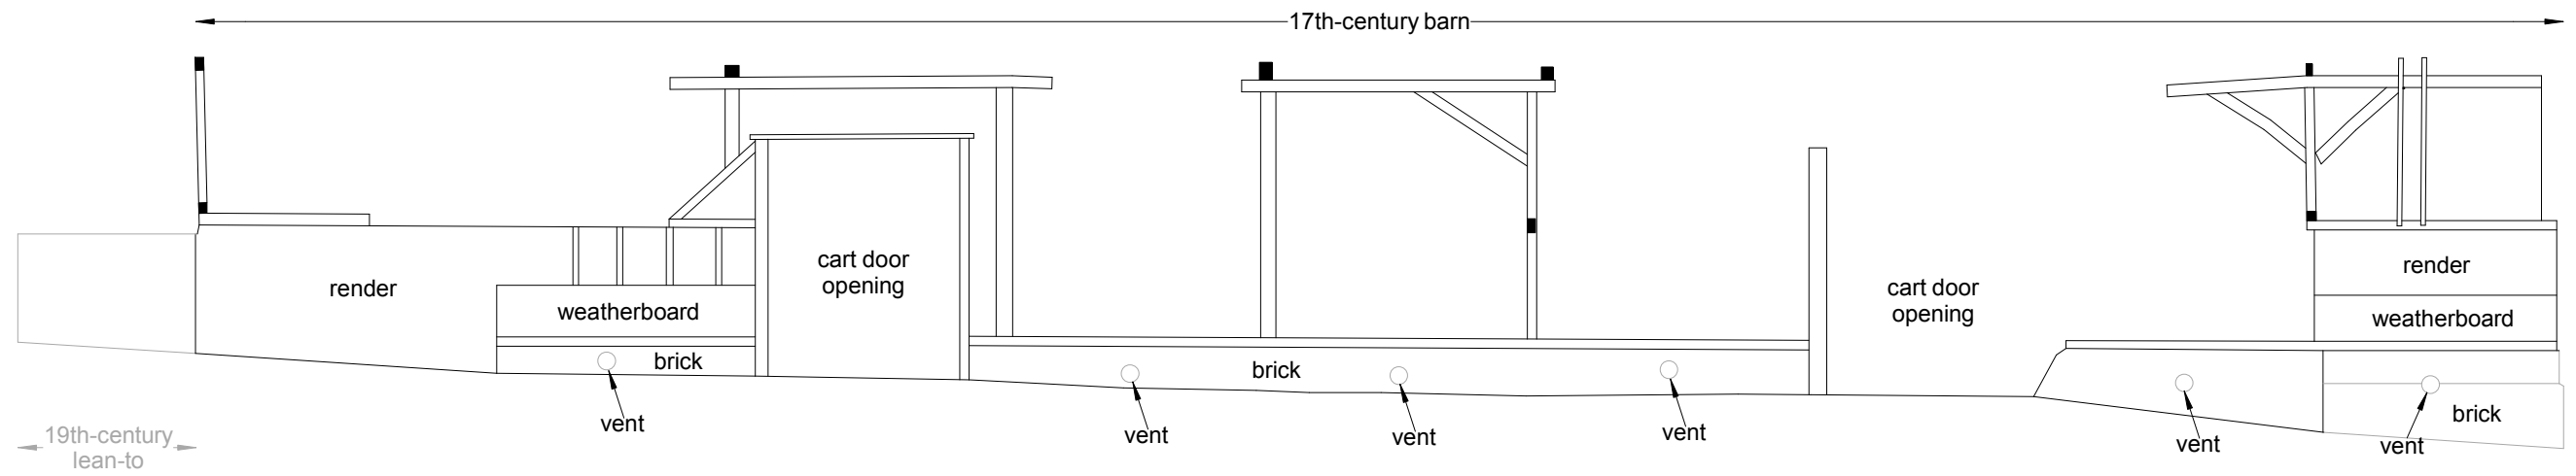
Fig 28 West elevation of structure 4 (17th-century aisled barn), with alterations shown grey.

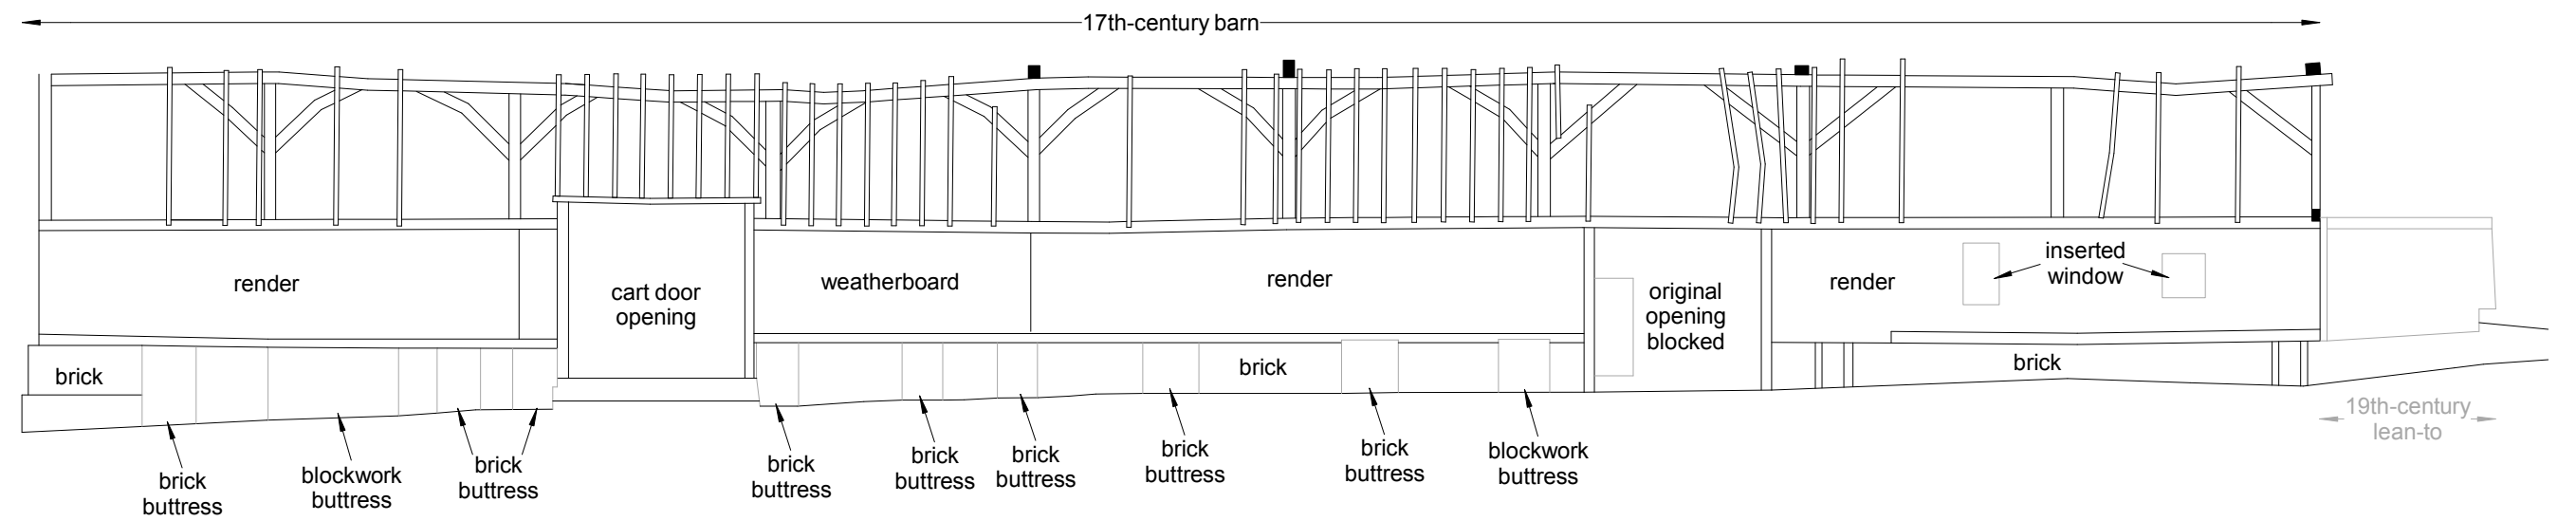
Fig 29 East elevation of structure 4 (17th-century aisled barn), with alterations shown grey.

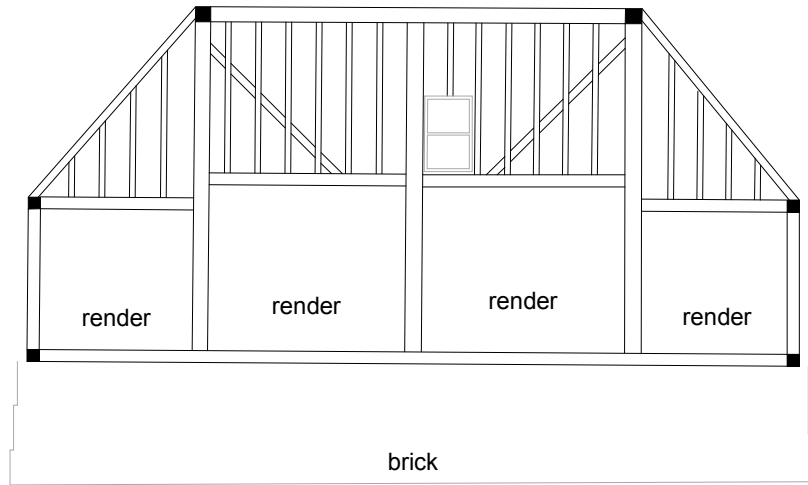
Fig 30 South elevation of structure 4 (17th-century aisled barn), with alterations shown grey.

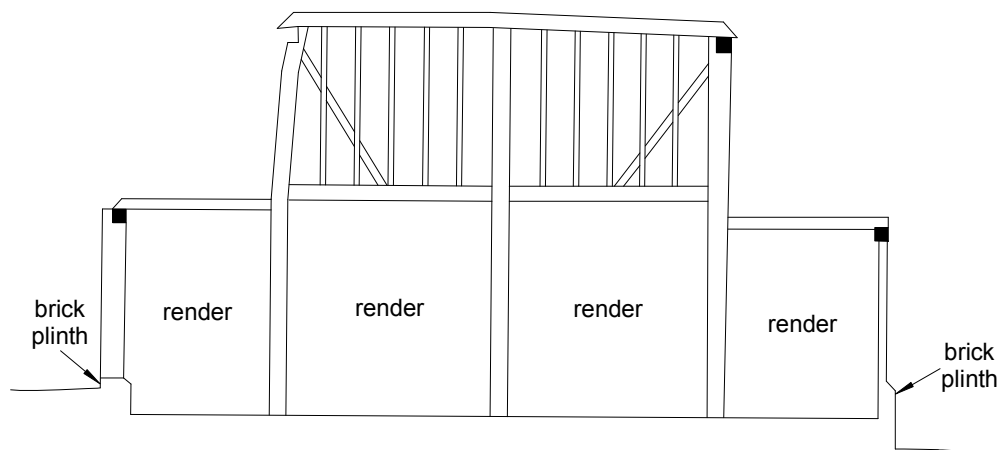
Fig 31 Internal elevation of north wall of structure 4 (17th-century aisled barn).

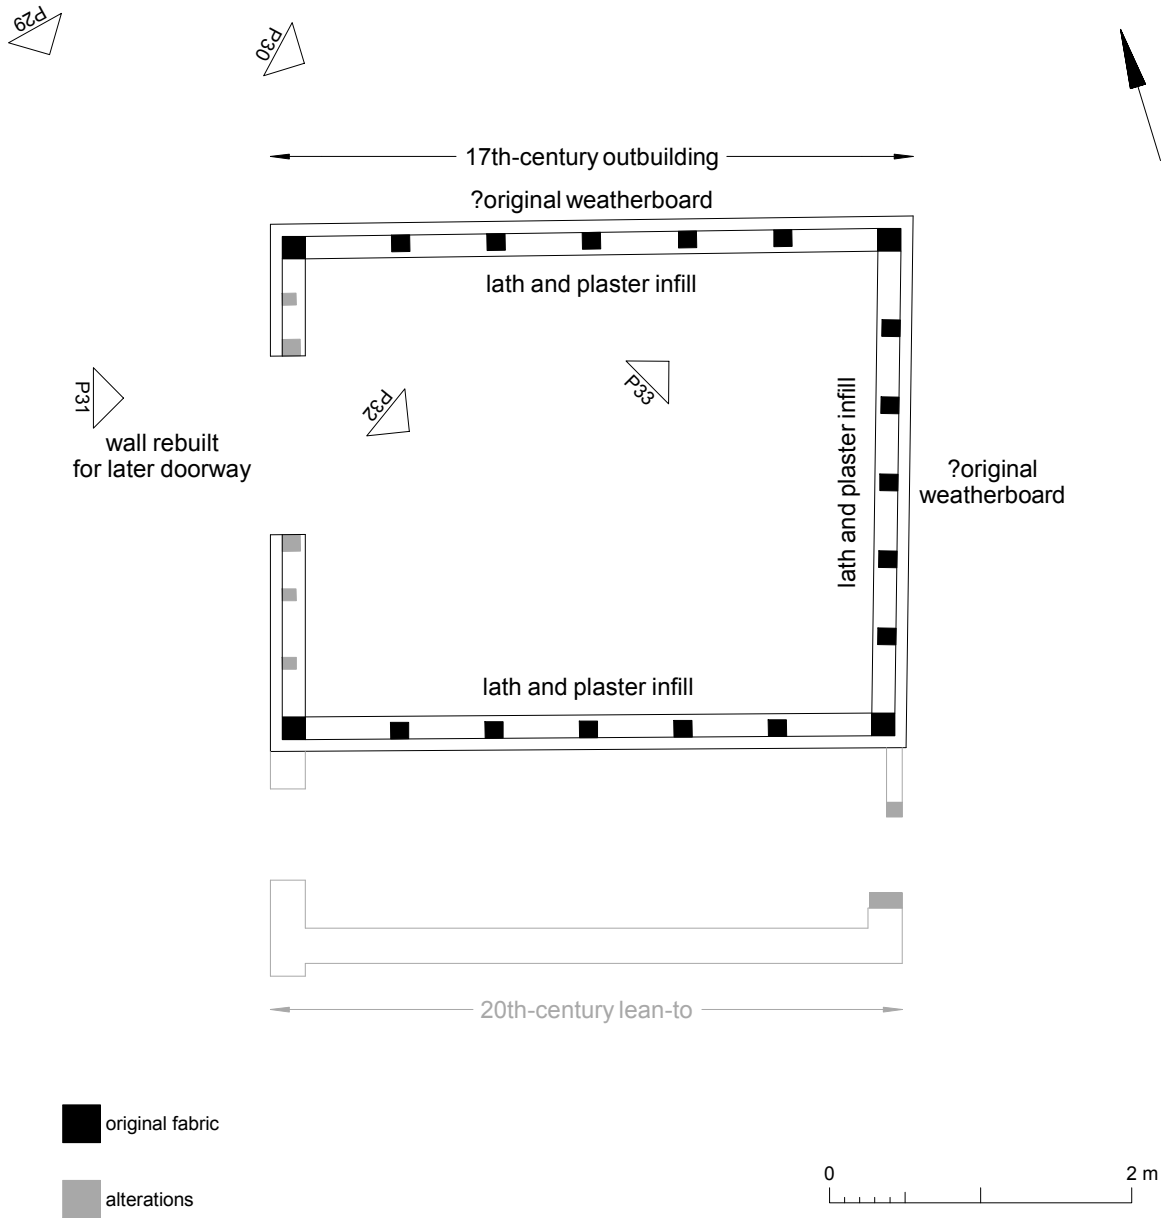
Fig 33 Floor plan of structure 5 (17th-century outbuilding), showing the location and orientation of photographs included in this report.

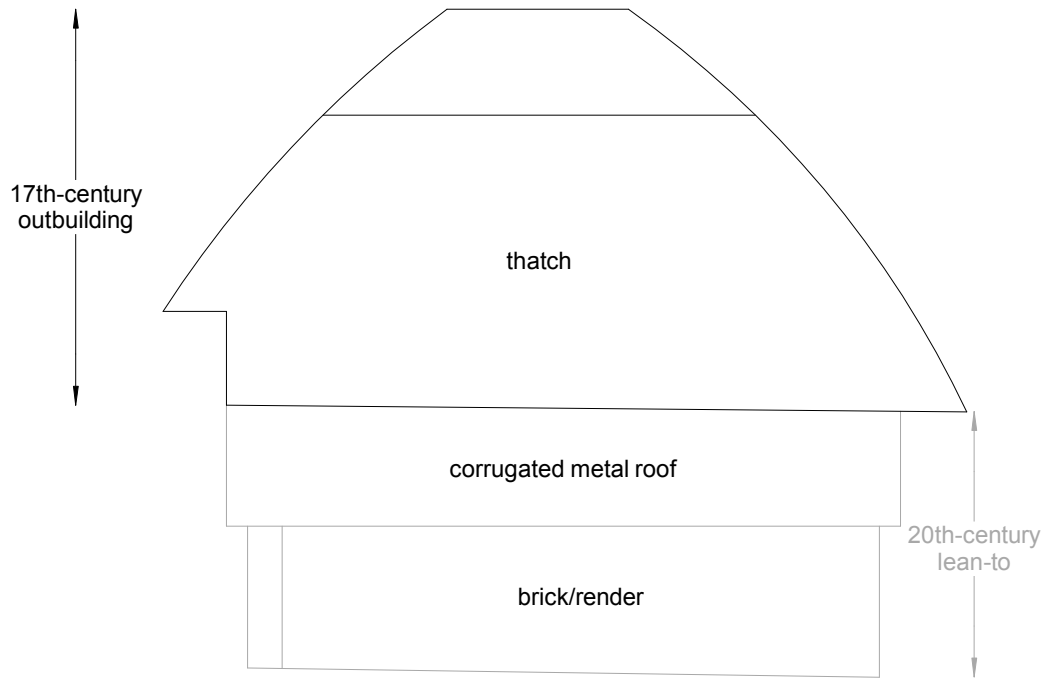
Fig 34 South elevation of structure 5 (17th-century outbuilding), with alterations shown grey.

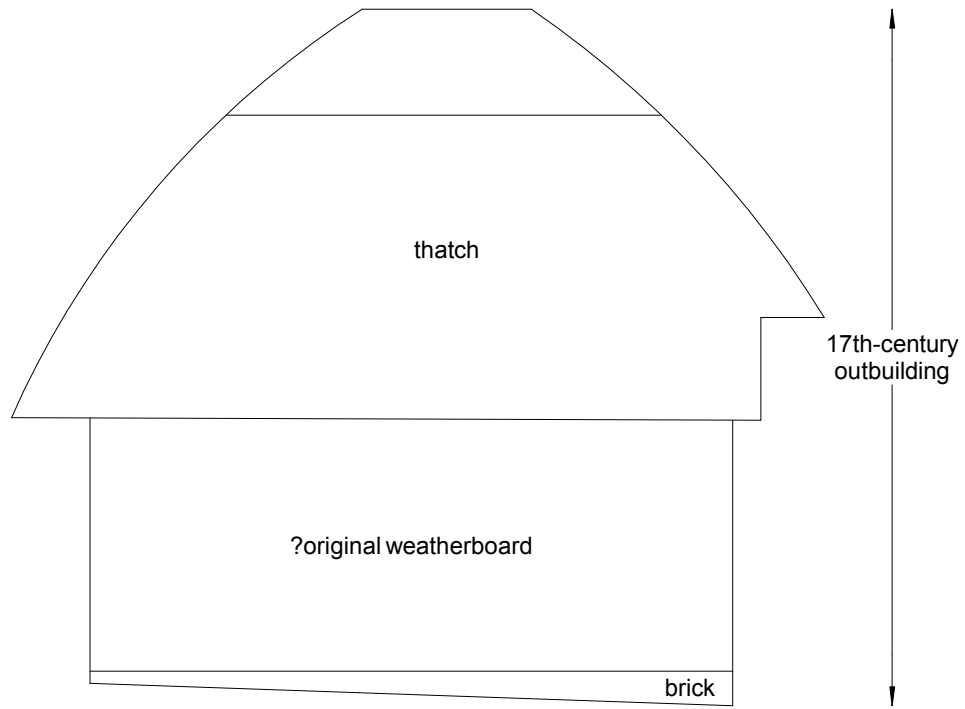
Fig 35 West elevation of structure 5 (17th-century outbuilding), with alterations shown grey.

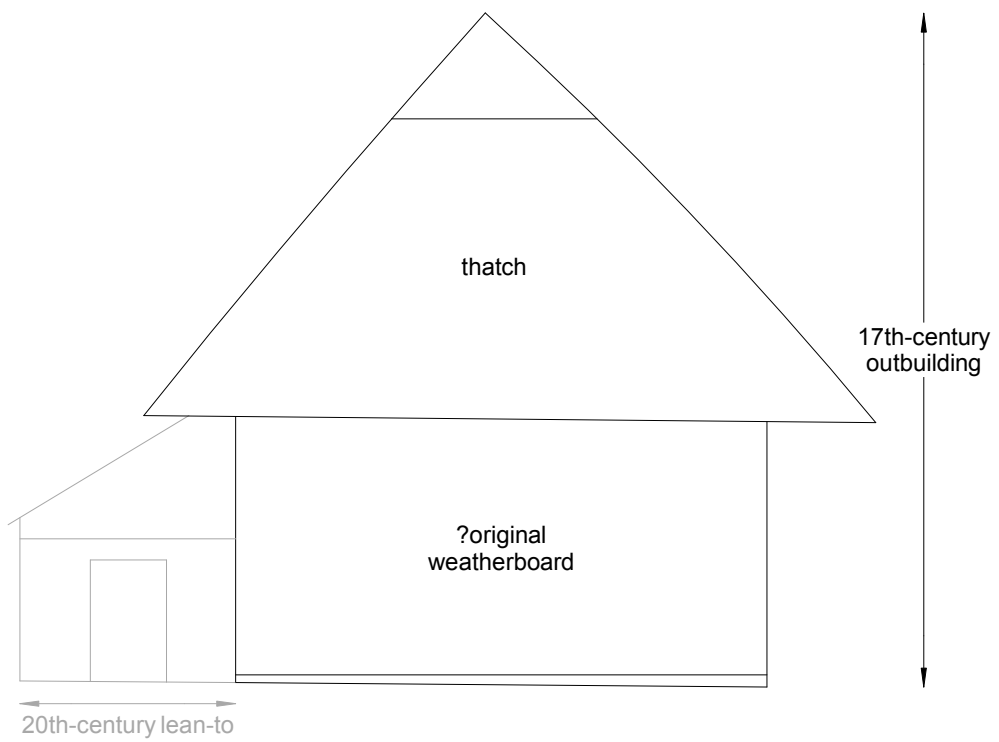
Fig 36 North elevation of structure 5 (17th-century outbuilding).

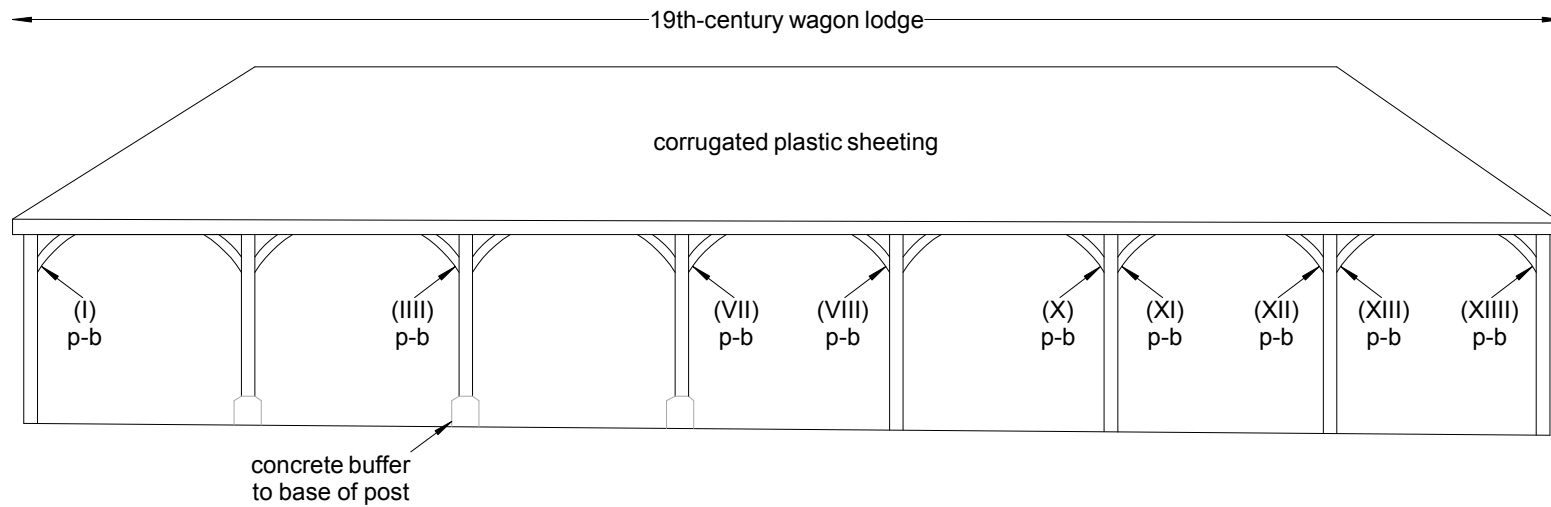
Fig 38 Floor plan of structure 6 (19th-century wagon lodge), showing the location and orientation of photographs included in this report.

(VII) = carpenter's mark
 p = post
 b = brace

There is an abundance of carpenters' marks on the posts and braces of the south-east elevation. The braces to the wall plate have chiselled marks starting with (I) at the north-west corner and continuing in sequence to (XIII) at the south-east corner, although some are too worn to read (Plate 37). The braces of the posts to the tie beams appear to have (I-VI) starting at the south-east corner and continuing sequentially to the north-west corner, although only marks (V) and (VI) are legible. There are marks on the posts and braces of the north-east elevation suggesting the same type of sequential numbering, although far fewer examples are legible. Marks equivalent to the numbers on the tie beam braces can also be found at the joint of the tie beam to the queen posts.

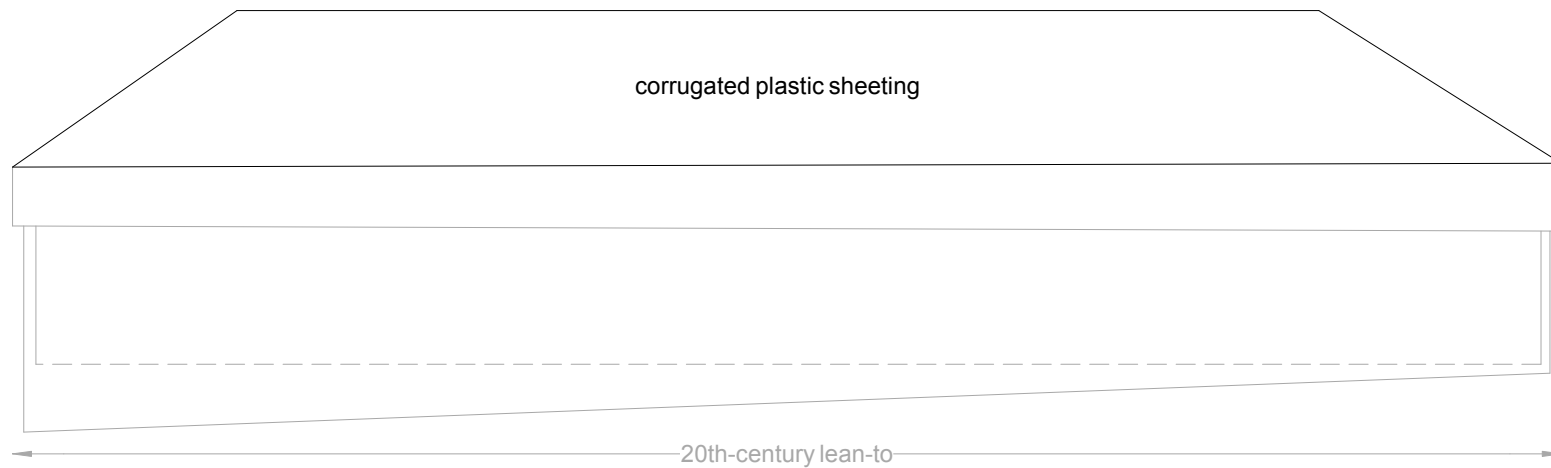
Fig 39 South-west elevation of structure 6 (19th-century wagon lodge), with alterations shown grey.

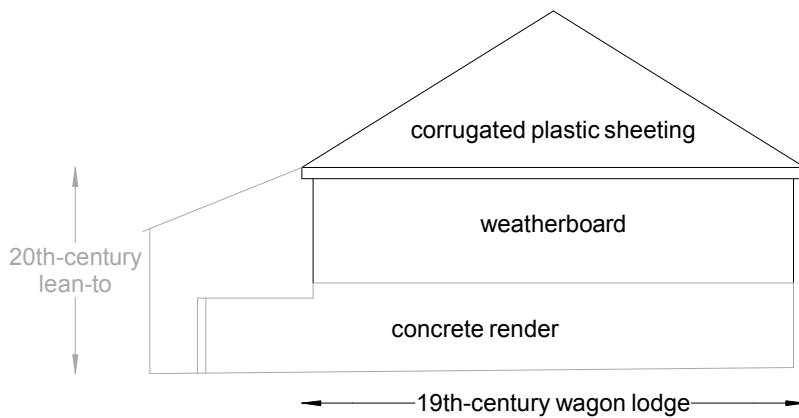
Fig 41 South-east elevation of structure 6 (19th-century wagon lodge), with alterations shown grey.
