**Building recording
at Home Farm, Moor Place,
Much Hadham, Hertfordshire
October 2013**

**report prepared by
Chris Lister**

**commissioned by
Foxley Builders**

CAT Report 735
January 2015

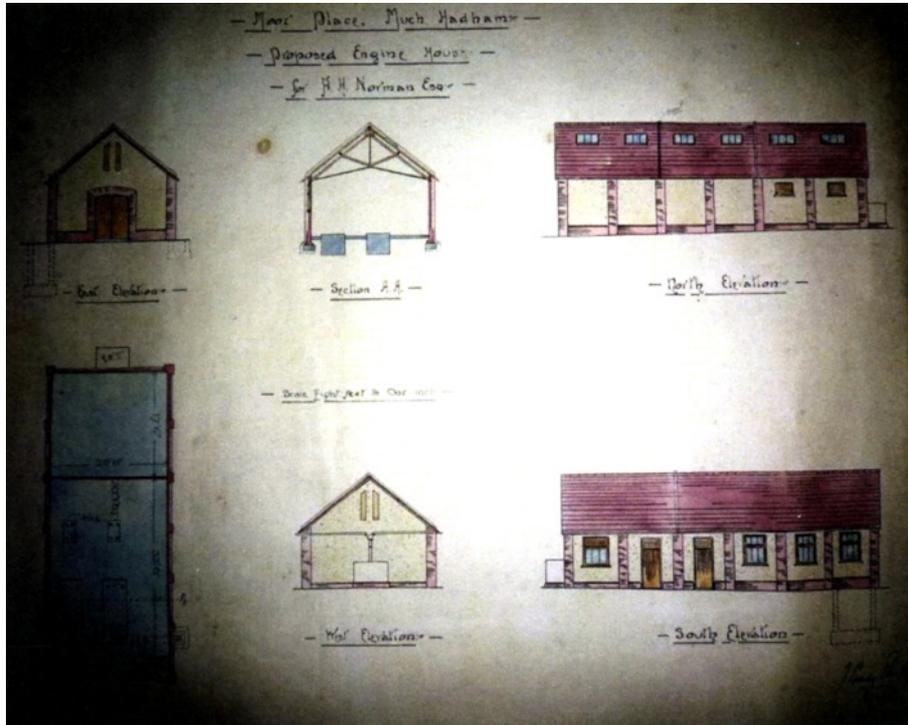
Illustration 3 Design plan for the engine house, 1911 (held in the estate office).

The early 20th century was a time of major expansion and modernisation at Home Farm. Moor Place was electrified in 1911, with the power supplied by generators housed in a purpose-built engine house (structure 15), designed by local architect J Sydney Bentley, the plans for which survived in the estate office.

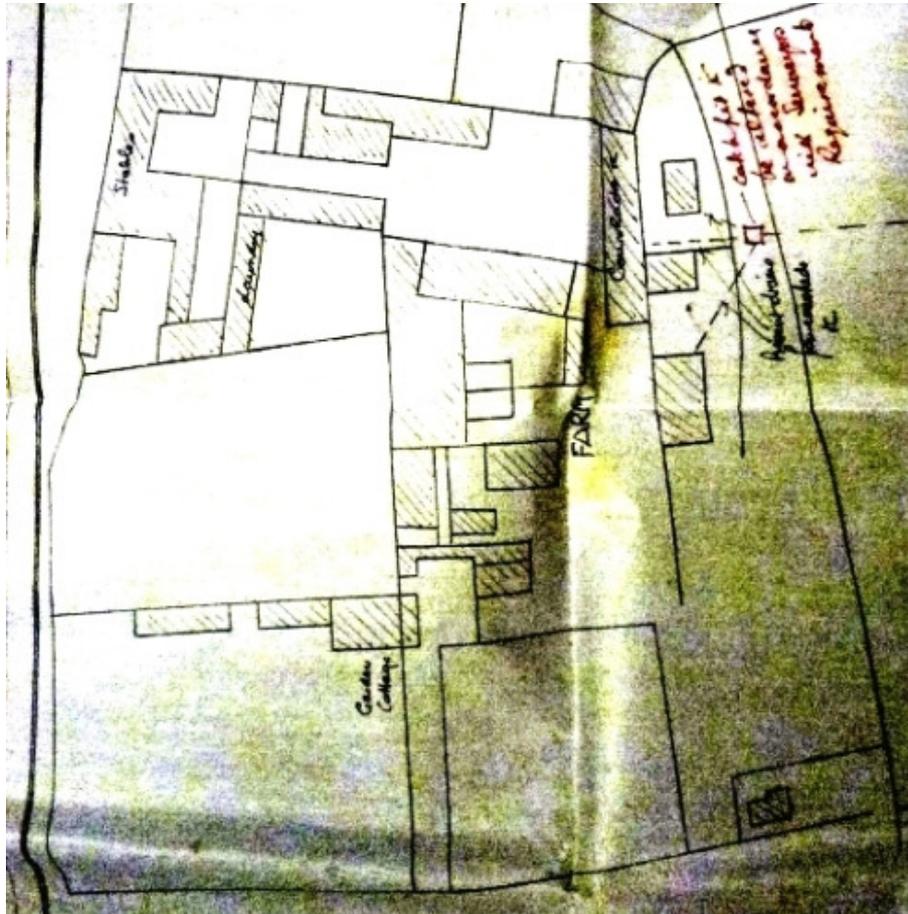
Map 10 1928 drainage map of Home Farm (HALS RDC 6 26/128).

This layout remained predominantly the same until at least 1928, as shown on a drainage plan of Home Farm (Map 10). The only significant change is the addition of what appears to be a structure built up against the south side of structure 4a, Farm

Cottage. However, this must represent a walled garden or yard rather than a building. It should also be noted that structure 20, the apple store, is omitted from this plan.

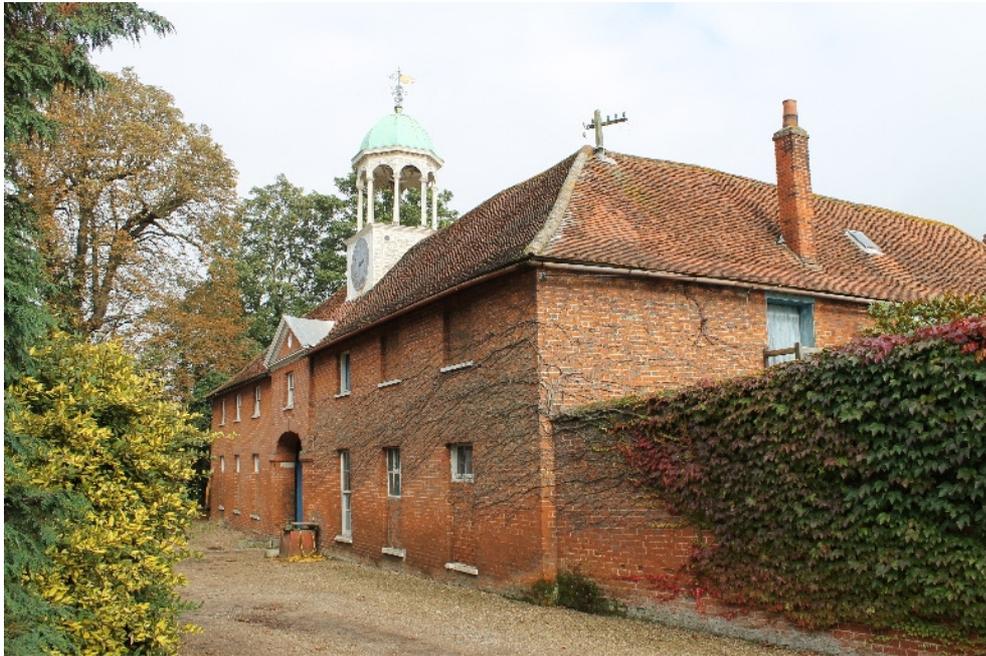
Plate 1 Structure 1/2 stable block, north-west elevation with the wooden cupola and the farmyard wall to the right - view north-east

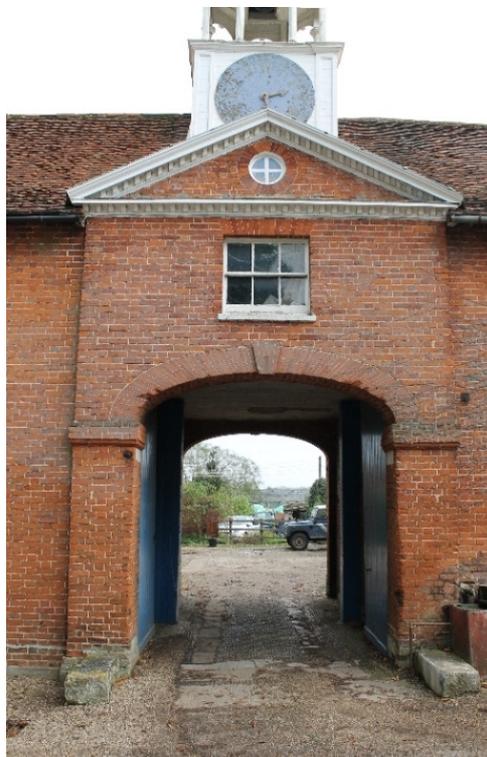
Plate 2 Structure 1/2, carriage arch in the main range of the stable block, with the stable courtyard beyond - view south-east

The surface of the carriage arch has two wheel runs formed of wide limestone slabs, with cream and blue bricks laid in a chevron pattern in between. Doorways open off either side of the archway, probably the original entrances to the stables: the one to the north has been infilled. On either wall of the carriage arch are timber boxes rising through the roof of the arch (Plate 4). These contain the counterbalances for the tower clock.

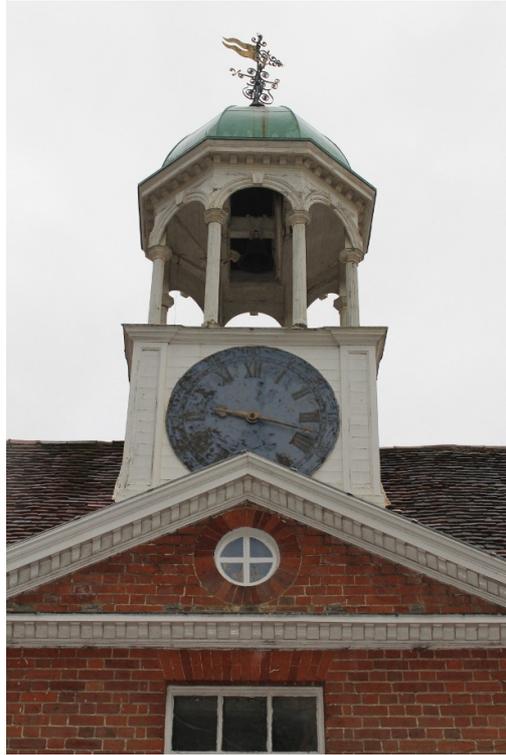
Plate 3 Structure 1/2, clock tower on the roof of the main range of the stable block - view south-east

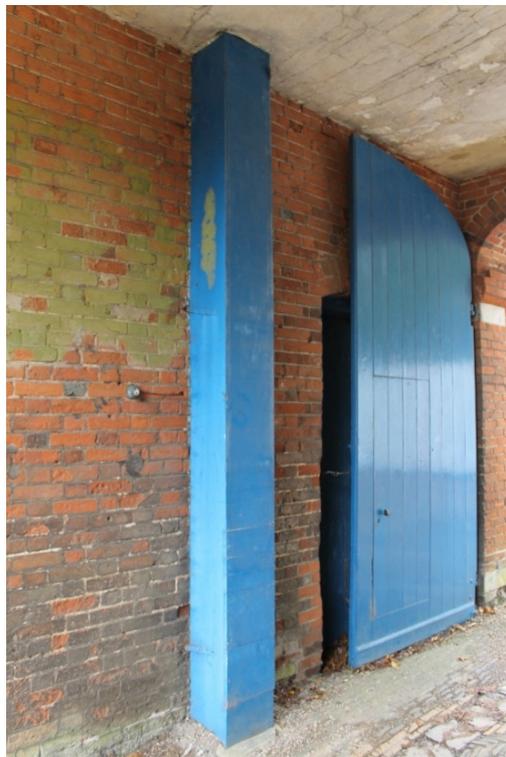
Plate 4 Structure 1/2, interior of the carriage arch showing one of the timber boxes housing the clock counterbalance with one of the original stable doors behind the blue gate - view west

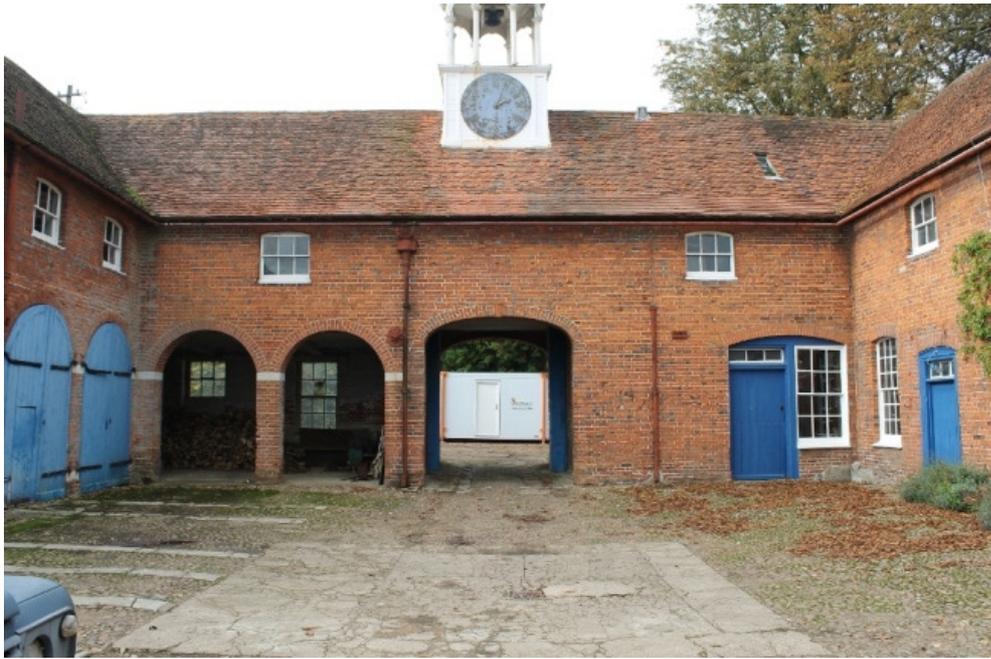
Plate 5 Structure 1/2, the south-east elevation of the main range of the stable block with the inserted entrance to stable 1 to the right of the carriage arch and the inserted arches to garage 1 on the left of the carriage arch. The coach house with Garage Flat above is to the left whilst the tack room is on the right - view north-west

The south-east elevation of the main range (Plate 5; Fig 7) is less ornate and the ground floor has been substantially altered. To the north of the carriage arch a large opening has been inserted. This has a cambered arch over a stable door and a sash window of six-over-six lights. South of the carriage arch two arched openings with limestone impostes have been inserted. These have jointed timber doors on sliding tracks. The first floor has a single sash window of three-over-three lights, surmounted by a cambered brick arch, on either side of the carriage arch.

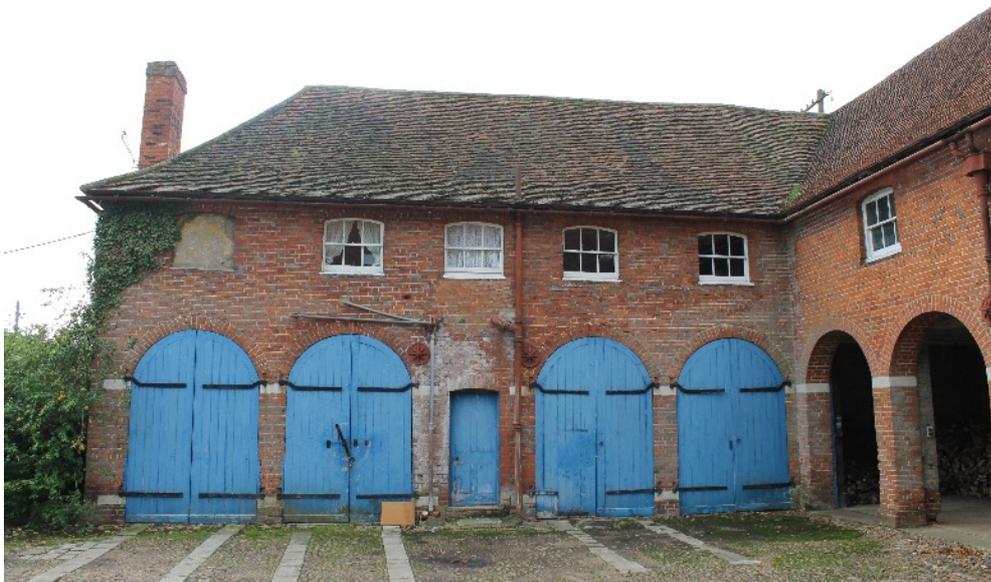
Plate 6 Structure 1/2, the north-east elevation of the south range with the coach house on the ground floor and Garage Flat above - view south-west

The south range was originally the coach house for the stables (Plate 6; Fig 8). The north-east elevation, facing the stable yard, has a centrally-positioned doorway with two arched openings on either side. Each archway has a pair of heavy timber doors with strap hinges held on iron pintels embedded in limestone impost blocks. The first floor has five window openings surmounted by cambered brick arches, four with sash windows of three-over-three lights and one that has been blocked.

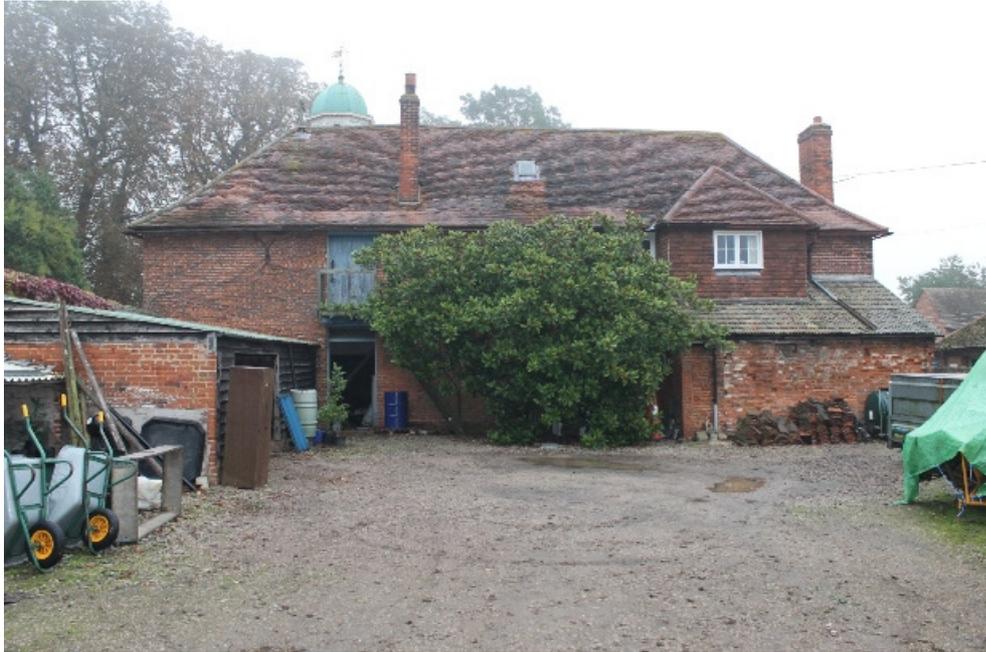
Plate 7 Structure 1/2, the south-west elevation of the south range with the remnant of the early extension and the 19th-century tile-hung extension to Garage Flat on the right - view north-east

The south-west elevation of the south range is partially obscured by a small, single-storey brick lean-to with a mono-pitch roof of clay tiles (Plate 7; Figs 7, 10). Above this there is a small tile-hung extension to the first floor, with a hipped roof. Next to the ground floor extension is a window of six lights converted from a doorway in the centre of the range. Above this, on the first floor, is a sash window of three-over-three lights, surmounted by a cambered brick arch. The remainder of this elevation has features associated with the stable block. A plank stable door with three lights above it has been inserted to the ground floor and a second doorway inserted directly above it, accessed by a steep flight of timber steps. At the corner of the elevation, concealed by a later lean-to structure, is a cambered arch for a former doorway into the stable block.

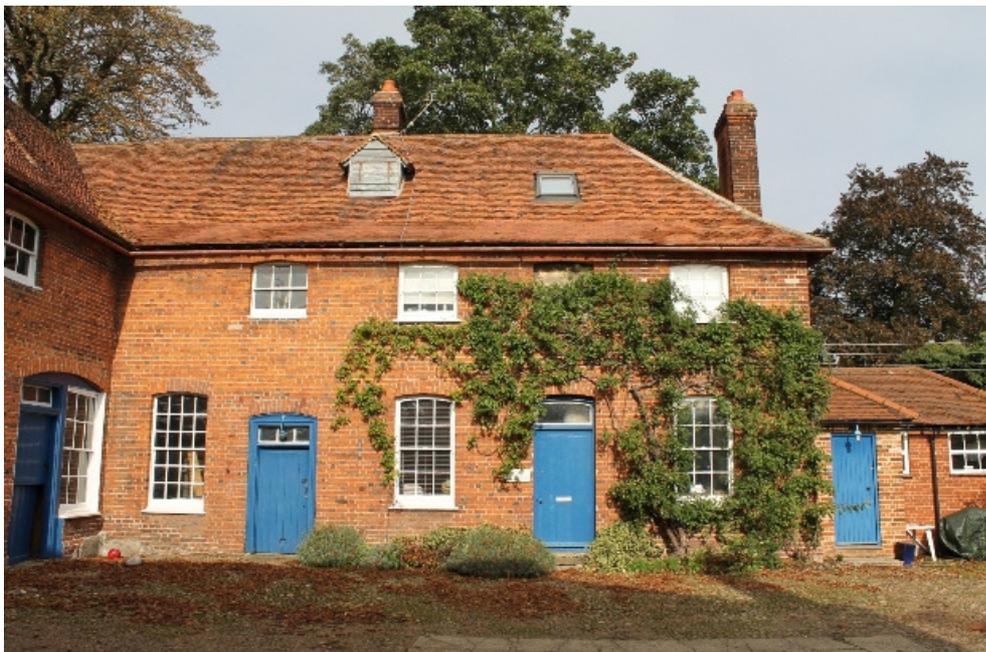
Plate 8 Structure 1/2, the south-west elevation of the north range with the tack room to the left and Stable Cottage to the right: the single-storey structures on the right are 20th-century extensions to the cottage - view north-east

The north range is divided between the tack room for the stables (which has a staircase to the grooms' accommodation on the first floor of the main range) and the self-contained Stable Cottage (Plate 8; Figs 7, 9, 11). The south-west elevation has an entranceway to the tack room surmounted by a cambered arch, below which is a simple plank door with three lights above it. To the west of this, a sash window of nine-over-nine lights, surmounted by a cambered brick arch, has been inserted into the brickwork. Stable Cottage has a doorway with a cambered brick arch which has been converted from an original window. This is flanked by sash windows of six-over-six lights, surmounted by a cambered brick arch. Between the doorway and the east window there is a narrow opening that has been blocked. This has a cambered brick arch and the opening originally cut the brick plinth to the building, suggesting this was a doorway rather than a window. The first floor has four window openings all surmounted by cambered arches, three with sash windows of three-over-three lights and one which has been blocked. The roof above this elevation has a timber dormer with a hatch.

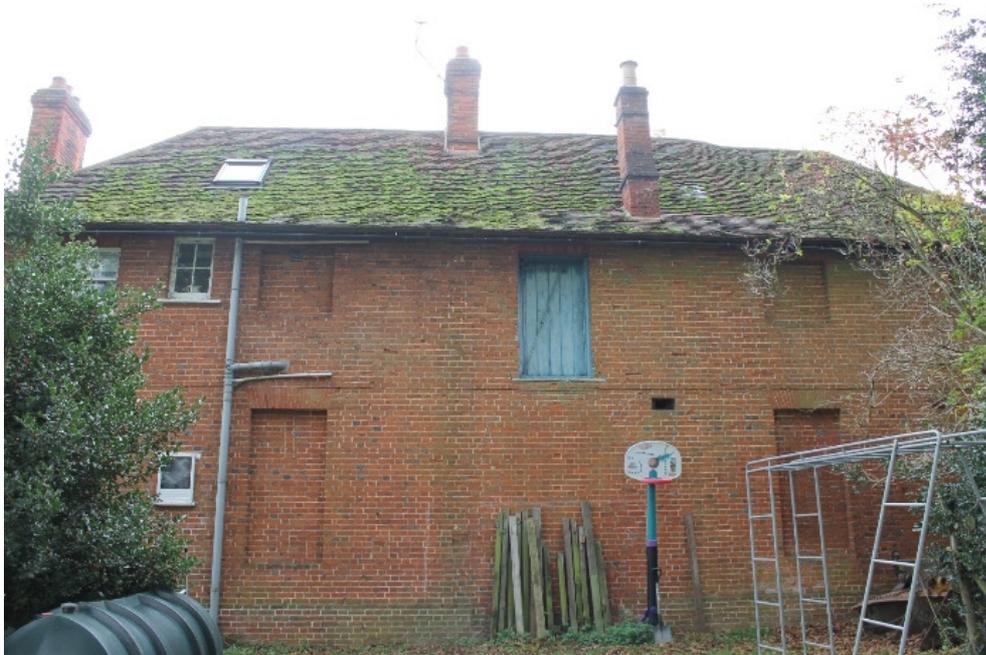
Plate 9 Structure 1/2, the north-east elevation of the north range, originally with blind windows to both ground and first floor. Windows have been inserted for Stable Cottage on the left and a doorway with a grain hoist has been inserted in the central window of the first floor. Below this there appears to be a blocked double doorway - view south-west

The north-west elevation has a symmetrical façade, originally with four large blind windows on the ground floor and five smaller blind windows on the first floor, all with flat rubbed and gauged brick arches (Plate 9; Fig 11). The conversion of Stable Cottage saw the insertion of actual windows through two of these, along with two additional windows. At the north end of the range a small window has been inserted through the ground floor blind window and the central blind window on the first floor has been converted to a doorway with a movable iron grain hoist attached. Below this, in the centre of the elevation, it appears as if a large opening has been blocked. There is a possibility this was a fifth blind window but, as the plinth stops either side of the opening, it is more likely to have been a wide doorway.

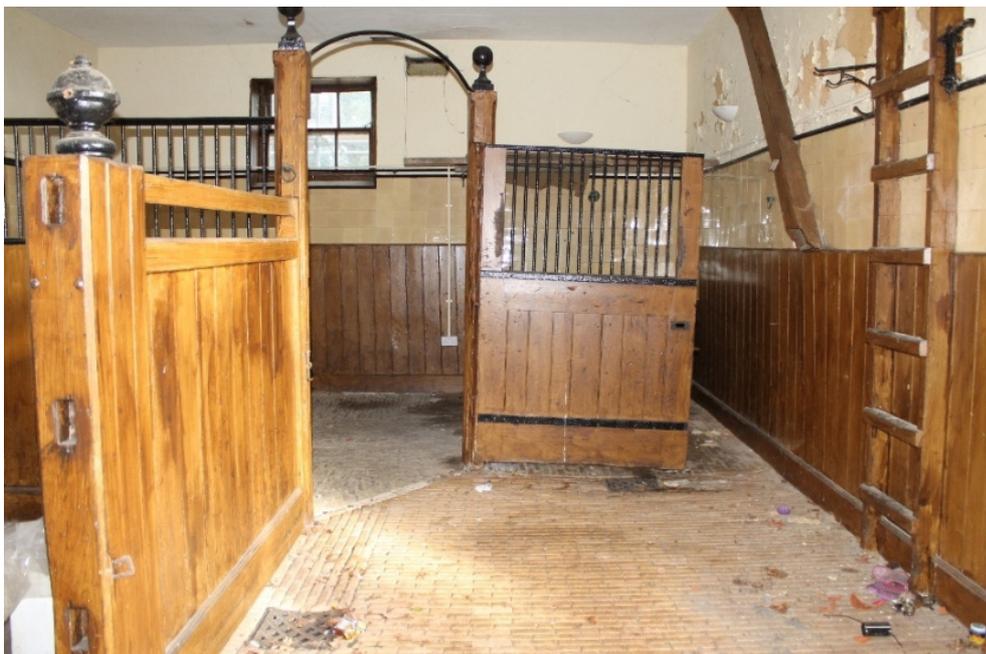
Plate 10 Structure 1/2, interior of stable 1 showing the 19th-century timber and iron stalls with the ladder to the grooms' rooms above on the right along with the chute from the grain bin located on the first floor - view north-east

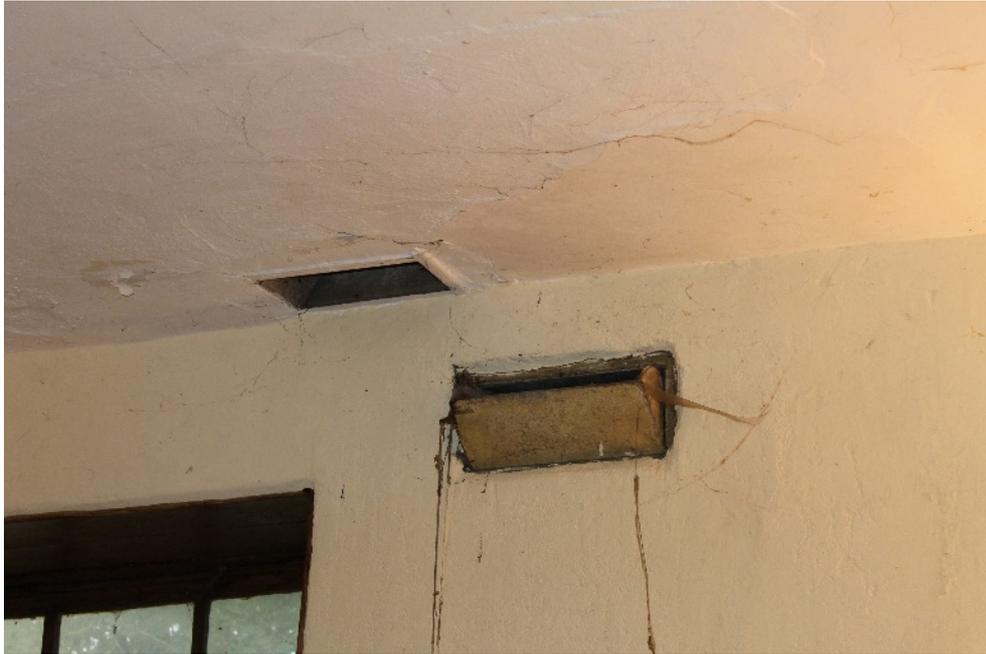
Plate 11 Structure 1/2, interior of stable 1 showing the 19th-century ventilation hopper with the mouth of the shaft for the original Georgian ventilation system in the ceiling to the left - view north

Although parts of the original structure have been internally altered, the overall plan of the Stables has remained unchanged, as has a significant amount of the original fabric. The surviving parts of the original stable ventilation system, the Georgian staircase and the late 18th-century clock mechanism are all important features which help build a picture of what the stable block would have originally looked like. Although most of the windows appear to be pre-1850s replacements, the inserted window to the tack room, with its small panes and thick glazing bars, may be an original sash window relocated from elsewhere in the stables, and this is further evidence for the original appearance of the building.

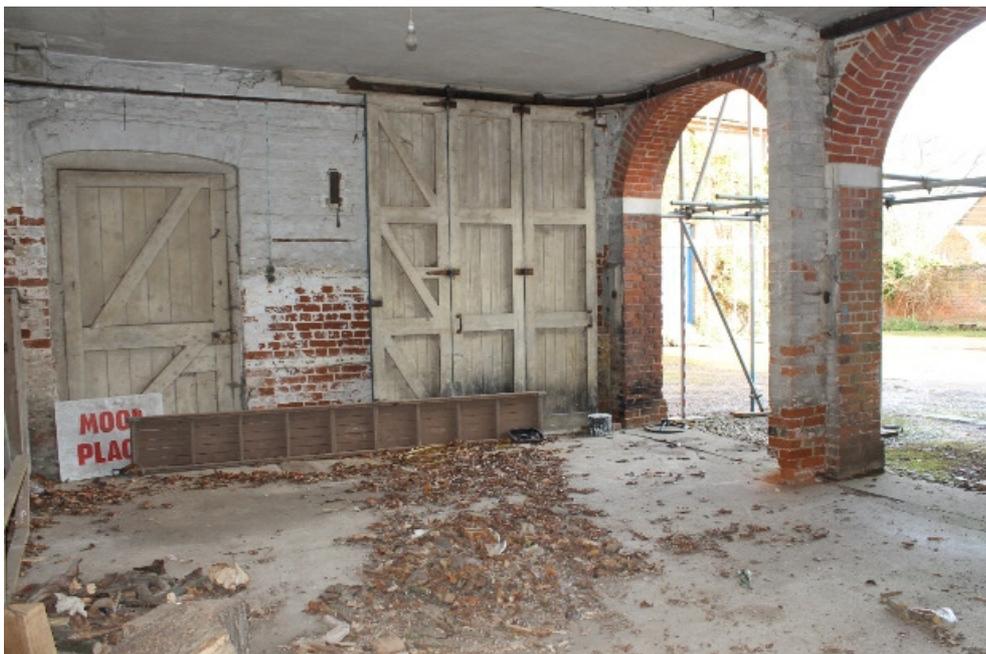
Plate 12 Structure 1/2, interior of garage 1 showing the arches inserted in the 20th century and the Henderson sliding garage doors. The original stable doorway to the carriage arch is to the left - view north-east

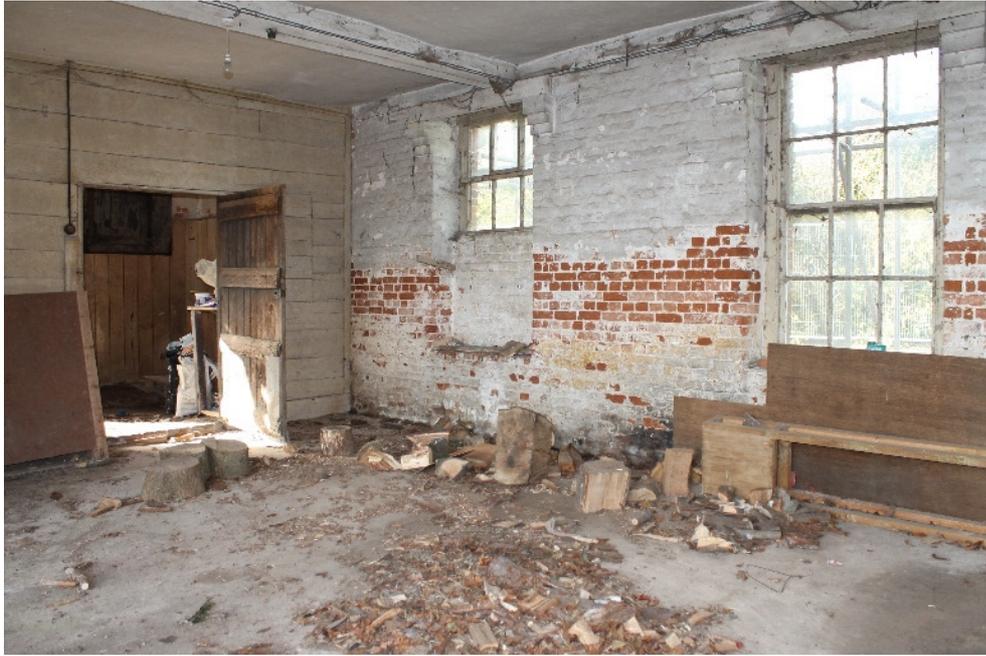
Plate 13 Structure 1/2, interior of garage 1 showing the original window openings with the corbelled lintels and the inserted dividing wall - view south-west

floor meet the north-west wall above these windows (Plate 13). To compensate for this, the timber lintels above the windows are stepped out on corbelled brick work.

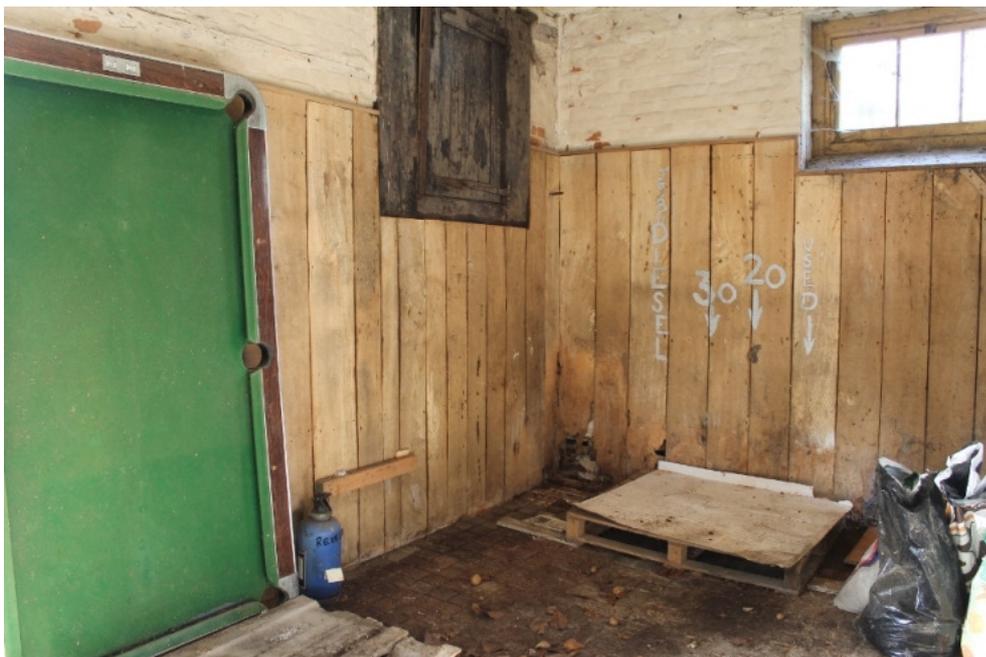
Plate 14 Structure 1/2, interior of stable 2 showing the later plank cladding partially obscuring an original doorway to the left and window to the right - view south-west

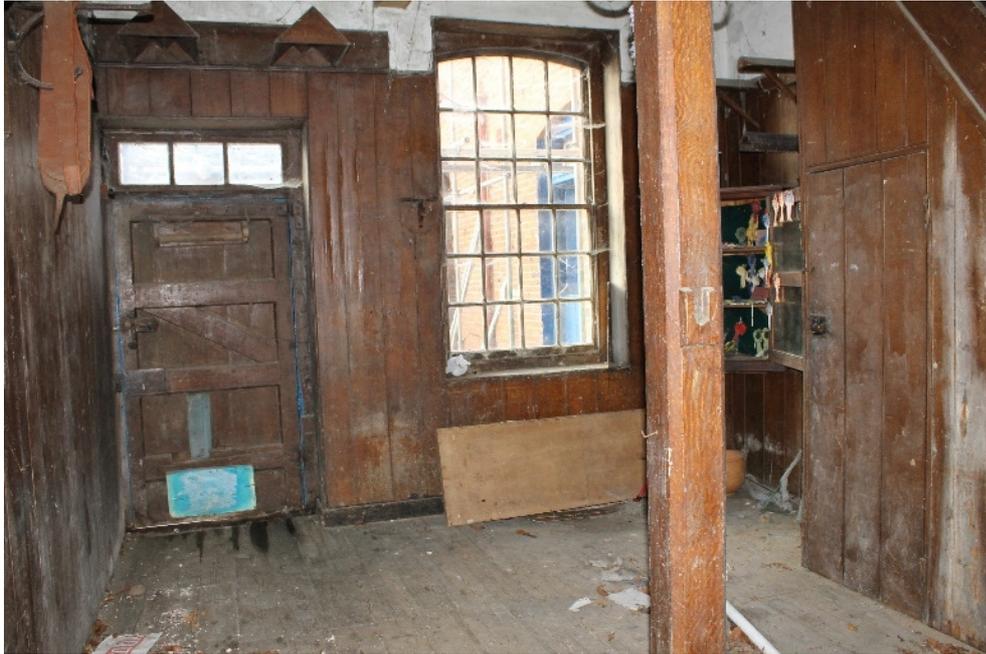
Plate 15 Structure 1/2, interior of the tack room showing the 19th-century plank cladding and the inserted window opening that appears to contain one of the original sash windows. The enclosed staircase leading to the first floor of the main range is to the right - view south-west

The staircase in the tack room is a 19th-century replacement for the lower part of the Georgian staircase on the first and second floors but maintains the original access to the first floors of both the main range and the north range. Other than the partitioned room containing the Georgian staircase, the original layout of the first floor of the north range has been completely replaced by that of Stable Cottage.

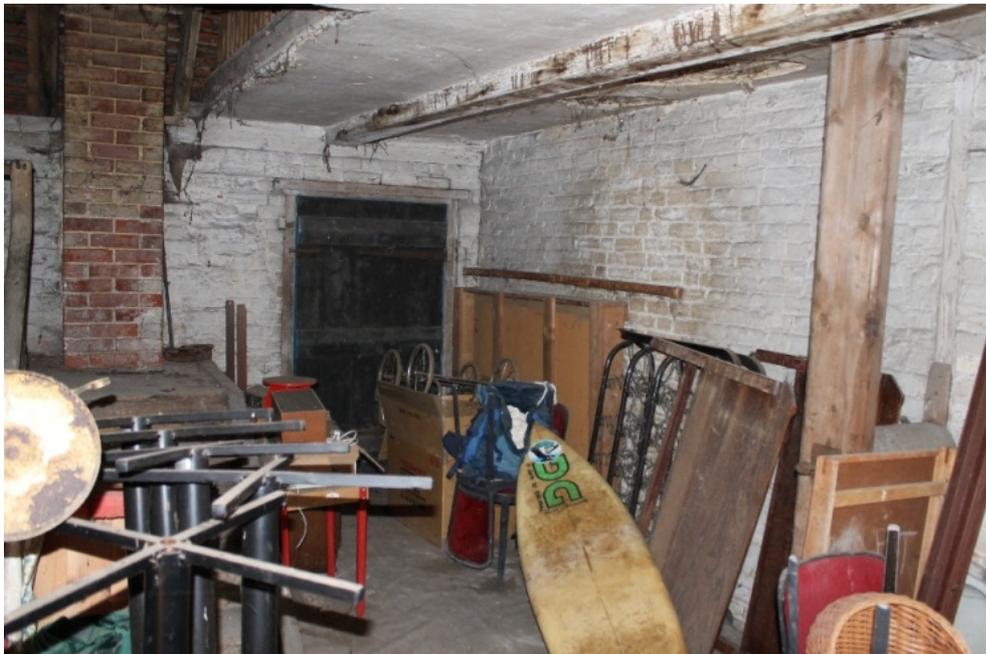
Plate 16 Structure 1/2, interior of FF1 showing the door inserted through one of the blind windows in the north-east wall with the inserted internal chimney stack for the tack room on the left, rising through the landing of the early-mid 18th-century staircase leading to the attic of the main range - view north-east

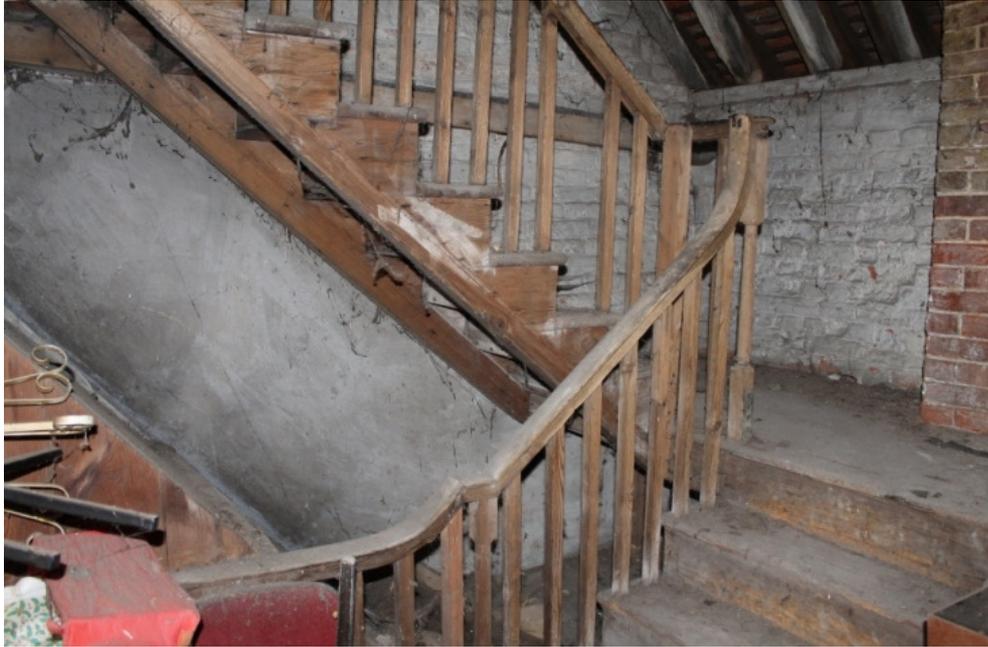
Plate 17 Structure 1/2, early-mid 18th-century staircase leading from FF1 to the attic of the main range - view north

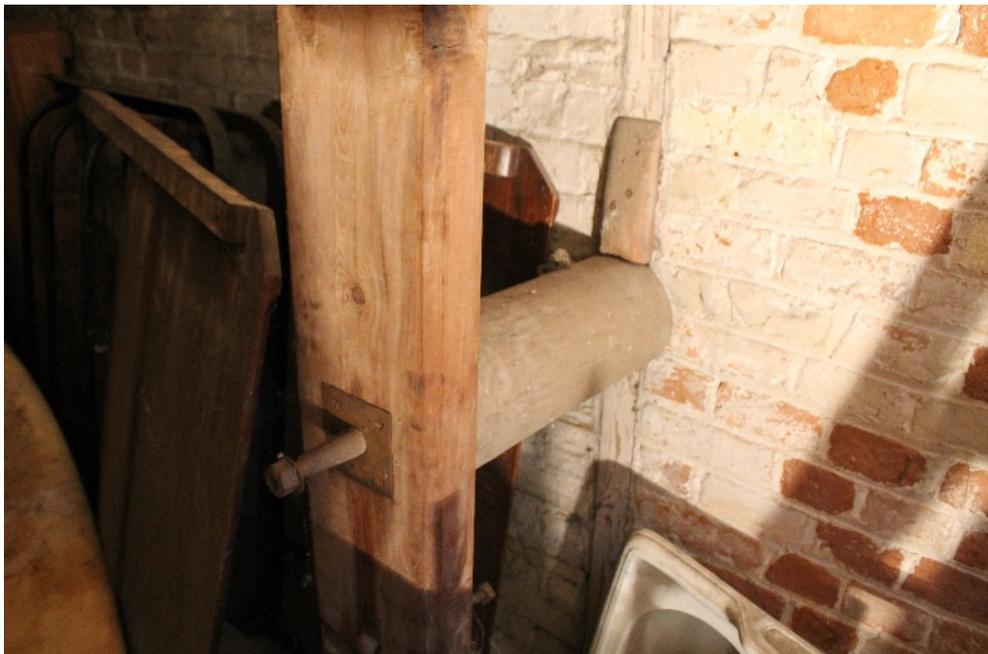
Plate 18 Structure 1/2, winch apparatus in FF1 for hoisting grain sacks up to the first floor through the inserted door in the north-east wall. The early connecting doorway to the first floor of the north range, since blocked, is on the right - view north-east

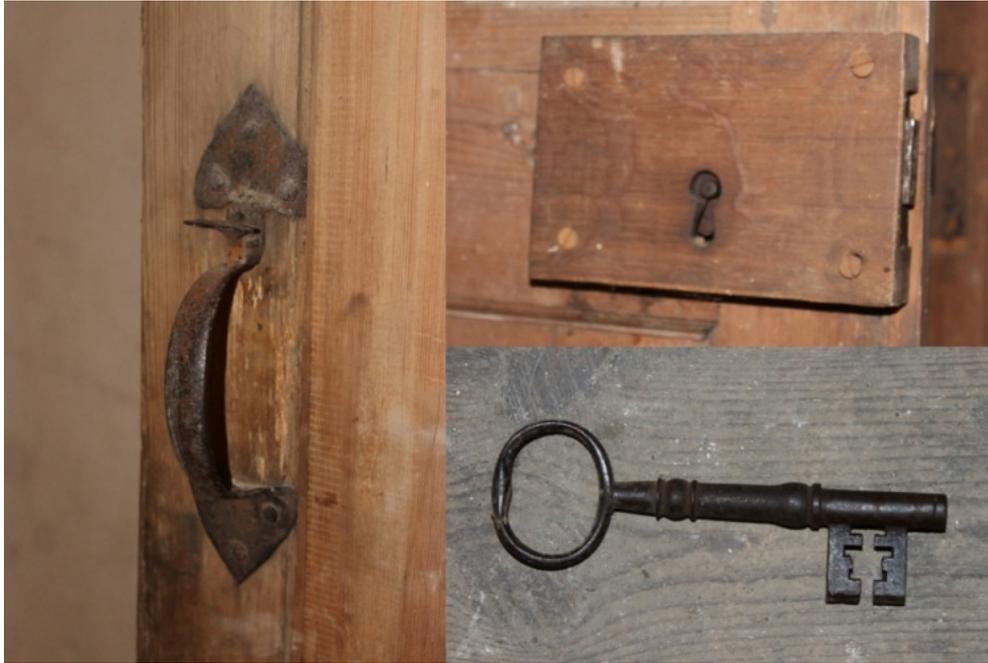
Plate 19 Structure 1/2, detail of original door latch, lock casing and door key re-used on the 19th-century four panel doors to the grooms' rooms on the first floor of the main range

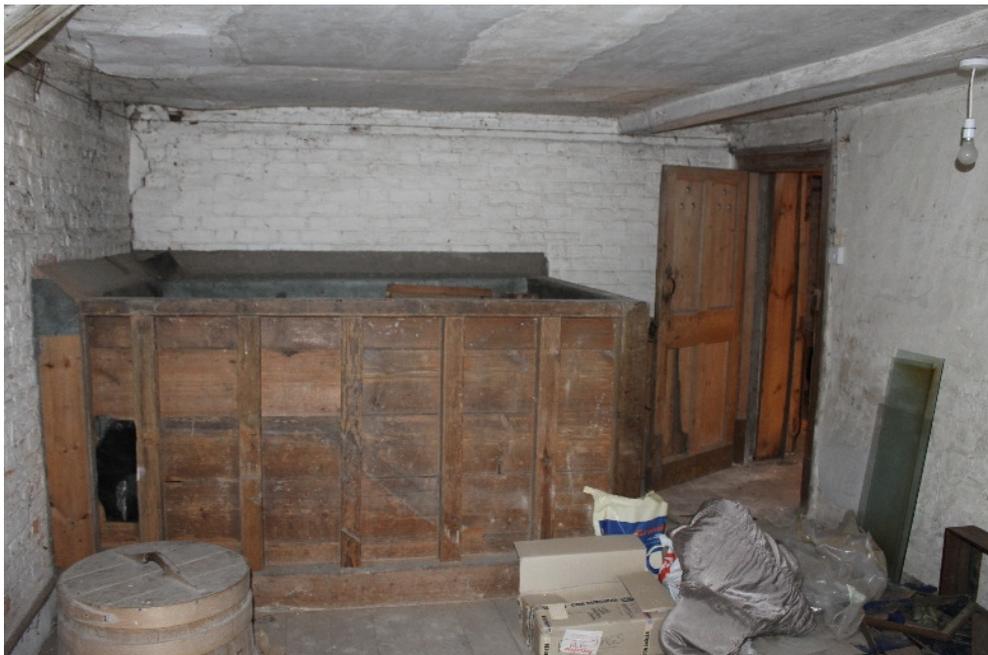
Plate 20 Structure 1/2, interior of FF2 showing the 19th-century grain bin delivering grain to stable 1 below - view south-east

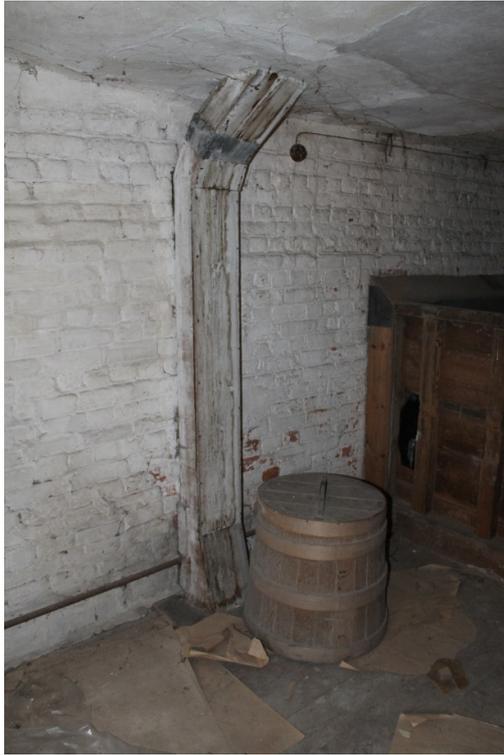
Plate 21 Structure 1/2, interior of FF2 showing the 18th-century timber-cased ventilation system rising from stable 1 below - view north-east

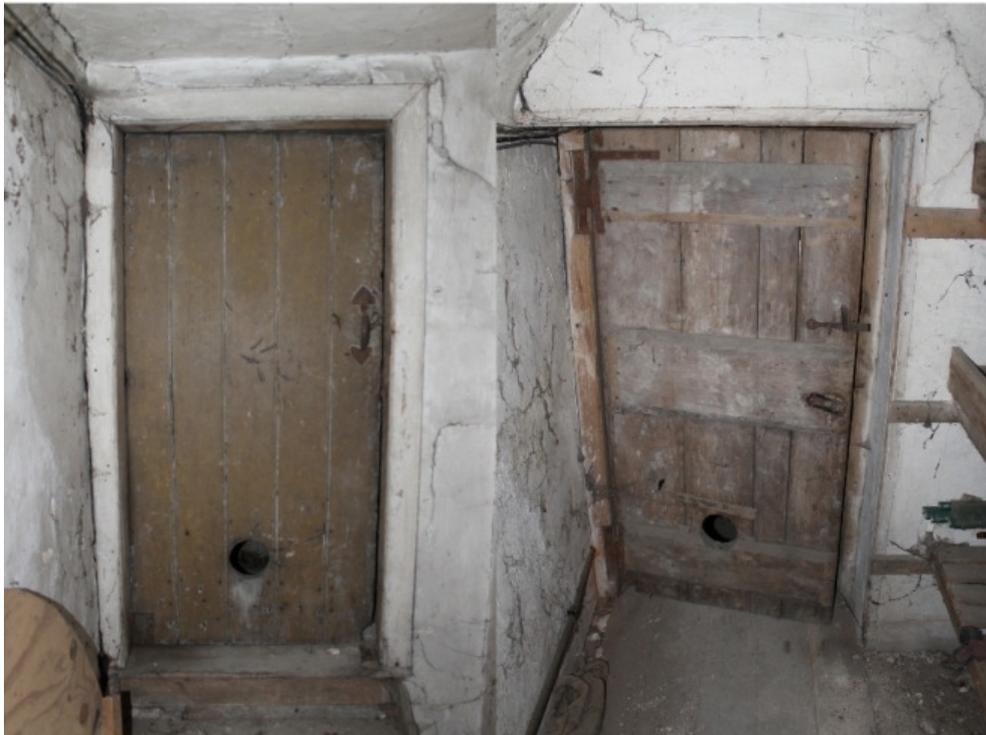
Plate 22 Structure 1/2, exterior of original plank door to FF5 and the internal face of the original door to FF6 - view south-west and north-east

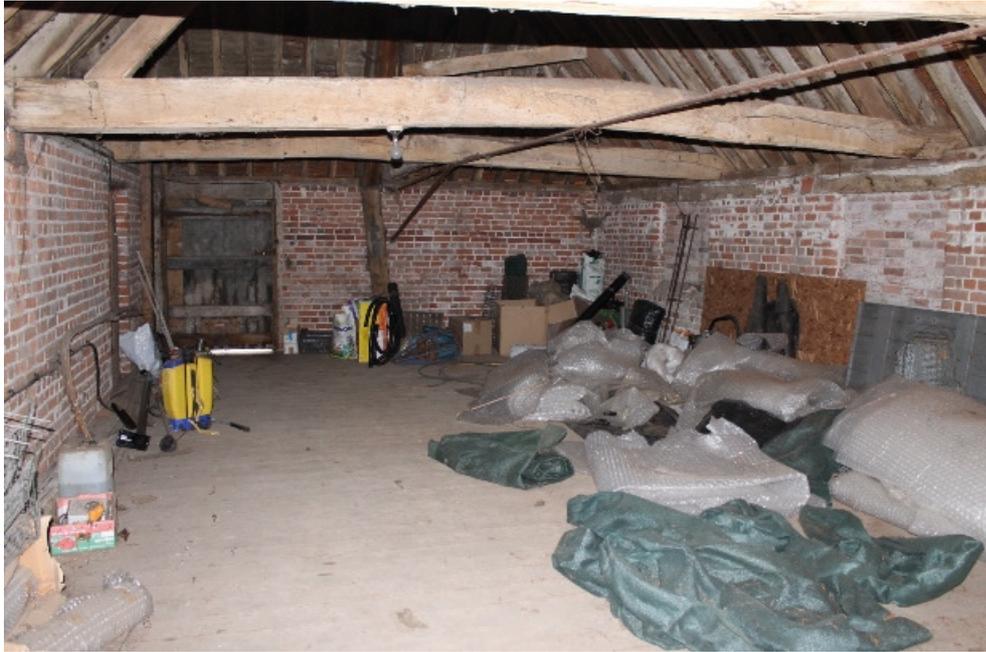
Plate 23 Structure 1/2, interior of FF6 showing the inserted doorway at the far end and the blocked windows in the right-hand wall. The blocked entrance to the first floor of the coach house is just visible to the left of the inserted doorway - view south-west

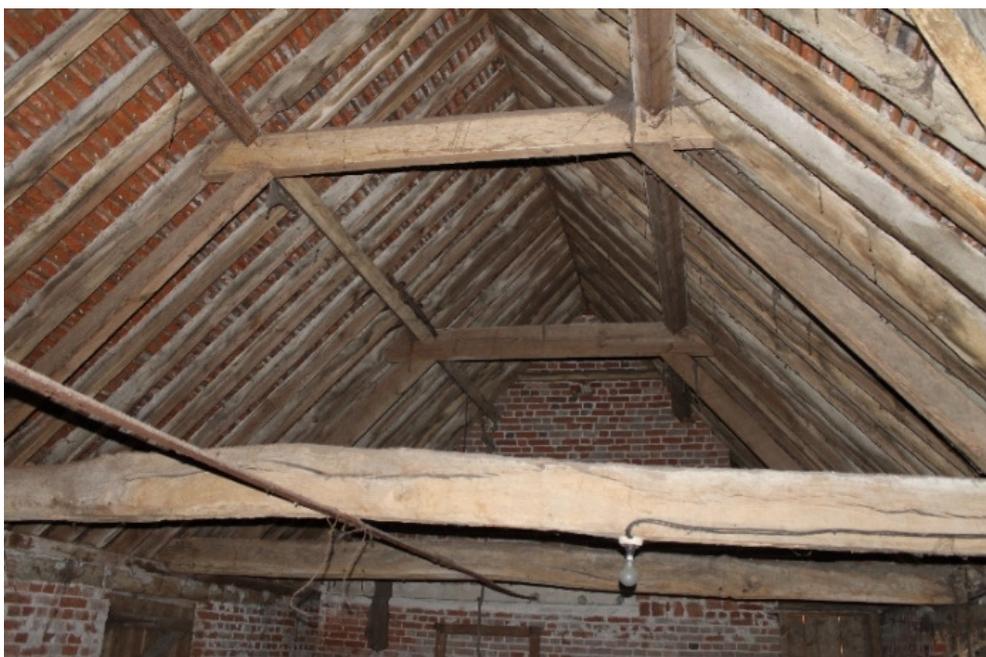
Plate 24 Structure 1/2, interior of FF6 showing roof truss B - view north

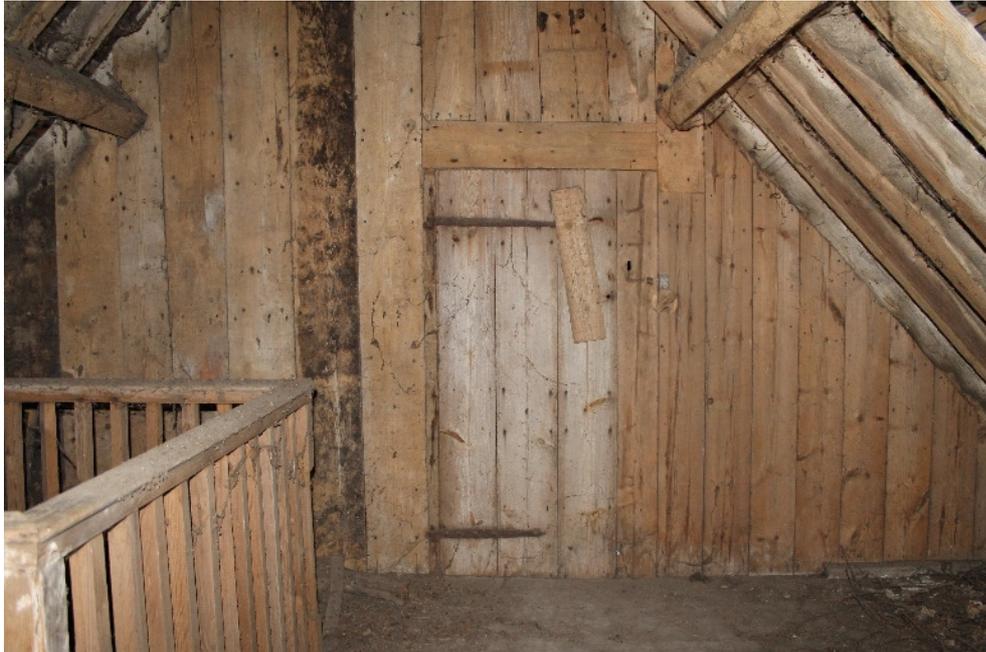
Plate 25 Structure 1/2, attic landing showing the inserted timber dividing wall between the attics of the main range and Stable Cottage, with the Georgian staircase to the left - view south-east

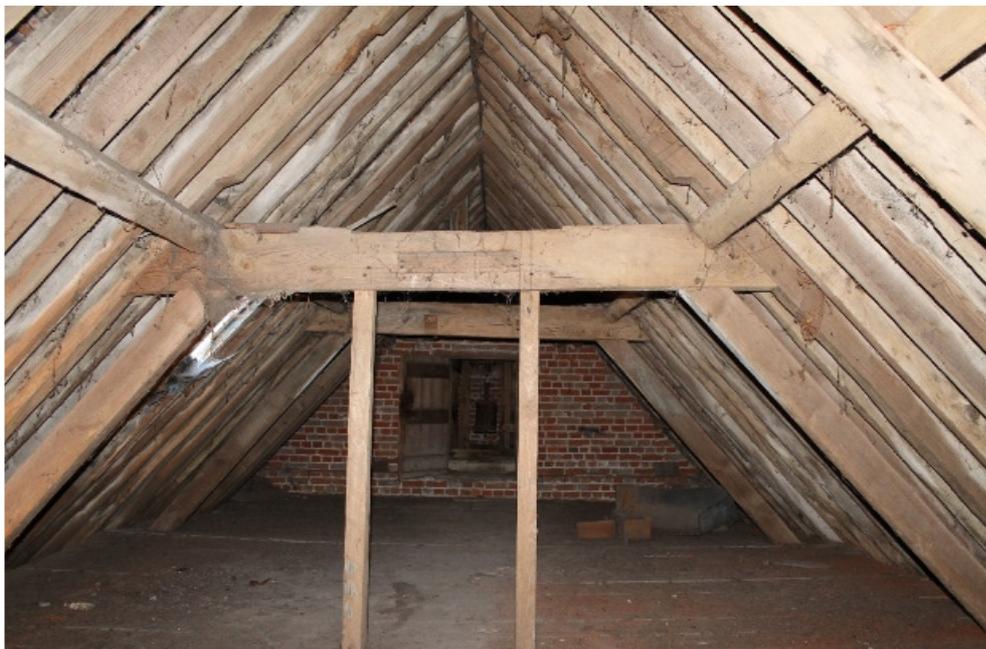
Plate 26 Structure 1/2, interior of the attic to the main range with the chamber housing the clock mechanism to the rear. The principal rafters either side of the collar beam have additional recesses, possibly for a high collar beam - view south-west

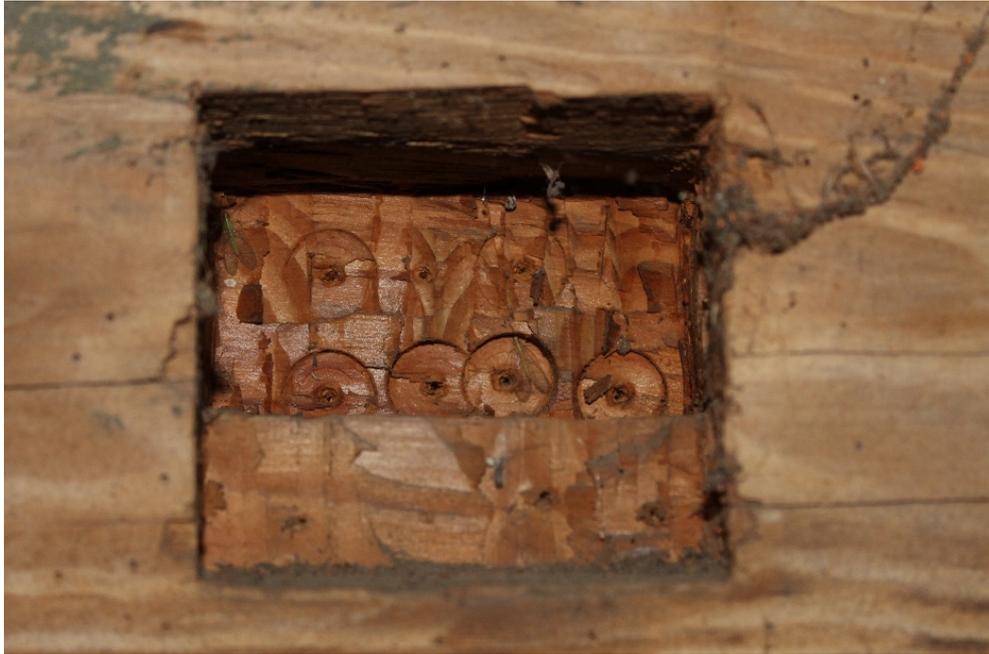
Plate 27 Structure 1/2, detail of exposed mortice in collar beam of attic truss A, showing the drill and chisel technique employed to cut a straight-sided hole - view south-west

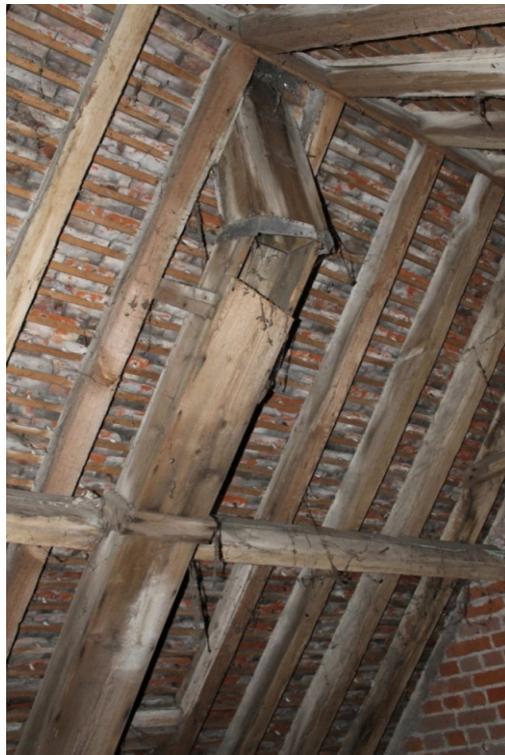
Plate 28 Structure 1/2, showing one of the original timber-cased ventilation shafts rising through the building and exiting the attic roof – view south-east

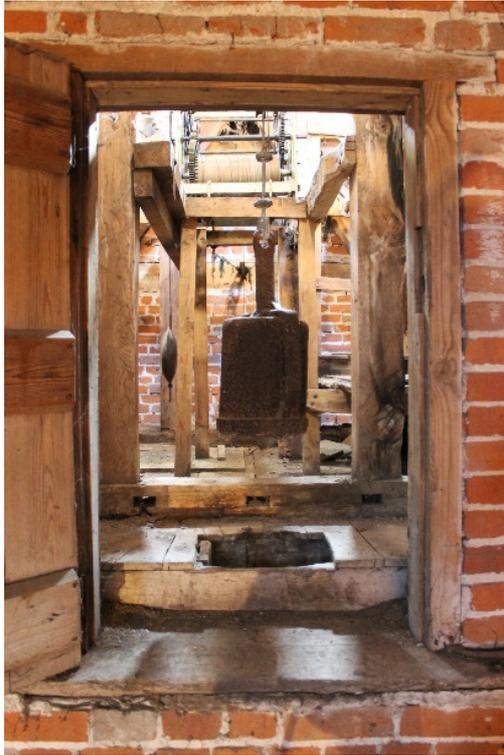
Plate 29 Structure 1/2, attic room below the cupola housing the clock mechanism, with one of the counterbalances in the foreground – view south-west

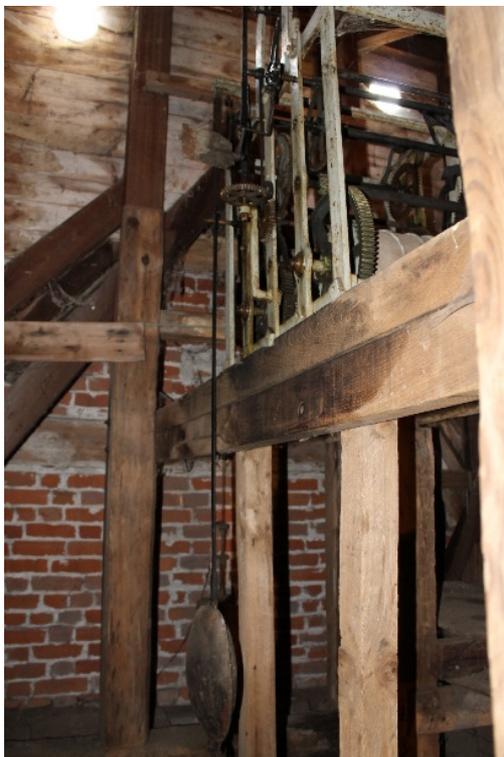
Plate 30 Structure 1/2, detail of the clock mechanism below the cupola – view south-west
