**Building recording
at Home Farm, Moor Place,
Much Hadham, Hertfordshire
October 2013**

**report prepared by
Chris Lister**

**commissioned by
Foxley Builders**

CAT Report 735
January 2015

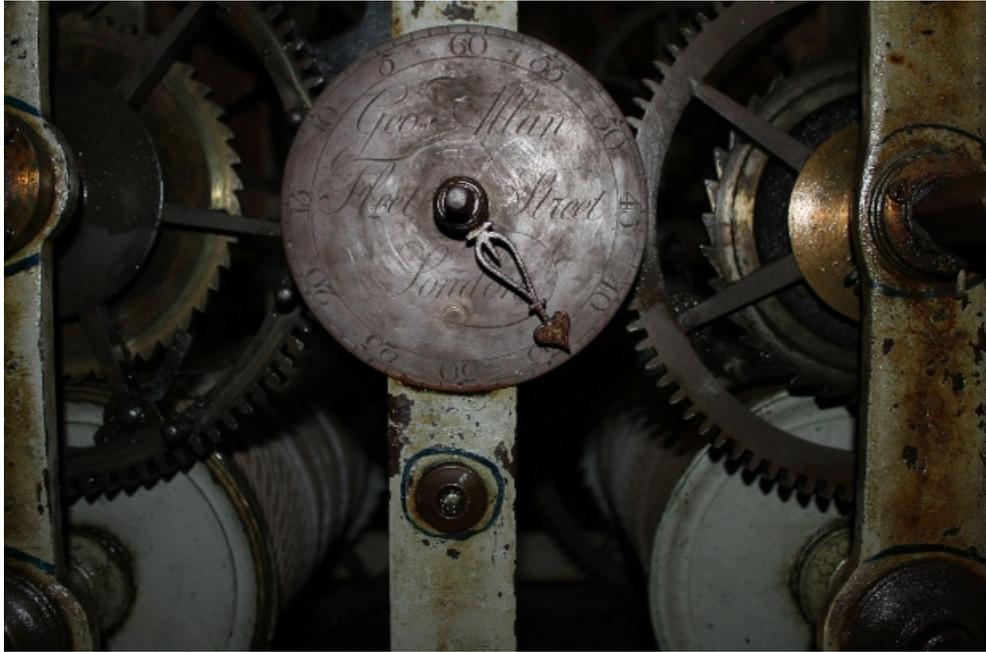
Plate 31 Structure 1/2, detail of the clock mechanism below the cupola bearing the manufacturer's details: Geo[rg]e Allan, Fleet Street, London

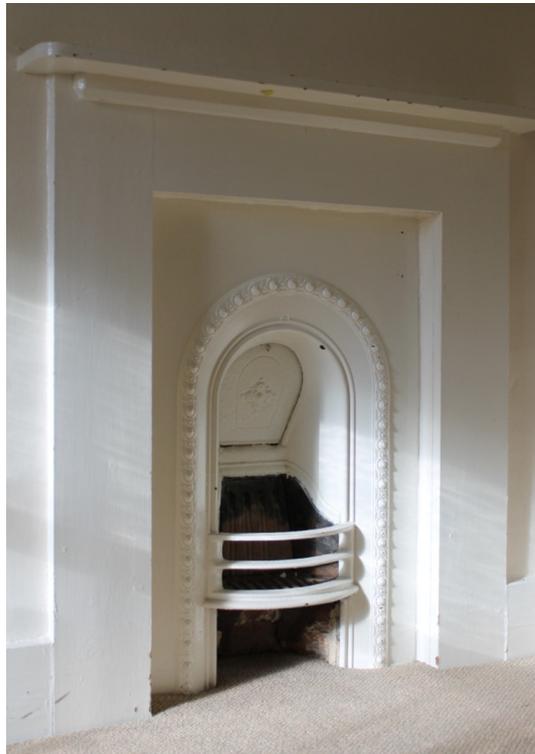
Plate 32 Structure 1/2, register grate in bedroom 1 of Stable Cottage dating to the 19th-century conversion works – view north-west

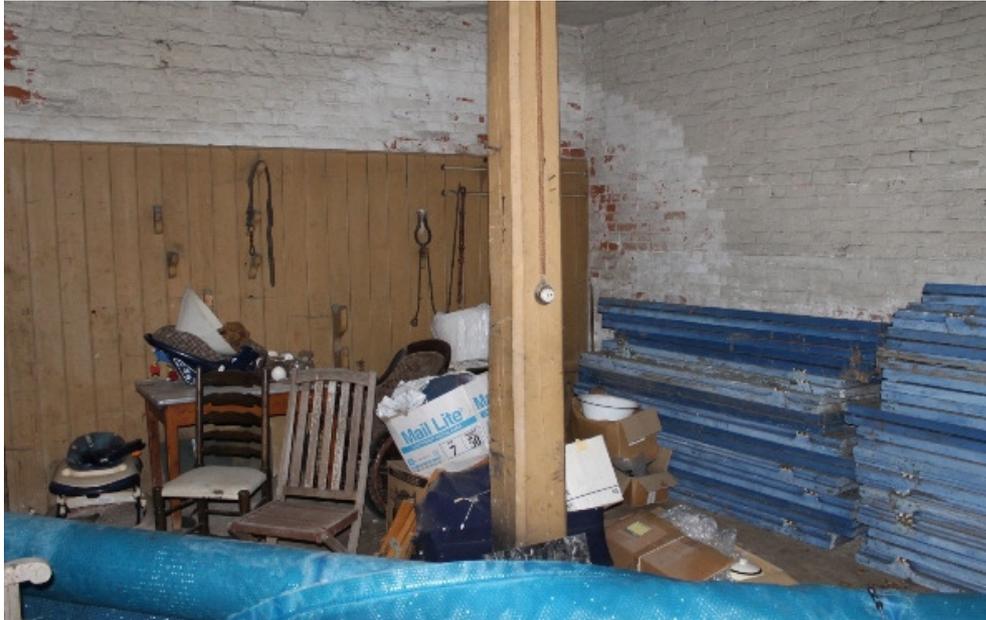
Plate 33 Structure 1/2, interior of garage 2, one of the former carriage stores with plank cladding and harness hooks probably dating to the 19th-century renovations – view west

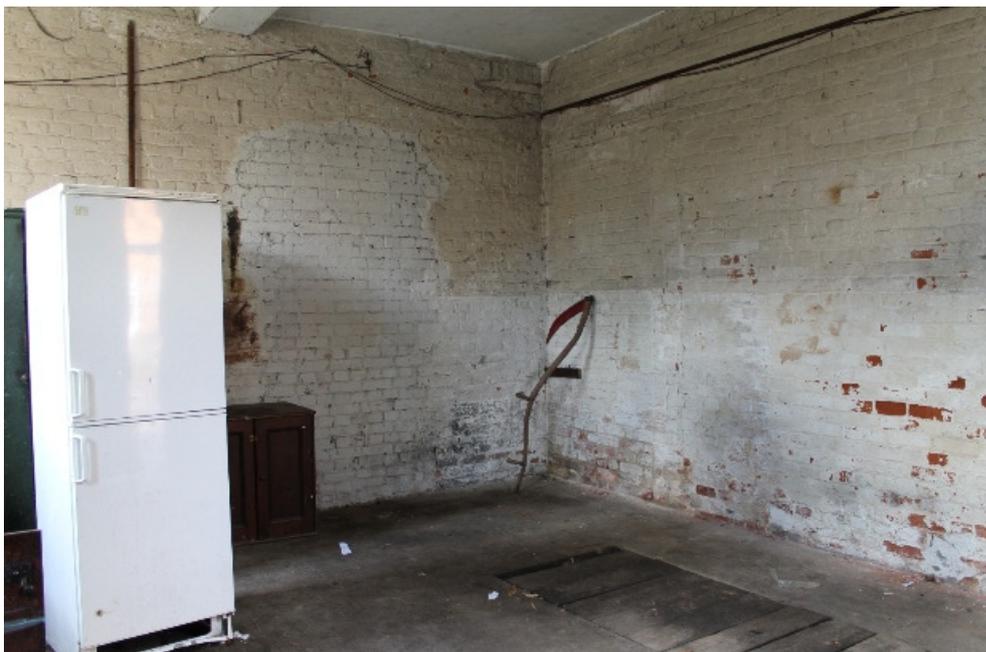
Plate 34 Structure 1/2, interior of garage 3, one of the former carriage stores with a blocked original doorway behind the scythe and a 20th-century vehicle inspection pit in the foreground – view west

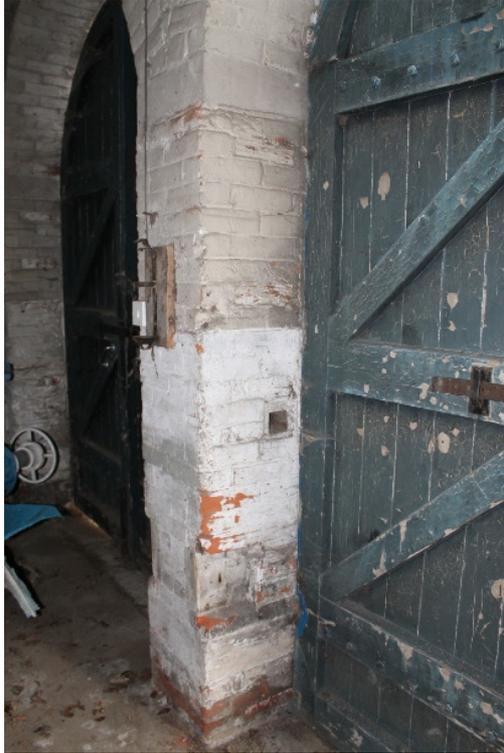
Plate 35 Structure 1/2, interior of garage 2, showing one of the timber-lined sockets in the brick pier between the archways, possibly for the original locking bar – view north

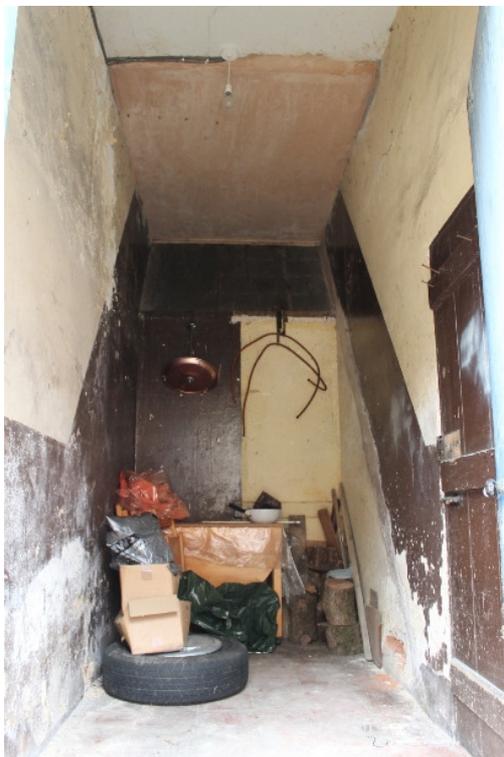
Plate 36 Structure 1/2, former stairwell to the coach house – view southwest

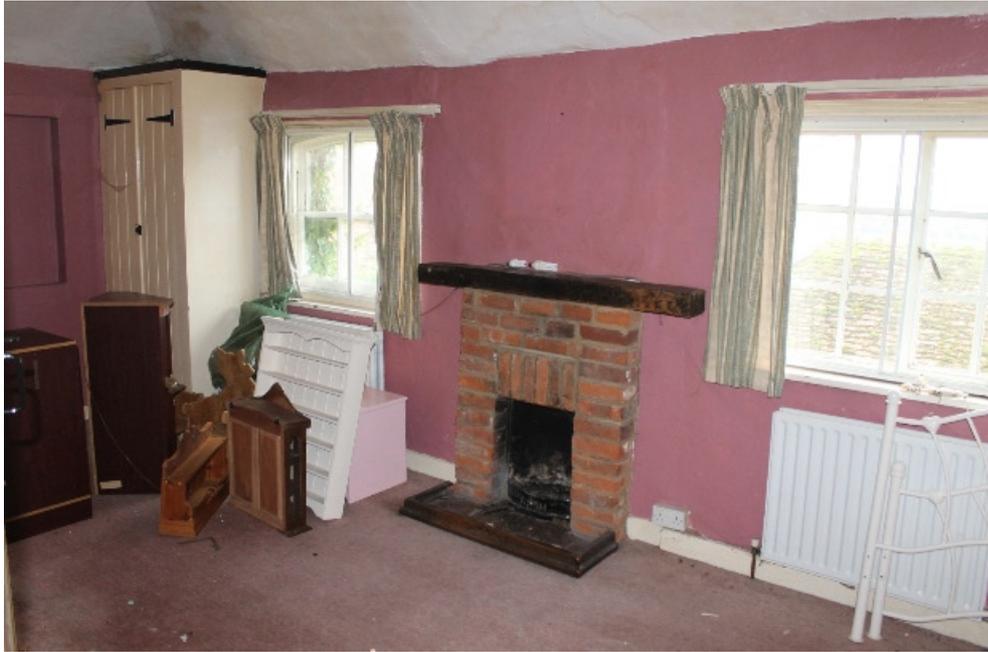
Plate 37 Structure 1/2, interior of Garage Flat sitting room, showing the fireplace to the inserted chimney stack and the blind openings converted to windows on either side. The sash window to the left of the fireplace has been relocated from the opening visible on the extreme left of the photograph – view north-east

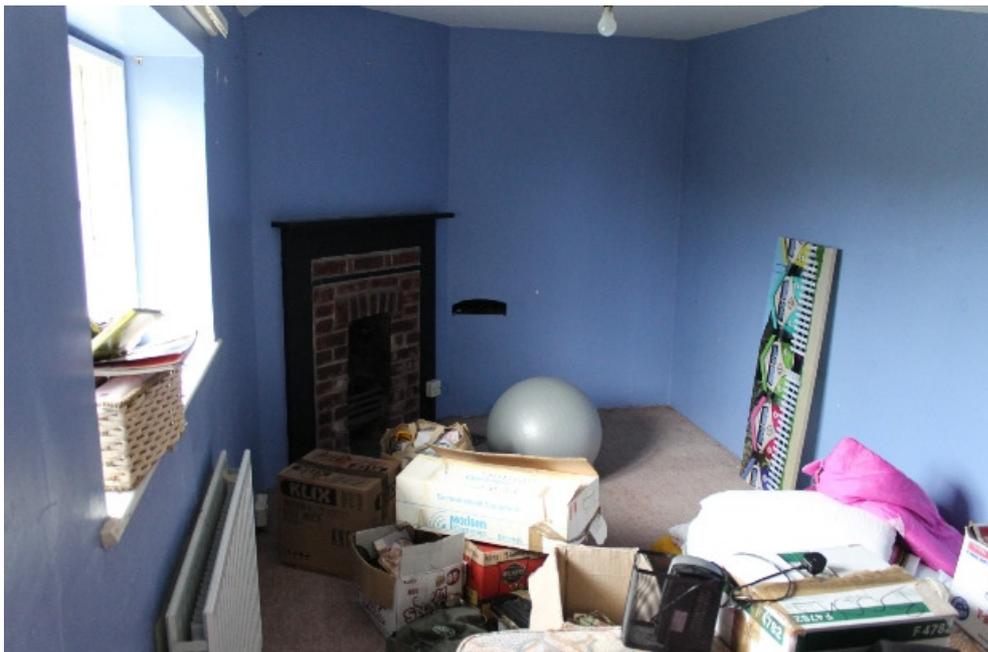
Plate 38 Structure 1/2, interior of Garage Flat bedroom 1, showing the inserted fireplace and dividing wall – view north-west

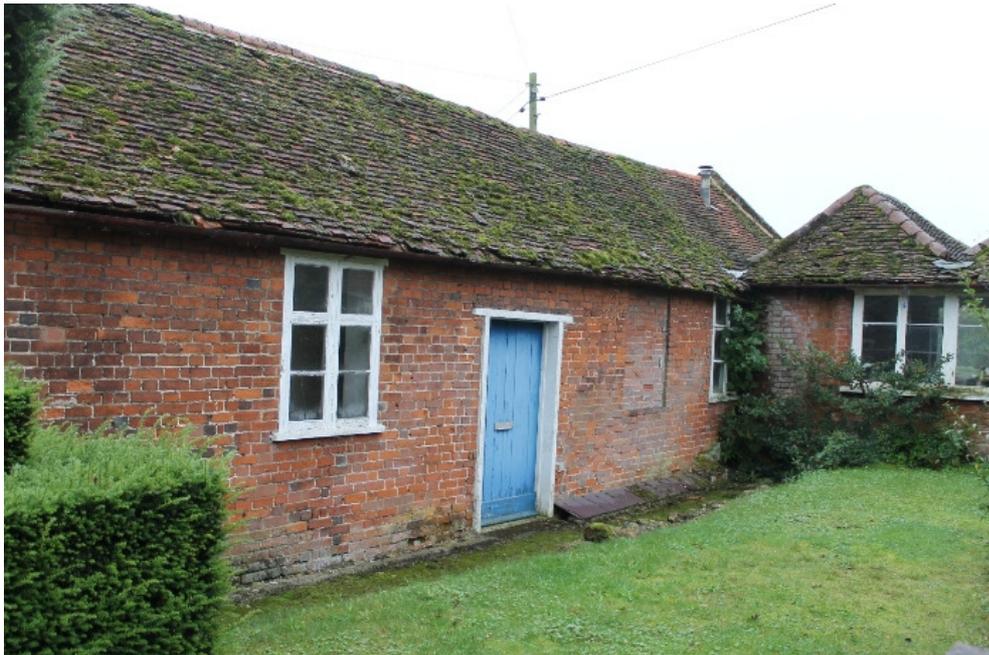
Plate 39 Structure 3 estate office, north-west elevation with the original doorway and structure 3a, the gardener's stores, to the right - view south

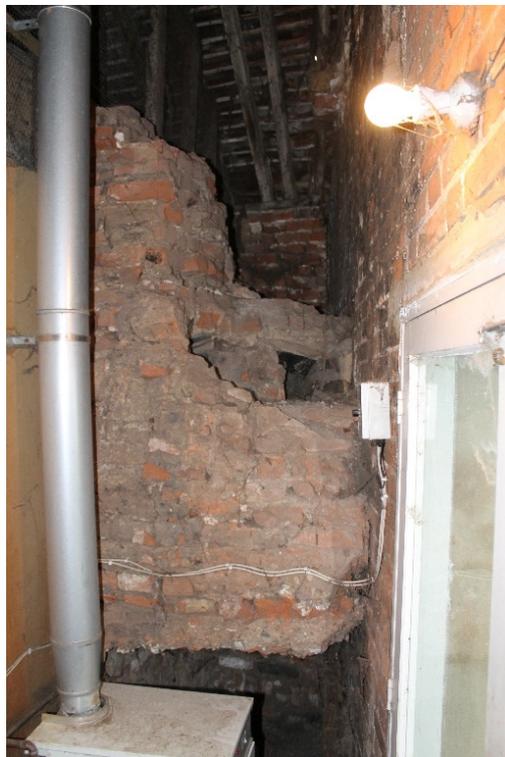
Plate 40 Structure 3 estate office, original brick oven to laundry built up against the kitchen garden wall - view east

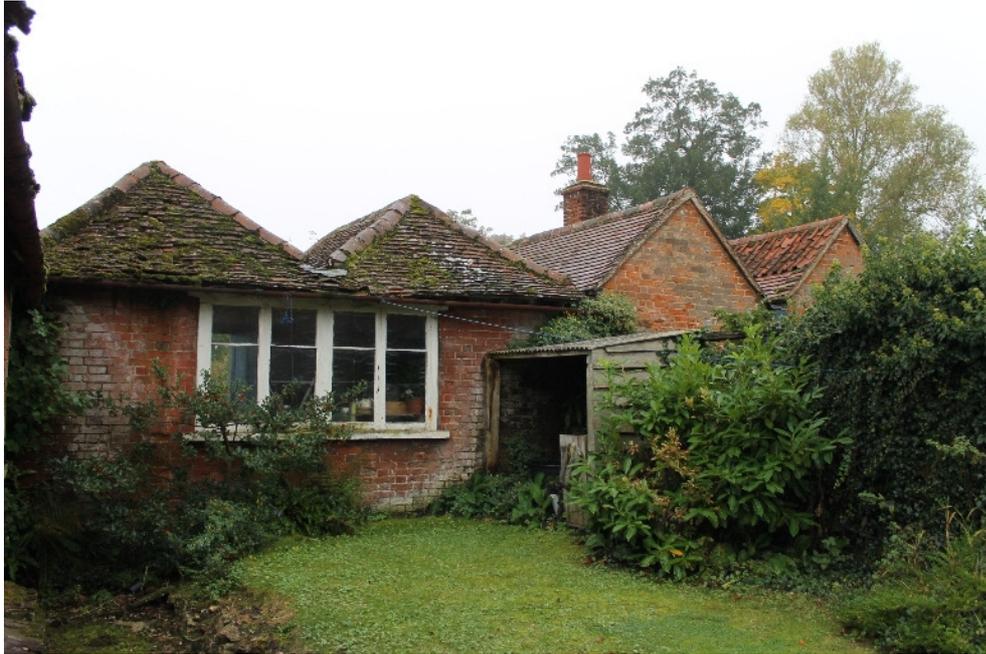
Plate 41 Structure 3a gardener's stores, north-east elevation showing the fully hipped roofs of the potting shed and the gabled ends of the western bays - view south-west

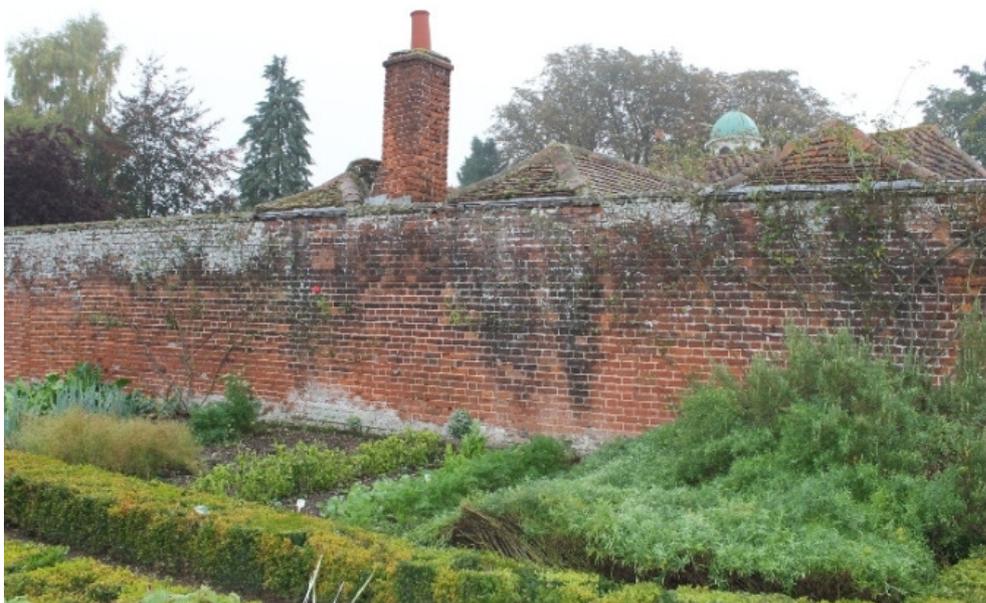
Plate 42 The hipped roofs of the gardener's stores built on top the north wall of the kitchen garden - view north-west

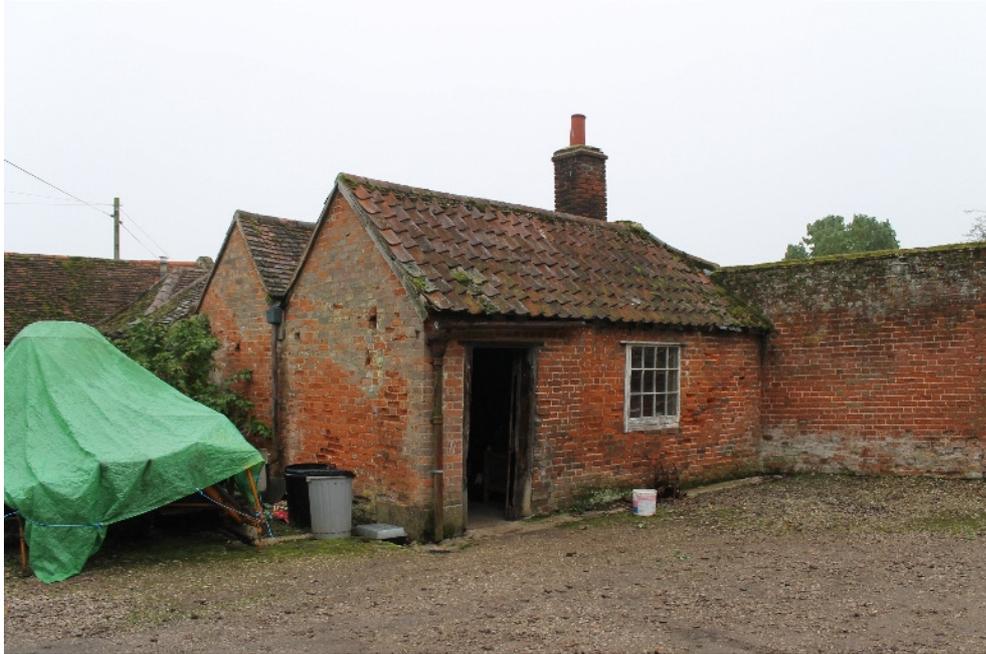
Plate 43 Structure 3a the gardener's stores, showing the gabled ends of the western bays and the inserted sash window in the north-west elevation - view south-east

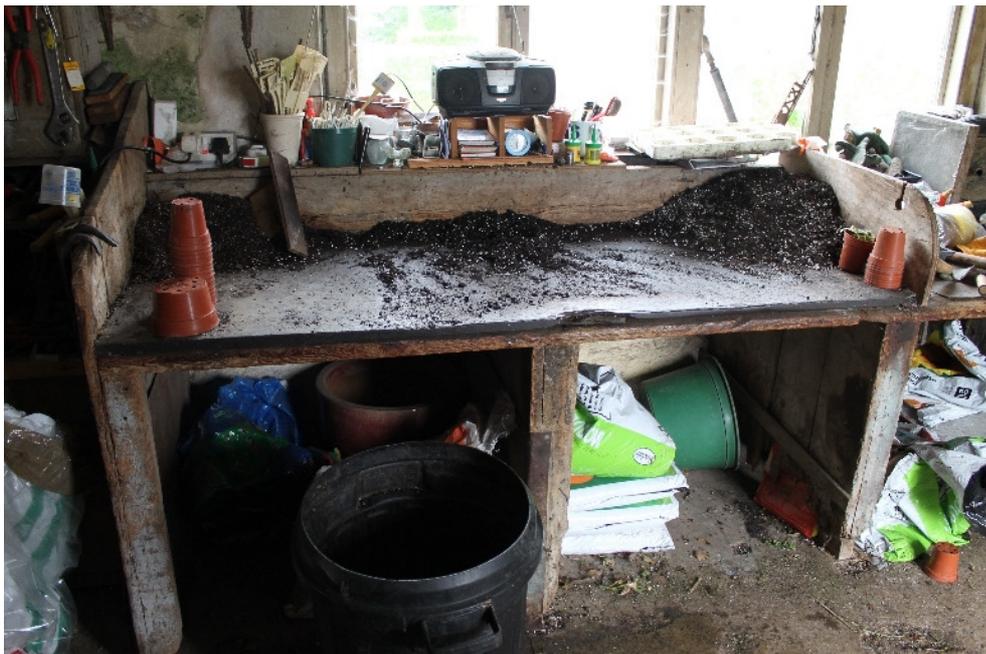
Plate 44 Structure 3a the gardener's stores, showing the slate-topped table in the potting shed - view north-east

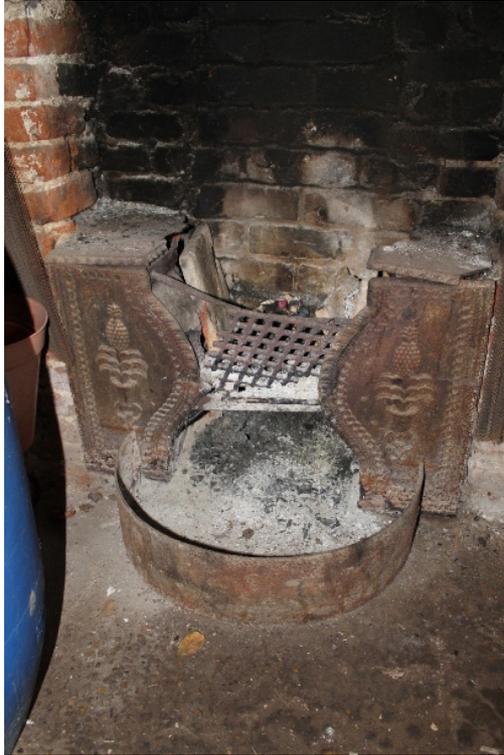
Plate 45 Structure 3a gardener's stores, showing the Georgian hob grate with pineapple motif - view south-west

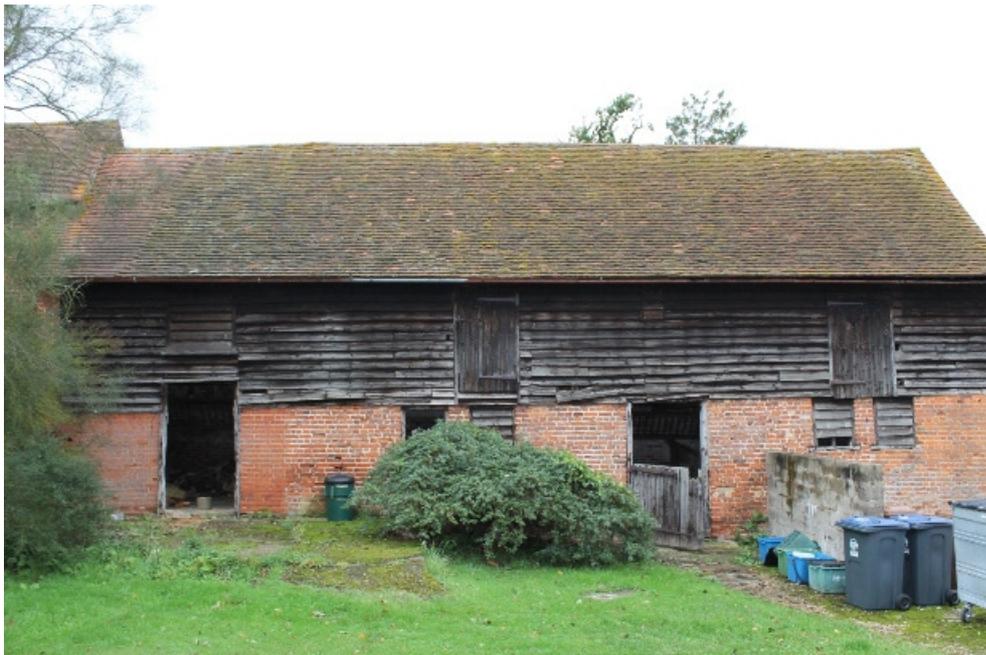
Plate 46 Structure 4 granary/cow house, south-west elevation with the infill building to the left - view north-east

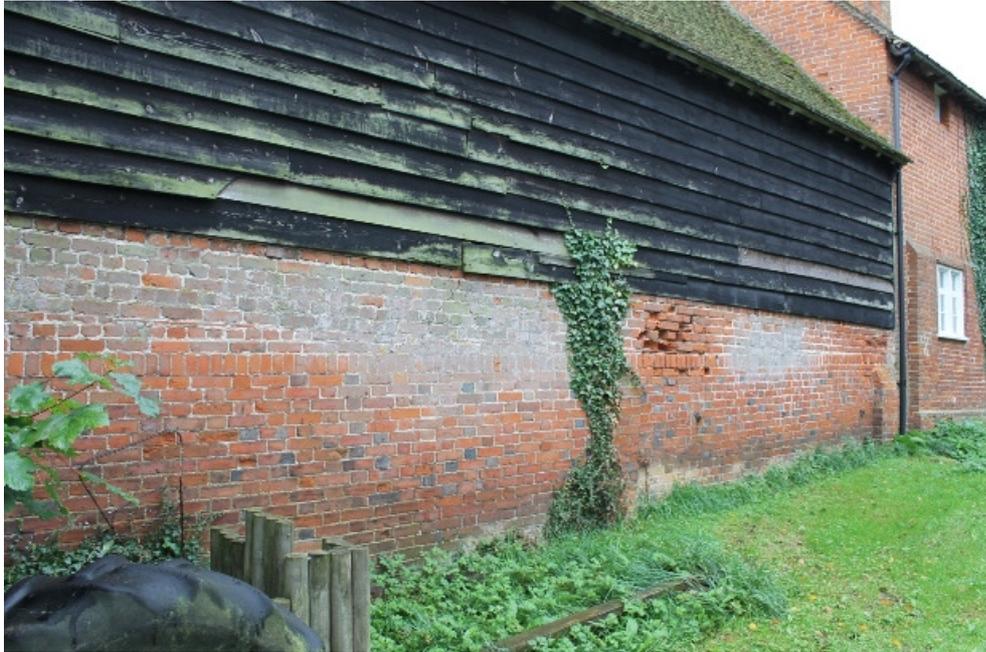
Plate 47 Structure 4 granary/cow house, north-east elevation constructed on the late 18th-century buttressed farmyard wall - view west

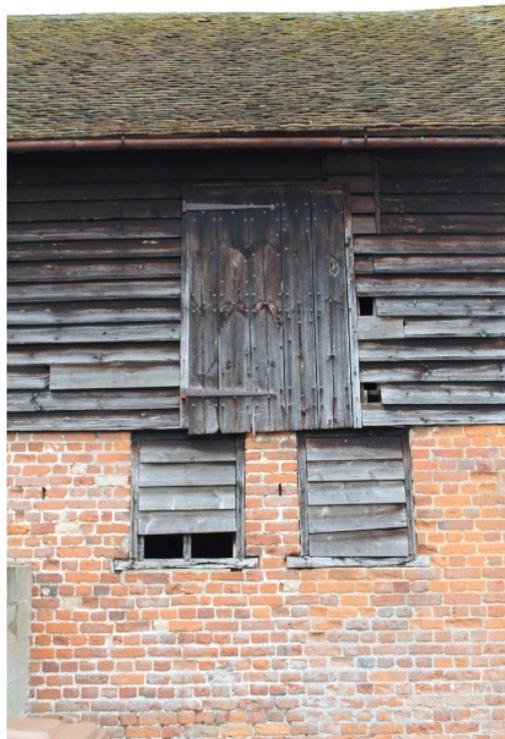
Plate 48 Structure 4, granary/cow house showing inserted pitching door above original louvre windows and the truncated owl door at the top right corner of the door - view north-east

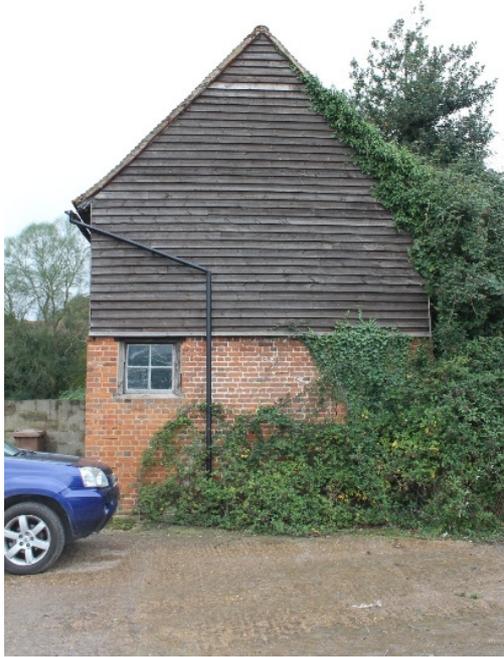
Plate 49 Structure 4, granary/cow house, south-east elevation showing the inserted window above the rebuilt corner - view north-west

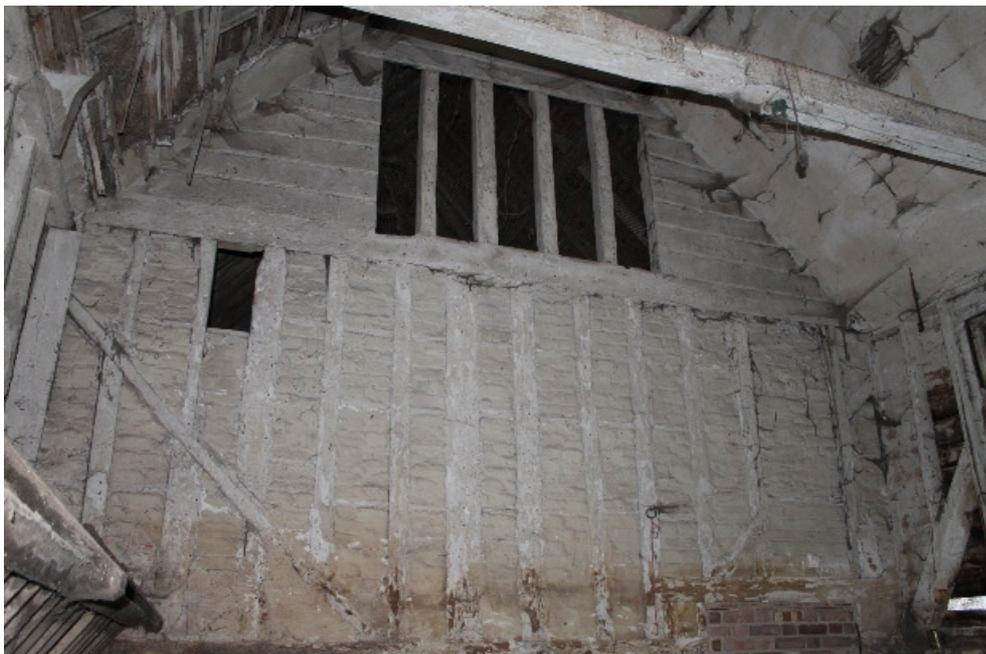
Plate 50 Structure 4 granary/cow house, north-west elevation concealed by the 19th-century infill building showing the exposed timber frame and the brick noggin - view south-east

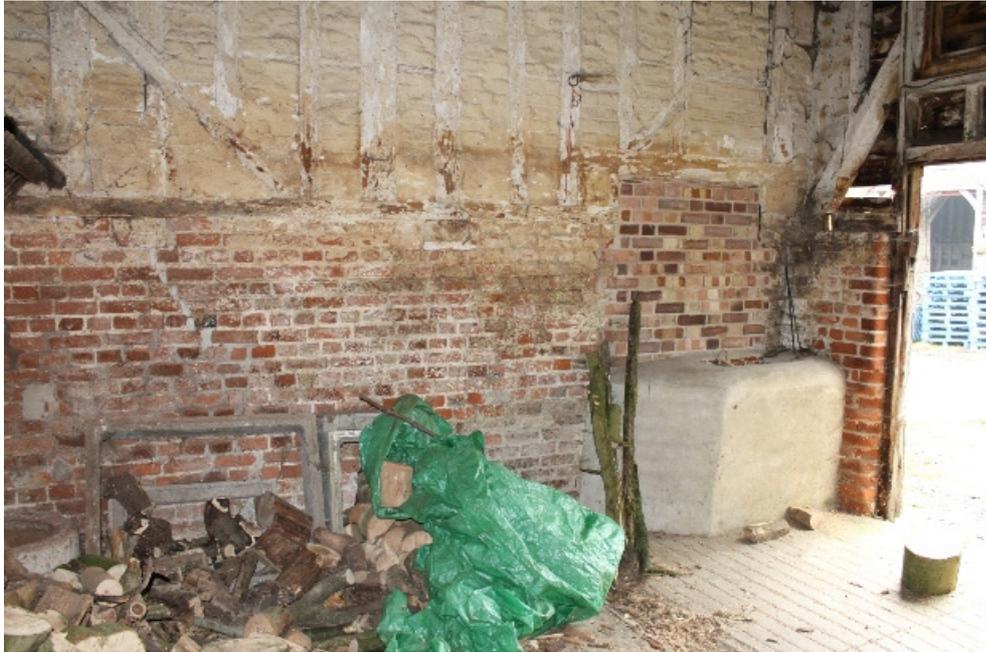
Plate 51 Structure 4 granary/cow house, north-west elevation concealed by the 19th-century infill building showing the raised sill beam of the timber frame and the blocked doorway below - view south-east

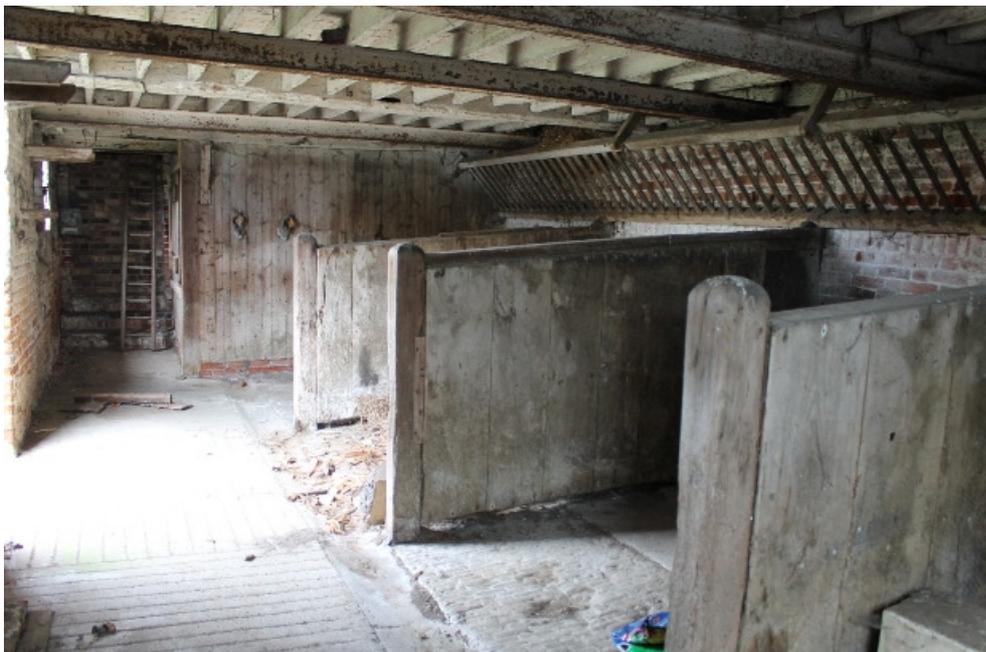
Plate 52 Structure 4 interior of cow house, with the stalls to the right and the grain box to the rear. The inserted I-beams can be seen below the granary floor joists and the ladder to the granary is in front of the blocked doorway to the infill building on the left - view north-west

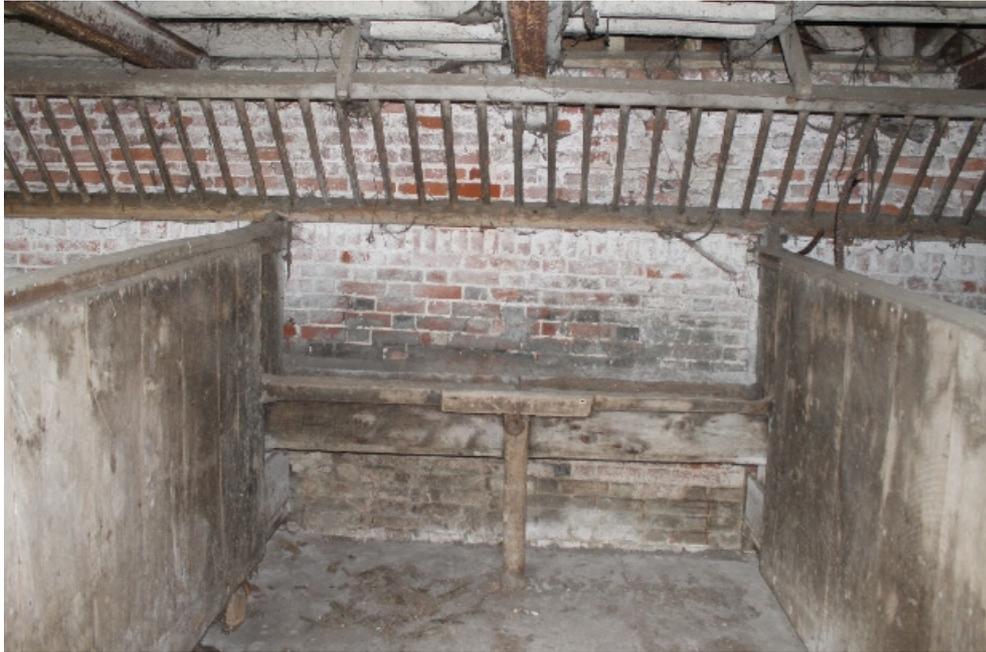
Plate 53 Structure 4 cow house, interior of stall 3 showing the manger with tethering ring and hay rack above - view north-east

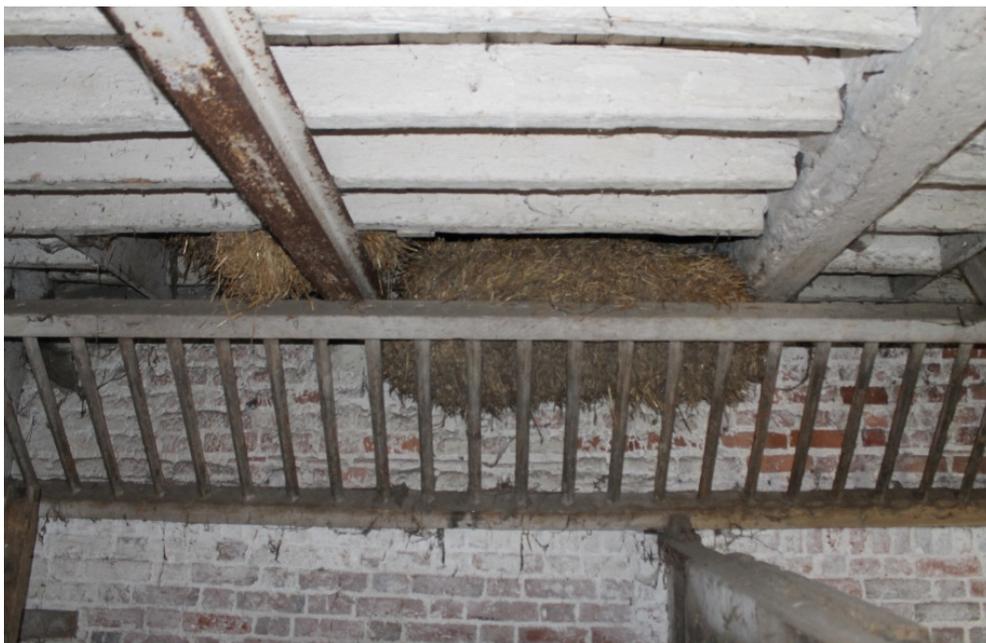
Plate 54 Structure 4 cow house, inserted I-beam and original tie beam carrying the joists of the granary floor - view north-east

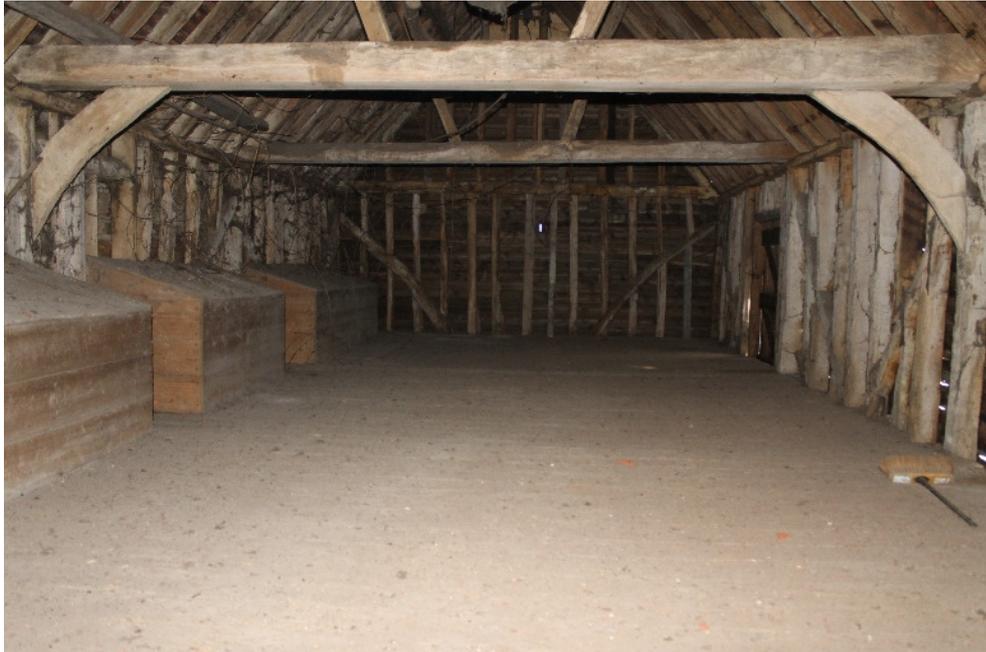
Plate 55 Structure 4 interior of granary with hay bins to the left - view south-east

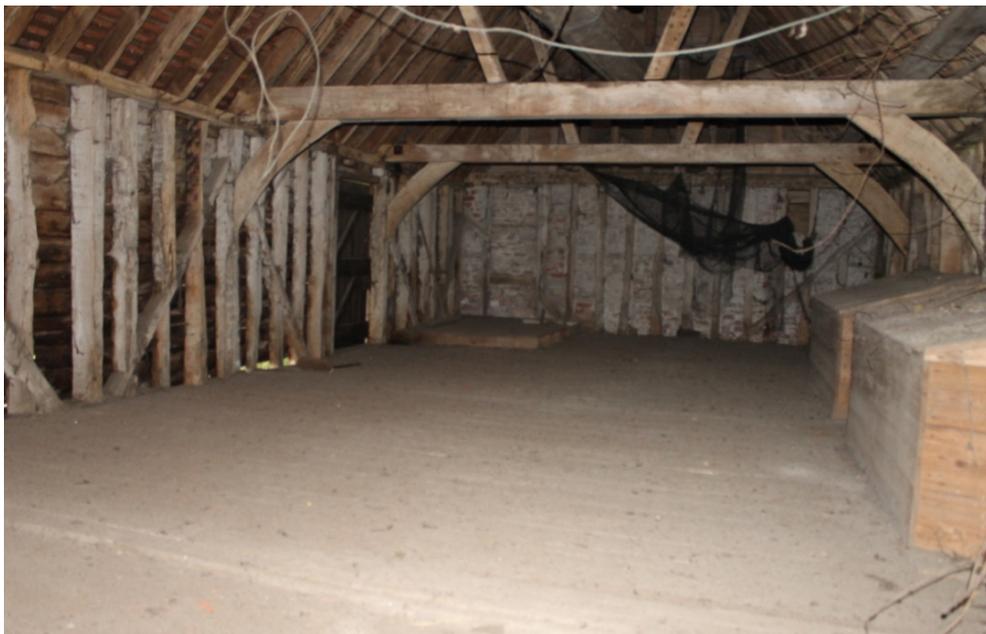
Plate 56 Structure 4 interior of granary showing raised platform around the granary access and the inserted pitching door of the south-west frame - view north-west

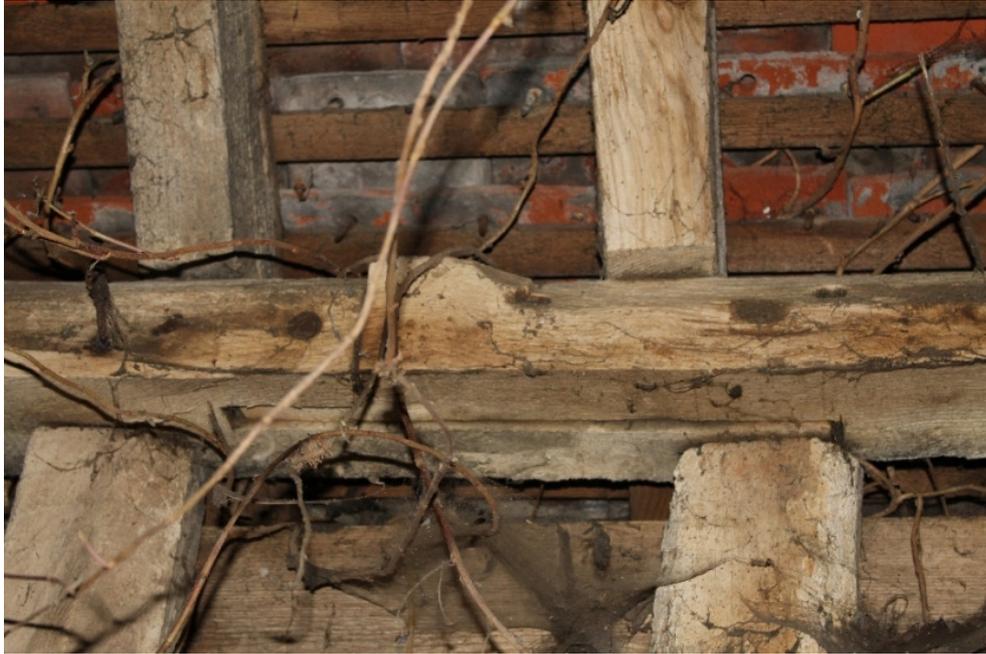
Plate 57 Structure 4 granary, scarf joint in wall plate of north-east frame showing the broached stop of the re-used chamfered beam - view north-east

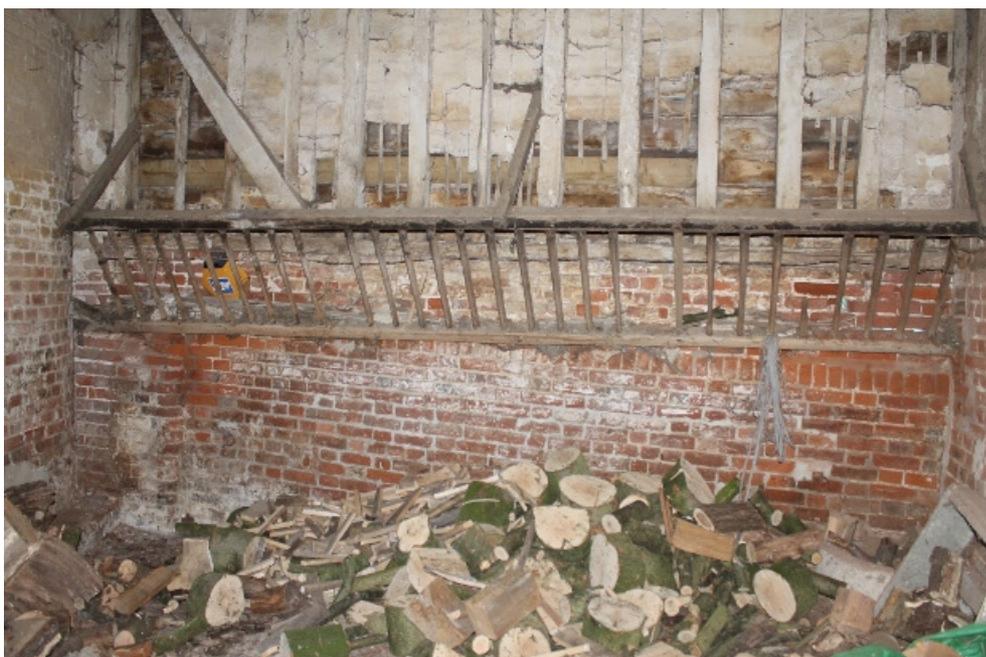
Plate 58 Interior of the infill building between structure 4 and 4a - view north-east

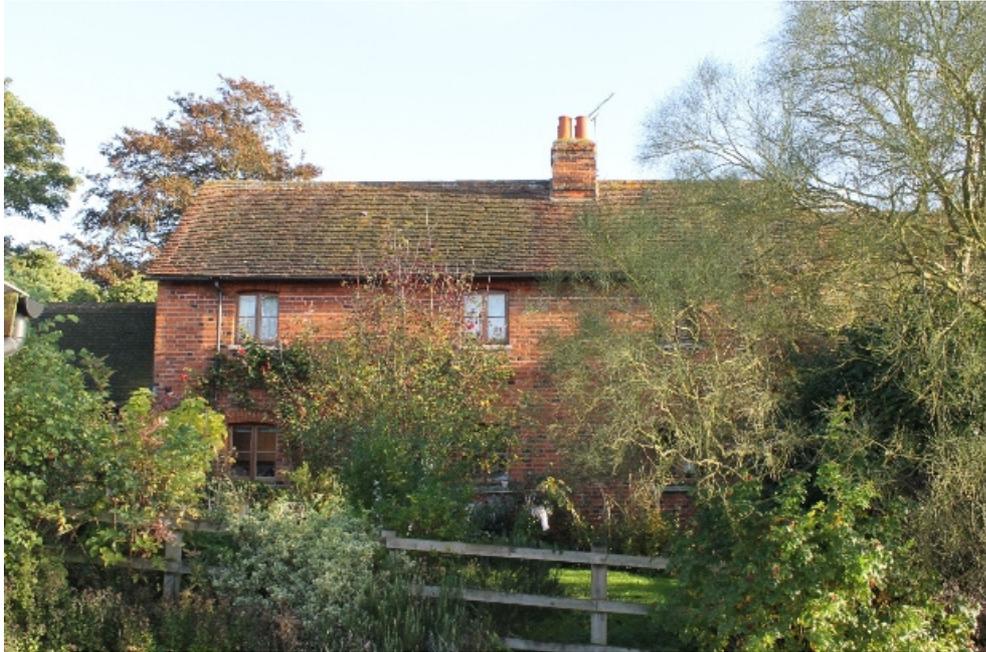
Plate 59 Structure 4a Farm Cottage, south-west elevation with the right-of-centre chimney stack and the 20th-century extension to the left - view north-east

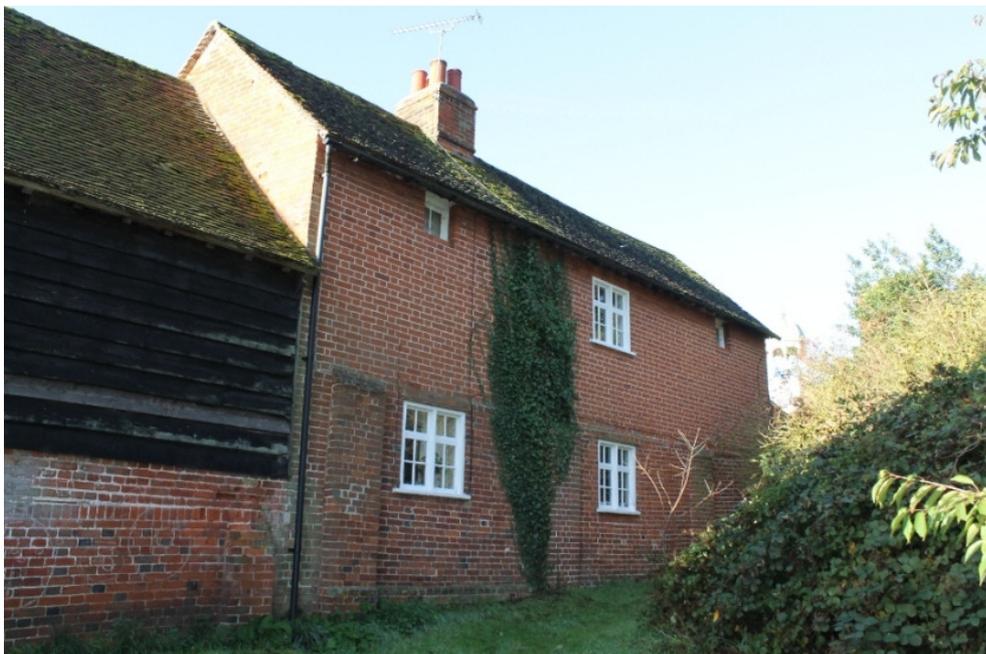
Plate 60 Structure 4a, north-east elevation showing Farm Cottage built upon the early 18th-century buttressed farmyard wall and the 19th-century infill building constructed on the later 18th-century farmyard wall to the left - view south-west

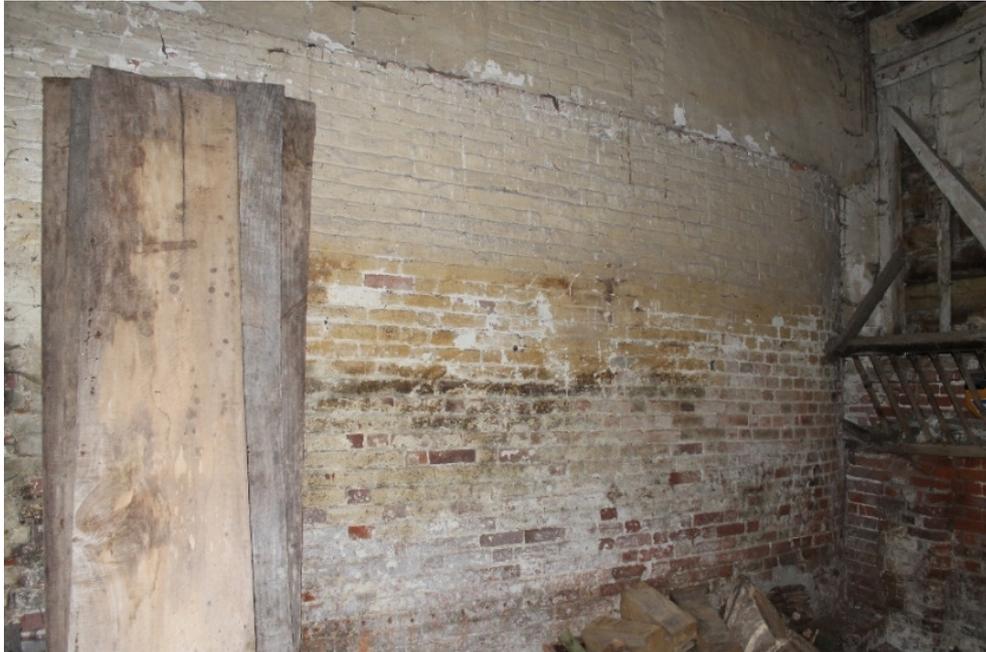
Plate 61 Structure 4a, south-east elevation obscured by the 19th-century infill building showing the curve of the early 18th-century farmyard wall with Farm Cottage built on top - view north

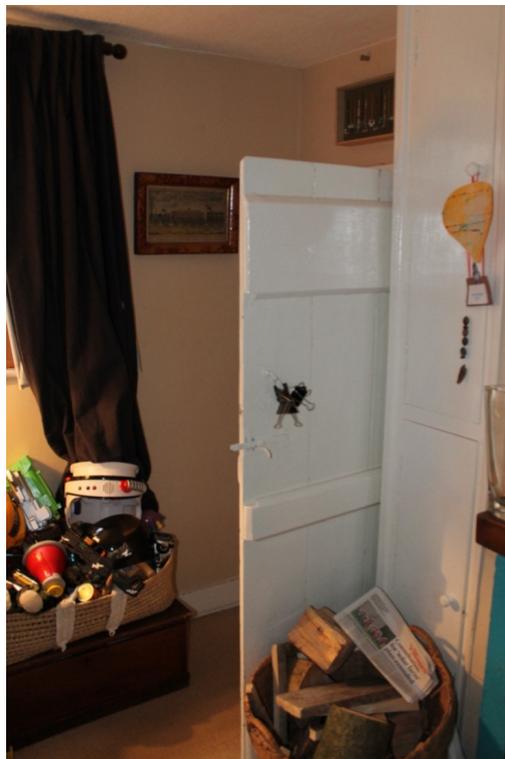
Plate 62 Structure 4a, interior of Farm Cottage dining room, showing the original plank door and cupboard next to the fireplace - view west

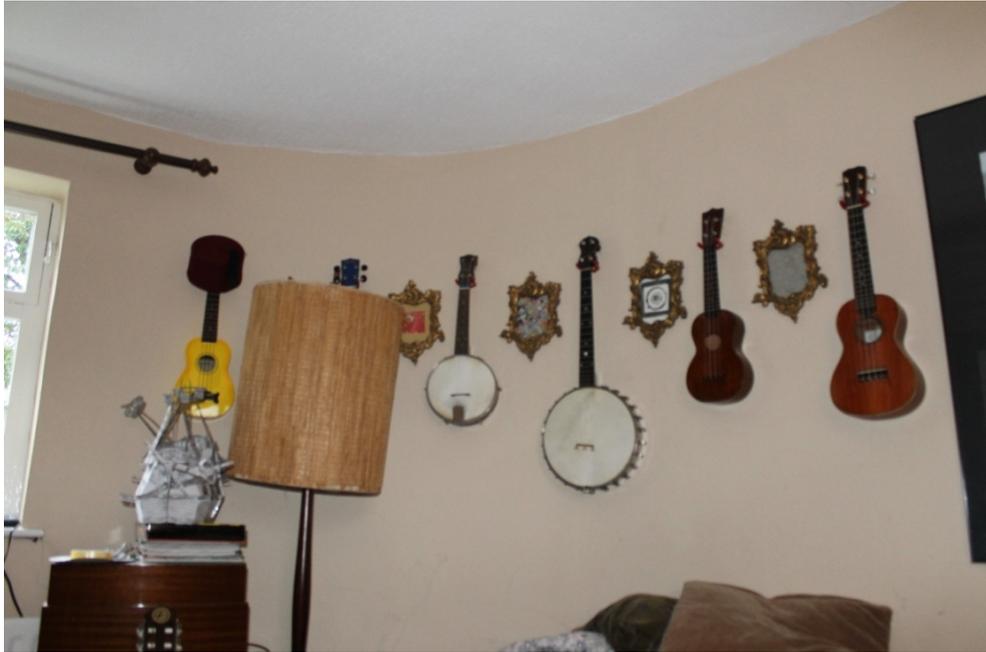
Plate 63 Structure 4a, interior of Farm Cottage dining room showing the curve of the early 18th-century farmyard wall incorporated into the fabric of the building - view east

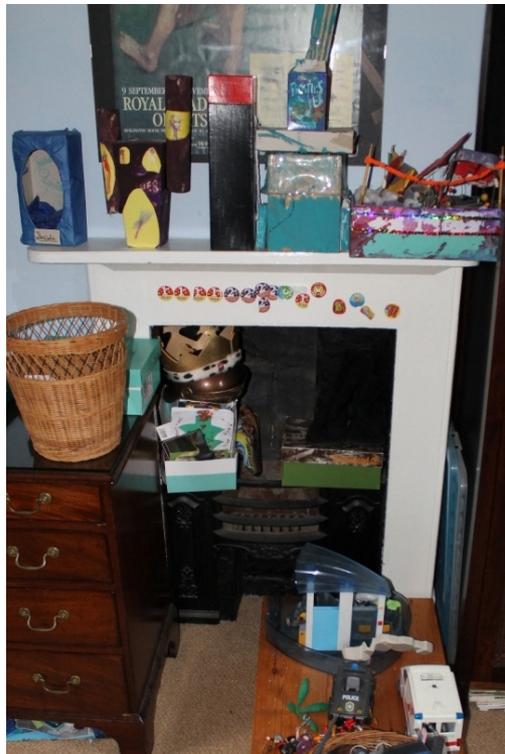
Plate 64 Structure 4a Farm Cottage, detail of early 19th-century register grate with plain timber surround and mantel in bedroom 2 - view south-east

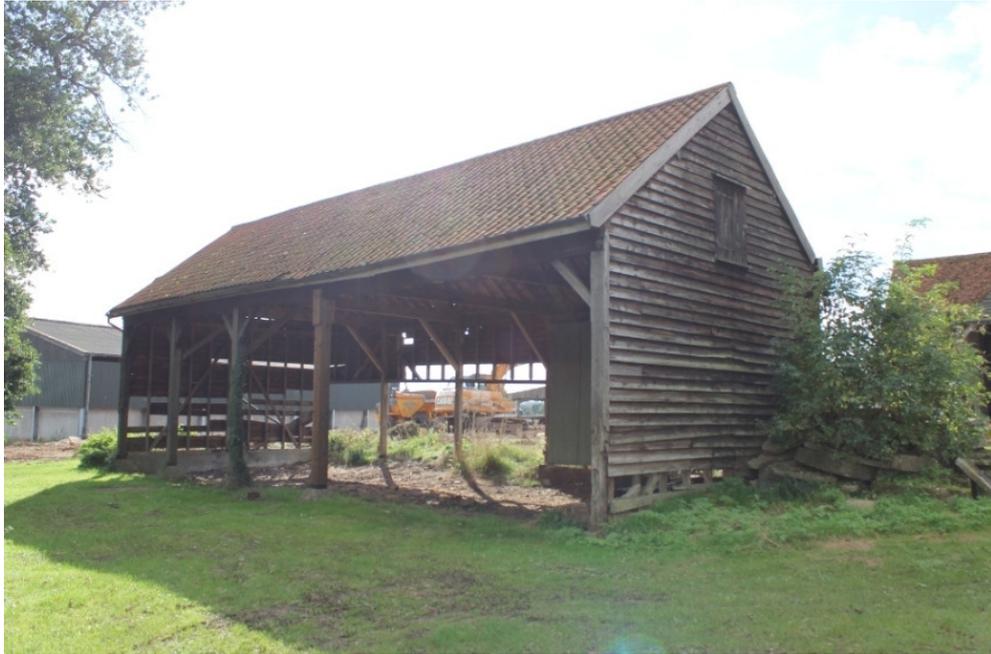
Plate 65 Structure 5 Dutch barn, showing the open-fronted north-east elevation with the two missing truss posts and the pitching door of the north-west elevation - view south-east

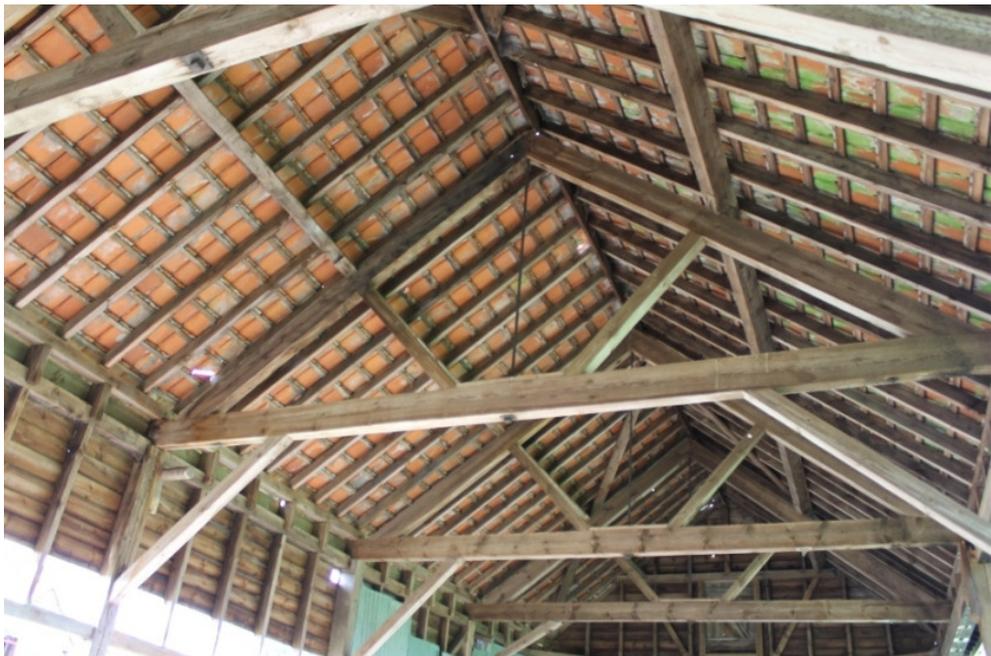
Plate 66 Structure 5 interior of the Dutch barn, showing the king bolt roof trusses - view east

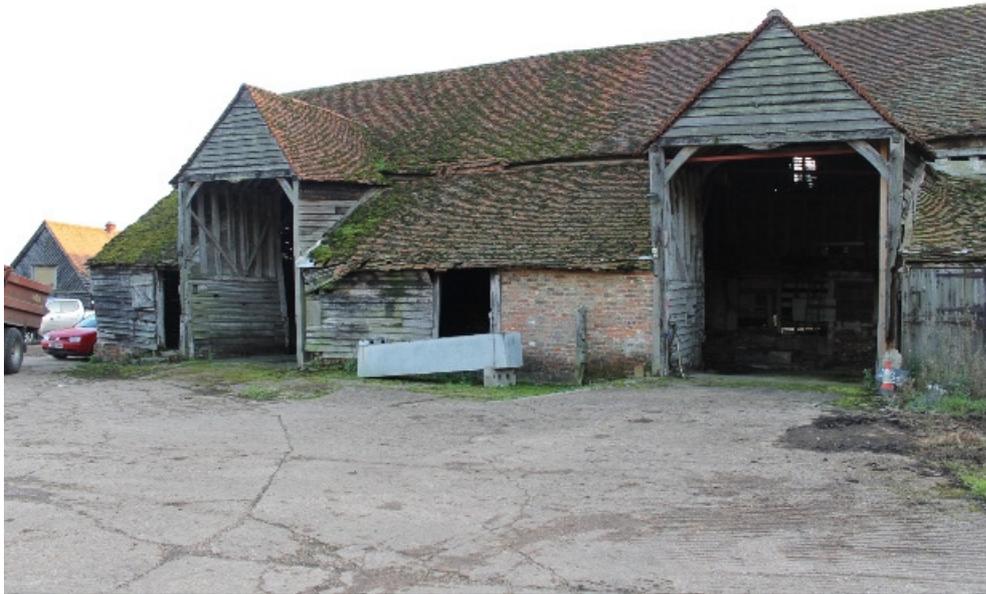
Plate 67 Structure 6 barn, north-east elevation with (l-r) lean-to 1, east midstrey, lean-to 2, west midstrey and lean-to 3 - view south-east

Lean-to 1 is located at the east end of structure 6 (Plates 67, 69; Fig 38). It sits on a low plinth of red brick with dimensions of 230 x 120 x 70mm laid in an irregular/rough English

Lean-to 2 is located between the midstreys (Plate 67; Fig 38). It has a centrally-positioned doorway with a timber-framed wall on the east side and a solid brick wall on the west side. The softwood frame sits in a low plinth of red brick with dimensions of 230 x 115 x 60mm laid in irregular bond, and comprises machine-cut studs 80-90mm x 100-110mm with divisions of 270-300mm. This frame is obscured by a concrete render apart from the area below the wall plate (100mm x 150mm) where there is a narrow ventilation hatch (the same type of ventilation hatch is also found in structure 10, the milking shed). The brick wall on the other side of the doorway has replaced the original timber frame.
