**Building recording
at Home Farm, Moor Place,
Much Hadham, Hertfordshire
October 2013**

**report prepared by
Chris Lister**

**commissioned by
Foxley Builders**

CAT Report 735
January 2015

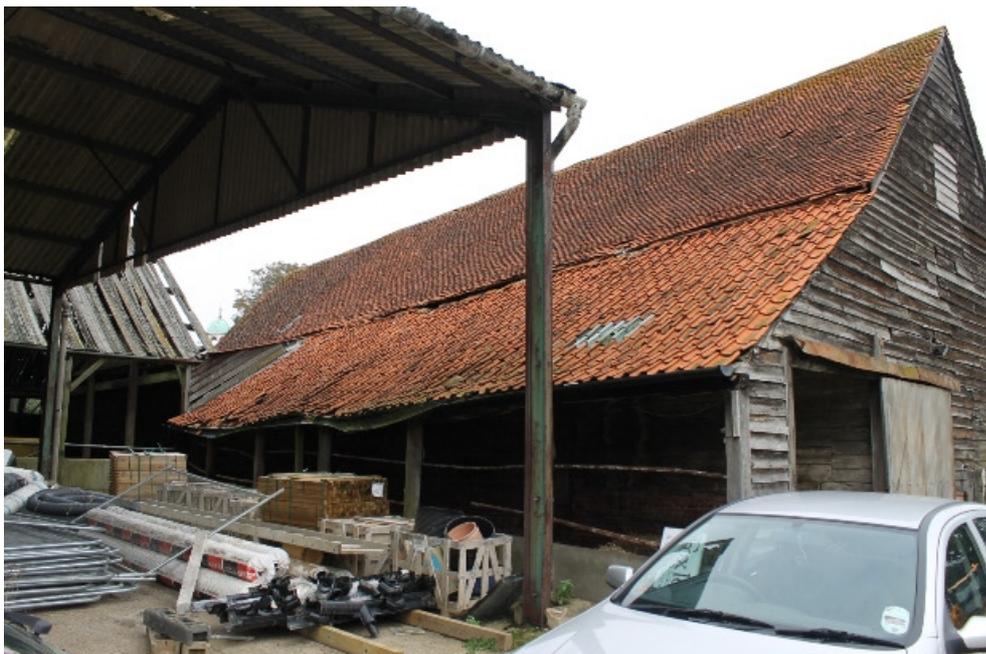
Plate 68 Structure 6 barn, south-west elevation partially obscured by lean-to 4, - view north-west

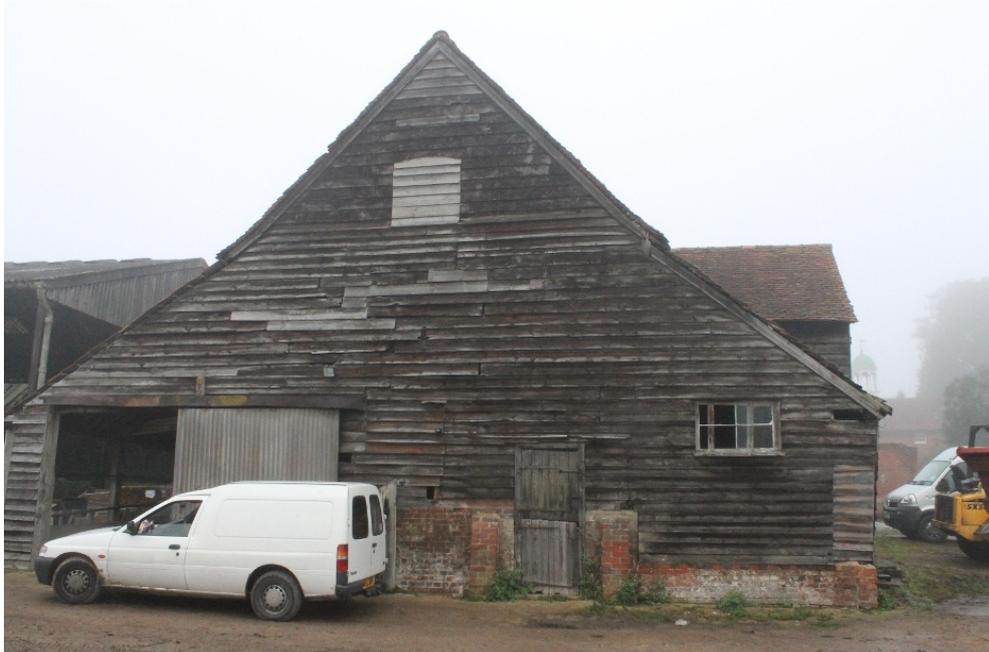
Plate 69 Structure 6 barn, east elevation with sliding door to lean-to 4 on the left and lean-to 1 on the right - view west

Lean-to 1 is located at the east end of structure 6 (Plates 67, 69; Fig 38). It sits on a low plinth of red brick with dimensions of 230 x 120 x 70mm laid in an irregular/rough English

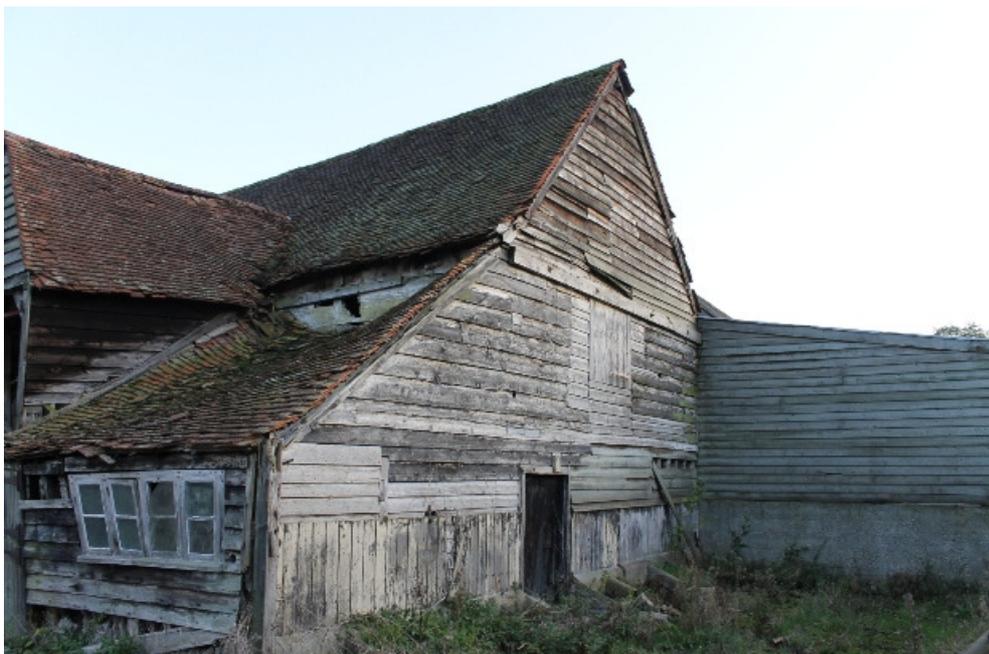
Plate 70 Structure 6 barn, north-west elevation with lean-to 3 to the left, showing the concrete feed troughs and vertical planking indicating an additional (demolished) lean-to - view south-east

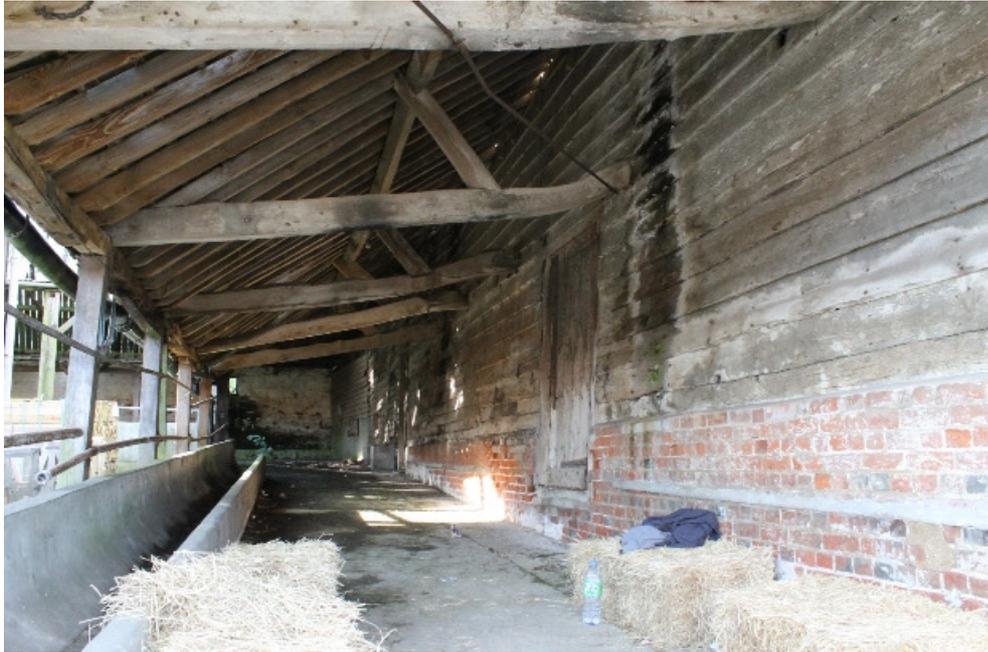
Plate 71 Structure 6 barn, interior of lean-to 4, showing the south-west elevation of the main range - view north-west

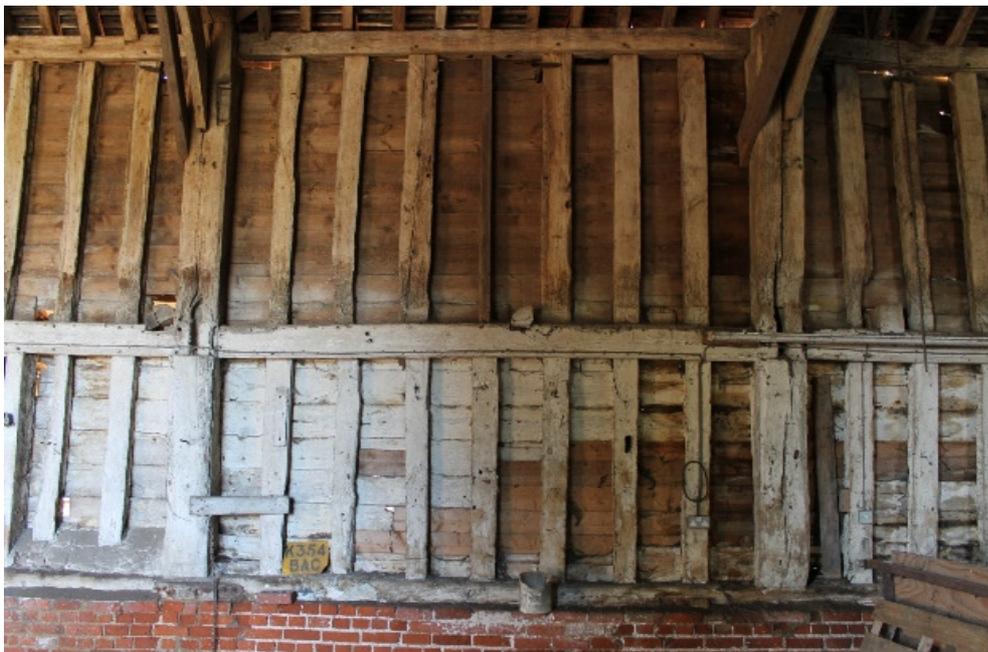
Plate 72 Structure 6 barn, south-west framing of bay 3: the narrow stud in the centre of the upper register has replaced an original window, the diamond-section mortices for the mullions of this can be seen in the underside of the wall plate - view south-west

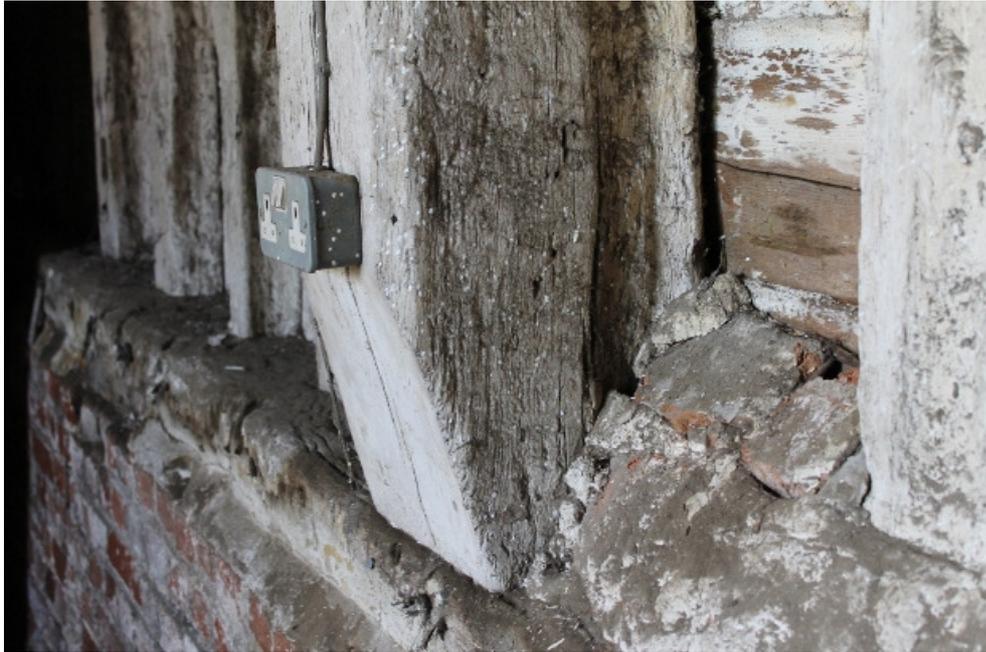
Plate 73 Structure 6 barn, chamfered base to the large-section post on the south-west side of truss A - view south

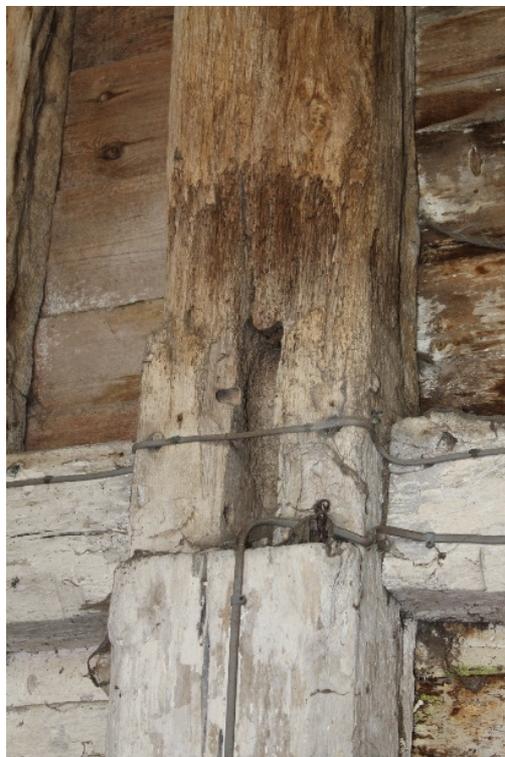
Plate 74 Structure 6 barn, mortice for bridging joist halfway up the post on the south-west side of truss A - view south

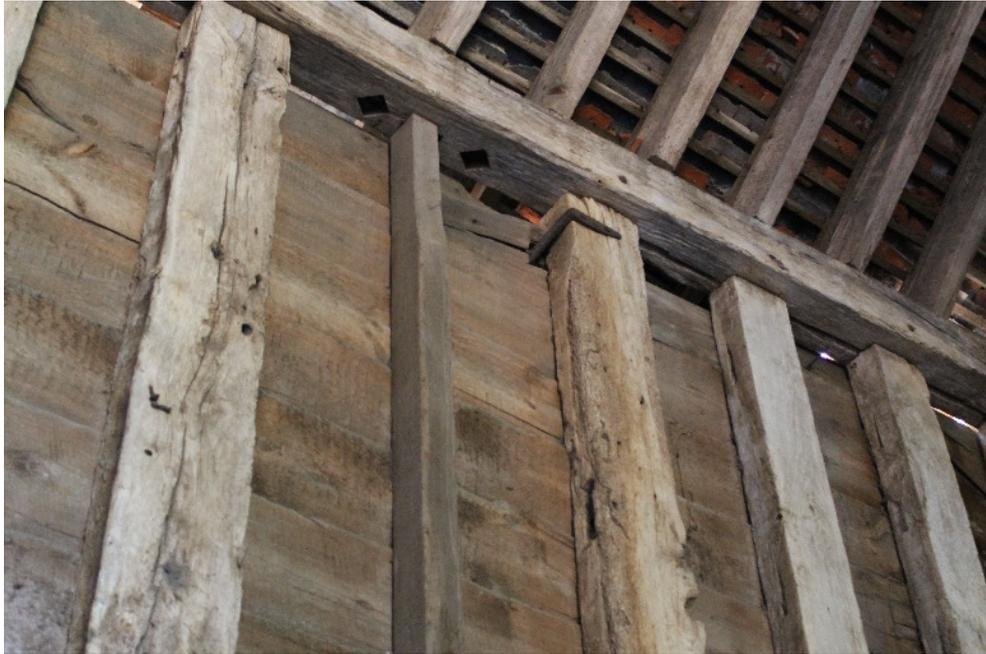
Plate 75 Structure 6 barn, south-west frame of bay 3; diamond-section mortices for window mullions in the underside of the wall plate and mortices for the mid rail forming the sill in the studs to either side of the window: the window interrupts a groove for infill panels in the underside of the wall plate - view south-west

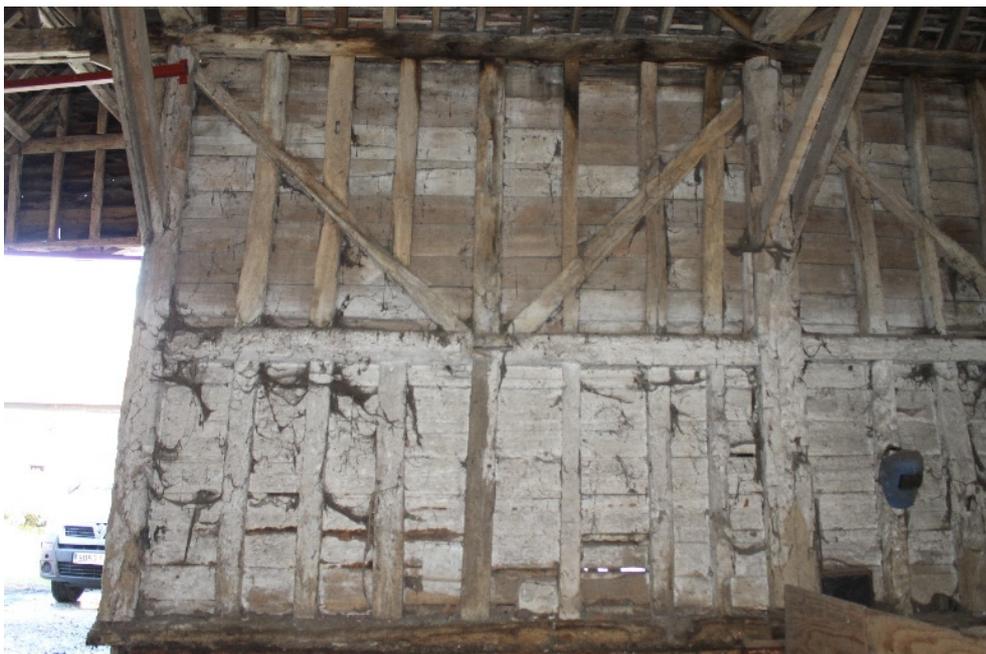
Plate 76 Structure 6 barn, north-east framing of bay 4 with primary bracing to the upper register which indicates a later construction date for this side of the building - view north-east

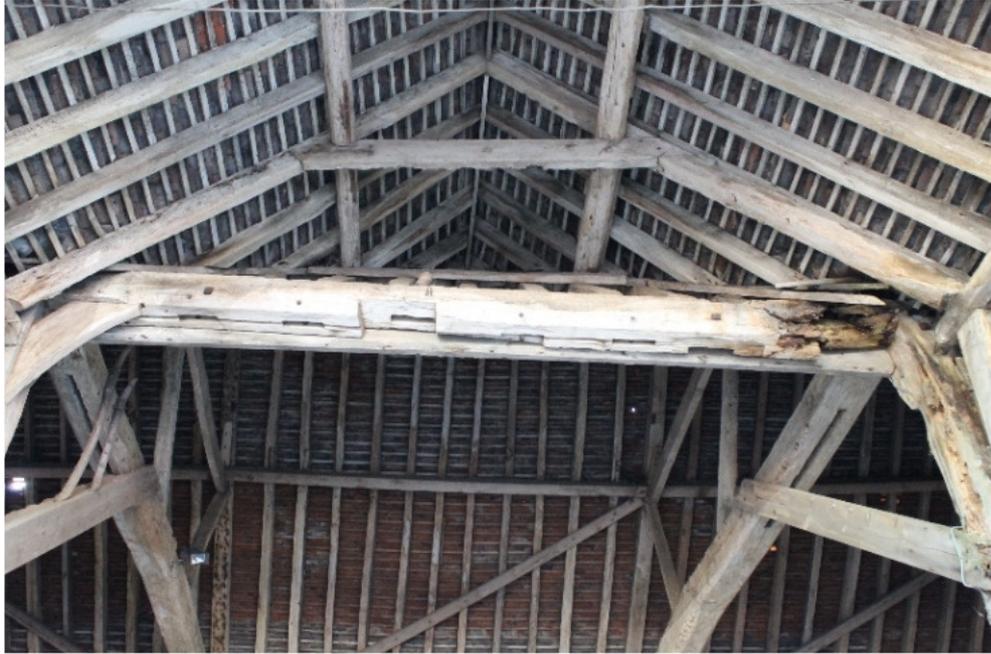
Plate 77 Structure 6 barn, wall plate to north-east side of bay 2 with exposed mortices which indicates the midstrey is a later addition - view south-west

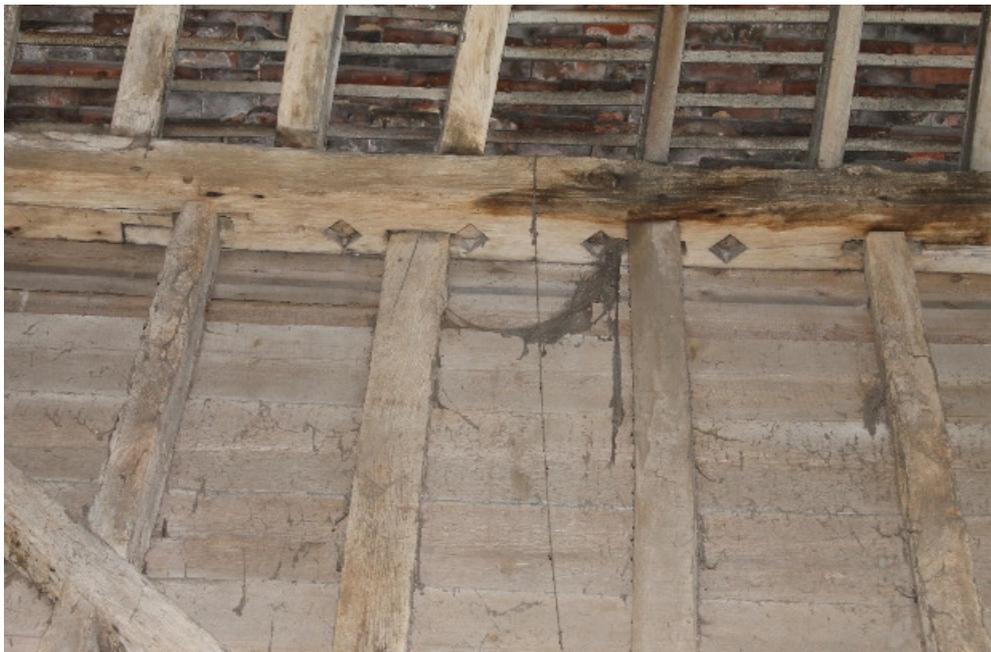
Plate 78 Structure 6 barn, north-east frame of bay 1, diamond-section mortices for window mullions in the underside of the wall plate, which interrupt a groove for infill panels visible in the underside of the wall plate to the right of the frame - view north-east

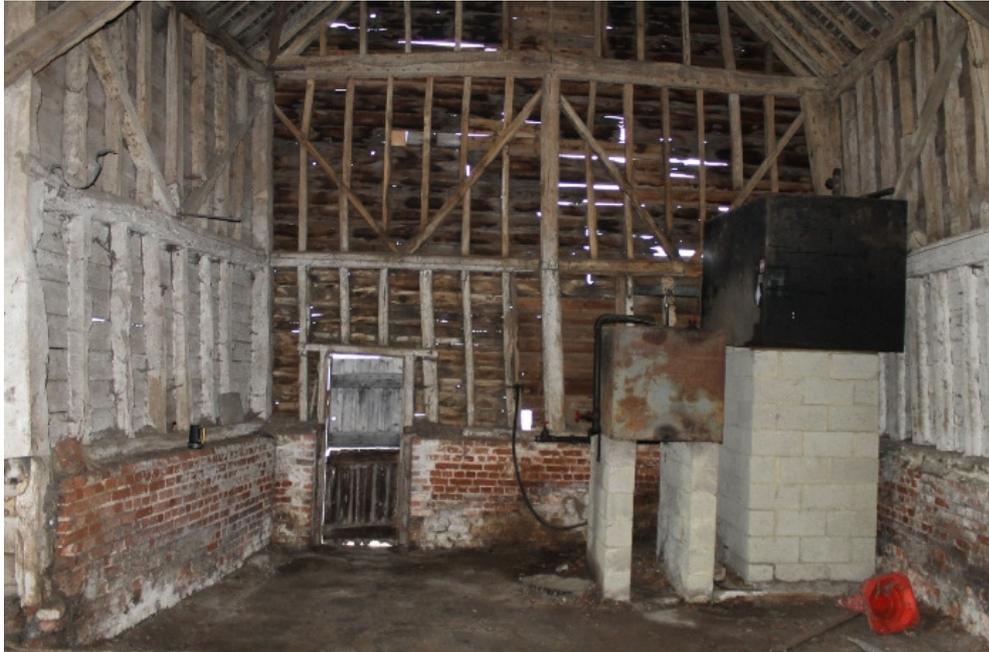
Plate 79 Structure 6 barn, east frame with primary bracing to the upper registers and re-used gable tie - view east

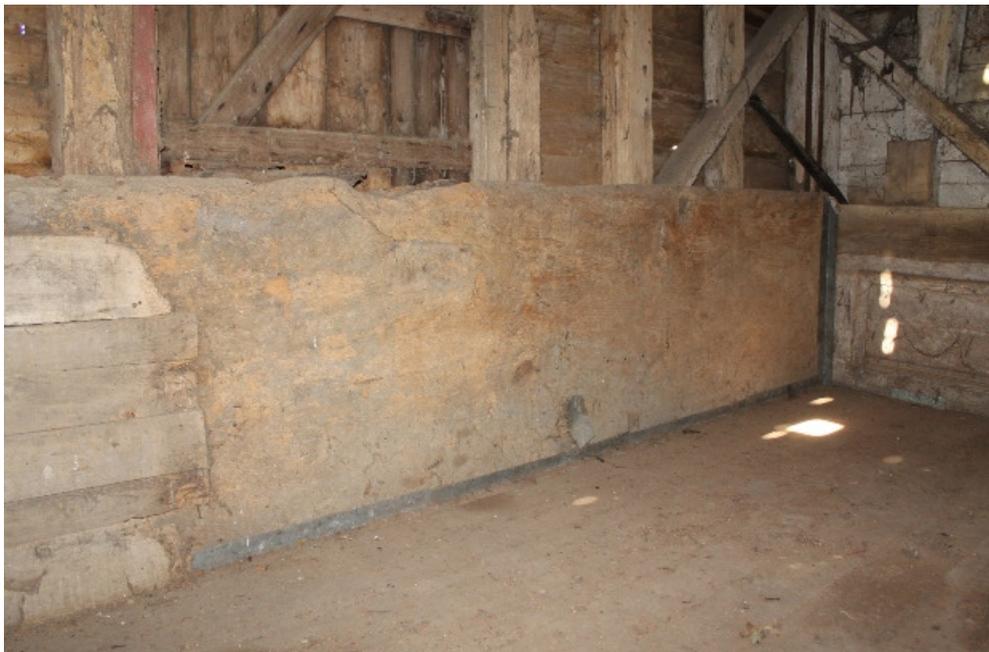
Plate 80 Structure 6 barn, mezzanine in bay 6 with walls formed from a 1m wide oak plank and doors laid horizontally: the inserted pitching door and primary bracing of the upper register to the north-west frame can be seen behind the mezzanine walls - view north-west

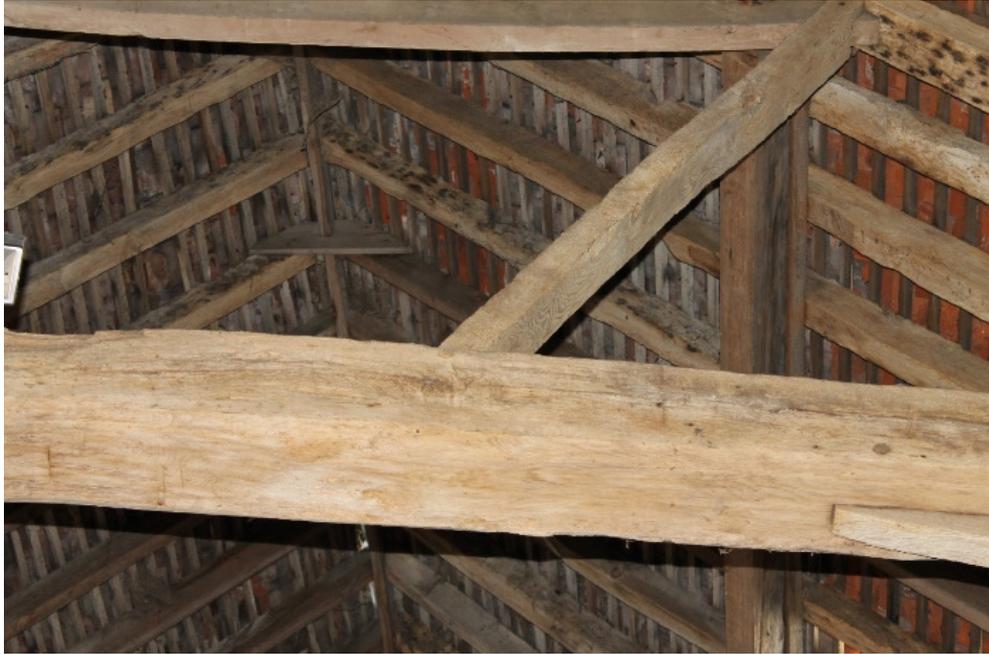
Plate 81 Structure 6 barn, detail of tie beam, raking strut and collar on south-west side of truss A with machine-cut purlins and re-laid rafters

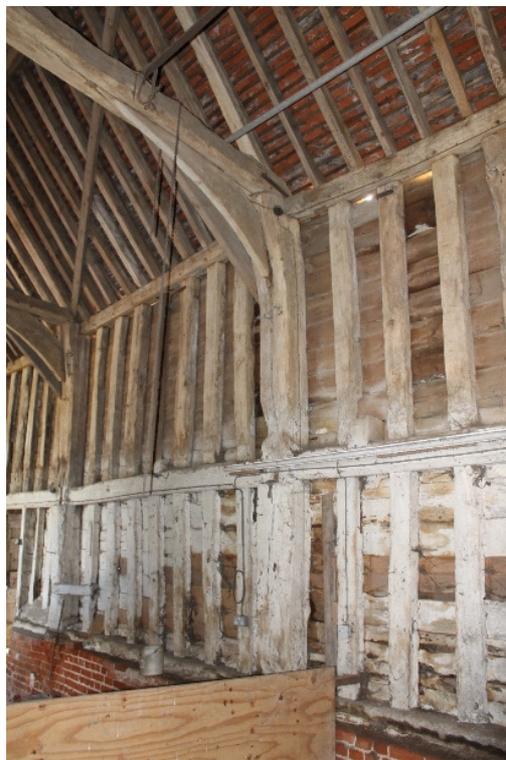
Plate 82 Structure 6 barn, south-west post to truss C with original arched brace to tie beam and later additional straight bracing nailed to the face of post and beam – view south

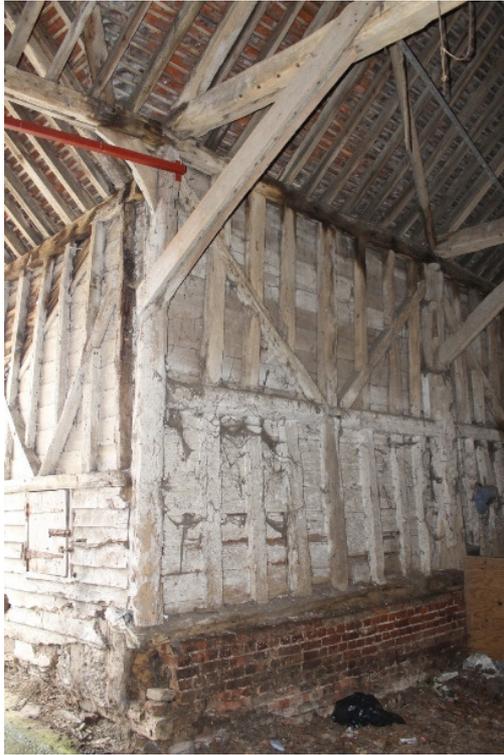
Plate 83 Structure 6 barn, north-east post to truss D with jointed straight brace and additional straight bracing nailed to the face of post and tie beam – view east

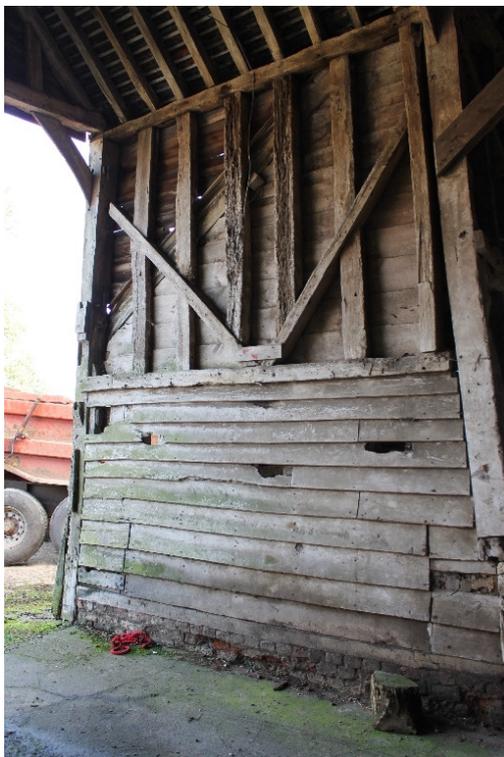
Plate 84 Structure 6 barn, east midstrey with weatherboard to lower register – view east

The hand-sawn oak frame of this midstrey projects from bay 2 and sits on a low brick plinth of red brick with dimensions of 230 x 110 x 65mm laid in English bond. It has a sill beam 100mm x 140mm with an edge-halved scarf joint in the west side. The corner post of the east frame is a straight timber (190mm x 190mm) and has a recess for a threshold leap and iron pintels for barn doors, whilst the corner post to the west frame is a replacement machine-cut timber (170mm x 170mm). Both sides of the midstrey have a girding beam with dimensions of 160mm x 110mm which stop short of the posts of the main range. The lower registers are covered with weatherboard, concealing studs with dimensions of 120-160mm x 90-100mm and divisions of 330-360mm (Plate 84). The upper registers have primary bracing falling from the corner posts and the studs adjacent to the main range. The wall plates differ in size: the east wall plate is 100mm x 160mm and the west wall plate is 80mm x 150mm. The gable tie is 160mm x 160mm and has slender, lightly arched braces, each with a carpenter's mark 'I'. Above the tie beam are large-section studs and a collar beam. There is a single purlin to each pitch, supporting closely-spaced rafters. With the exception of the gable truss and the majority of the rafters, the midstrey comprises re-used timbers.

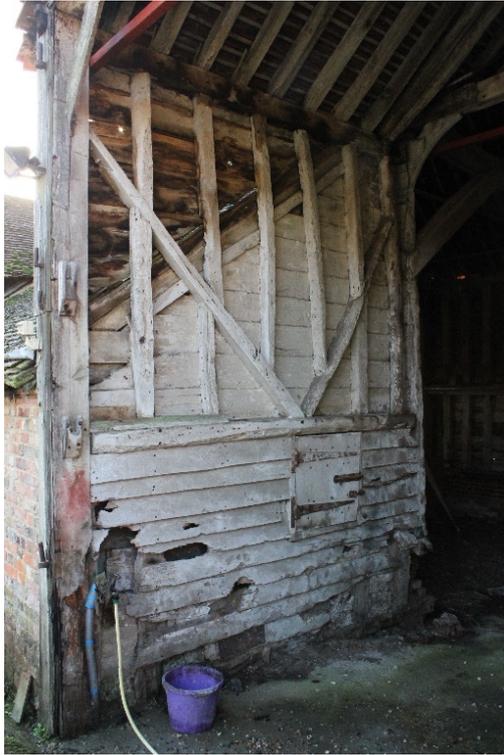
Plate 85 Structure 6 barn, west midstrey with weatherboard to lower register and inserted hatch to lean-to 2 – view south-east

The west midstrey is structurally almost identical to the east midstrey, although it is in a worse state of repair. The modern concrete floor to the barn and the lean-tos on either side have obscured all trace of any brick plinth, although it is assumed that there is one. The sill beam is approximately 130mm x 130mm and the corner posts are straight beams 200mm x 150mm with pintels for the barn doors but no trace of recesses for a threshold leap. The girding beam to both sides measures 120mm x 170mm and the wall plate is 160mm x 120mm. As with the east midstrey the lower registers are weatherboarded although each has an inserted hatch opening onto the lean-to on the other side of the wall, whilst the upper register has primary bracing (Plate 85). With the exception of the midstrey corner posts all of the beams and studs are re-used timbers. A large number of the rafters are machine-cut replacements. No carpenter's marks or scarf joints were apparent.

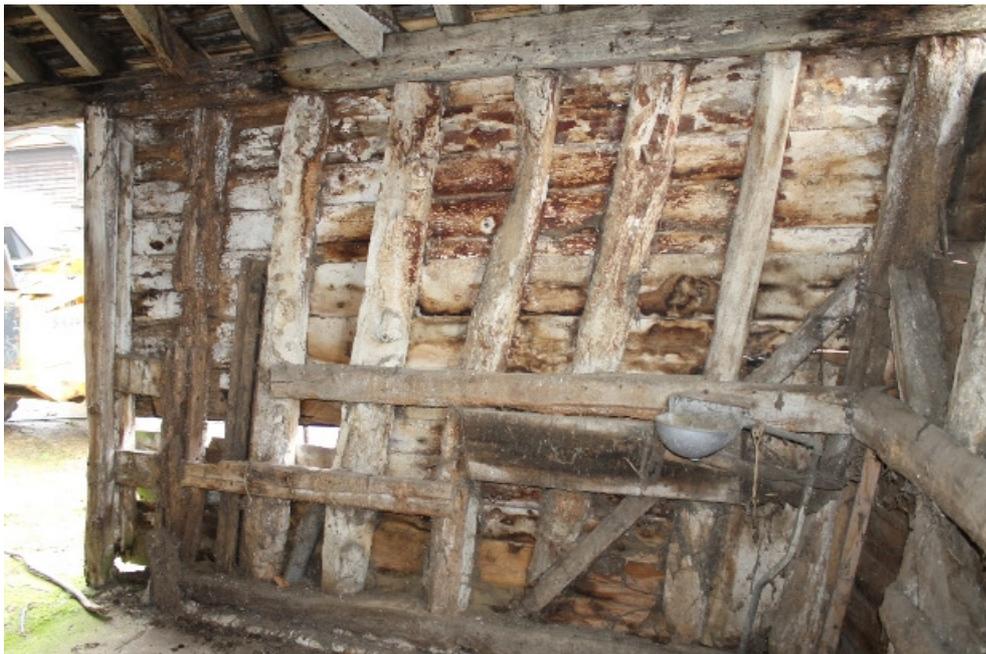
Plate 86 Structure 6 barn, interior of lean-to 1 – view north

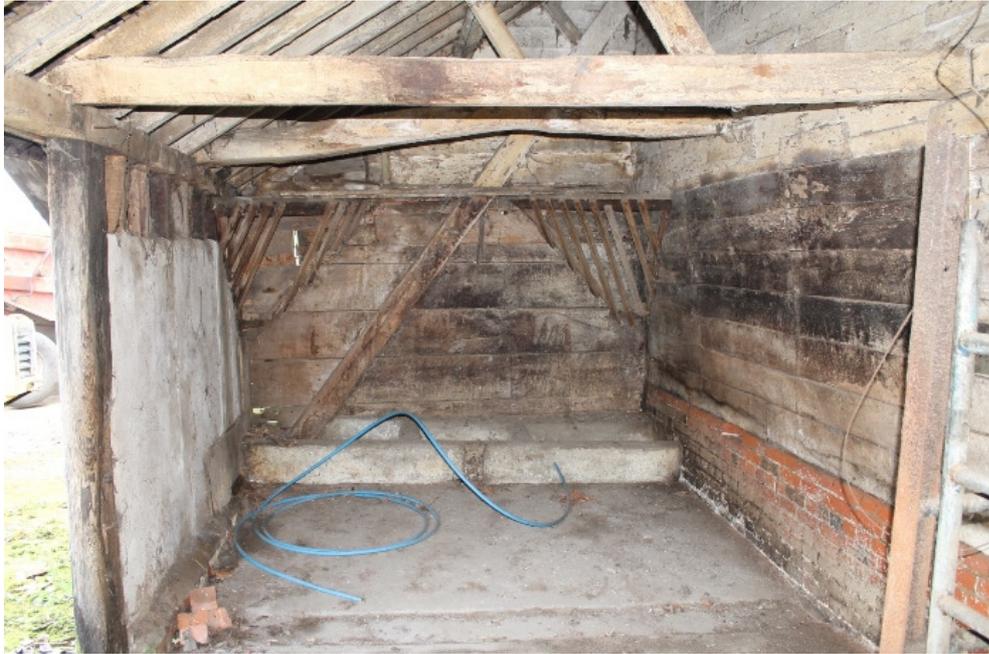
Plate 87 Structure 6 barn, interior of lean-to 2 showing the concrete feed troughs and hay racks above – view south-east

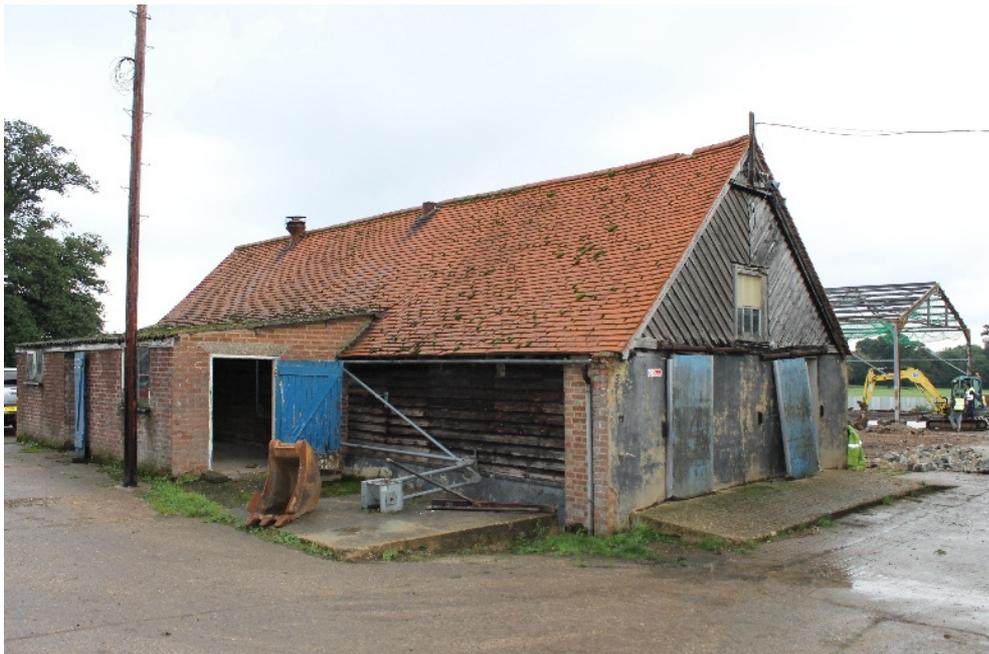
Plate 88 Structure 10 milking shed with post-1956 lean-to and sliding doors to south elevation - view north-east

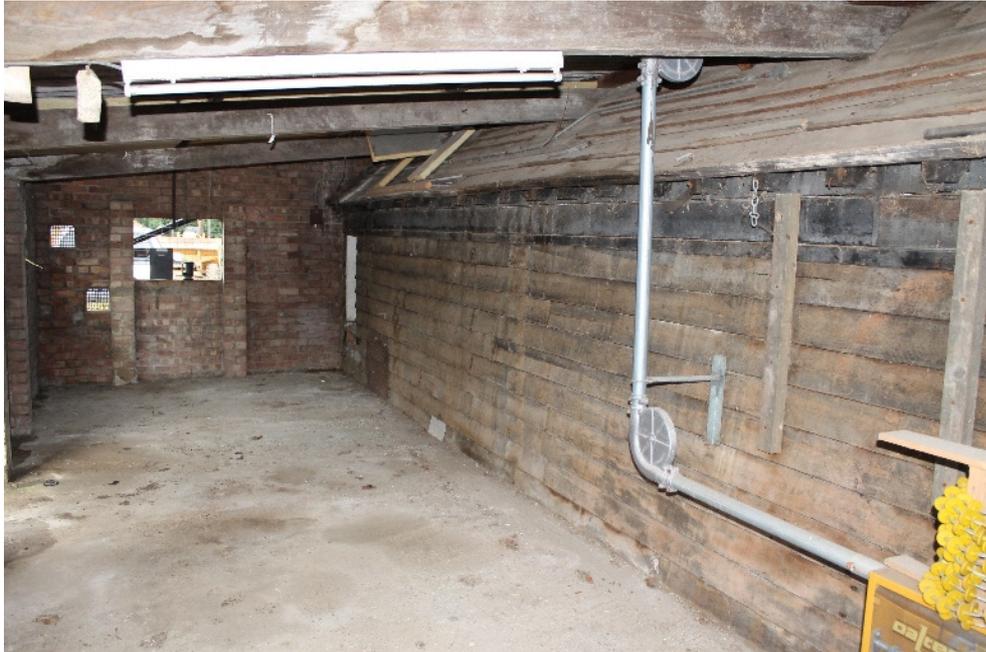
Plate 89 Structure 10 original weather-boarding to the earlier timber-framed building, concealed by the post-1956 lean-to. The ventilation hatches extending the length of the building can be seen below the eaves – view north-east

This is a rectangular timber-framed structure aligned roughly north to south with brick lean-tos on the east and west sides (Plate 88; Fig 48). The building has two distinct phases. The first phase comprises the main range, which measures 16m x 6.2m and is weather-boarded. The south elevation has been rebuilt to eaves level to accommodate a pair of sliding doors and has a brick pier at each corner (Fig 52). Both gables have diagonal boarding and a window. The roof is of plain tiles to the west pitch and machine-made tiles to the east, and has two metal ventilation cowls projecting from the ridge. The west elevation has what appears to be two blocked and boarded over windows at the south end (Fig 49). Immediately to the north of these are a series of hinged ventilation hatches just below the eaves, extending the remaining length of the building (Plate 89). Gaps in the weatherboard indicate the frame has softwood machine-cut studs with dimensions of 50mm x 100mm and divisions of 300-320mm.

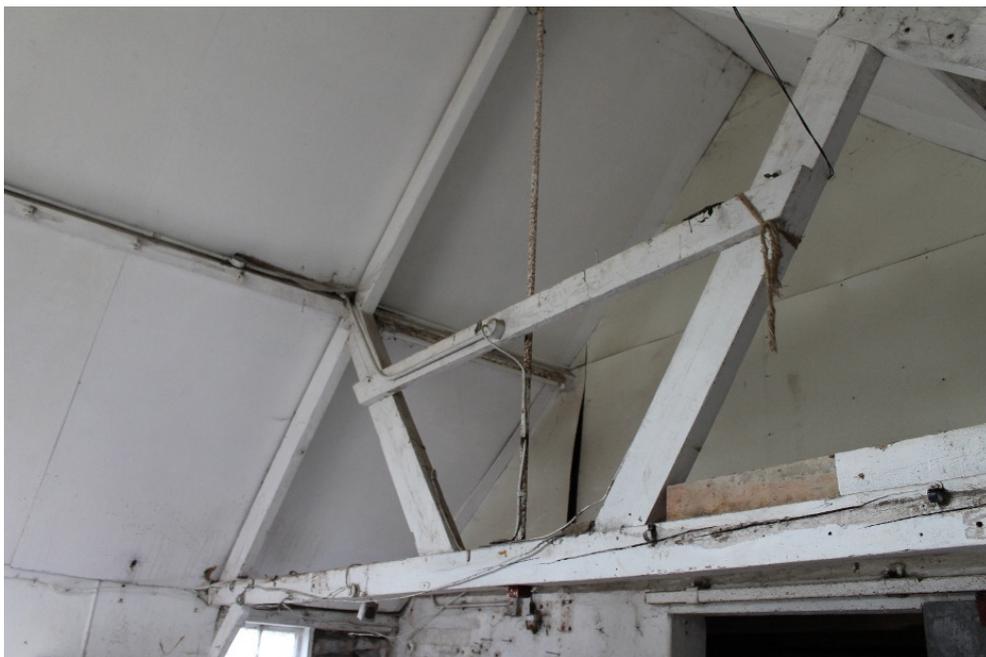
Plate 90 Structure 10 milking shed, truss E located within the later dairy - view south-east

The interior of the main range has been substantially altered. The first phase of the building comprised an open plan structure of six bays with king bolt trusses and raking struts rising from tie beams (Plate 90; Fig 53). The interior of the timber frame is clad in vertical planking which obscures the posts and studs.

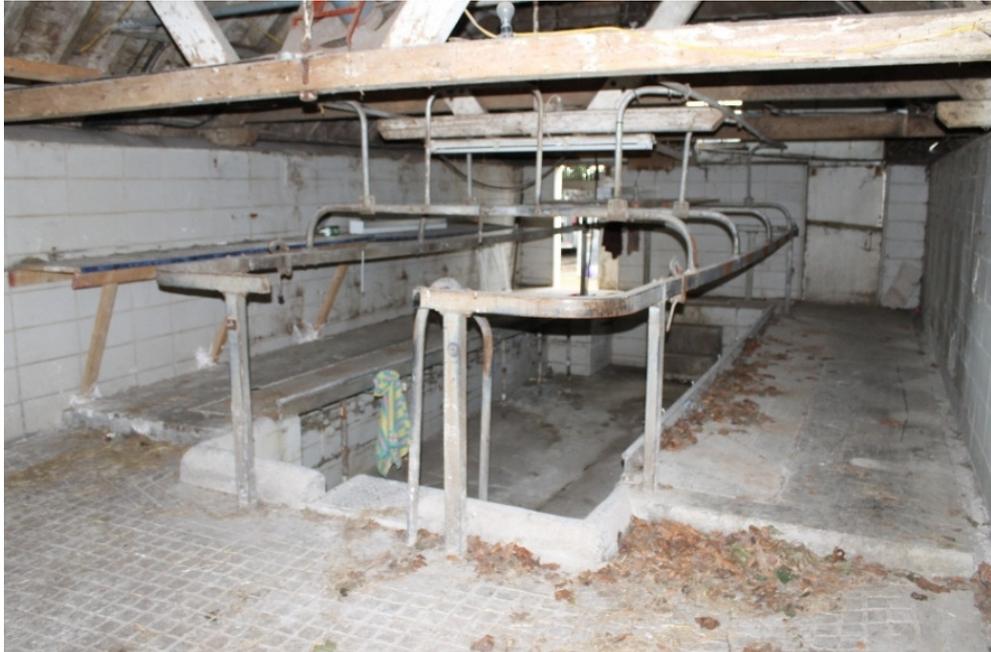
Plate 91 Structure 10 interior of the milking shed, showing the post-1956 'herringbone' parlour layout imported from New Zealand - view north-west

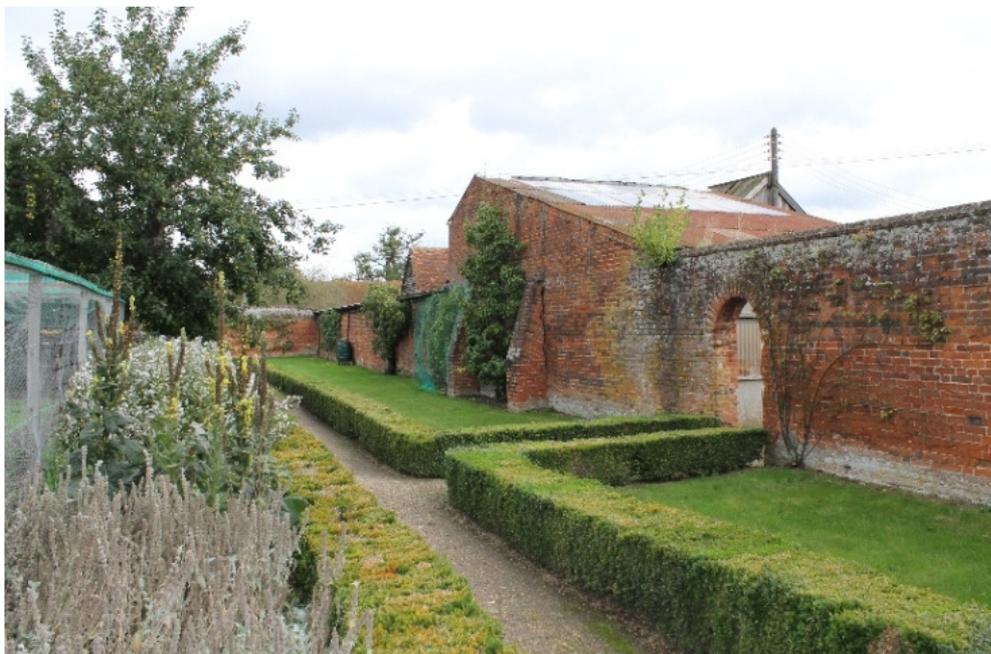
Plate 92 Structure 14 squash court built partially on the east wall of the kitchen garden, showing the buttresses added to spread the load of the building and the archway inserted through the wall providing access to the court - view north-east

This is a rectangular structure built up against and on top of the 18th-century east wall of the kitchen garden (Plate 92; Fig 54). It is aligned north-east to south-west and constructed of red brick with dimensions of 222 x 108 x 65mm laid in English bond (Plate 93). Including the width of the garden wall it measures 6.3m x 9.9m and has unadorned elevations (Figs 57-8). Two brick buttresses have been built against the garden wall to spread the load of the building (Fig 56). Despite being constructed outside of the walled garden, access is via an archway inserted into the garden wall just south of the building. The roof of the structure has one long shallow pitch and one short, steep section at the north end, formed from sheets of corrugated iron and plastic, likely a replacement covering. The south elevation has a later screen of timber and corrugated plastic sheeting (Fig 55).

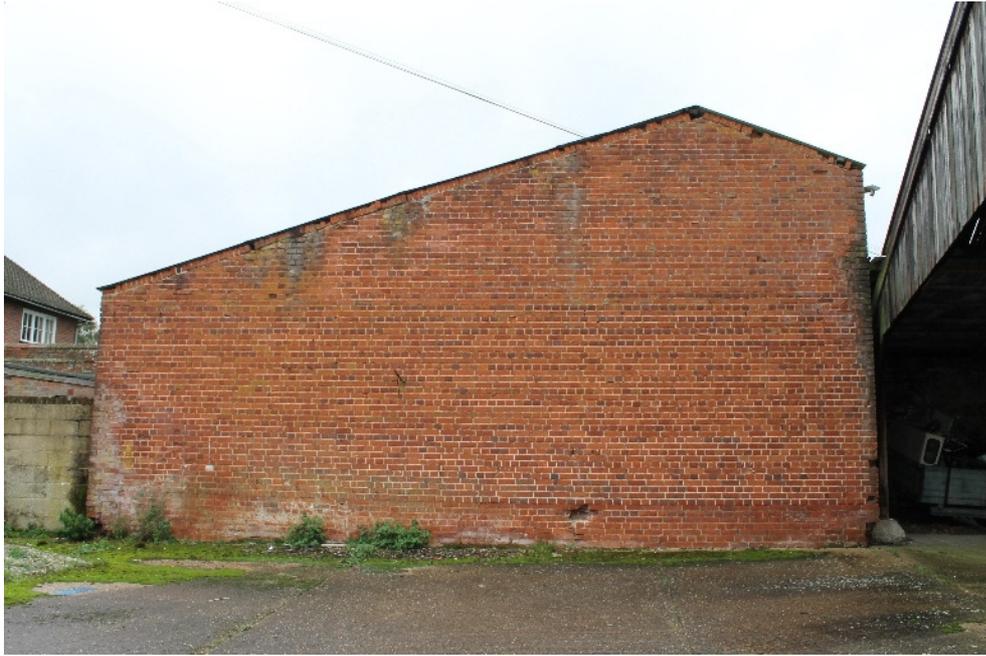
Plate 93 Structure 14 unadorned east elevation of the squash court, showing the long shallow pitch and short steep pitch to the roof - view west

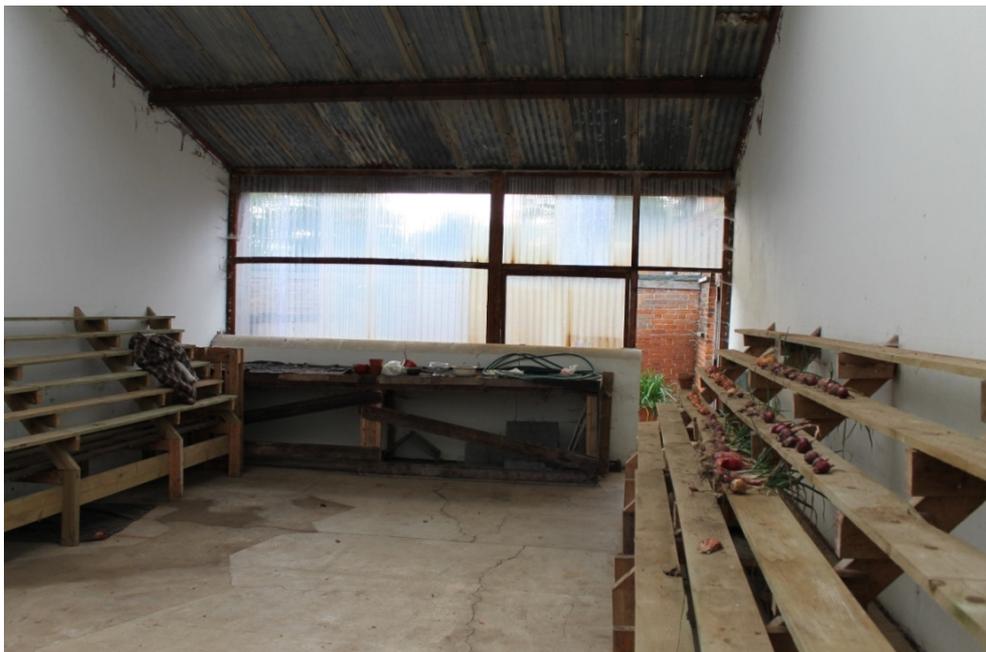
Plate 94 Structure 14 interior of the squash court, showing the original half wall of the south side, the finely grained concrete playing surface and later gardener's shelves - view south

The interior is one large open room with a finely-grained and polished concrete floor and rendered walls (Plate 94). Wooden shelving has been placed along all four walls but this is a later feature, installed by the estate gardener to provide additional sheltered space for seedlings and young plants. Behind the modern screen at the south end of the structure is a low brick wall with an opening to the west. The roof is carried on five steel I-beams.

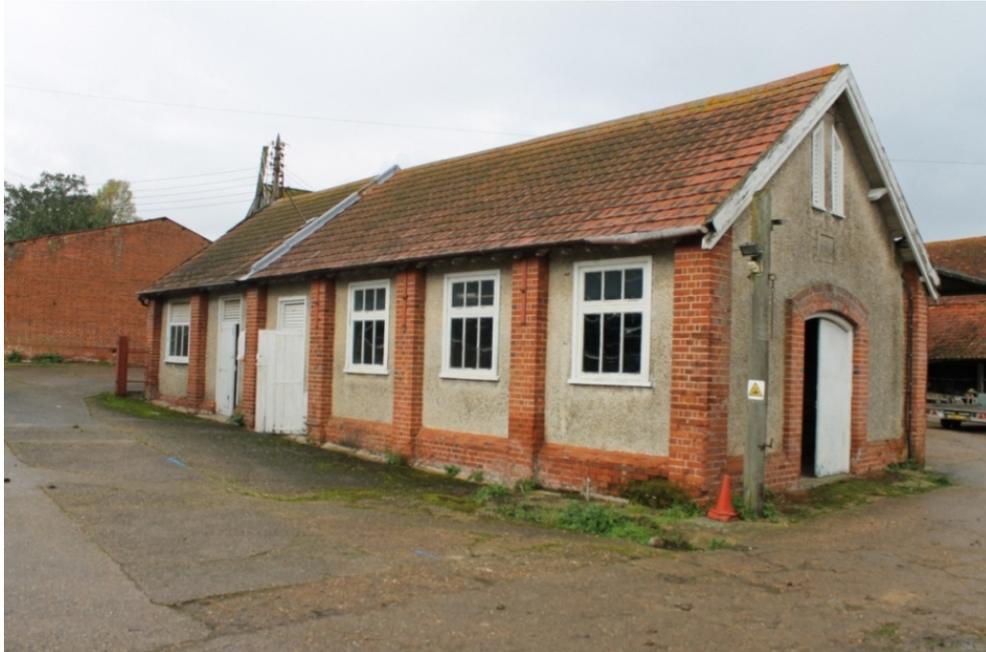
Plate 95 Structure 15 south and east elevations of the engine house, showing the original doors and windows – view north-west

This is a single-storey rectangular structure aligned roughly east to west, measuring 15.9m x 6.5m (Plate 95; Fig 59). It has a brick plinth, corner piers and buttresses with pebble-dashed infill panels and a gabled roof covered in clay pan tiles. The plinth is red stock brick laid in Flemish bond with dimensions of 220 x 110 x 70mm. The buttresses divide the structure into six bays. The east elevation has an entrance with double doors and a brick surround with a shallow arched head. At the apex of the gable, beneath the overhanging eaves, are a pair of timber-framed louvre windows. Between these and the head of the double doors is a date stone inscribed '1911' (Plate 96; Fig 62). Of the six bays of the south elevation, three have windows of three-over-three lights, one has a window of three lights with a louvre over and two have a wooden doorway with a louvre over (Fig 60). The north elevation has timber-framed louvre windows in the two westernmost bays (Fig 61). The west elevation has the same overhanging eaves and timber-framed louvre windows as the east elevation and also has a wooden post attached to the exterior rising through the eaves supporting electricity cables supplying power to the various farm buildings (Fig 63).

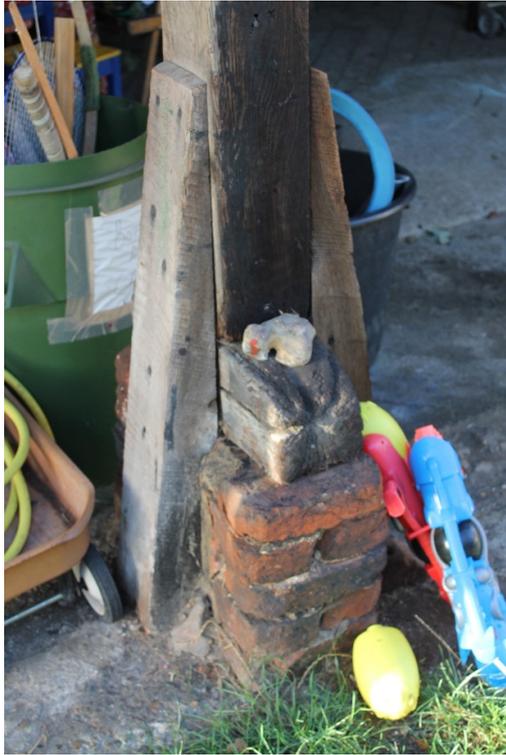
Plate 104 Structure 22 tool shed opposite Farm Cottage, built up against the wall of the laundry drying ground and showing the lightly arched braces to the posts and the low brick plinths and sill beams supporting the posts – view west

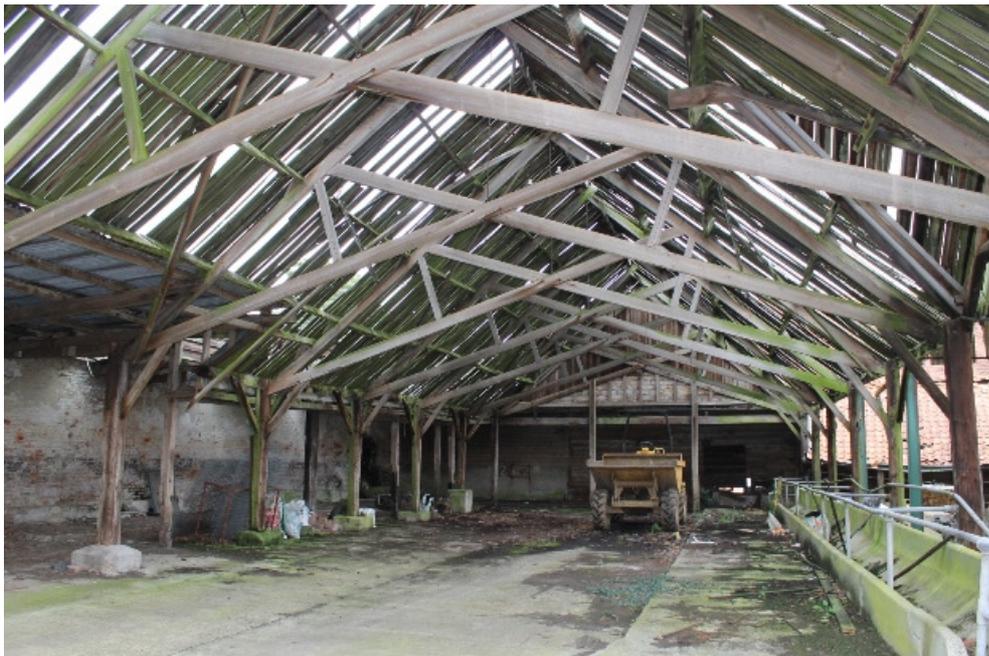
Plate 115 Structure 12 large shed south of barn – view north

This is a rectangular shed with open sides constructed from softwood timbers and with a simple plank roof supported on scissor-braced trusses (Plates 115, 116). The structure, aligned north-east to south-west, (along with the flat-roofed infill structure between this and the kitchen garden wall) is shown on the 1918 estate plan (Map 9) as a dotted line and must date to shortly afterwards. Constructed either as cover for animals or a ventilated shelter for the storage of crops it was most recently used as a feeding shed for cattle, indicated by a concrete trough extending the length of the eastern side.

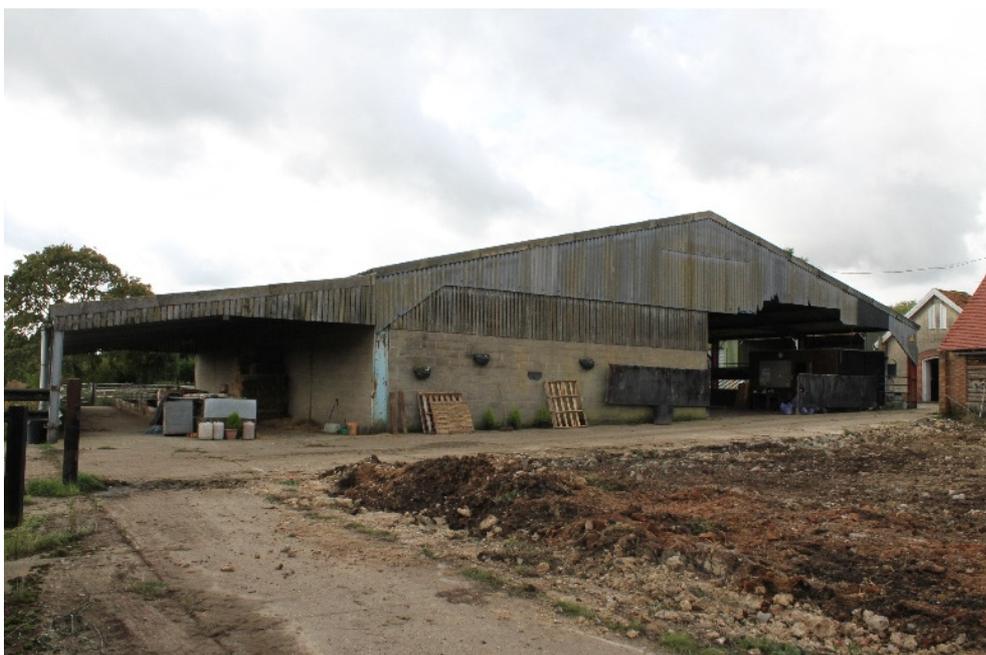
Plate 117 Structure 13 second large shed south of barn – view north-west

This is a rectangular open-sided structure, aligned north-east to south-west, constructed from a steel frame with a roof of corrugated asbestos sheeting (Plate 117). Post-dating 1946, the shed was used as a storage building for agricultural machinery.

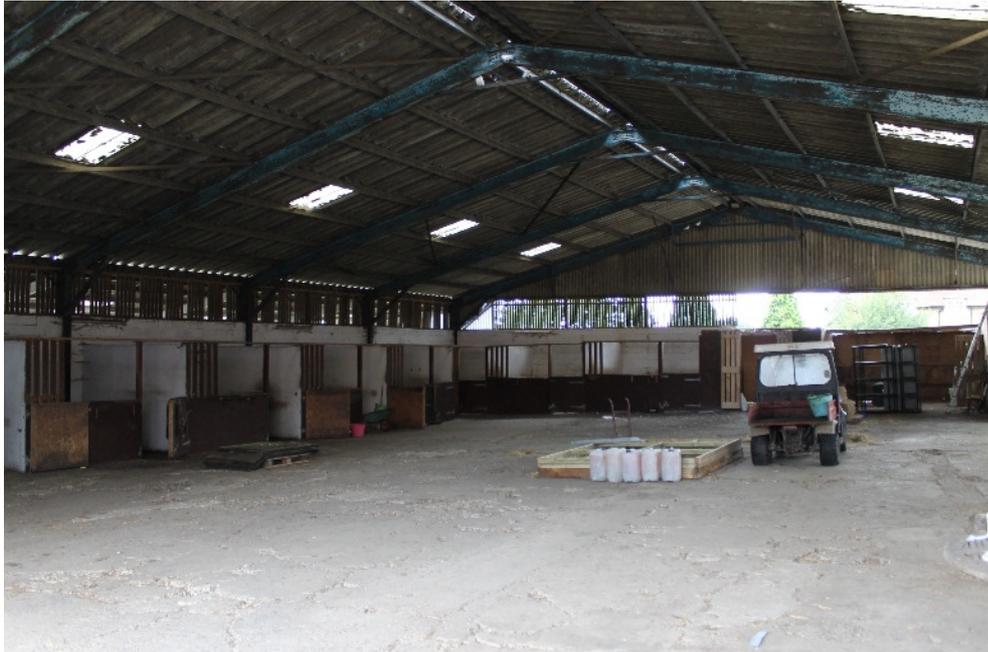
Plate 118 Structure 16 modern stables and manège – view south-west

This is a large rectangular steel-framed structure, aligned roughly north-east to south-west, with a lean-to extending the length of its eastern side (Plates 118, 119). It has a gabled roof of corrugated asbestos sheeting and concrete infilling on the north, east and south walls. Post-dating 1946, the building was originally designed as a covered shelter for cattle but has been converted into stables and a manège for a riding school.
